**ALBERTA TRANSPORTATION AND  
ECONOMIC CORRIDORS  
GEOHAZARD – INSTRUMENTATION MONITORING  
PEACE REGION – (PEACE RIVER DISTRICT)  
SPRING 2025**

Site Number	Location	Name	Hwy	km
PH072	HWY 744:04 C1 58.154	Sunshine Slide	744:04	Km 58.2
<b>Legal Description:</b>		<b>UTM Co-ordinates</b>		
16-20-83-21 W5		11U E 483111	N	6230075

<b>Current Monitoring:</b>	10-June-2025	<b>Previous Monitoring</b>	23-May-2024
<b>Instruments Read By:</b>	Mr. Niraj Regmi, G.I.T and Mr. Godfred Etiendem, of Thurber

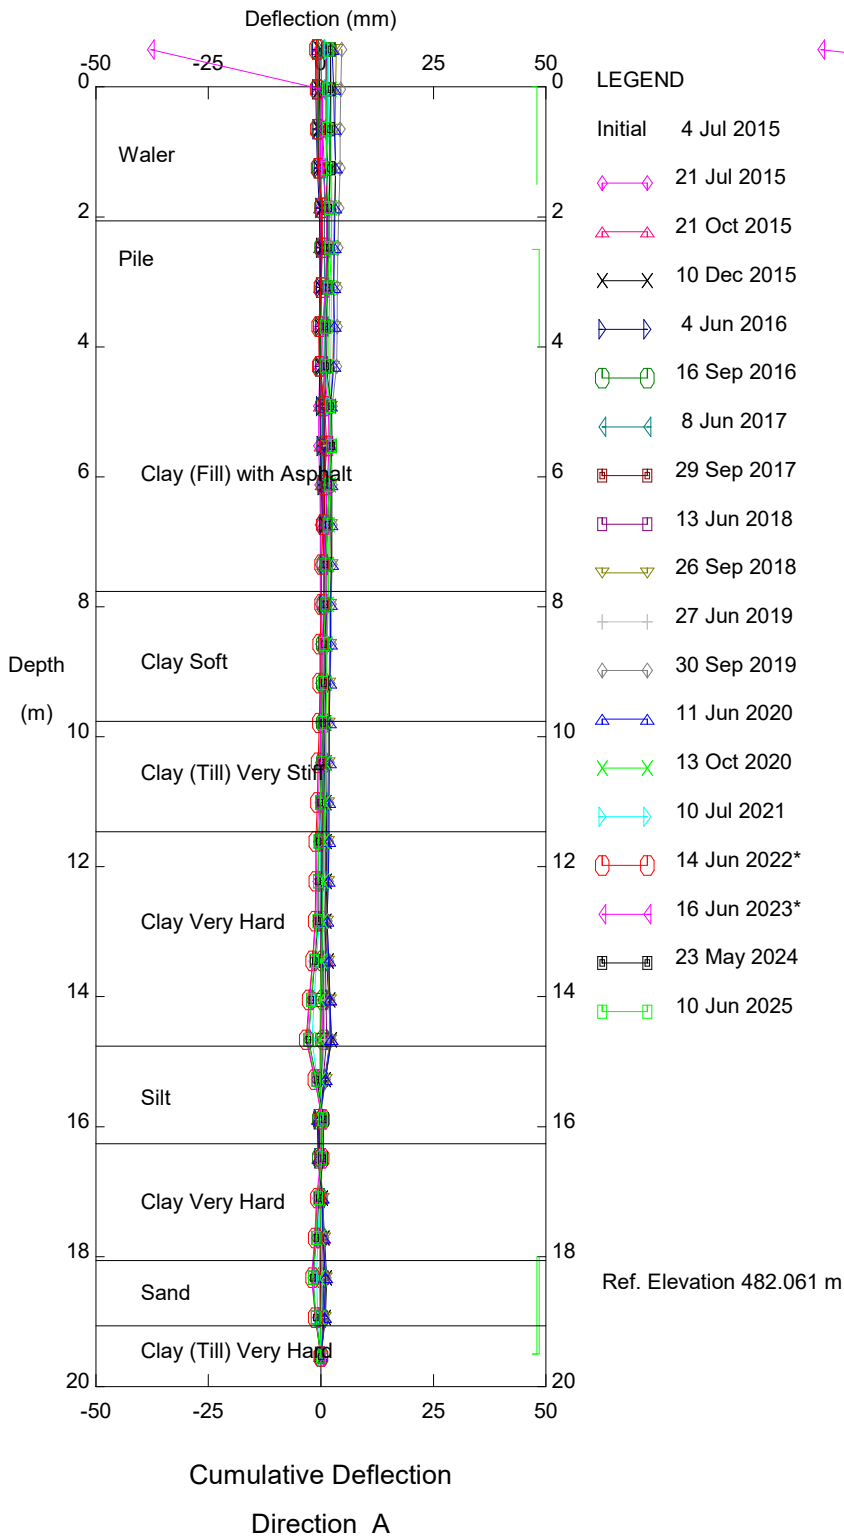
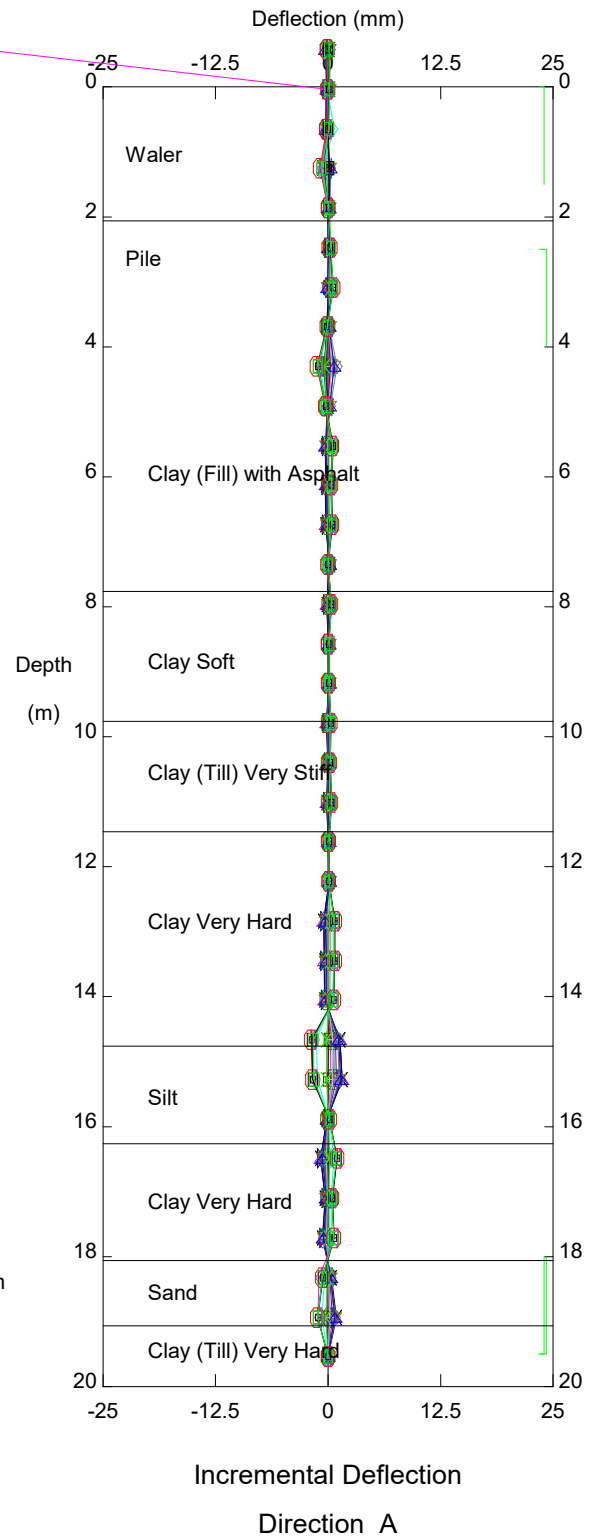
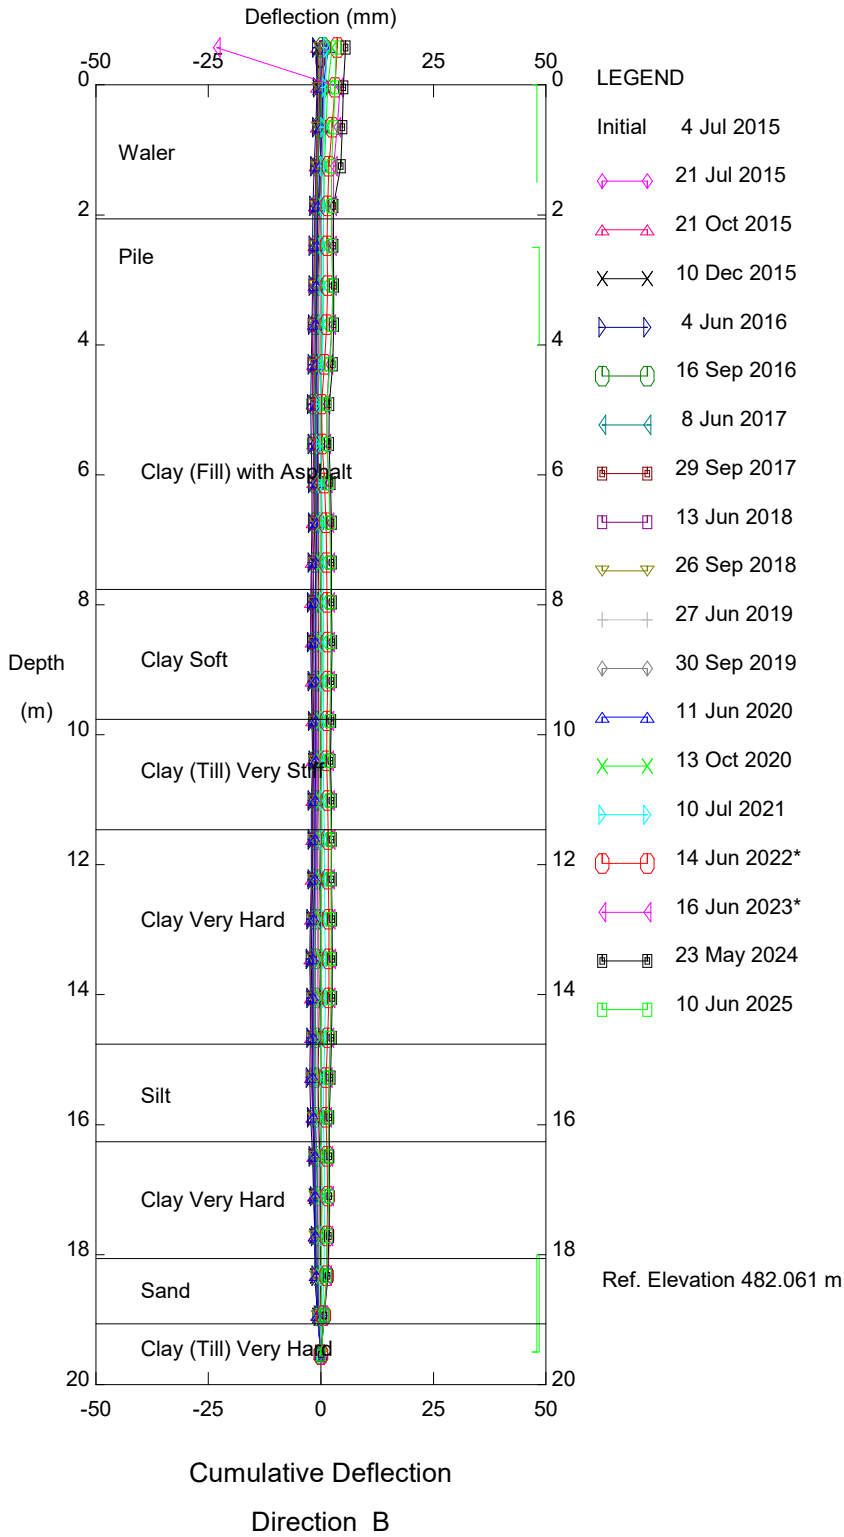
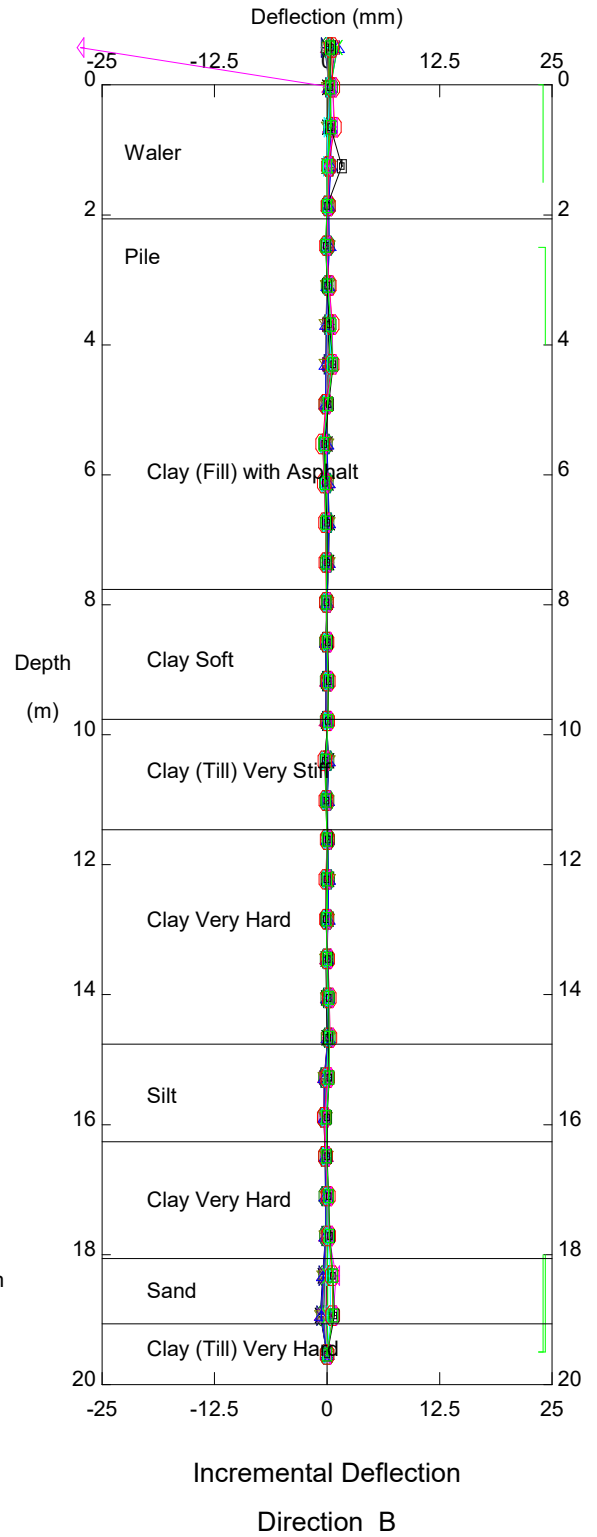
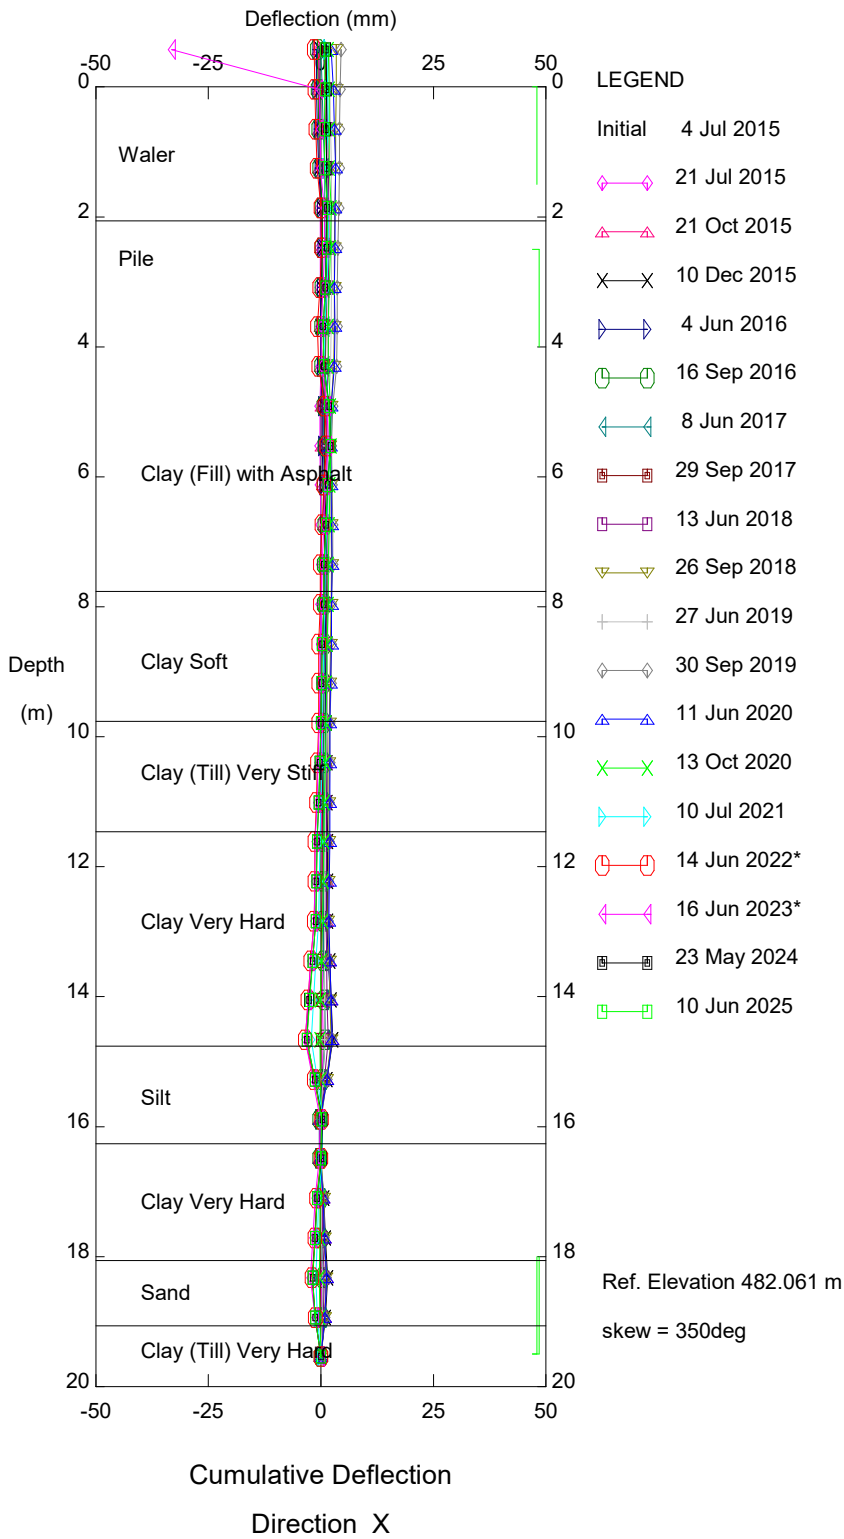
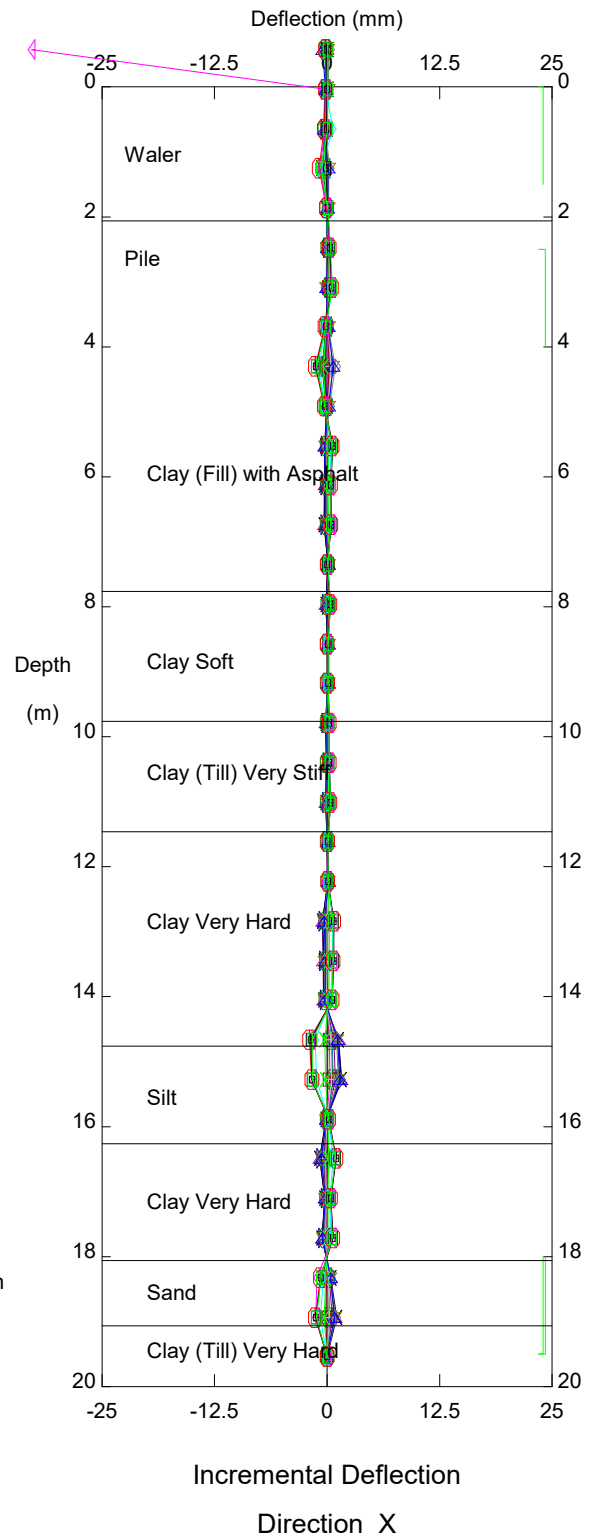
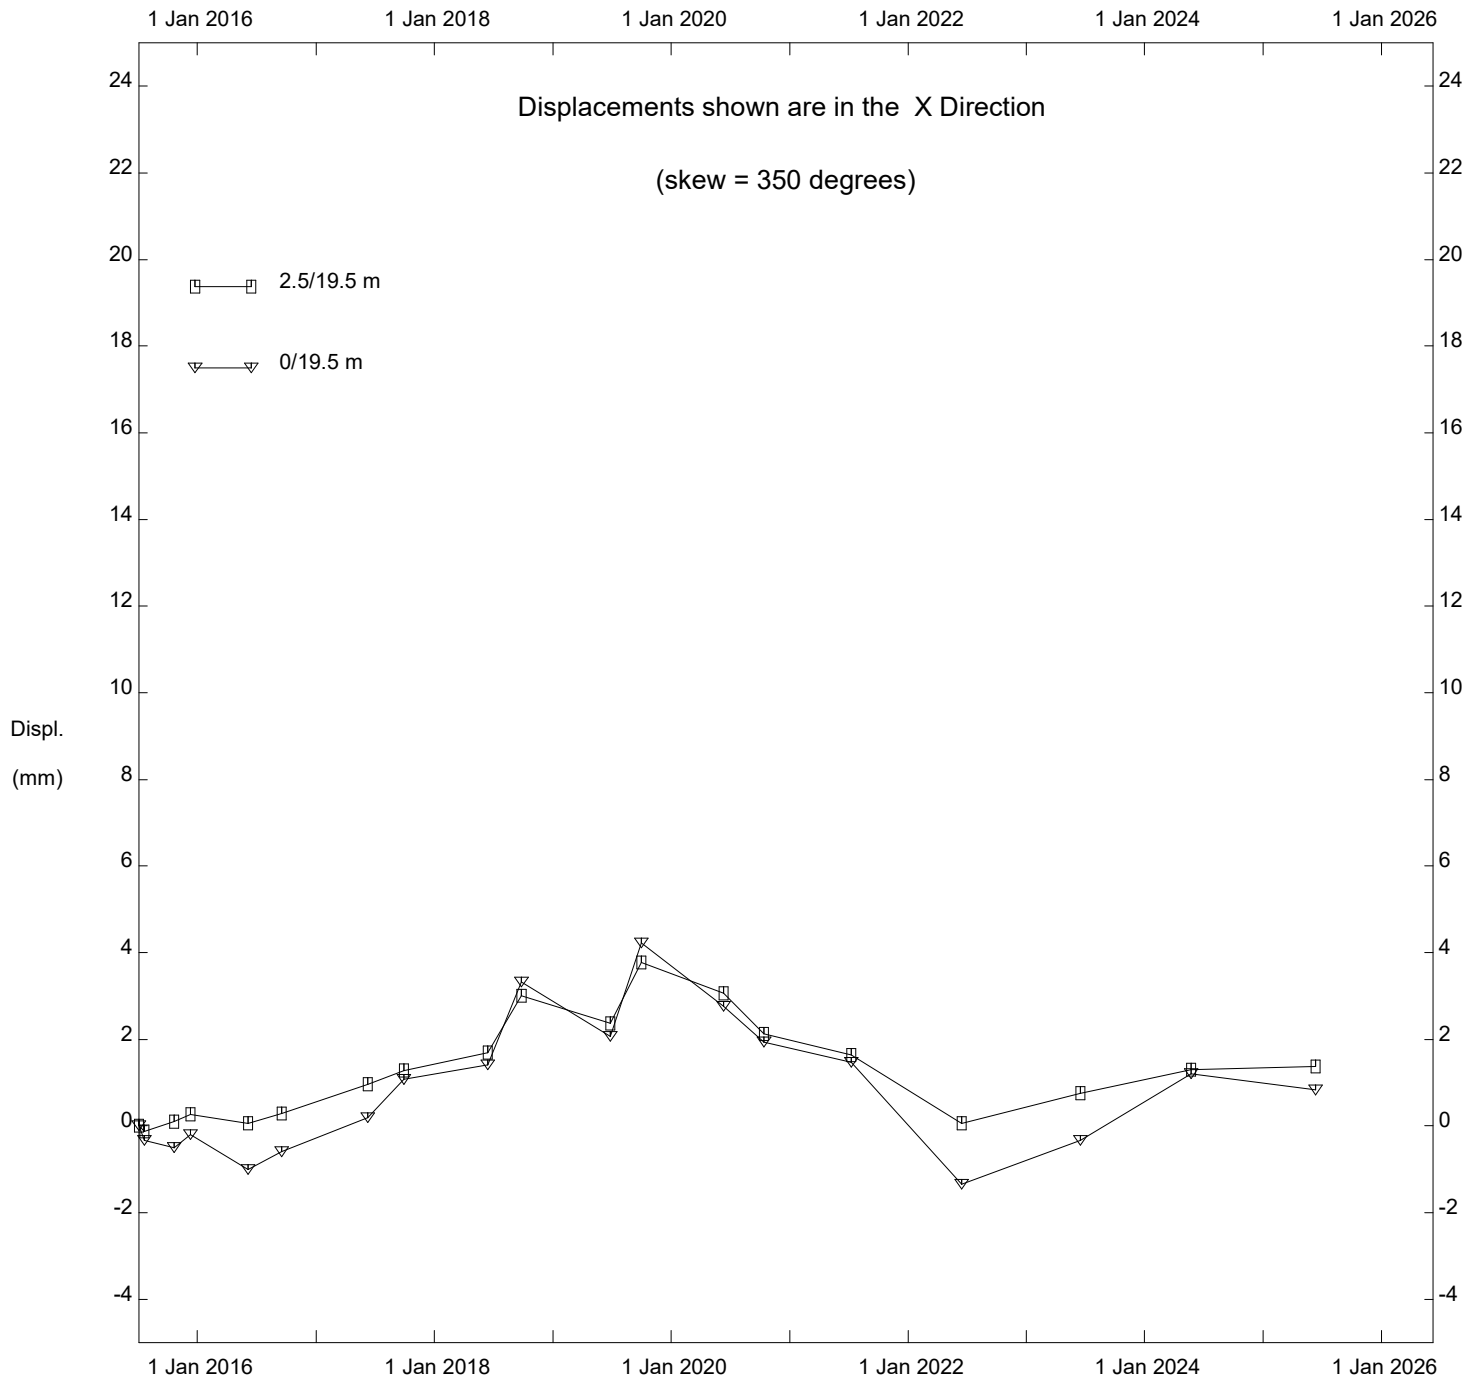
PH072 Sunshine (Post Construction), Inclinator Pile 34

Discussion	
<b>Zones of New Movement:</b>	None
<b>Interpretation of Monitoring Results:</b>	<p><b>Slope Indicators</b></p> <p>All three slope indicators at this site are installed in the pile wall built in 2015. Slope indicator Pile 34 showed a rate of movement of less than 1 mm/yr over the length of the pile and no discernible movement over the combined length of the pile and waler since the 2015 readings. Pile 34 has shown a total cumulative pile head movement of 1.4 mm in the downslope direction since completion of construction and a total cumulative movement of 0.8 mm in the downslope direction over the combined length of the pile and waler.</p> <p>Pile 59 showed a rate of movement of 0.8 mm/yr over the length of the pile and a rate of movement of 0.7 mm/yr over the combined length of the pile and waler since the spring of 2024 readings. Pile 59 has shown a total cumulative pile head movement of 5.2 mm in the downslope direction since completion of construction, with a total cumulative movement of 6.4 mm in the downslope direction over the combined length of the pile and waler. The movement pattern at Pile 59 suggests a potential slight acceleration of movements is occurring.</p> <p>Pile 82 showed a rate of movement of 1.2 mm/yr over the length of the pile and a rate of movement of 0.9 mm/yr over the combined length of the pile and waler, since the spring of 2024 readings. Pile 82 has shown a total cumulative pile head movement of 6.6 mm in the downslope</p>

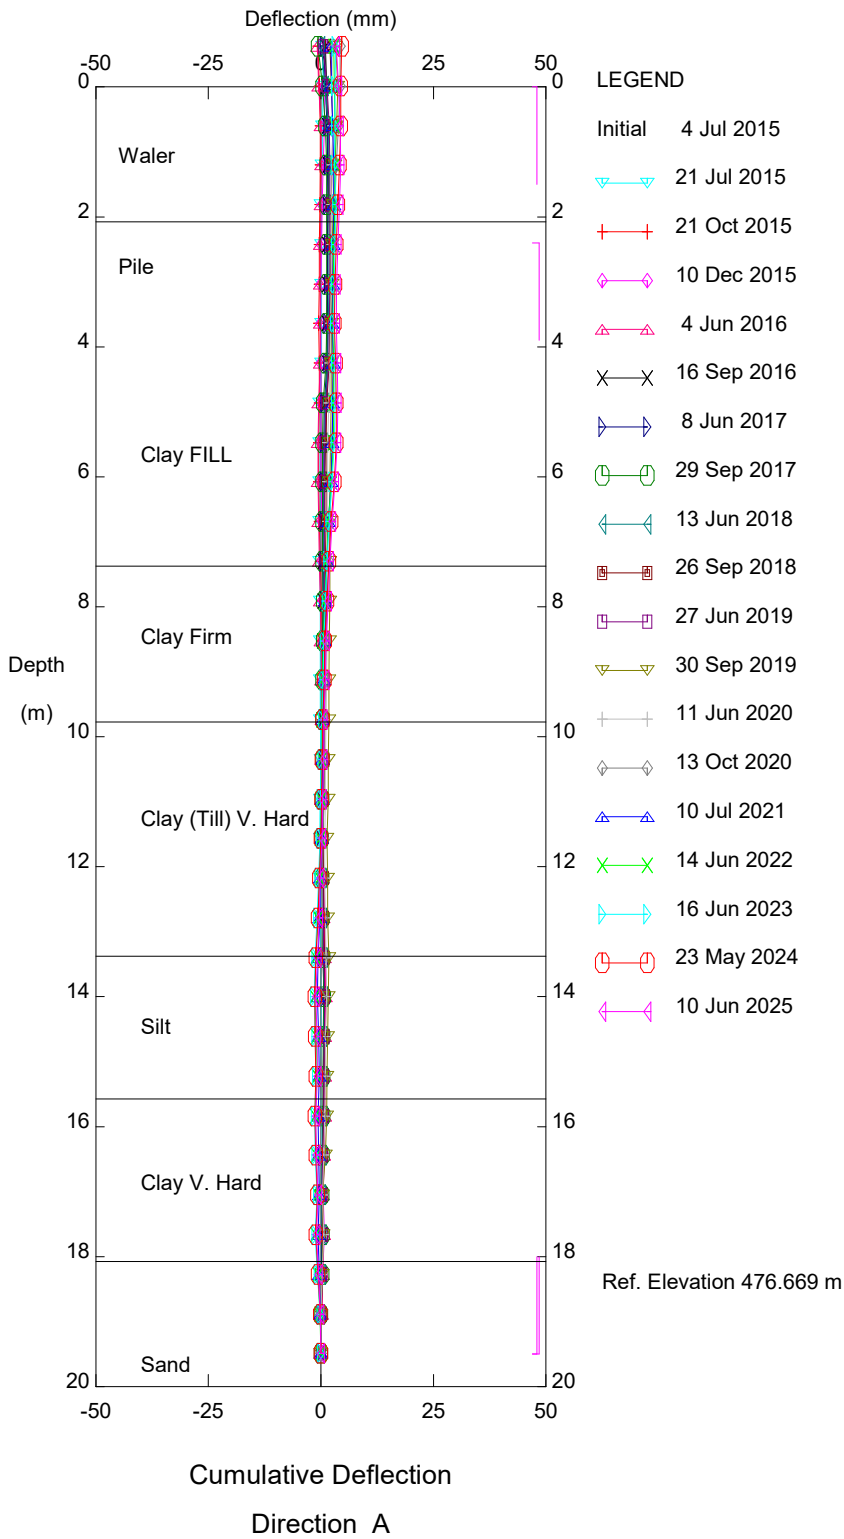
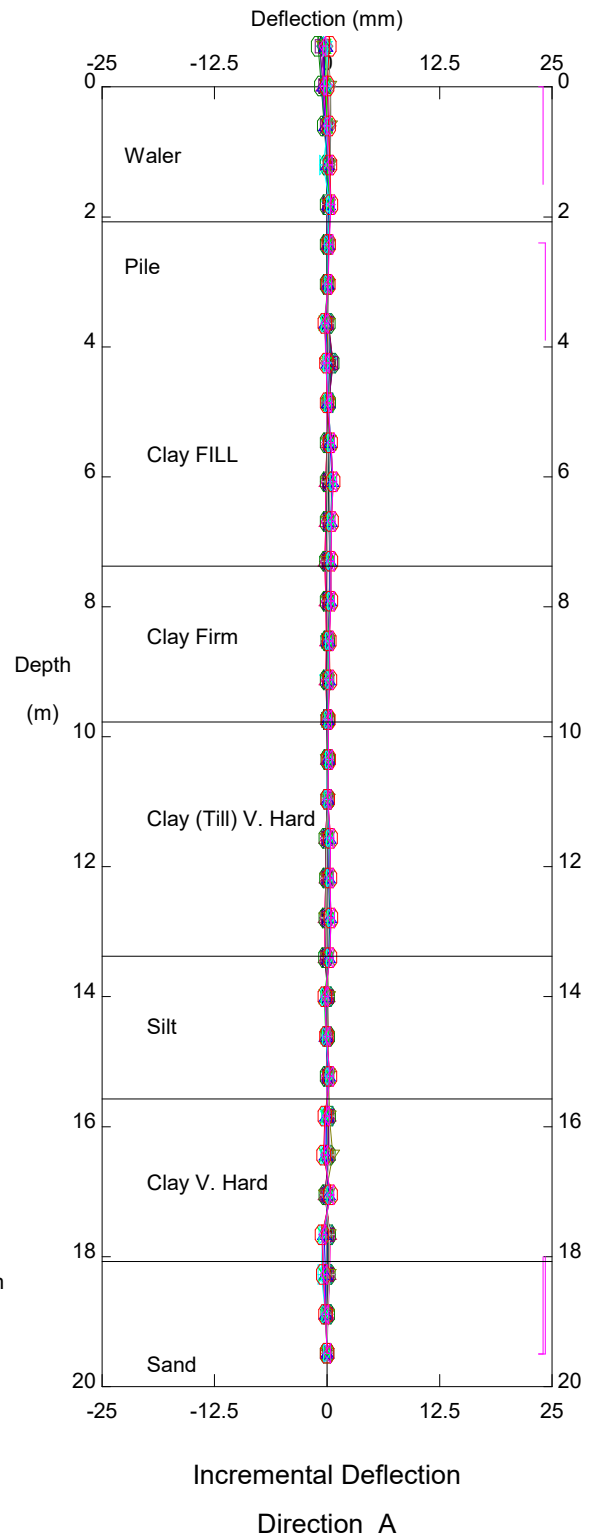
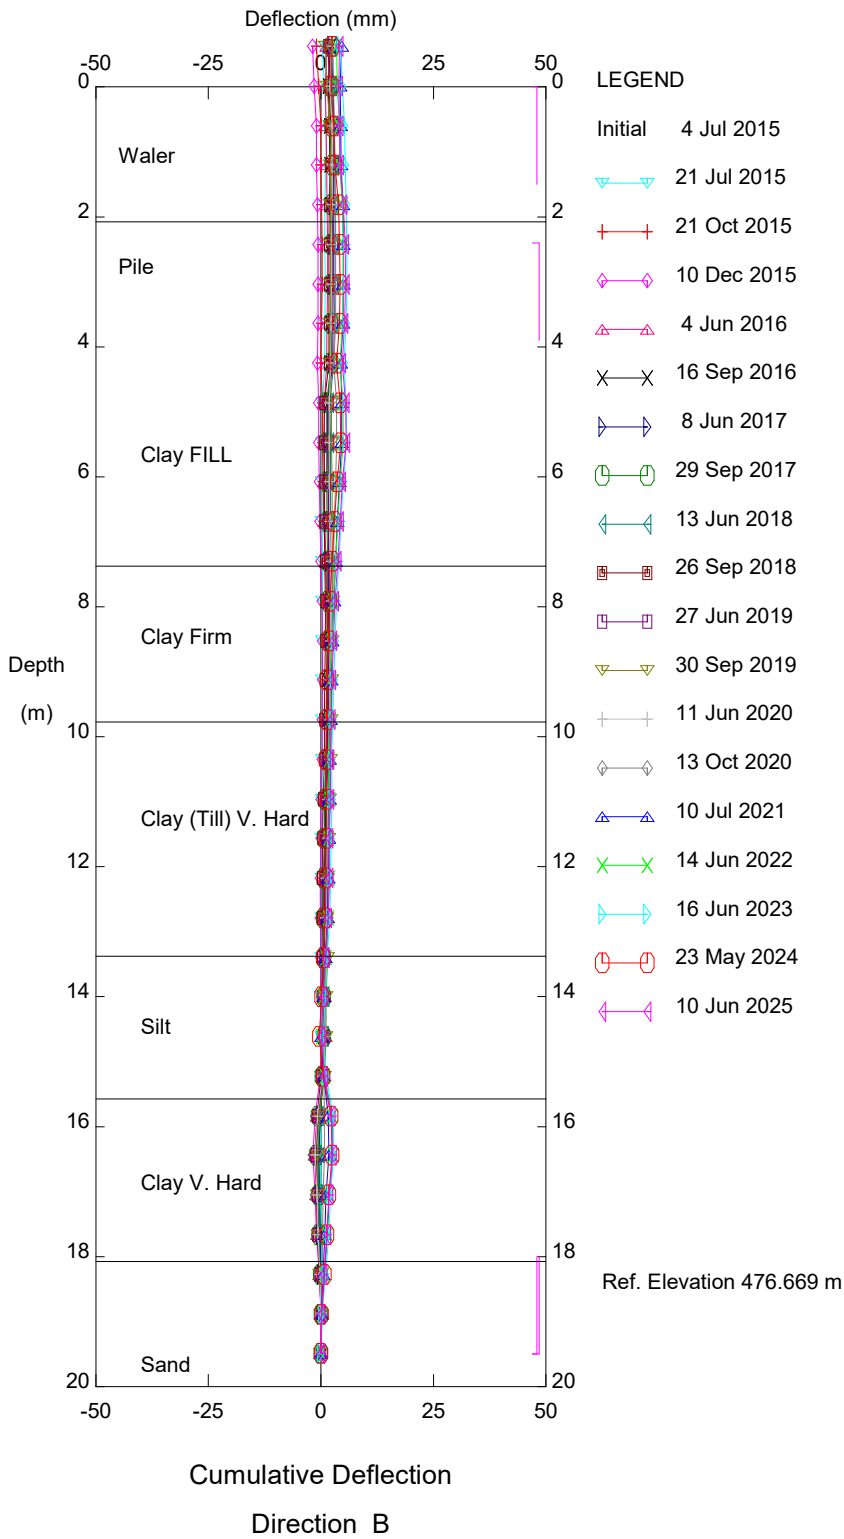
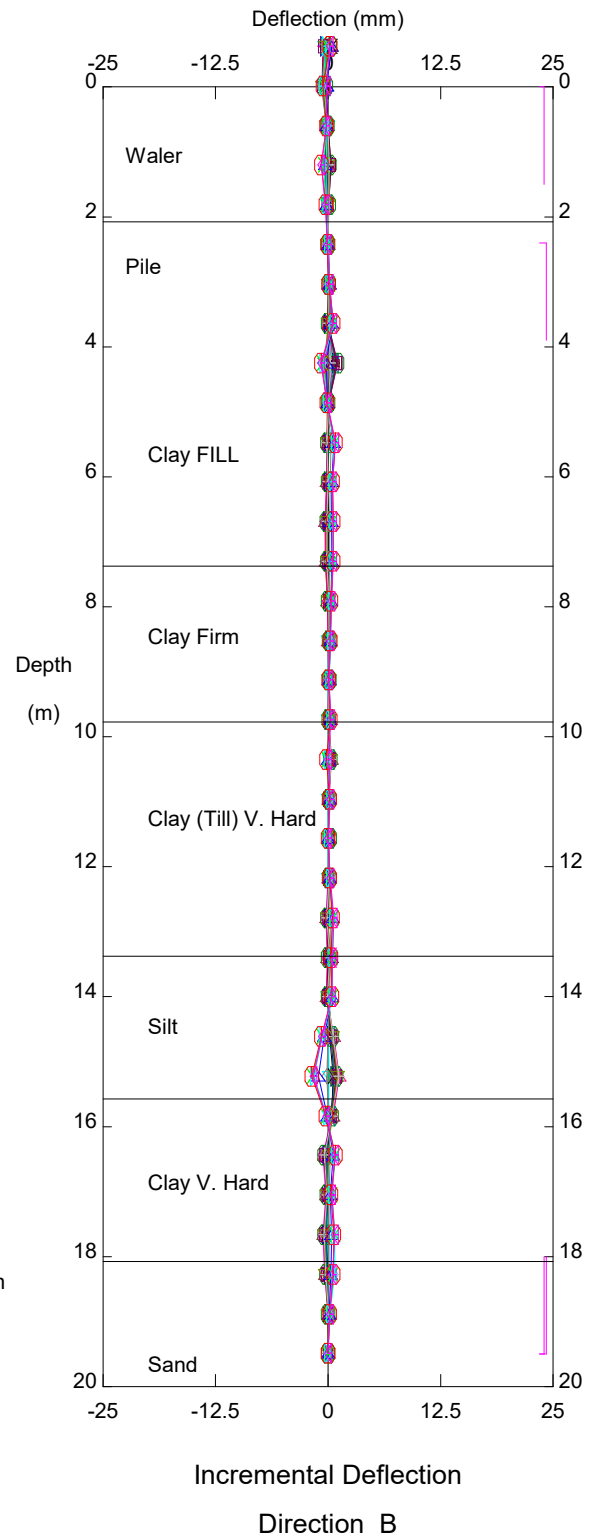
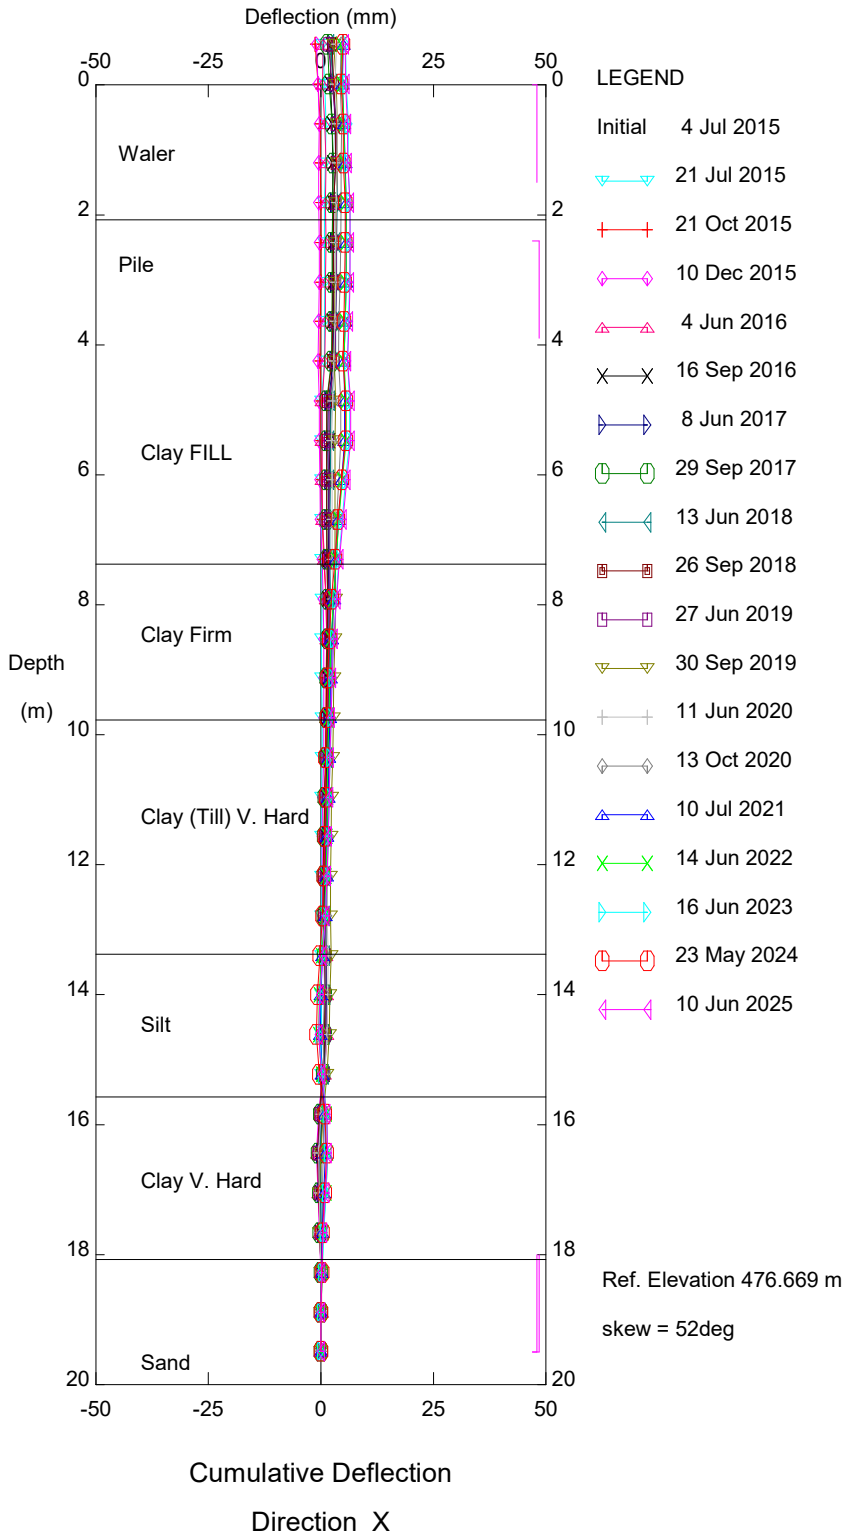
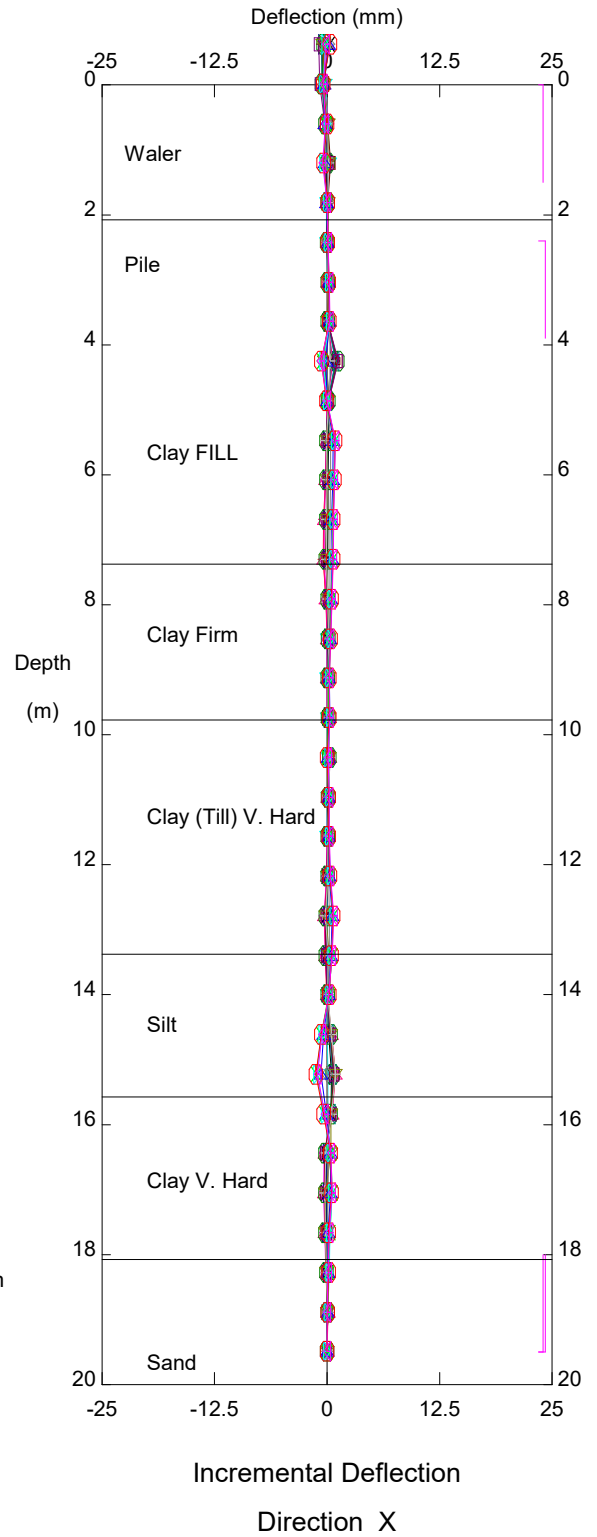
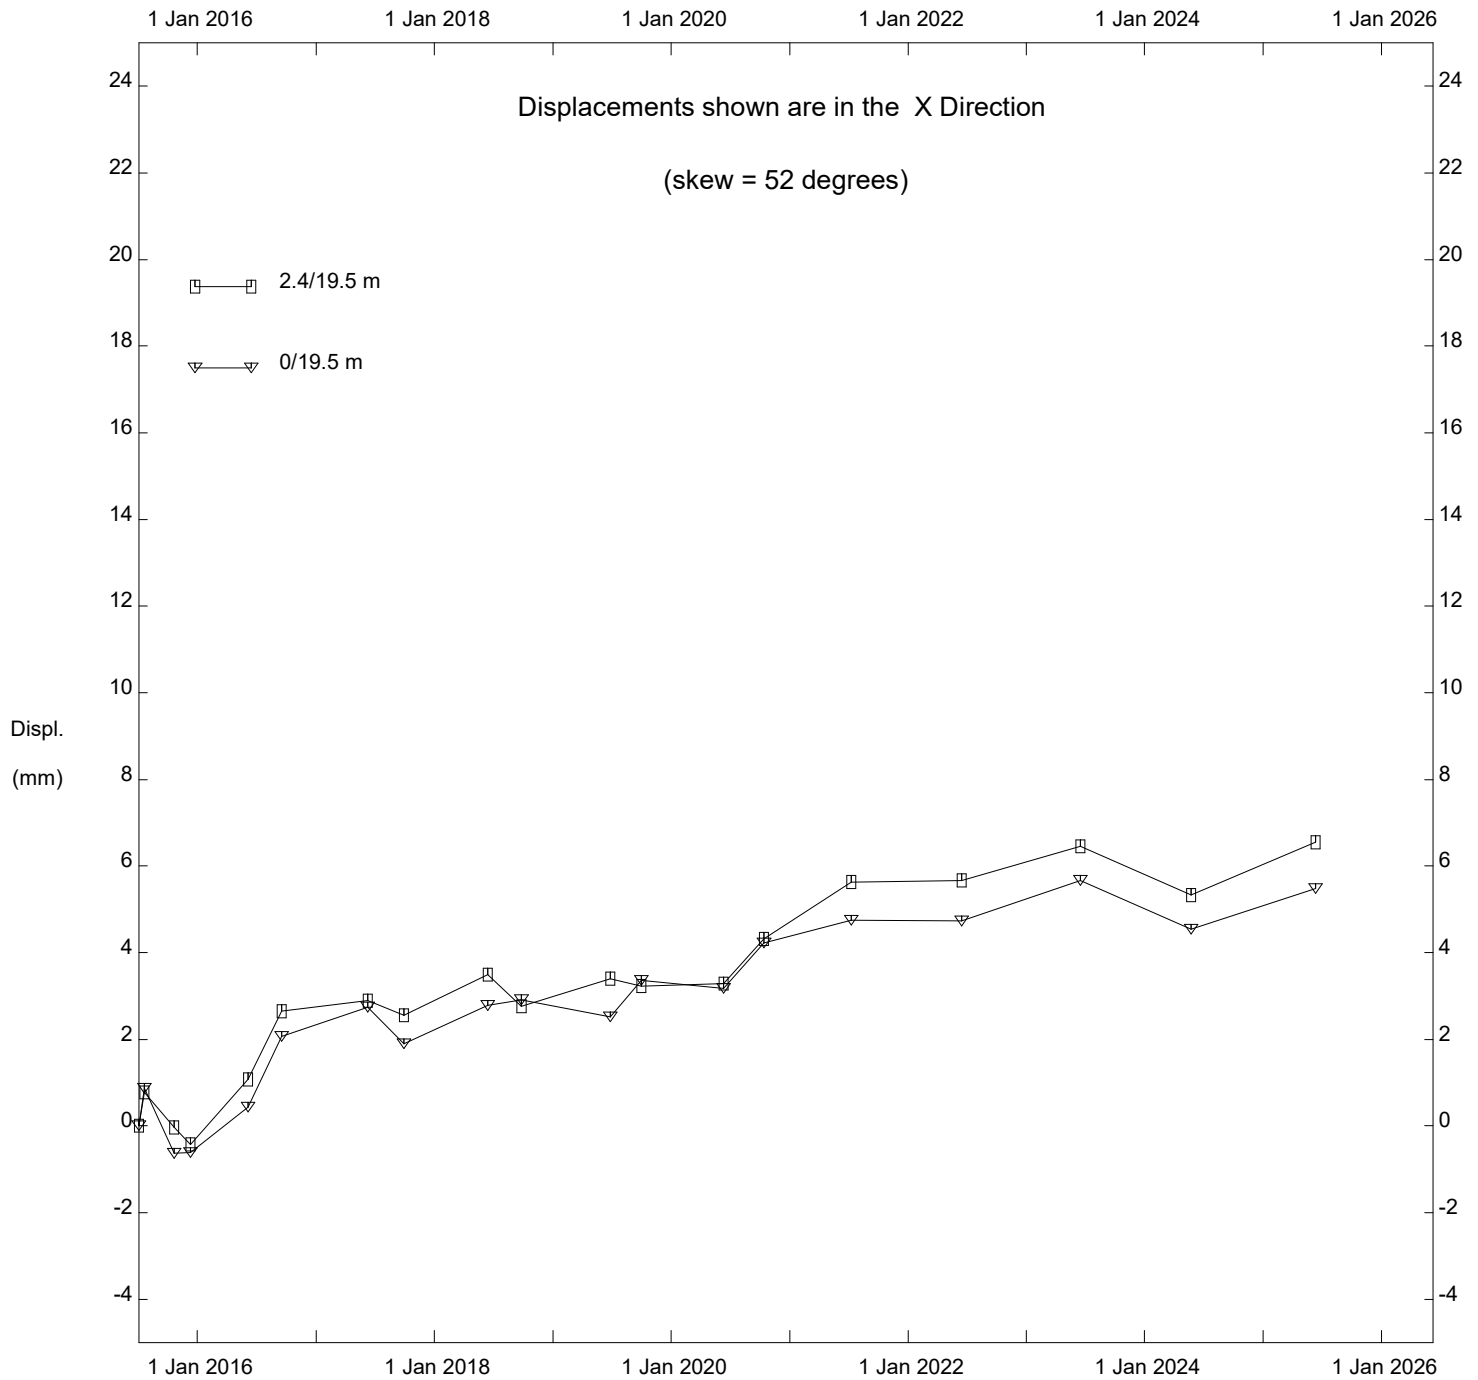
PH072 Sunshine (Post Construction), Inclinator Pile 82

<p>direction since completion of construction and a total cumulative movement of 5.5 mm in the downslope direction over the combined length of the pile and waler.</p> <p><b>Load Cells</b></p> <p>The six load cells (VC1805, VC1806, VC1801, VC1802, VC1803 and VC1804) are connected to an RST DT2040 datalogger which was initially programmed to take readings once per day. Starting in the spring of 2015, the datalogger was reprogrammed to take readings twice per day. The latest load cell readings, as of June 10, 2025, show minor changes compared to the previous readings taken in on May 23, 2024. The changes range from a decrease of 1.03 kN in load cell VC1806 (anchor 34L) to an increase of 1.15 kN in VC1805 (anchor 34U). Load cells VC1803 (anchor 82U) and VC1804 (anchor 82L) measured all-time high loads of 191.66 kN on February 5, 2025 and of 190.47 on March 20, 2025, respectively.</p> <p>Load cells VC1801 (anchor 60U) and VC1802 (anchor 60L) are showing loads that are higher than the design service load, but still lower than the ULS factored design load. Overall, the load cells show a trend of stable loads over the past several readings cycles. Experience at other pile wall sites suggests loads may increase in response to stress relief downslope of the pile wall.</p> <p>Overall, the SI and load cell readings show that the pile wall has been effective in stabilizing the landslide movement at this site.</p>

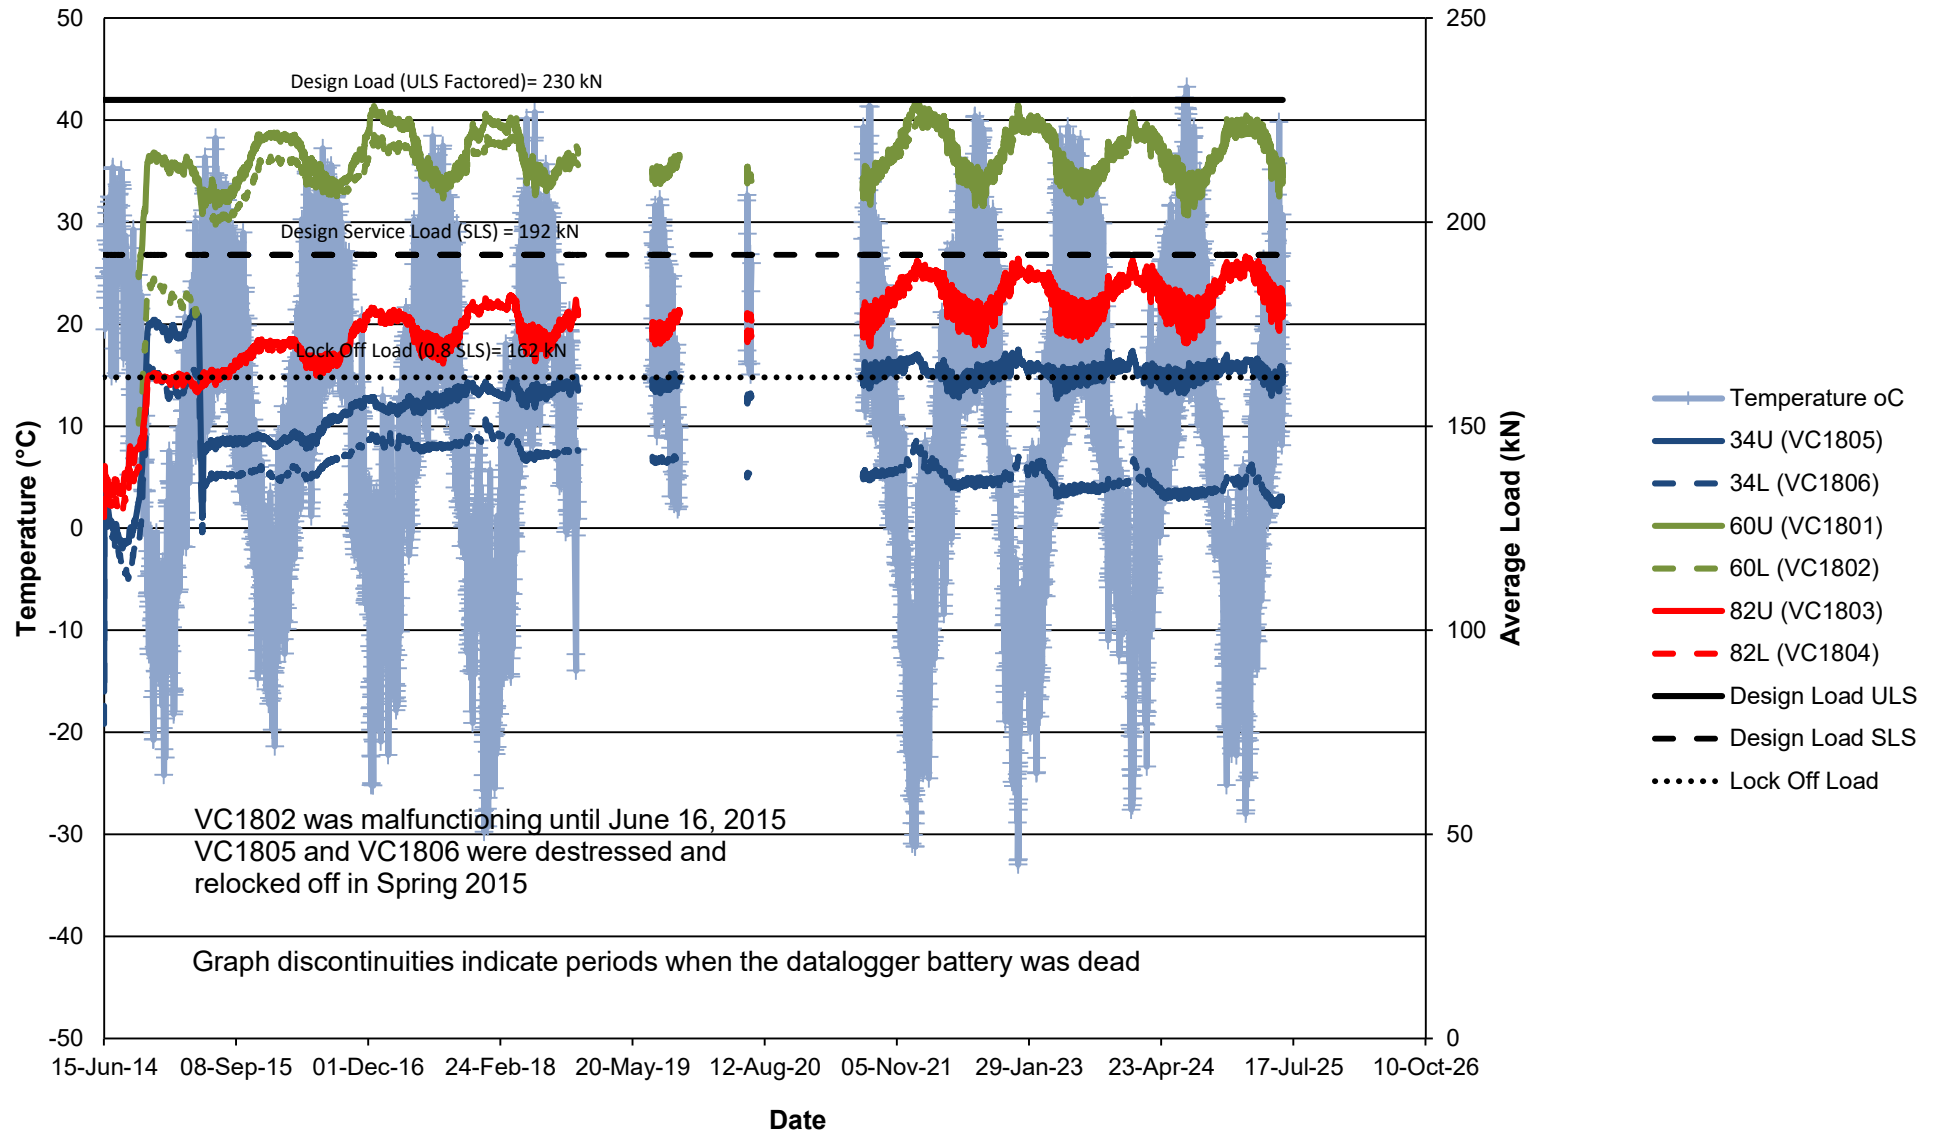
# FIGURE PH072-1 SUNSHINE PILE WALL - LOAD CELLS

1. Load cell data is recorded twice daily with datalogger on site. Dataloggers are uploaded twice annually during instrumentation readings. See Figure PH072-1 in Appendix A for combined historical instrument readings. Datalogger battery was dead between November 14, 2018 to July 25, 2019, October 27, 2019 to June 11, 2020, and between June 27, 2020 to July 10, 2021.
