**ALBERTA TRANSPORTATION
GEOHAZARD ASSESSMENT PROGRAM
PEACE REGION (PEACE RIVER DISTRICT)
2021 INSPECTION**

Site Number	Location	Name	Hwy	km
PH033-2	Judah Hill	Judah Trunk	744:04	58.761
Legal Description		UTM Co-ordinates		
SE¼ 29-083-21 W5M		11V E 482906	N 6230669

PH033-2 JUDAH HILL - JUDAH TRUNK
 2021 SITE INSPECTION PLAN

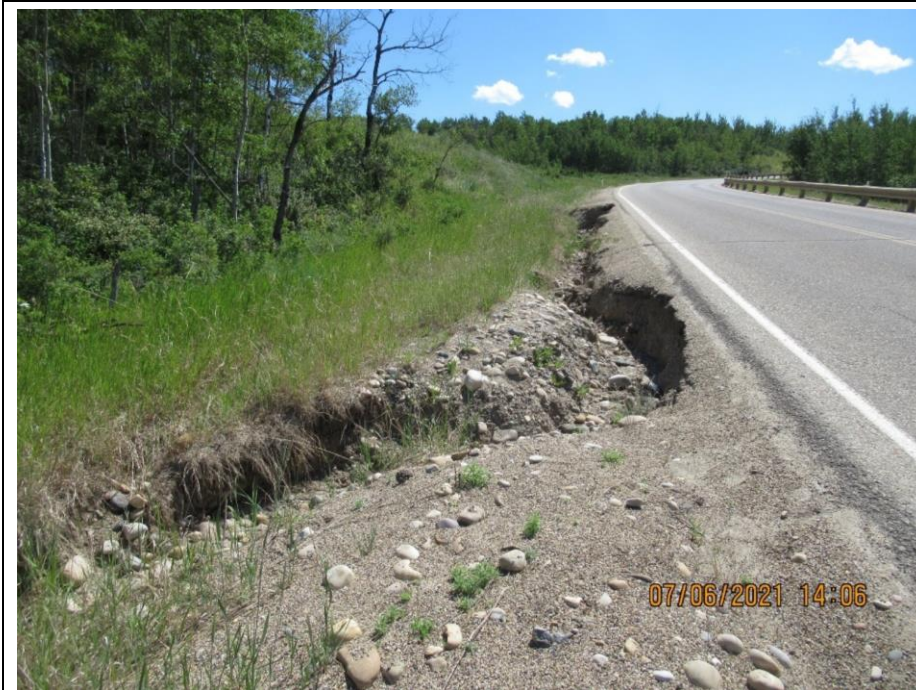
Photo 1.
Looking south at the ditch erosion upslope from the Judah Truck Inlet towards the Sunshine Slide site. Erosion is worse and cutting towards the road and has begun to undermine the ACP shoulder in select areas creating a hazard for vehicles.

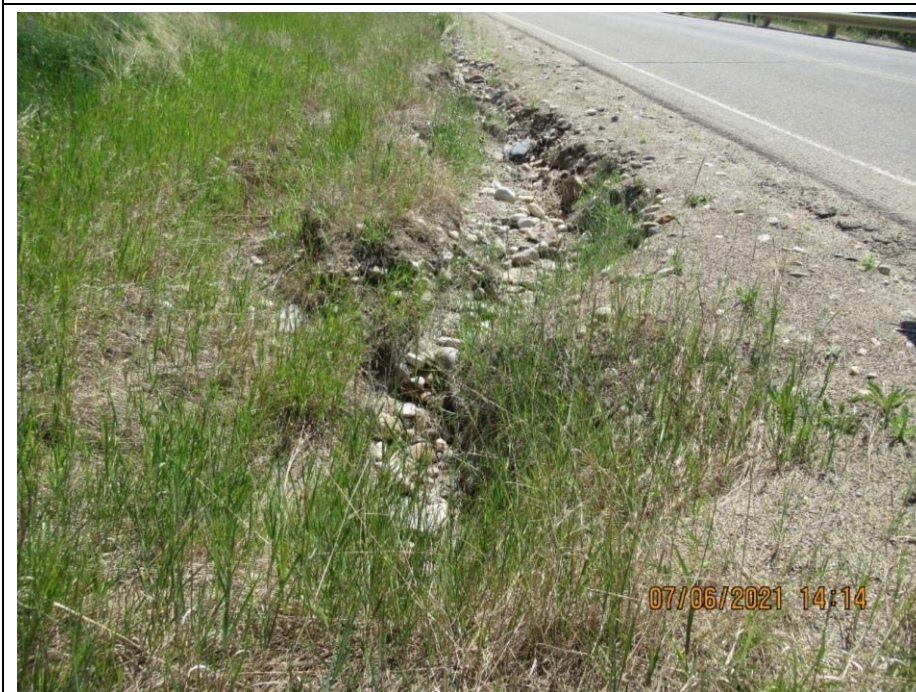
<p>1.2 m deep. Erosion is ongoing beneath the trunk culvert on the west side of the highway but there has not been major expansion the last few years. (Photos 2 to 4). Gully south of the trunk drain was well vegetated and appeared unchanged. (Photo 4).</p> <p>Erosion rills from runoff were noted on the west side of the road near km 58.85 and were slightly worse from last year (Photo 9).</p>	
<input type="checkbox"/> Seepage		<input type="checkbox"/>
<input checked="" type="checkbox"/> Bridge/Culvert Distress	The inlet to the drain remains open. Trunk condition appeared unchanged. (Photos 3 and 4)	<input type="checkbox"/>
<input type="checkbox"/> Other		<input type="checkbox"/>
Instrumentation:		
SI98-6i	<p>Inclinometer installed at the toe of the slope, north of the drain. Showed a rate of movement of 6.6 mm/yr over 0.4 m to 3.4 m depth and a rate of movement of 6.9 mm/yr over 0.4 m to 9.5 m depth since the fall of 2020 readings. The last three datasets have shown a trend of steady to increasing movement rates within these two zones. Prior to this cyclic or seasonal displacement trends were observed.</p>

Photo 2.
Looking southeast at the ditch erosion upslope from the Judah Truck Inlet. No significant change from 2020 condition.

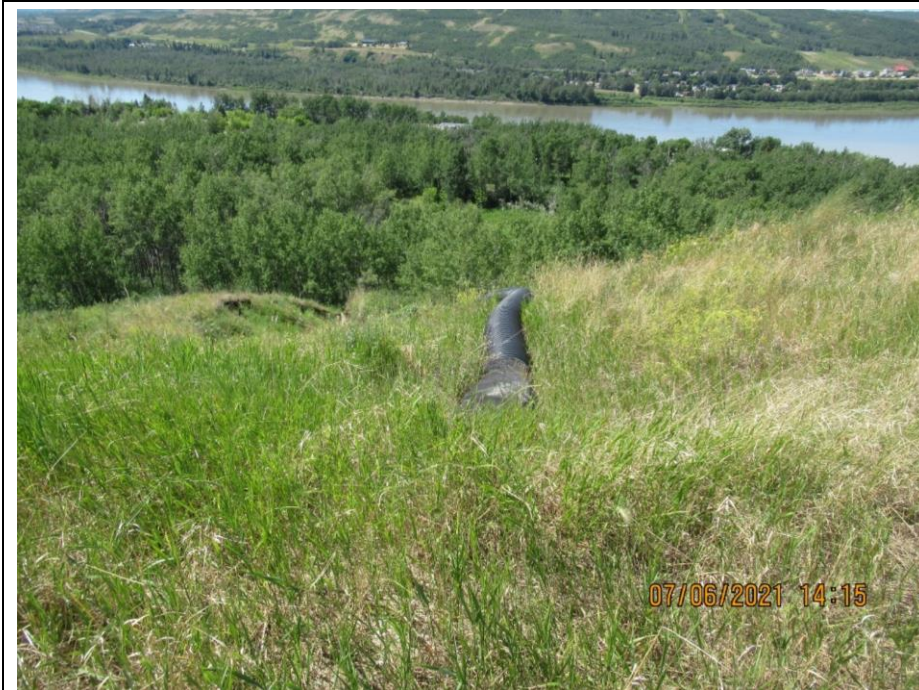
Photo 3.
Looking west at km 58.9 at the corrugated plastic down-drain at connection to the centerline culvert. No change from 2020.

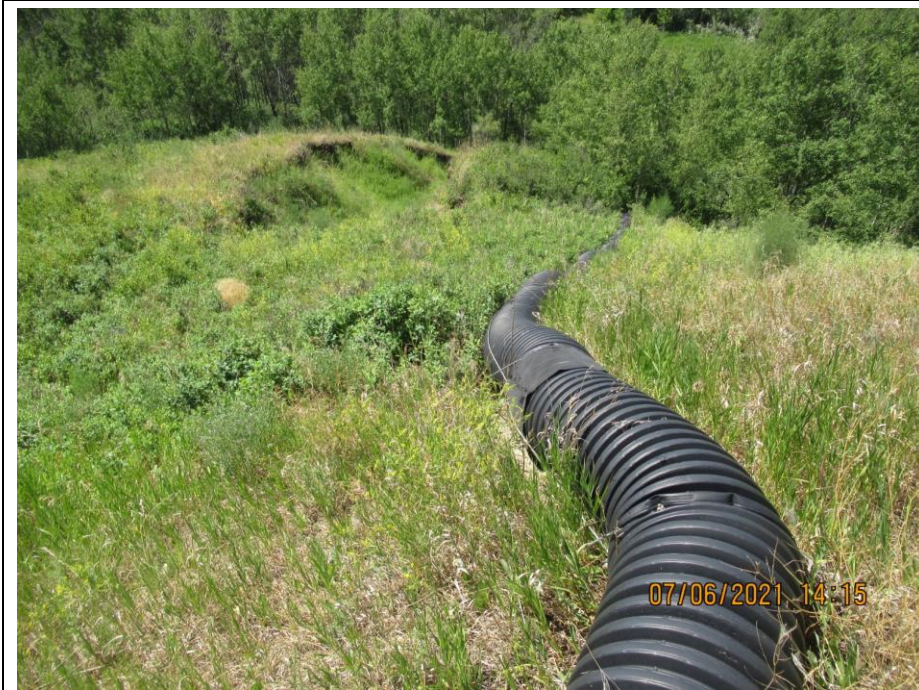
Photo 4.
Looking southwest at km 58.9 at CPP drain and erosion gully further downslope. Gully is well vegetated and has not visibly changed from 2020.

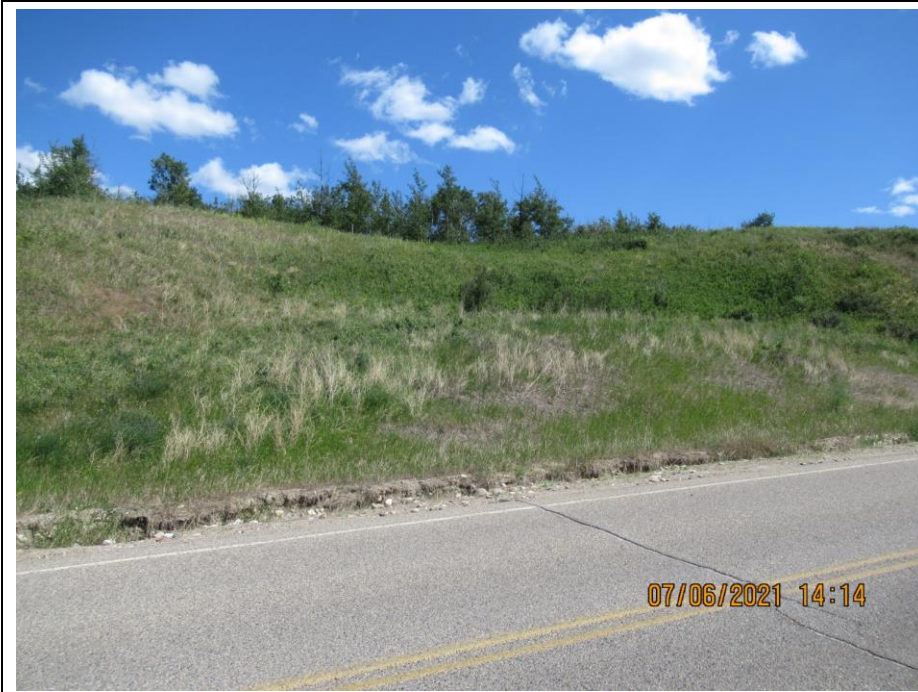
<input checked="" type="checkbox"/> Slope Movement	Vegetated backslope slide scarp near km 58.9 had no visible changes. (Photo 5) No change noted in the slope below the vicinity of slope inclinometer SI10-10. (Photo 7)	<input type="checkbox"/>
<input checked="" type="checkbox"/> Erosion	There is extensive ditch erosion in the east ditch between this site and the Sunshine Slide site that is undermining the road shoulder in several areas creating a hazard to motorists. (Photo 1) Ditch erosion is occurring within the ditch upslope from the trunk inlet up to 2.5 m wide and	<input checked="" type="checkbox"/>

Photo 5.
Looking east from
km 58.9 at
vegetated
backslope slide
scarp No change
from 2020.

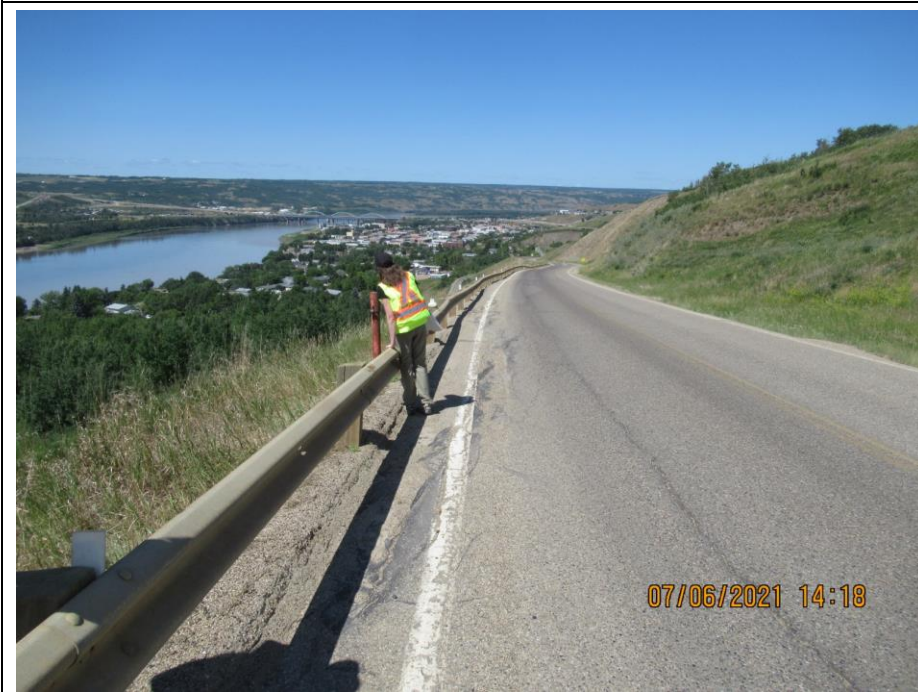
Primary Site Issue:	Failure of joints on band-coupled 450 mm diameter corrugated plastic pipe down-drain installed at km 58.9. Erosion on slope due to water discharging from failed couplings. Cracking and pavement distress on downslope shoulder of road.	
Dimensions:	Cracking and pavement distress extend from shoulder to the middle of the south-bound lane, along approximately 120 m length of road north of the down drain.	
Maintenance:	The highway was closed from May 2013 until December 2013 due to the occurrence of the Sunshine Landslide. The connection between the culvert under the road and the down-drain was reconnected and wrapped with polyethylene in 2010 and other failed couplings were wrapped with a polyethylene sleeve.	
Observations:	Description	Worsened?
<input checked="" type="checkbox"/> Pavement Distress	Longitudinal cracking, settlement, and occasional transverse cracks along 120 m length of road north of the trunk drain. Longitudinal cracks extend from the downslope shoulder into the middle of the south-bound lane. At km 58.95 the SBL dip has not visibly changed, cracks are open between 50 mm to 170 mm in width. Stone columns are showing the ACP and there is cracking in the shoulder near SI10-11, no change from 2020. (Photos 6 and 8)	<input checked="" type="checkbox"/>

Photo 6.
Looking northwest
from km 58.95.
Dip in the SBL has
not visibly
changed. Crack
apertures are
open from 50 mm
to 170 mm in
width.

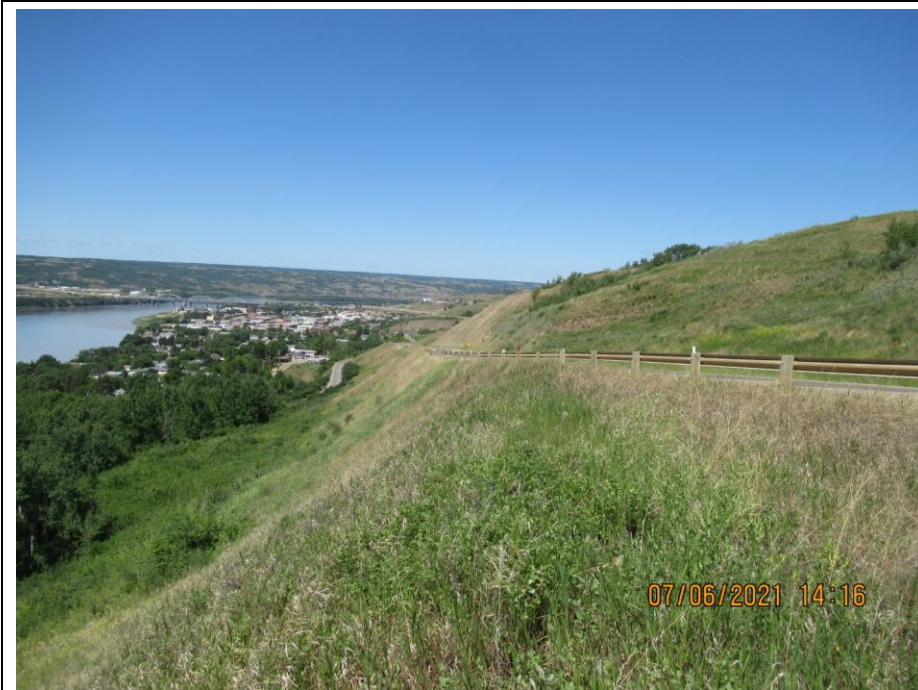
Photo 7.
Looking northwest from km 58.93 at slope below the highway near SI10-10. No change from 2020.

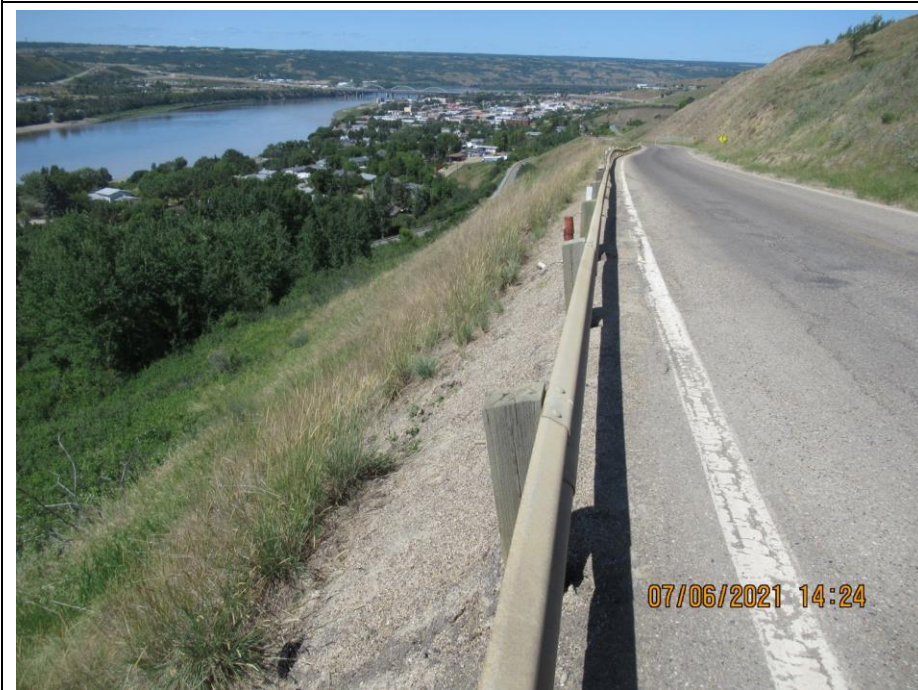
Photo 8.
Looking northwest from km 59.01 at cracking within the shoulder and southbound lane near SI10-11. Stone columns showing through the ACP in the SBL. No major change since 2020.

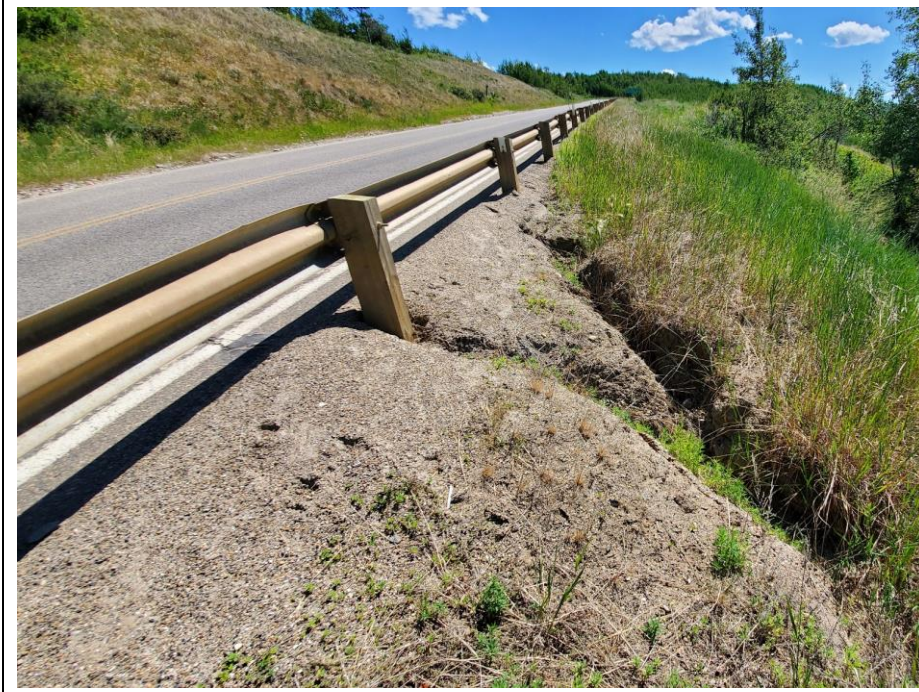
Photo 9.
Looking south at erosion rills on the west side of the highway near km 58.85. Slightly worse from 2020 condition.
