**ALBERTA TRANSPORTATION
GEOHAZARD ASSESSMENT PROGRAM
PEACE REGION (PEACE RIVER DISTRICT)
2022 INSPECTION**

| PH033-2 | Judah Hill | Judah Trunk | 744:04 | 58.761 |

PH033-2 JUDAH HILL - JUDAH TRUNK
2022 SITE INSPECTION PLAN

DWG No. 32121-PH033-2-1

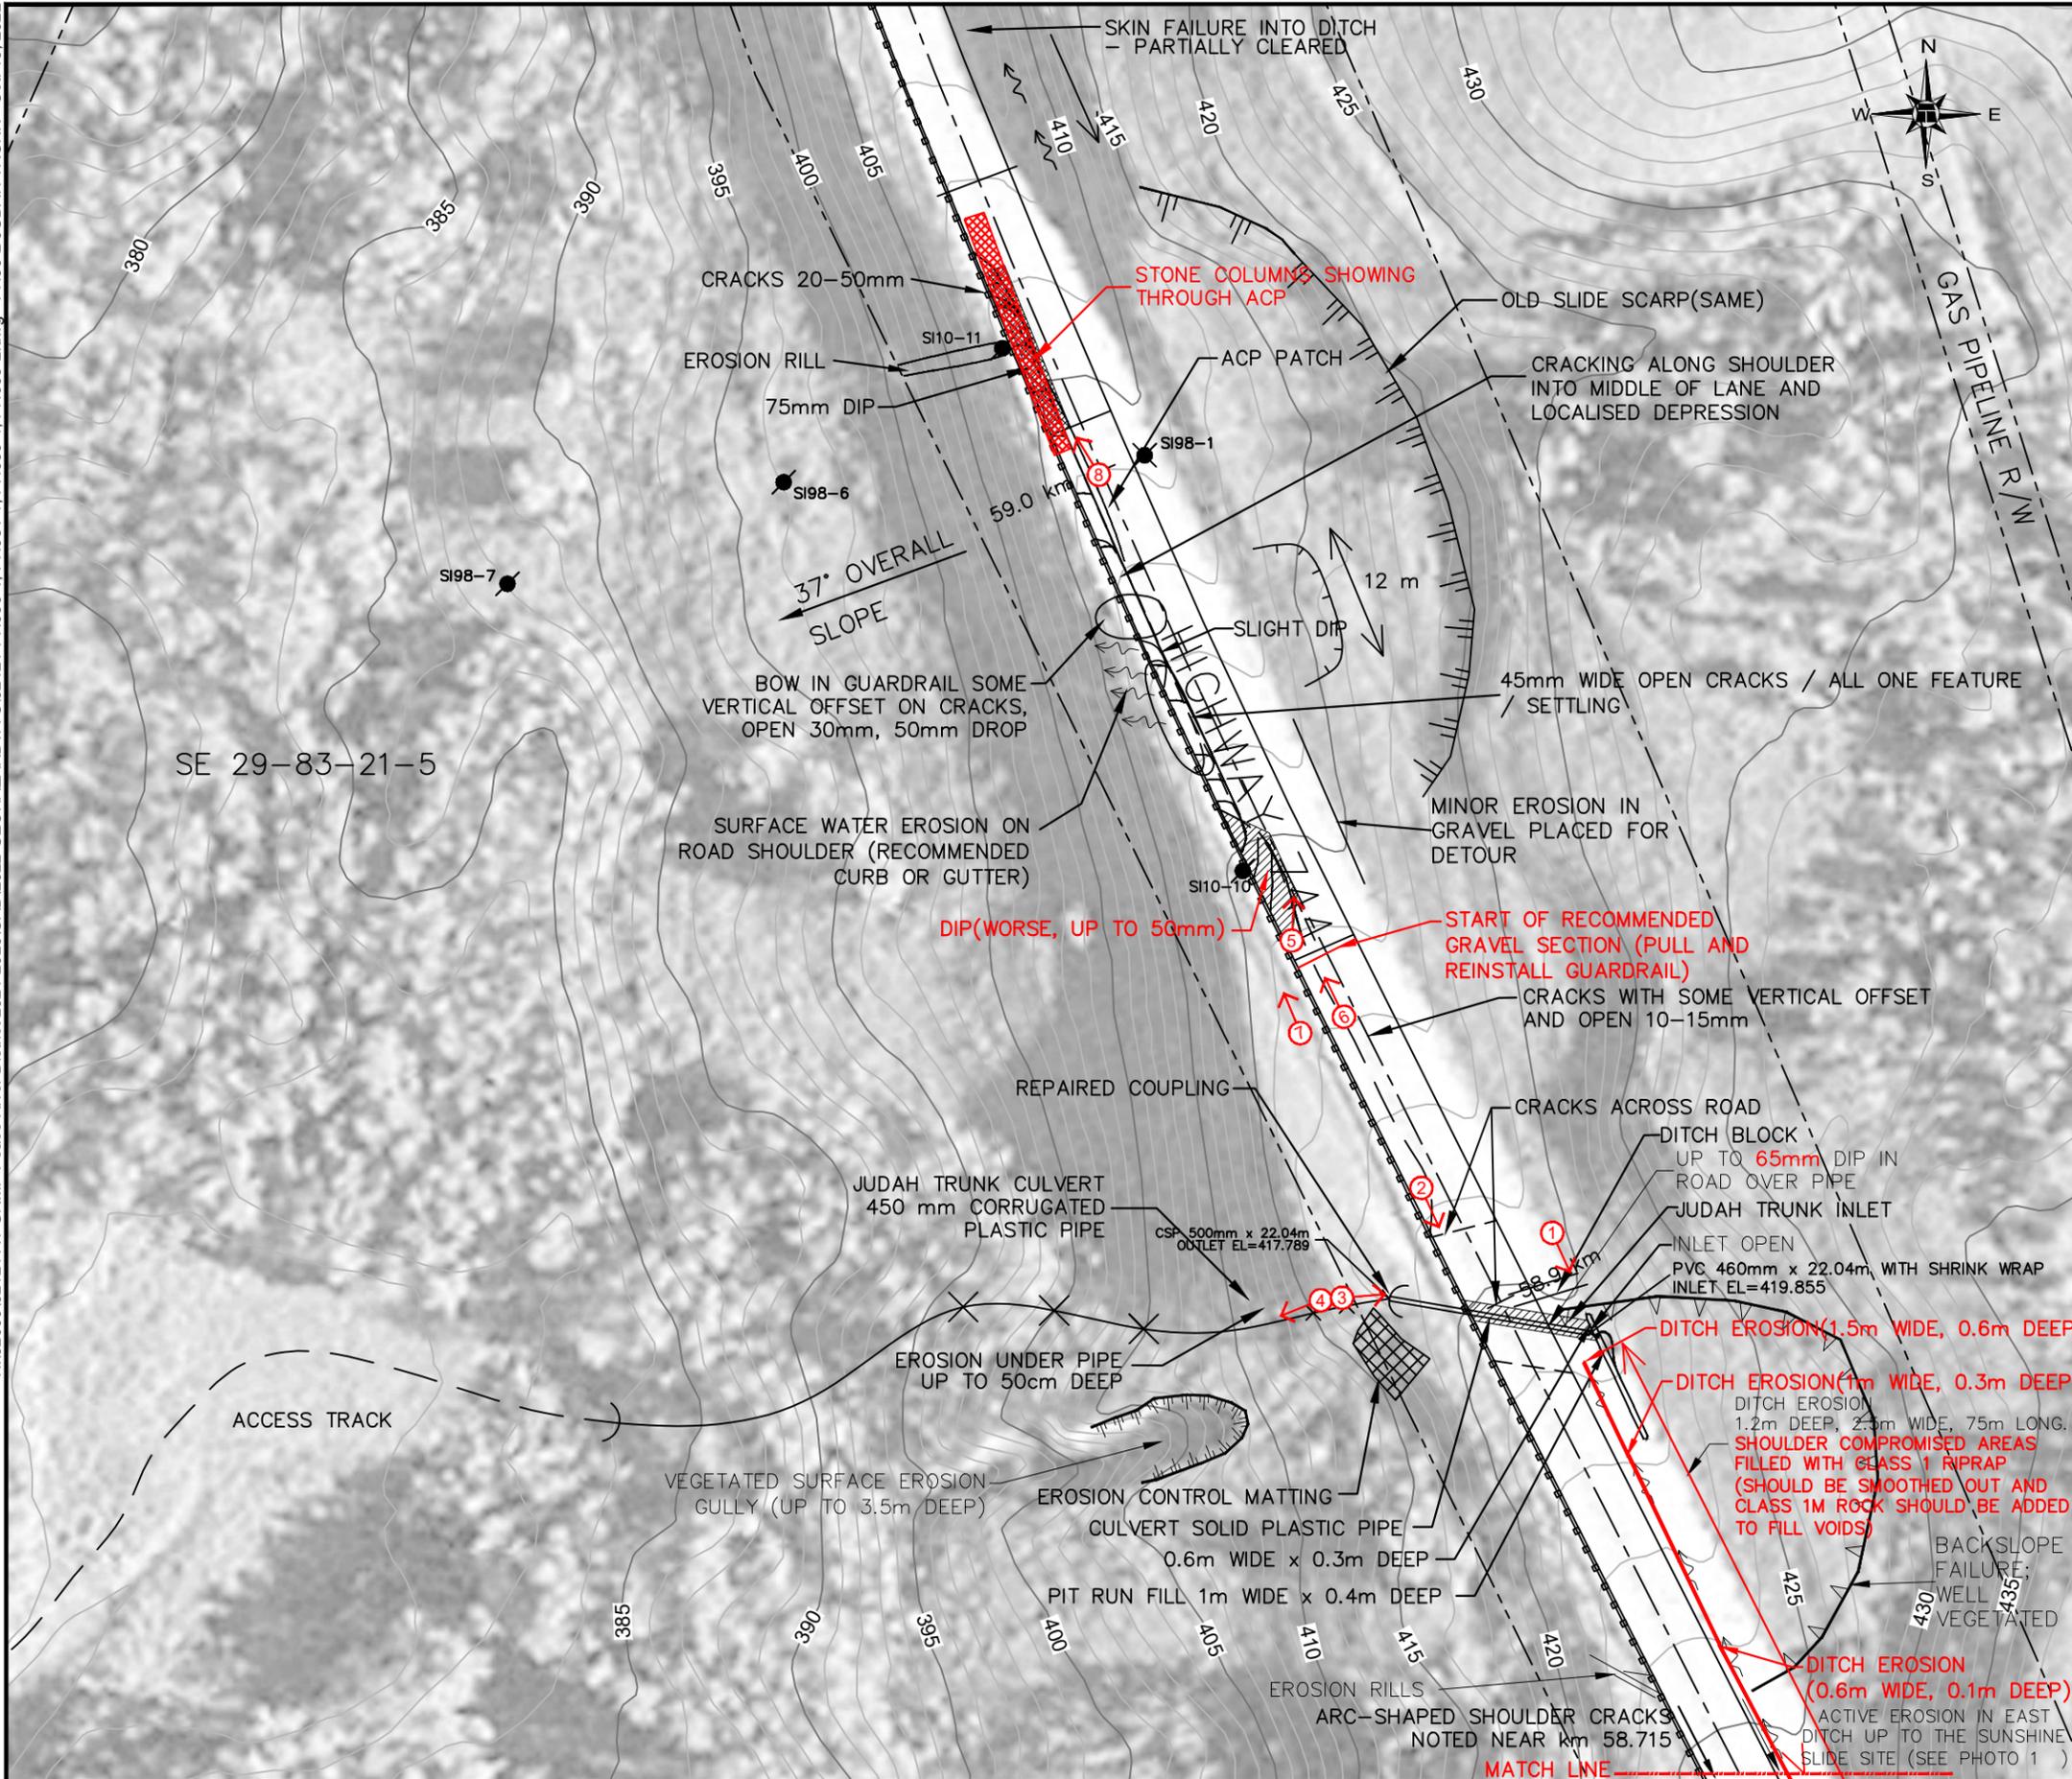
NOTES:
 1 LOCATION DATA RECORDED USING HANDHELD GPS RECEIVER. ALL LOCATIONS ARE APPROXIMATE AND ARE FOR ILLUSTRATIVE PURPOSES ONLY.
 2 MAY 24, 2022 OBSERVATIONS SHOWN IN RED

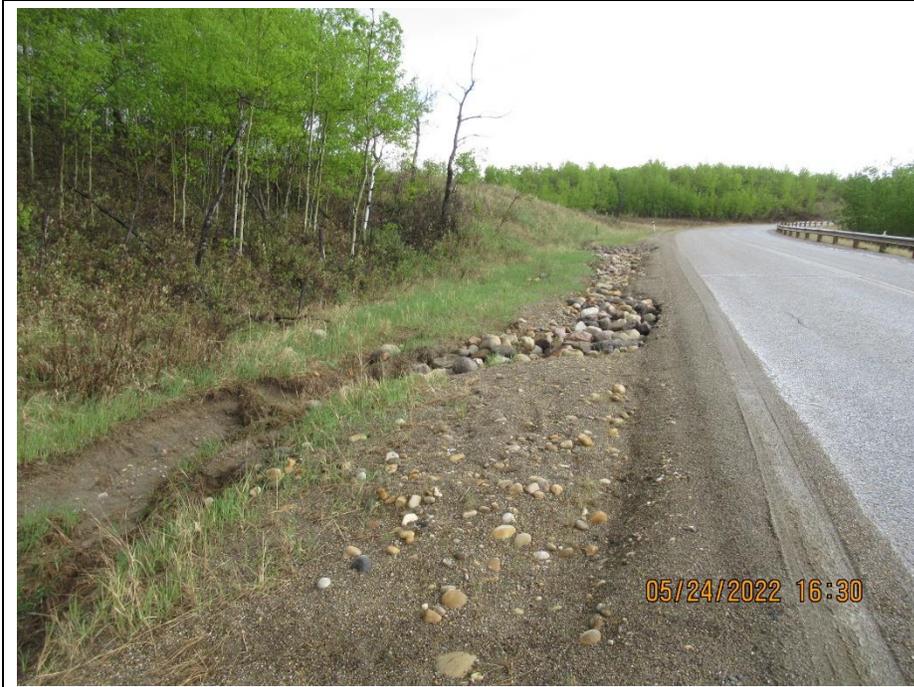
| <input checked="" type="checkbox"/> Erosion | The worse areas of the extensive ditch erosion in the east ditch between this site and the Sunshine Slide site that was undermining the road shoulder in several areas has been filled with rock riprap. (Photo 1) | <input checked="" type="checkbox"/> |

Photo 1.
Looking south at the ditch erosion upslope from the Judah Truck Inlet towards the Sunshine Slide site that has been partially filled in with rock riprap.

| Recommendations: | Cost |
|---|---|
| Ditch erosion damage should be repaired as per Thurber recommendations. | Maintenance |

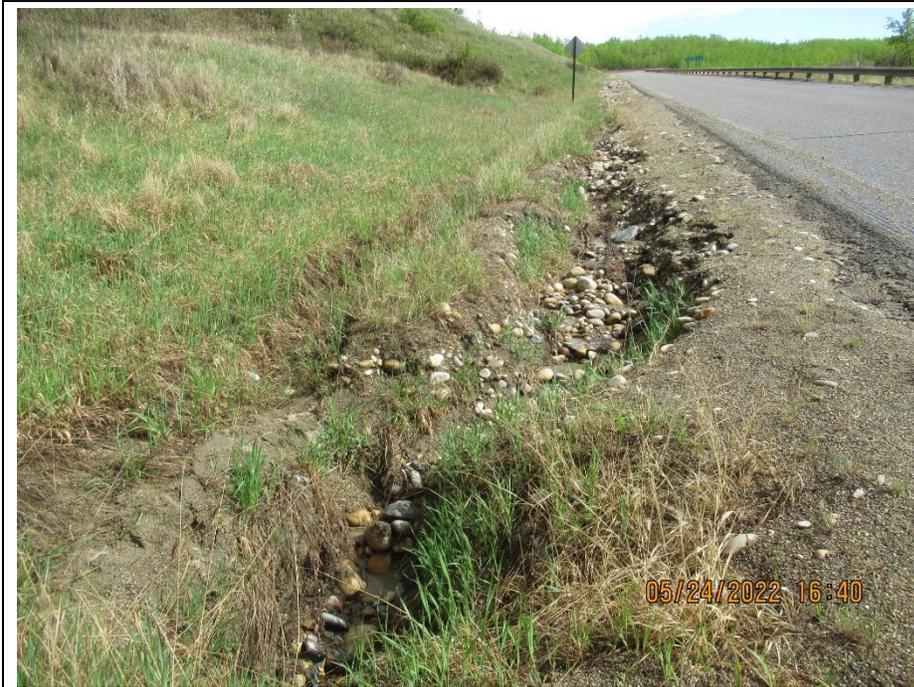
| | Ditch erosion is occurring within the ditch upslope from the trunk inlet up to 2 m wide and 0.6 m deep. Erosion is ongoing beneath the trunk culvert on the west side of the highway but there has not been major expansion the last few years. (Photos 2). Gully south of the trunk drain was well vegetated and appeared unchanged. (Photo 4). Erosion rills from runoff were noted on the west side of the road near km 58.85. | |

Photo 2.
Looking southeast at the ditch erosion upslope from the Judah Truck Inlet. No significant change from 2021 condition.

| Recommendations: | Cost |
|---|---|
| Flatten/re-grade upslope sideslope around drain inlet, remove debris and re-armour with Class 1M rip rap. | Maintenance |

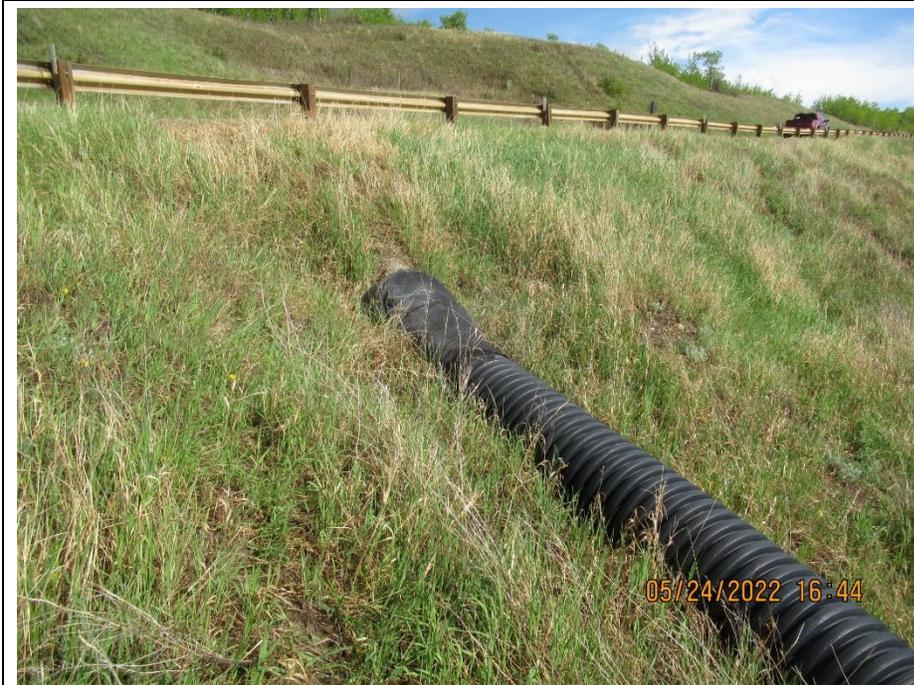
| Primary Site Issue: | Failure of joints on band-coupled 450 mm diameter corrugated plastic pipe down-drain installed at km 58.9. Erosion on slope due to water discharging from failed couplings. Cracking and pavement distress on downslope shoulder of road. | |

| <input checked="" type="checkbox"/> Bridge/Culvert Distress | The inlet to the drain remains open. Trunk condition appeared unchanged. (Photo 3) | <input type="checkbox"/> |

Photo 3.
Looking east at km 58.9 at the corrugated plastic down-drain at connection to the centerline culvert. No change from 2021.

| Recommendations: | Cost |
|---|---|
| As a short-term fix, repair remaining damaged band couplings on down-drain. | Maintenance |
| Replace corrugated plastic down drain with welded HDPE pipe with appropriate flow capacity as a longer-term fix. Repair connection to culvert under road. | \$ 250,000 |

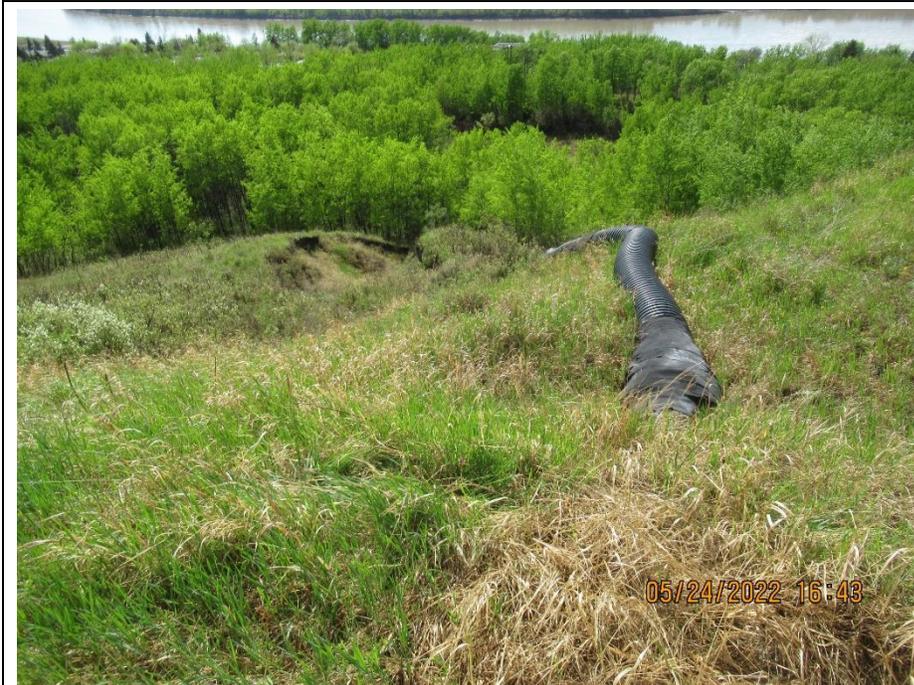
Photo 4.
Looking southwest at km 58.9 at CPP drain and erosion gully further downslope. Gully is well vegetated and has not visibly changed from 2021.

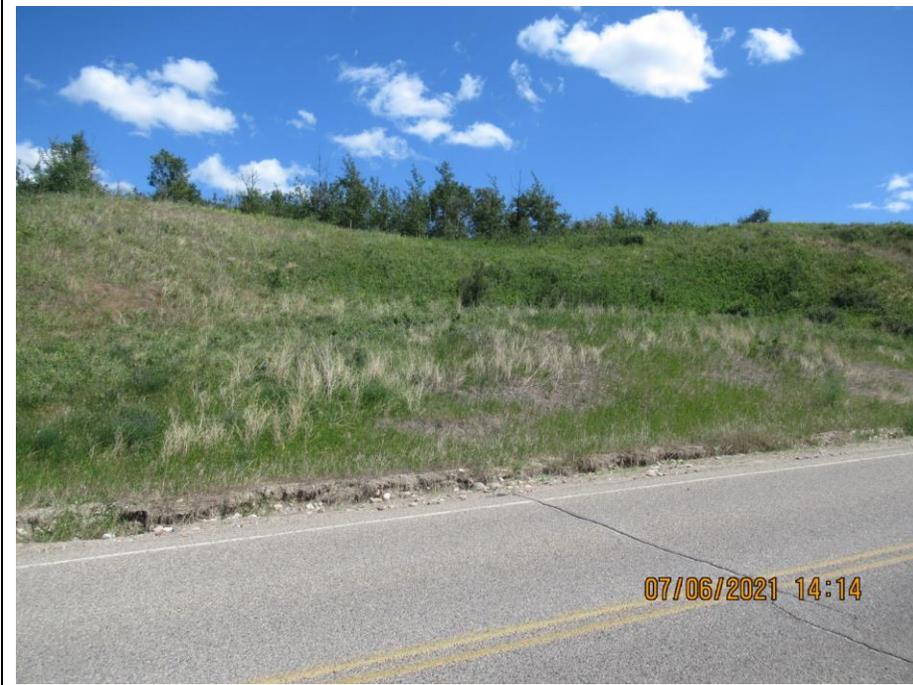
| <input checked="" type="checkbox"/> Slope Movement | Vegetated backslope slide scarp near km 58.9 had no visible changes. (Photo 5) No change noted in the slope below the vicinity of slope inclinometer S110-10. (Photo 7) | <input type="checkbox"/> |

| Further skin failures should be expected in the steep cut slopes above the road – the maintenance burden does not appear very great at this stage. | | |

Photo 5.
Looking east from
km 58.9 at
vegetated
backslope slide
scarp. No change
from 2021.

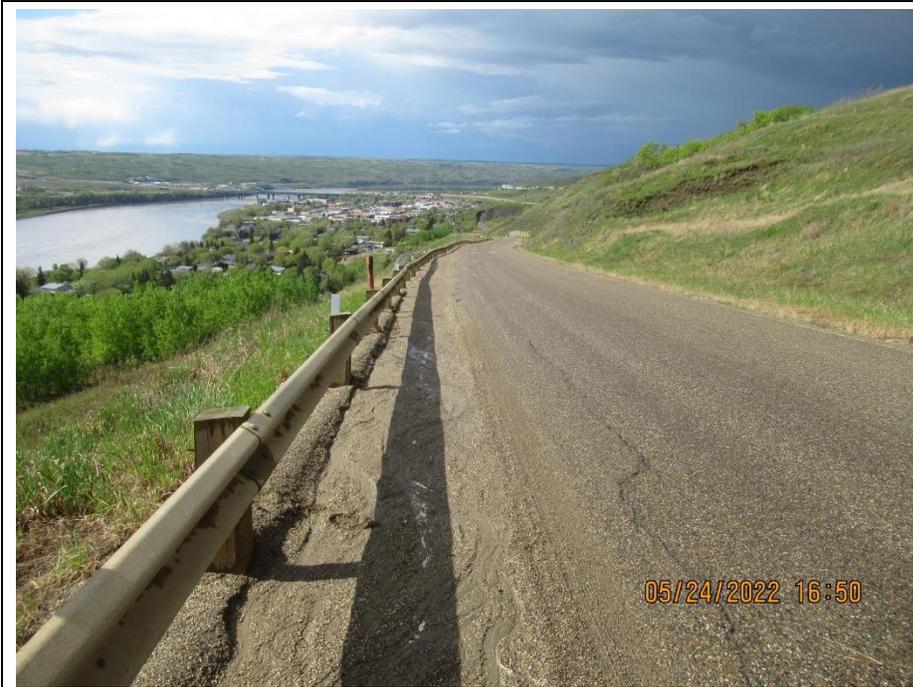
| <input checked="" type="checkbox"/> Pavement Distress | Dip over the Judah trunk pipe below the road (up to 65 mm). Longitudinal cracking, settlement, and occasional transverse cracks along 120 m length of road north of the trunk drain. Longitudinal cracks extend from the downslope shoulder into the middle of the south-bound lane but no major change from 2021. Dip near S110-10 in the SBL is worse, up to 50 mm. Stone columns are showing the ACP and there is cracking in the shoulder near S110-11. (Photos 6 and 8) | <input checked="" type="checkbox"/> |

Cracking, settlement and pavement distress on the downslope shoulder and southbound lane indicate the onset of future slope stability problems that could affect the use of the southbound lane of the highway. The slip surface of the slides varies from 8.3 m to 5 m at SI10-10 and SI10-11, respectively. If the trend of increasing measured movement rate at SI10-10 and/or pavement damage worsens the risk level should be increased and a temporary detour construction towards the upslope will likely be required.

Photo 6.
Looking northwest
from km 58.95.
Dip is worse up to
50 mm. Cracks in
the SBL have not
visibly changed
since 2021.

| Recommendations: | Cost |
|---|---|
| A highway re-alignment into the backslope could be considered to deal with the slide movements that are affecting the shoulder of the highway. This could buy some time before the slides affect the highway again in the future. | \$300,000 |
| A more permanent, but more expensive, solution would be a pile wall. | \$3,000,000 |

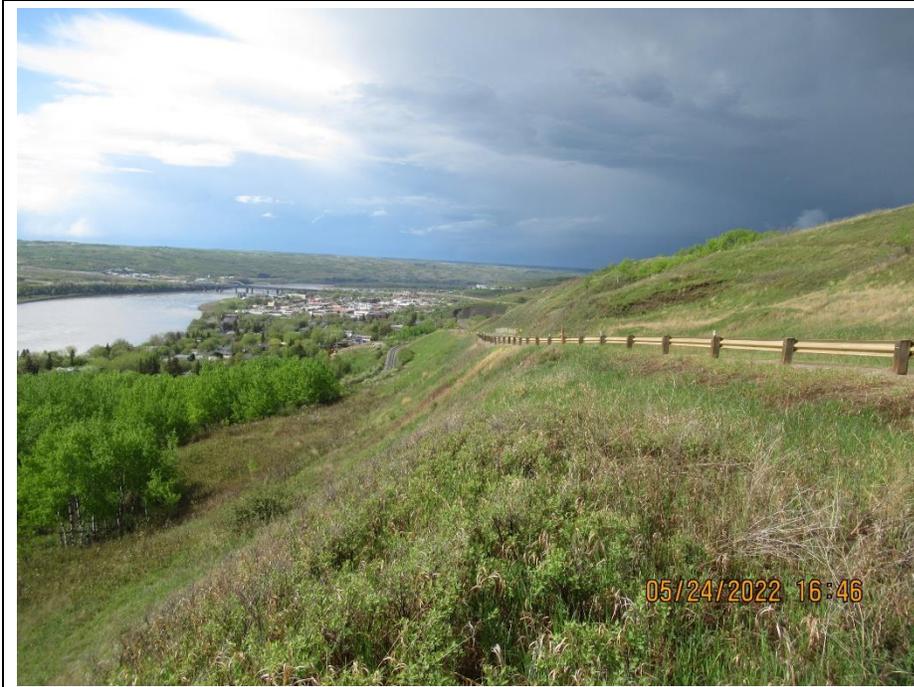
Photo 7.
Looking northwest from km 58.93 at slope below the highway near SI10-10. No change from 2021.

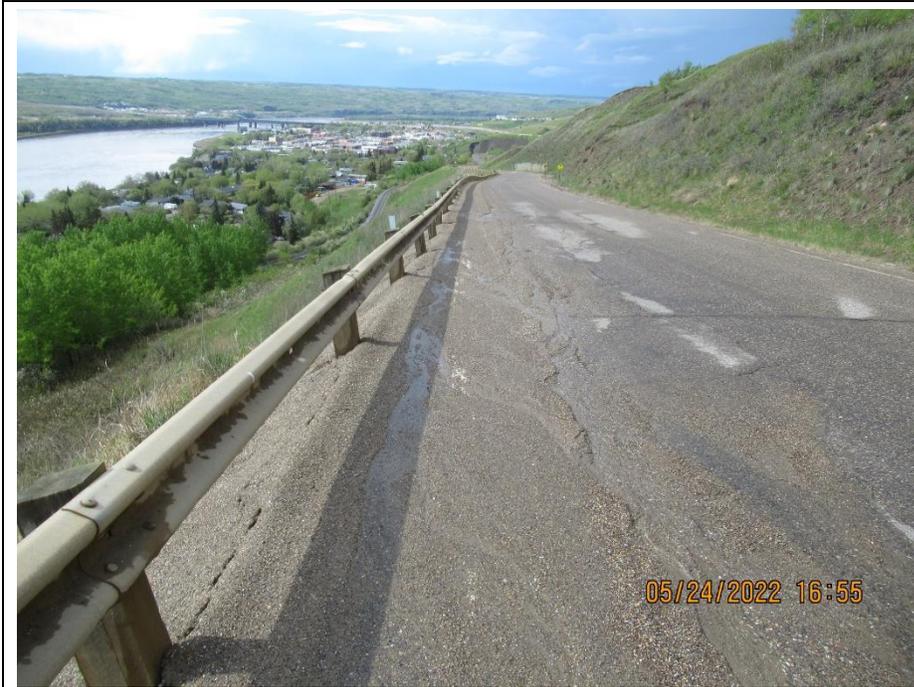
| SI10-10 and SI10-11 | Installed at road shoulder in area of cracking either side of km 59. SI10-10 showed a rate of movement of 7.1 mm/yr over 1.0 m to 8.3 m depth since the fall of 2021 readings. SI10-10 recorded the highest rate of movement since initialization within the upper 2 m, representative of surficial slide movement within the fill. SI10-11 showed a rate of movement of 4.7 mm/yr over 2.0 m to 5.0 m depth since the fall of 2021 readings for a total cumulative movement of 67 mm. Last year the instrument had the highest recorded movement rate since installation (11.9 mm/yr). | |

Photo 8.
Looking northwest from km 59.01 at cracking within the shoulder and southbound lane near SI10-11. Stone columns showing through the ACP in the SBL. No major change since 2021.
