ALBERTA TRANSPORTATION GEOHAZARD ASSESSMENT PROGRAM PART A: FILE REVIEW

PEACE REGION – PEACE-HIGH LEVEL

PH31 JUDAH HILL – MICHELIN SLIDE

Legal Location:	NE¼20-083-21 W5M
Nearest Landmark:	1.8 km south of the CN Rail crossing on Hwy 744
Highway Control Section:	Hwy 744:04
Date of Initial Observation:	1984
Date of Last Inspection:	2008
Last Inspected By:	Thurber Engineering Ltd.
Instrumentation Installed:	10 inclinometers At least 2 pneumatic piezometers
Instrumentation Operational:	2 inclinometers 2 pneumatic piezometers
Risk Assessment: (as of last inspection)	PF = 9 CF = 4 Risk = 36

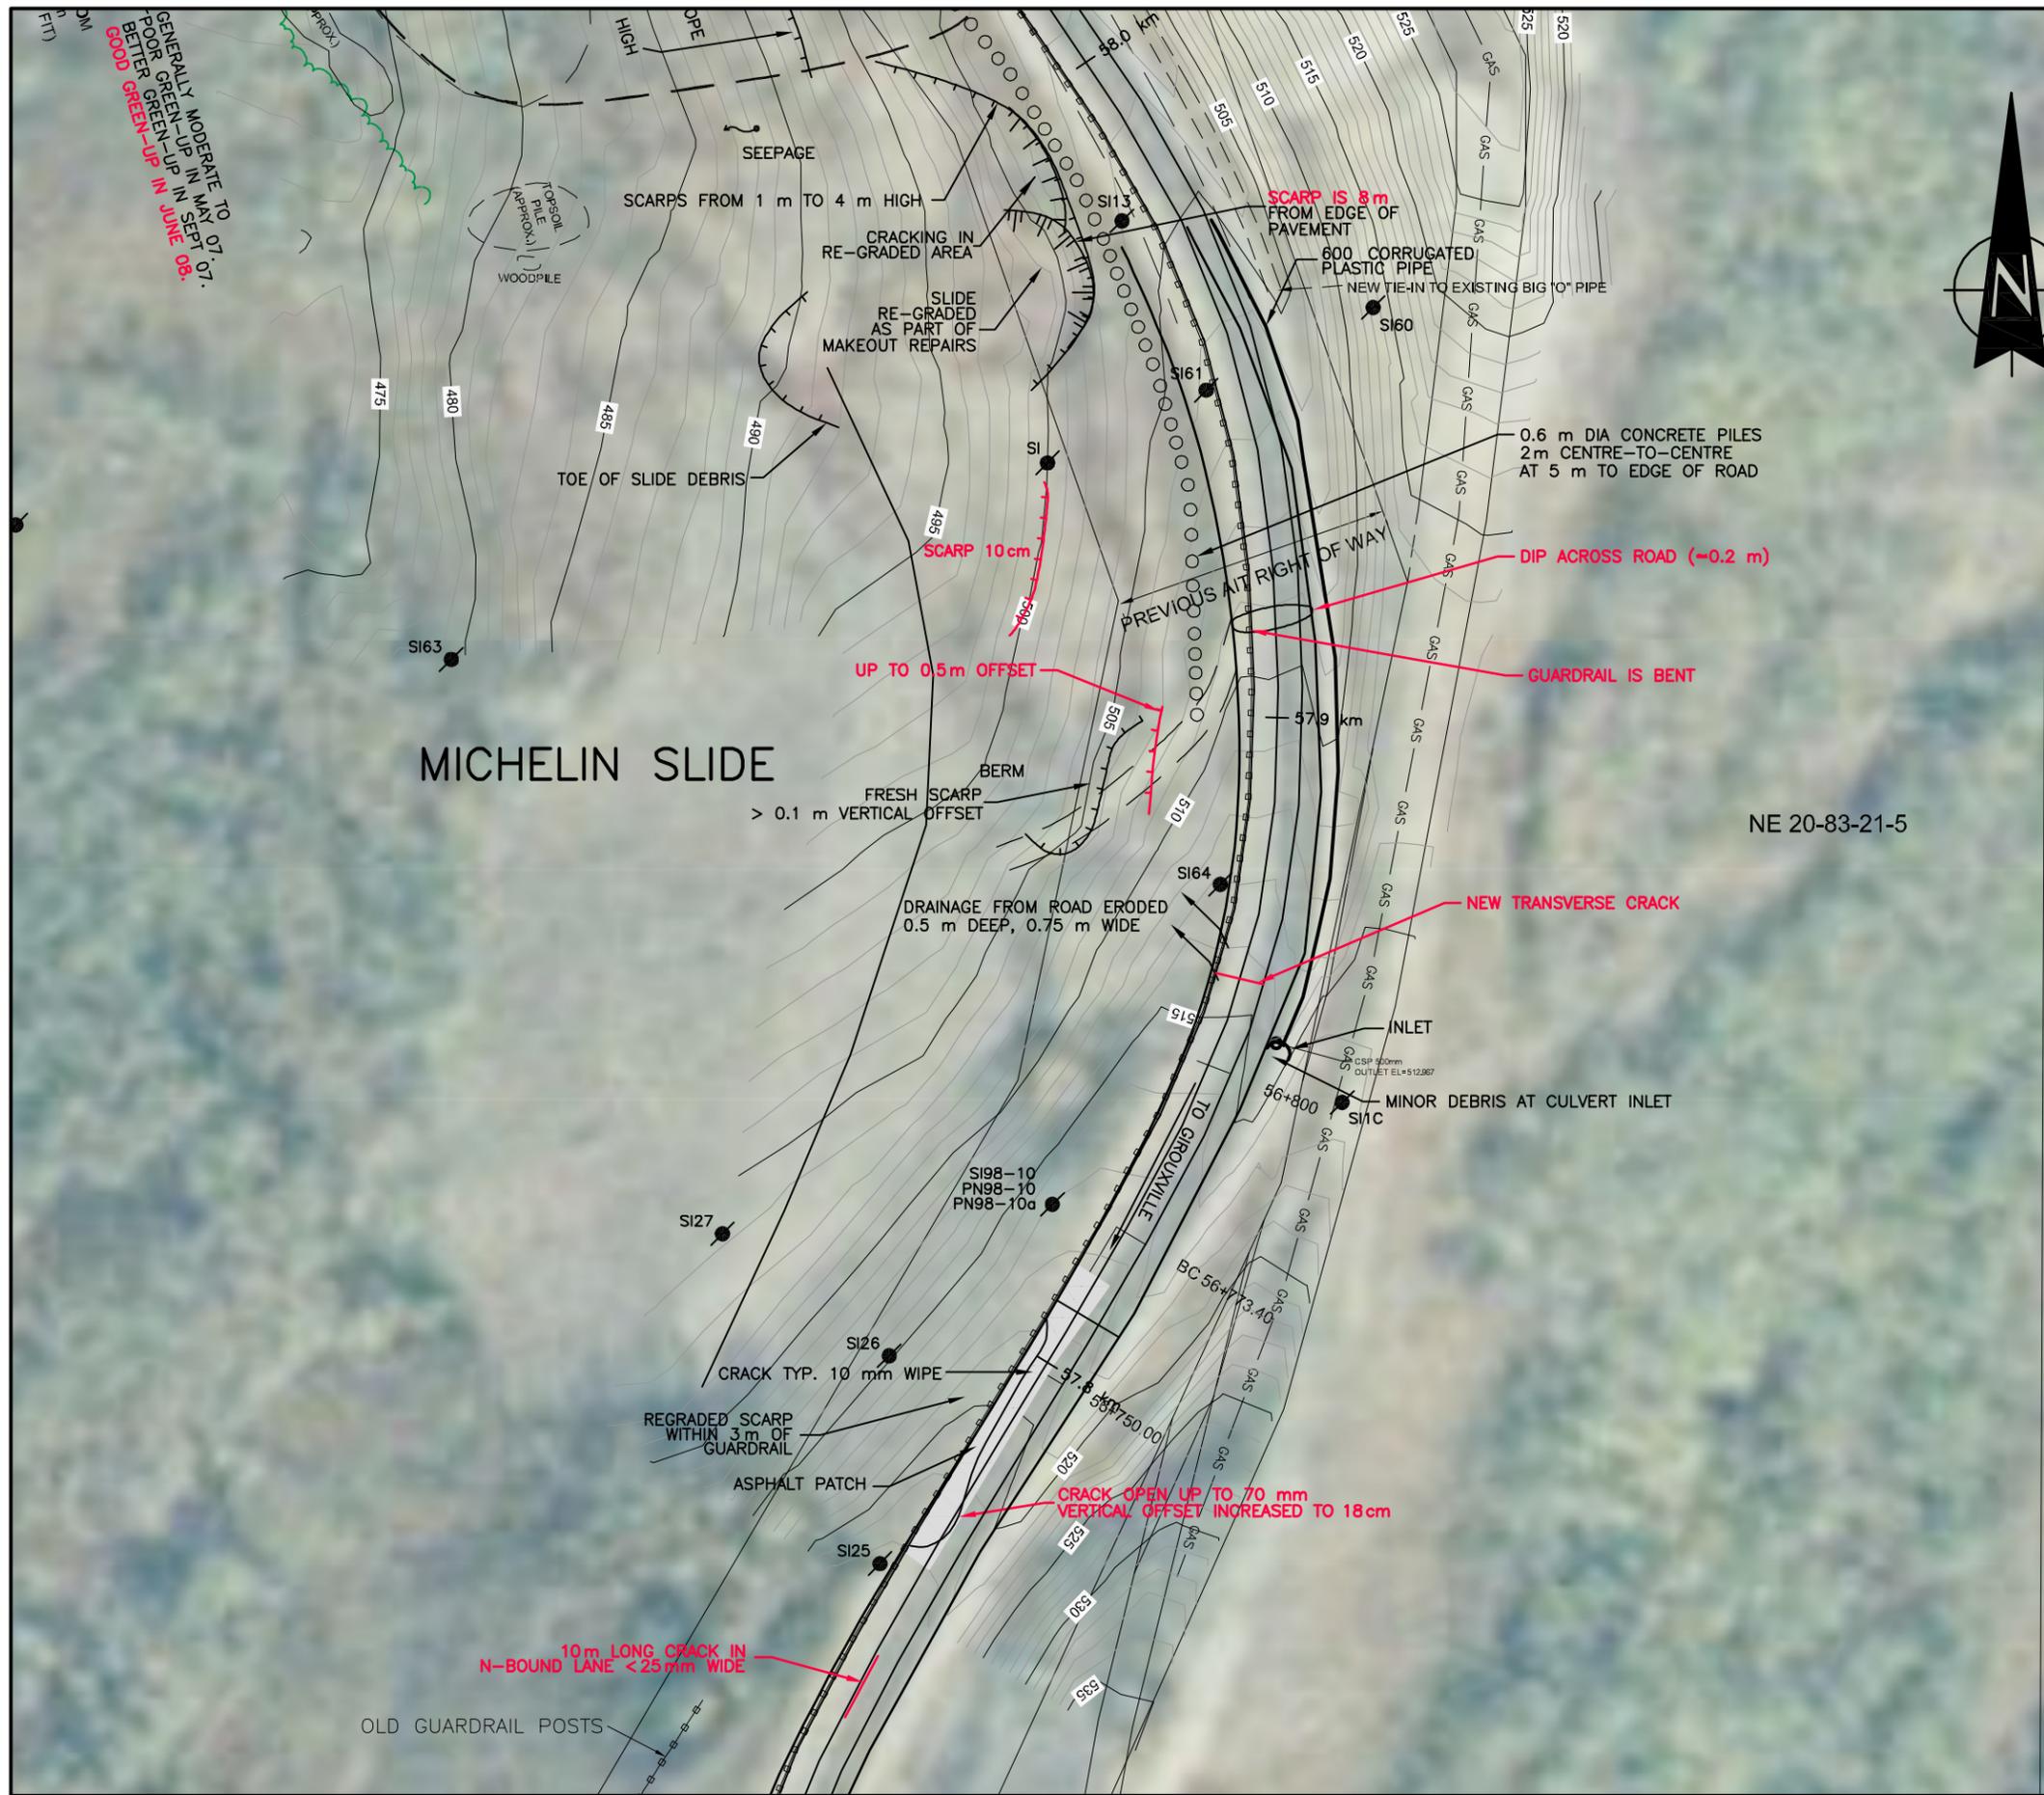
FIGURE 2

GENERALLY MODERATE TO POOR GREEN-UP IN SEPT. 07. BETTER GREEN-UP IN JUNE 08. GOOD GREEN-UP IN JUNE 08.

10m LONG CRACK IN N-BOUND LANE < 25mm WIDE

CRACK OPEN UP TO 70 mm VERTICAL OFFSET INCREASED TO 18 cm

DIP ACROSS ROAD (-0.2 m)

UP TO 0.5m OFFSET

SCARP IS 8 m FROM EDGE OF PAVEMENT

SCARP 10cm

SCARPS FROM 1 m TO 4 m HIGH

CRACKING IN RE-GRADED AREA

TOE OF SLIDE DEBRIS

GUARDRAIL IS BENT

FRESH SCARP > 0.1 m VERTICAL OFFSET

DRAINAGE FROM ROAD ERODED 0.5 m DEEP, 0.75 m WIDE

NEW TRANSVERSE CRACK

MINOR DEBRIS AT CULVERT INLET

REGRADED SCARP WITHIN 3m OF GUARDRAIL
