**ALBERTA TRANSPORTATION
GEOHAZARD ASSESSMENT PROGRAM
PEACE REGION – PEACE-HIGH LEVEL
2018 CALL OUT**

Site Number	Location	Name	Hwy	km
PH031	Judah Hill	Michelin Slides	744:04	57.664
Legal Description		UTM Co-ordinates		
NE¼ 20-083-21 W5M		11V E 483226	N 6229678

Date	PF	CF	Total
Previous Inspection:	14-May-2018	17	6	100
Current Inspection:	30-Oct-2018	17	6	100
Road AADT:	540		Year:	2017
Inspected By:	Ed Szmata, TRANS		Shawn Russell, Thurber	
Report Attachments:	<input checked="" type="checkbox"/> Photographs <input checked="" type="checkbox"/> Plans <input type="checkbox"/> Maintenance Items

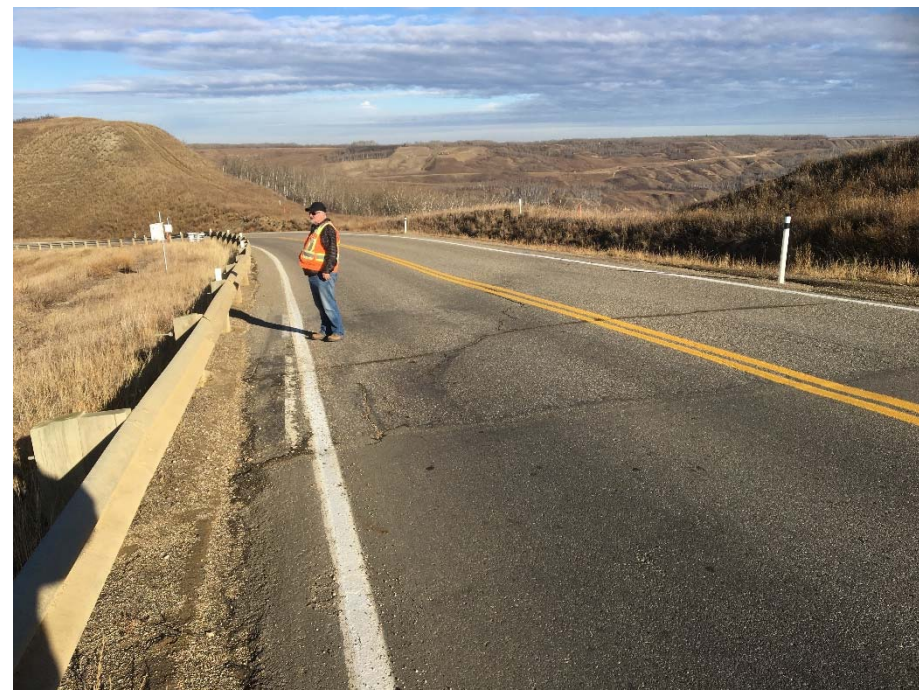
Photo 1.
Looking northeast along the SBL guardrail of Hwy 744:04 from km 57.8 at the dip in the SBL immediately north of the 2015 realignment. No significant change since May 2018.

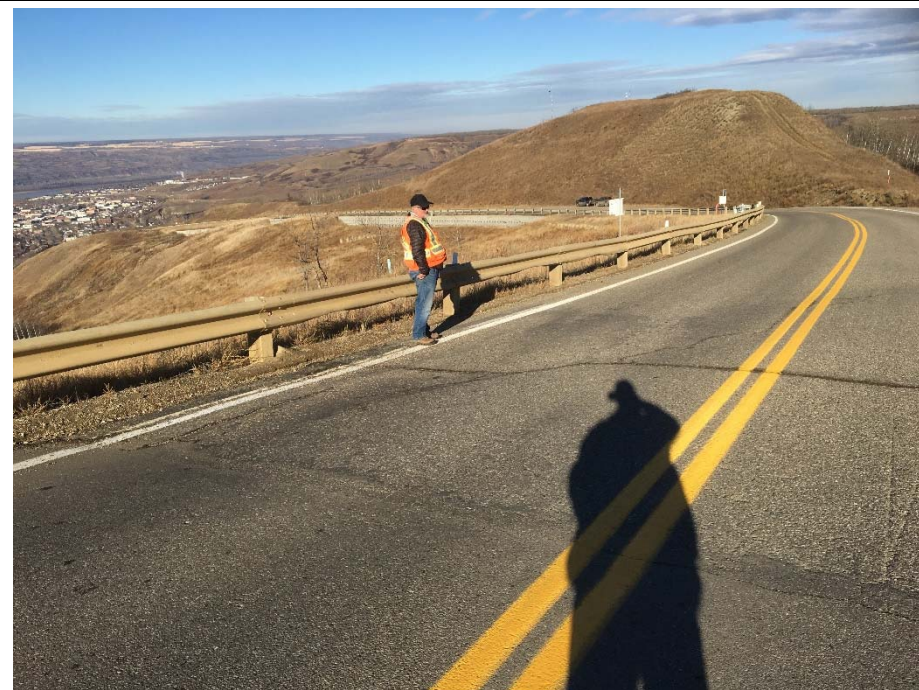
Photo 2.
Looking north from the centerline of Hwy 744:04 from km 57.81 at the dip in the SBL to the north of the 2015 realignment.

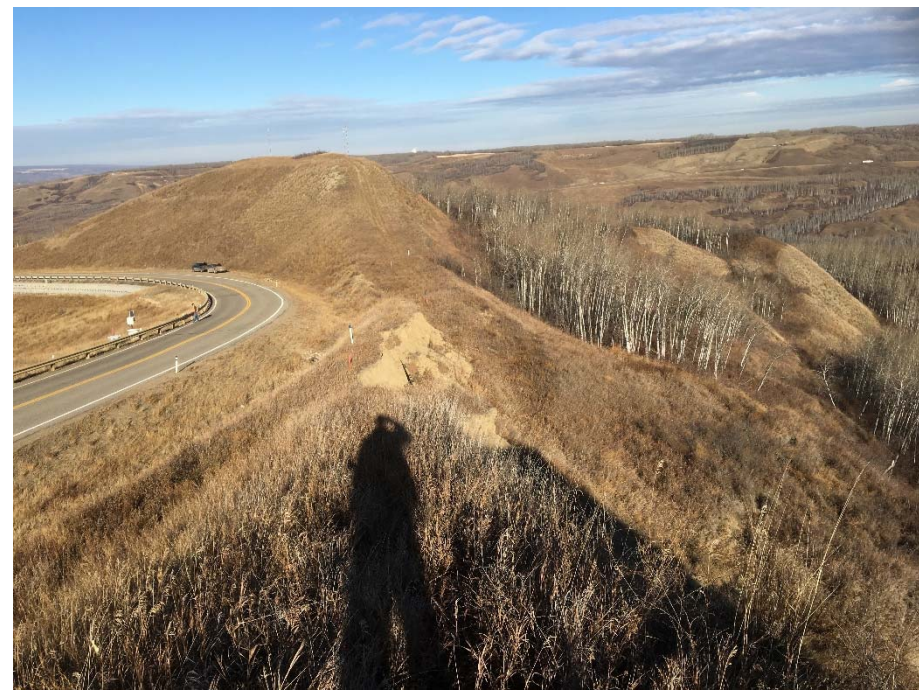
Photo 3.
Looking northeast from the top of scarp of the slide on the Heart River side along the former ATCO pipeline right-of-way. There has been some retrogression of the backscarp and the graben at the center of the slide has dropped since May 2018.

Long-term repair using ~ 230 m of tied back retaining walls.

Approximately 80 m would be required on the Heart River side and 150 m on the Peace River side, extending south from the km 58 wall. ~ \$ 13 million

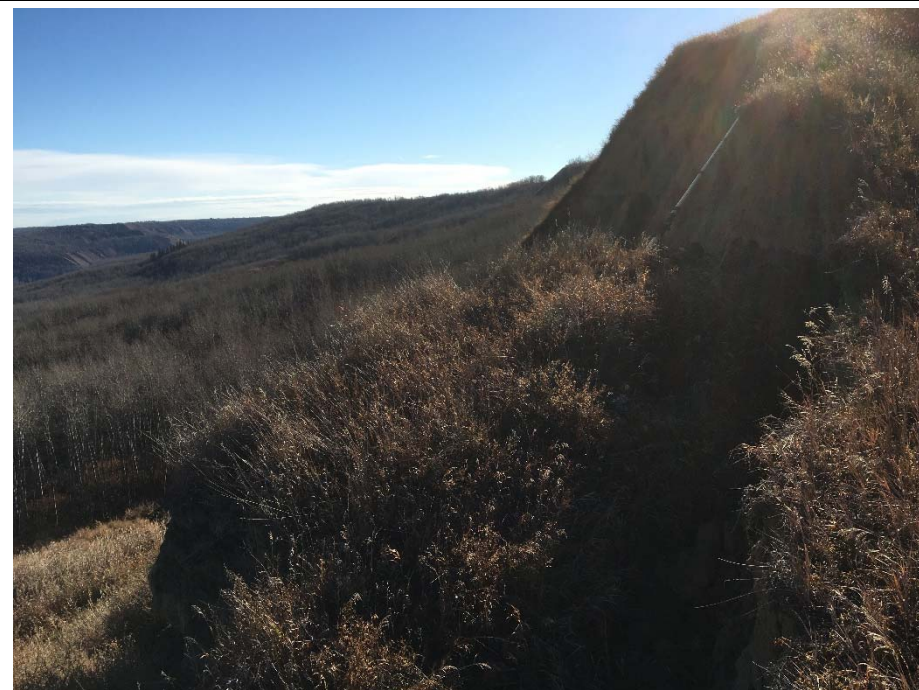
Photo 4.
Looking south at the south flank of the Heart River side slide from the former ATCO pipeline right-of-way. There has been some additional retrogression and soil loss along the backscarp since May 2018.

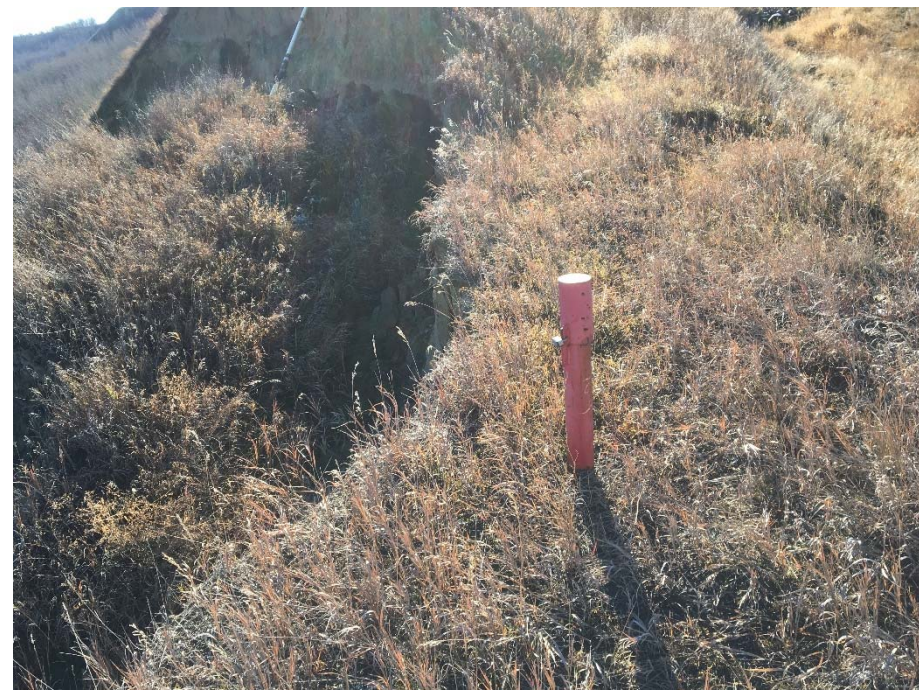
Photo 5.
Looking south at the south flank of the Heart River side slide from the former ATCO pipeline right-of-way. The scarp is 0.4m from SI10-04 and the drop along the scarp is at 4.5 m.

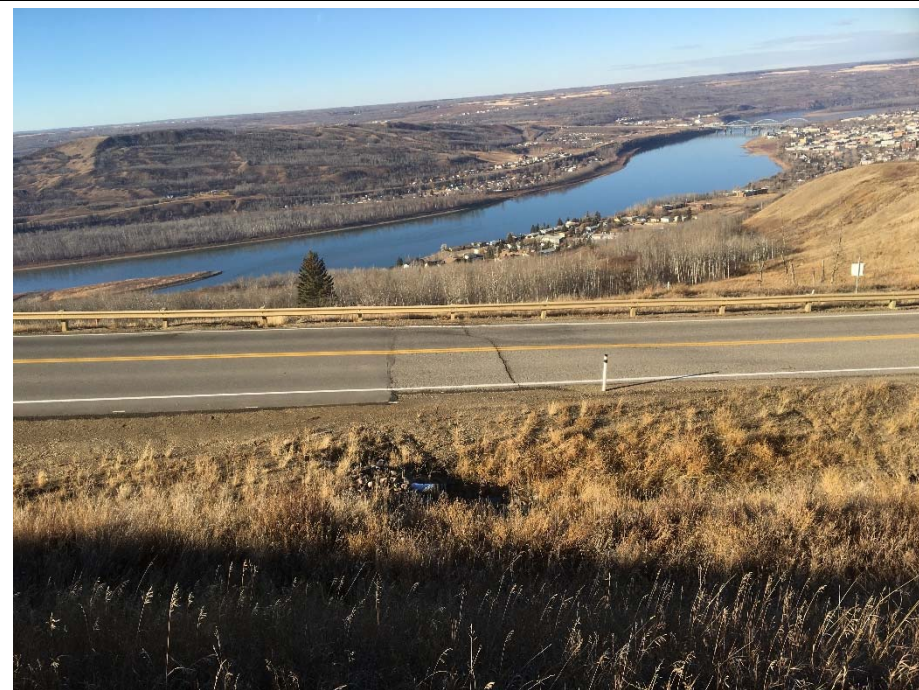
Photo 6.
Looking west from the former ATCO pipeline right-of-way towards the outlet of the 600 mm Diameter CPP and the dip in the SBL at km 57.825.
