**ALBERTA TRANSPORTATION
GEOHAZARD ASSESSMENT PROGRAM
PEACE REGION – SWAN HILLS
2019 INSPECTION**

| Site Number | Location | Name | Hwy | km |
|---|---|---|---|---|
| SH031-1 | Southwest of High Prairie | Road Gear Ranch | 747:02 | 32.1-32.3 |

**SH031: HWY 747:02 km 32.1 to km 32.3
2019 SITE INSPECTION PLAN**

DWG No. 13355-SH031-1

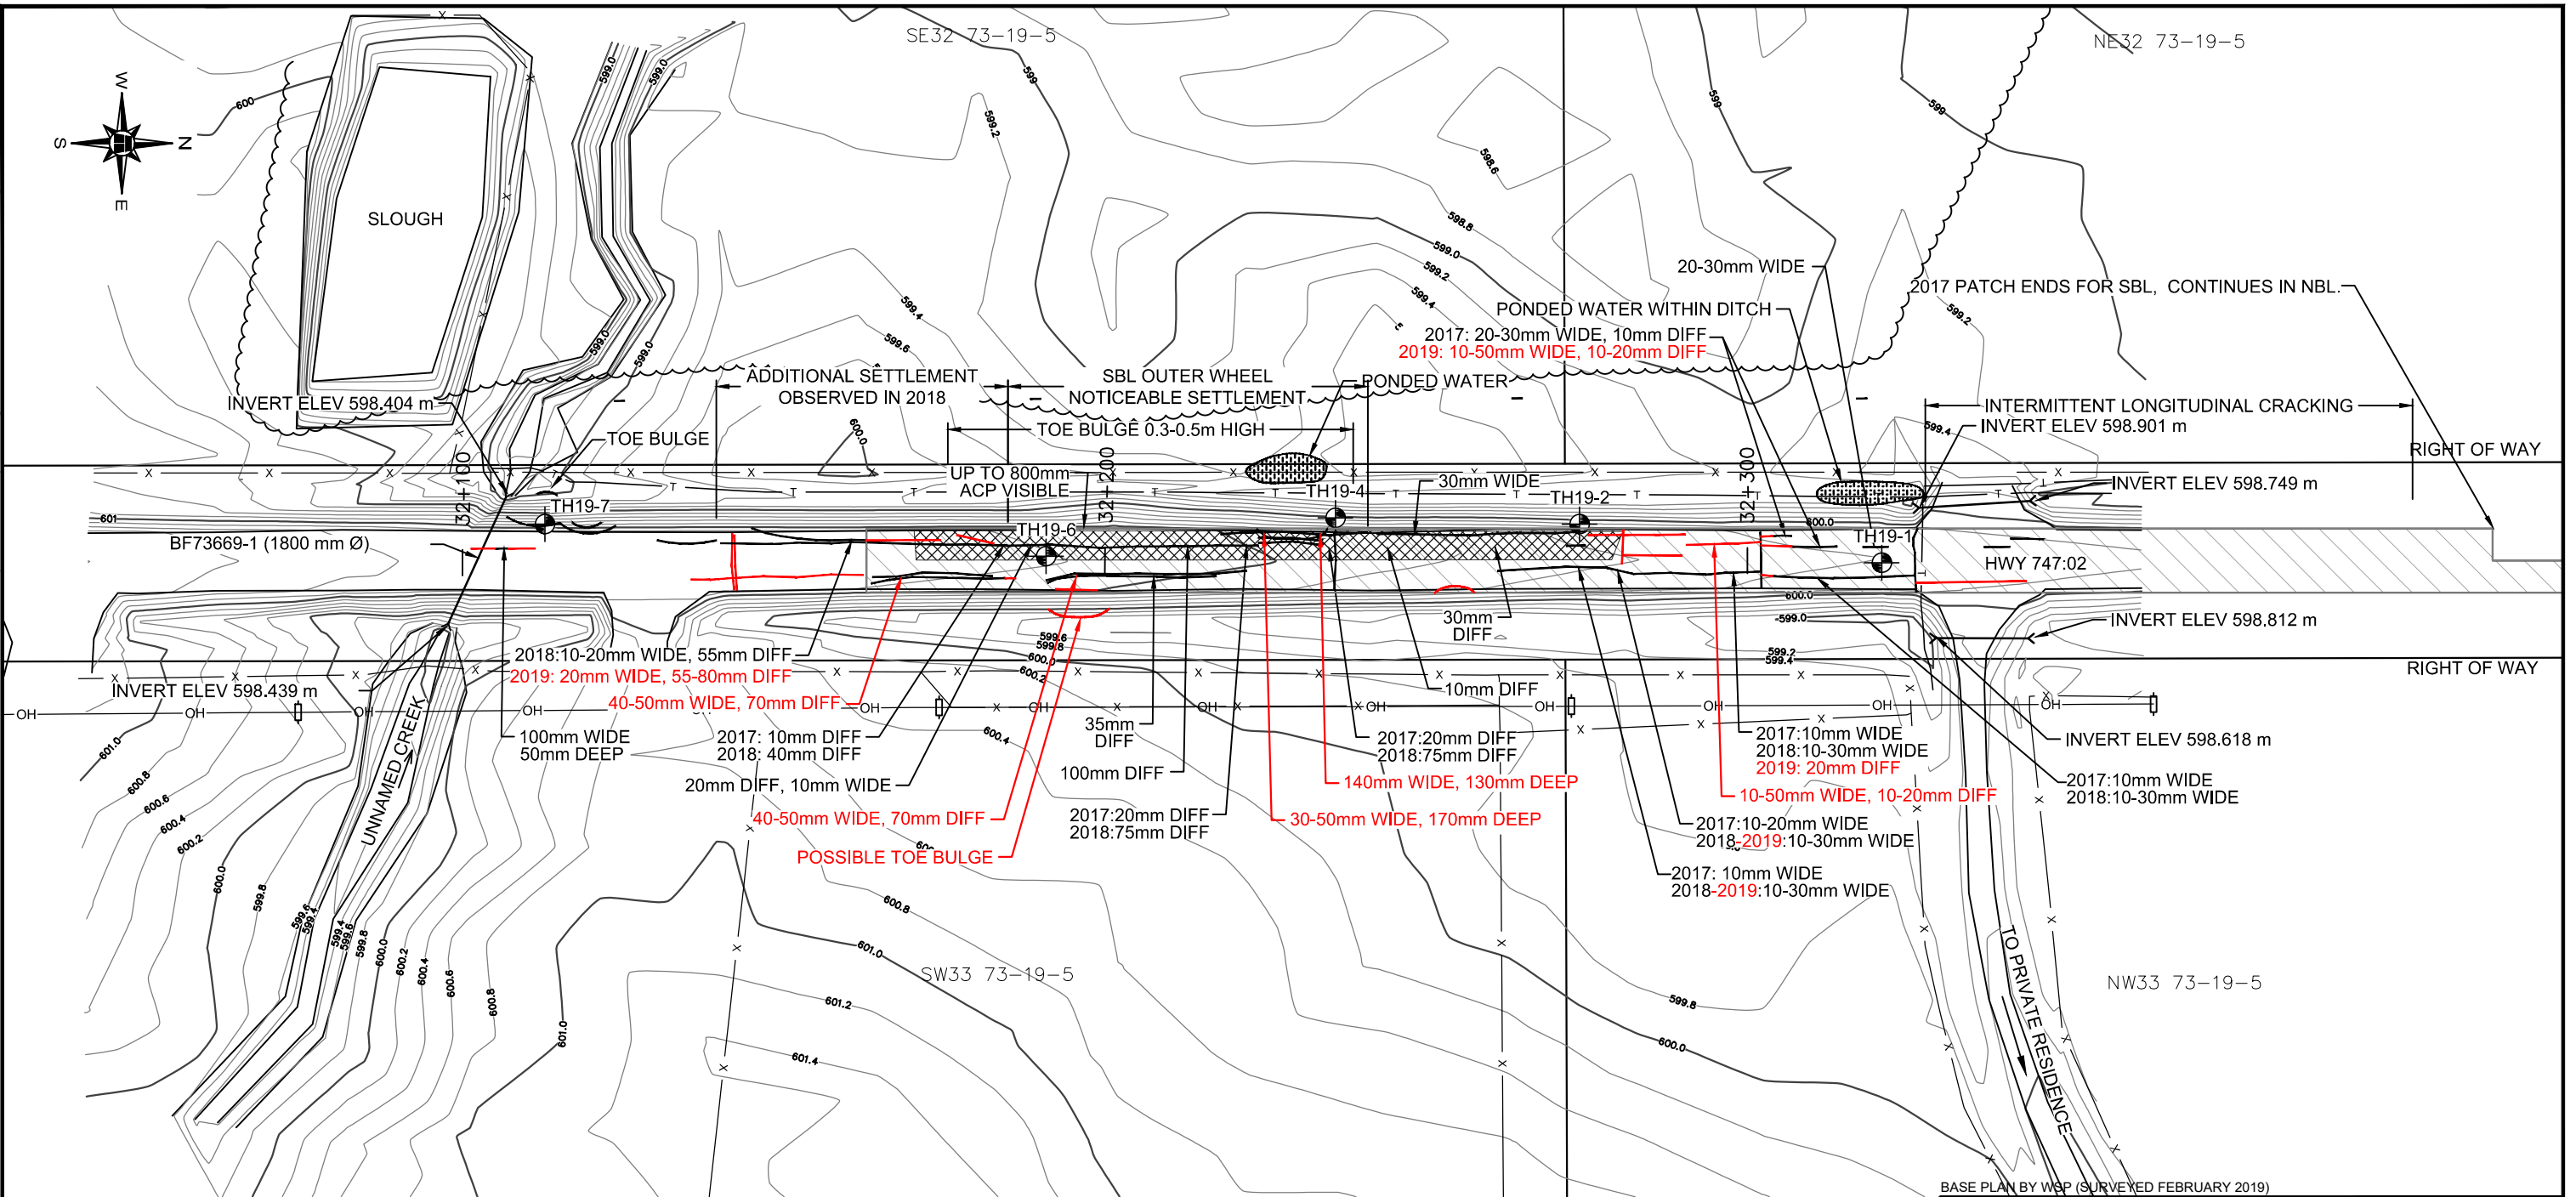
| <input checked="" type="checkbox"/> Pavement Distress | Longitudinal cracking over 245 m and subsidence of west half of SBL and shoulder. | <input checked="" type="checkbox"/> |
| <input checked="" type="checkbox"/> Slope Movement | Settlement of highway surface and bulging at toe of highway embankment. | <input checked="" type="checkbox"/> |

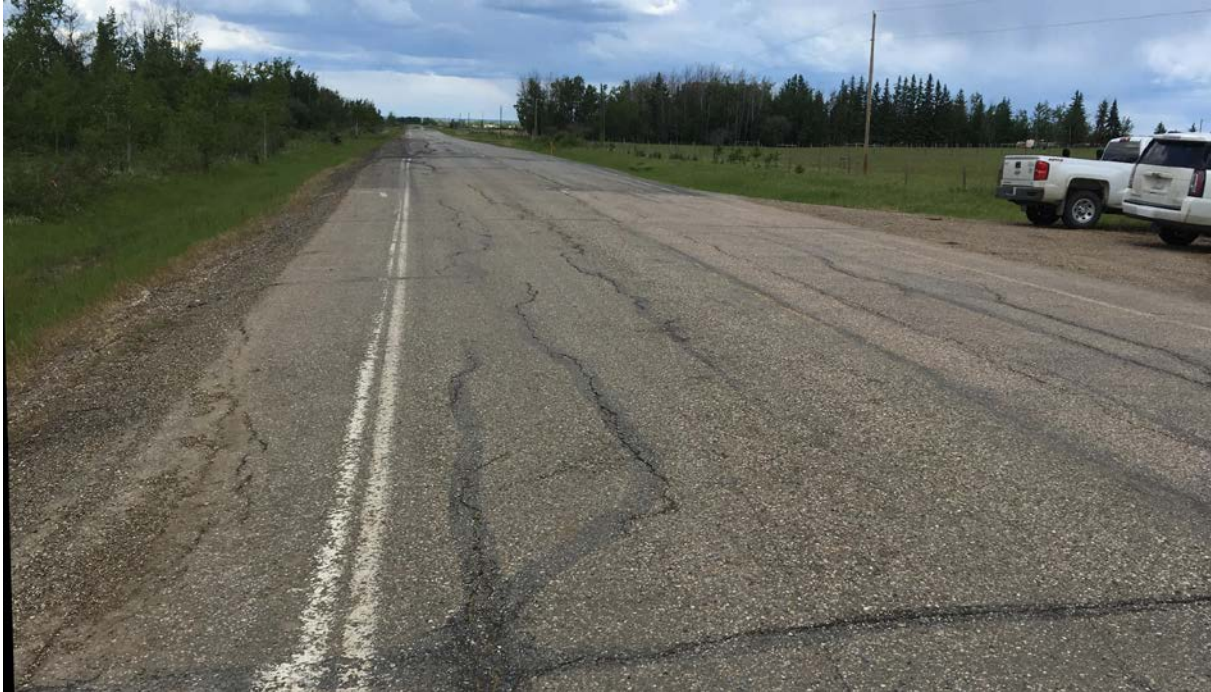
Photo 1 – Looking north along (west) shoulder of SBL just north of 1800 mm dia. culvert where there is a slight bulge along the embankment.

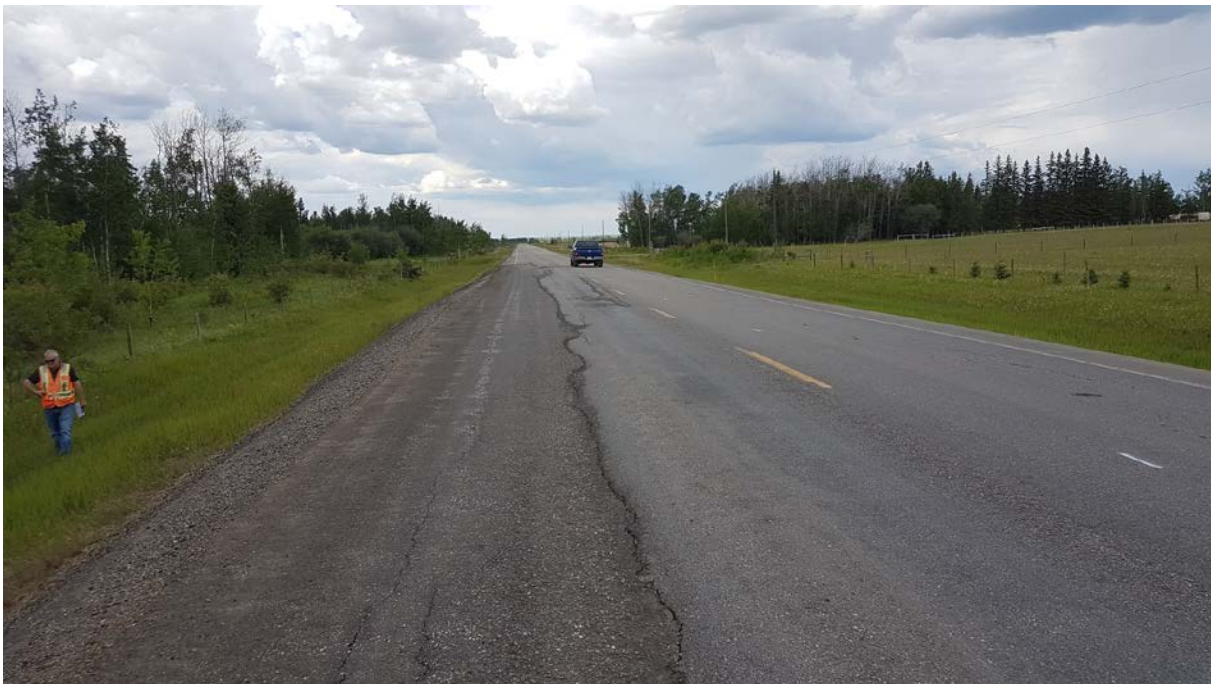
Photo 2 – Looking north at south end of main crack.

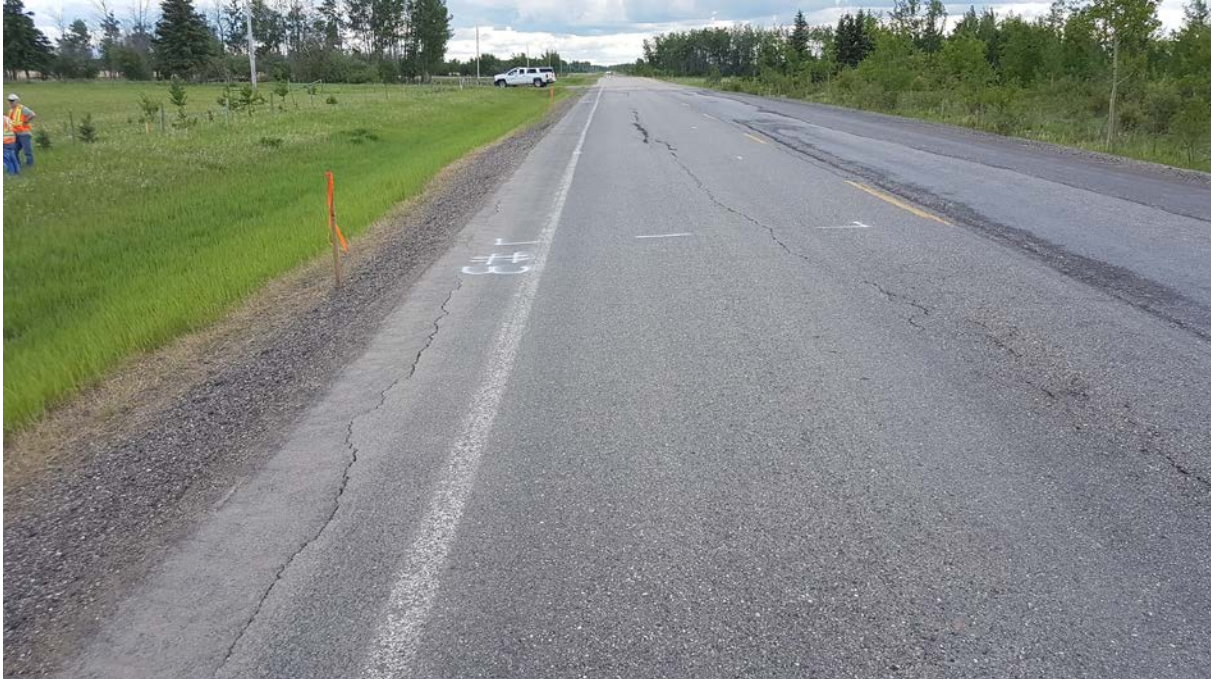
Photo 3: Looking south at new cracking in outer wheel path of NBL and shoulder.

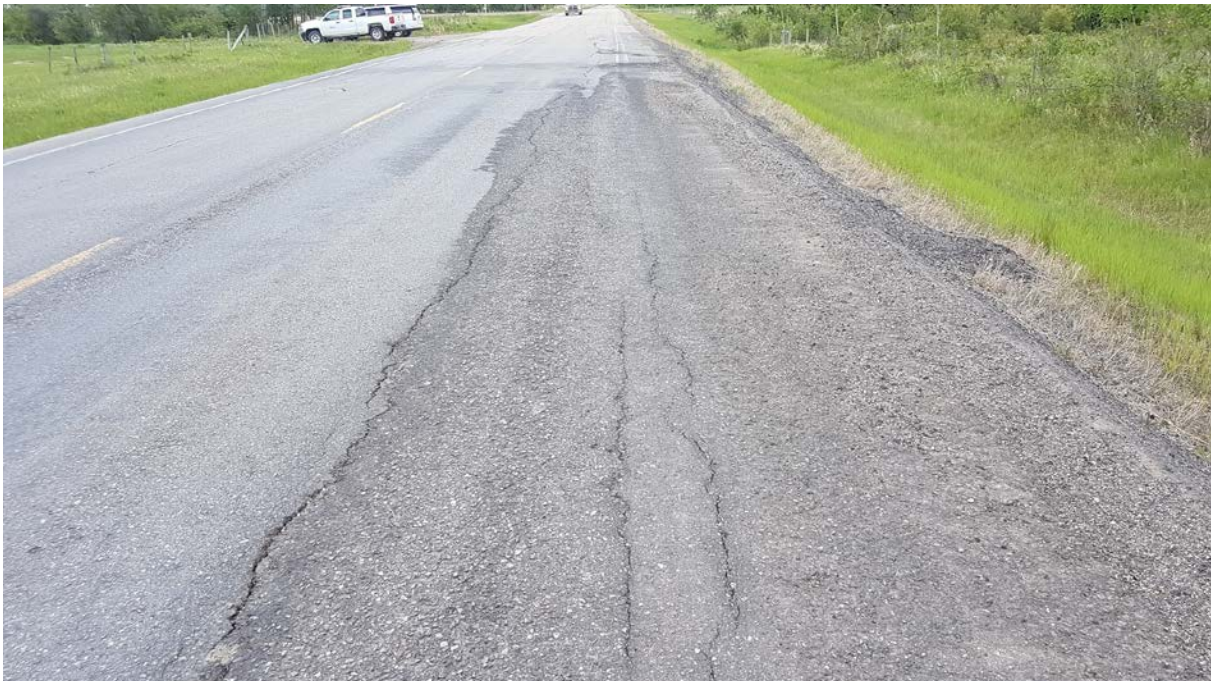
Photo 4: Looking south at previous location of significant cracking in SBL and shoulder.

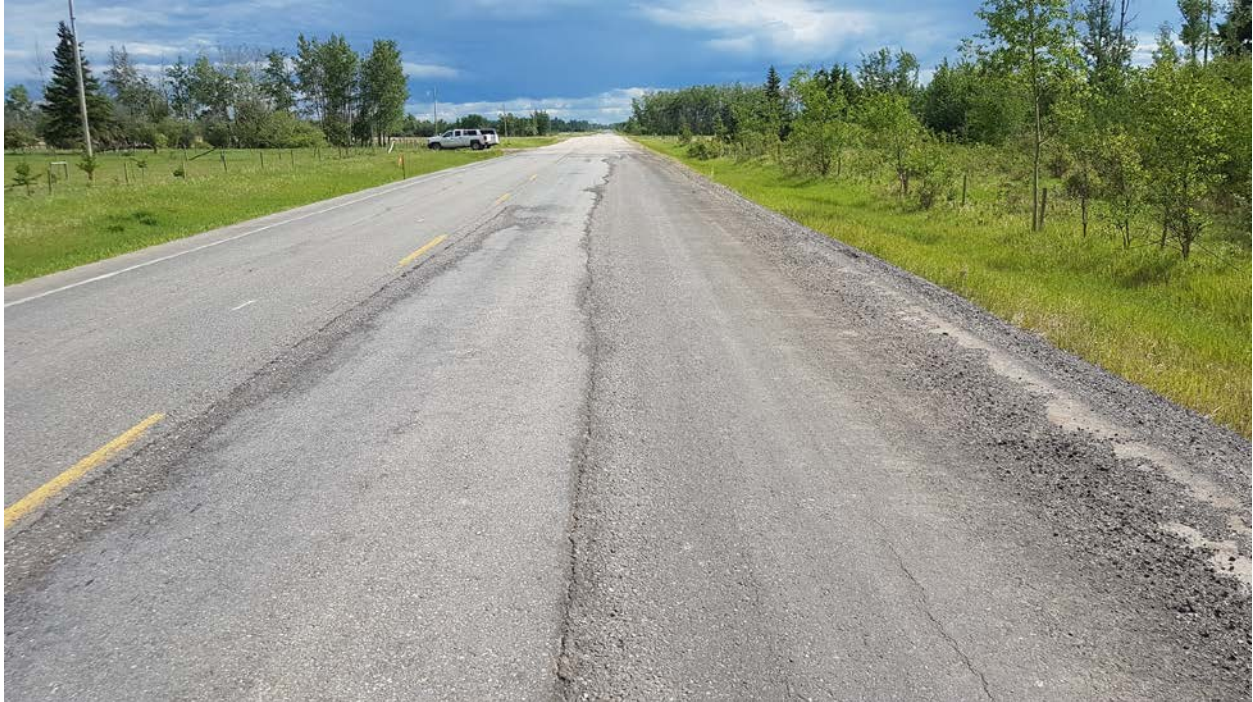
Photo 5: Looking south at main crack and previous void in the shoulder of the SBL.

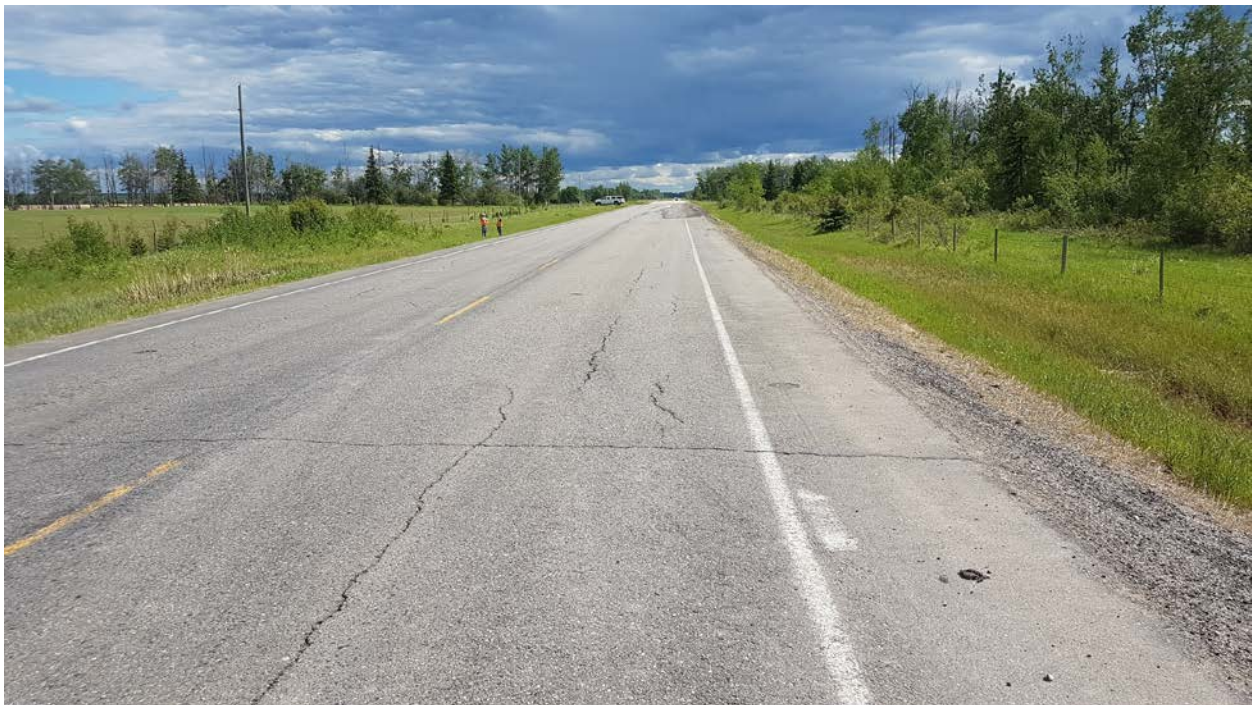
Photo 6 – Looking south at typical SBL cracking near residence approach.
