**ALBERTA TRANSPORTATION
GEOHAZARD ASSESSMENT PROGRAM
PEACE REGION (PEACE RIVER DISTRICT)
2021 INSPECTION**

Site Number	Location	Name	Hwy	km
SH031-1	Southwest of High Prairie	Road Gear Ranch	747:02	32.1-32.3
Legal Description		UTM Co-ordinates		
NE&SE32/NW&SW33-73-19-W5M		11U E 508,043		N 6,135,622

**SH031-1: HWY 747:02 km 32.1 TO km 32.3
2021 SITE INSPECTION PLAN**

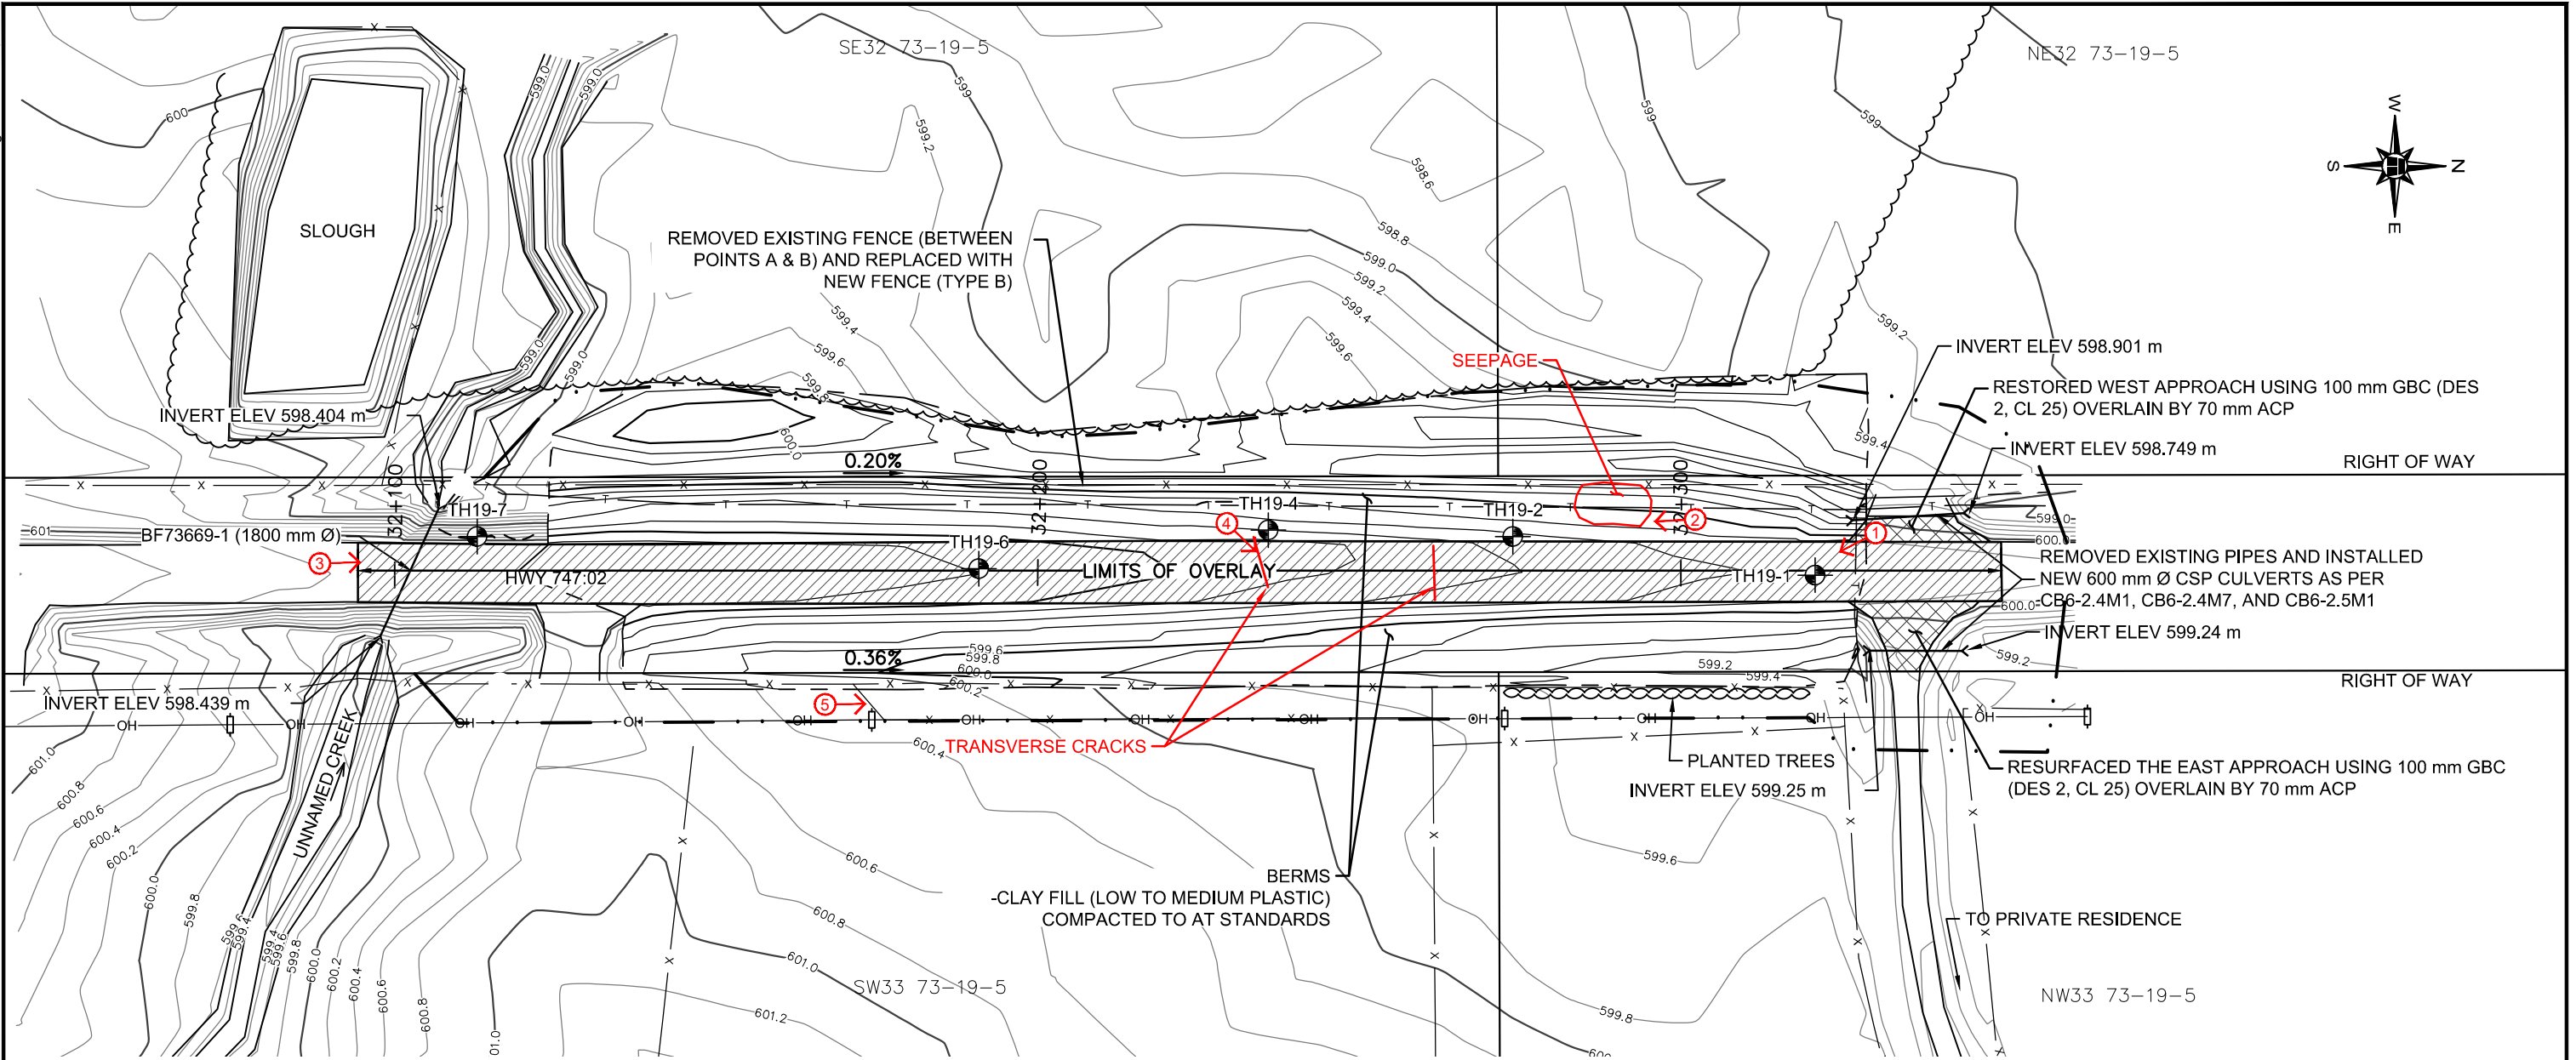
DWG No. 32121-SH031-1

1. ORIGINAL SURVEY COMPLETED BY WSP ON FEBRUARY 5, 2019
2. AS-BUILT SURVEY COMPLETED BY WSP ON JULY 25, 2020
3. ALL DISTURBED AREAS COVERED WITH SALVAGED TOPSOIL AND SEEDED
4. JUNE 2021 OBSERVATIONS SHOWN IN RED.

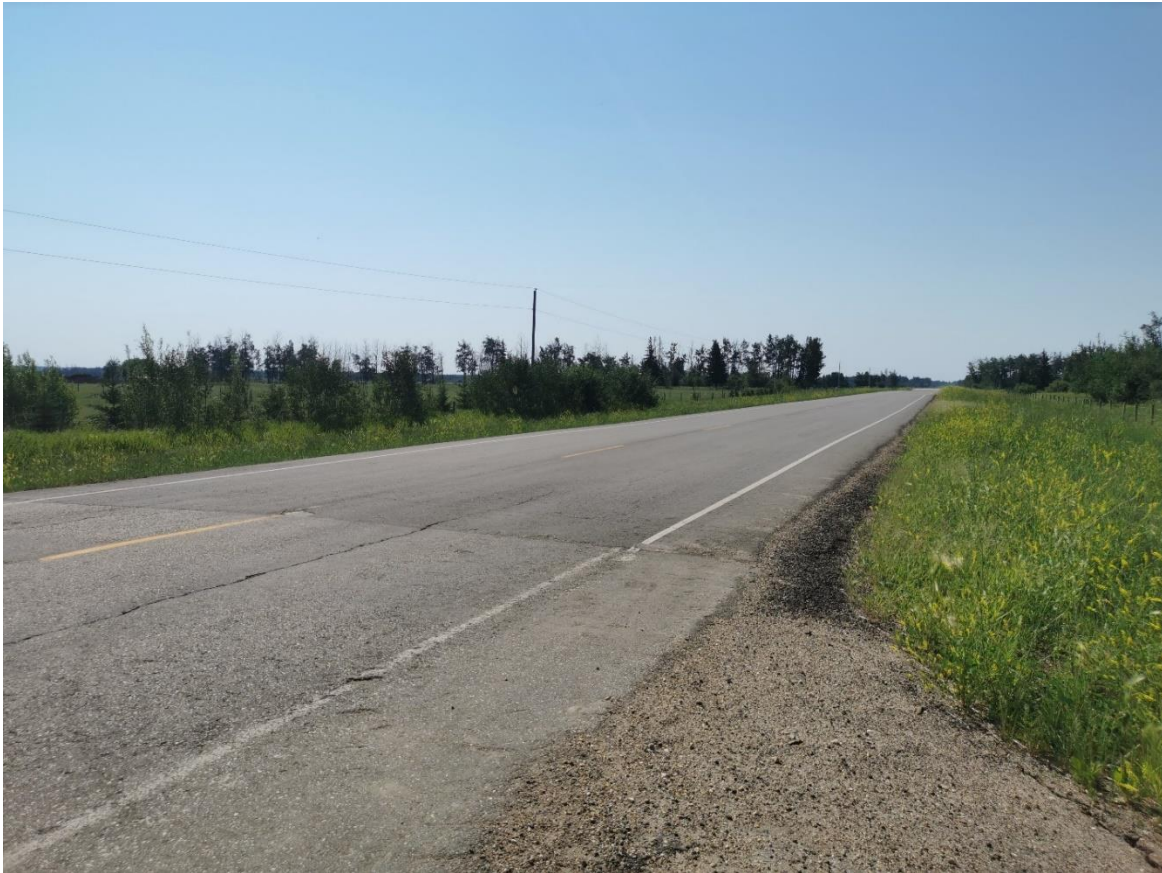
Photo 1 – Looking southeast along SBL at the north end of the site.

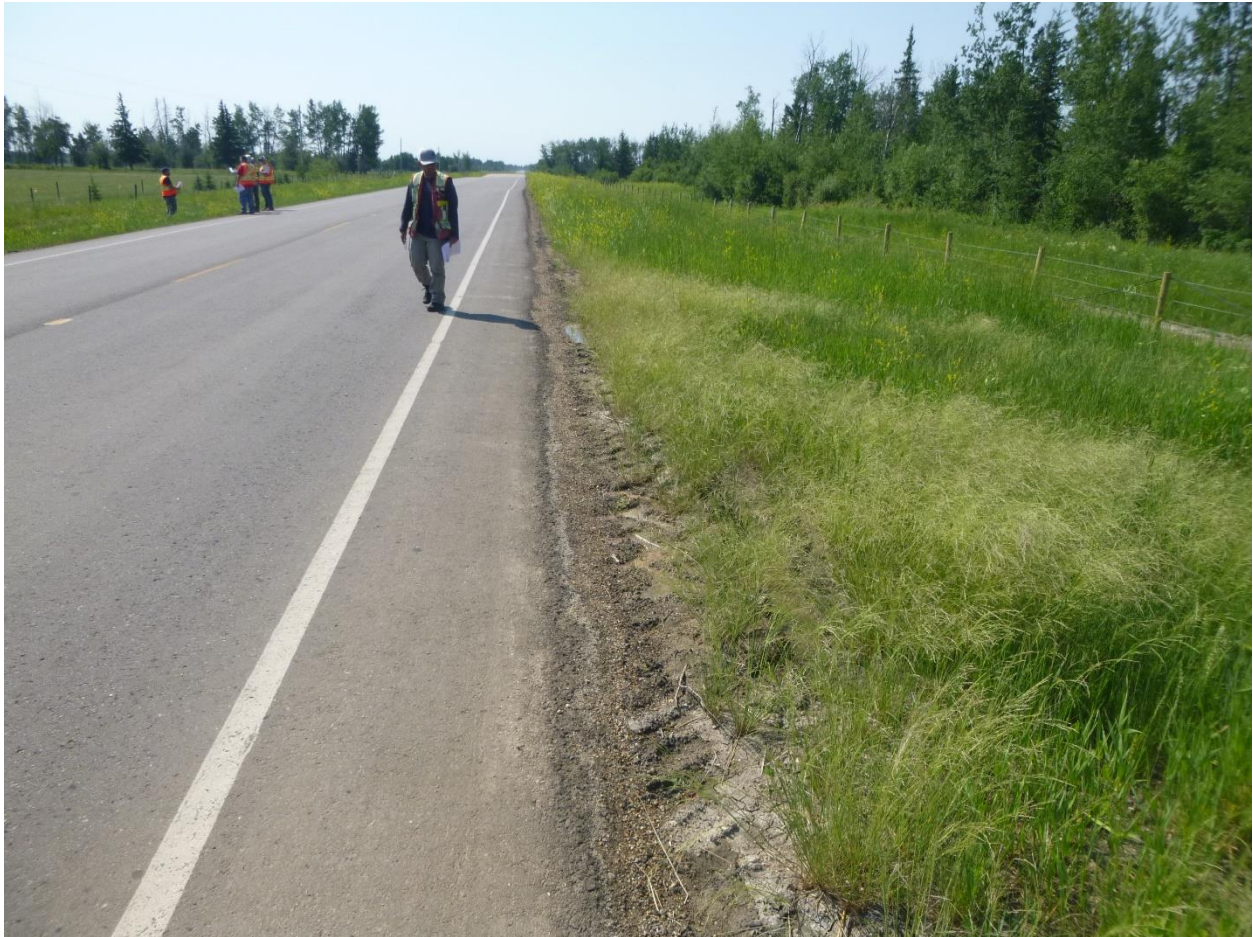
<input checked="" type="checkbox"/> Seepage	Ponded water observed along SBL, just off the pavement	<input type="checkbox"/>
<input checked="" type="checkbox"/> Bridge/Culvert Distress	1800 mm culvert at south end of site – in good condition.	<input type="checkbox"/>
<input type="checkbox"/> Other		<input type="checkbox"/>
Instrumentation:	None	
Assessment:	Landslide activity was noted at this location in June 2016 following a period of higher-than-average rainfall in the preceding weeks. The significant thickness of asphalt through this portion of road would indicate that frequent patching was required in the past prior to the significant movements observed in 2016. At the time of the 2017 assessment, there were several parallel longitudinal cracks along the SBL and shoulder with vertical displacements up to 100 mm and crack widths up to 30 mm. At the

Photo 2 – Looking south along SBL where ponded water was observed just off the pavement.

- Monitor the ponded water along the SBL just off the pavement.
- The bunched-up erosion control blanket along the east ditch should be unravelled and properly stapled to prevent erosion of the ditch in this area.

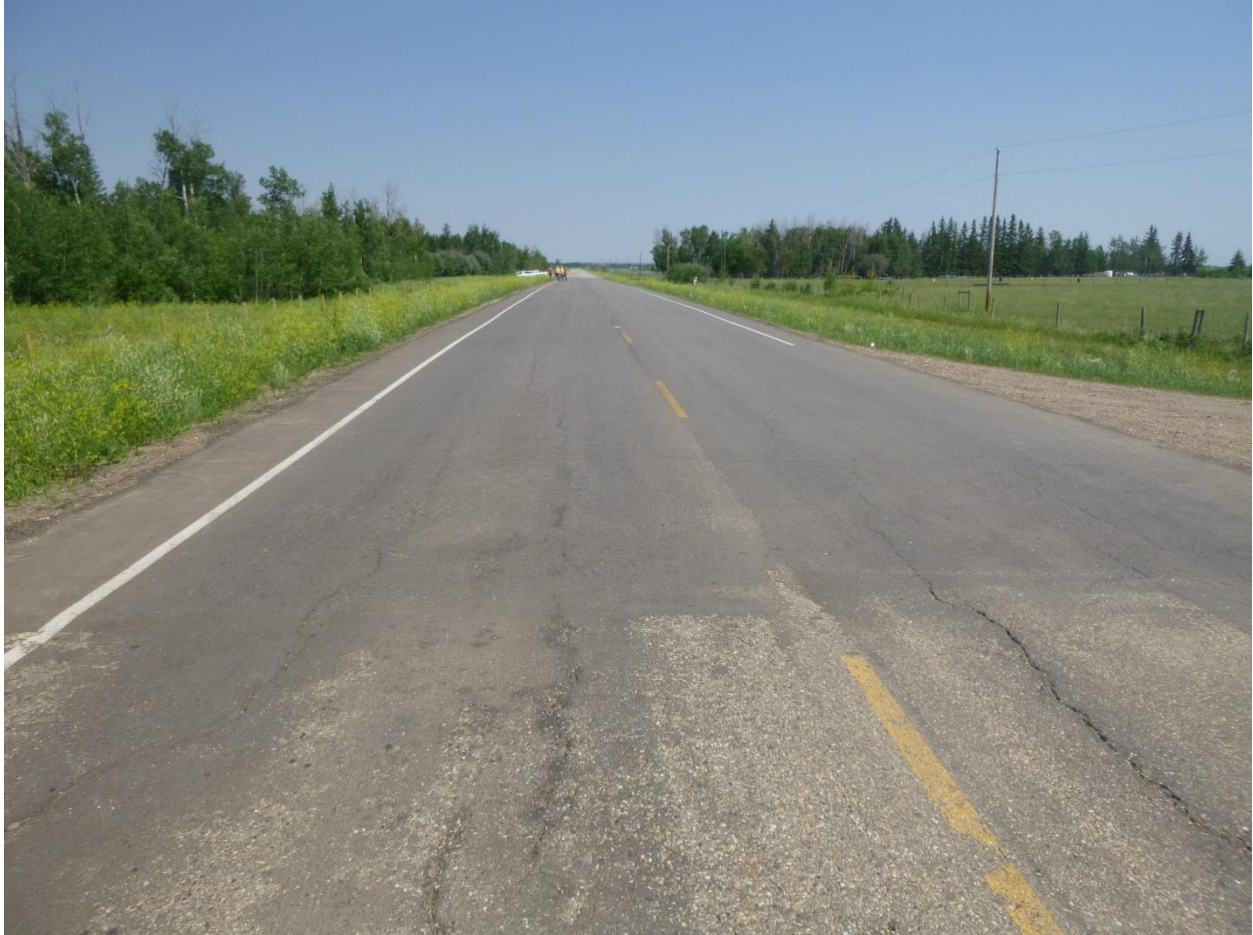
Photo 3: Looking north from the south end of the site near the 1800 mm diameter culvert.

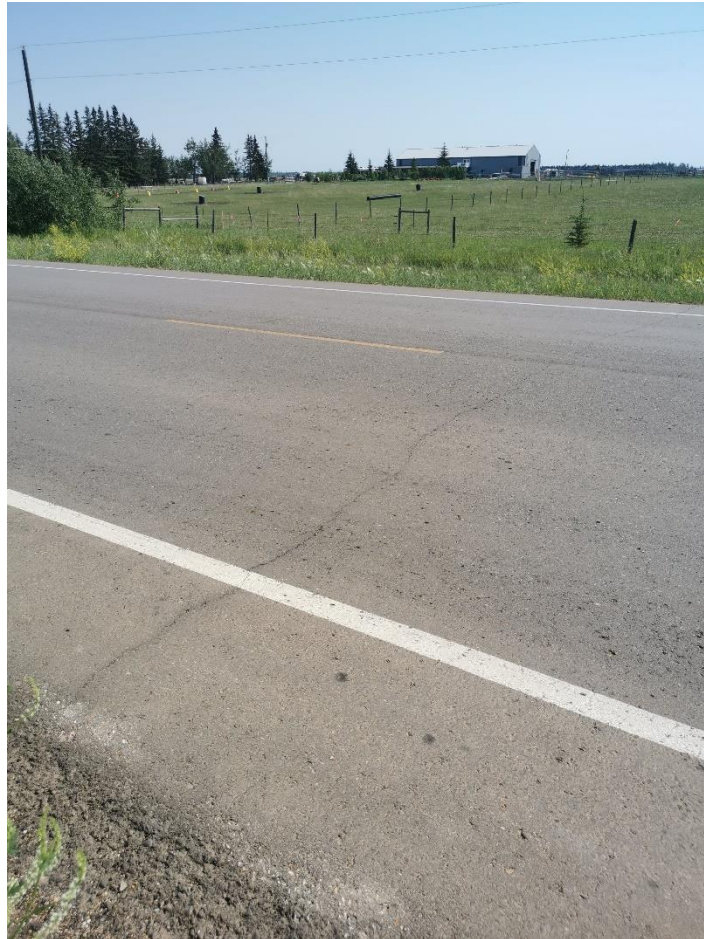
Photo 4: Looking northeast at transverse cracking on the pavement at the middle portion of the site.

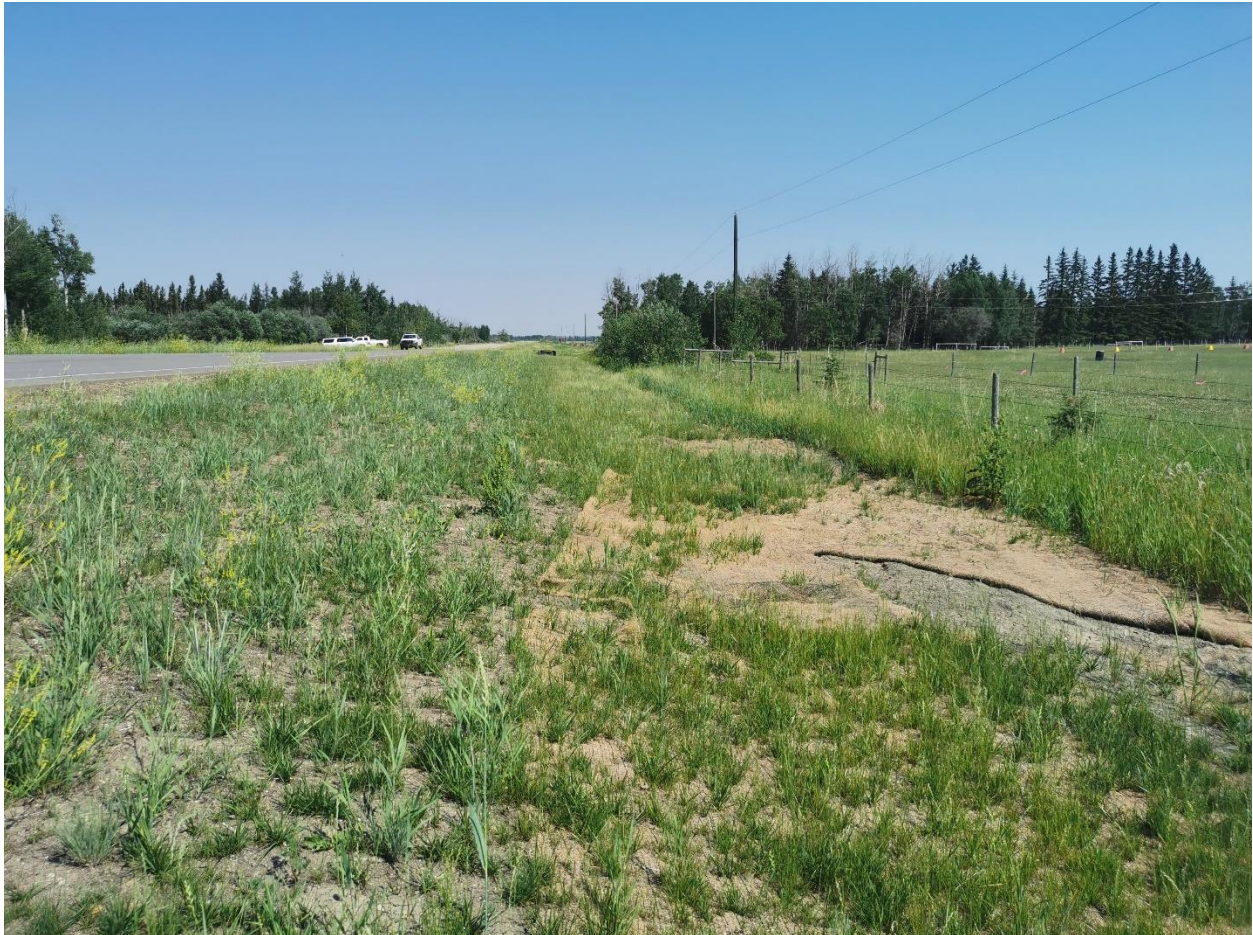
Primary Site Issue:	Longitudinal cracking and subsidence of SBL lane and shoulder.	
Dimensions:	200 m long and embankment heights between 1.5 m and 2 m.	
Date of Remediation:	2020: Constructed earth fill toe berms on both sides of highway; remove and replace approach culverts; install new ACP	
Maintenance:	2016: ACP patching 2017: ACP patching 2018: ACP patching 2019: ACP patching	
Observations:	Description	Worsened?
<input checked="" type="checkbox"/> Pavement Distress	Longitudinal cracking removed with repaving; transverse cracks noted in the middle portion of the site; Longitudinal cracking observed towards the south, past the repaved area	<input type="checkbox"/>
<input checked="" type="checkbox"/> Slope Movement	Slow creep movement significantly reduced with placement of toe berm	<input type="checkbox"/>
<input type="checkbox"/> Erosion	Erosion matting along the east ditch near the fence is bunched up	<input type="checkbox"/>

Photo 5: Looking north along east ditch where erosion control matting is bunched up.
