**ALBERTA TRANSPORTATION AND
ECONOMIC CORRIDORS
GEOHAZARD RISK MANAGEMENT PROGRAM
PEACE REGION (PEACE RIVER DISTRICT)
2025 INSPECTION**

Site Number	Location	Name	Hwy	km
SH031-1	Southwest of High Prairie	Road Gear Ranch	747:02	32.1-32.3
Legal Description		UTM Co-ordinates		
NE&SE32/NW&SW33-73-19-W5M		11U E 508,043	N 6,135,622

SH031-1: HWY 747:02 km 32.1 TO km 32.3
2025 SITE INSPECTION PLAN

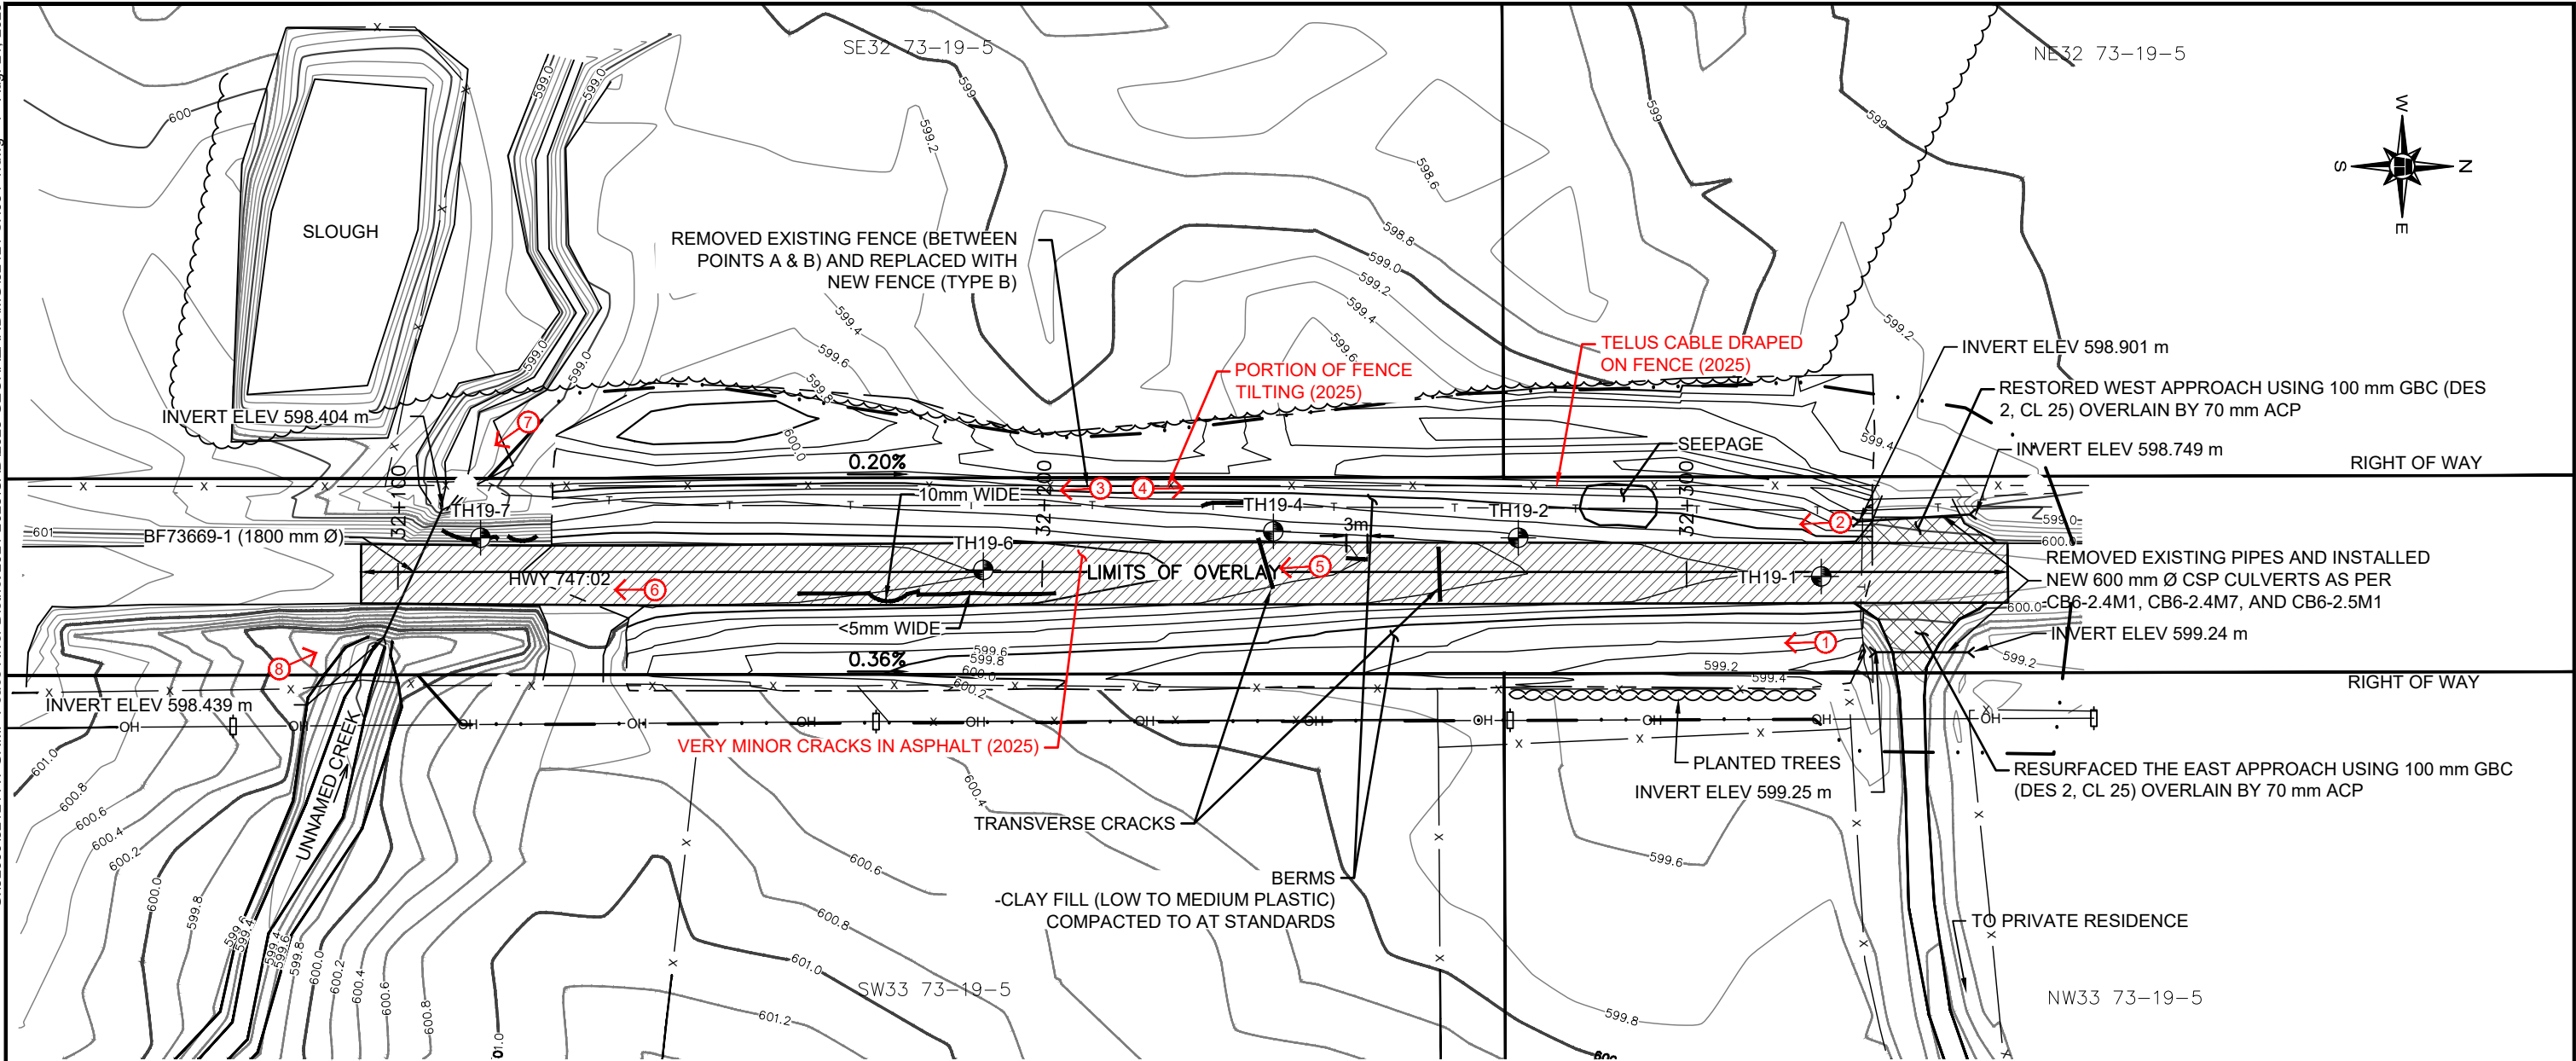
DWG No. 32121-SH031-1

- ORIGINAL SURVEY COMPLETED BY WSP ON FEBRUARY 5, 2019
- AS-BUILT SURVEY COMPLETED BY WSP ON JULY 25, 2020
- ALL DISTURBED AREAS COVERED WITH SALVAGED TOPSOIL AND SEEDED
- MAY 2025 OBSERVATIONS SHOWN IN RED.

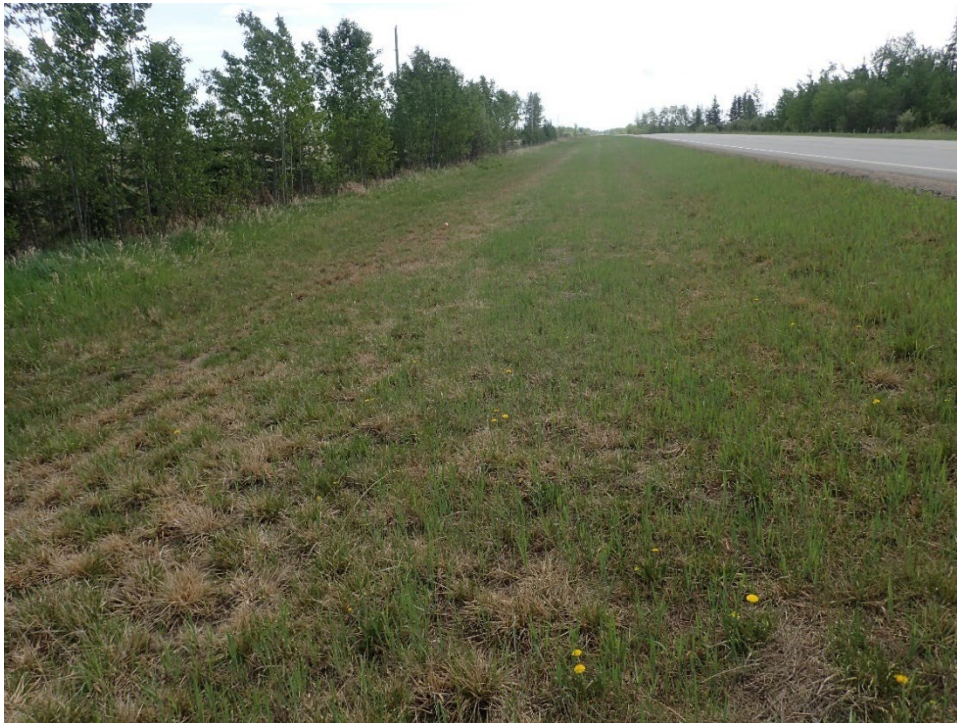
Photo 1 – Looking south along east ditch at the north end of the site.

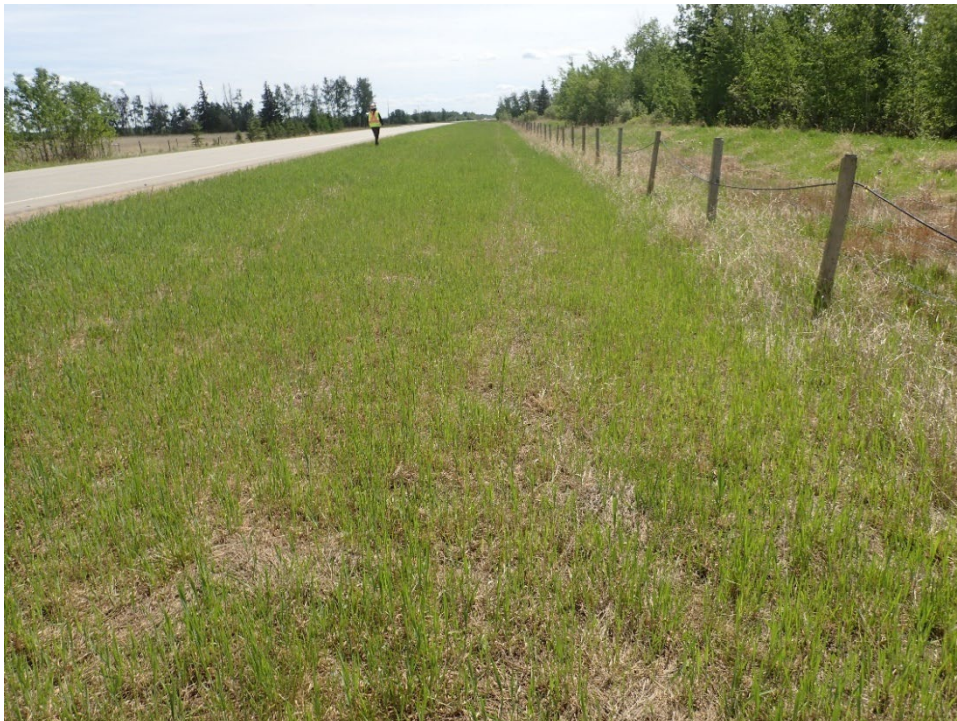
Photo 2 – Looking south along west ditch at the north end of the site.

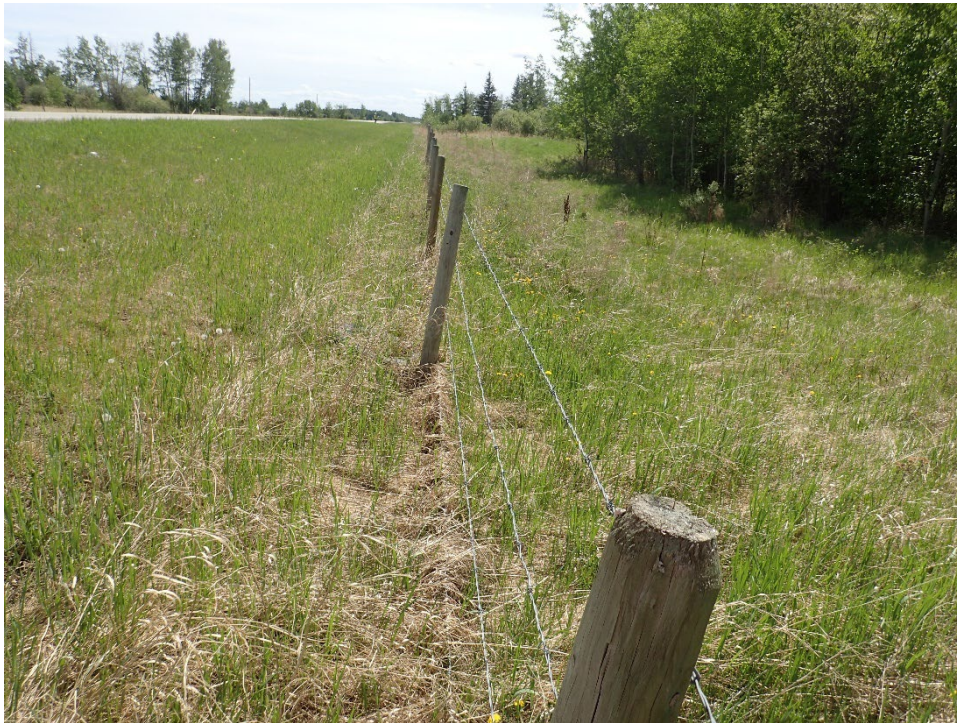
Photo 3: Looking south along west ditch at portion of fence that is tilting.

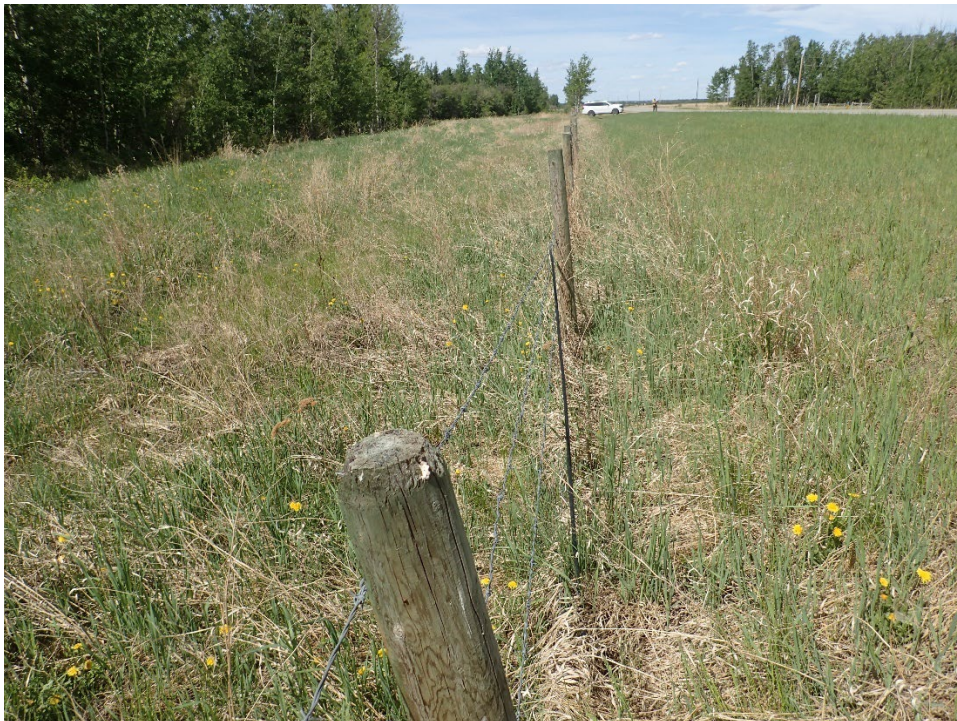
Photo 4: Looking north along west ditch where Telus cable was draped on fence.

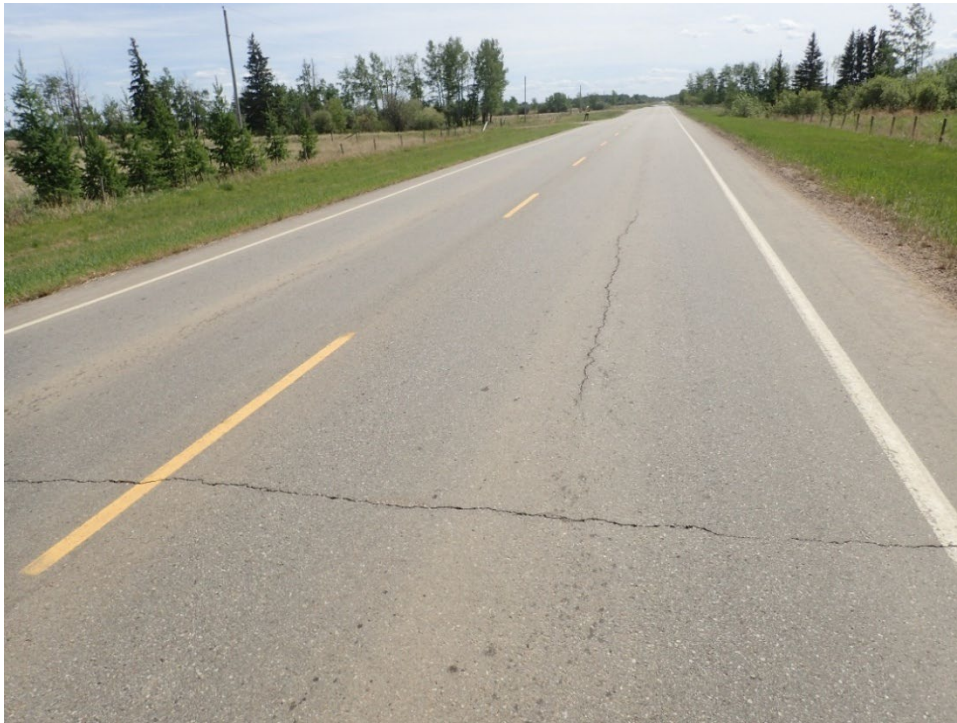
Photo 5: Looking south along southbound lane.

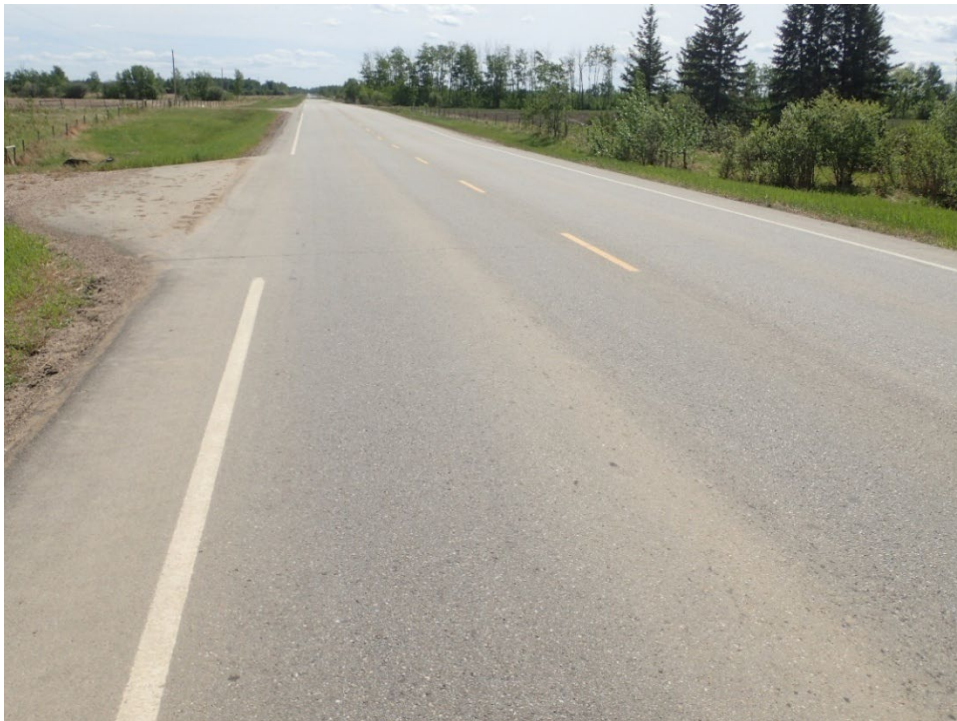
Photo 6: Looking south along northbound lane at south end of site.

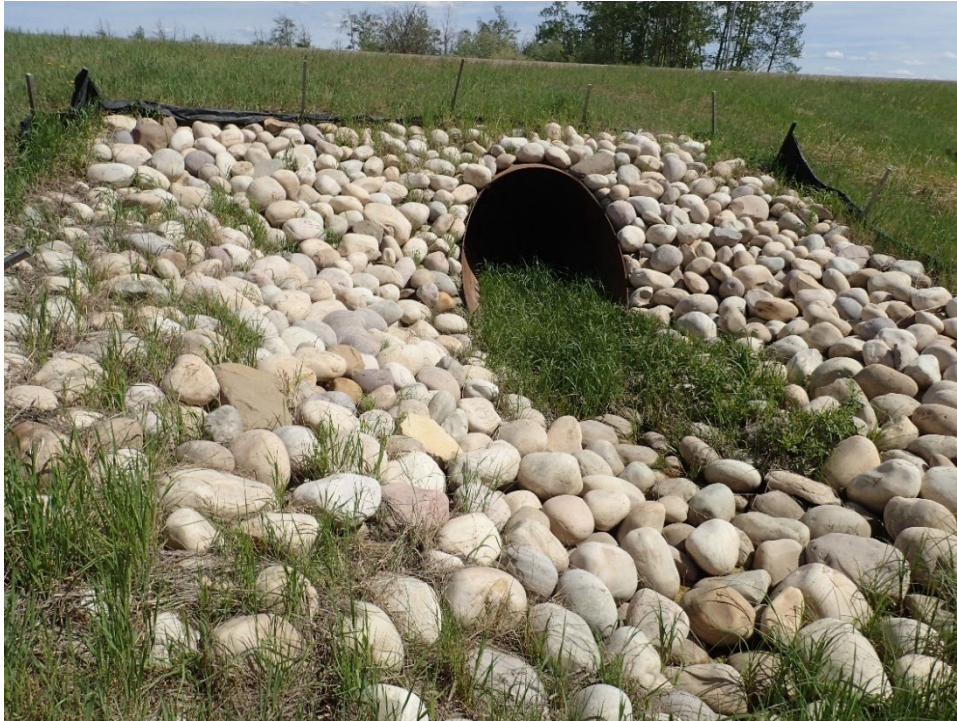
Photo 7: Looking southeast at SWSP culvert outlet.

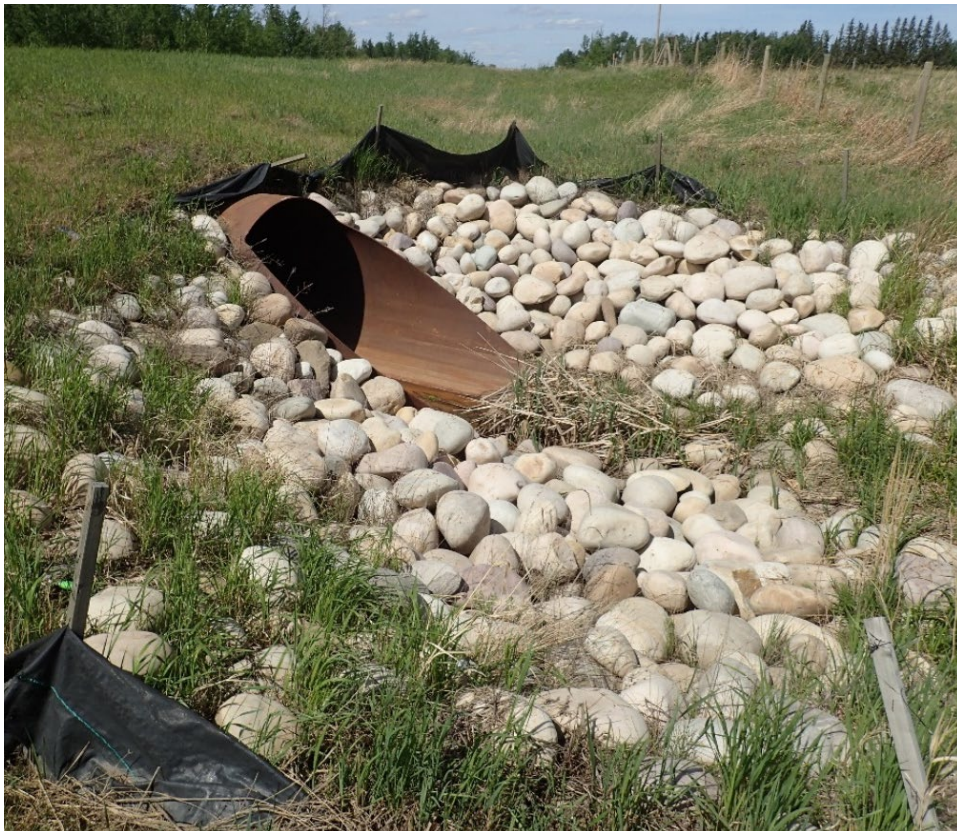
Photo 8: Looking northwest at SWSP culvert inlet.
