**ALBERTA TRANSPORTATION
GEOHAZARD ASSESSMENT PROGRAM
PEACE REGION – PEACE RIVER DISTRICT
2022 CALLOUT INSPECTION**

Site Number	Location	Name	Hwy	km
Callout	S of High Prairie	Nicholls Creek Slide	747:02	35.2
Legal Description		UTM Co-ordinates (NAD 83)		
SW09-74-19-W5		11U N 6,138,622	E 508,118

Date	PF	CF	Total
Previous Inspection:				
Current Inspection:	August 9, 2022	12	4	48
Road AADT:	440	Year:		2021
Inspected By:	Don Proudfoot, Nicole Wilder (Thurber) Ed Szmata, Max Shannon (AT)			
Report Attachments:	<input checked="" type="checkbox"/> Photographs <input checked="" type="checkbox"/> Plans <input type="checkbox"/> Maintenance Items

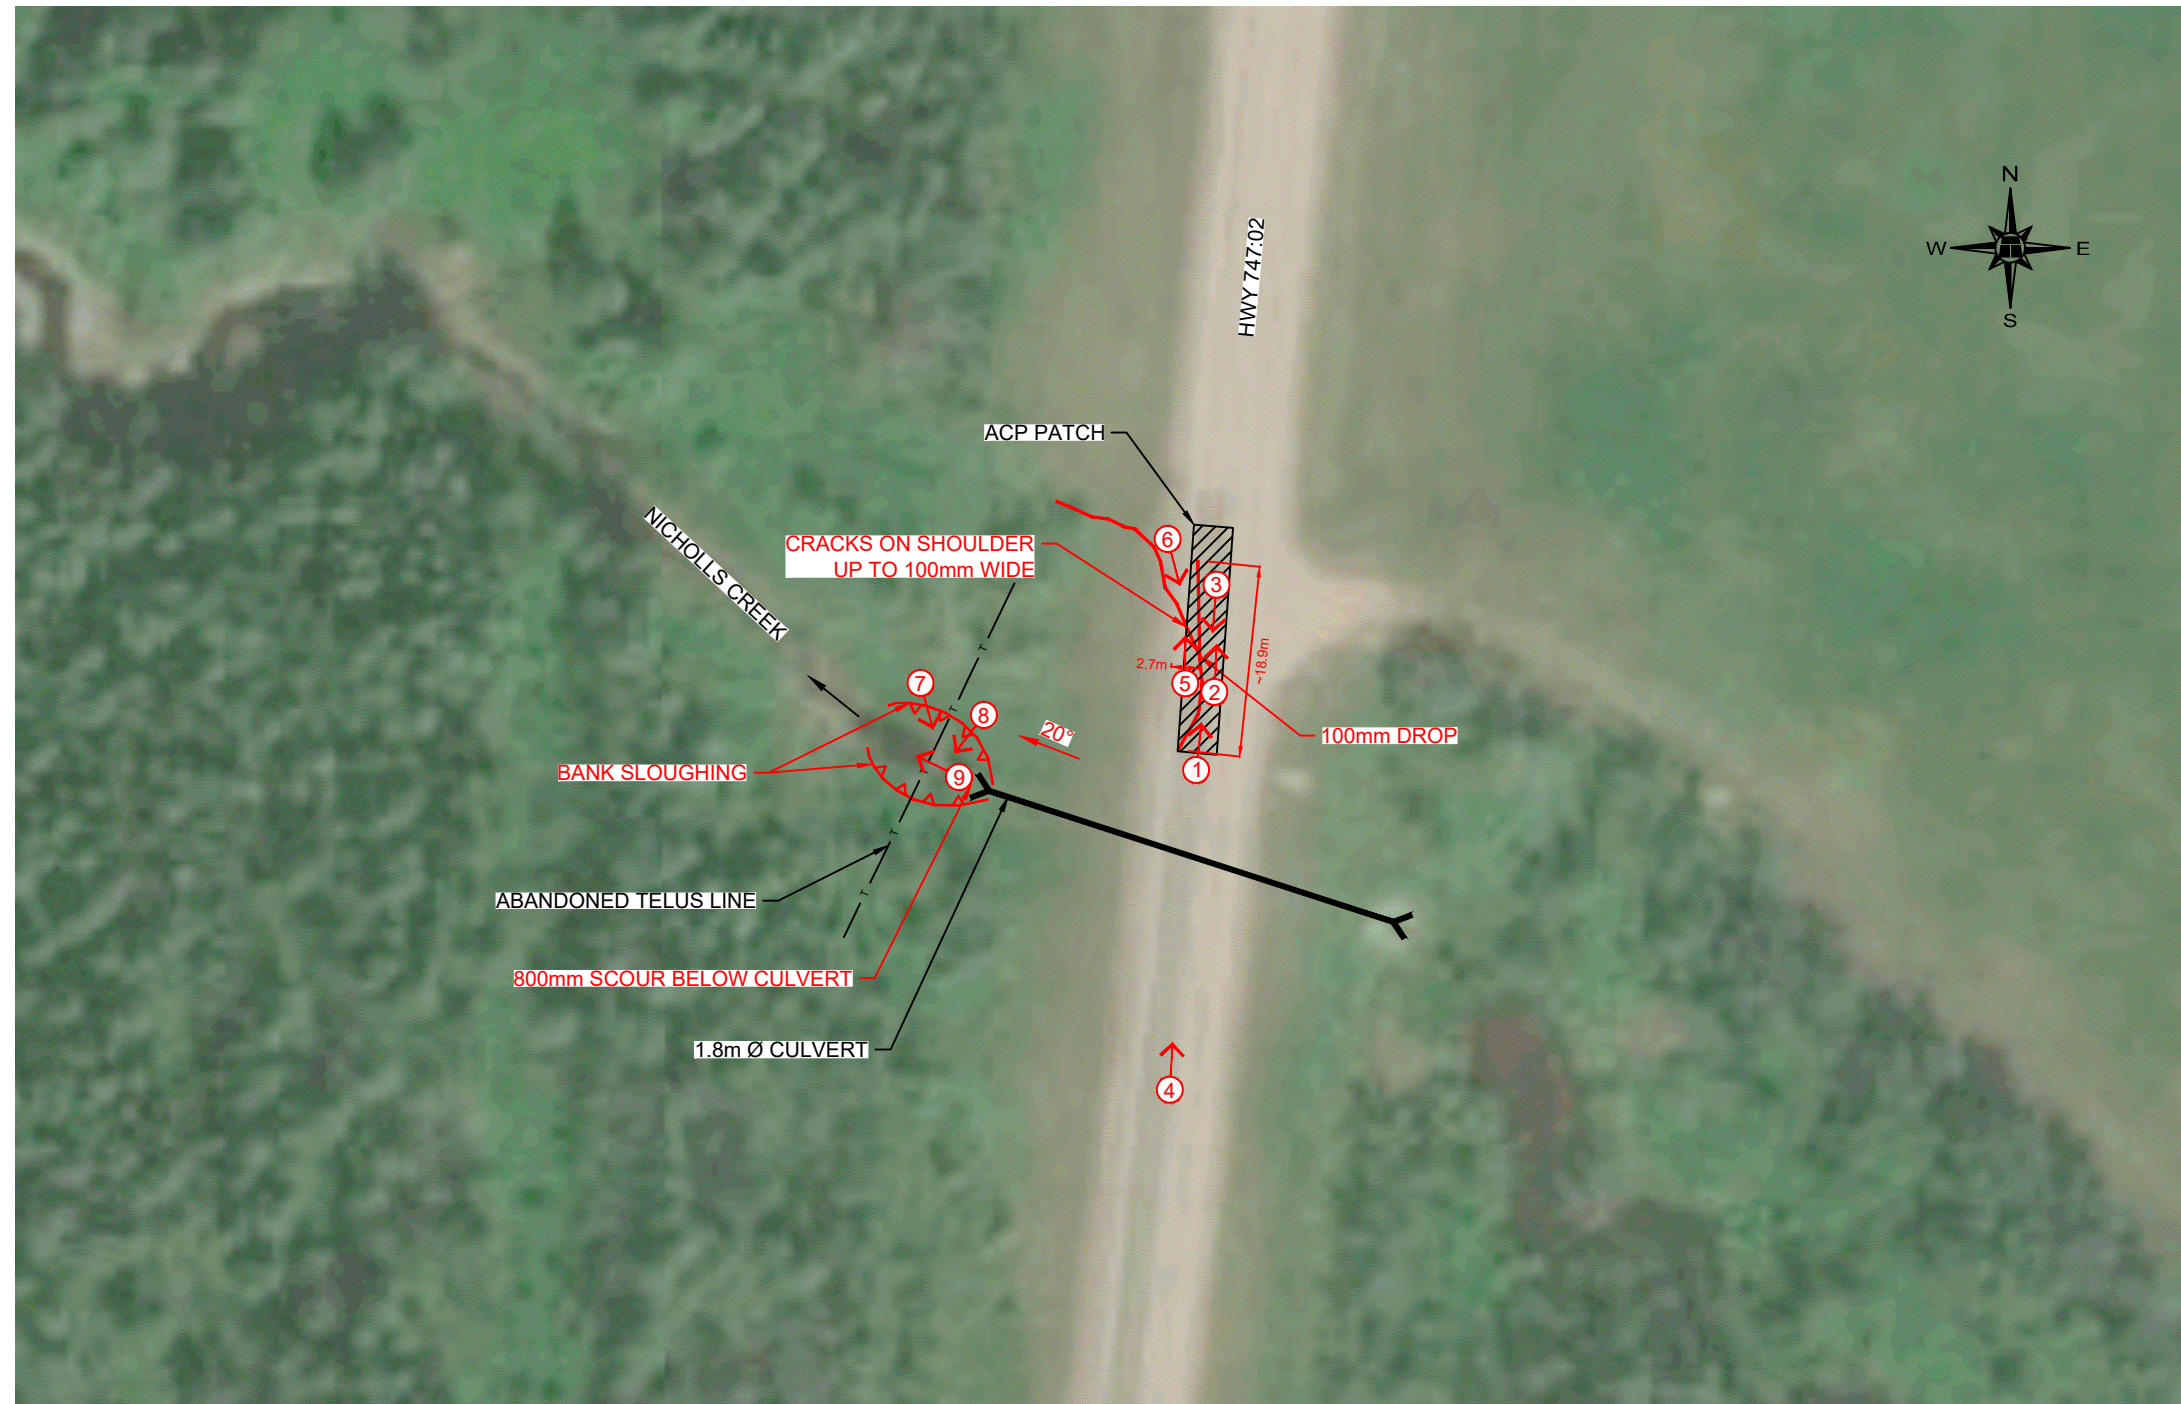
FIGURE 1

**HWY 747:02 km 35.2 NICHOLLS CREEK
CALLOUT SITE PLAN**

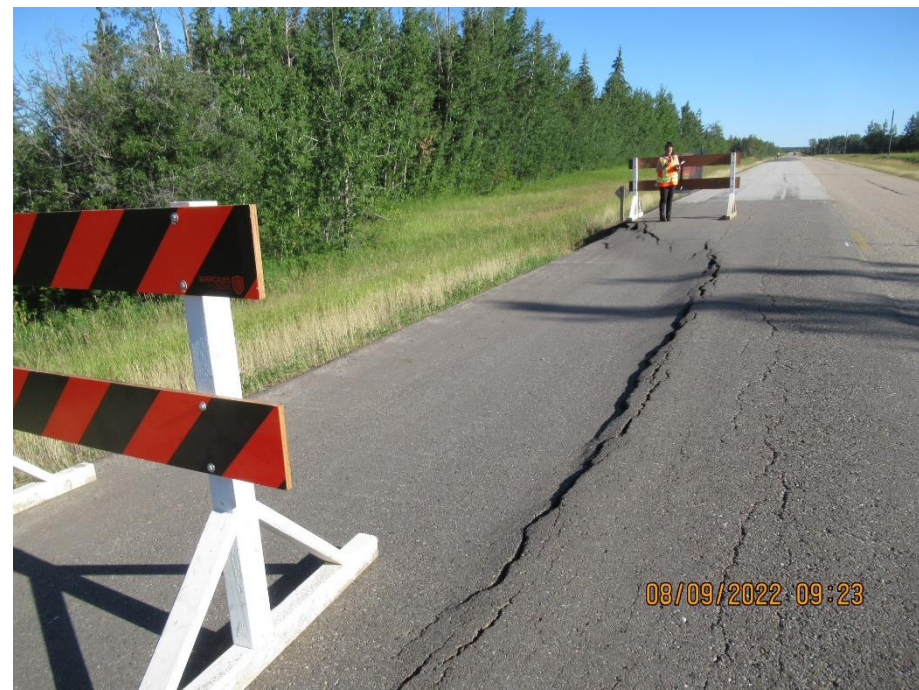
The pavement in the southbound lane has dropped approximately 100 mm over an 18 m length, hence why it was blocked off from traffic. It appeared that the road had been patched several times over the years as approximately 300 mm of ACP was observed near the middle of the slide

Photo 1.
Looking north at scarp affecting the southbound lane.

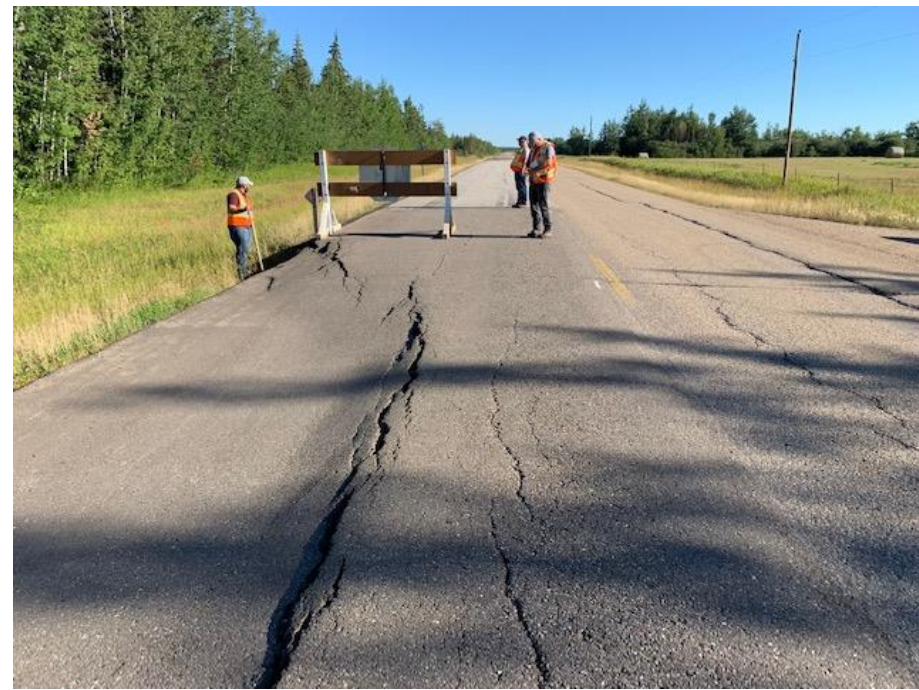
Photo 2.
Looking north standing near middle of scarp crack.

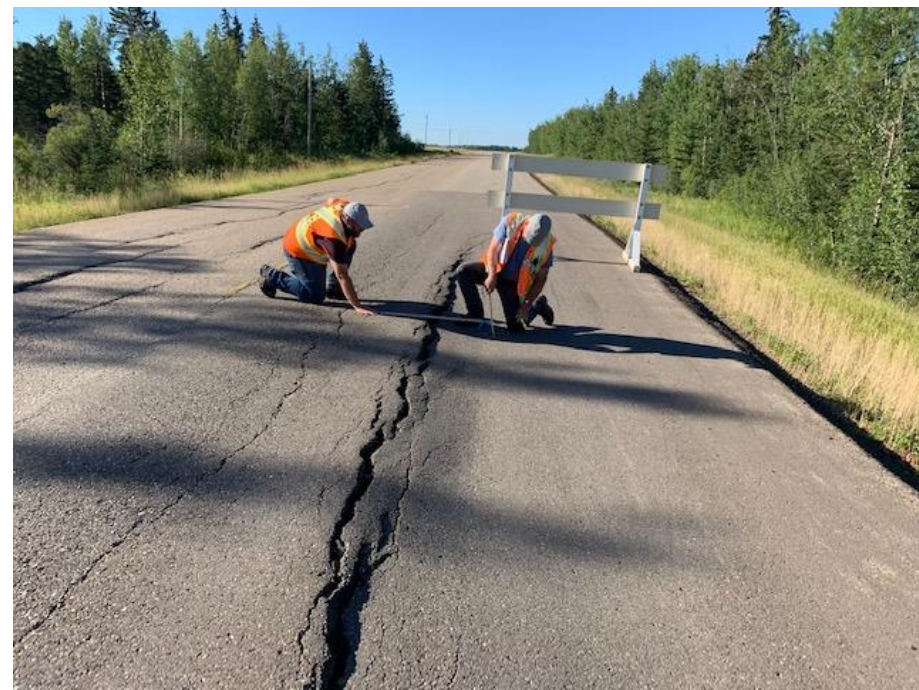
Photo 3.
Looking south at
scarp drop being
measured.

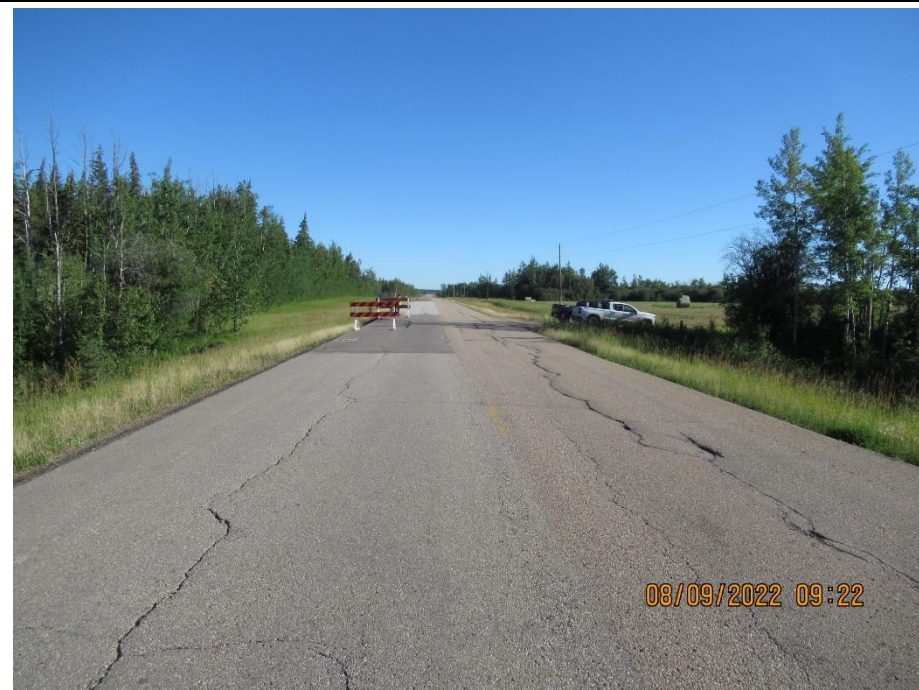
Photo 4.
Looking north at
lane patching and
barricades on
either side of scarp.

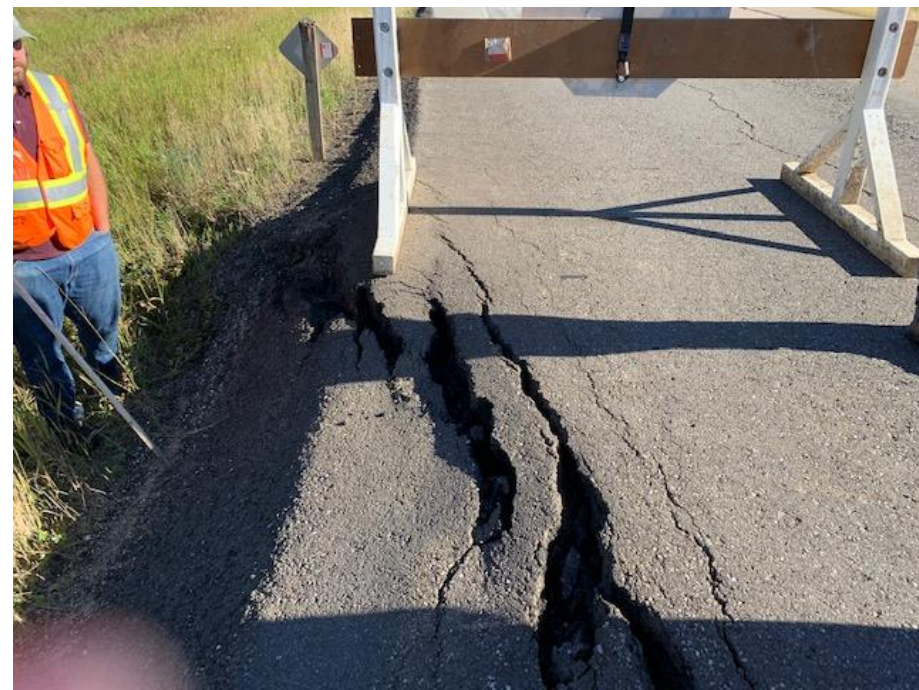
Photo 5.
Looking at cracks
on shoulder of
highway open up to
100 mm wide.

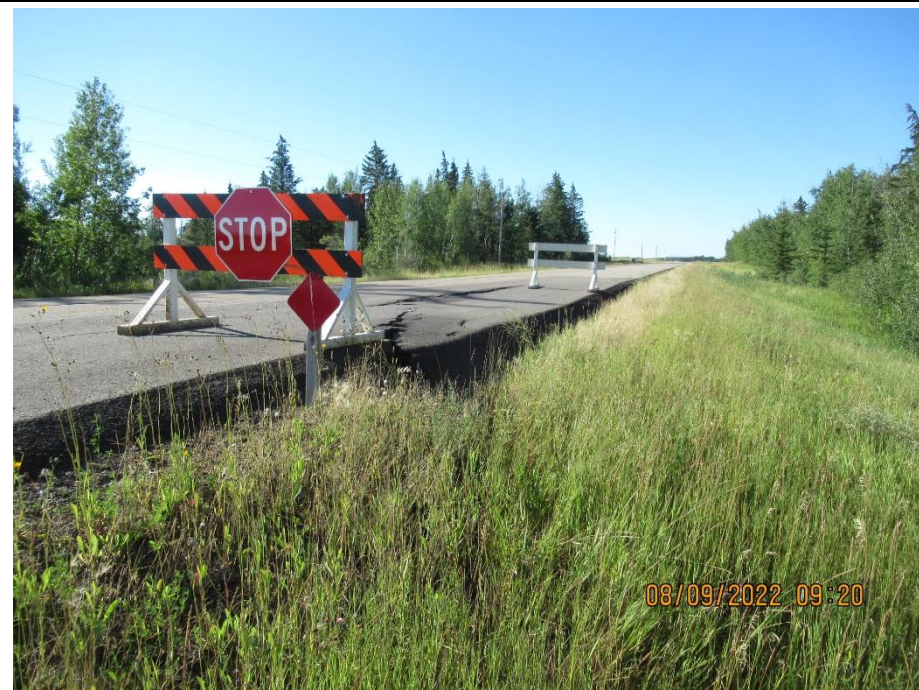
Photo 6.
Looking southeast
at where scarp
extends into the
grass.

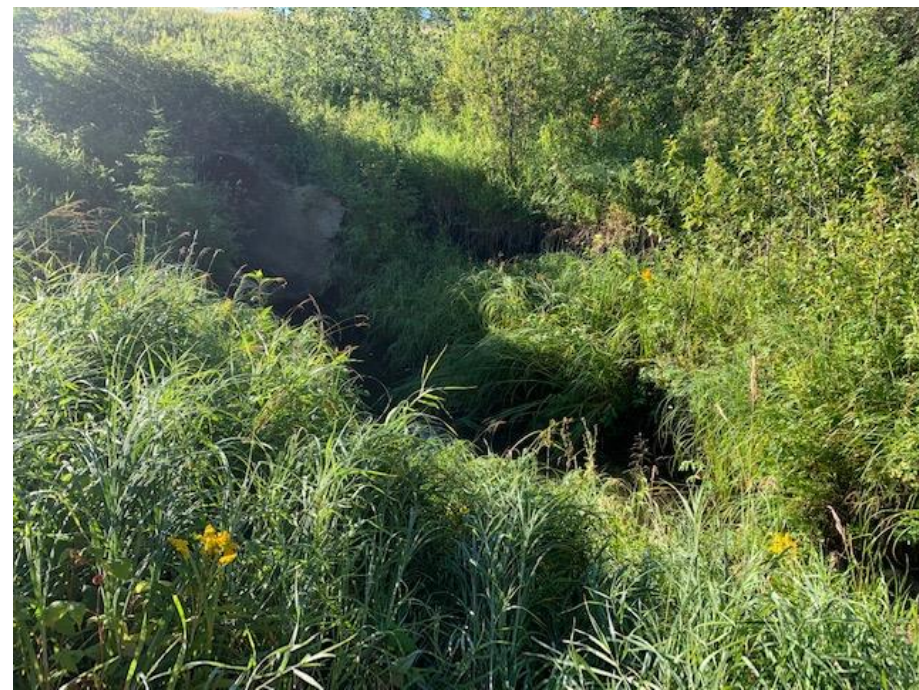
Photo 7.
Looking east at
1.8 m diameter
corrugated multi-
plate.

A temporary detour will likely have to be constructed on the east side of existing highway to accommodate traffic during construction. The outlet of the culvert should also be rehabilitated, and Class 2 riprap placed around the outlet and downstream to mitigate the scour issue. A water act permit might be required to perform in-stream work. The cost of the detour is included in the above ballpark costs. The ballpark cost for the culvert rehabilitation and riprap is provided below.

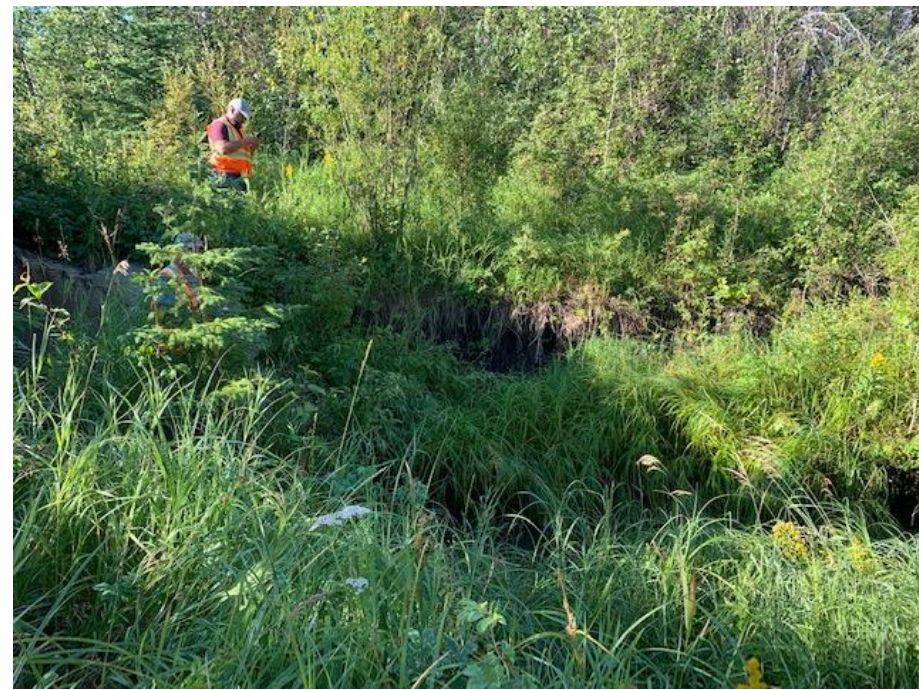
The creek appears to be eroding/undercutting the bank which causes overhang to slough into the creek and this process continues to retrogress towards the highway, is now behind the culvert outlet and there is also a scour hole below the culver outlet.

Photo 8.
Looking south at
where bank erosion
has taken place.

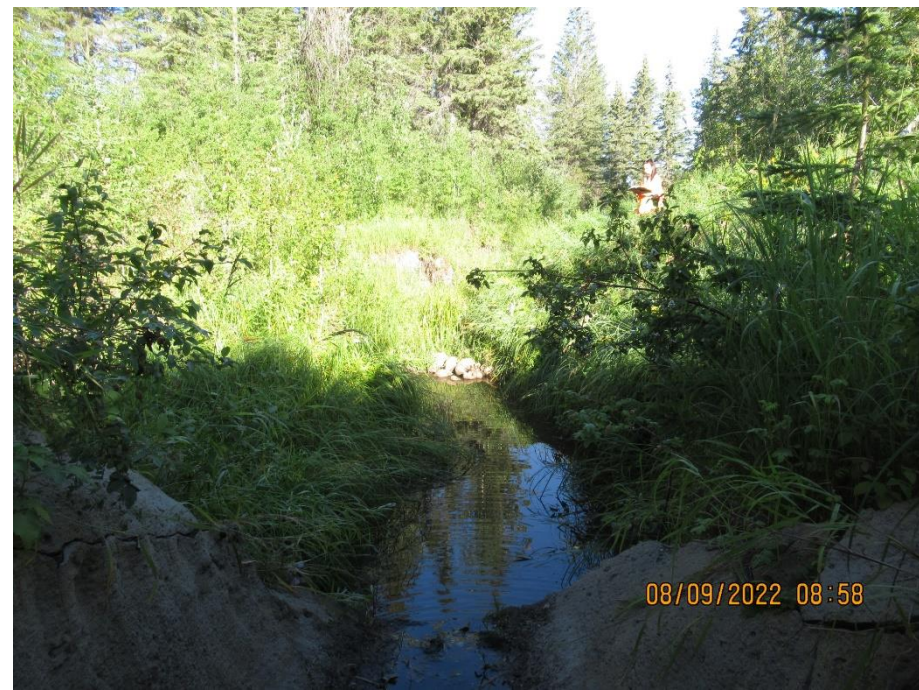
Photo 9.
Looking west from
culvert outlet at
creek and creek
erosion.
