**ALBERTA TRANSPORTATION  
GEOHAZARD ASSESSMENT PROGRAM  
PEACE REGION – SWAN HILLS DISTRICT  
2020 CALL OUT INSPECTION**

| Call Out | South of High Prairie | West Prairie River Oxbow Slide | 749:02 | 20.2 |

| <b>Current Inspection:</b> | June 18, 2020 | 13 | 4 | 52 |

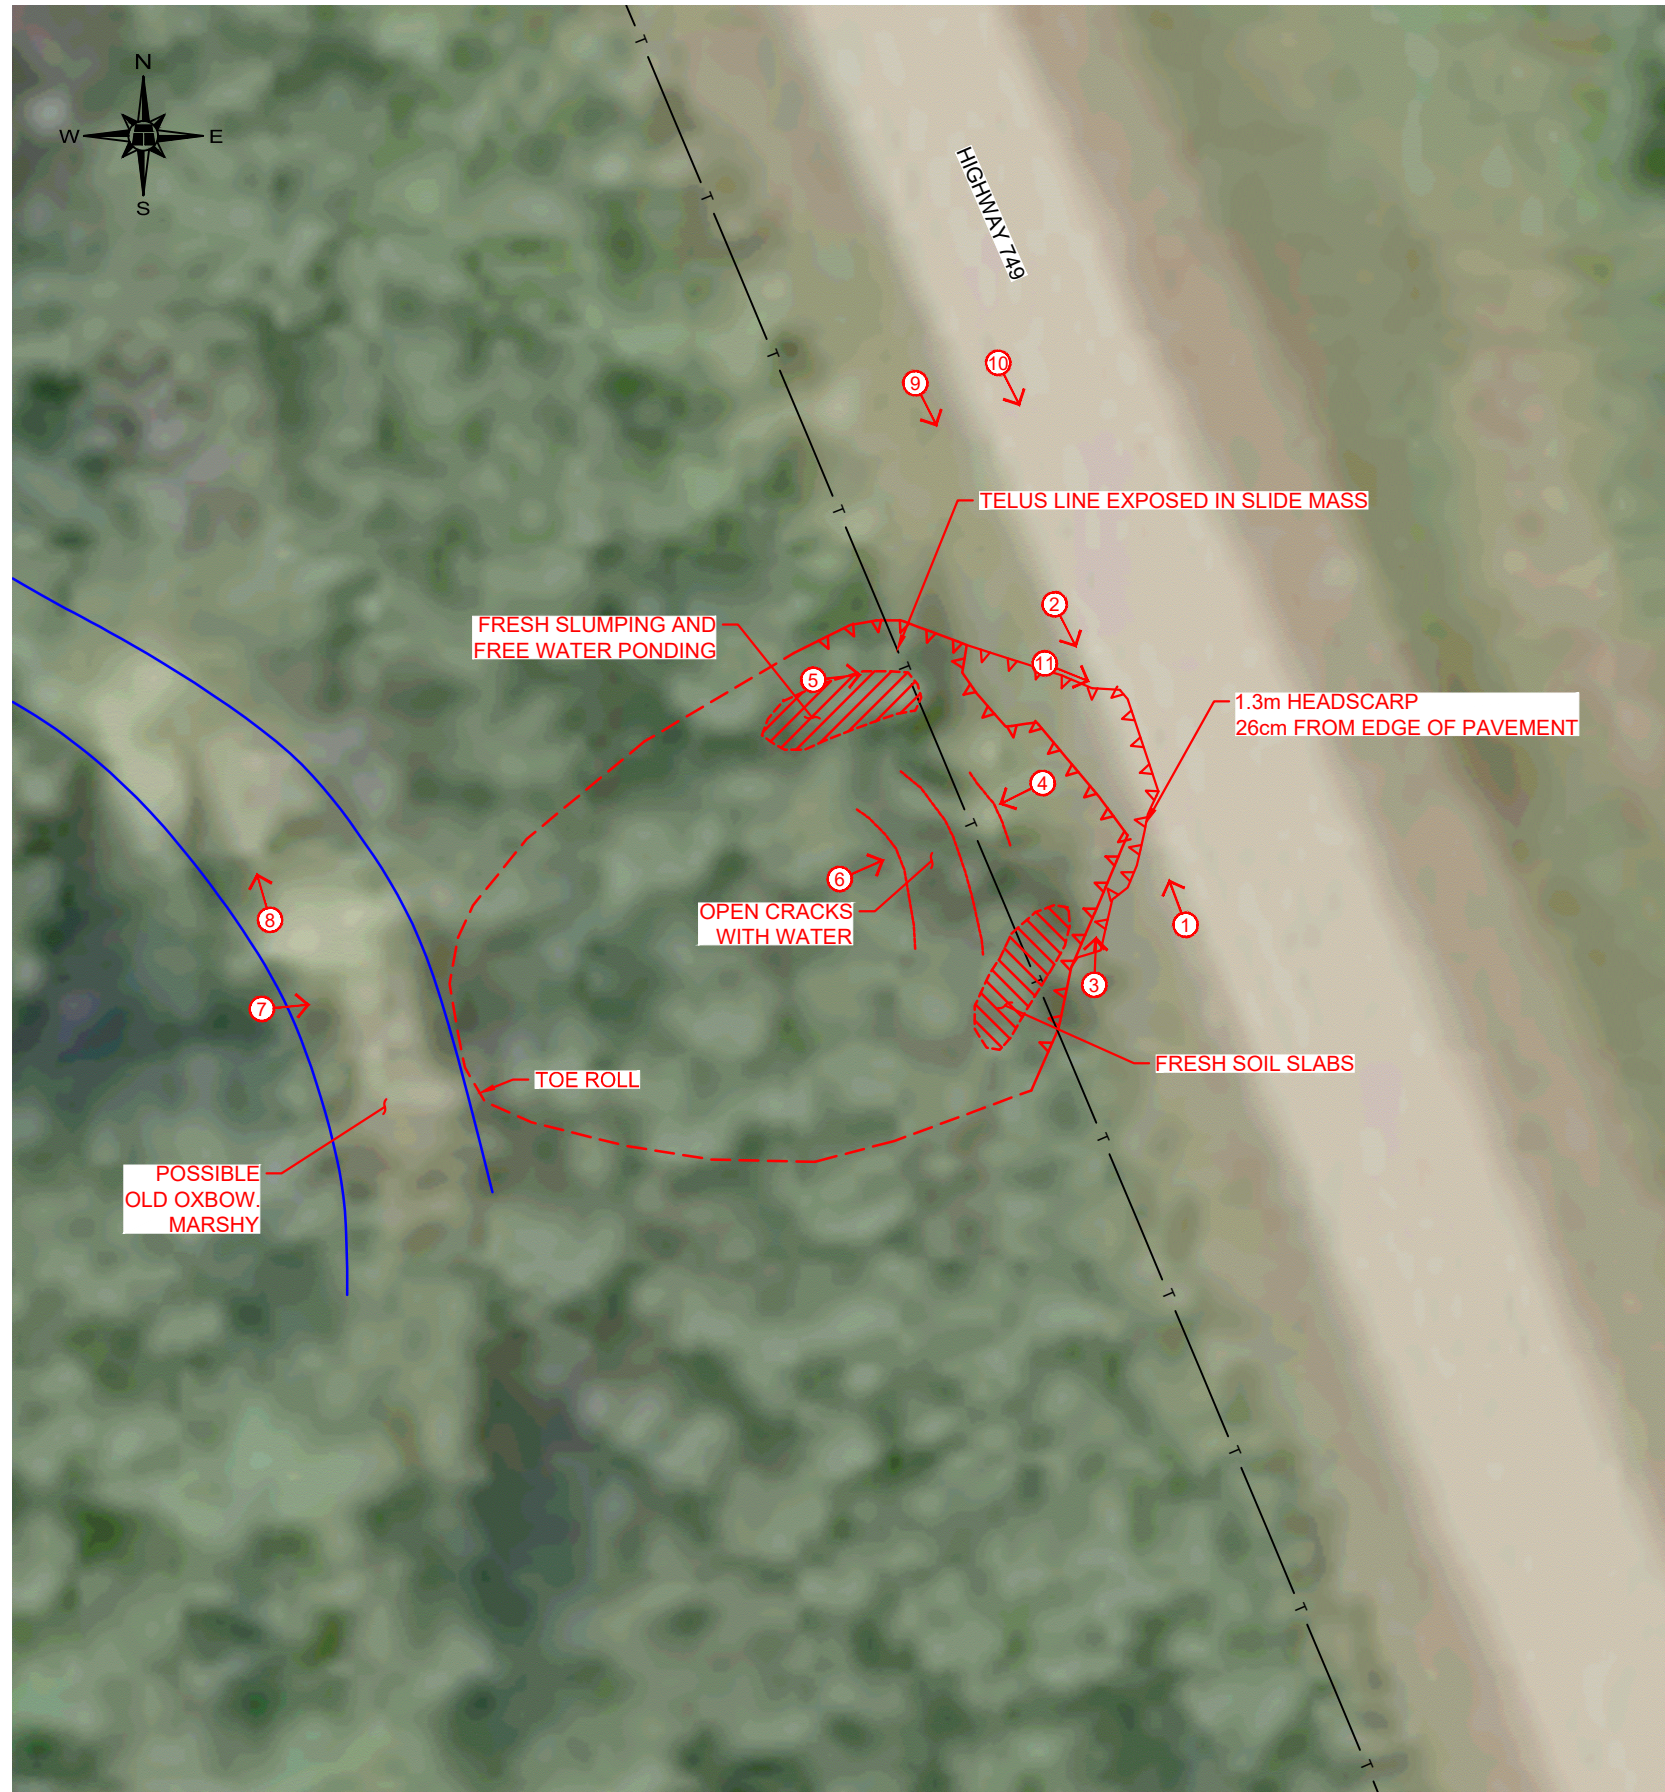
**FIGURE 1**

**SITE PLAN**  
SCALE 1:400

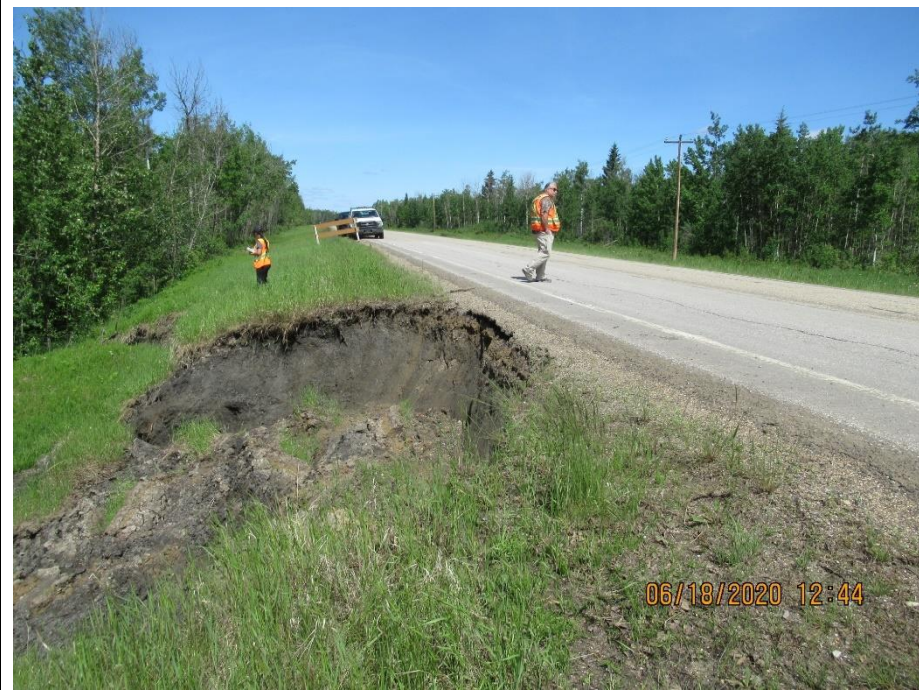
It is anticipated that the slide is a relatively shallow, retrogressive slide that was triggered by water seepage and weathering leading to loss of cohesion in the embankment fill. Weak high plastic clay embankment materials and a relatively steep slope may also have contributed to causing the slide. The main scarp of the active landslide is retrogressing further back towards the highway and was measured

**Photo 1.**  
Looking north at  
backscarp  
retrogression  
towards highway.

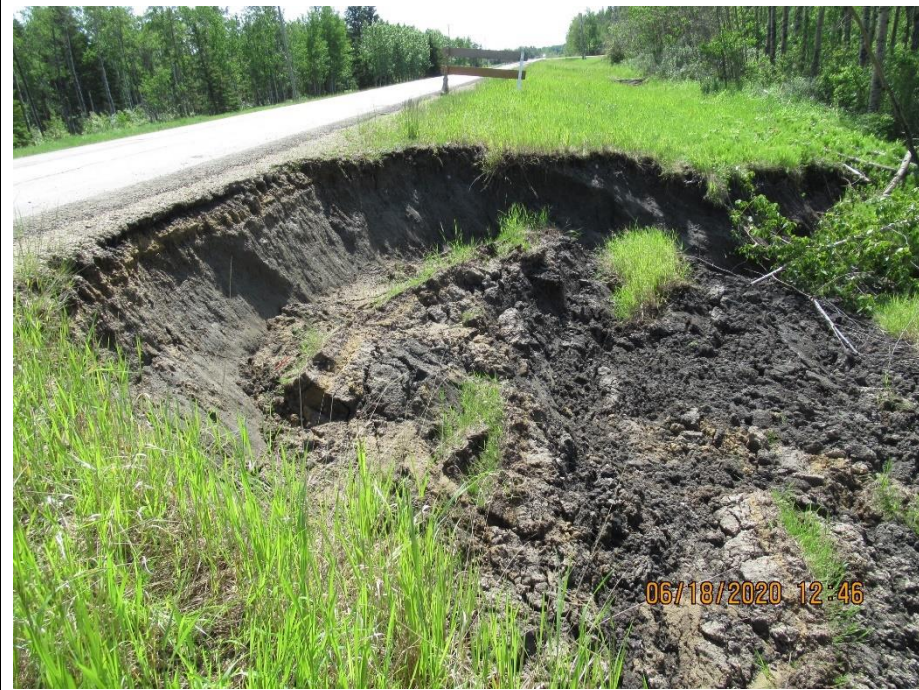
**Photo 2.**  
Looking south at  
backscarp.

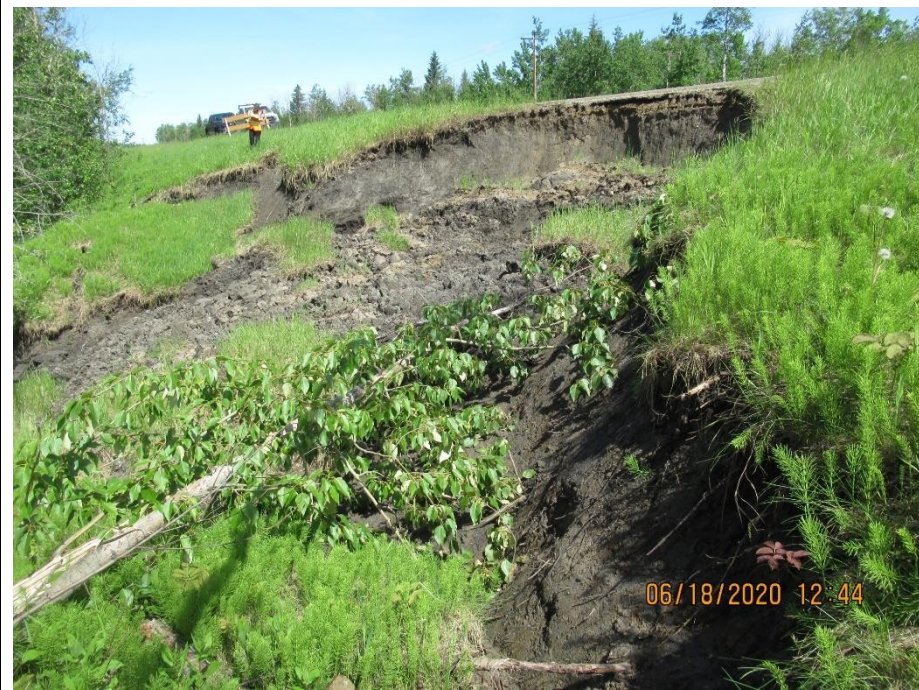
**Photo 3.**  
Looking northeast  
towards backscarp  
and slabs of soil  
that have fallen  
downslope.

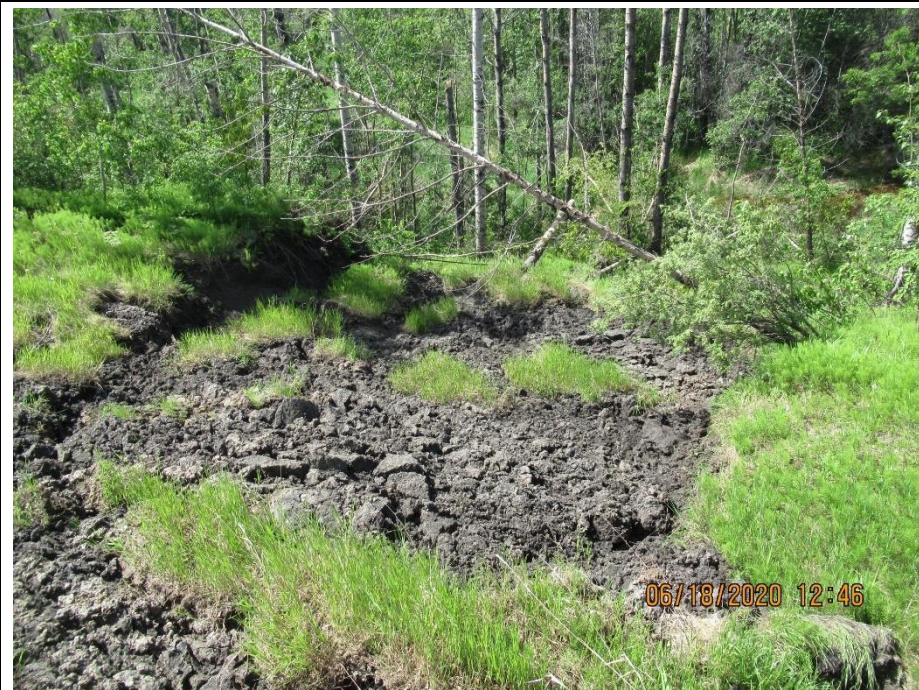
**Photo 4.**  
Looking west  
downslope at slide  
mass.

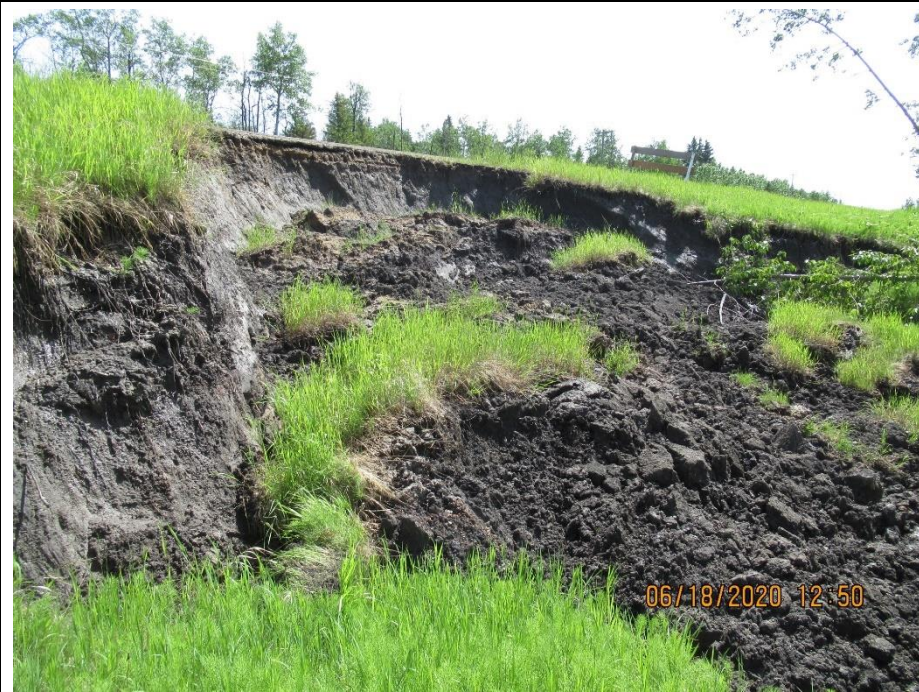
**Photo 5.**  
Looking southeast  
towards backscarp  
and slabs of soil.

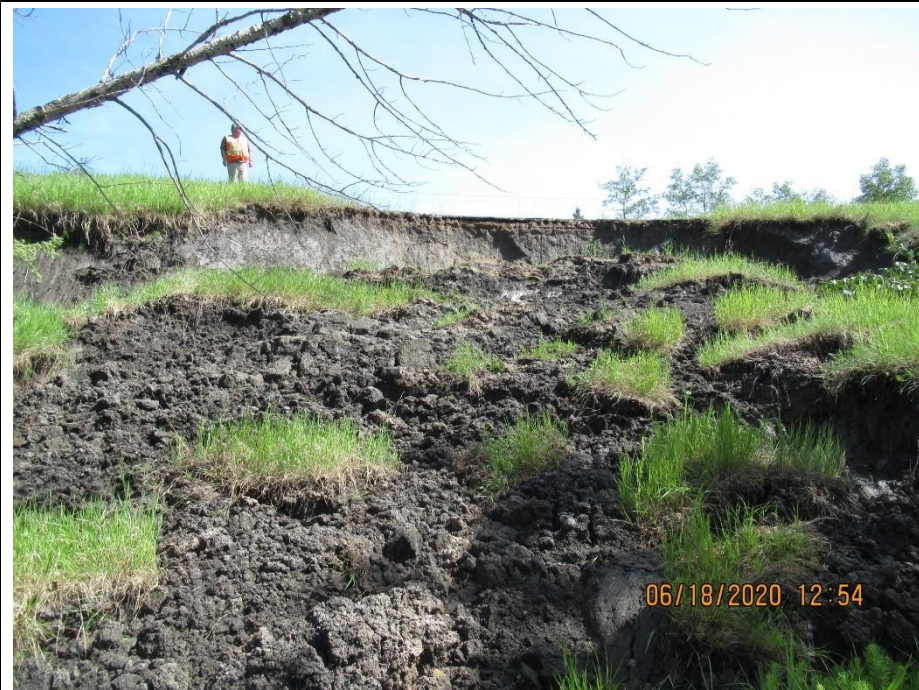
**Photo 6.**  
Looking east  
towards highway  
and landslide  
backscarp.

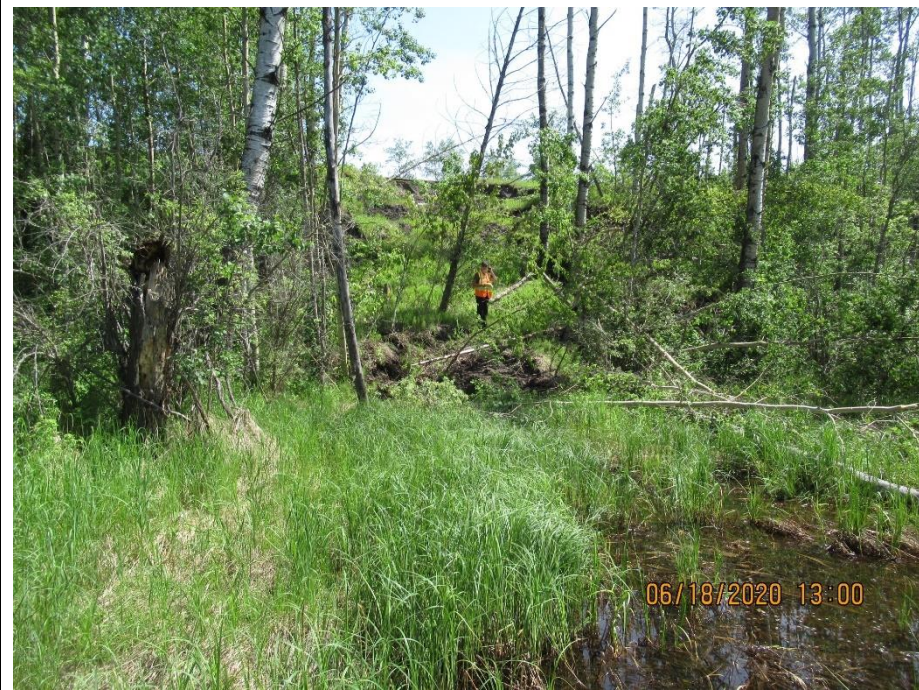
**Photo 7.**  
Looking east  
towards landslide  
from oxbow.

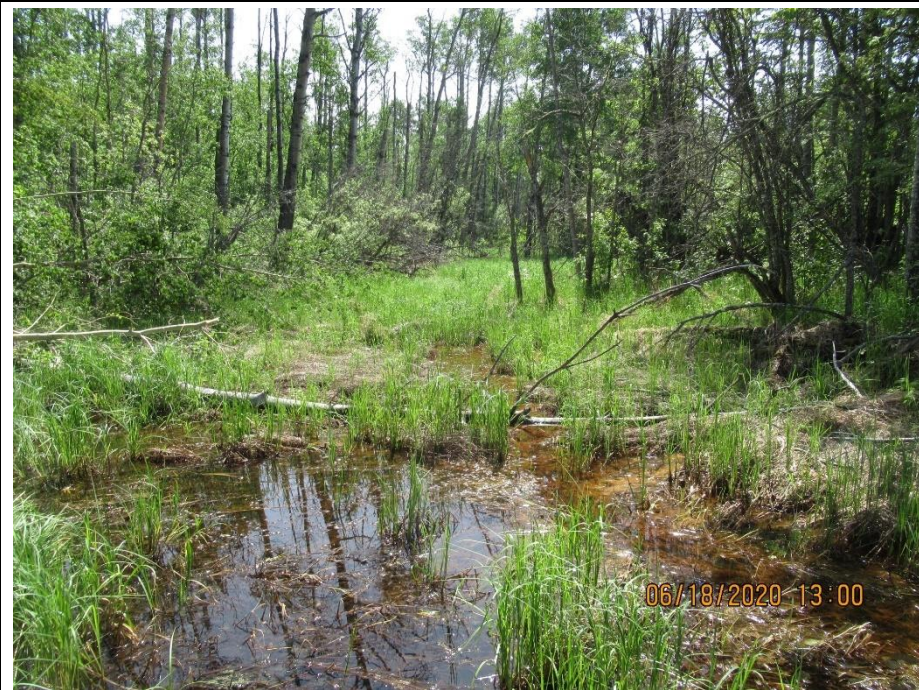
**Photo 8.**  
Looking north  
towards oxbow.

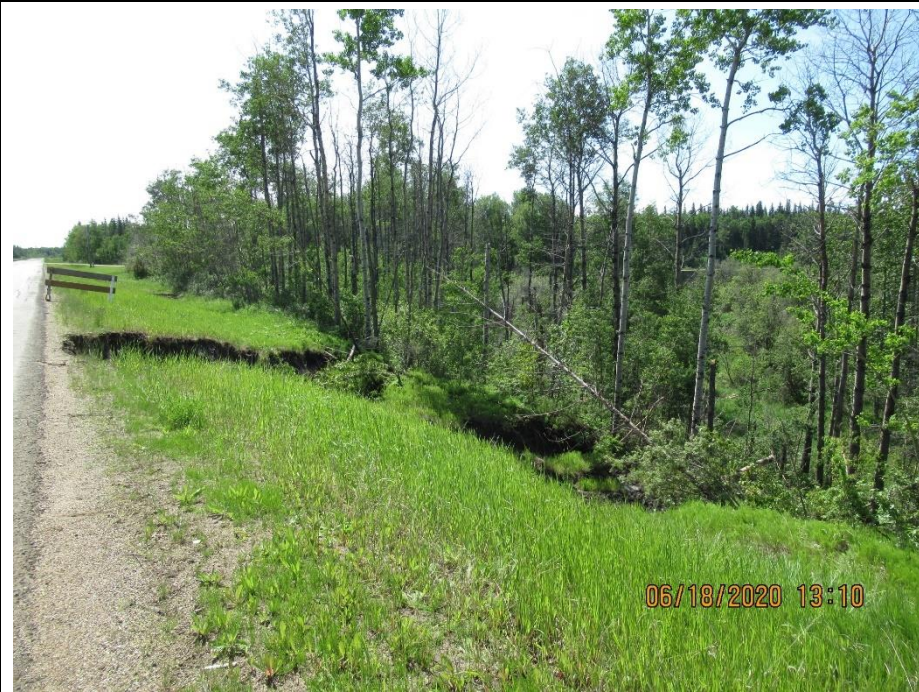
**Photo 9.**  
Looking south at  
landslide scarp  
retrogressing close  
to the highway  
pavement.

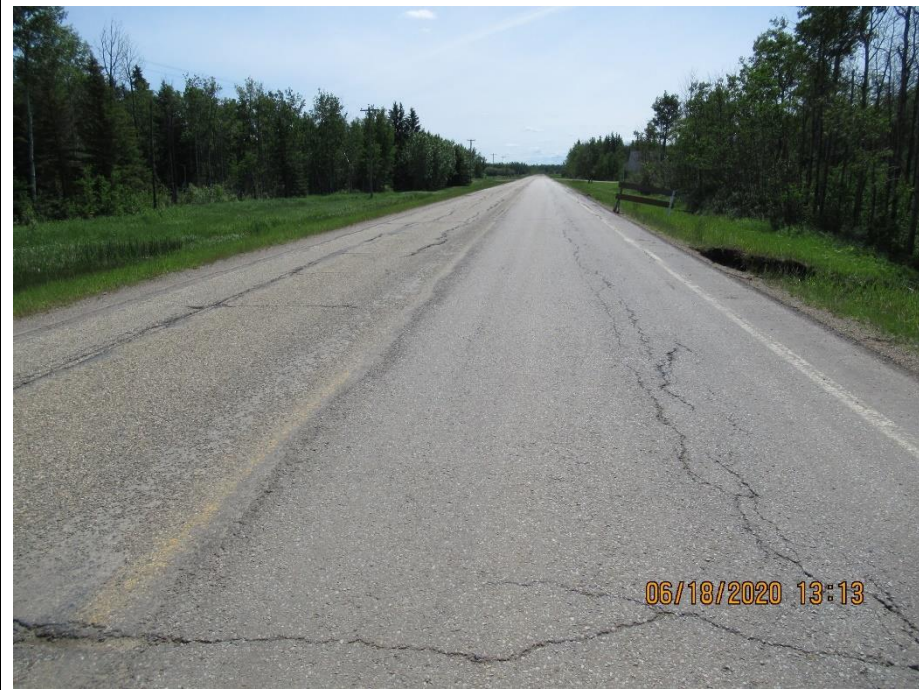
**Photo 10.**  
Looking south at  
highway 749.

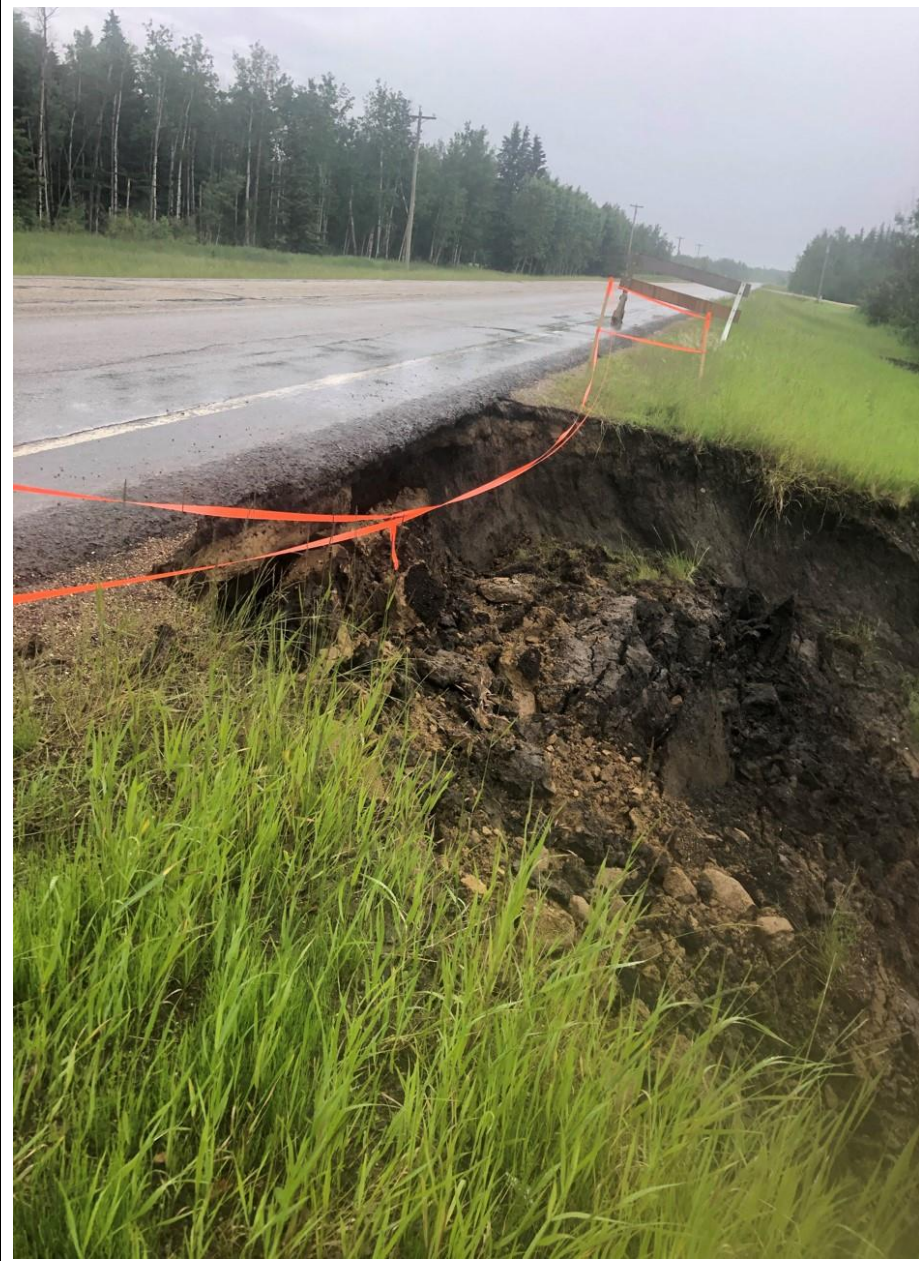
to be 26 cm from the pavement during our inspection; however, on July 2, 2020 a photograph was taken by the MCI and the slide has now retrogressed into the highway pavement and is expected to continue which may require partial closure of the highway.

**Photo 11.**  
Looking south at landslide scarp that has retrogressed further cutting into pavement taken after call out inspection on July 2, 2020.

In the short term, the slide should be regularly monitored for regression of the slide scarp. The southbound lane may need to be closed if retrogression continues and more signage/barricades placed.
