**ALBERTA TRANSPORTATION  
GEOHAZARD ASSESSMENT PROGRAM  
PEACE REGION – SWAN HILLS  
2020 CALLOUT**

Site Number	Location	Name	Hwy	km
SH014-1	Northeast of High Prairie	Salt Creek Slide	750:02	30.57
Legal Description		UTM Co-ordinates		
NE34-76-14-W5		11U E 558,308	N	6,165,584

Date	PF	CF	Total
<b>Previous Inspection:</b>	1-Jun-2020	11	5	55
<b>Current Inspection:</b>	30-Jul-2020	11	5	55
<b>Road AADT:</b>	440		<b>Year:</b>	2020
<b>Inspected By:</b>	Russell Romick, TRANS Ed Szmata, TRANS		Nicole Wilder, Thurber	
<b>Report Attachments:</b>	<input checked="" type="checkbox"/> Photographs <input checked="" type="checkbox"/> Plans <input type="checkbox"/> Maintenance Items

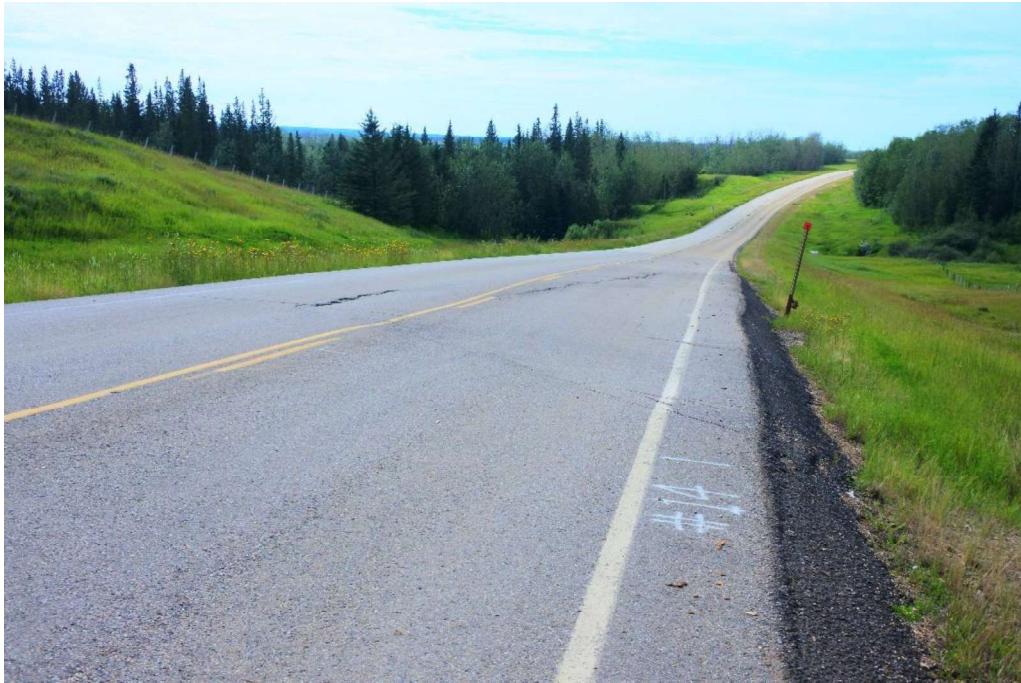
Photo 1 – Looking south at main crack and dip in highway surface. Significant thickness of asphalt visible at the edge of the pavement.

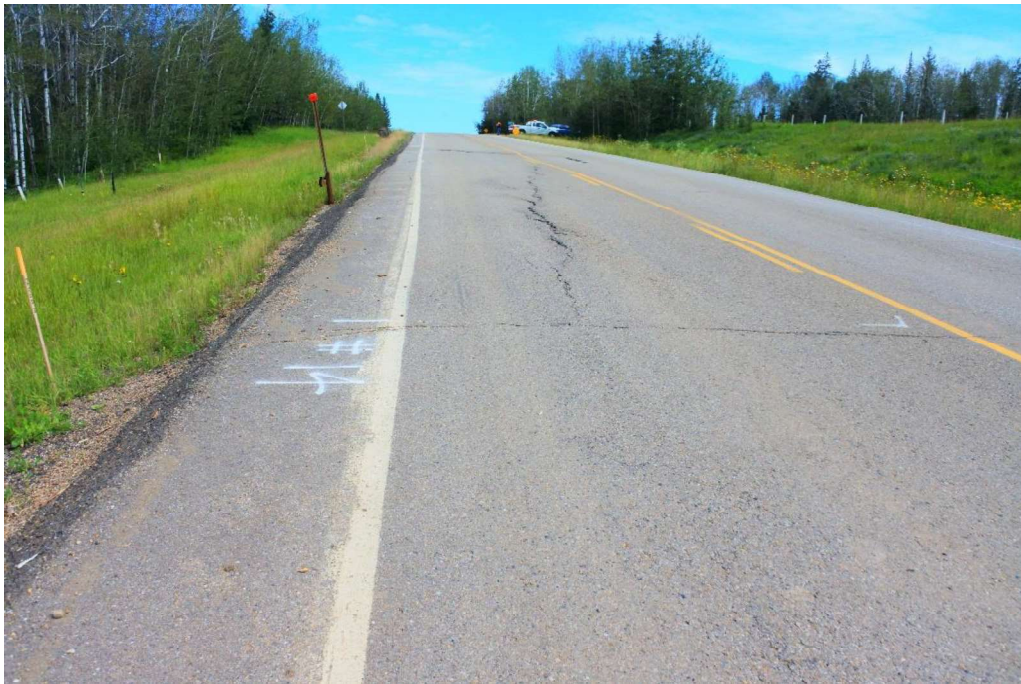
Photo 2 – Looking north at main crack and dip in highway surface.

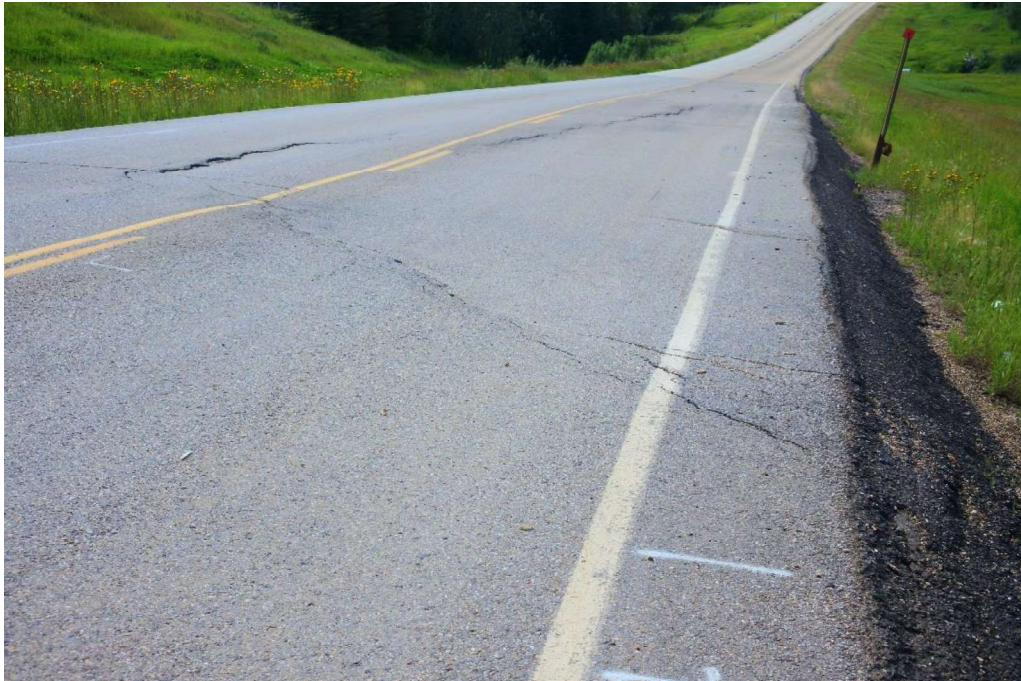
Photo 3 – Looking south at differential across crack.

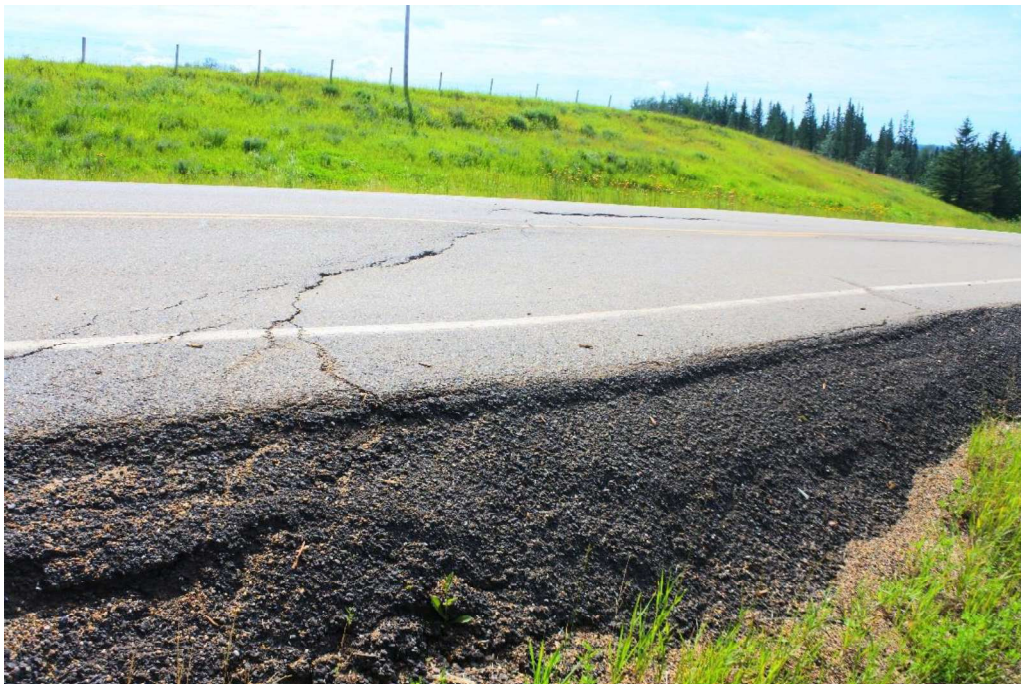
Photo 4 – Looking southeast at north end of crack pattern and several layers of ACP patches.

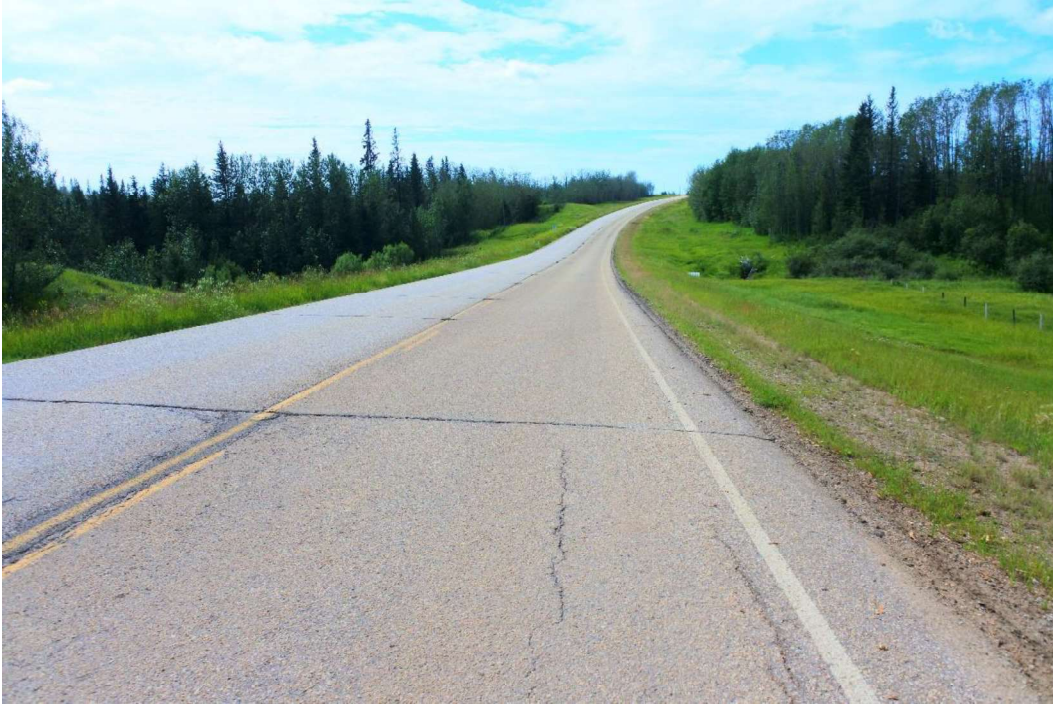
Photo 5 – Looking south at potential extension of slide-related cracks.

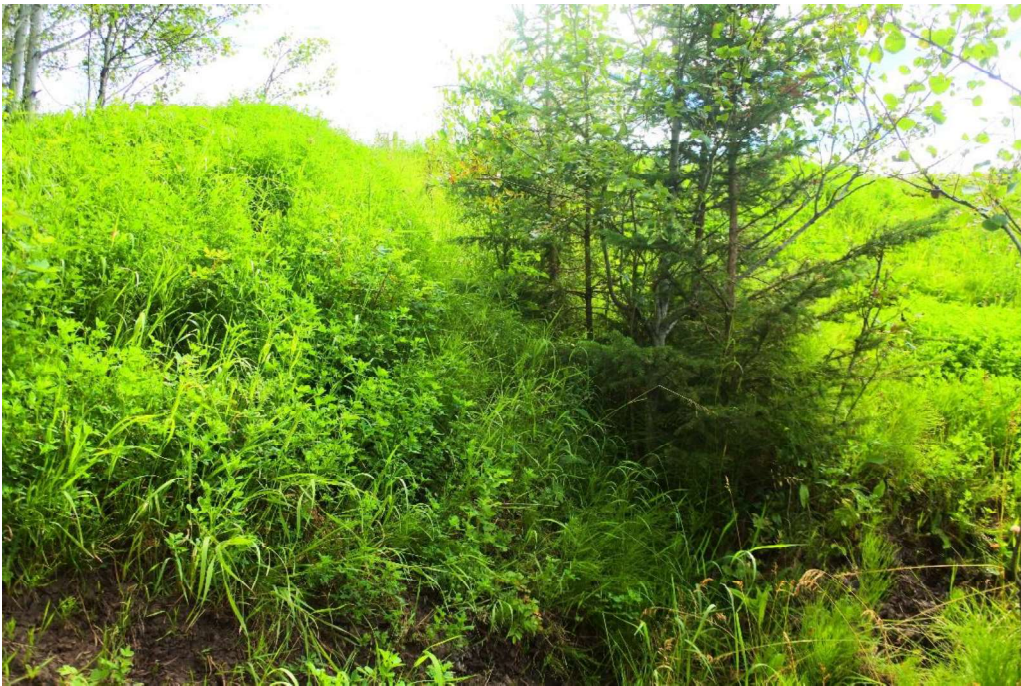
Photo 6 – Looking east at erosion gully forming on north side of toe berm (west of the highway).

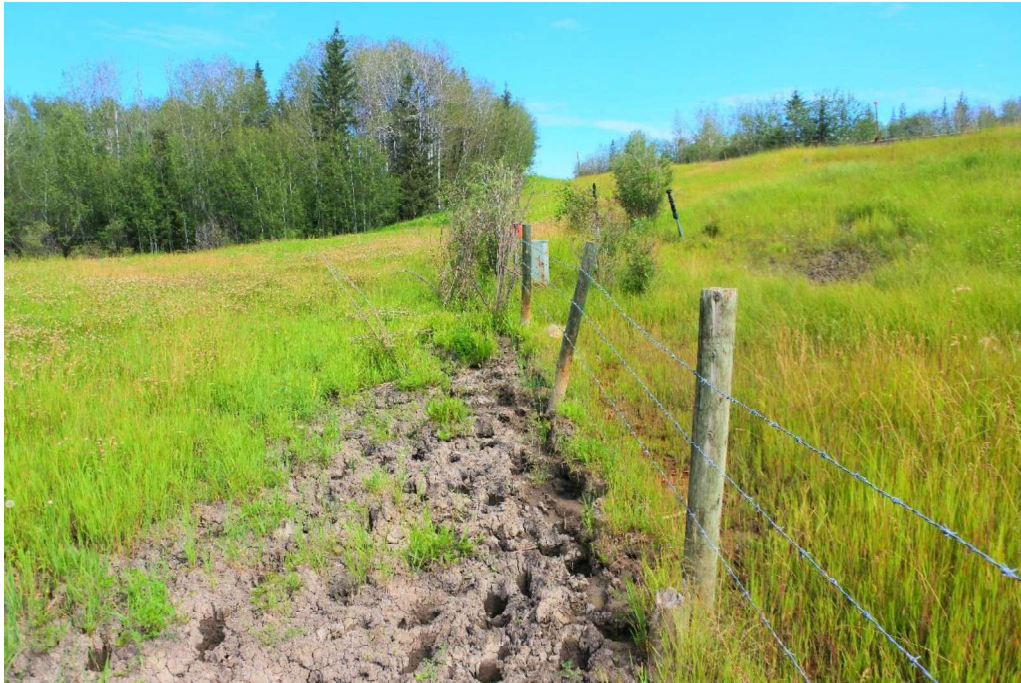
Photo 7 – Looking north at where soil was wet and had rutting from livestock.

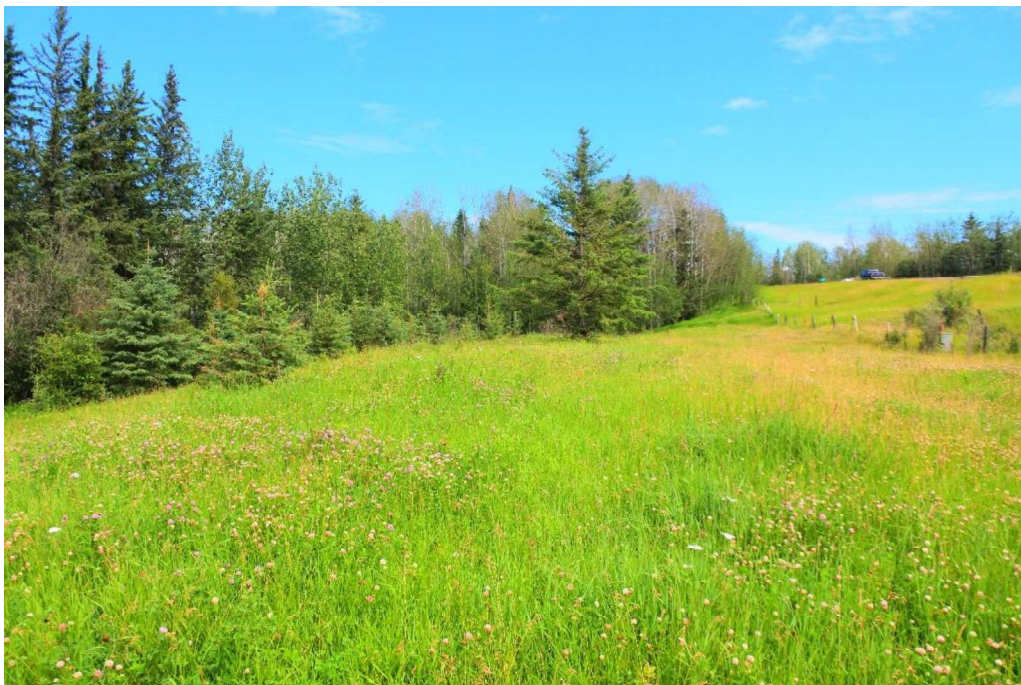
Photo 8 – Looking northeast along the top of the back-tilted toe berm and leaning fence

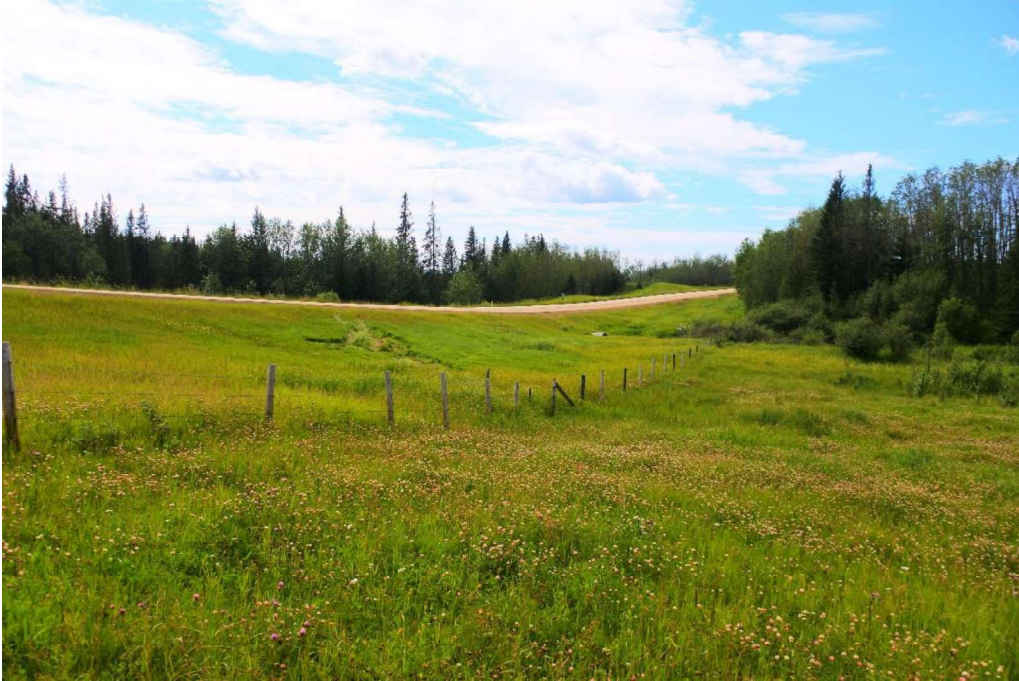
<input checked="" type="checkbox"/> Other	Possible intermediate scarps, or old equipment ruts, exist near crest of toe berm downslope edge	<input type="checkbox"/>
<b>Instrumentation (Fall 2020):</b>		
Damaged/Destroyed	SI02-2 sheared in 2005 at 4.7 m in clay below fill SI02-4, paved over in 2005, was moving at 5.2 m in native clay just below fill	
P02-3	At fence line on top of berm; 2.15 m BGL	
P02-4	At west edge of pavement was dry.

Photo 9 – Looking south at where linear disturbance along toe berm which might be a scarp or previous equipment rutting/disturbance; however, was grown over in July.

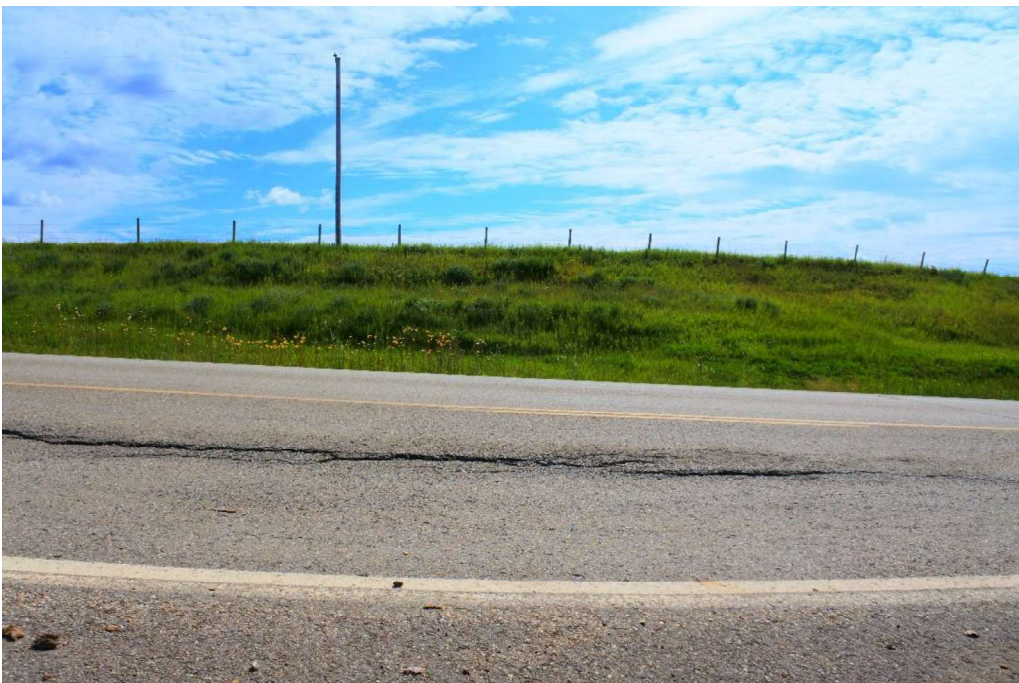
Photo 10 – Looking northeast at backslope slumps just south of the power pole.

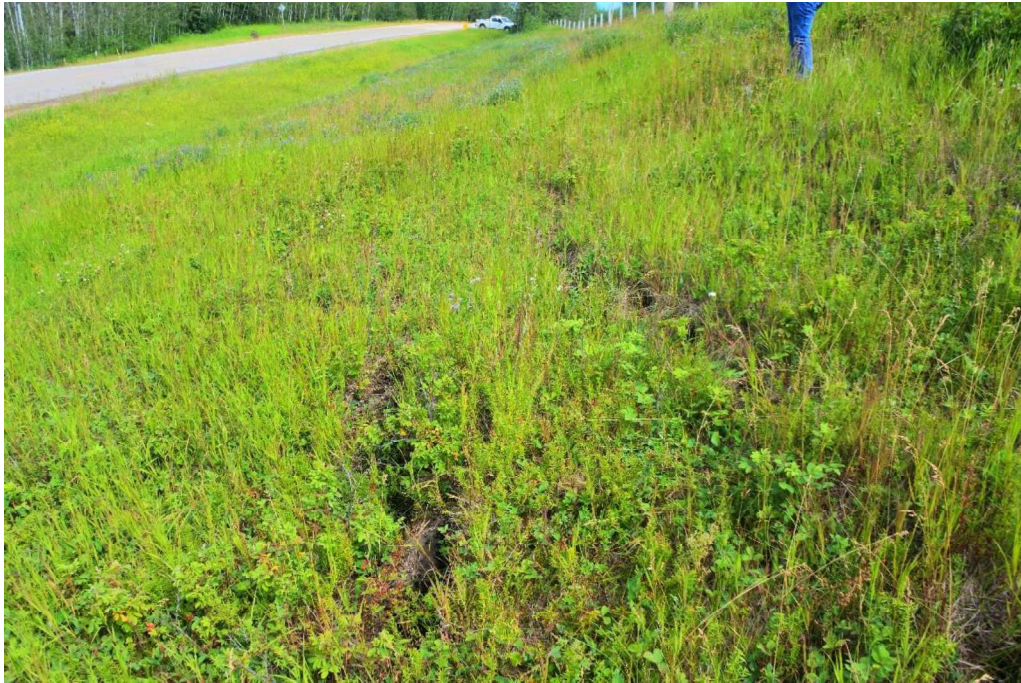
Photo 11 – Looking north at slumping backslope below power pole with open tension cracks.

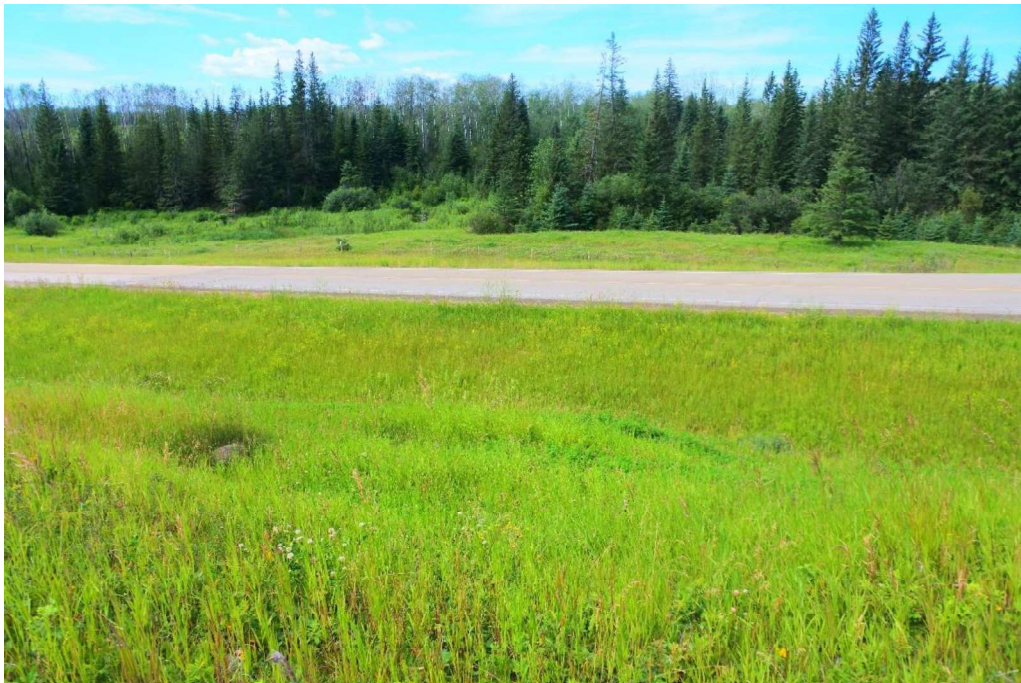
Photo 12 – Looking west from the backslope at the subsiding area in the pavement.

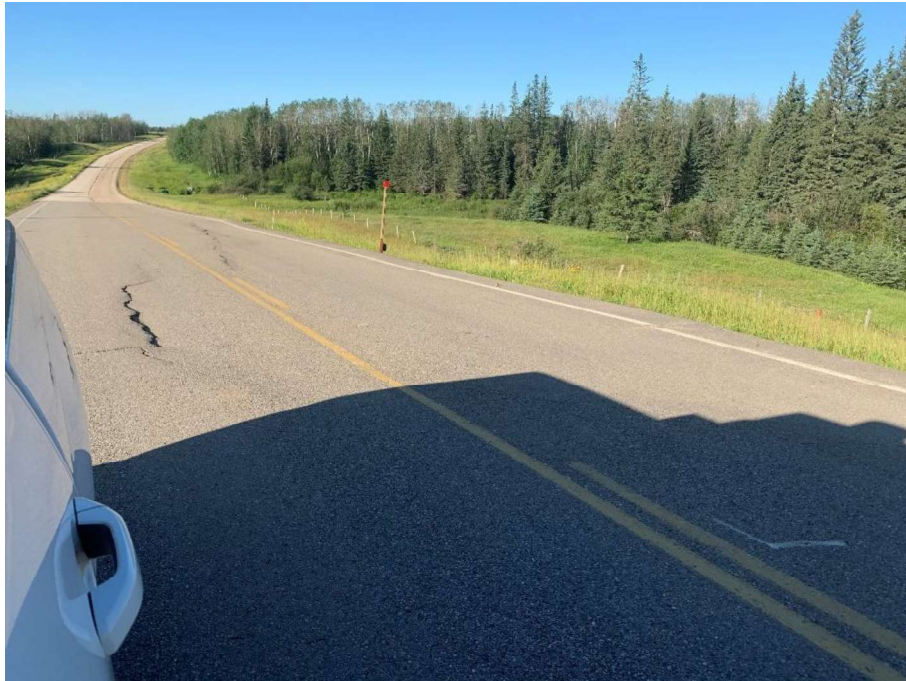
Photo 13 – Looking south at scarp crack taken on July 29, 2020 by MCI
