**ALBERTA TRANSPORTATION
GEOHAZARD ASSESSMENT PROGRAM
PEACE REGION (PEACE RIVER DISTRICT)
2021 INSPECTION**

Site Number	Location	Name	Hwy	km
SH014-1	Northeast of High Prairie	Salt Creek Slide	750:02	30.57
Legal Description		UTM Co-ordinates		
NE34-76-14-W5		11U E 558,308	N	6,165,584

Date	PF	CF	Total
Previous Inspection:	30-Jul-2020	11	5	55
Current Inspection:	29-Jun-2021	10	5	50
Road AADT:	400		Year:	2020
Inspected By:	Ed Szmata, TRANS Max Shannon, TRANS Rocky Wang, TRANS Rodney Johnston, TRANS		Barry Meays, Thurber Mark Gallego, Thurber	
Report Attachments:	<input checked="" type="checkbox"/> Photographs <input checked="" type="checkbox"/> Plans <input type="checkbox"/> Maintenance Items

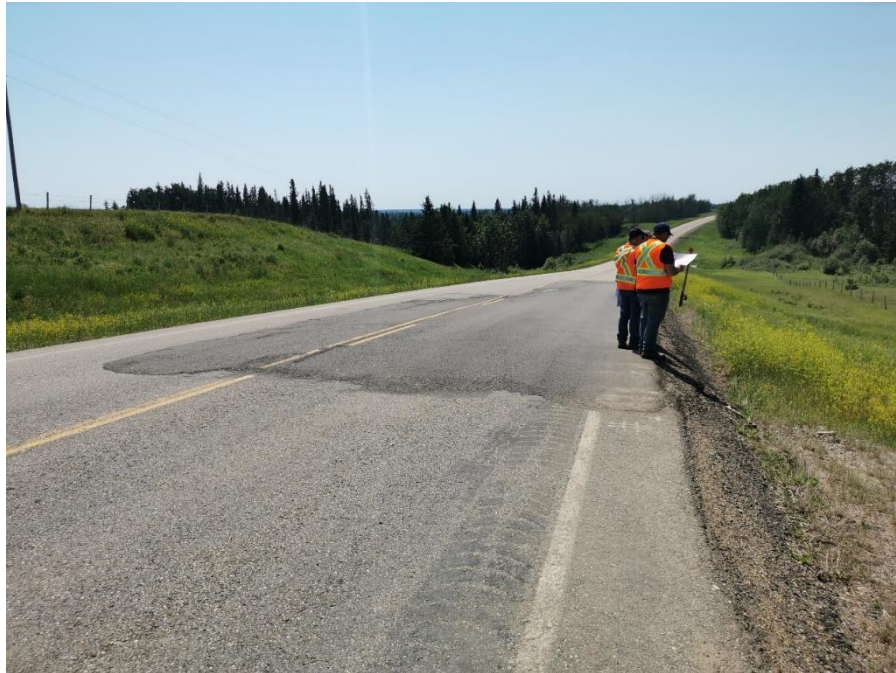
Photo 1 – Looking south at main crack and dip area that was patched. Significant thickness of asphalt visible at the edge of the pavement.

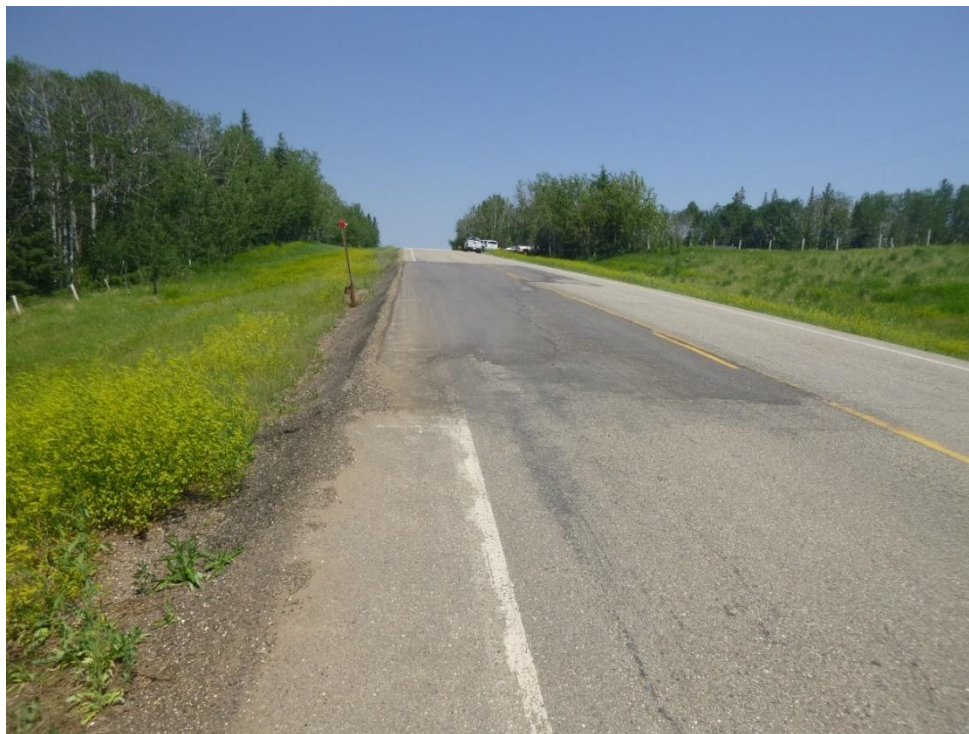
Photo 2 – Looking north at main crack and dip in highway surface.

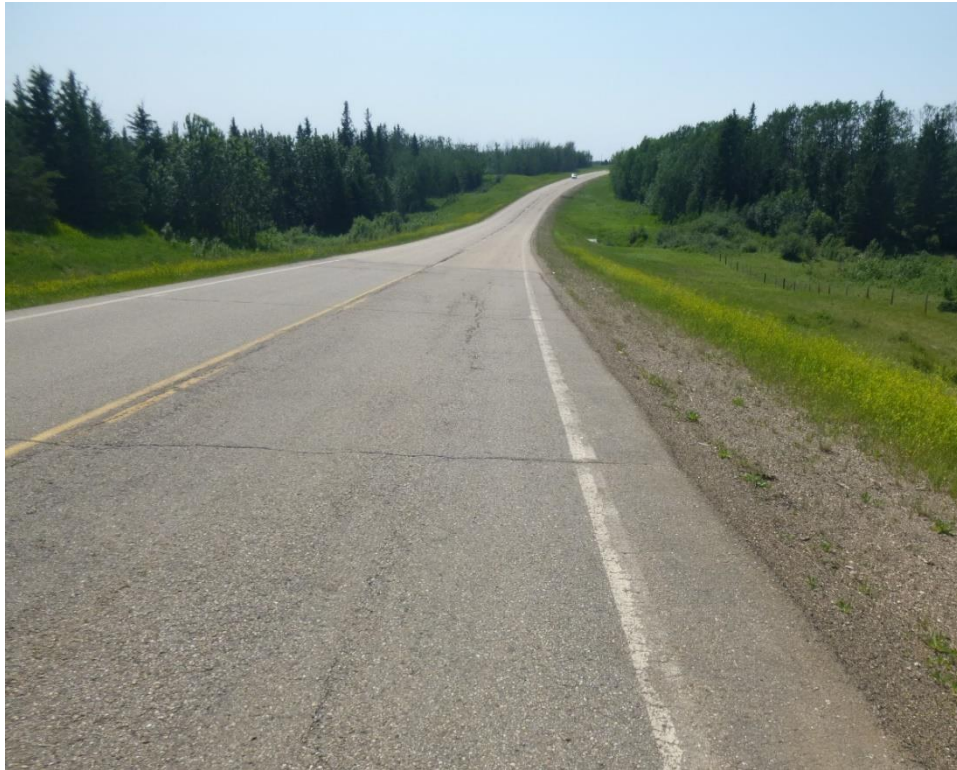
Photo 3 – Looking south at potential extension of slide-related cracks.

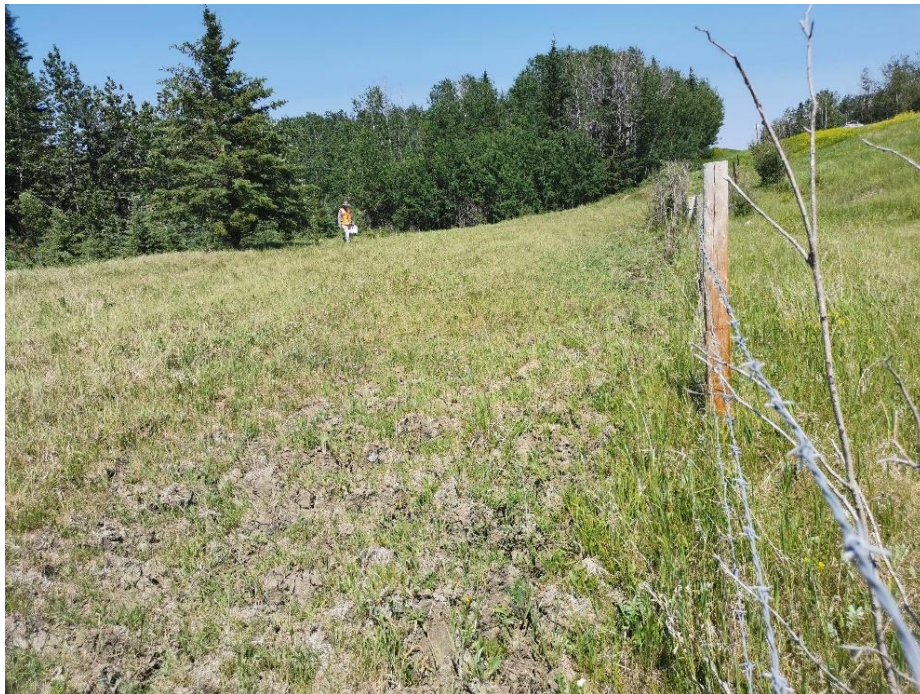
Photo 4 – Looking north at where soil was wet and had rutting from livestock.

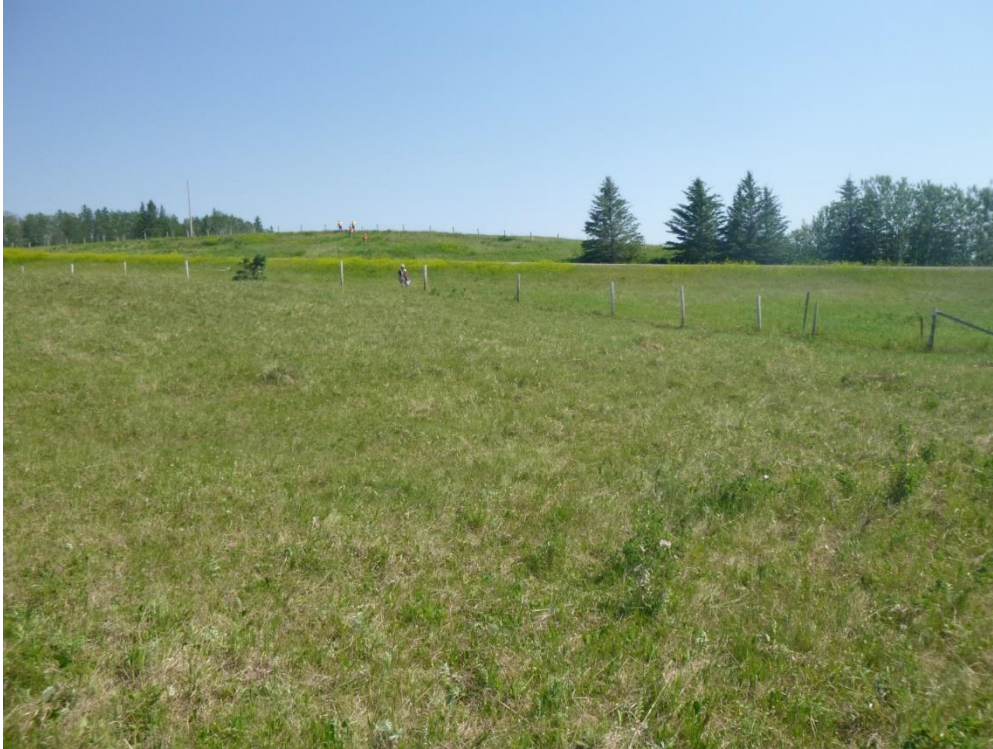
Photo 5 – Looking east at where linear disturbance along toe berm might be a scarp or previous equipment rutting/disturbance observed; however, area was grown over since.

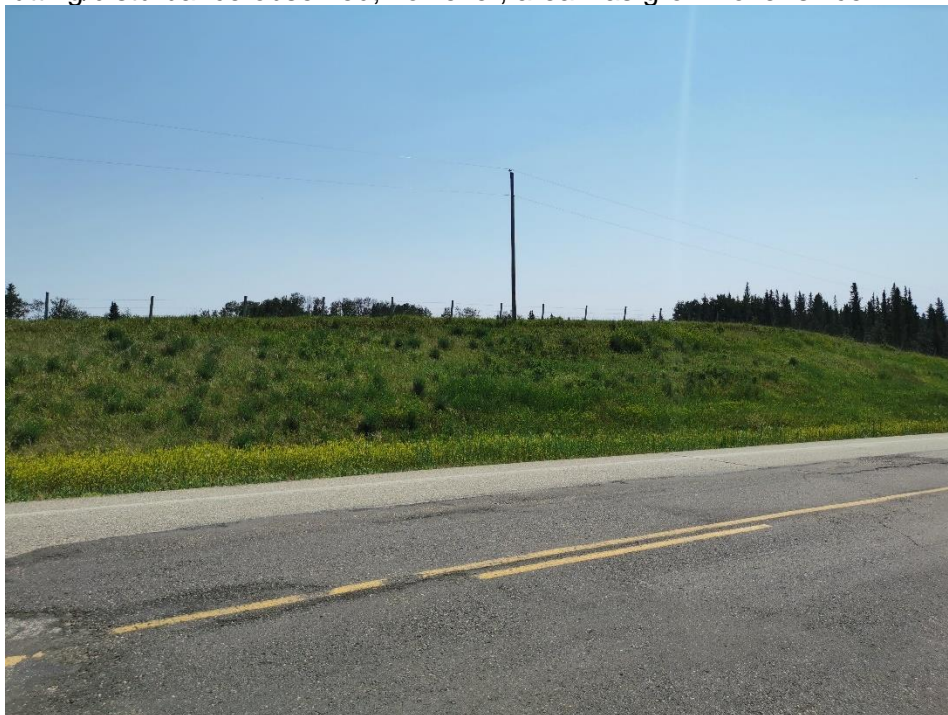
Photo 6 – Looking northeast at backslope slumps just south of the power pole.

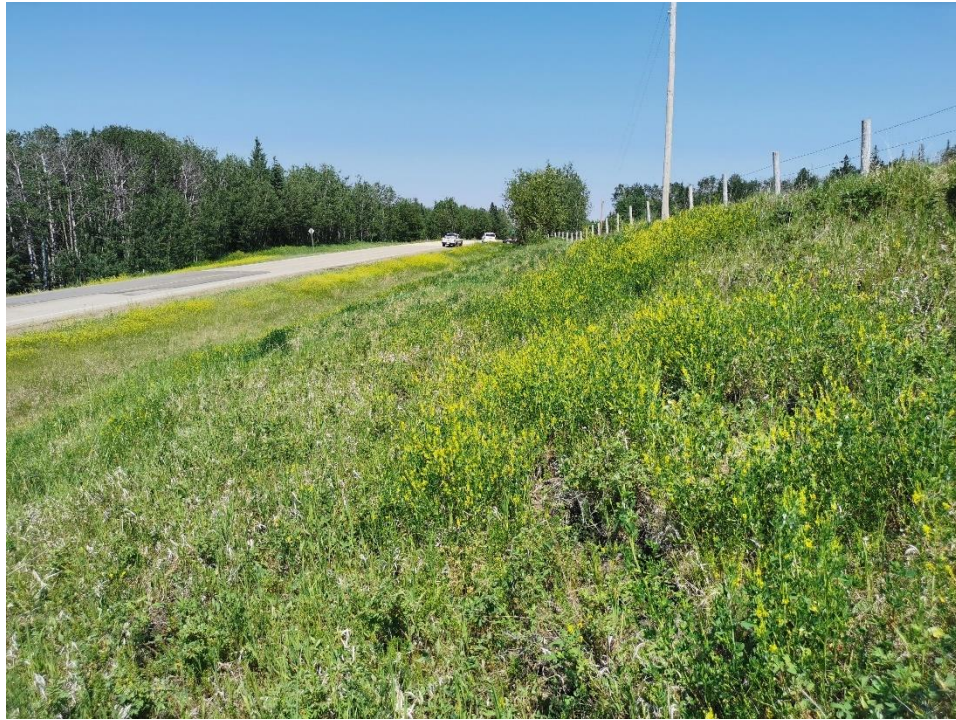
Photo 7 – Looking north at slumping backslope below power pole with open tension cracks.

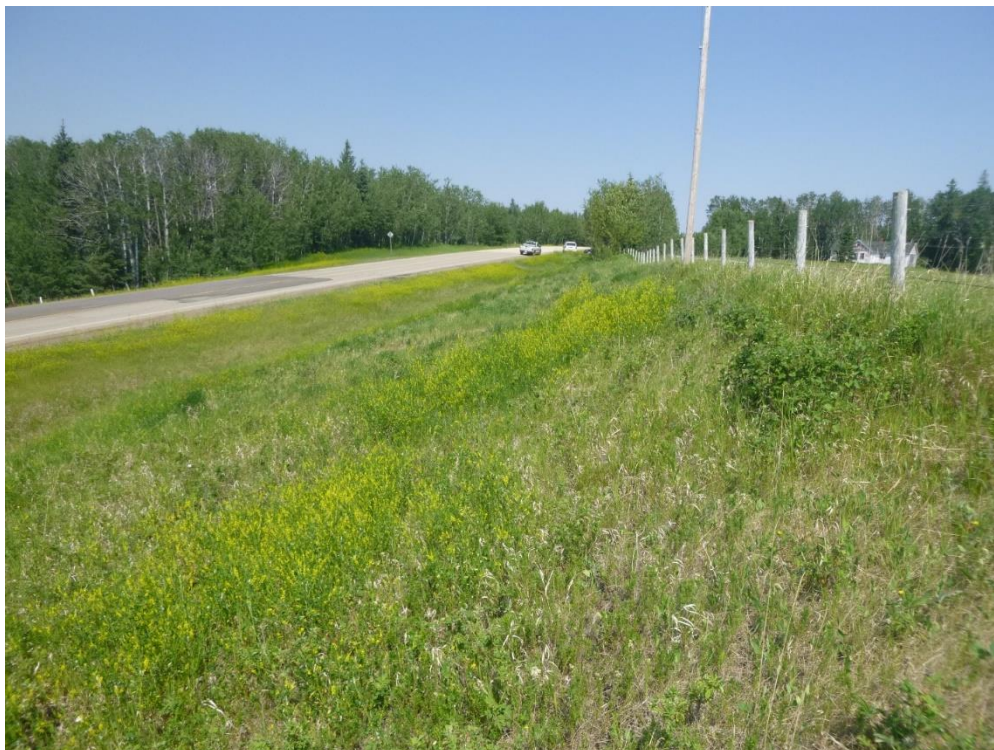
Photo 8 – Looking northwest from the backslope at the subsiding area in the pavement.
