**ALBERTA TRANSPORTATION
GEOHAZARD ASSESSMENT PROGRAM
PEACE REGION (PEACE RIVER DISTRICT)
2022 INSPECTION**

Site Number	Location	Name	Hwy	km
SH014-1	Northeast of High Prairie	Salt Creek Slide	750:02	30.57
Legal Description		UTM Co-ordinates		
NE34-76-14-W5		11U E 558,308	N	6,165,584

SH014-1: HWY 750:02 SALT CREEK SLIDE
2022 SITE INSPECTION PLAN

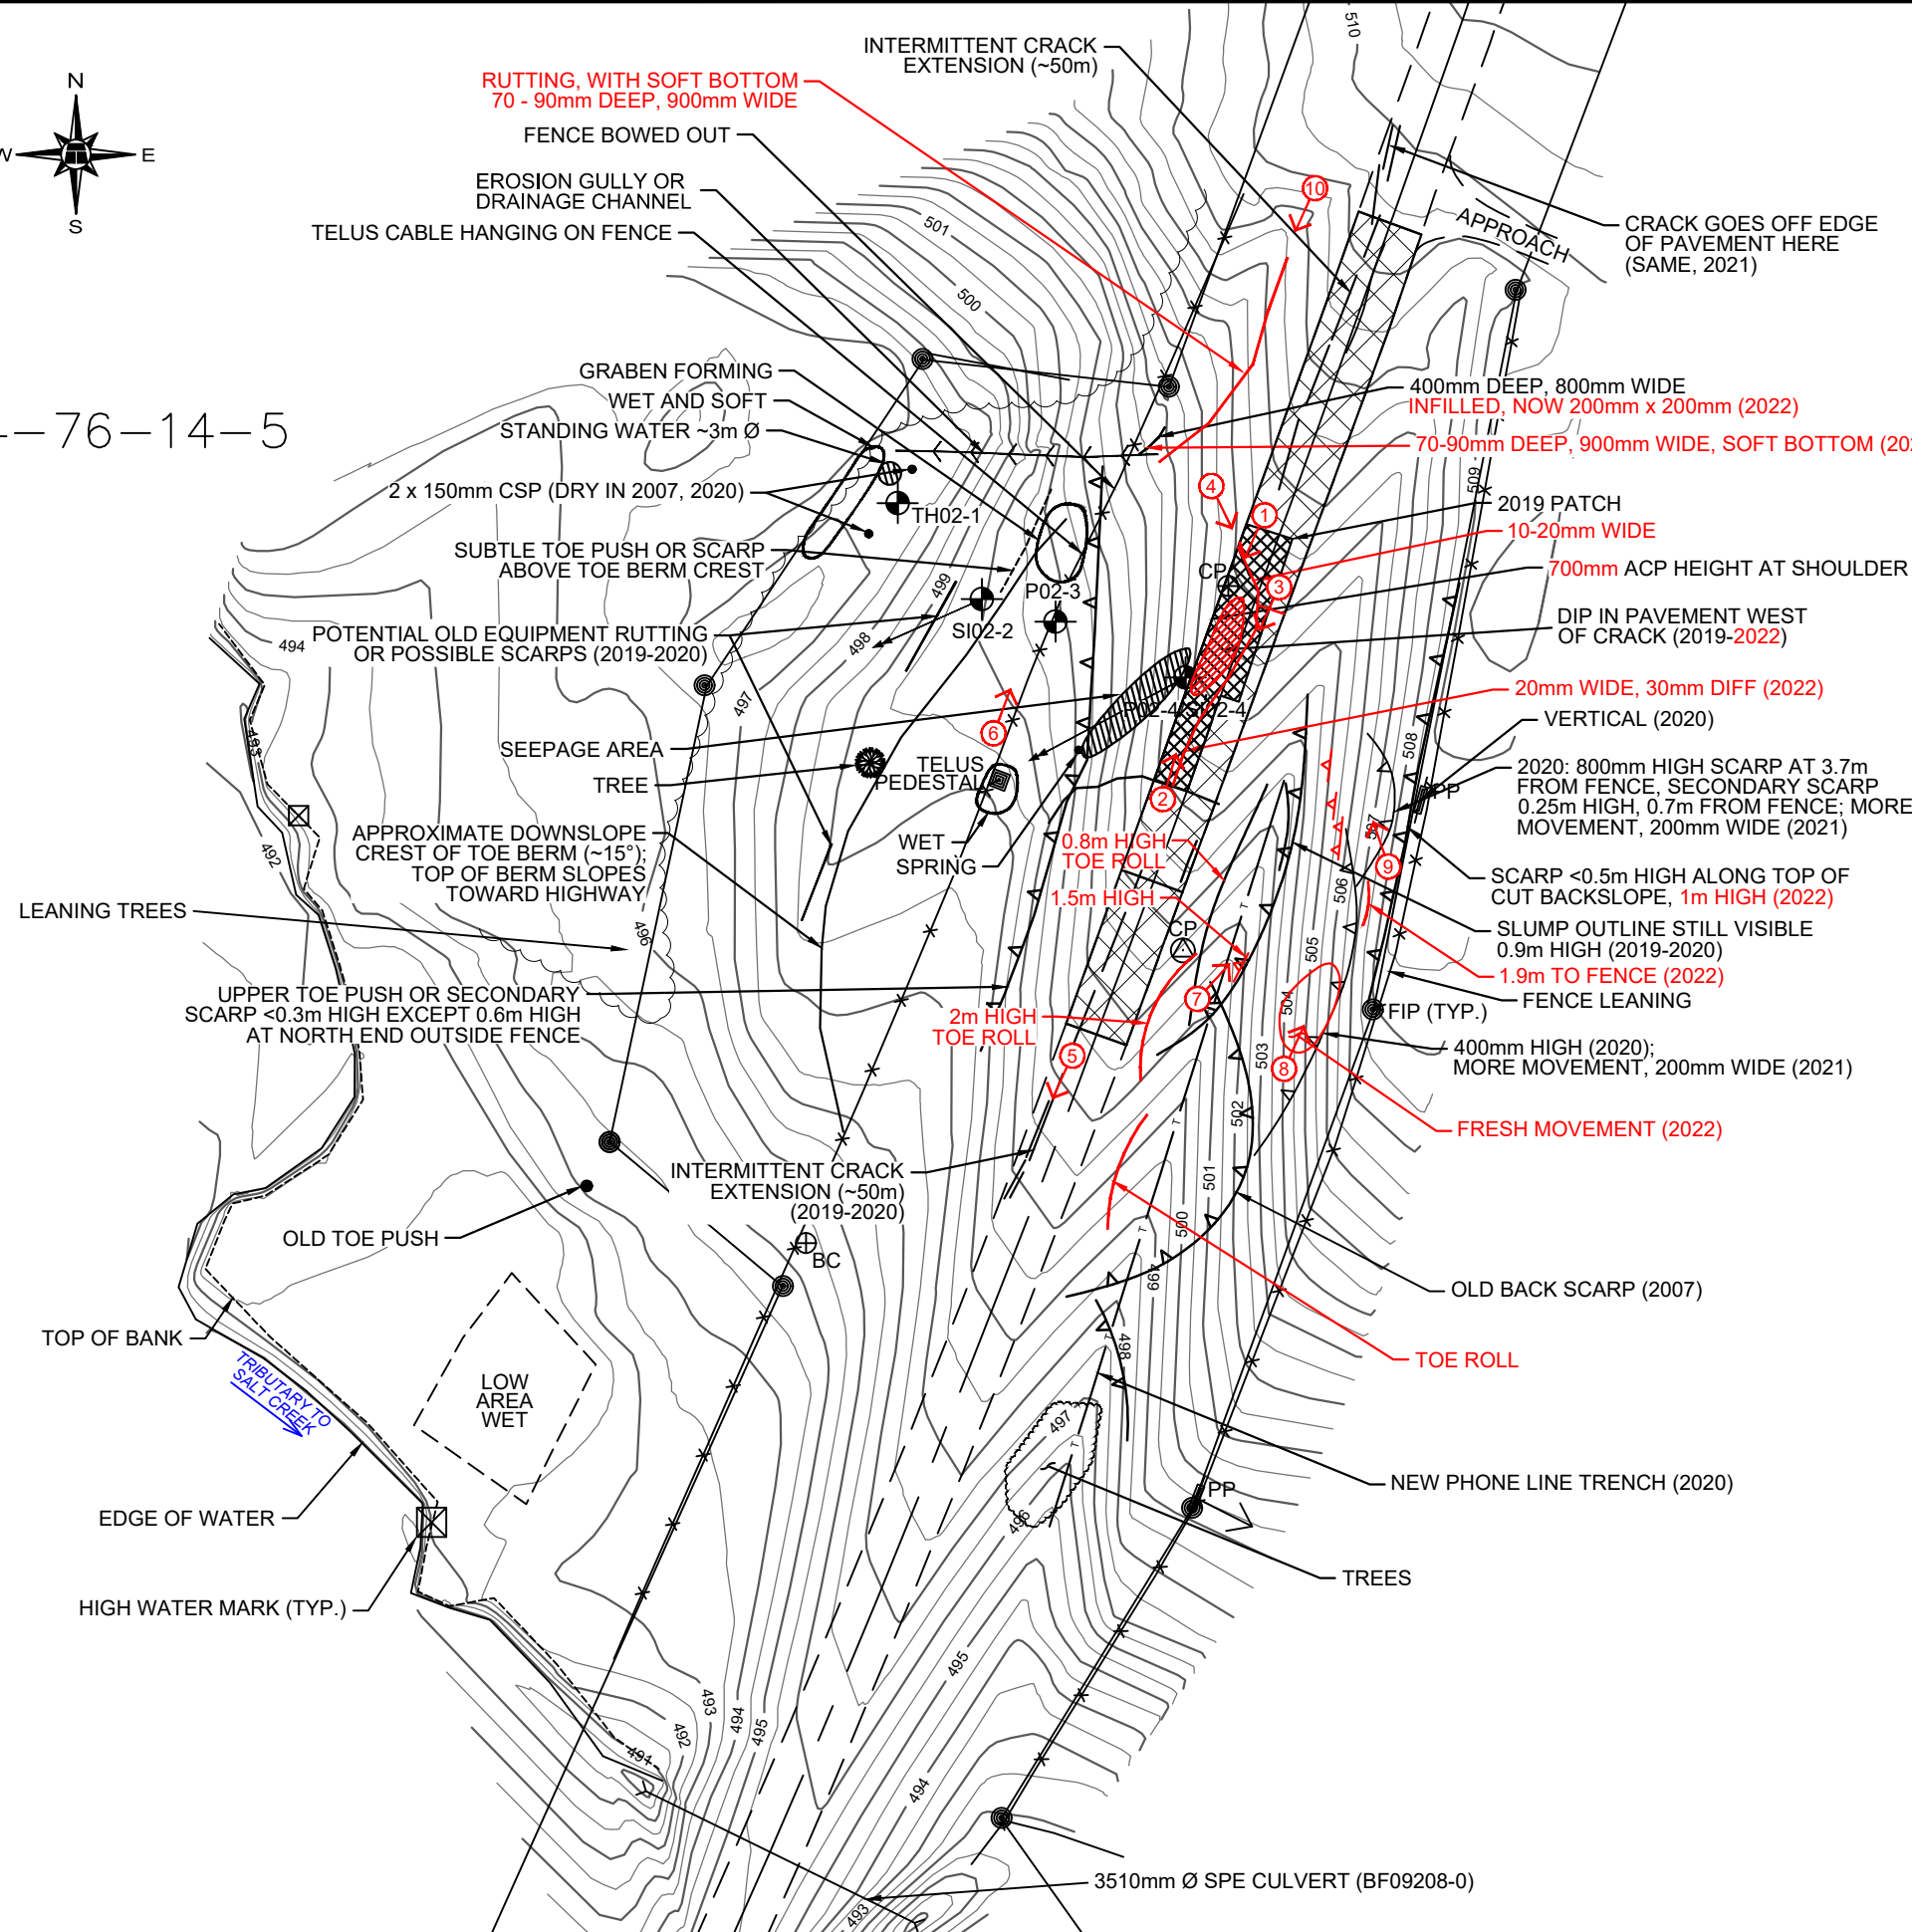
DWG No. 32121-SH014-1

As shown on Drawing 32121-SH014-1, the old inclinometer movement vectors show the slide is moving along an azimuth of about 242 degrees, nearly perpendicular to the general creek alignment and at a 50° skew to the highway.

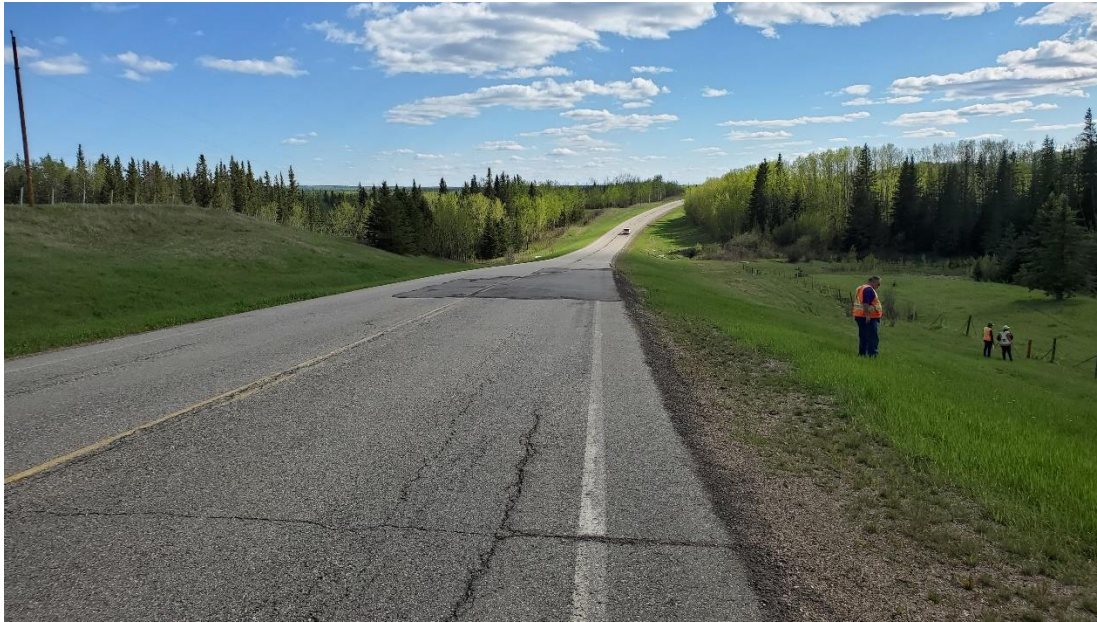
The dominant crack is about 33 m in length with an approximately 20 m long dip on the west side of the crack that has dropped about 30 mm. Crack widths were typically 20-30 mm wide. These movements are likely attributed to the upper, shallower slide block. There is some concern that the extent of the overall slide may be larger than previously thought and affecting a greater length of paved roadway. This is evidenced by a previous 115 m long full width pavement patch, and the intermittent crack that straddles the outside wheel path of the southbound lane through and beyond that patch. It is possible that movement on the lower slide block may be contributing to this greater extent.

Photo 1 – Looking south at main crack and dip area that was patched. Significant thickness of asphalt visible at the edge of the pavement.

- The MCI should regularly monitor this area for further movements or enlargement. Crack sealing and patching should be undertaken as required. If conditions worsen to the point where the slide affects traffic, barricades and/or warning/speed reduction signs may need to be erected around the distressed area in conjunction with constructing a temporary detour on the east side of the highway until repairs are undertaken.

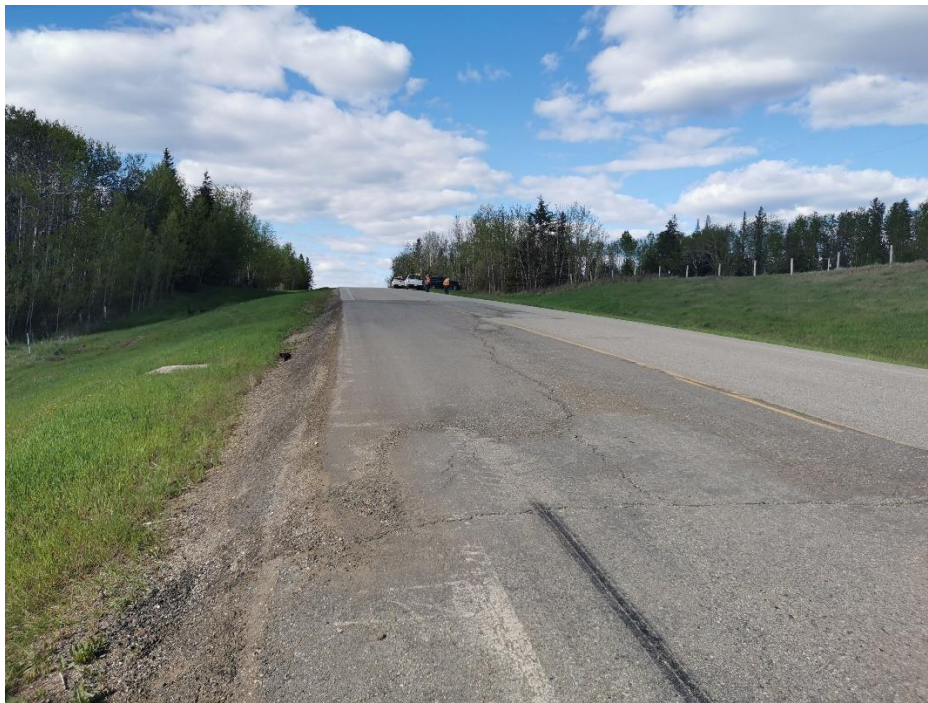
Photo 2 – Looking north at main crack and dip in highway surface.

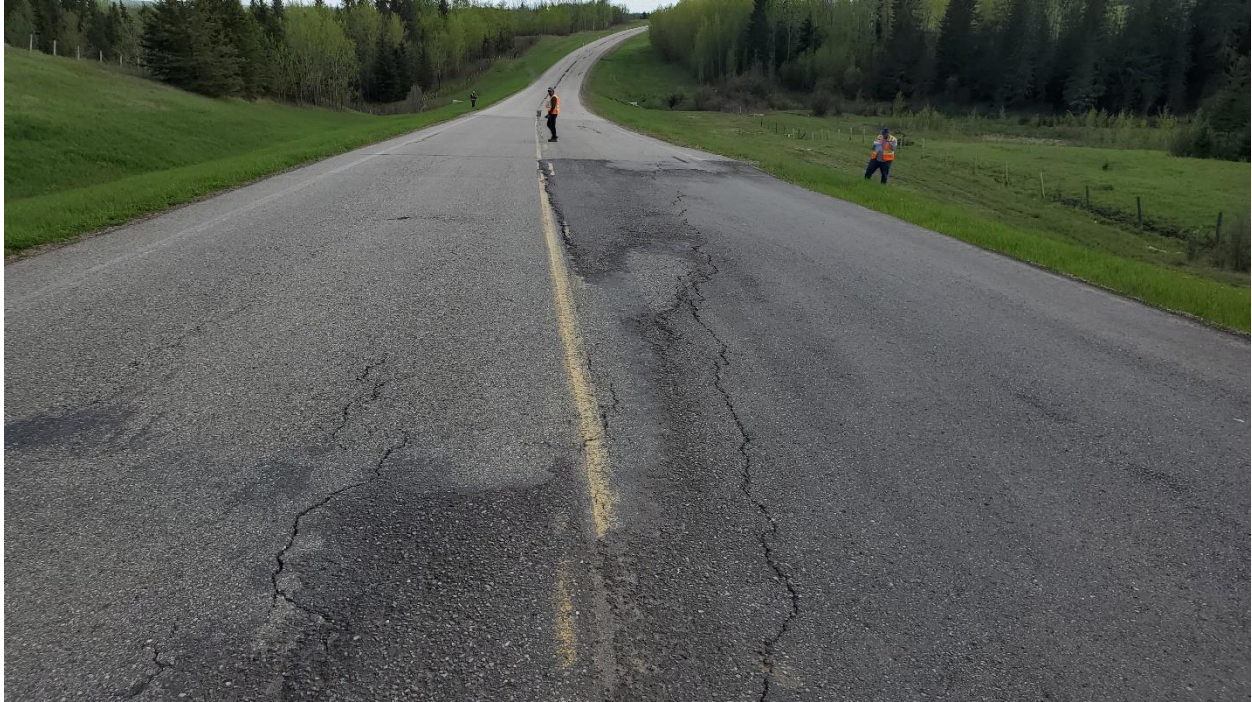
Photo 3 – Looking south at differential across crack near SI02-4 (no longer functional).

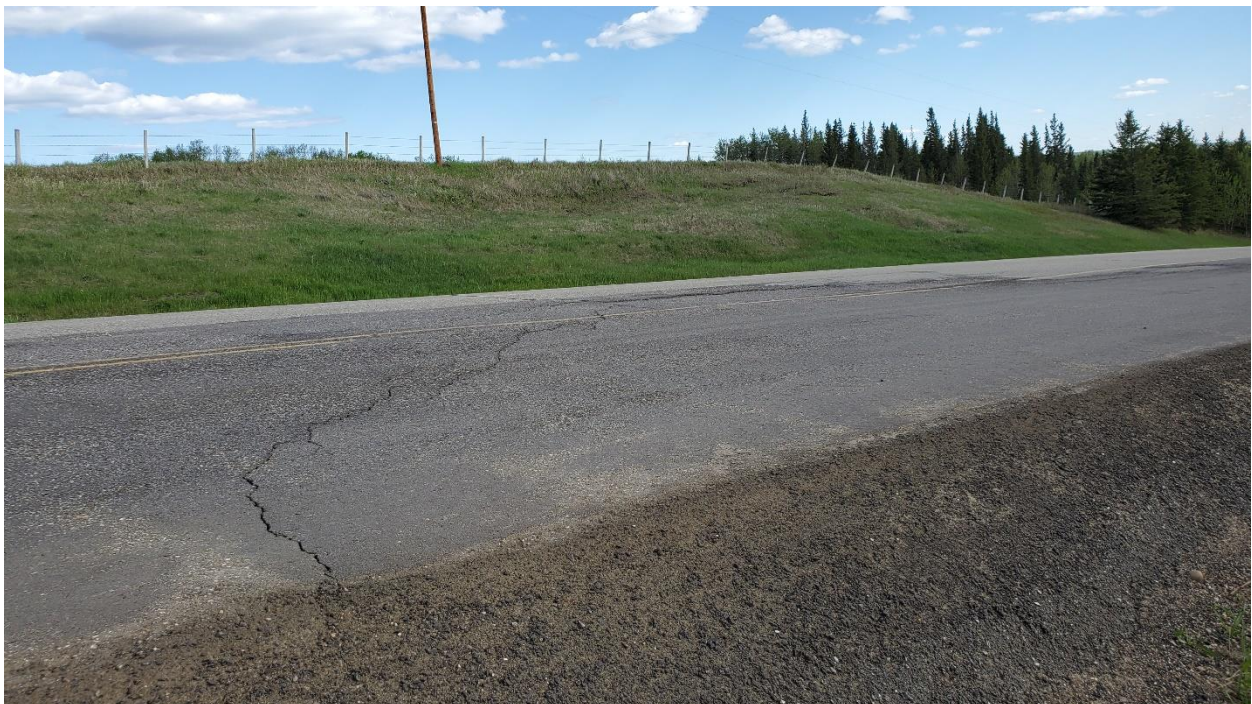
Photo 4 – Looking southeast at north end of crack pattern.

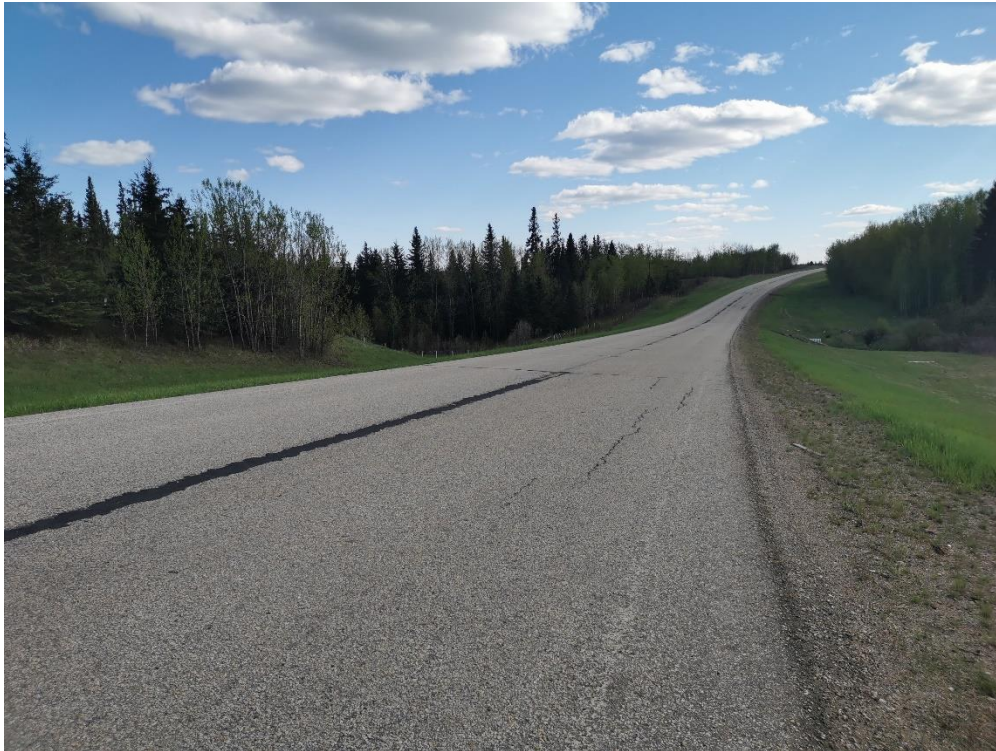
Photo 5 – Looking south at potential extension of slide-related cracks.

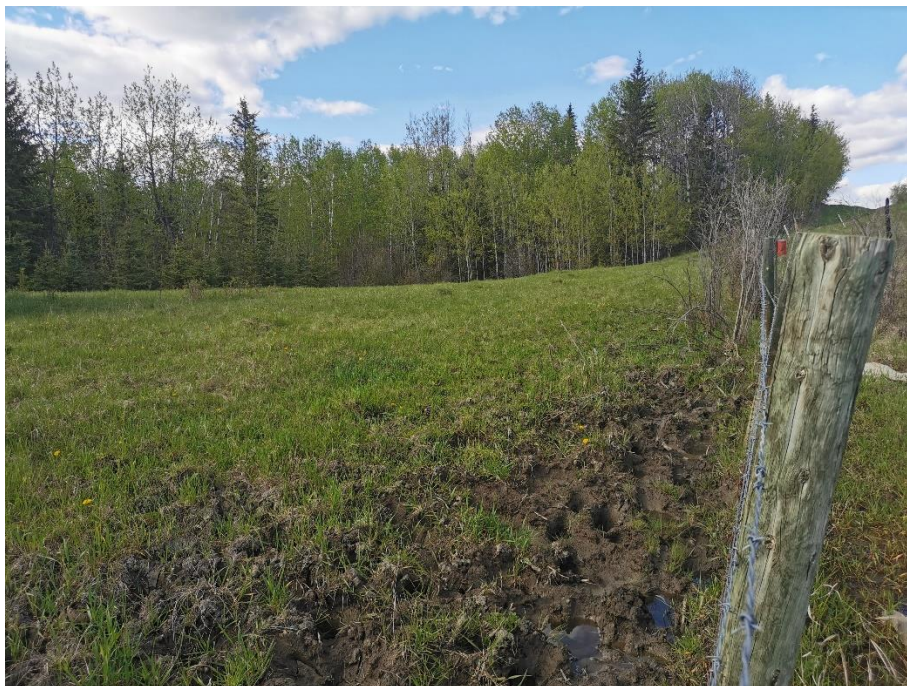
Photo 6 – Looking north at where soil was wet and had rutting from livestock.

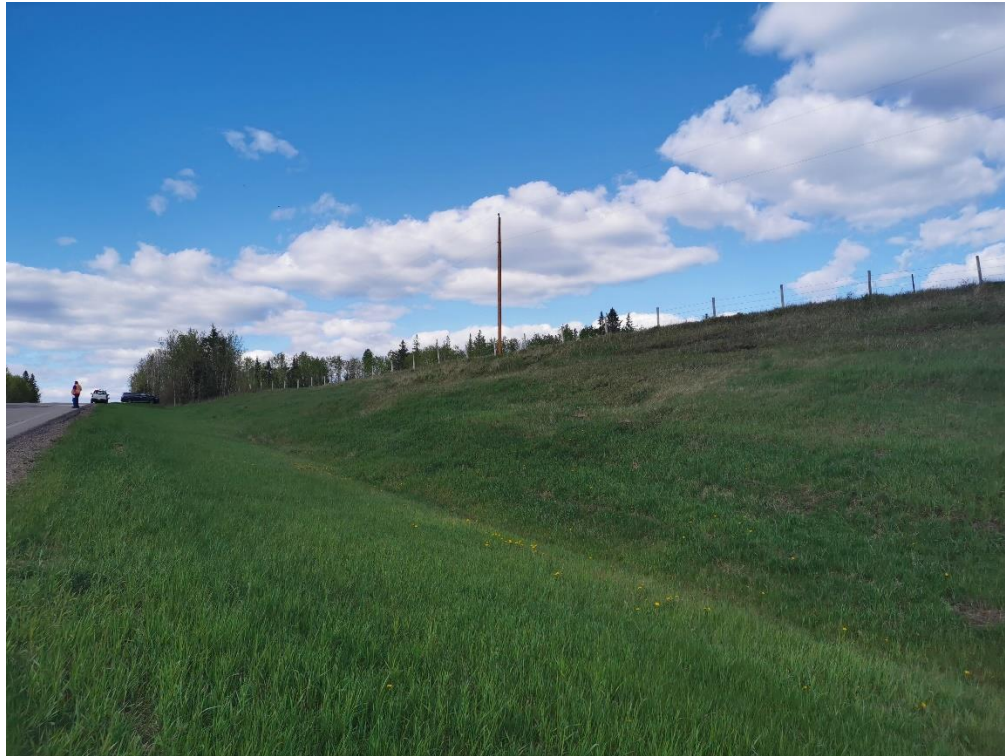
Scarps and tension cracks have formed along the top of the east backslope and are with a 2 m of the fence line. Although the fence appears to be leaning slightly, the power pole is still vertical. It is not clear if the east backslope movements are linked to the movements at and below the roadway or if they have merely been triggered by the same cause. In 2021, movement was observed at both scarps and the scarp cracks have widened to 200 mm. In 2022, a few smaller tension cracks opened up just downslope of the main scarps and the toe rolls became more obvious.

Photo 7 – Looking northeast at backslope slumps just south of the power pole.

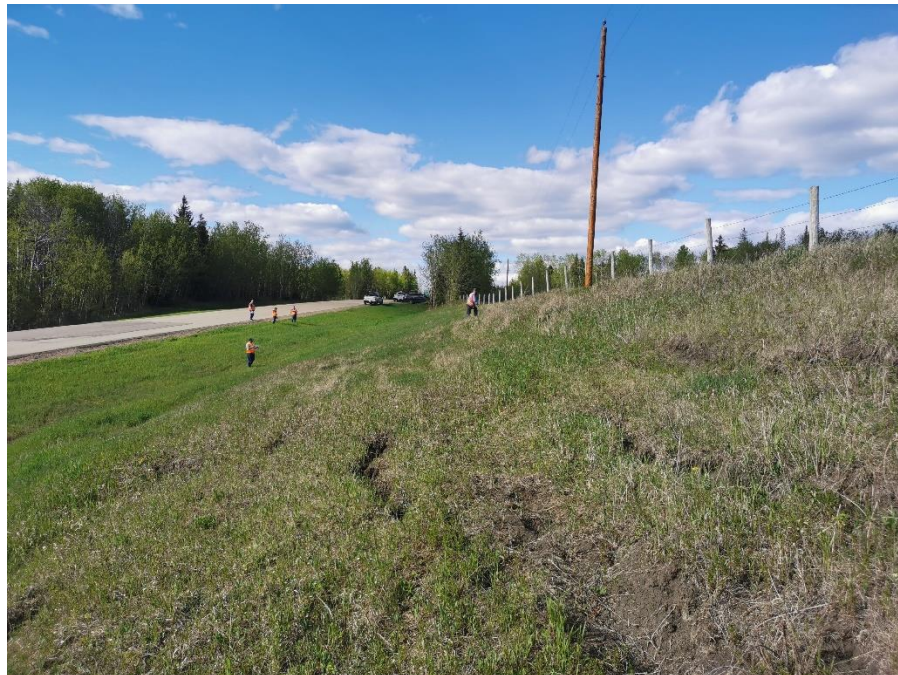
Photo 8 – Looking north at slumping backslope below power pole with open tension cracks.

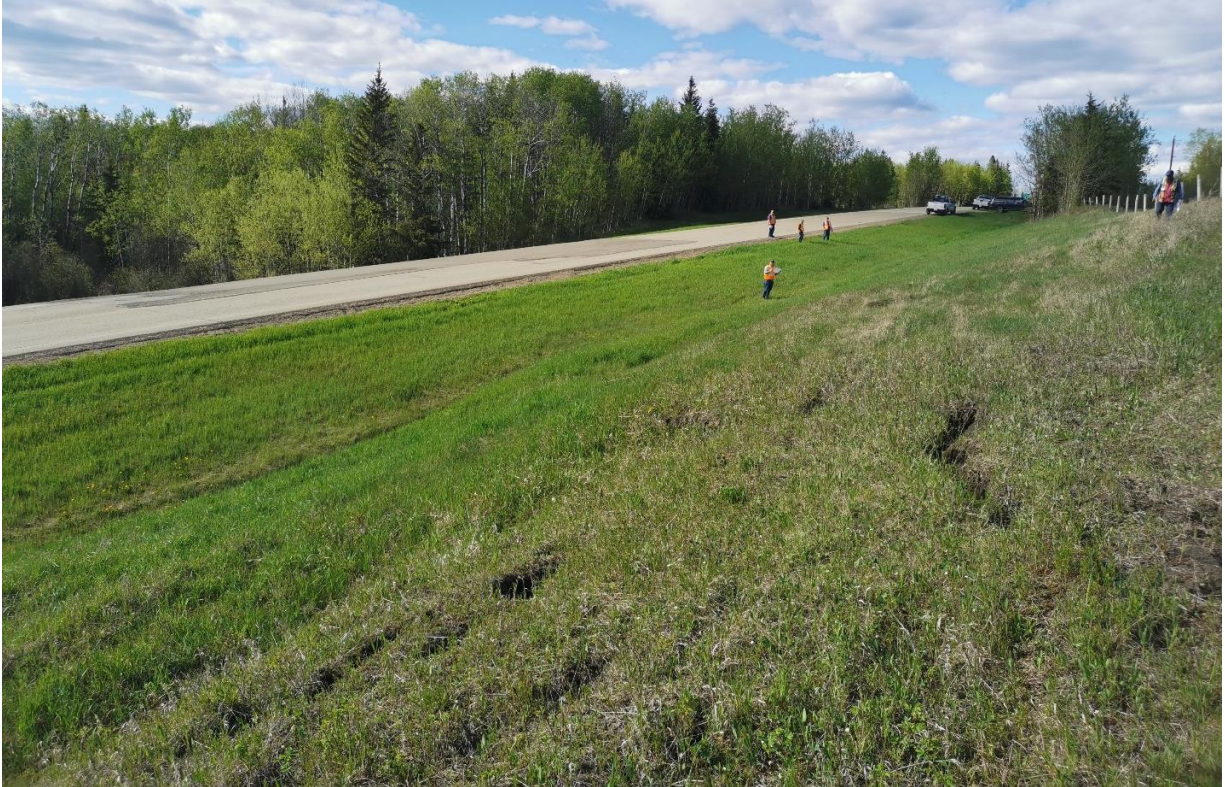
Photo 9 – Looking northwest from the backslope at the subsiding area in the pavement.

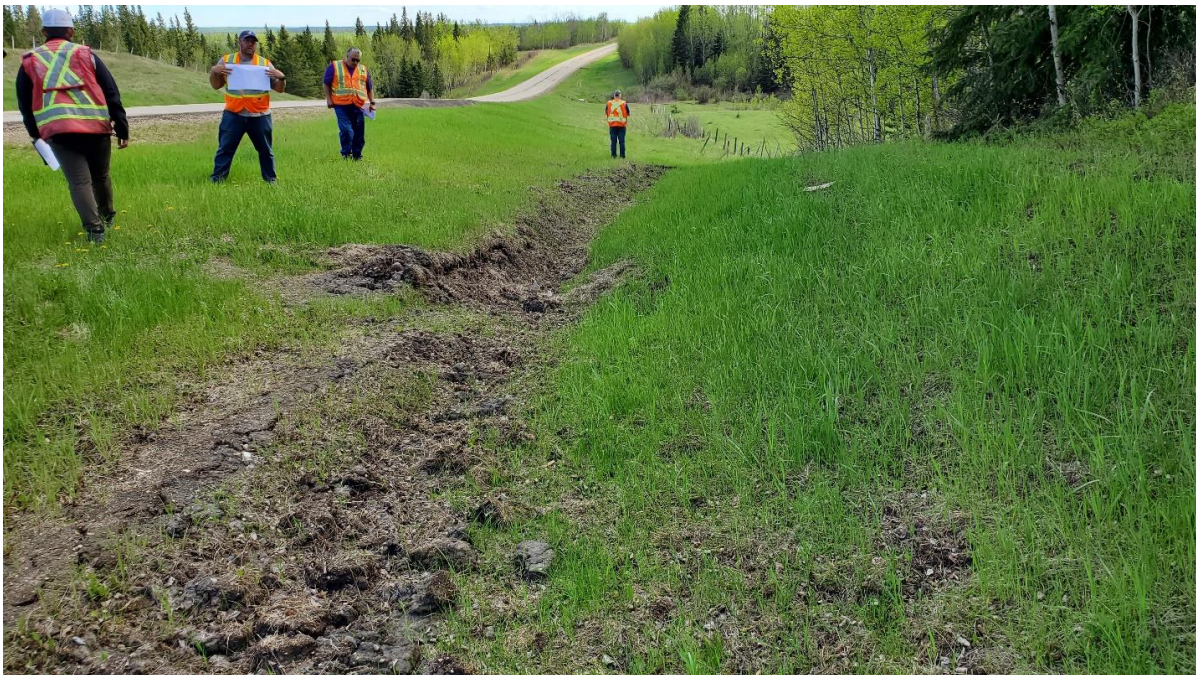
Photo 10 – Looking south at rutting in west ditch at the north end of the site.
