**ALBERTA TRANSPORTATION AND  
ECONOMIC CORRIDORS  
GEOHAZARD RISK MANAGEMENT PROGRAM  
PEACE REGION (PEACE RIVER DISTRICT)  
2025 INSPECTION**

Site Number	Location	Name	Hwy	km
SH014-1	Northeast of High Prairie	Salt Creek Slide	750:02	30.57
Legal Description		UTM Co-ordinates		
NE34-76-14-W5		11U E 558,308	N	6,165,584

SH014-1: HWY 750:02 SALT CREEK SLIDE  
2025 SITE INSPECTION PLAN

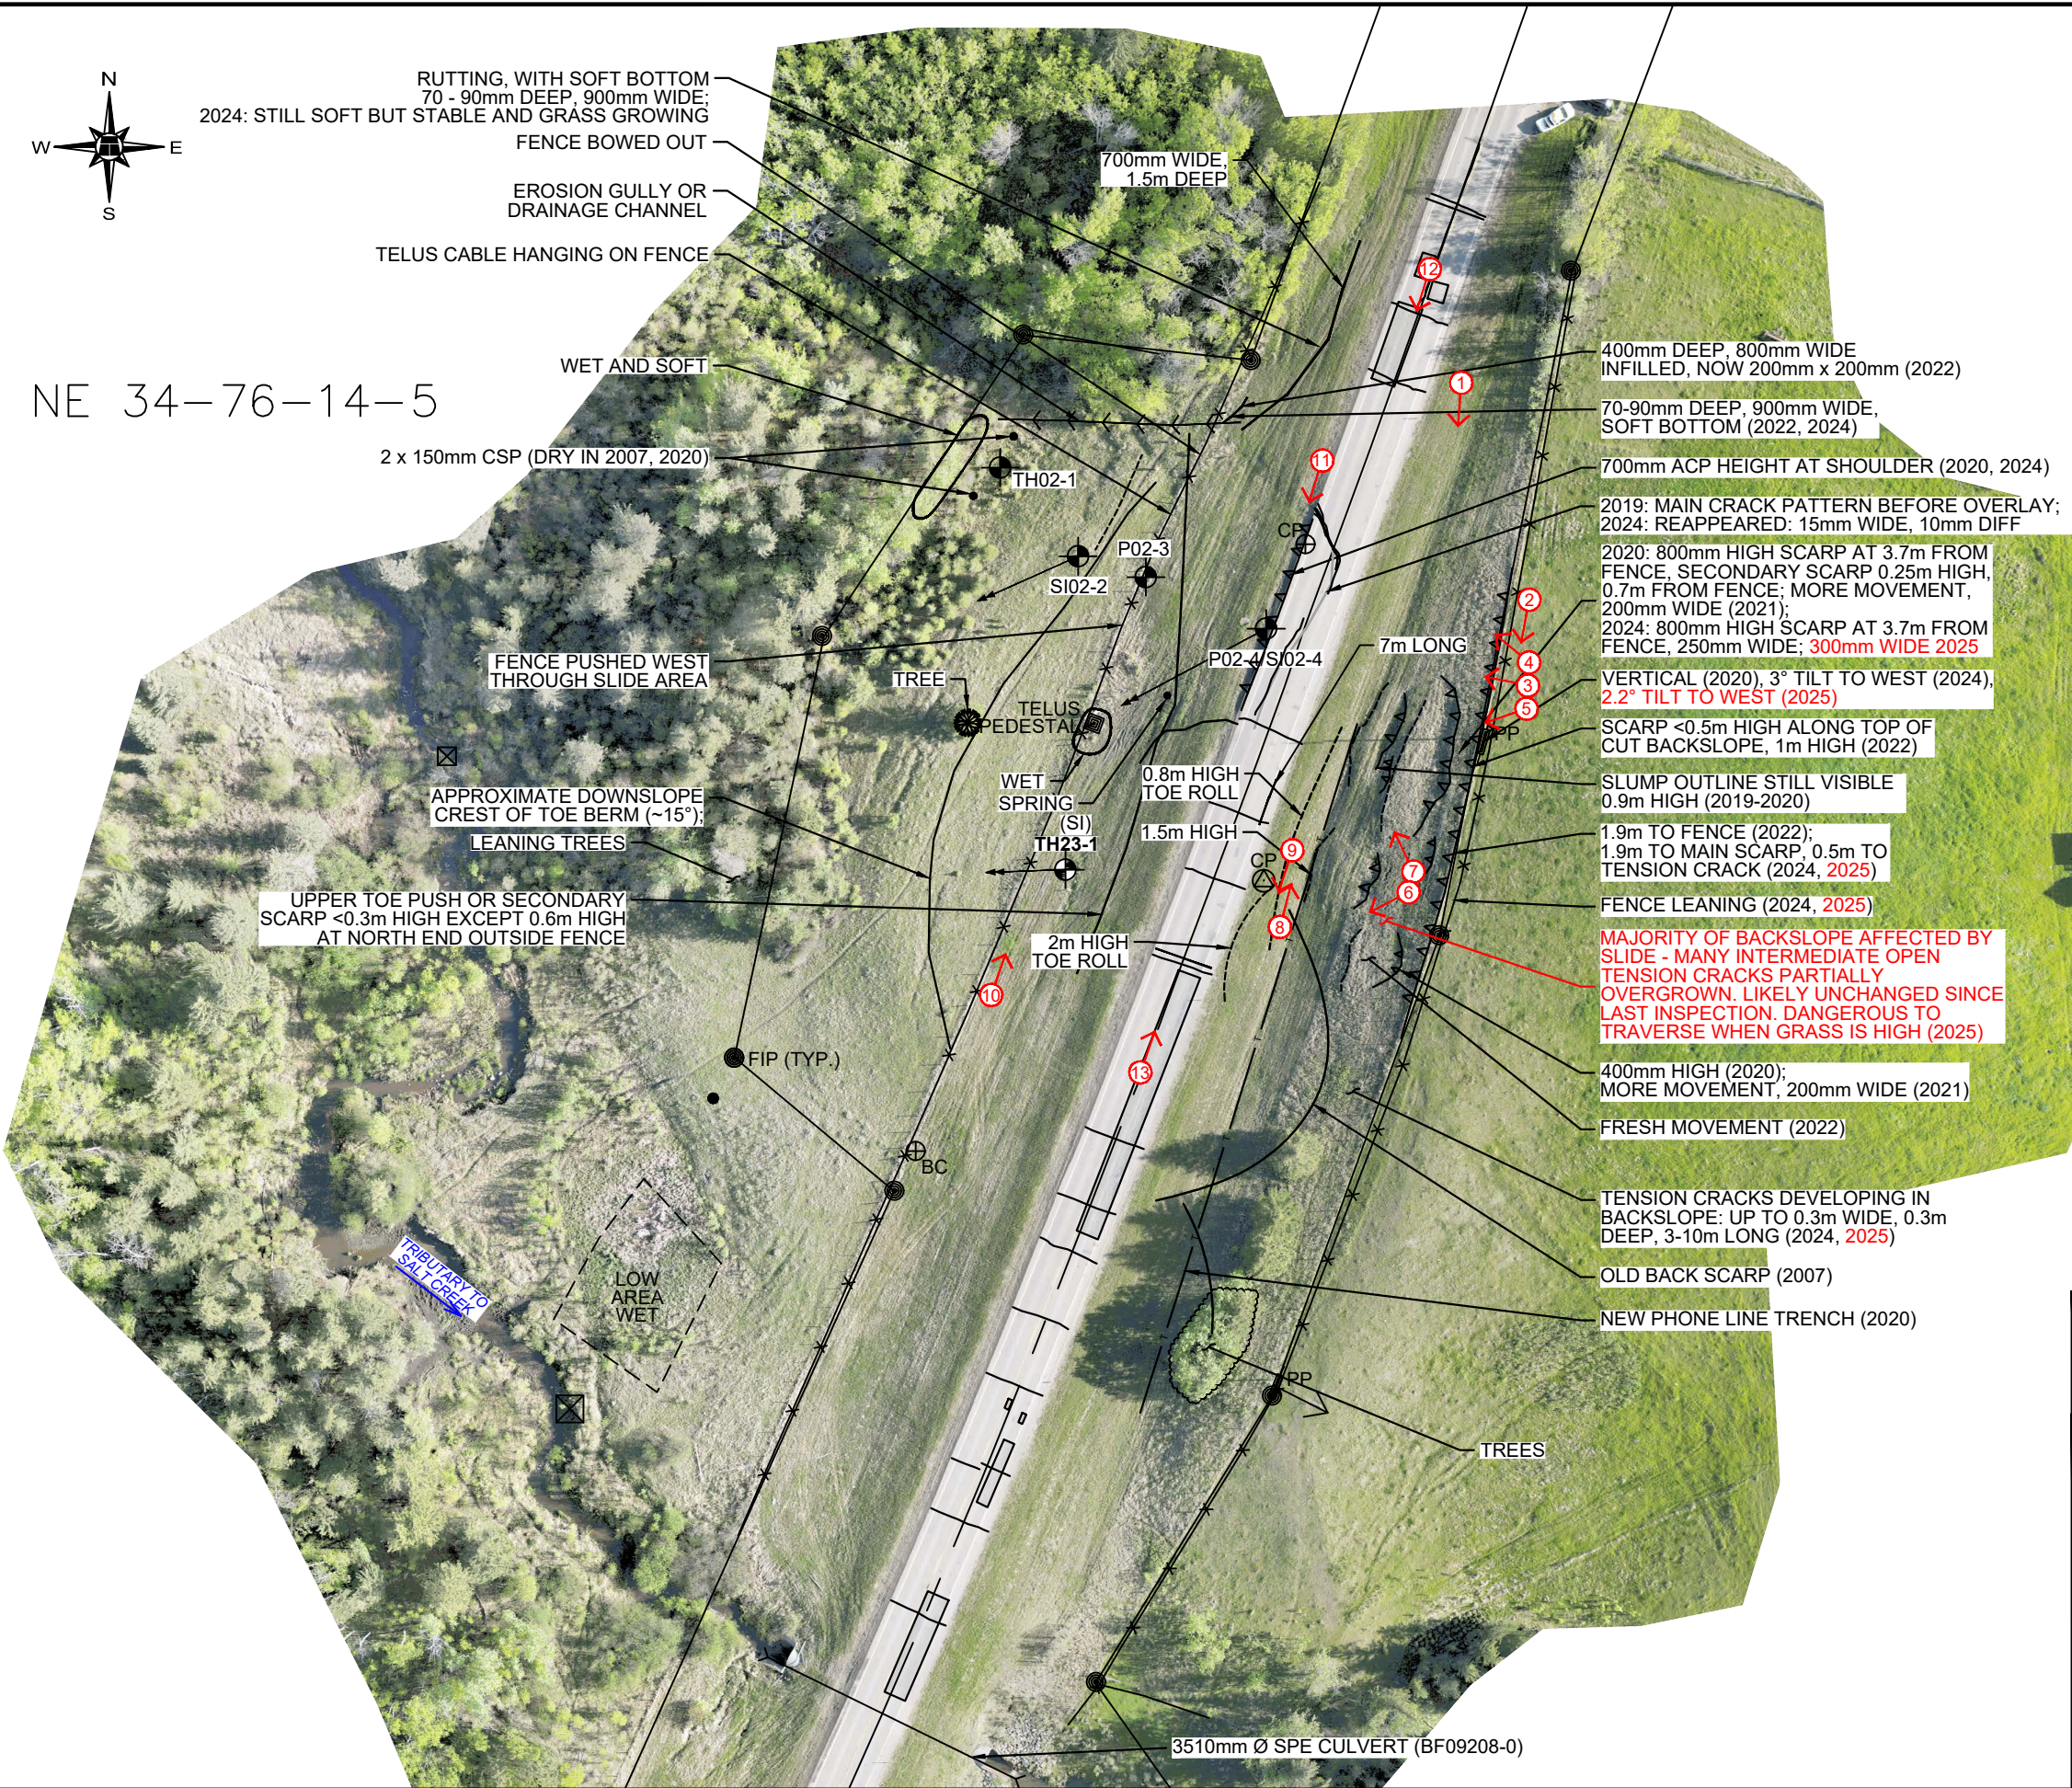
DWG No. 32121-SH014-1-1

The inclinometer movement vectors shown on Drawing 32121-SH014-1 indicate the slide is moving along an azimuth of about 242 degrees, nearly perpendicular to the general creek alignment and at a 50° skew to the highway.

2019: MAIN CRACK PATTERN BEFORE OVERLAY;  
2024: REAPPEARED: 15mm WIDE, 10mm DIFF

2020: 800mm HIGH SCARP AT 3.7m FROM  
FENCE, SECONDARY SCARP 0.25m HIGH,  
0.7m FROM FENCE; MORE MOVEMENT,  
200mm WIDE (2021);  
2024: 800mm HIGH SCARP AT 3.7m FROM  
FENCE, 250mm WIDE; 300mm WIDE 2025

VERTICAL (2020), 3° TILT TO WEST (2024),  
2.2° TILT TO WEST (2025)

1.9m TO FENCE (2022);  
1.9m TO MAIN SCARP, 0.5m TO  
TENSION CRACK (2024, 2025)

MAJORITY OF BACKSLOPE AFFECTED BY  
SLIDE - MANY INTERMEDIATE OPEN  
TENSION CRACKS PARTIALLY  
OVERGROWN. LIKELY UNCHANGED SINCE  
LAST INSPECTION. DANGEROUS TO  
TRAVERSE WHEN GRASS IS HIGH (2025)

TENSION CRACKS DEVELOPING IN  
BACKSLOPE: UP TO 0.3m WIDE, 0.3m  
DEEP, 3-10m LONG (2024, 2025)

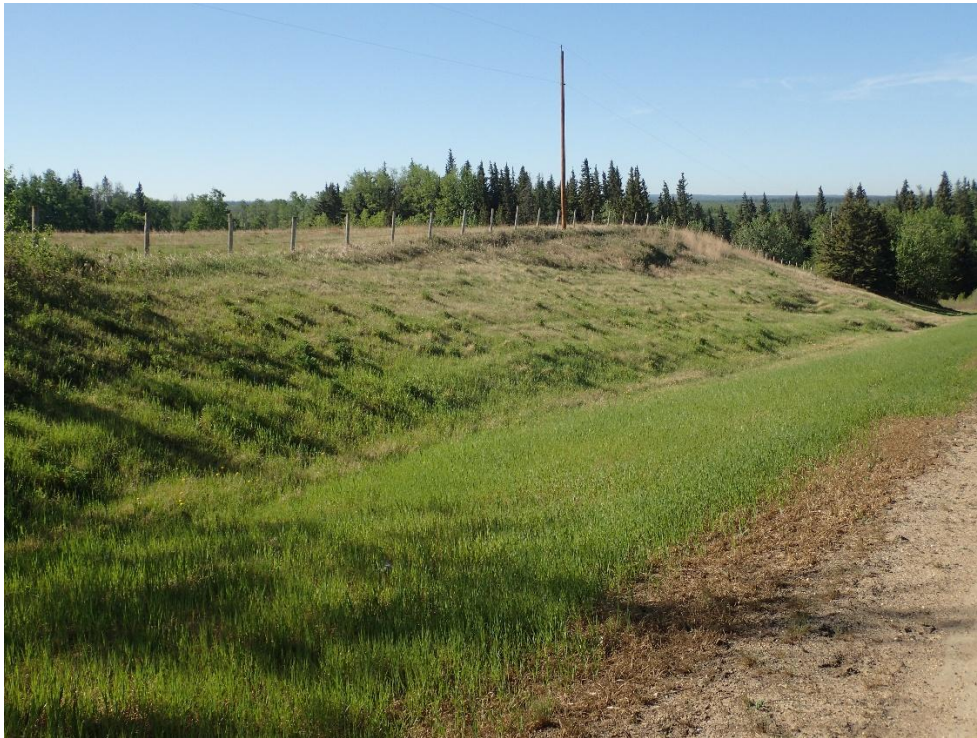
Scarps and tension cracks have formed along the top of the east backslope. The main scarp was 1.9 m from the fence and a tension crack upslope of the main scarp was 0.5 m from the fence. The fence appears to be leaning slightly. The power pole was previously observed to be vertical, however, it was observed to have a 2.2 degree tilt to the west during the 2025 inspection. It is not clear if the east backslope movements are linked to the movements at and below the roadway or if the two areas of

**Photo 1 – Looking southeast at east backslope slumps.**

- The MCI should regularly monitor this area for further movements or enlargement. Crack sealing and patching should be undertaken as required. Consideration should be given to filling and sealing the open cracks present along the east backslope. These cracks capture rain and snow melt which increases the water tables and encourages more slide movement.

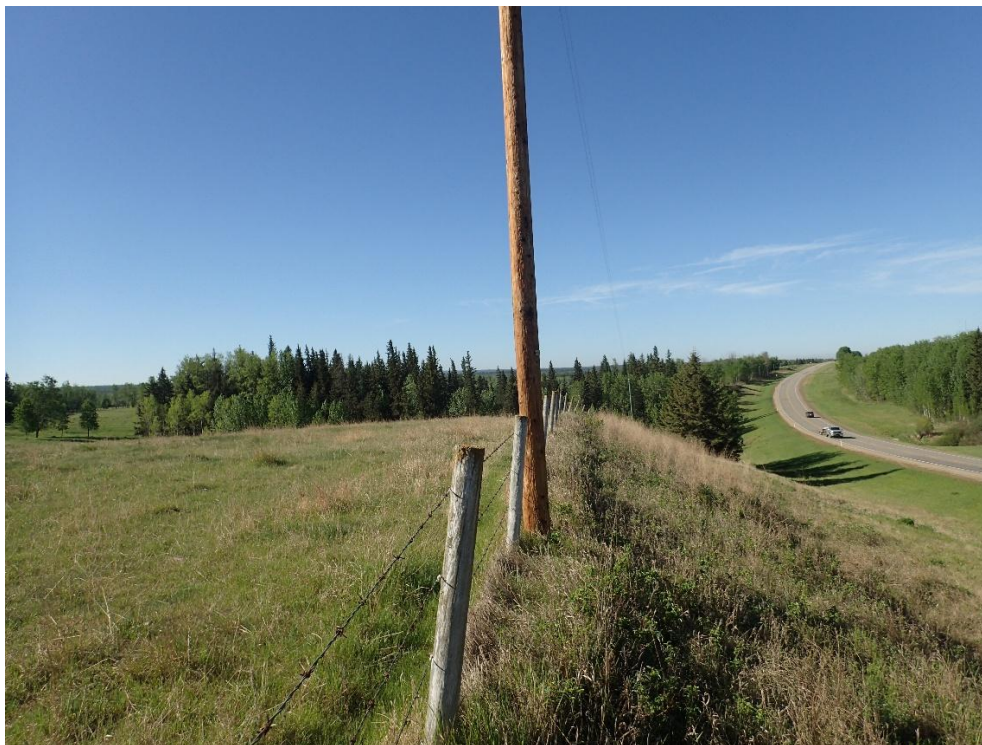
**Photo 2 – Looking south at tilted power pole on east backslope.**

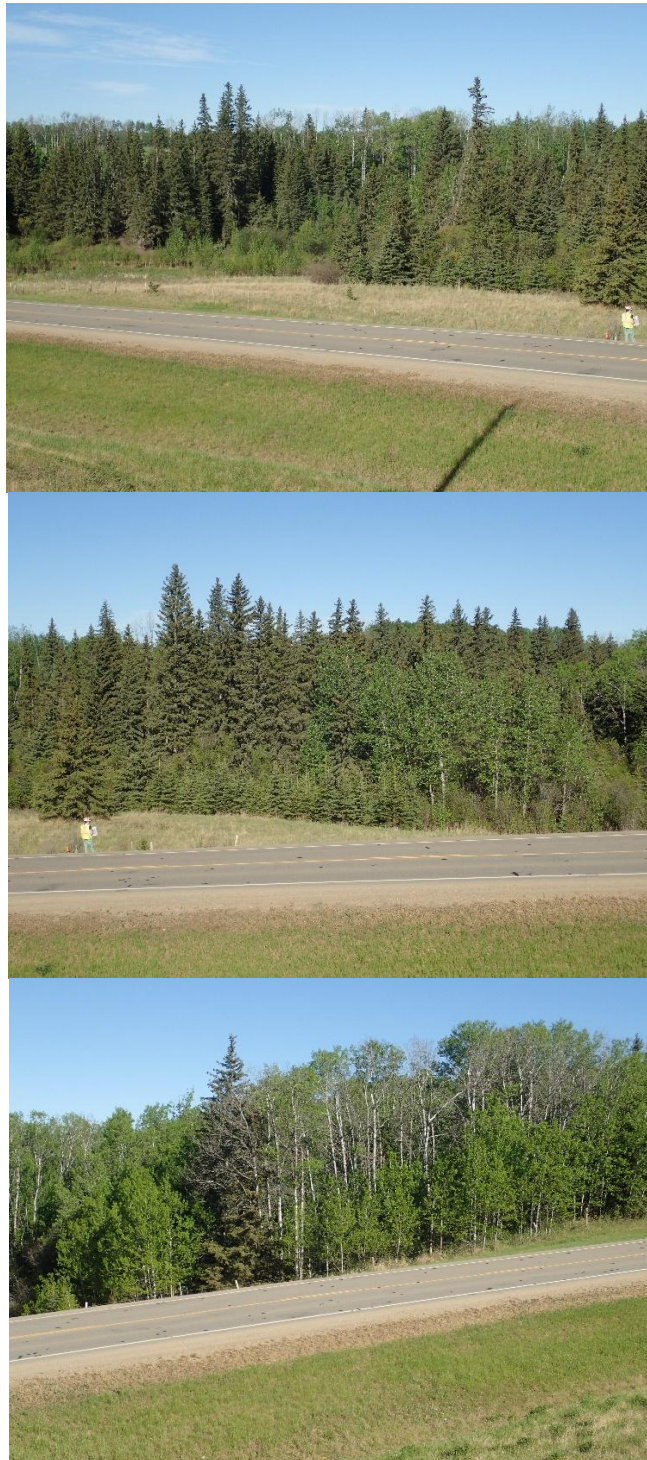
The dominant crack was about 33 m in length with an approximately 20 m long dip on the west side of the crack that had dropped about 30 mm. Crack widths were typically 20 mm to 30 mm wide. These cracks were mostly obscured by the 2022 overlay. The main crack reappeared and was 15 mm wide and had 10 mm of vertical displacement. The movements were attributed to the upper, shallower slide block. There is some concern that the extent of the overall slide may be larger than previously thought and affecting a greater length of paved roadway. This was evidenced by a previous 115 m long full width pavement patch that spans from the north approach to 30 m south of the extent of the main crack. During the 2024 inspection, there were smaller patches within this area, north of the main crack. It is possible that movement on the lower slide block may be contributing to this greater extent. There were a few long patches observed along the northbound lane, south of the main crack during the 2024 inspection. There was a linear feature just below the crest of the toe berm that appeared somewhat indicative of a forming scarp. However, it could also be related to equipment rutting. During the 2025 inspection, observed conditions downslope of the highway embankment were similar to the previous inspection.

**Photos 3-5 – Looking east from east backslope at the highway surface where main scarp was previously observed.**

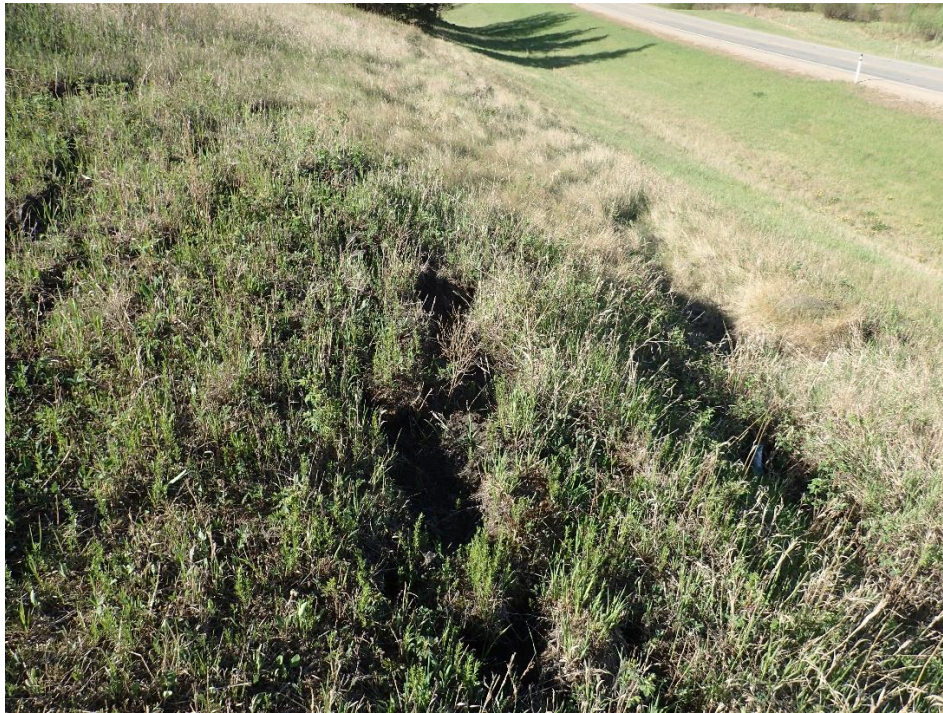
**Photo 6 – Looking southwest at lower backslope slumps.**

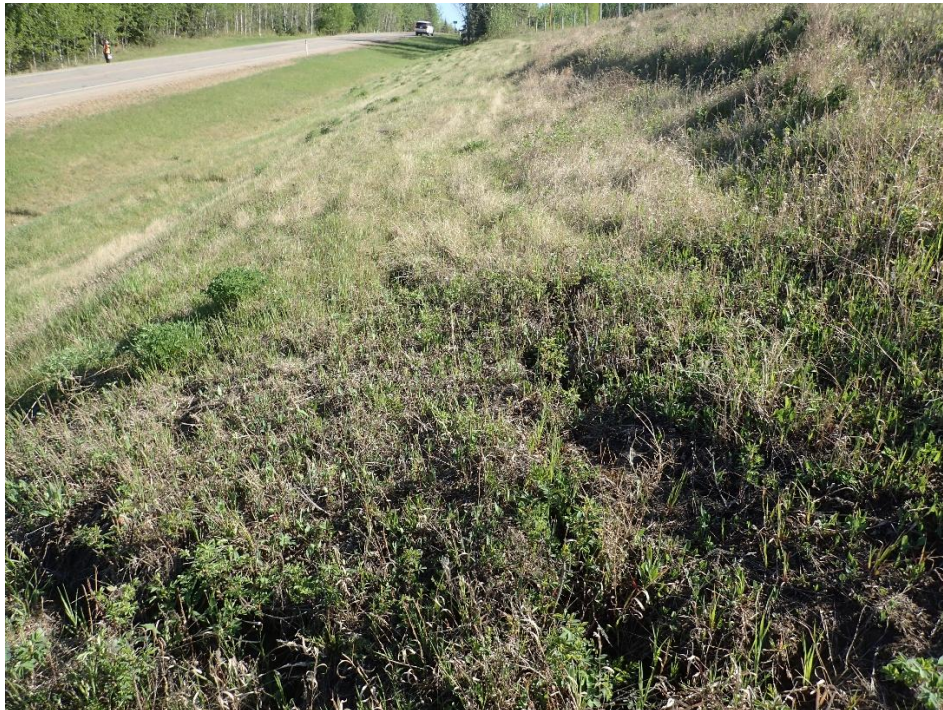
**Photo 7 – Looking northwest at lower backslope slumps.**

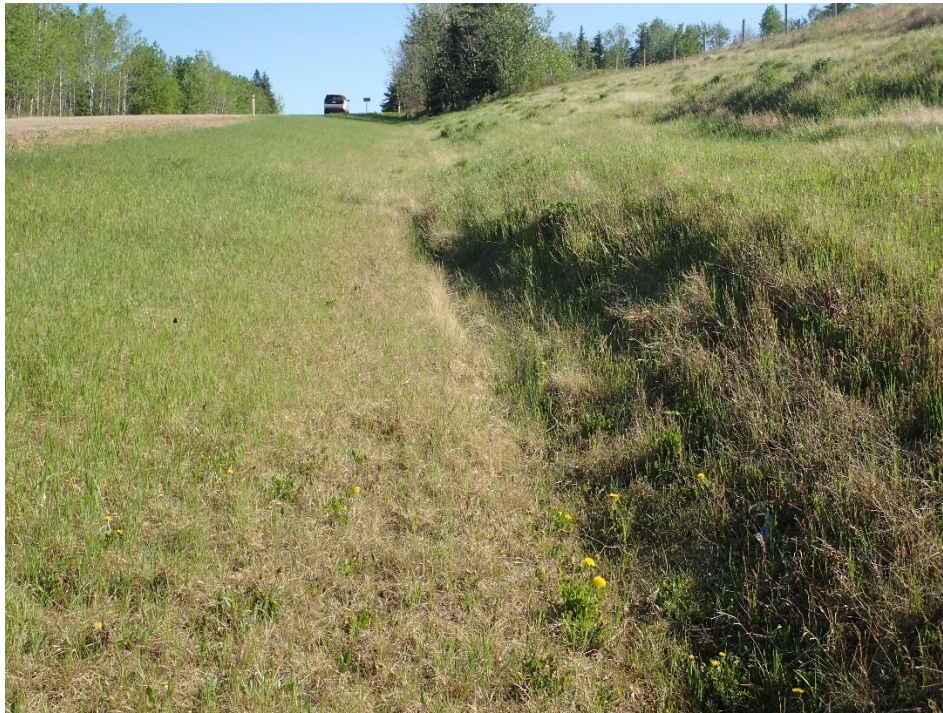
**Photo 8 – Looking north at toe roll of backslope slumps.**

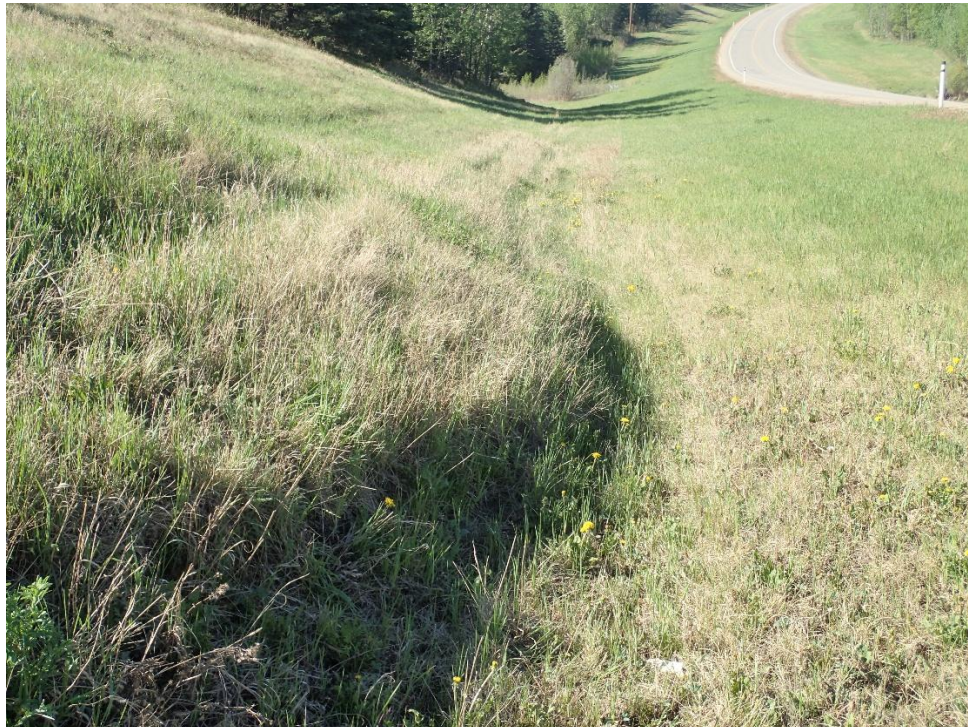
**Photo 9 – Looking south at toe roll of backslope slumps.**

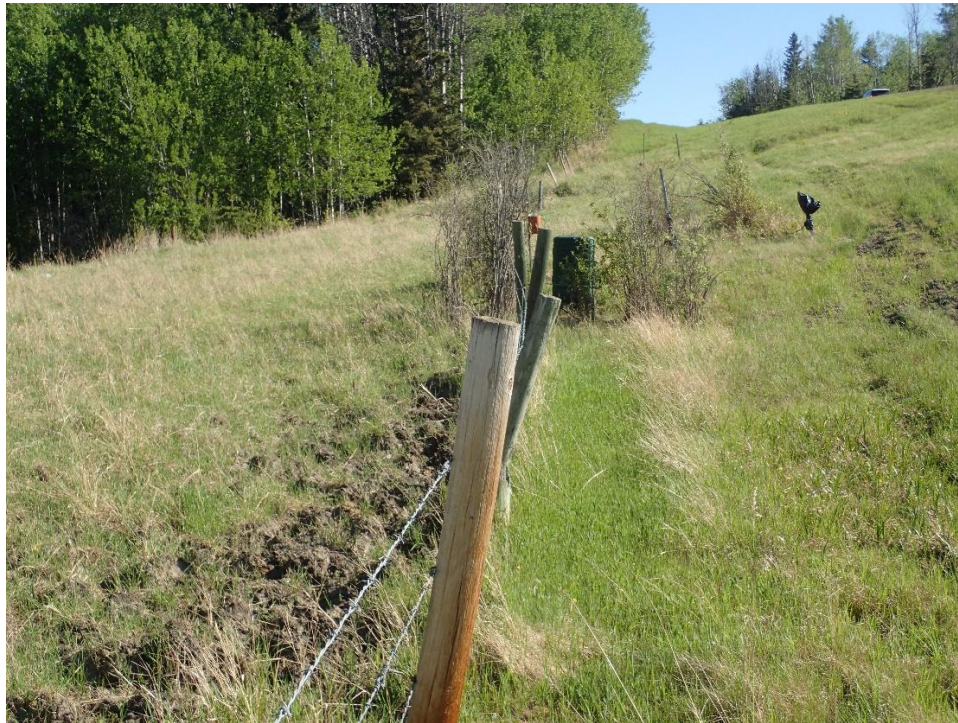
Based on previous information, the slide appears to be moving at two levels. There is a shallow upper block sliding within high plastic clay that is moving out onto the top of the toe berm and pushing out the fence. There is also a lower deep-seated block, also in high plastic clay, that extends below the toe berm potentially to the creek. The overall weight of the highway embankment and toe berm fills is too great for the existing relatively weak and wet clay foundation soils and has resulted in the current slide conditions. Ingress of water into the slide mass via open cracks and impeded drainage can also influence the rate of slide movement.

**Photo 10 – Looking north along fence line downslope of highway.**

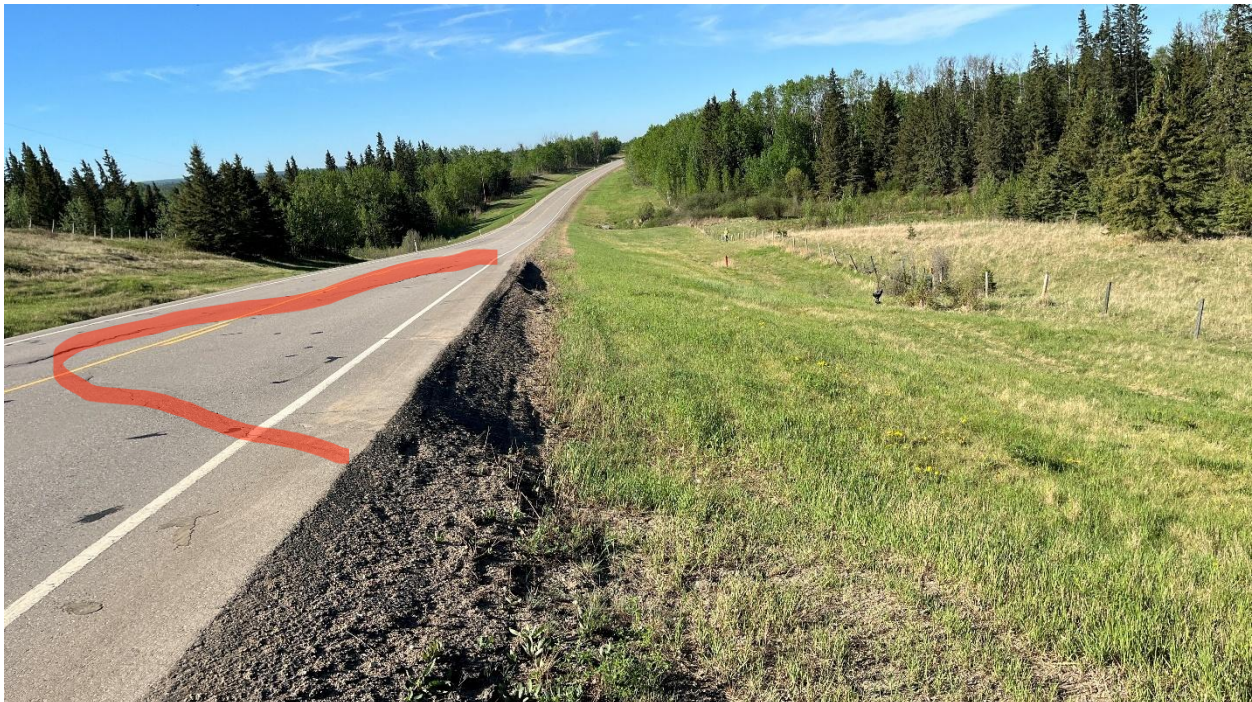
**Photo 11 – Looking south at main crack (highlighted in red) near the north end of the site.**

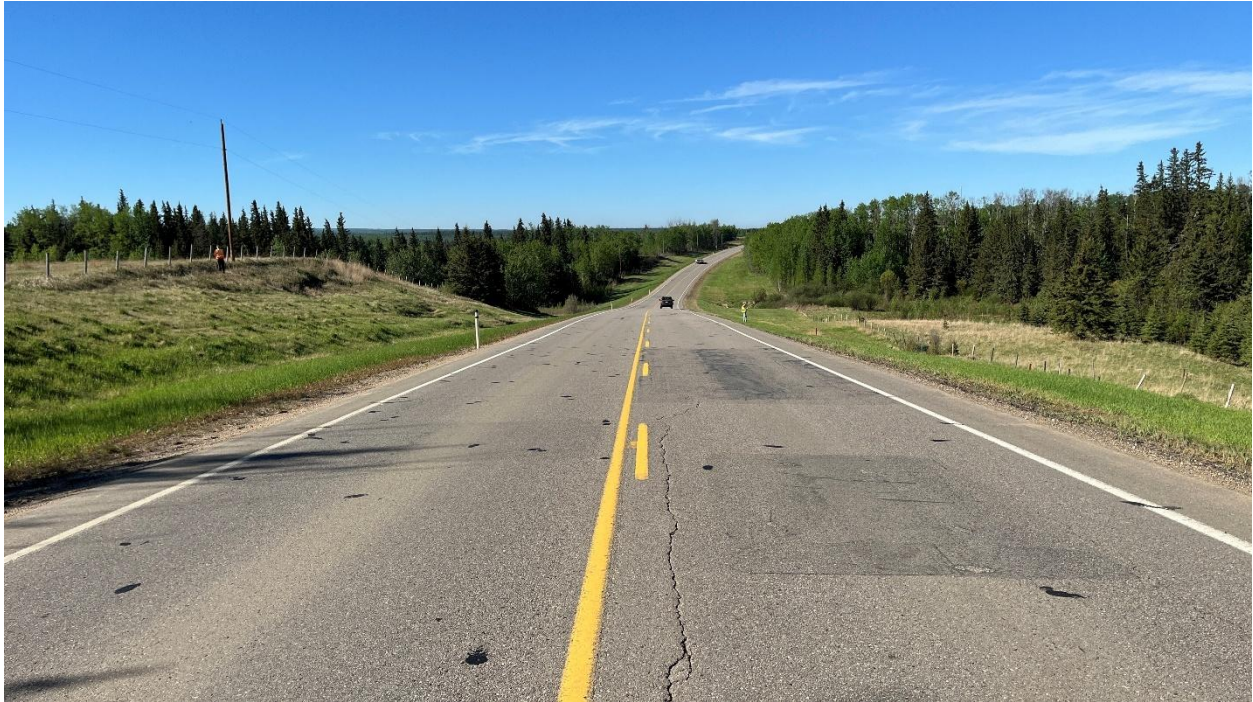
**Photo 12 – Looking south at the highway surface from the northern limit of the site.**

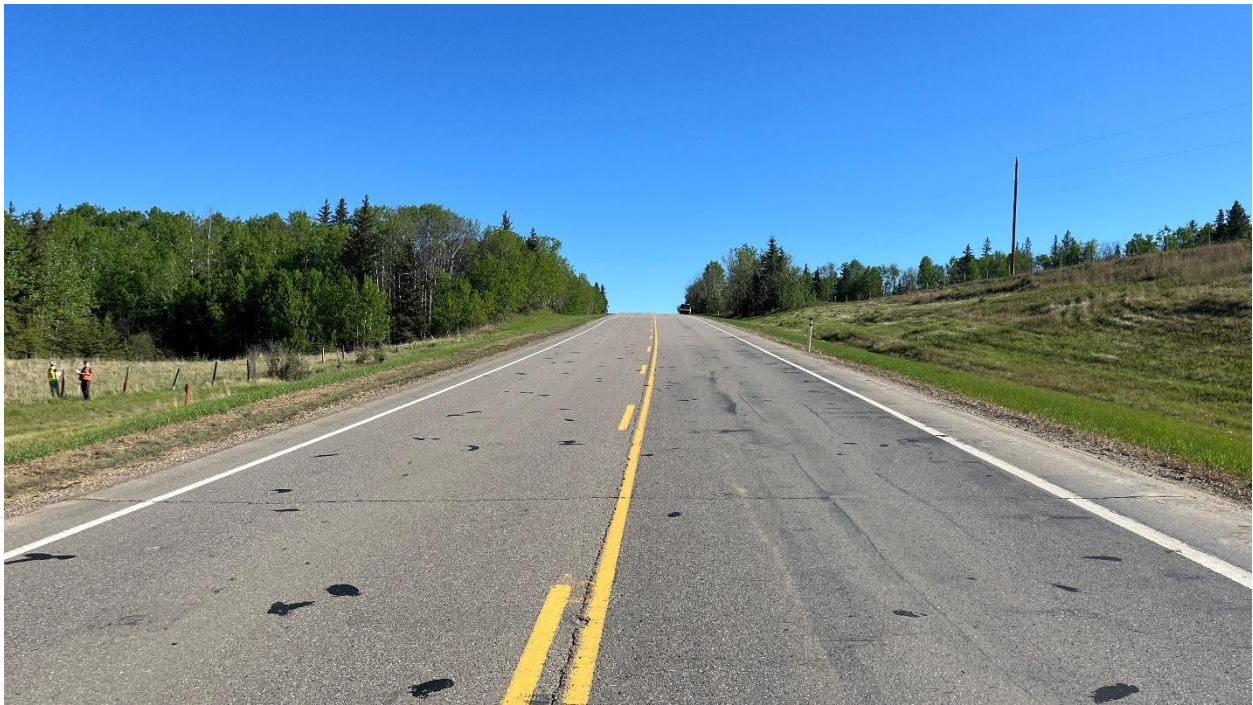
**Photo 13 – Looking north at the highway surface from the south area of the site.**
