**ALBERTA TRANSPORTATION GEOHAZARD ASSESSMENT PROGRAM
PEACE REGION – PEACE-HIGH LEVEL
2020 INSPECTION**

Site Number	Location	Name	Hwy	km
PH42	Daishowa East Hill	Pumping Well	986:01	33.2
Legal Description		UTM Co-ordinates		
NE7-85-20 W5M		11V E 491155	N 6246175

Date	PF	CF	Total
Previous Inspection:	20-Jun-2017	3	6	18
Current Inspection:	11-Jun-2020	3	6	18
Road WAADT:	900		Year:	2019
Inspected By:	Ed Szmata, TRANS Rocky Wang, TRANS		Don Proudfoot, TEL Tyler Clay, TEL	
Report Attachments:	<input checked="" type="checkbox"/> Photographs		<input type="checkbox"/> Maintenance Items	
	<input checked="" type="checkbox"/> Plans

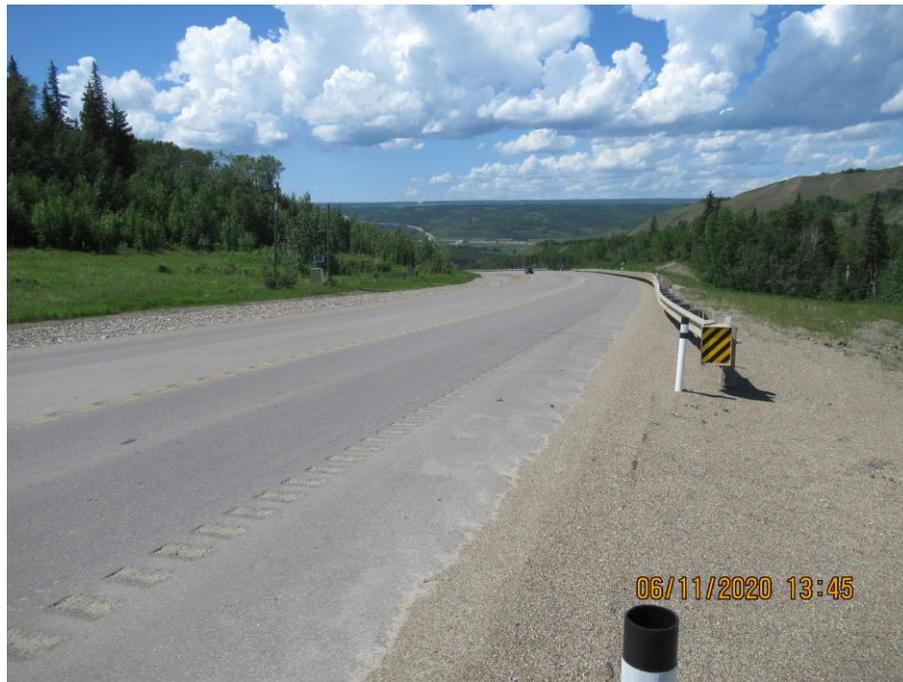
Primary Site Issue:	Roadway and embankment have history of active landsliding. Headscarp extends across both driving lanes (Photos 42-01 and 42-03). Site was remediated once (successfully in short term) with a series of pumping wells installed on upslope side of roadway. The pumps required ongoing maintenance that was impractical to sustain and eventually the pumps were no longer effective at reducing the rate of landslide movement. Mitigation work was completed between the fall of 2016 to the summer of 2018 involving construction of a 98 m long reinforced tangent pile wall to mitigate a landslide affecting the highway.	
Dimensions:	Slide is 100 m wide and extends from east bound driving lane to (presumably) creek approximately 150 m downslope of roadway.	
Maintenance:	Road patching 2015/16.	
Observations:	Description	Worsened?
<input type="checkbox"/> Pavement Distress	ACP was in good condition at the time of the inspection with no signs of cracking or subsidence along previously observed extents of pavement damage due to slide movement (Photos 42-01 and 42-03).	<input type="checkbox"/>

<input type="checkbox"/> Slope Movement	No observations of slope movement were evident at the road surface or below the pile wall along or outside the previous landslide extents (Photos 42-01 and 42-04).	<input type="checkbox"/>

Photo 42-01.
Looking west across the repaired slide area. Guardrail and pavement surface replaced.

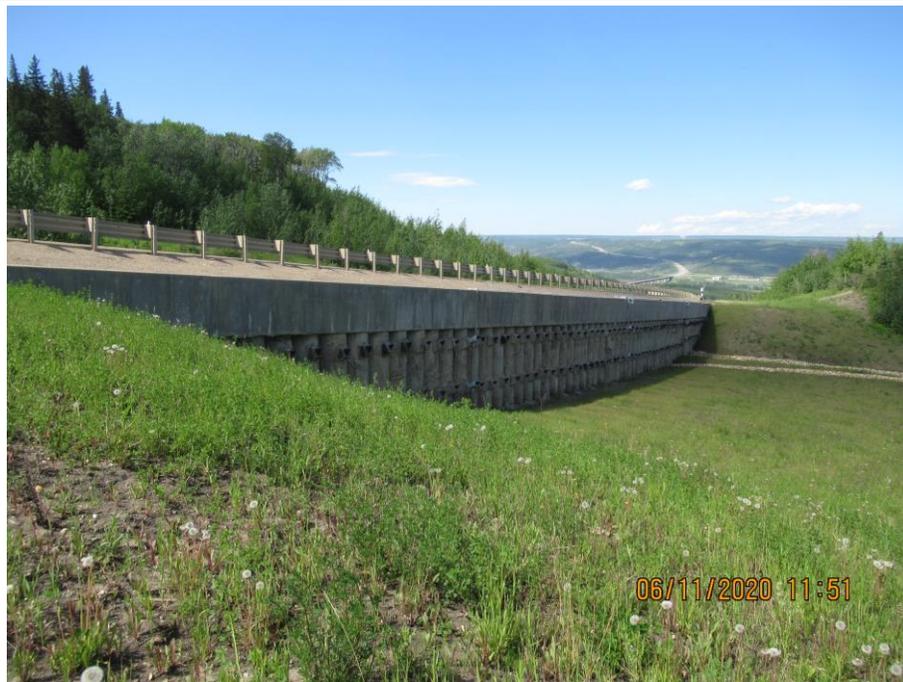
Photo 42-02.
Looking west at the new pile wall and regraded slope below.

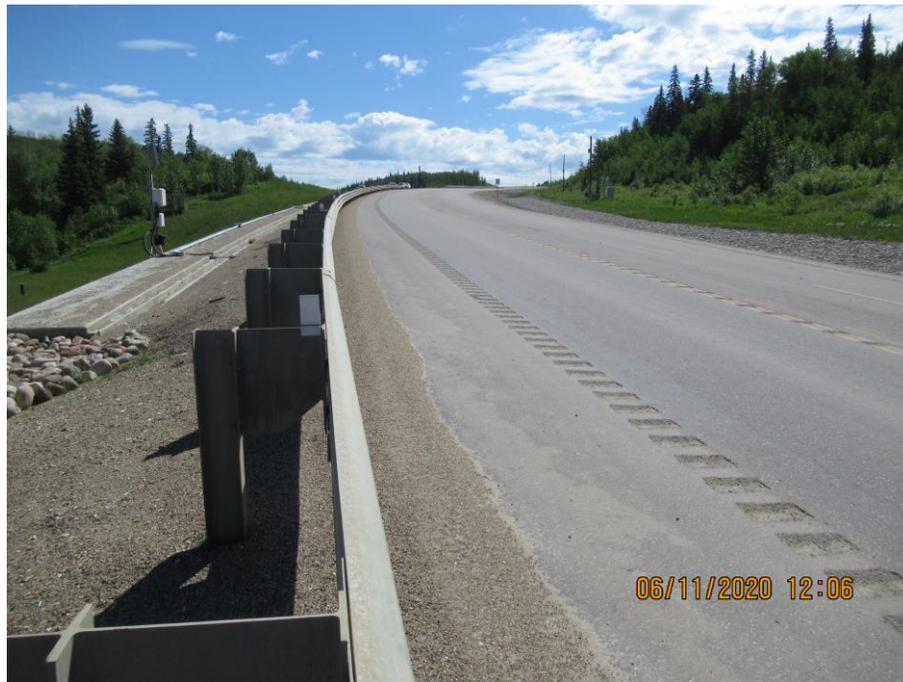
Photo 42-03.
Looking east at the replaced highway segment that previously had cracking and settlement across the roadway due to landslide movement (33+210). Road surface was in good condition at time of inspection.

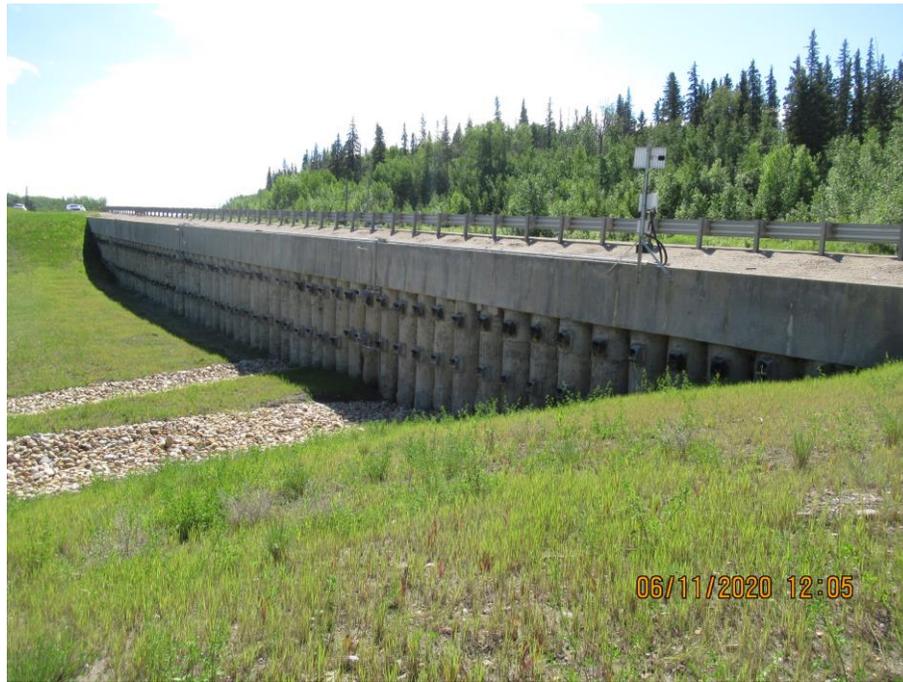
Photo 42-04.
Looking southeast at the new pile wall and drainage swales.

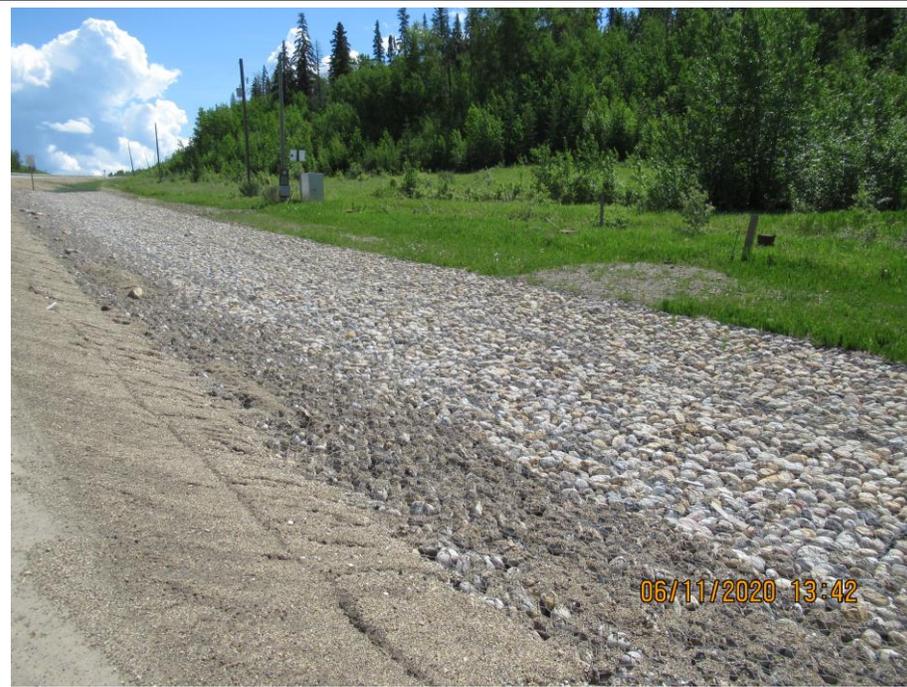
<input checked="" type="checkbox"/> Erosion	Previous gully erosion in the south ditch was repaired and ditch has been armored with a gabion mattress. Minor rill erosion was noted between the road edge and edge of the gabion. (Photo 42-05).	<input type="checkbox"/>
<input type="checkbox"/> Seepage		<input type="checkbox"/>
<input type="checkbox"/> Bridge/Culvert Distress		<input type="checkbox"/>
<input type="checkbox"/> Other		<input type="checkbox"/>
<p>Instrumentation: Legacy SI instrumentation (installed in 2009): SI09-1 - Upslope of roadway; sheared at 2.6 m after September 2013 SI09-2 - Downslope of roadway; sheared at 16.8 m after June 2011 SI09-3 - Downslope of roadway; sheared at 11.0 m after May 2010 SI09-4 - Downslope of roadway; sheared at 9.8 m after September 2010</p> <p>New instrumentation has been installed to monitor performance of the pile wall and includes the following: 9 vibrating wire (VW) piezometers, 1 slope inclinometer (SI), 3 shape accelerometer arrays (SAA), 14 vibrating wire strain gauges (SG), and 9 load cells. Battery issues at the datalogger resulted in data collection gaps for the SAA's.</p> <p>SI18-1 (installed in the bench downslope of the pile wall) has not shown any discernible movement since it was reinitialized during Spring 2019.</p> <p>Wall deflections have been measured in SAA17-P20 and SAA17-P40 over the length of the piles and over the combined length of the piles and waler cap beam with a maximum total resultant movement up to 49 mm. These deflections are within expected design limits.</p> <p>SAA18-1 (installed in the bench downslope of the pile wall) showed an average rate of movement of 4.3 mm/yr over 0.5 m to 12.5 m depth since Fall 2019 with a total cumulative movement of 7.6 mm. SAA17-P40 has shown a total cumulative movement of 4.1 mm over 0.5 m to 12.5 m depth since June 2018, indicating that the bench below the pile wall has moved 3.5 mm in the downslope direction relative to the pile wall during this time span. On this basis, the soil bench is still providing support to the wall.</p> <p>Strain Gauge Summary: Compared to the Fall 2019 readings, the strain gauges have shown changes in measured microstrain ranging from an increase in tension at 0.5 m depth from the pile cut-off elevation on the downslope pile face, to an increase in compression at 8.5 m depth from the pile cut-off elevation on the upslope pile face. Overall, the strain gauges on the upslope pile face below 14.5 m depth showed an overall increase in tension since Fall 2019, while the gauges above this depth mostly showed an increase in compression. Conversely, the strain gauges on the downslope pile face installed below 14.5 m depth showed an overall trend of increasing compression, while the strain gauges installed above this depth showed mainly increases in tension.</p> <p>VW Summary (at pile wall): VW17-1A and VW17-3B showed increases in groundwater level of 0.05 m and 0.73 m, respectively, since the Fall 2019. VW17-2B showed a decrease in groundwater level of 0.42 m compared to the fall of 2019 readings. The current groundwater levels in VW17-1B and VW17-3B are the same as those measured Fall 2019. VW17-1A, VW17-1B and VW17-3A</p>

Photo 42-05. New gabion mattress installed in the south ditch across the entire site extents to repair previous erosion damage. Minor rill erosion was noted between the road edge and edge of the gabion. Previous non-functioning pumping wells were decommissioned and VW piezometers were added with a datalogger.
