**ALBERTA TRANSPORTATION GEOHAZARD  
ASSESSMENT PROGRAM  
PEACE REGION (PEACE RIVER DISTRICT)  
2021 INSPECTION**

<b>Site Number</b>	<b>Location</b>	<b>Name</b>	<b>Hwy</b>	<b>km</b>
PH042	Daishowa East Hill	Pumping Well	986:01	33.2
<b>Legal Description</b>		<b>UTM Co-ordinates</b>		
NE7-85-20 W5M		11V E 491155	N 6246175

DAISHOWA  
HWY 986:01 (PH042)  
LOCATION PLAN

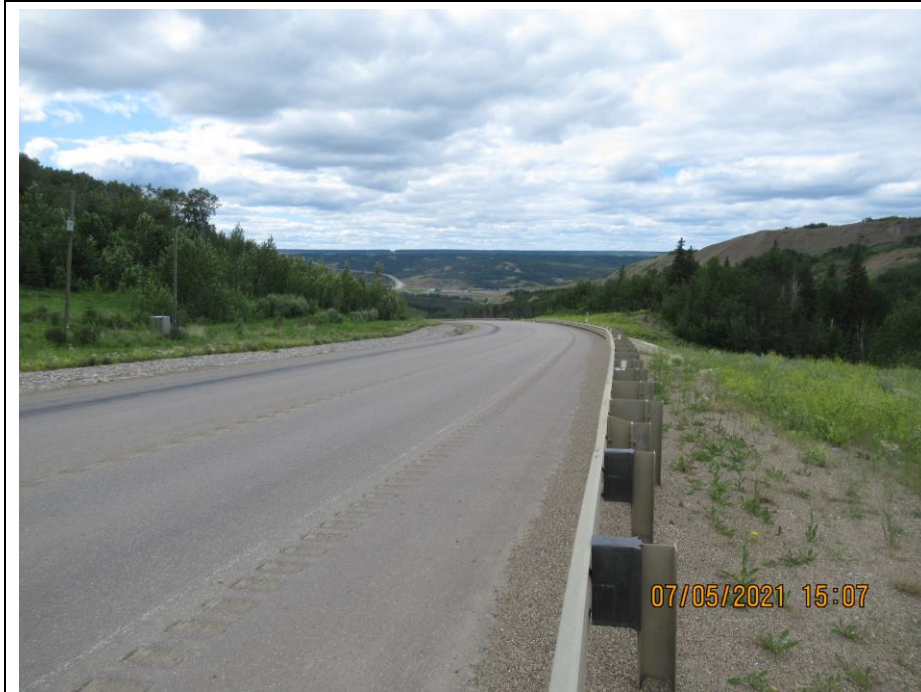
**Photo 42-01.**  
Looking west across the repaired slide area. Guardrail and pavement surface in good condition with no major change since previous inspection.

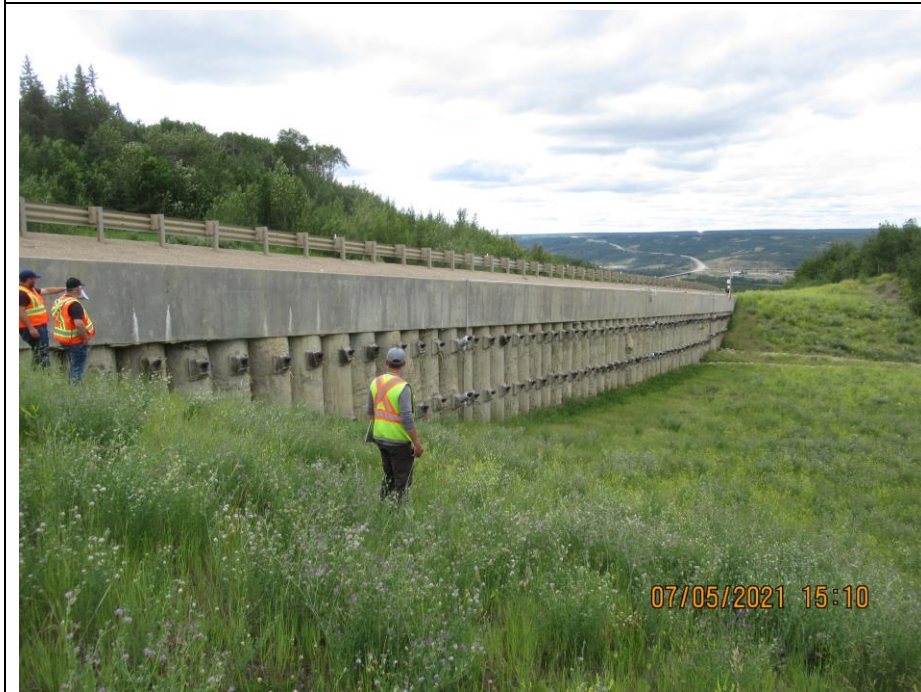
along or outside the previous landslide extents (Photos 42-02). Backslope failure that occurred in 2020 near 33+125 has ongoing movement. The toe roll has lifted and deformed approximately 75 m of the gabion mattress in the south ditch, with vertical displacement up to 1.1 m (Photo 42-06).	
<input checked="" type="checkbox"/> Erosion	Previous gully erosion in the south ditch was repaired and ditch has been armored with a gabion mattress. Minor rill erosion was noted between the road edge and edge of the gabion but has not significantly changed since the previous inspection. (Photo 42-05 and 42-06).	<input type="checkbox"/>
<input checked="" type="checkbox"/> Seepage	Drain outlets between the piles were dripping at the west end of the wall and area at the base of the wall was wet. Subdrain outlet at the end of the riprap swale was dripping. (Photo 42-04)	<input type="checkbox"/>
<input type="checkbox"/> Bridge/Culvert Distress		<input type="checkbox"/>

**Photo 42-02.**  
Looking west at the new pile wall and regraded slope below. No significant change since 2020.

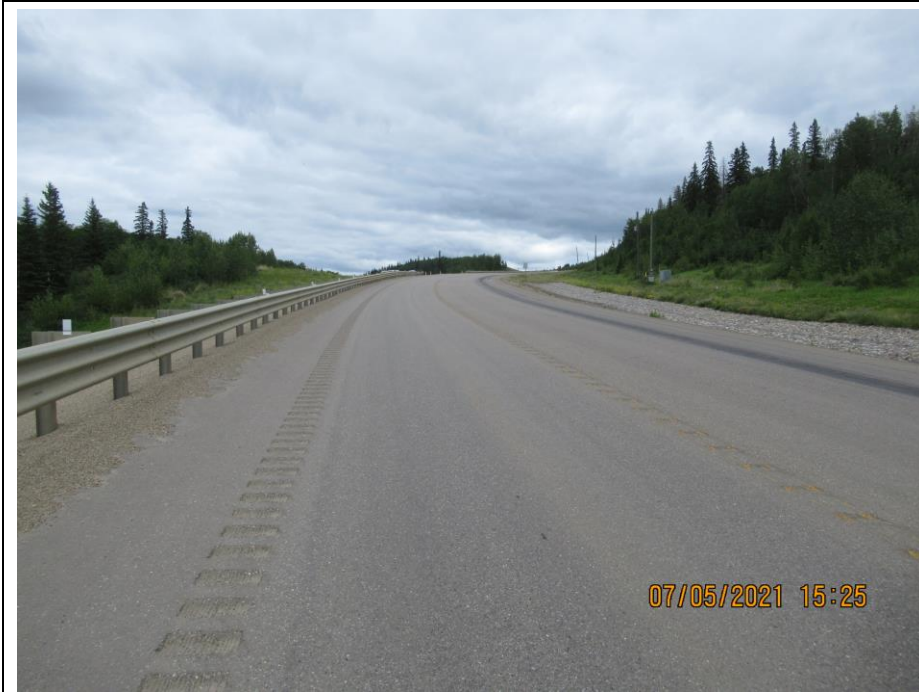
**Photo 42-03.**  
Looking east at the replaced highway segment that previously had cracking and settlement across the roadway due to landslide movement (33+210). Road surface was in good condition at time of inspection.

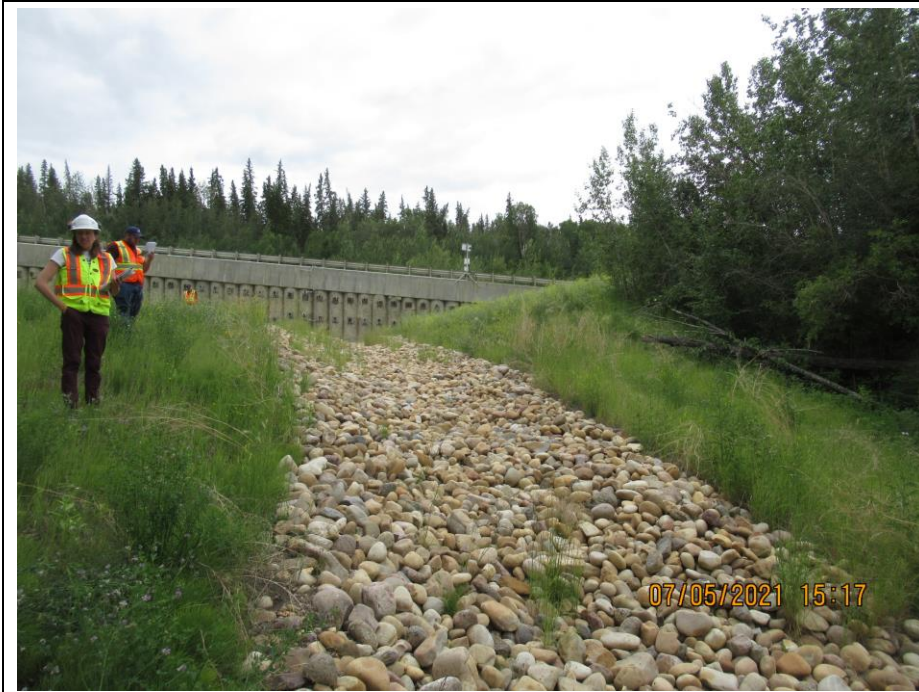
**Photo 42-04.**  
Looking south, upslope at one of two drainage swale branches at the west side of the wall.

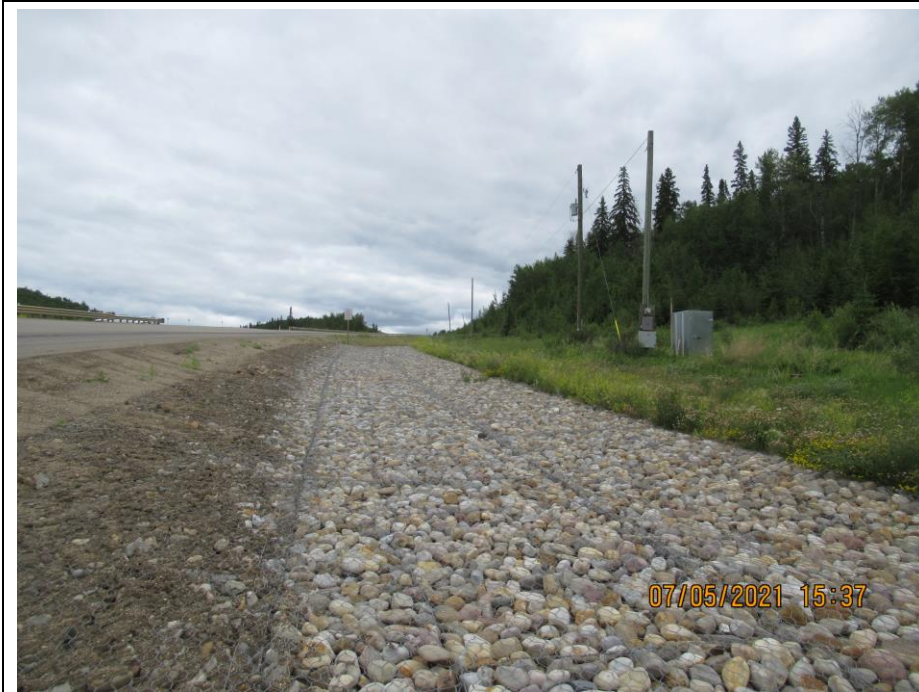
**Photo 42-05.**  
View looking east at the gabion mattress installed in the south ditch across the entire site extents to repair previous erosion damage. Minor rill erosion was noted between the road edge and edge of the gabion. No major change within the area east of 33+175 since 2020.

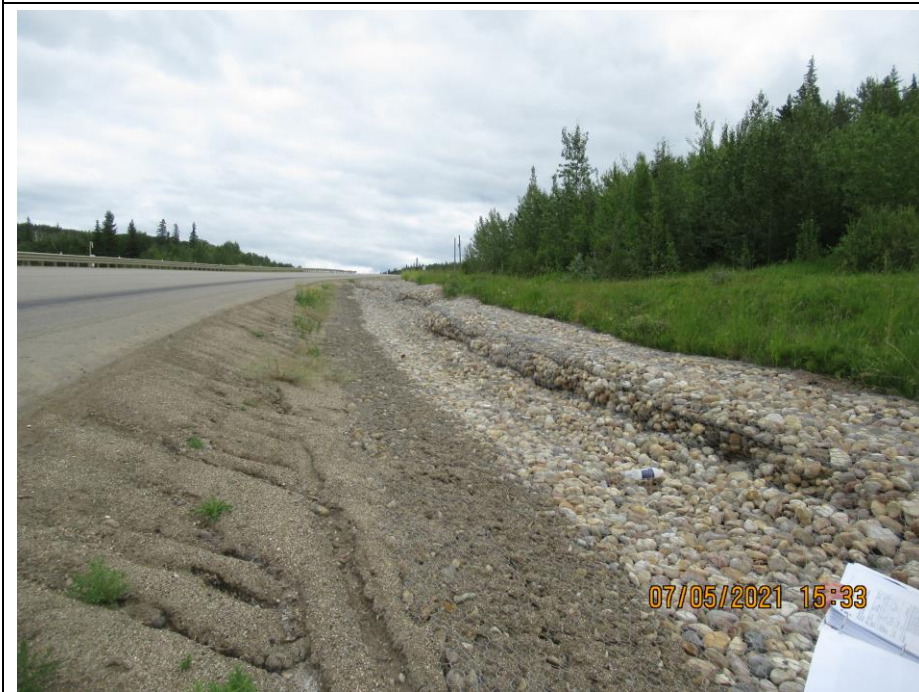
The hillside upslope/south of the highway has been affected by historic landslide movements and has always appeared hummocky during previous inspections. However, higher than usual precipitation and groundwater levels over the last few years (up to 2020) have triggered the recent new more aggressive movements. The toe roll of the landslide is clearly marked by the near-vertical heaving of the gabion mattress lining in the ditch. The west flank is also clearly marked by shearing and displacement of the bush covered ground surface. However, the uphill backscarp and east flank were not as well defined. The toe heave has impacted the ditch lining, which could hamper ditch drainage and possibly lead to overflowing of water onto the highway and erosion of the edge of the highway under high runoff conditions.

**Photo 42-06.**  
View looking east at the gabion mattress installed in the south ditch near 33+125. The toe roll of a landslide that occurred in 2020 has encompassed and deformed the gabion pushing it upwards and towards the highway. The length of gabion affected is approximately 85 m.

Short term remedial measures could consist of removing the eastmost 30 m of gabion mattress (and salvaging the stones), excavating the heaved ground back to the pre-disturbance level and replacing a new gabion mattress over this section. The risk with this method is that further ground movements might heave the mattress again.

Longer term remedial measures could consist of removing the gabion mattress (and salvaging the stones) over the disturbed zone, strengthening the subsurface foundation soil, trimming the ditch smooth and then relaying new gabion mattress. The subsurface strengthening could consist of either of the following methods:

- Sub-excavating the slide material under the ditch to a depth below the slip surface and constructing a well compacted granular shear key zone to force the slip surface to toe out uphill of the ditch. The shear key would likely need to be at least 2.5 m deep and 5 m wide; or
- Installing spaced H piles parallel to, and offset about 1 m south, of the uphill edge of the ditch lining. The piles would likely need to be at about 6 m long/deep.
