THURBER ENGINEERING LTD.

July 28, 2022

**ALBERTA TRANSPORTATION GRMP (CON0022164)
PEACE REGION (PEACE RIVER DISTRICT)
INSTRUMENTATION MONITORING RESULTS – SPRING 2022**

SITE PH042: HWY 986:01, DAISHOWA EAST HILL (WELL SITE SLIDE)

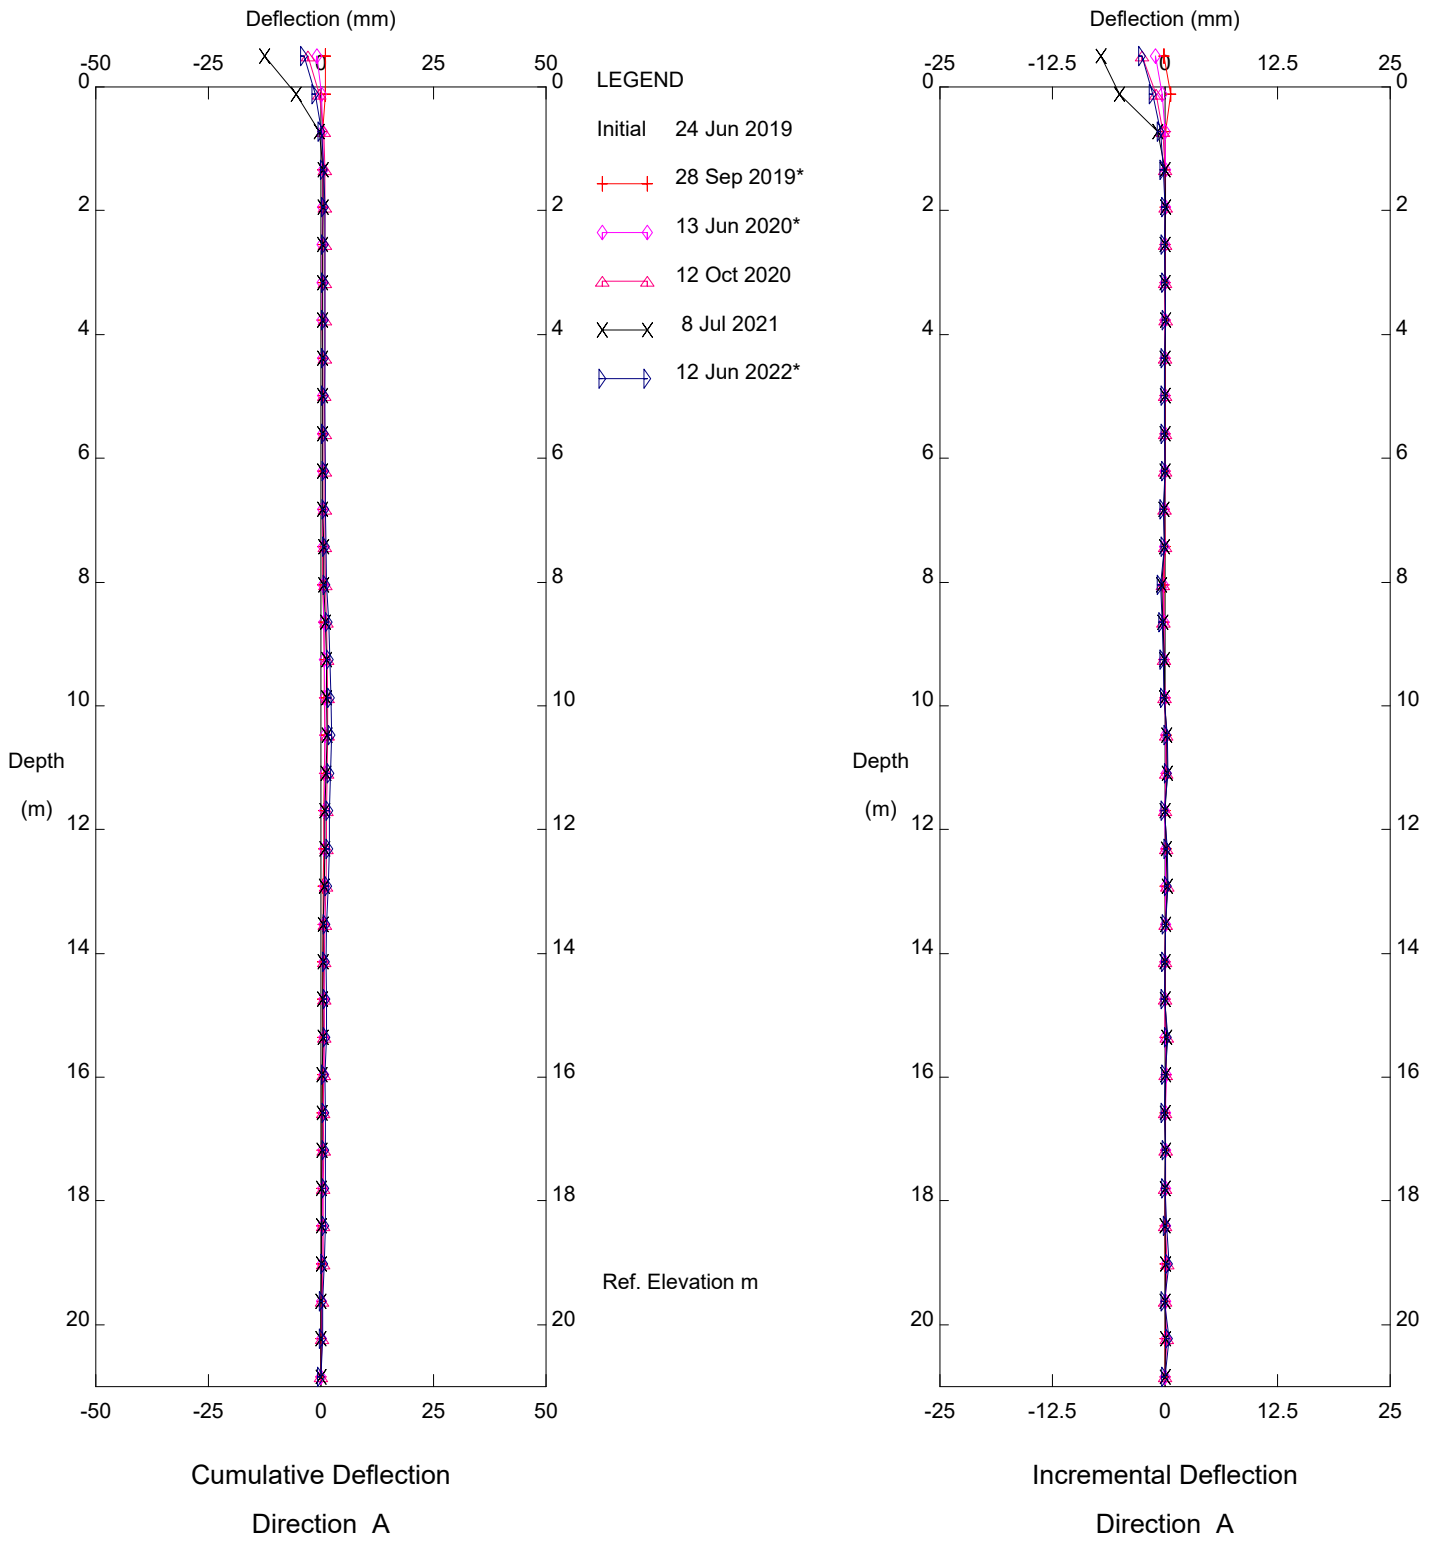
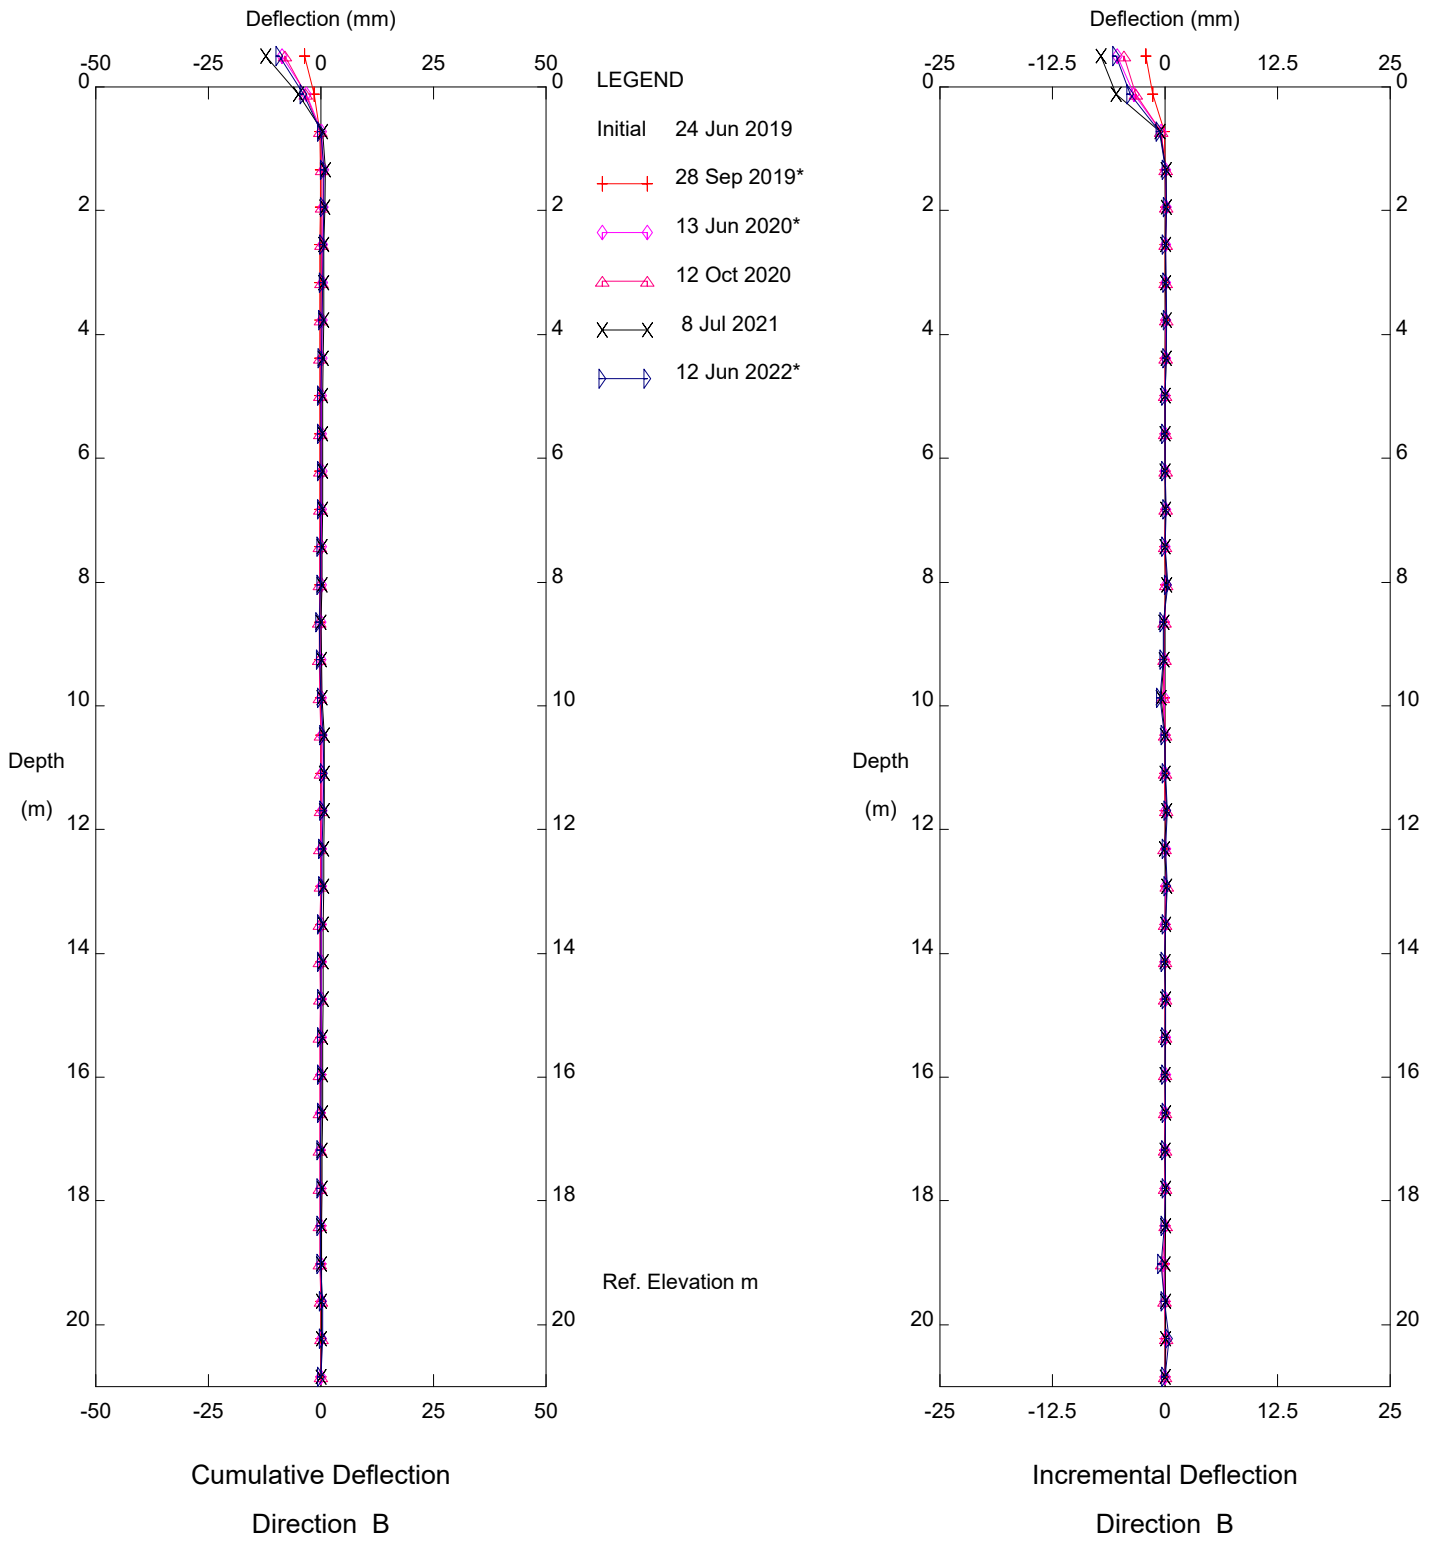
Hwy 986:01 Daishowa East Hill, Inclinometer SI18-1

SI18-1 has not shown any discernible movement since it was reinitialized during the spring of 2019 readings.

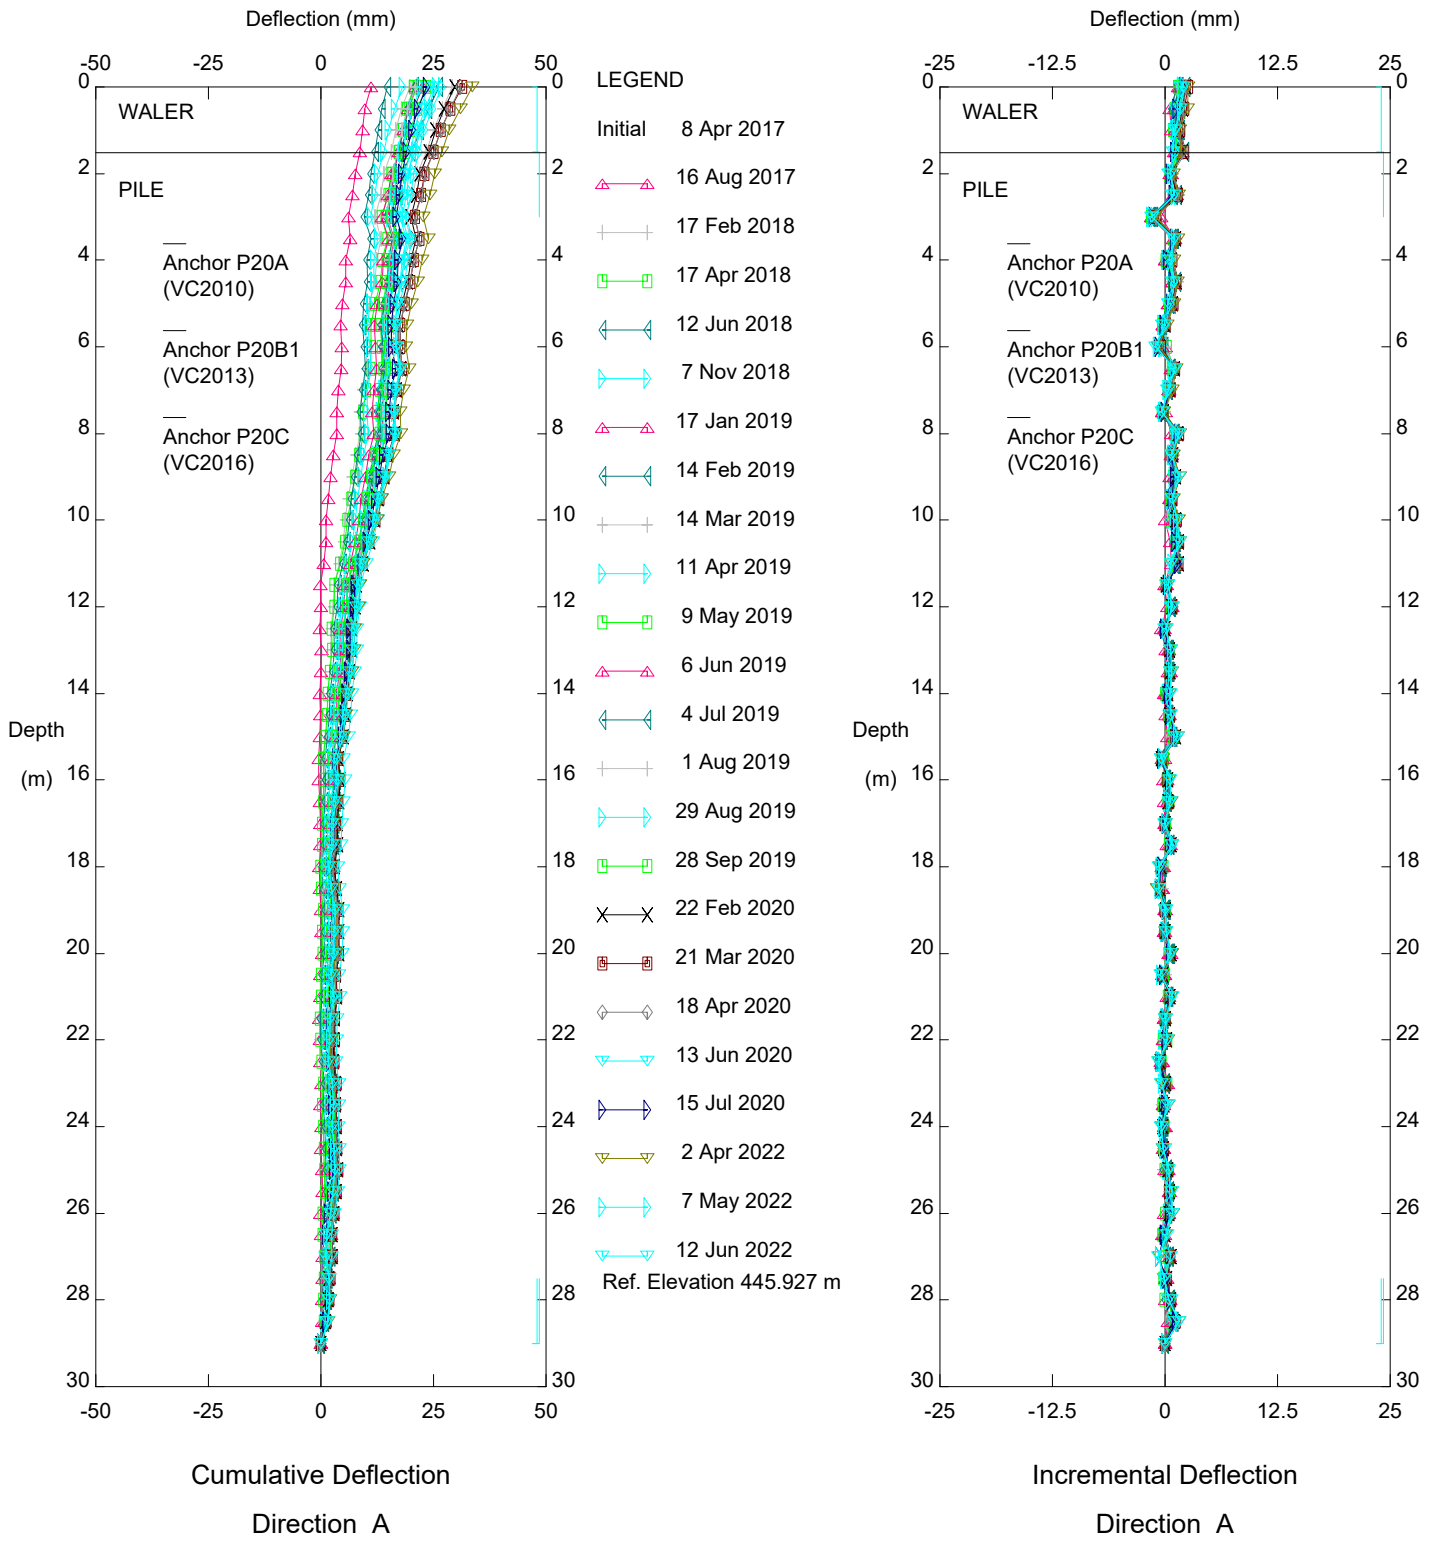
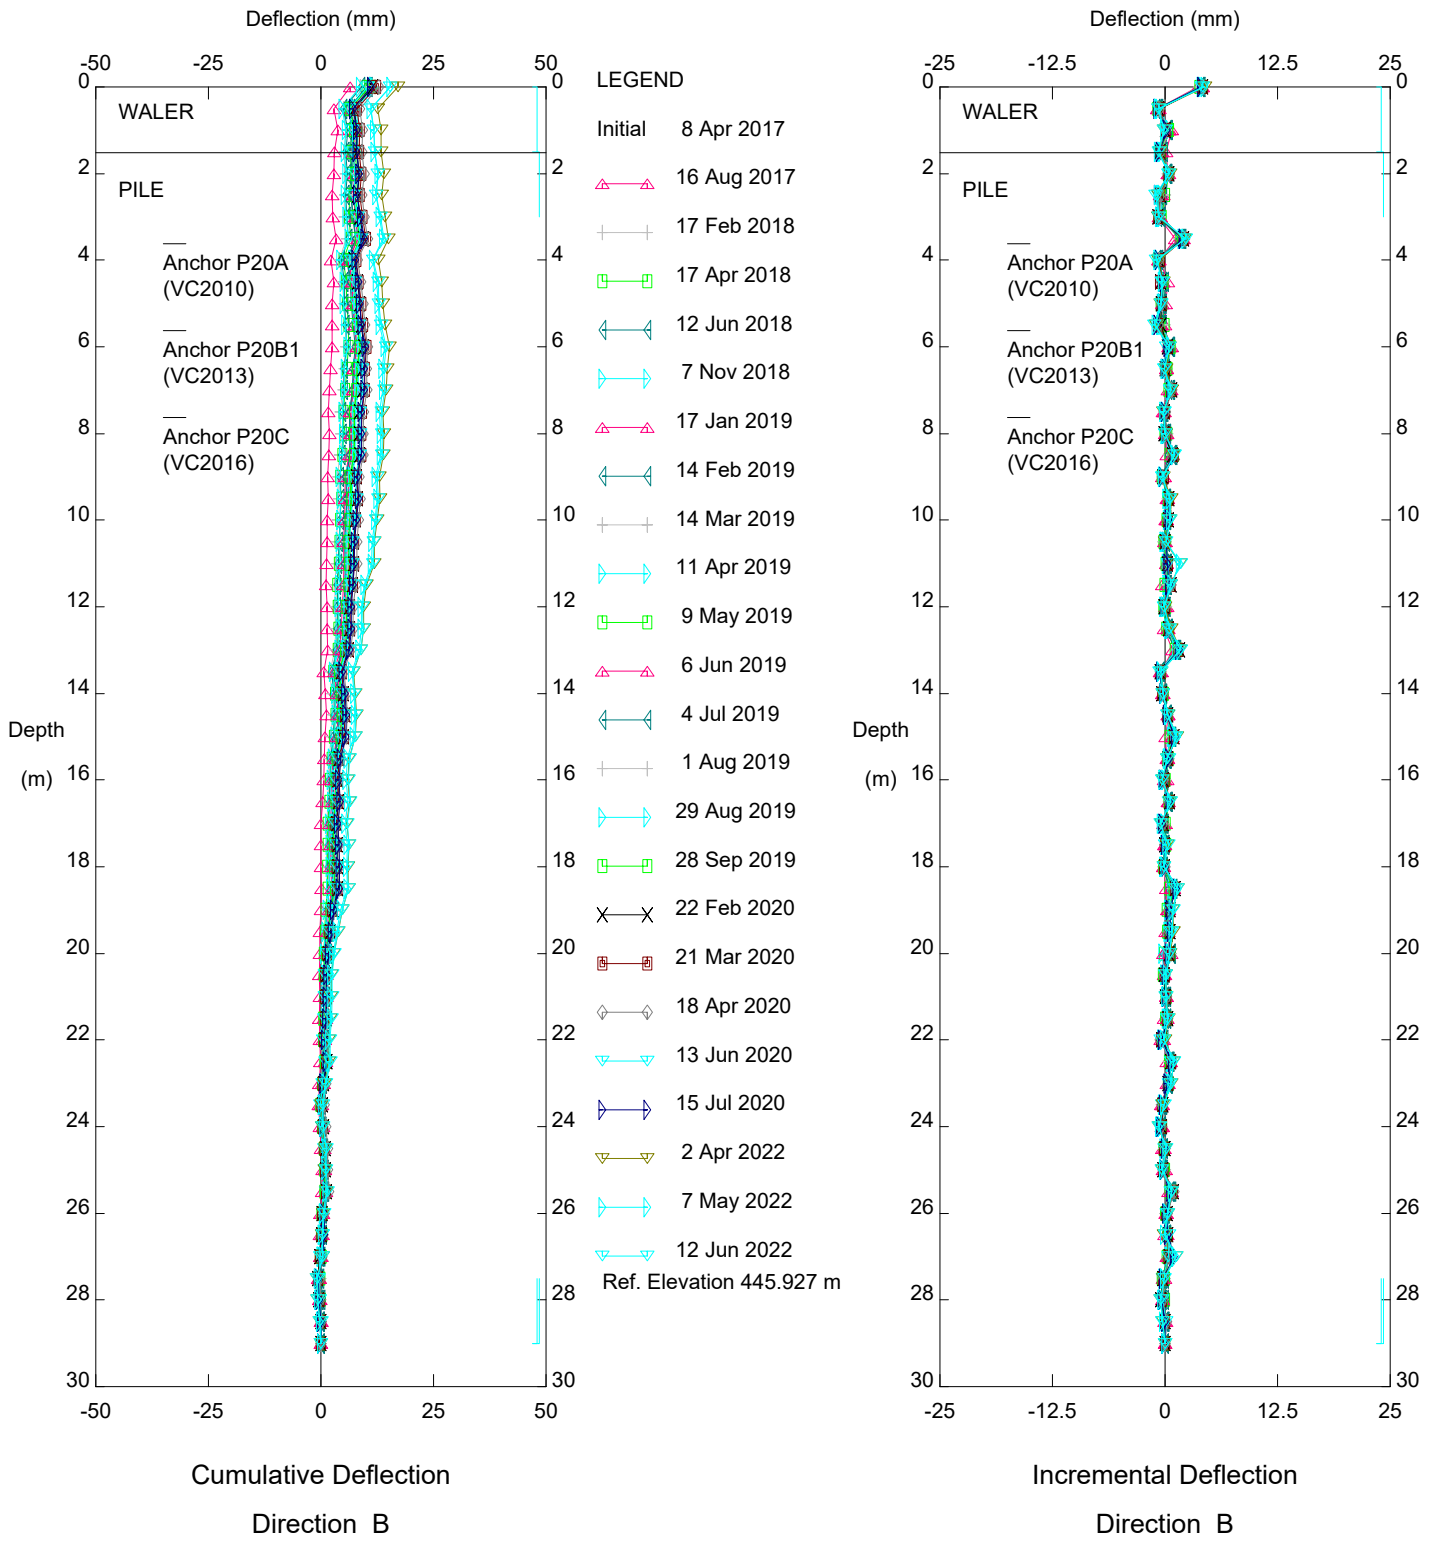
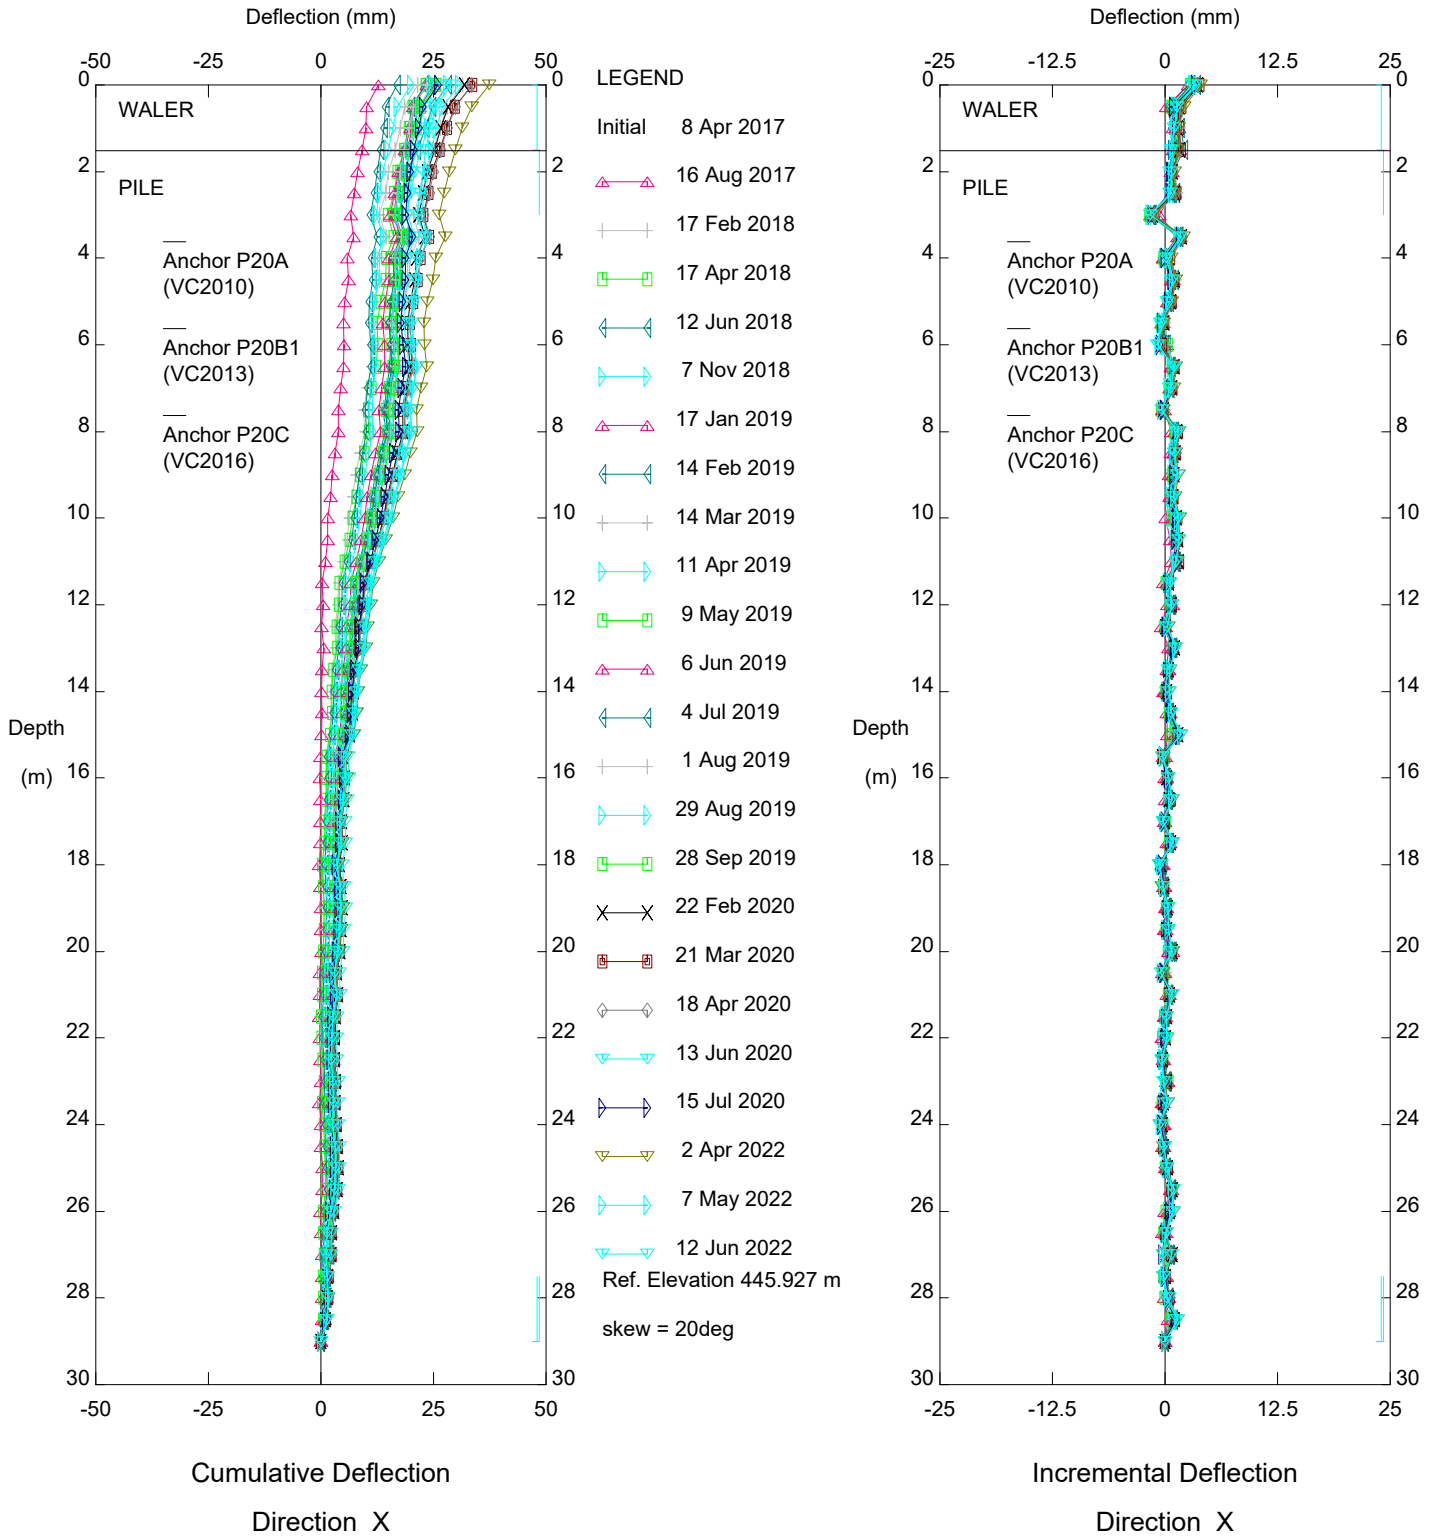
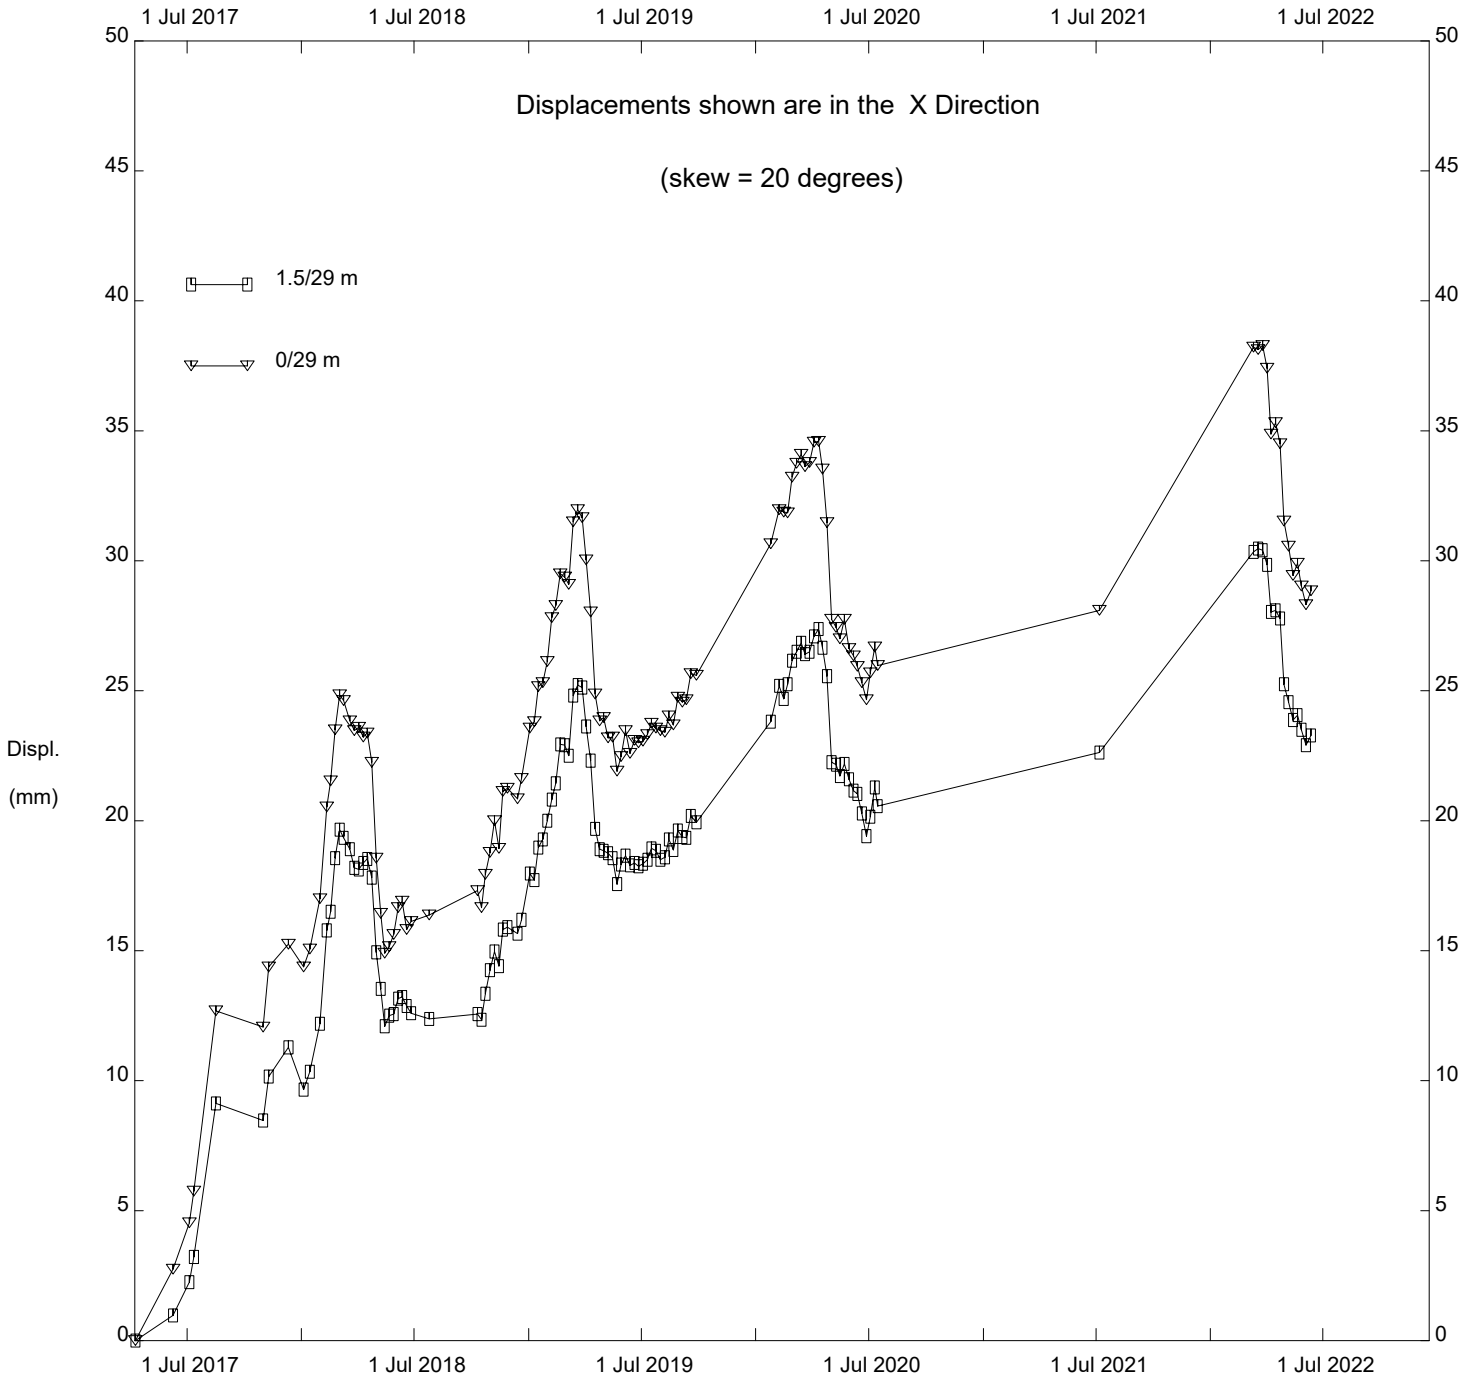
Hwy 986:01 Daishowa East Hill, Inclinometer SAA17-P20

SAA17-P20 showed an average rate of movement of 0.7 mm/yr over the length of the pile and an average rate of movement of 0.8 mm/yr over the combined length of the pile and waler since the spring of 2021 readings. SAA-P20 has shown a total pile head movement of 23.3 mm in the downslope direction to date.

Both of the SAAs installed in the pile wall have shown an overall trend of downslope movement since they were installed, with higher deflections (in the order of 8 to 12 mm) during the winter months under frost loads, which rebound once the ground thaws. The total cumulative movement in the SAAs includes initial deflections during excavation and anchor installation as well as post construction movements.

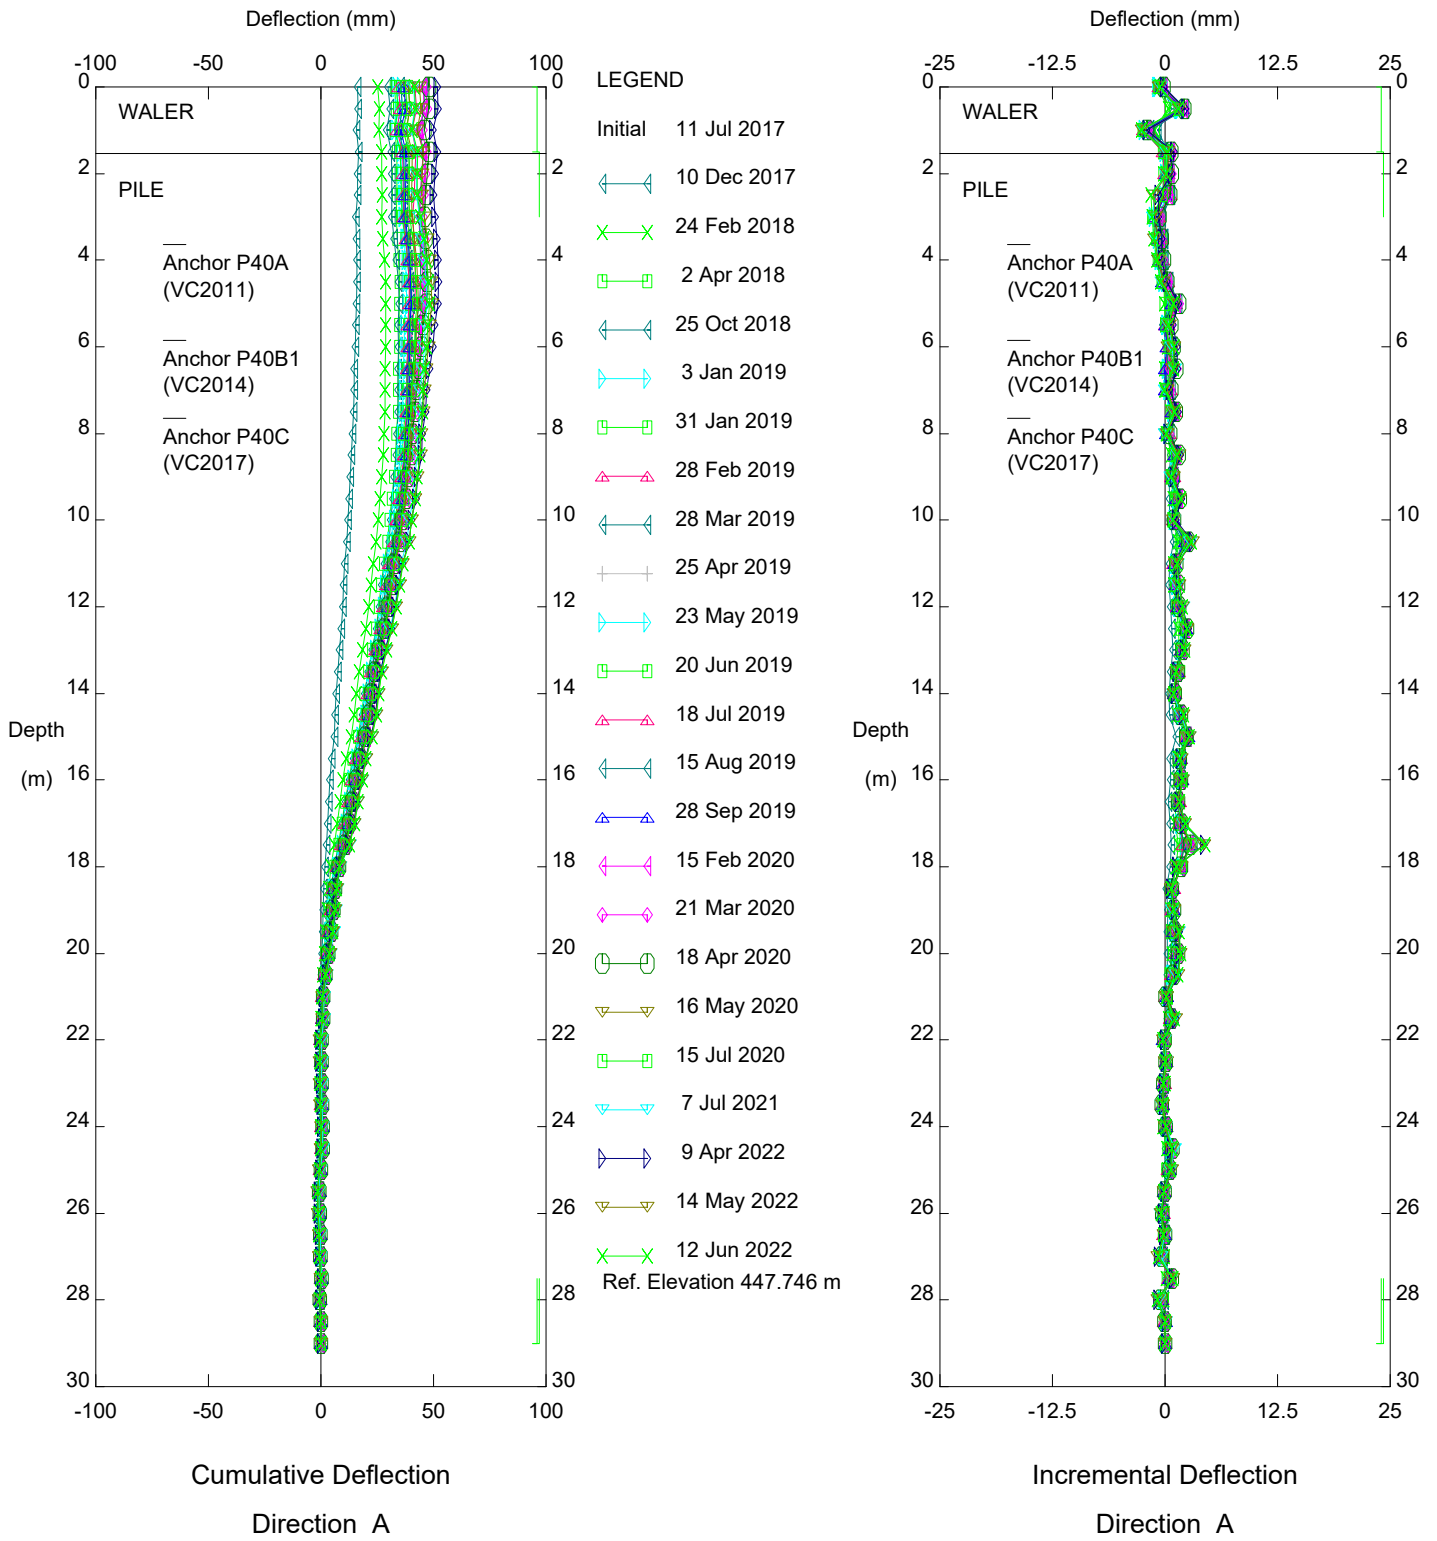
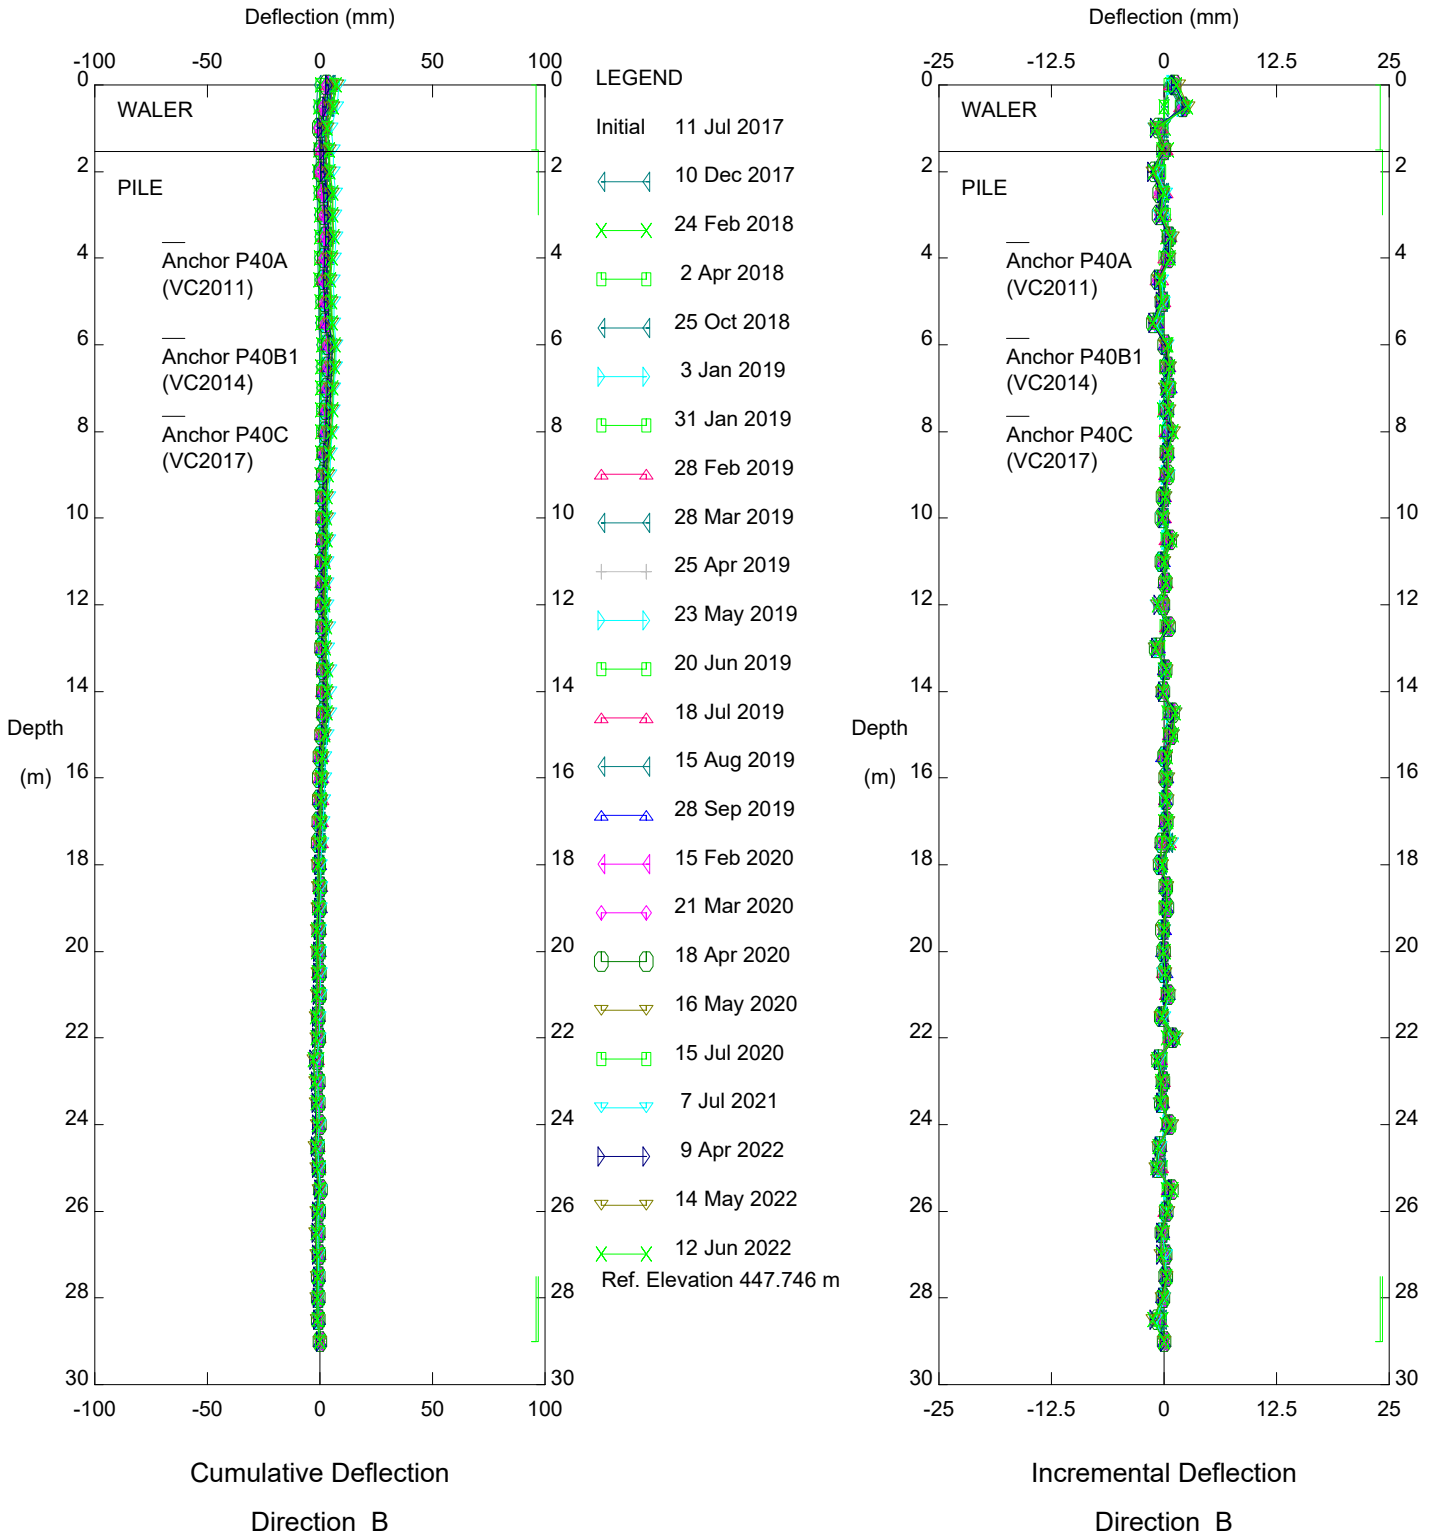
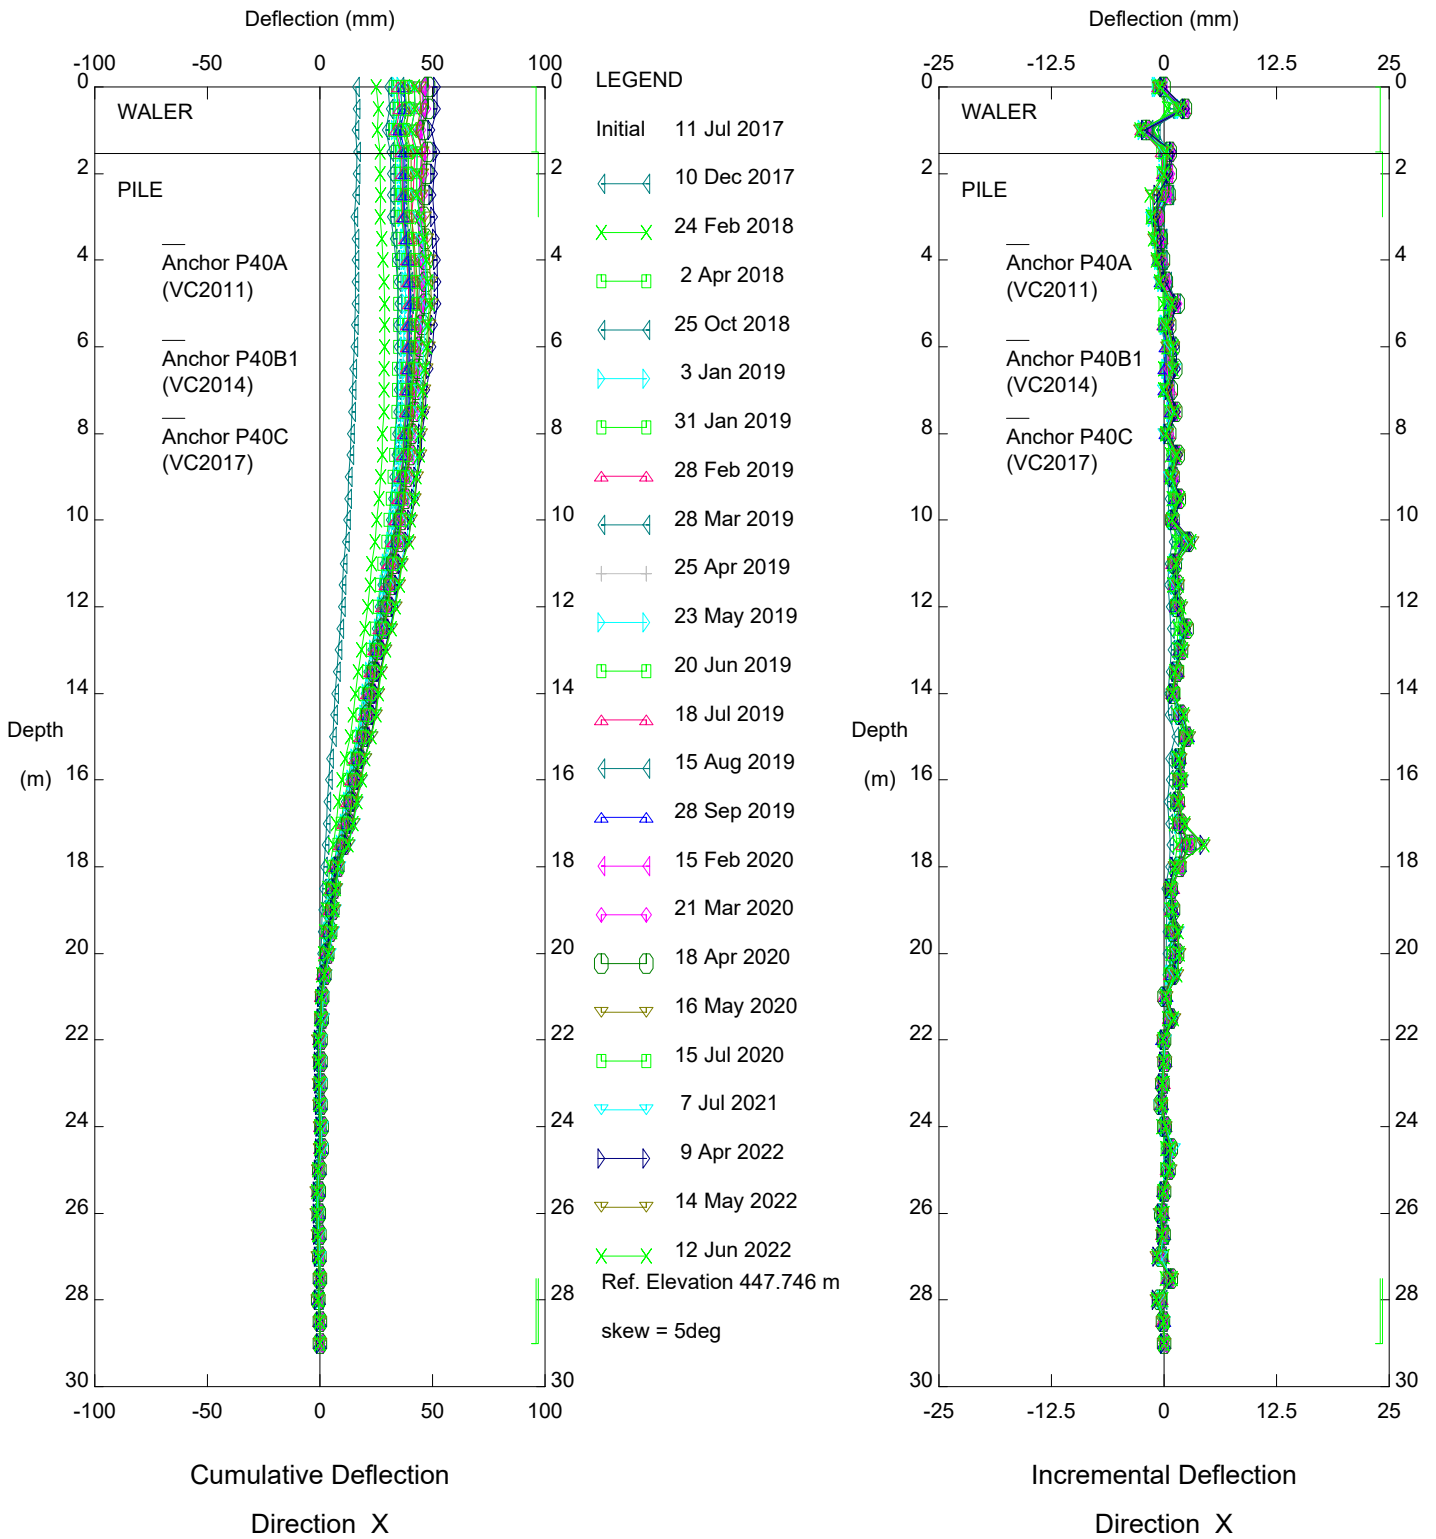
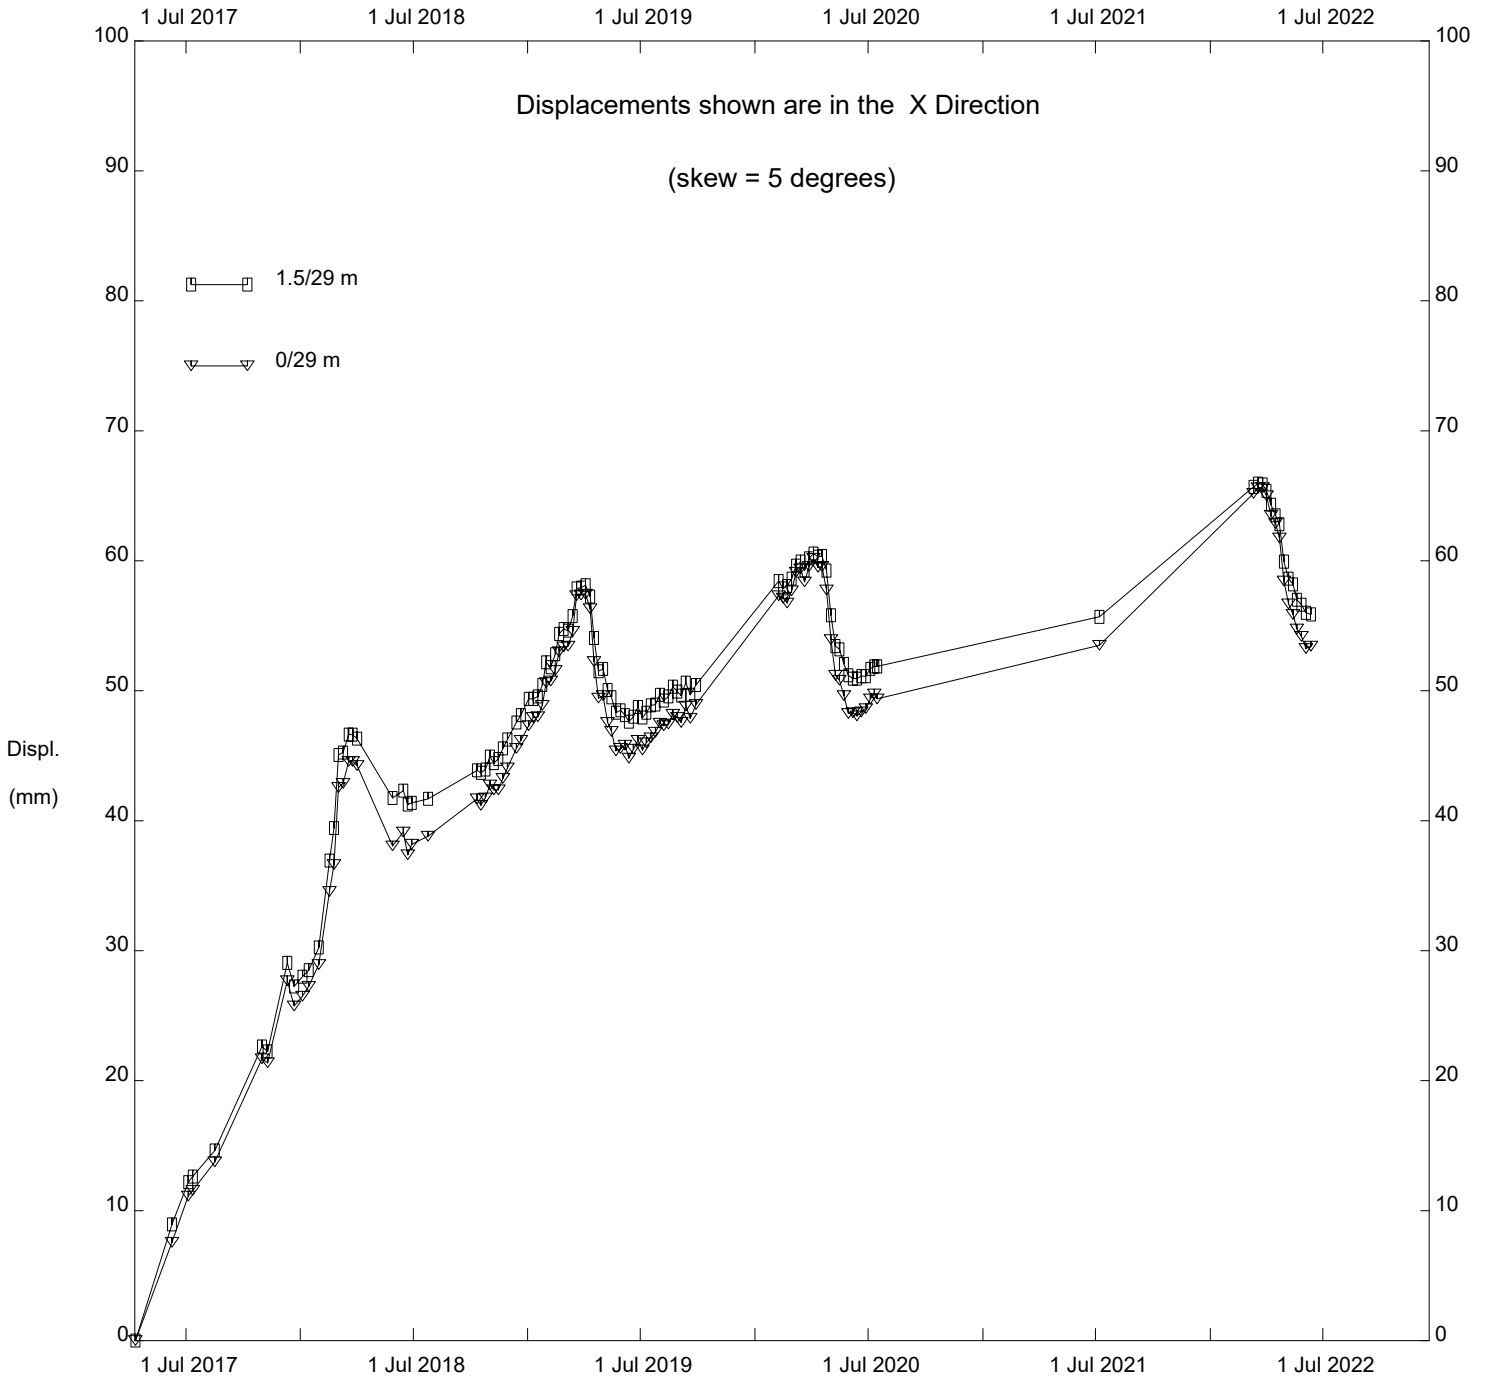
Hwy 986:01 Daishowa East Hill, Inclinometer SAA17-P40

SAA17-P40 showed an average rate of movement of 0.2 mm/yr over the length of the pile and no discernible downslope movement over the combined length of the pile and waler since the spring of 2021 readings. SAA17-P40 has shown a total pile head movement of 55.9 mm in the downslope direction to date.
