THURBER ENGINEERING LTD.

July 28, 2022

**ALBERTA TRANSPORTATION GRMP (CON0022164)
PEACE REGION (PEACE RIVER DISTRICT)
INSTRUMENTATION MONITORING RESULTS – SPRING 2022**

SITE PH042: HWY 986:01, DAISHOWA EAST HILL (WELL SITE SLIDE)

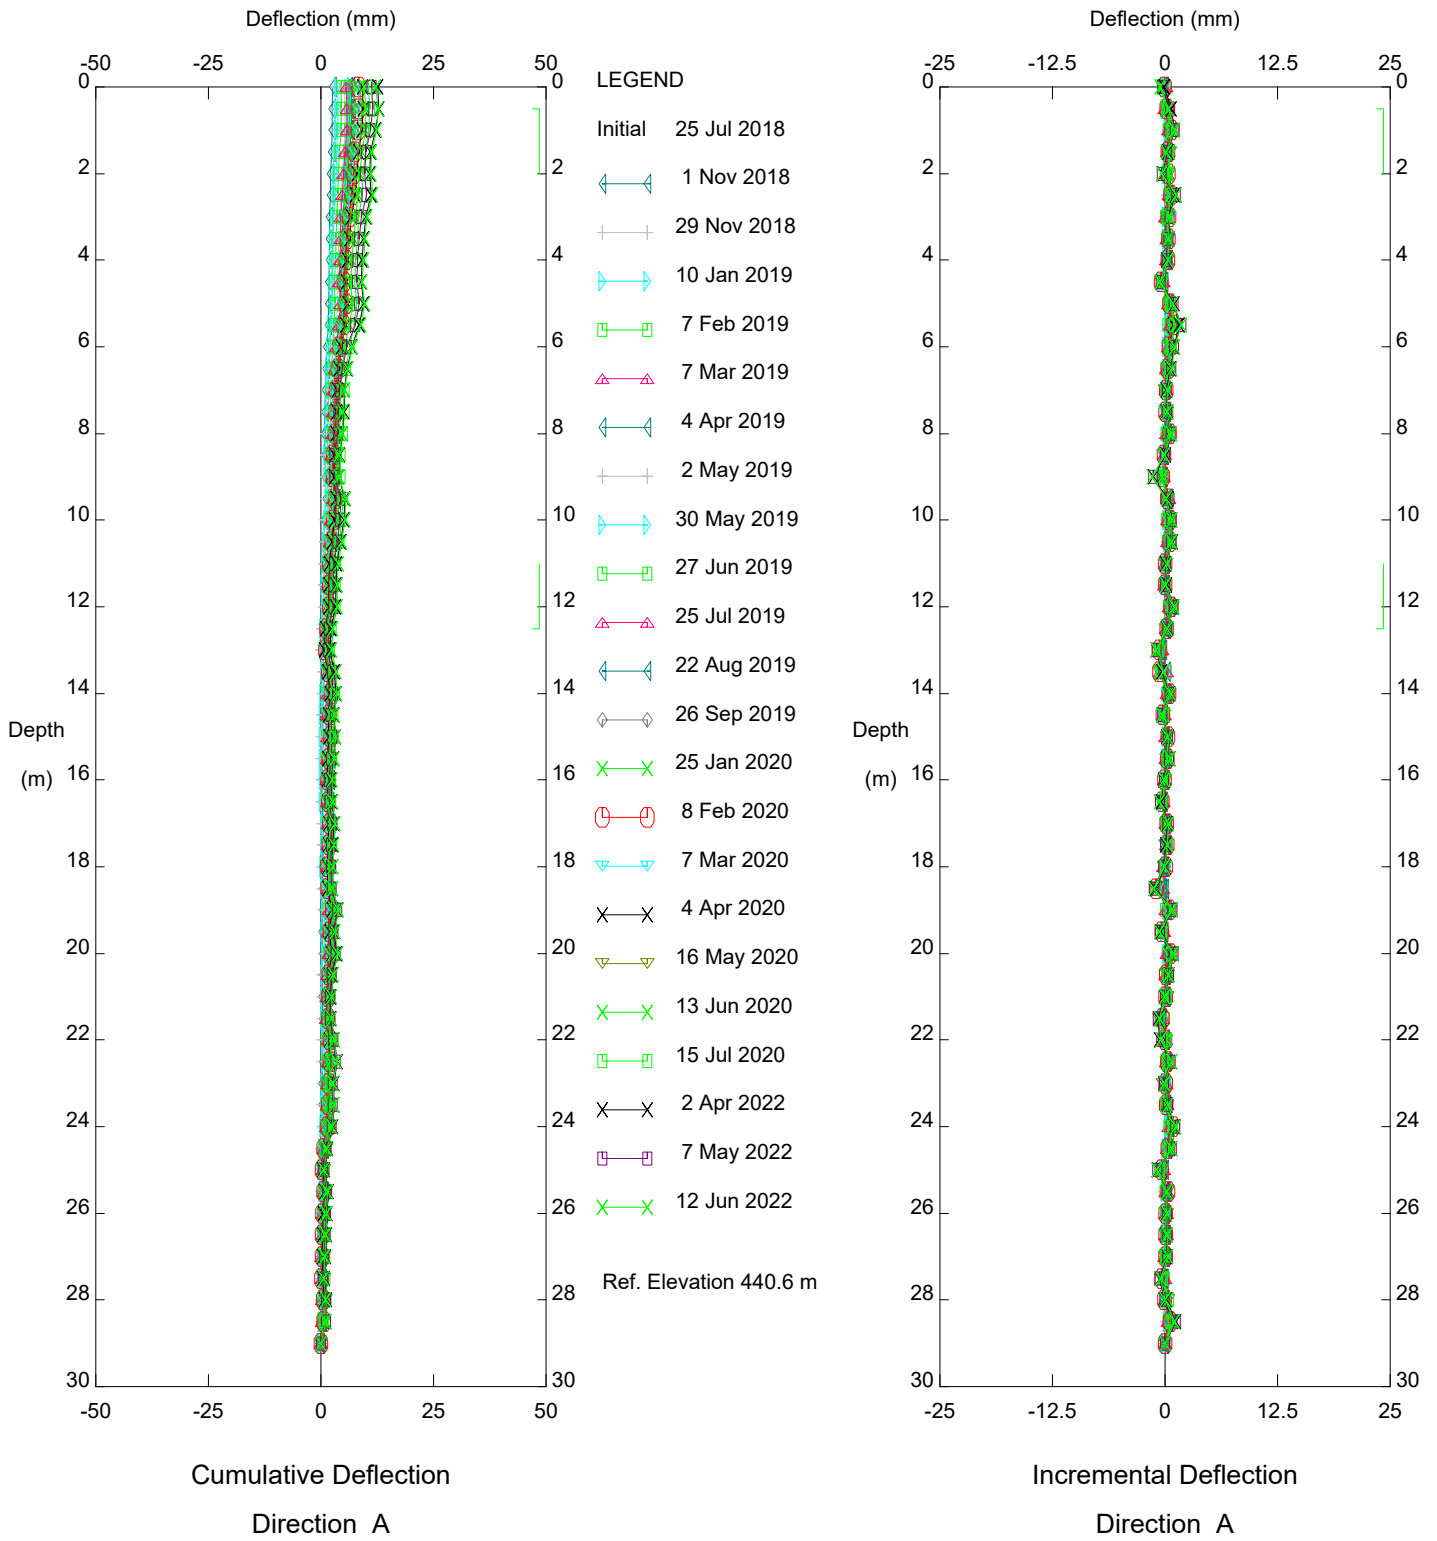
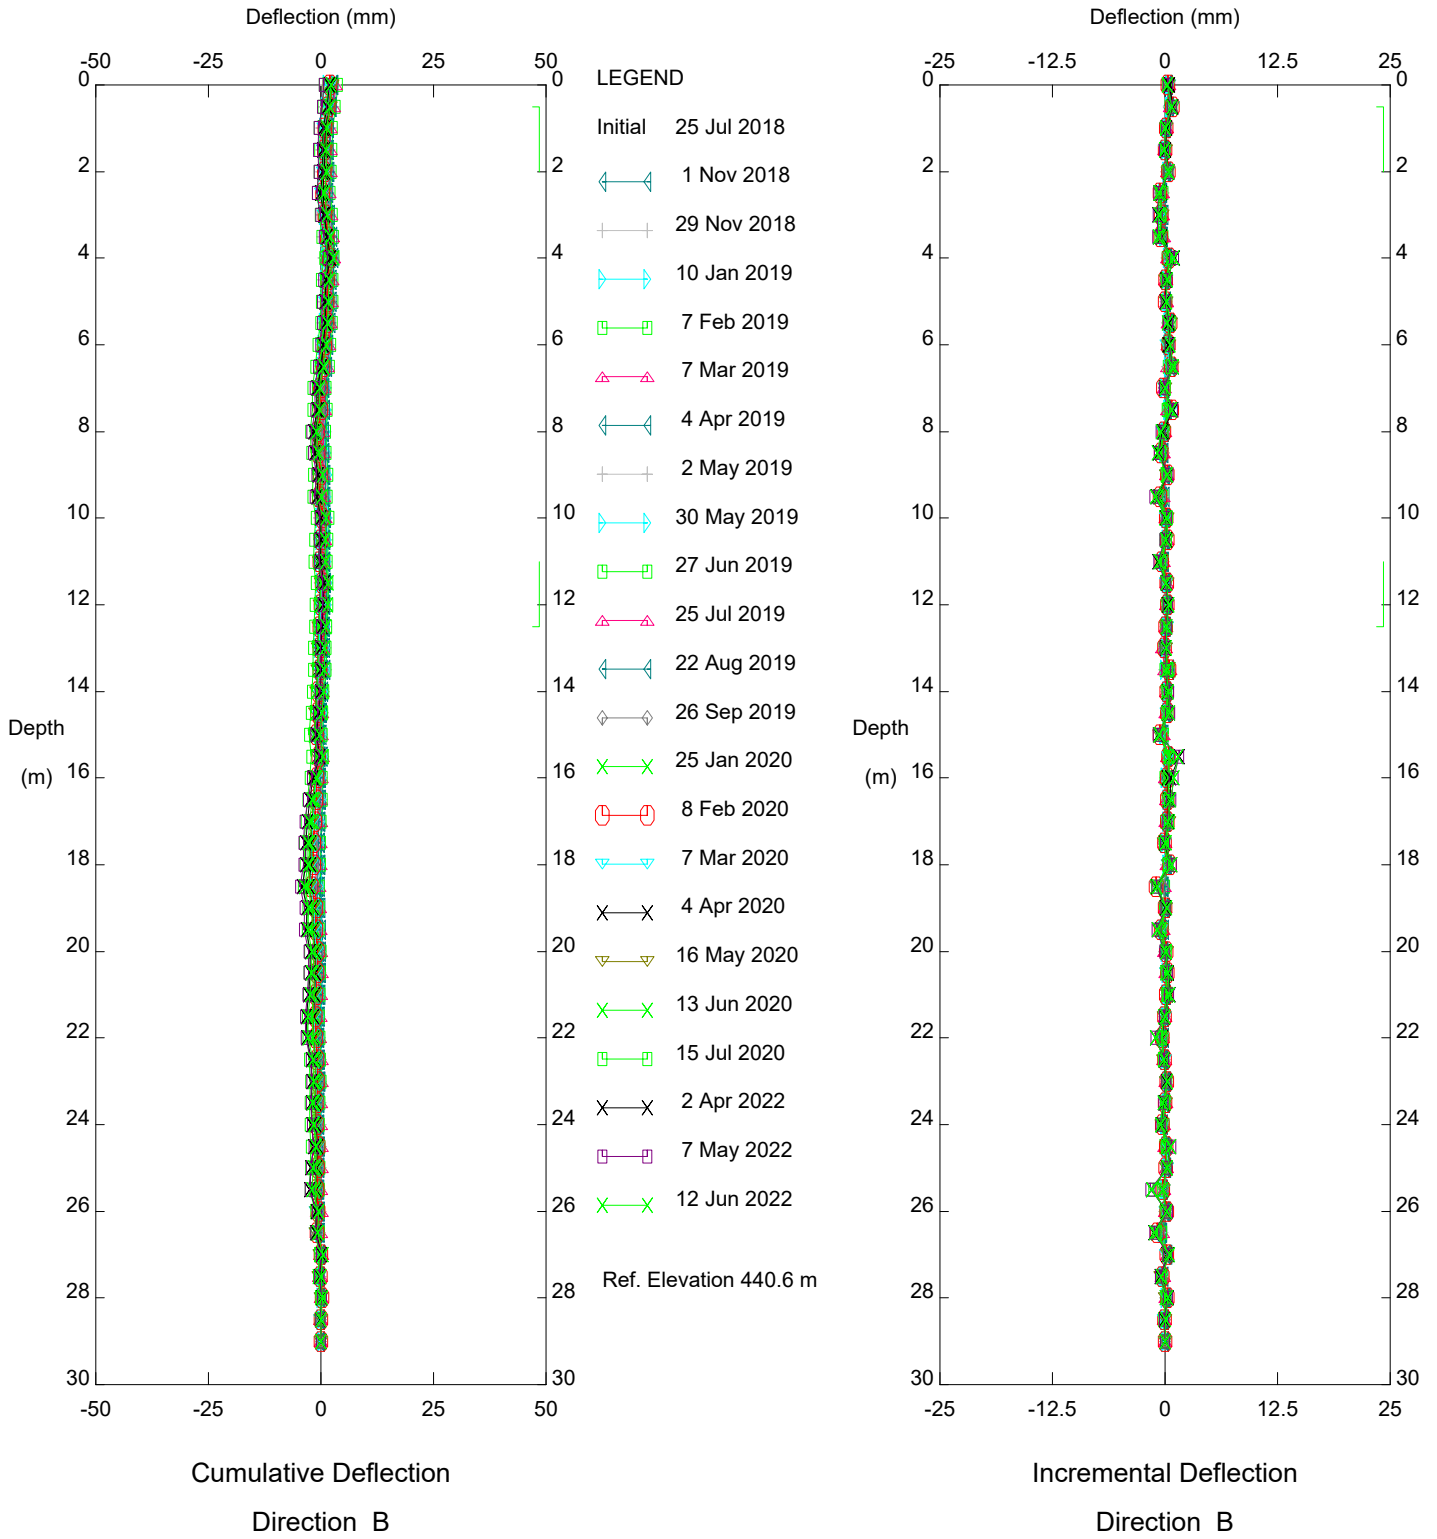
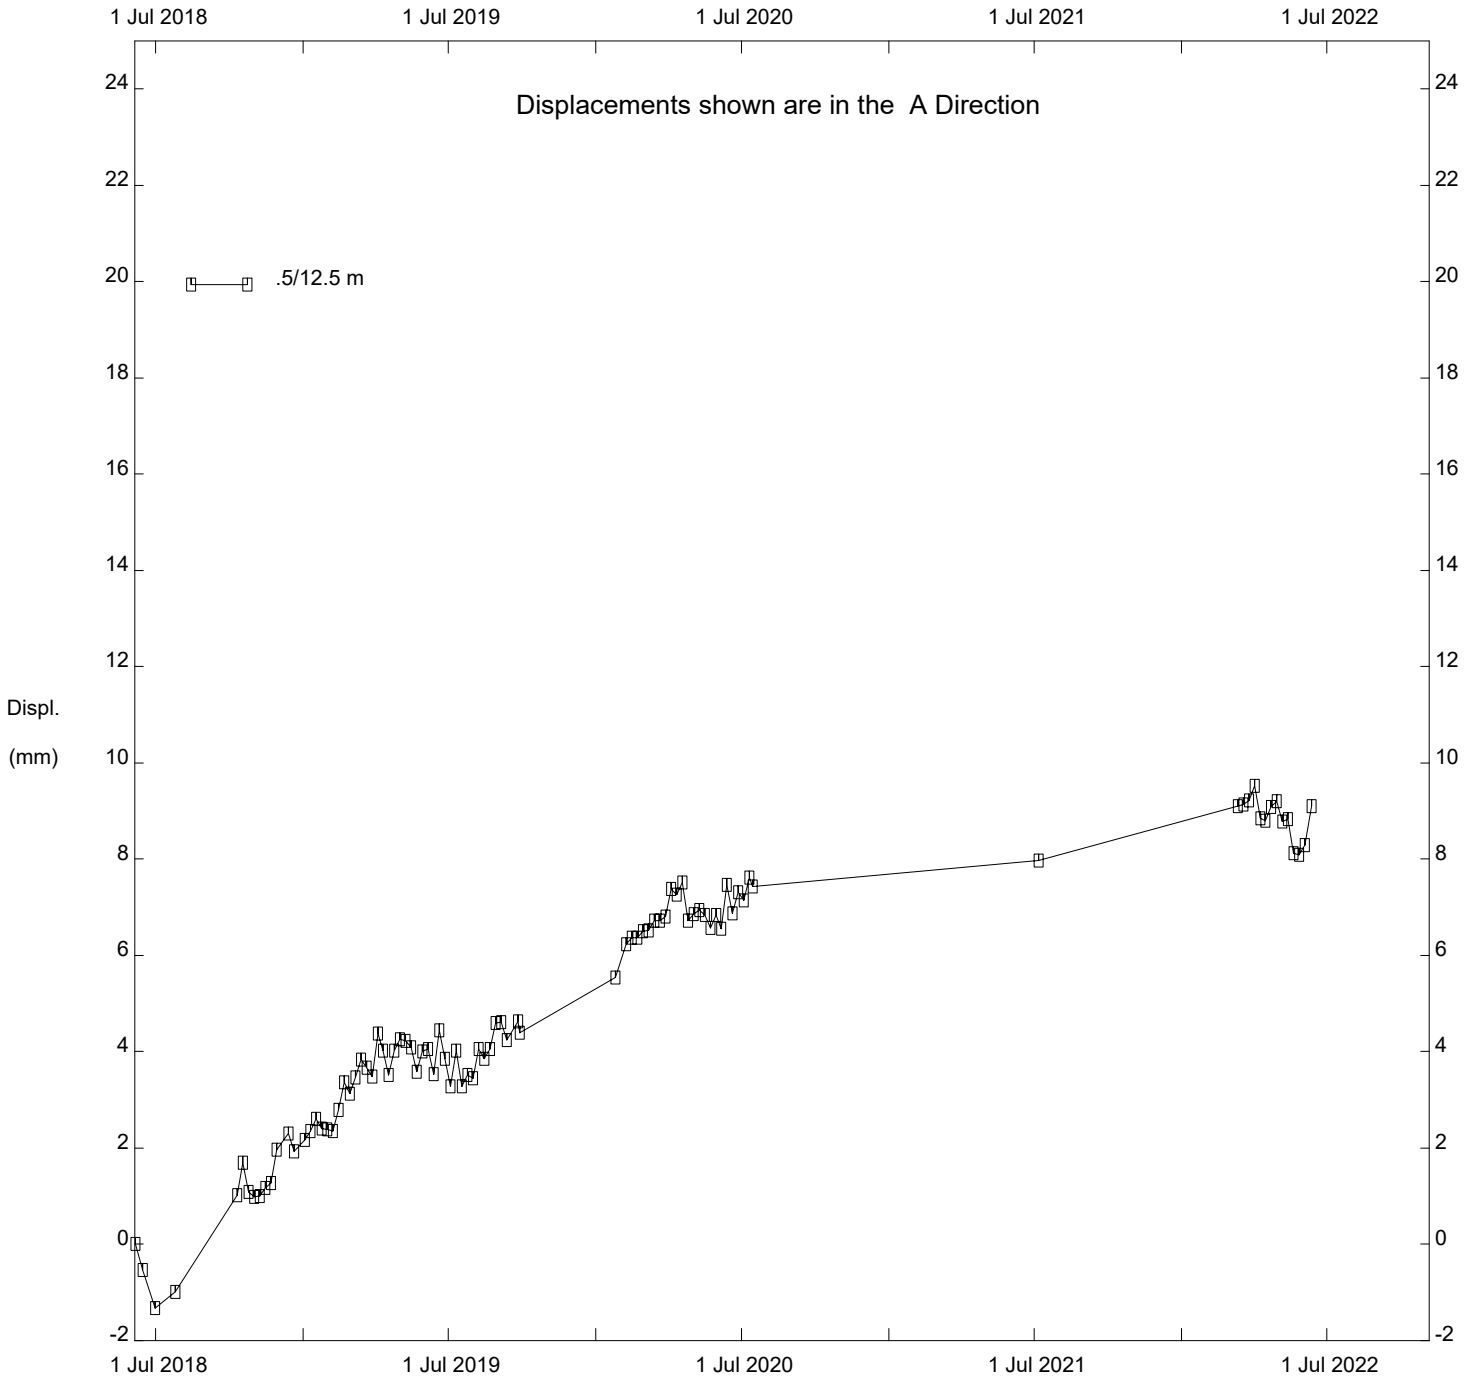
Hwy 986:01 Daishowa East Hill, Inclinometer SAA18-1

SAA18-1, installed in the bench downslope of the pile wall, showed an average rate of movement of 1.2 mm/yr over 0.5 m to 12.5 m depth since the spring of 2021 readings. SAA18-1 has shown a total cumulative movement of 9.2 mm over this zone since it was initialized in June 2018. By comparison, SAA17-P40 has shown a total cumulative movement of 9.5 mm over this same zone since June 2018, indicating that the pile wall has moved 0.3 mm in the downslope direction relative to the bench during this time span. A plot comparing these movements is included in Appendix A. The movement in SAA18-1 should continue to be compared to the pile wall movements at SAA17-P40 for future readings to see if the bench exhibits faster downslope movement than the pile wall. The wall relies on lateral support from the bench and hence if significant separation is noted in the future, another row of tie-back soil anchors would need to be added to the wall beneath the existing anchors.

The instruments should be read again in the spring of 2023. It is recommended that the design parameters of the wall be reviewed, so that warning thresholds can be developed with regard to the pile wall deflections and load cell readings. This will be helpful in determining if more tie-back anchors need to be added to the pile wall.

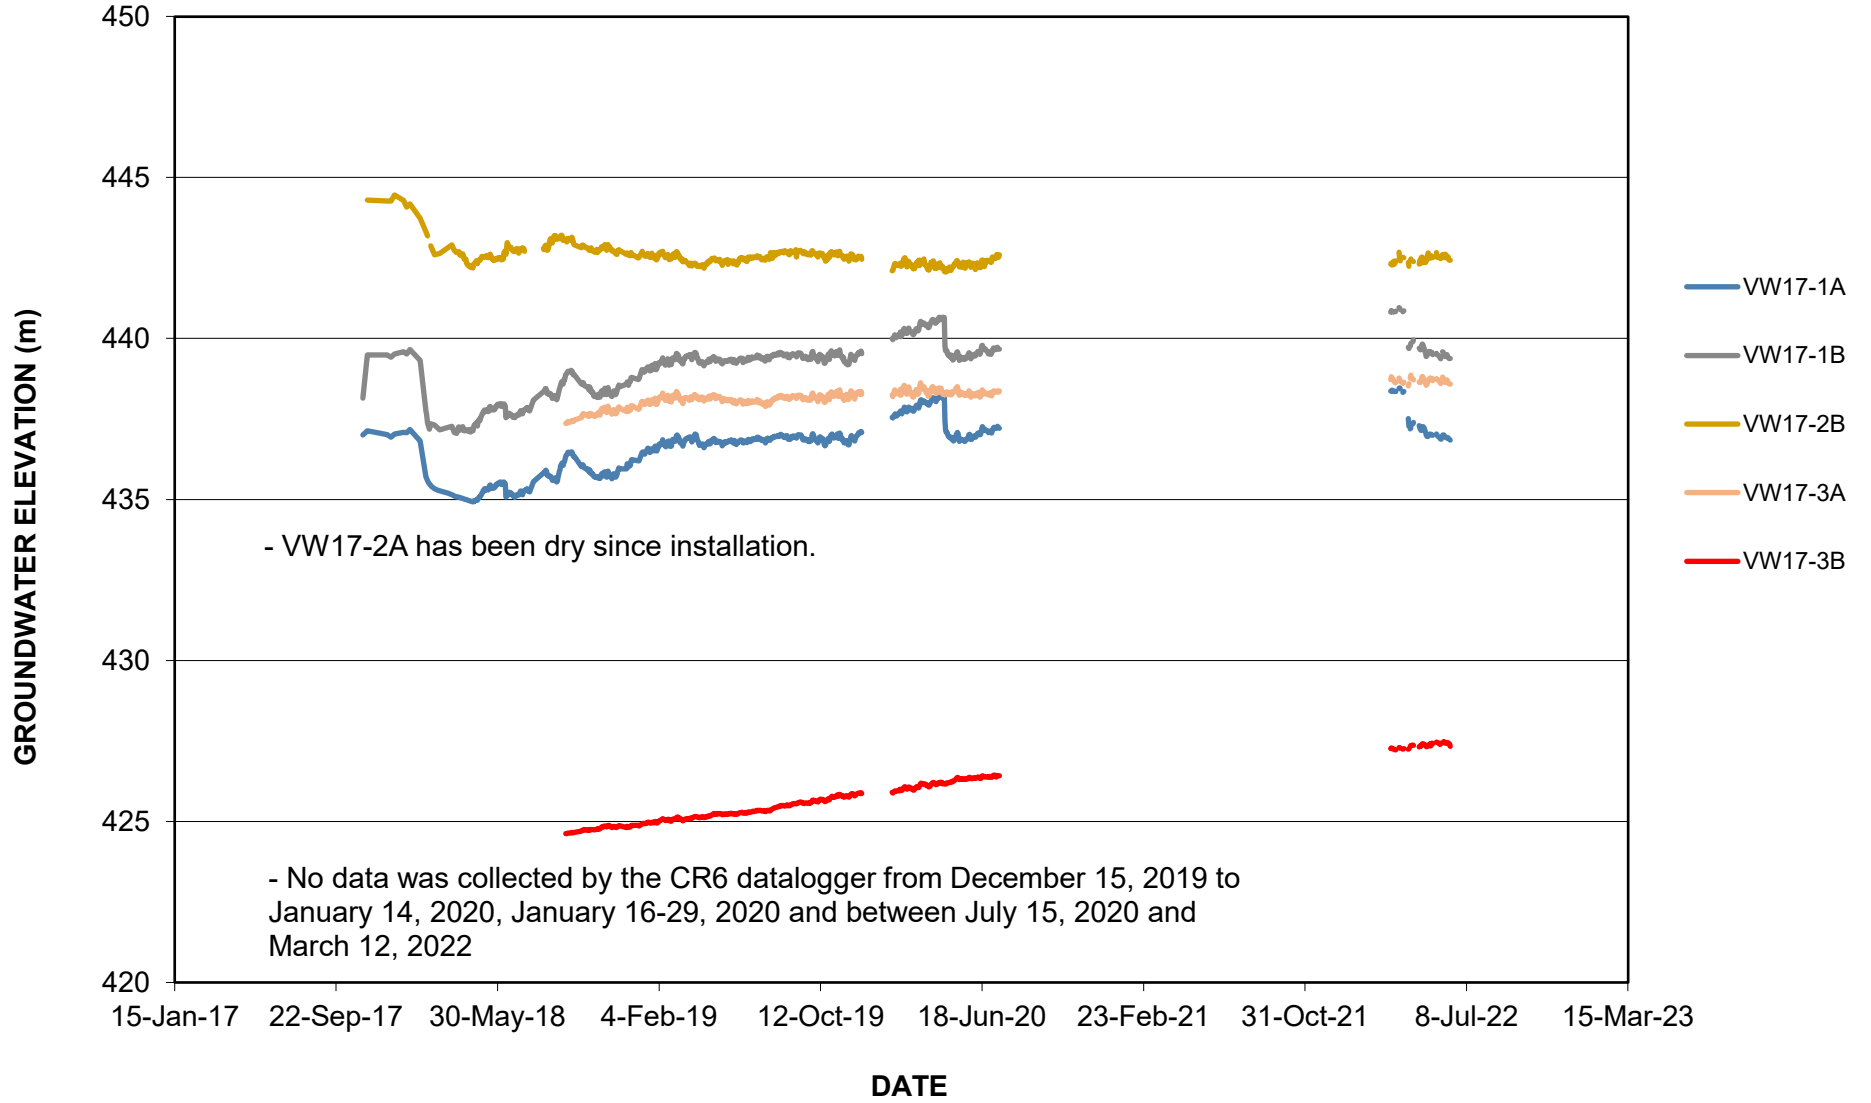
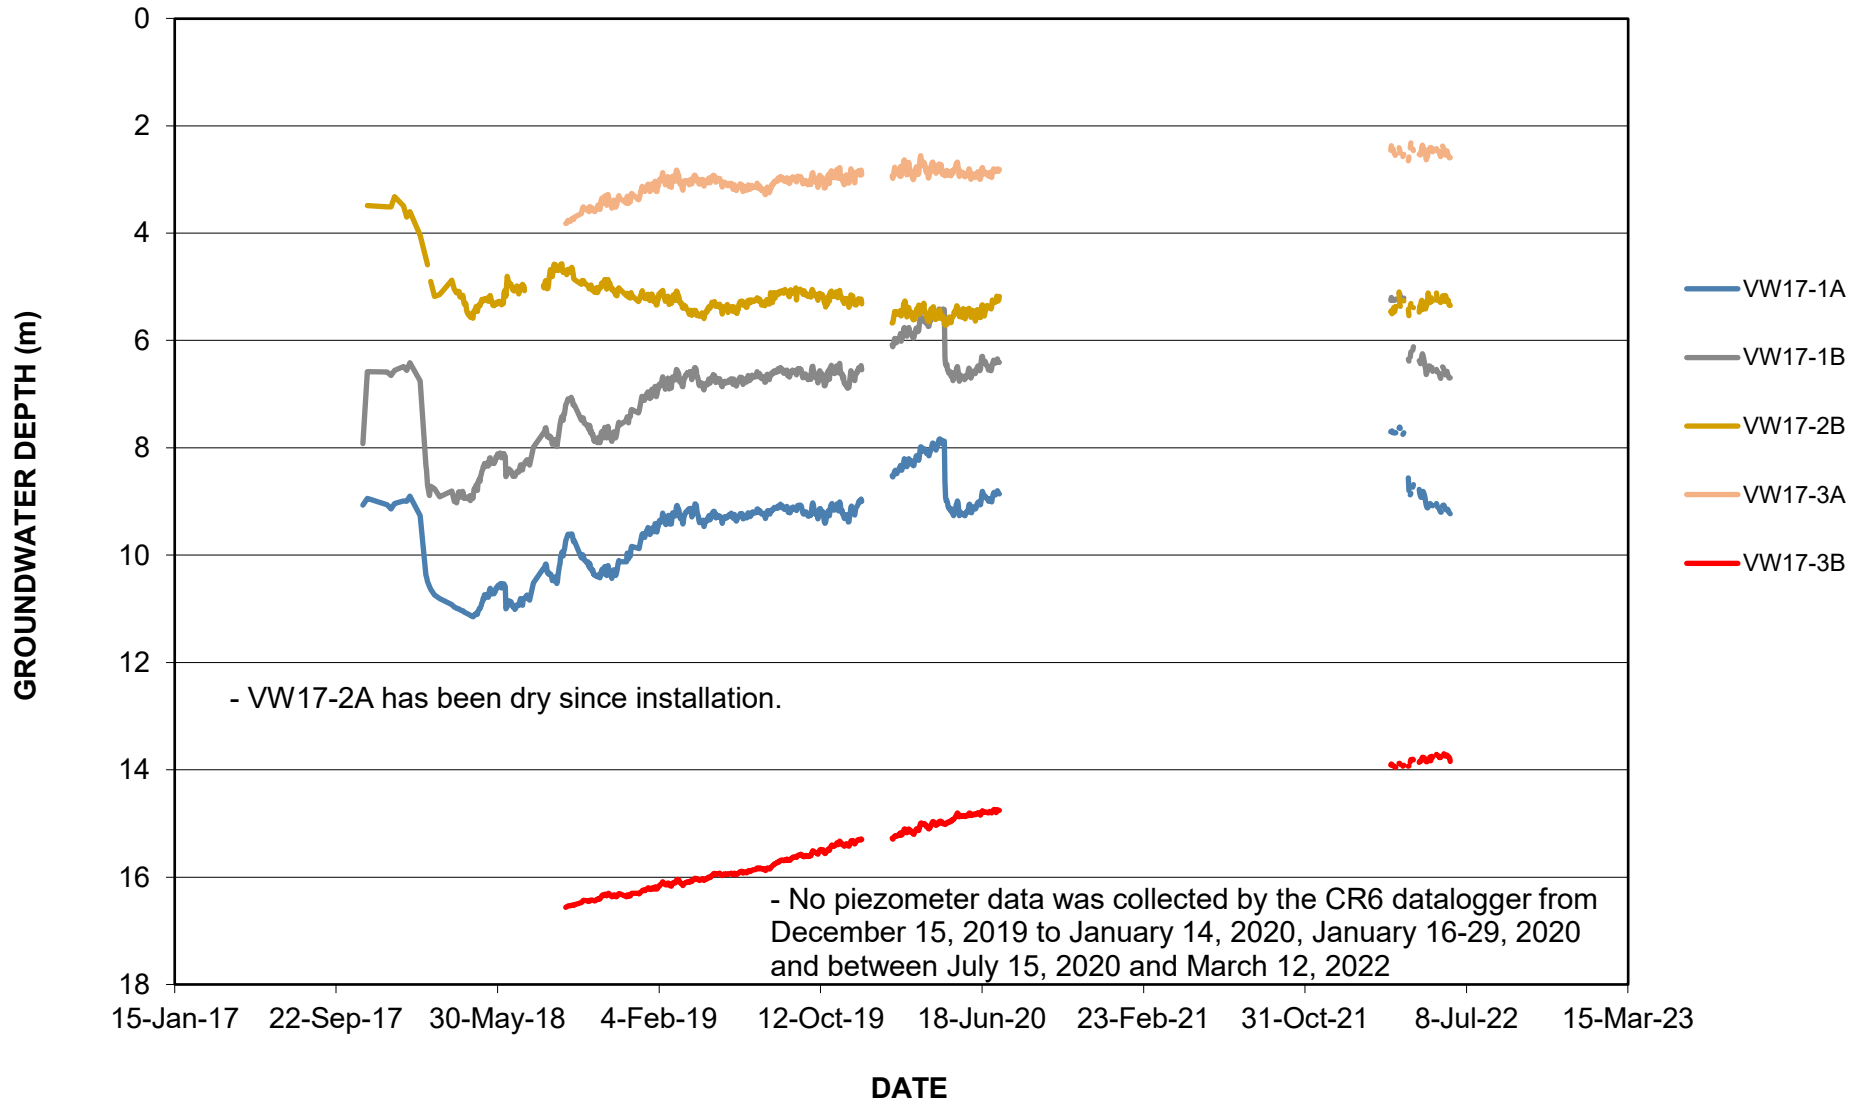
**FIGURE PH042-1
PIEZOMETRIC ELEVATIONS FOR HWY 986:01, DAISHOWA EAST HILL
(PILE WALL PIEZOMETERS)**

Since they were previously read on July 14, 2020, VW17-1A, VW17-1B and VW17-2B showed decreases in groundwater level of 0.37 m, 0.29 m, and 0.16 m, respectively. During that same time period, VW17-3A and VW17-3B showed increases in groundwater level of 0.22 m and 0.91 m, respectively. VW17-2A has been dry since initialization. VW17-1A, VW17-1B, VW17-3A and VW17-3B registered all-time high groundwater levels between March 25, 2022, and May 31, 2022. Overall, the piezometers at the pile wall show relatively stable groundwater levels, with the exception of VW17-3B, which is showing a trend of slowly increasing groundwater level over time.

The piezometers installed at the pile wall are summarized in Table PH042-4 below and are plotted on Figures PH042-1 (by elevation) and PH042-2 (by depth) in Appendix A.

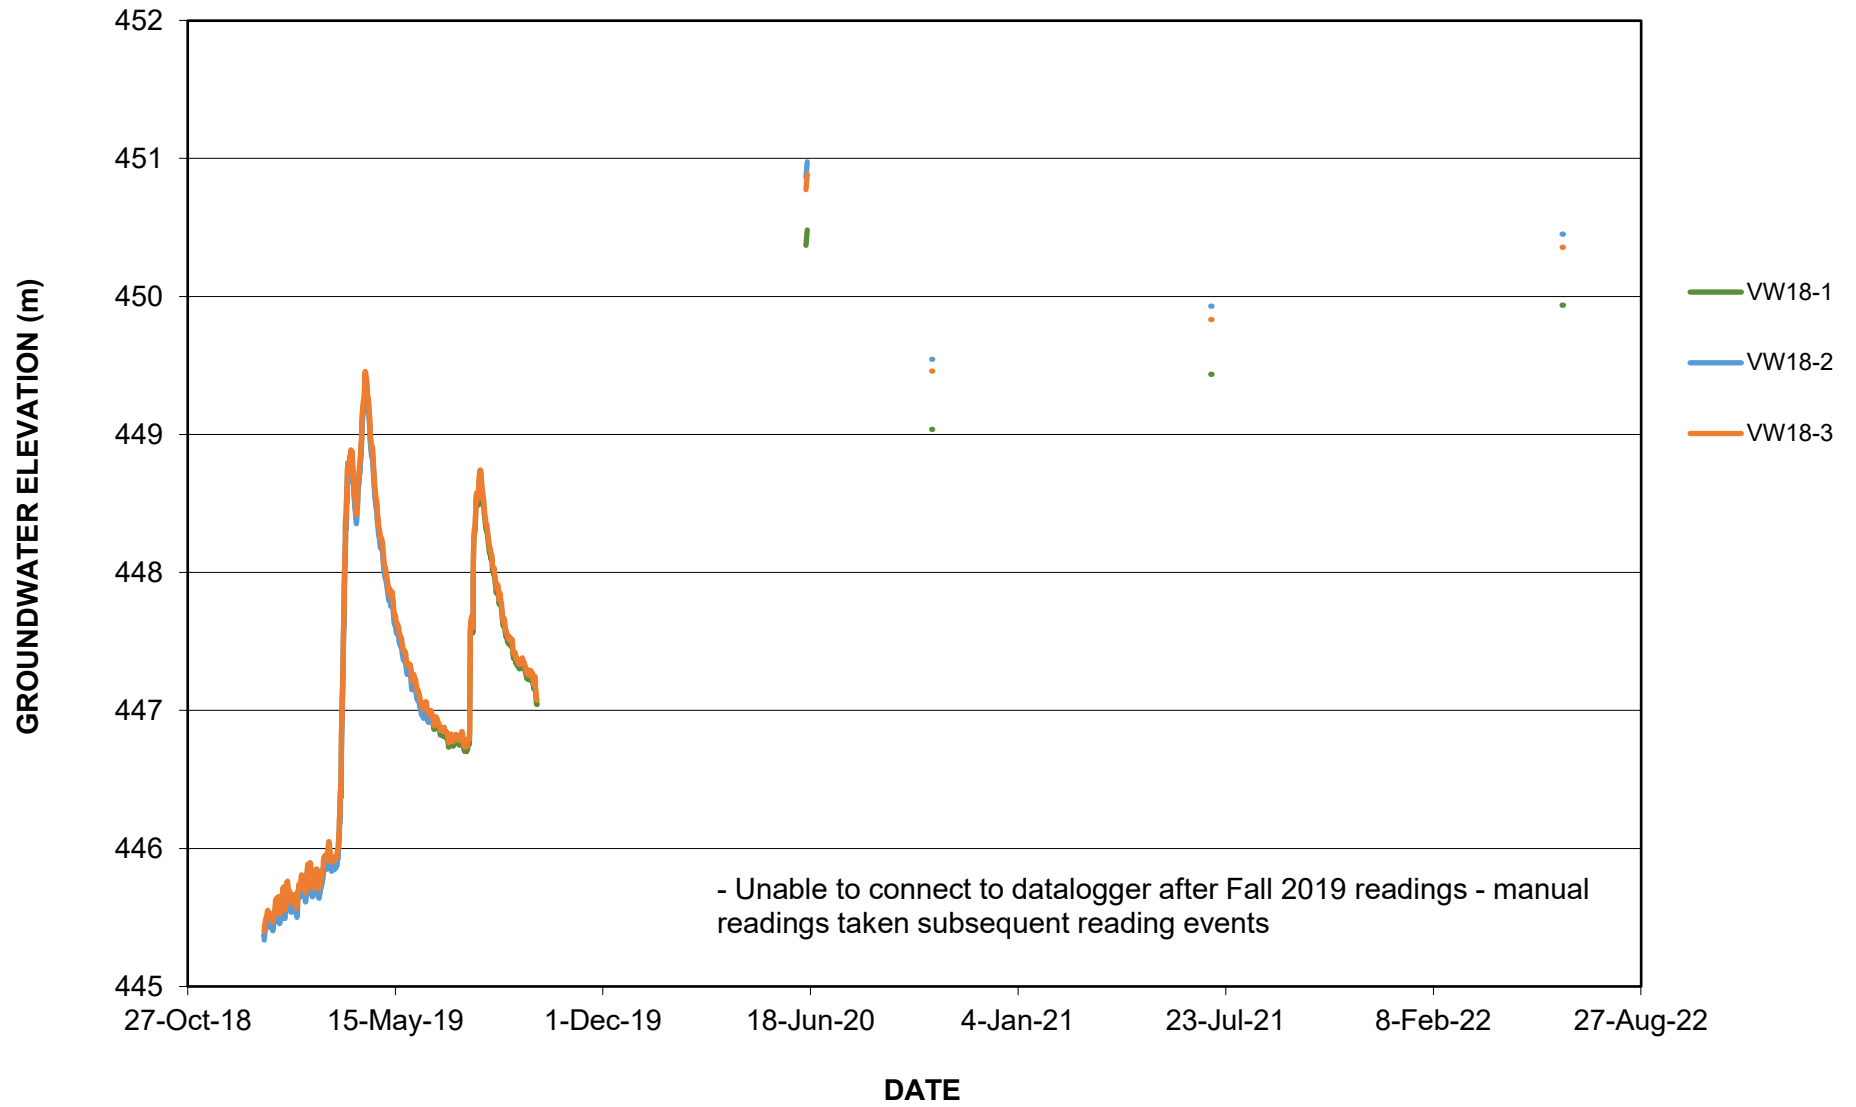
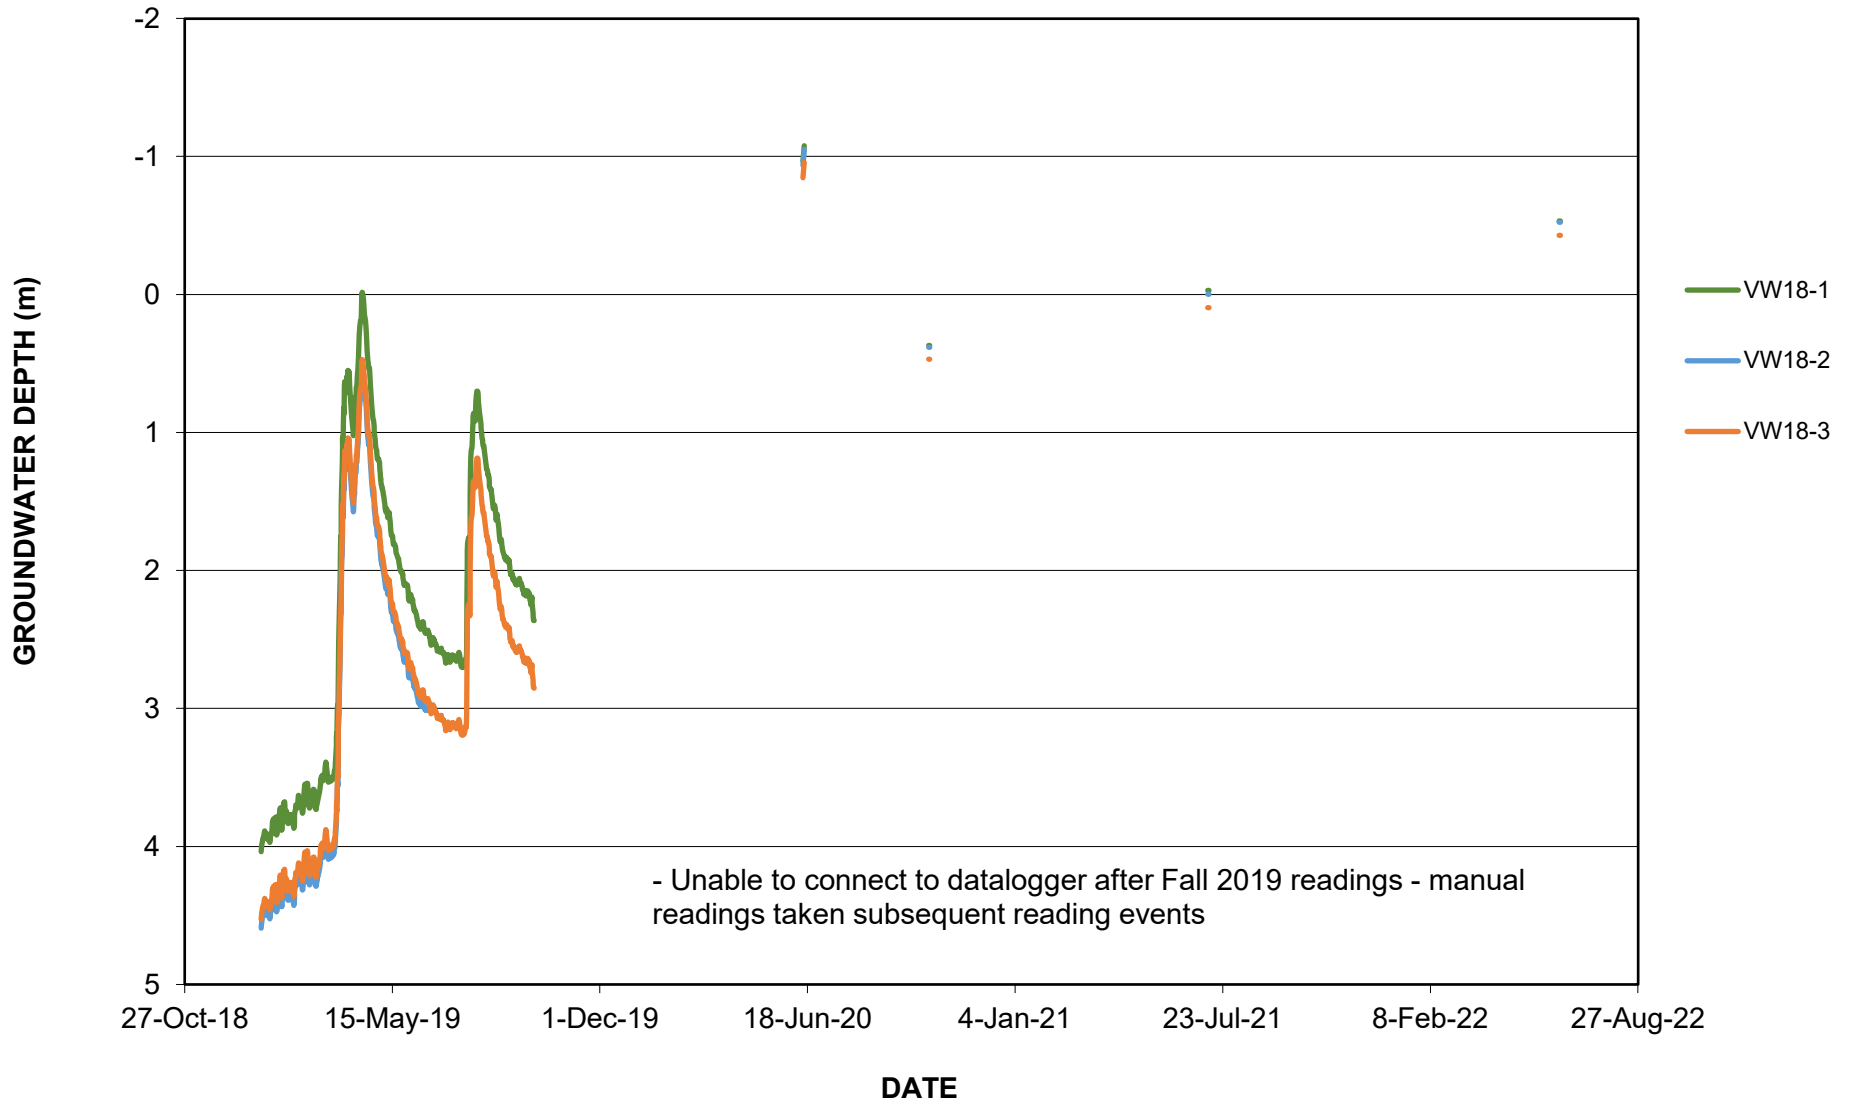
FIGURE PH042-3
PIEZOMETRIC ELEVATIONS FOR HWY 986:01, DAISHOWA EAST HILL
(SOUTH HIGHWAY DITCH PIEZOMETERS)

Vibrating wire piezometers VW18-1, VW18-2, and VW18-3, installed in the south highway ditch to the east of the pile wall, showed increases in groundwater level of 0.47 m, 0.56 m, and 0.57 m, respectively, since the spring of 2021 readings. The piezometers installed in the south highway ditch are summarized in Table PH042-4 below and are plotted on Figures PH042-3 (by elevation) and PH042-2-4 (by depth) in Appendix A.

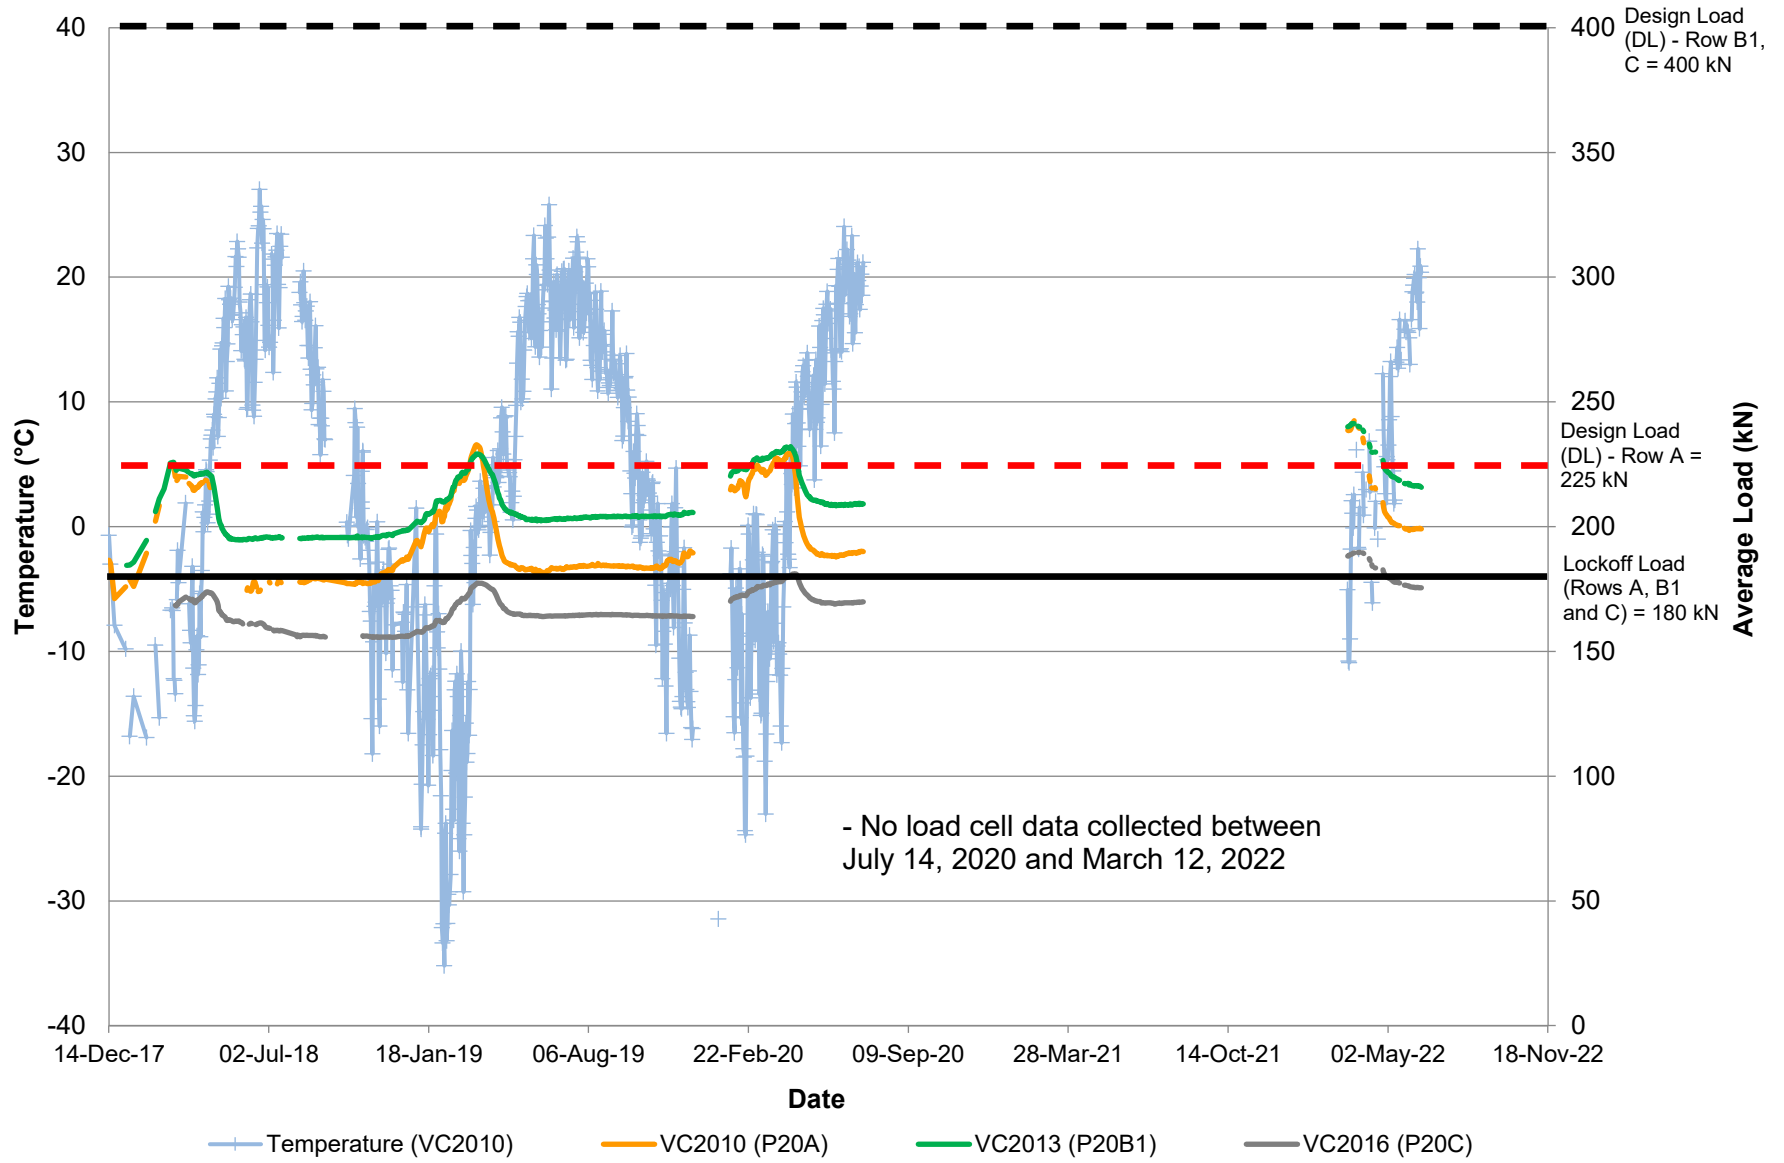
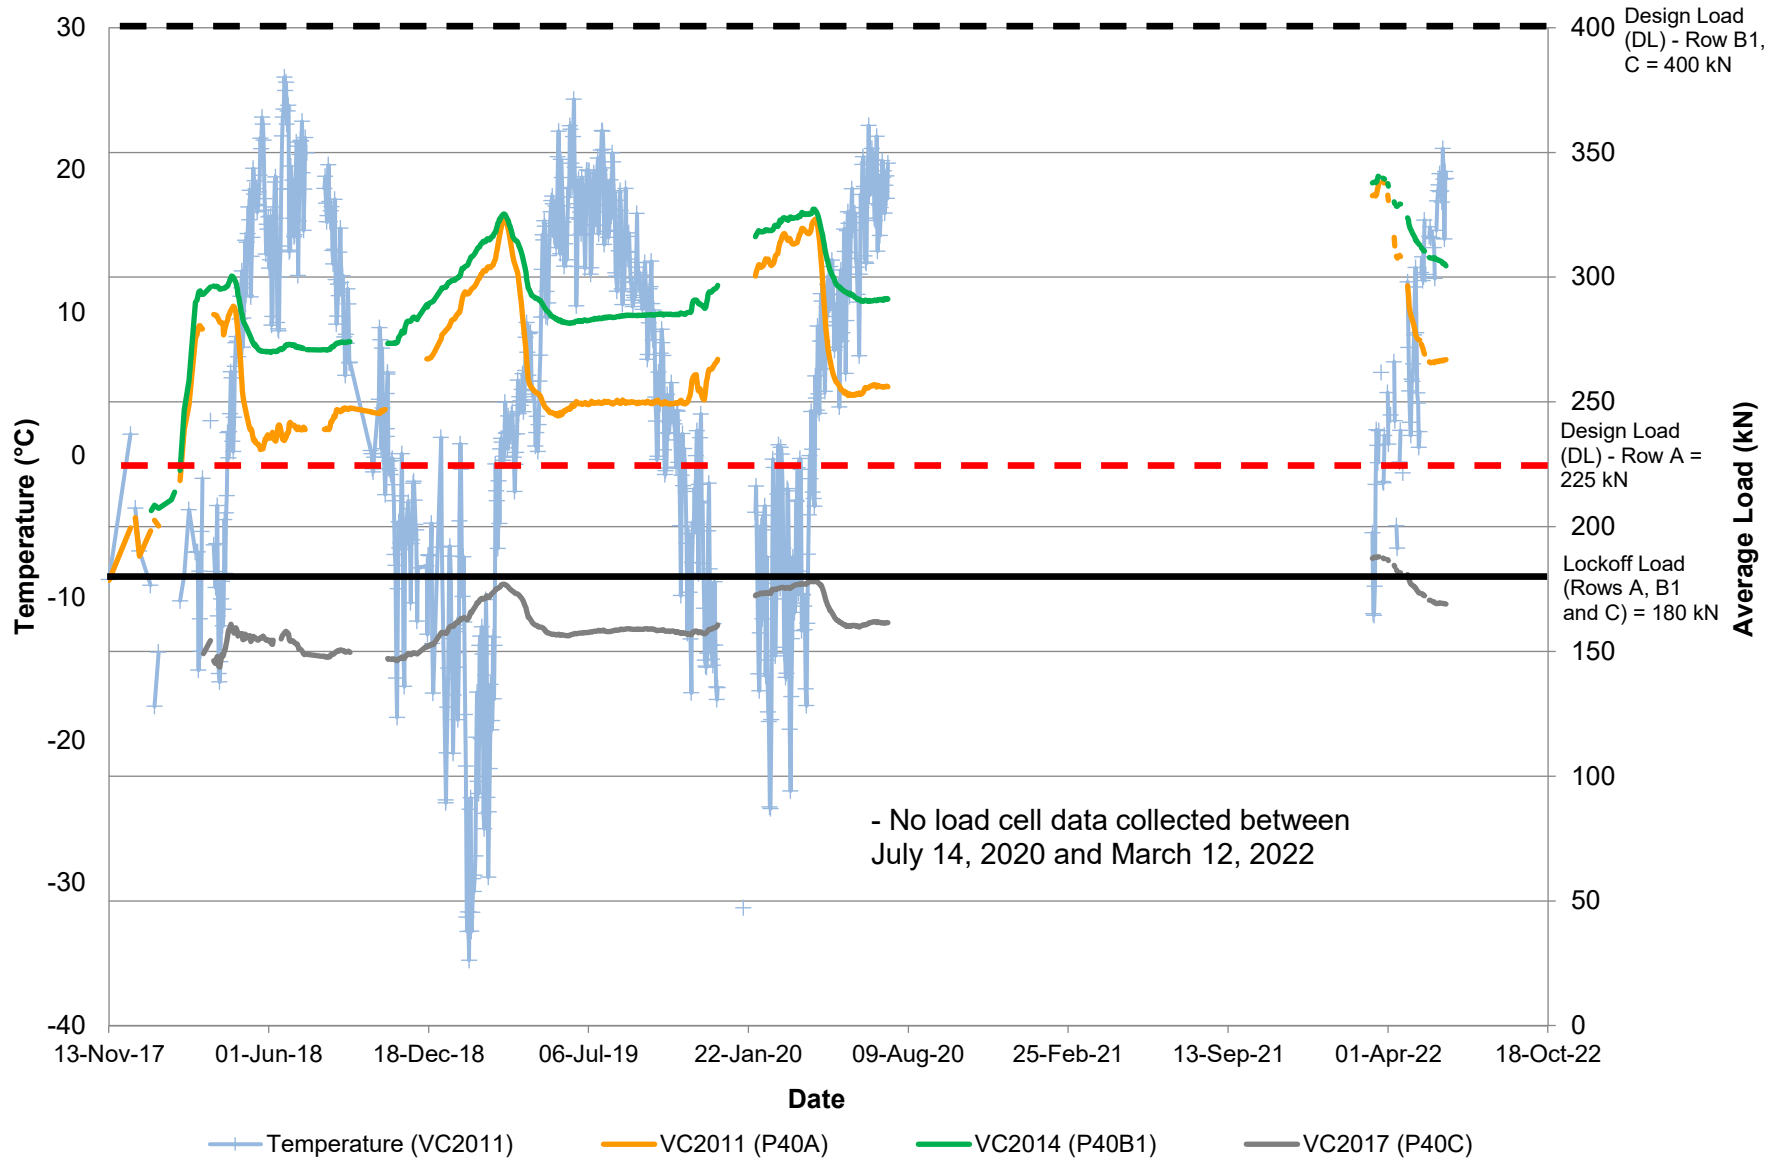
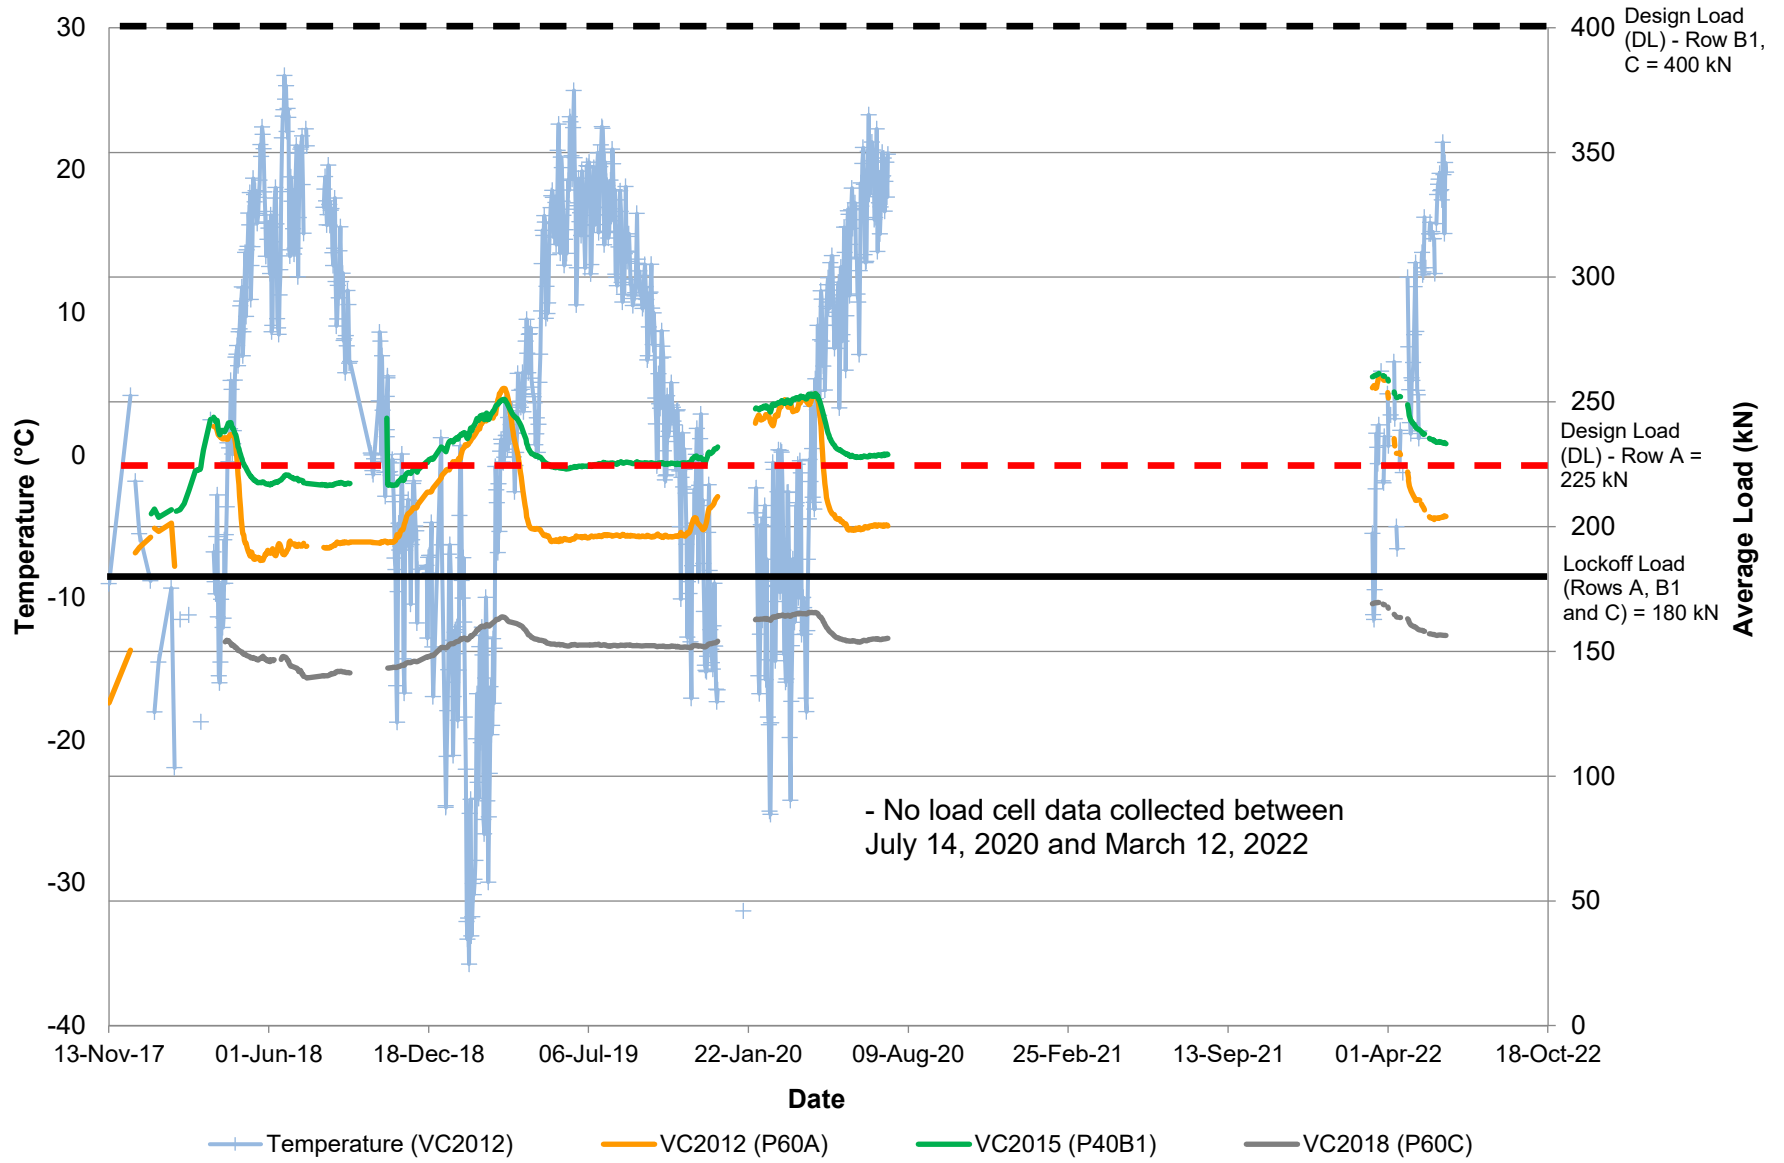
Compared to when they were previously read on July 14, 2020, the load cells all showed increases in measured load, ranging from an increase of 1.12 kN in VC2018 (anchor P60C) to an increase of 13.41 kN in VC2014 (anchor P40B). Additionally, the anchors all measured all-time high loads between March 19-23, 2022. It should be noted that VC2011 (anchor P40A) is measuring a current load that is above its design load. Overall, the load cells show steady to slowly increasing anchor loads, with the highest loads measured in late winter to early spring, when the depth of frost penetration is greatest. The load cell readings for piles P20, P40 and P60 are summarized in Table PH042-5 and are plotted on Figures PH042-5, PH042-6, and PH042-7, respectively, in Appendix A.
