ALBERTA TRANSPORTATION AND
ECONOMIC CORRIDORS
GEOHAZARD ASSESSMENT PROGRAM
PEACE REGION (PEACE RIVER DISTRICT)
2025 INSPECTION

Site Number	Location	Name	Hwy	km
PH042	Daishowa East Hill	Pumping Well	986:01	33.2
Legal Description		UTM Co-ordinates		
NE7-85-20 W5M		11V E 491155	N	6246175

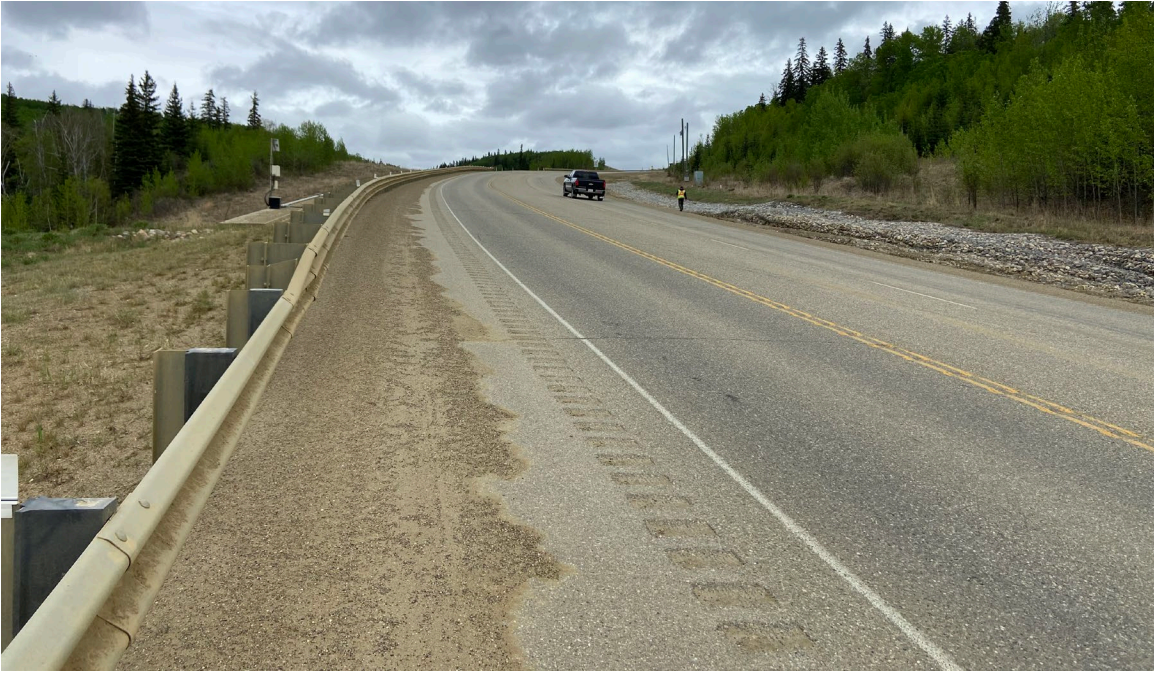
Observations:	Description	Worsened?
<input checked="" type="checkbox"/> Pavement Distress	ACP was in good condition at the time of the inspection with no signs of cracking or subsidence along previously observed extents of pavement damage due to landslide movement (Photos 42-01 and 42-03).	<input type="checkbox"/>
<input checked="" type="checkbox"/> Slope Movement	No observations of slope movement were evident at the road surface or below the pile wall along or outside the previous landslide extents (Photo 42-02). Backslope failure that occurred in 2020 near 33+125 had no major visible change. The gabion was slightly more heaved at the slide toe (up to 1.1 m in height) but there was no significant change from the 2023 condition (Photo 42-06).	<input type="checkbox"/>
<input checked="" type="checkbox"/> Erosion	Minor rill erosion was noted between the road edge and the edge of the gabion mattress but has not significantly changed since the previous inspection. An erosion gully (up to 0.5 m deep, 1.1 m wide, 17 m long) has formed near km 33+150 between the south road shoulder and heaved gabion mattress and had become worse since 2023. (Photo 42-06)	<input checked="" type="checkbox"/>

Photo 42-01.: Looking east across the repaired slide area. Guardrail and pavement surface in good condition with no major change since previous inspection.

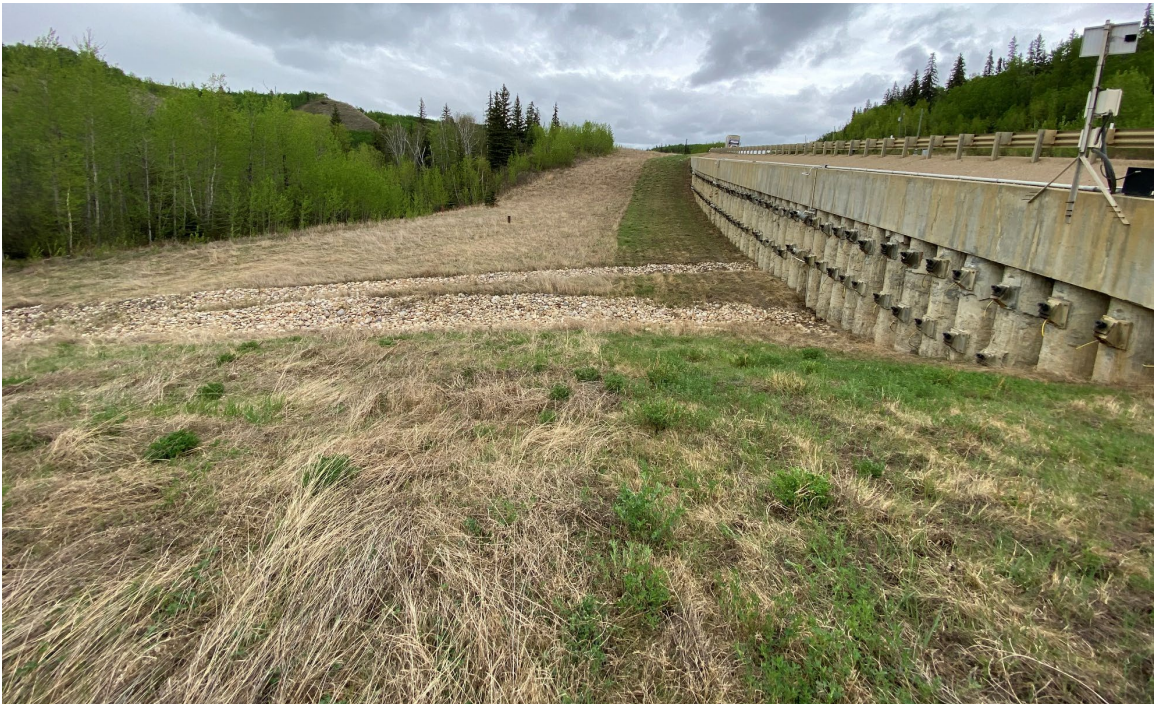
Photo 42-02.: Looking east at the pile wall and regraded slope below. Wall appears in a good condition and there has been no observable changes in the slope below since 2023.

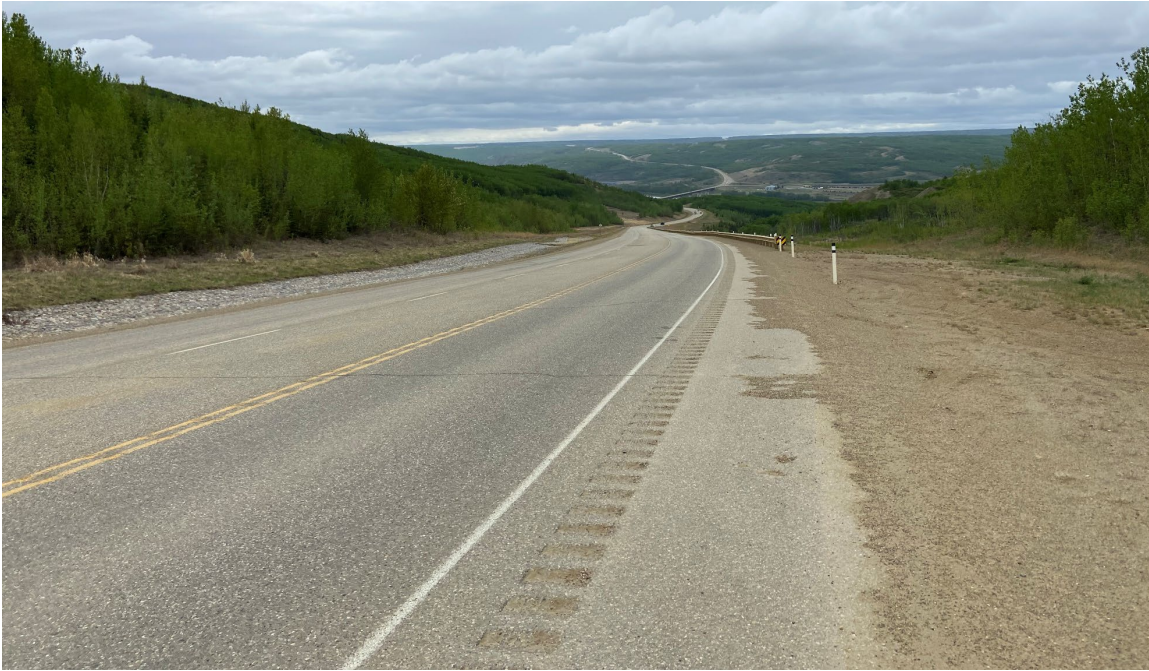
Photo 42-03.: Looking west at the replaced highway segment that previously had cracking and settlement across the roadway due to landslide movement (33+300). Road surface was in a good condition at time of inspection and had no observable change from the 2023 condition.

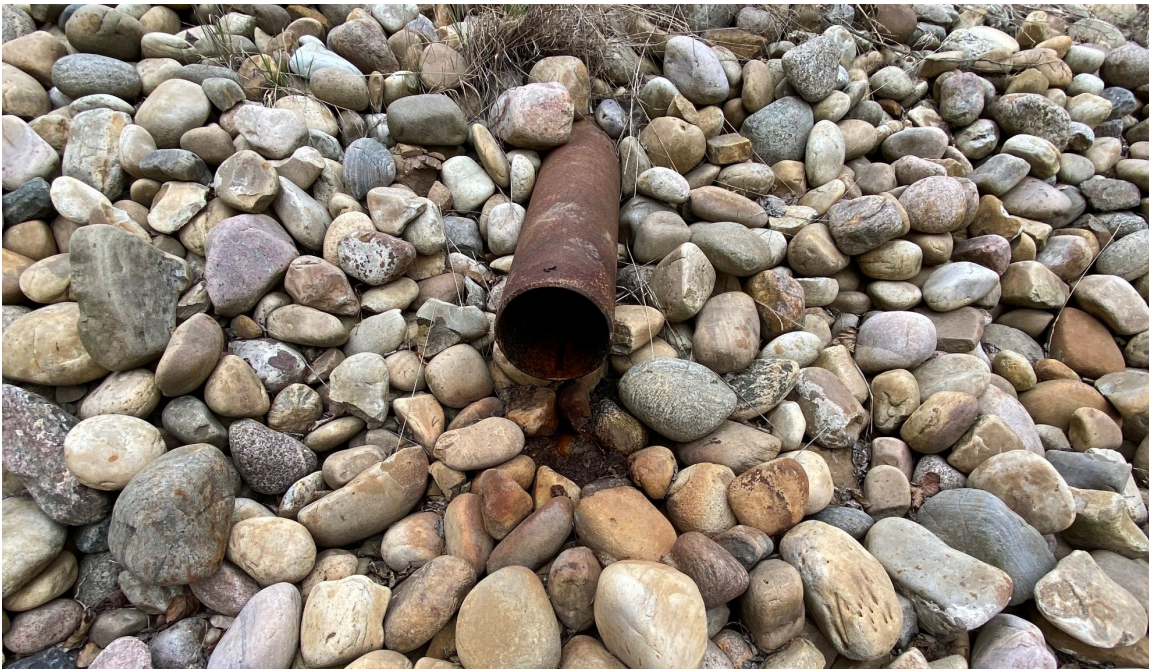
<input type="checkbox"/> Seepage		<input type="checkbox"/>
<input type="checkbox"/> Bridge/Culvert		<input type="checkbox"/>
<input checked="" type="checkbox"/> Other	Drain outlets between the piles were dripping at the west end of the wall and area at the base of the wall was wet. Subdrain outlet at the end of the riprap swale was dripping. (Photo 42-04) PVC conduit along the top of the wall for instrument cables had become disconnected from the junction box and tie-down clamps were broken.	<input type="checkbox"/>

Photo 42-04.: Looking at subdrain pipe outlet that was slowly dripping within the end of the armoured drainage swale from the west side of the wall.

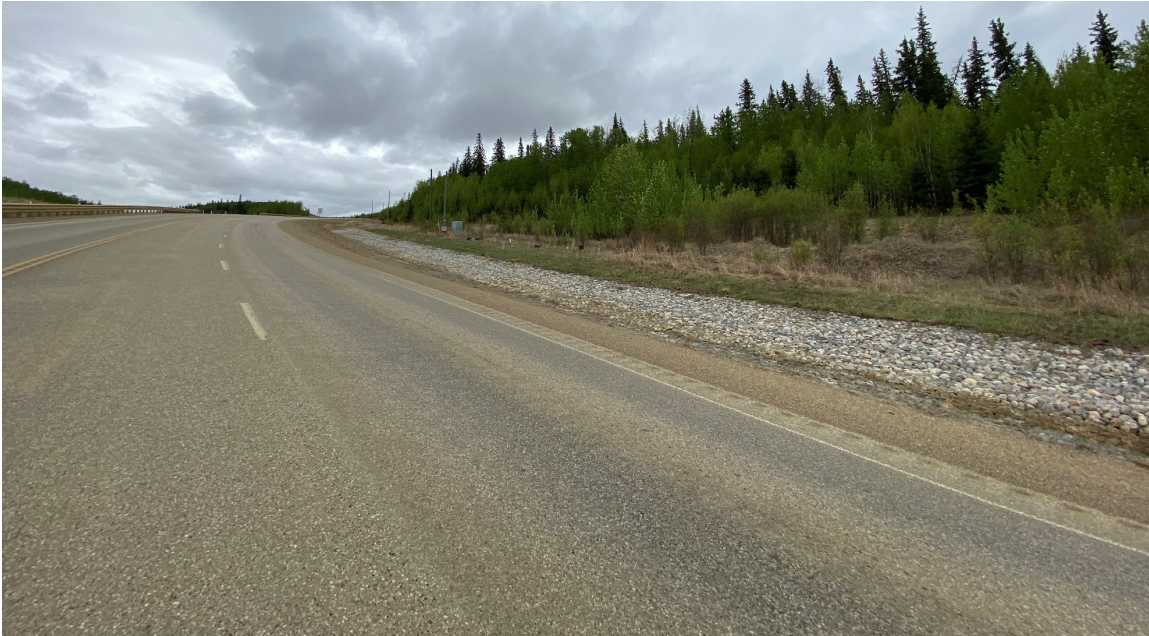
Photo 42-05.: View looking east at the gabion mattress installed in the south ditch across the entire site extents to repair previous erosion damage. Minor rill erosion was noted between the road edge and edge of the gabion. No major visible changes within the area east of 33+175 since 2023.

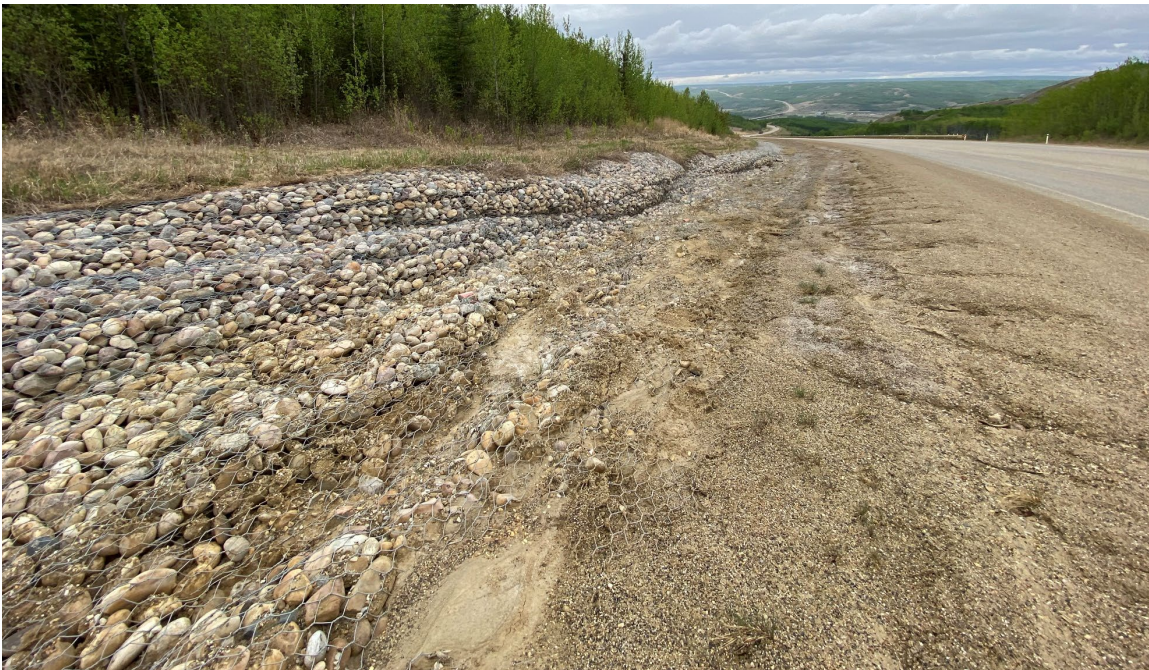
Photo 42-06.: Looking west at the gabion mattress installed in the south ditch near 33+125 deformed by the toe roll of an upslope landslide that occurred in 2020. Gabion was slightly more heaved but had no significant change since previous inspection. Some increased erosion in ditch sideslope due to restricted flow from gabion heave.

- Maintenance: Repairs are required along the top of the wall to the PVC conduit and junction box for instrumentation cables.
- Maintenance: The south ditch erosion gully due to the heaved gabion mattress near 33+150 should be filled with Class 1M riprap over non-woven geotextile.
- Short term remedial measures could consist of removing the eastmost 30 m of gabion mattress (and salvaging the stones), excavating the heaved ground back to the pre-disturbance level and replacing a new gabion mattress over this section. The risk with this method is that further ground movements might heave the mattress again. (\$75k)

- Longer term remedial measures could consist of removing the gabion mattress (and salvaging the stones) over the disturbed zone, strengthening the subsurface foundation soil, trimming the ditch smooth and then relaying new gabion mattress. The subsurface strengthening could consist of either of the following methods (\$250k to \$400k):
 - Sub-excavating the slide material under the ditch to a depth below the slip surface and constructing a well compacted granular shear key zone to force the slip surface to toe out uphill of the ditch. The shear key would likely need to be at least 2.5 m deep and 5 m wide; or
 - Installing spaced H-piles parallel to, and offset about 1 m south, of the uphill edge of the ditch lining. The piles would likely need to be at about 6 m long/deep.
