**ALBERTA TRANSPORTATION  
GEOHAZARD ASSESSMENT PROGRAM  
PEACE REGION (PEACE RIVER DISTRICT)  
2022 INSPECTION**

Site Number	Location	Name	Hwy	km
PH043A	Daishowa East Hill	Site A - Pile Wall	986:01	33.45
Legal Description		UTM Co-ordinates		
NE7-85-20 W5M		11V E 491380	N 6246075

<b>Site Number</b>	<b>Location</b>	<b>Name</b>	<b>Hwy</b>	<b>km</b>
PH043B	Daishowa East Hill	Site B	986:01	33.74
<b>Legal Description</b>		<b>UTM Co-ordinates</b>		
NW8-85-20 W5M		11V E 491630	N 6245925

**DAISHOWA  
HWY 986:01 (PH043)  
LOCATION PLAN**

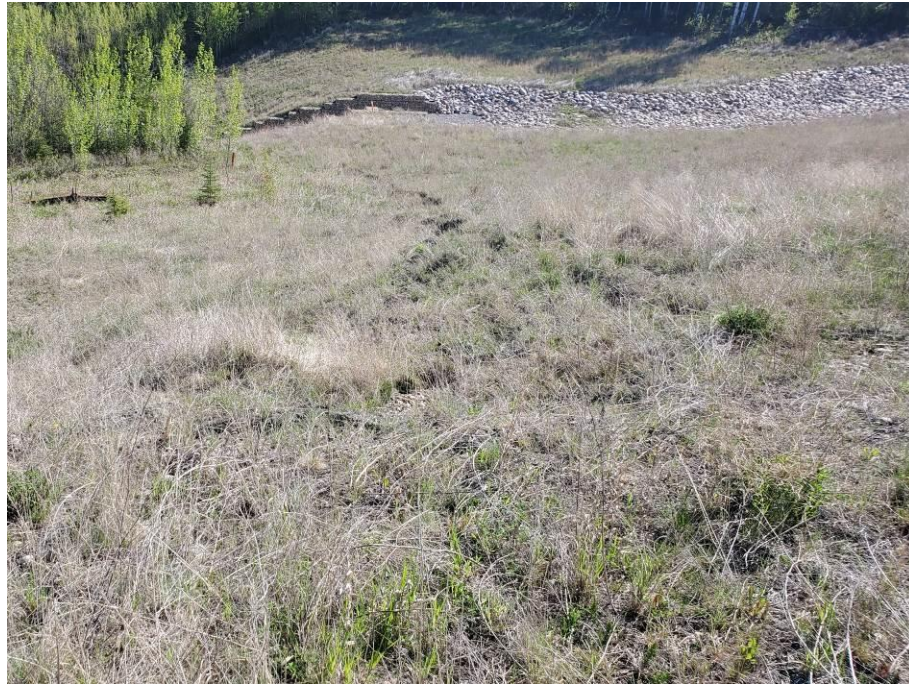
**Photo 43-01.**  
At the west edge of Site A near top of the buried pile wall looking northeast towards the overflow area and gabion drop structure. No major change from 2021.

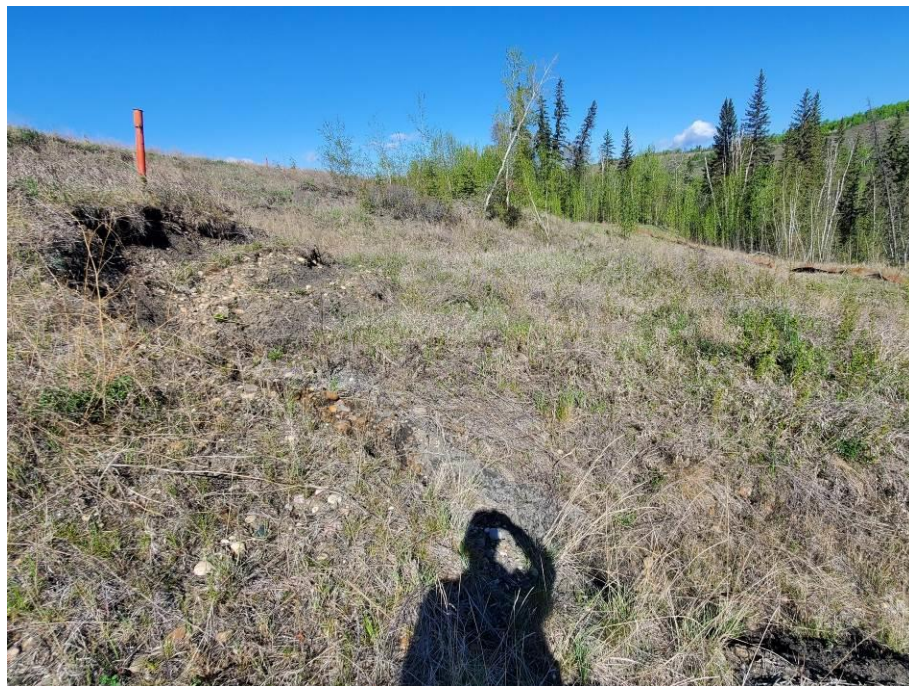
**Photo 43-02.**  
Main slide scarp of active shallow failure downslope of the buried pile wall (33+325) first observed in 2017. Area is vegetated and has shown only minor retrogression and expansion since the previous inspection.

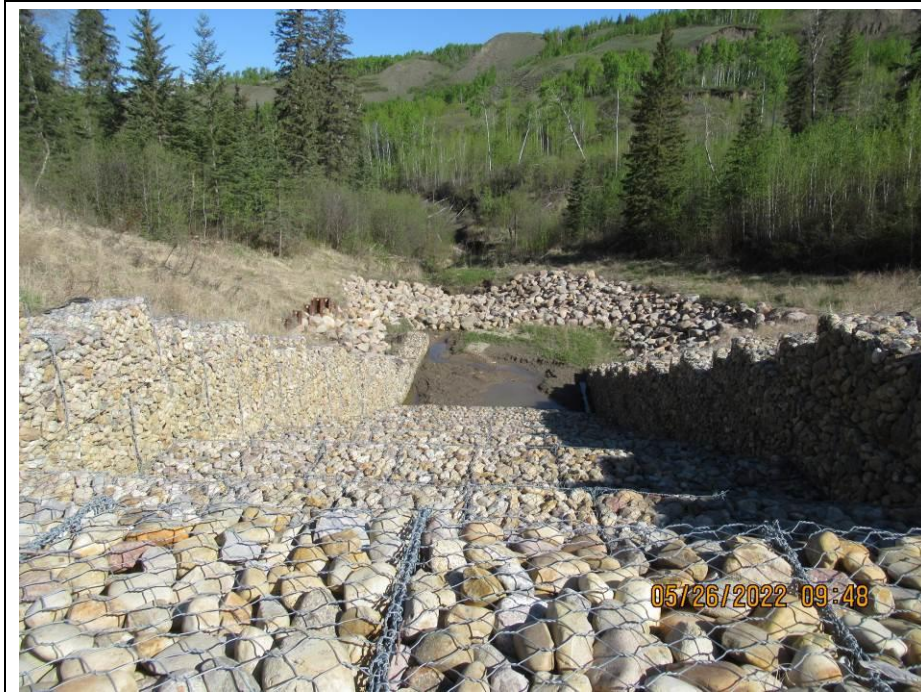
section) was noted (staked with lathe to monitor measuring 1.18 m offset to outside bottom).	
<input checked="" type="checkbox"/> Erosion	No change to erosion rills observed at the steel pile wall (Photo 43-03). Vegetation is more established relative to the 2021 inspection. At the culvert inlet (km 33+500) the south channel bank erosion was slightly worse with additional riprap fallen away. (Photo 43-06). The swale riprap at the east end of Site A with erosion damage from a 2019/2020 high flow event had increased damage, gullying was deeper and wider (Photo 43-13).	<input checked="" type="checkbox"/>
<input type="checkbox"/> Seepage		<input type="checkbox"/>
<input checked="" type="checkbox"/> Bridge/Culvert Distress	Gabion drop structure silt buildup at the base (Photo 43-03). Silt buildup at the culvert inlet (Photo 43-06).	<input type="checkbox"/>
<input checked="" type="checkbox"/> Other	No significant beaver activity noted at the creek between Sites A and B.	<input type="checkbox"/>

**Photo 43-03.**  
 Overflow gabion drop structure and dissipation bowl at the previous culvert outlet that had extensive erosion and gullyng below Site A (33+430). Some rill erosion was noted within the fill areas that were still vegetating. Base of drop structure had a large amount of silt buildup. Minor change from 2021 condition.

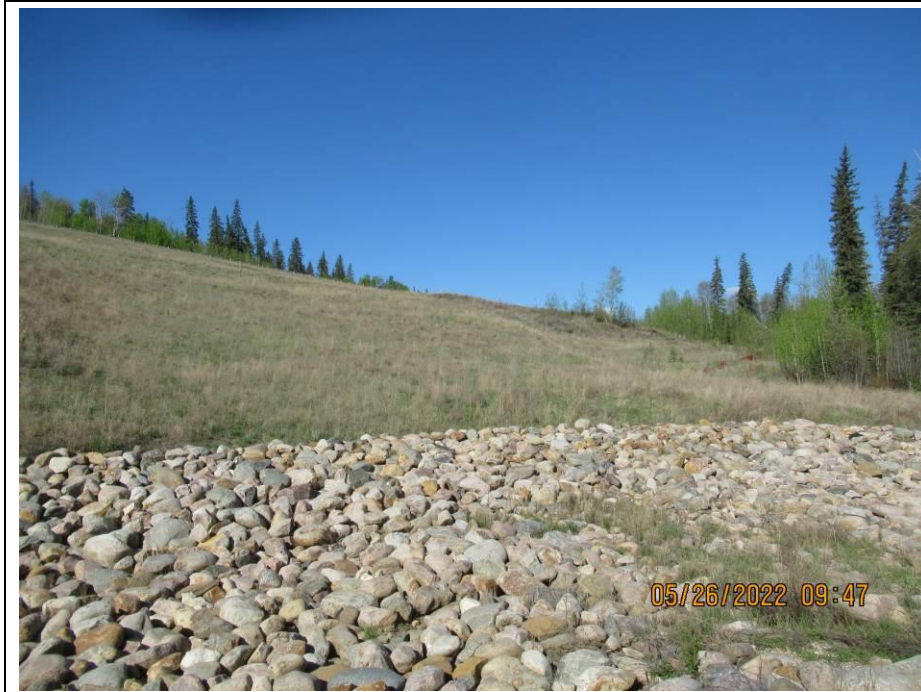
**Photo 43-04.**  
 Looking southwest at the area of previous slumping associated with culvert erosion below pile wall (33+430). Area has since been graded and finished with straw matting.

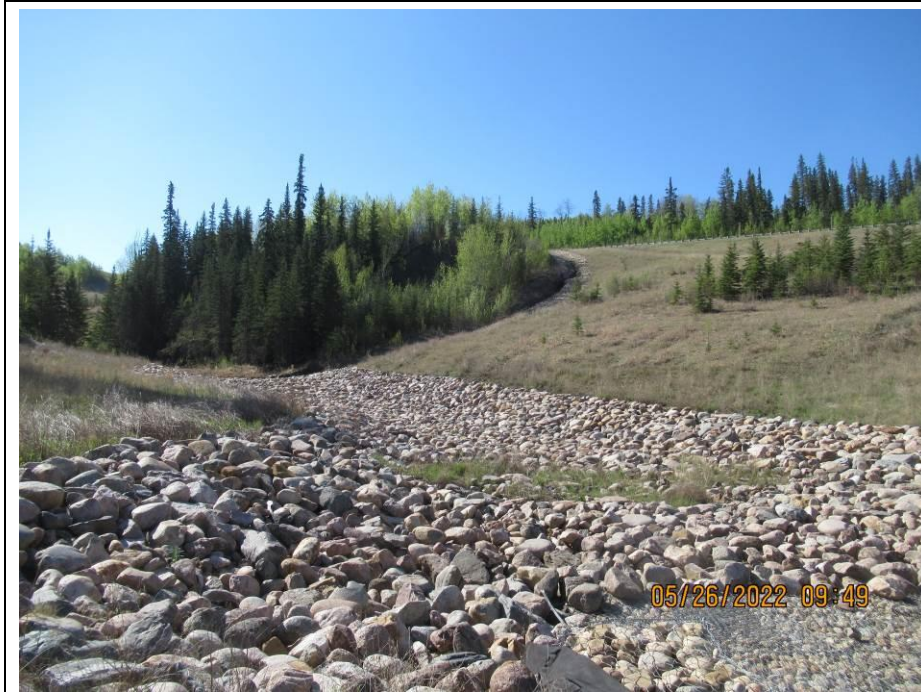
**Photo 43-05.**  
 Standing at the top of the gabion drop structure looking east towards the overflow channel riprap (33+450). Vegetation has re-established.

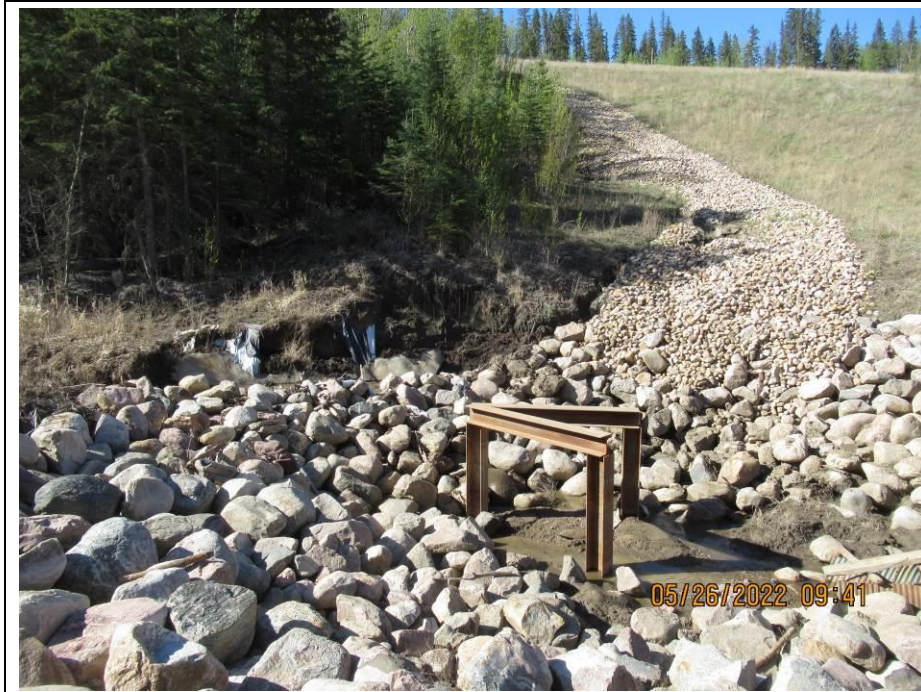
**Photo 43-06.**  
 Looking south towards the culvert inlet riprap, riprap swale, and debris deflector (33+500). Note south channel bank erosion, silt buildup and erosion within the riprap swale. Slightly worse from the 2021 condition.

Recommendations:	Cost
<b>Monitoring:</b>	
Continue to monitor instruments twice yearly and undertake annual inspections.	-
<b>Maintenance:</b>	
Sediment buildup at the culvert should be monitored and cleaned out as required.	
Maintenance work required at the culvert inlet, swale riprap south channel bank requires shaping and additional riprap placement.	\$30,000
Remove sand accumulation from side of roadway, which is causing channelization of surface runoff, resulting in erosion rills on embankment (maintenance).	\$10,000
Repair the east crotch swale by backfilling the eroded base and replacing the riprap with gabion mattress	\$25,000

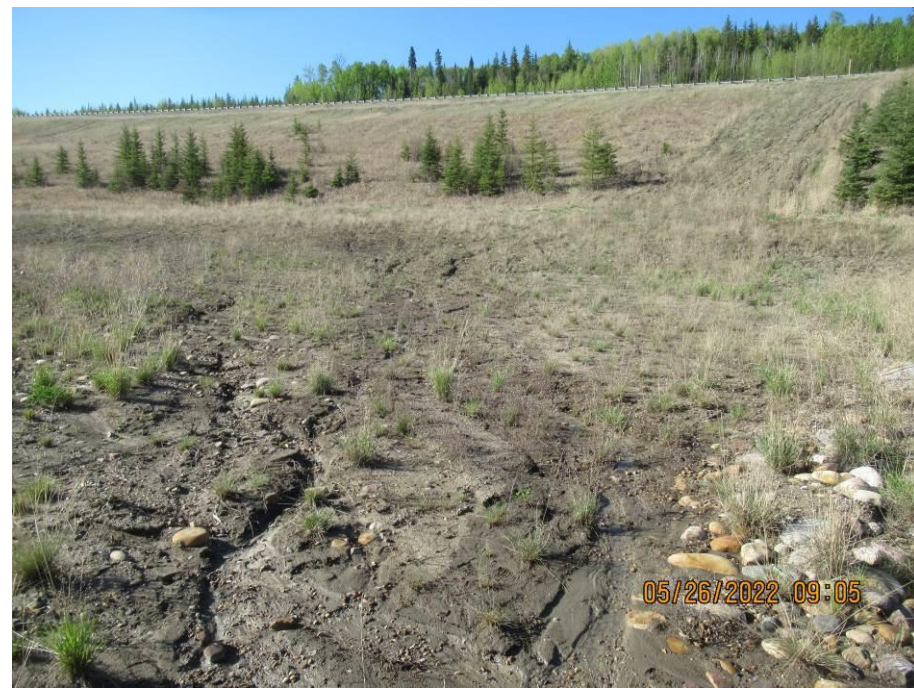
<p>Increased gully erosion was noted near the outlet of the CPP down pipe (33+800) due to a leaking joint caused by a local landslide movement (Photo 43-16).</p> <p>Minor rill erosion and poor vegetation noted in the overland flow area above the drop structure (Photo 43-07).</p>	
<input type="checkbox"/> Seepage		<input type="checkbox"/>
<input checked="" type="checkbox"/> Bridge/Culvert Distress	<p>Culvert inlet at 33+800 is still damaged from high flow event and has severely reduced flow capacity. Additional riprap above the inlet had collapsed above it and slid down partially burying it (Photo 43-15).</p> <p>Piping erosion has formed a void in the previously damaged area and location where culvert joint and grouting repairs were made. The gabion baskets and mattresses in the bottom part of the drop structure have settled and tilted around the area of damage (Photo 43-08).</p>	<input checked="" type="checkbox"/>

**Photo 43-07.**  
Looking south towards the Site B highway embankment and overland flow area. Minor rill erosion is visible on the right top corner of the photo along the slope.

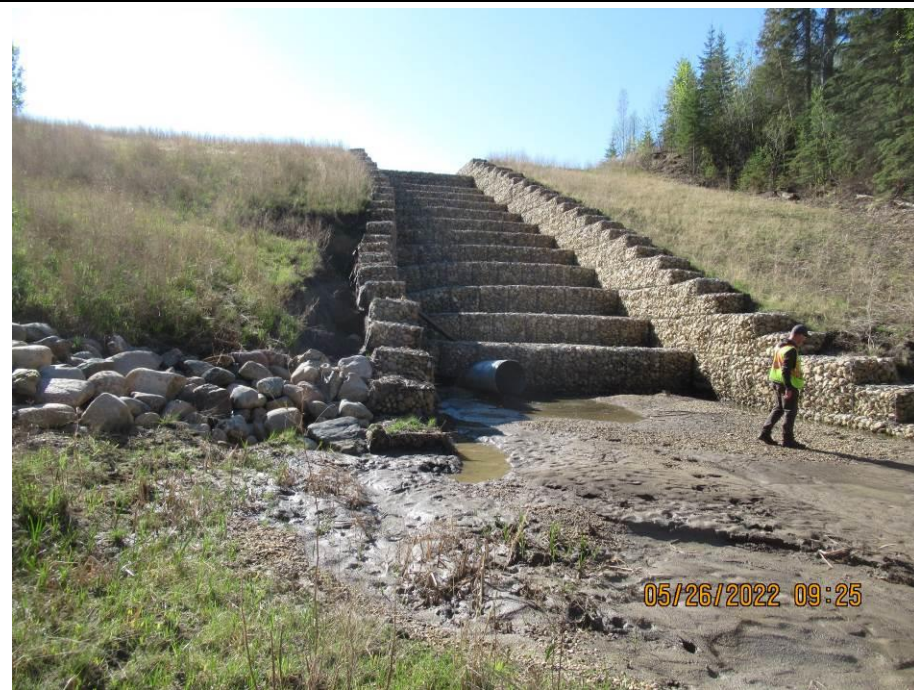
**Photo 43-08.**  
View of the gabion drop structure and riprap dissipation bowl at the culvert outlet at Site B. (33+600). Additional erosion and gabion deformation due to piping erosion from leak in the culvert joint (left side).

<b>Maintenance:</b> The outlet of the drop structure should be carefully cleared of excess ice and the outlet of the CSP steamed open in early Spring to limit further sinkhole expansion and damage. The void beside the drop structure should be backfilled with Class 1 rock riprap over geotextile to limit further damage.	\$100k
--	--------

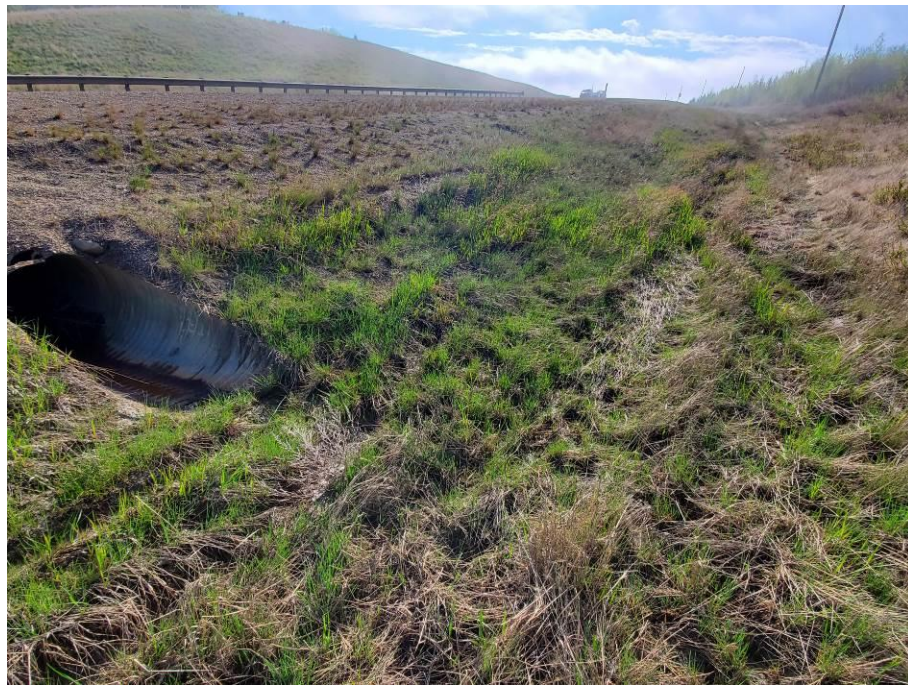
<input checked="" type="checkbox"/> Erosion	<p>South ditch erosion has been repaired with TRM near km 34+125 and is in good condition (Photos 43-09).</p> <p>Minor rills were slightly worse between the road and north ditch gabion armour at km 34+000 (Photo 43-10).</p> <p>Previous area of erosion rills at top of embankment at the east end of the site has been graded and TRM installed with vegetation regrowth starting (Photo 43-12). Where the TRM ends at the west end of the site there was increased rill erosion near km 33+650 (Photo 43-19)</p>	<input checked="" type="checkbox"/>

**Photo 43-09.**  
South ditch TRM installation at Site B to repair erosion damage and mitigate against future erosion (34+125). Ditch has well established vegetation.

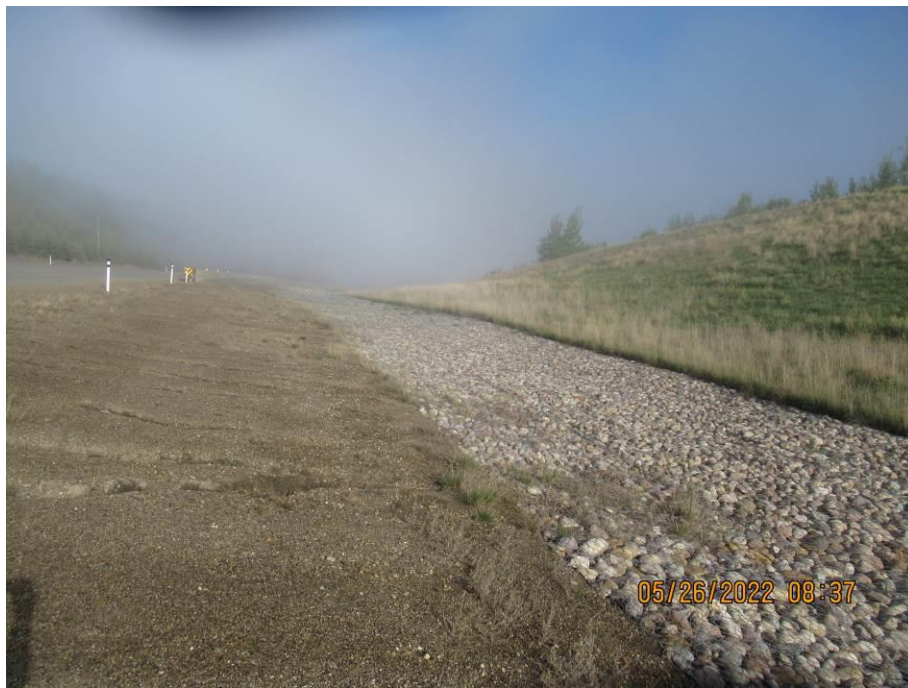
**Photo 43-10.**  
Looking west towards the north ditch gabion mattress installation at Site B.

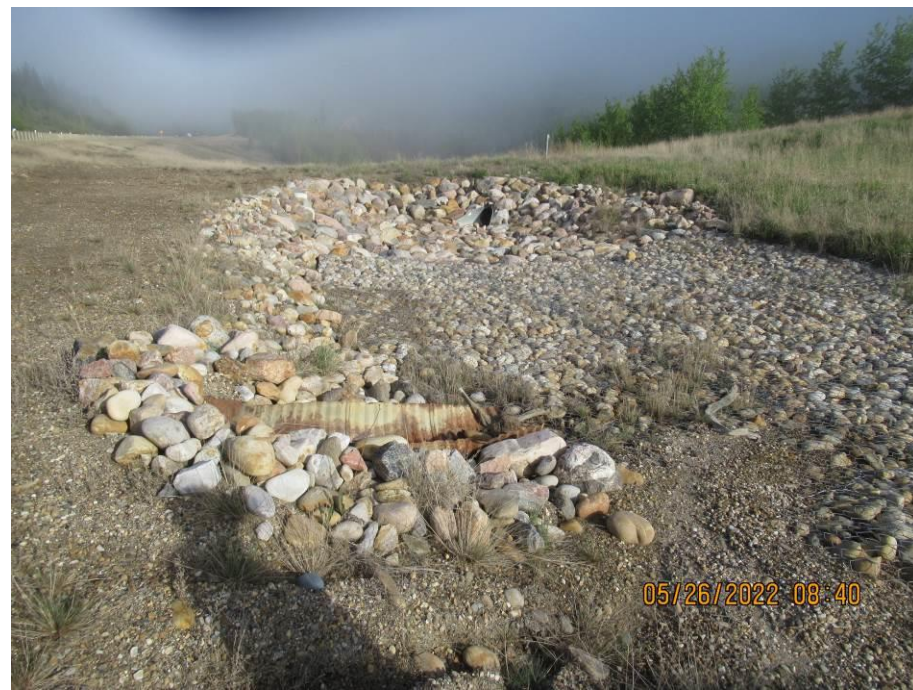
**Photo 43-11.**  
View of culvert inlet and riprap protection near 33+900 on north side of road.

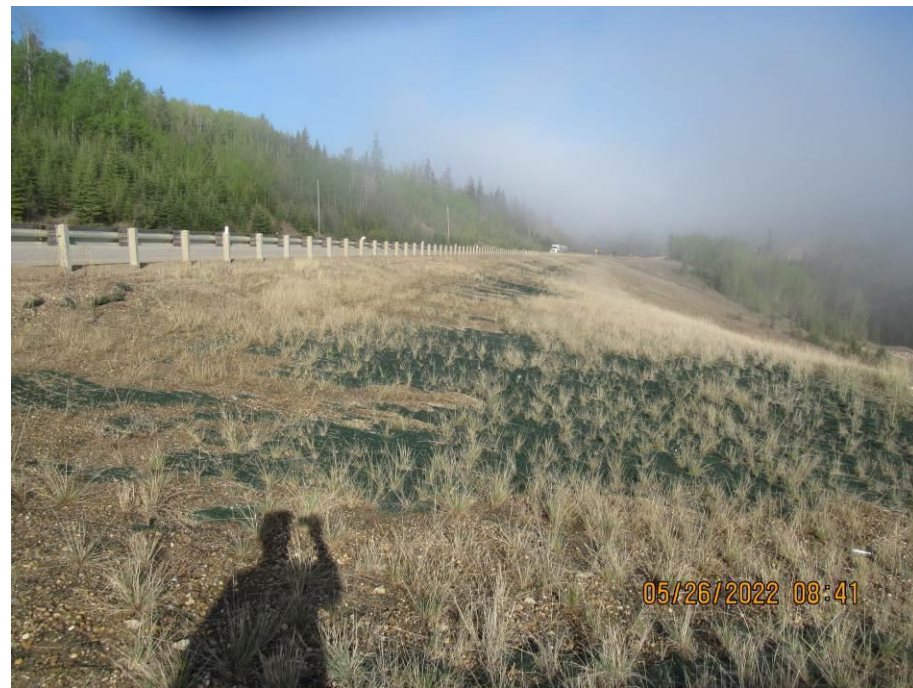
**Photo 43-12.**  
Looking west towards the TRM installation on the upper portion of the slope north of the road (33+700). Some vegetation growth has started.

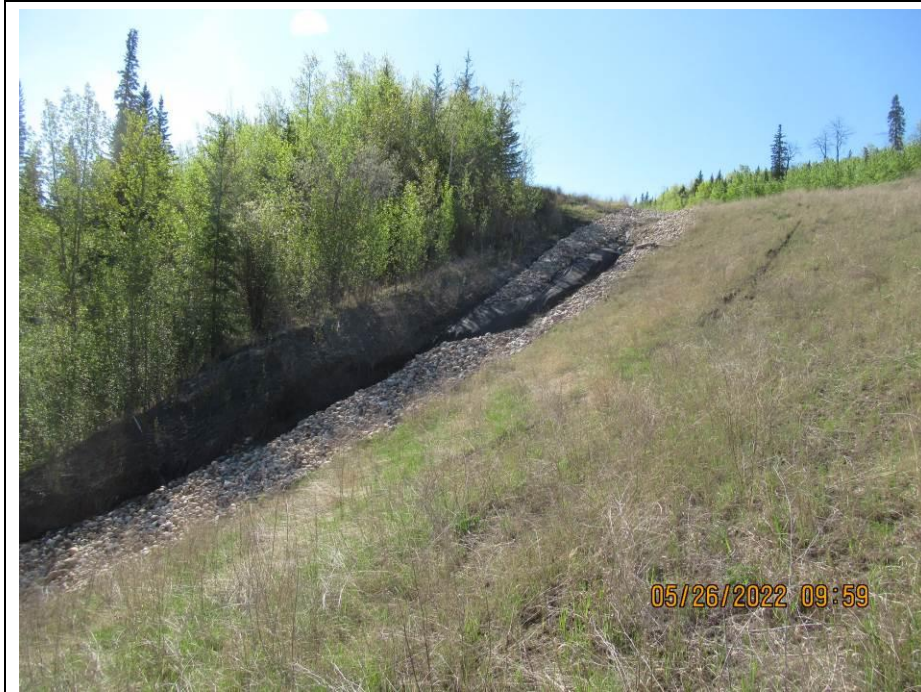
**Photo 43-13.**  
Looking south, upslope towards washed out riprap and extensive erosion damage within the riprap swale at the east side of Site A (33+500), likely the result of a high-flow event in 2019/2020. Increased erosion damage since 2021.

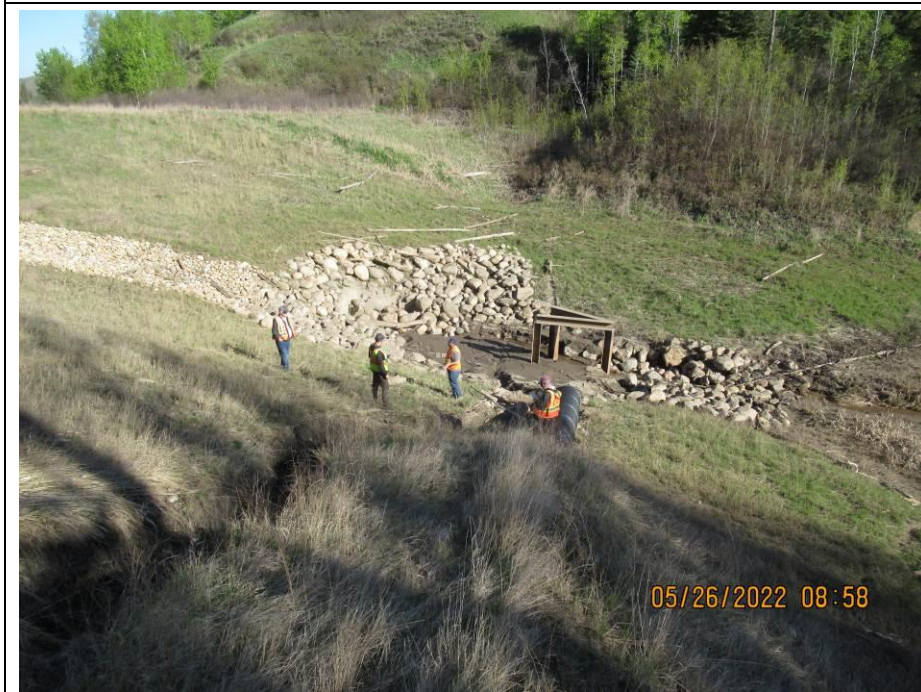
**Photo 43-14.**  
Site B culvert inlet with riprap protection and steel H-beam debris deflector. Inlet become severely damaged and blocked with fallen riprap during a high flow event in 2019/2020 (33+800). No major changes from 2021 condition. Increased erosion at gully on left side of photo. Repairs required in this area.

Repairs required at the culvert inlet at the creek including, inlet replacement, riprap placement and reconfiguration, and joint repair at the CPP down pipe.	\$150k
---	--------

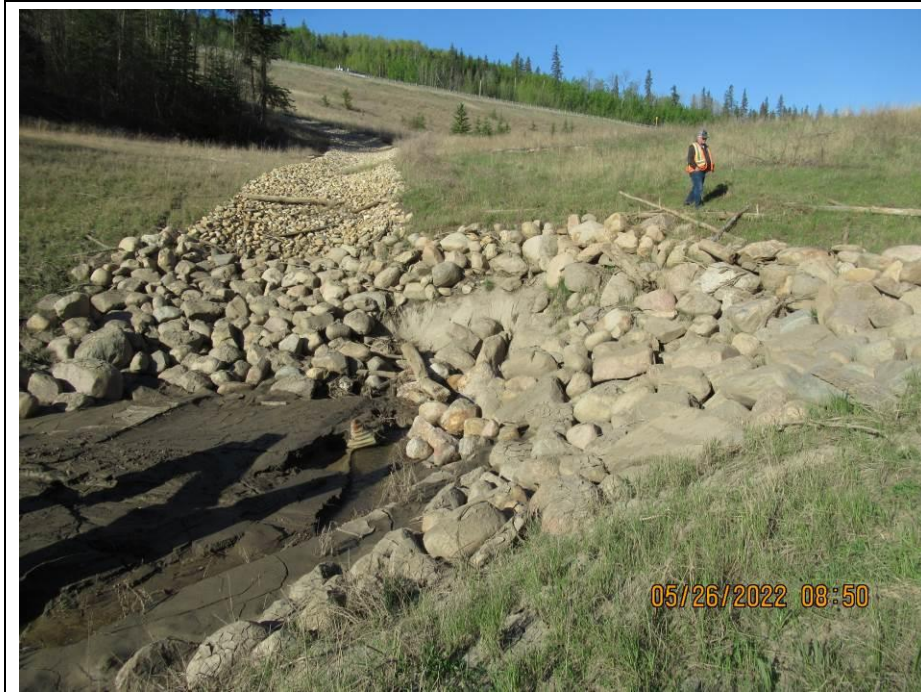
<input checked="" type="checkbox"/> Other	Sediment and debris buildup near the culvert inlet indicative of flooding during a high flow event. (Photo 43-15)	<input type="checkbox"/>
<p><b>Instrumentation:</b></p> <p>Spring 2022 Readings:</p> <ul style="list-style-type: none"> <li>• SI-7 – No discernible movement measured.</li> <li>• SI-8 –3.7 mm/yr over 0.3 m to 1.5 m depth, creep (&lt; 1.0 mm/yr) over 1.5 m to 4.0 m depth.</li> <li>• SI-9 –7.8 mm/yr over 0.3 m to 2.7 m depth.</li> </ul>		
<p><b>Assessment:</b></p> <p>The culvert and erosion control mitigation work should reinforce the embankment toe and reduce rates of soil loss from this area and the potential of destabilizing the upper embankment slope. Current erosion control measures appear mostly effective in controlling drainage at the site with the exception of the lower embankment culvert inlet (33+800) which has become damaged apparently during a high flow event. The culvert inlet requires repairs to restore full drain capacity. The end slope of the inlet should be cut steeper and shorter and possibly lined with a stronger SWSP (or reinforced within a concrete headwall) to resist hydraulic uplift forces. The riprap around the culvert needs to be reconfigured and should be “benched” into the slope as is practical to reduce displacement and sliding. The CPP downpipe requires repairs at a leaking joint, which was caused by a local landslide in the lower valley slope.</p> <p>During the spring of 2018 a sinkhole developed beside the lower portion of the drop structure, caused by water flowing under pressure from a separated joint in the underlying C.S.P. culvert creating a subsurface void. The void was grouted, and the sinkhole backfilled, however distortions to the overlying gabion baskets/mattresses remain. It is believed the outlet of the C.S.P., which sits in the flow dissipation bowl, froze underwater and that the pressurized water eroded the sinkhole out the side of the pipe and drop structure. During the 2022 inspection further void formation as a result of piping erosion was observed to occur and cause displacement of the gabion drop structure and ongoing erosion damage. Repair of this area is required to prevent further damage to the drop structure and proper culvert function. The disturbed soils should be removed and then the sink hole and related erosion gully beside the gabion wall should be backfilled with Class 1 riprap over geotextile. The side of the gabion drop structure wall should be pushed back into vertical orientation as is practically possible during the riprap backfill activity. Maintenance and cleaning of the outlet to limit sediment and ice buildup prior to spring thaw will be critical to limit potential water backup and further damage. Consideration should be given to bypassing the compromised culvert joint by inserting a new internal reline pipe (e.g., expandable “slipline” or similar)</p>

**Photo 43-15.**  
 Damage around culvert inlet due to a high flow event. Culvert pipe at the inlet was effectively pinched and twisted shut and was filled with woody debris. Riprap above the inlet had collapsed and slid down over it. No change to riprap damage or woody debris buildup. Increased silt buildup relative to 2021 condition. Repairs required in this area (33+800).

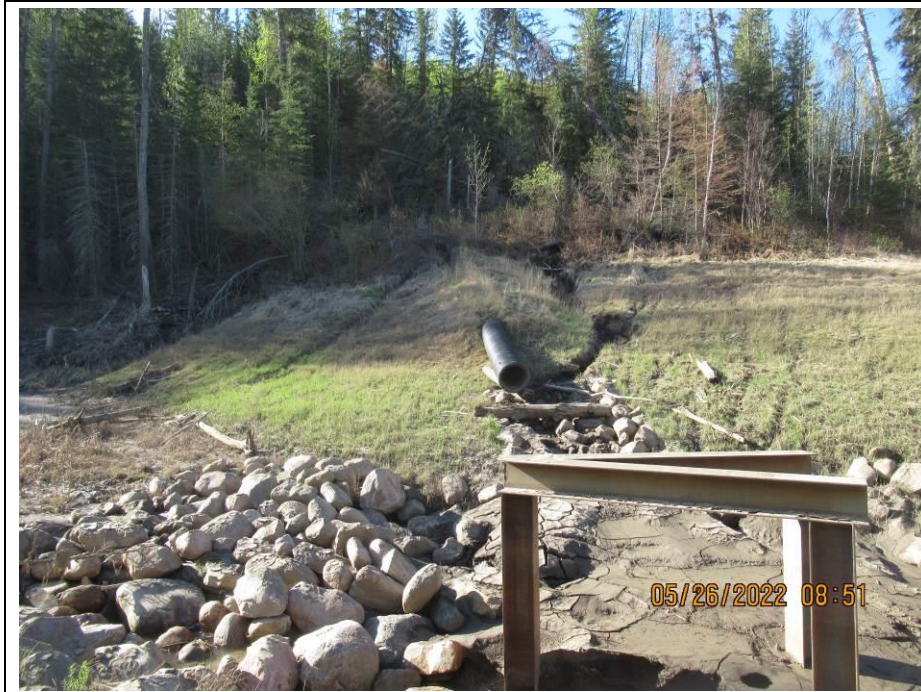
**Photo 43-16.**  
 Looking south towards the outlet of the CPP down pipe near the culvert inlet (33+800). Rill erosion was noted to be occurring upslope from the pipe outlet due to a leaking joint that requires repair. Increased gully erosion was noted on the right side of the pipe.

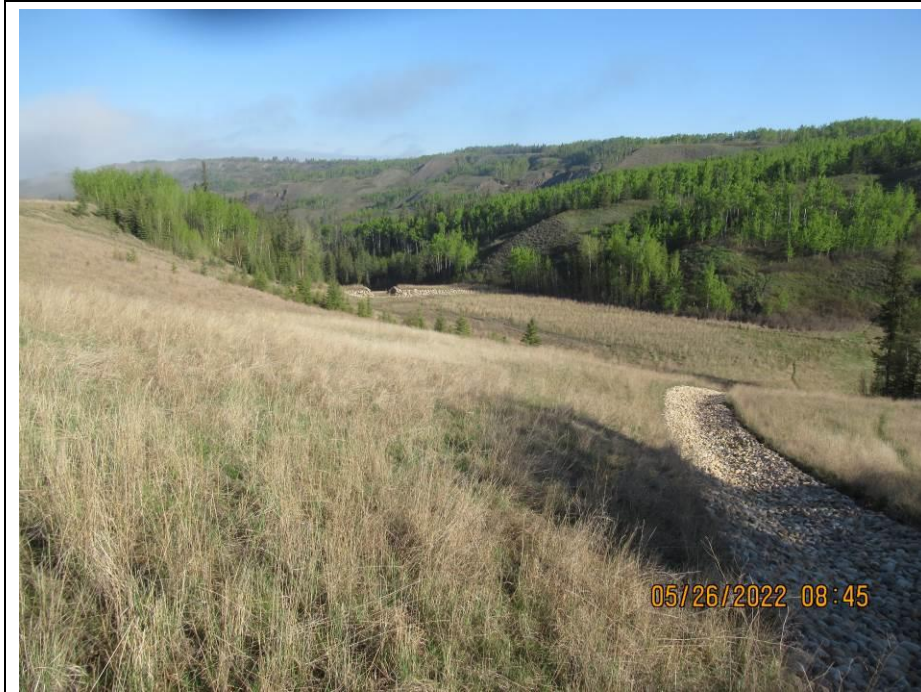
**Photo 43-17.**  
Looking west towards the highway slope, overland flow area of Site B.

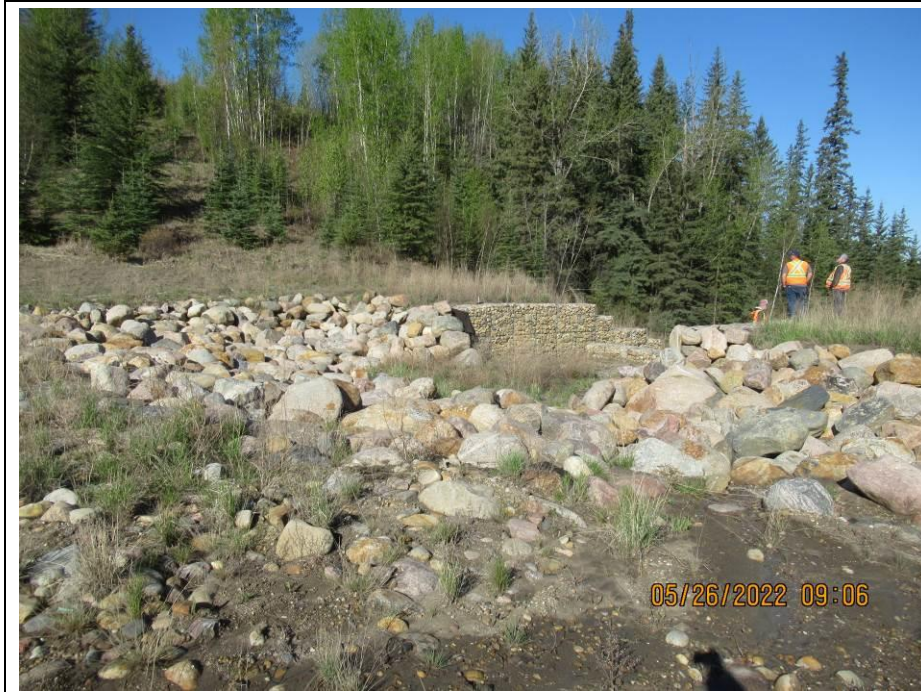
**Photo 43-18.**  
View of the riprap berm located near the top of the gabion drop structure (33+650)

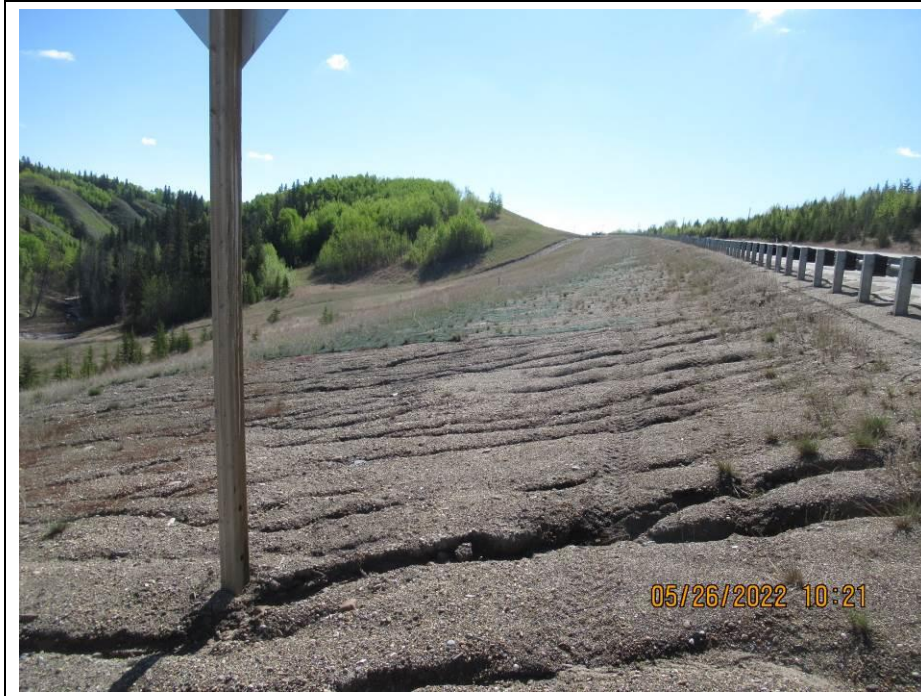
**Photo 43-19.**  
View of the minor rill erosion near the top of the embankment of Site B (33+650) where TRM is not installed.
