July 26, 2022

**ALBERTA TRANSPORTATION GRMP (CON0022164)
PEACE REGION (PEACE RIVER DISTRICT)
INSTRUMENTATION MONITORING RESULTS – SPRING 2022**

**SITE PH043-1: HWY 986:01, DAISHOWA EAST HILL PILE WALL
SITE PH043-2: HWY 986:01, DAISHOWA EAST HILL SITE B**

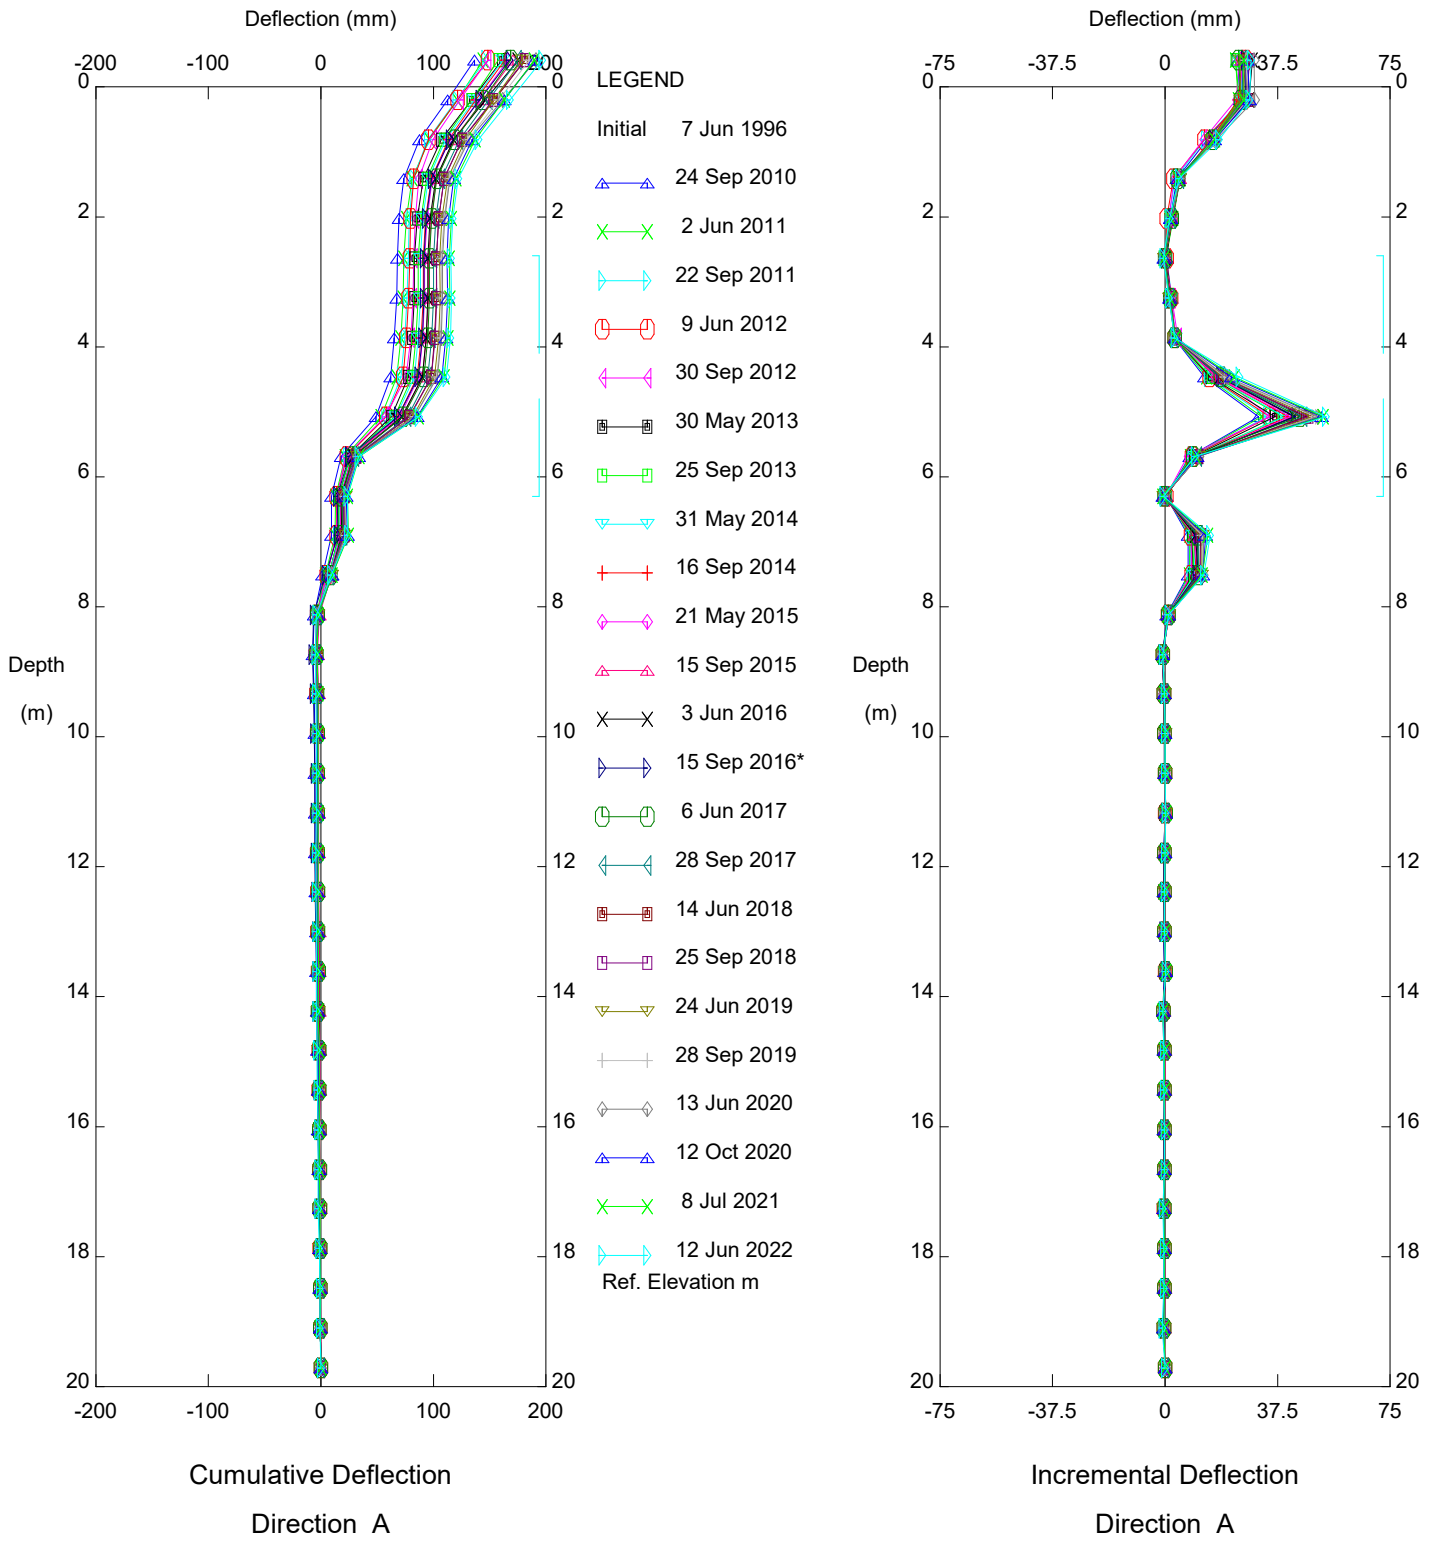
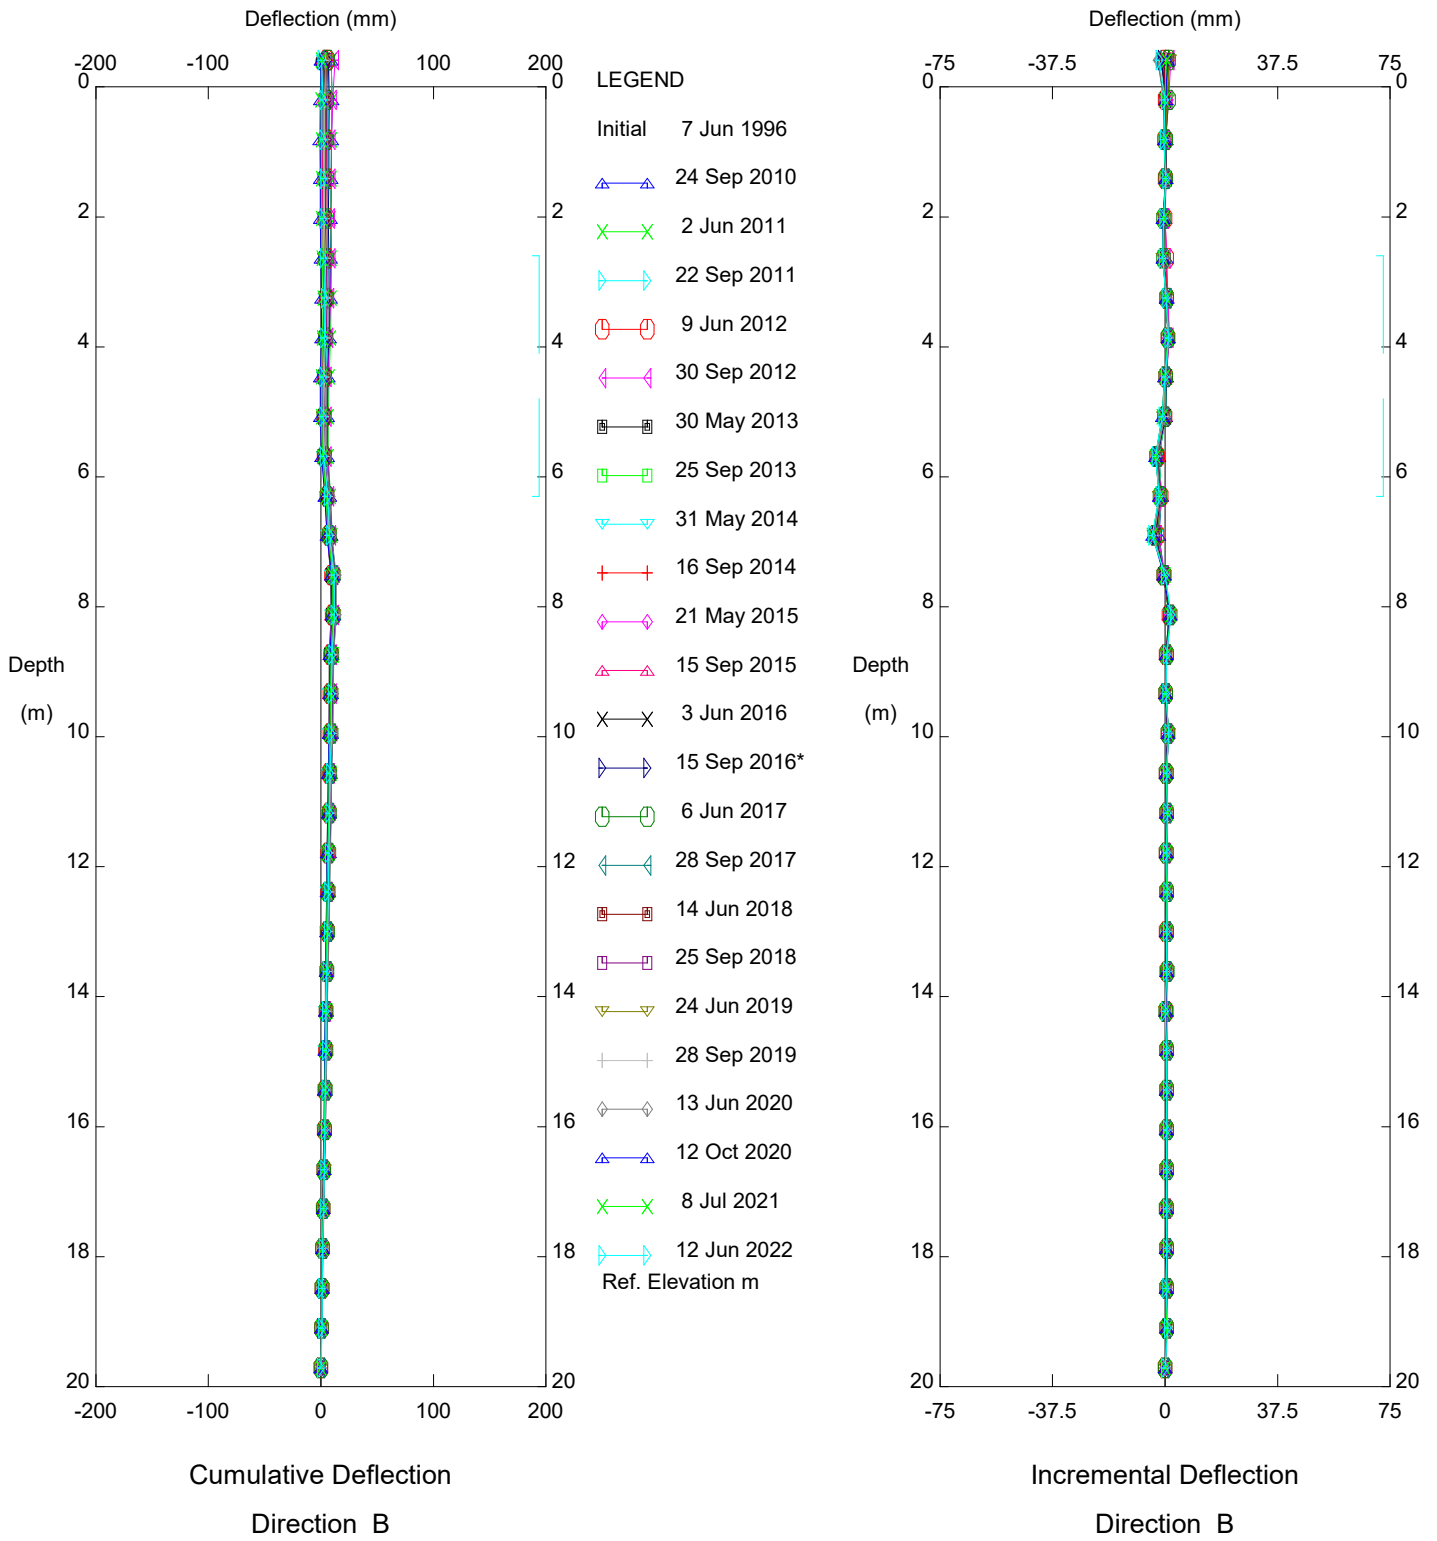
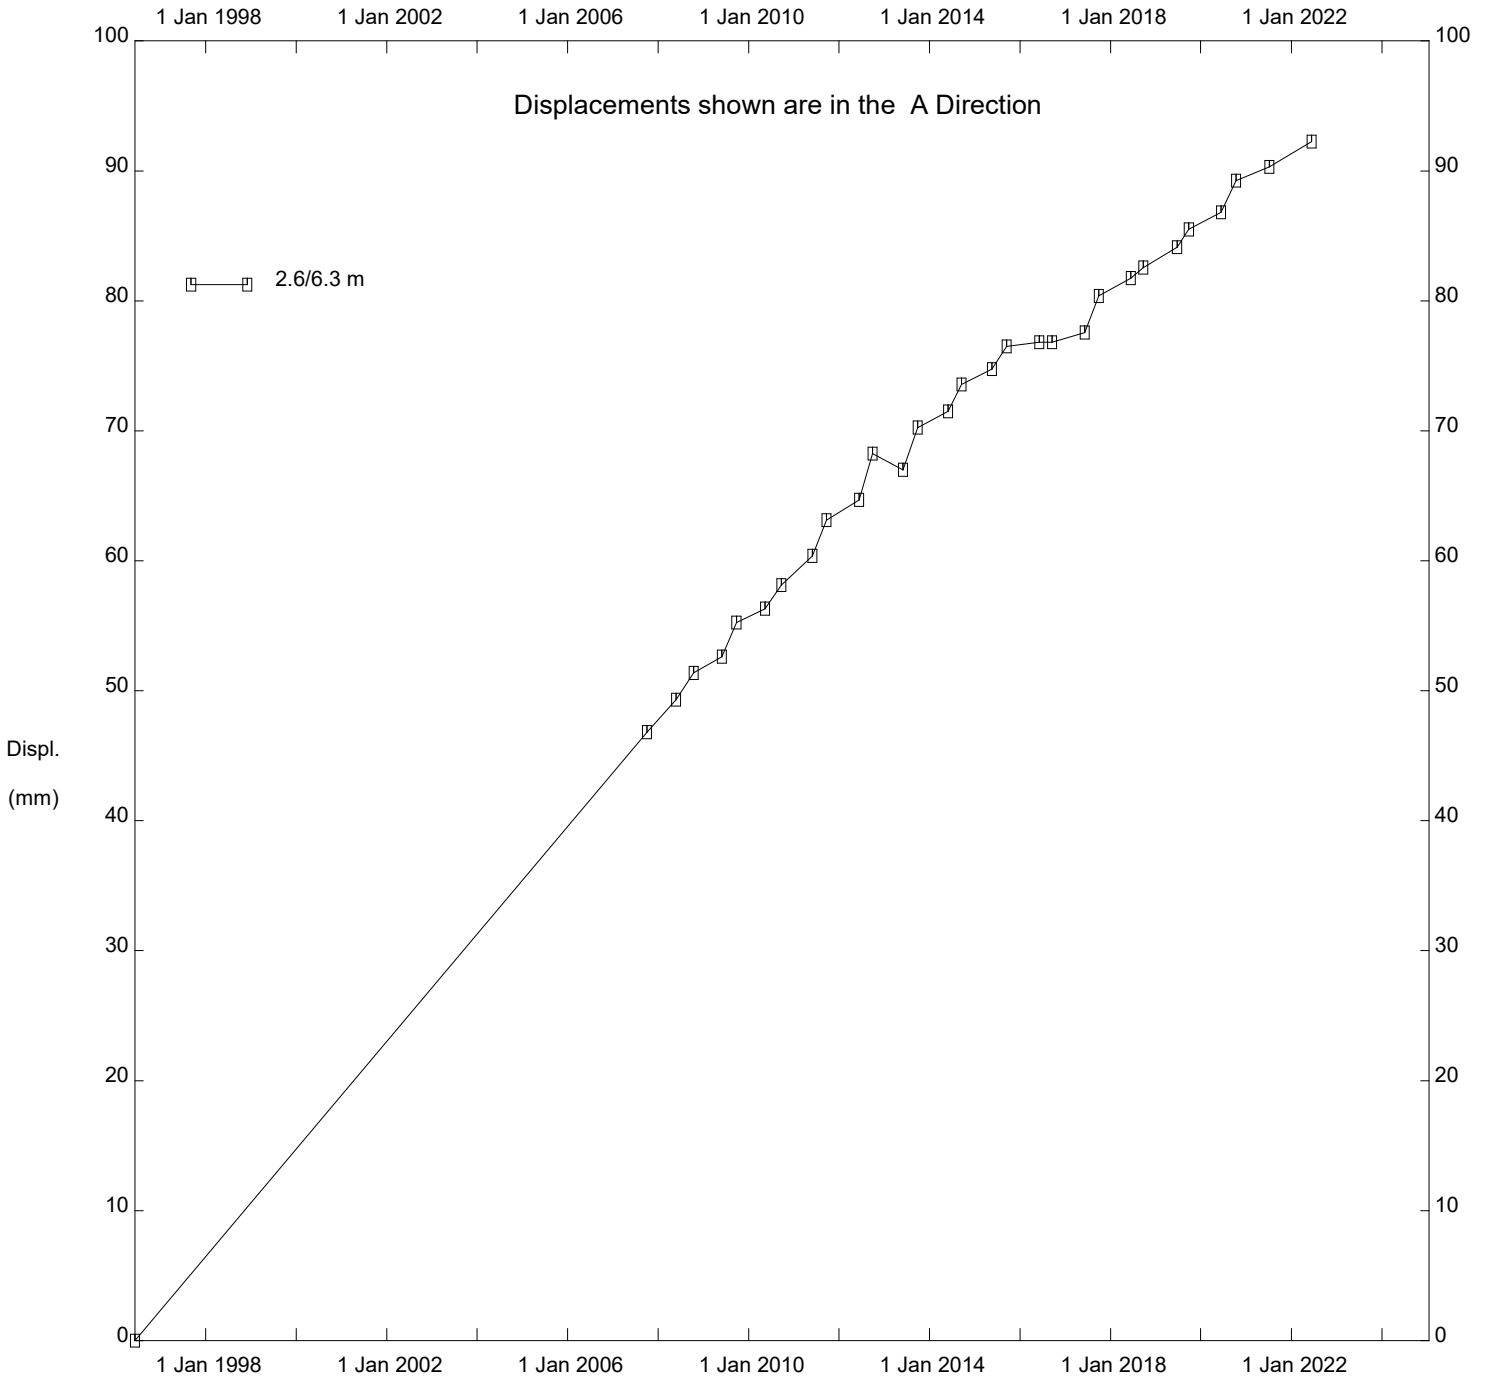
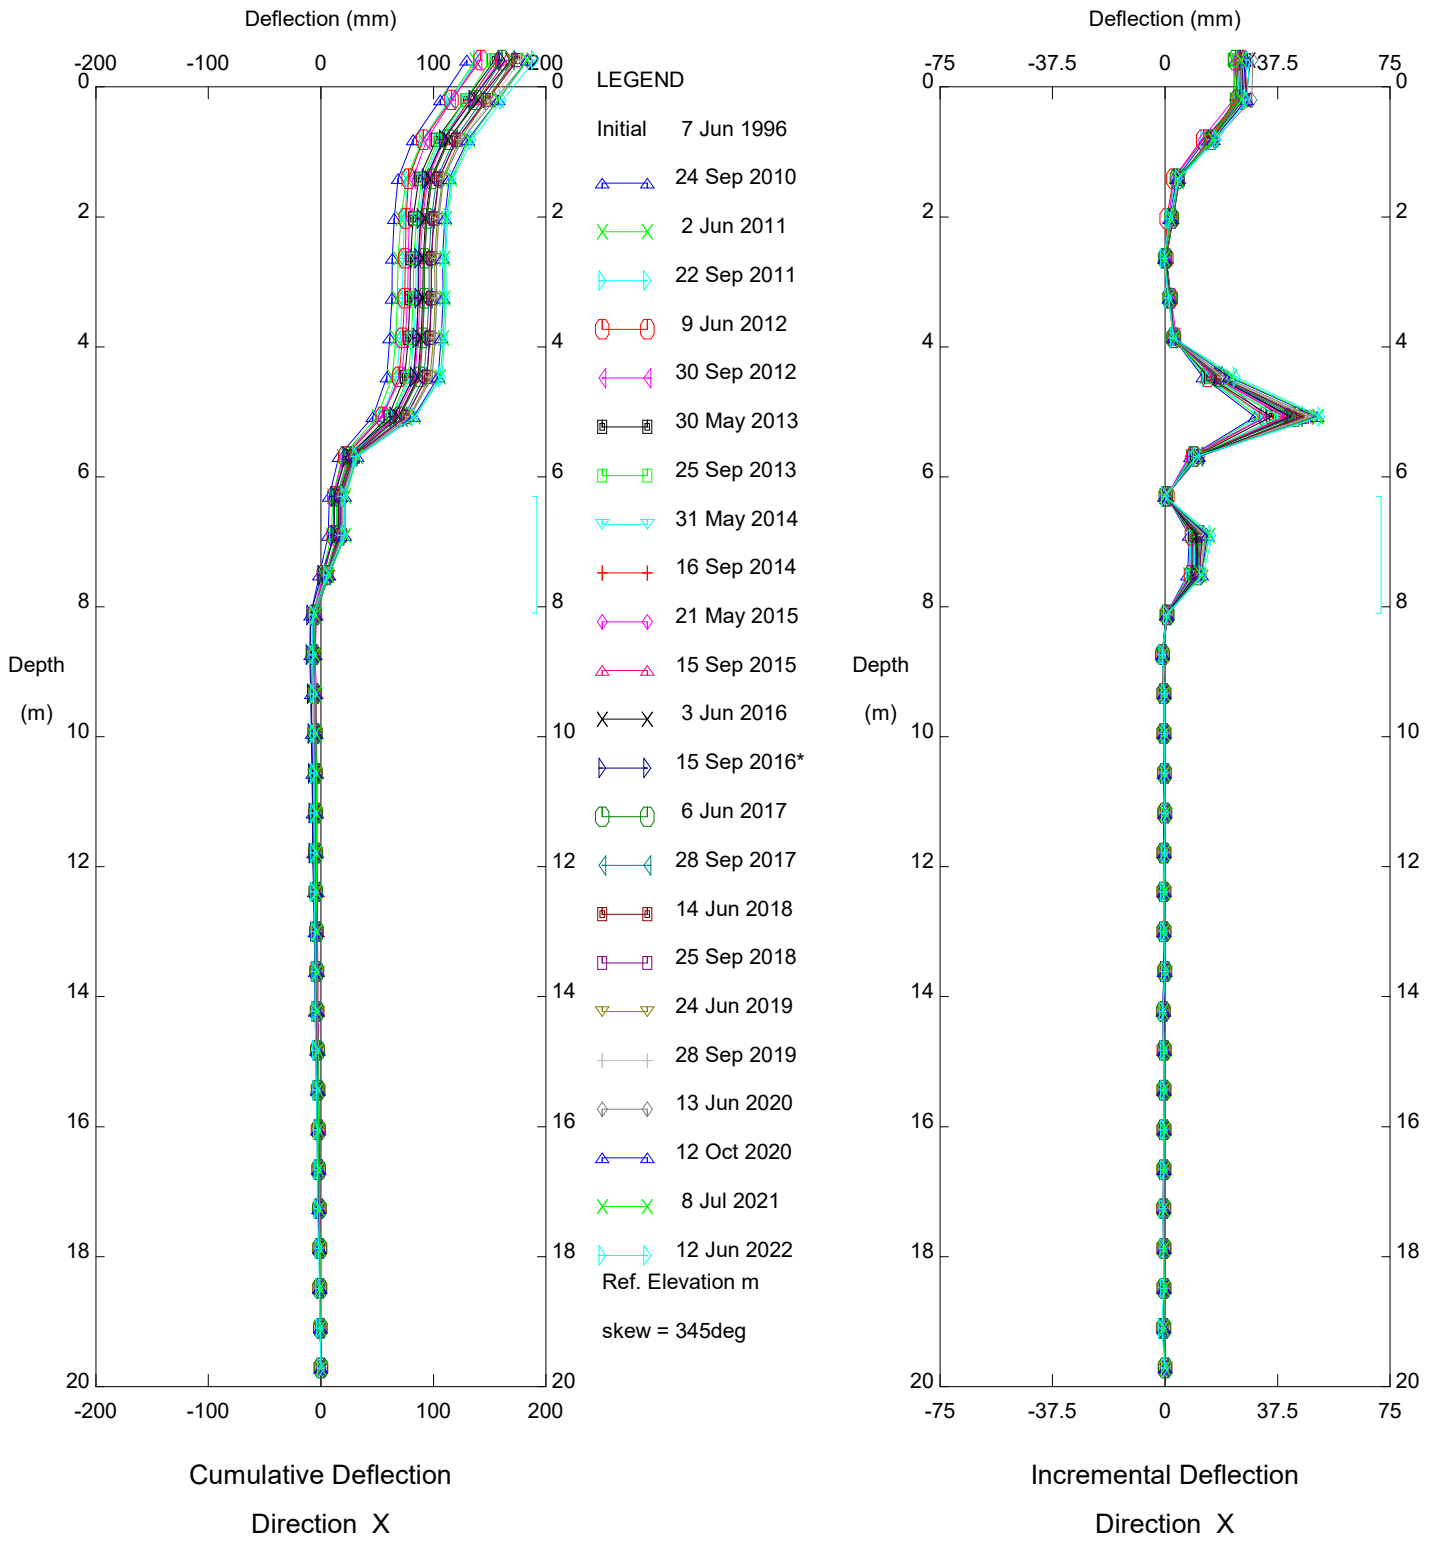
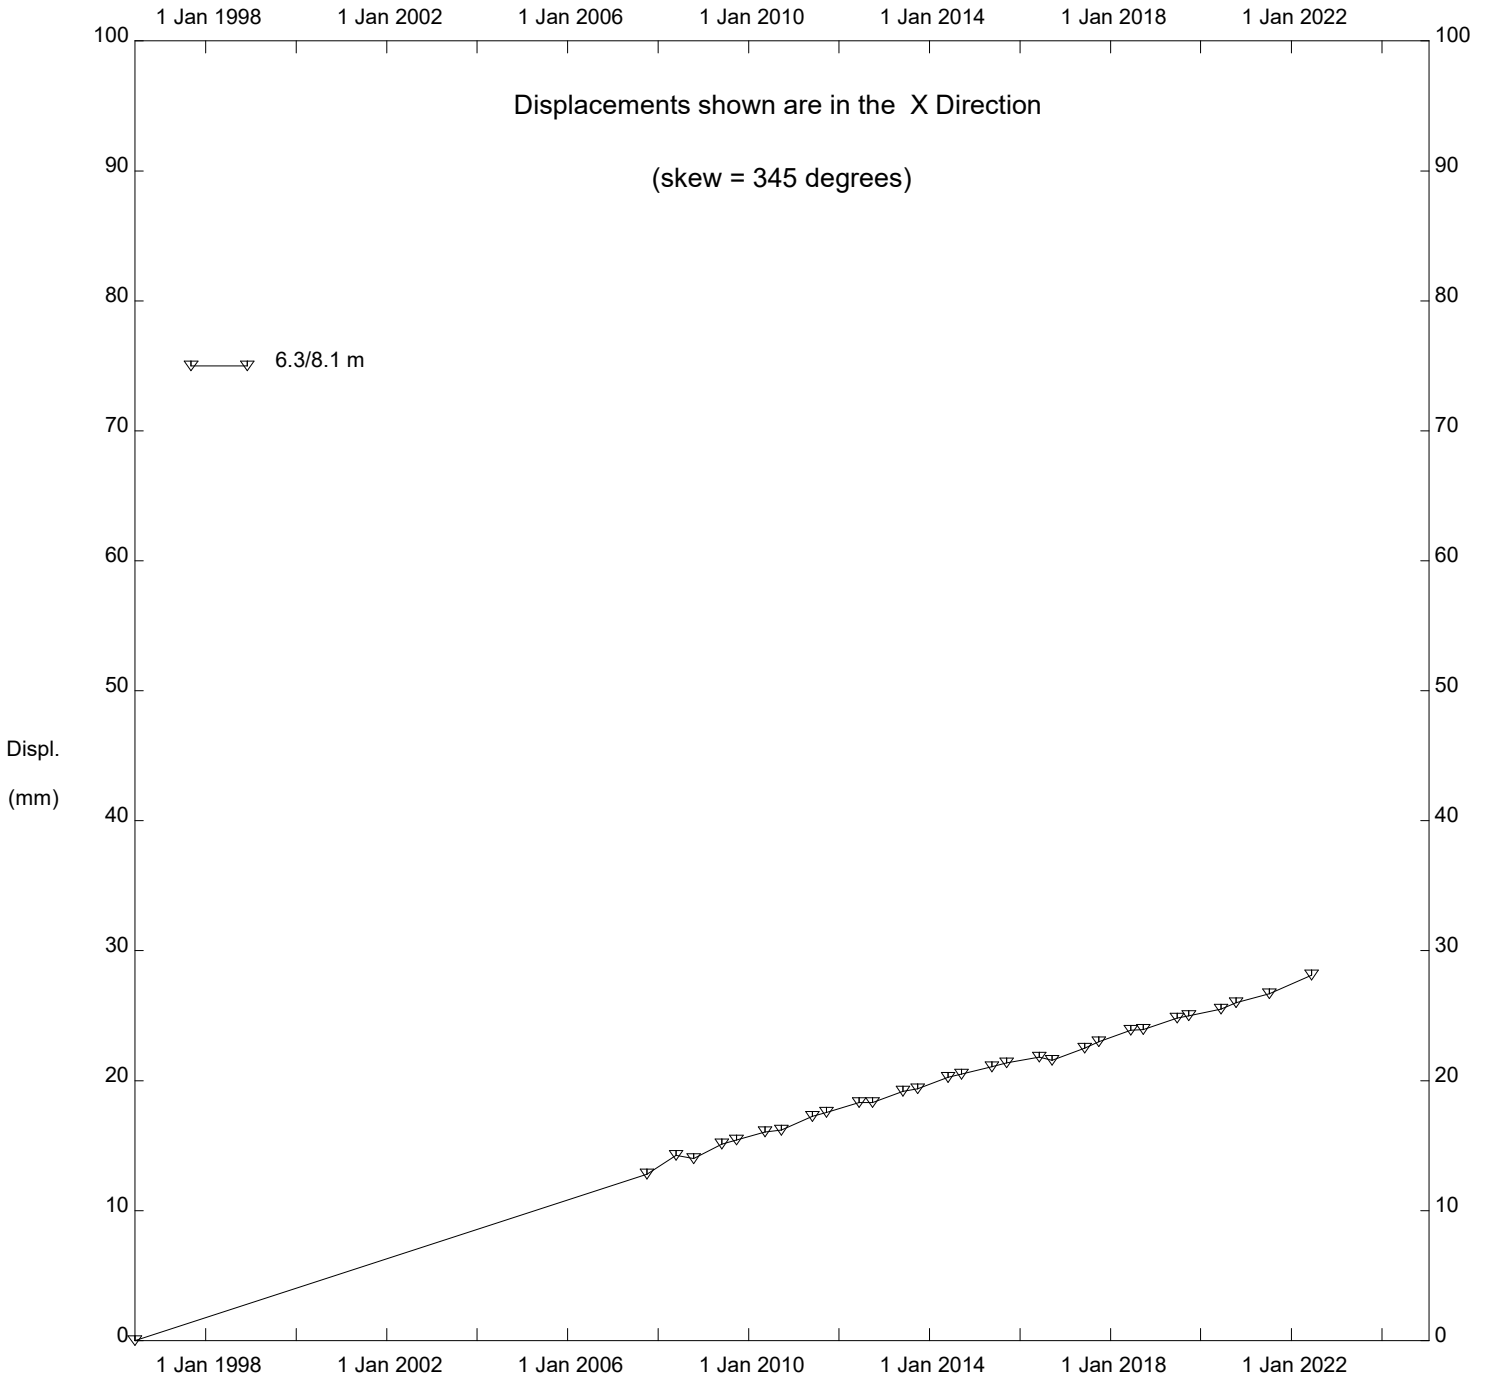
HWY 986:01 - STA. 13+540, Inclinometer SI-4

Slope inclinometers SI-4, and SI-6 are located east of the wall and the main slide block. Slope inclinometer SI-4 showed rates of movement of 2.1 mm/yr and 1.5 mm/yr over 2.6 m to 6.3 m depth and 6.3 m to 8.1 m depth, respectively, since the spring of 2021 readings. SI-6 showed no discernible movement over 0.1 m to 5.0 m depth and a rate of movement of 3.7 mm/yr over 5.0 m to 6.8 m depth.

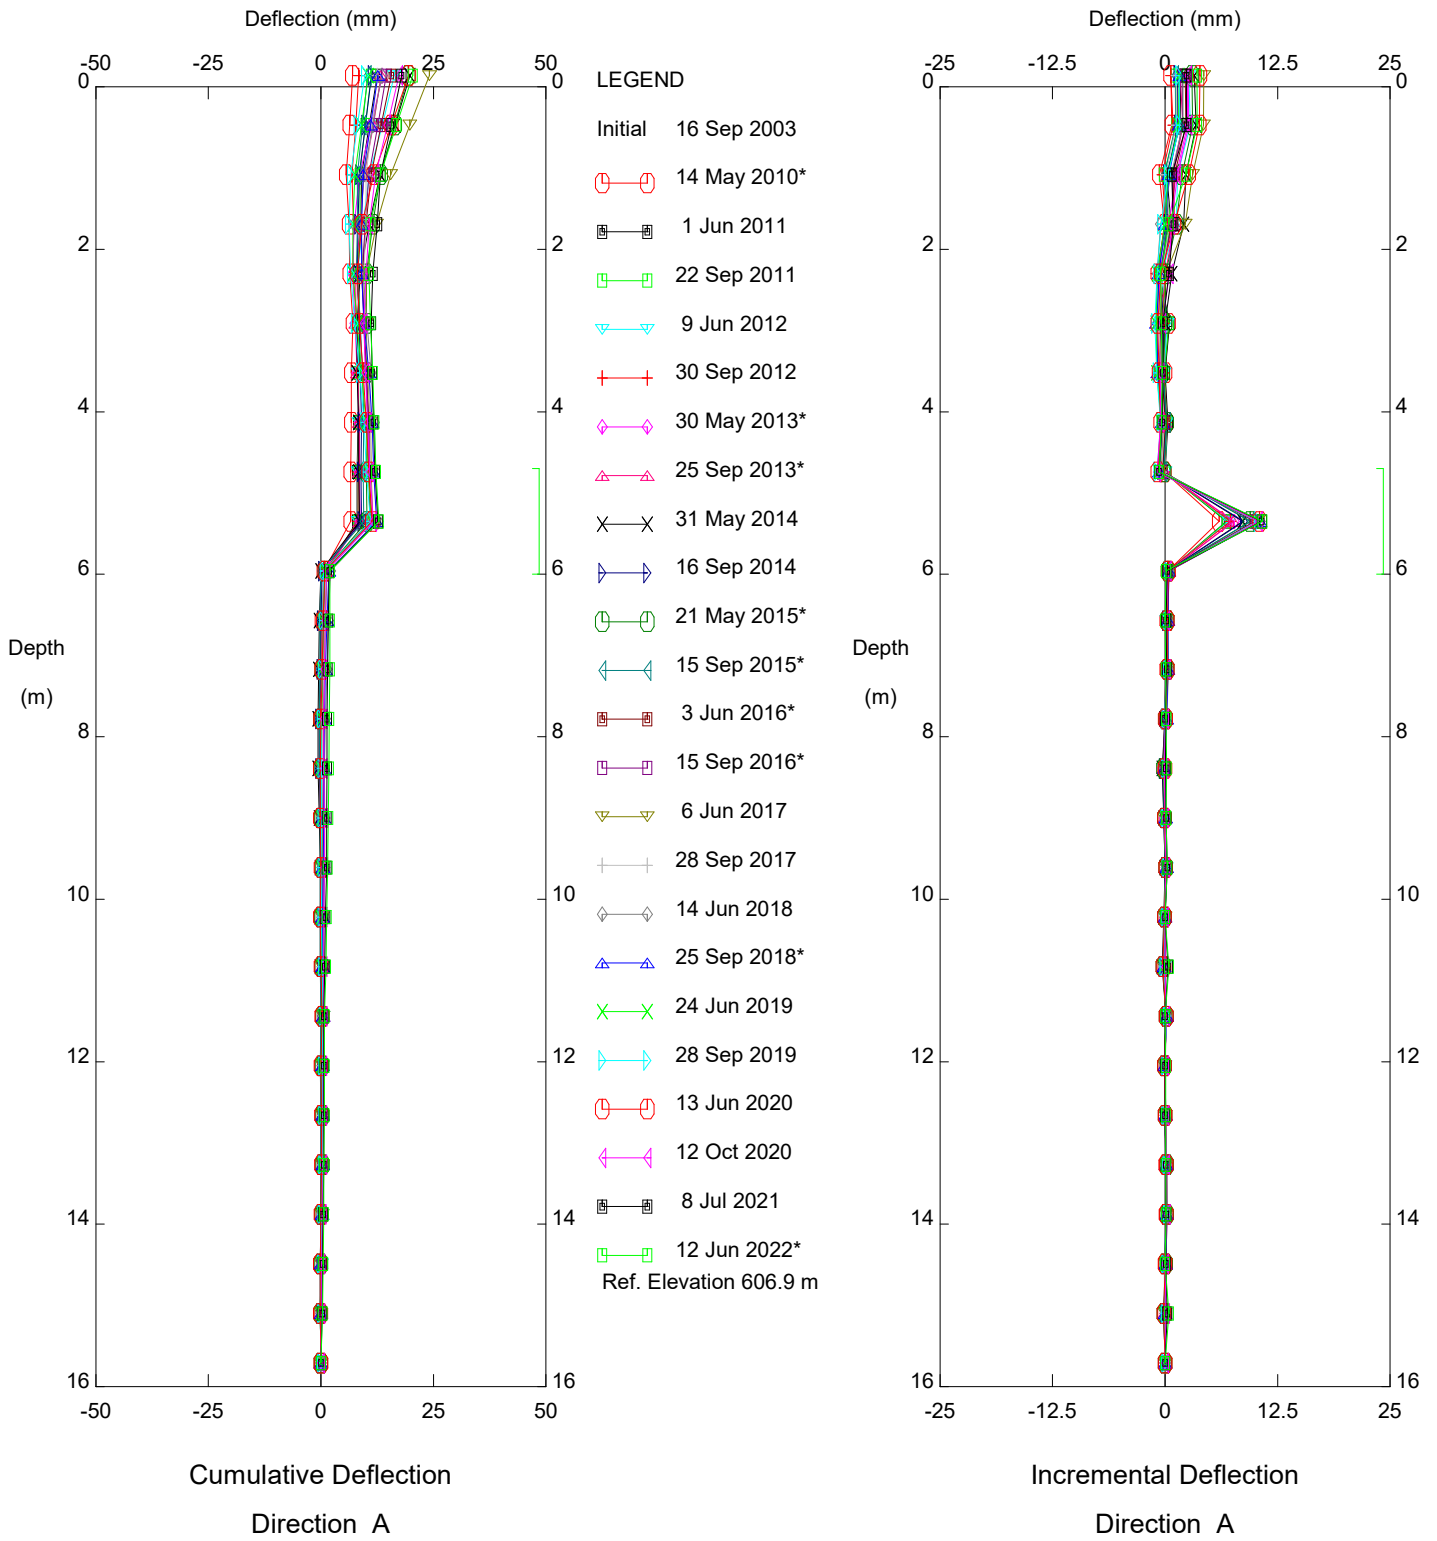
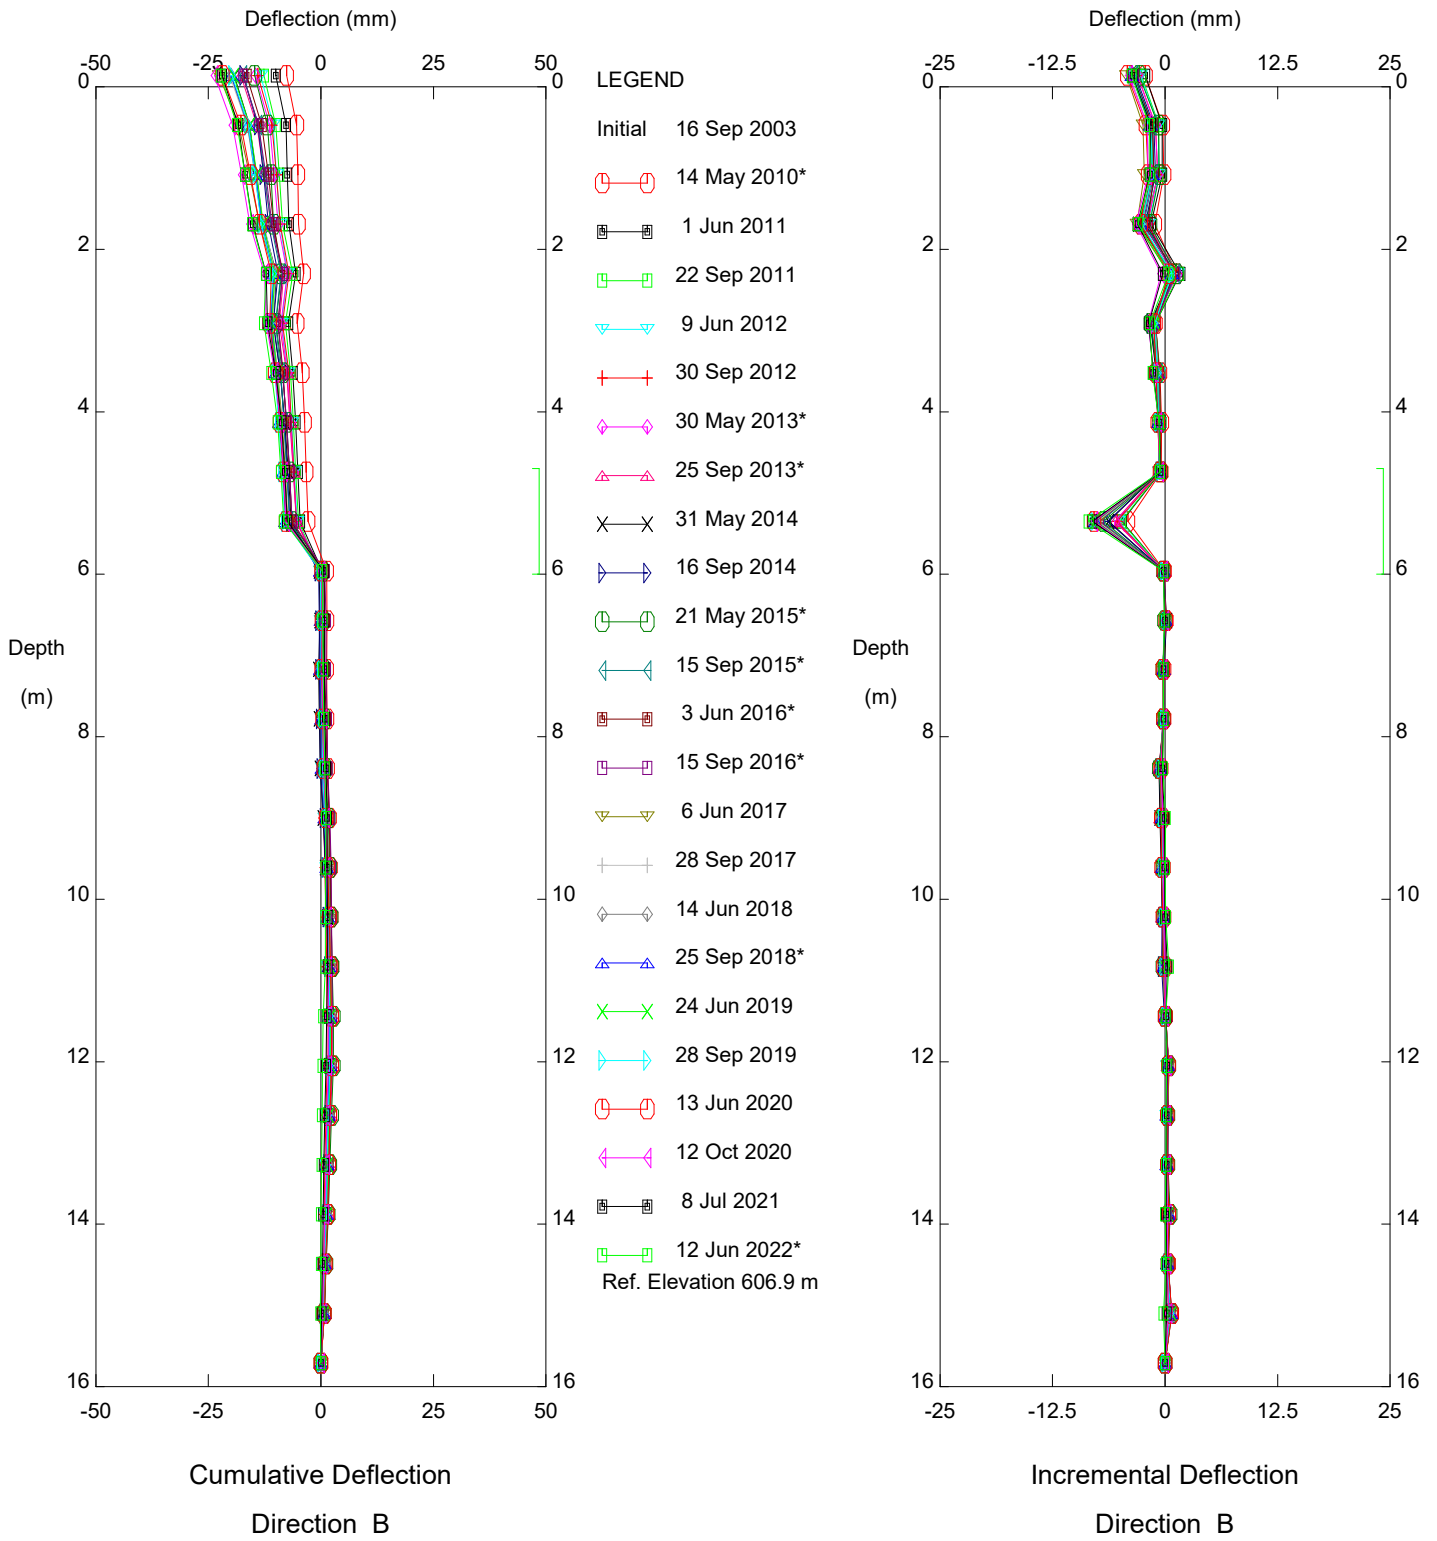
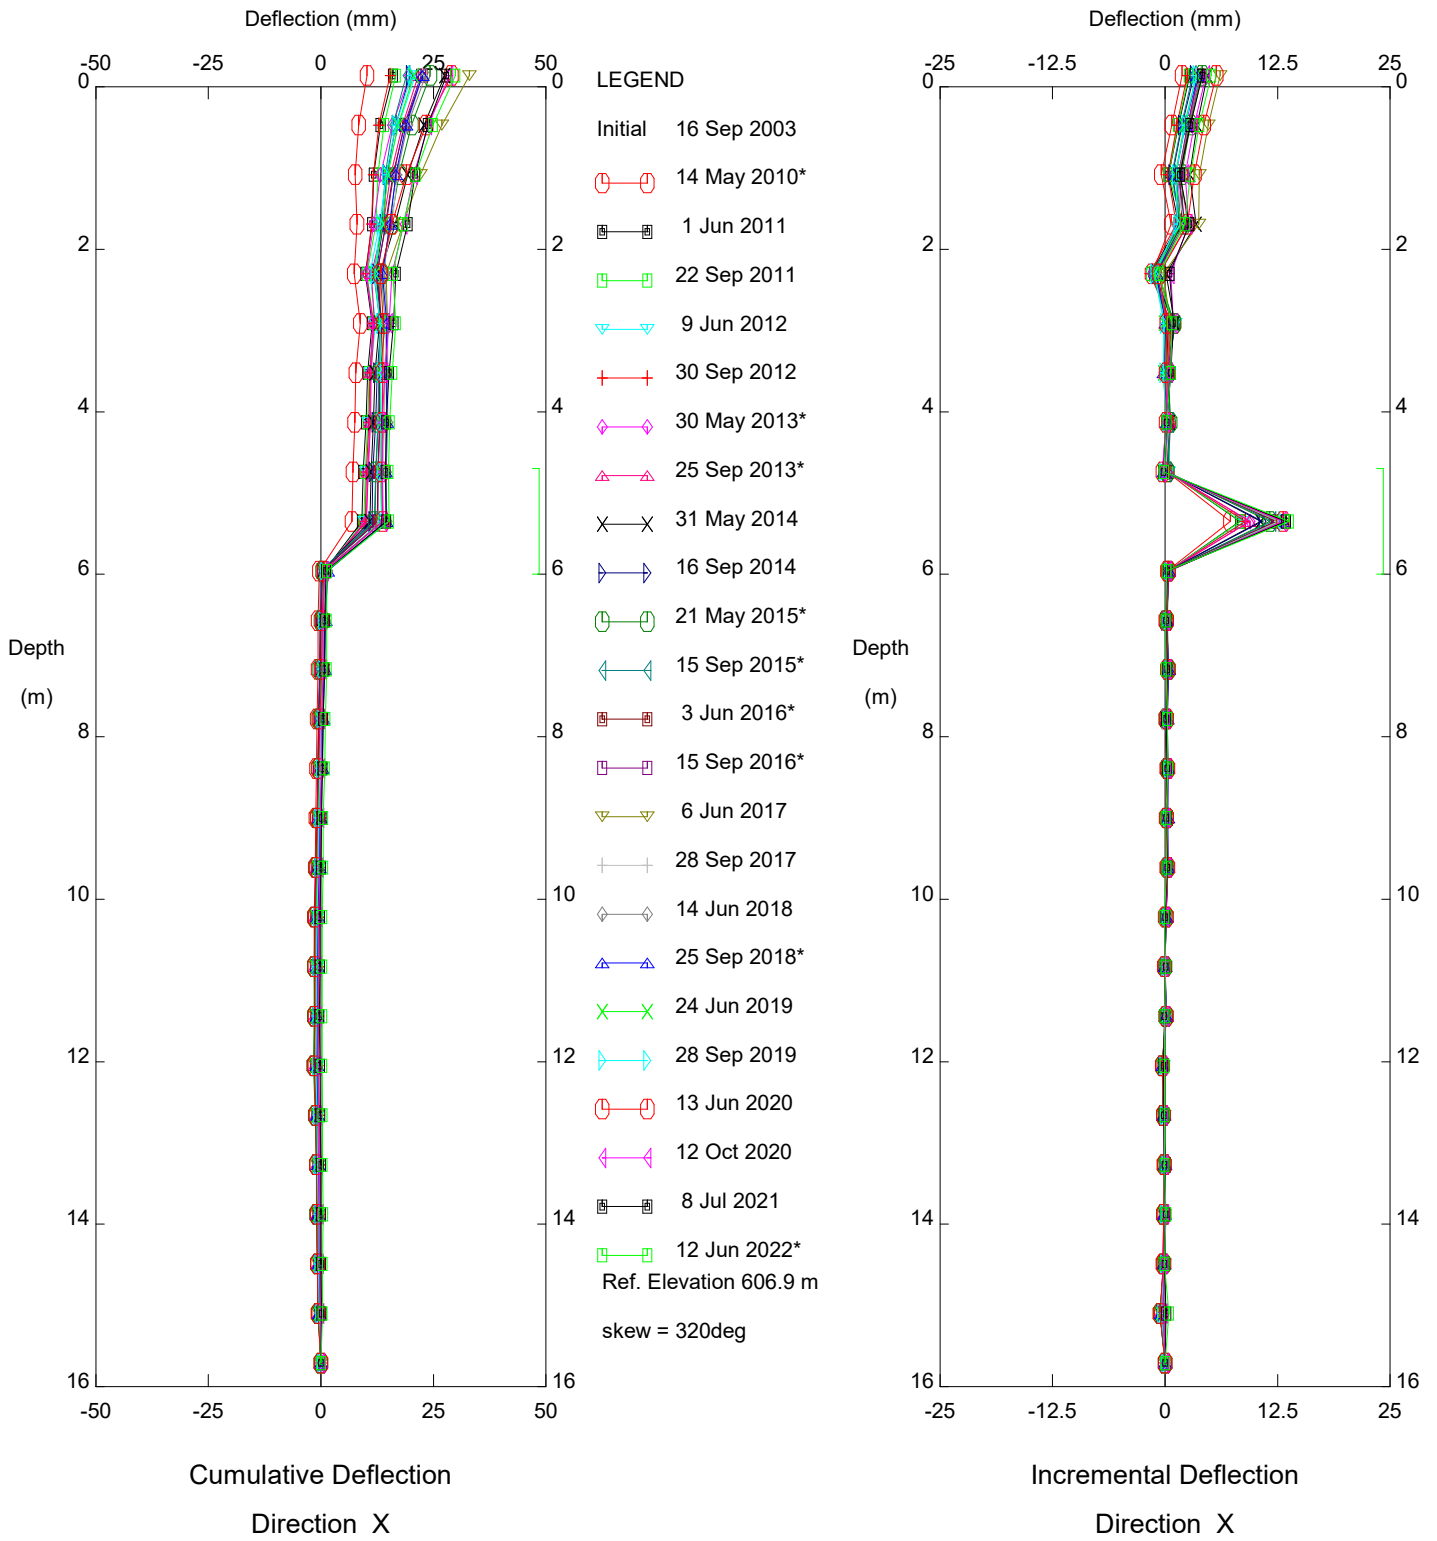
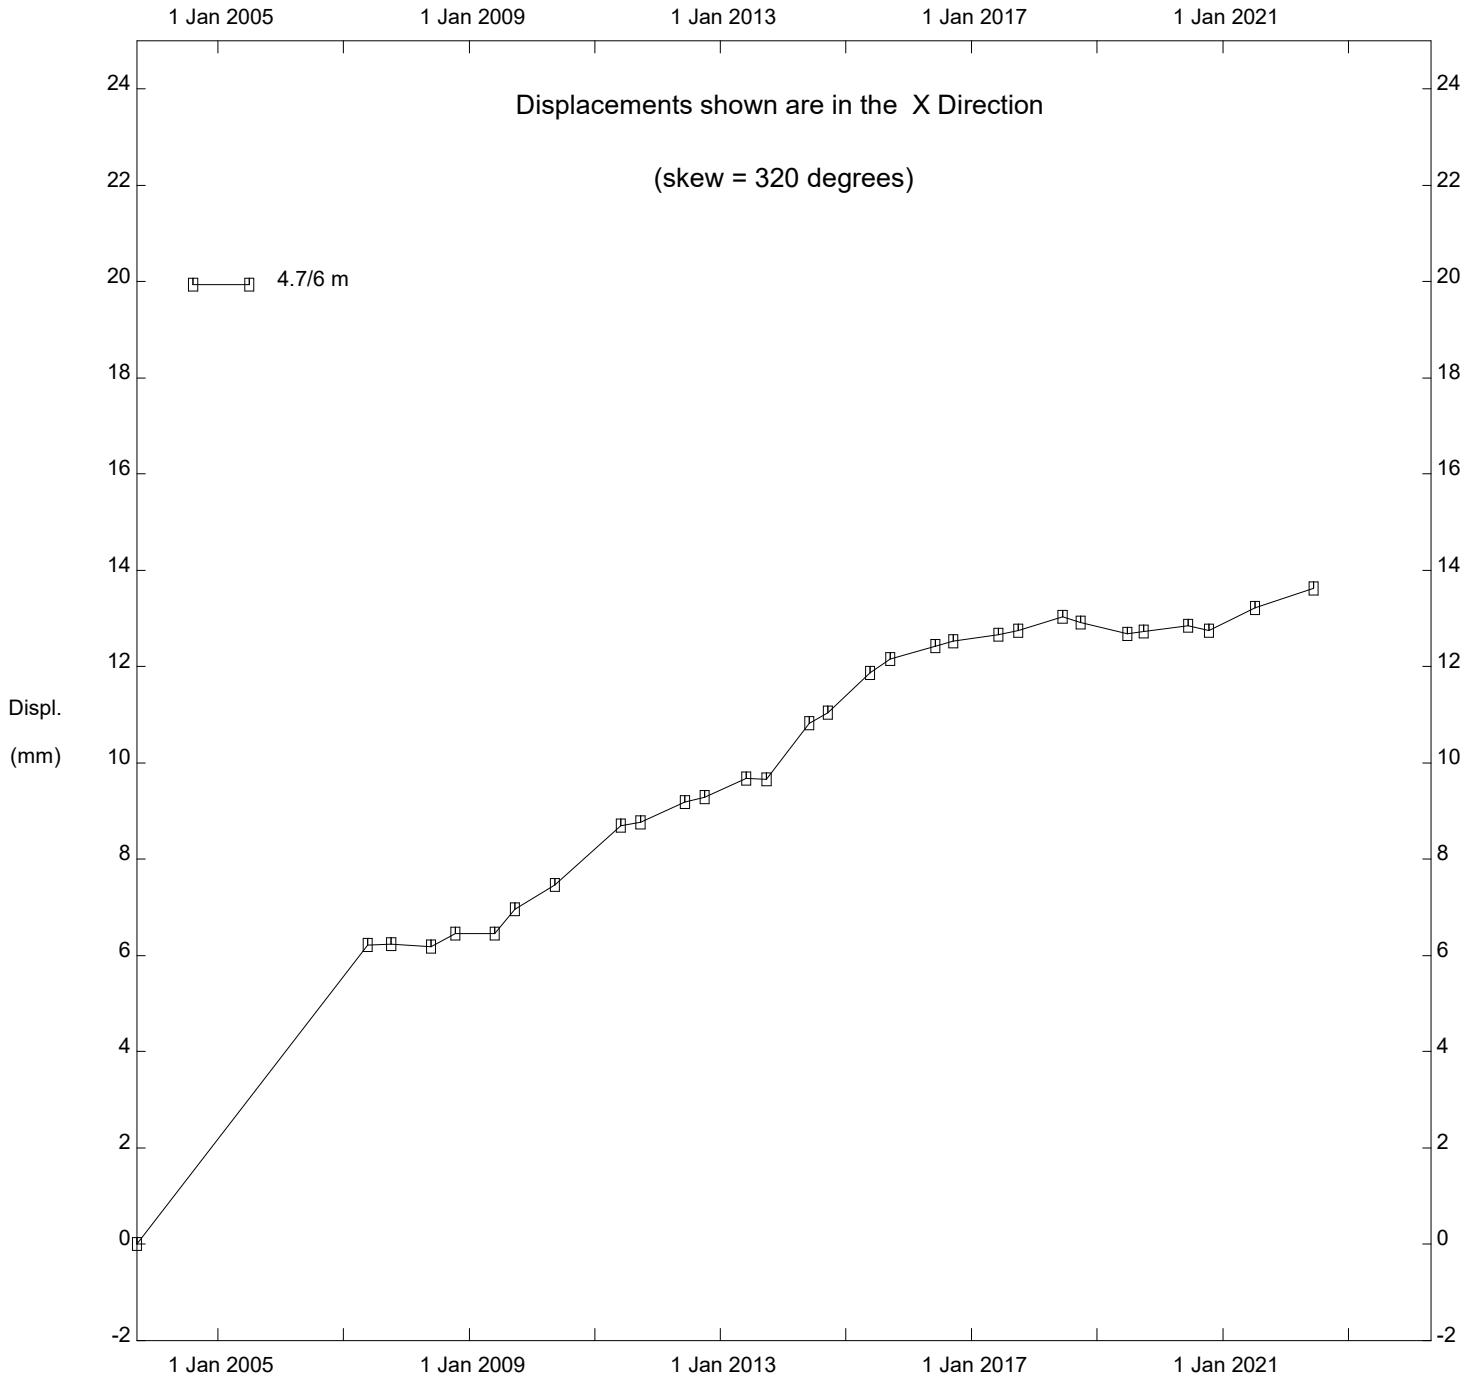
HWY 986:01 - STA. 13+540, Inclinometer SI03-6

Slope inclinometer SI03-6, installed upslope of the pile wall and highway, showed a rate of movement of 0.4 mm/yr over 4.7 m to 6.0 m depth since the spring of 2021 readings.
