July 26, 2022

**ALBERTA TRANSPORTATION GRMP (CON0022164)
PEACE REGION (PEACE RIVER DISTRICT)
INSTRUMENTATION MONITORING RESULTS – SPRING 2022**

**SITE PH043-1: HWY 986:01, DAISHOWA EAST HILL PILE WALL
SITE PH043-2: HWY 986:01, DAISHOWA EAST HILL SITE B**

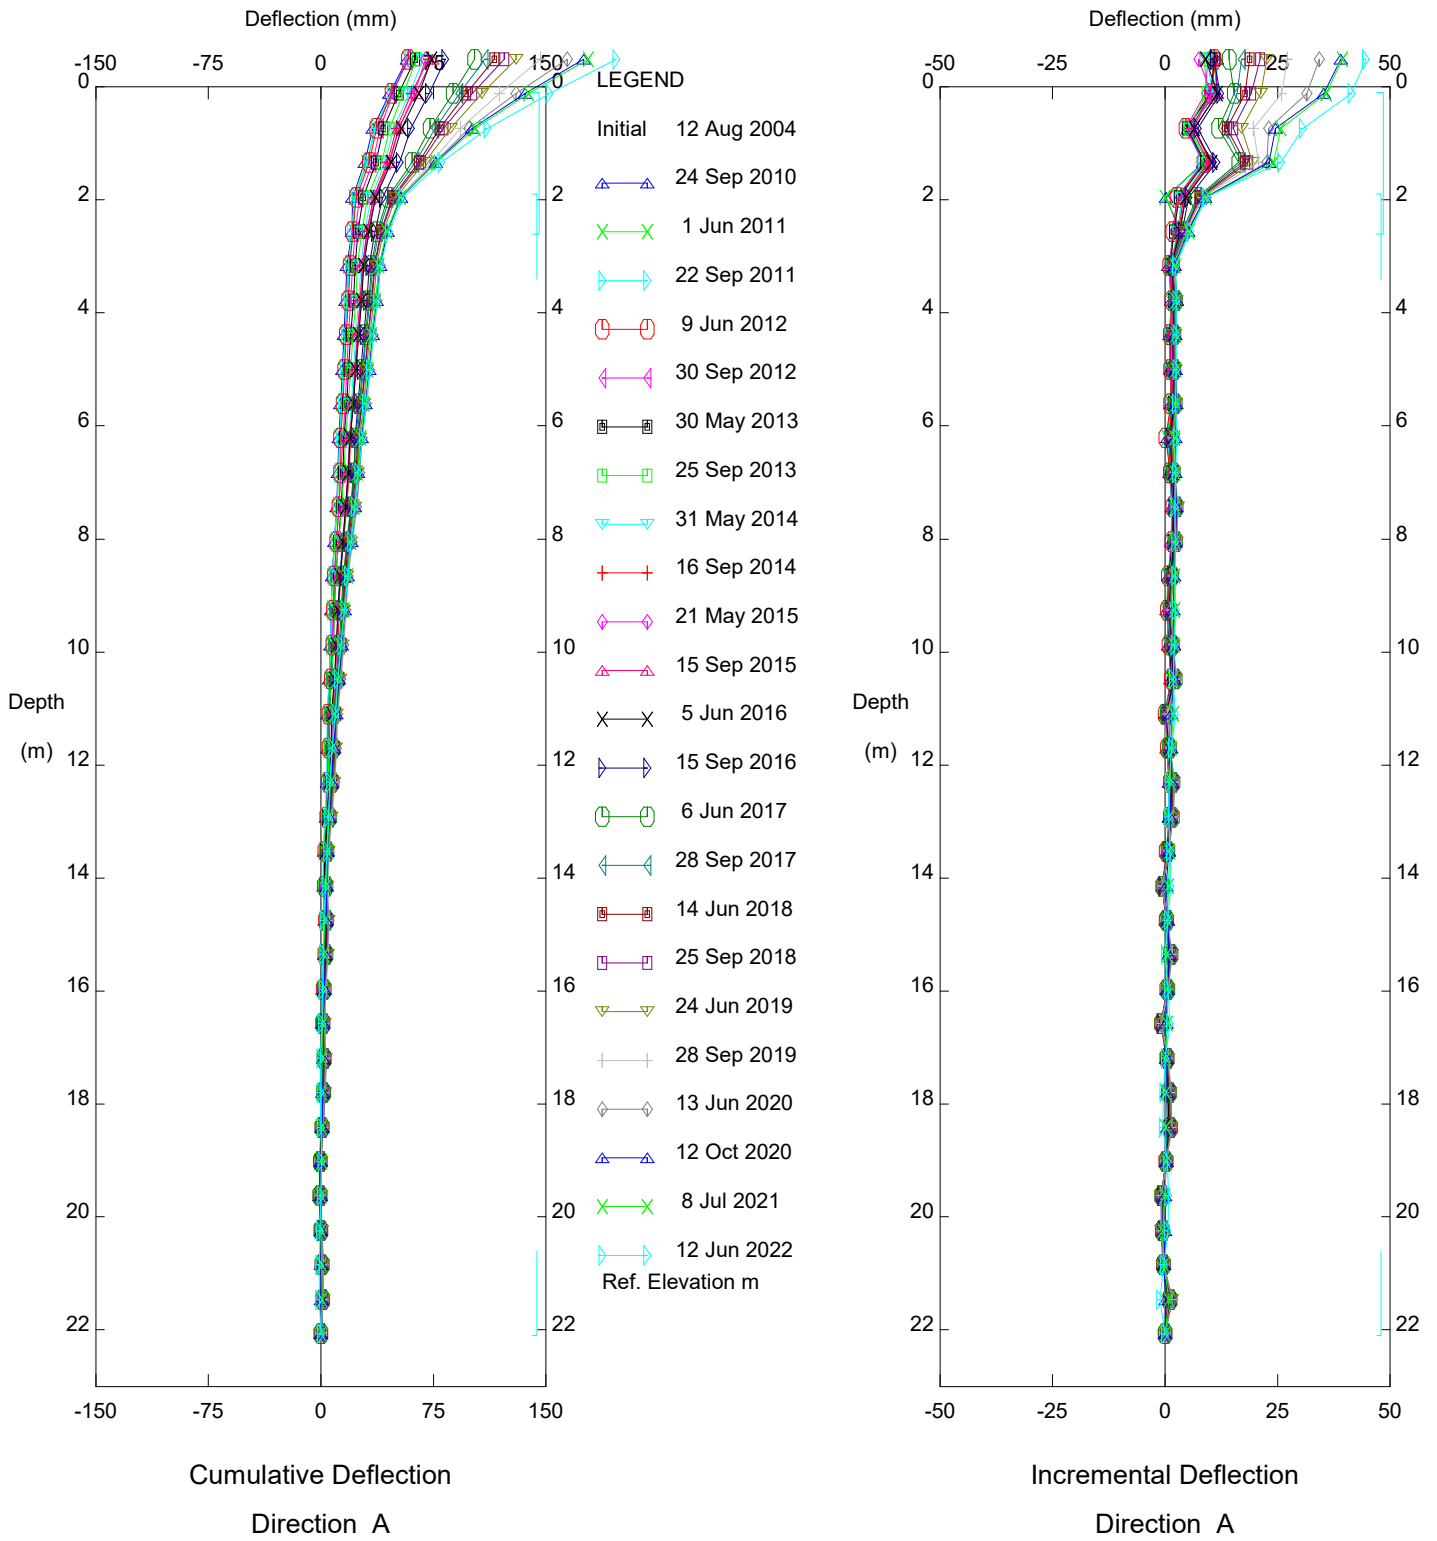
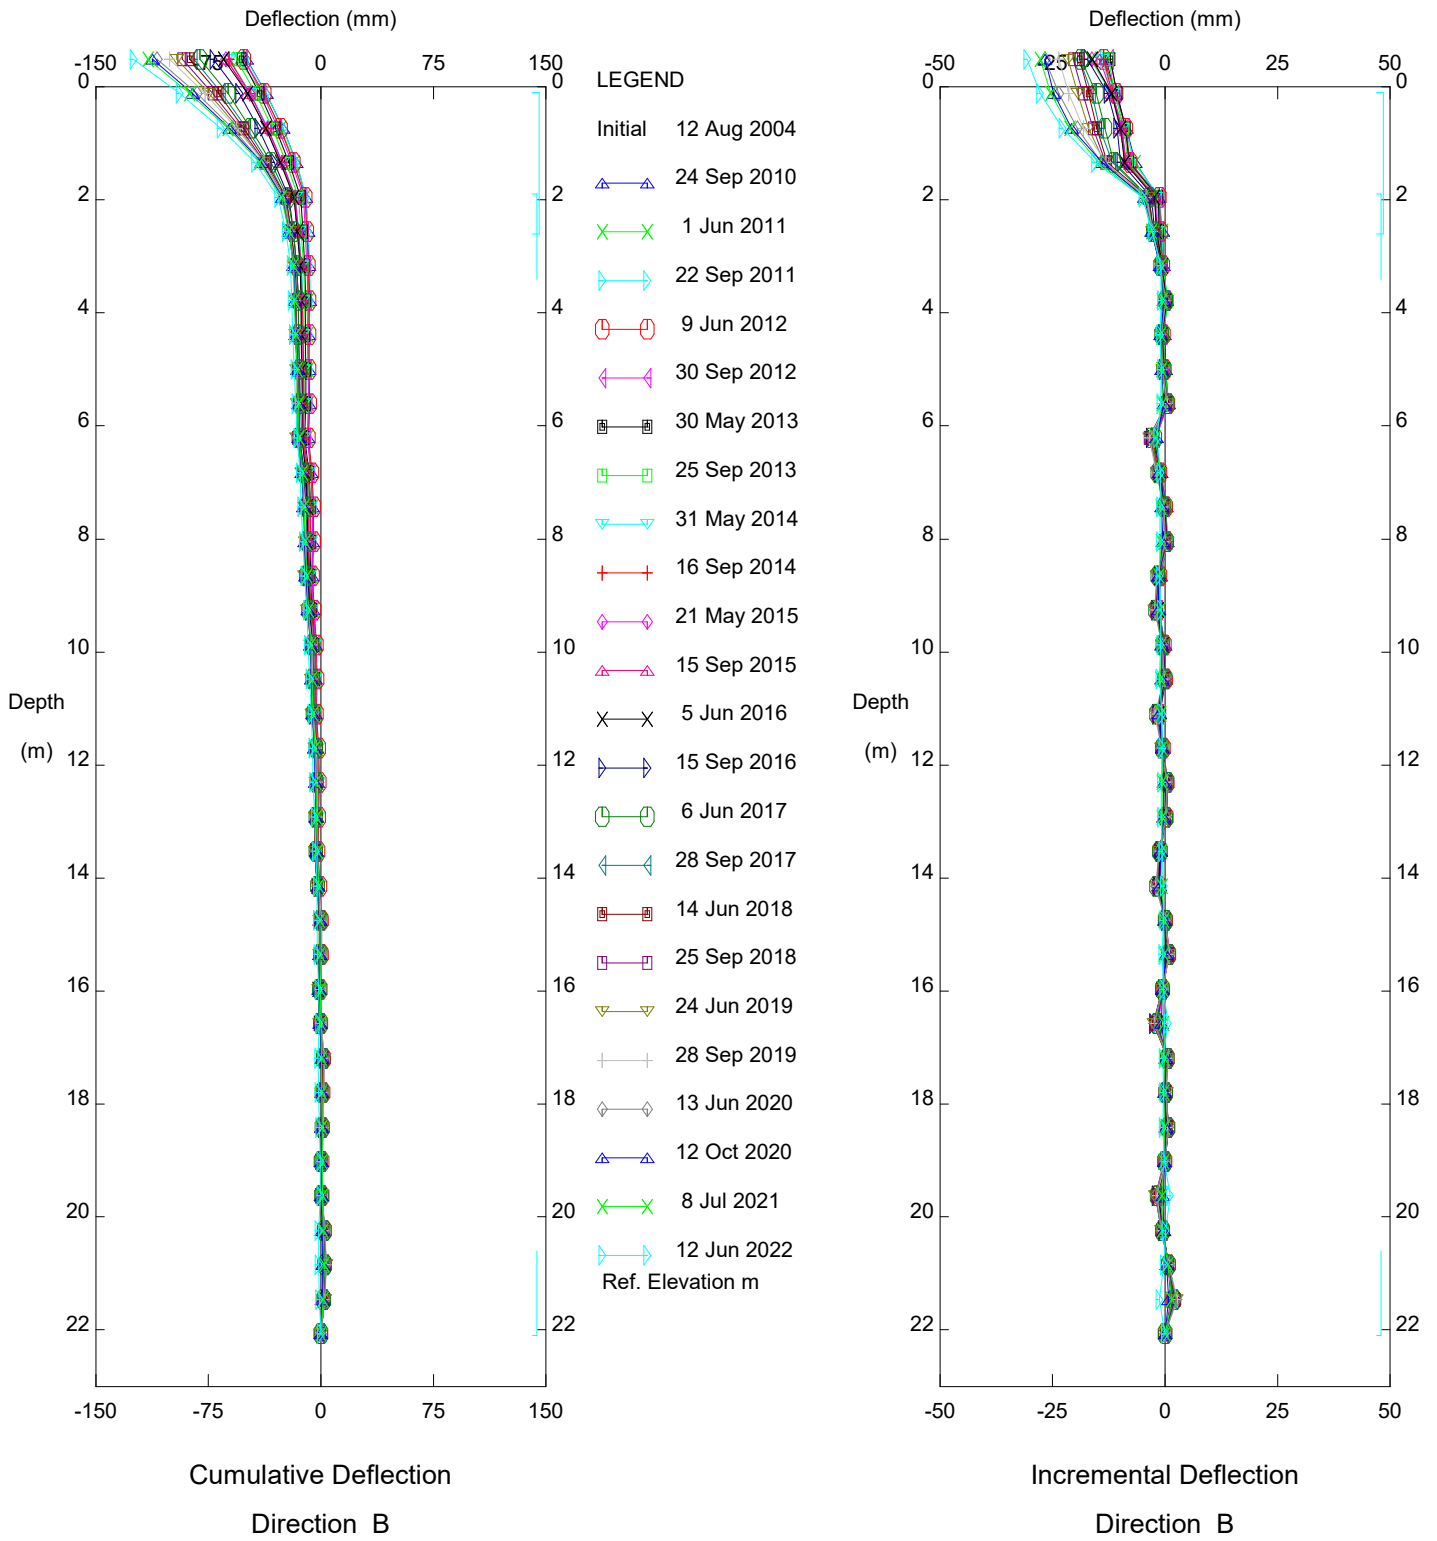
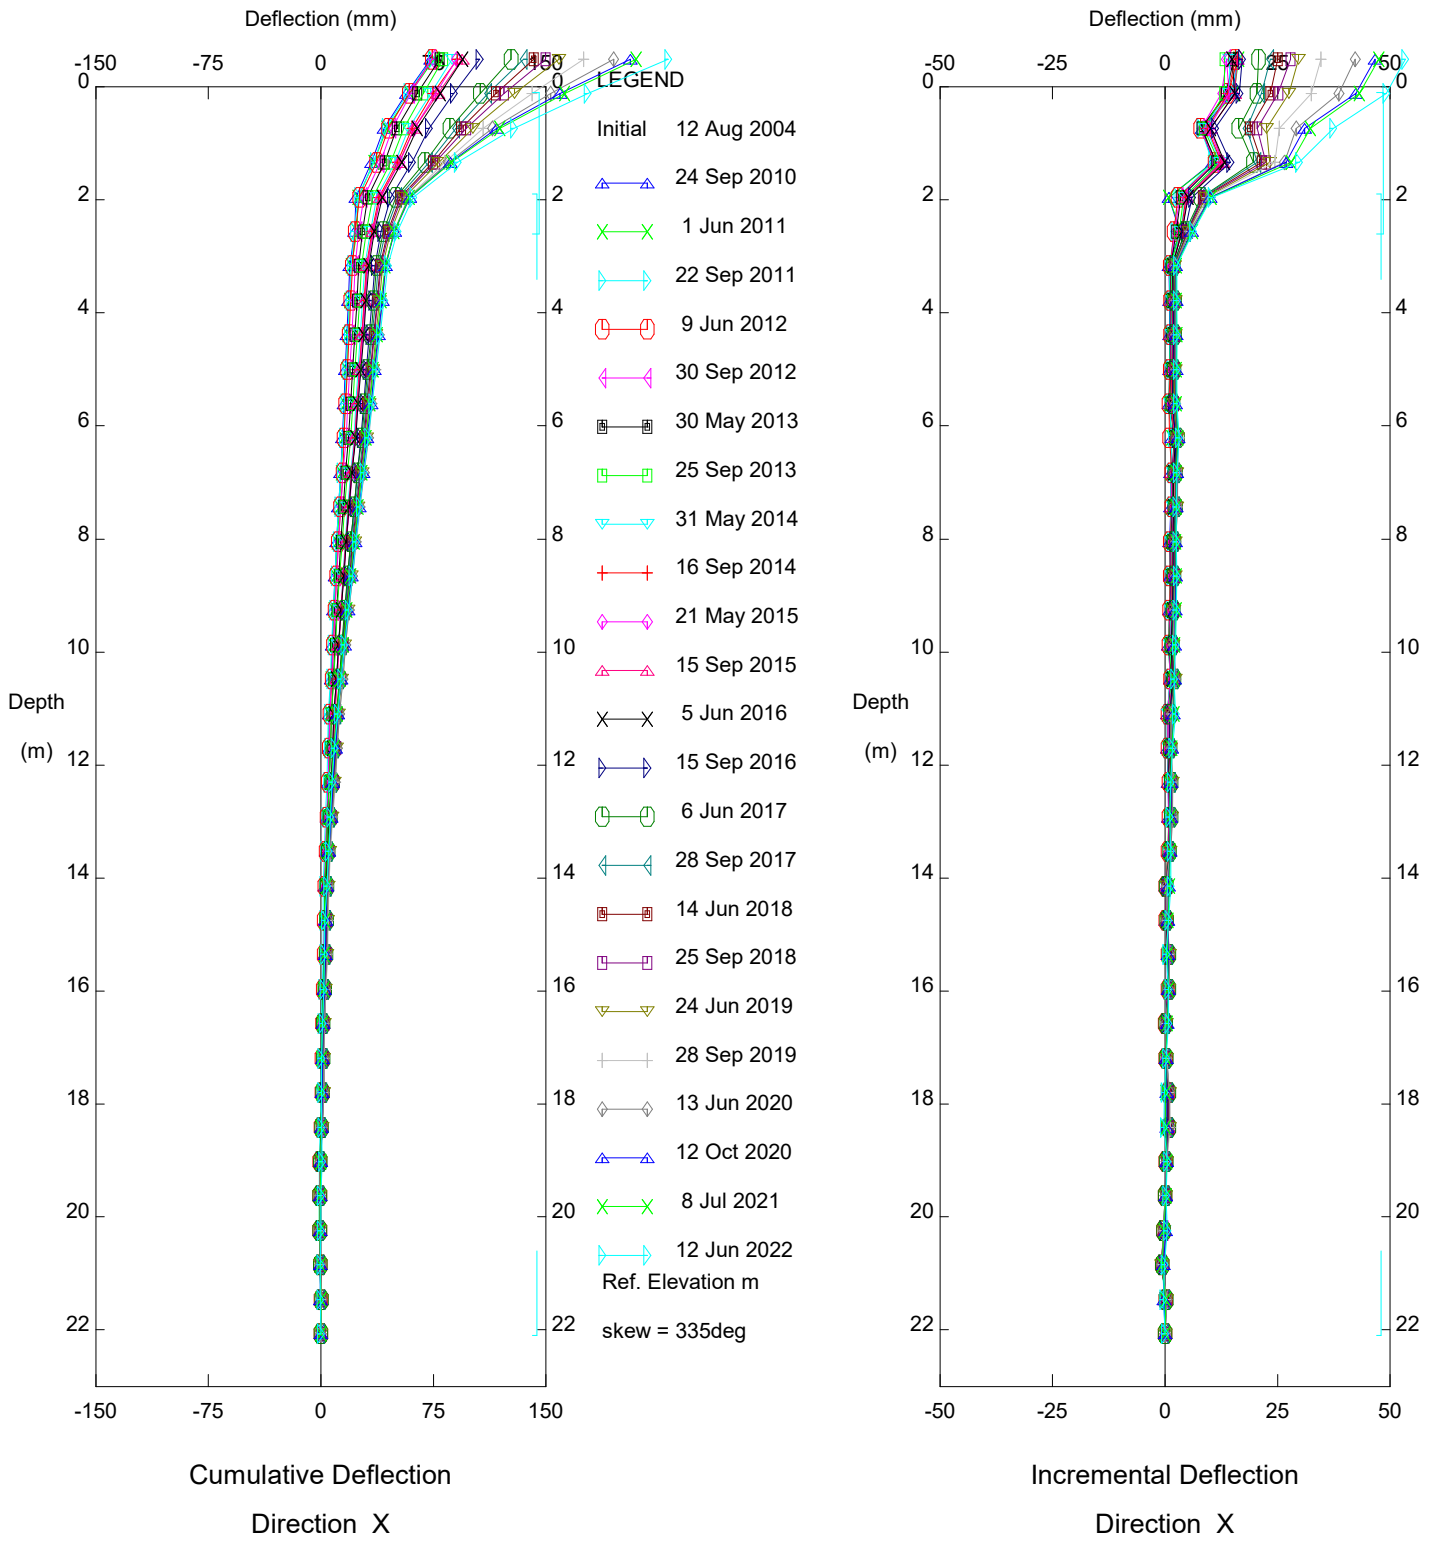
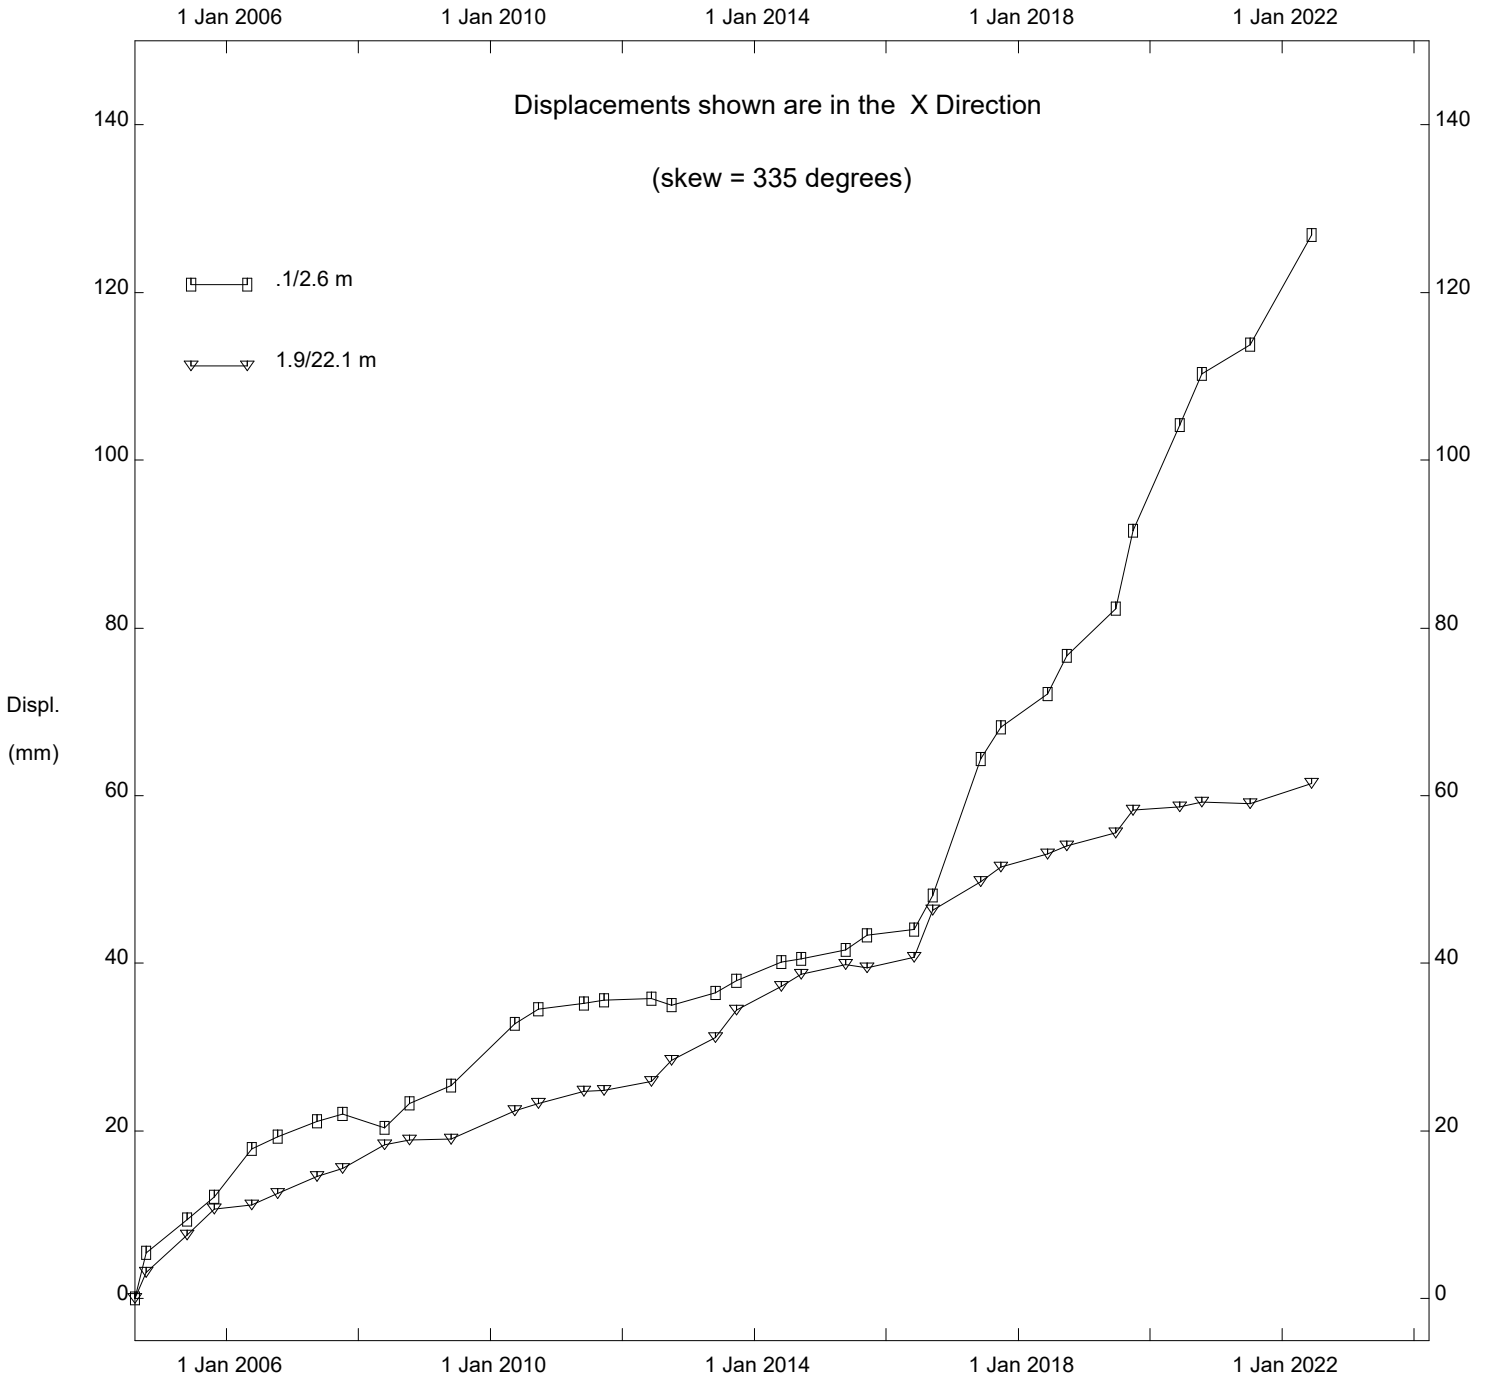
HWY 986:01 - STA. 13+540, Inclinometer SI04-1

Only two (SI04-1 and SI04-3) of the three slope inclinometers installed in the pile wall are currently operational. Total deflections of 126.8 mm (SI04-1) and 146.2 mm (SI04-3) have been measured in the clay backfill above the wall over the upper portion of each SI since original construction of the wall. SI04-1 showed a rate of movement of 14.1 mm/yr, while SI04-3 showed a rate of movement of 16.2 mm/yr within the upper movement zones since the spring of 2021 readings. The current reading for SI04-1 indicates that the pile head has deflected a total of 61.4 mm to date with a rate of movement of 2.6 mm/yr over the length of the pile. The current reading for SI04-3 indicates 99.0 mm of pile head movement to date with a current rate of movement over the length of the pile of 8.0 mm/yr. There was a noticeable increase in movement in SI04-1 during 2017 and 2018 when a landslide movement occurred downslope of the wall during erosion repairs of erosion and construction of a gabion drop structure at the creek level. A driven steel pile wall and grading were carried out to mitigate those movements. The increased movement rate trend is still observed within the upper 2 m. Some slope flattening was also carried out consisting of removing some soil from the top of the pile wall near SI04-3.

According to AT's latest schedule, the instruments should be read again in the spring of 2023. Consideration should be given to reading the instruments at the PH043-1 pile wall (SI04-1 and SI04-3) bi-annually, since these instruments have shown relatively high movement rates during recent reading cycles.

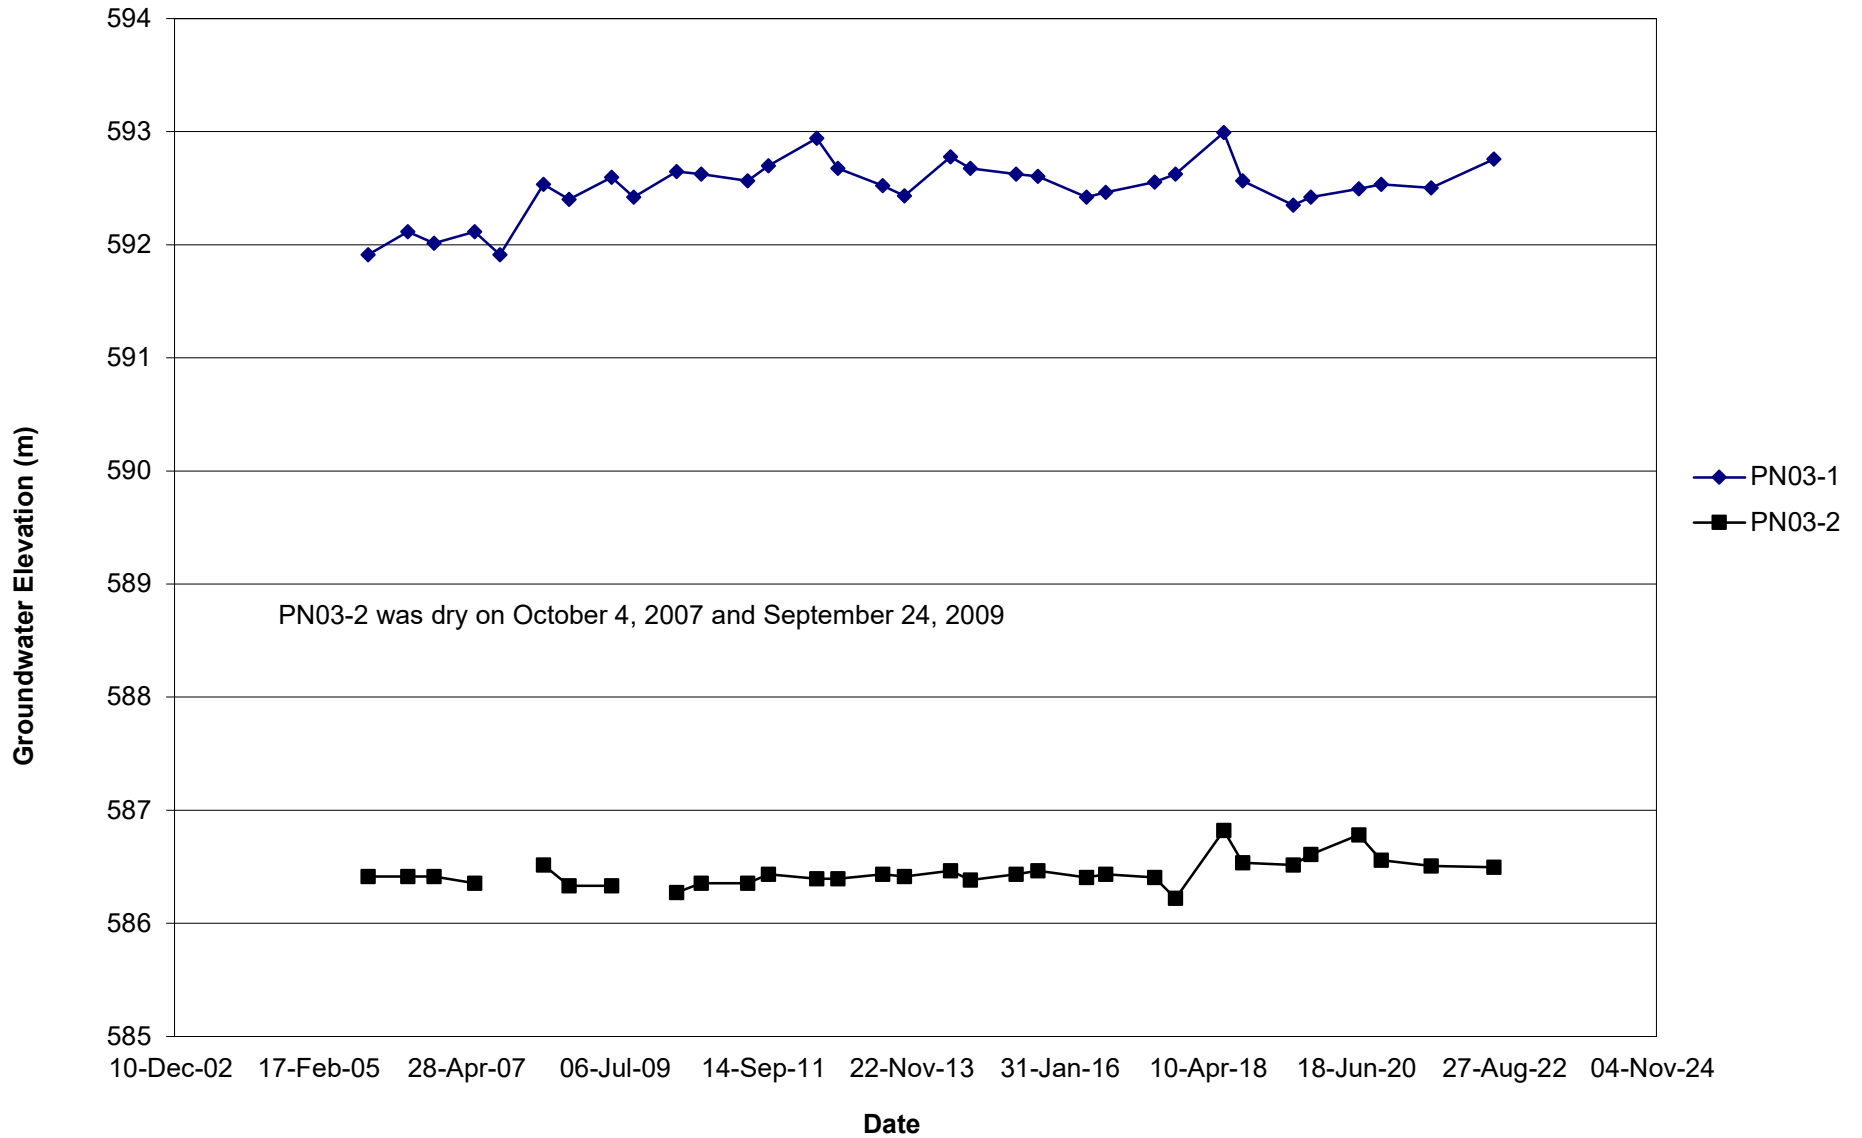
**FIGURE PH043-1
PIEZOMETRIC ELEVATIONS FOR HWY 986:01 DAISHOWA EAST HILL**

Pneumatic piezometer PN03-1 showed an increase in groundwater level of 0.26 m since the spring of 2021 readings. Pneumatic piezometer PN03-2 showed a decrease in groundwater level of 0.01 m since the spring of 2021 readings. The pneumatic piezometer readings are summarized in Table PH043-1-2 above and are plotted in Figure PH043-1 (by elevation) in Figure PH043-2 (by depth) in Appendix A.
