ALBERTA TRANSPORTATION AND  
ECONOMIC CORRIDORS  
GEOHAZARD ASSESSMENT PROGRAM  
PEACE REGION (PEACE RIVER DISTRICT)  
2025 INSPECTION

Site Number	Location	Name	Hwy	km
PH043	Daishowa East Hill	Daishowa Retaining Wall – Site A / Site B	986:01	33.45 – 33.74
<b>Legal Description</b>		<b>UTM Co-ordinates (NAD 83)</b>		
NE7/NW8-85-20 W5M		11V E 491380	N	6246075

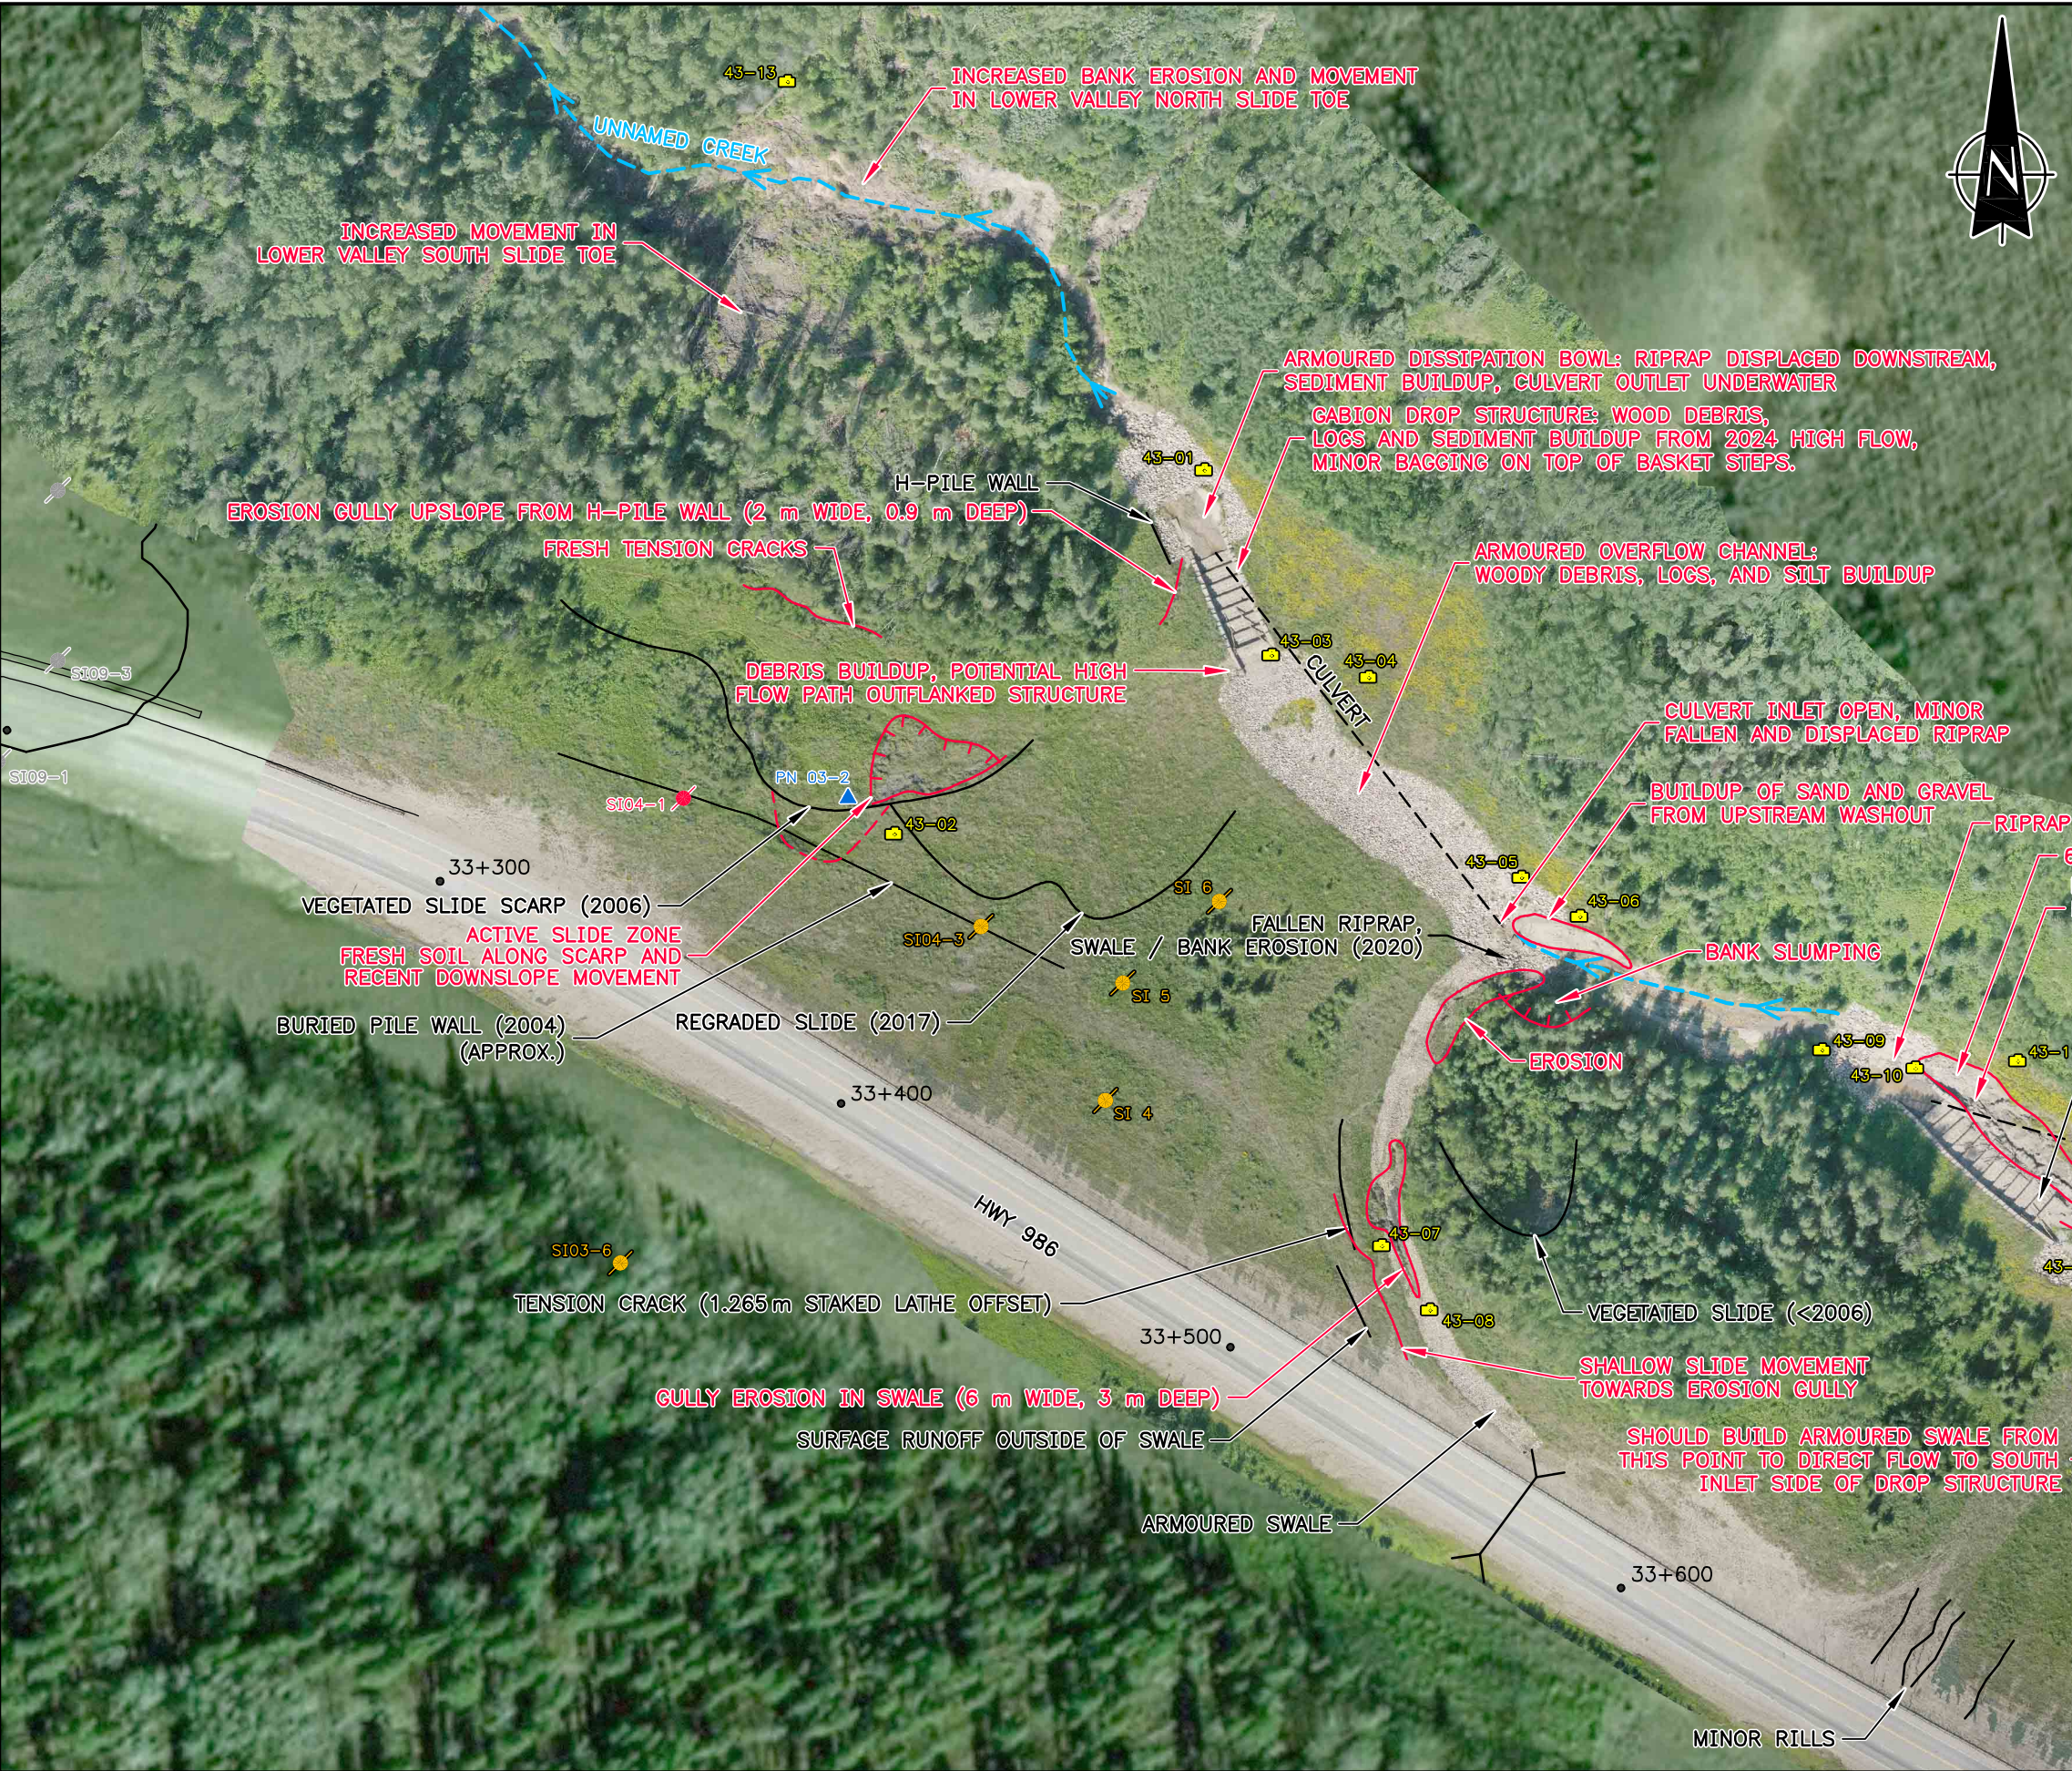
FIGURE PH043-2

Pile wall appears to be limiting sliding of area upslope of the wall and is protecting the west portion of the Site A embankment. The erosion repair work has reinforced the embankment toe and reduced the rate of soil loss from this area and the potential of destabilizing the upper embankment slope.

Slide activity in the lower part of the valley slope that was initiated during construction was mitigated via driven steel piles which appear effective in limiting new slide development. Instruments at the existing buried pile wall indicated a trend of increased movement rates since construction; however, current movement rates are consistent with long-term movement rates. There is ongoing slide activity directly below the west end of the old wall, but it appears relatively shallow and not currently a direct threat to the highway. The embankment above the old pile wall has not exhibited signs of slide movement and slide related pavement damage has not been observed. The apparent tension crack adjacent to the swale has increased in size and appears to be related to shallow movement likely as a result of reduce toe support due to the gully erosion.

Debris and sedimentation buildup has occurred around the erosion mitigation structures following the 2024 high flow event. Maintenance work is required around the culvert inlet and outlet (dissipation bowl cleanout) in the valley bottom. The east crotch swale riprap is no longer effective and should be rebuilt to prevent expansion of the erosion damage and minimize further upslope movement. Due to the gradient in this area, either angular riprap or anchored gabion mattress will be required.

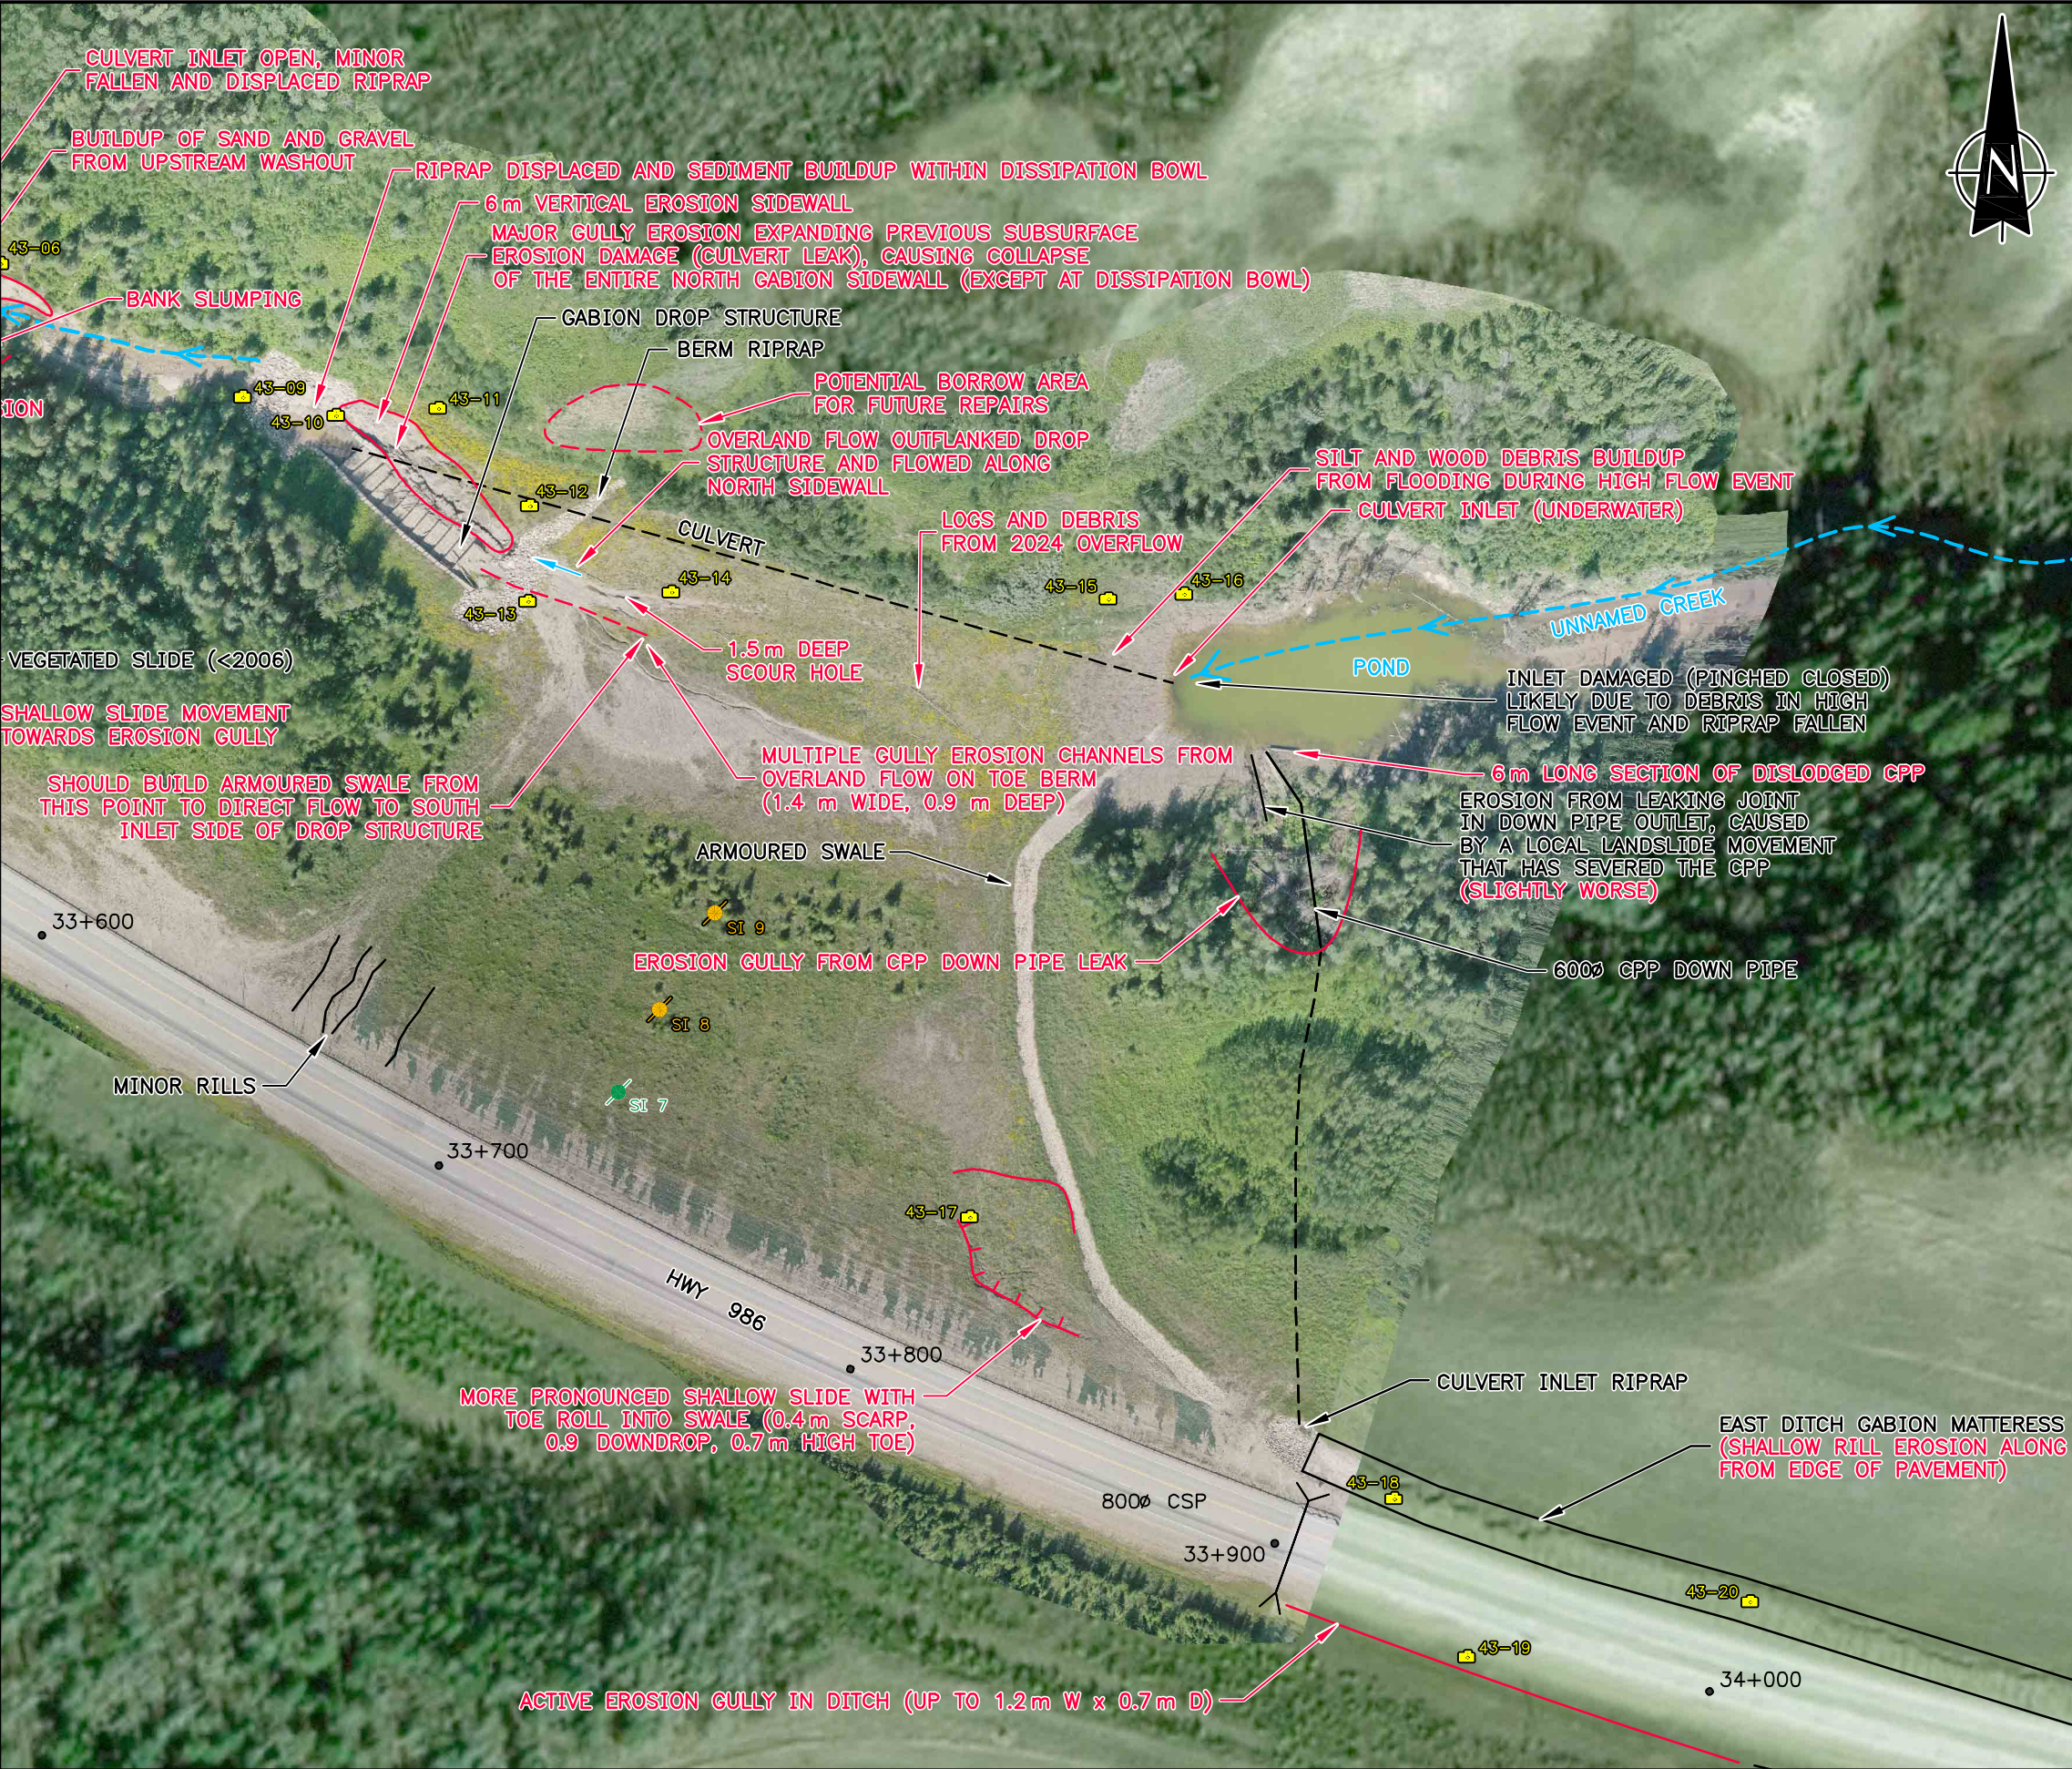
FIGURE PH043-3

The culvert and erosion control mitigation work within the valley bottom requires repairs to restore full effectiveness and reduce rates of progressive damage. The culvert inlet is nearly pinched closed/partially blocked and requires repairs to restore full drain capacity. The end slope of the inlet should be cut steeper and shorter and lined with a stronger SWSP (with concrete collar) to resist hydraulic uplift forces. The riprap around the culvert needs to be reconfigured and should be “benched” into the slope as is practical to reduce displacement and sliding. The CPP downpipe requires replacement and realignment, which was caused by a local landslide in the lower valley slope. The gully erosion occurring downslope from the break will continue to retrogress upslope towards the highway and could initiate deeper instabilities.

During the spring of 2018 a sinkhole developed beside the lower portion of the drop structure, caused by water flowing under pressure from a separated joint in the underlying C.S.P. culvert creating a subsurface void. The void was grouted, and the sinkhole backfilled, however progressive distortions to the overlying gabion baskets/mattresses still occurred. It is believed the outlet of the C.S.P., which sits in the flow dissipation bowl, froze underwater and that the pressurized water eroded the sinkhole out the side of the pipe and drop structure. During the 2023 inspection further void expansion caused additional displacement of the gabion drop structure and ongoing erosion damage. Damage to the drop structure was significantly exacerbated during the July 2024 high flow event where overland flow went outside the armoured channel to the north side of the structure resulting in an erosion gully that undermined the north sidewall and has now caused it to collapse. The previous piping damage likely contributed to the outside flow path undermining the structure.

The current instrumentation indicates shallow movement (less than 3 m depth) at slow and steady rates (<10 mm/yr). The SI closest to the highway (SI-7) has not measured movement. A shallow slide has developed upslope of the swale near km 33.825 that is currently offset approximately 18 m from the highway and does not represent an immediate threat. The instability can likely be attributed to a slightly oversteepened slope profile following construction of the armoured swale.

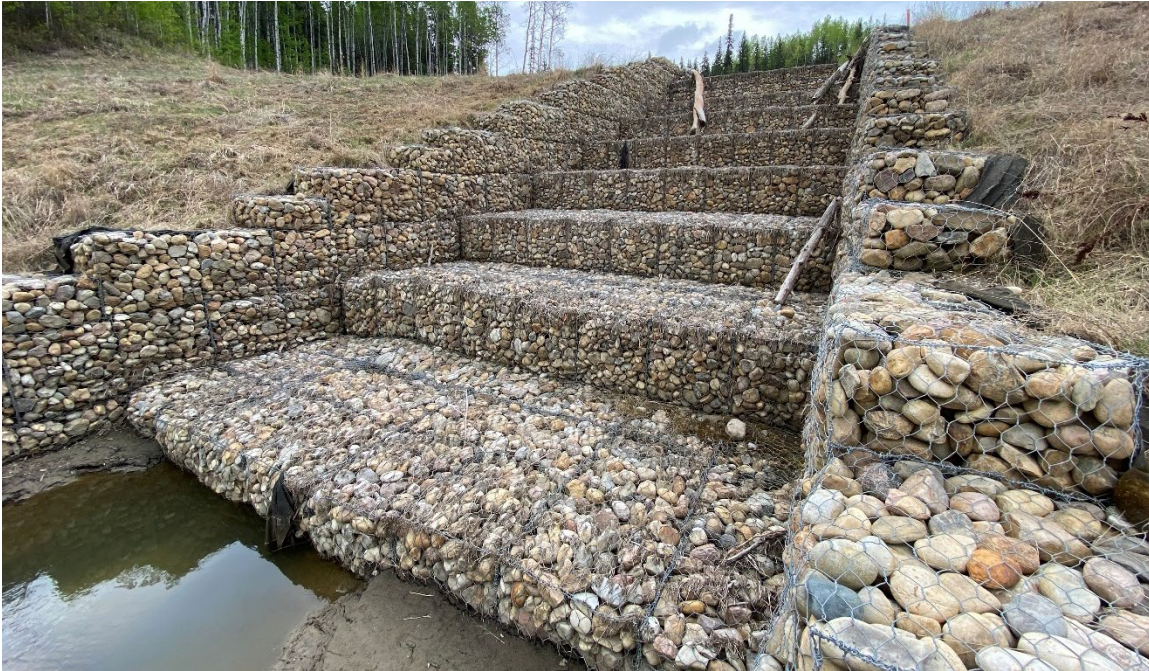
**Photo 43-01.:** View towards the southeast (upstream) from the base of the Site A gabion drop structure. No major change from 2024 condition. Debris visible from high flow event and there was sediment buildup within the dissipation bowl at the base of the drop structure.

- Sediment buildup within the dissipation bowls of both drop structures should be cleaned out.
- Logs and woody debris within the drop structures should be cleaned out.
- Remove sand accumulation from side of roadway which is causing channelization of surface runoff on embankments and highway ditch.

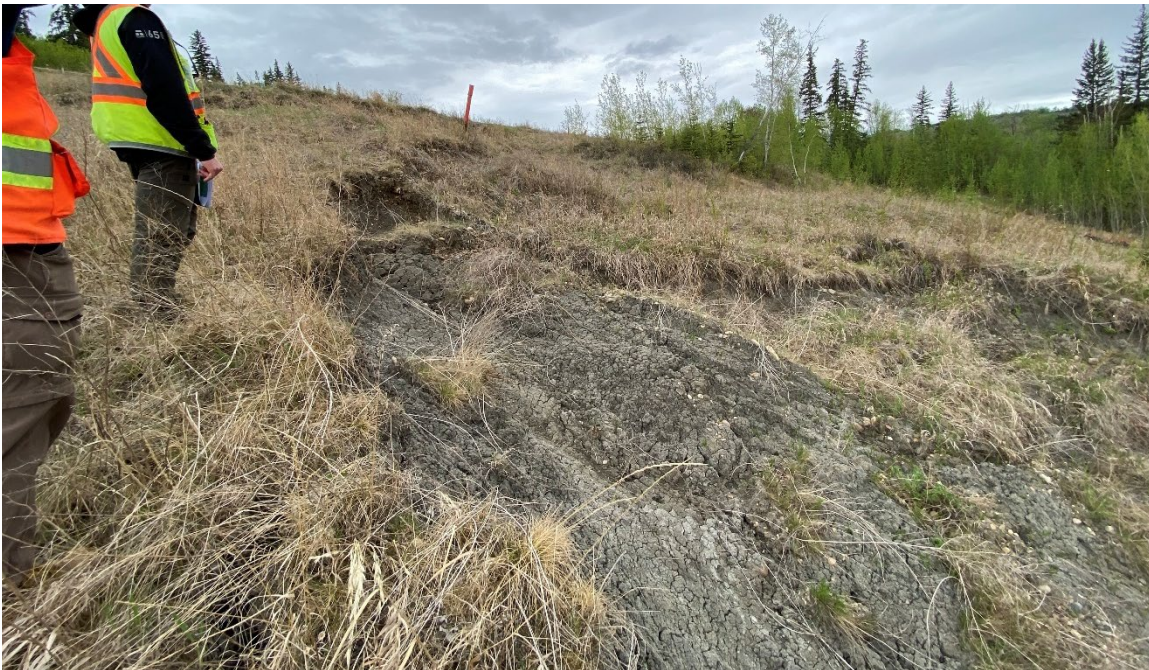
**Photo 43-02.:** Main slide scarp of active shallow failure downslope of the buried pile wall (33+325) first observed in 2017. Fresh scarps were observed in 2024 and had additional movement and minor retorgression.

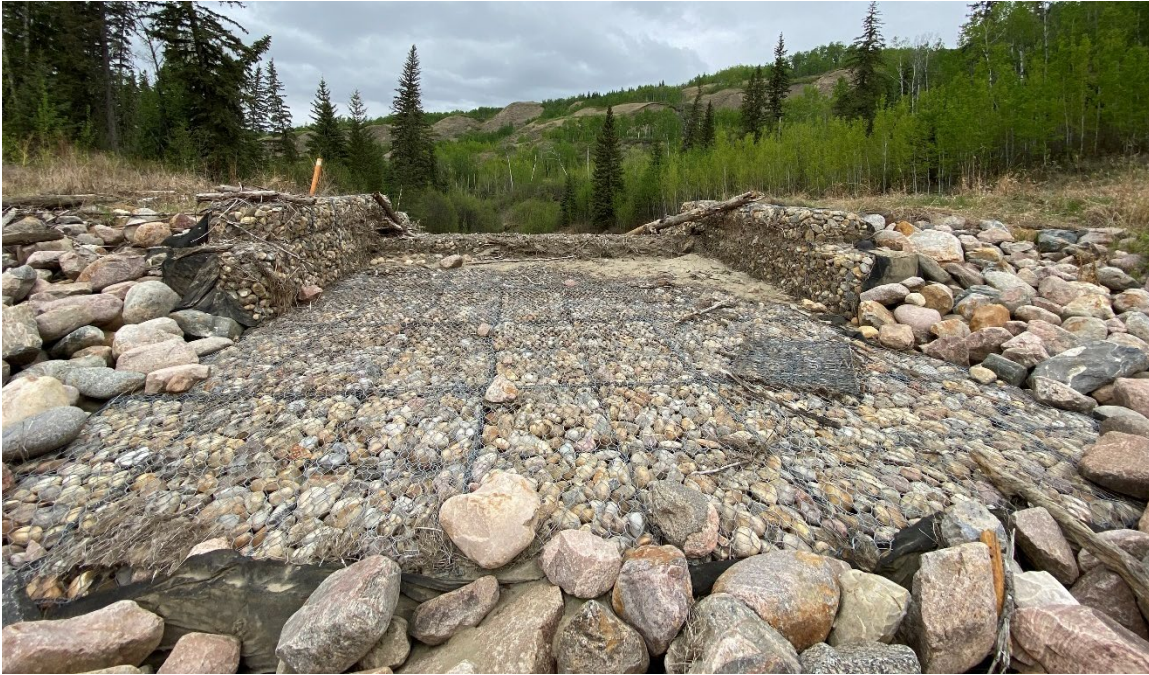
<input checked="" type="checkbox"/> Other	<p>No significant beaver activity noted at the creek between Sites A and B.</p> <p>Sediment, log and wood debris buildup present throughout the overland flow areas and within the drop structures at Sites A and B from the 2024 high flow event. (Photos 43-03, 43-04, 43-05, 43-12, 43-15)</p>	<input type="checkbox"/>

**Photo 43-03.:** View towards the northwest (downstream) at from the top of the Site A gabion drop structure (33+400). Debris and sediment buildup visible at the top of the structure from the 2024 high flow event. No major changes.

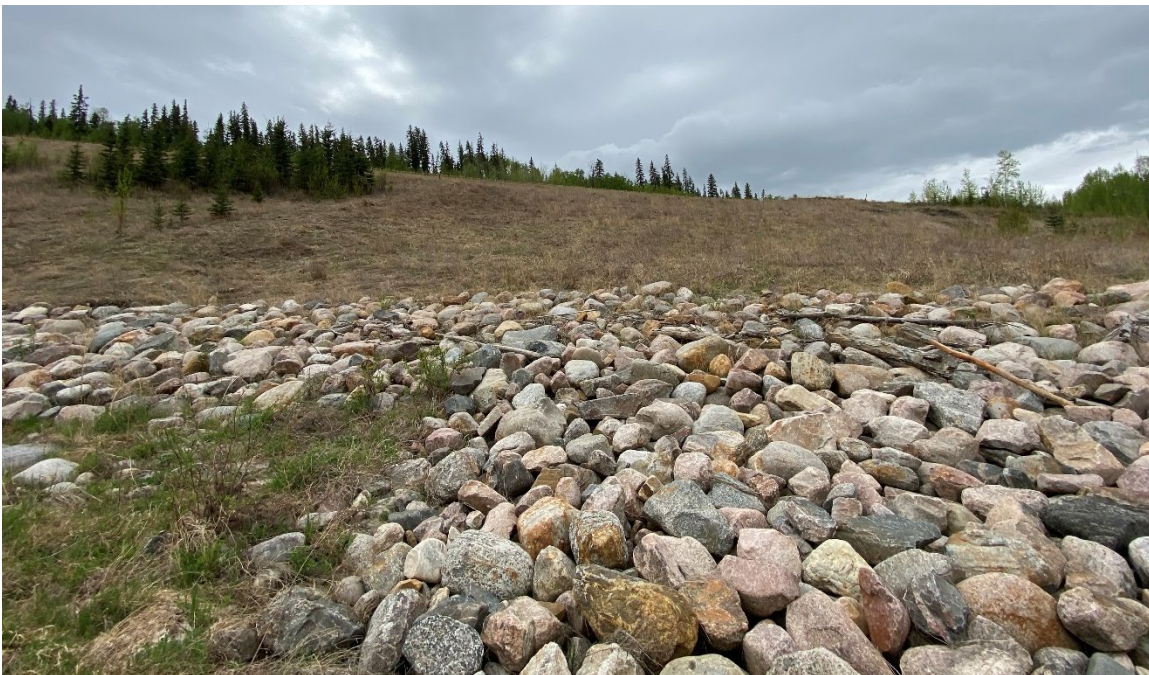
**Photo 43-04.:** Looking south at the area of previous slumping associated with culvert erosion below pile wall and regraded slide during construction in 2017 (33+430). No visible changes from 2024 condition.

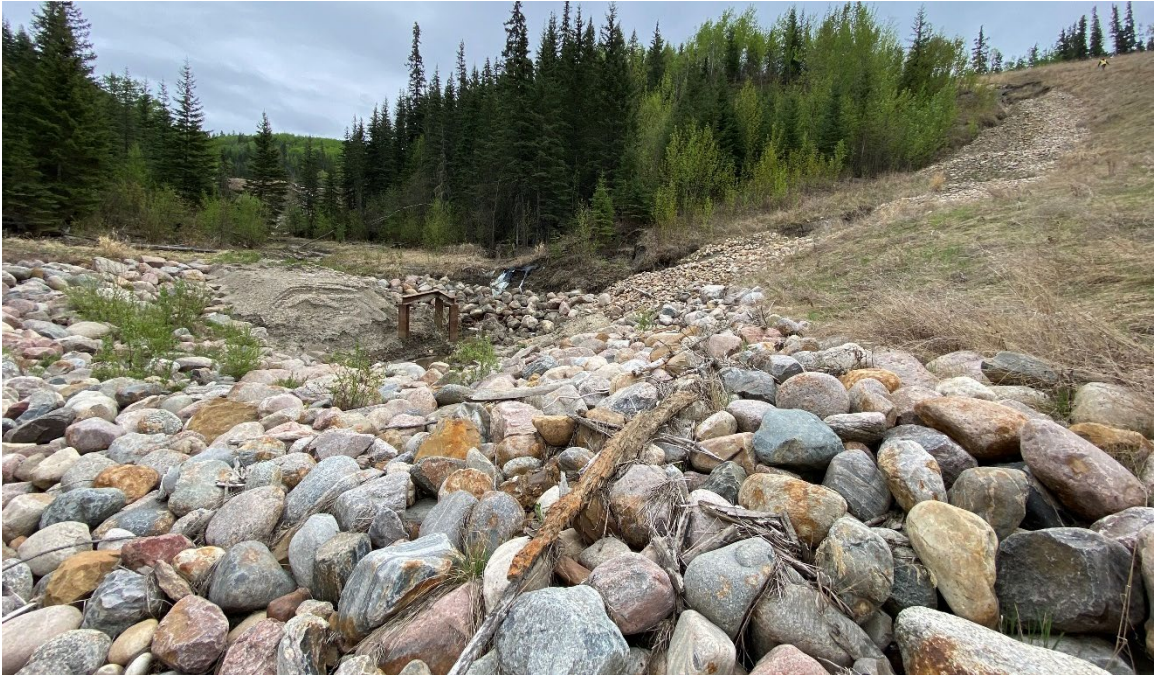
**Photo 43-05.:** Site A - Standing atop the armoured overflow channel looking towards the southeast (upstream) near 33+525. Buildup of woody debris and sediment visible from the 2024 high flow event. Increased gully erosion along the armoured swale and slumping of the south channel banks.

- (3) Site B - replace CPP down pipe severed by landslide. Replace with welded HDPE pipe. (\$175k)
- (3) Site A - repair south channel bank erosion near the culvert inlet and toe of the armored swale. The disturbed soils should be excavated and backfilled with gravel over non-woven geotextile. Additional Class 2 riprap should be added over the bank and blended into the toe of the armored drainage swale. (\$25k)

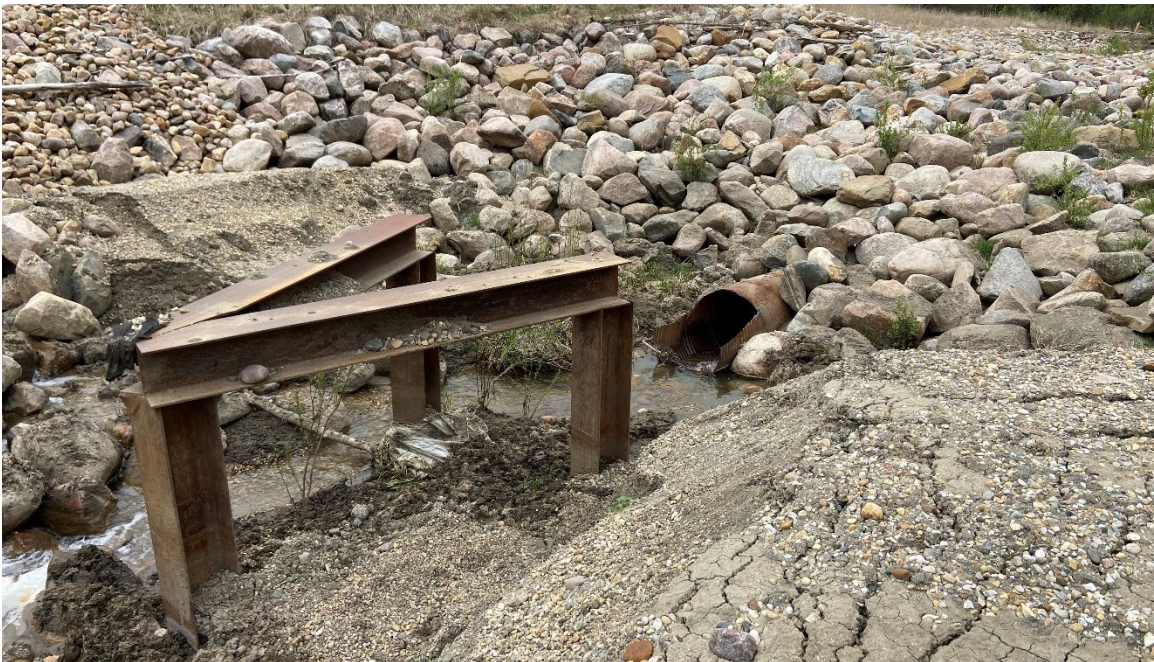
**Photo 43-06.:** Site A - View southwest towards the culvert inlet and debris deflector (33+500). Large buildup of sand and gravel from upstream washout during 2024 high flow event. Inlet was open and flowing. No significant change from 2024 condition.

- (4) Site A - replacement of the damaged culvert inlet with a stronger SWSP with steeper end bevel. The new culvert should be grouted into the existing CSP. Additional Class 2 riprap should be added and shaped to better funnel water into the inlet. (\$30k)

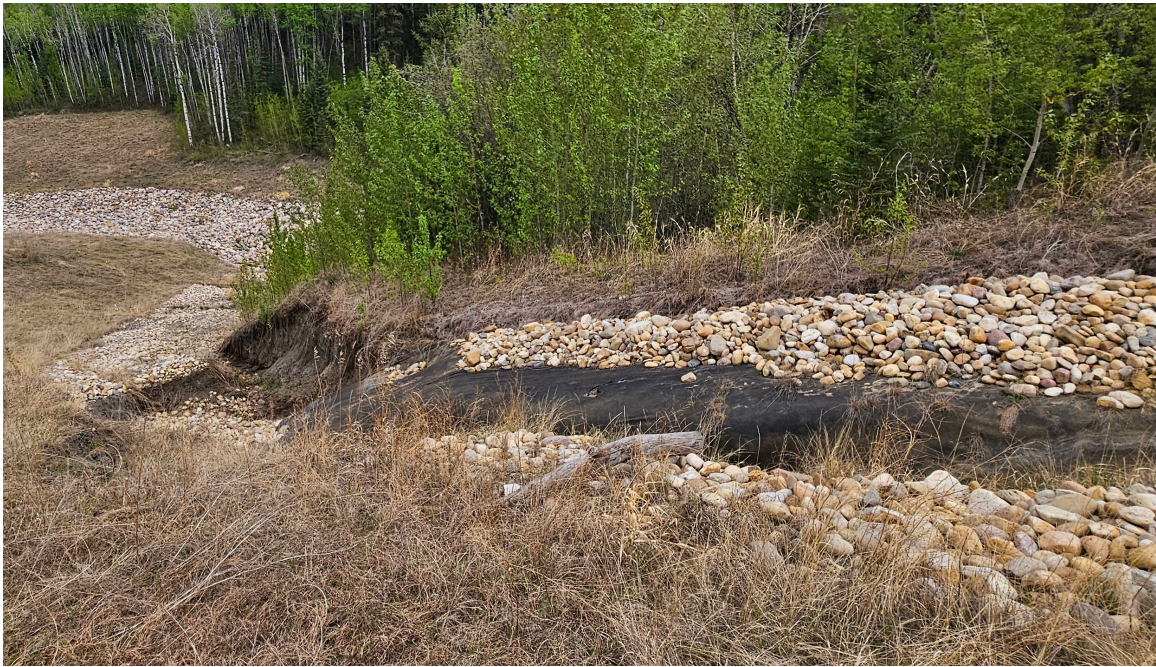
<input checked="" type="checkbox"/> Erosion	<p><b>Site A</b></p> <p>Rill erosion upslope from the steel pile wall was deeper (0.9 m) and wider (2 m) relative to the 2024 condition.</p> <p>At the culvert inlet (33+500) erosion along the south channel bank and within the lower part of the armoured swale was slightly worse. (Photo 43-05)</p> <p>The armoured swale at the east end of Site A with erosion damage from a 2019/2020 high flow event had increased damage, gullying was deeper and wider. (Photo 43-07)</p>	<input checked="" type="checkbox"/>

**Photo 43-07.:** Downslope view towards the north at the washed out riprap and extensive erosion gully damage within the armoured swale at the east side of Site A (33+500) first observed in 2020. Deeper and expanded erosion damage since 2024.

- (4) Site A - repair of the armored swale. Existing rock should be salvaged and used with additional imported material to line the armored swale with gabion mattress anchored at intervals to the slope. Swale alignment improvements should also be made (reduction of super elevation in the upper curve) and a cross berm should be added near the top to divert highway runoff into the swale. (\$45k)

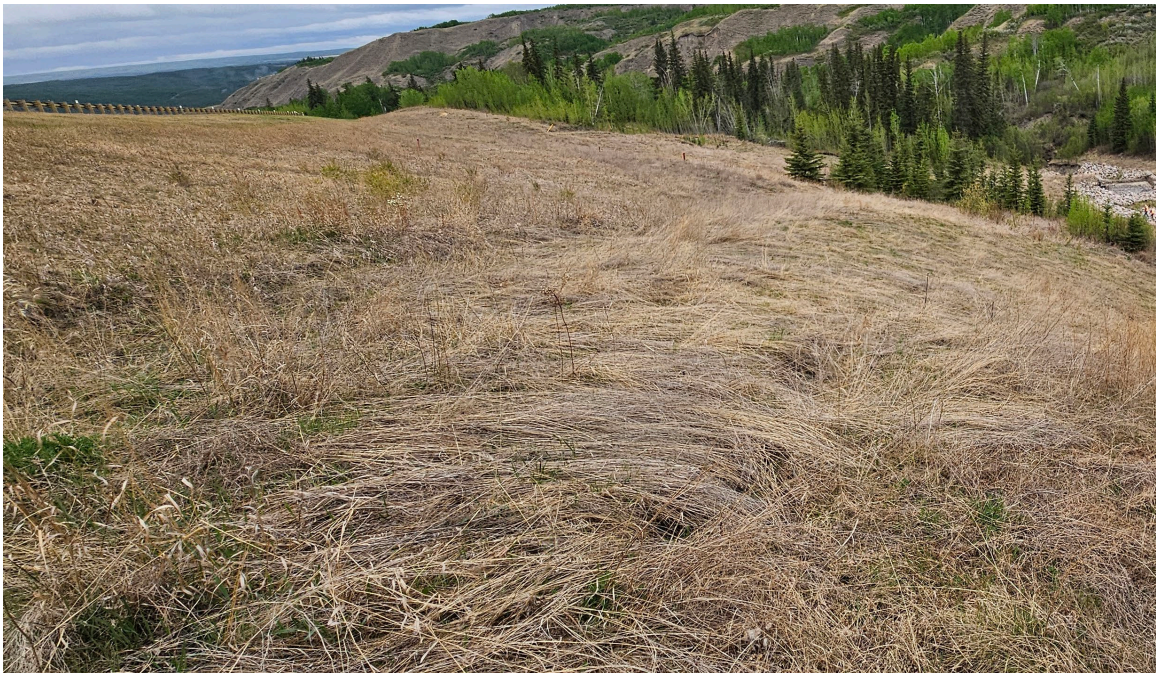
**Photo 43-08.:** View west along the sideslope above the armoured swale at the east side of Site A (33+530). Tension cracks have formed from shallow slide movement towards the erosion gully.

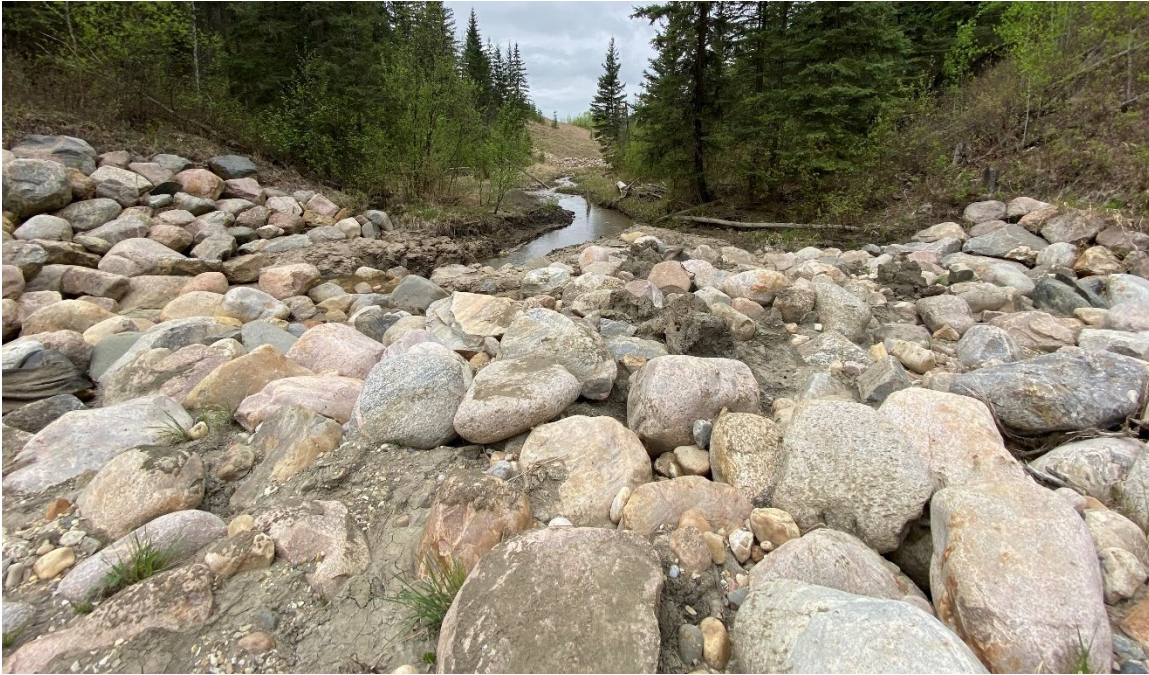
**Photo 43-09.:** Site B - View west (downstream) along the channel downstream of the gabion drop structure with displaced riprap and sediment buildup (33+600).

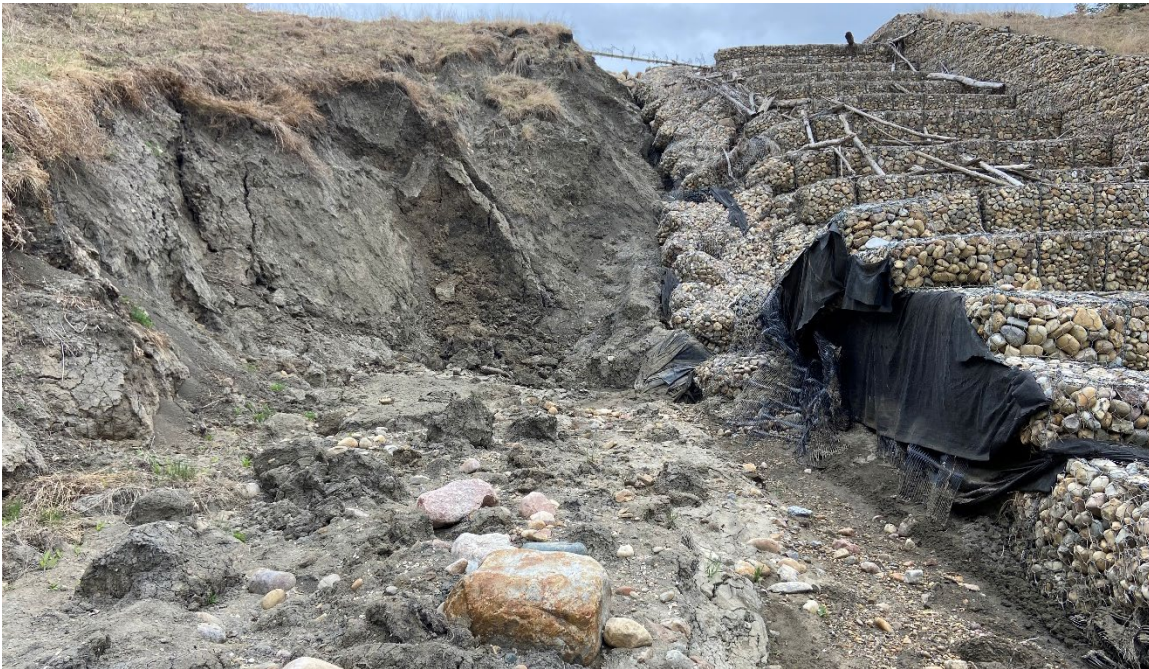
**Photo 43-10.:** Site B- view east (upstream) from the base of the gabion drop structure and riprap dissipation bowl at the culvert outlet (33+600). Additional erosion expansion and complete gabion collapse along the north sidewall of the drop structure from the erosion gully that formed when high flow outflanked the structure in 2024. Lower area previously compromised from culvert joint leak and piping.

- (4) Site B - drop structure erosion temporary gully armouring. The disturbed soils outside the drop structure wall should be excavated and backfilled with Class 1M riprap placed over non-woven geotextile. Class 1 rock should be placed as armour cover and to reinforce the toe of the backfilled zone. (\$250k)

- Site B – the following measures are recommended to reinstate the drop structure to the original design function:
  - Cut away and dismantle damaged baskets along north sidewall and salvage gabion stone. Care should be taken to keep step baskets intact.
  - Excavate disturbed gully soils.
  - Remove gabion baskets at bottom of structure to access culvert joint and replace with bolted connection and concrete collar.
  - Re-establish slope on north side of the drop structure with benched steps (matching drop structure geometry as close as possible) using compacted clay fill and install low permeability liner.
  - Install sheet pile cut-off wall at the top of the drop structure on the north side.
  - Place graded rock armouring over liner comprised of gravel bedding, salvaged gabion stone followed by Class 2 riprap blended into the intact drop structure steps.

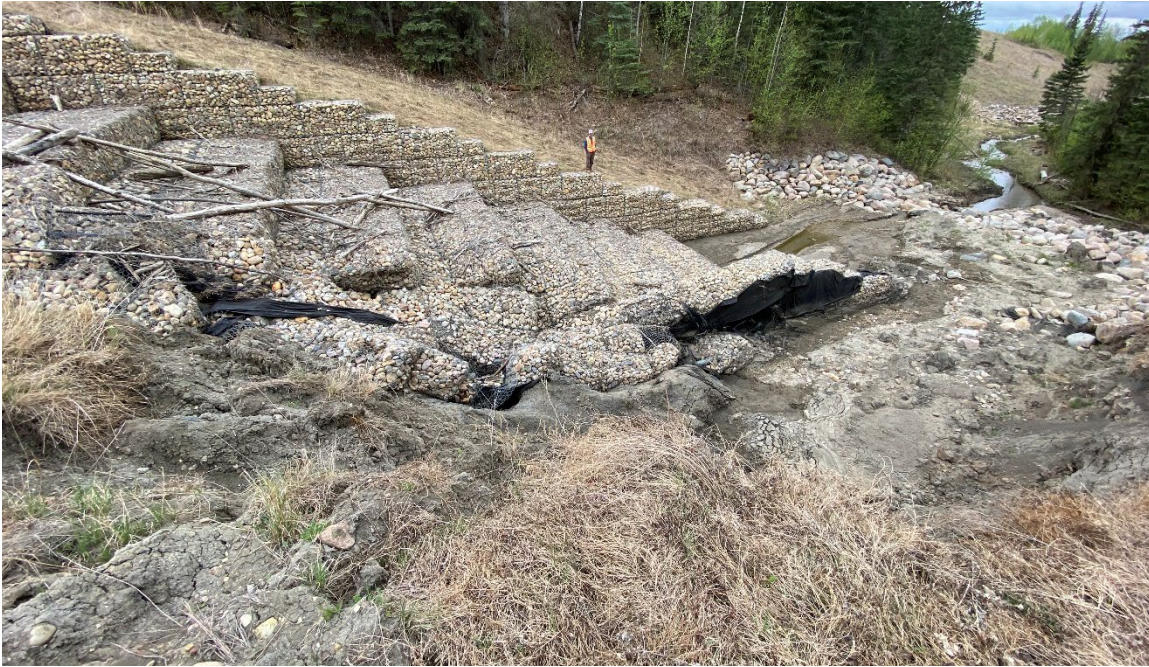
**Photo 43-11.:** Site B- view south towards the expanded damage and erosion gully along the north side of the gabion drop structure (33+610). Increased sediment buildup in dissipation bowl. Culvert outlet was open and flowing.

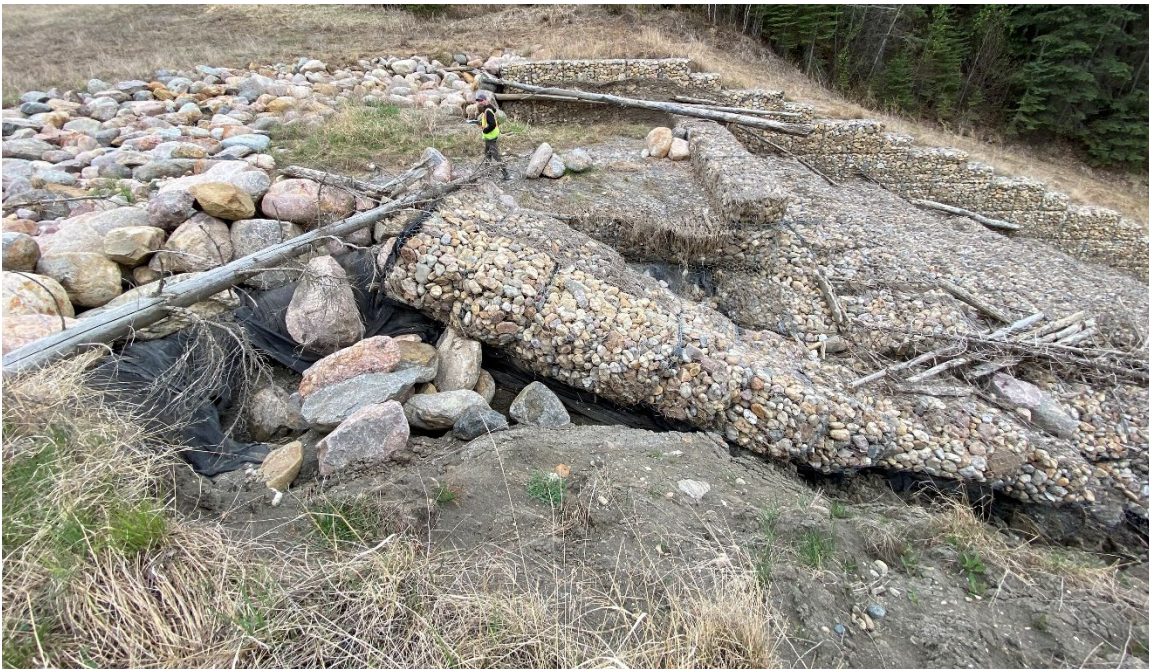
**Photo 43-12.:** Site B- view south towards the top of the gabion drop structure where high flow outflanked the structure along the outside of the north sidewall during the 2024 high flow event causing subsequent collapse from undermining. Logs and wood debris buildup visible.

Extensive repairs of this area are required to limit further damage to the drop structure and allow proper culvert function. Work upstream of the drop structure within the overland flow area is required to direct future surface flows towards the south side of the drop structure inlet to minimize flow within the north erosion gully prior to full repairs of the drop structure can be completed. The erosion gully at the base of the drop structure has resulted in easier access to the compromised culvert joint for repair. The compromised joint section should be excavated and replaced with a bolted connection and concrete collar. Repairs at the drop structure will need to involve removal of the disturbed soils and damaged baskets, slope regrading, installation of a cut-off wall at the top and impermeable liner, and installation of new riprap armouring and salvaged gabion stone from damaged baskets that is blended into the intact structure.

- (5) Site B - establish an armoured swale and diversion berm from the south side of the drop structure inlet to direct overland flow outside of the erosion gully and minimize surface flow to the north side of the structure into the erosion gully. (\$50k)

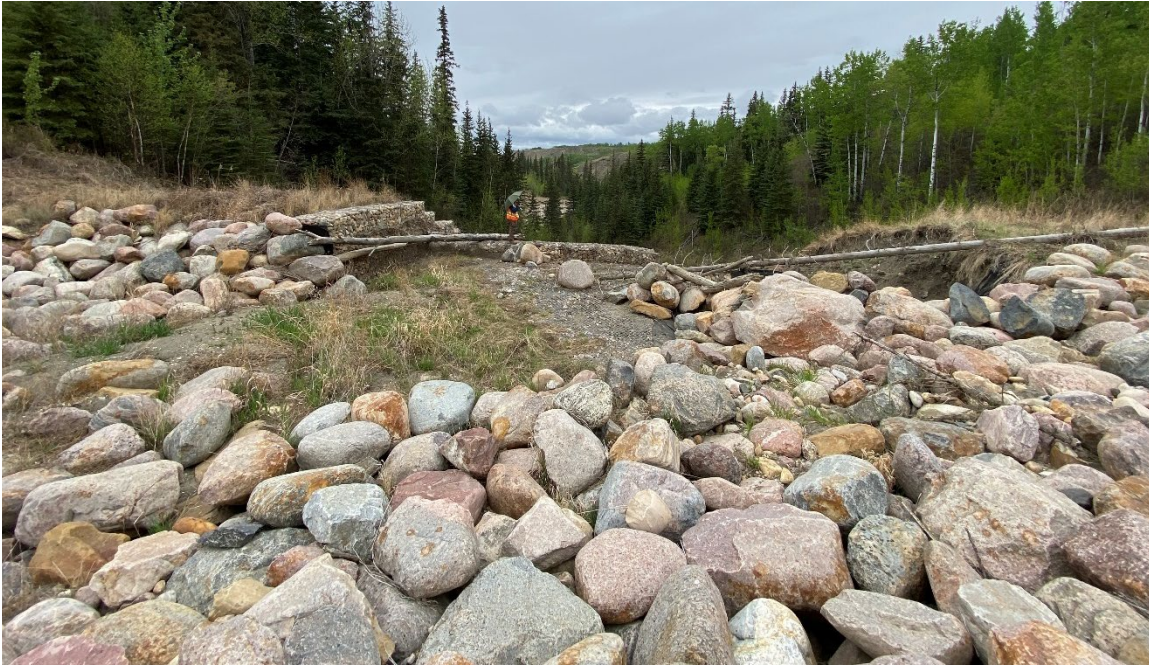
**Photo 43-13.:** Site B- view east at upstream end/inlet of the gabion drop structure with riprap berm near west end of the overland flow toe berm (33+625). Increased erosion and riprap displacement near the head of the erosion gully at the north side of the drop structure.

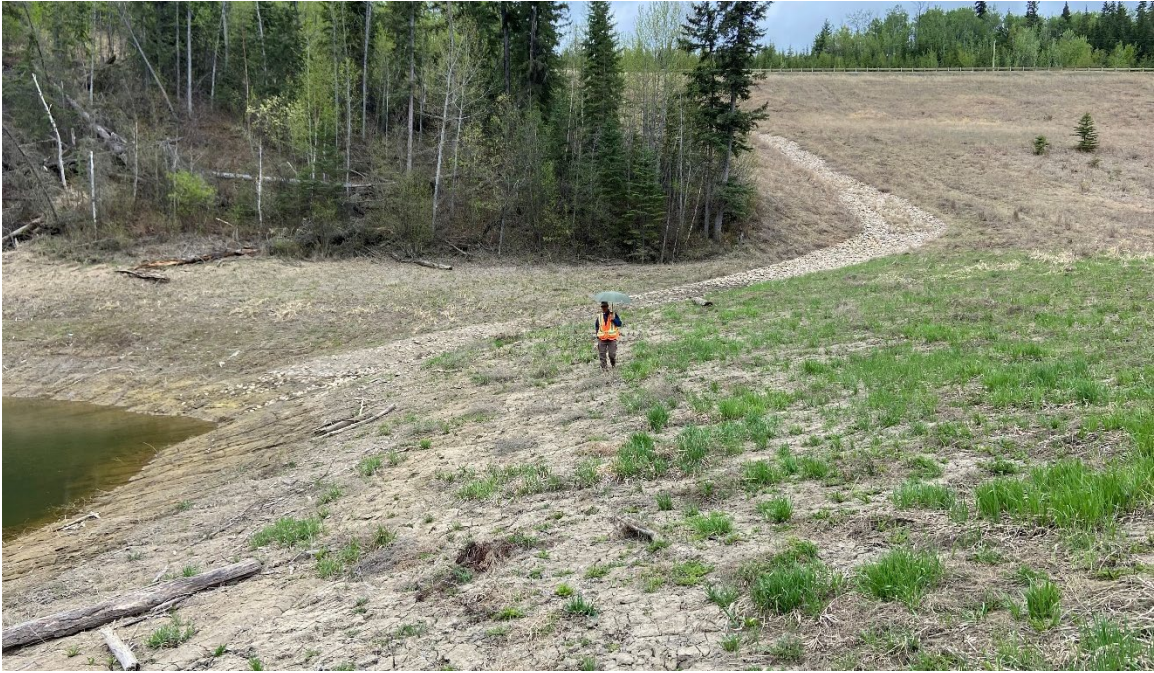
**Photo 43-15.:** Site B- view south of overland flow area above the culvert inlet near 33+800. Log and sediment debris buildup were visible from the 2024 high flow event.
