ALBERTA TRANSPORTATION AND  
ECONOMIC CORRIDORS  
GEOHAZARD ASSESSMENT PROGRAM  
PEACE REGION (PEACE RIVER DISTRICT)  
2025 INSPECTION

Site Number	Location	Name	Hwy	km
PH043	Daishowa East Hill	Daishowa Retaining Wall – Site A / Site B	986:01	33.45 – 33.74
<b>Legal Description</b>		<b>UTM Co-ordinates (NAD 83)</b>		
NE7/NW8-85-20 W5M		11V E 491380	N	6246075

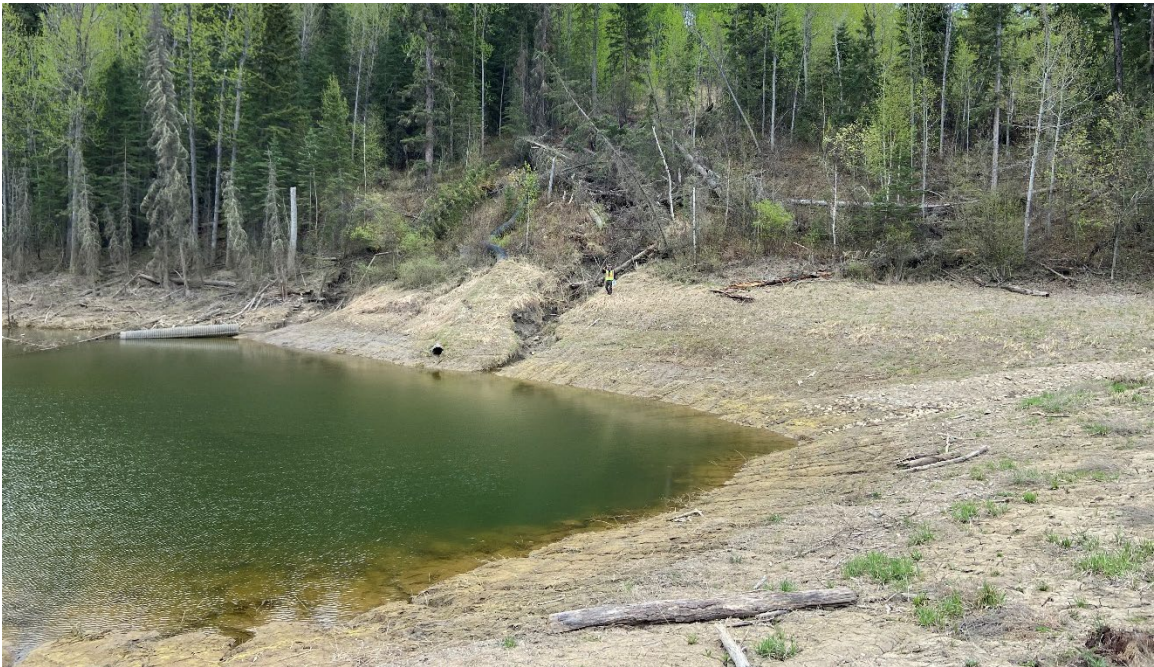
The culvert and erosion control mitigation work within the valley bottom requires repairs to restore full effectiveness and reduce rates of progressive damage. The culvert inlet is nearly pinched closed/partially blocked and requires repairs to restore full drain capacity. The end slope of the inlet should be cut steeper and shorter and lined with a stronger SWSP (with concrete collar) to resist hydraulic uplift forces. The riprap around the culvert needs to be reconfigured and should be “benched” into the slope as is practical to reduce displacement and sliding. The CPP downpipe requires replacement and realignment, which was caused by a local landslide in the lower valley slope. The gully erosion occurring downslope from the break will continue to retrogress upslope towards the highway and could initiate deeper instabilities.

**Photo 43-16.:**Site B - Looking south towards the outlet of the CPP down pipe near the culvert inlet (33+850). Increased gully erosion and sliding since 2024 due to a leaking joint that requires repair. Water is ponded above the damaged culvert inlet (pinched) that has significantly restricted flow capacity.

- (4) Site B - replace culvert inlet at km 33+800 within valley bottom. Replace with concrete faced headwall and rebuild embankment slope. The new inlet should comprise a liner with SWSP. Additional rip should be added and shaped around the reinforced headwall. (\$85k)

- (3) Site B - replace CPP down pipe severed by landslide. Replace with welded HDPE pipe. (\$175k)
- (3) Site A - repair south channel bank erosion near the culvert inlet and toe of the armored swale. The disturbed soils should be excavated and backfilled with gravel over non-woven geotextile. Additional Class 2 riprap should be added over the bank and blended into the toe of the armored drainage swale. (\$25k)

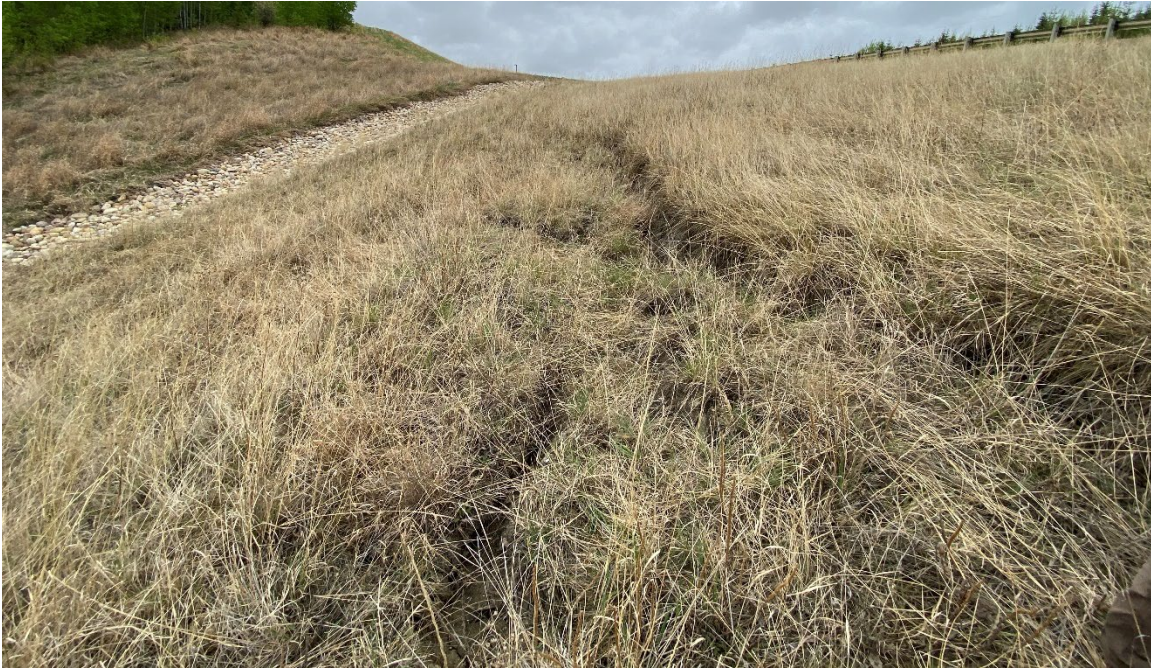
<p>erosion. At Site A the work also included the installation of a driven steel pile retaining wall to allow the construction of the drop structure; further regrading work across the embankment slope that slid during construction; and the construction of an armored swale to repair an erosion gully down the east edge (crotch) of the embankment fill sideslope. At Site B the work also included construction of a swale to repair an erosion gully down the east edge (crotch) of the highway embankment sideslope and lining the highway ditch further east with gabion mattress and ECM.</p>	
<b>Maintenance:</b>	None	
<b>Observations:</b>	<b>Description</b>	<b>Worsened?</b>
<input type="checkbox"/> Pavement Distress		<input type="checkbox"/>
<input checked="" type="checkbox"/> Slope Movement	<p><b>Site A</b></p> <p>During mitigation work in 2017/2018 a slide was initiated within the lower slope near the new drop structure that was mitigated via a driven steel pile wall. There is shallow slide activity with ongoing movement within the disturbed slide mass and minor retrogression and expansion downslope of the west end of the older buried tangent pile wall.</p> <p>(Photo 43-02)</p> <p>Previous cracking further east from this area have been graded during the mitigation work and appeared in good condition. No evidence of slope movement was observed upslope of the buried pile wall. (Photo 43-04)</p> <p>Bank slumping south of the culvert inlet was slightly worse with fresh soil exposures since the previous inspection. (Photo 43-05)</p> <p>Tension cracks from apparent shallow sliding towards the east crotch riprap swale (near damaged section) had expanded and the measured offset between the installed lath stakes from the 2024 condition was 1.265 m (+105 mm). (Photo 43-08)</p> <hr/> <p><b>Site B</b></p> <p>Sliding is ongoing within the erosion gully at the broken CPP down pipe near 33+850.</p> <p>(Photo 43-16)</p> <p>Increased movement at the surficial slide that developed near the upper slope adjacent to the swale (33+825) first identified during the July 2024 callout. Slide had a 0.4 m scarp height, 0.9 m downdrop and a visible toe roll up to 0.7 m in height that extended to the edge of the swale. (Photo 43-17)</p>	<input checked="" type="checkbox"/>

The current instrumentation indicates shallow movement (less than 3 m depth) at slow and steady rates (<10 mm/yr). The SI closest to the highway (SI-7) has not measured movement. A shallow slide has developed upslope of the swale near km 33.825 that is currently offset approximately 18 m from the highway and does not represent an immediate threat. The instability can likely be attributed to a slightly oversteepened slope profile following construction of the armoured swale.

**Photo 43-17.:** Site B - Looking east towards the scarp of a shallow slide developing above the armoured swale that was identified in 2024 (33+850). Slide was more pronounced with a 0.4 m high main scarp and visible toe roll that extended to the edge of the swale.

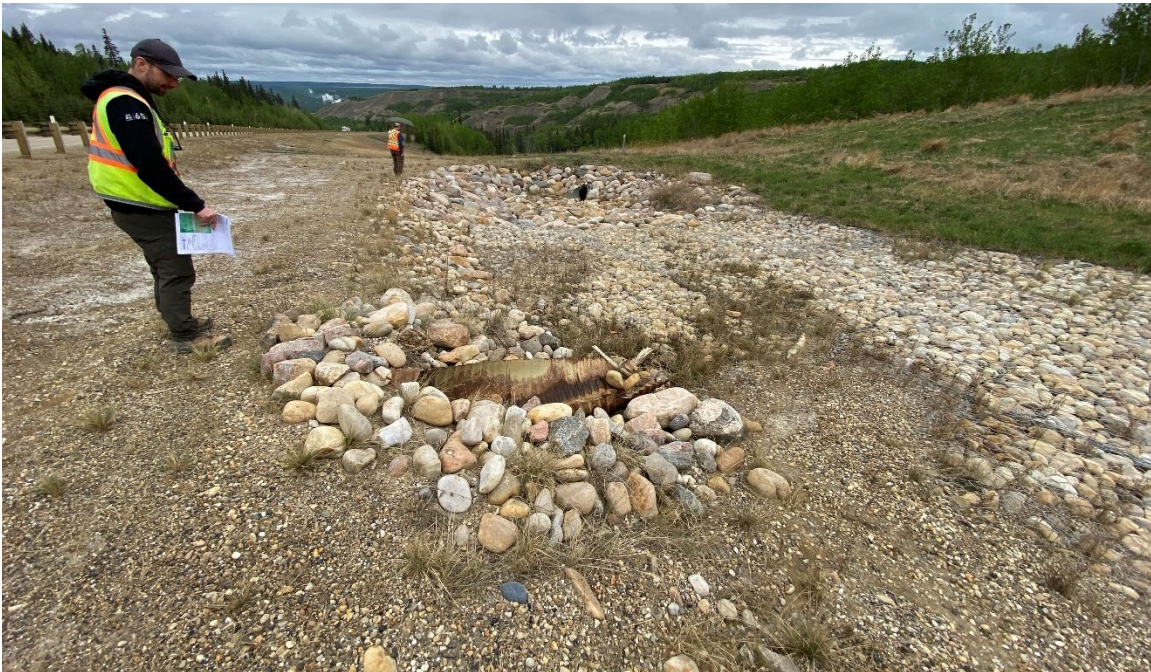
**Photo 43-18.:** Site B - View west towards centreline culvert outlet, CPP downpipe inlet and riprap protection near 33+900 on north side of road. No visible changes from the 2024 condition.

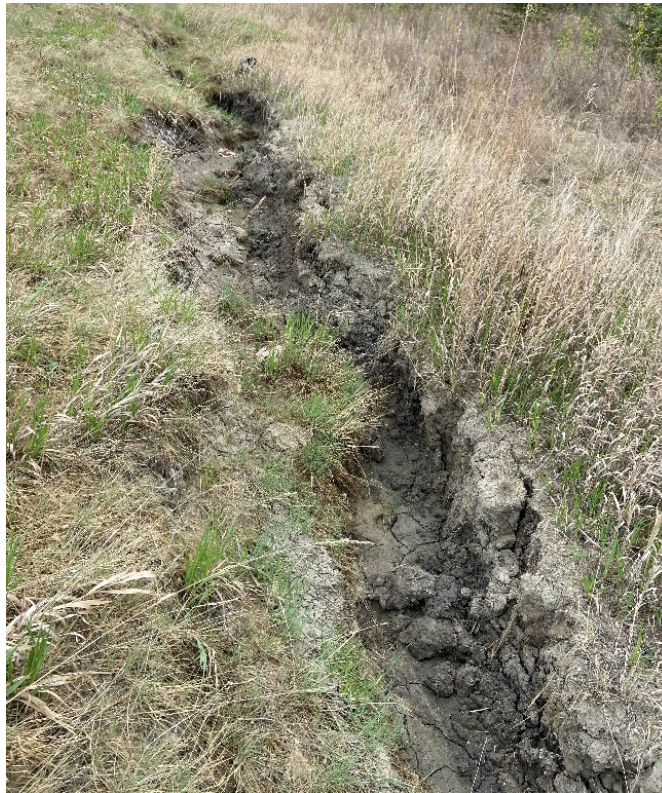
**Photo 43-19.:** Site B – Increased erosion within gully that has formed upstream of the culvert inlet within the south ditch between approximately 33+900 to 34+010.

- (2) Site B - repair erosion in south ditch and armor similar to north ditch with TRM and gabion mattress in section with gradient above 5%. Backslope could be used as borrow source to fill gullies. Estimate length of repair section is between 250 m to 300 m in order to extend the armoured section to the culvert inlet. (\$85k)

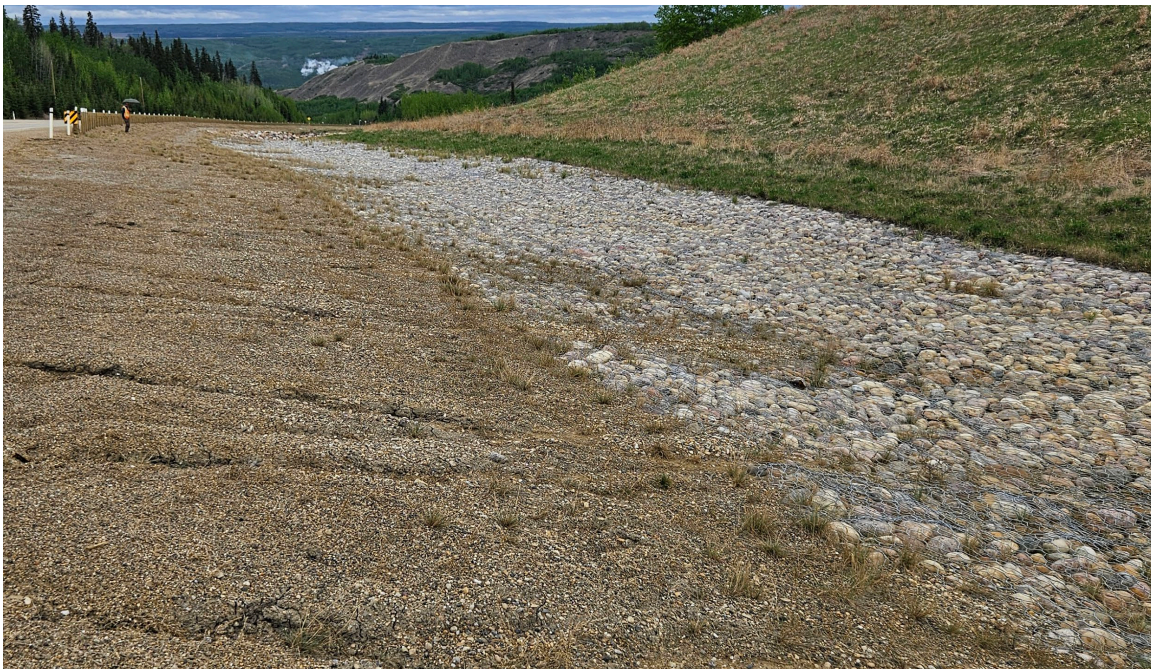
**Photo 43-20.:** Site B – Shallow rill erosion between the road sideslope and north ditch gabion armour had no major change compared to the 2024 condition (34+000).

- (1) Site B -repair erosion rills on north sideslopes above gabion mattress in ditch. Grade and line with TRM and composite rolls. (\$15k)
- (1) Site A - fill erosion gully with rock above pile wall at outlet drop structure. (\$5k)
