Site Number	Location	Name	Hwy	km
PH043	HWY 986:01 C1 33.357	Daishowa Retaining Wall	986:01	Km 33.4
Legal Description:		UTM Co-ordinates		
9-7-85-20 W5		11U E 491412.57	N	6246098.92

Current Monitoring:	8-June-2025	Previous Monitoring	20-May-2024
Instruments Read By:	Mr. Niraj Regmi, G.I.T and Mr. Godfred Etiendem, of Thurber

**ALBERTA TRANSPORTATION AND ECONOMIC CORRIDORS GRMP (CON0022164)
PEACE REGION (PEACE RIVER DISTRICT)
INSTRUMENTATION MONITORING RESULTS**

**SITE PH043-1: HWY 986:01, DAISHOWA EAST HILL PILE WALL
SITE PH043-2: HWY 986:01, DAISHOWA EAST HILL SITE B**

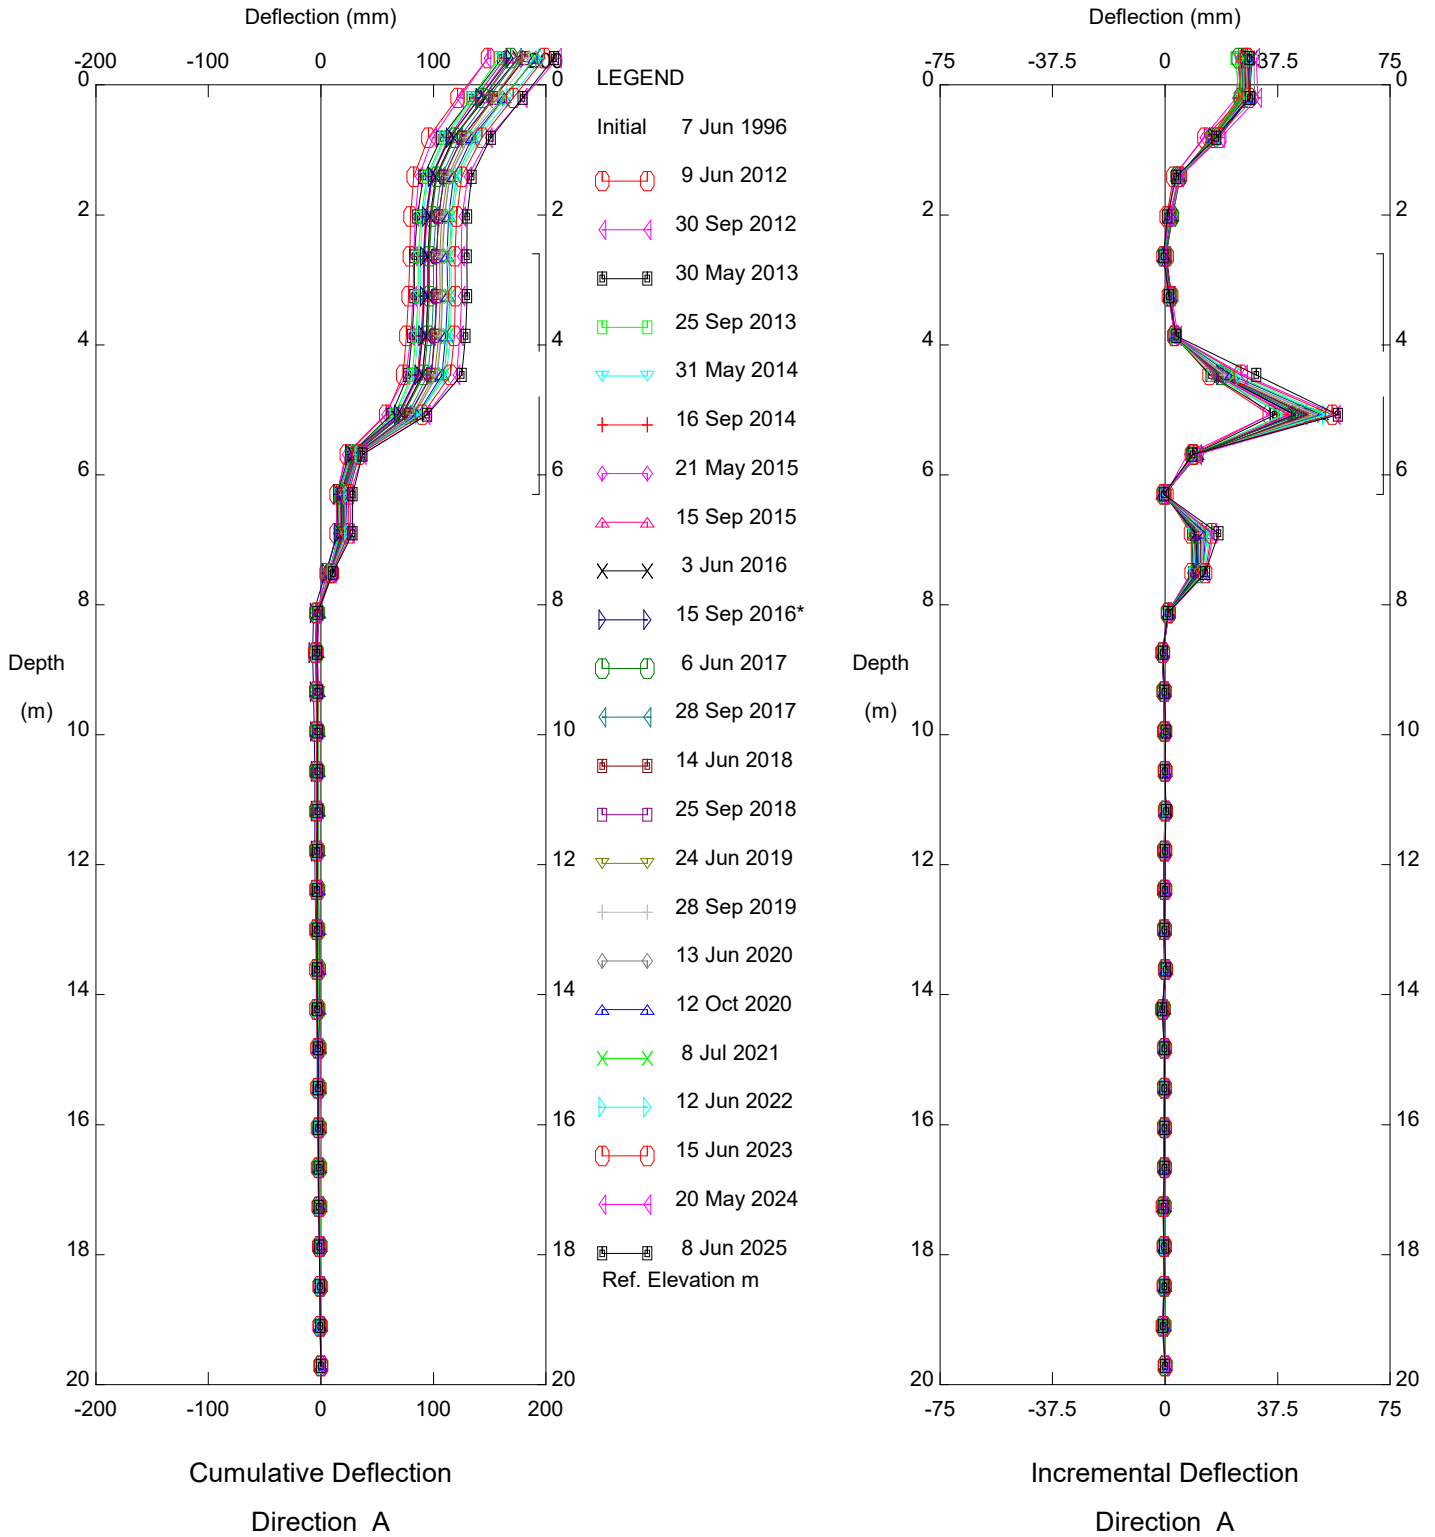
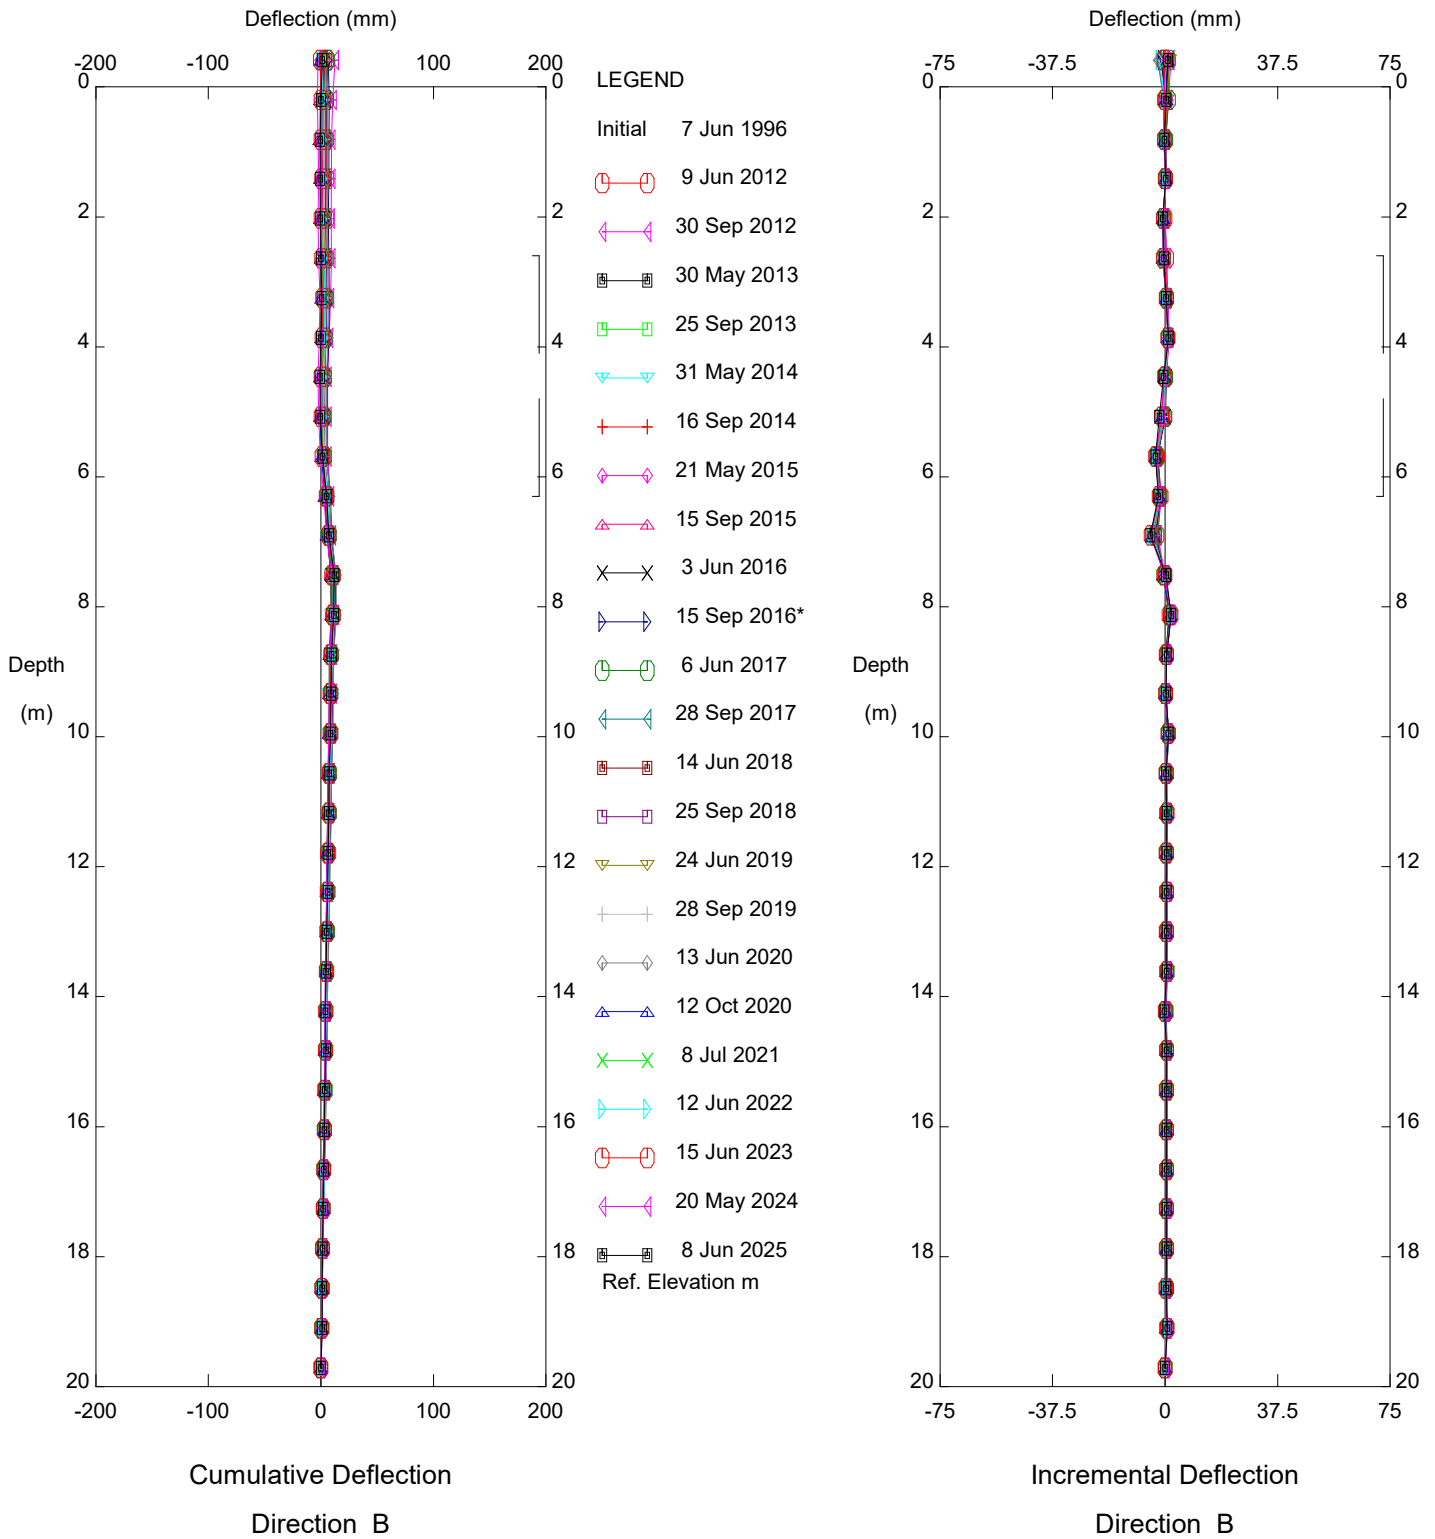
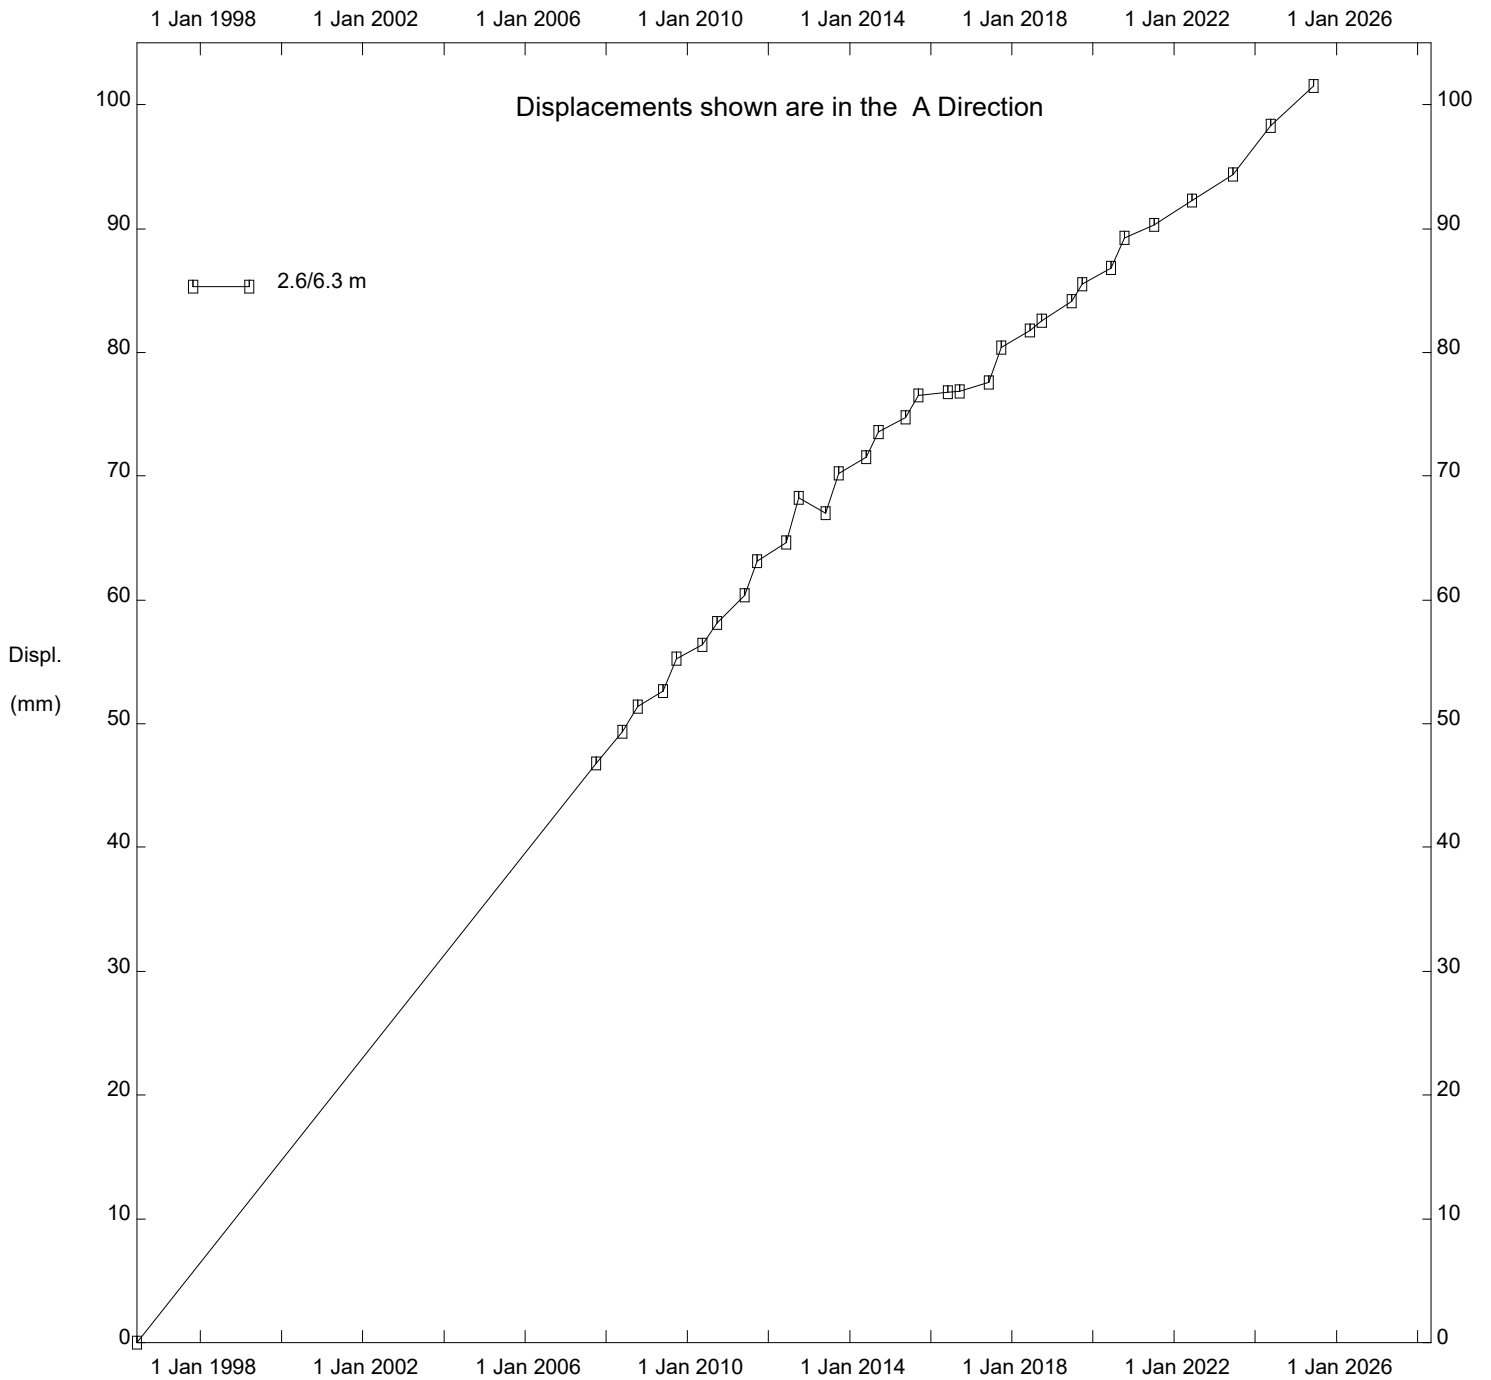
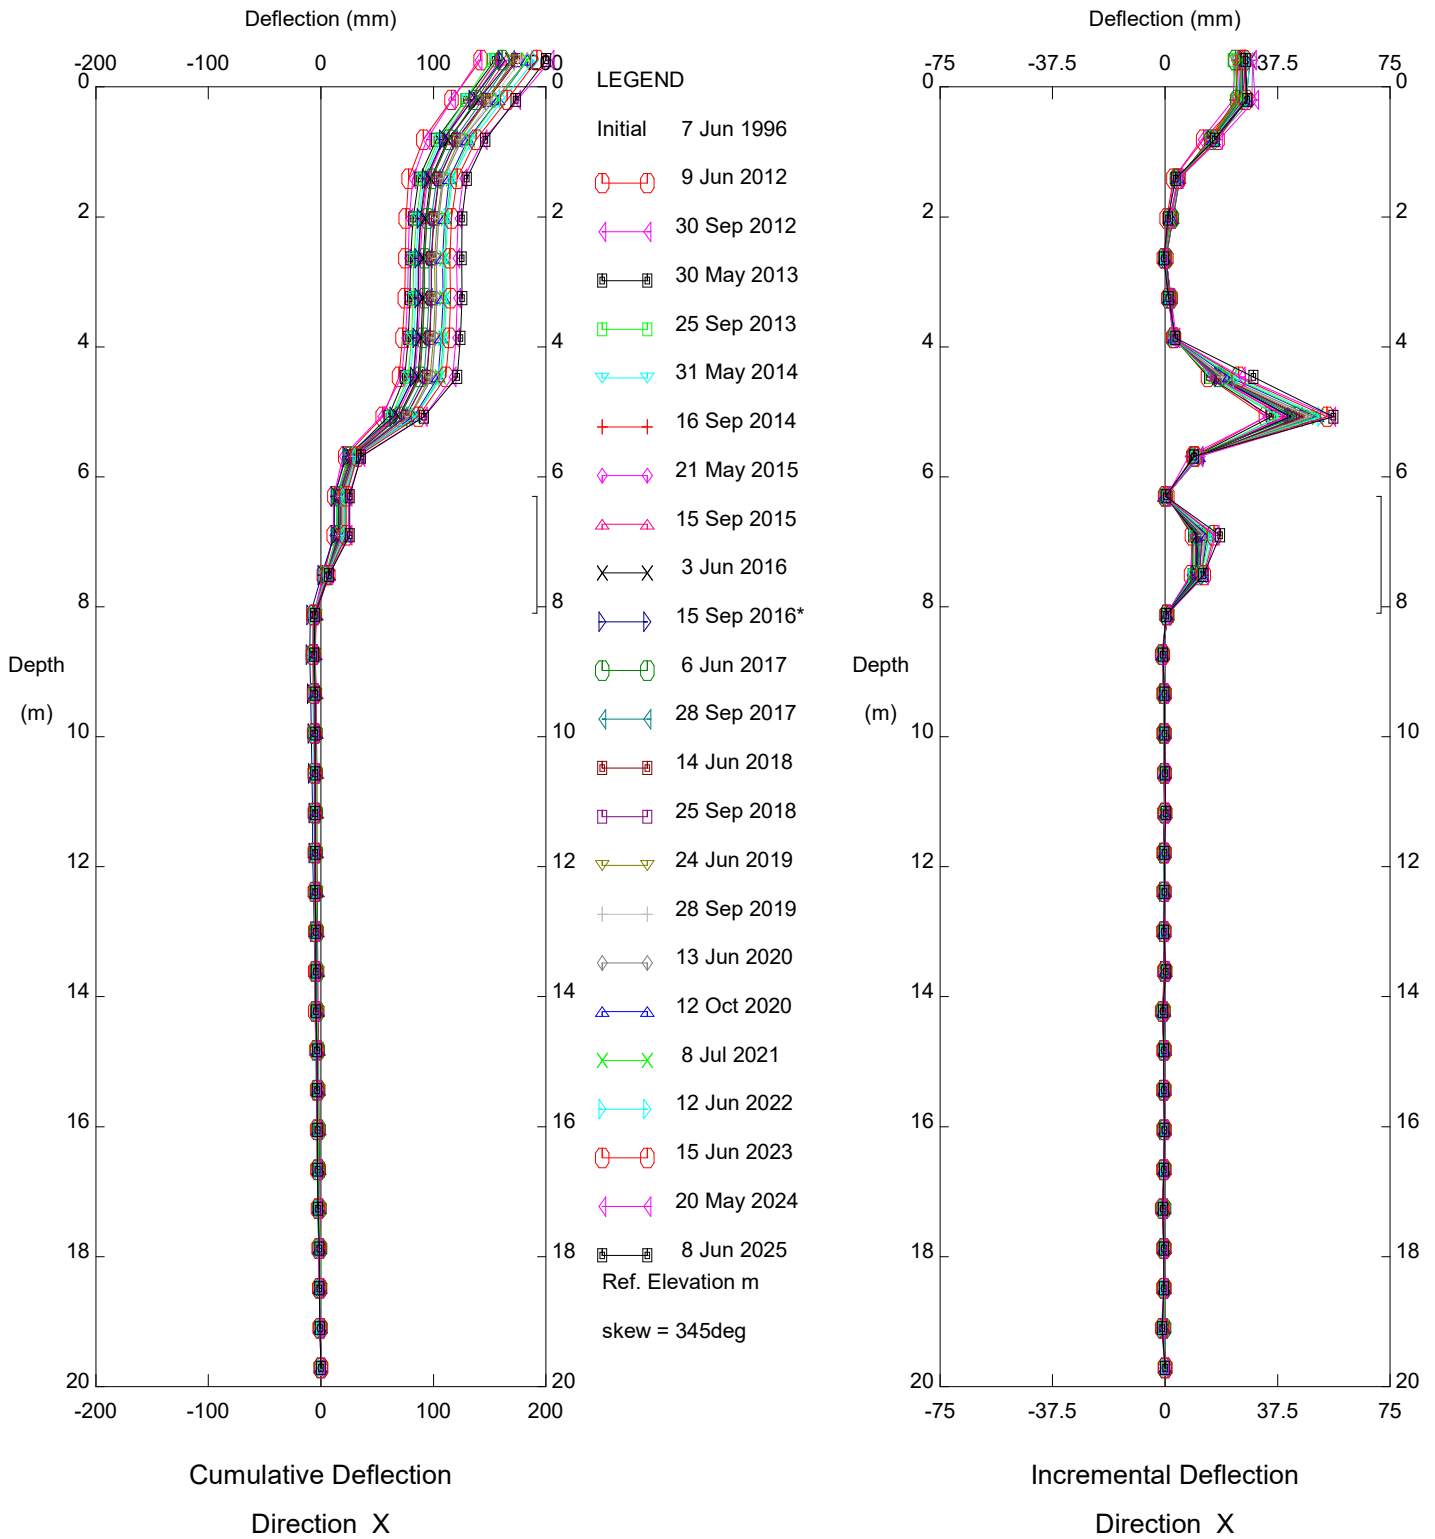
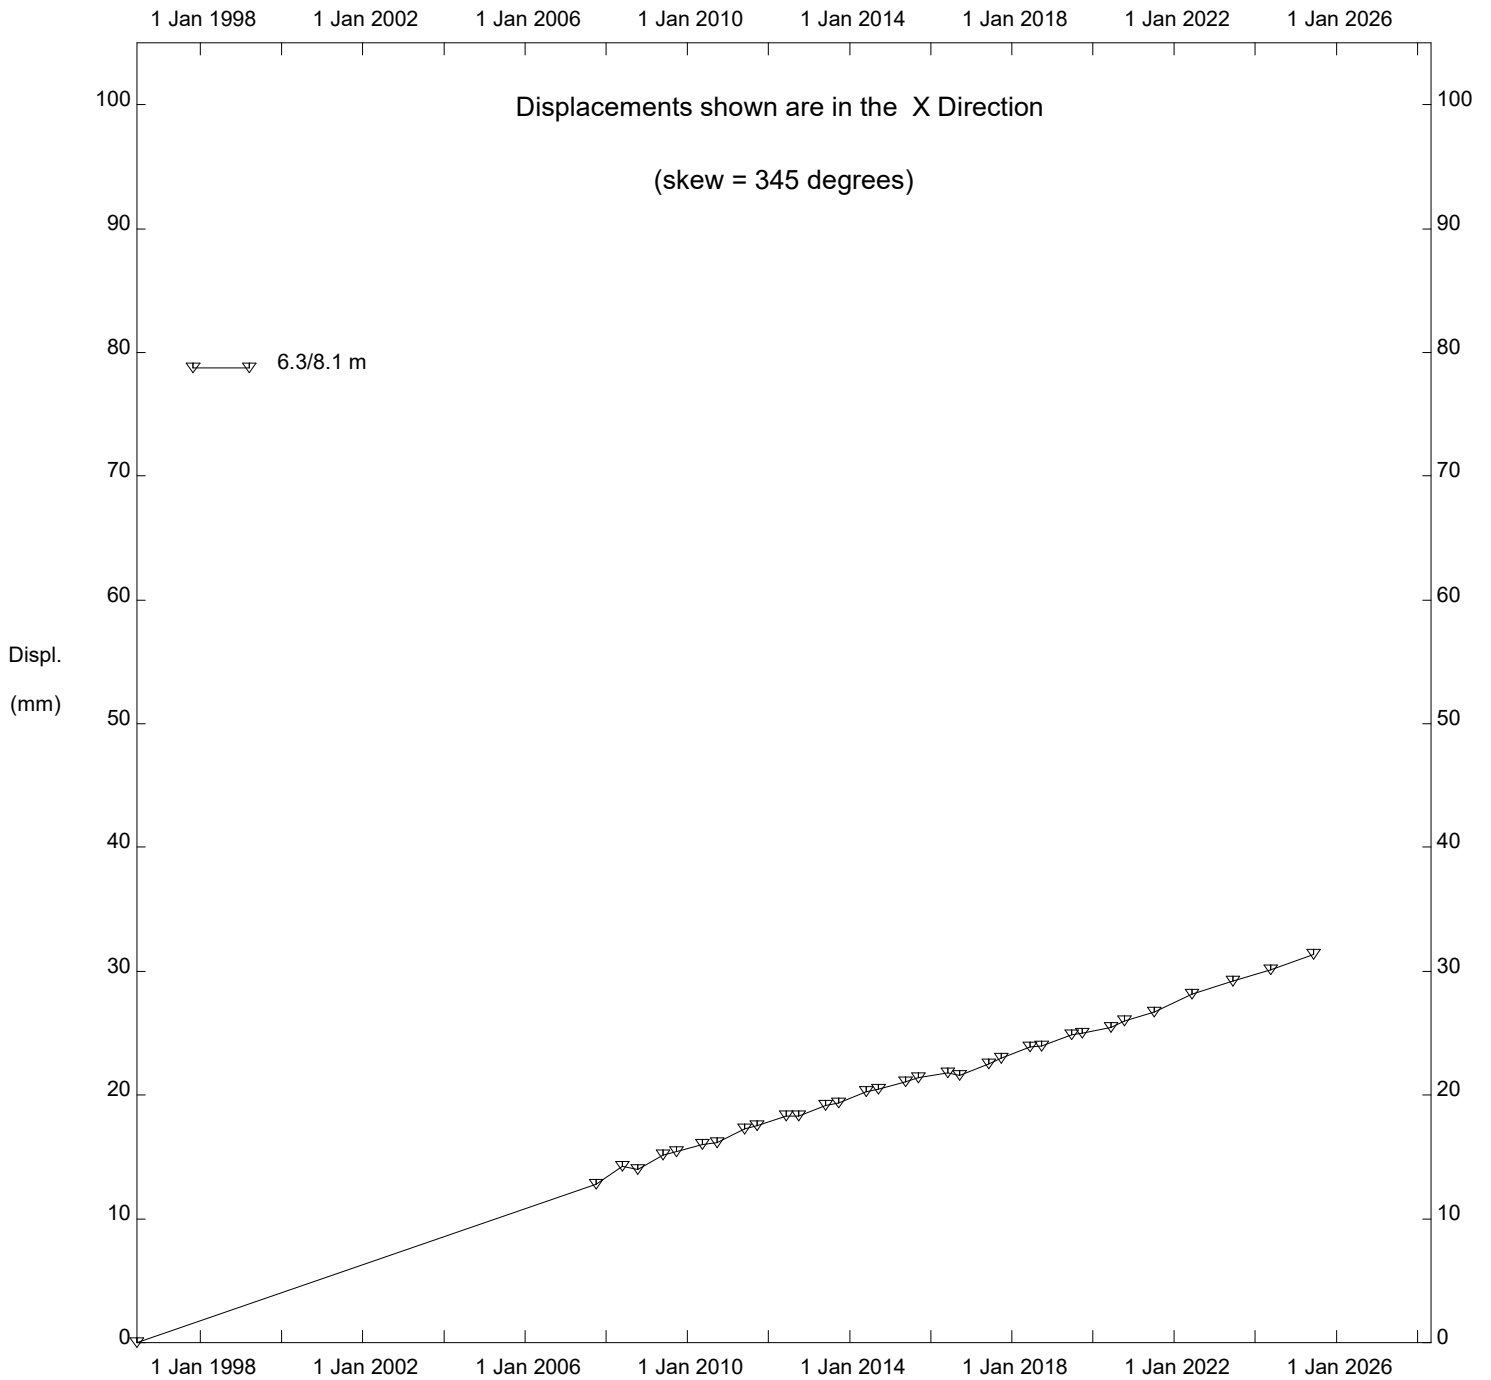
HWY 986:01 - STA. 13+540, Inclinometer SI-4

Discussion	
Zones of New Movement:	None
Interpretation of Monitoring Results:	<p>Pile Wall Site (PH043-1)</p> <p>Slope inclinometers SI-4, SI-5 and SI-6 are located east of the wall and are considered to be outside the main slide block. All three SI's have shown a relatively consistent movement trend and pattern.</p> <p>SI-4 has two distinct movement zones. Since the spring of 2024 SI-4 has shown a rate of movement of 3.0 mm/yr over 2.6 m to 6.3 m depth, which is consistent with a long term rate of movement of 2.7 mm/yr since 2012. SI-4 also showed a rate of movement of 1.2 mm/yr over 6.3 m to 8.1 m depth, which is consistent with the long-term rate of movement of 1.1 mm/yr at that depth.</p> <p>SI-5 has two movement zones. Since the spring of 2024 Si-5 has shown a rate of movement of -4.5 mm/yr over 0.5 m to 1.7 m depth and 1.9 mm/yr over 1.7 to 4.1 m depth. The upper movement zone may be impacted by surface activities and movements fluctuate by 5 to 8 mm within a year while showing an overall increase in movement by about 2.2 mm/yr since 2014. The lower zone rate of movement is consistent with long-term rate of movement of 1.6 mm/yr.</p> <p>SI-6 showed no discernible movement over 0.1 m to 5.0 m depth which is consistent with a fluctuating movement pattern since about 2017. SI-6 also shows a rate of movement of 9.1 mm/yr over 5.0 m to 6.8 m depth. This rate</p>

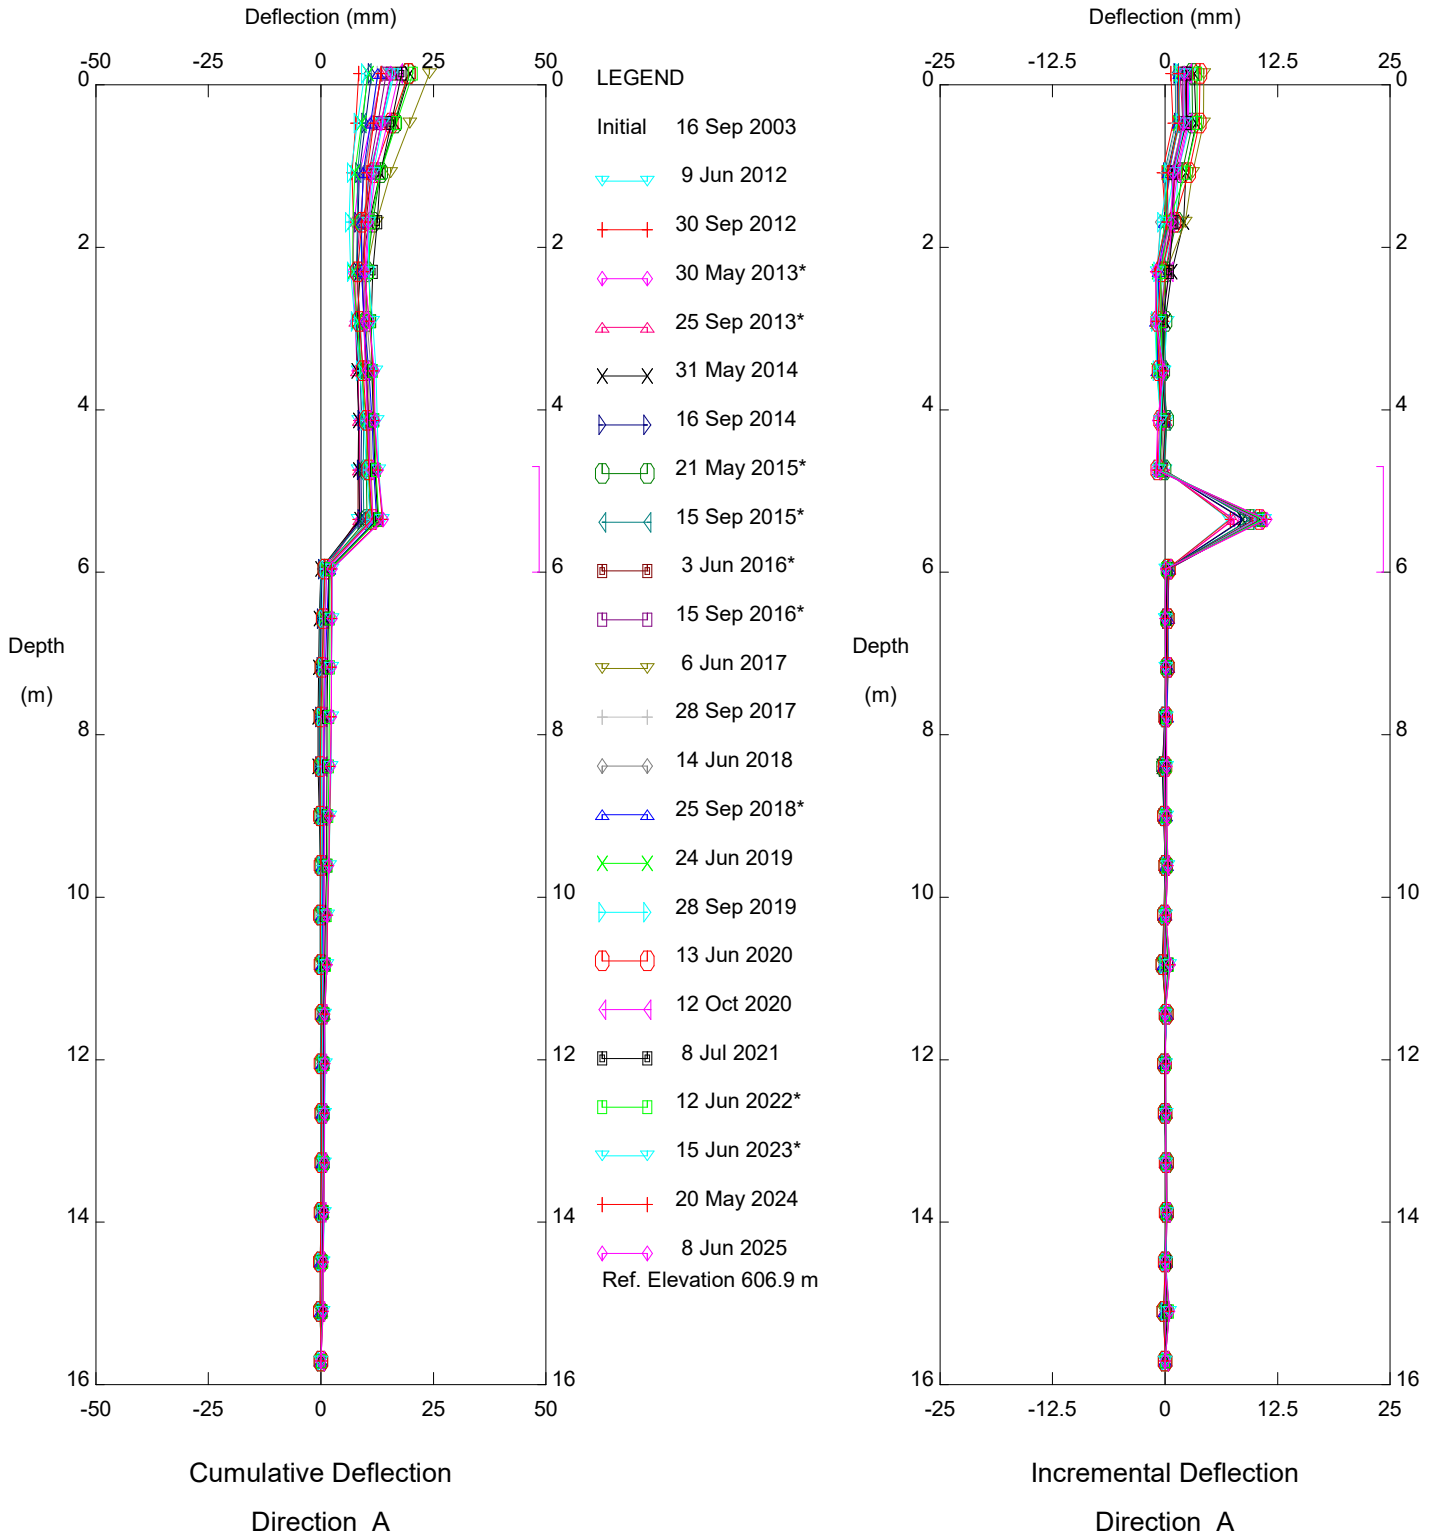
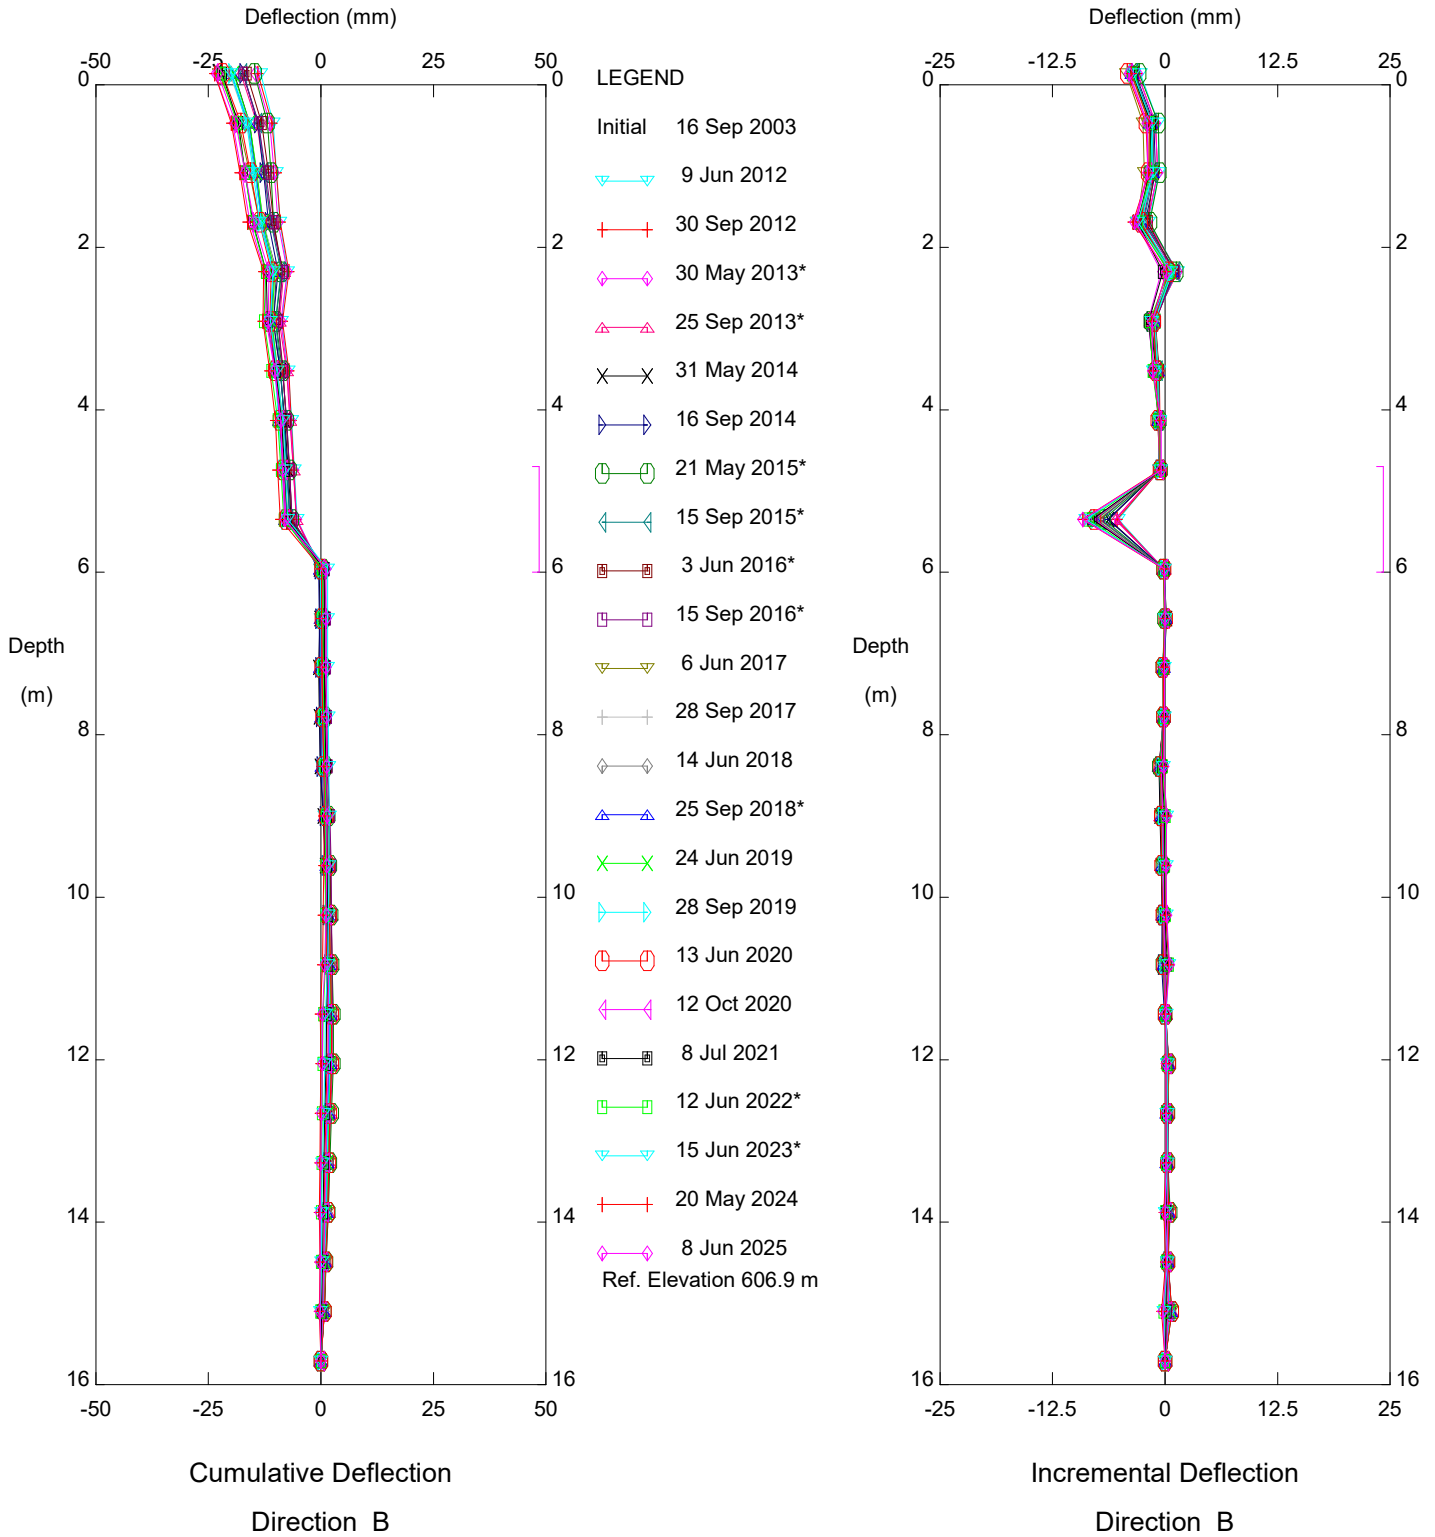
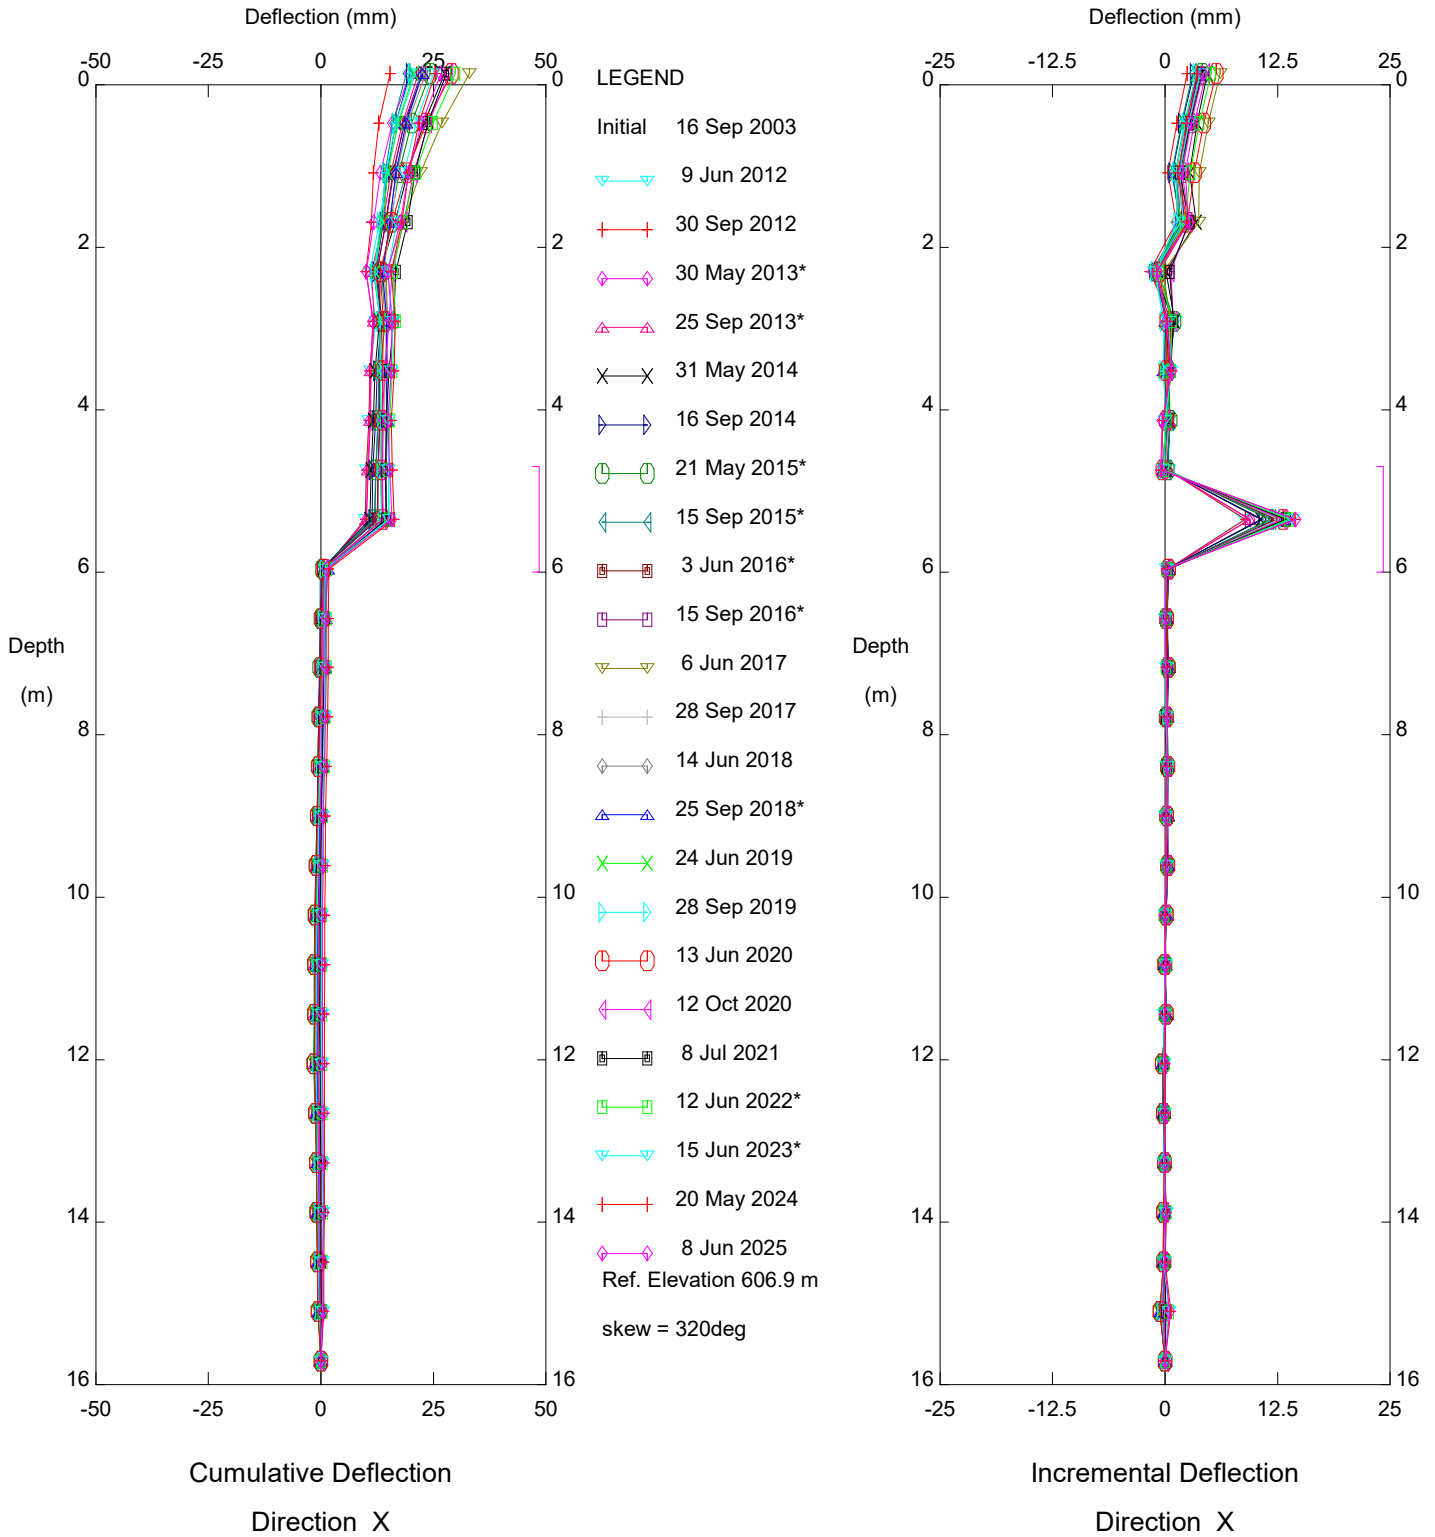
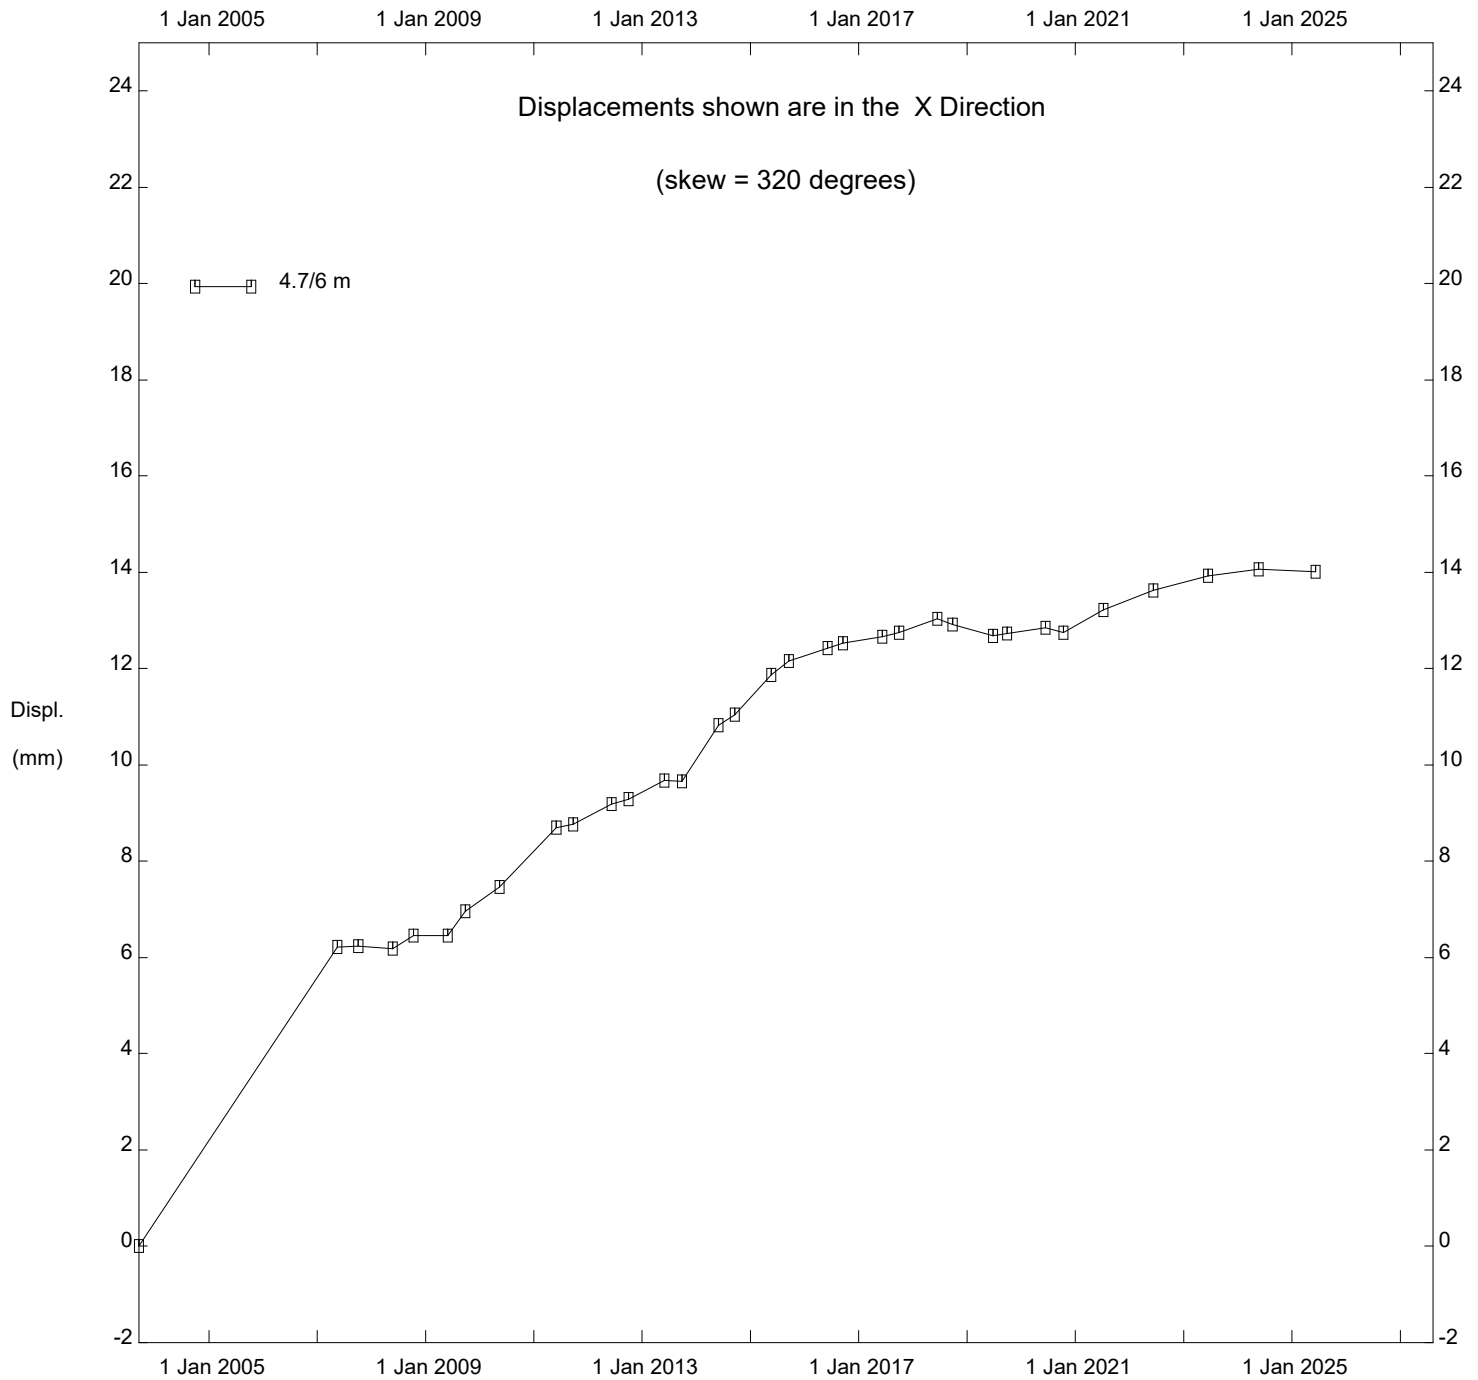
HWY 986:01 - STA. 13+540, Inclinometer SI03-6

<p>reflects an increasing rate of movement over the past 3 years relative to the long-term rate of movement of 1.1 mm/yr at that depth.</p> <p>Slope inclinometer SI03-6, installed upslope highway, showed no discernible movement over 4.7 m to 6.0 m depth since the spring of 2024 readings which is consistent with an asymptotic movement pattern that has leveled out at about 14 mm of total movement.</p> <p>Only two (SI04-1 and SI04-3) of the three slope inclinometers installed in the pile wall are currently operational.</p> <p>SI04-1 showed a rate of movement of 1.9 mm/yr over 0.1 to 2.6 m since the spring of 2024 which continues a slowing trend relative to the long-term average of 12.6 mm/yr since 2016. SI04-1 also showed a rate of movement of 3.0 mm/yr over the length of the pile which is consistent with the long-term rate of 2.5 mm/yr since 2016. Above 14 m depth the pile is gradually tilting and the pile head has deflected a total of 69.0 mm to date.</p> <p>SI04-3 showed no discernible movement over 0.1 to 1.4 m depth since the spring of 2024 readings, however the pattern of movement is consistent with annual fluctuating readings and an overall rate of movement of 6.0 mm/yr since 2018. SI04-3 also showed a rate of movement of 7.6 mm/yr over the length of the pile which is consistent with the long-term rate of 7.8 mm/yr since 2018. Above 12 m depth the pile is gradually tilting, and the pile head has deflected 118.4 mm to date.</p> <p>Pneumatic piezometer PN03-1 showed a decrease in groundwater level of 0.15 m since the spring of 2024 readings, which represents the lowest groundwater level measured in the instrument since October 2007. Pneumatic piezometer PN03-2 showed a decrease in groundwater level of 0.02 m since the spring of 2024 readings.</p> <p>Site B (PH043-2)</p> <p>Slope inclinometers SI-7, SI-8 and SI-9 are located in the highway side slope (Station 33+820), about 300 m north of the pile wall.</p> <p>SI-7 continued to show no discernible movement.</p> <p>SI-8 showed -5.7 mm/yr over 0.3 m to 1.5 m depth since the spring of 2024 however the pattern of movement is consistent with fluctuating readings and an overall rate of movement of 1.1 mm/yr since 2008. readings. SI-8 also showed -2.5 mm/yr and over 1.5 m to 4.0 m depth since the spring of 2024 which represents a slowing rate of movement relative to an overall rate of movement of 0.6 mm/yr since 2008.</p> <p>SI-9 showed a rate of movement of 2.5 mm/yr over 0.3 m to 2.7 m depth since the spring of 2024 readings. This is consistent with the long-term rate of movement of 3.0 mm/yr since 2008</p>
