Site Number	Location	Name	Hwy	km
PH043	HWY 986:01 C1 33.357	Daishowa Retaining Wall	986:01	Km 33.4
Legal Description:		UTM Co-ordinates		
9-7-85-20 W5		11U E 491412.57	N	6246098.92

Current Monitoring:	8-June-2025	Previous Monitoring	20-May-2024
Instruments Read By:	Mr. Niraj Regmi, G.I.T and Mr. Godfred Etiendem, of Thurber

**ALBERTA TRANSPORTATION AND ECONOMIC CORRIDORS GRMP (CON0022164)
PEACE REGION (PEACE RIVER DISTRICT)
INSTRUMENTATION MONITORING RESULTS**

**SITE PH043-1: HWY 986:01, DAISHOWA EAST HILL PILE WALL
SITE PH043-2: HWY 986:01, DAISHOWA EAST HILL SITE B**

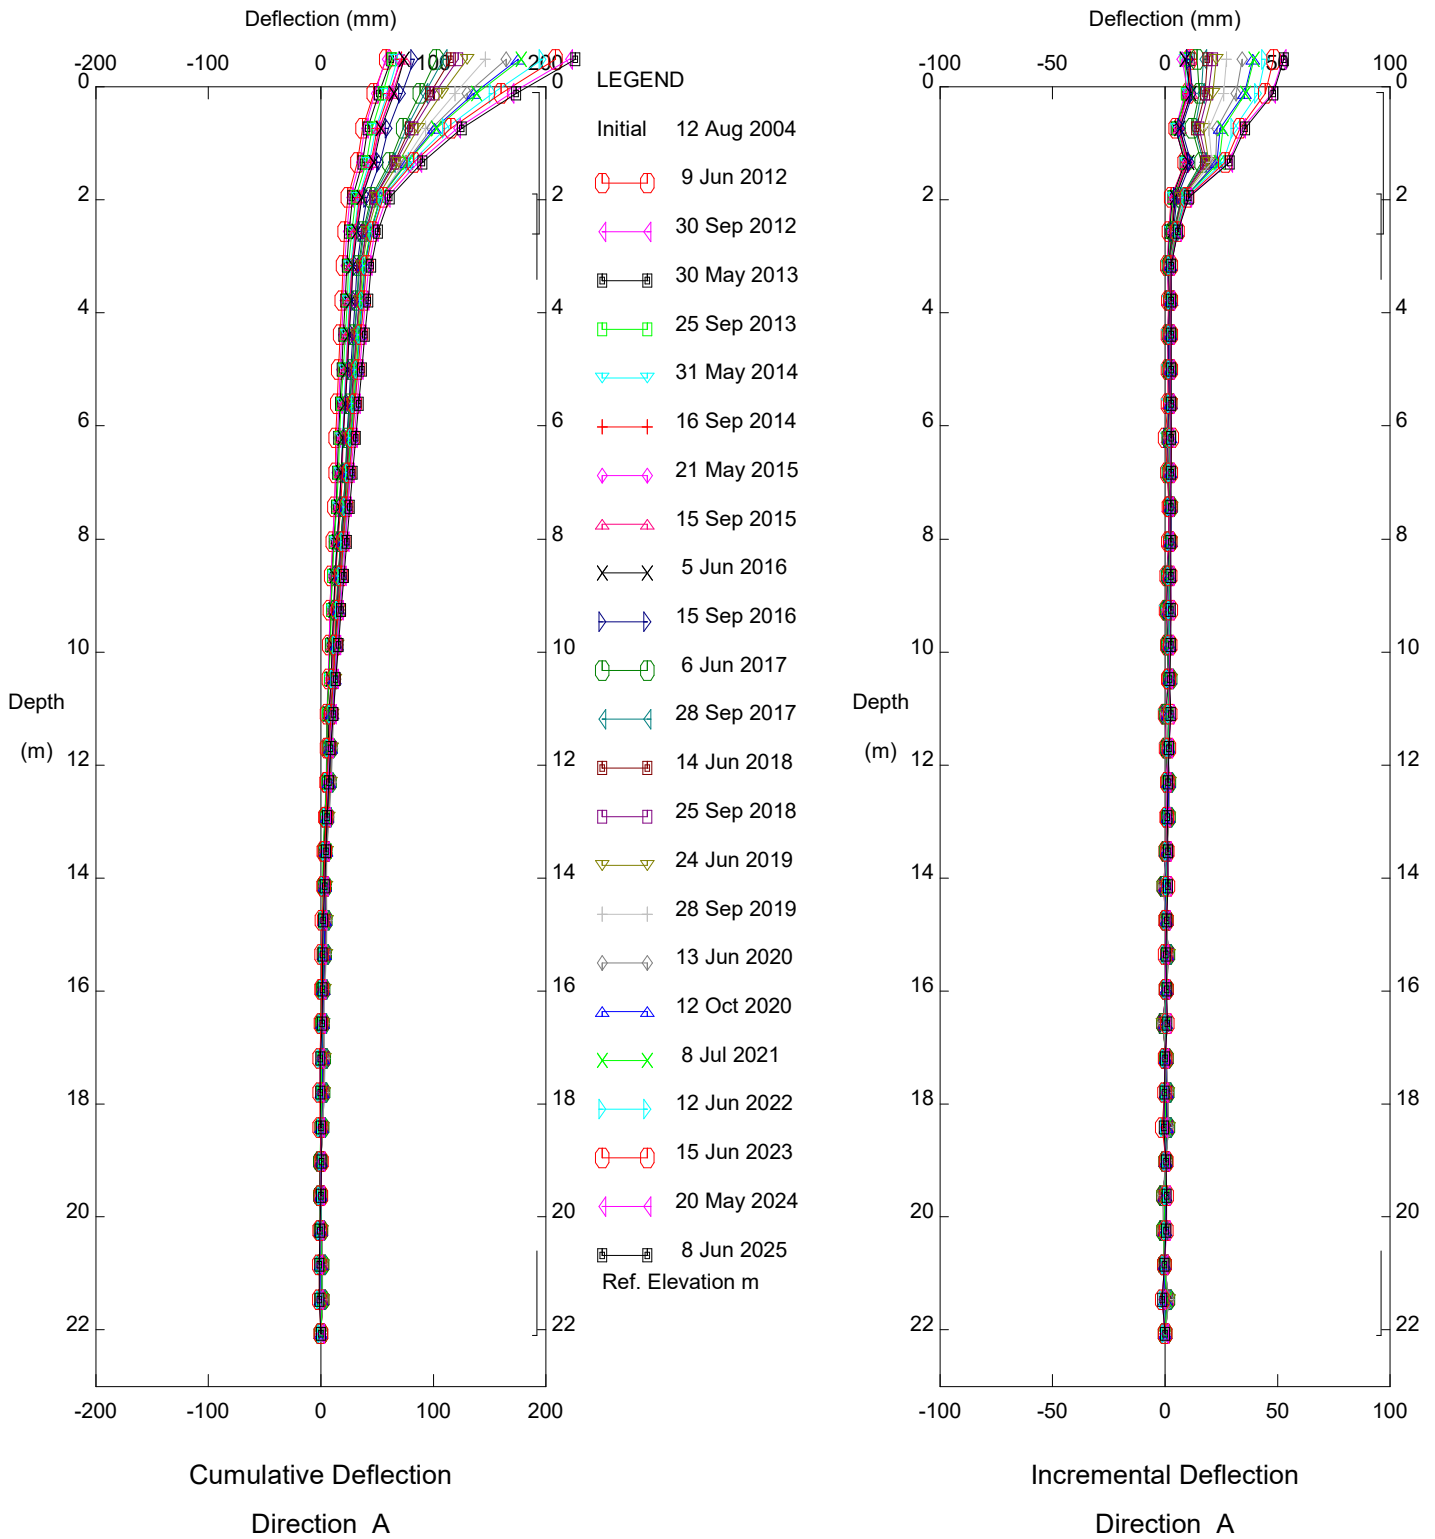
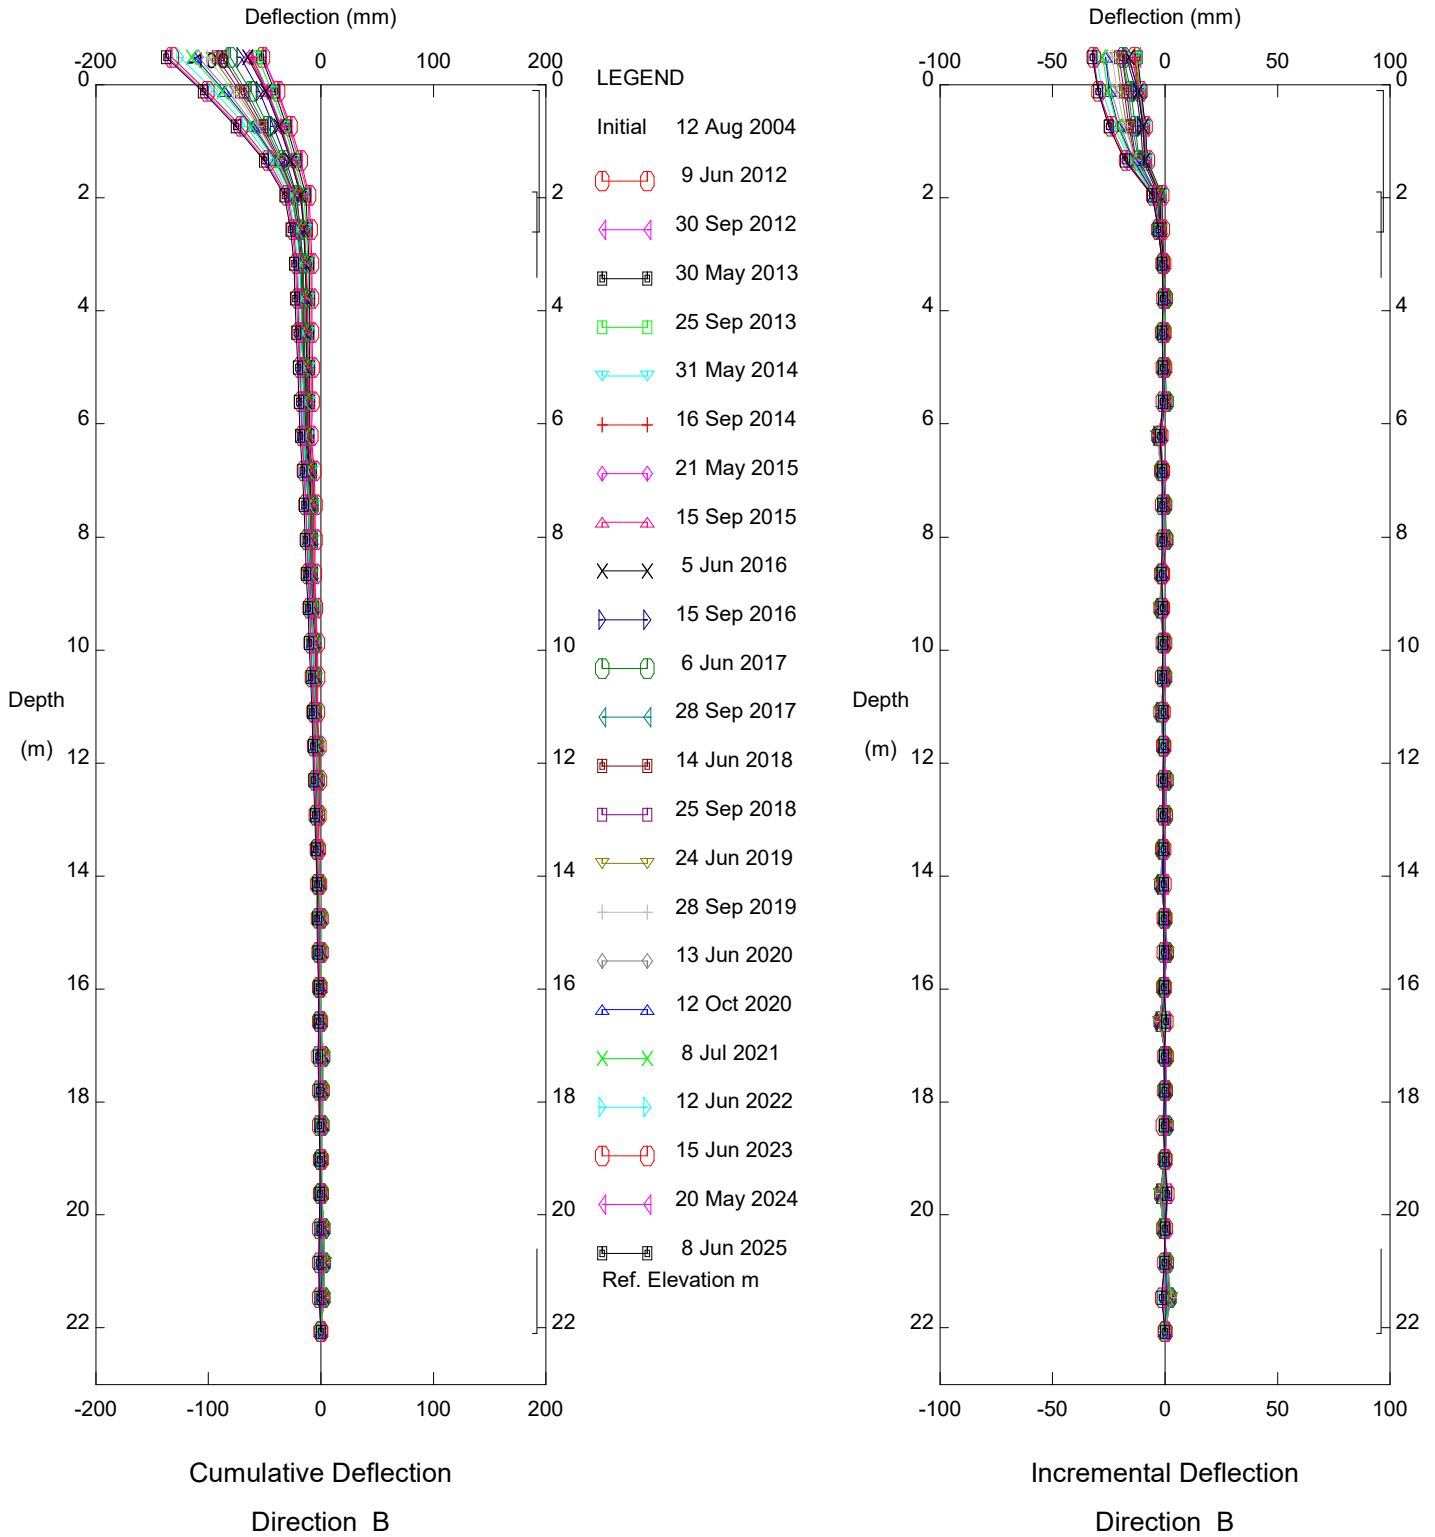
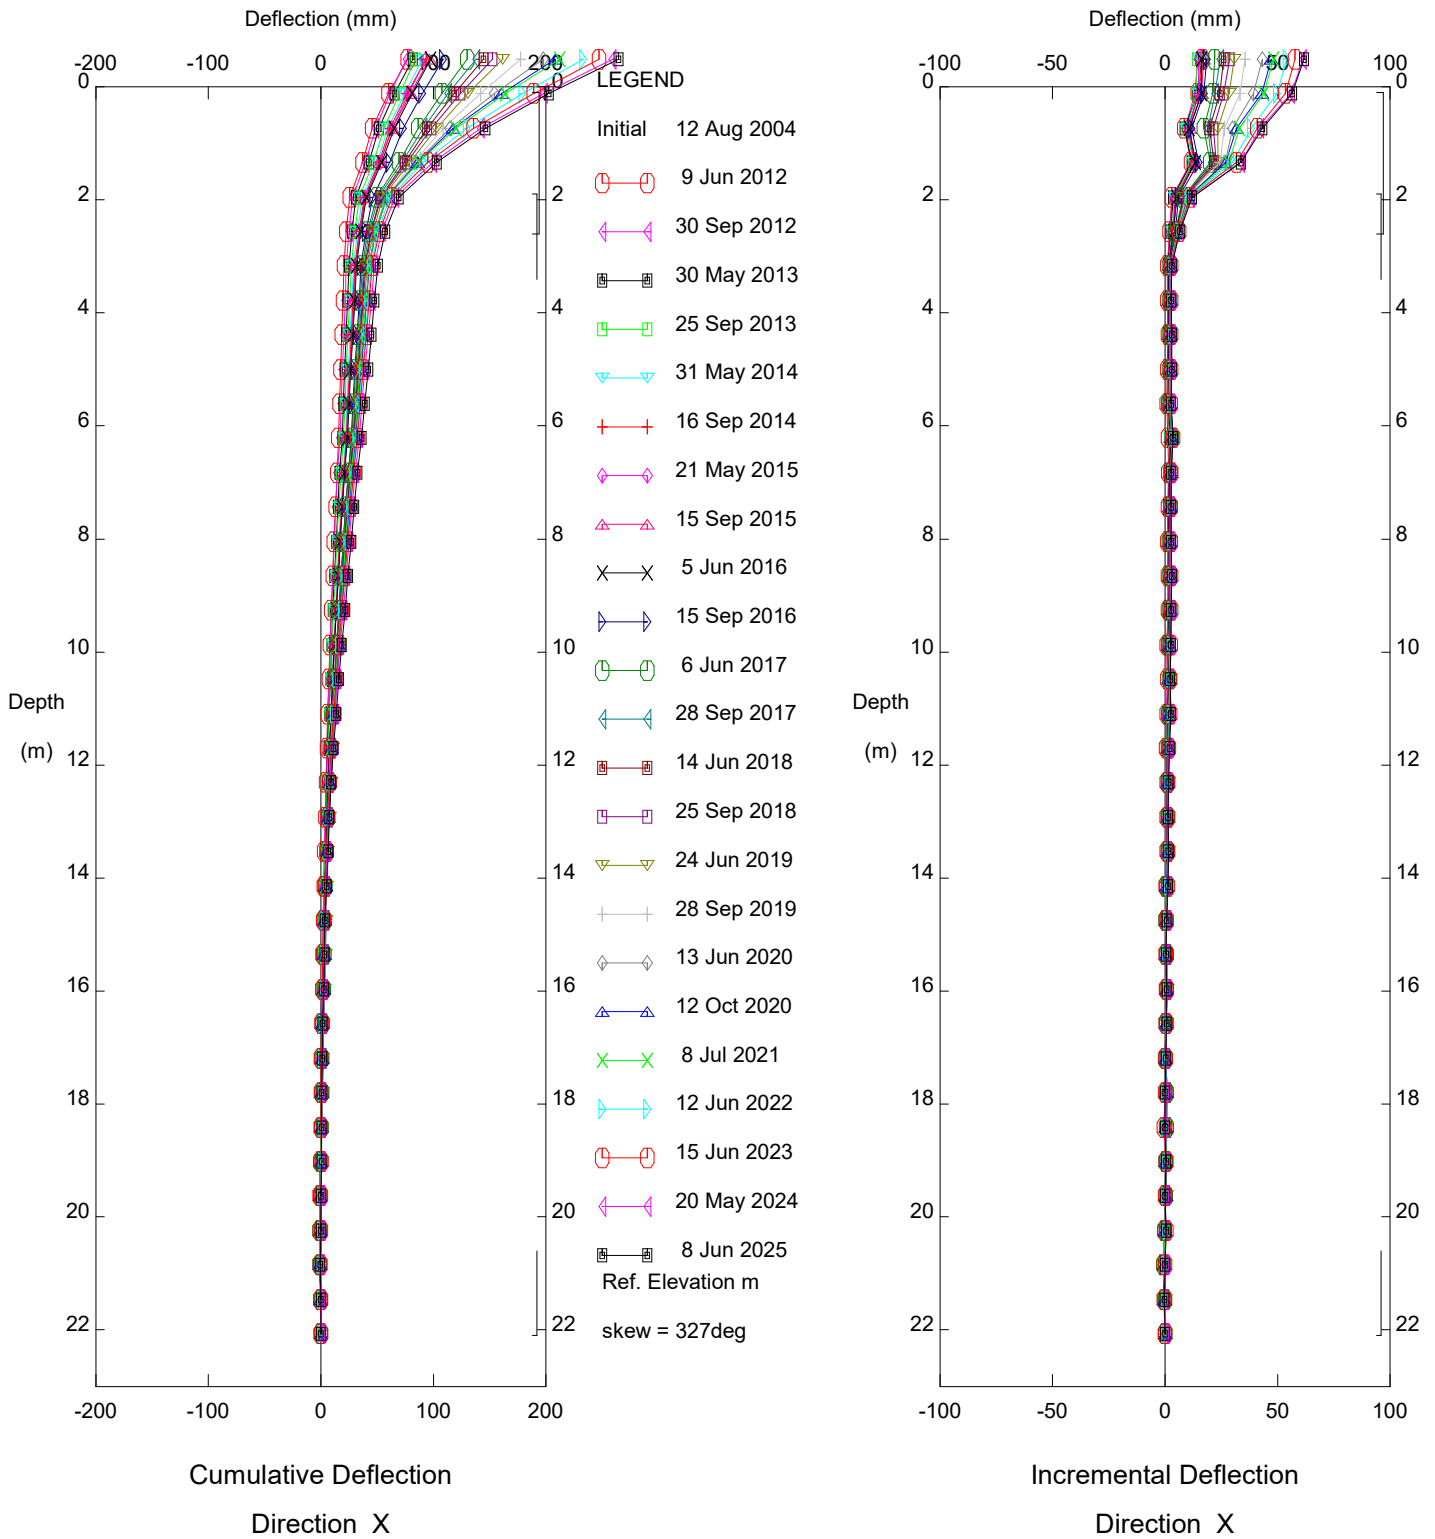
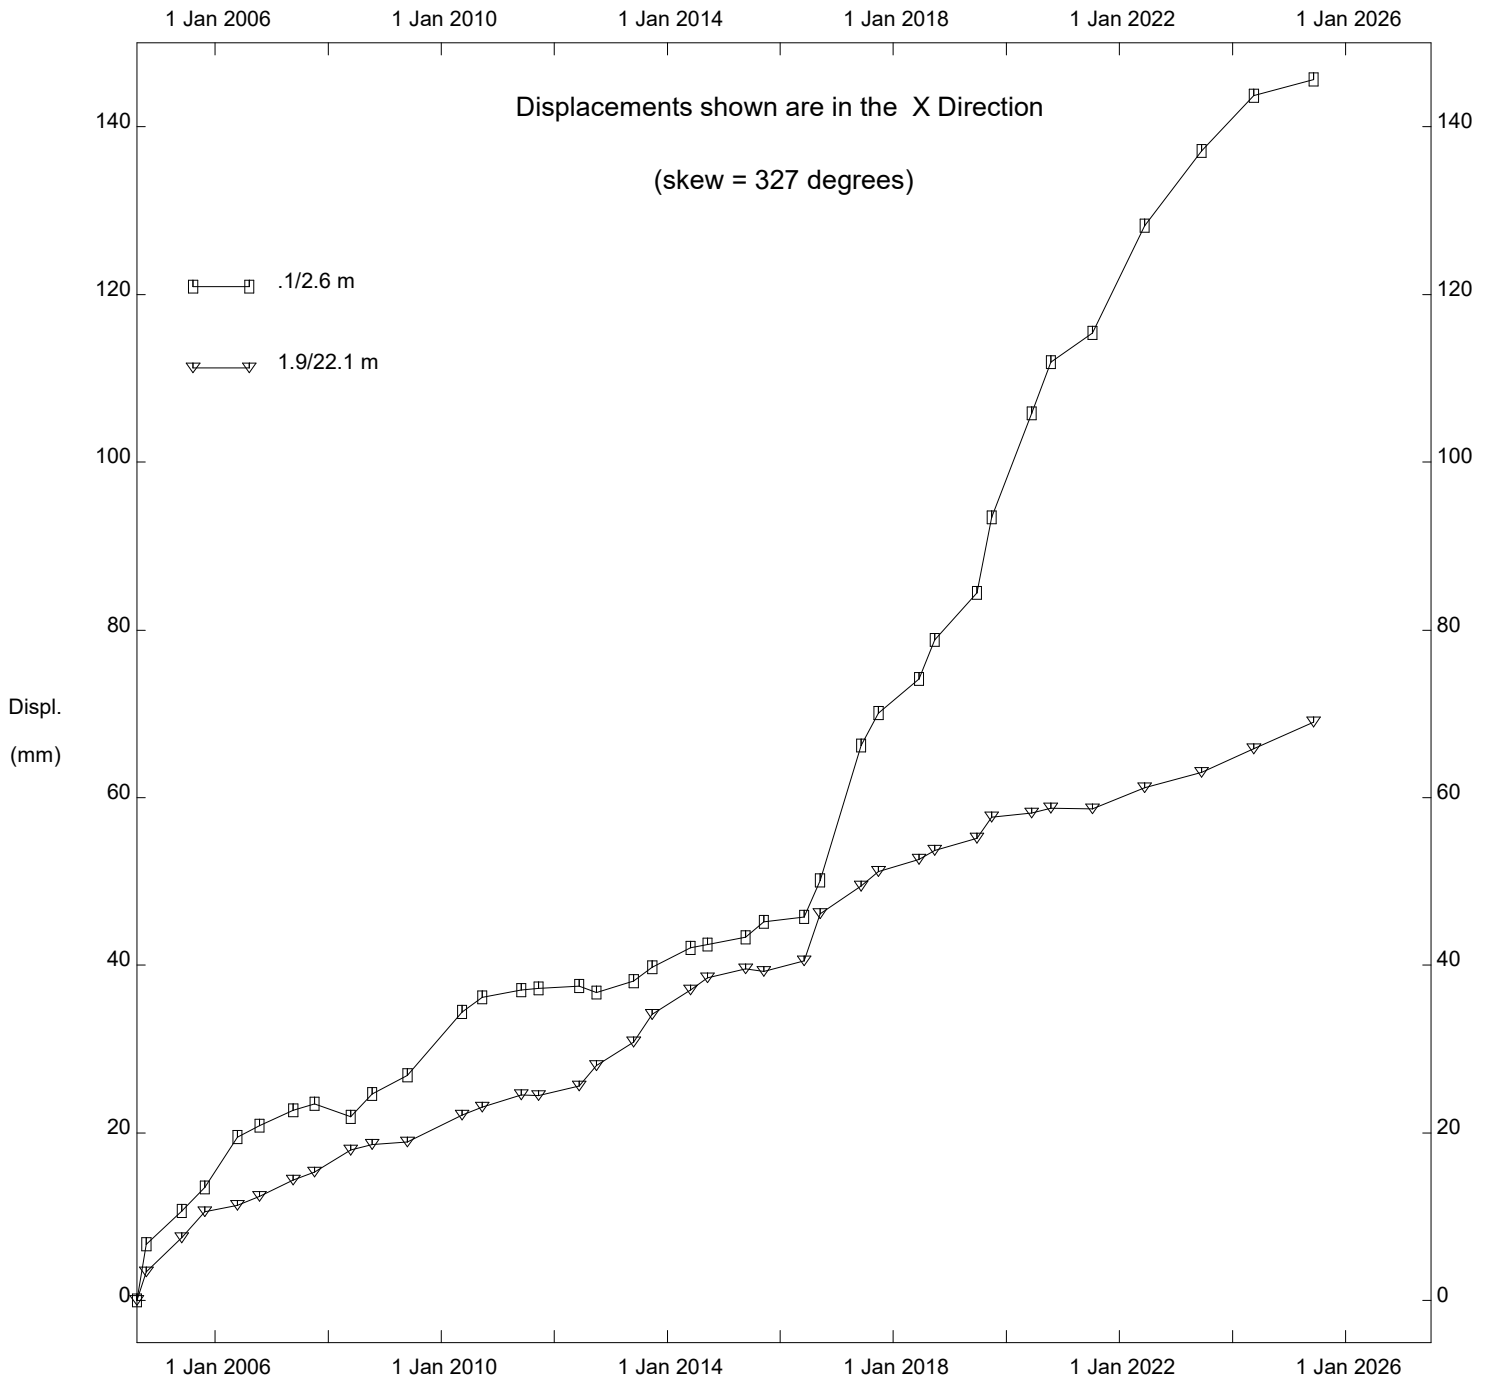
HWY 986:01 - STA. 13+540, Inclinometer SI04-1

Future Work:	The instruments should be read again in the spring of 2026.
Instrumentation Repairs:	No instrument repairs are required at this time.
Additional Comments:	There was a noticeable increase in movement in SI04-1 during 2017 and 2018 when a landslide movement occurred downslope of the wall during erosion repairs of erosion and construction of a gabion drop structure at the creek level. A driven steel pile wall and grading were carried out to mitigate those movements. The increased rate of movement trend is still observed within the upper 2 m. Some slope flattening was also carried out, consisting of removing some soil from the top of the pile wall near SI04-3.

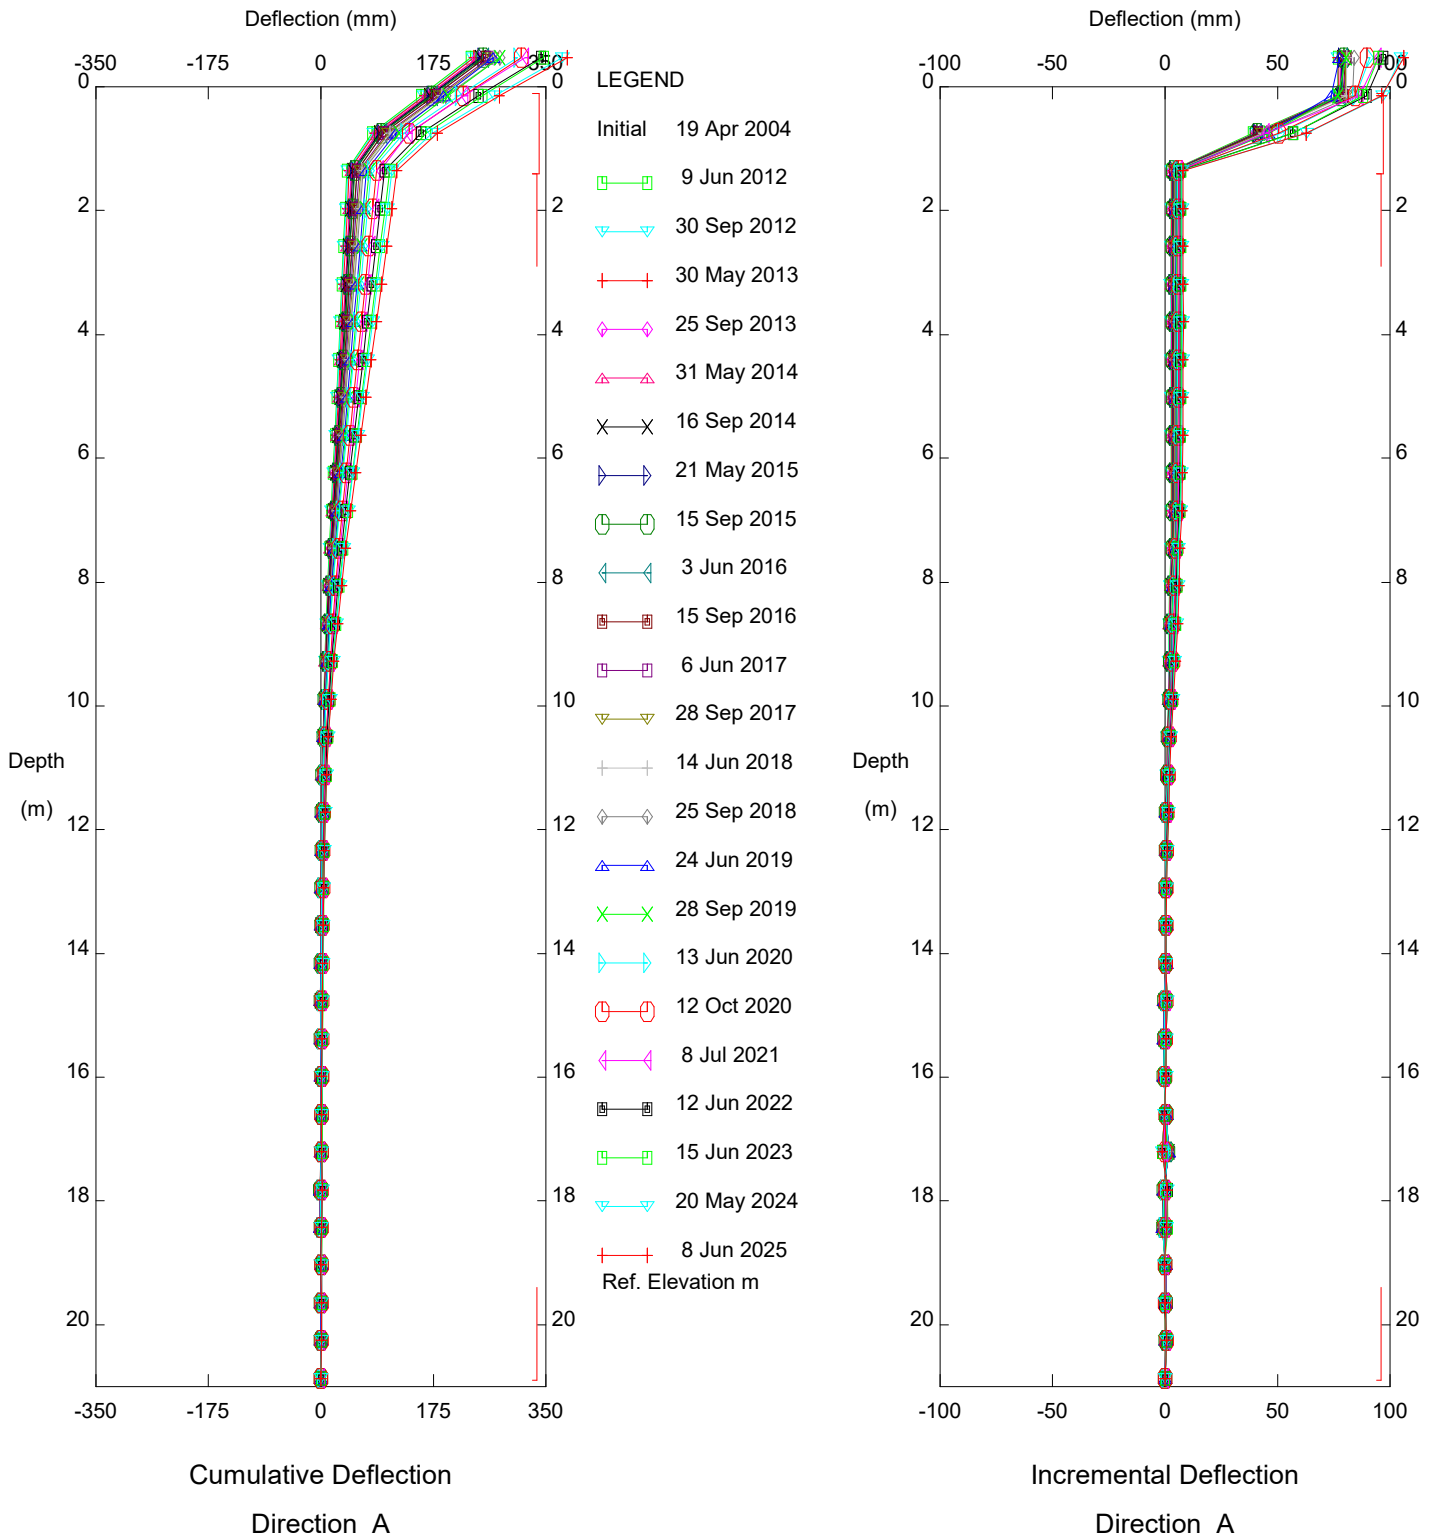
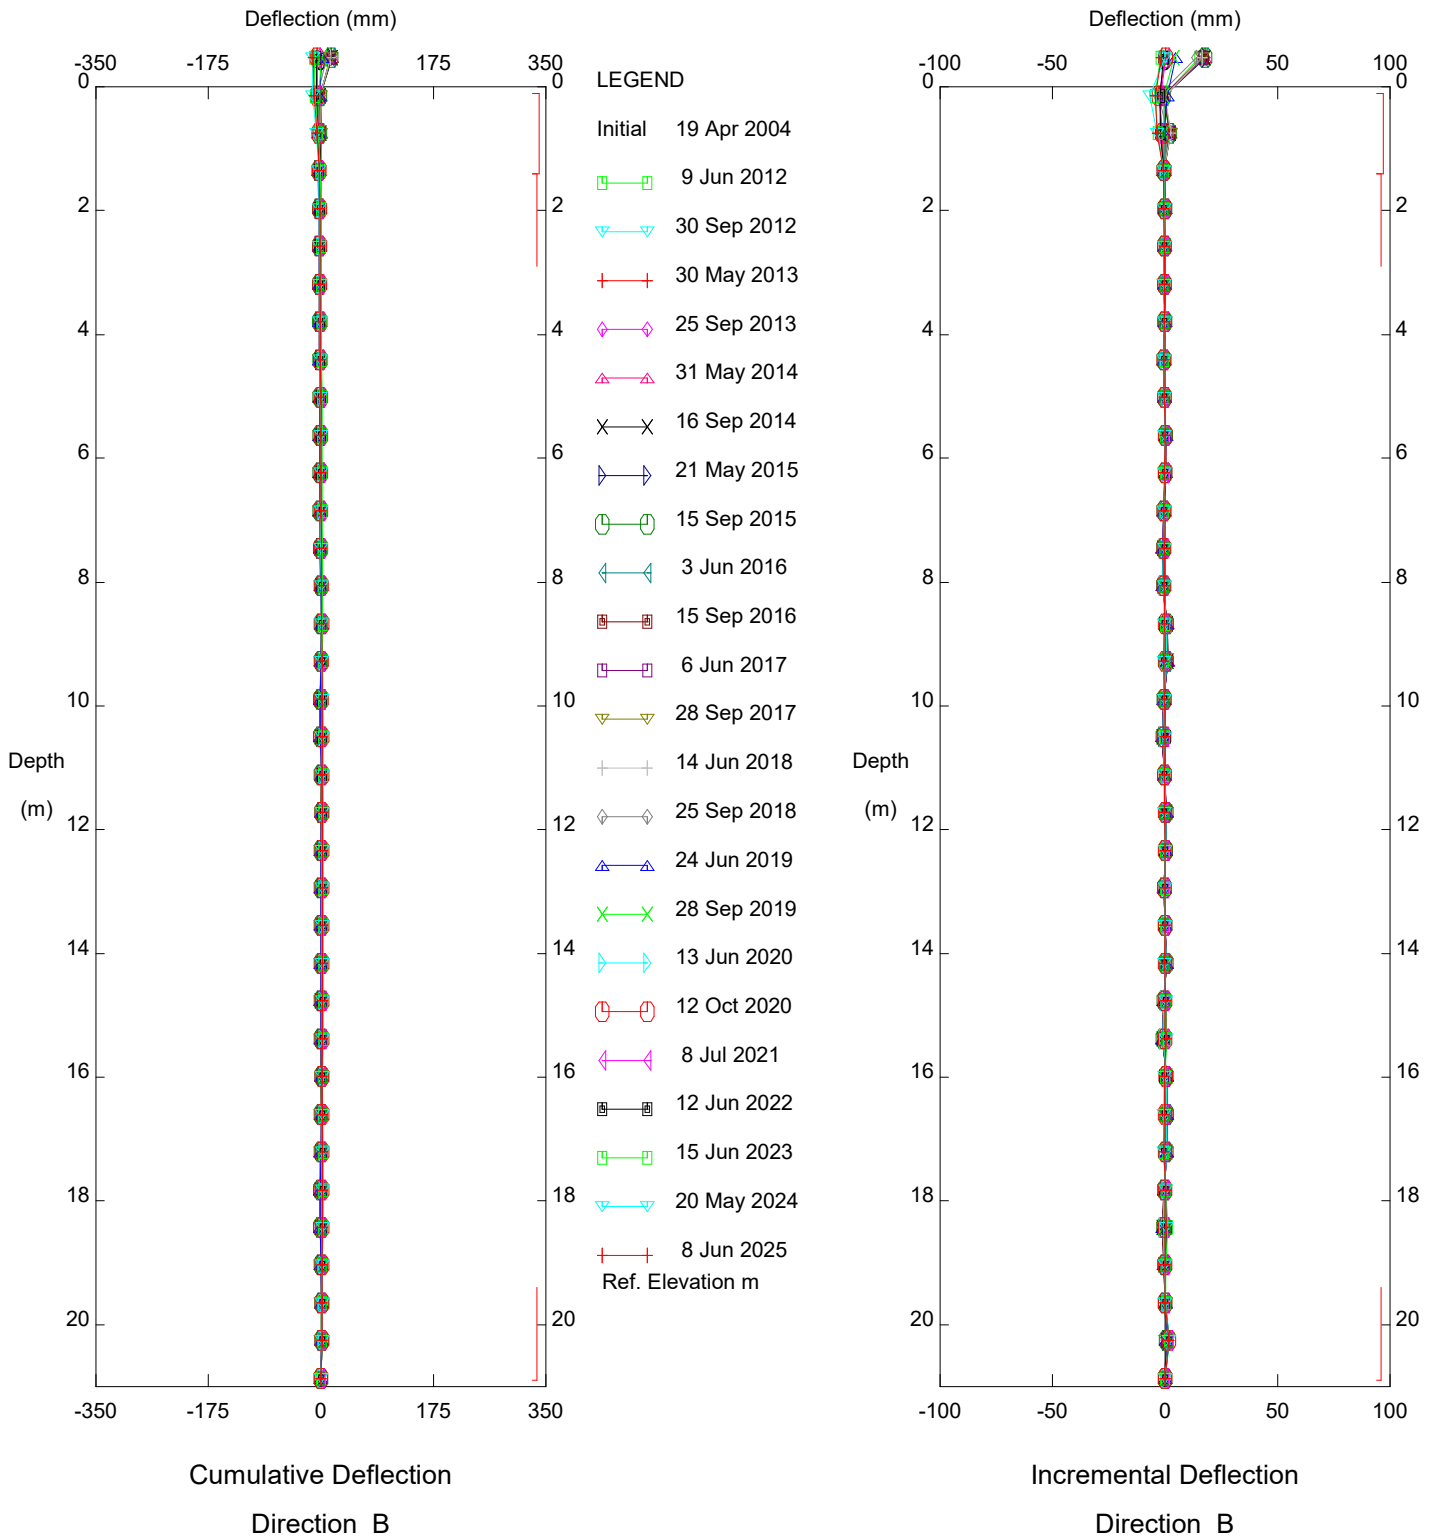
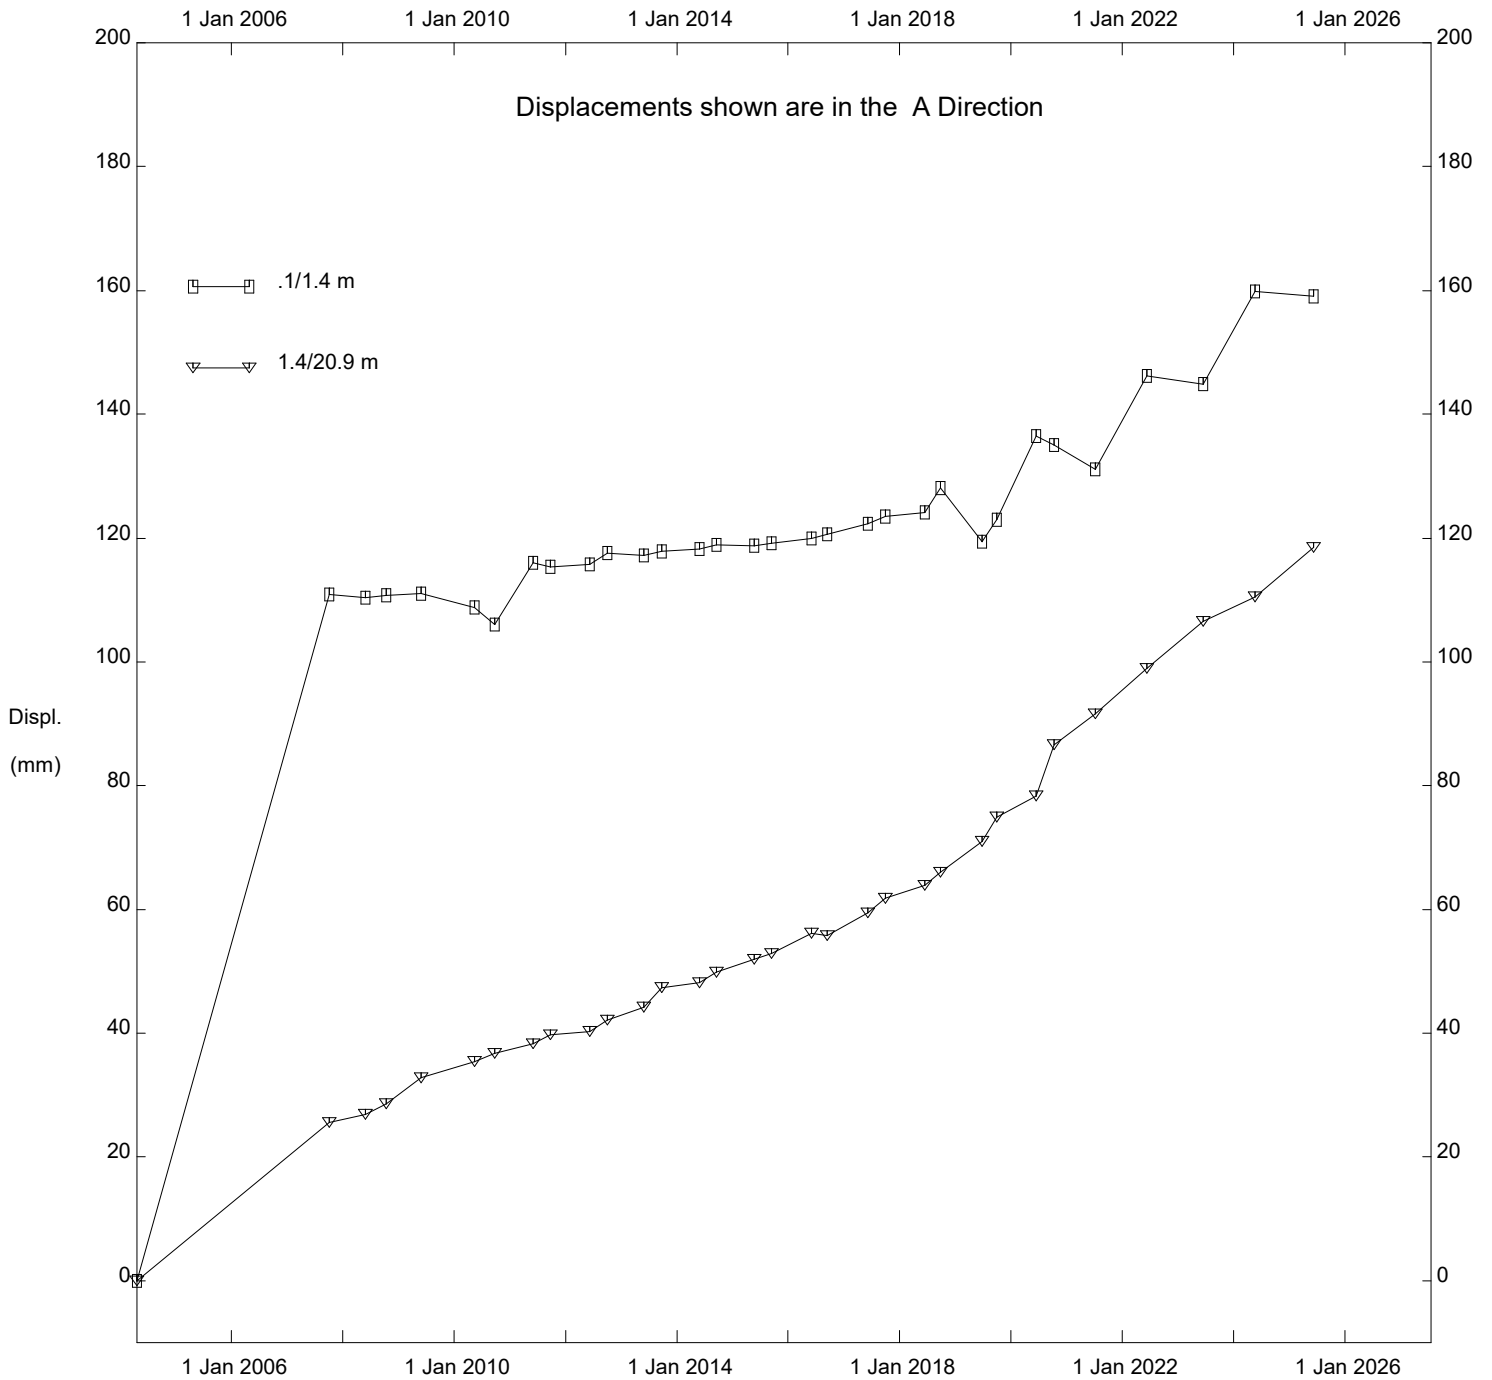
HWY 986:01 - STA. 13+540, Inclinometer SI04-3

* Bottom of SI04-3 sitting at 69ft
