THURBER ENGINEERING LTD.

October 25, 2004

15-16-190

**PEACE REGION – PEACE HIGH LEVEL GEOHAZARD ASSESSMENT
(CE049/2004) CALL-OUT FOR EMBANKMENT
AND DITCH EROSION DISTRESSES
ON HWY 986:01, DAISHOWA EAST ACCESS PH 7**

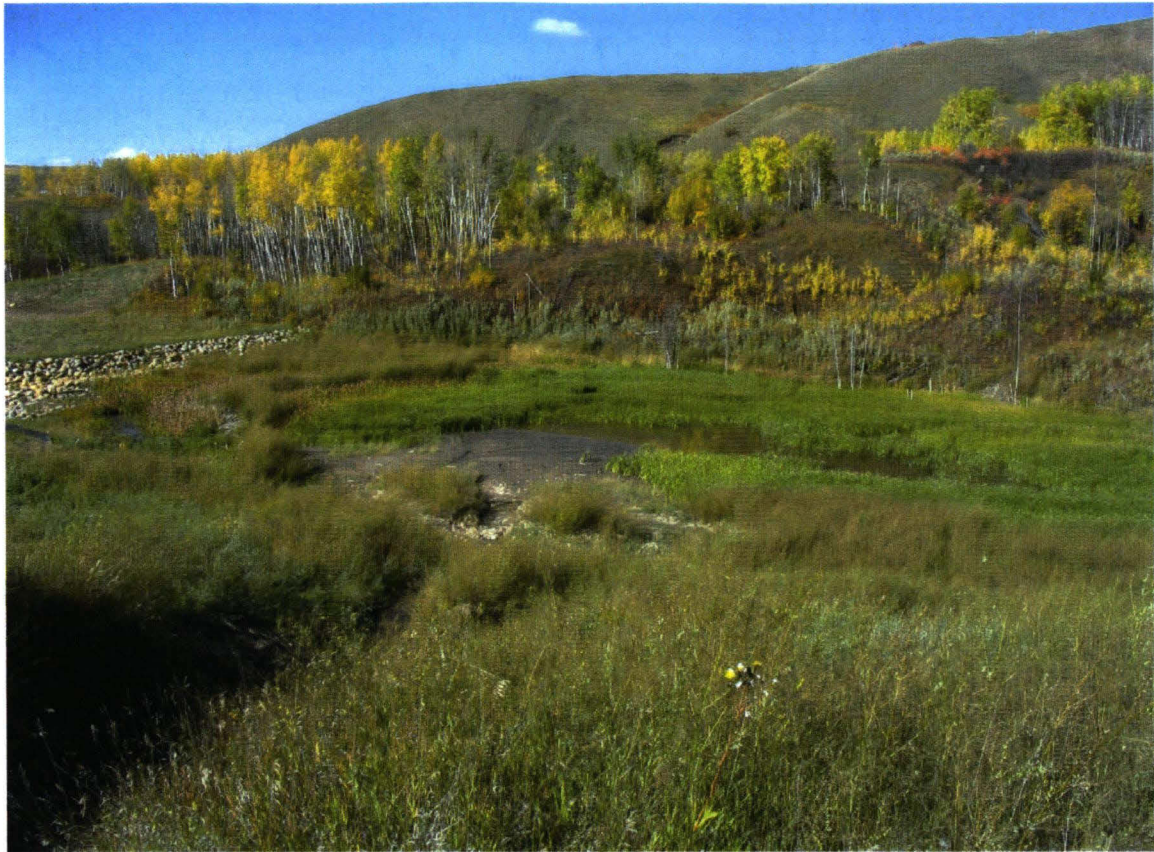
A significant amount of silt has been deposited in the pond as shown in Photo 1.

PHOTO 1 SILT FROM DITCH EROSION HAS SETTLED IN POND

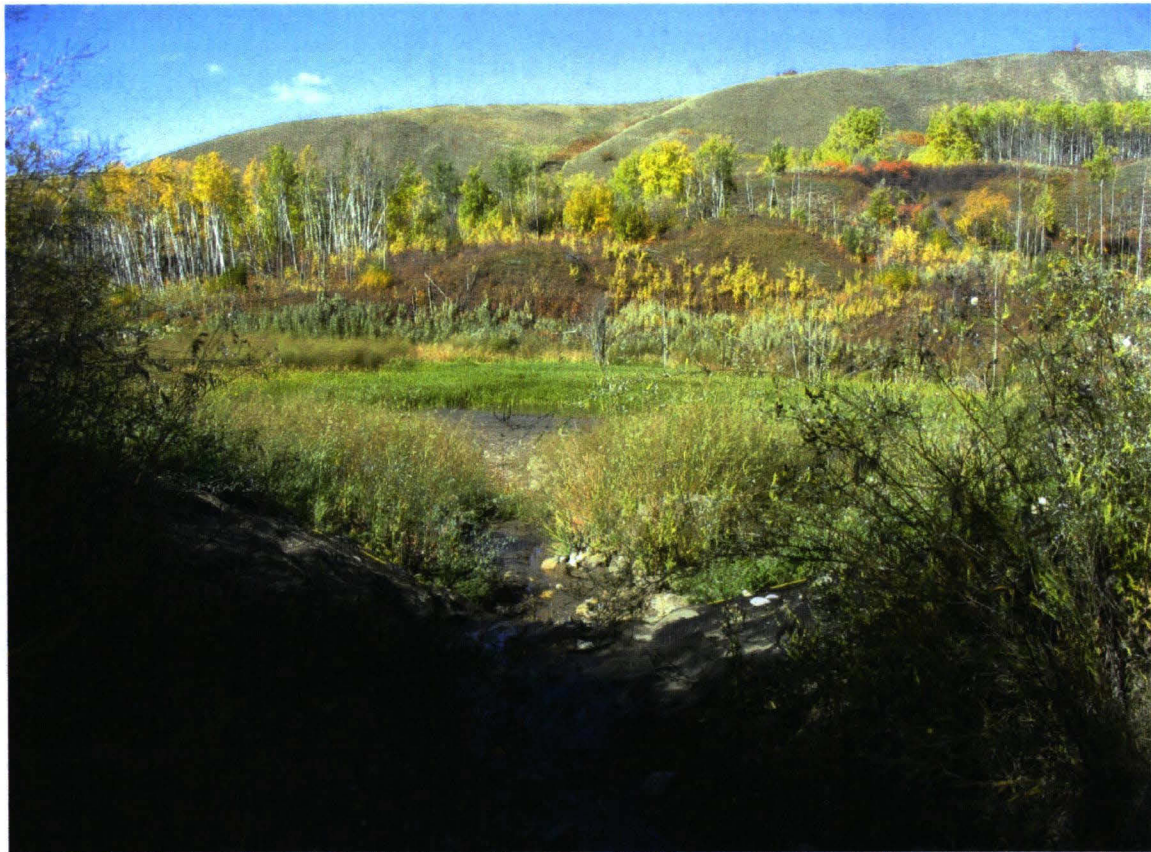
PHOTO 2 NORTH END OF EROSION CHANNEL NEAR OUTLET TO POND

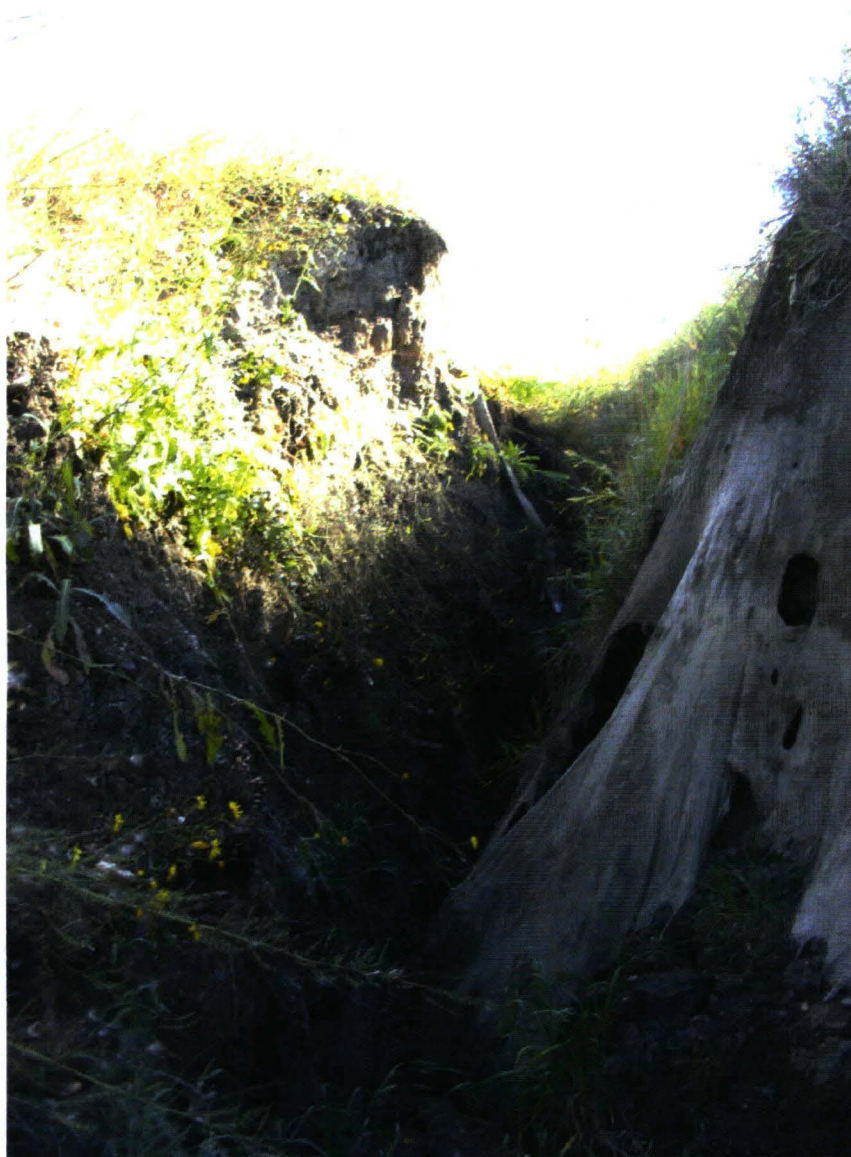
As shown on Photo 3, a non-woven geotextile, perhaps in conjunction with gravel or riprap, had been placed along the gully bottom in the past. However, since the depth of the gully extended below the geotextile it appears that this technique was not sufficient to prevent further down cutting of the erosion gully.

PHOTO 3 DEEPEST PART OF EROSION CHANNEL IS ABOUT 3m DEEP

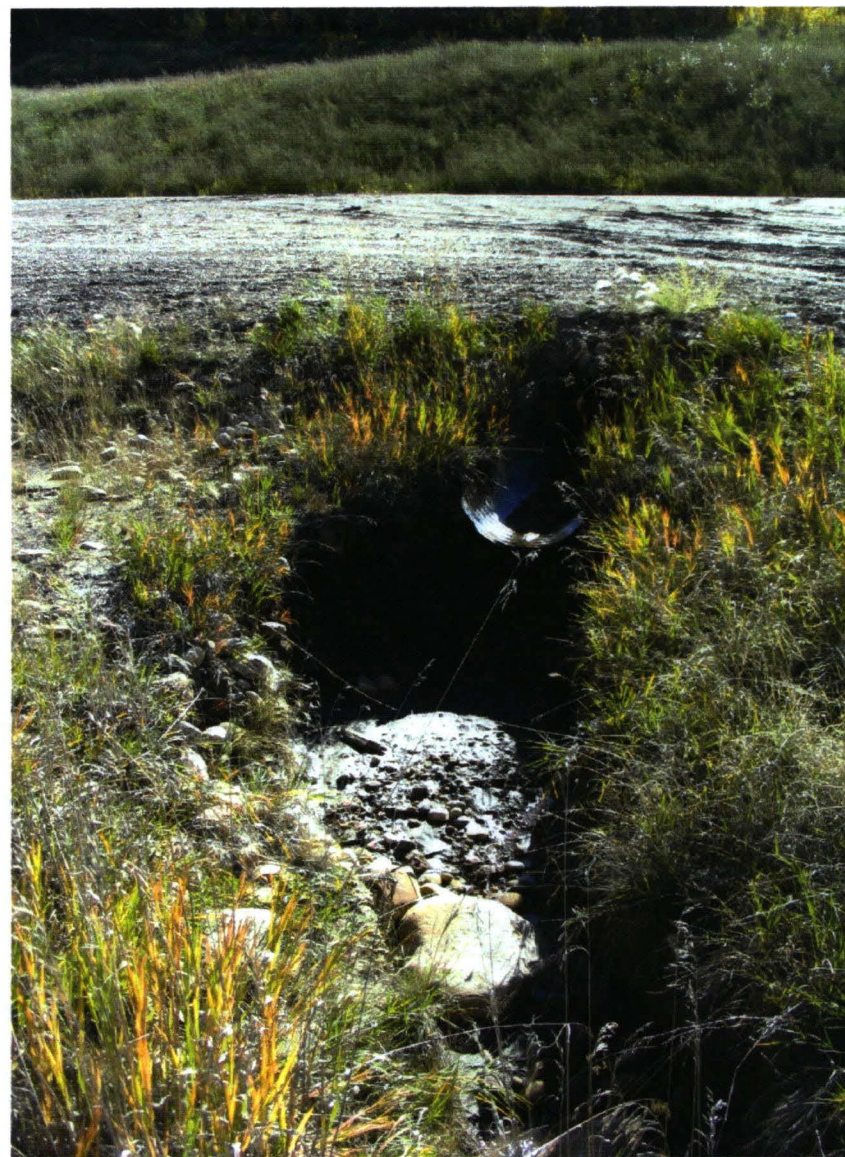
The ground surface north of the culvert outlet slopes at about 5 degrees for about 45 m and then dips at about 15 degrees for another 50 m before flattening out over an additional 20 m length into the pond. At the outlet of the culvert there is a scour hole of about 0.8 m in depth by 1.2 m in width. The erosion channel, extending north of the culvert, has a maximum depth of about 3 m, top width varying from 3 to 5 m and base width of less than 1m, roughly below the inflection point between the 5 and 15 degree slopes.

PHOTO 4 SCOUR BELOW OUTLET OF CULVERT

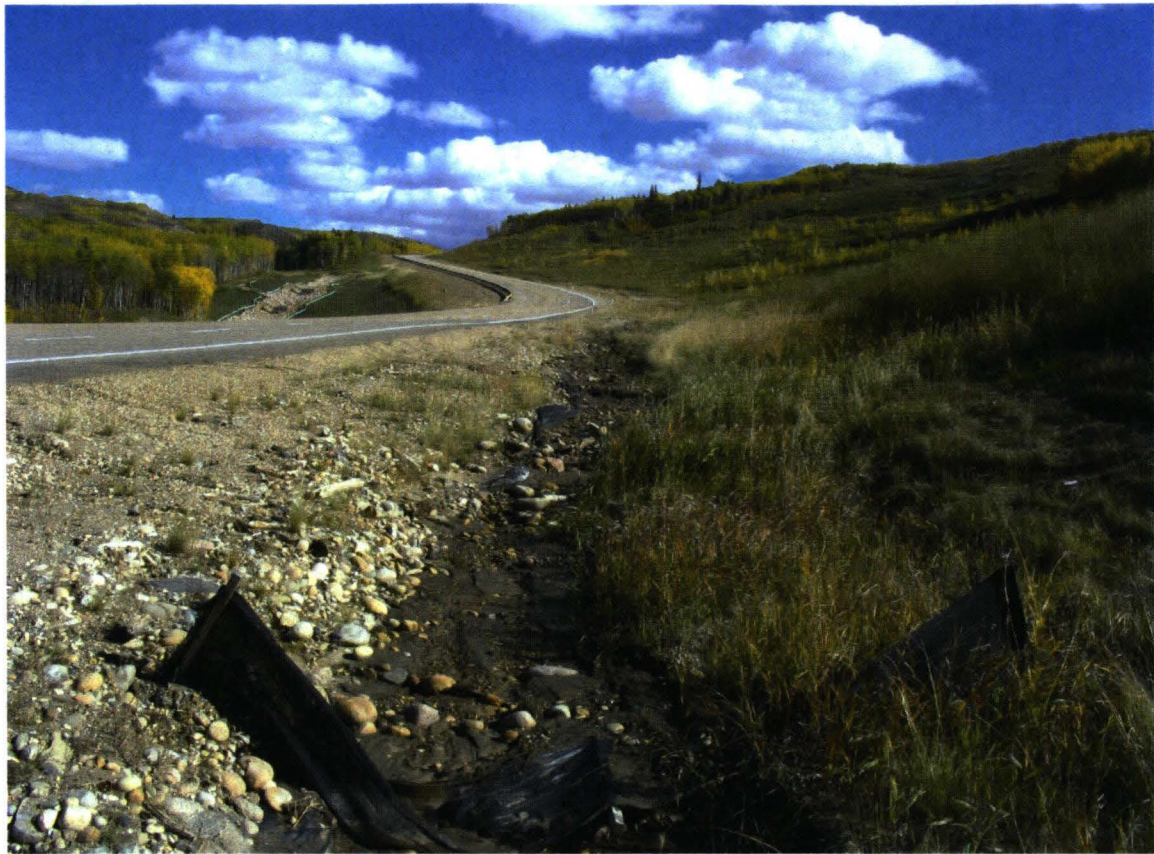
PHOTO 5 LOOKING UPSTREAM (EAST) FROM INLET OF CULVERT AT ABOUT STA. 12+120

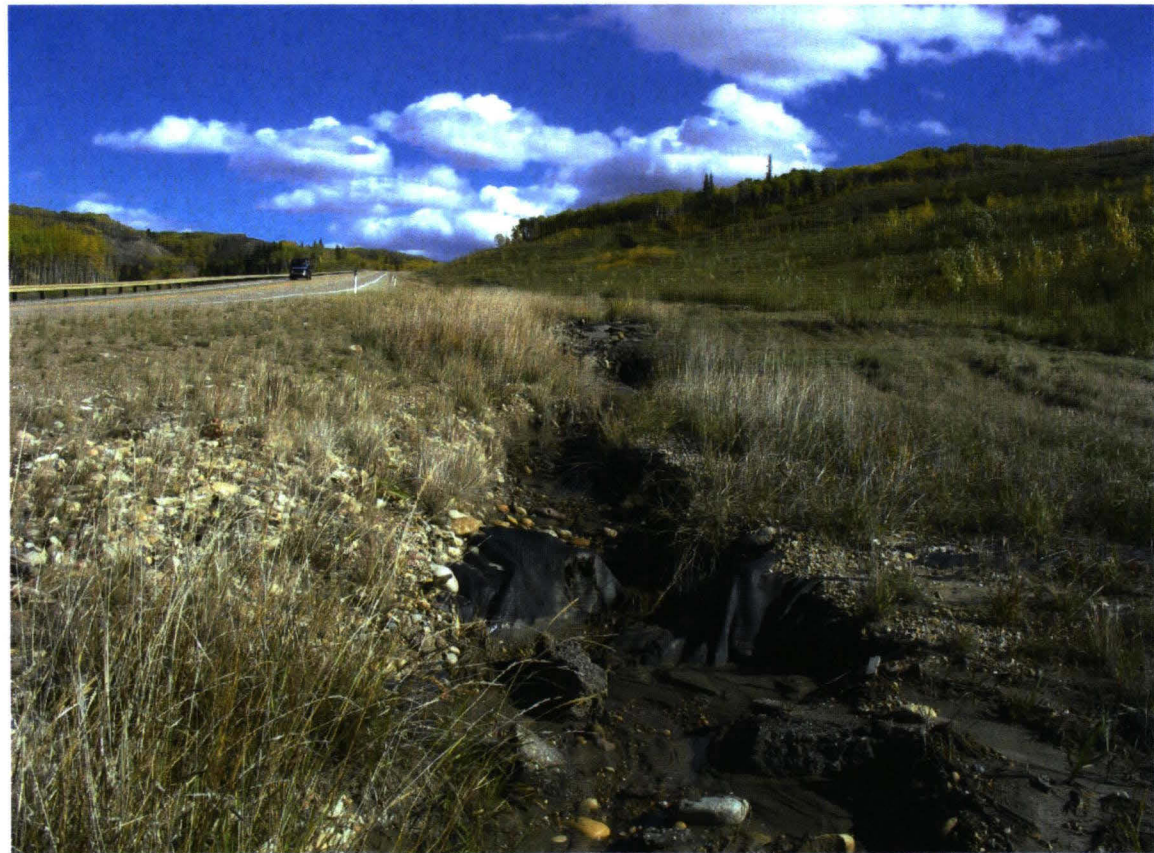
PHOTO 6 LOOKING UPSTREAM FROM ABOUT STA. 12+320

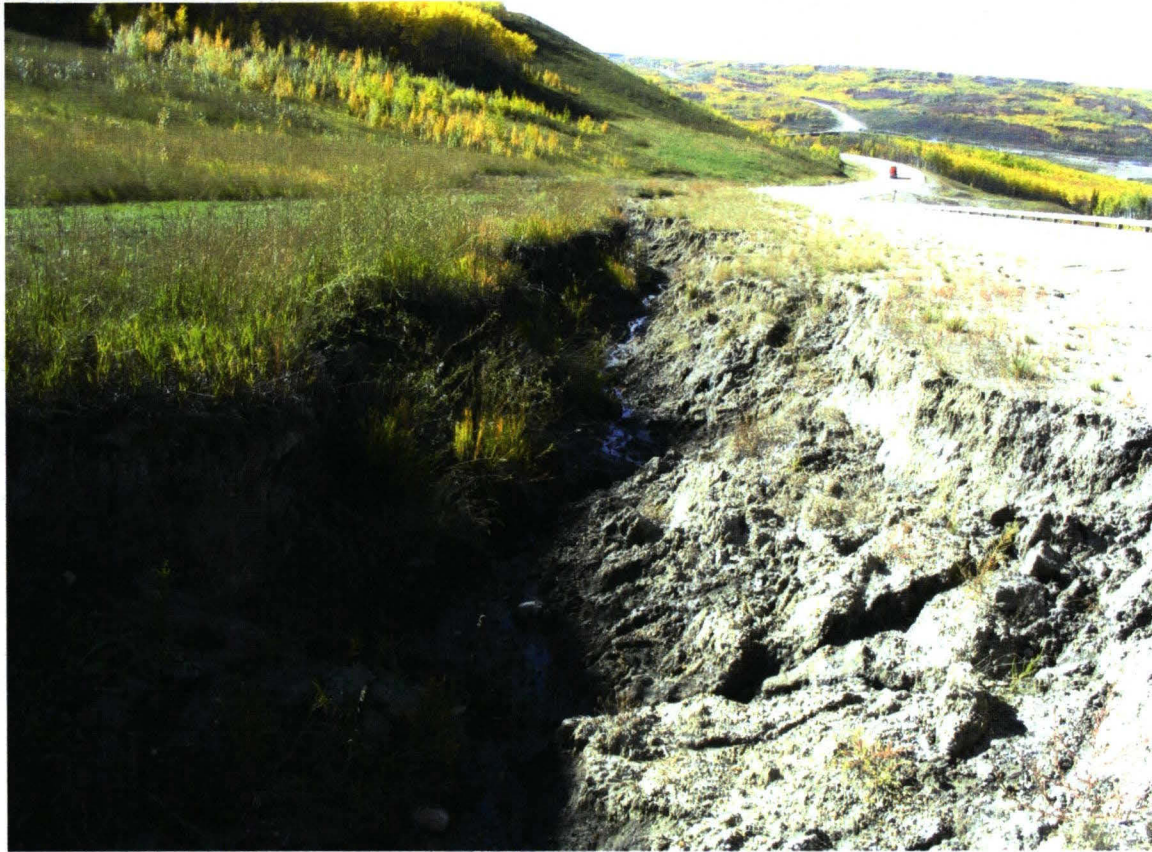
PHOTO 7 LOOKING DOWNSTREAM FROM ABOUT STA. 12+520

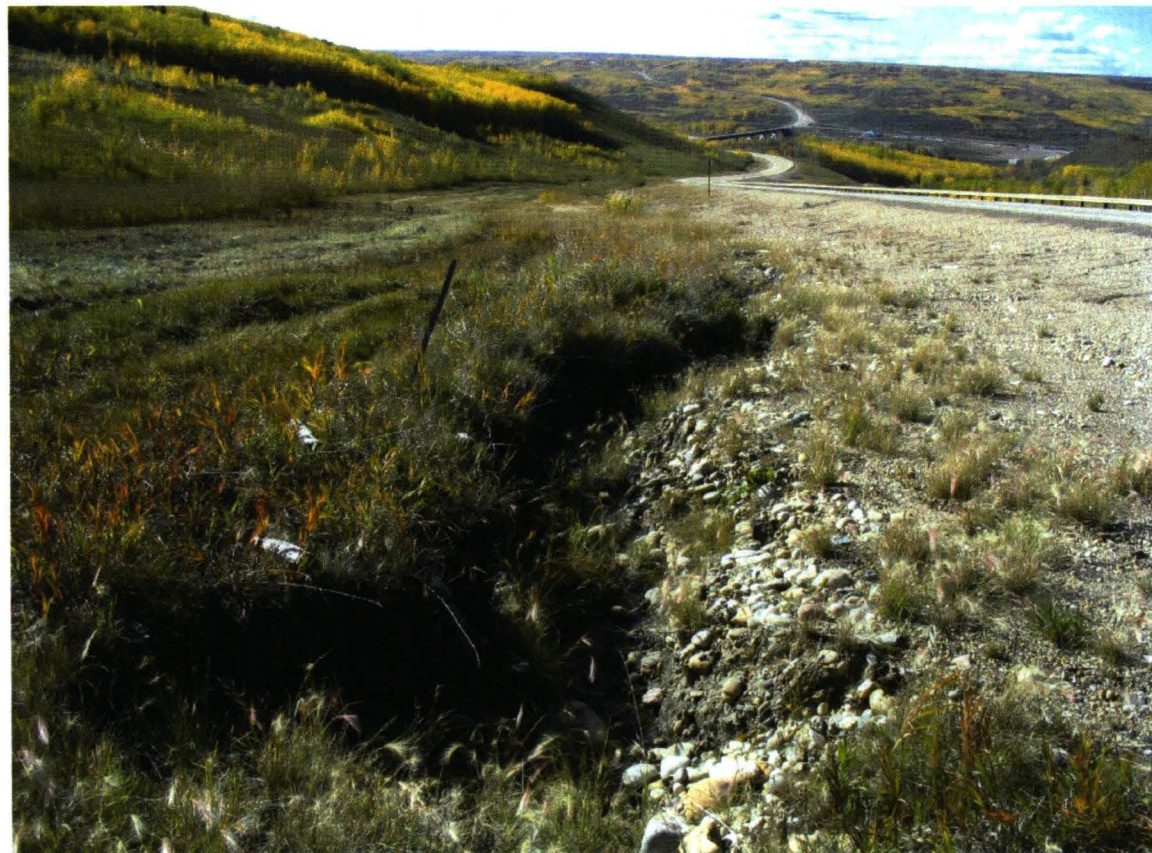
PHOTO 8 LOOKING DOWNSTREAM FROM EAST END OF ERODED DITCH AT ABOUT STA. 12+920

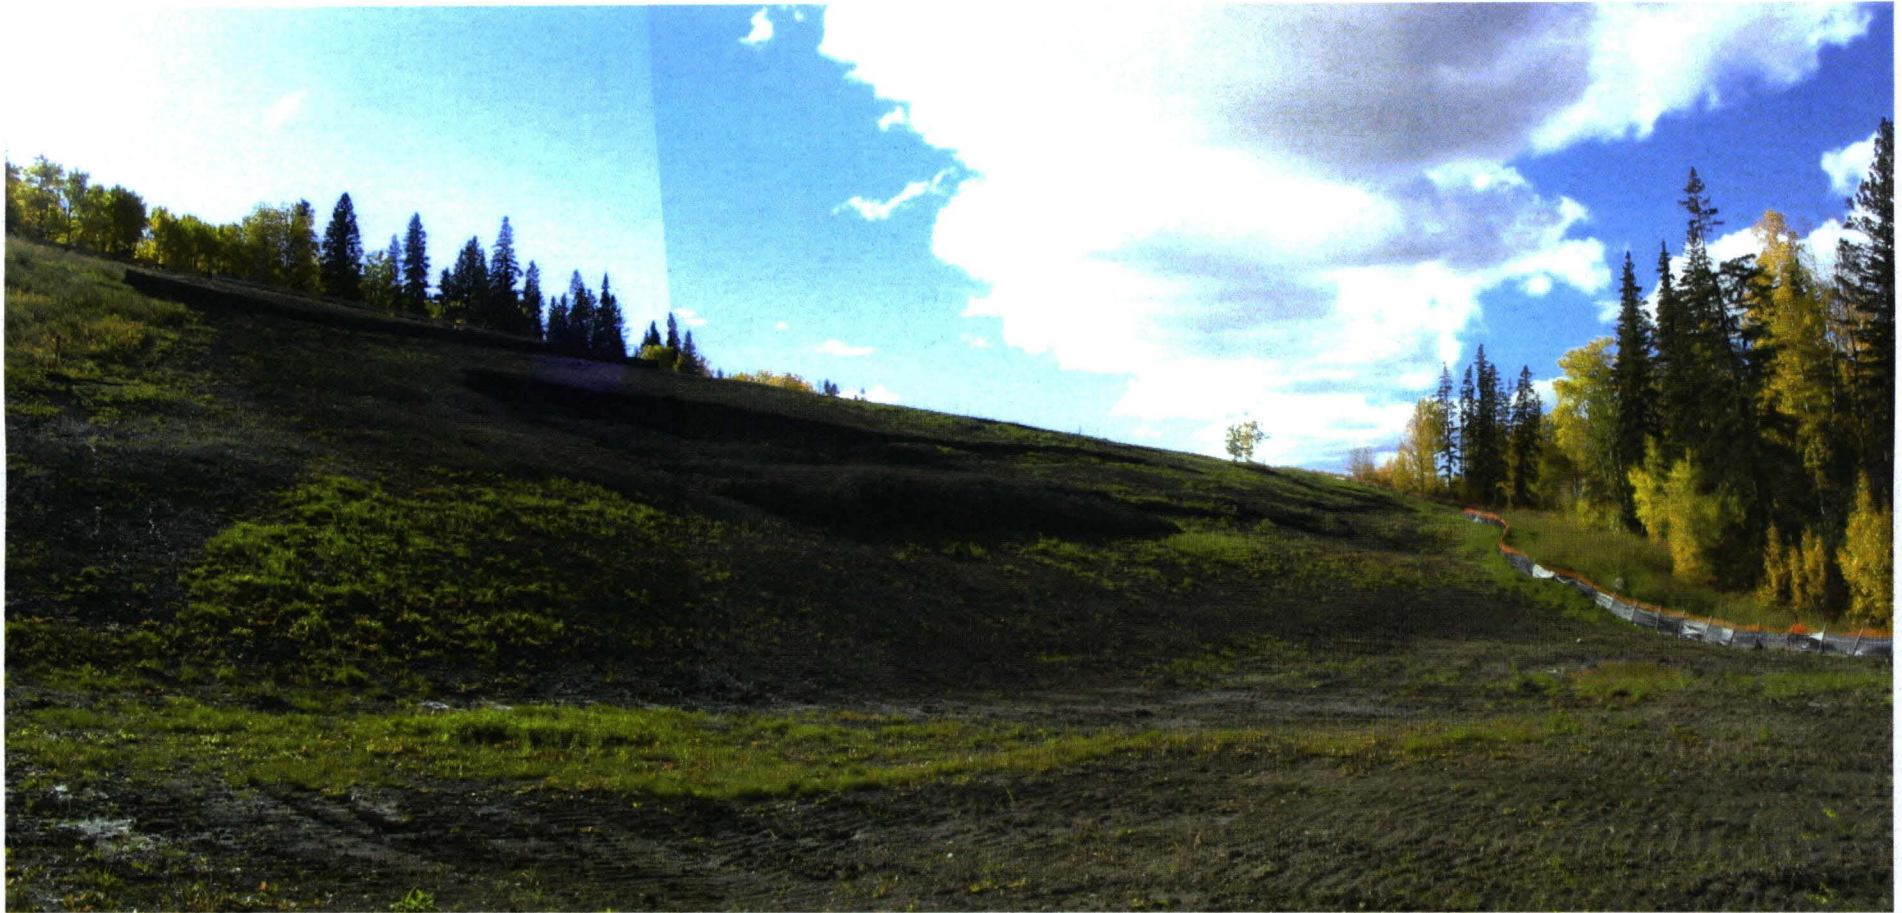
At the time of the site visit, a well-developed slide was present in the slope below the east portion of the pile wall. The slide had a total length of about 75 m from flank to flank and was located approximately within the footprint of the soil stockpile that was temporarily placed over the lower slope during pile wall construction. The backscarp of the slide was located within about 5 m to 10 m downslope of the centerline of the pile wall. There was a well defined toe roll as shown on the photographs and Figure 2.

The slide appears to be a relatively shallow rotational slide. The limits of the slope failure closely correspond to that of the 2003 slide. The pile wall was designed to stabilize the portion of the slope above the wall where the highway is located but not the section of slope located below the wall where the current instability is located. The soil below the current slide was likely remolded from past slide events and the placement of the temporary soil stockpile during pile wall construction in this area may have further weakened the soil.

PHOTO 9 LOOKING WEST AT SLIDE IN SLOPE BELOW PILE WALL

It is recommended that the slide condition be dealt with before it begins to remove support from the downslope side of the pile wall. The recommended immediate remedial measure is to seal and track pack the slide cracks with clay to reduce potential surface water infiltration into the slide mass. A tracked backhoe would likely be the best piece of equipment to complete this work.

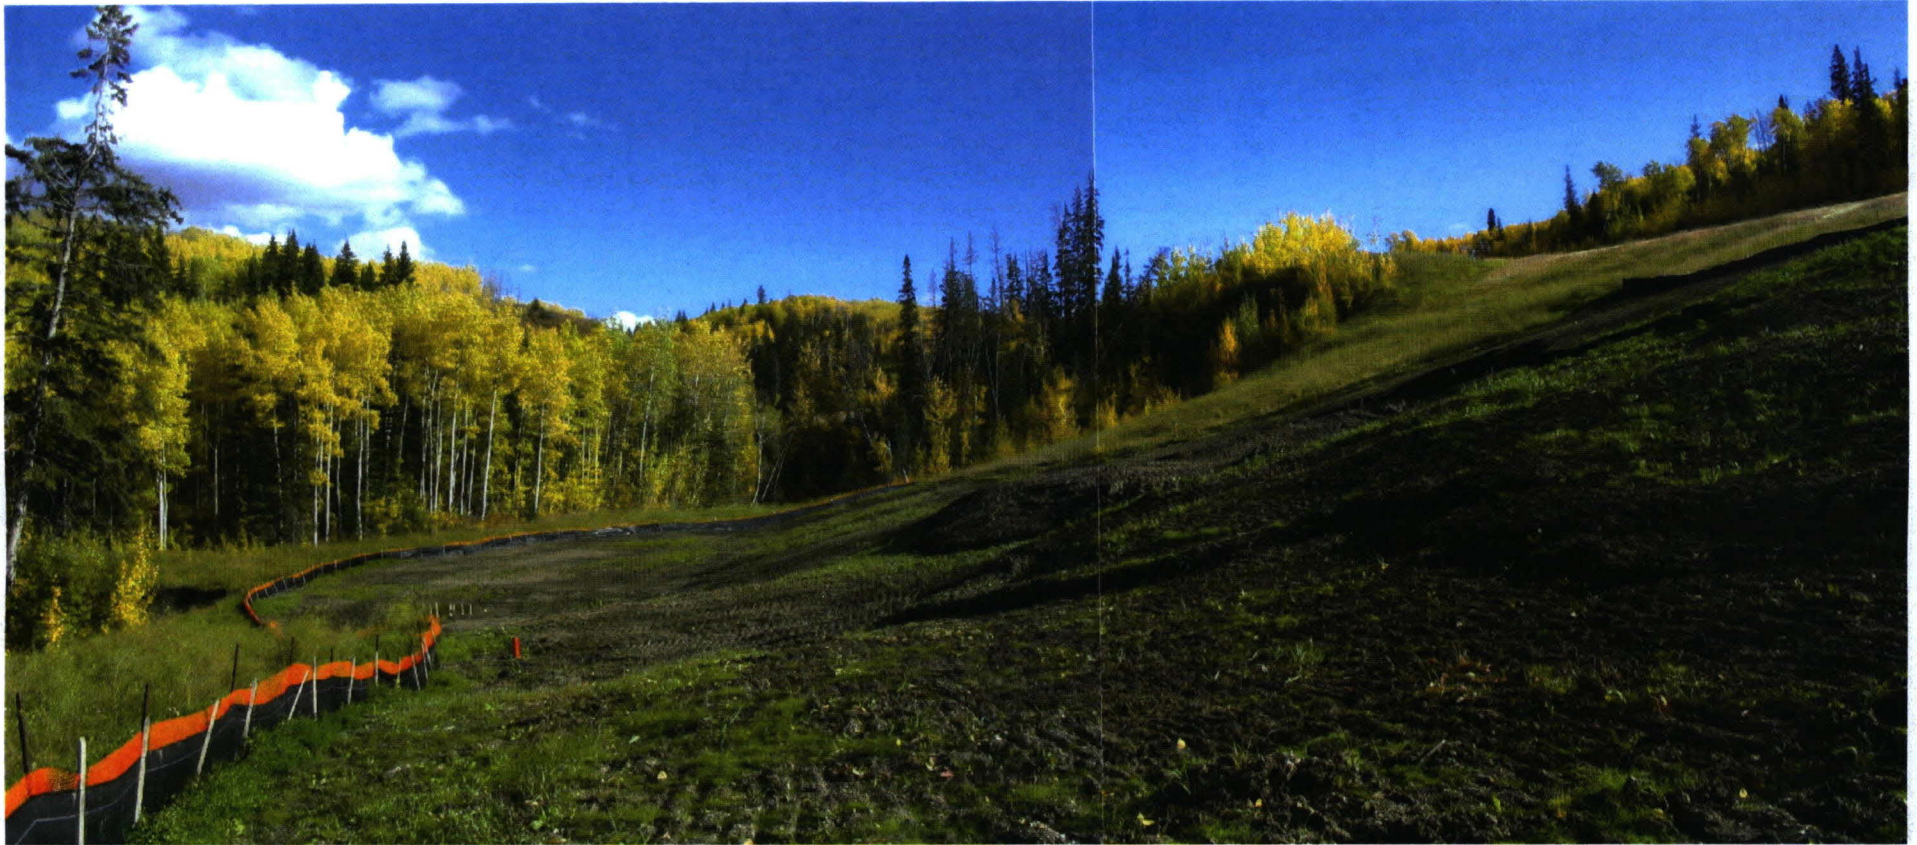
PHOTO 10 LOOKING EAST AT SLIDE TOE ROLL

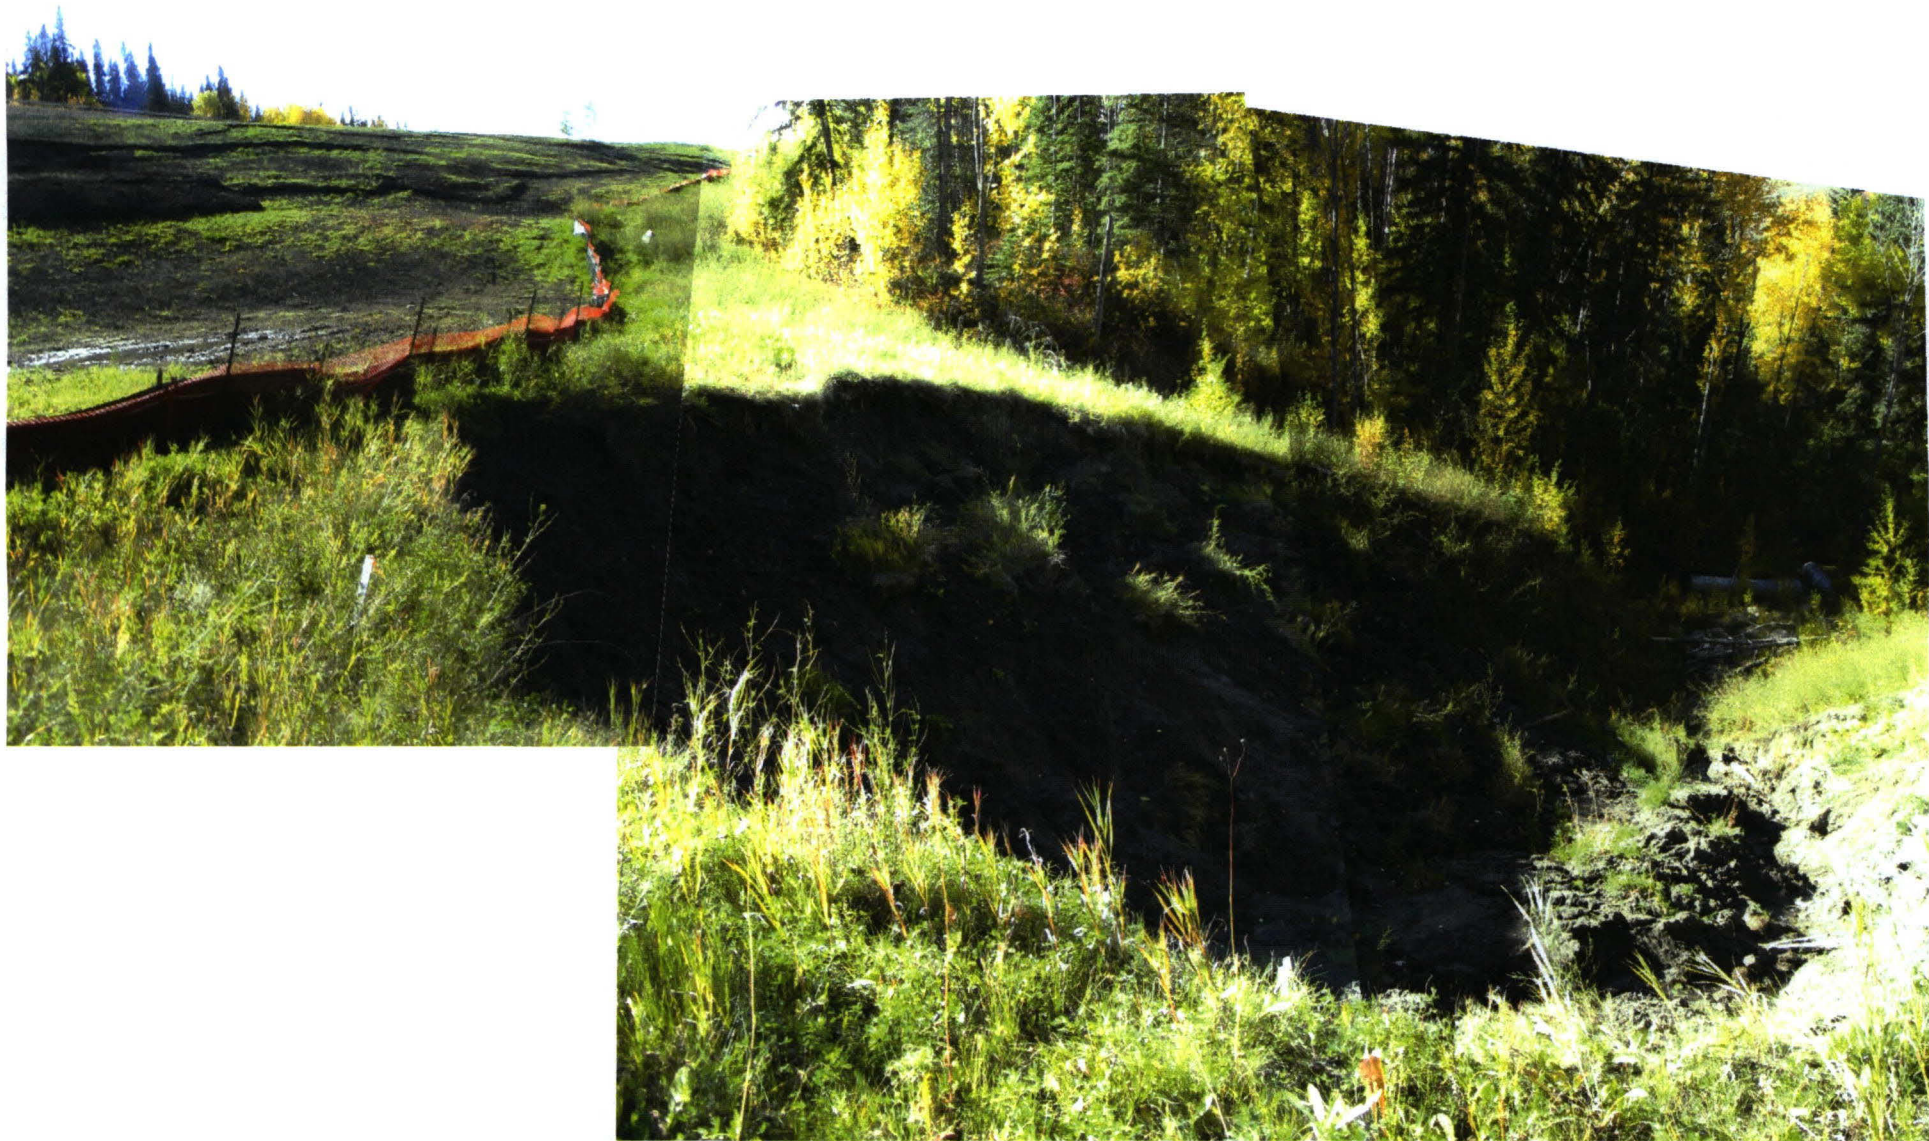
Other observations of note were a wet spot and some ground subsidence in the vicinity of Pile 25. Also, as shown on Photo 11, water flowing in the creek in the valley bottom continues to erode the toe of the valley slope causing additional instability in the lower slope area.

PHOTO 11 CREEK EROSION AND SLUMPING AT TOE OF LOWER SLOPE

A recommended long term remedial option, which would address the current slope stability problem as well as the instability in the lower portion of the slope near the creek, is to backfill the creek valley up to the level of the berm that is present

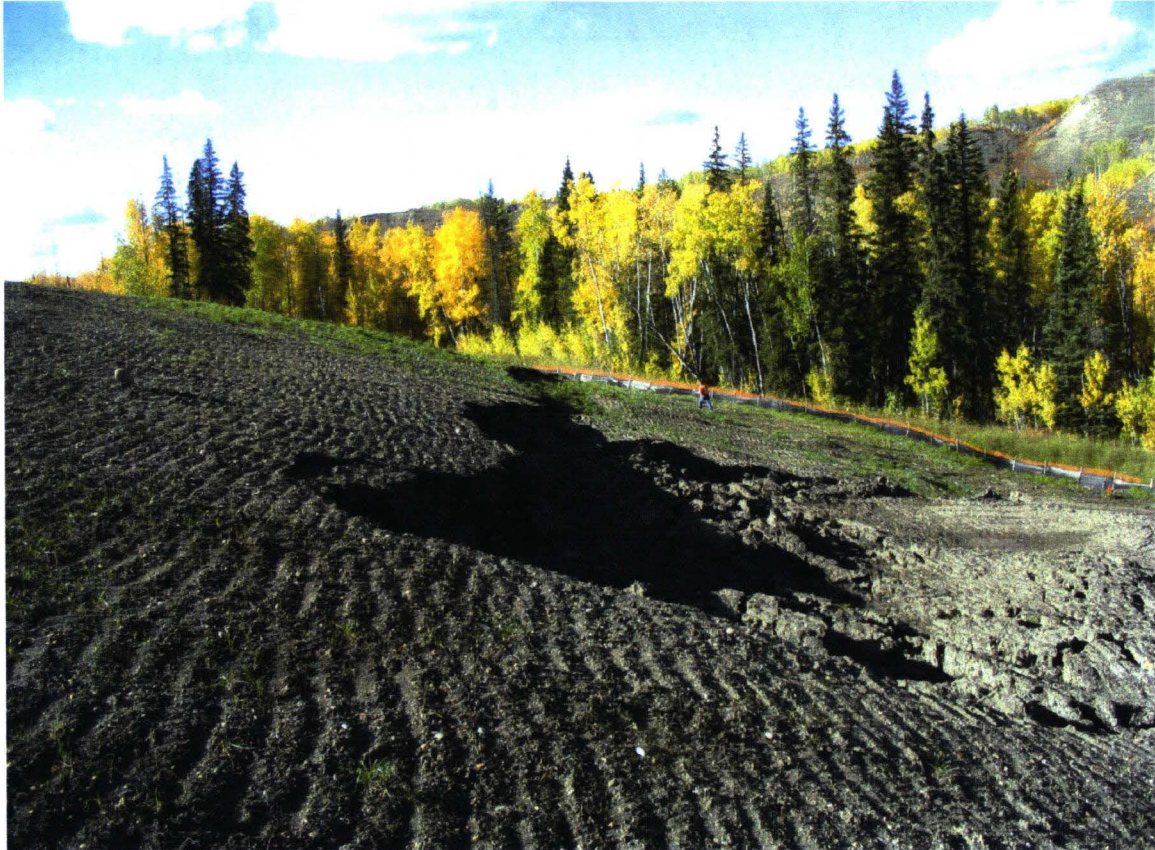
PHOTO 12 LOOKING WEST AT SLIDE AREA
