**PEACE REGION (PEACE RIVER / HIGH LEVEL)  
GEOTECHNICAL INSTRUMENTATION SUMMARY  
FALL 2004**

# ALBERTA TRANSPORTATION INSTRUMENTATION MONITORING RESULTS FALL 2004

#### SITE PH7: HWY986:01, DAISHOWA EAST ACCESS

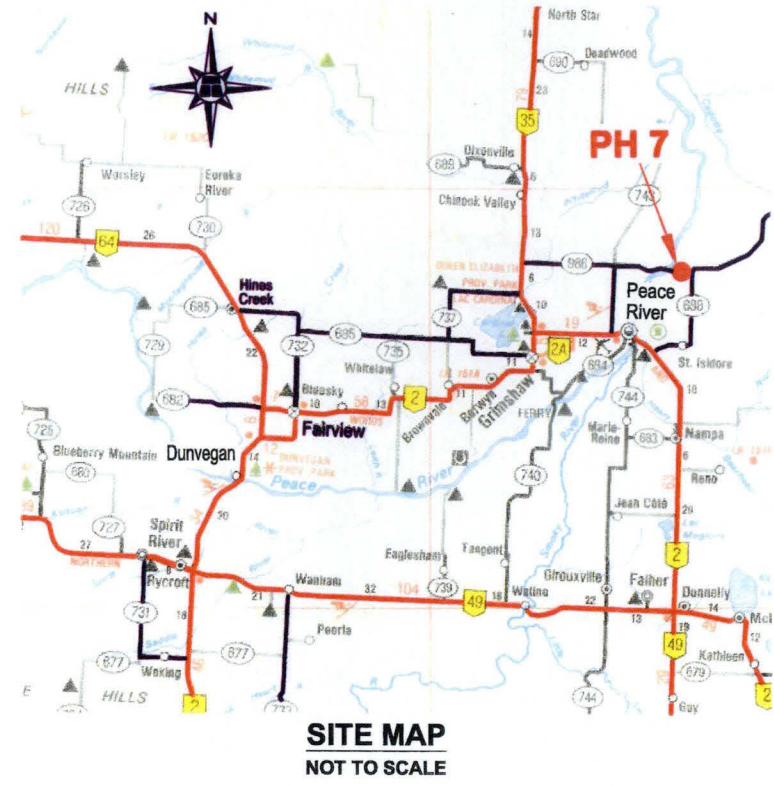
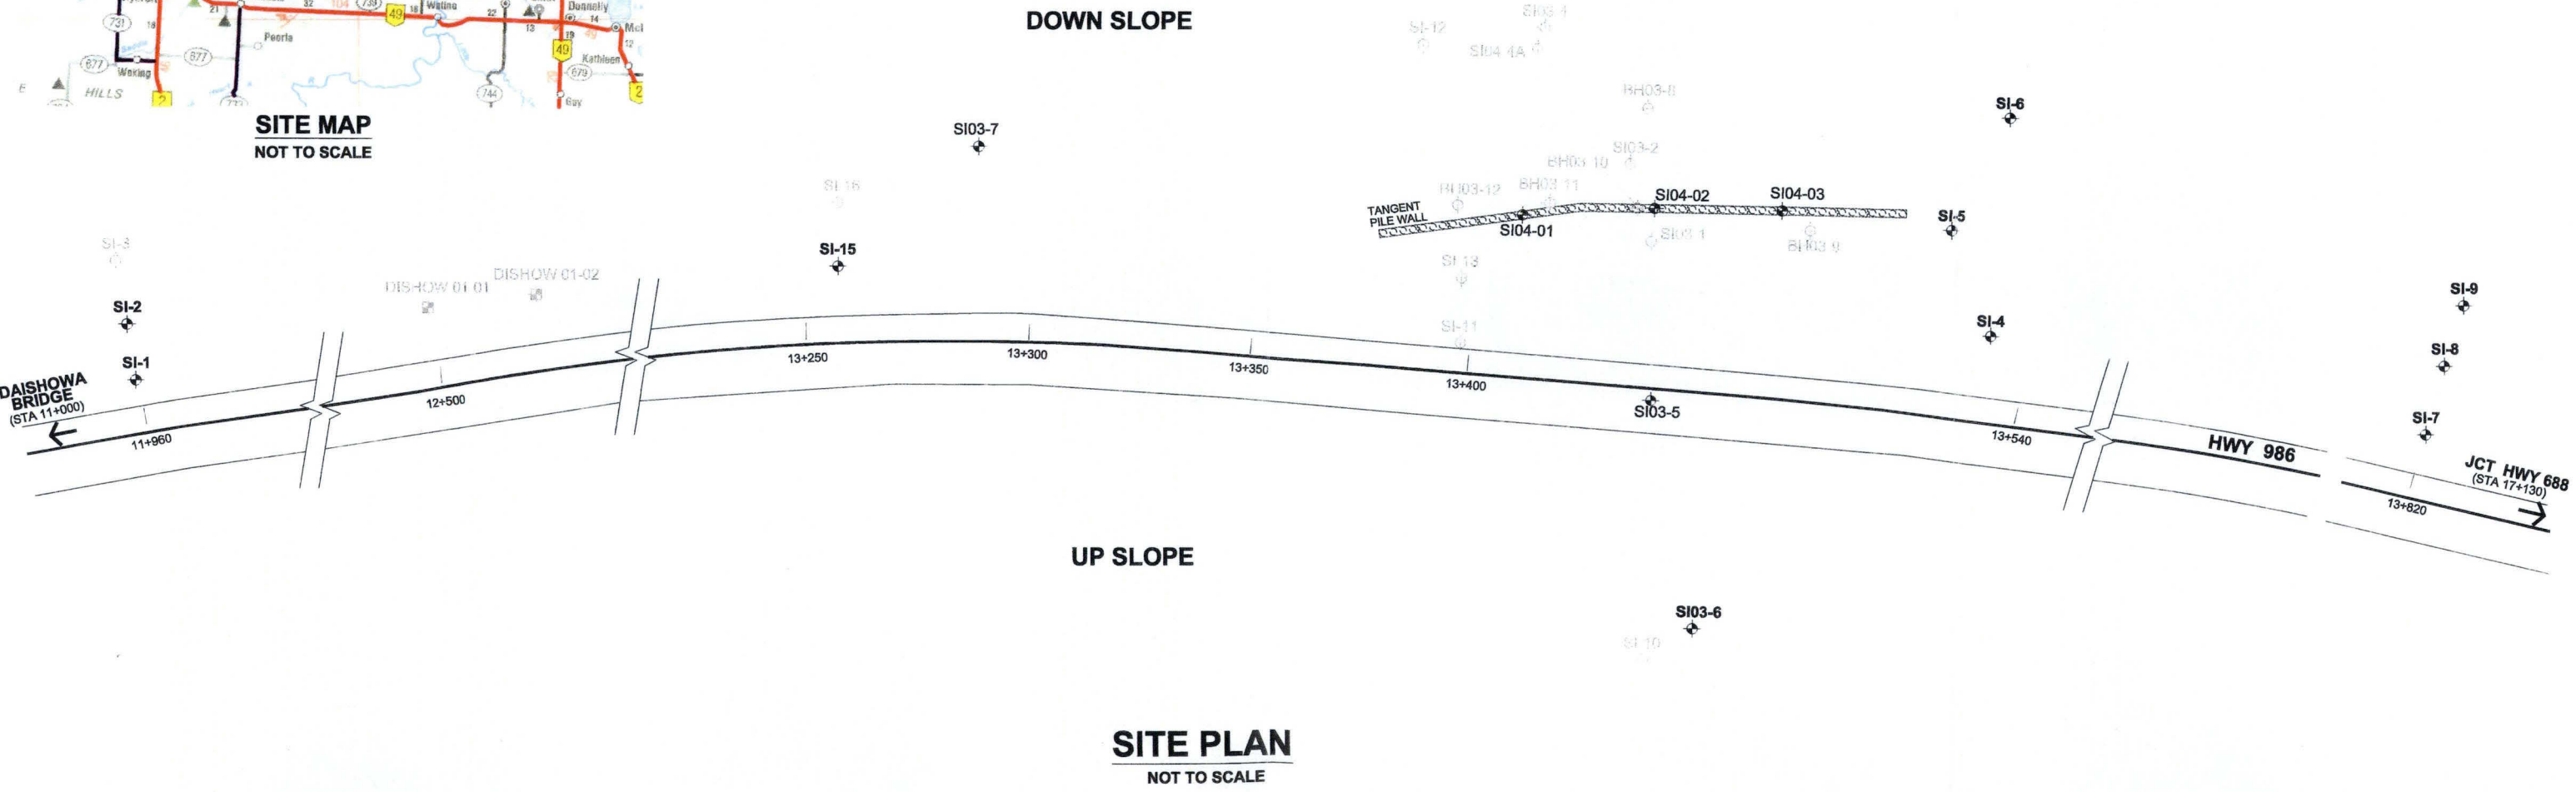
**FIGURE PH7-1**  
PH7-1 : HWY 986:01 - DAISHOWA EAST ACCESS  
SITE PLAN SHOWING APPROXIMATE INSTRUMENT LOCATIONS  
PEACE REGION (PEACE RIVER / HIGH LEVEL) INSTRUMENTATION READINGS - C  
DATE : NOVEMBER, 2004  
THURBER PROJECT #15-16-187

- 1) Recent slide downslope of the pile wall, extending along most of the pile wall length.
- 2) Crack across the highway at SI-15 noted during the Spring 2004 visit (near Sta. 13+250) was repaired. No signs of cracking were noted at the time of the fall 2004 visit at this location.
- 3) No signs of recent movement visible on the highway.

A pile wall was constructed to stabilize this slide area in 2003-2004. A surficial slump has developed downslope of the pile wall location since the completion of the pile wall construction and site grading operations. The slump extends along most of the pile wall length.

Slope inclinometers SI03-1 and SI03-2, installed at the location of the 2003 slope failure, have sheared off at 11.3 and 8.2 m, respectively. SI04-3A and SI04-4A were installed in 2004 as a replacement for SI03-3 and SI03-4 located downslope of the pile wall. Both of the recently installed SIs have sheared off and could not be read. SI03-5, located in the highway immediately upslope of the slide could not be located, and was presumed destroyed during the new highway construction. However, upon completion of the instrumentation monitoring program, Thurber has obtained information indicating that SI03-5 has been modified as to allow for future readings. The monitoring of SI03-5 will require traffic accommodations. No discernible movement was recorded in SI03-6 located upslope of the highway.

Two of the three slope inclinometers (SI04-1 and SI04-3), installed in the pile wall, indicated increased movement in the surficial movement zones. According to the design drawings there is about 2m of fill above the cap beam of the pile wall. The movement rates in the top 3.7 m range from 35.8 mm/y (SI04-3) to 141.1 mm/y (SI04-1). Based on the conversation with AMEC upon completion of the spring 2004 monitoring program, SI04-2 was understood to be damaged and was not monitored during the fall 2004 monitoring program. However, recent information indicates that the SI may have been repaired and is currently operational, in which case it will be read during the spring 2005 monitoring program.

The readings indicate continued movement in the area, especially downslope of the pile wall. In light of the 2003 slope failure and continued movement in the area, ongoing visual monitoring of the site by AT personnel and MCI should be performed when possible to look for signs of major slope failure. All of the instruments should be read again during the Spring 2005 program.
