**ALBERTA TRANSPORTATION GEOHAZARD ASSESSMENT PROGRAM
PEACE REGION – PEACE-HIGH LEVEL
2018 INSPECTION**

Site Number	Location	Name	Hwy	km
PH7	Daishowa East Hill	Gabion Channel & Erosion Control Section	986:01	12.55
Legal Description		UTM Co-ordinates		
NE7-85-20 W5M		11V E 490505	N 6246235

Date	PF	CF	Total
Previous Inspection:	20-Jun-2017	3	2	6
Current Inspection:	12-Jun-2018	3	2	6
Road AADT:	840		Year:	2010
Inspected By:	Tyler Clay			
Report Attachments:	<input checked="" type="checkbox"/> Photographs <input checked="" type="checkbox"/> Plans <input checked="" type="checkbox"/> Maintenance Items

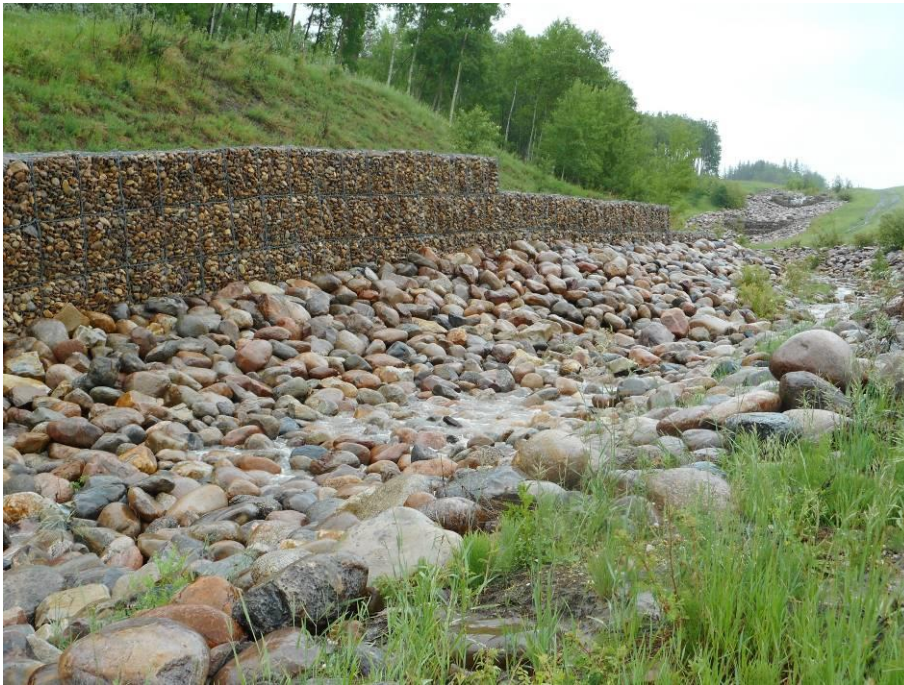
Major erosion and gulying appears to have been mitigated along both the north and south sides of the highway. The localized damage in the north channel (bank slumping and breach of the rip rap) has been repaired with additional riprap placement as part of the PH42 Daishowa East Hill repair work. The cables in the concrete section have been cut; however, there is still some protruding rebar pins in the pillow concrete section that should be driven deeper or cut flush.

Photo 7-01.
Looking at protective gabion wall along north side of channel near end of armoring. Previous area of channel erosion and armour breach has since been repaired (32+290).

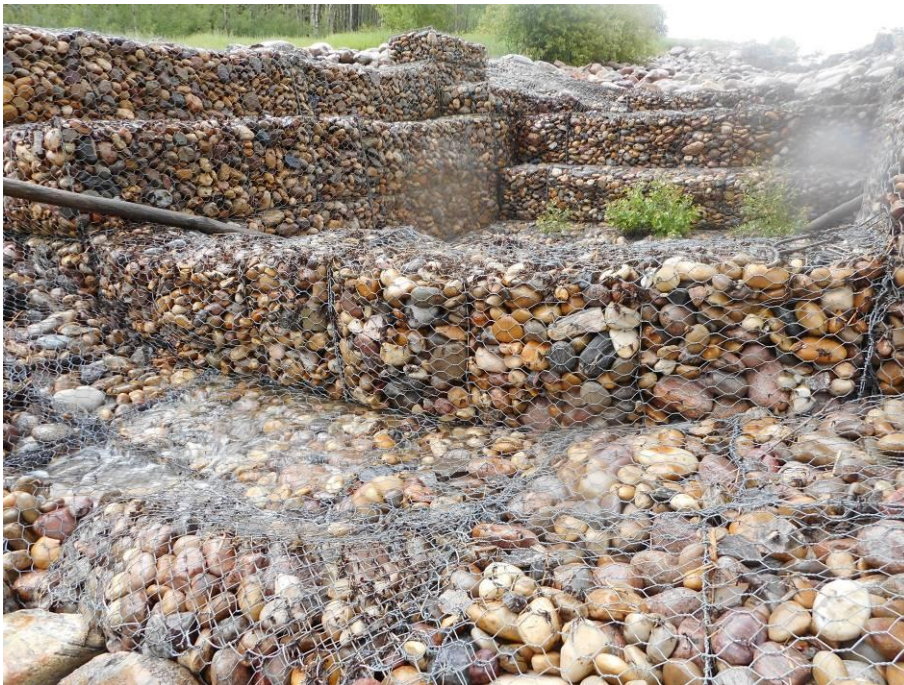
Photo 7-02.
Looking upstream from lower gabion drop structure (32+495).

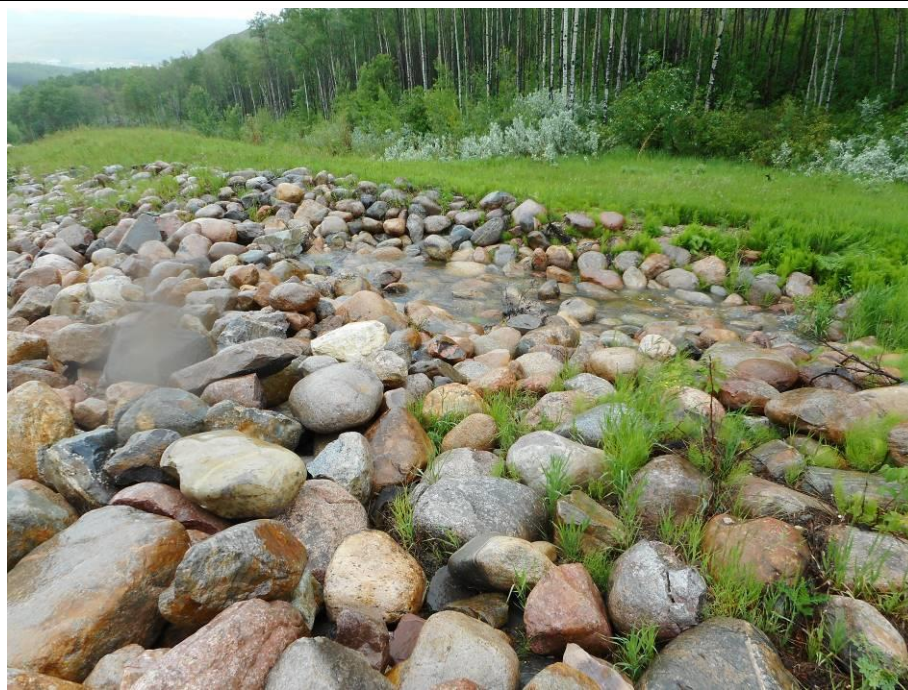
The old shallow slide or settlement noted at 32+500 is not considered a threat to the highway at this time, but should continue to be monitored.

Photo 7-03.
Previous area of geotextile exposure and bank erosion at north side gabion drop structure that has been filled in with additional rip rap (32+500).

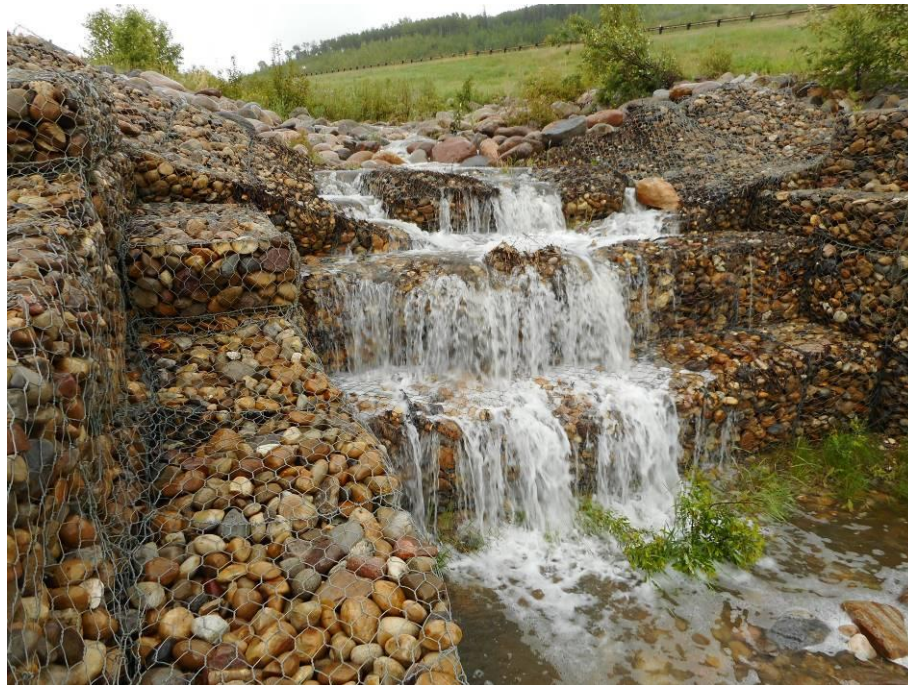
Photo 7-04.
Upper gabion drop structure (32+540).

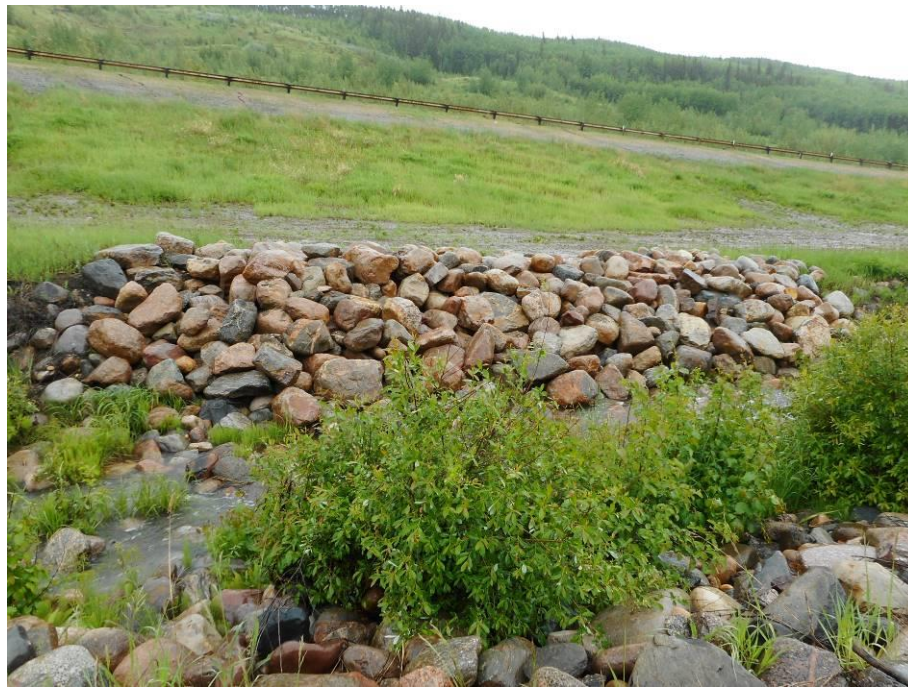
Photo 7-05.
Previous area of bank erosion and breach of armour on south side, recently repaired with placement of additional rip rap (32+660).

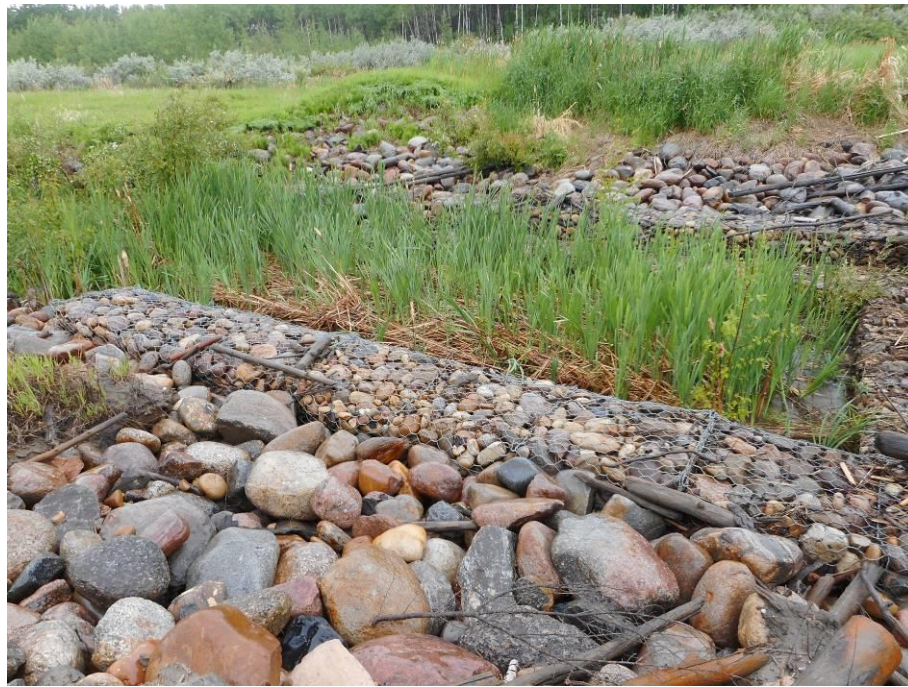
The willows noted within the upper portion of the North Channel may reduce the hydraulic capacity of the inlet and should be checked by a hydraulic engineer.

Photo 7-06.
North channel inlet structure. Note vegetation and willow growth (32+855).

Recommendations:	Cost
Continue to monitor the site and undertake annual inspections.	-
If it is determined that the hydraulic capacity of the north channel inlet is being adversely affected by willow growth, they should be cut flush to the channel bottom with the roots left in place.	\$ 5,000
The Coletanche geomembrane should be cut for 40 m, the exposed underlying erosion channel should be backfilled with compacted gravel and then patched. The erosion channel section is about 2000 mm wide by 600 mm high.	\$ 10,000
Consideration should be given to a permanent curb constructed along the guard rail with all flow directed to controlled discharge points, such as a split culvert, that carries the flow to the lined channel at the toe of the slope. "Geocell" would be one possible option to construct the curb. The curb would have to be on the north side of the guard rail to avoid conflict with snow clearing equipment. If such an option were to be implemented, about 150 m of curb would be required. Two controlled discharges, likely 300 m length would be required. Damage noted at 32+850 not significant yet but may need similar type of repair if left unchecked.	\$ 60,000

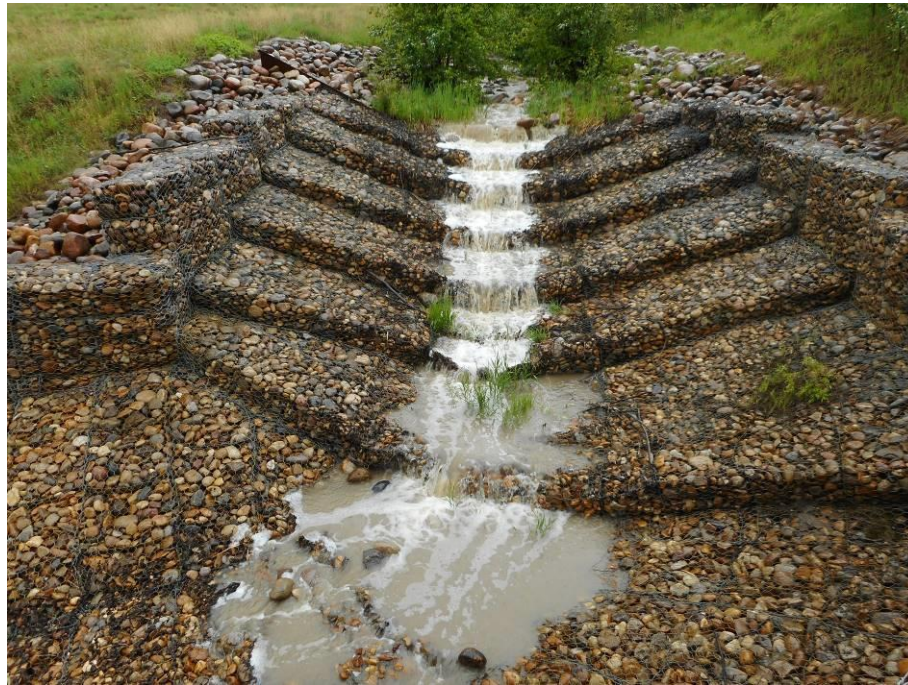
Photo 7-07.
Upper segment of the
gabion channel bend
and drop structure
(31+800).

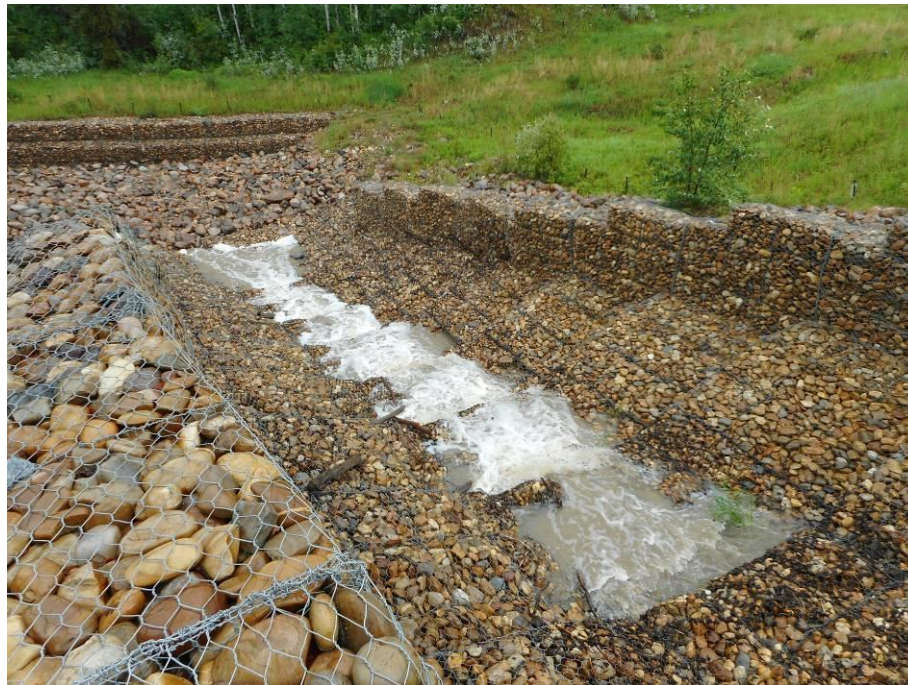
Photo 7-08.
Lower segment of the
gabion channel bend
and drop structure
(31+800).

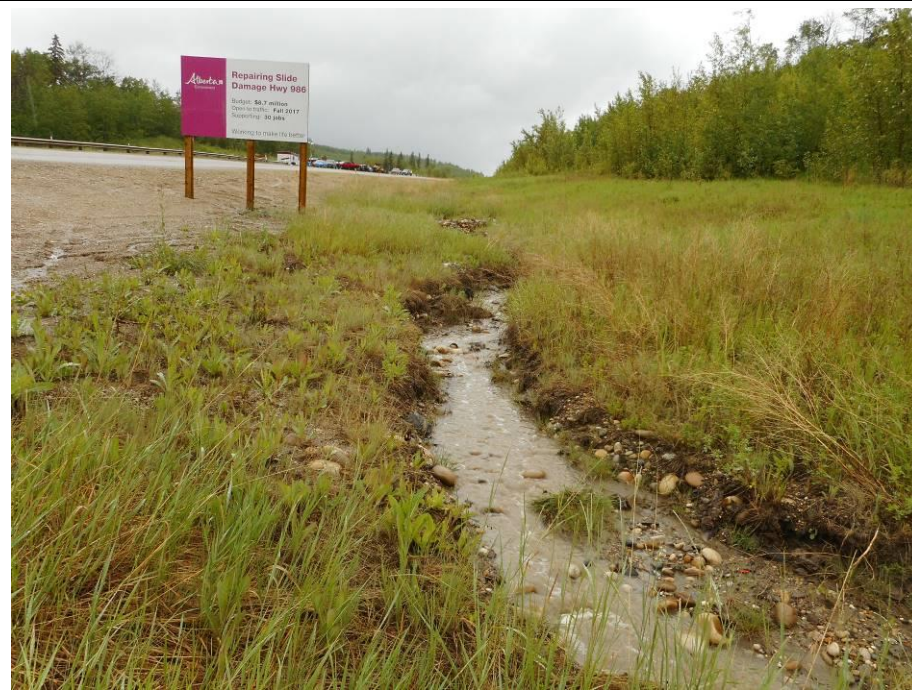
Photo 7-9.
Looking up the ditch slope (east) at end of erosion control section (32+900).

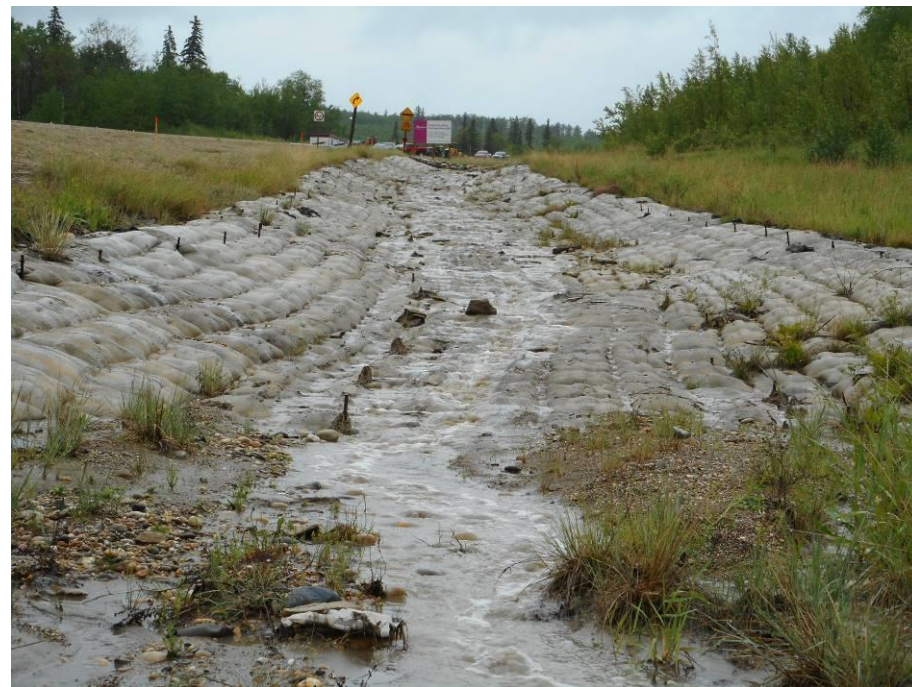
Photo 7-10.
Looking upslope the ditch (east) at the pillow concrete erosion control section (32+825). Note rebar protruding.

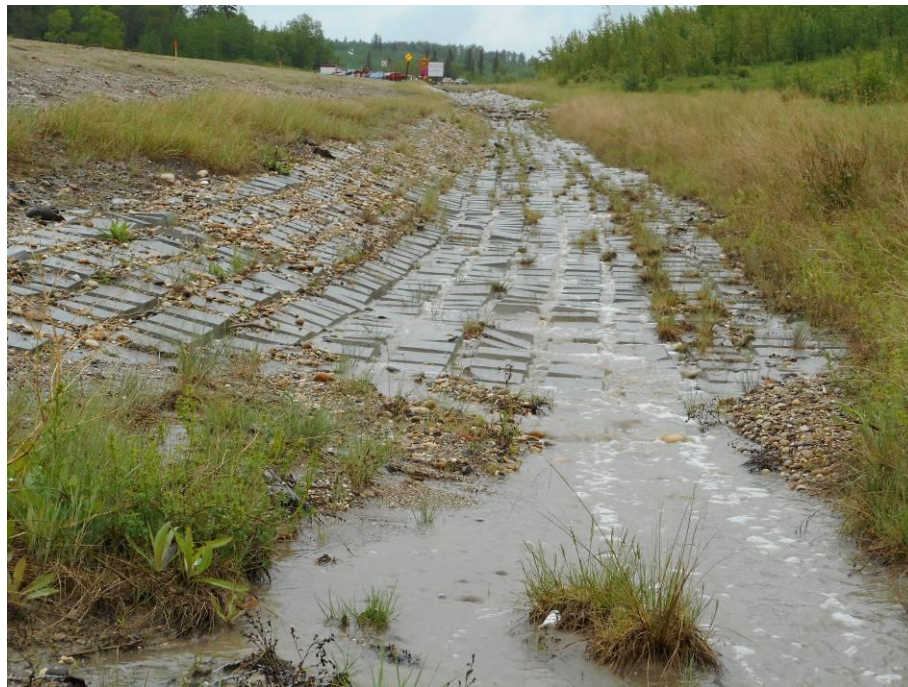
Photo 7-11.
Looking up the ditch slope (east) at the cabled concrete erosion control section (32+700). Nearly all exposed cable loops in this segment have been cut.

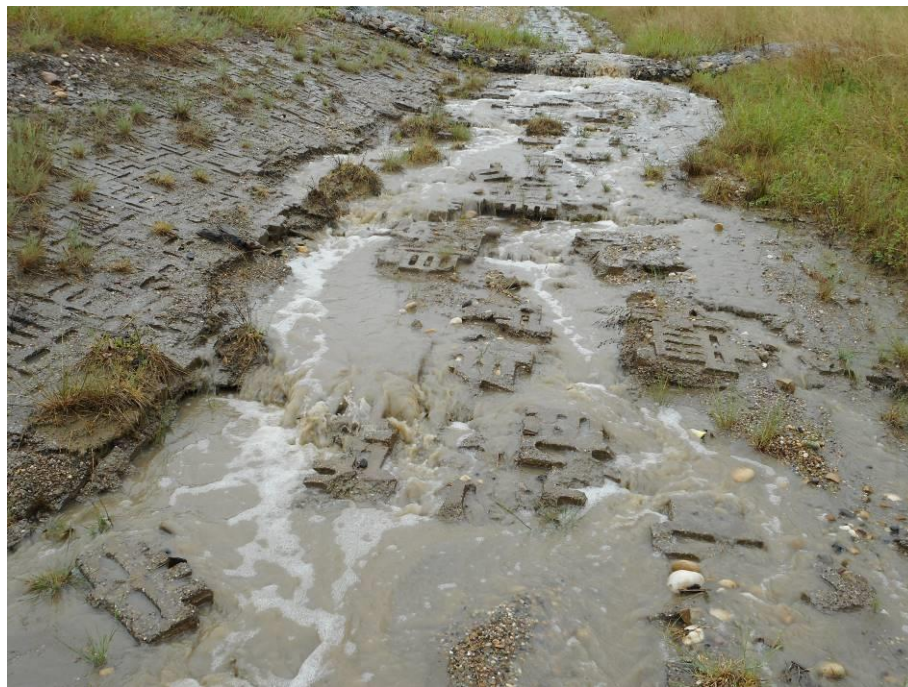
Photo 7-12.
Looking upslope (east) at weathered and broken interlocked concrete blocks (100 mm thick Lafarge paving stones) (32+660).

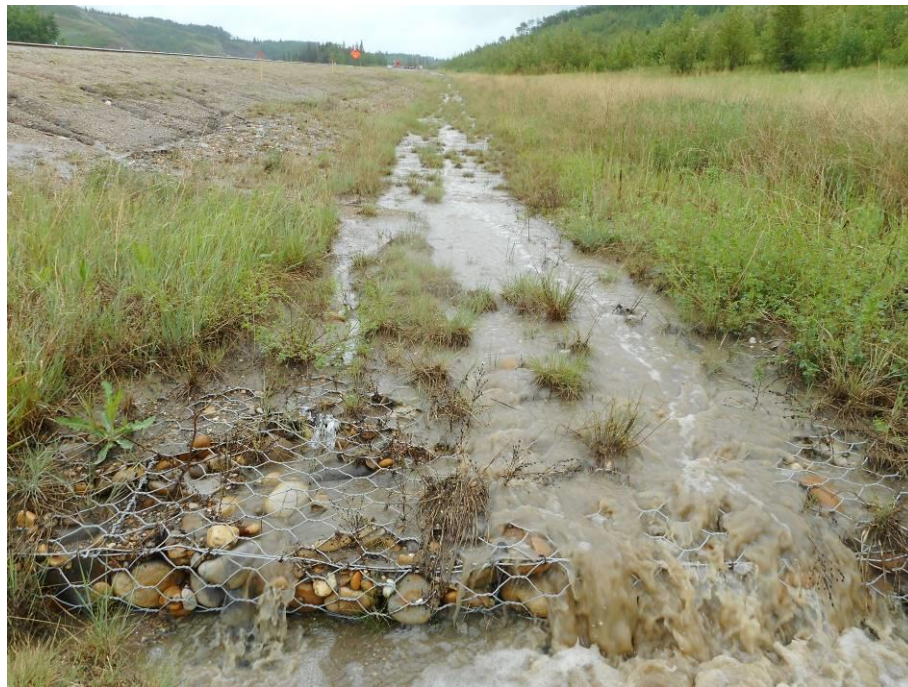
Photo 7-13.
Looking upslope the ditch (east) at the 300 mm thick gabion mattress erosion control section (32+450). Section had vegetation growth and was performing well.

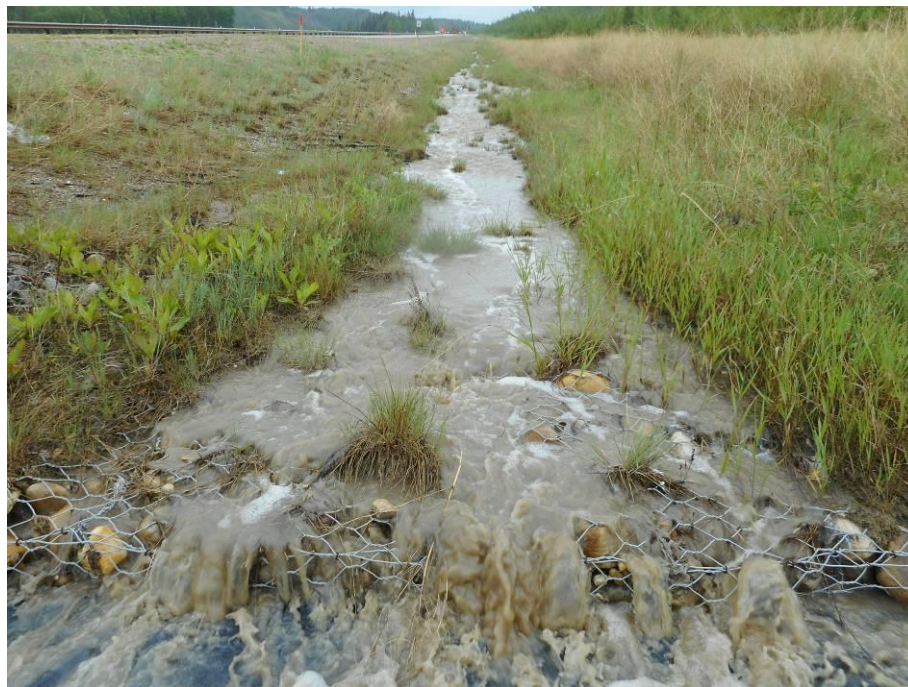
Photo 7-14.
Looking upslope the ditch (east) at the geocell filled with gravel (32+350). Section had vegetation growth and was performing well.

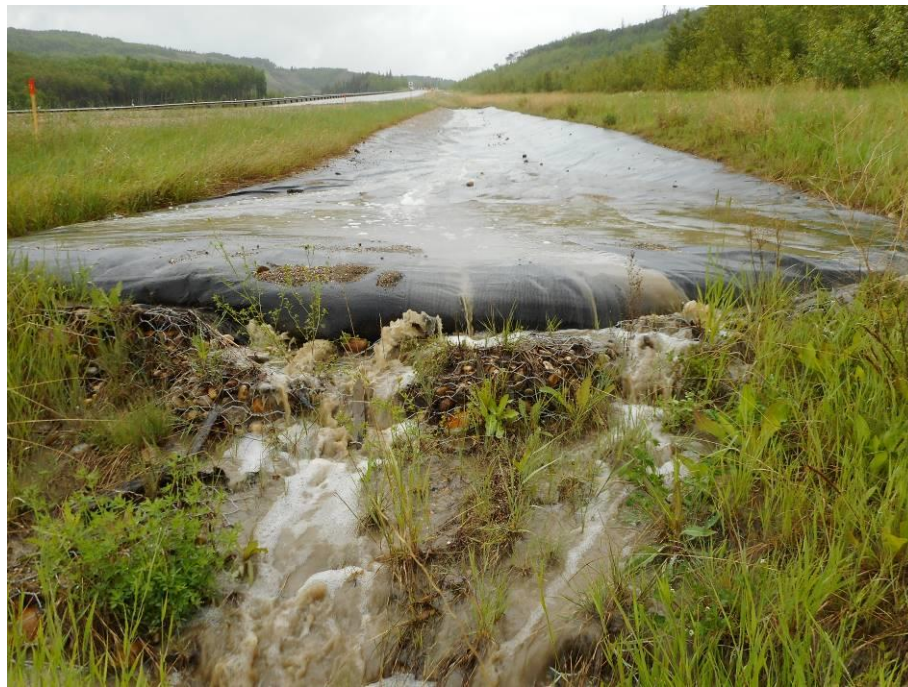
<p>in similar condition as last year (Photos 7-10 to 7-17) with exception of the Coletanche geomembrane damage at 32+280. Channelized erosion occurring beneath the membrane is expected to be ongoing but difficult to observe or measure (Photo 7-15) The gabion mattress, geocell, turf reinforced matting and channel socks had vegetation growth and were functioning well. The protruding cables in the cabled concrete section have been cut away as part of the repair work.</p> <p>North Channel (Photo 7-06): inlet had willow growth but reduced debris relative to previous years. Previous areas of bank erosion and breach of armour have been repaired with additional riprap placement (Photos 71-03 and 71-05). The two gabion drop structures (32+490 and 32+540) were in good condition except for some minor basket deformation (Photos 7-02 to 7-04). Previous channel erosion and breach of armour (including geotextile exposure) compromising the foundation of the protective gabion wall (32+290) has been repaired with additional riprap placement (Photo 7-01).</p> <p>Culvert inlet and outlets (32+050 and 31+990 respectively) were functioning well. Minor erosion beneath inlet mouth was noted (Photo 7-18). Gabion flow dissipater at outlet was performing as intended.</p> <p>Gabion structure at channel bend (31+800) was in good condition and observed to performing well under flowing conditions (Photos 7-07 and 7-08).</p>

Erosion under the Coletanche geomembrane damage at 32+280 is currently undermining the south ditch up to 40 m downstream from this location.

Photo 7-15.
Looking upslope (east) at the Coletanche geomembrane erosion control section (32+250).

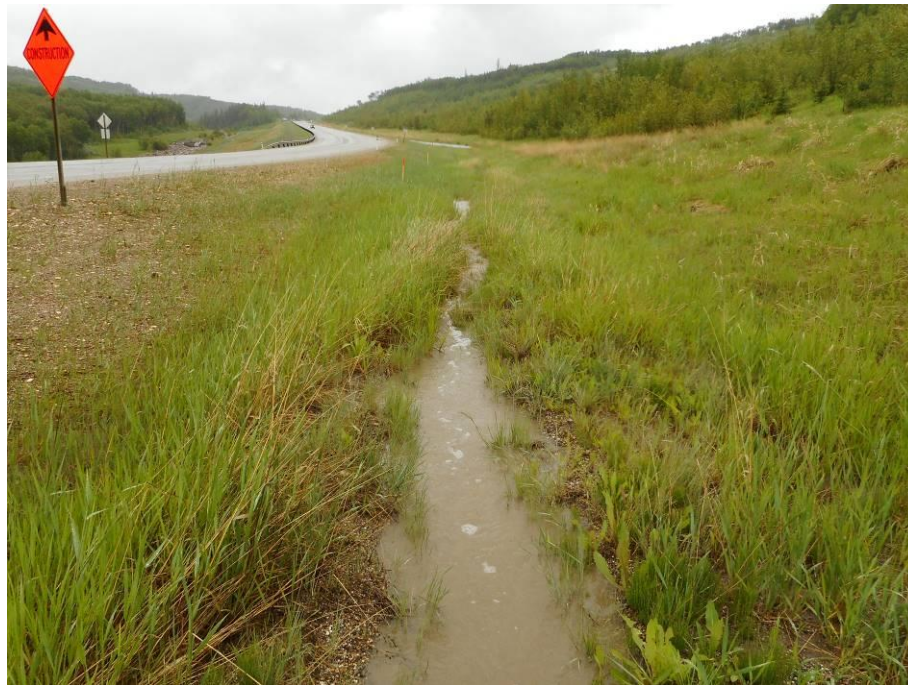
Photo 7-16.
Looking east towards 300 m diameter channel sock erosion control section (32+150). Section had good vegetation growth.

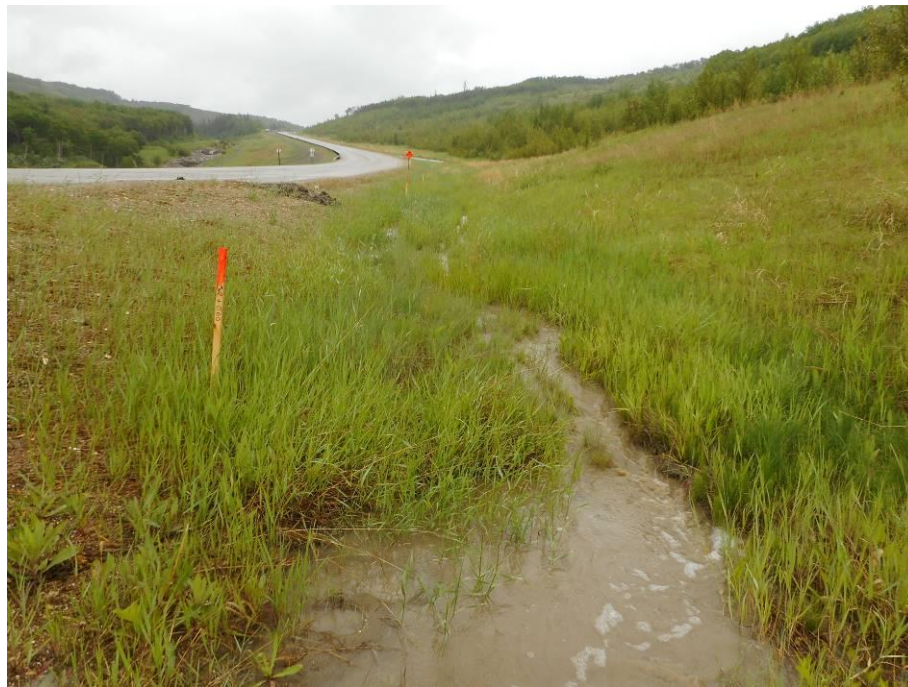
Photo 7-17.
Looking east towards
rolled erosion control
product (turf
reinforced matting)
section (32+75).

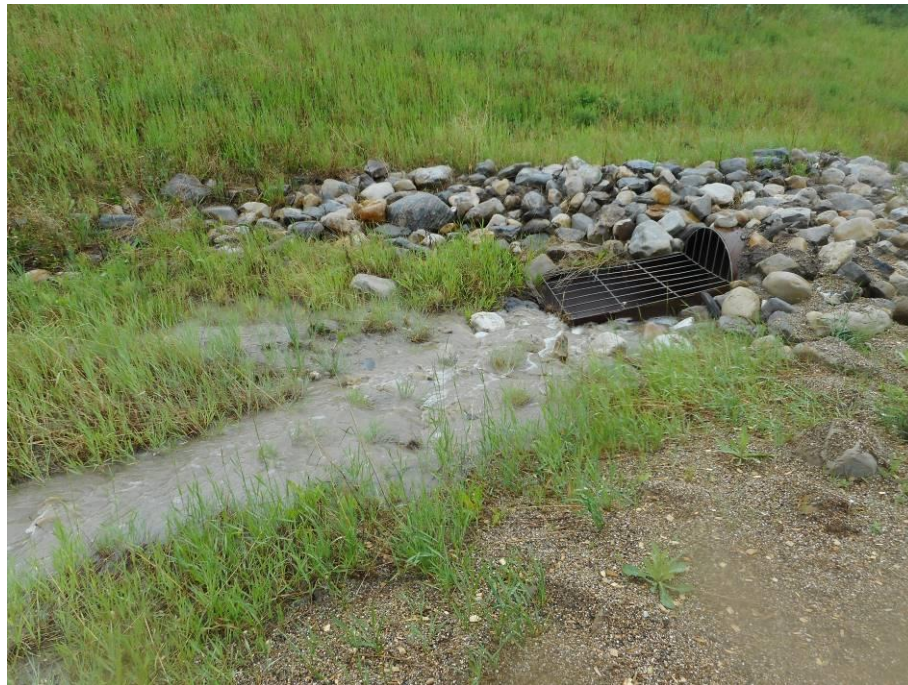
Photo 7-18.
Culvert inlet at west
end of erosion control
section (32+050).
