**ALBERTA TRANSPORTATION GEOHAZARD ASSESSMENT PROGRAM
PEACE REGION – PEACE-HIGH LEVEL
2020 INSPECTION**

Site Number	Location	Name	Hwy	km
PH7	Daishowa East Hill	Gabion Channel & Erosion Control Section	986:01	12.55
Legal Description		UTM Co-ordinates		
NE7-85-20 W5M		11V E 490505	N 6246235

**DAISHOWA
HWY 986:01 (PH7)
LOCATION PLAN**

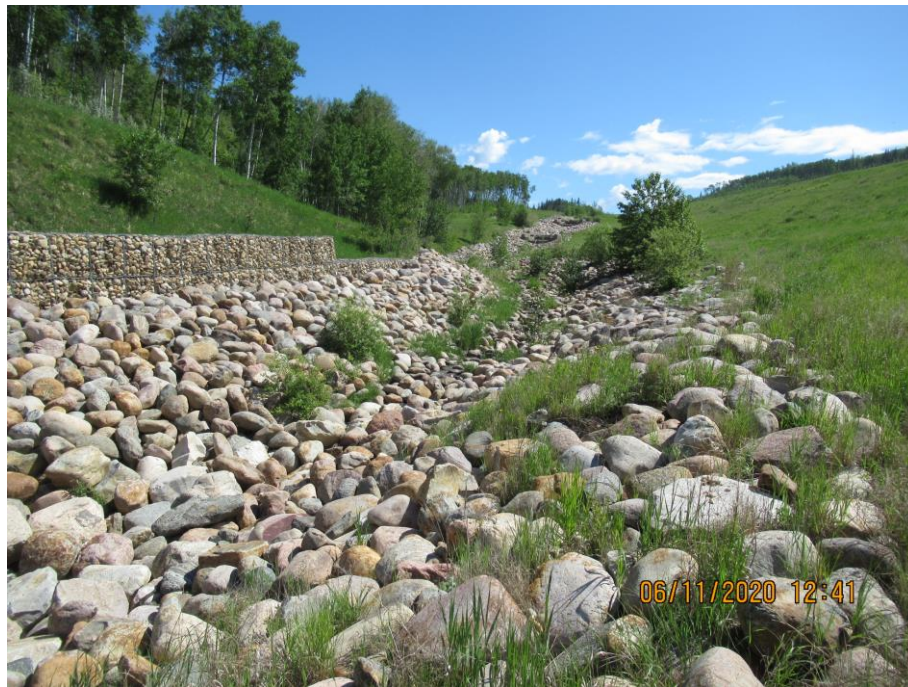
Photo 7-01.
Gabion retaining wall and armoured channel observed in good condition (32+290).

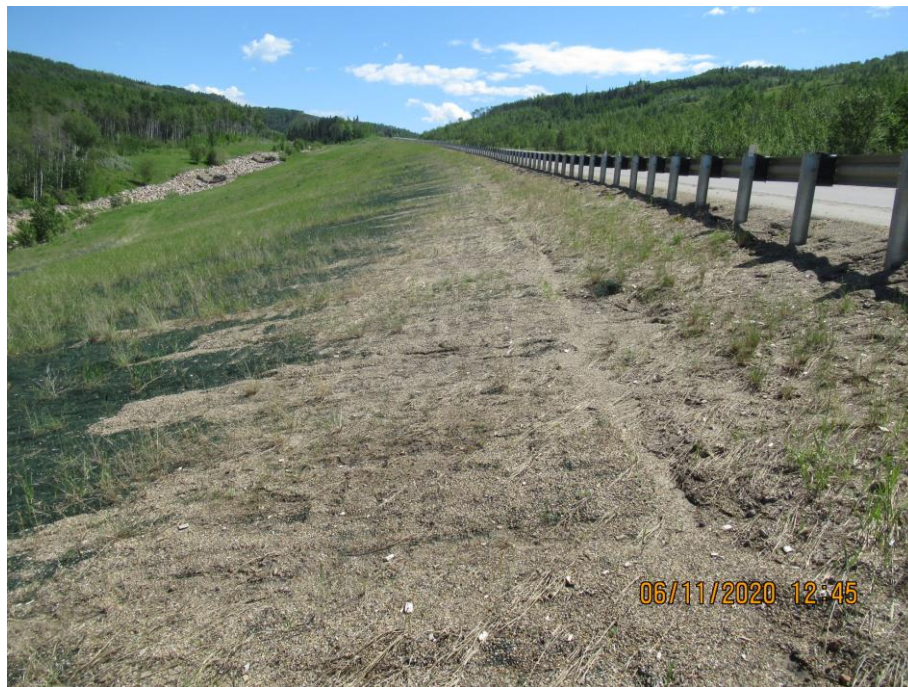
Photo 7-02.
Looking east towards area with previous rill erosion that was repaired in 2018 with backfill and TRM (32+300). Overall area was in good condition.

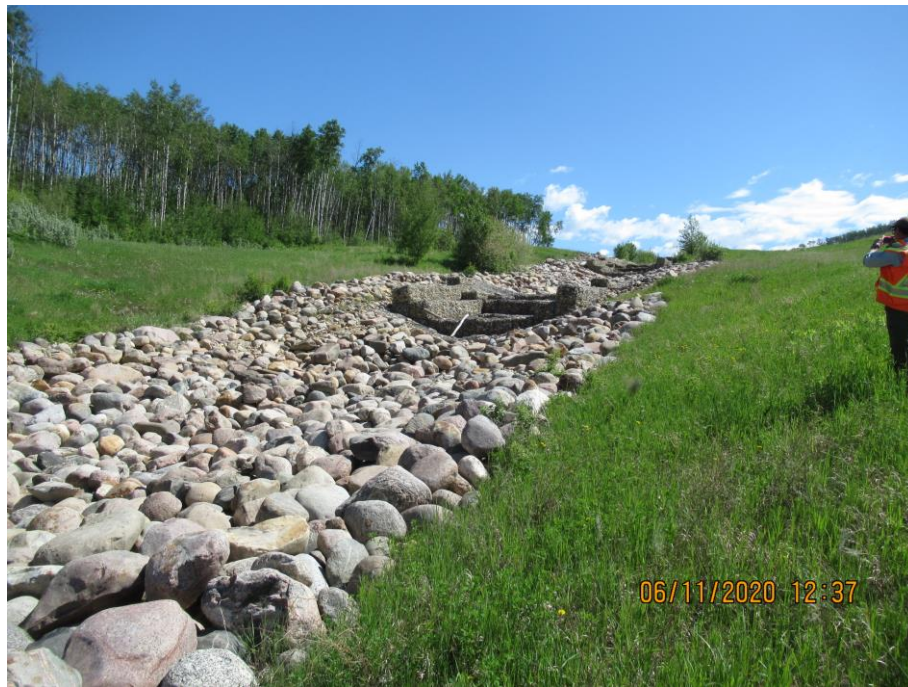
Photo 7-03.
Looking east, upslope from below two gabion drop structures. Overall the armoured channel was in good condition and recently repaired areas of rip-rap replacement/bank erosion were intact (32+450).

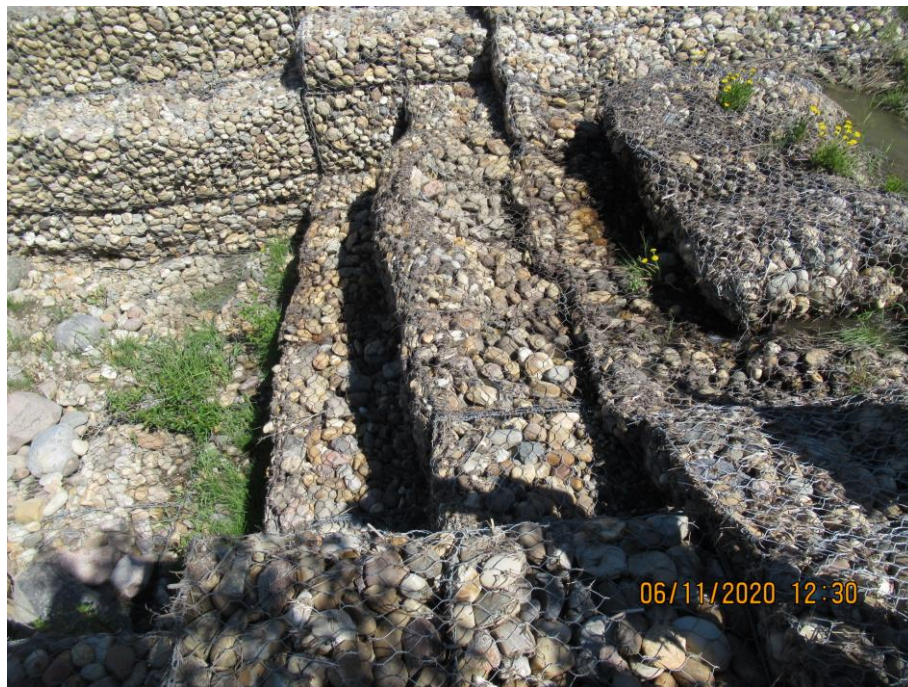
<p>The two gabion drop structures (32+490 and 32+540) were in good condition except for some bagging and broken wire within the centre of the channel (Photo 7-04). Previous channel erosion and breach of armour (including geotextile exposure) compromising the foundation of the protective gabion wall (32+290) has been repaired with additional riprap placement and was in good condition (Photo 7-01). Within the lower drop structure (31+800) some gabions within the middle of the channel showing some bagging and wire damage (Photo 7-07).</p> <p>Embankment area with rill damage has been repaired and TRM installed, overall appeared in good condition (Photo 7-02).</p>	
<input type="checkbox"/> Seepage		<input type="checkbox"/>
<input type="checkbox"/> Bridge/Culvert Distress		<input type="checkbox"/>
<input checked="" type="checkbox"/> Other	<p>Bump in road (32+050) may be a result of frost heave or swelling conditions in the subgrade (no change from 2019).</p>	<input type="checkbox"/>

Photo 7-04.
Close-up view of the internal upper gabion drop structure (32+540). Baskets in the channel centre have some bagging and broken wire. Maintenance recommended to prevent further damage / loss of gabion rock. Otherwise structure is intact and functioning as intended.

Recommendations:	Cost
The erosion around the culvert inlet (32+050) should be backfilled and riprap reconfigured.	Maintenance
Continue to monitor the site and undertake annual inspections.	-
Gabion baskets in the north channel within the drop structure should be rewired and shaped where they have come apart.	-
If it is determined that the hydraulic capacity of the north channel inlet is being adversely affected by willow growth, they should be cut flush to the channel bottom with the roots left in place.	\$ 5,000
Consideration should be given to a permanent curb constructed along the guard rail with all flow directed to controlled discharge points, such as a split culvert, that carries the flow to the lined channel at the toe of the slope. "Geocell" would be one possible option to construct the curb. The curb would have to be on the north side of the guard rail to avoid conflict with snow clearing equipment. If such an option were to be implemented, about 150 m of curb would be required. Two controlled discharges, likely 300 m length would be required. Damage noted at 32+850 not significant yet but may need similar type of repair if left unchecked.	\$ 60,000

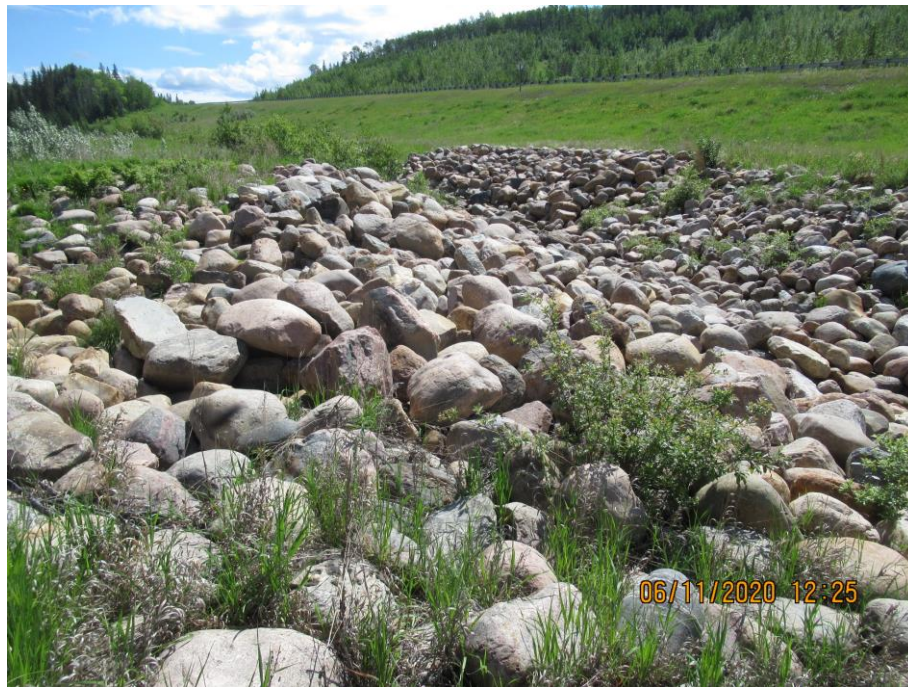
Photo 7-05.
 Previous areas of bank erosion and breach of armour on south side, repaired with placement of additional rip rap which was still intact (32+650).

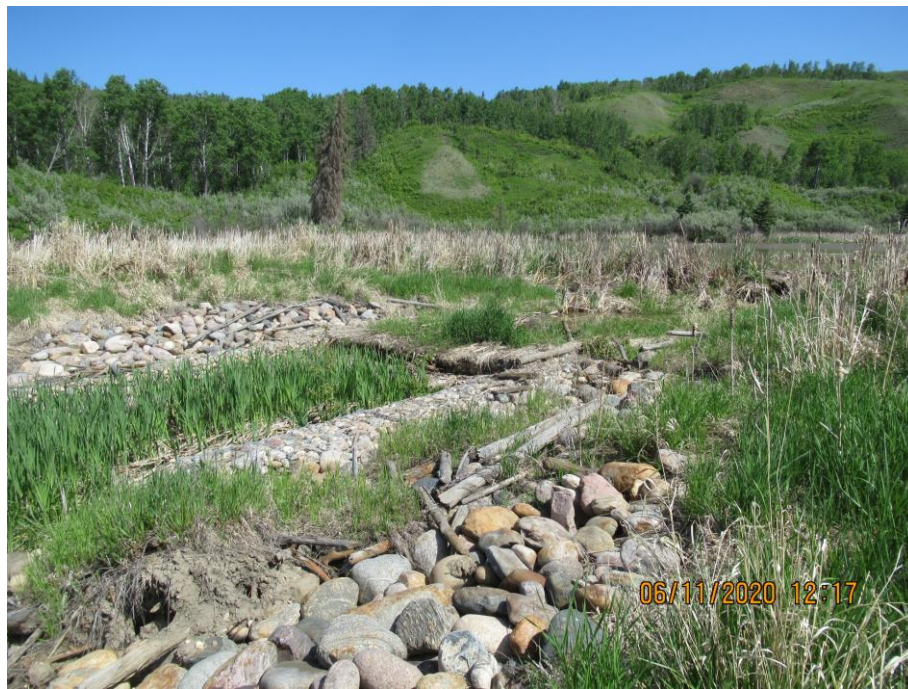
Photo 7-06.
 North channel gabion inlet structure. Condition was comparable to previous inspections (32+855).

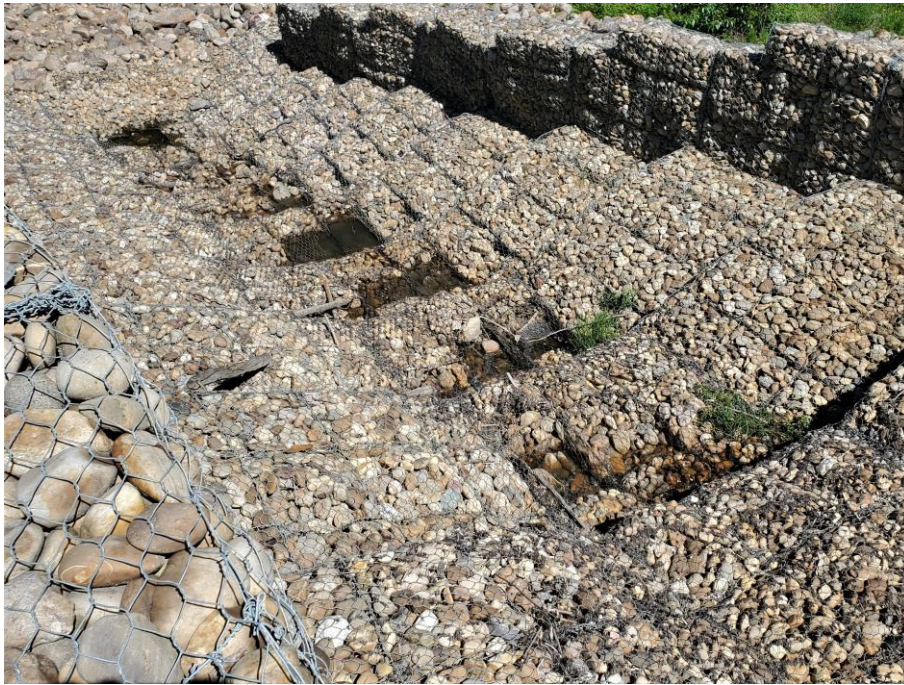
Photo 7-07.
View of the lower segment of the gabion channel bend and drop structure (31+800). Gabions within the middle of the channel showing some bagging and wire damage that will require eventual maintenance to prevent further basket damage. Overall structure was intact and functioning as intended.

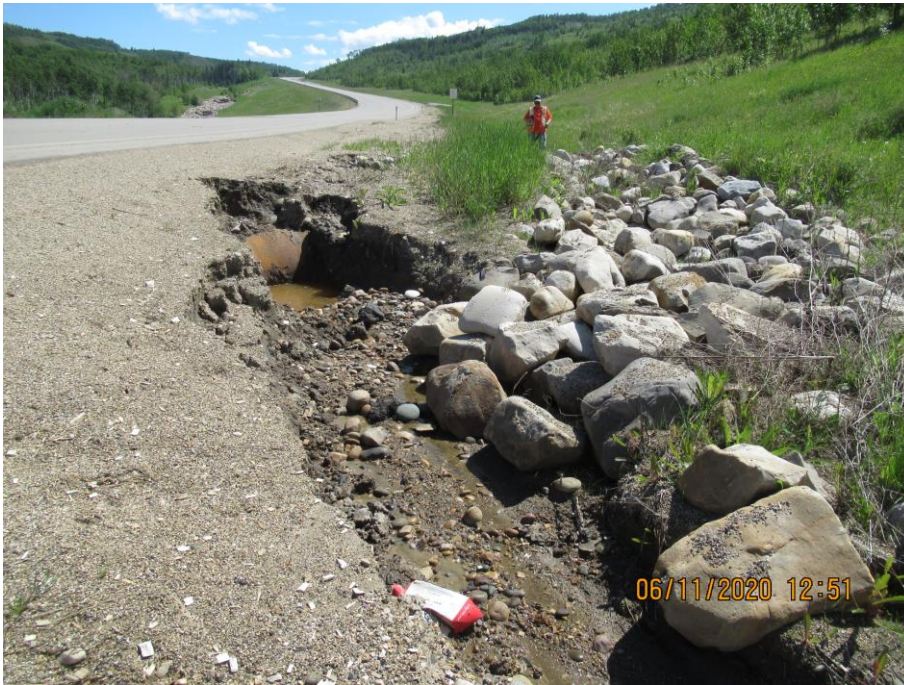
<input checked="" type="checkbox"/> Erosion	New erosion / washout around culvert intake at the west end of the erosion control test ditch (32+050) (Photo 7-8).	<input checked="" type="checkbox"/>

Photo 7-8.
New erosion / washout around the culvert intake structure at the west end of the erosion control test ditch (32+050).

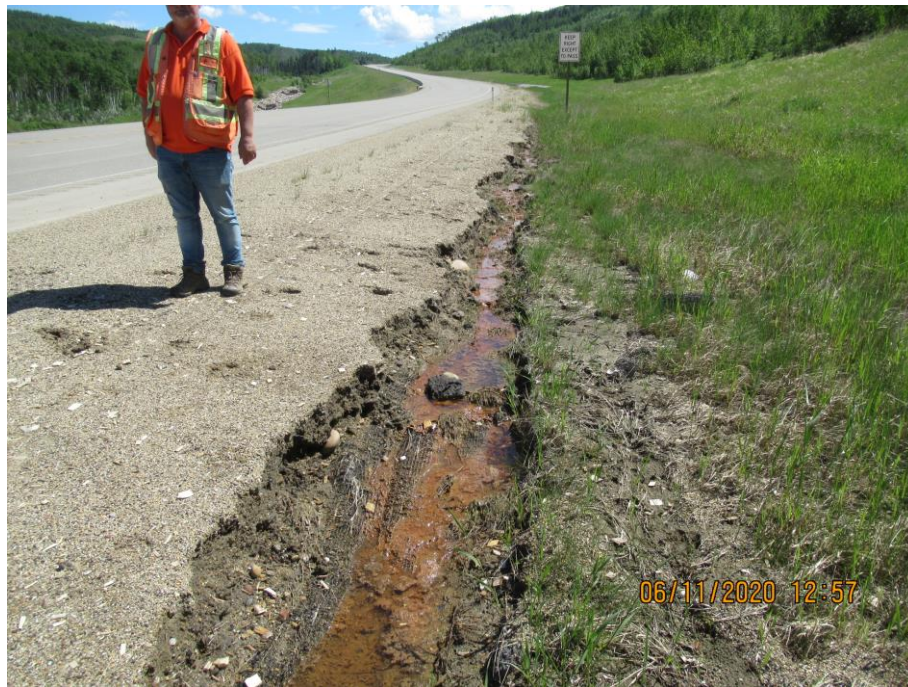
<p>South Ditch Test Section Summary:</p> <p>TRM Section (32+100) - new channelized erosion damage on the north side of the ditch within the vegetated sediment over the rolled erosion control product (Photo 7-9).</p> <p>Channel Sock Section (32+150) - good vegetation growth but increased channelized erosion at the top of the section near the boundary of the geomembrane section (Photo 7-10).</p> <p>Coletanche Geomembrane Section (32+250) – Membrane was recently patched, the erosion underneath was backfilled and overall appeared to be performing well (Photo 7-11).</p> <p>Geoweb Section (32+400) - Section had vegetation growth and was performing well. Some minor rill damage was noted on the north side of the ditch (Photo 7-12).</p> <p>Gabion Mattress Section (32+500) - Section had vegetation growth and was performing well (Photo 7-13).</p> <p>Paving Stones Section (32+600) - Blocks have deteriorated and broken up in numerous locations and have been undermined by erosion exposing geotextile fabric beneath (Photo 7-14).</p> <p>Cabled Concrete Section (32+150) – Minor erosion/rill damage was noted on the north side of the ditch (Photo 7-15).</p> <p>Pillow Concrete Section (32+750) - Minor concrete deterioration was noted in select areas but erosion mitigation function was not impacted (Photo 7-16).</p> <p>North Channel Summary:</p> <p>(Photo 7-06): inlet had willow growth and condition was comparable to previous inspections. Previous areas of bank erosion and breach of armour have been repaired with additional riprap placement (Photos 71-05).</p>

Photo 7-9.
New channelized erosion through vegetated sediment buildup on the north side of the ditch within the rolled erosion control product (turf reinforced matting) test section (32+100).

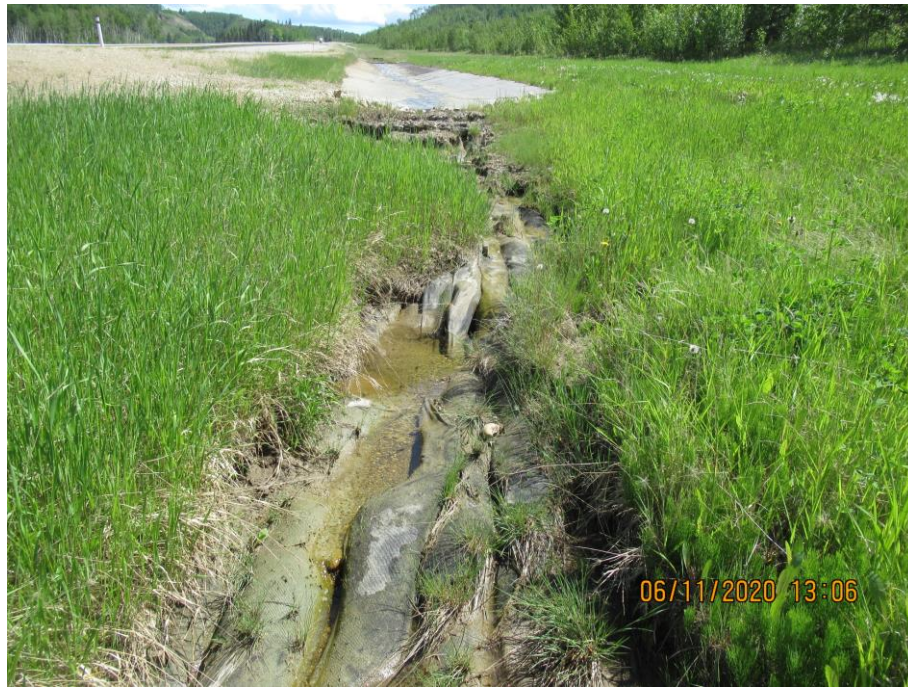
Photo 7-10.
Looking east towards 300 m diameter channel sock erosion control section (32+150). Section had good vegetation growth but increased channelized erosion at the top of the section near the boundary of the geomembrane section.

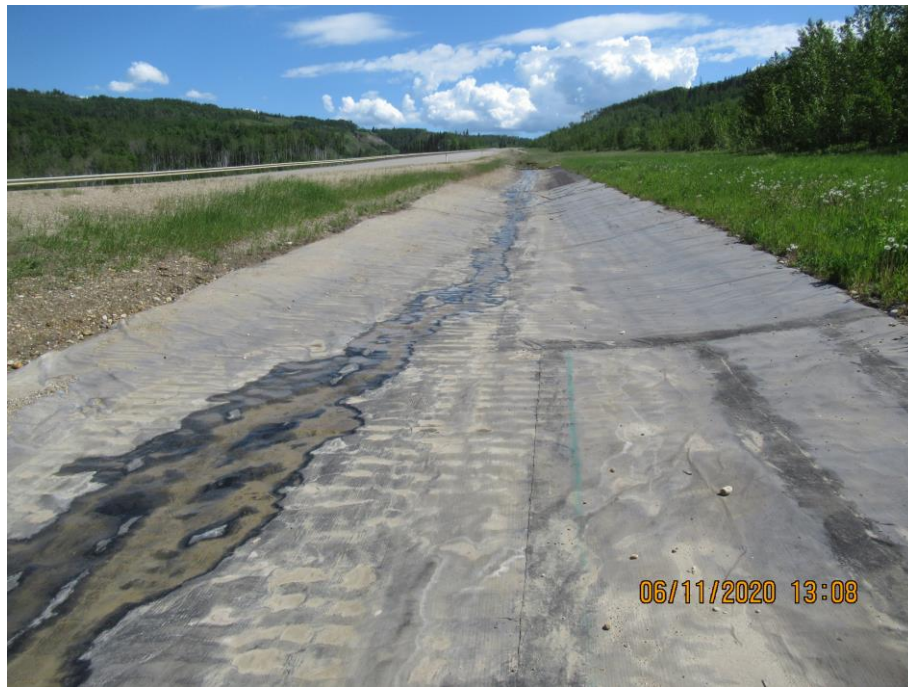
Photo 7-11.
Looking upslope (east) at the Coletanche geomembrane erosion control section (32+250). Membrane was recently patched, the erosion underneath was backfilled and overall appeared to be performing well.

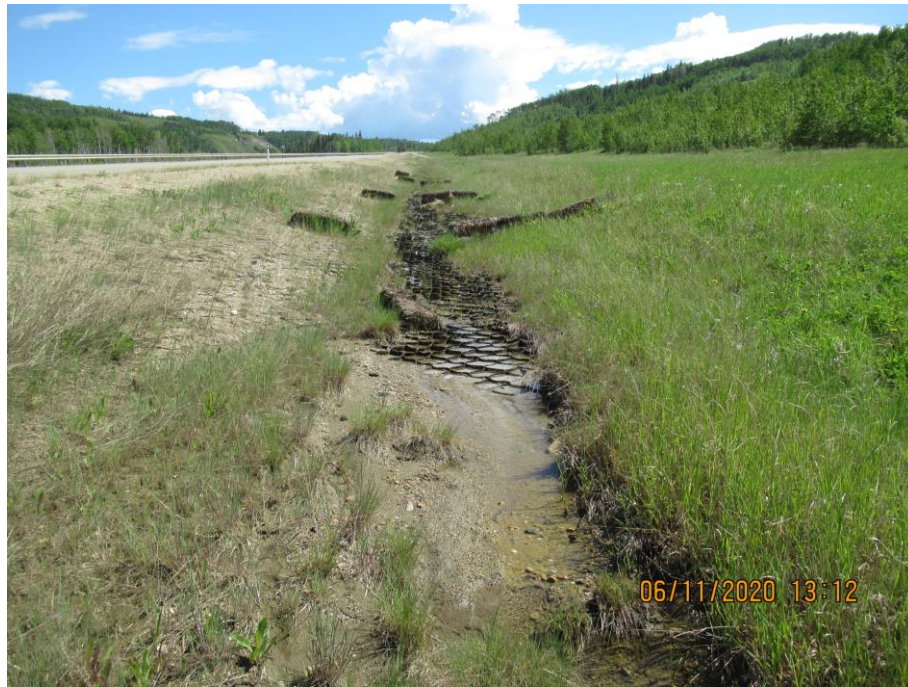
Photo 7-12.
Looking upslope the ditch (east) at the geoweb control section (32+400). Section had vegetation growth and was performing well. Some minor rill damage was noted on the north side of the ditch.

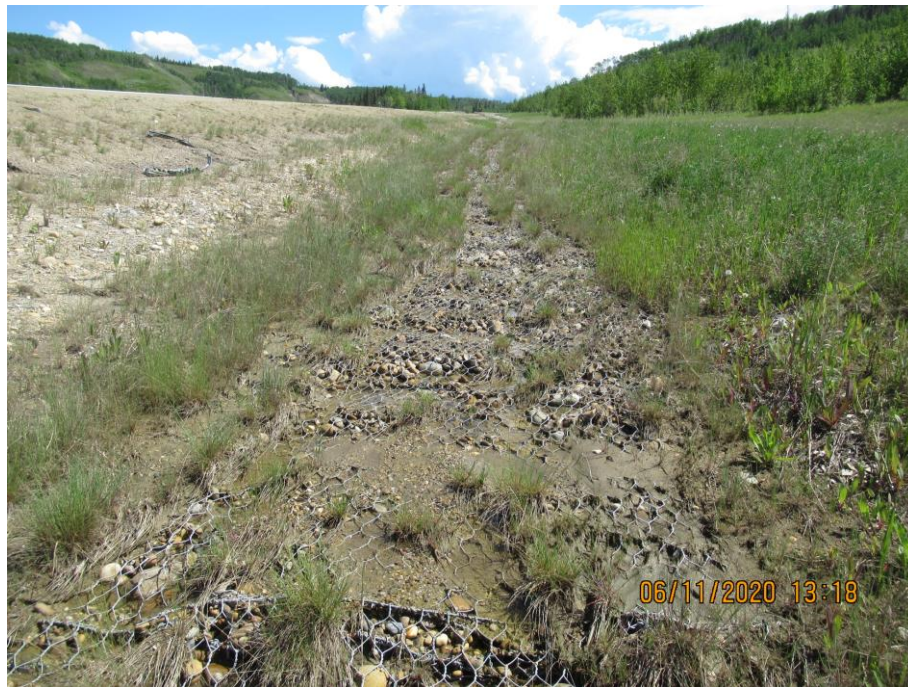
Photo 7-13.
Looking upslope the ditch (east) at the gabion mattress section (32+500). Section had vegetation growth and was performing well.

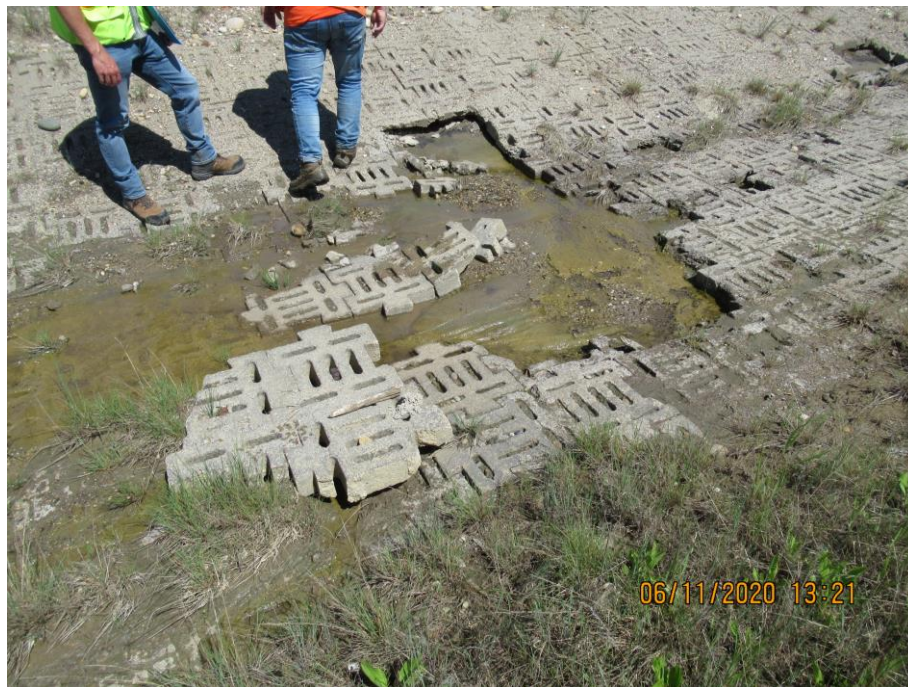
Photo 7-14.
View of the damage within the interlocked concrete block (i.e. Lafarge paving stones) paving stone section (32+600). Blocks have deteriorated and broken up in numerous locations and have been undermined by erosion exposing geotextile fabric beneath. Overall section is performing poorly.

The paving stones section of the south ditch lining will continue to deteriorate and will eventually need to be repaired. Gabion mattress would be a good replacement strategy.	\$ 30,000

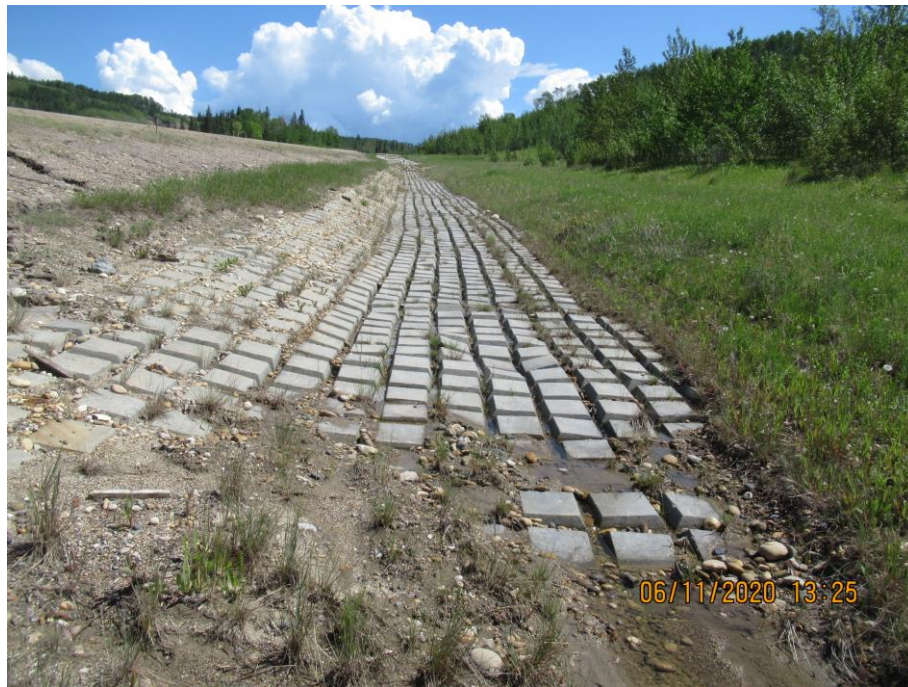
Photo 7-15.
Looking east towards cabled concrete section (32+700). Section was performing well. Minor erosion damage was noted on the north side of the ditch

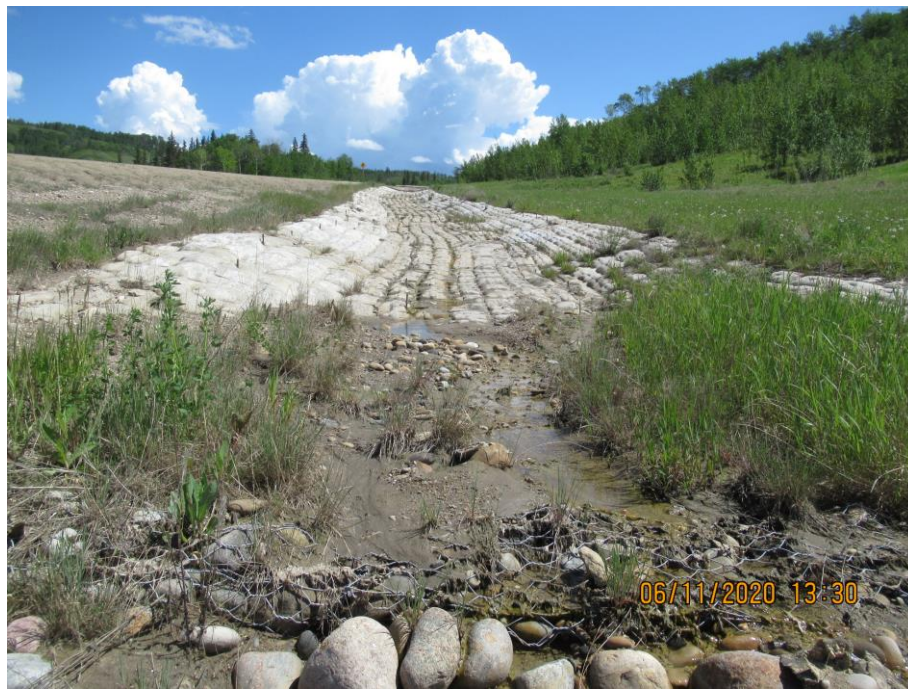
Photo 7-16.
Looking east towards pillow concrete section (32+800). Section was performing well. Minor concrete deterioration was noted in select areas but erosion mitigation function was not impacted.

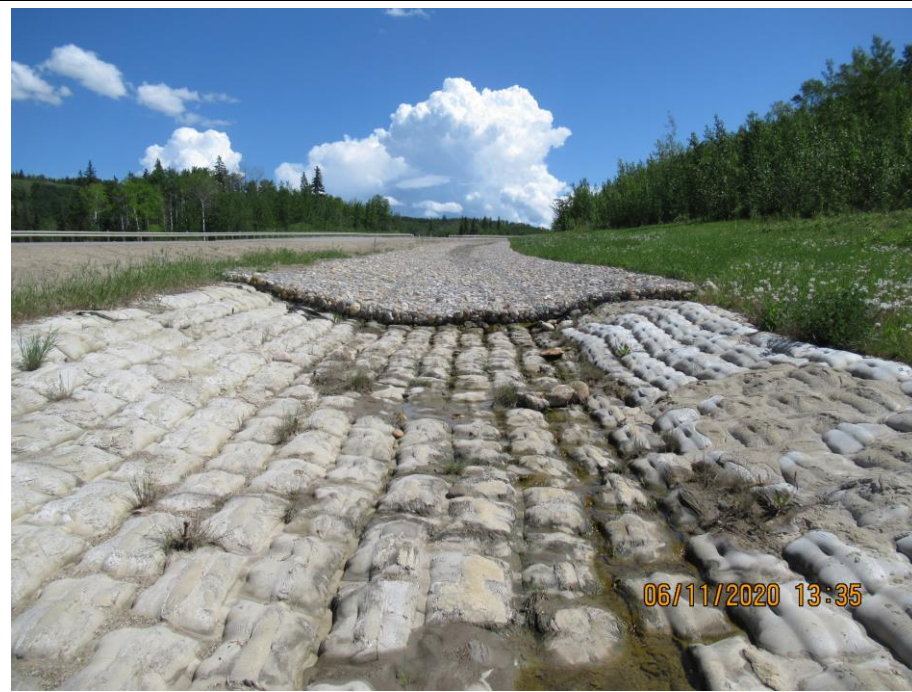
Photo 7-17.
Looking east
(upslope) at the top
of the erosion control
test ditch (32+900).
Ditch upslope of the
test section has been
lined with gabion
mattress as part of
the 2018/2019 East
Daishowa (PH42)
mitigation work. The
ditch and new
mitigation works were
in good condition.
