ALBERTA TRANSPORTATION AND
ECONOMIC CORRIDORS
GEOHAZARD ASSESSMENT PROGRAM
PEACE REGION (PEACE RIVER DISTRICT)
2025 INSPECTION

Site Number	Location	Name	Hwy	km
PH007	Daishowa East Hill	Gabion Channel & Erosion Control Section	986:01	32.007
Legal Description		UTM Co-ordinates (NAD 83)		
NE7-85-20 W5M		11V E 490505	N	6246235

Date	PF	CF	Total
Previous Inspection:	18-May-2023	9	4	36
Current Inspection:	14-May-2025	10	4	40
Road AADT:	1020		Year:	2024
Inspected By:	Rocky Wang, TEC Tyler Clay, Thurber Don Proudfoot, Thurber			
Report Attachments:	<input checked="" type="checkbox"/> Photographs <input checked="" type="checkbox"/> Plans <input type="checkbox"/> Maintenance Items

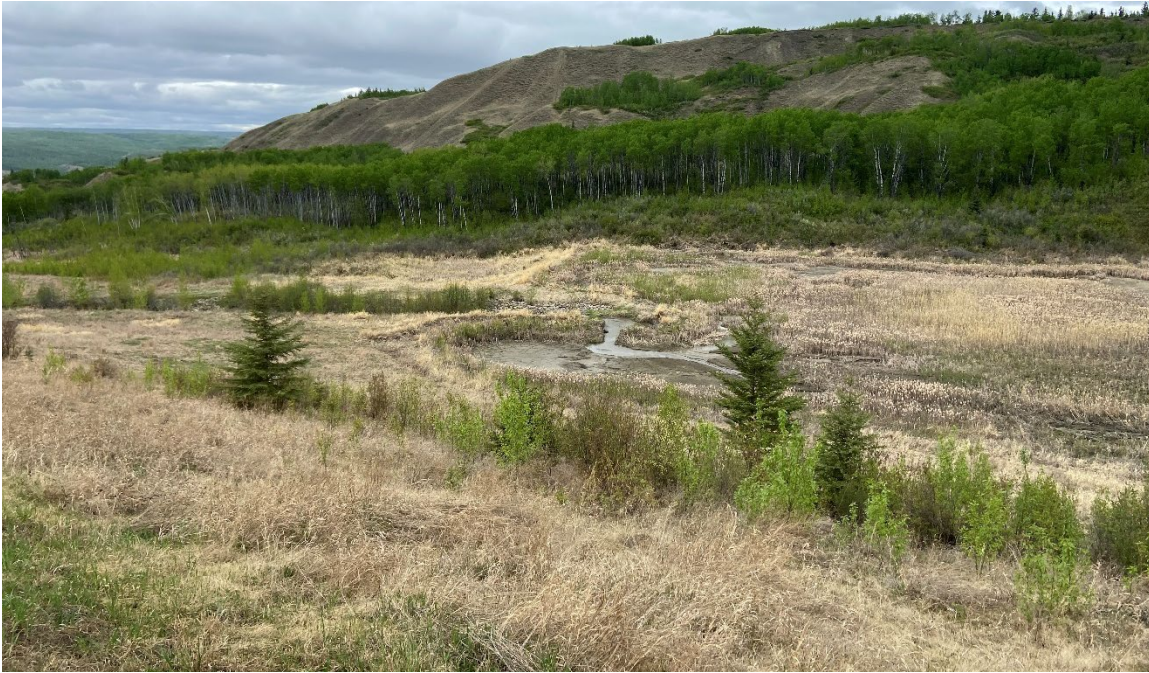
<input checked="" type="checkbox"/> Bridge/Culvert	Culvert was open and flowing at 32+050. Previous erosion around the headwall was filled in with riprap. There was partial flow beneath the base of the culvert. (Photo 7-20)	<input type="checkbox"/>
<input checked="" type="checkbox"/> Other	The beaver dam pond was drained with a large buildup of sediment. There was a breach location near the south side of the dam from the 2024 high flow event (no major change). (Photo 7-01)	<input type="checkbox"/>

Photo 7-01.: Wetland area near km 31+950 with silt buildup and breach through beaver dam following 2024 high flow event.

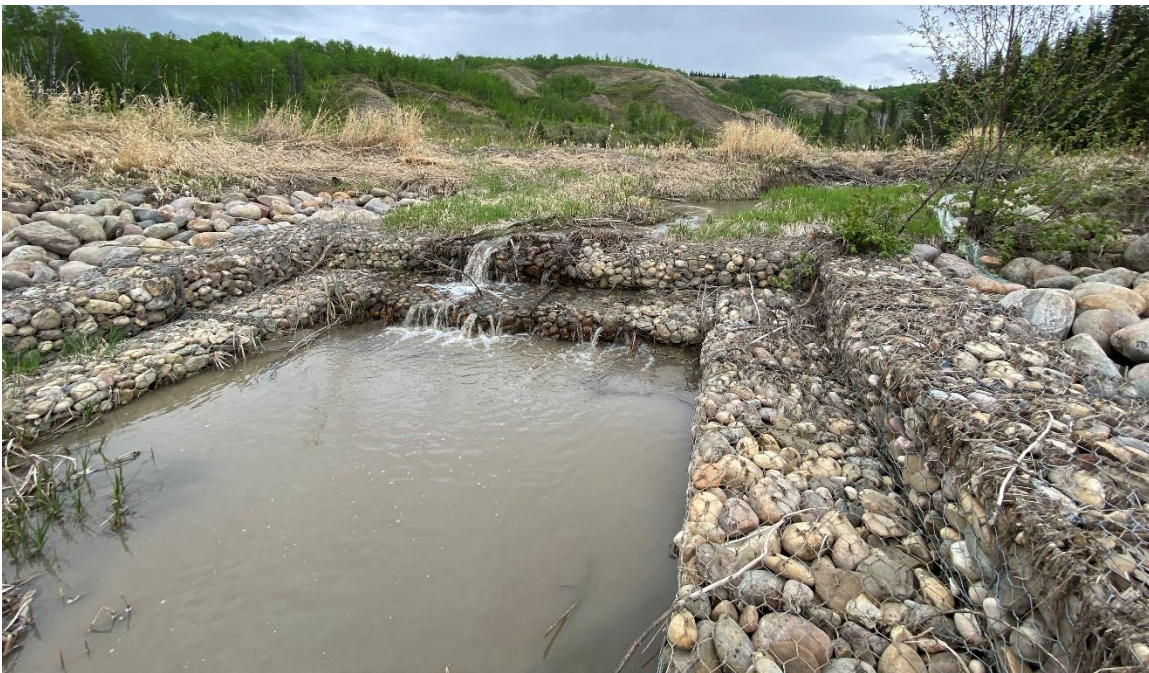
Photo 7-02.: View upstream at the gabion inlet structure near 32+850. Debris buildup and vegetation displacement (willows laid over) from the 2024 high flow event. Minor deformation of the gabion baskets at the inlet.

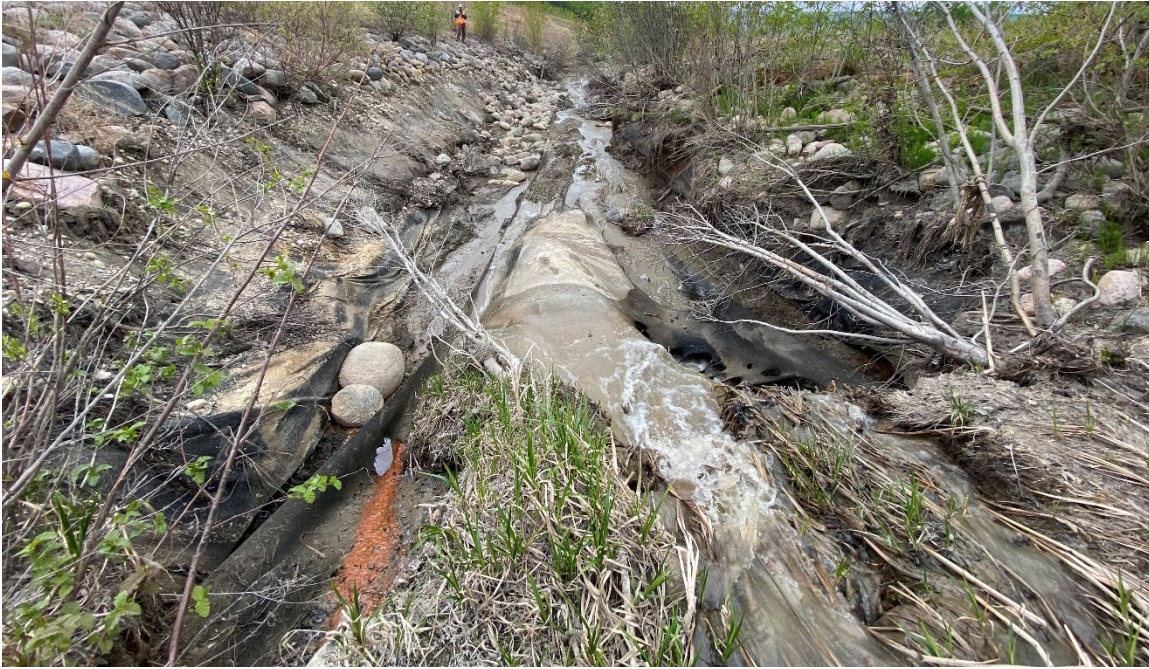
Photo 7-03.: Looking west (downstream) at the eastern end of the primary scour (up to 1.5 m deep) and initiation of severe channel degradation and bank washout within the north channel segment that extends from approximately 32+800 to 32+600.

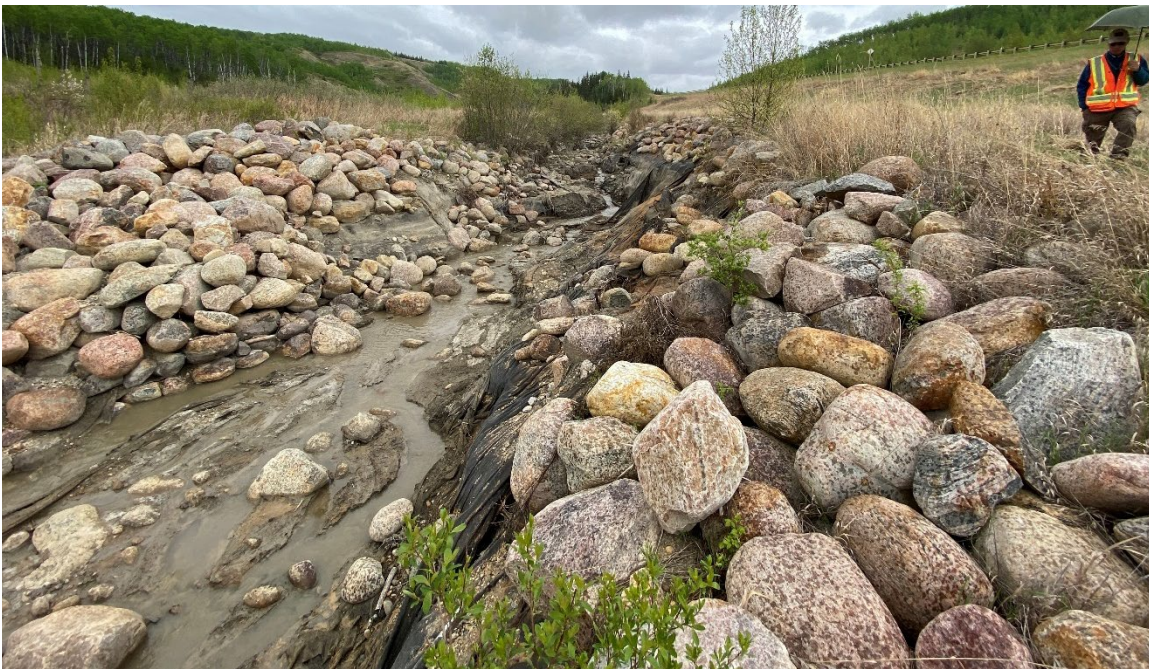
Photo 7-04.: Looking east at channel downcutting (up to 2 m depth) and bank washout creating near vertical bank exposures within the channel bottom resulting in collapse of the riprap along the top of bank (32+650).

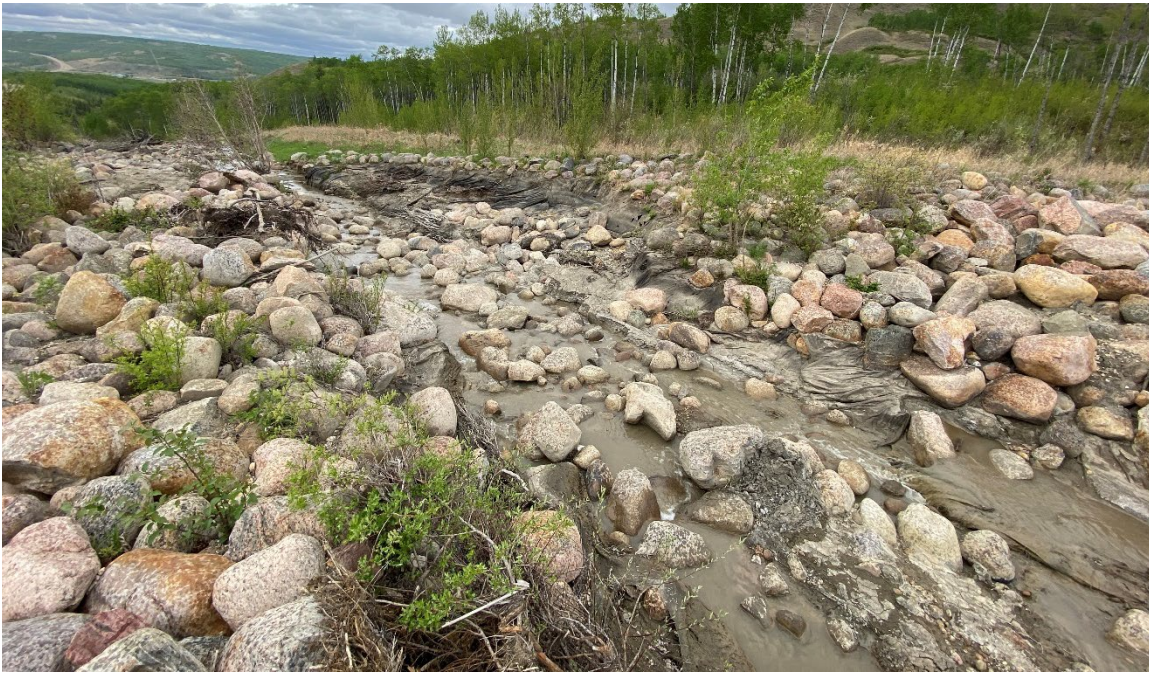
Photo 7-05.: Looking west (downstream) at channel erosion (32+650). There was slightly worse channel downcutting and washout of the riprap rock within the bottom of the channel since the 2024 callout inspection.

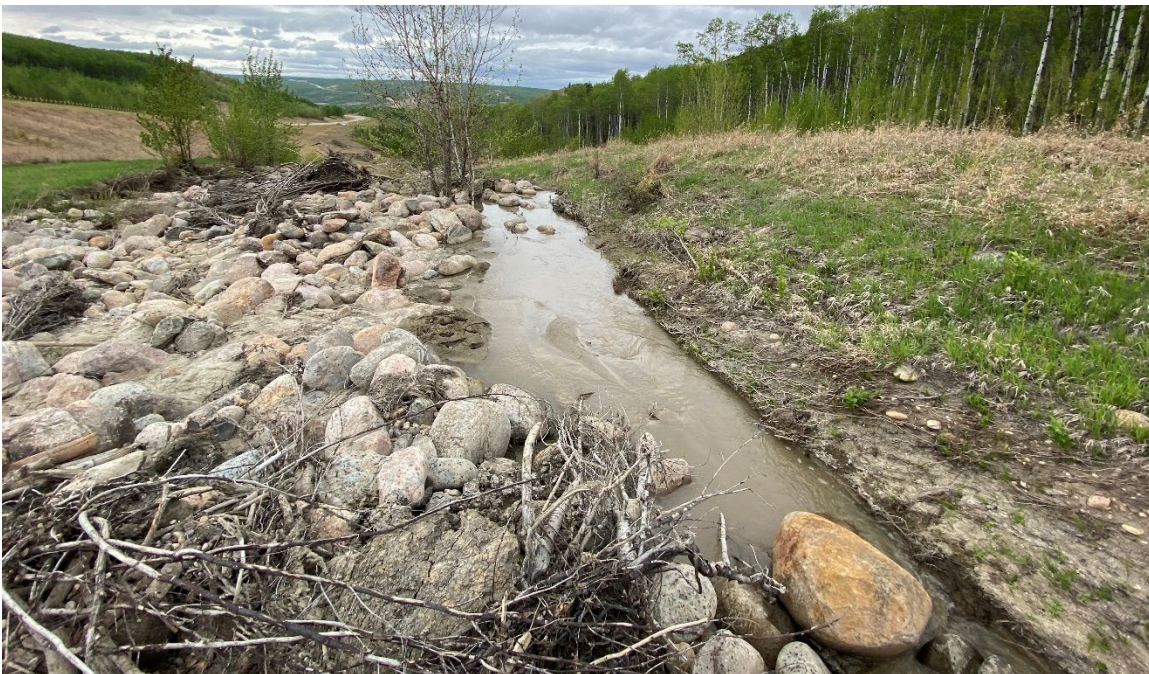
Photo 7-06.: Looking west (downstream) at a buildup of washed out riprap, sediment and woody debris from erosion within the upstream north channel that has caused channel infill near 32+575 and diverted the high water flow to overtop both banks and flow around the upper drop structure on the south side.

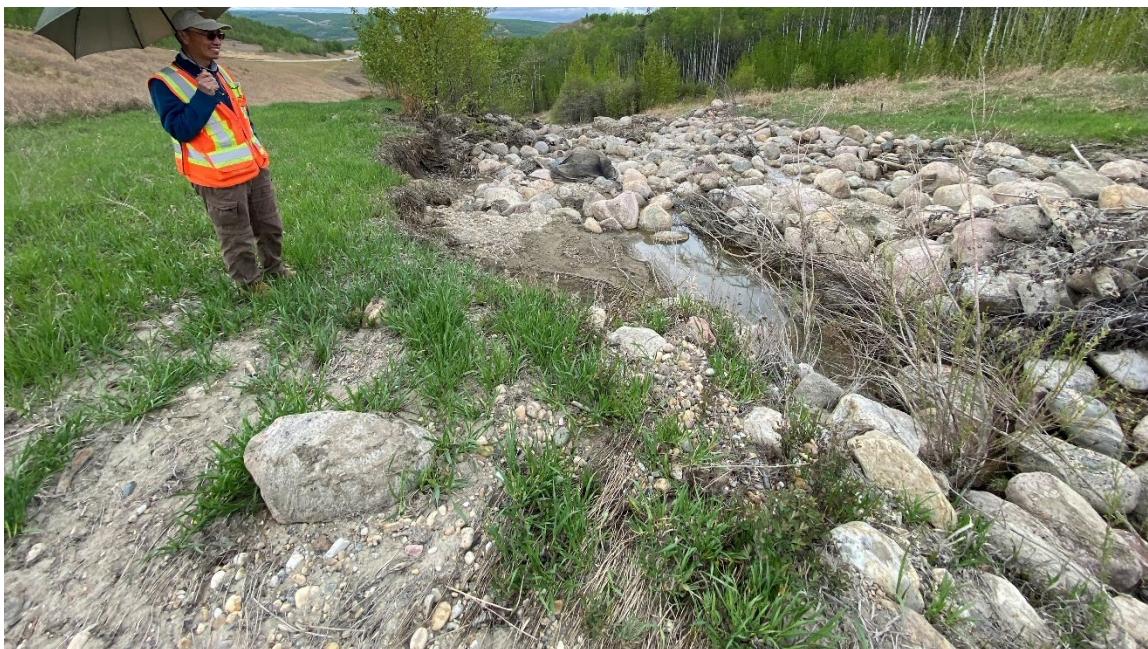
Photo 7-07.: Looking west (downstream) along the south channel bank where an upstream buildup of washed out riprap has infilled the channel and caused overflow above the south bank and outside the upper gabion drop structure (32+550). High flow path evident from grass disturbance and sediment buildup outside the banks.

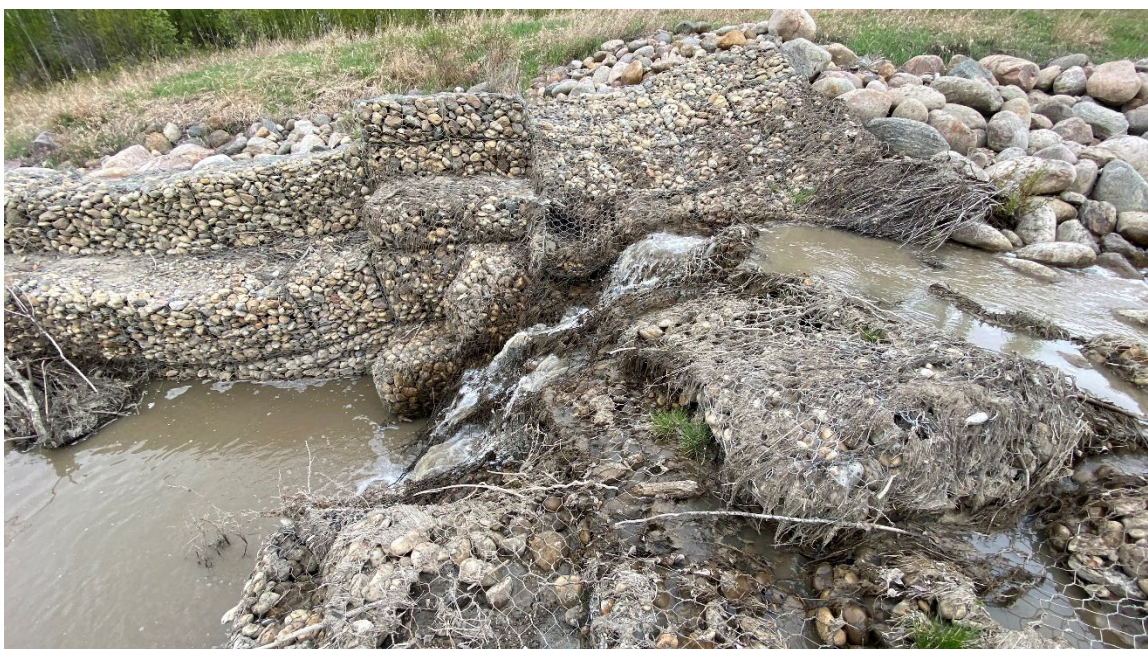
Photo 7-08.: View north towards the upper gabion drop structure (32+550). Major basket deformation and wire damage along channel centreline. Scour within the bottom of the structure has caused sag of the sidewalls. Sediment buildup and pooling in bottom.

- Repair of the upper gabion drop structure will be difficult without extensive excavation and disassembly of the existing gabion baskets. The repaired or new drop structure should have additional design elements to increase flow capacity that may include subsurface flow cutoff structures or buried impermeable liners. The length, width and gradient of the drop structure may need to be revised to reduce flow velocity and the potential for basket damage.

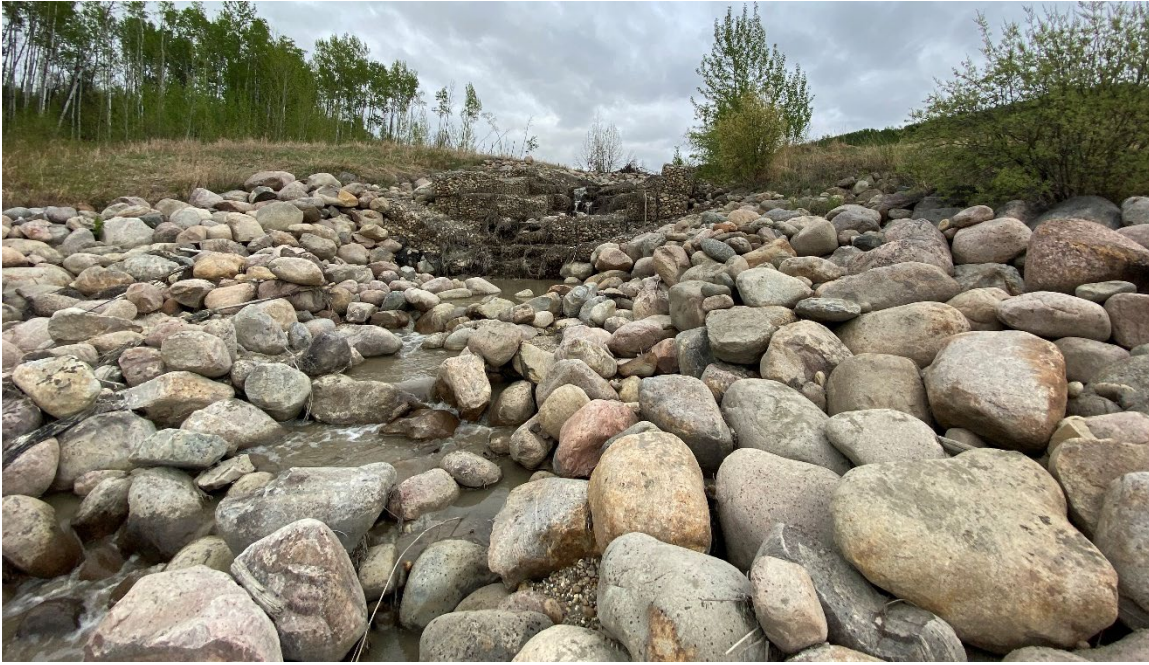
Photo 7-09.: View east towards the upper gabion drop structure (32+550) with major basket deformation and damage. Some riprap was displaced at the toe of the structure, but the downstream channel riprap was intact up to the lower drop structure approximately 40 m further downstream.

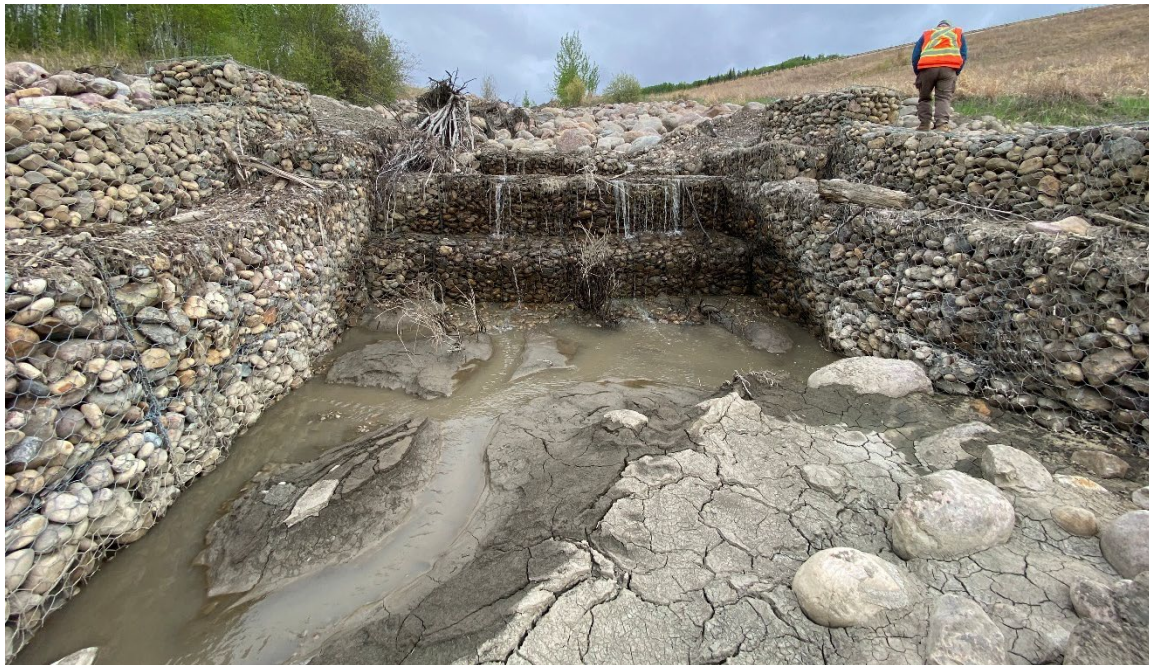
Photo 7-10.: View east towards the lower gabion drop structure (32+480). Minor basket deformation in the southeast inlet area. Debris and sediment buildup indicative of high flow around the outside of the structure with an erosion gully formed on the north side.

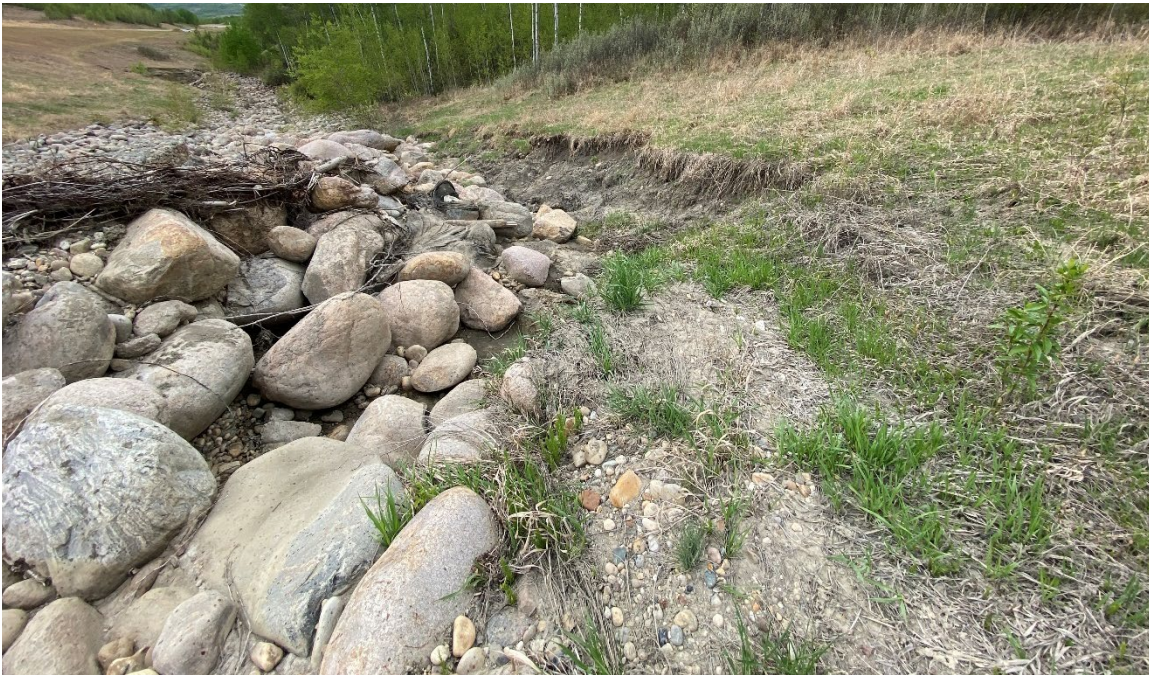
Photo 7-11.: View west at the top of the lower gabion drop structure (32+480). The 2024 high flow went outside the drop structure on the north side and formed an erosion gully which in 2025 was approximately 6 m wide and 2 m deep. Previous erosion damage has been observed in this area in the past.

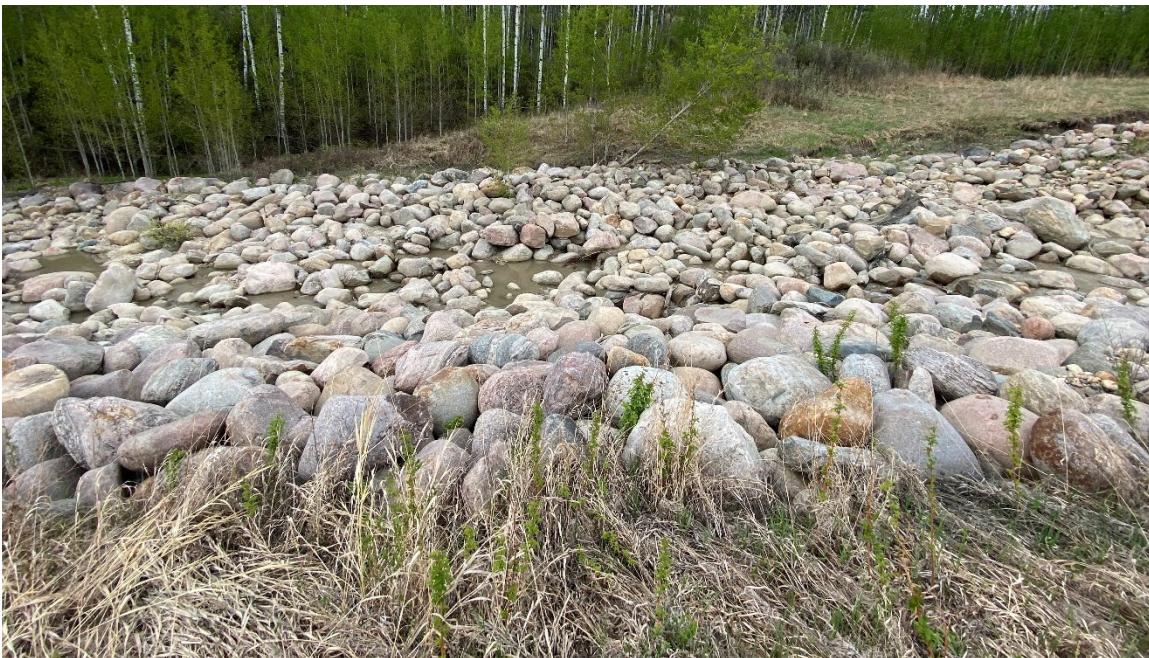
Photo 7-12.: Multiple areas with localized scour and riprap displacement were observed within the channel segment for an approximately 100 m length downstream of the lower drop structure (32+425). Majority of riprap was intact and there was no major erosional downcutting or washout.

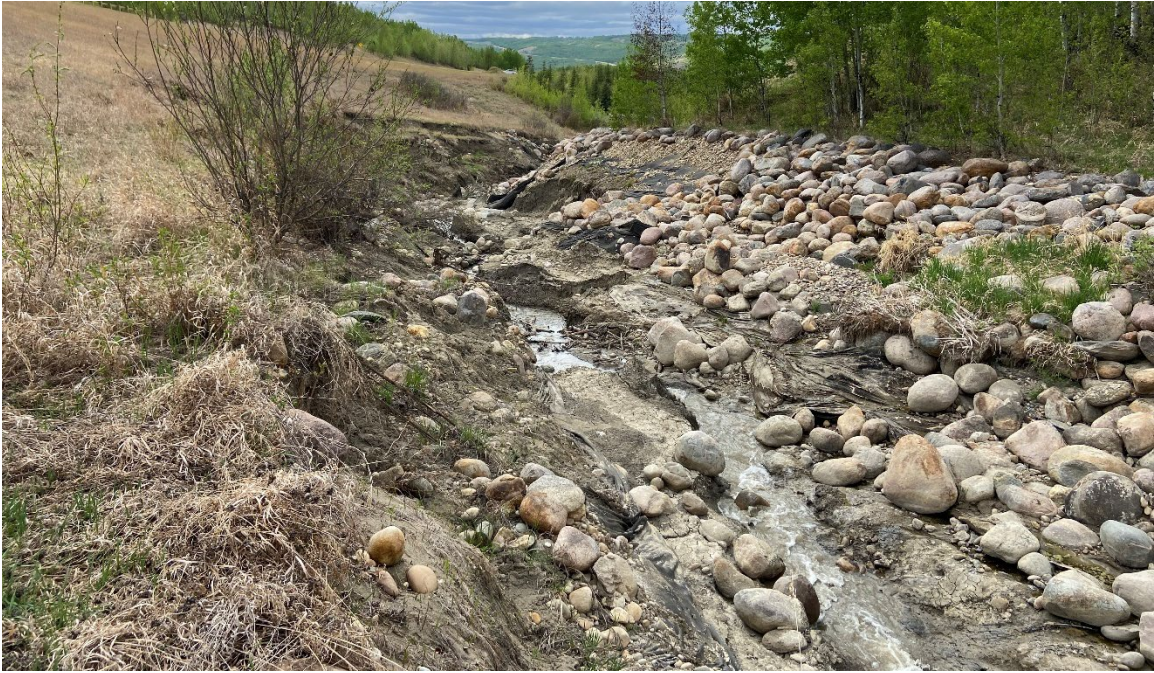
<p>☒ Erosion</p>	<p>North Channel Summary:</p> <p>There was localized scour erosion (up to 1 m wide and 0.3 m deep) and minor gabion basket damage on the upstream side of the gabion inlet structure (32+850). The upstream side of baskets had a buildup of flood debris and previous high water flow was evident from laid over willows and grass. Water was ponded within the inlet structure. (Photo 7-02).</p> <p>Major scour and channel degradation began at a 2 m deep knickpoint near 32+800 and extended approximately 200 m to the east where there was extensive downcutting up to 1.5 m, riprap washout and damage to the non-woven geotextile fabric. (Photo 7-03)</p> <p>Scour and channel downcutting (up to 2 m depth) had resulted in near vertical bank exposures within the channel bottom resulting in undermining and collapse of the riprap along the top of bank between 32+615 to 32+675. (Photos 7-04 and 7-05)</p> <p>Downstream from the erosion damage there was a buildup of the washed out riprap and sediment that infilled the channel near km 32.575. The channel infilling diverted high water flow paths to overtop either side of the banks. Overflow paths were apparent from sediment buildup and grass disturbance. The overflow on the south side of the channel went outside the upper gabion drop structure at 32+525. (Photos 7-06 and 7-07)</p> <p>The upper gabion drop structure (32+525) had major basket deformation and wire damage, resulting in some broken baskets and rock loss primarily within the channel centreline. Scour within the bottom of the structure has caused sag of the sidewalls. There was sediment buildup and pooling in the dissipation pool. Riprap up to 40 m downstream of the drop structure was displaced within the channel centreline but there was no major scour observed up to the next drop structure. (Photos 7-08 and 7-09)</p> <p>The lower gabion drop structure (32+480) was in better condition relative to the upper drop structure. The high flow appeared to flow into and around the structure on both north and south sides based on debris and sediment buildup. There was minor basket deformation within the southeast corner of the upper inlet area. There was a buildup of silt in the base of the drop structure. (Photo 7-10)</p> <p>High water flow outflanked the north side of the lower drop structure forming an erosion gully approximately 6 m wide and 2 m deep. (Photo 7-11)</p> <p>There were multiple areas with localized scour and riprap displacement downstream of the lower drop structure for an approximately 100 m long segment of the channel (from approximately 32+375 to 32+475). The majority of riprap was intact and there was no major erosional downcutting or riprap washout. (Photo 7-12)</p> <p>The most significant segment of channel erosion was observed between 32+280 and 32+380. Upstream of the gabion retaining wall there was channel downcutting (up to 3 m in depth) and riprap washout, leaving near vertical bank exposures up to 5 m in height and undermined riprap within the upper channel banks. (Photos 7-13 to 7-15)</p>	<p>☒</p>

The channel alignment and increased gradient within the armoured channel upstream of the gabion retaining wall directed high flow volume into the south bend resulting in severe downcutting, bank undermining and subsequent bank sliding with a high potential for retrogressive sliding towards the northern highway embankment toe if left unmitigated. Thurber has prepared a channel repair design for this interval to restore the original channel mitigation and reduce further degradation to the highway embankment toe.

Photo 7-13.: View downstream (west) of major channel downcutting (up to 5 m in depth) and washout for an approximately 100 m length of the channel between 32+280 and 32+380.

- Construct the north channel repair design completed by TEL for the interval between approximately km 32.2 to km 32.4.
- Long-term mitigation repair and/or improvements would benefit from updated hydraulic engineering assessment with consideration of climatic trend adjustments of the high flow return periods. Updated hydrotechnical assessment would be useful in determining the magnitude and return period of the July 2024 high-flow event and inform future cost-benefit analyses for ongoing maintenance at the site. It is expected that the erosion mitigation capacity of the channel would be improved from a combination of one or more design elements:

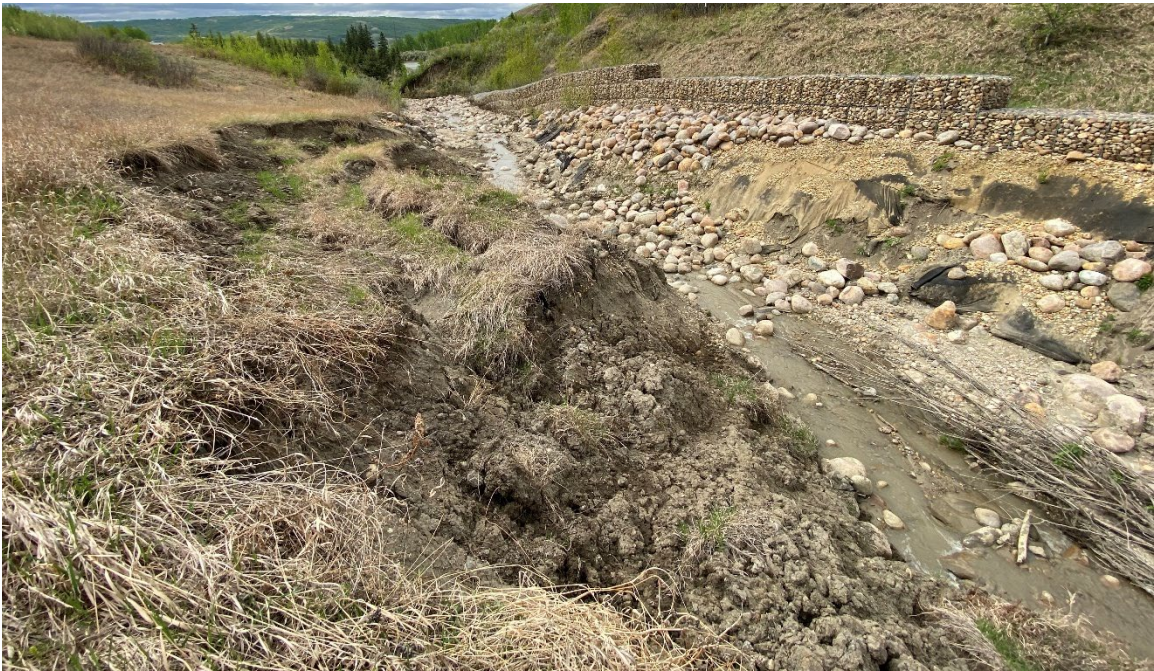
Photo 7-14.: View northeast of the channel segment with major channel downcutting and washout near 32+325. Undermining of the south bank has resulted in bank collapse and sliding towards the highway embankment. Near vertical bank exposures have developed on the north bank.

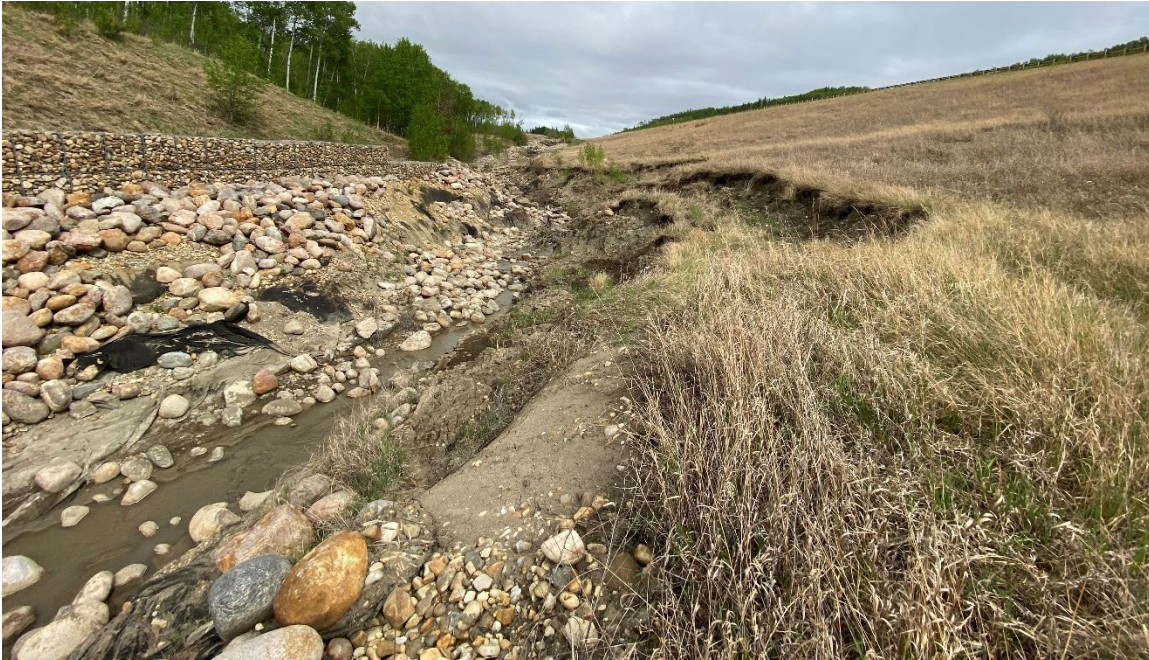
Dimensions:	<p>South ditch: 800 m long</p> <p>North channel: 580 m long</p> <p>Slide at 32+300: 75 m long in North Channel</p>		
Date of Remediation:	2003		
Maintenance:	None		
Observations:	Description	Worsened?	
<input checked="" type="checkbox"/> Pavement Distress	Minor pavement heave over centreline culvert (32+050) may be a result of frost heave or swelling conditions in the subgrade (no change from 2023).	<input type="checkbox"/>	
<input checked="" type="checkbox"/> Slope Movement	Severe north channel downcutting and undercutting of the banks following the 2024 high flow event has resulted in active sliding with retrogression towards the north highway embankment toe between 32+275 to 32+350. (Photo 7-15)	<input checked="" type="checkbox"/>

Photo 7-15.: View east of the channel segment with major channel downcutting and undermining of the south bank that has resulted in the development of slides into the north toe of the highway embankment between approximately 32+275 and 32+350.

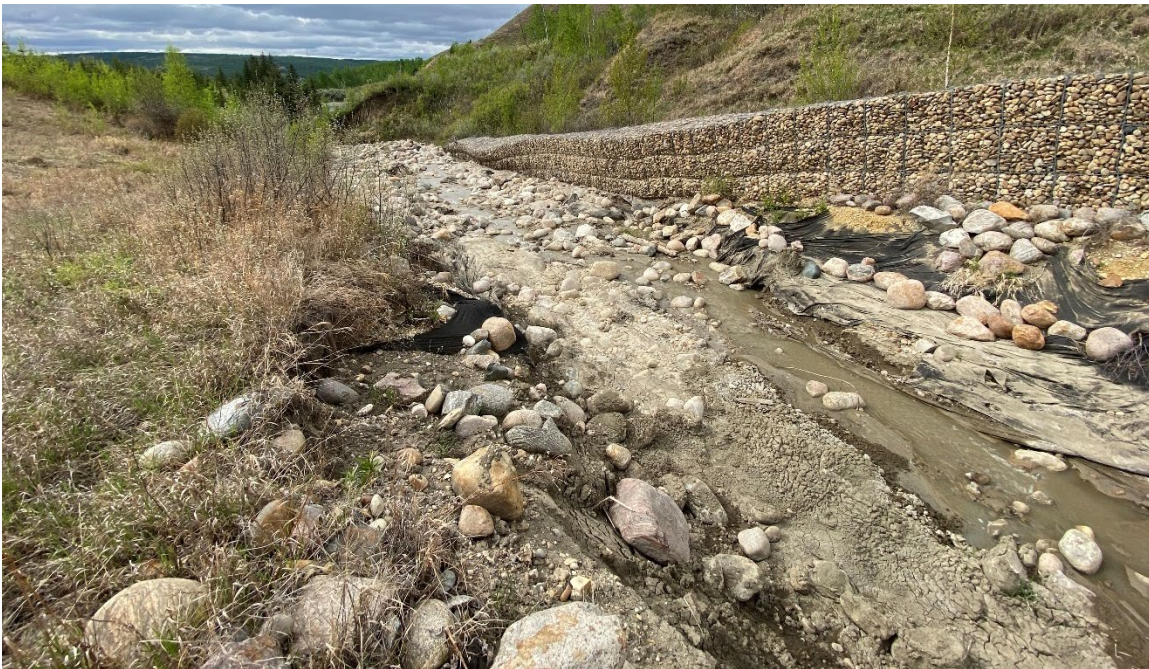
<p>There was riprap washout and exposure of the underlying geotextile below the gabion retaining wall near 32+275 due to channel downcutting. The west end of the gabion retaining wall was tilted into the channel likely due to undermining along the base (32+250). No open scouring was visible, and the area appeared to have been infilled with upstream washout material. (Photos 7-16 and 7-17)</p> <p>Downstream from the western limits of the channel armouring section near 32+250, there was significant accumulation of washed out riprap and granular material within the natural creek channel from the upstream erosion damage in the armoured channel section. (Photos 7-18 and 7-19)</p> <p>South Ditch Test Section Summary:</p> <p>TRM Section (32+100) – previous channelized erosion damage on the north side of the ditch has vegetated over the rolled erosion control product. There was erosion within tire ruts. (Photo 7-21).</p> <p>Channel Sock Section (32+150) - good vegetation growth within previous channelized erosion areas at the top of the section near the boundary of the geomembrane section. There was 0.5 m deep scour pool near the transition of the control sections near 32+250 (Photo 7-22).</p> <p>Coletanche Geomembrane Section (32+250) – Membrane was in a good condition with no new damage observed. (Photo 7-23).</p> <p>Geoweb Section (32+400) - Section had vegetation growth and some cells were only partially filled with sediment and broken along the ditch bottom. Some minor rill damage was noted on the north side of the ditch. No major changes from the previous inspection condition. (Photo 7-24).</p> <p>Gabion Mattress Section (32+500) - Section had vegetation growth and was performing well. Minor rill damage was noted on the ditch sideslope. No major changes from the previous inspection condition. (Photo 7-25).</p> <p>Paving Stones Section (32+600) - Blocks have deteriorated and broken up in numerous locations and have been undermined by erosion exposing geotextile fabric beneath. Deterioration was worse relative to other test sections but no significant change from 2023. (Photo 7-26).</p> <p>Cabled Concrete Section (32+700) – Minor rill erosion damage was noted on the ditch sideslope. Section performing well with no major change from the 2023 condition. (Photo 7-27).</p> <p>Pillow Concrete Section (32+750) - Minor concrete deterioration was noted in select areas, but erosion mitigation function was not impacted. Rebar pins protruding in some areas. (Photo 7-28).</p> <p>Ditch upslope of the test section lined with gabion mattress as part of the 2018/2019 mitigation work. was in good condition with no observable change apart from increased vegetation growth since 2023. (Photo 7-29).</p>

Photo 7-16.: View northwest towards the gabion retaining wall near 32+275 where the riprap at the base of the wall has been washed out as a result of severe channel downcutting.

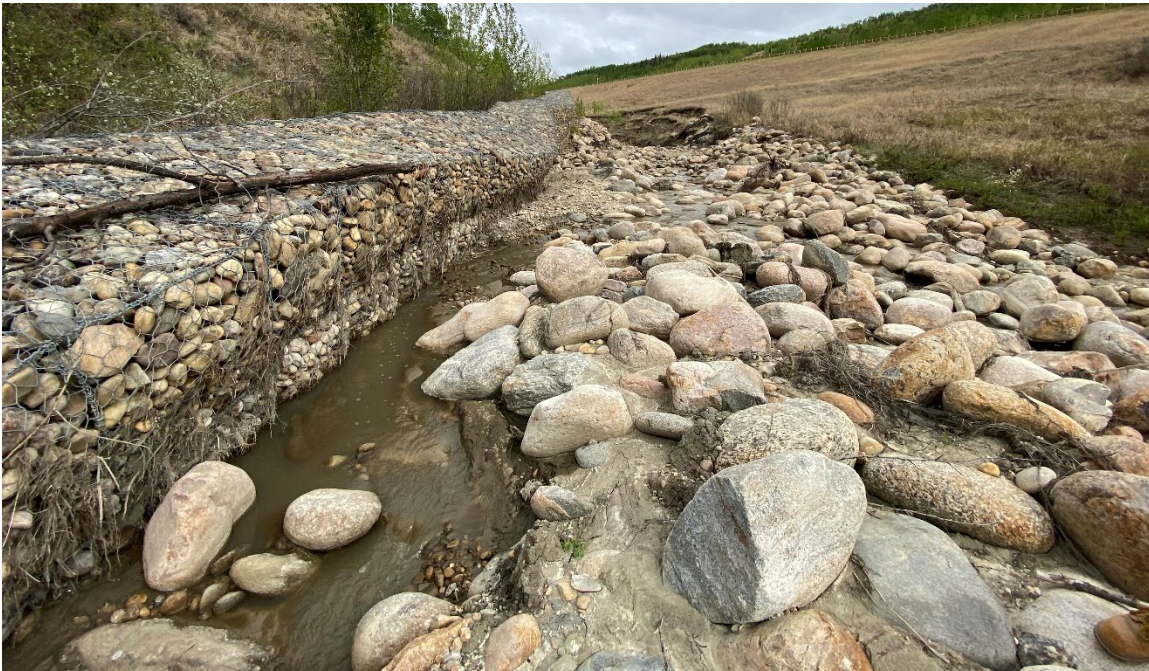
Photo 7-17.: View east along the west end of the gabion retaining wall with visible tilt towards the channel due to undermining at the base from channel scour (32+225).

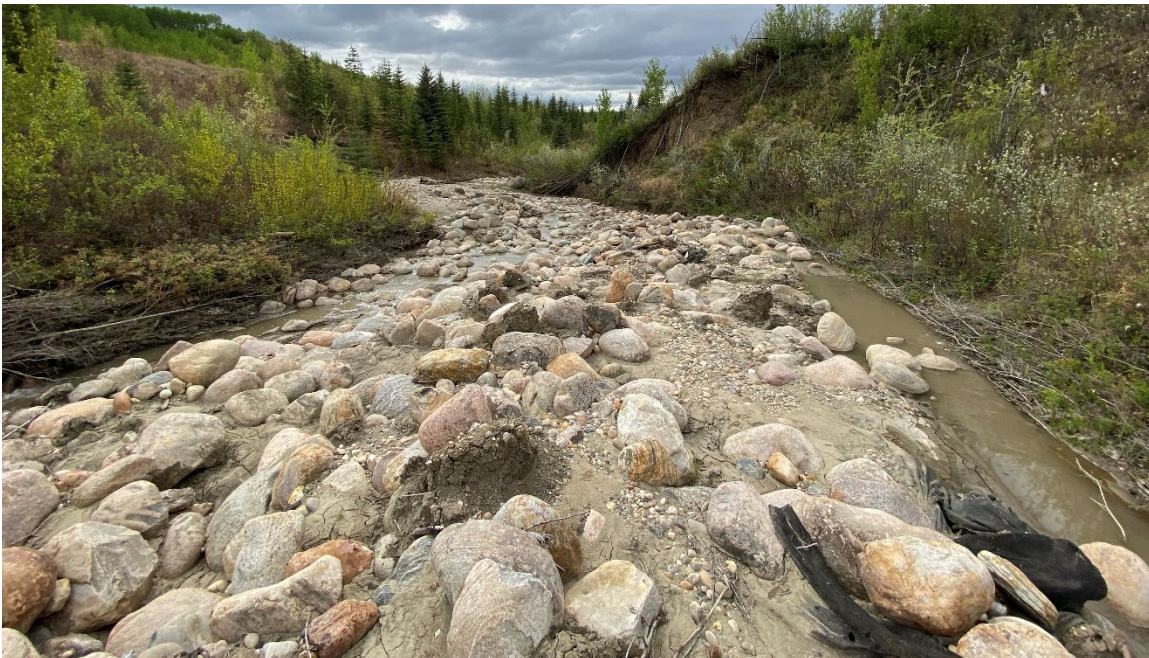
Photo 7-18.: View downstream from west end of the gabion retaining wall (32+250) where channel was infilled with a buildup of washed out channel riprap and sediment, displacing water flow to the channel sides.

- Salvage and redistribute washed-out riprap to upstream areas with significant scour/soil exposure placed over non-woven geotextile. Re-establish original channel geometry at infill areas to restore channel capacity.

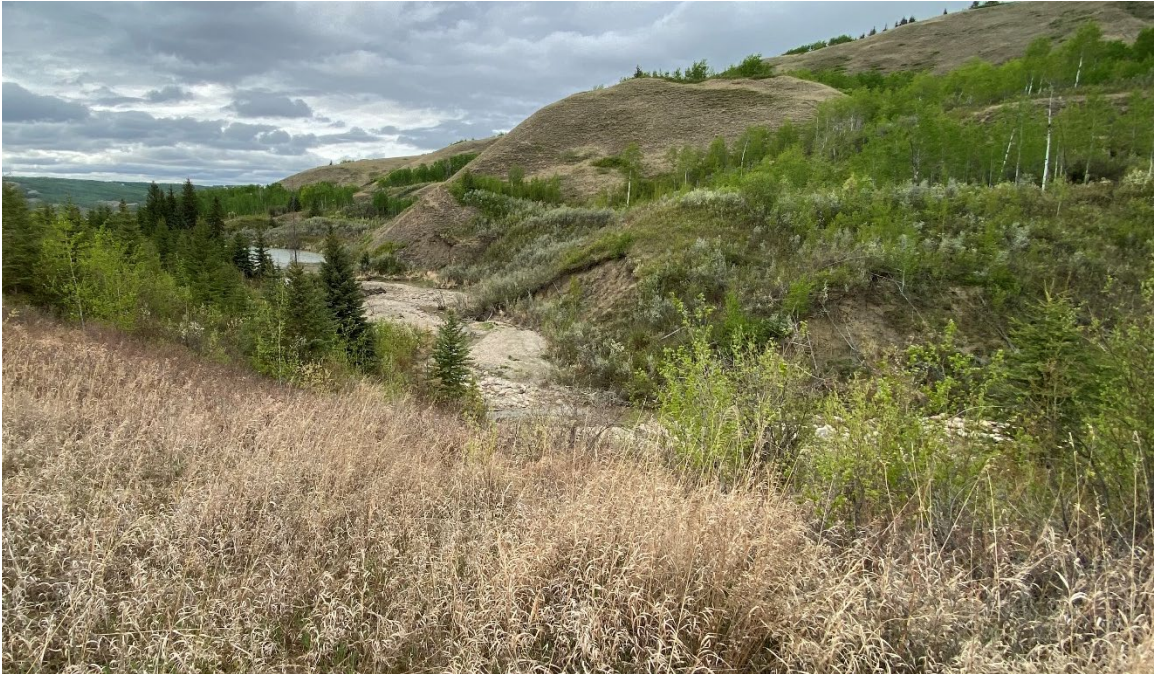
Photo 7-19.: View of the channel downstream from the western limits of the channel armouring section near 32+200 that had significant accumulation of washed out riprap and channel soils.

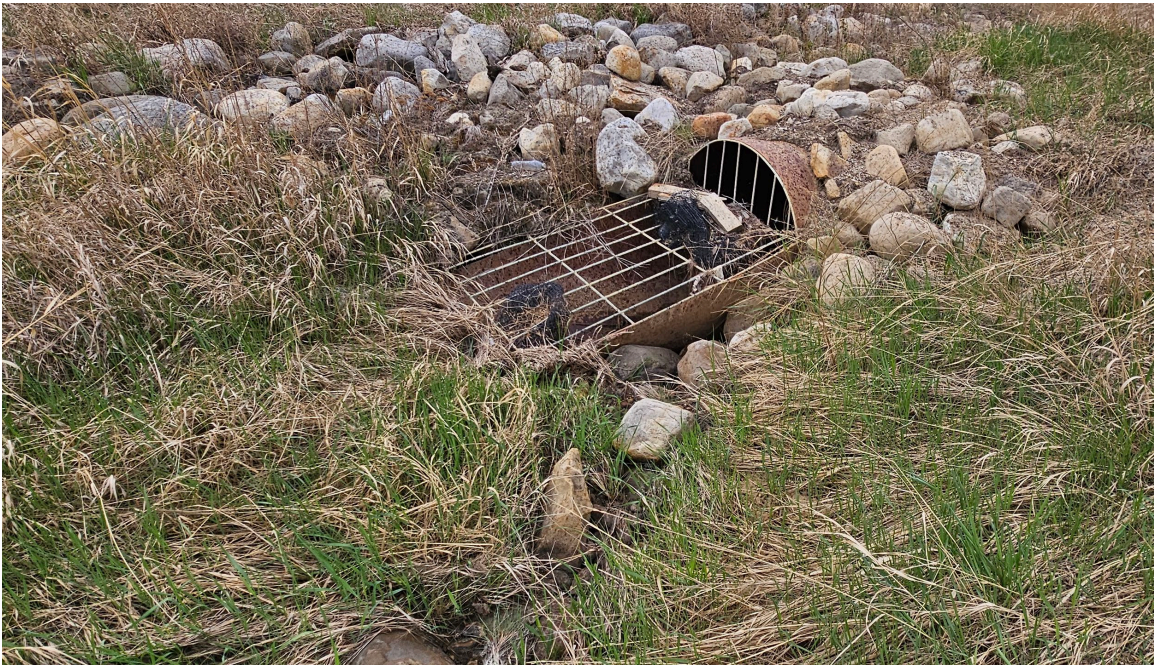
Photo 7-20.: Centreline culvert inlet at the south ditch near 32+050. Minor ditch erosion and partial flow beneath the culvert.

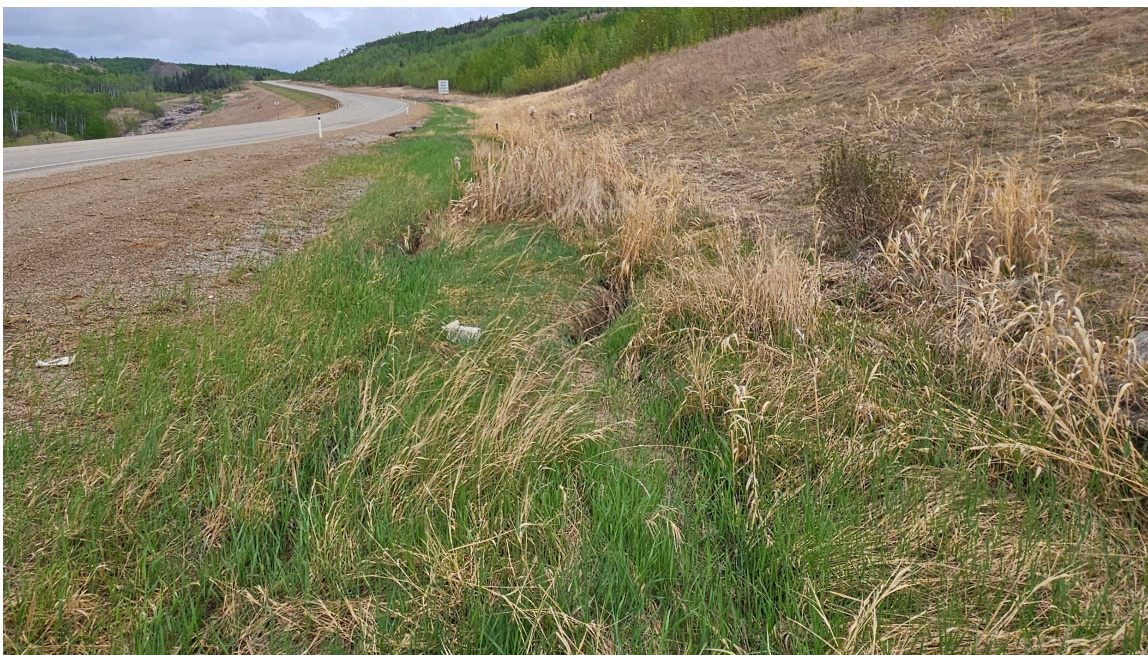
Photo 7-21.: Previously observed channelized erosion has since revegetated within the rolled erosion control product (turf reinforced matting) test section (32+100). Minor erosion was present along tire ruts.

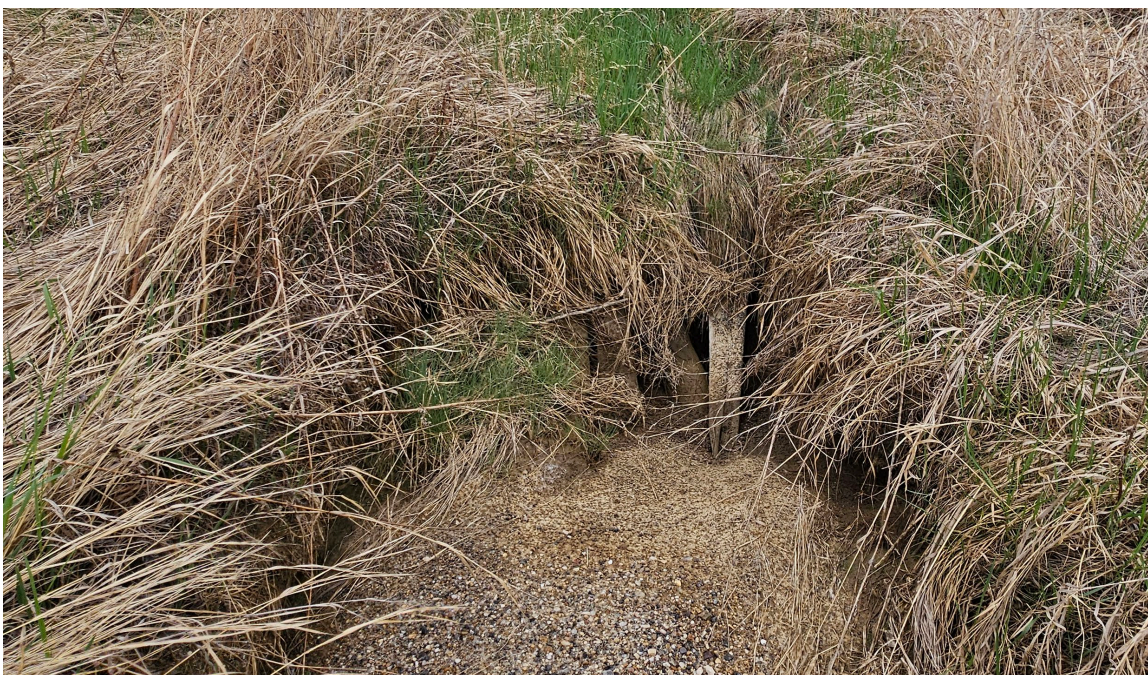
Photo 7-22.: Looking east towards 300 m diameter channel sock erosion control section (32+150). Section generally had good vegetation growth within previous erosion gully in ditch bottom. A 0.5 m deep scour pool was observed downstream of the Coletanche erosion control transition.

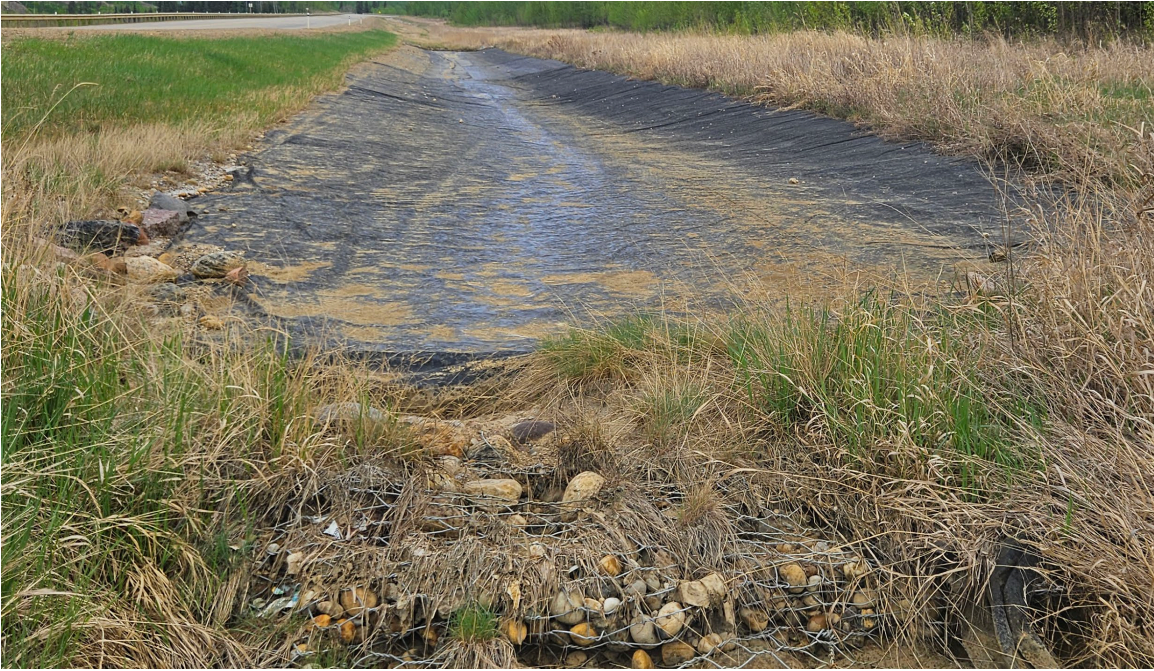
Photo 7-23.: Looking upslope (east) at the Coletanche geomembrane erosion control section (32+250). Was in good condition with no new damage observed in previous patch repair area.

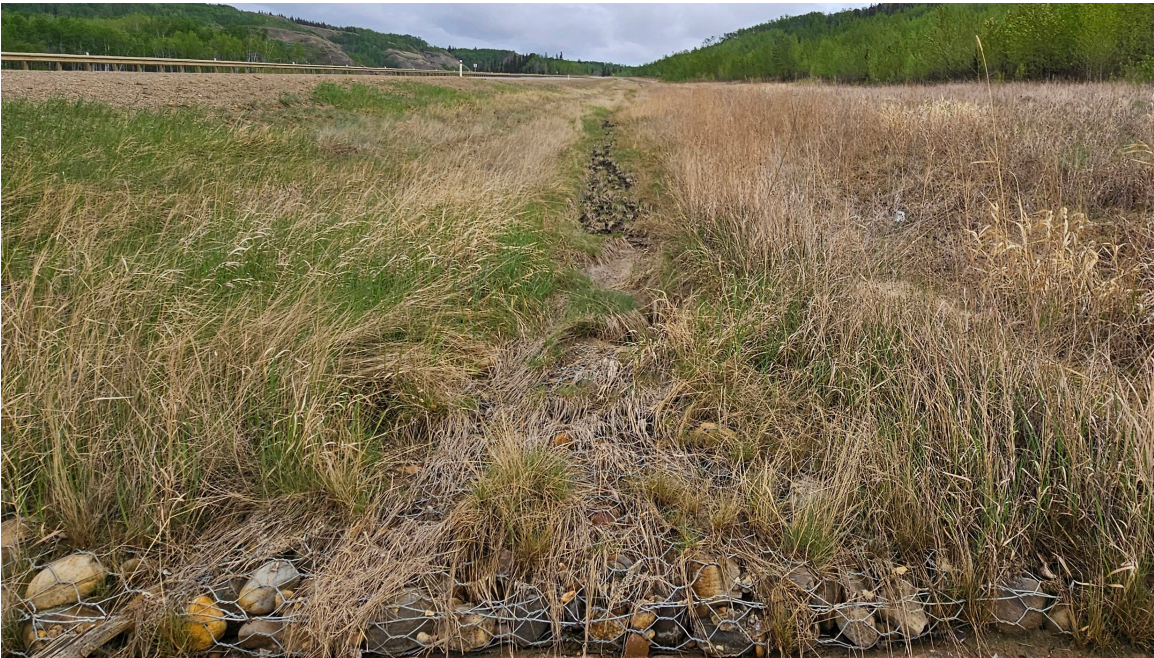
Photo 7-24.: Looking upslope the ditch (east) at the geoweb control section (32+400). No major change since the 2023 condition. Section had vegetation growth and some cells along the ditch bottom were only partially filled and broken.
