ALBERTA TRANSPORTATION AND
ECONOMIC CORRIDORS
GEOHAZARD ASSESSMENT PROGRAM
PEACE REGION (PEACE RIVER DISTRICT)
2025 INSPECTION

Site Number	Location	Name	Hwy	km
PH007	Daishowa East Hill	Gabion Channel & Erosion Control Section	986:01	32.007
Legal Description		UTM Co-ordinates (NAD 83)		
NE7-85-20 W5M		11V E 490505	N	6246235

Date	PF	CF	Total
Previous Inspection:	18-May-2023	9	4	36
Current Inspection:	14-May-2025	10	4	40
Road AADT:	1020		Year:	2024
Inspected By:	Rocky Wang, TEC Tyler Clay, Thurber Don Proudfoot, Thurber			
Report Attachments:	<input checked="" type="checkbox"/> Photographs <input checked="" type="checkbox"/> Plans <input type="checkbox"/> Maintenance Items

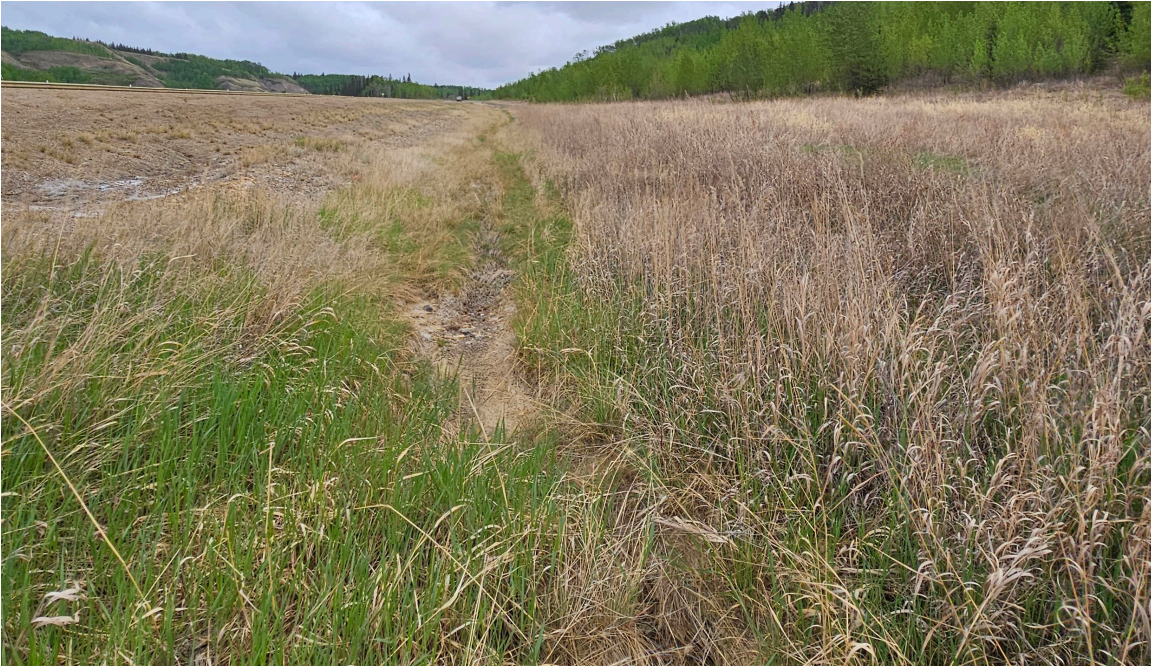
Photo 7-25.: Looking upslope the ditch (east) at the gabion mattress section (32+500). Section had vegetation growth and was performing well. Minor rill damage was noted on the north side of the ditch.

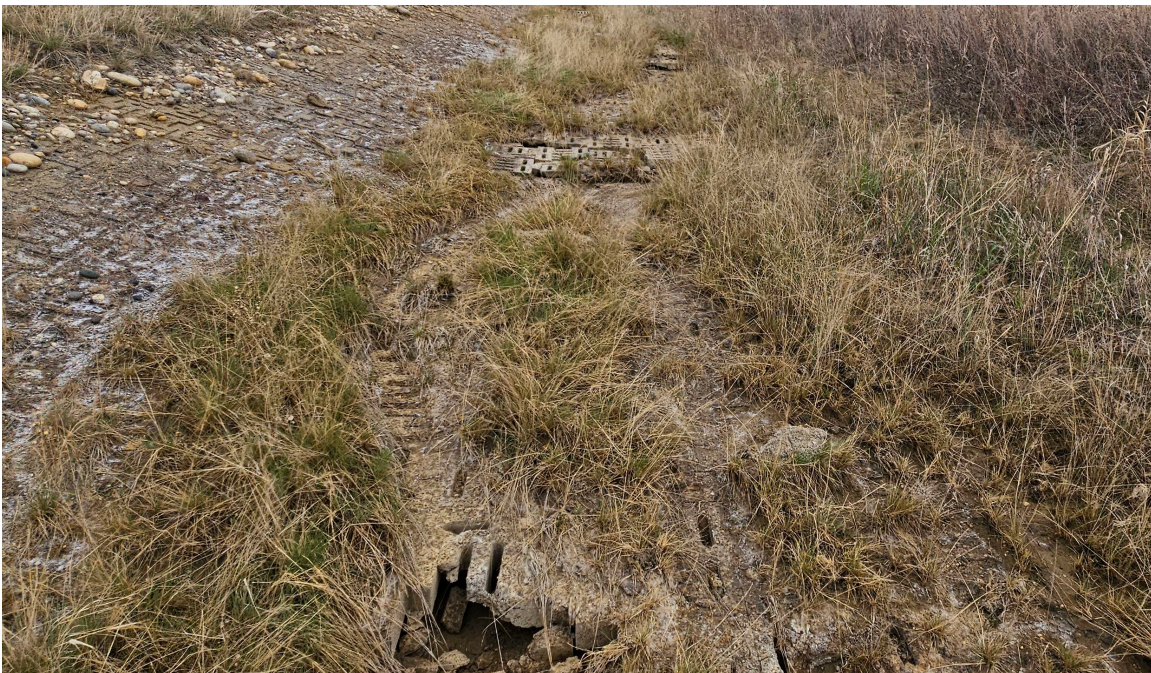
Photo 7-26.: View of the damage within the interlocked concrete block (i.e., Lafarge paving stones) paving stone section (32+600). Blocks have deteriorated and broken up in numerous locations and have been undermined by erosion exposing geotextile fabric beneath. Overall section is worse relative to the other test sections but had no major changes since the 2023 condition.

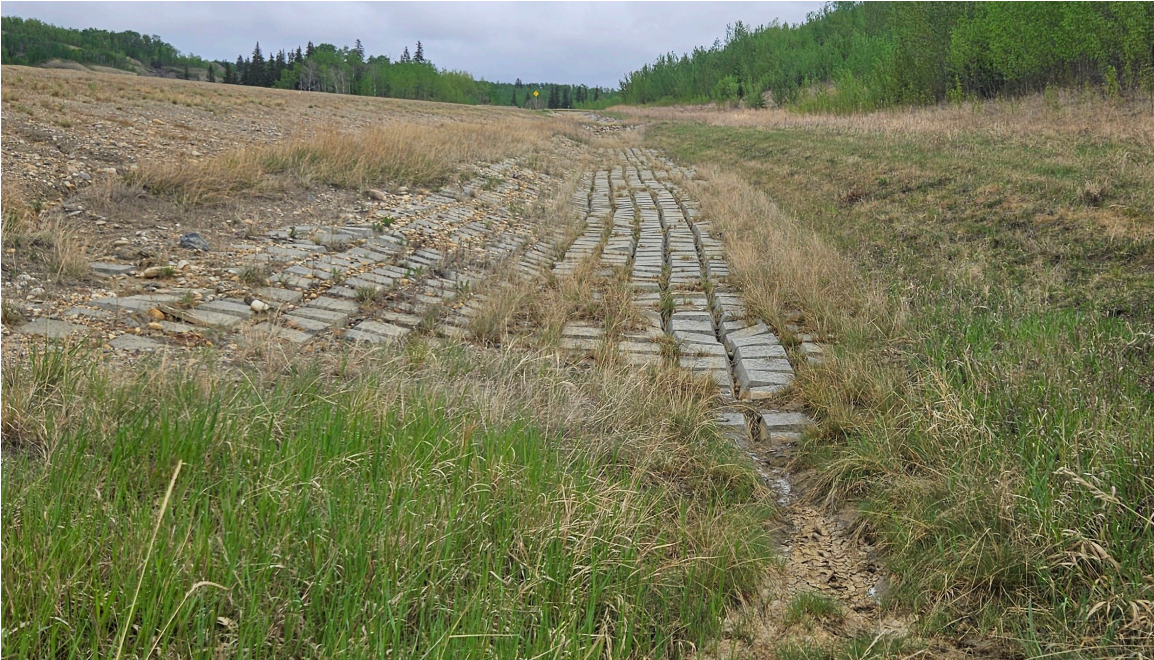
Photo 7-27.: Looking east towards cabled concrete section (32+700). Section was performing well. Minor erosion damage was noted on the north side of the ditch. No major change from the 2023 condition.

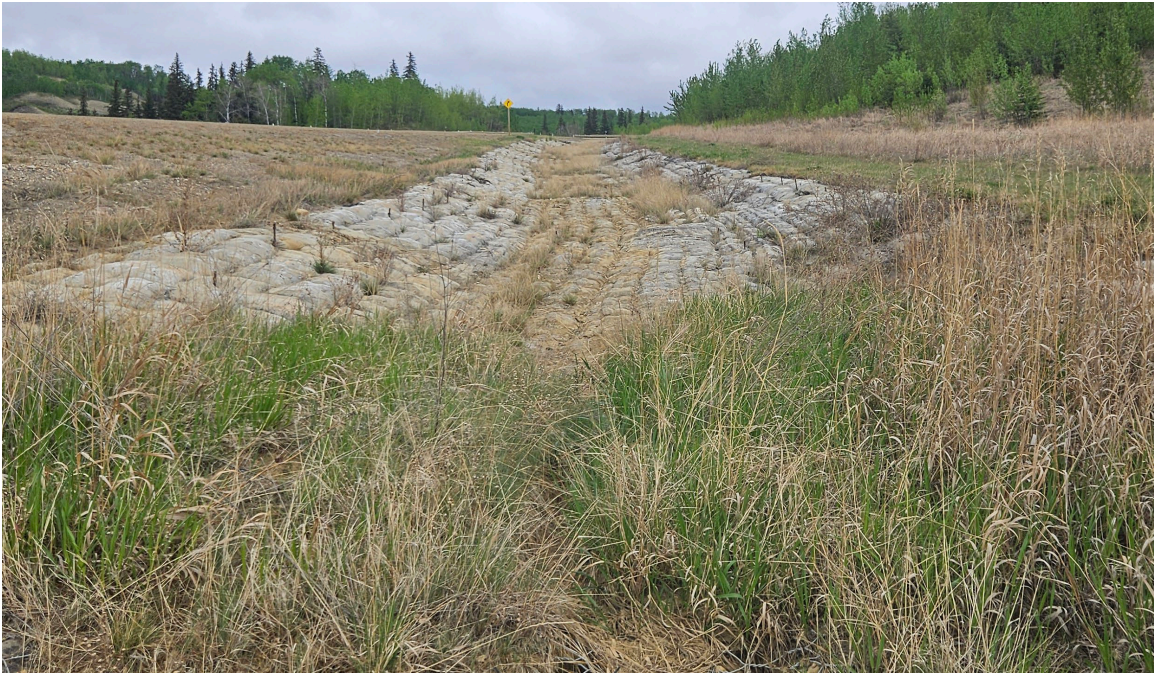
Photo 7-28.: Looking east towards pillow concrete section (32+800). Section was performing well. Minor concrete deterioration was noted in select areas and there were some protruding rebar pins, but erosion mitigation function was not impacted.
