**ALBERTA TRANSPORTATION GEOHAZARD ASSESSMENT PROGRAM
PEACE REGION – PEACE-HIGH LEVEL
2015 CALLOUT**

Site Number	Location	Name	Hwy	km
PH71	Daishowa West Hill	Daishowa West Hill Slide - Km 26.8	986:01	26.8
Legal Description		UTM Co-ordinates		
SE¼ 09-085-21 W5M		11V E 485015	N 6245524

Date	PF	CF	Total
Previous Inspection:	17-Jun-2014	11	4	44
Current Inspection:	23-July-2015	14	5	70
Road AADT:	1060		Year:	2012
Inspected By:	Ed Szmata		Luis Martinez	
Report Attachments:	<input checked="" type="checkbox"/> Photographs <input checked="" type="checkbox"/> Plans <input checked="" type="checkbox"/> Maintenance Items

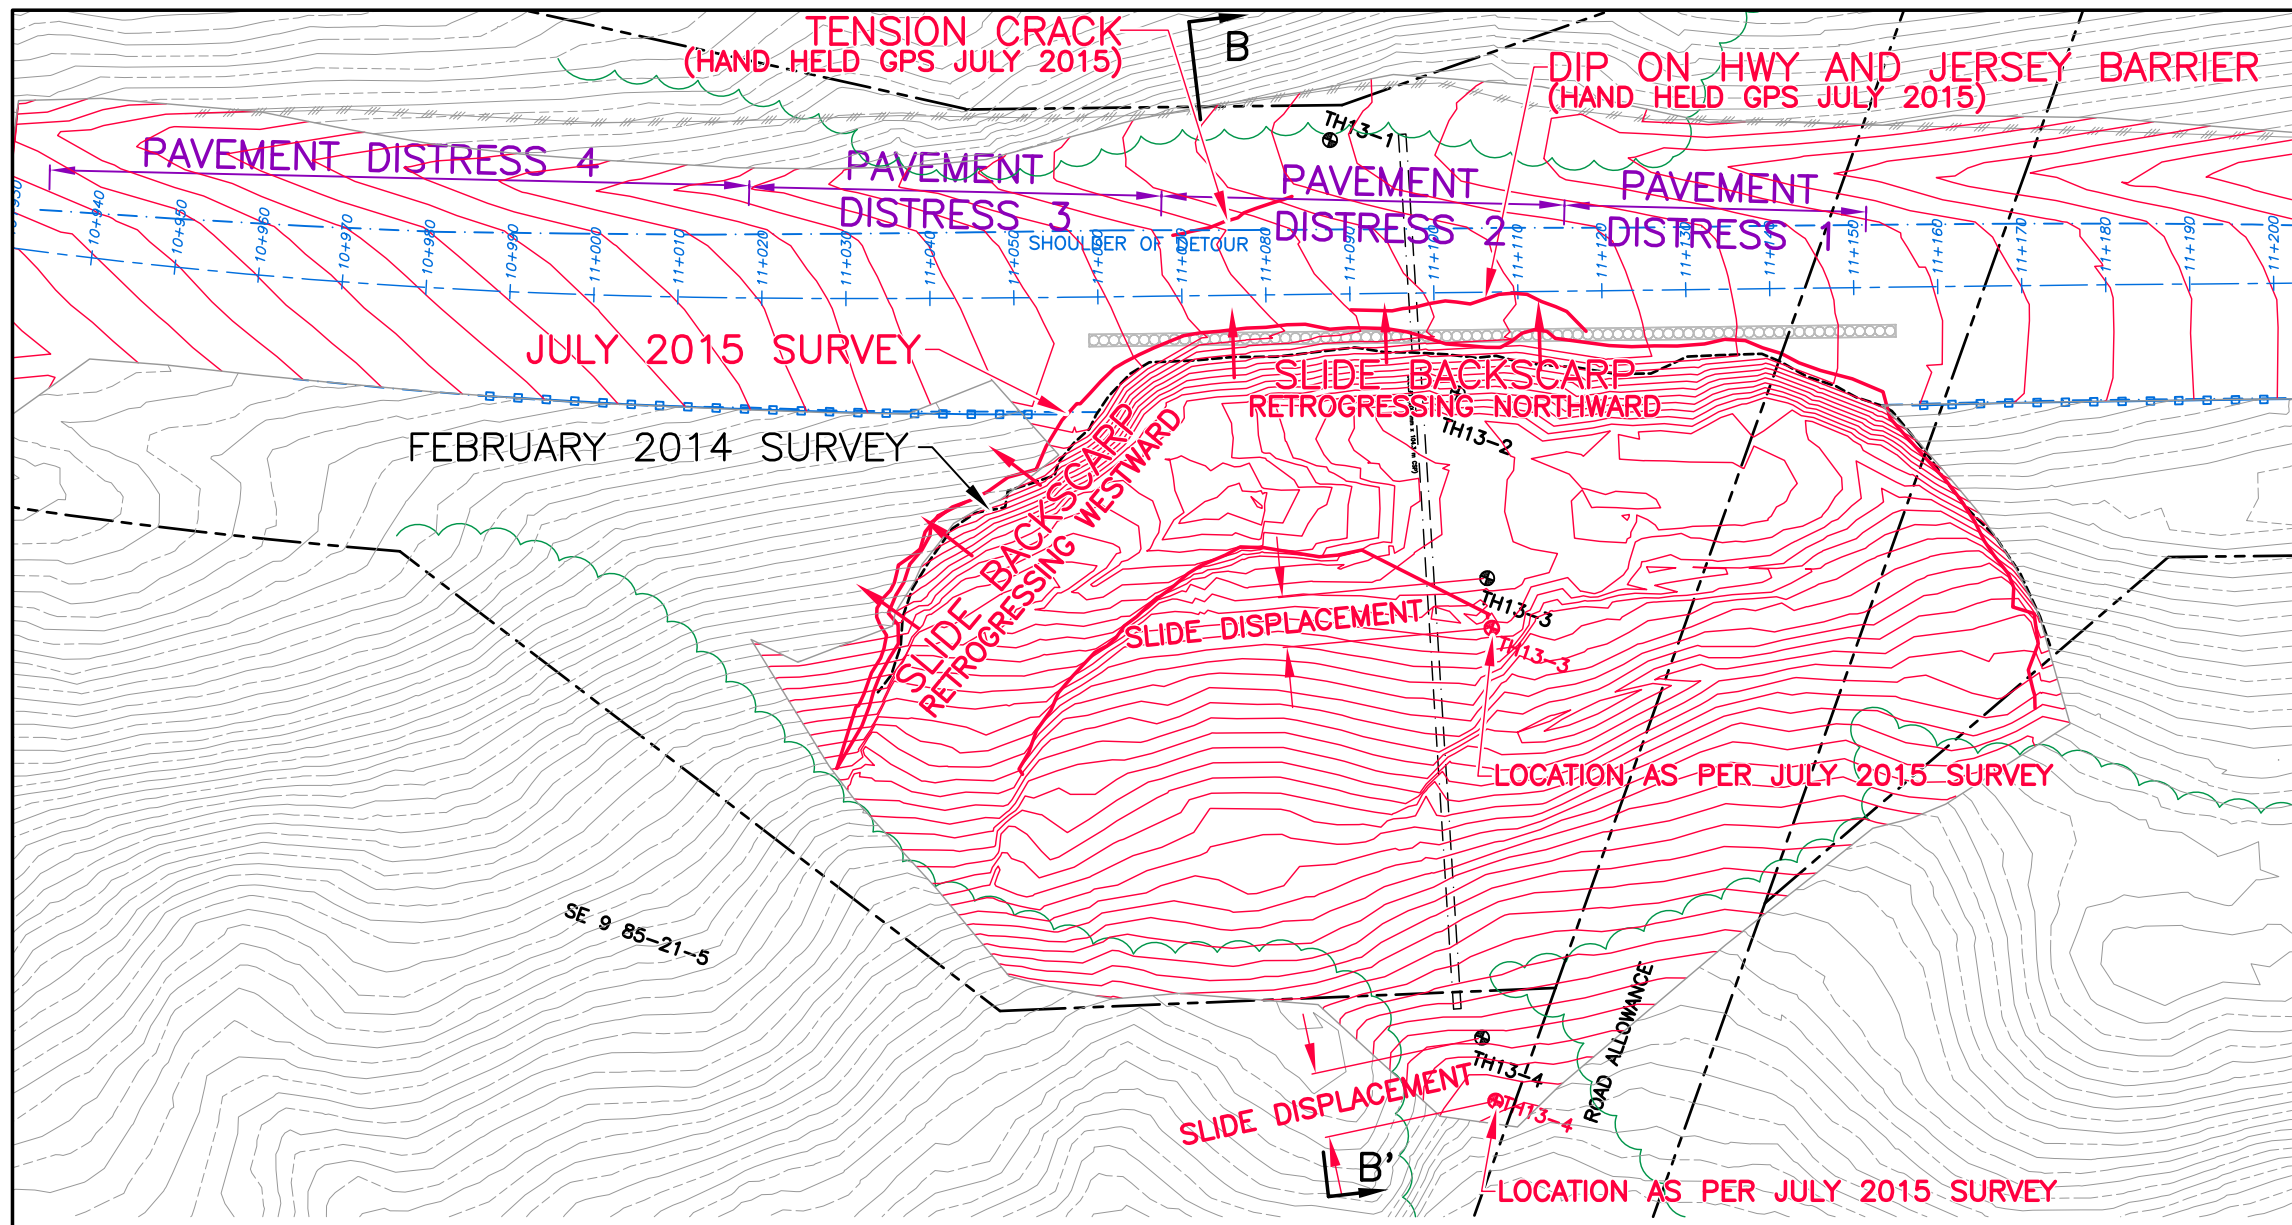
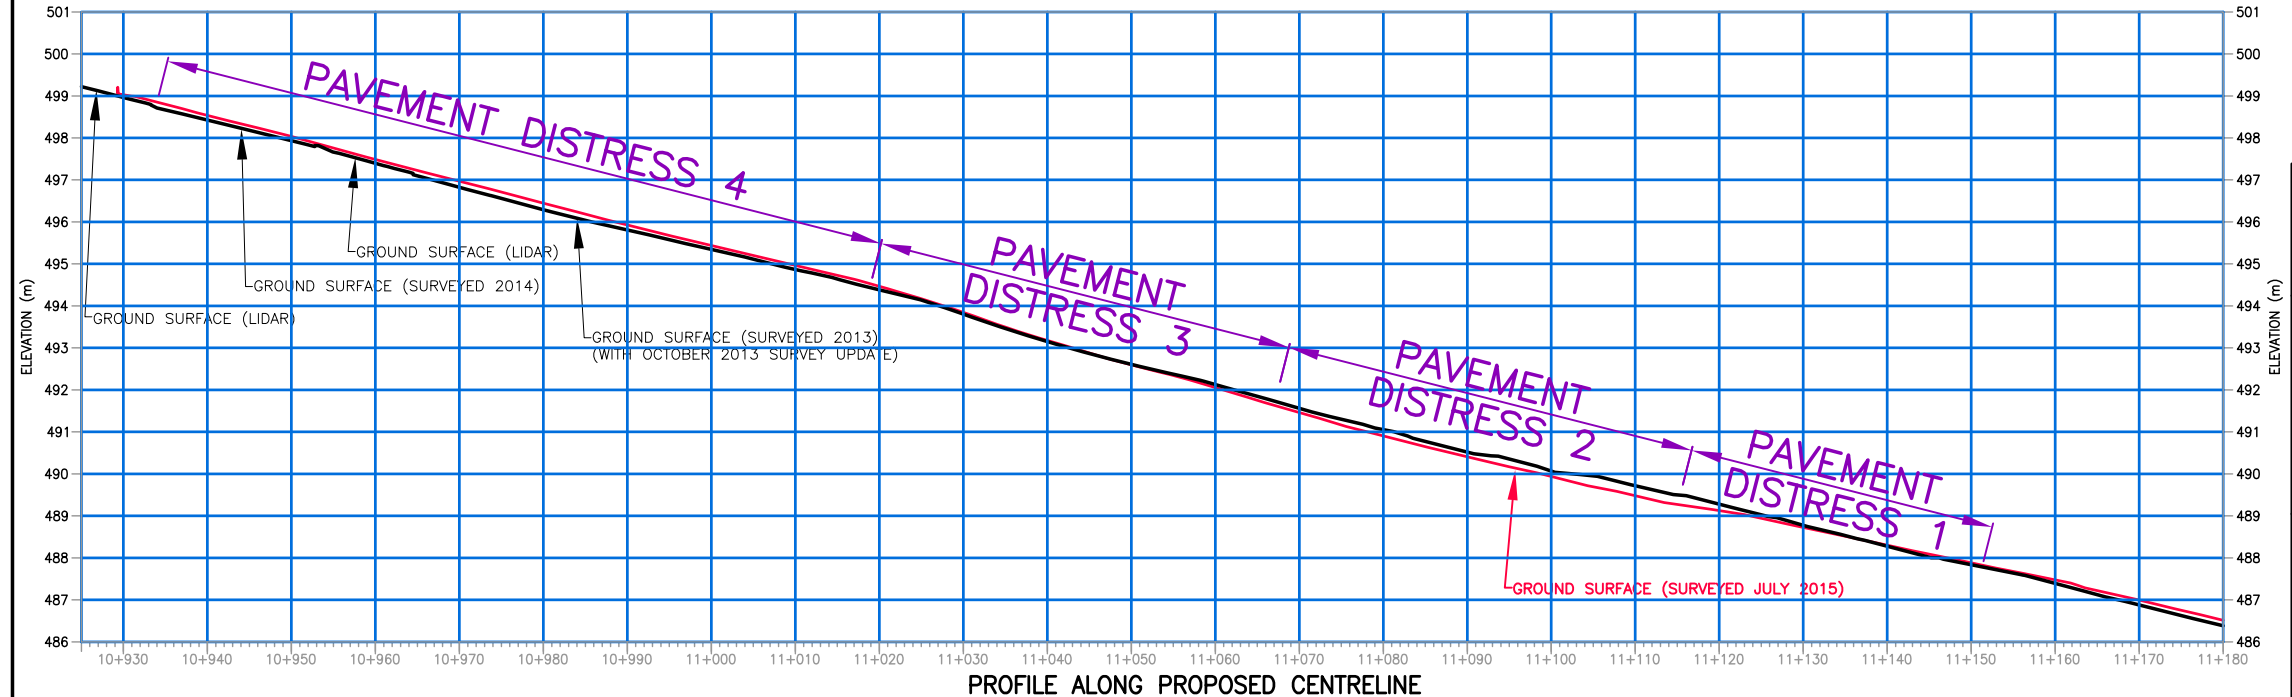
SITE PLAN AND PROFILE ALONG PROPOSED CENTRELINE
 FIGURE PH71-2

Observations:	Description	Worsened?	
<input checked="" type="checkbox"/> Pavement Distress	There are 4 distress patterns (settlement and tension cracks) along the road embankment is as shown in Figure PH71-2 and Figure PH71-3.	<input checked="" type="checkbox"/>

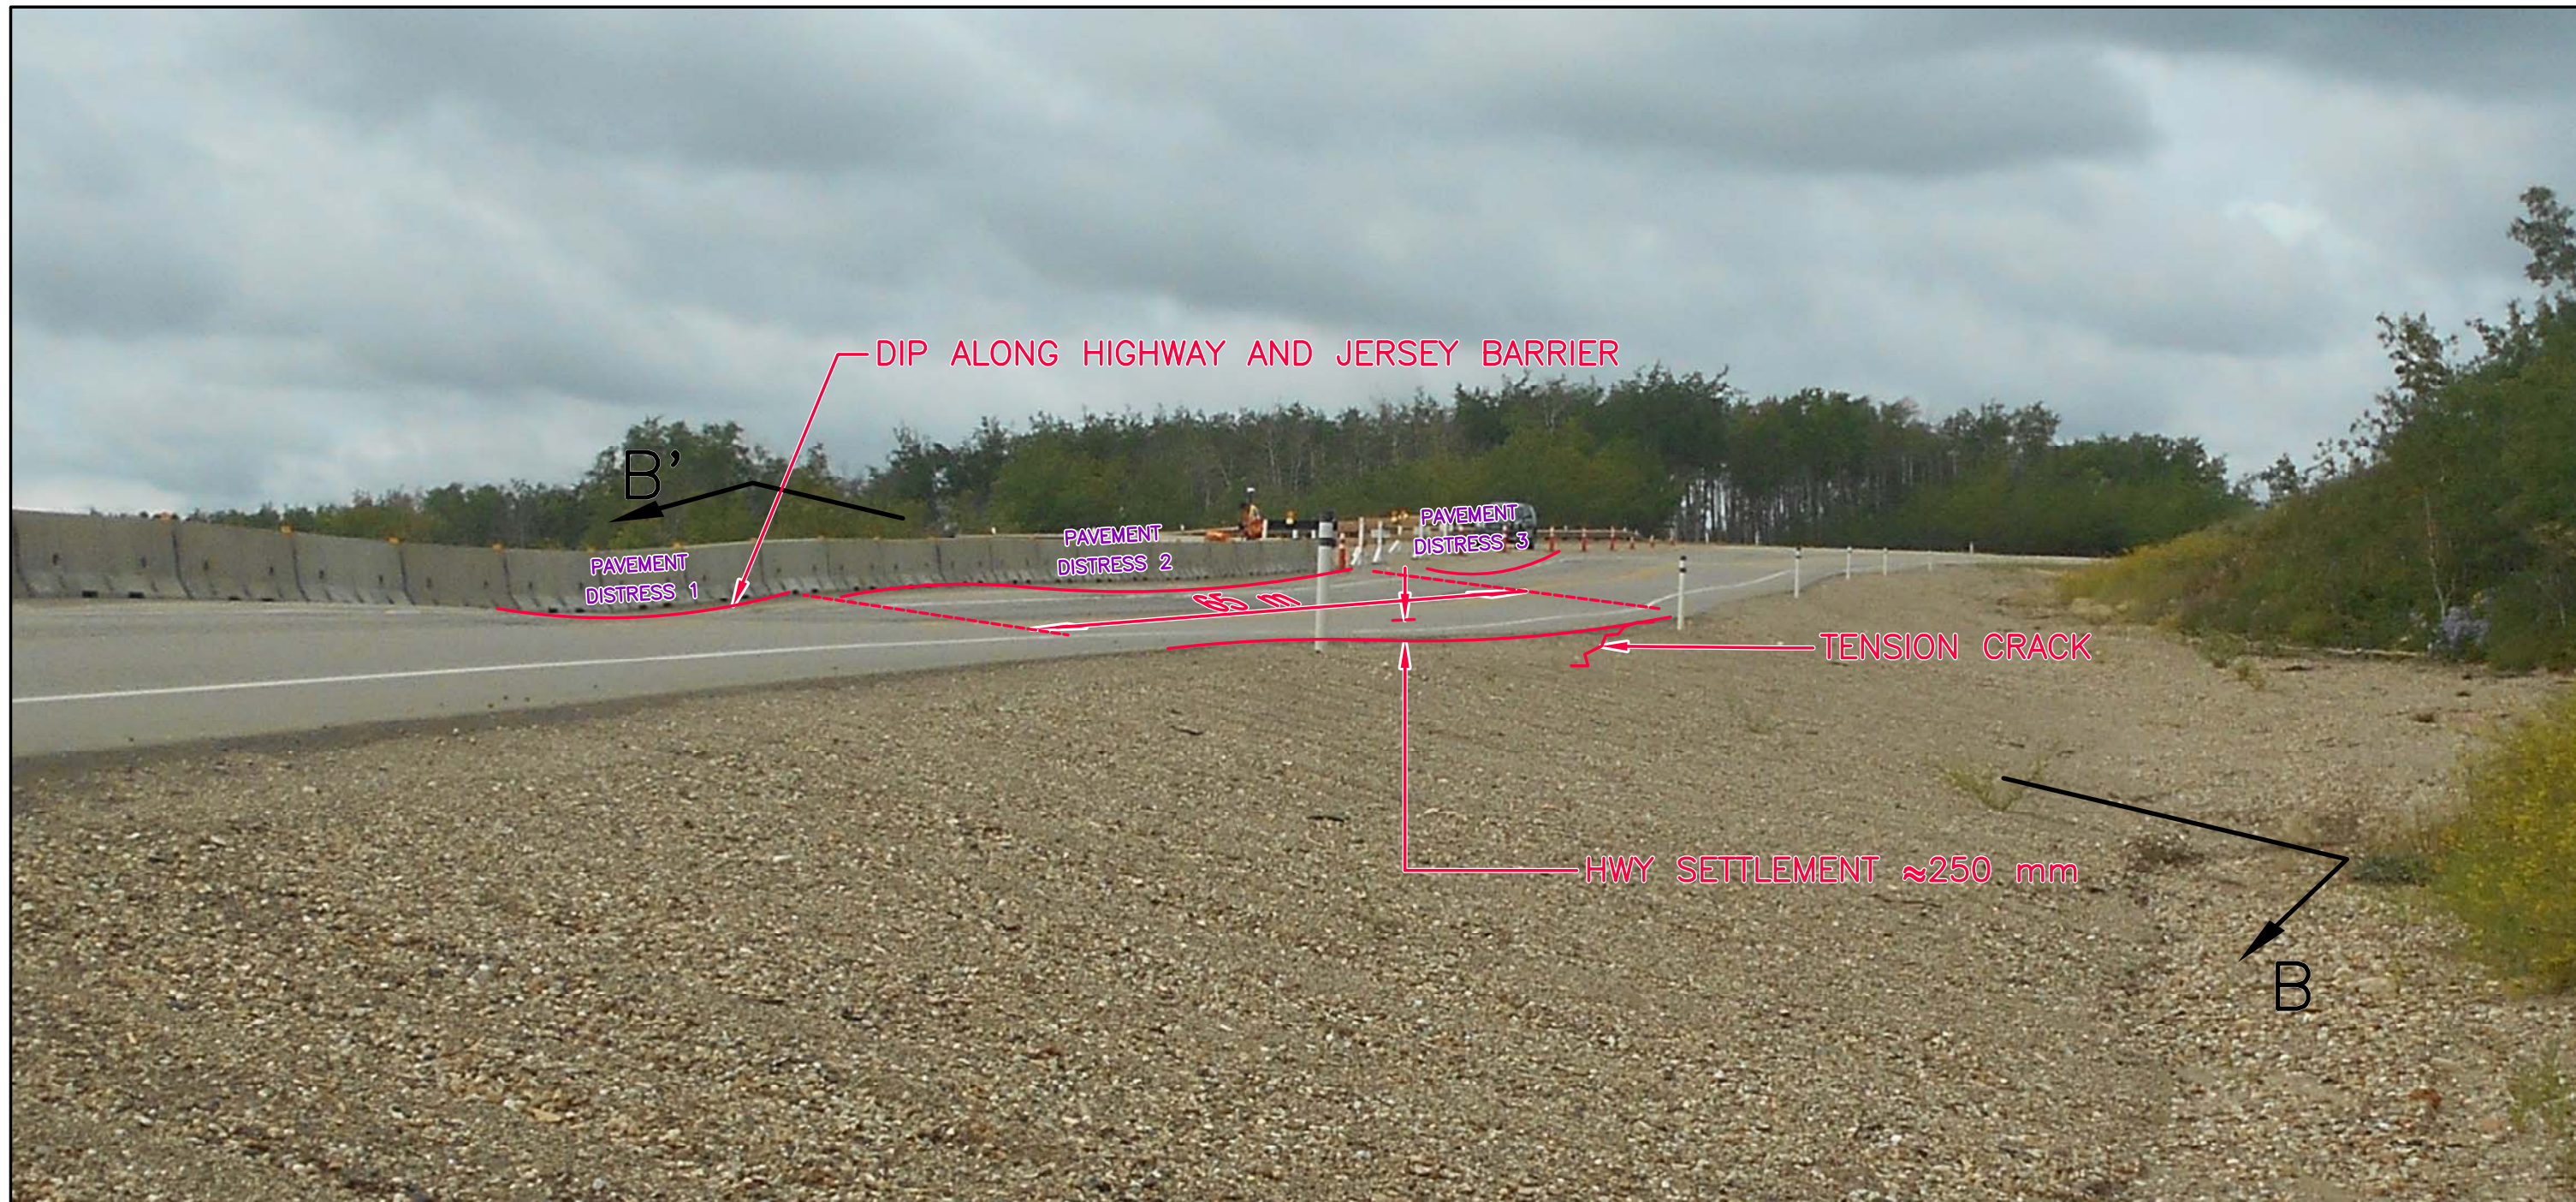
FIGURE PH71-3

The main distress pattern (Distress 2, Figure PH71-3) consist of a vertical drop of up to 250 mm and is 65 m long. The other important pattern (Distress 3, Figure PH71-3) extends 30 to 35 m to the west from the proposed pile wall.	
<input checked="" type="checkbox"/> Slope Movement	<p>In 2013, the original EBL was partially lost due to a landslide and a temporary detour was built to shift the highway to the north. In 2014, the landslide retrogressed and completely removed the original EBL. In 2015, the landslide continue encroaching further north into the original south WBL. By the time of the inspection, tension cracks and highway settlement have developed throughout the remaining original WBLs upslope of the retrogressing landslide backscarp (Figure PH71-4 and Photo 71-04).</p> <p>One of the observed tension cracks is encroaching into the north shoulder of the highway (Photo 71-02) suggesting that the deep failure surface observed during the initial geotechnical investigation may have retrogressed and may be impacting the whole road embankment (Section B-B', Figure PH71-4).</p> <p>The landslide backscarp has retrogressed and is at or slightly upslope of the jersey barrier (Photo 71-01). The center line of the proposed pile wall coincides with the location of jersey barrier. The difference in elevation between the road pavement surface and the toe of the backscarp is about 6.0 to 6.5 m.</p>	<input checked="" type="checkbox"/>

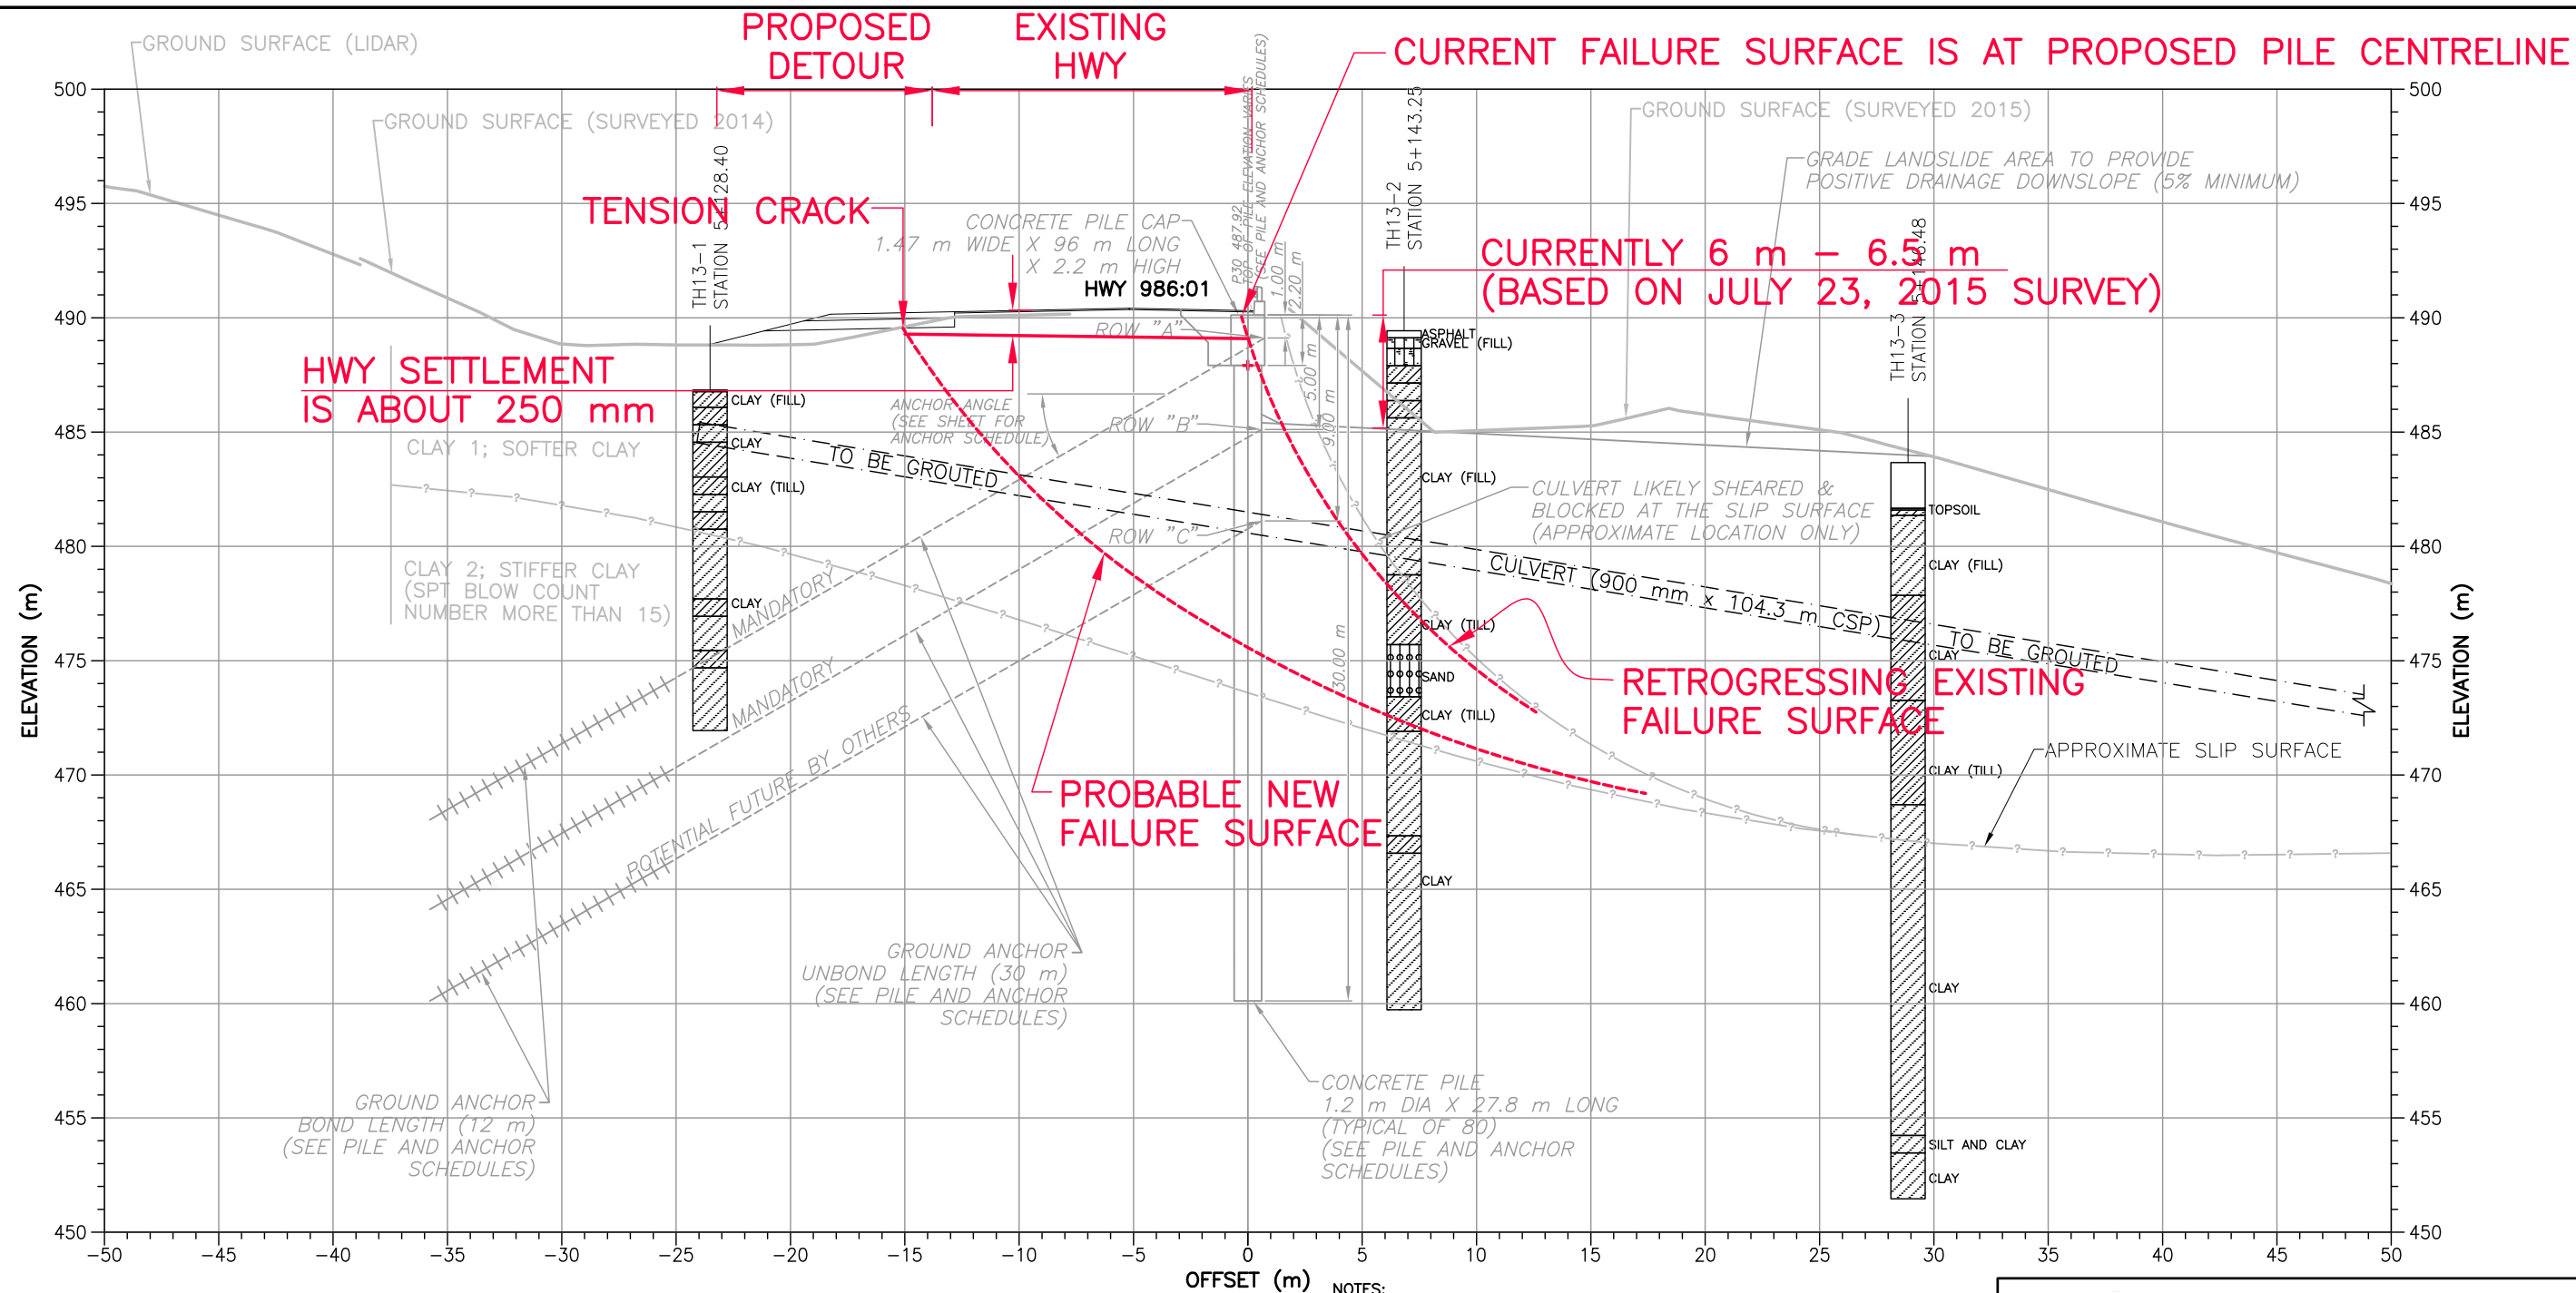
FIGURE PH71-4

SECTION B - B'
PROBABLE NEW FAILURE SURFACE

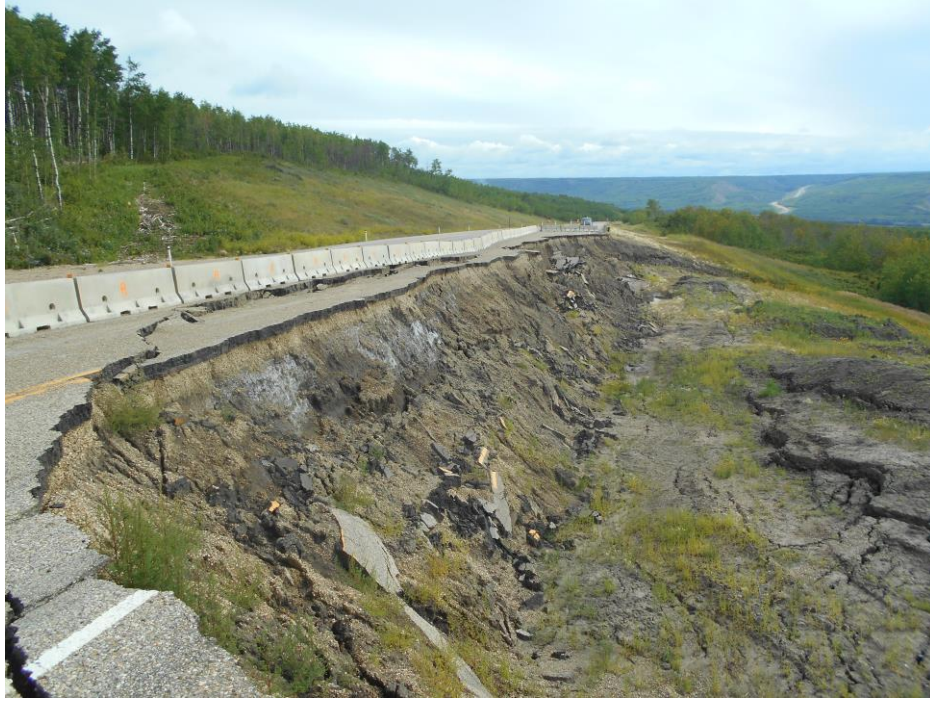
Primary Site Issue:	A landslide is retrogressing and is affecting the original EBL and WBLs of the road embankment. The landslide backscarp is currently encroaching onto the south WBL (Photo 71-01). Tension cracks and dips in the pavement can be observed on the north WBL (Photo 71-02 and Photo 71-03).		
Dimensions:	The highway at the site runs east to west on a sidehill cross-section. Originally, in the vicinity of the site, there were two westbound lanes and one eastbound lane. The lanes were about 4 m wide. The road embankment was about 21.5 m high with side slopes in the order of 3H:1V. A CSP culvert is traversing under the road embankment. Currently, the main landslide area is retrogressing and has increased in size from 100 m to about 130 m long (since June 2015) measured from east to west, and is encroaching into the original south WBL.		
Maintenance:	A temporary westbound detour lane was built in November 2013 after the initial slope failure.

Photo 71-01. Looking east at current back scarp along the highway south shoulder. The backscarp is about 6.0 to 6.5 m in height.

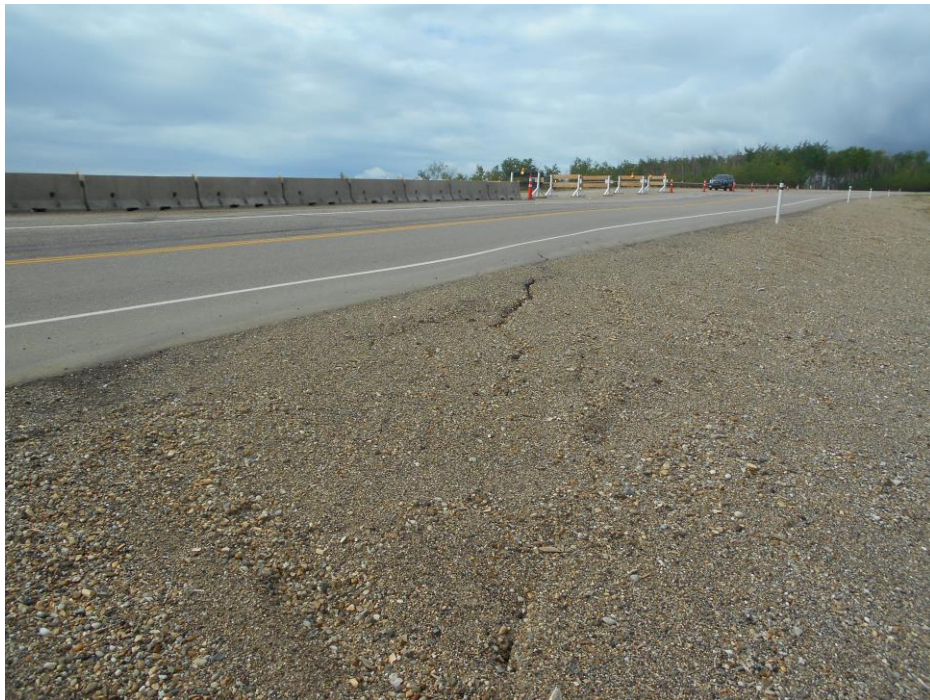
Photo 71-02. Tension crack developing just behind the highway north shoulder.

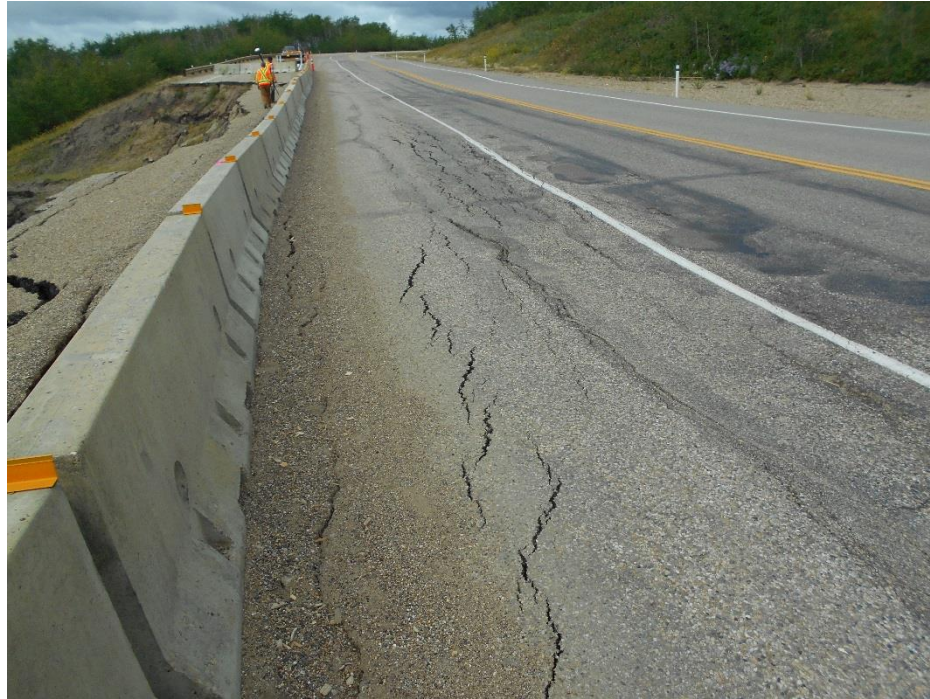
Photo 71-03. Tension cracks developing just behind the jersey barrier.

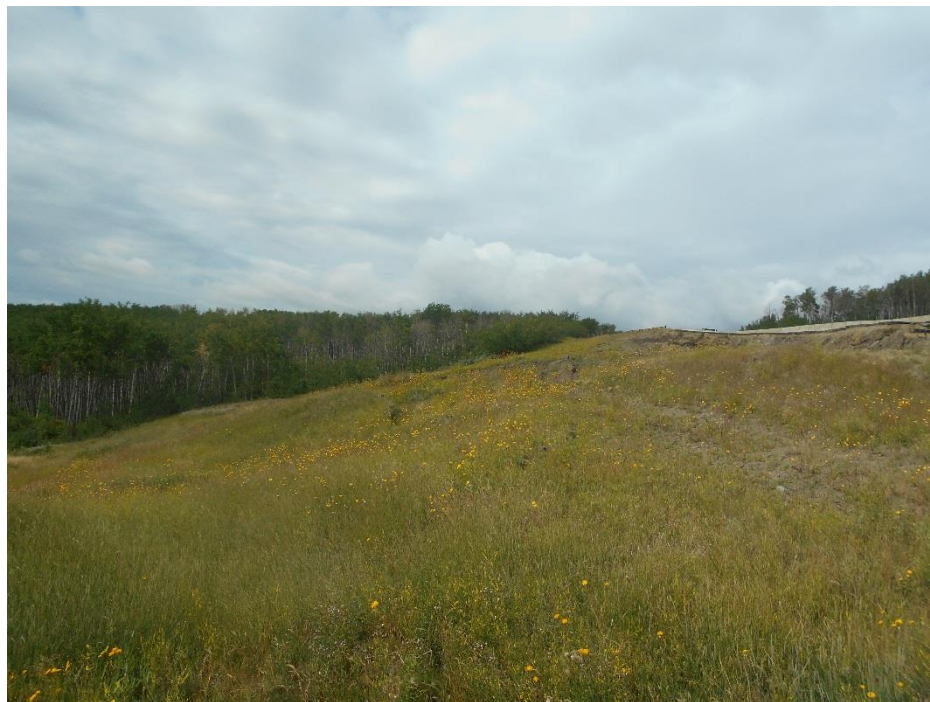
Photo 71-04. Landslide looking west. Slight bulging is developing mainly above the culvert outlet.
