**ALBERTA TRANSPORTATION GEOHAZARD ASSESSMENT PROGRAM
PEACE REGION – PEACE-HIGH LEVEL
2020 INSPECTION**

Site Number	Location	Name	Hwy	km
PH71	Daishowa West Hill	Daishowa West Hill Slide - Km 26.8	986:01	26.8
Legal Description		UTM Coordinates		
SE¼ 09-085-21 W5M		11V E 485015	N 6245524

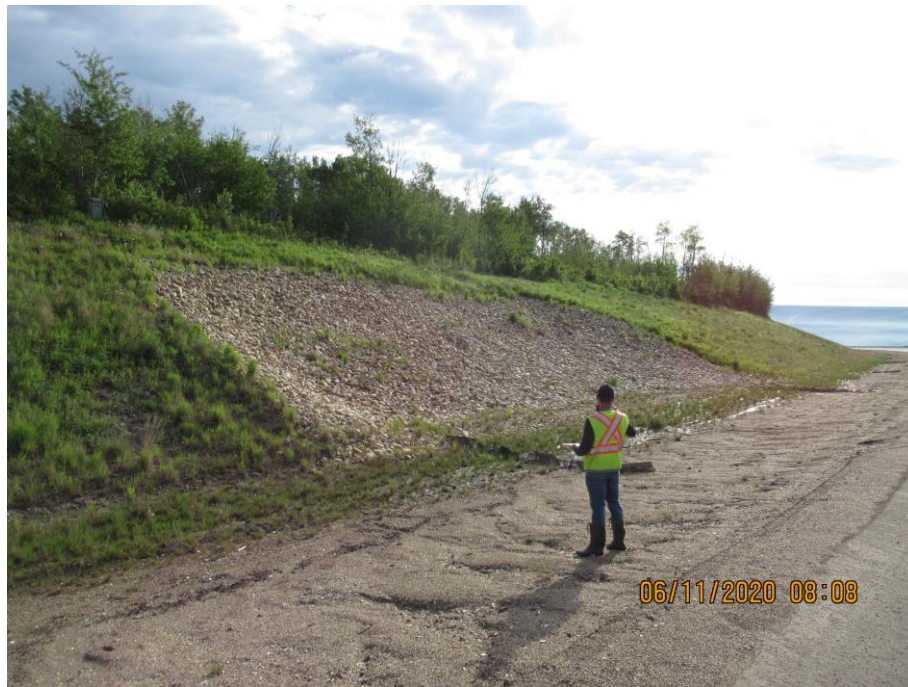
Photo 71-1.
Granular backslope repair on north side of road was in good condition (26+350).

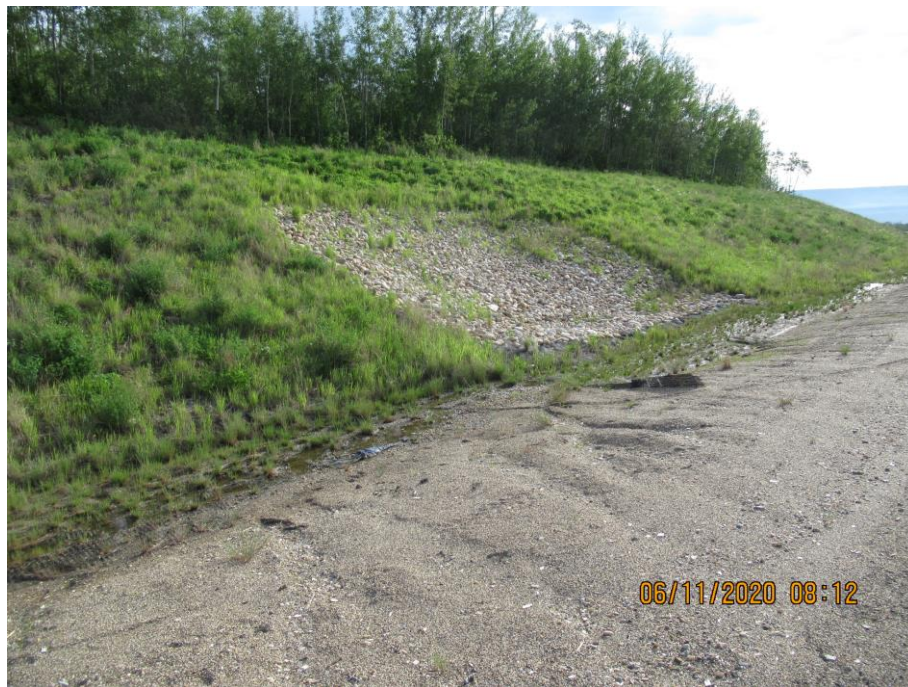
Photo 71-2.
Second area of granular backslope repair on north side of road. Minor ditch erosion but overall slope was in good condition (26+500).

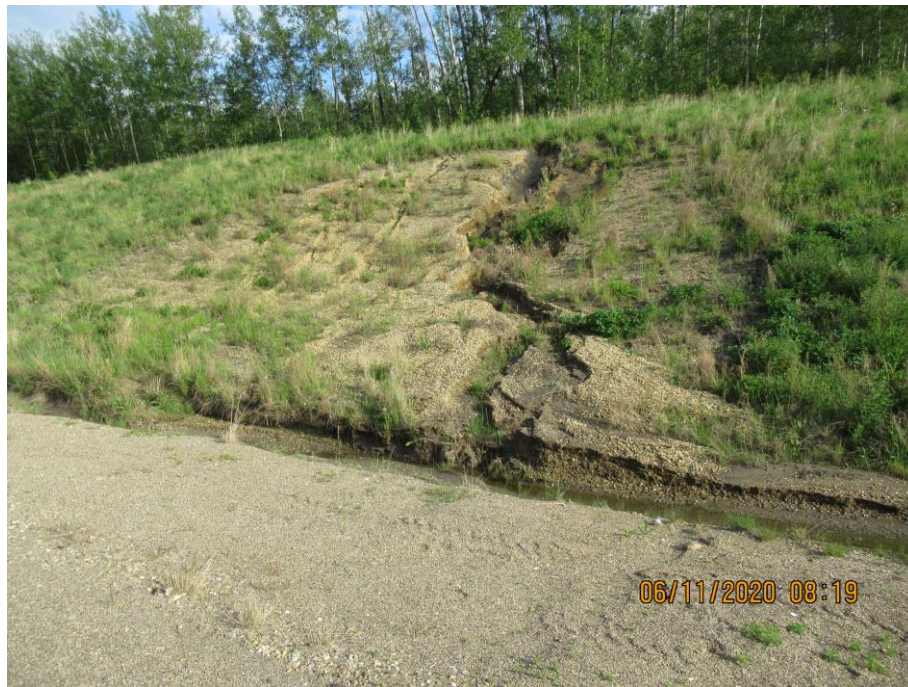
Photo 71-3. Backslope area upslope of the highway above the pile wall near the west end of the site looking towards the northwest (26+550). Granular fill within the backslope has eroded and partially washed out. Increased erosion within backslope and ditch since 2019. Geordige ditch barriers have been outflanked in some sections.

Erosion damage and sediment buildup was observed in some areas in the backslope and upslope ditch through the site area. These areas should be addressed by the repair contractor as part of the warranty process. The culvert inlet at the west end of the site requires to be cleaned out. Where the surface runoff from the road is flowing around the armored inlet consideration should be given to an asphalt berm at the edge of pavement to direct runoff or installing a swale with ECM along the road edge in this area to reduce further erosion rates.

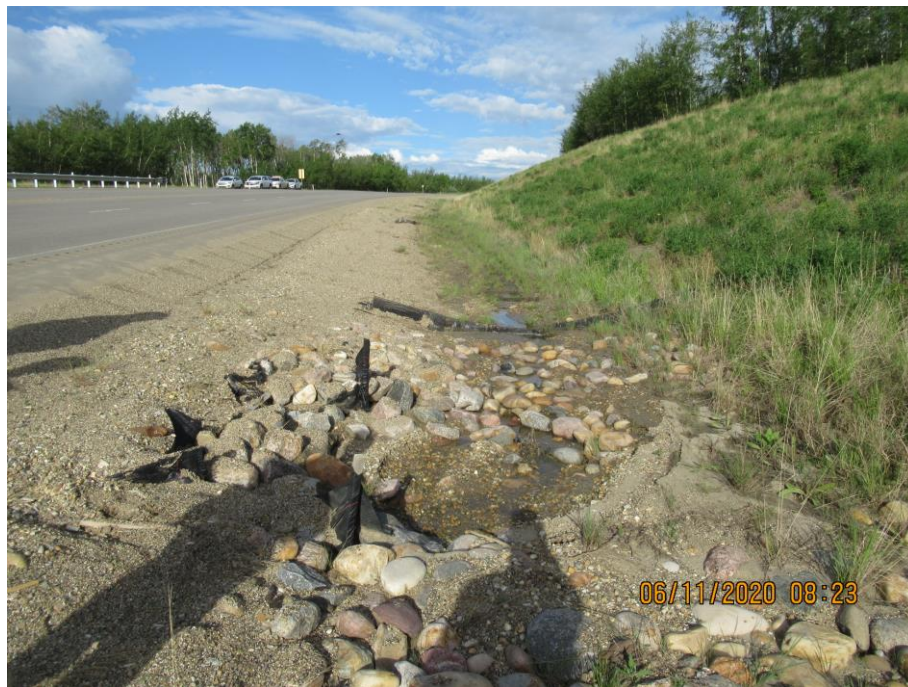
Photo 71-4. View toward the west looking upslope in the north ditch at the culvert inlets (26+650). One of the two culverts has been blocked due to silt buildup.

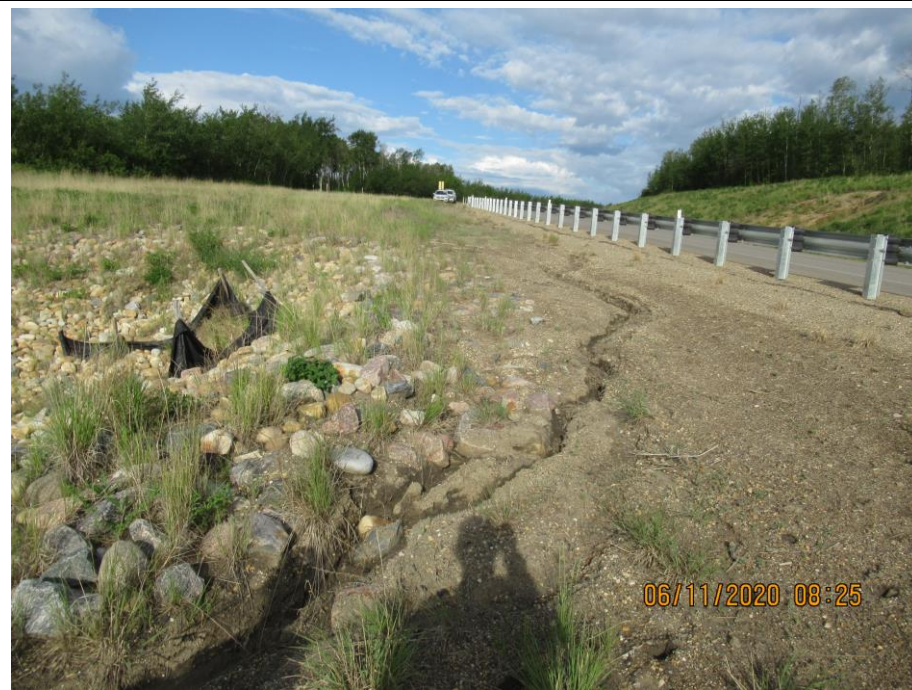
Photo 71-5.
West of the wall on the south side of the road (26+650), water runoff from the road currently flows around the armored swale in an erosion rill. Slightly worse from the 2019 condition.

Recommendations:	Cost
Continue to visually inspect the repaired slide area regularly and read instruments to monitor pile wall performance (particularly after heavy and/or prolonged rain or rapid snowmelt).	-
Maintenance should continue to check the ditch structures and culverts and cleanout as required. Water runoff near km 26+050 should be managed via an armored swale or asphalt berm to direct water to existing armored swale.	Maintenance

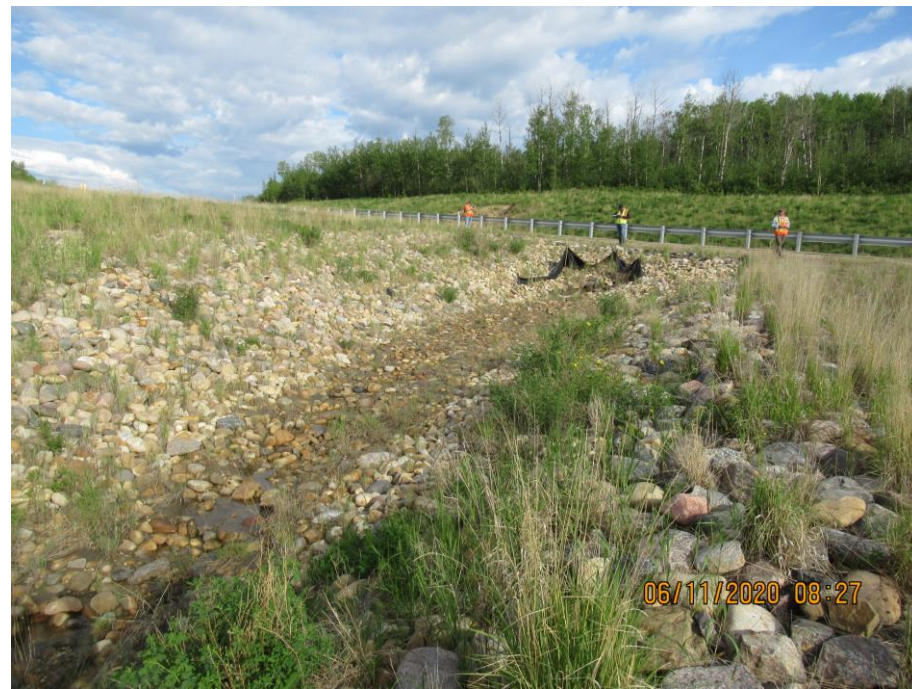
Photo 71-6.
View of the armored swale at the culvert outlets (26+650). No issues were noted at the time of inspection.

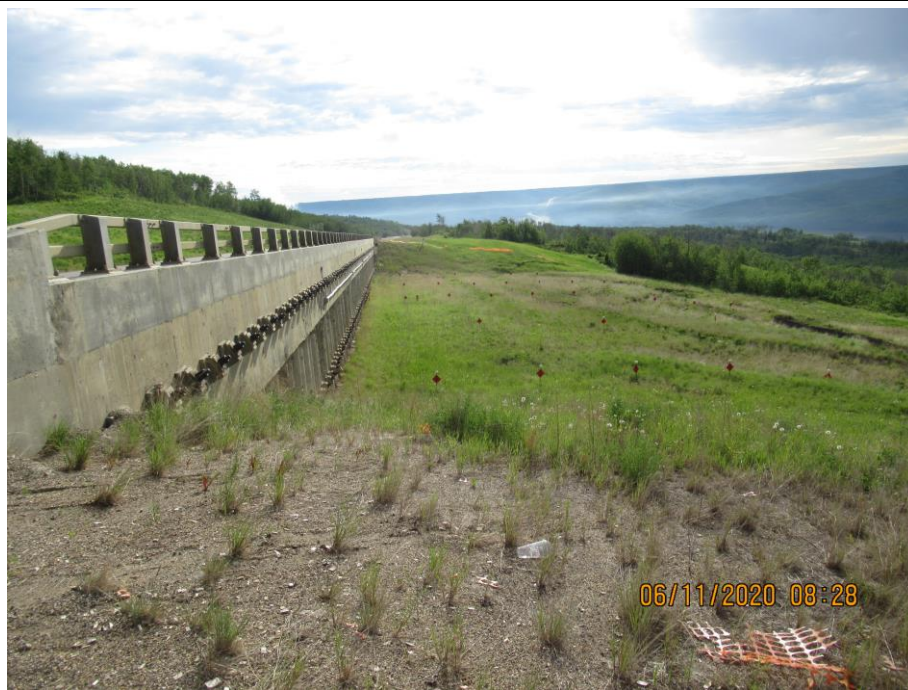
Photo 71-7.
At the west end of the pile wall looking towards the east downslope of the wall.

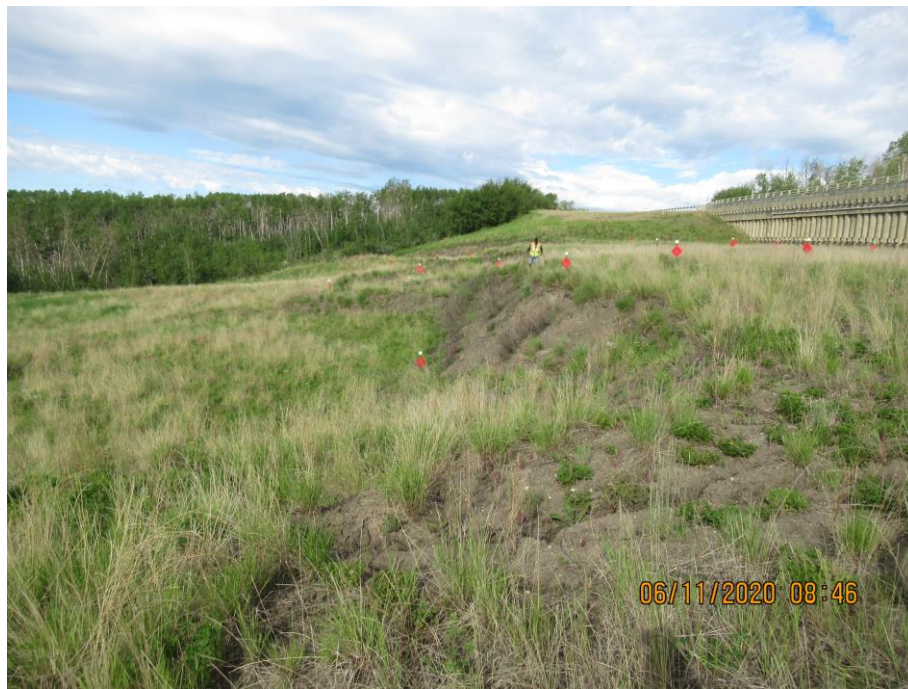
Slope movement is expected to continue downslope of the pile wall, which has been observed to be active along previous slide extents since 2016. The pile wall is designed to accommodate

approximately 6.5 m of slope subsidence or 'drop' below the second row of anchors downslope of the pile wall. Movement of the soil bench downslope of the wall should therefore be monitored on an annual basis to determine if/when another row of support anchors might be required.

Photo 71-8.
Looking towards the west at the downslope area below the wall at the main scarp where landslide movement has continued since the pile wall was constructed. Scarps and cracking has typically followed along previously observed slide extents prior to the regrading and wall construction.

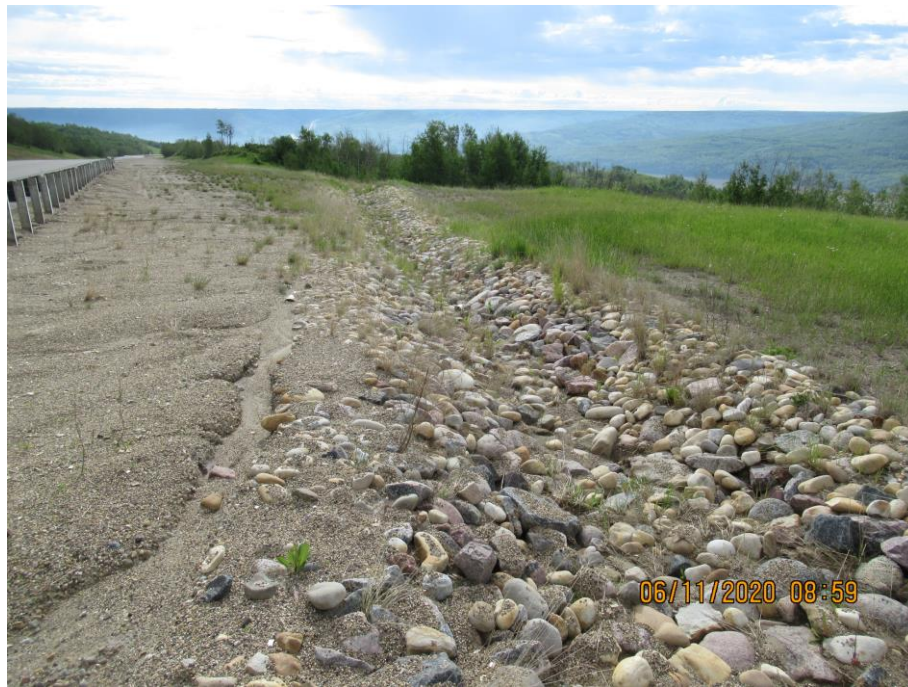
Photo 71-11.
Looking towards the east at the east end of the pile wall at the armoured drainage swale. Minor rill erosion was observed between the swale and road edge in areas of poor vegetation.

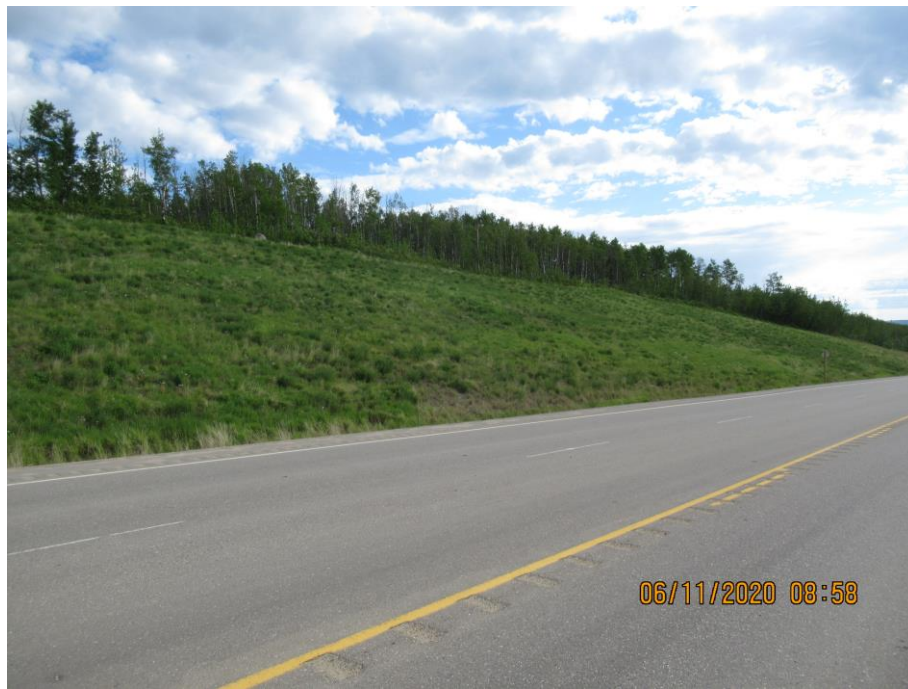
Photo 71-12.
Looking northeast towards the backslope area across from the pile wall (26+800). Slope had good vegetation coverage and no issues were observed.
