**ALBERTA TRANSPORTATION  
GEOHAZARD ASSESSMENT PROGRAM  
PEACE REGION (PEACE RIVER DISTRICT)  
2021 INSPECTION**

Site Number	Location	Name	Hwy	km
PH071	Daishowa West Hill	Daishowa West Hill Slide - Km 26.8	986:01	26.8
Legal Description		UTM Coordinates		
SE¼ 09-085-21 W5M		11V E 485015		N 6245524

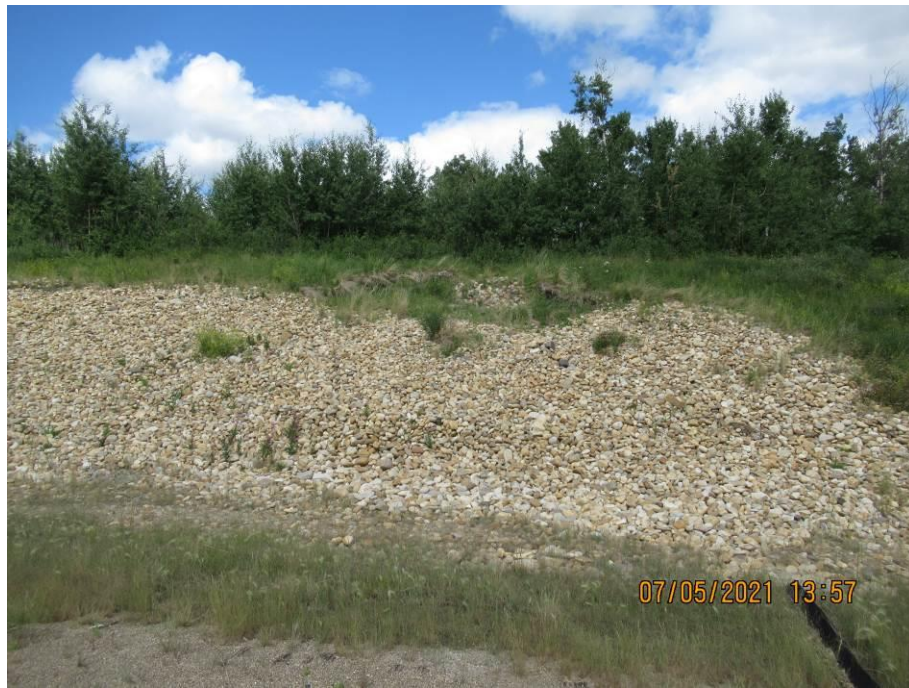
**Photo 71-1.**  
A shallow earth slide developed within the swale at the top of the granular backslope repair on north side of road since the previous inspection (26+350). There was a slight toe bulge at the mid-slope under the riprap.

The slide in the granular backslope repair at KM 26+350 should be repaired by excavating the disturbed slide material, reducing the backslope angle, rebuilding with granular fill and relining with riprap. \$15k

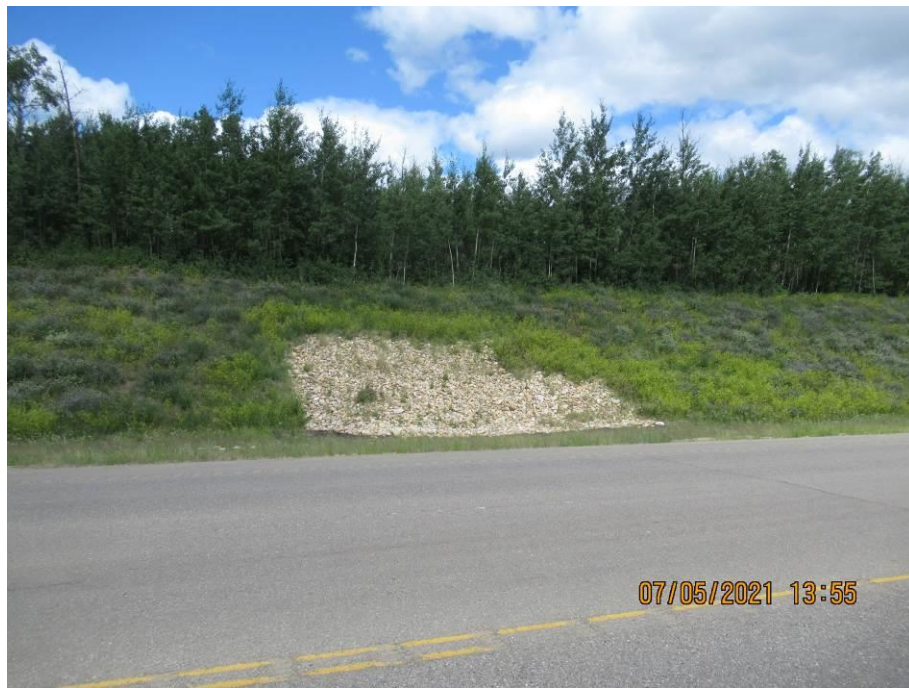
**Photo 71-2.**  
Second area of granular backslope repair on north side of road. Overall slope was in good condition and vegetation was filling in (26+500).

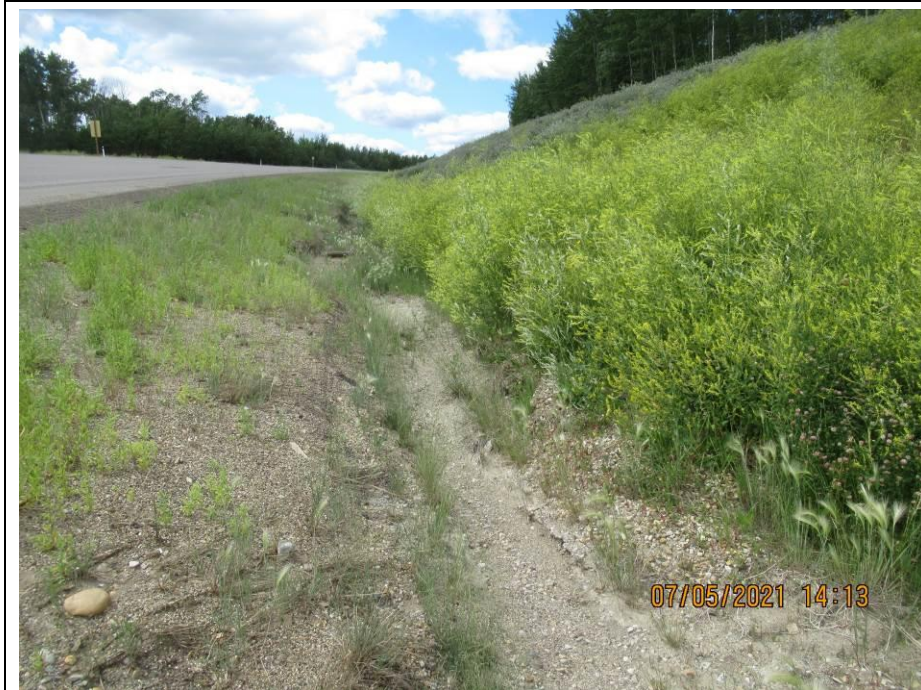
Erosion damage and sediment buildup was observed in some areas in the backslope and upslope ditch through the site area. The culvert inlet at the west end of the site requires to be cleaned out. Where the surface runoff from the road is flowing around the armored inlet consideration should be

**Photo 71-3.**  
Backslope area upslope of the highway above the pile wall near the west end of the site looking towards the northwest (26+550). Granular fill had eroded and partially washed out but has since had increased vegetation growth. Ditch erosion is slightly worse. Georidge ditch barriers have been outflanked in some sections.

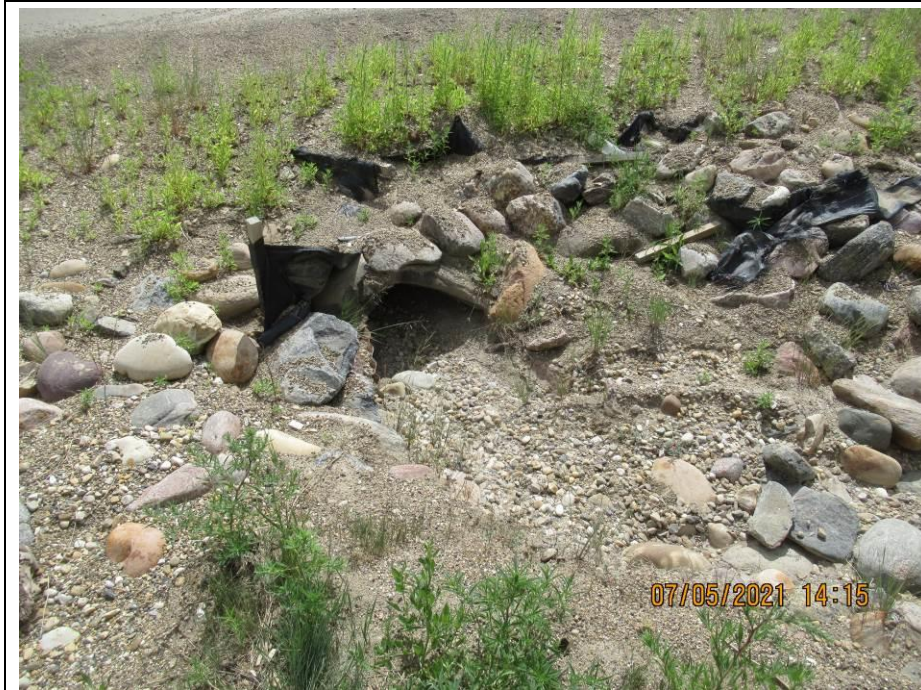
**Photo 71-4.**  
View toward the north ditch culvert inlets (26+650). One culvert has been fully blocked due to silt buildup and the other is about  $\frac{3}{4}$  full.

Maintenance should continue to check the ditch structures and culverts and cleanout as required. Water runoff near km 26+050 should be managed via an armored swale or asphalt berm to direct water to existing armored swale. Maintenance

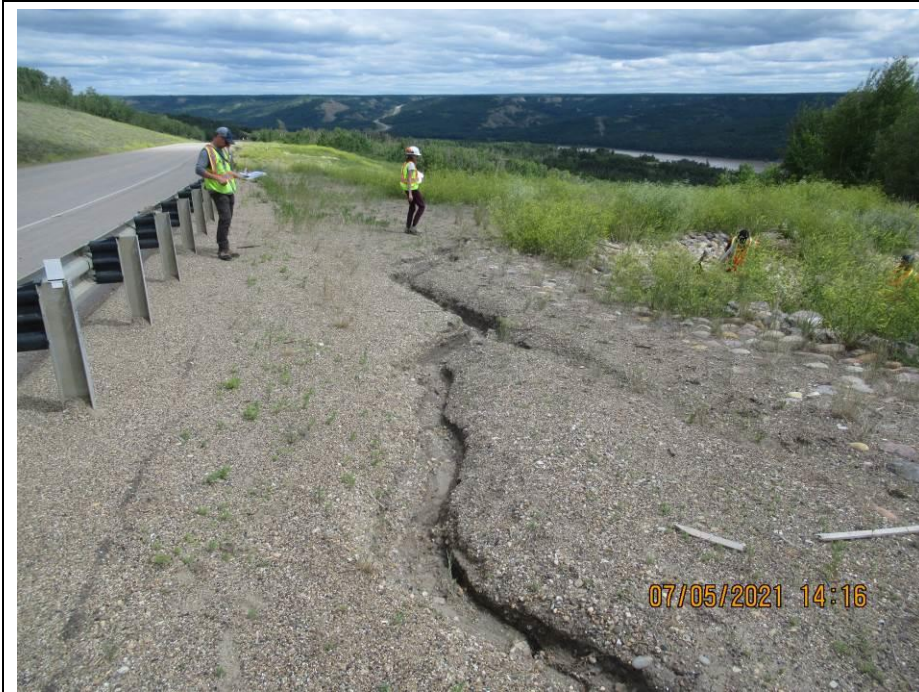
**Photo 71-5.**  
West of the wall on the south side of the road (26+650), water runoff from the road currently flows around the armored swale in an erosion rill. No major change from the 2020 condition.

given to an asphalt berm at the edge of pavement to direct runoff or installing a swale with ECM along the road edge in this area to reduce further erosion rates.

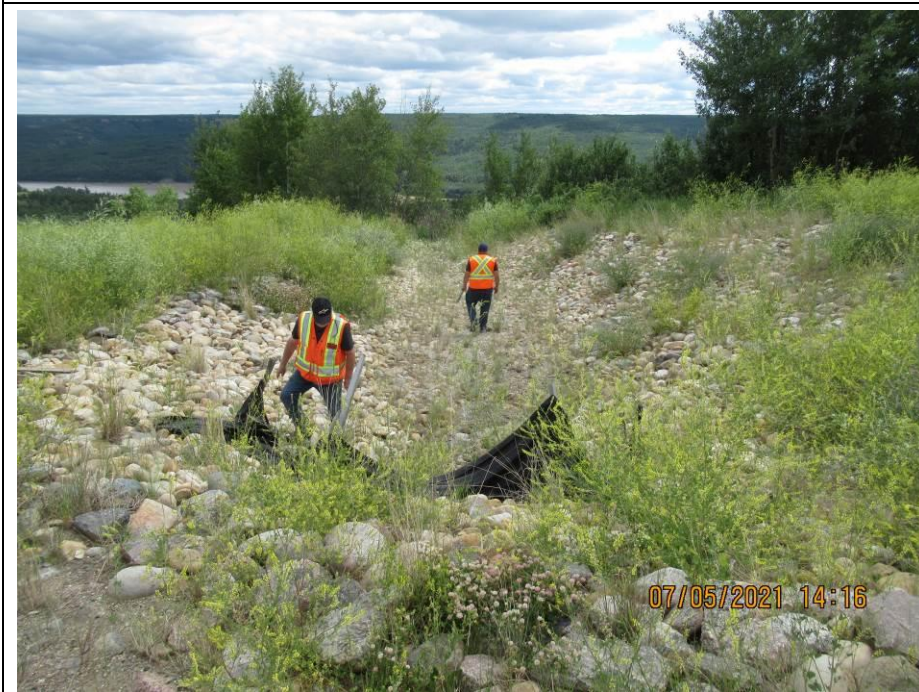
**Photo 71-6.**  
View of the armored swale at the culvert outlets (26+650). No issues were noted at the time of inspection.

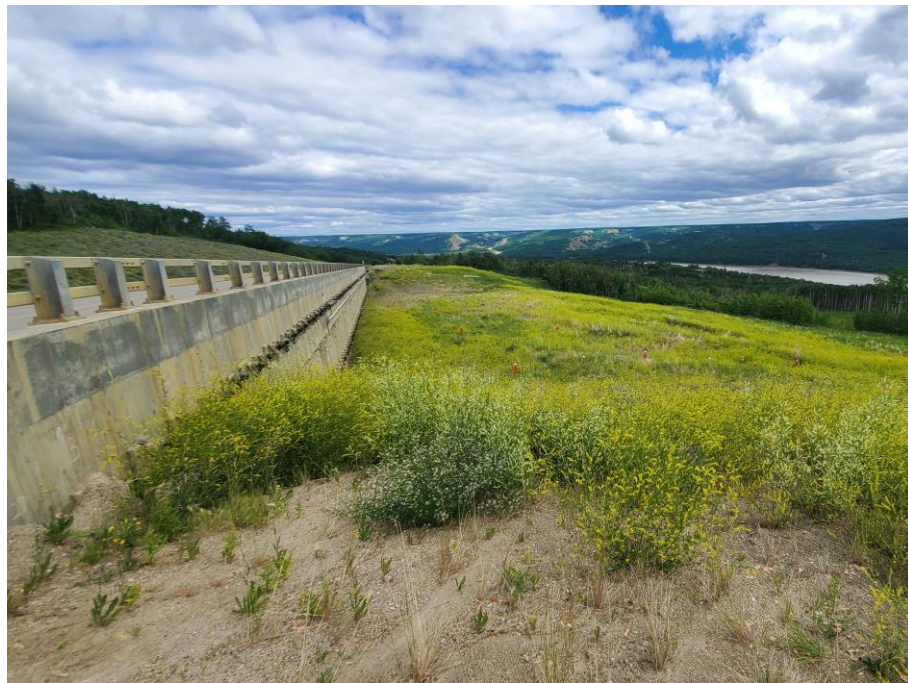
<input checked="" type="checkbox"/> Slope Movement	<p>Tension cracks and slide scarps with up to approximately 4 to 5 m of dropdown observed downslope of the pile wall along previously observed slide extents (Photos 71-7 and 71-8). Main slide scarp was offset approximately 5 m from SI16-3.</p> <p>A shallow earth slide with 0.4 m high scarp developed within the swale at the top of the granular backslope repair on north side of road near KM 26+350 that has displaced the riprap (Photo 71-1).</p>	<input checked="" type="checkbox"/>
<input checked="" type="checkbox"/> Erosion	<p>Upslope ditch between 26+500 to 26+600 has ongoing scour and gulying within the invert (Photo 71-3) that is slightly worse from last year (1.3 m wide and 0.7 m deep). Repaired backslope area where granular fill washed out (first noted in 2019) had increased vegetation growth and did not appear significantly worse (Photo 71-3). Erosion gully from road runoff west of the wall flows above armored swale was slightly deeper but no major change (Photo 71-5). Road runoff had caused minor rill erosion between the armored swale and road edge at the east end of the pile wall near km 26+850 (Photo 71-11).</p>	<input checked="" type="checkbox"/>

**Photo 71-7.**  
At the west end of the pile wall looking towards the east downslope of the wall. Vegetation is well established below the wall.

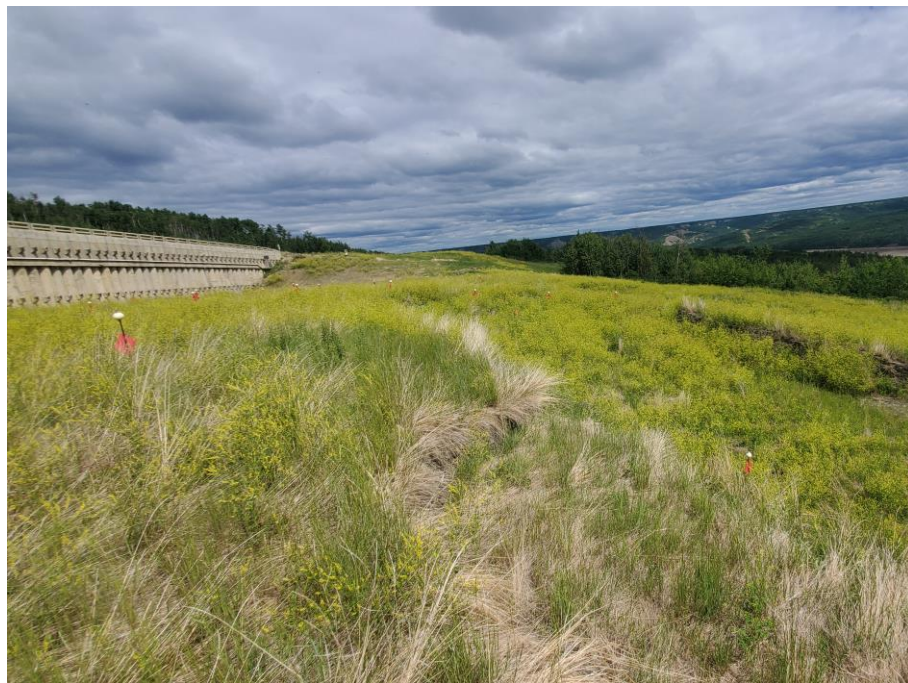
Slope movement is expected to continue downslope of the pile wall, which has been observed to be active along previous slide extents since 2016. The pile wall is designed to accommodate approximately 6.5 m of slope subsidence or 'drop' below the second row of anchors downslope of the pile wall. Movement of the soil bench downslope of the wall should therefore be monitored on an annual basis to determine if/when another row of support anchors might be required.

**Photo 71-8.**  
Looking towards the east at the downslope area below the wall at the main scarp where landslide movement has continued since the pile wall was constructed. Scarps have typically followed along previously observed slide extents prior to the regrading and wall construction.

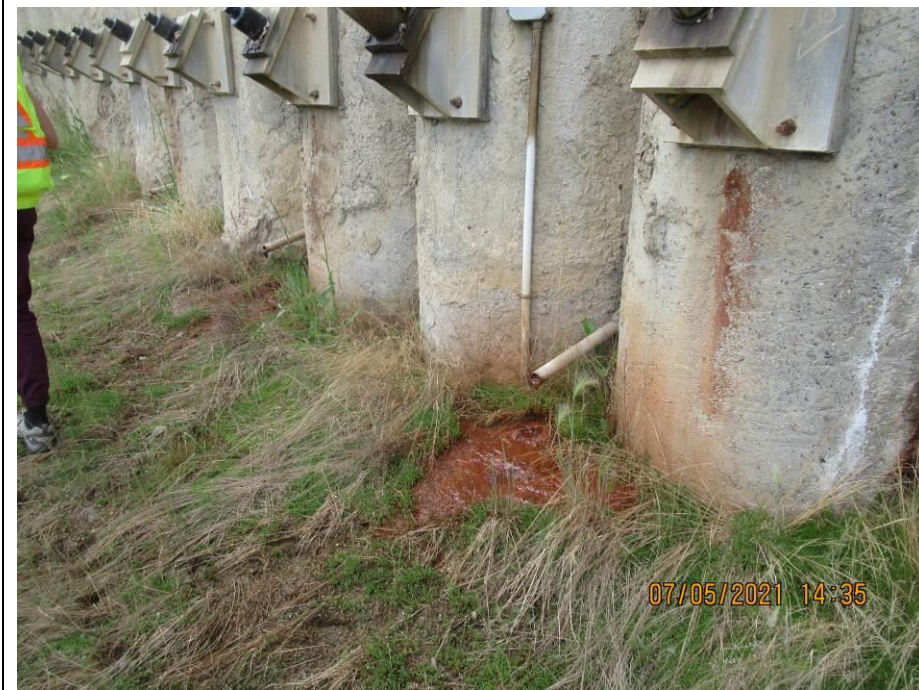
<input checked="" type="checkbox"/> Seepage	<p>At the downslope base of the wall on the east end, drain outlets were slowly dripping, oxidation staining was visible on the paving blocks, and area was wet at eastern side at base of wall (Photo 71-9).</p>	<input type="checkbox"/>
<input checked="" type="checkbox"/> Bridge/Culvert Distress	<p>One of two culvert inlets in the north ditch near km 26+650 has been fully blocked and the other is about ¾ full due to silt buildup (Photo 71-4).</p>	<input checked="" type="checkbox"/>
<input type="checkbox"/> Other		<input type="checkbox"/>
<p><b>Instrumentation:</b></p> <p>Instrumentation installed as part of the geotechnical investigation has been sheared off and/or decommissioned.</p> <p>Instrumentation has been installed to monitor pile wall performance that includes:</p> <ul style="list-style-type: none"> <li>▪ Three shape-acceleration arrays (SAA) installed within concrete piles of the wall (<b>SAA-P022</b>, <b>SAA-P060</b>, and <b>SAA-P097</b>)</li> <li>▪ Nine vibrating wire load cells on the wall anchor plates (<b>VC1917</b> to <b>VC1925</b>)</li> <li>▪ Six vibrating wire (VW) piezometers (<b>VW16-1A</b>, <b>VW16-1B</b>, <b>VW16-1C</b>, <b>VW16-2A</b>, <b>VW16-2B</b> and <b>VW16-2C</b>)</li> <li>▪ Three test holes south (downslope) of the pile wall with one slope inclinometer (<b>SI16-3</b>) and six additional VW piezometers (<b>VW16-3A</b>, <b>VW16-3B</b>, <b>VW16-4A</b>, <b>VW16-4B</b>, <b>VW16-5A</b> and <b>VW16-5B</b>)</li> <li>▪ 28 VW strain gauges</li> </ul> <p><b>SAA-P022</b>, six of the 28 strain gauges <b>VW16-5B</b> stopped functioning before the end of construction. As of May 7, 2017, <b>VW16-4B</b> is no longer functional.</p> <p><b>SI16-3</b>: rates of movement have been steady since 2018 at approximately 4 to 6 mm/yr within the upper 4 m and with total resultant movement of approximately 20 mm. Creep measured in deeper zones.</p>

**Photo 71-9.**  
Weep holes at the east end of the wall had active seepage and area was wet.

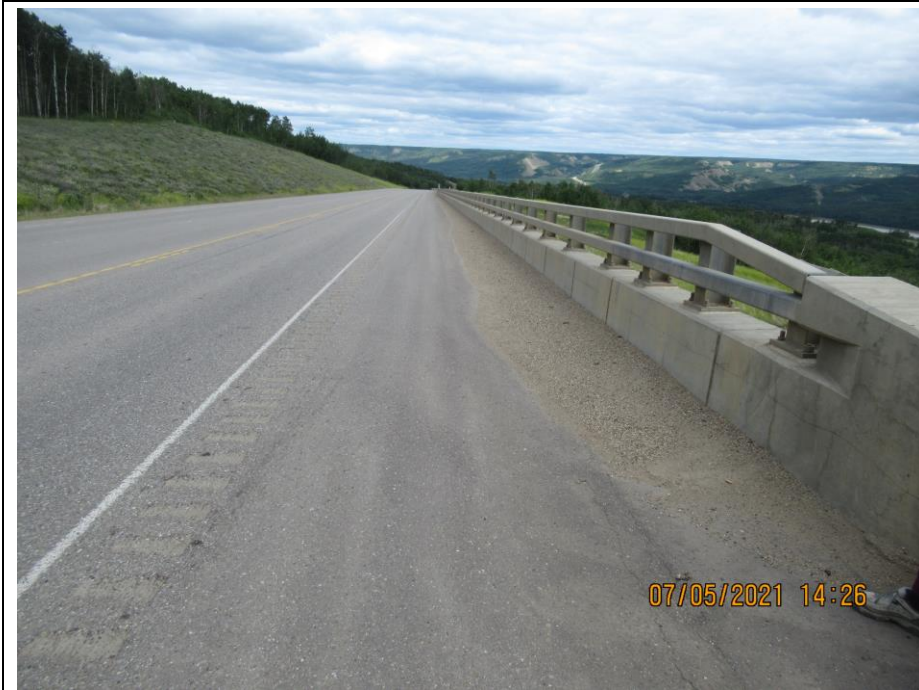
<b>Maintenance:</b>		
<b>Observations:</b>	<b>Description</b>	<b>Worsened?</b>
<input checked="" type="checkbox"/> Pavement Distress	Minor reflective cracking observed at the top of the pile wall that follows the edge of the pile cap. No change from the 2020 condition. (Photo 71-10)	<input type="checkbox"/>

**Photo 71-10.**  
Looking east along the highway above the pile wall. Pavement was in good condition. Minor buildup of sand and gravel at the base of the guardrail along the top of the wall.

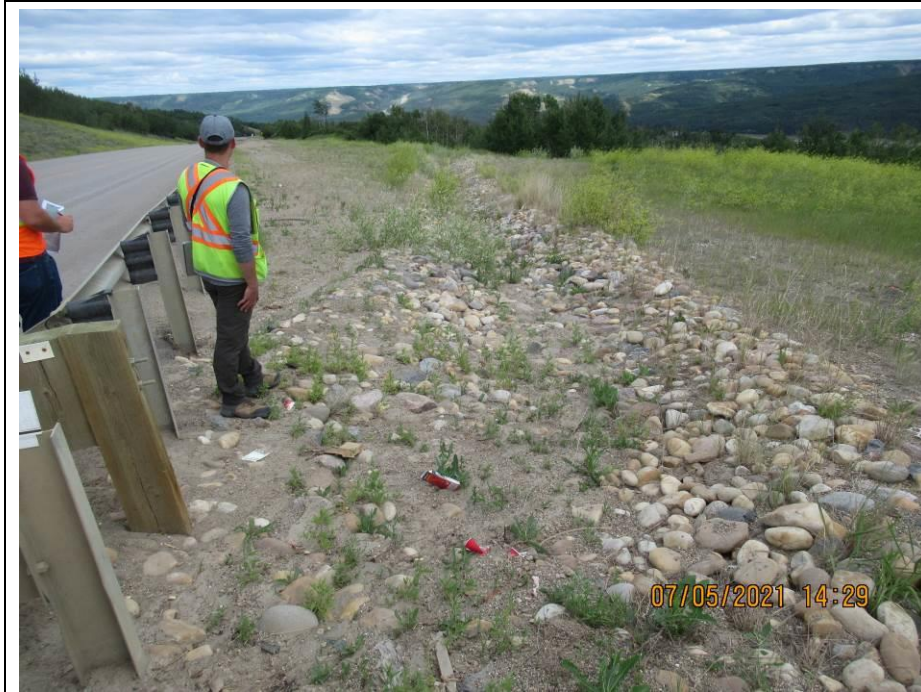
**Photo 71-11.**  
Looking towards the east at the east end of the pile wall at the armoured drainage swale. Minor rill erosion was observed between the swale and road edge in areas of poor vegetation. Some increased sediment buildup in the swale but no major change from 2020 condition.

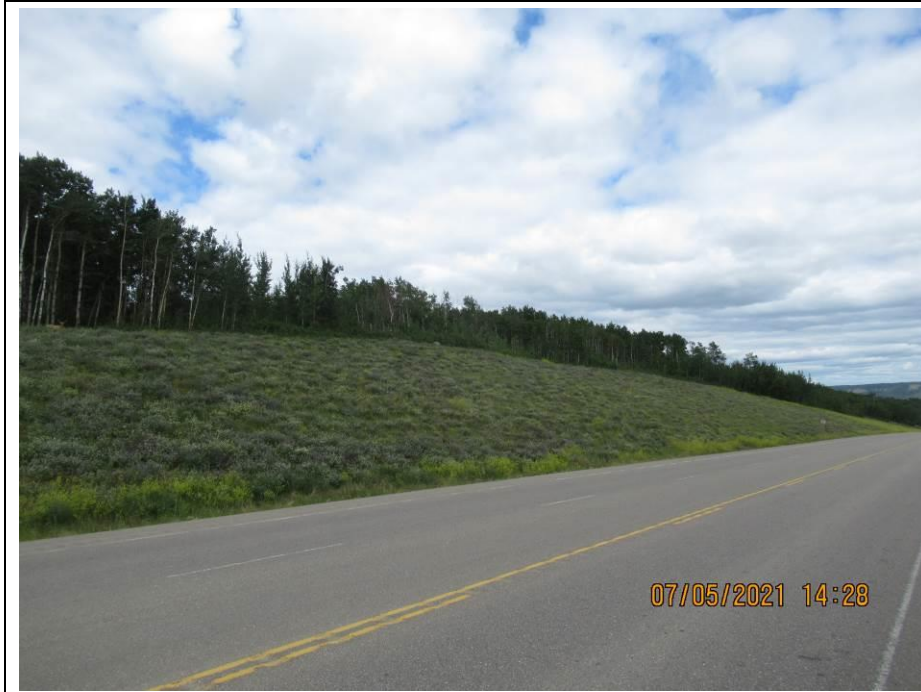
**Photo 71-12.**  
Looking northeast towards the backslope area across from the pile wall (26+800). Slope had good vegetation coverage and no issues were observed.
