**THURBER** ENGINEERING LTD.

**ALBERTA TRANSPORTATION GRMP (CON0022164)  
PEACE REGION (PEACE RIVER DISTRICT)  
INSTRUMENTATION MONITORING RESULTS – FALL 2022**

**SECTION C**

**SITE PH071: HWY 986:01, DAISHOWA WEST HILL**

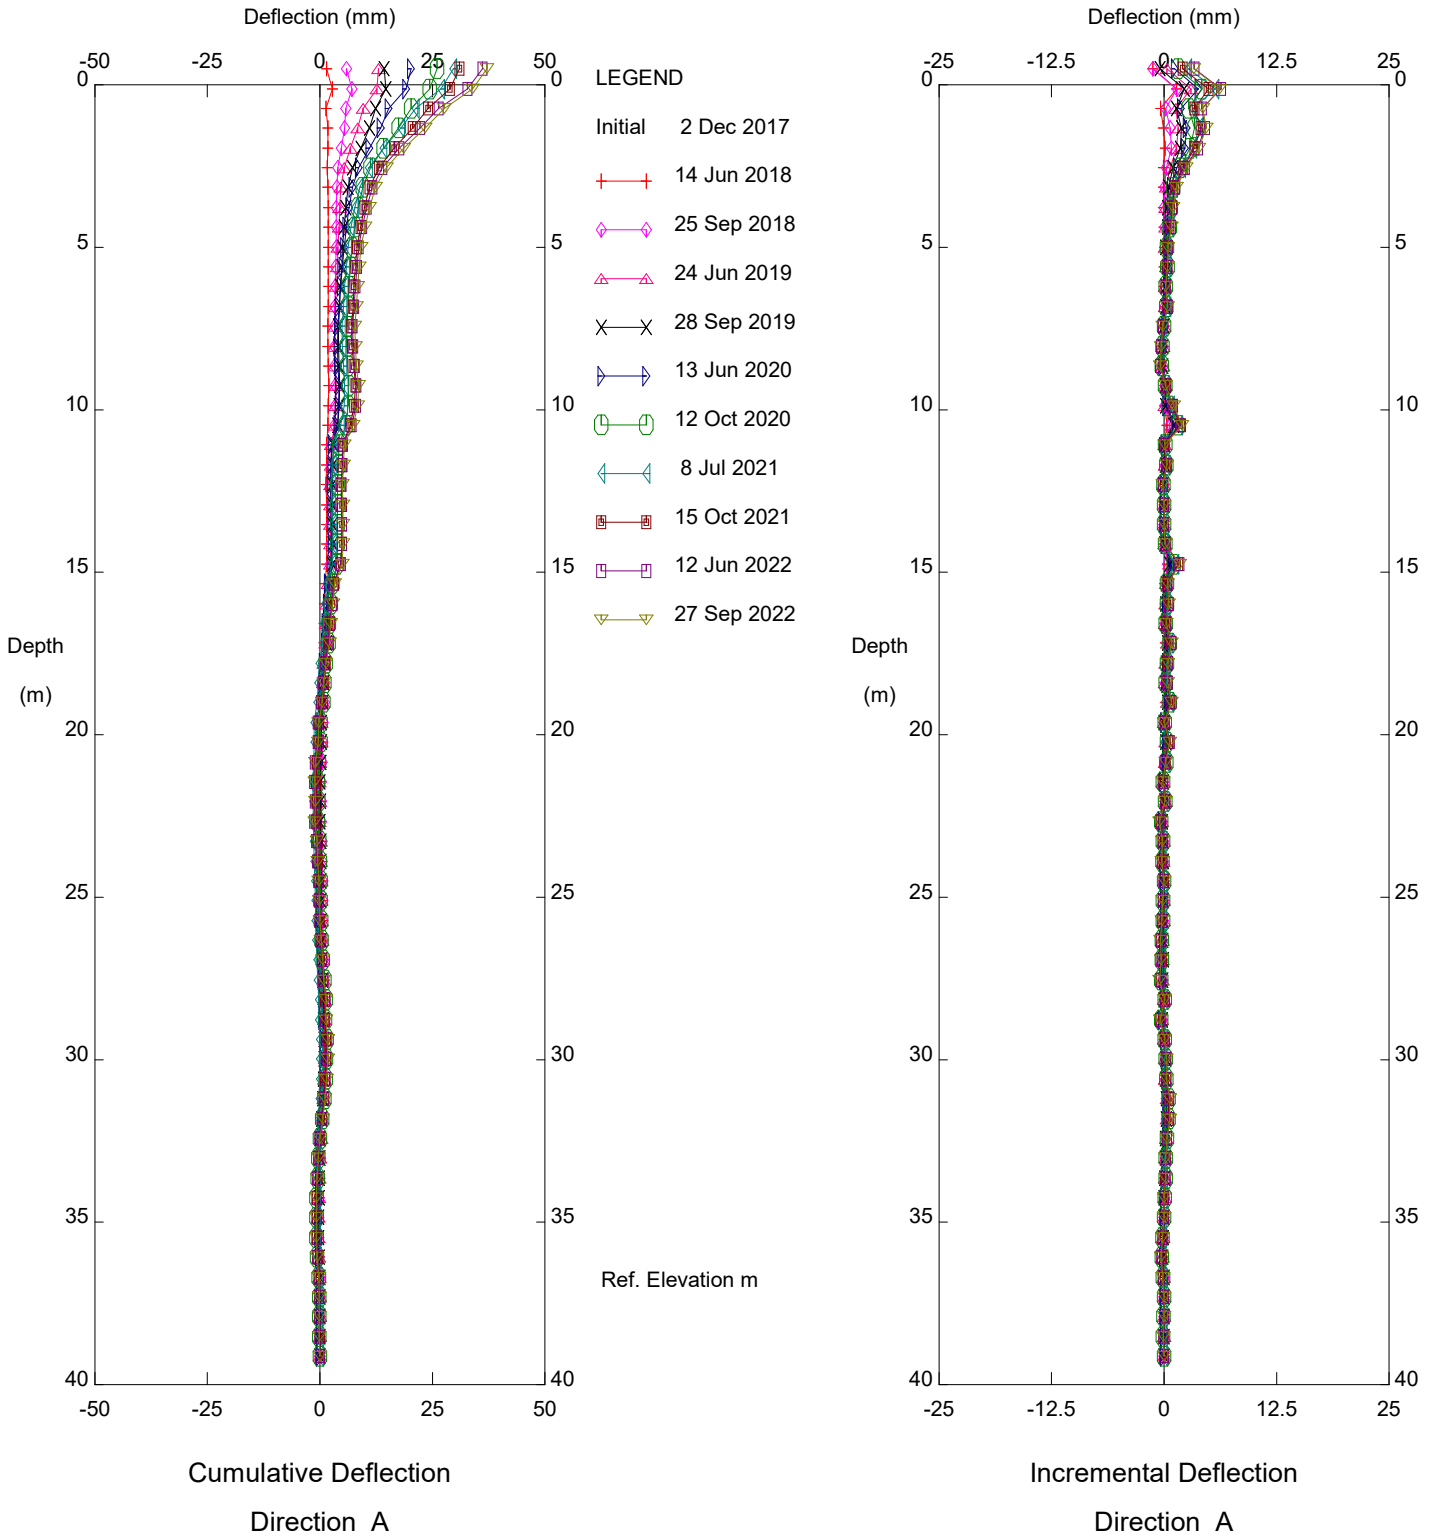
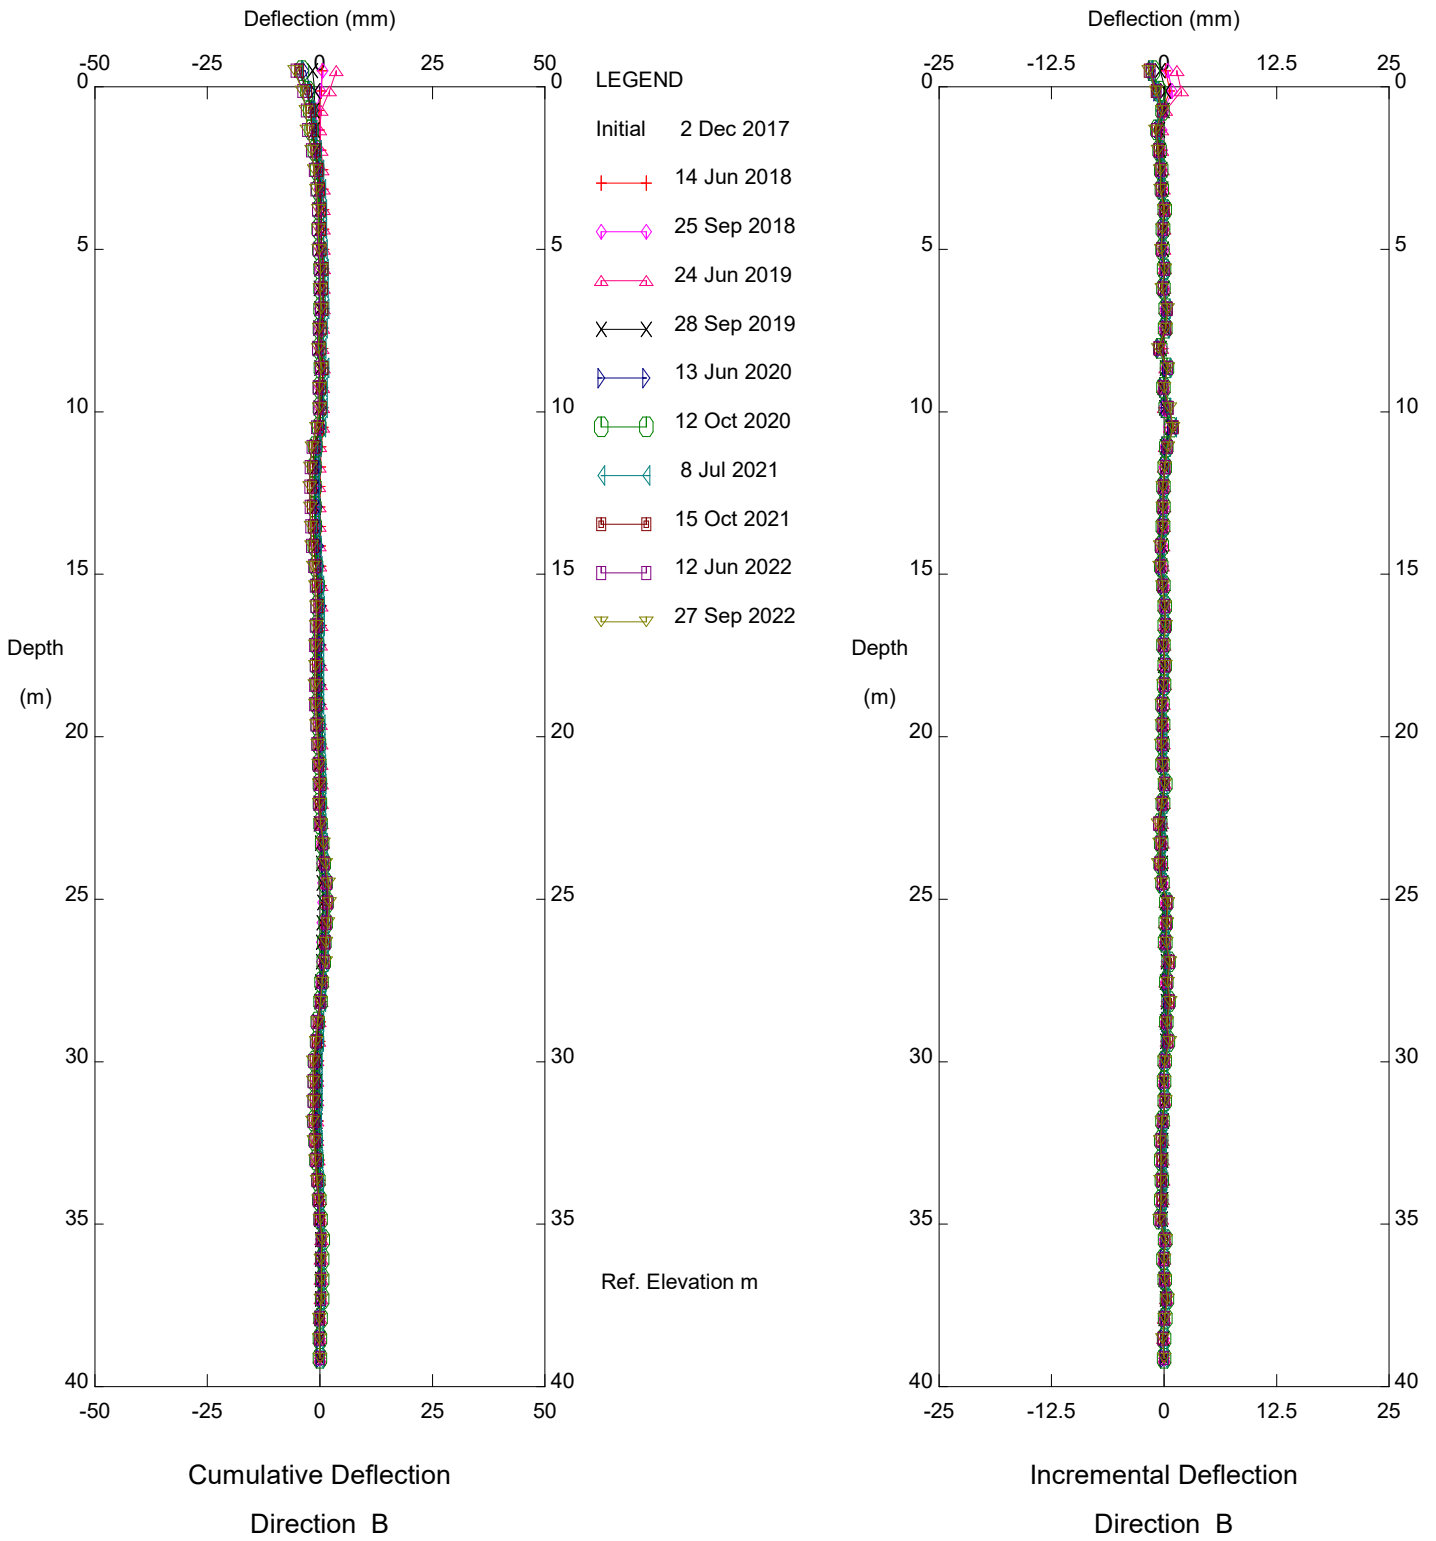
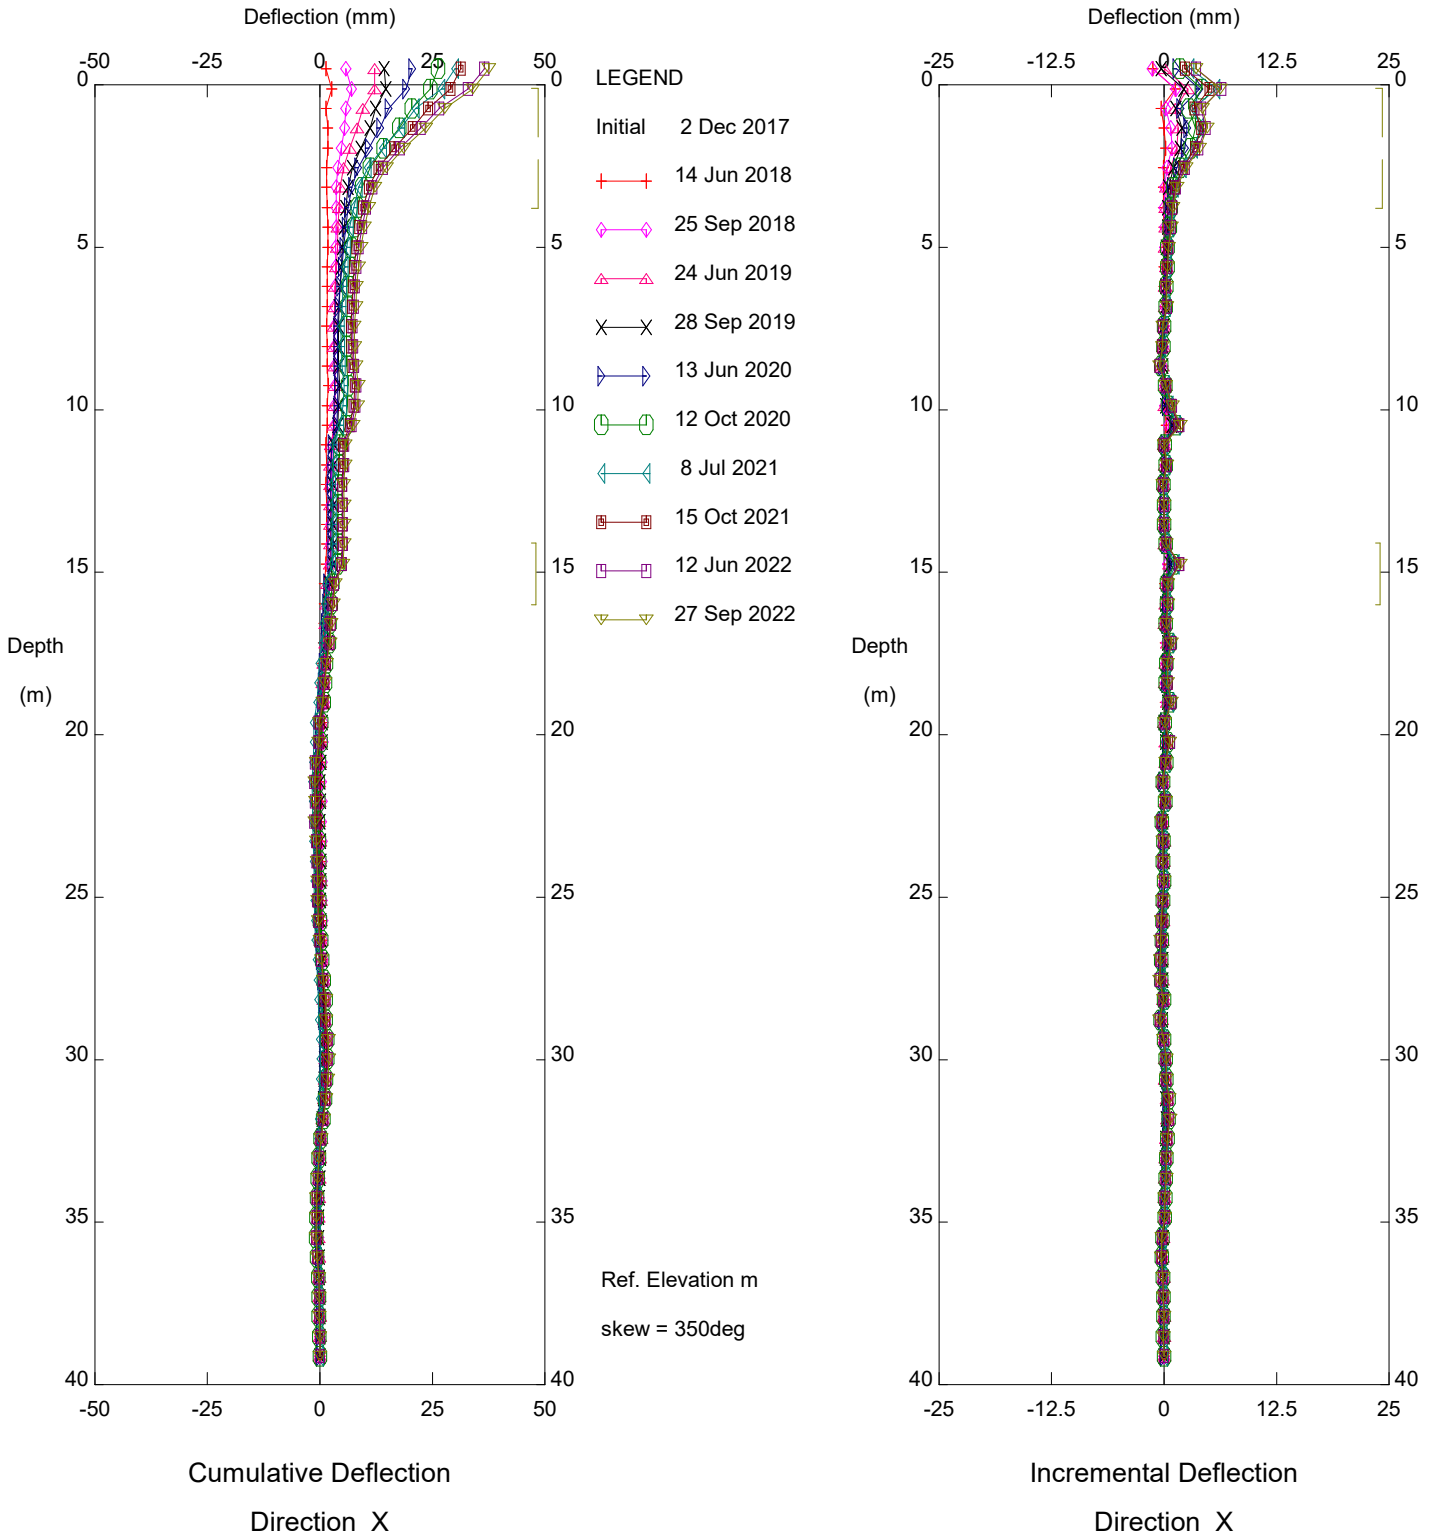
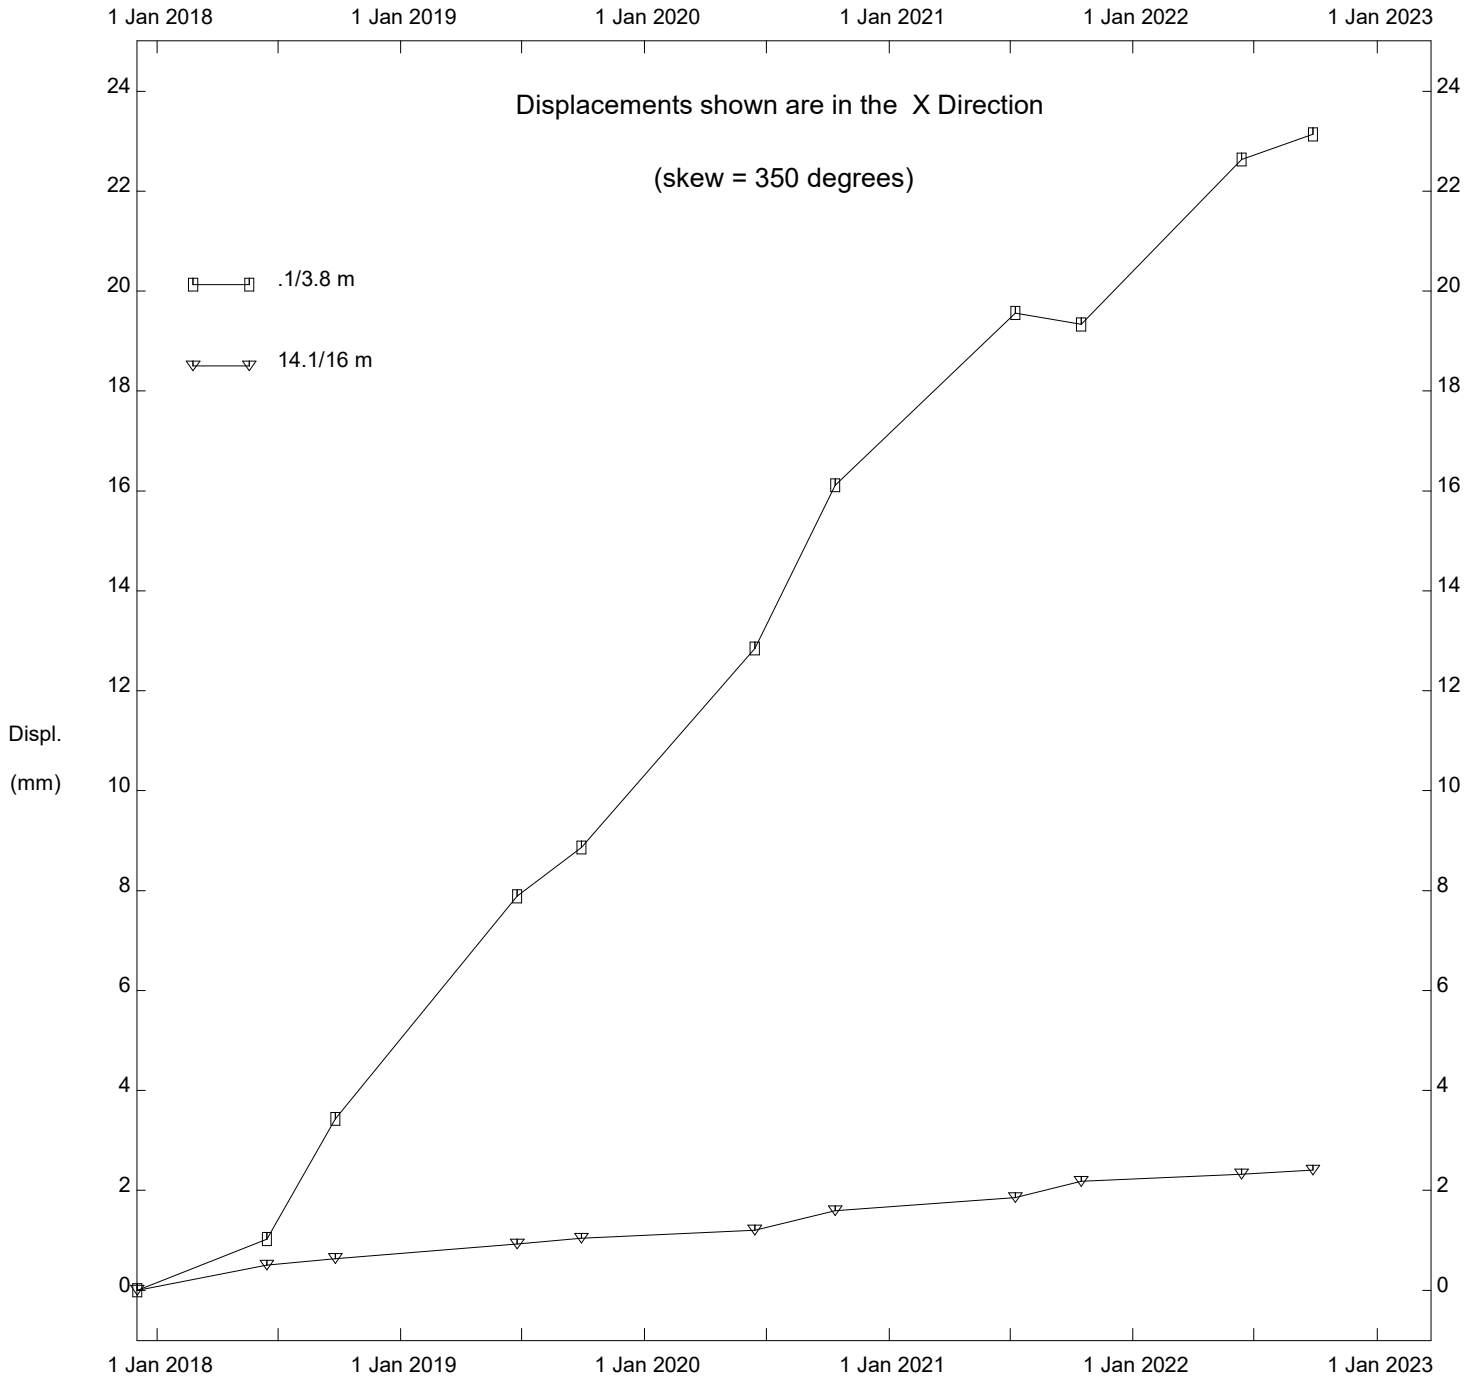
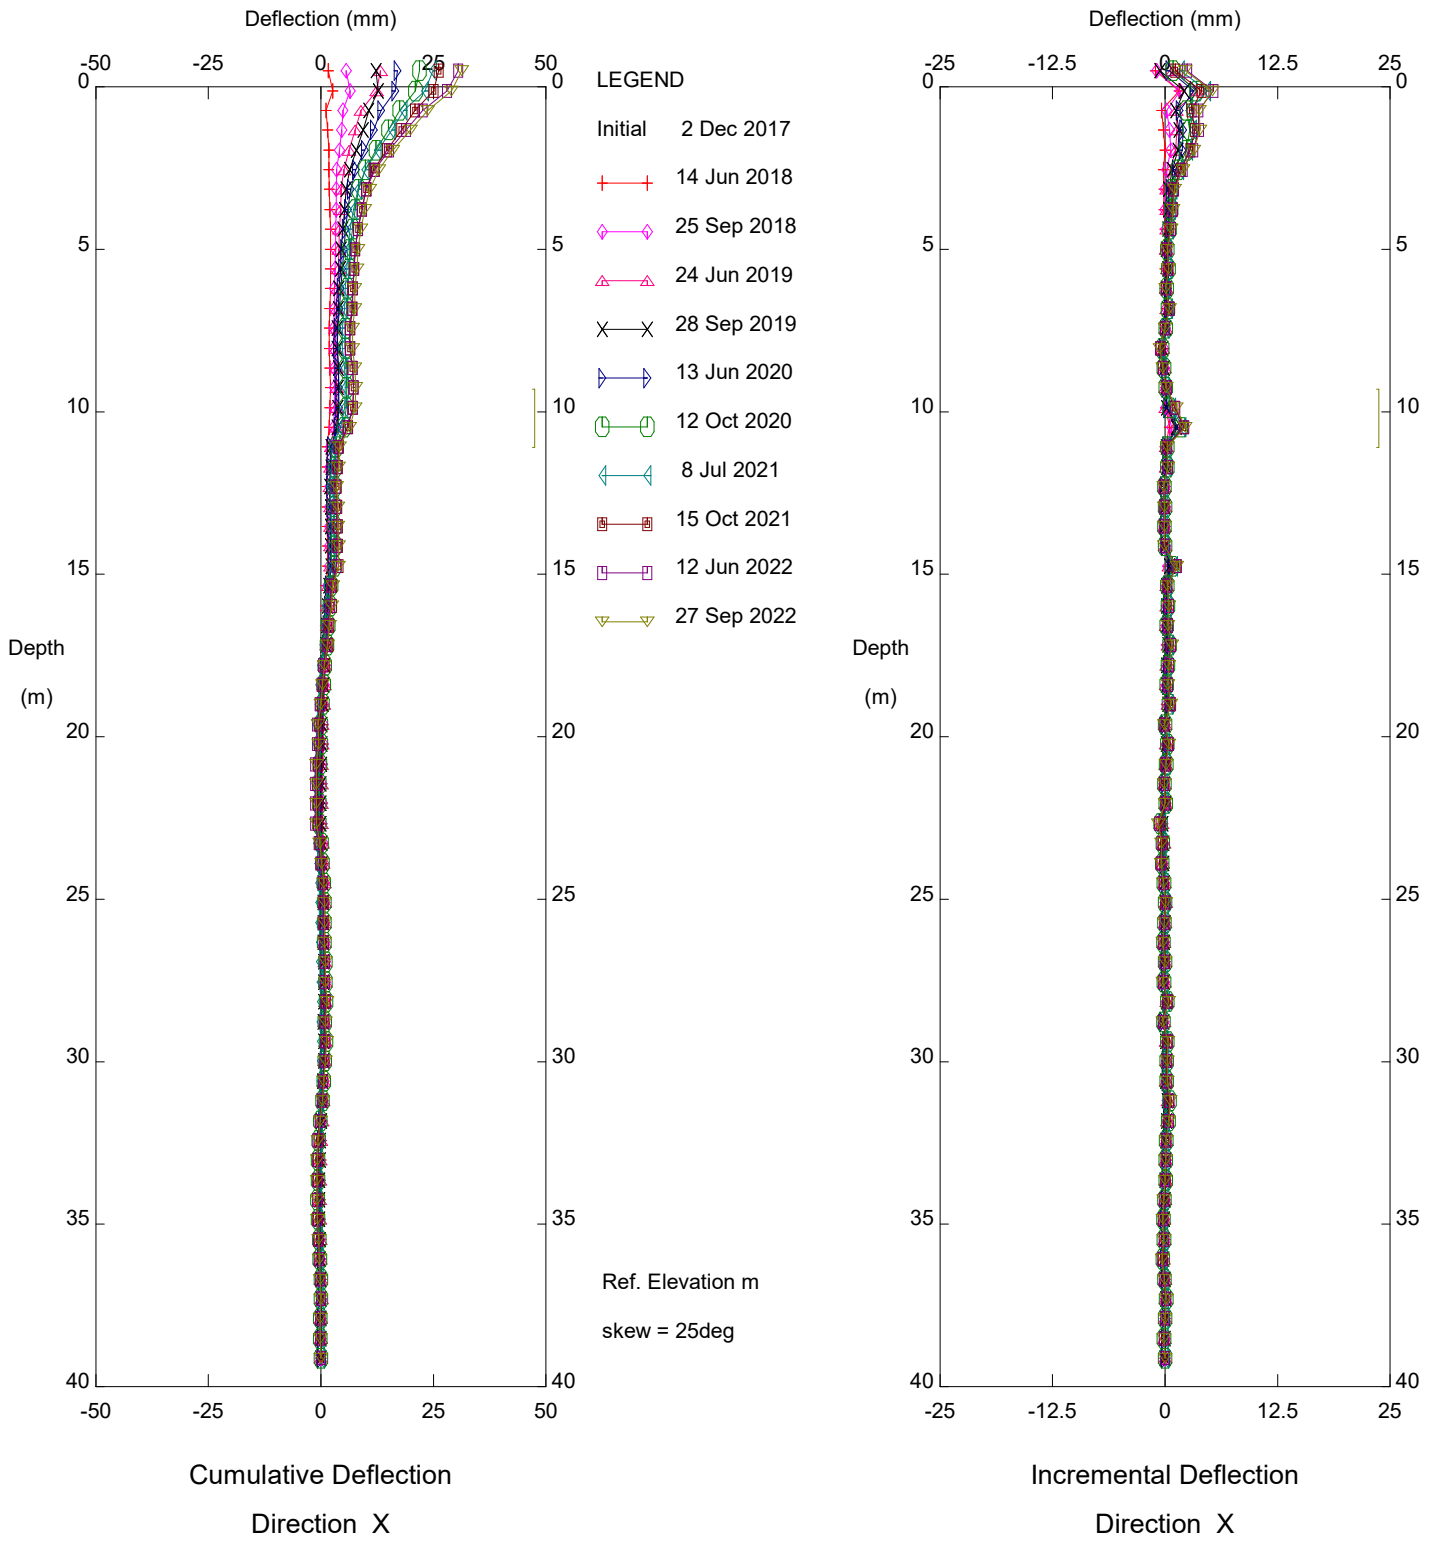
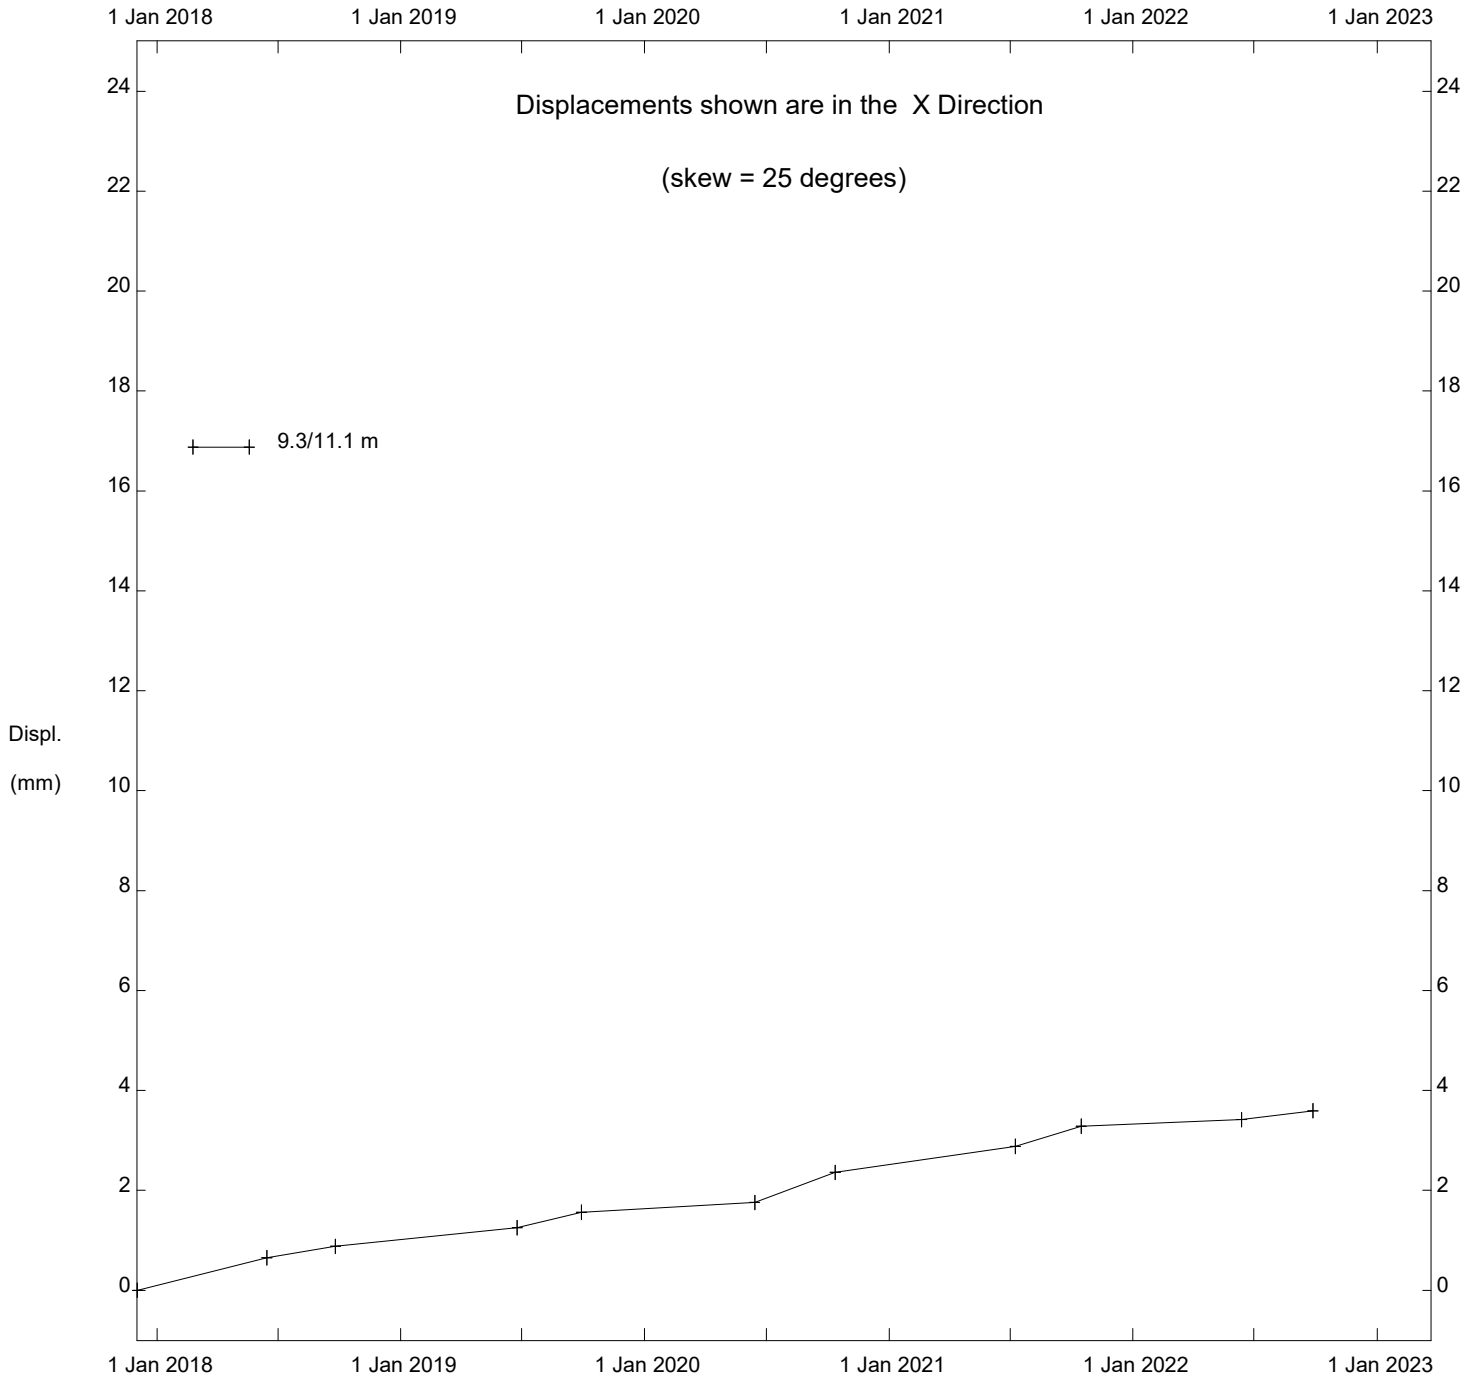
PH071 Daishowa West, Inclinator SI16-3

SI16-3 showed rates of movement of 1.7 mm/yr, 0.7 mm/yr and 0.3 mm/yr over 0.1 m to 3.8 m depth, 9.3 m to 11.1 m depth and 14.1 m to 16.0 m depth, respectively, since the spring of 2022 readings.

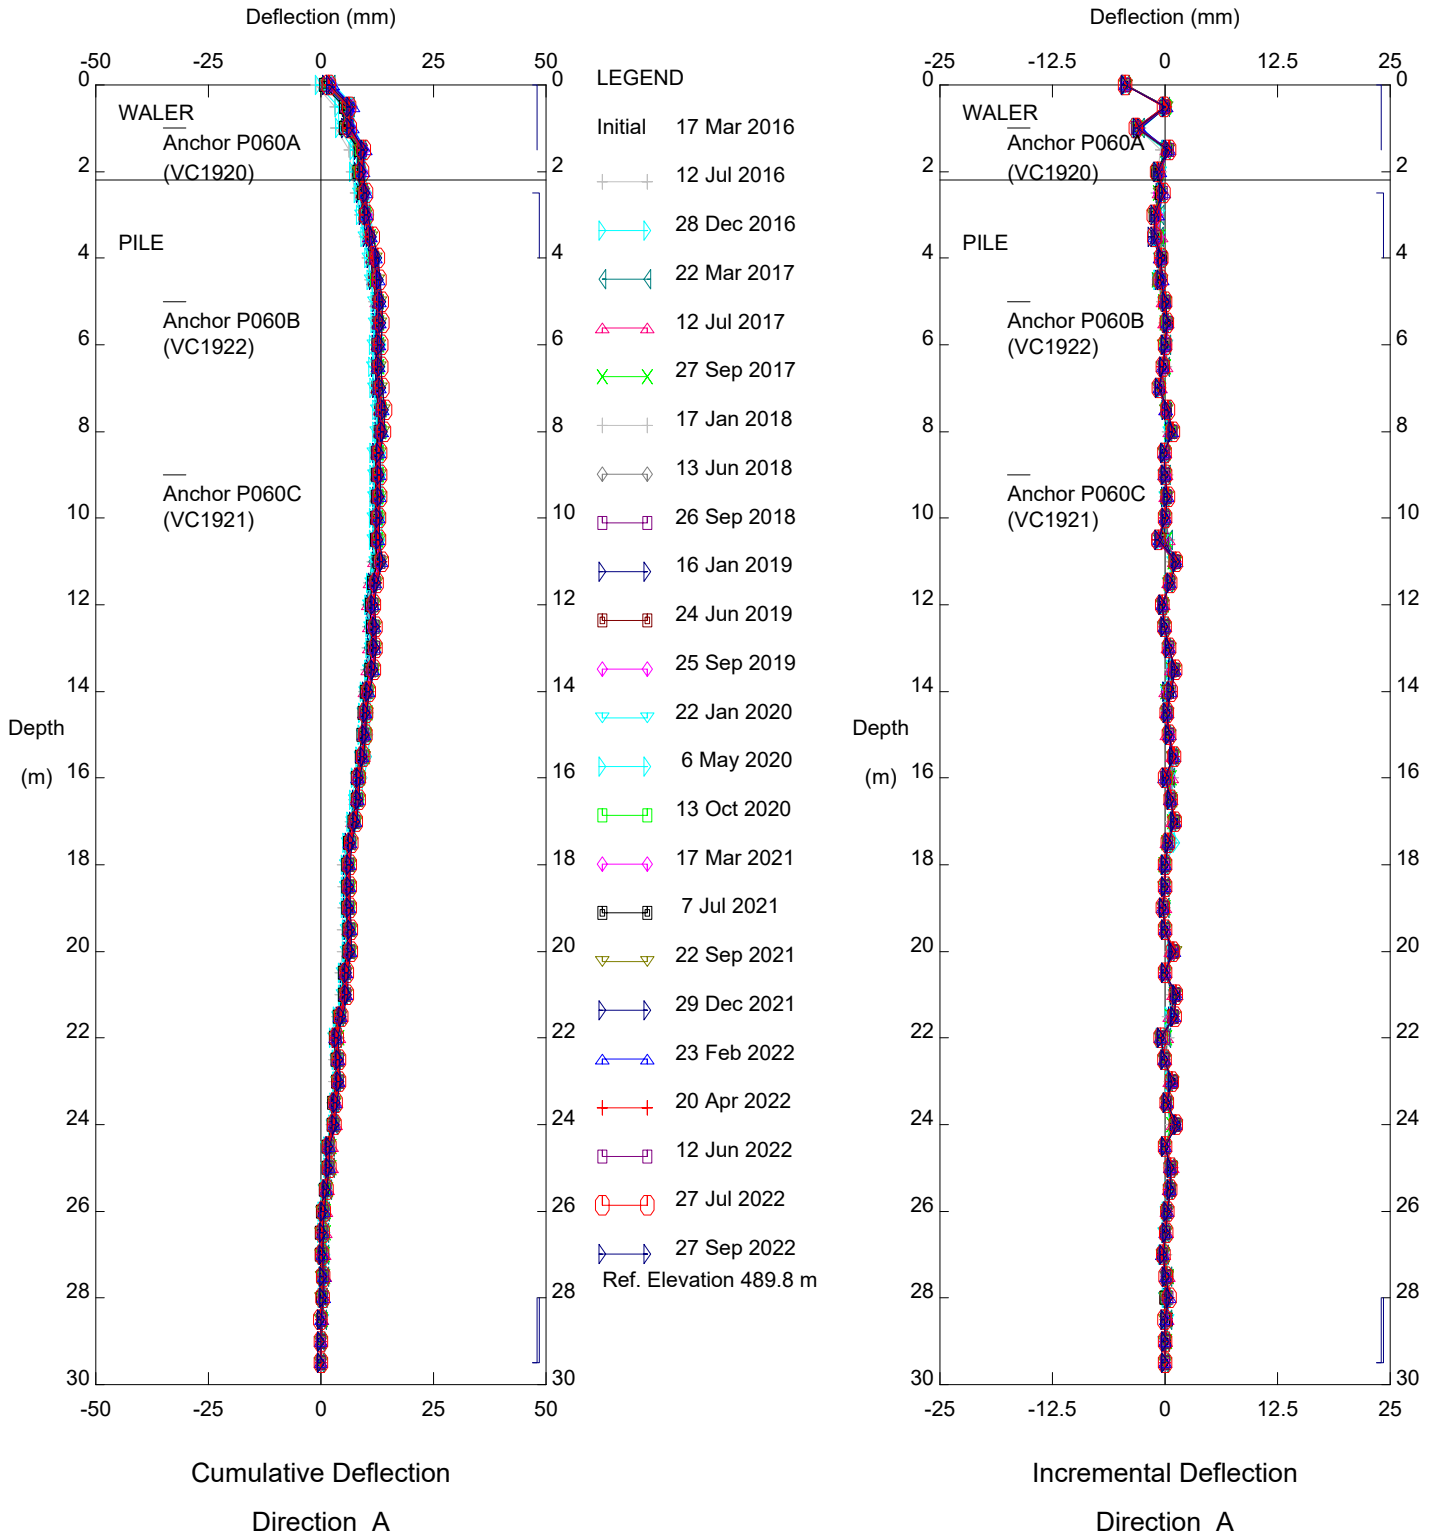
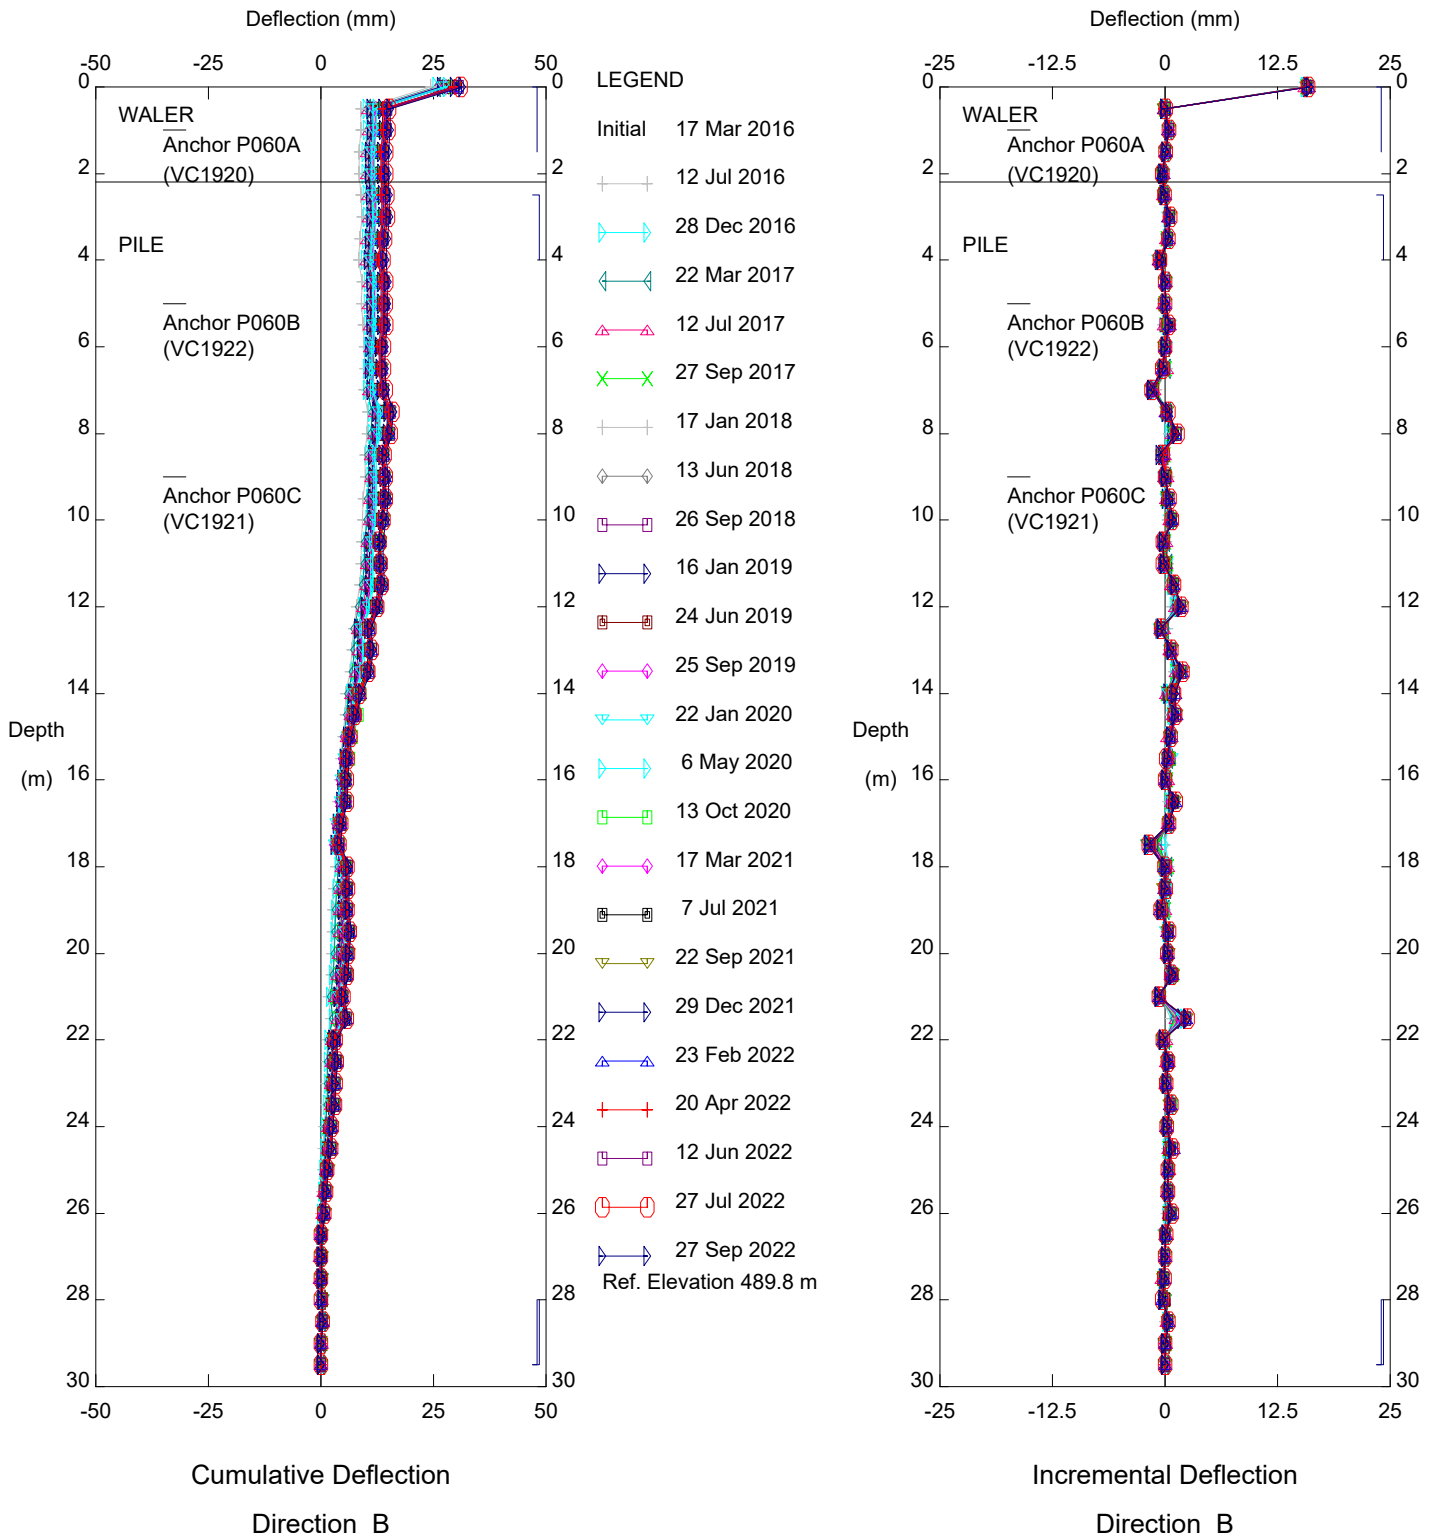
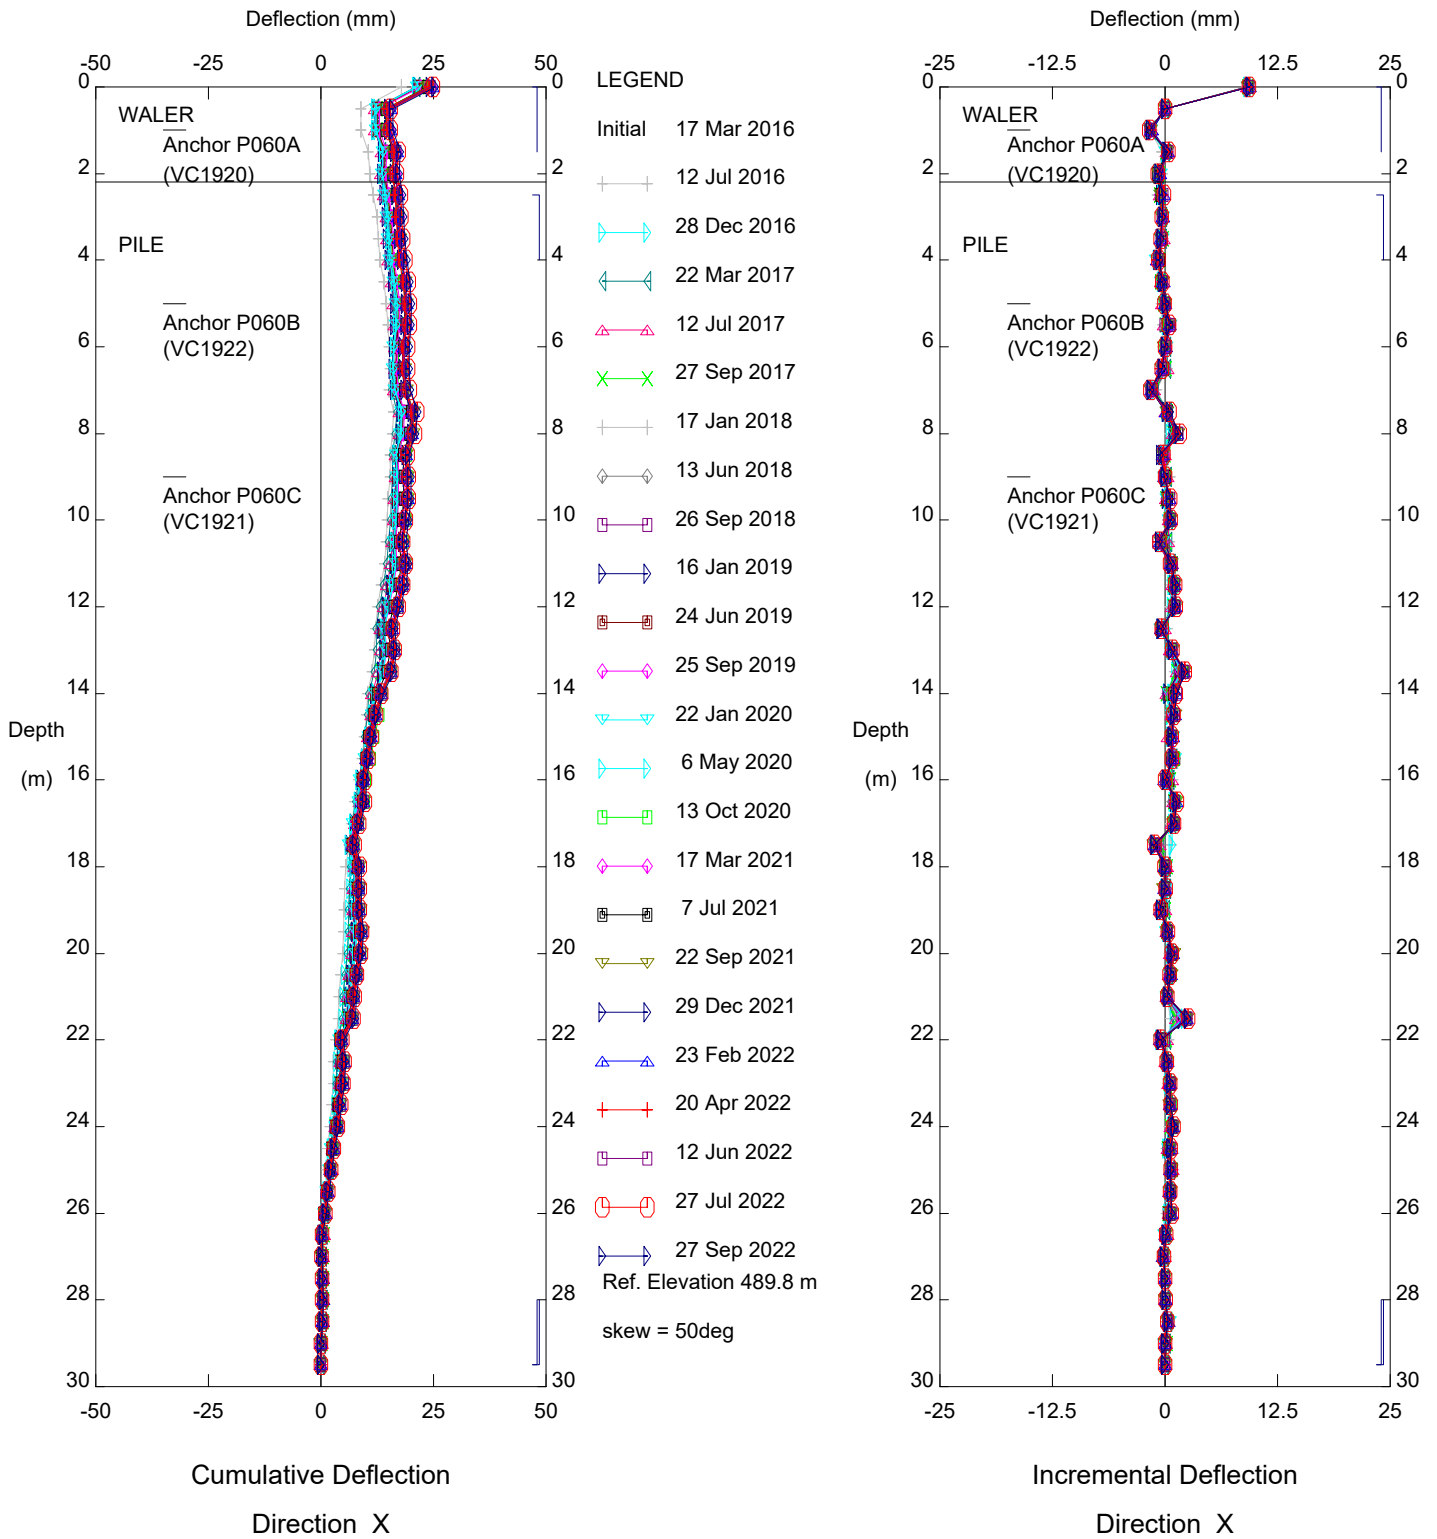
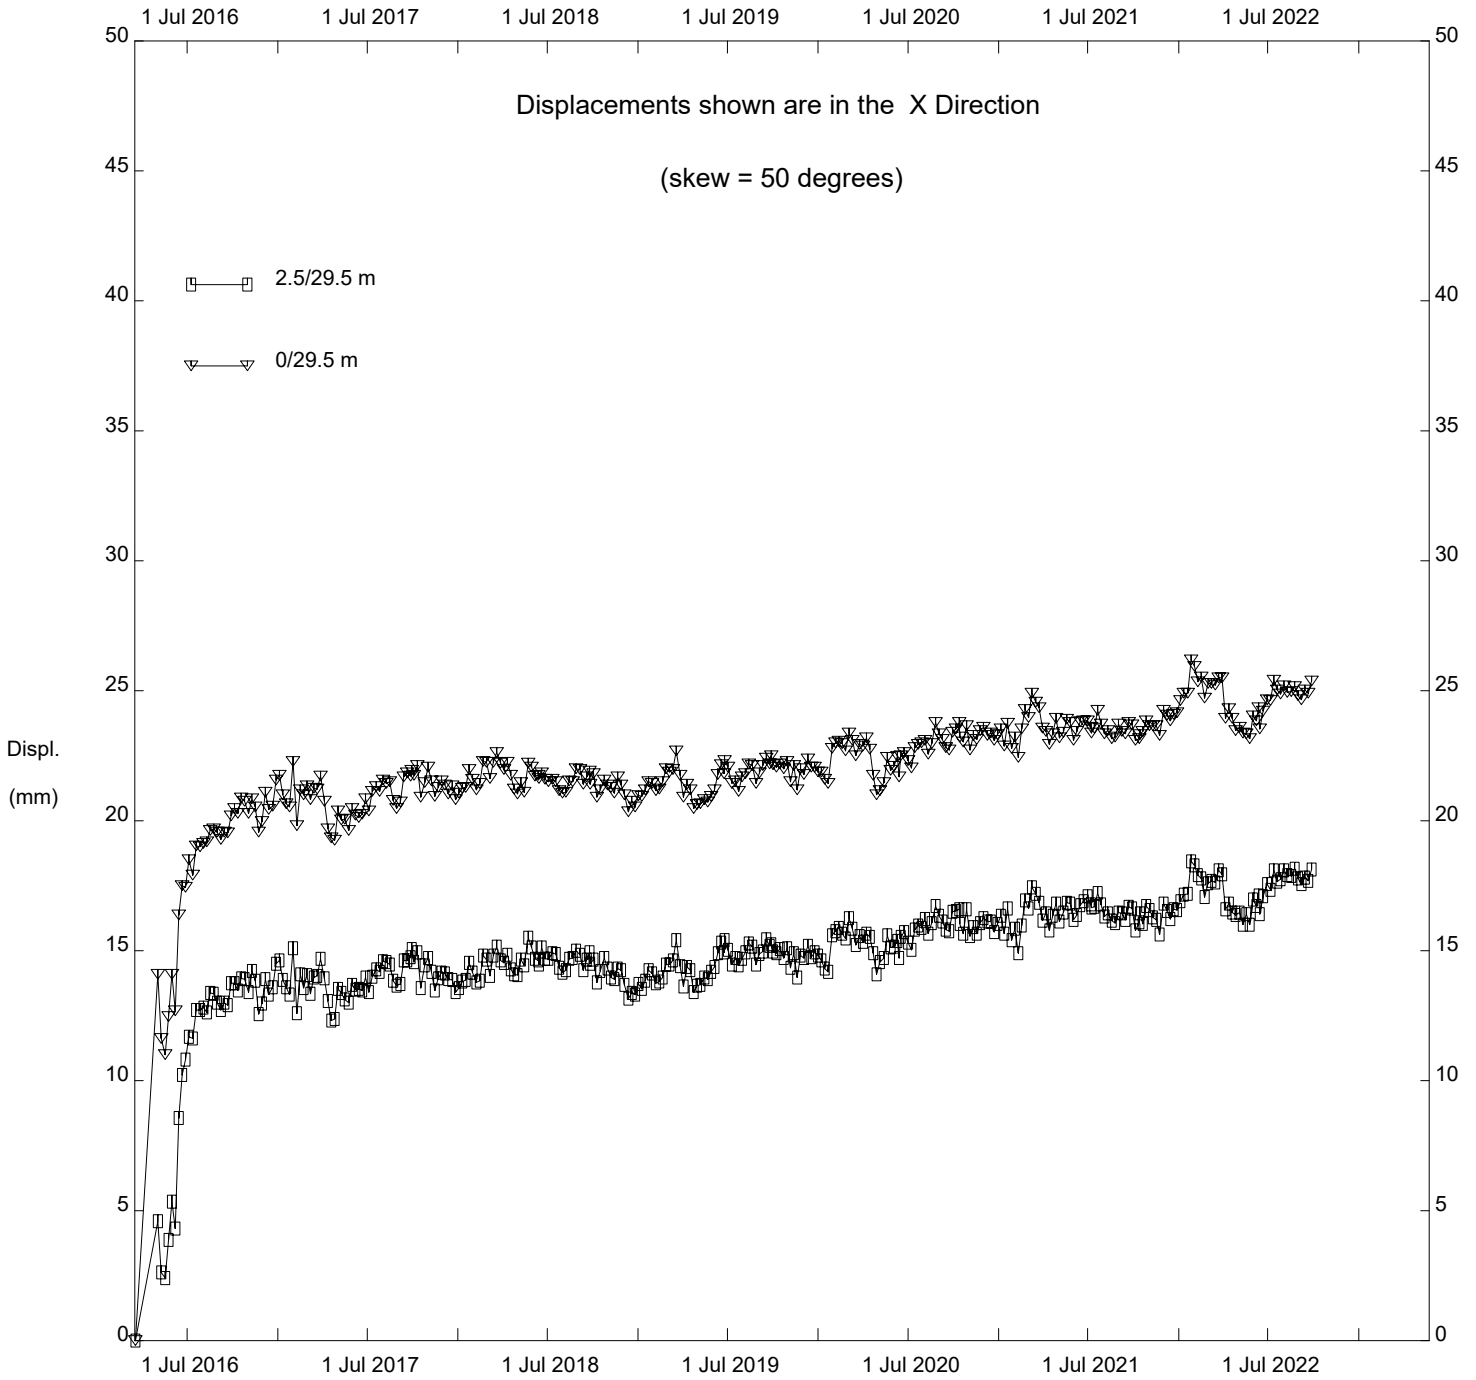
Hwy 986:01 Daishowa West, Inclinator SAA-P060

SAA-P060 showed an average rate of movement of 3.4 mm/yr in the downslope direction over the length of the pile and an average rate of movement of 3.5 mm/yr in the downslope direction over the combined length of the pile and waler, respectively, since the spring of 2022 readings. SAA-P060 has shown a cumulative pile head deflection of 18.1 mm to date in the downslope direction. SAA-P060 has shown an overall relatively stable trend of movement since the end of construction.
