**THURBER** ENGINEERING LTD.

**ALBERTA TRANSPORTATION GRMP (CON0022164)  
PEACE REGION (PEACE RIVER DISTRICT)  
INSTRUMENTATION MONITORING RESULTS – FALL 2022**

**SECTION C**

**SITE PH071: HWY 986:01, DAISHOWA WEST HILL**

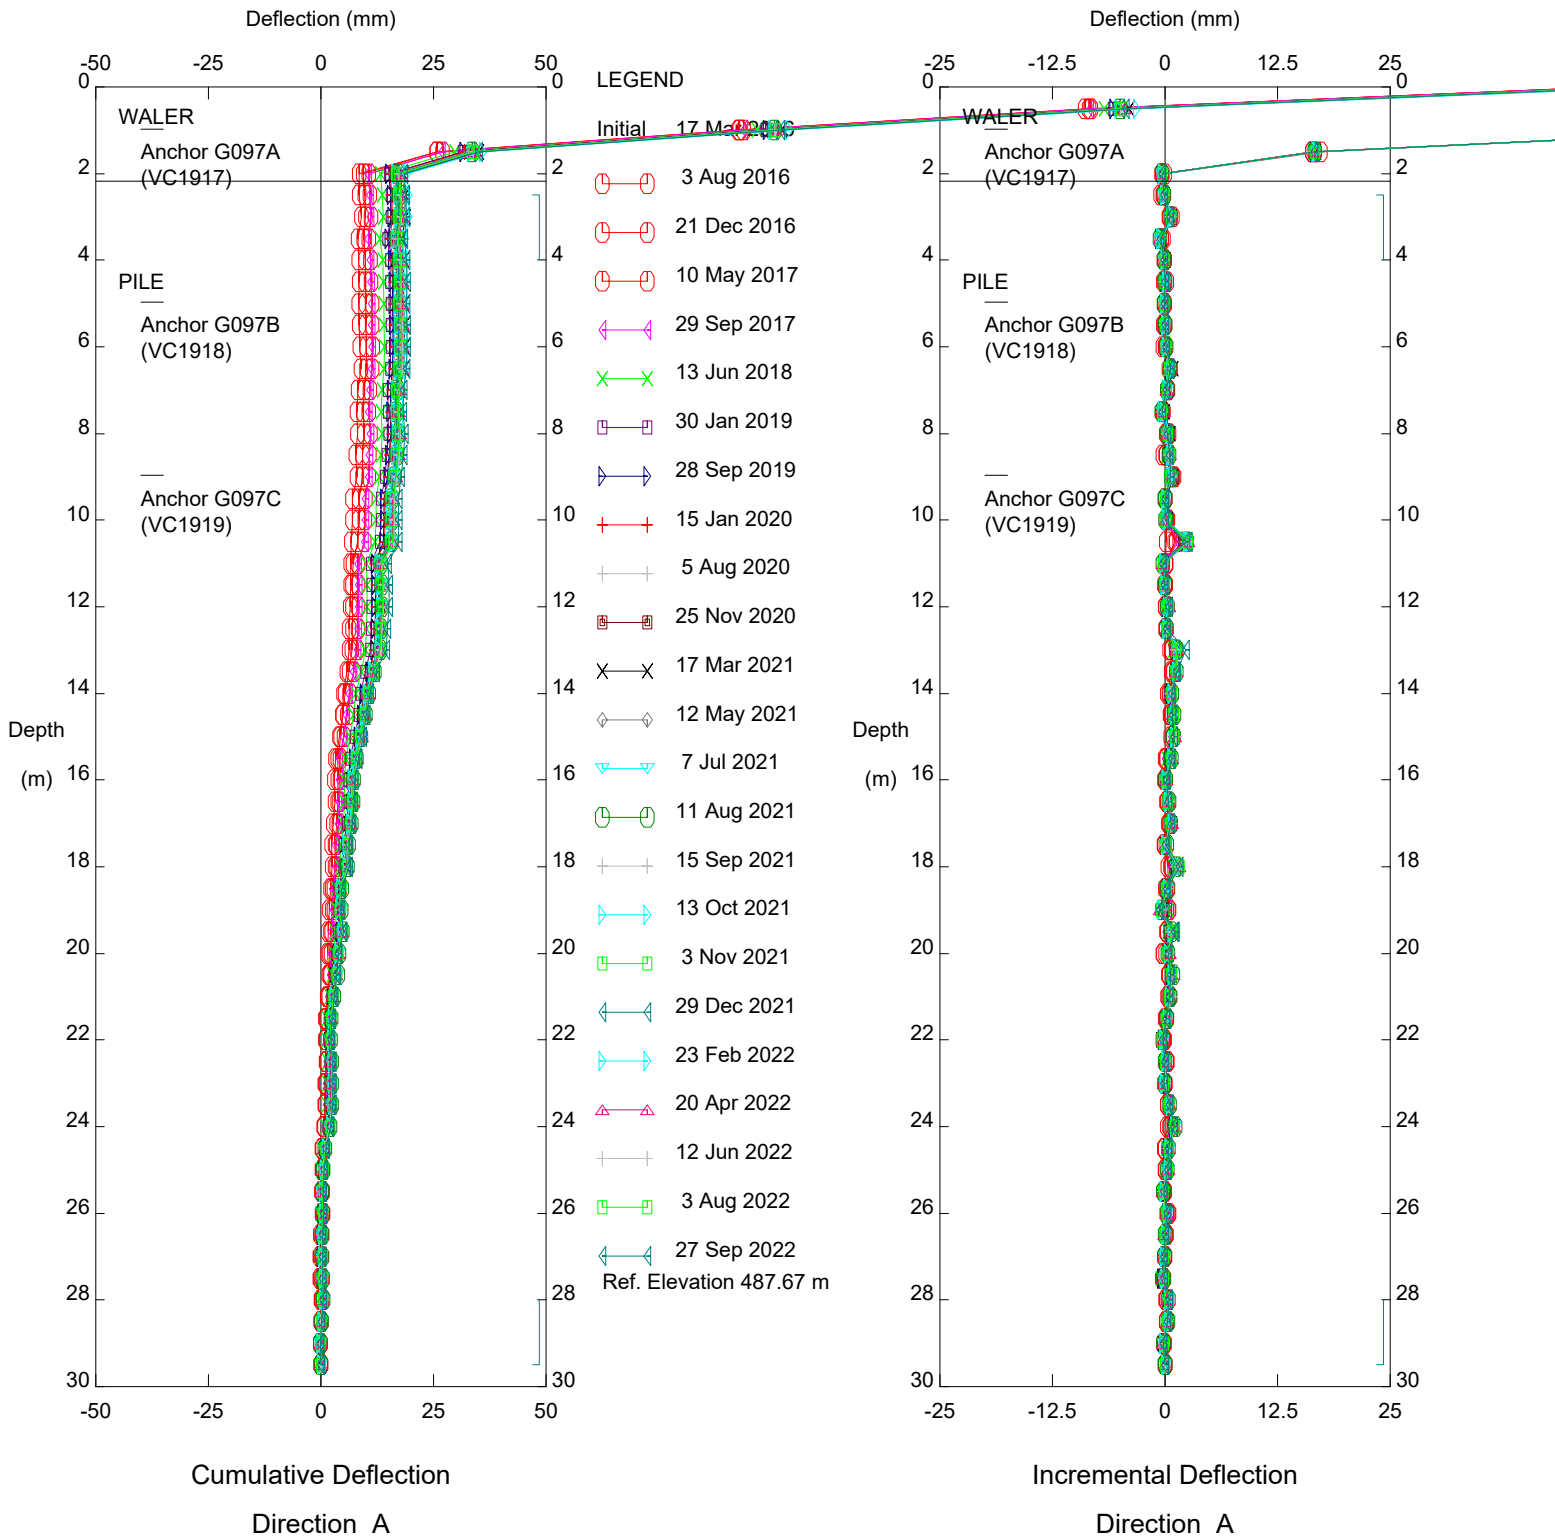
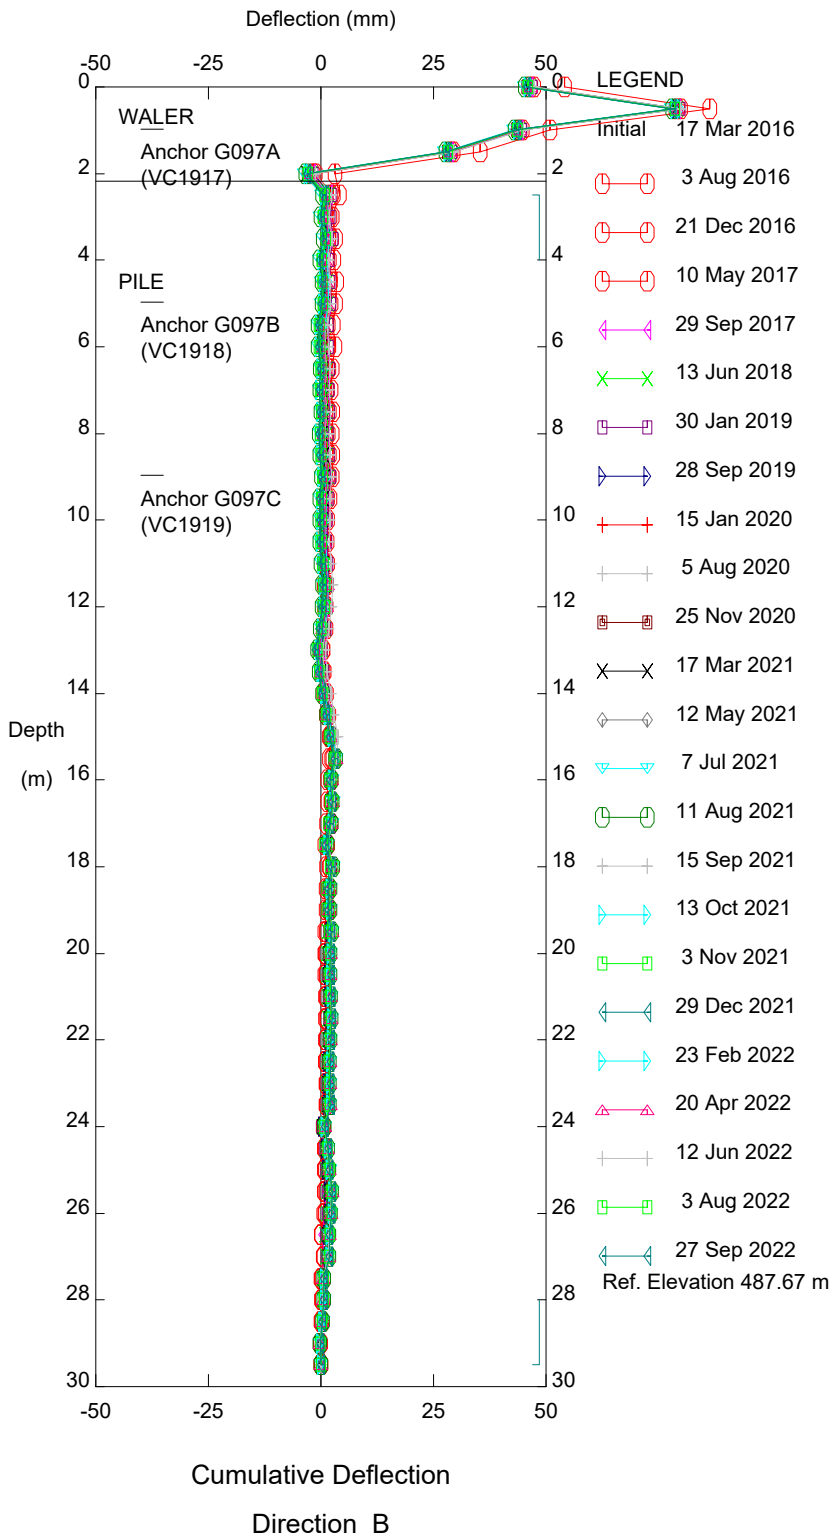
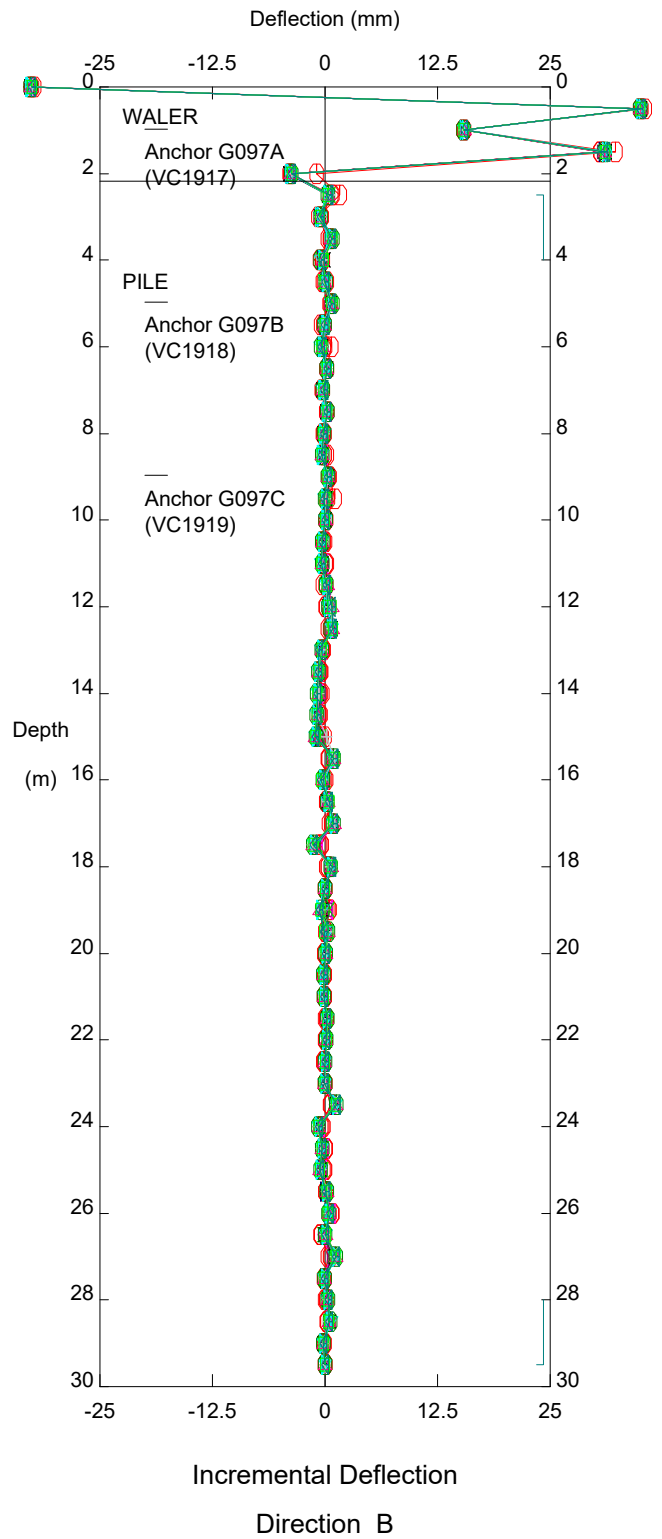
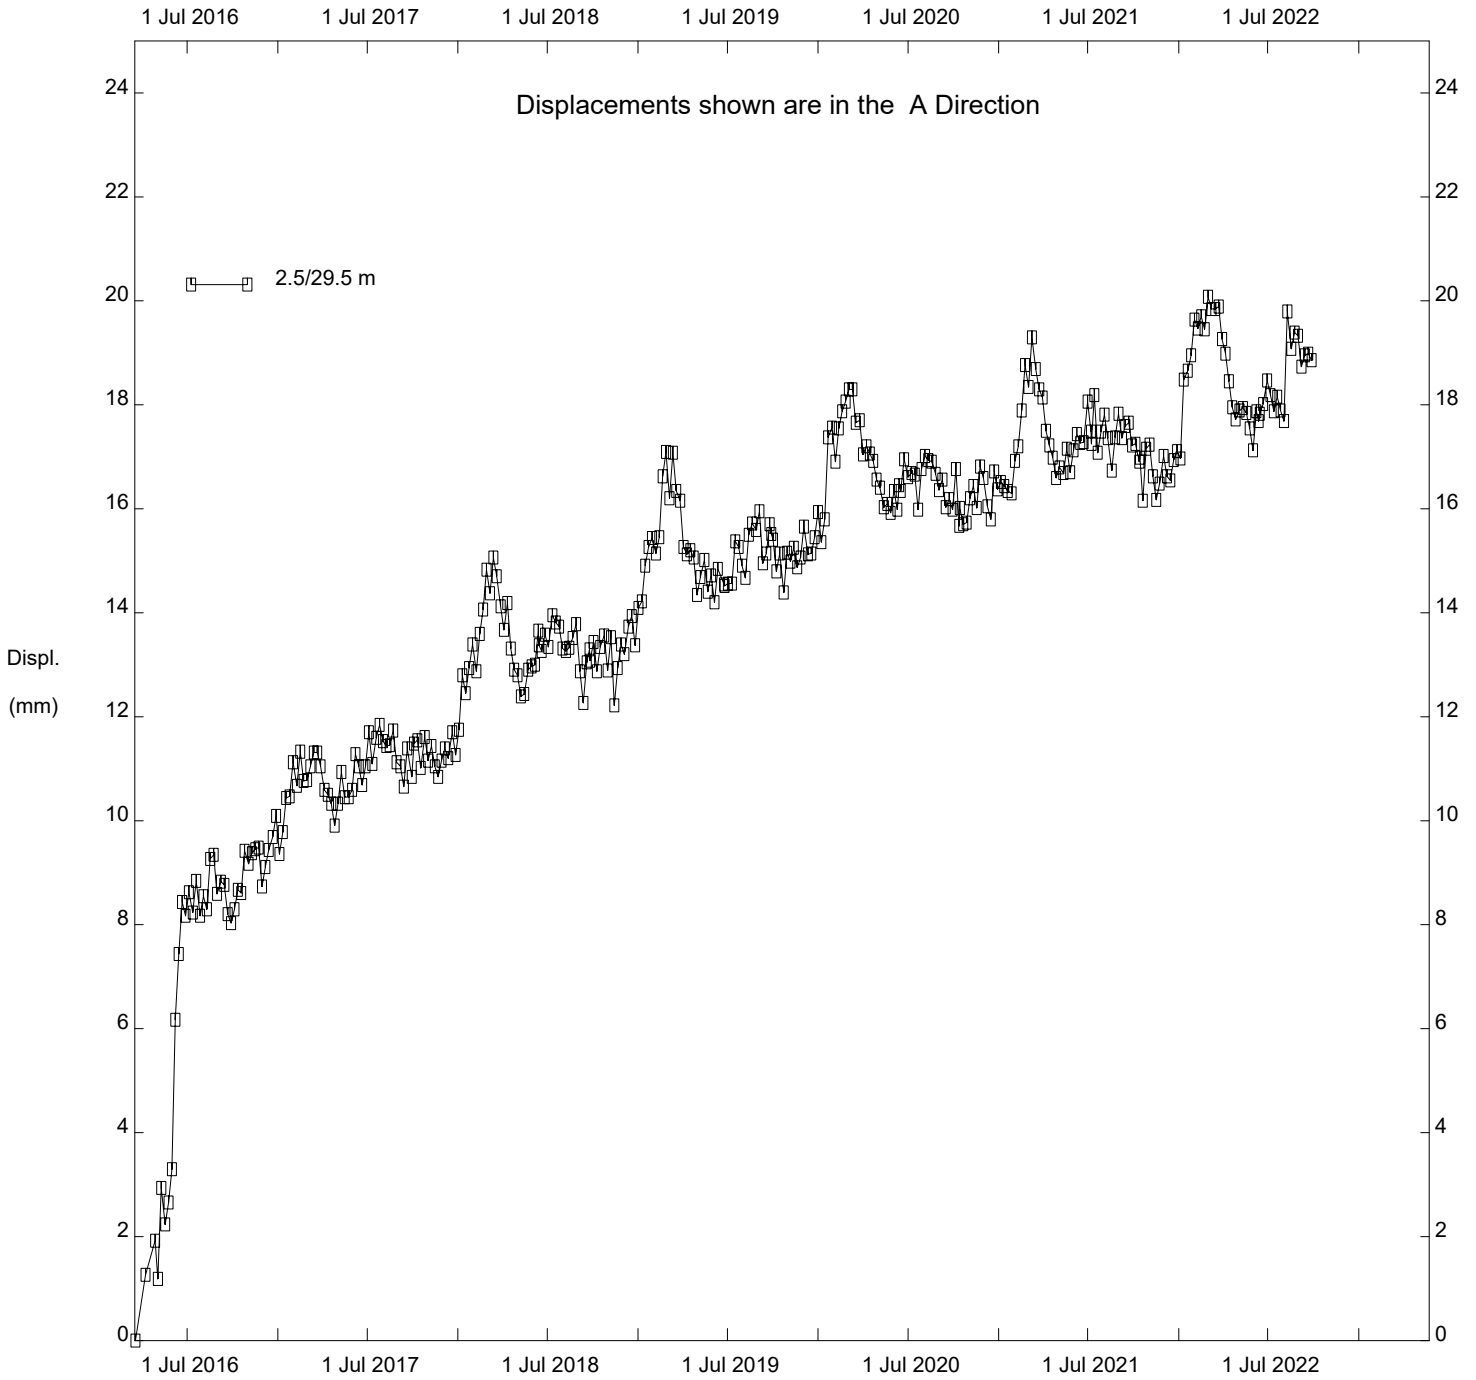
Hwy 986:01 Daishowa West, Inclinator SAA-P097

SAA-P097 showed an average rate of movement of 4.0 mm/yr in the downslope direction over the length of the pile since the spring of 2022 readings. SAA-P097 has shown a total pile head deflection of 18.9 mm in the downslope direction to date. SAA-P097 has shown an overall trend of steady downslope movement, with peaks of higher downhill movement rates during the winter months.

The instruments should be read again in the spring of 2023. It is recommended to continue monitoring the deflections in the pile wall and the load cell readings to see if there are further increases in deflection or loads compared to the warning threshold values. If the deflections and or load cell readings continue to increase, it may become necessary to add additional anchors to the pile wall.

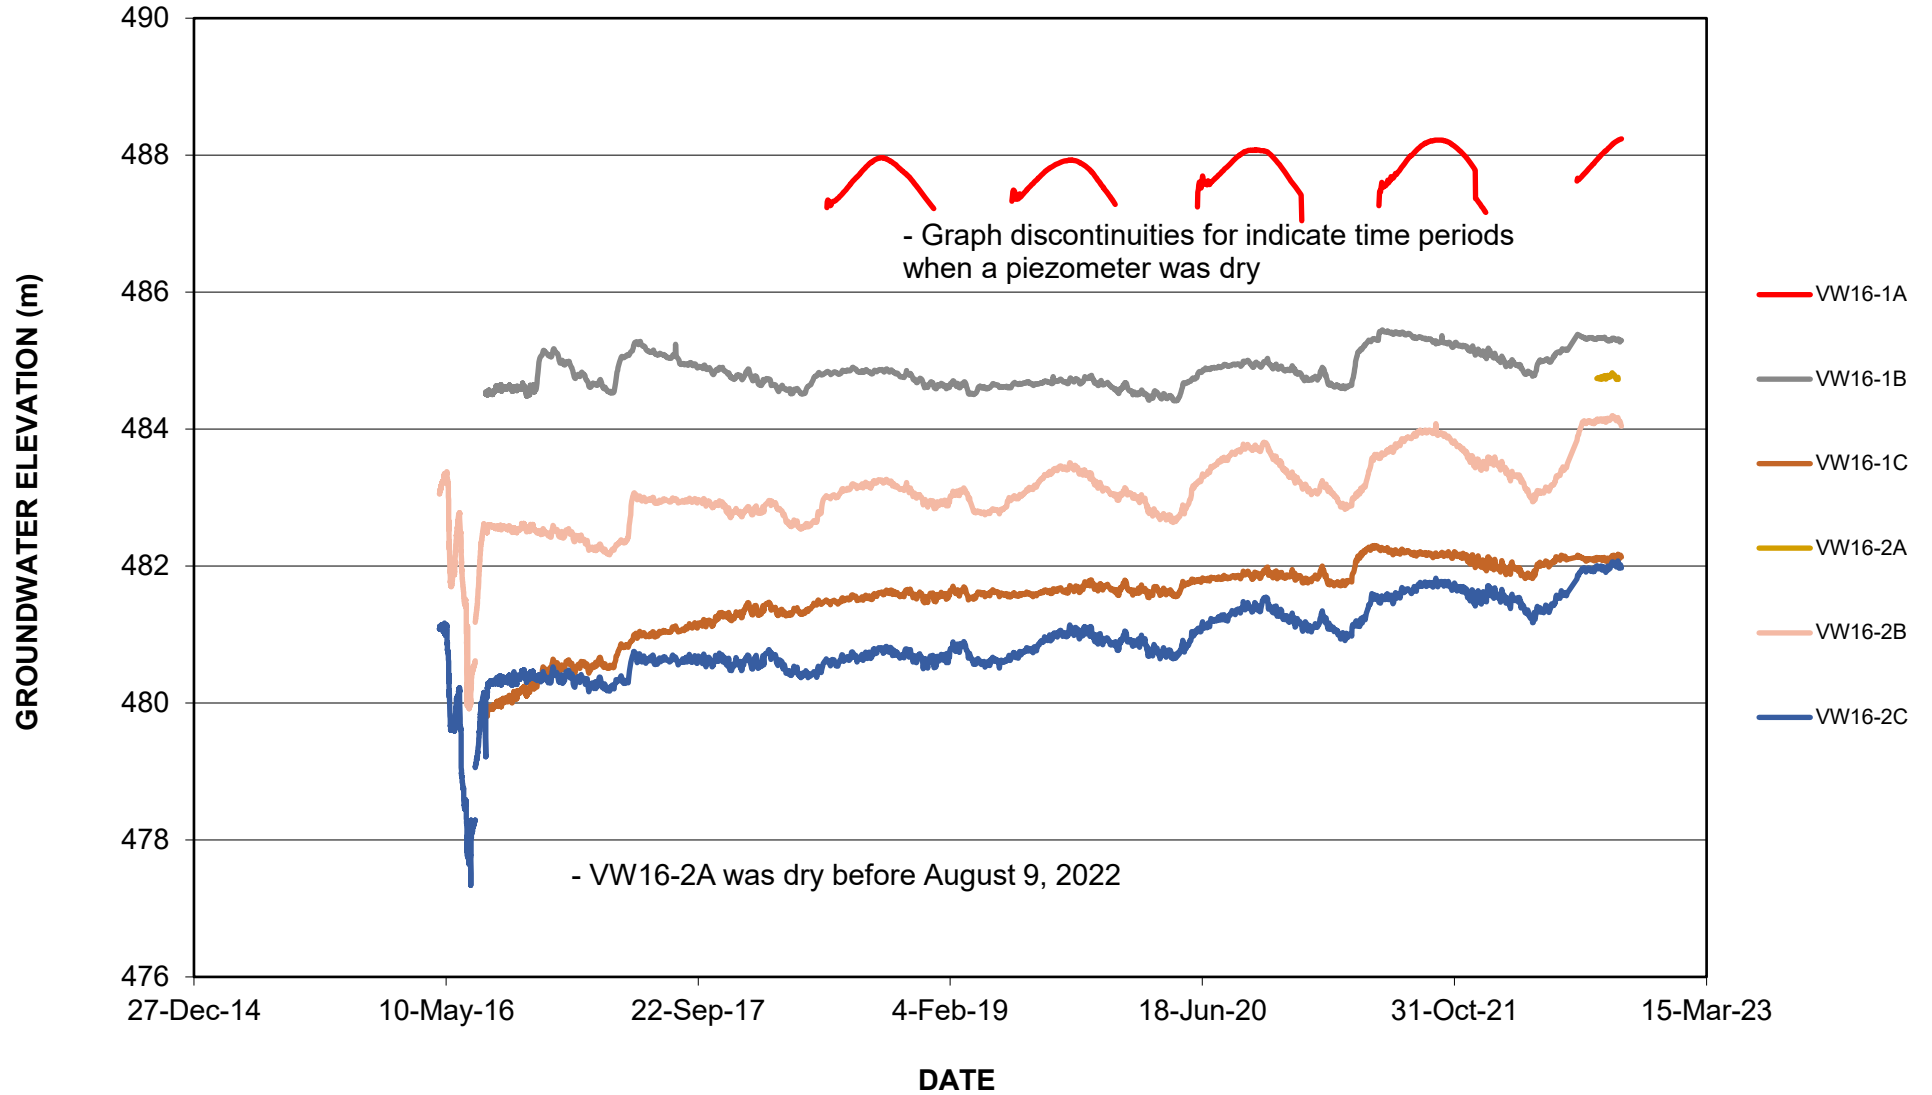
**FIGURE PH071-1  
PIEZOMETRIC ELEVATION FOR HWY 986:01, DAISHOWA WEST HILL  
(UPSLOPE PIEZOMETERS)**

Vibrating wire piezometers VW16-1B, VW16-1C, VW16-2B, VW16-2C, VW16-3A and VW16-3B showed increases in groundwater level of 0.14 m, 0.03 m, 0.54 m, 0.36 m, 0.02 m, and 0.05 m, respectively, since the spring of 2022 readings. VW16-1A, VW16-2B and VW16-2C registered all-time high groundwater levels during September 2022. VW16-1A showed a groundwater elevation of 488.24 m, after having been dry during the spring of 2022 readings, indicating that the groundwater level increased by at least 1.20 above the tip elevation since the spring readings. VW16-2A had previously been dry since initialization, however it showed a groundwater level above the tip depth for a period between August 9, 2022 and September 21, 2022. The highest groundwater level measured in VW16-2A was 0.09 m above the piezometer tip on September 9, 2022. VW16-4A and VW16-5A were both dry during the current readings.

VW16-1A appears to follow an overall cyclical pattern, with groundwater levels registered above the tip elevation each year from late spring to early winter, while for the rest of the year the groundwater level remains below the tip. VW16-1B and VW16-3A appear to show stable overall groundwater levels for the past several years. VW16-1C, VW16-2B and VW16-2C appear to show an overall trend of slowly increasing groundwater levels over time. VW16-3B shows an unusual oscillating reading pattern, which might indicate that the instrument is damaged. VW16-4A and VW16-5A tend to remain dry except for brief periods that correspond to either higher than normal rainfall or spring thaw. The vibrating wire piezometer readings are summarized in Table PH071-4. The readings for VW16-1A, VW16-1B, VW16-1C, VW16-2A, VW16-2B and VW16-2C are plotted on Figure PH071-1 in Appendix A. The readings for VW16-3A, VW16-3B, VW16-4A, VW16-4B, and VW16-5A are plotted on Figure PH071-2 in Appendix A.

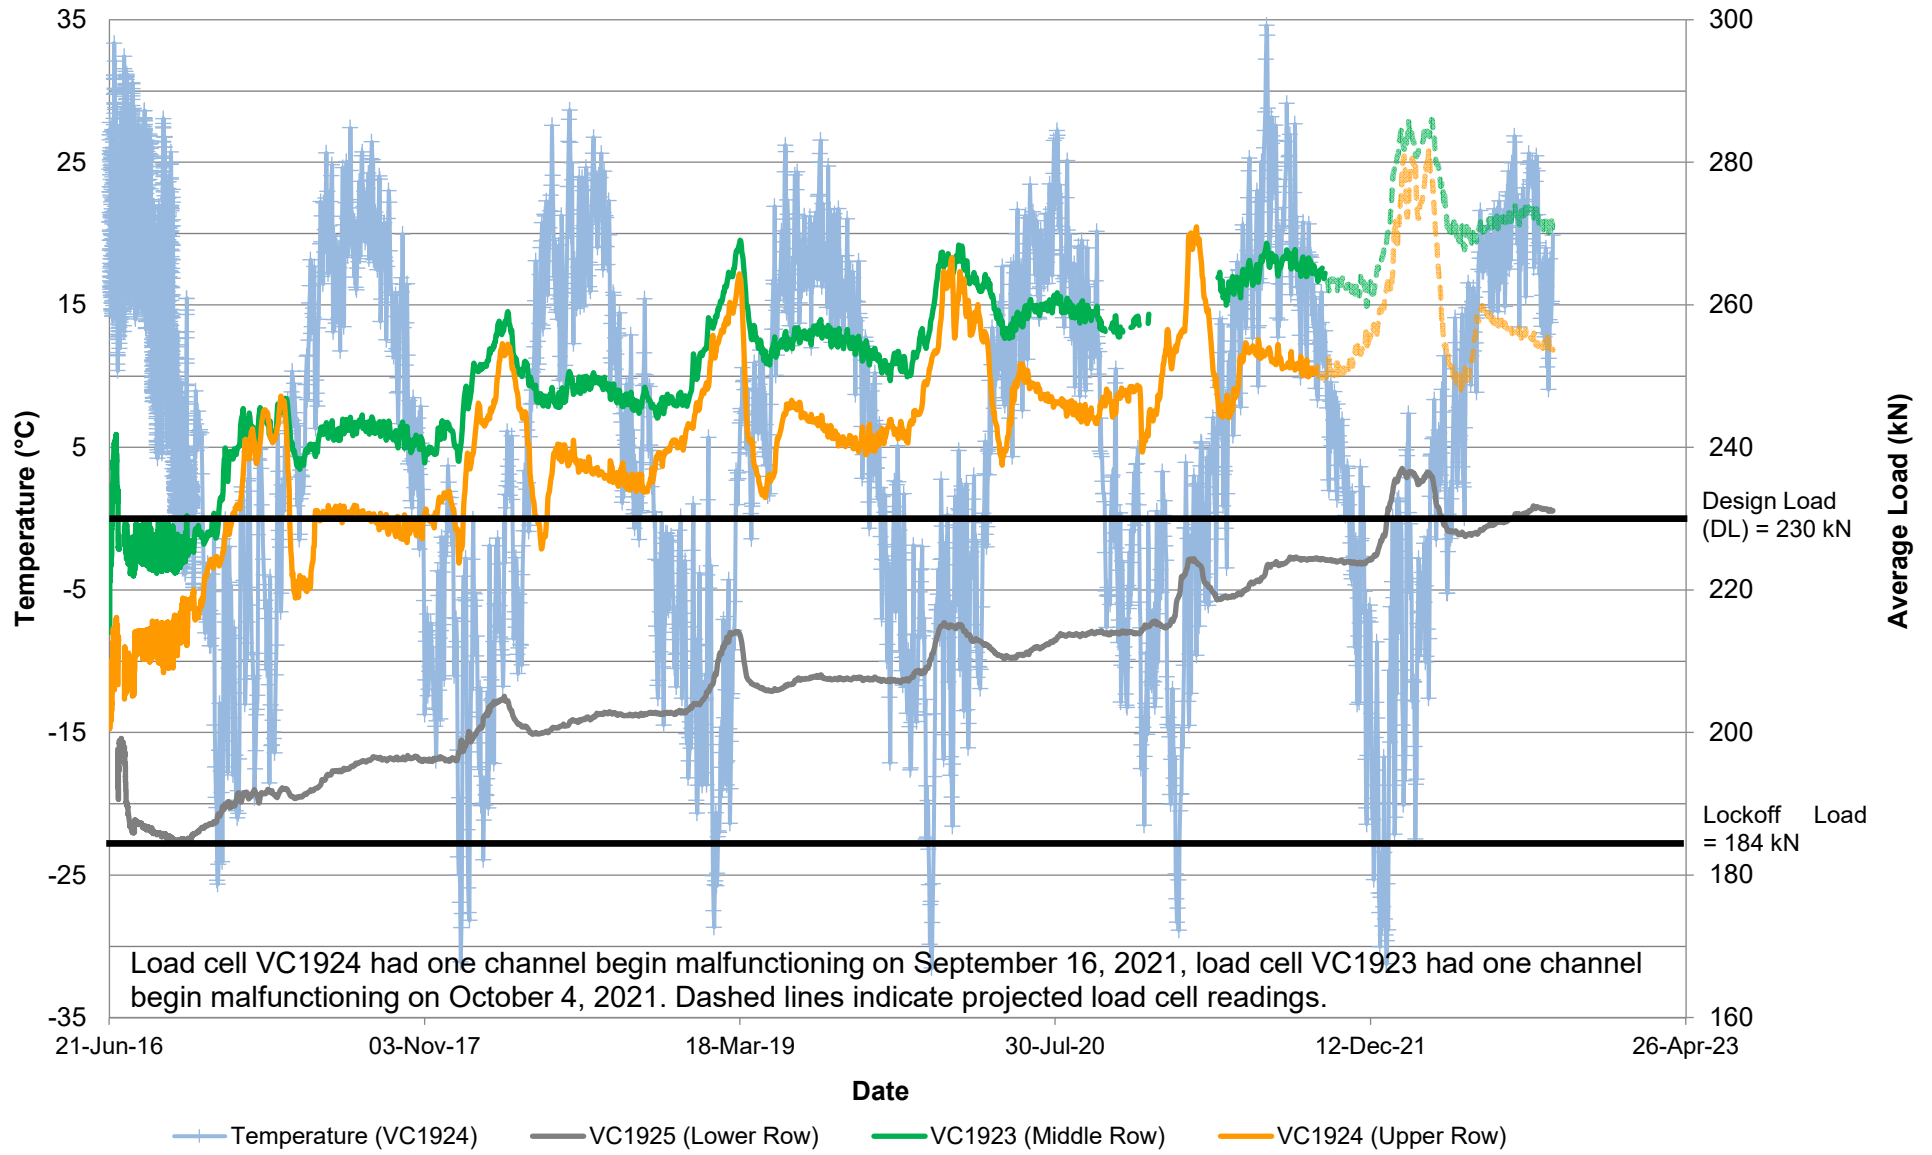
**FIGURE PH071-3  
LOAD CELL DATA FOR HWY 986:01, DAISHOWA WEST (PILE P022)**

The load cells generally showed a mix of small increases and decreases in measured load compared to the spring of 2022 readings, ranging from a decrease of 7.79 kN in VC1917 (anchor P097A) to an increase of 2.33 kN in VC1925 (anchor P022C). It should be noted that load cells VC1924 (anchor P022A), VC1923 (anchor P022B) and VC1918 (anchor P097B) have each lost the function of one vibrating wire channel. The loads that are now reported for these three load cells are based on the average of the two functional channels and projecting a reading for the now malfunctioning channel based on the last reading taken for that channel and the changes observed in the two functional channels since that time.

Since the end of construction, the load cells have generally shown an overall trend of increasing load, with the highest seasonal loads measured towards the end of each winter. The current loads measured in the upper two anchor rows at all three piles, as well as the lower row at P022, are above the design loads. The load cell readings are summarized in Table PH071-5. The load cell readings for piles P022, P060 and P097 are plotted on Figures PH071-3, PH071-4, and PH071-5, respectively, in Appendix A.
