Site Number	Location	Name	Hwy	km
PH071	Hwy 986:01 C1 28.474	Daishowa West Hill	986:01	Km 28.5
Legal Description:		UTM Co-ordinates		
8-9-85-21 W5		11U E 485023	N	6245526

Current Monitoring:	24-Sep-2025 to 29-Oct-2025	Previous Monitoring	8-Jun-2025
Instruments Read By:	Mr. Niraj Regmi, G.I.T and Mr. Angelo Castillo, of Thurber

**ALBERTA TRANSPORTATION AND ECONOMIC CORRIDORS GRMP (CON0022164)
PEACE REGION (PEACE RIVER DISTRICT)
INSTRUMENTATION MONITORING RESULTS**

SITE PH071: HWY 986:01, DAISHOWA WEST HILL

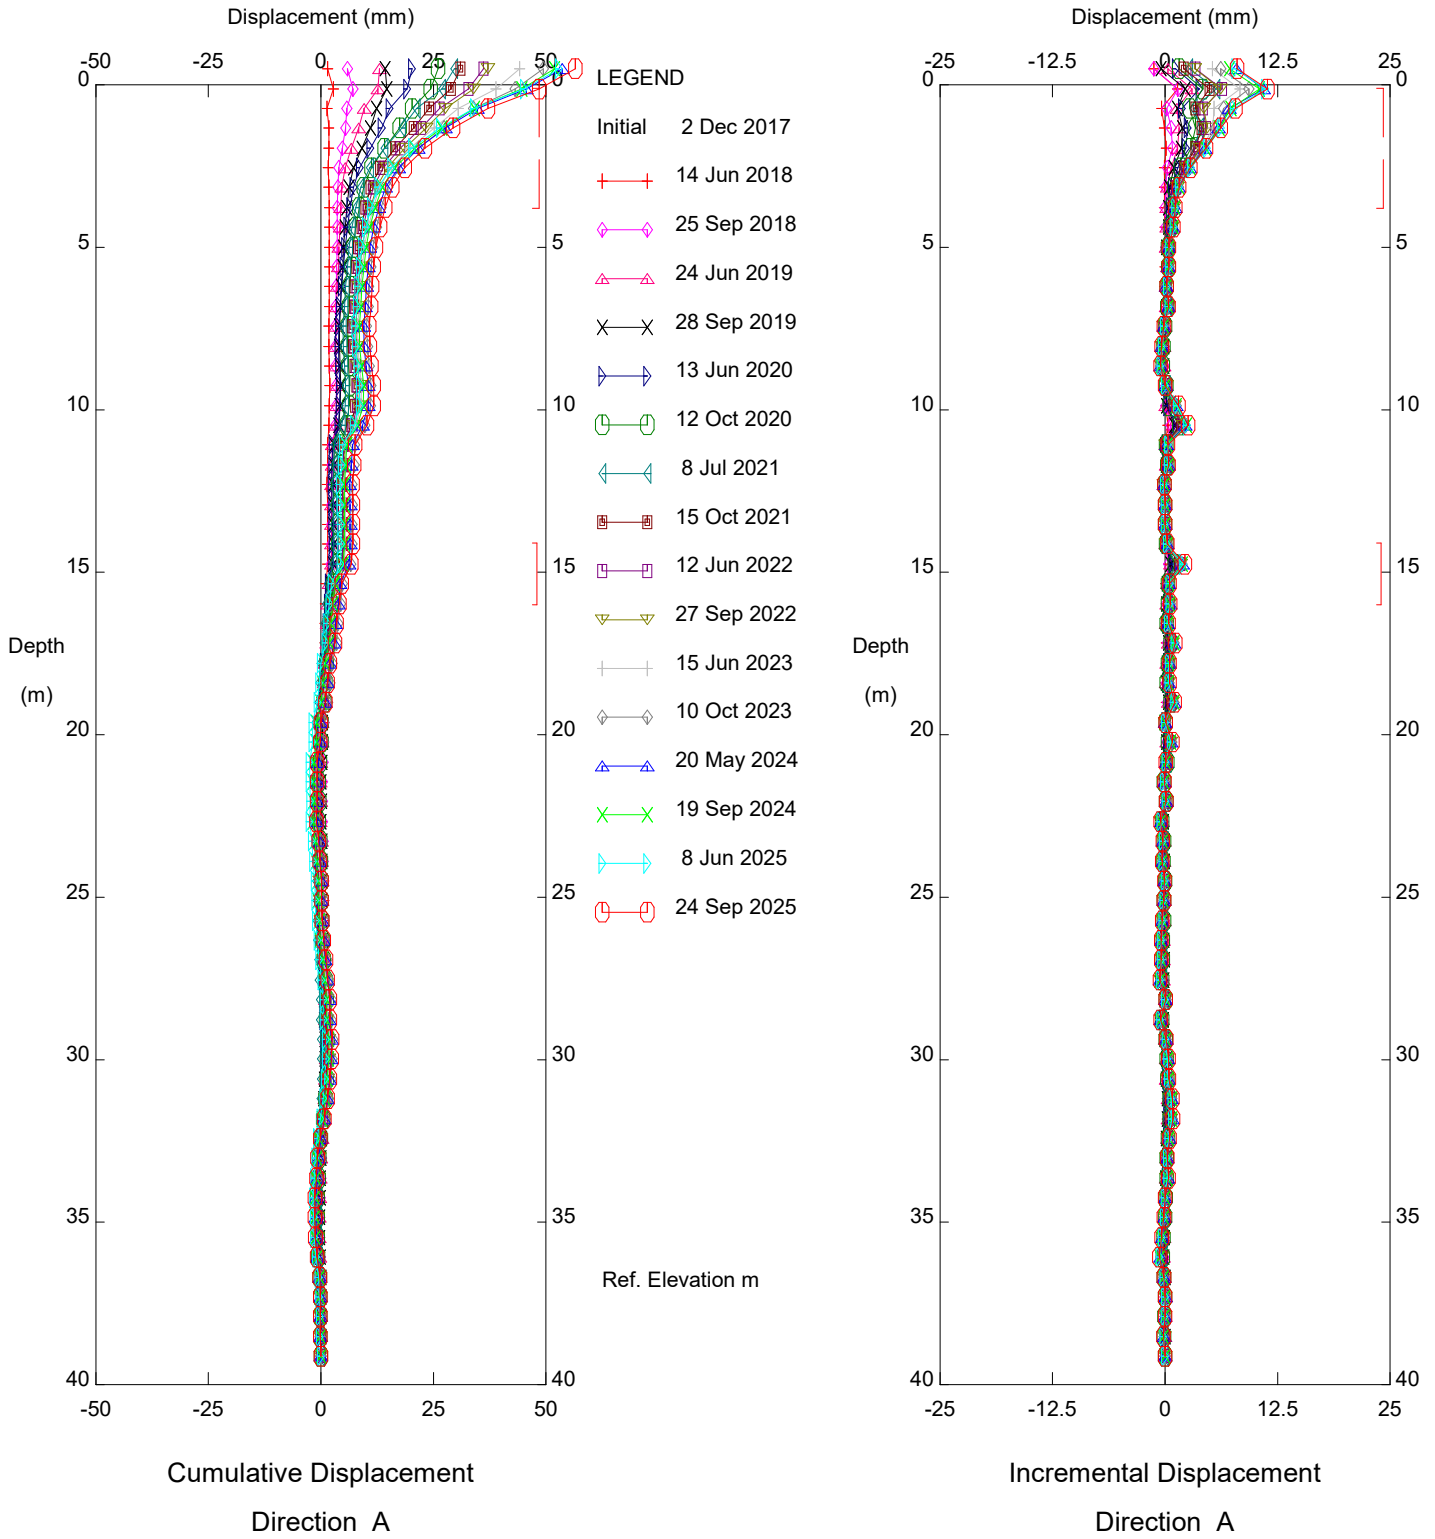
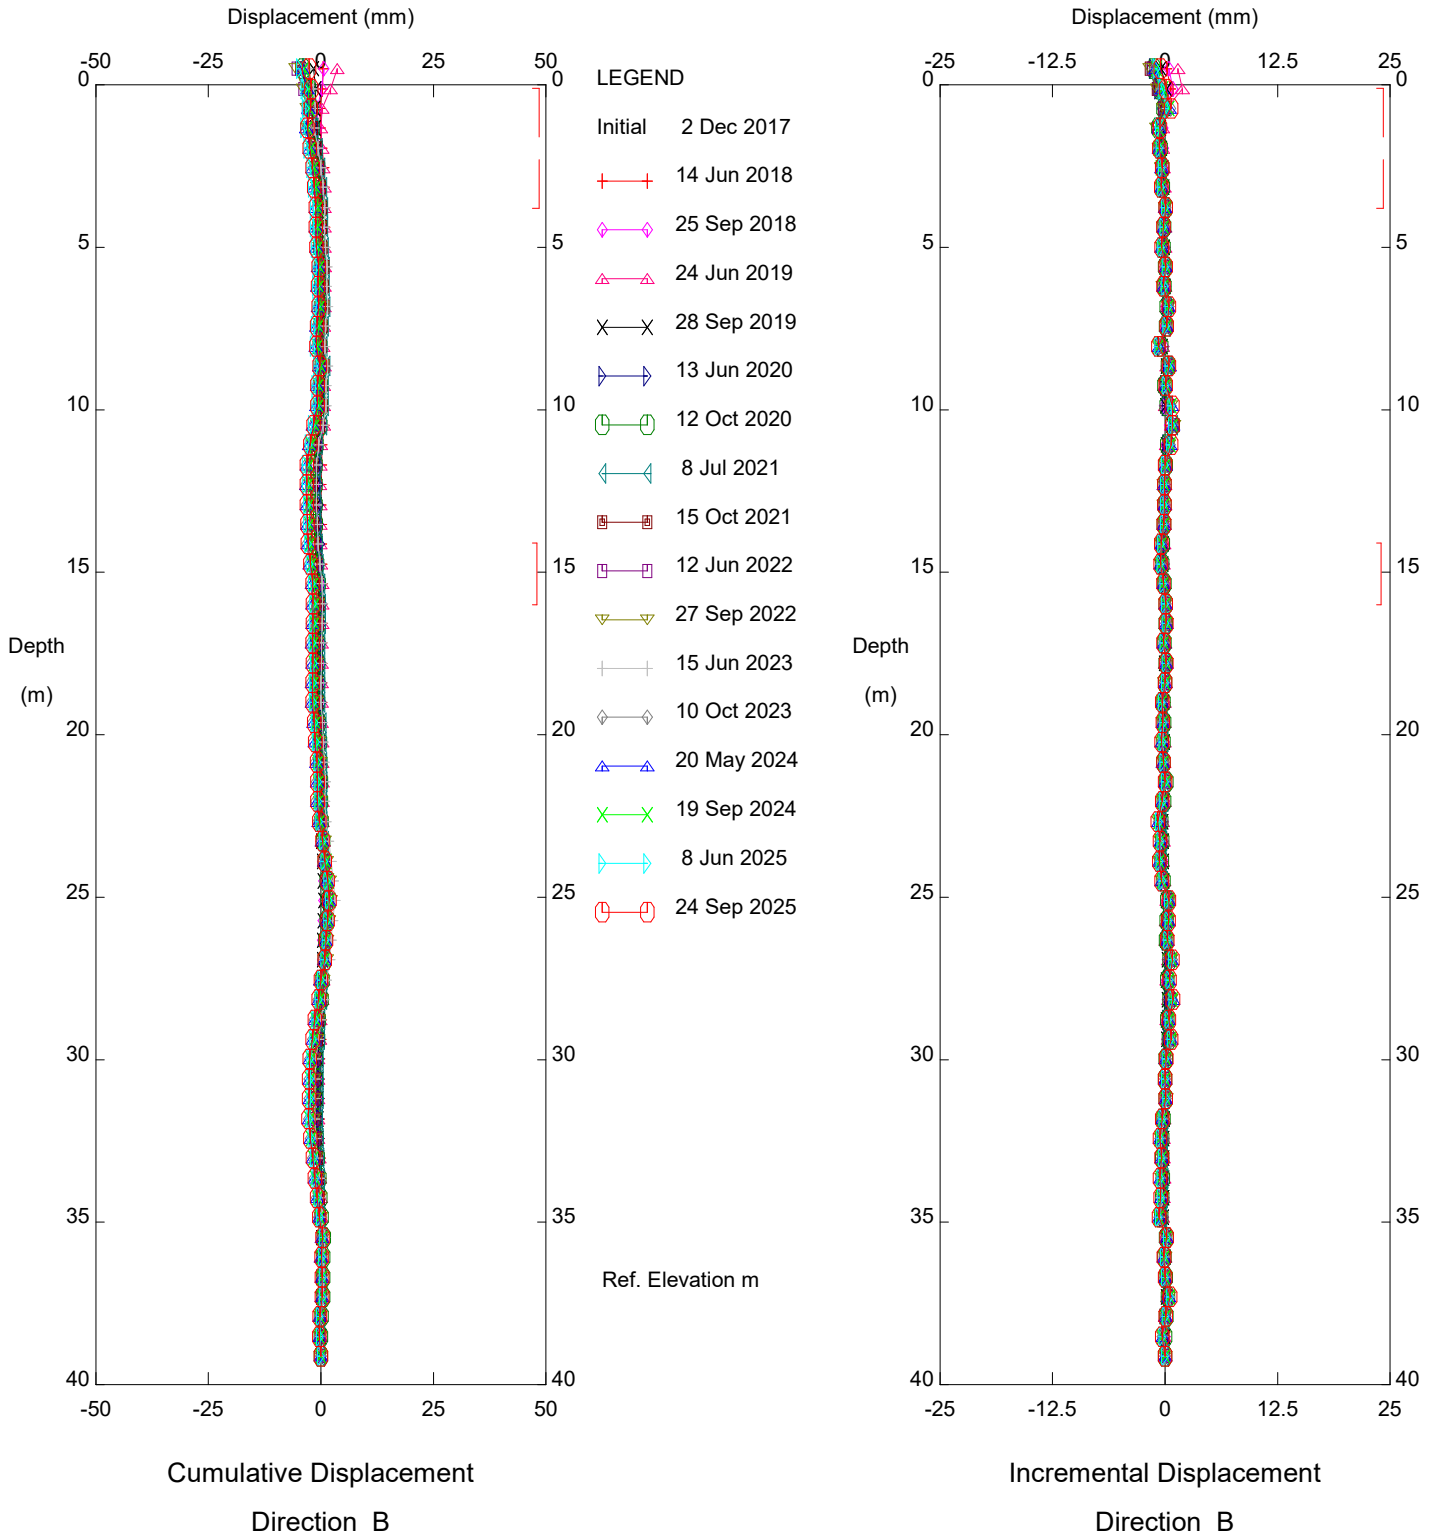
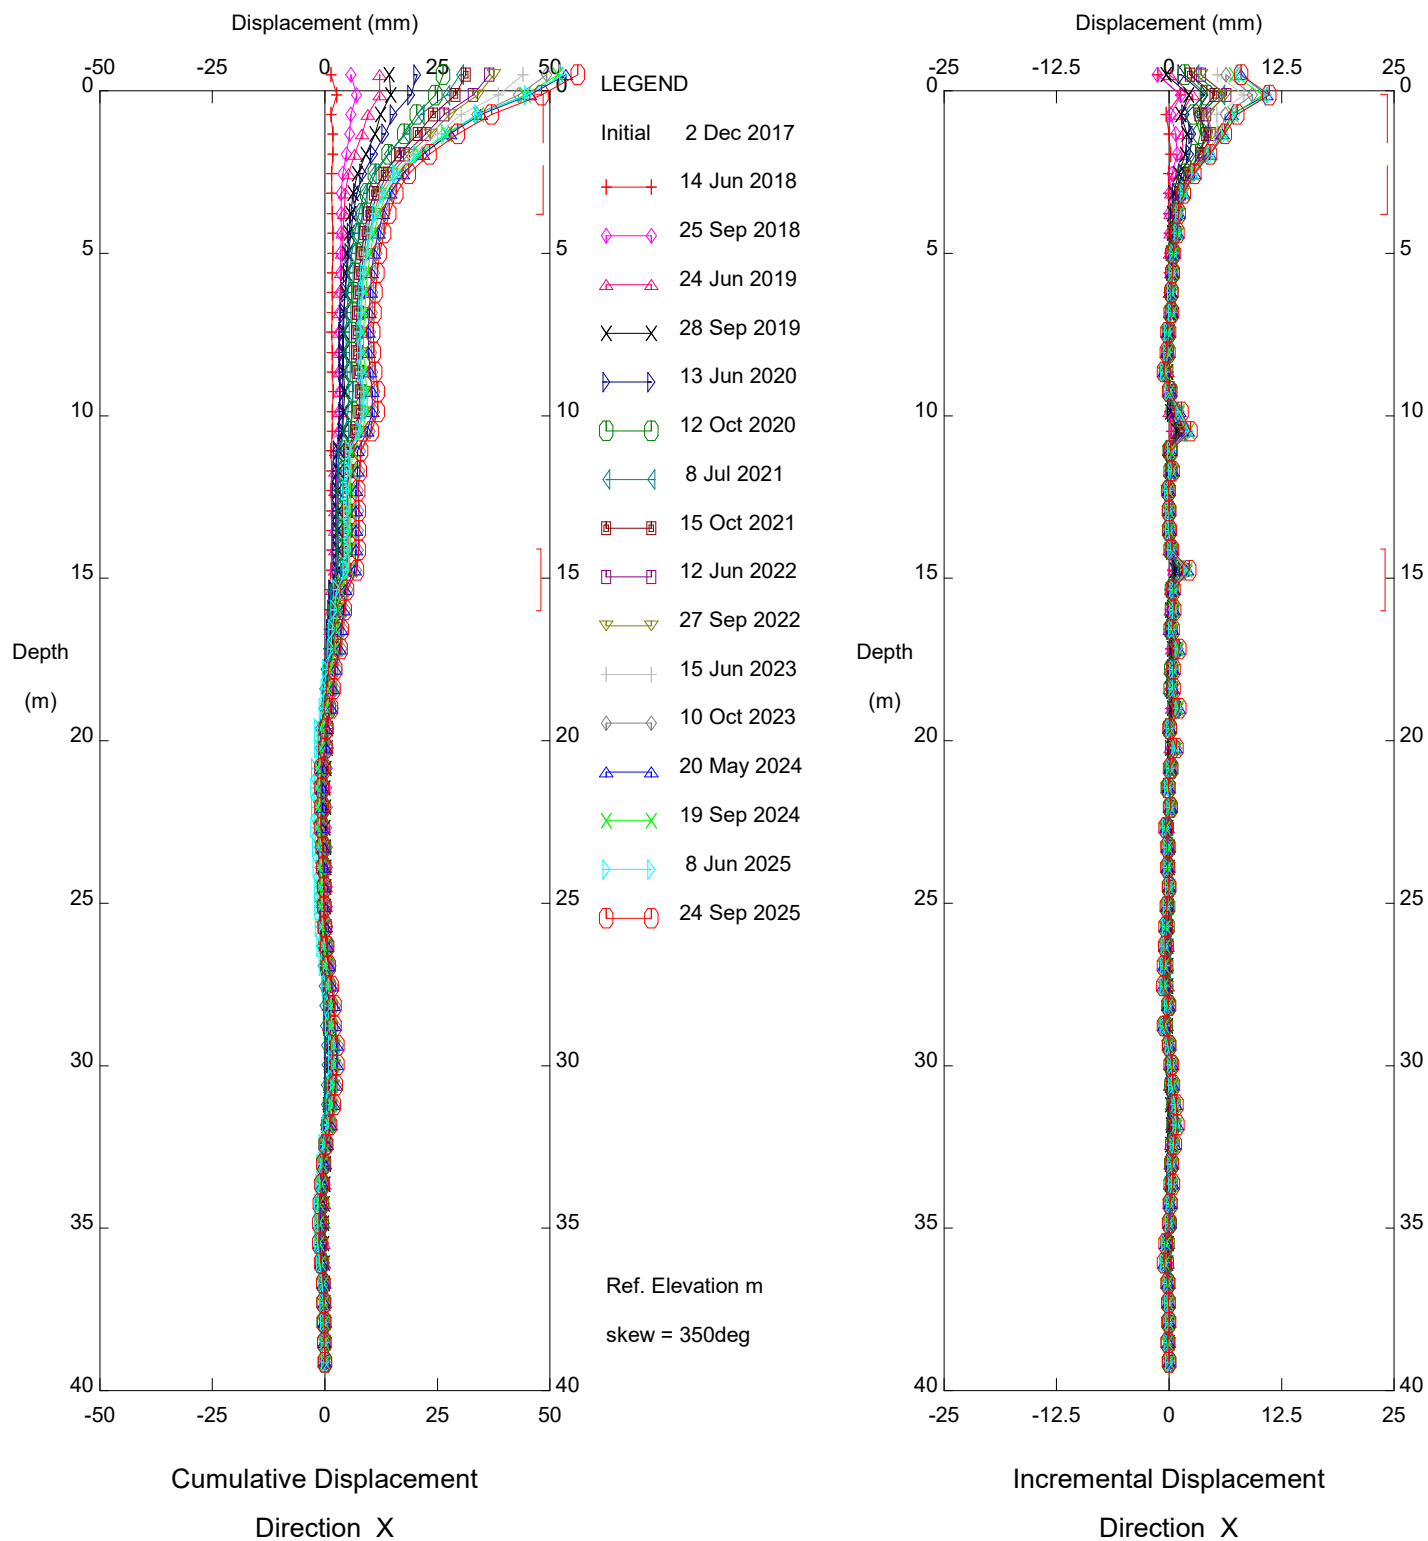
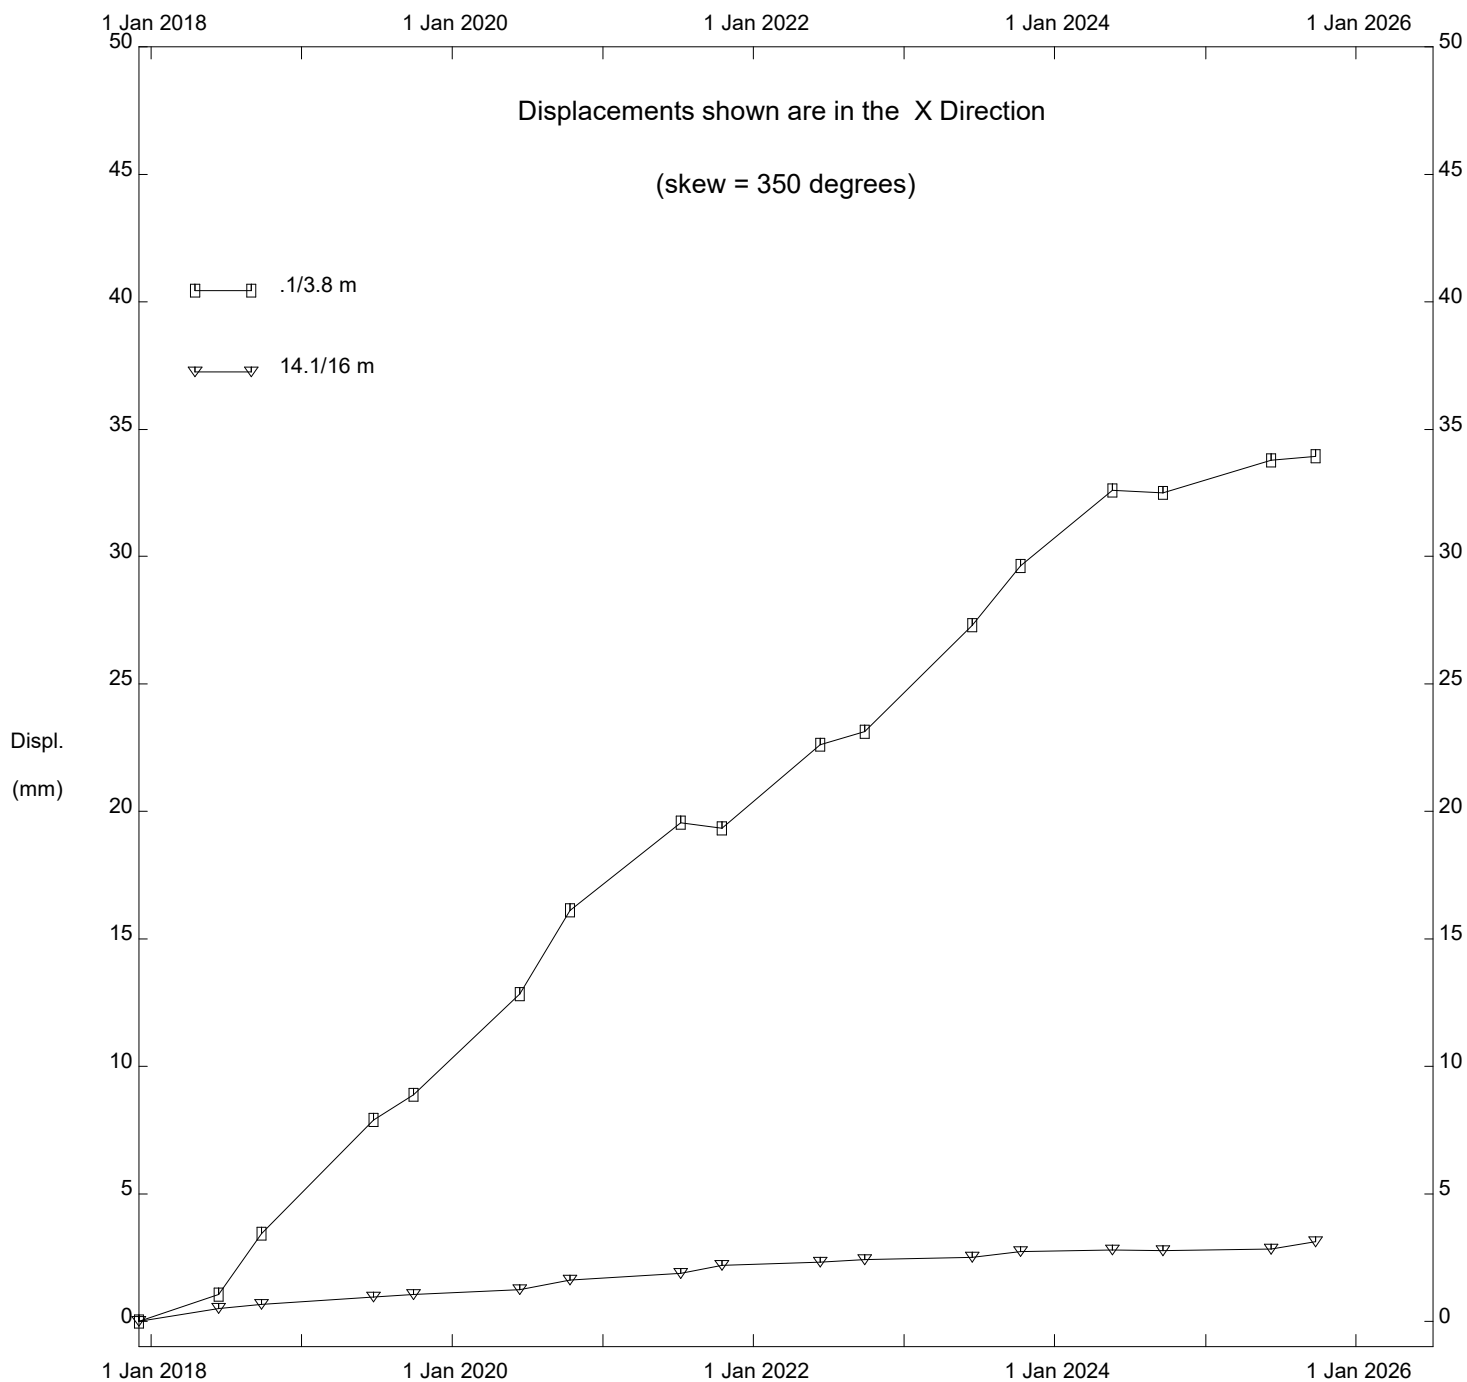
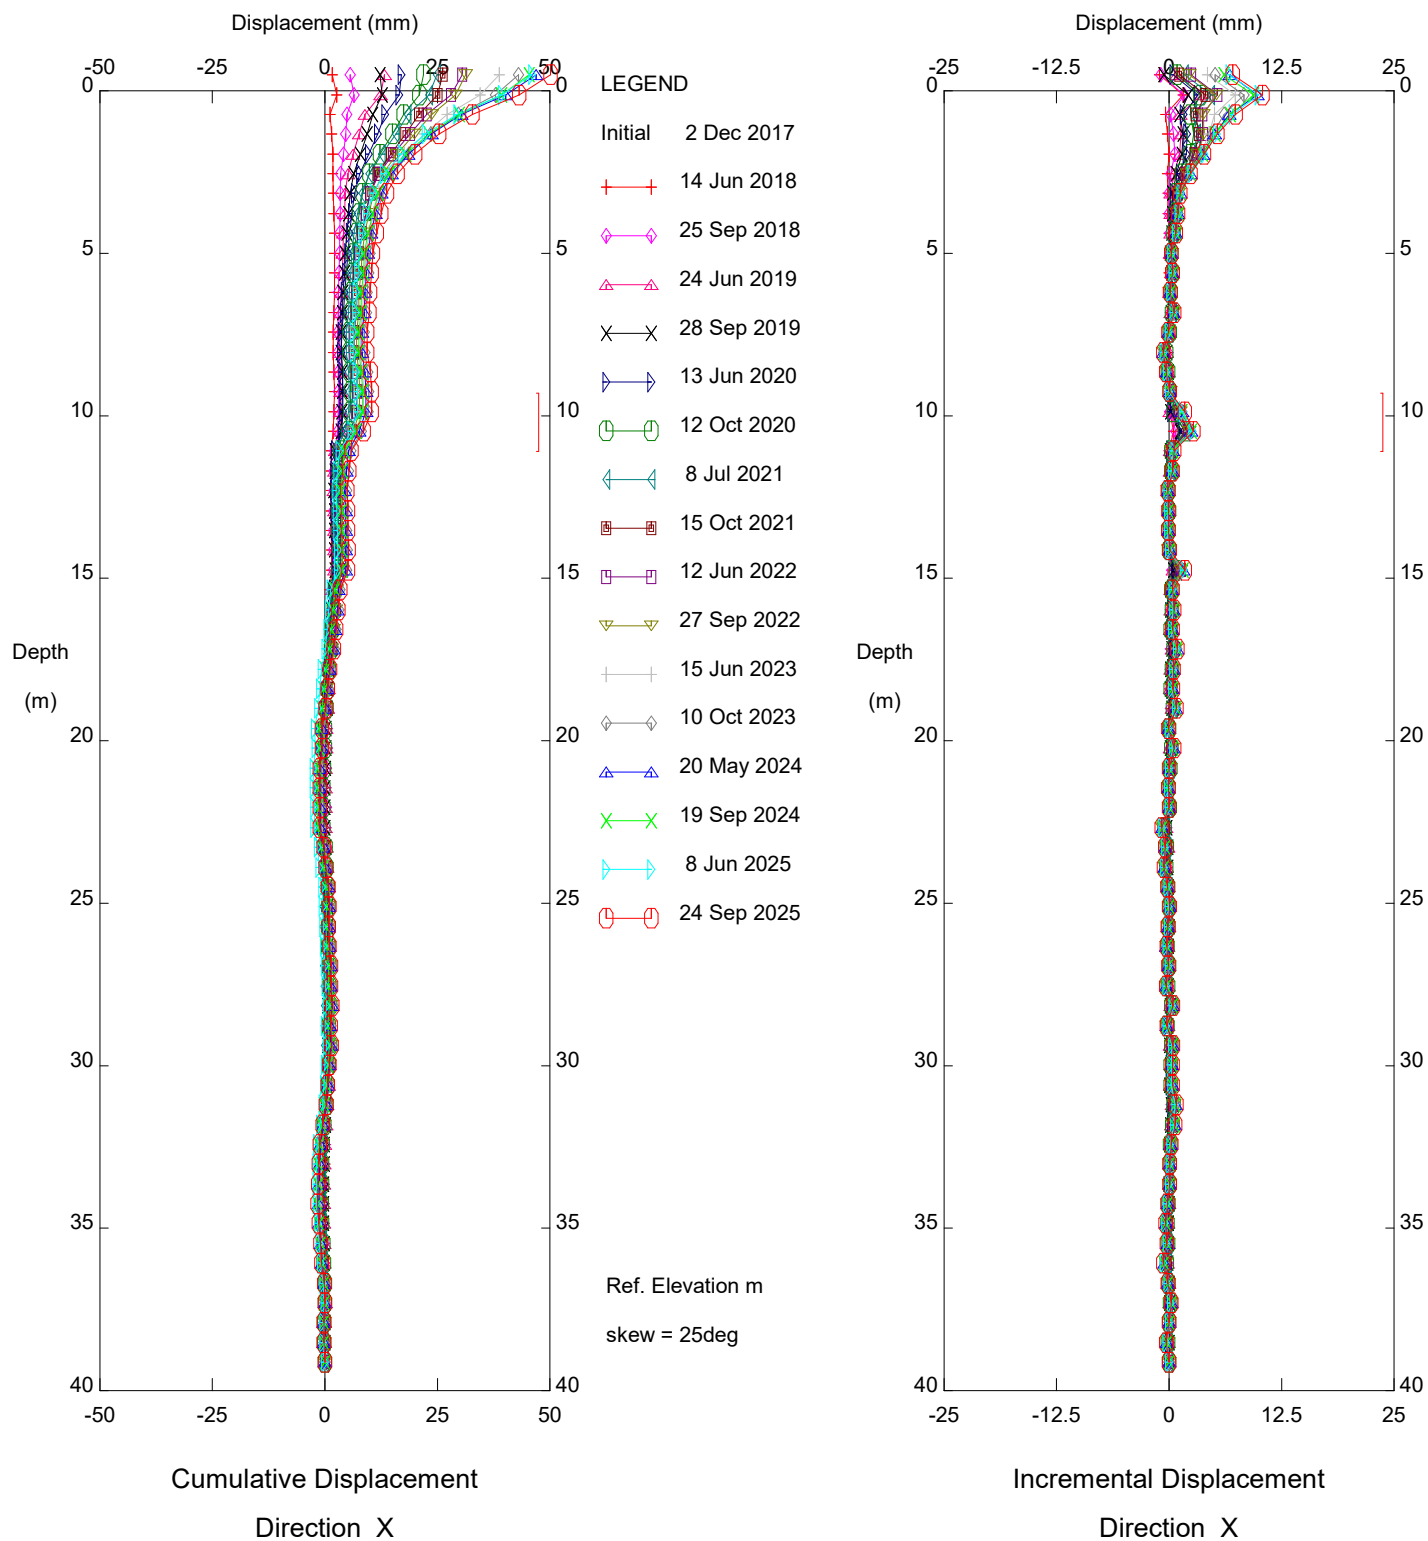
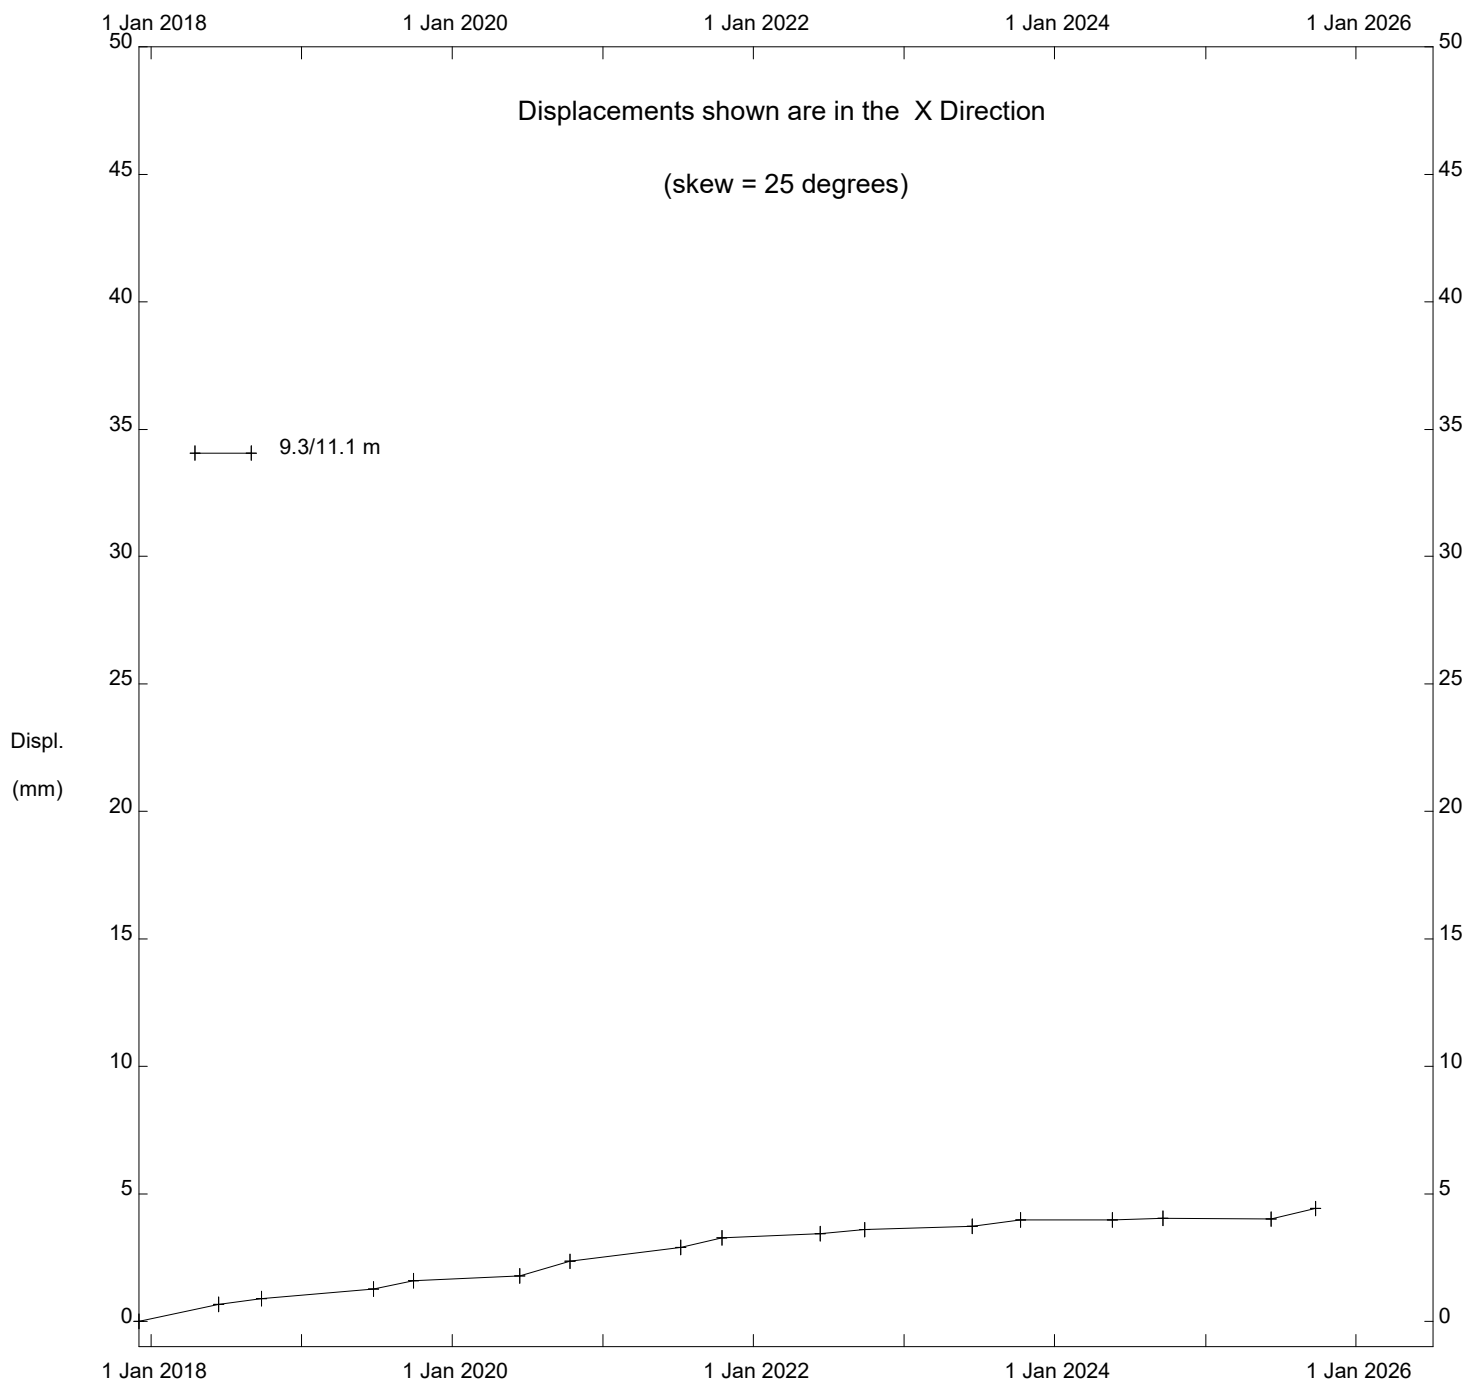
PH071 Daishowa West, Inclinometer SI16-3

Discussion	
Zones of New Movement:	None
Interpretation of Monitoring Results:	<p>Slope Inclinometers and SAAs</p> <p>SI16-3 is located 7 m downslope of the pile wall and has three movement zones. Rates of movement of 0.4 mm/yr over 0.1 m to 3.8 m depth, 1.4 mm/yr over 9.3 m to 11.1 m depth, and 0.9 mm/yr over 14.1 m to 16.0 m depth, were measured since the spring of 2025 readings. These movement rates are reduced from, or consistent with those observed over the past 3 years.</p> <p>SAA-P060 showed a rate of movement of 1.5 mm/yr over 2.5 m to 29.5 m depth, and 1.6 mm/yr over the full length of the pile and waler since the spring of 2025 readings. SAA-P060 has shown a cumulative pile head deflection of 18.8 mm to date in the downslope direction. SAA-P060 has shown an overall relatively steady rate of movement since the end of construction with a total incremental movement of about 6.8 mm in the downslope direction since</p>

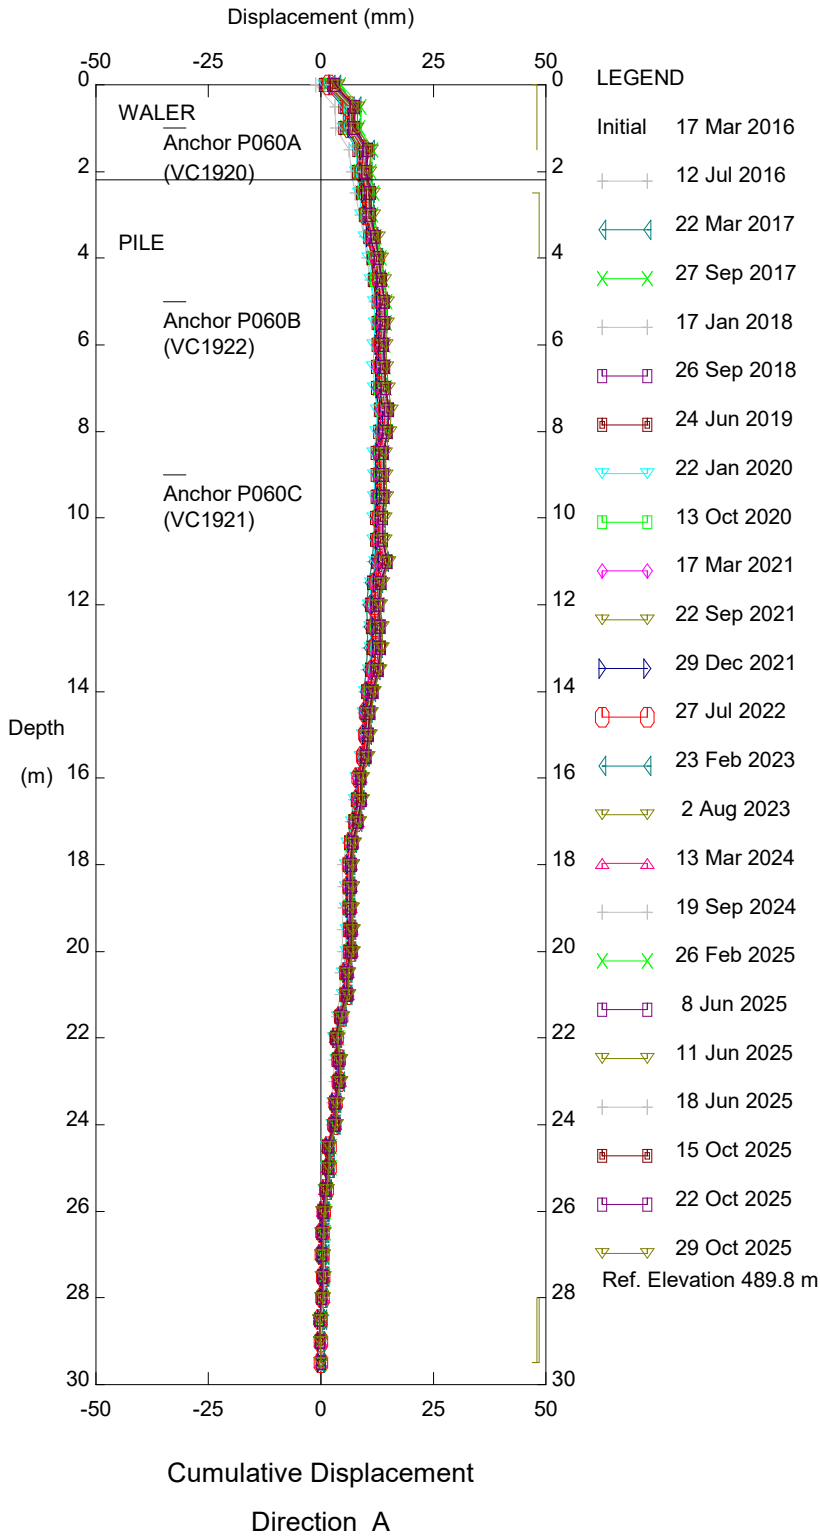
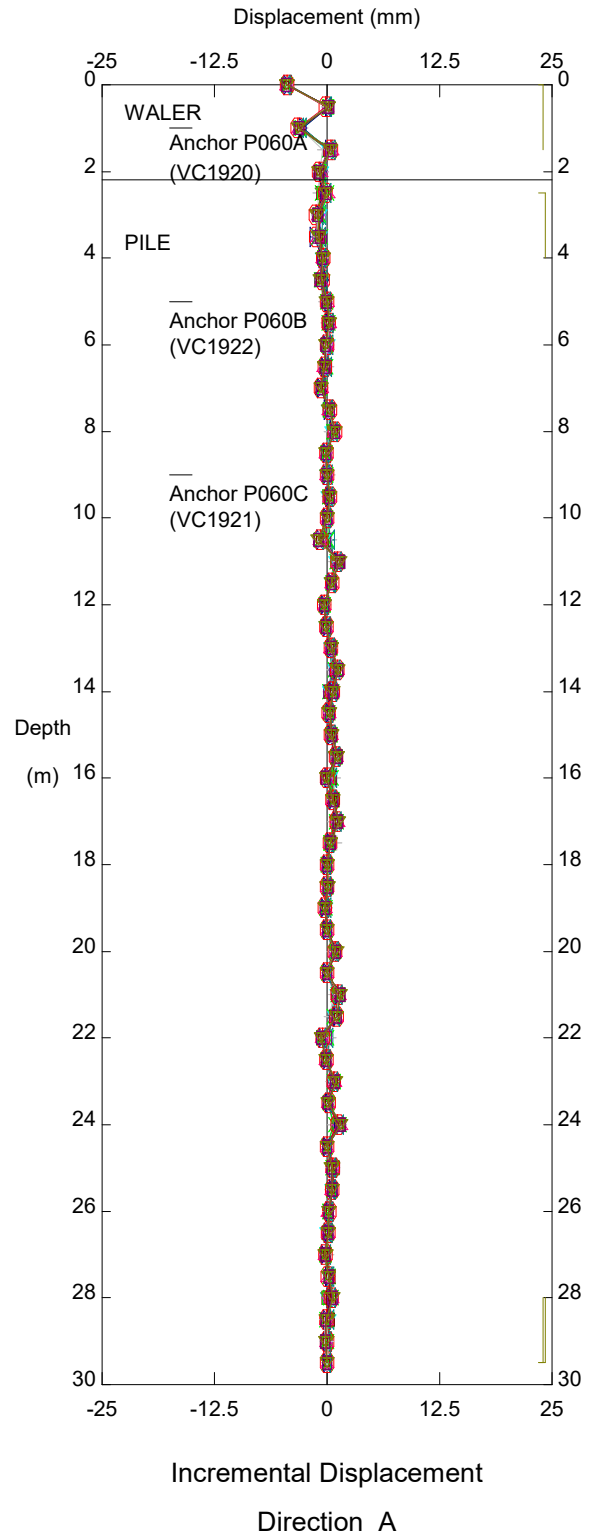
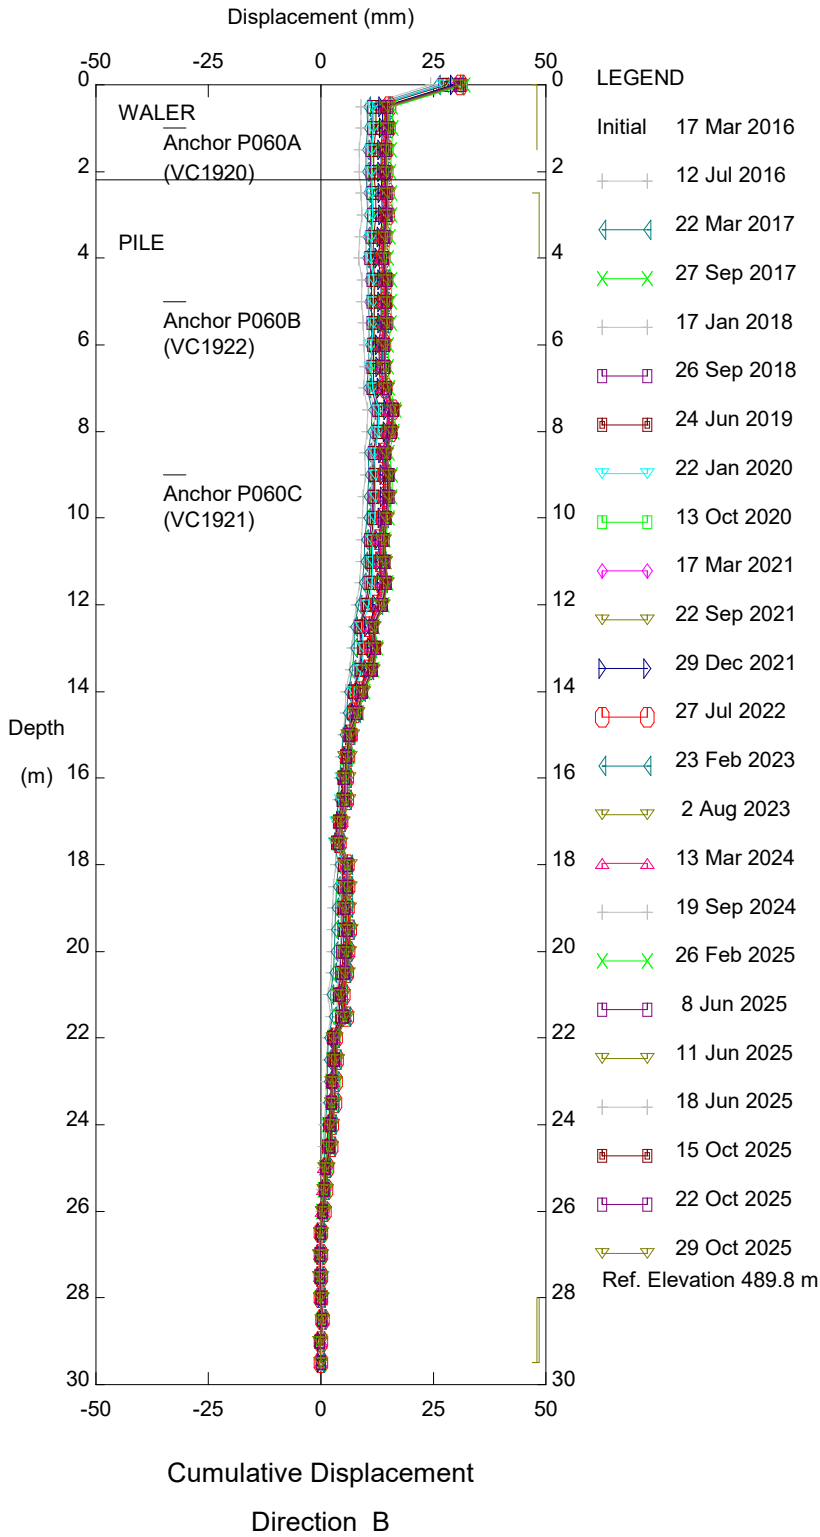
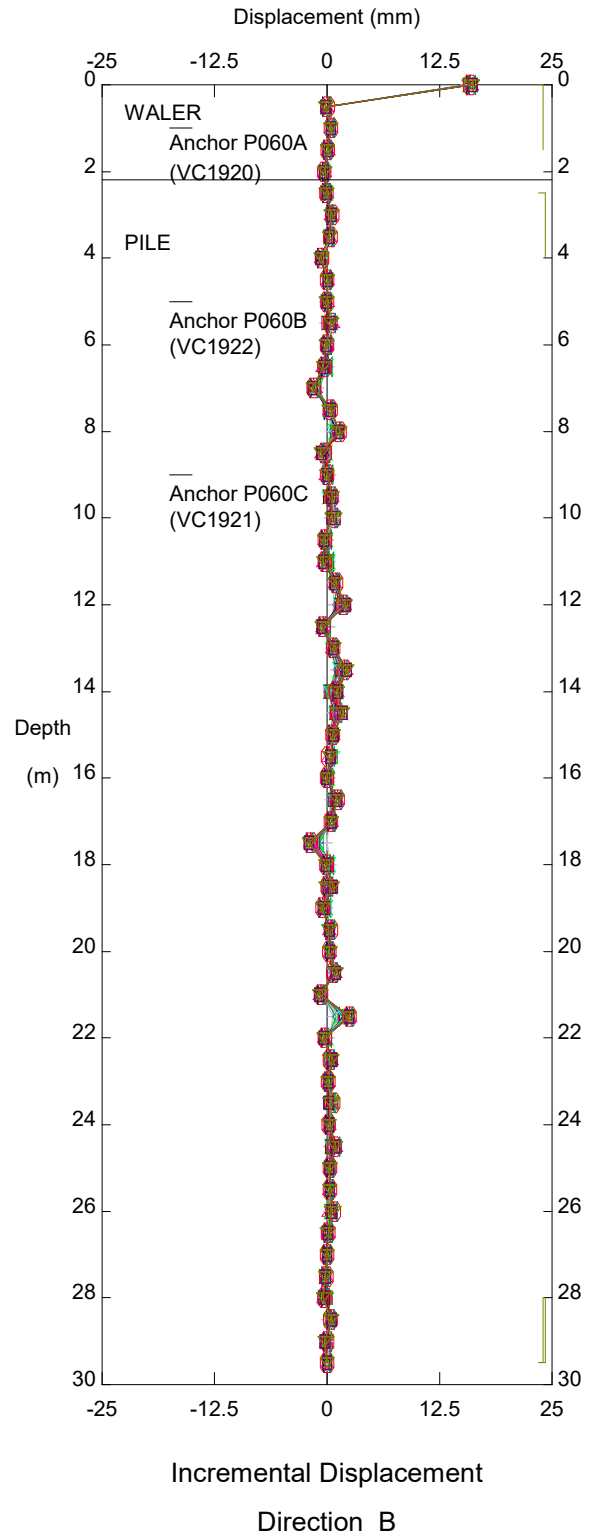
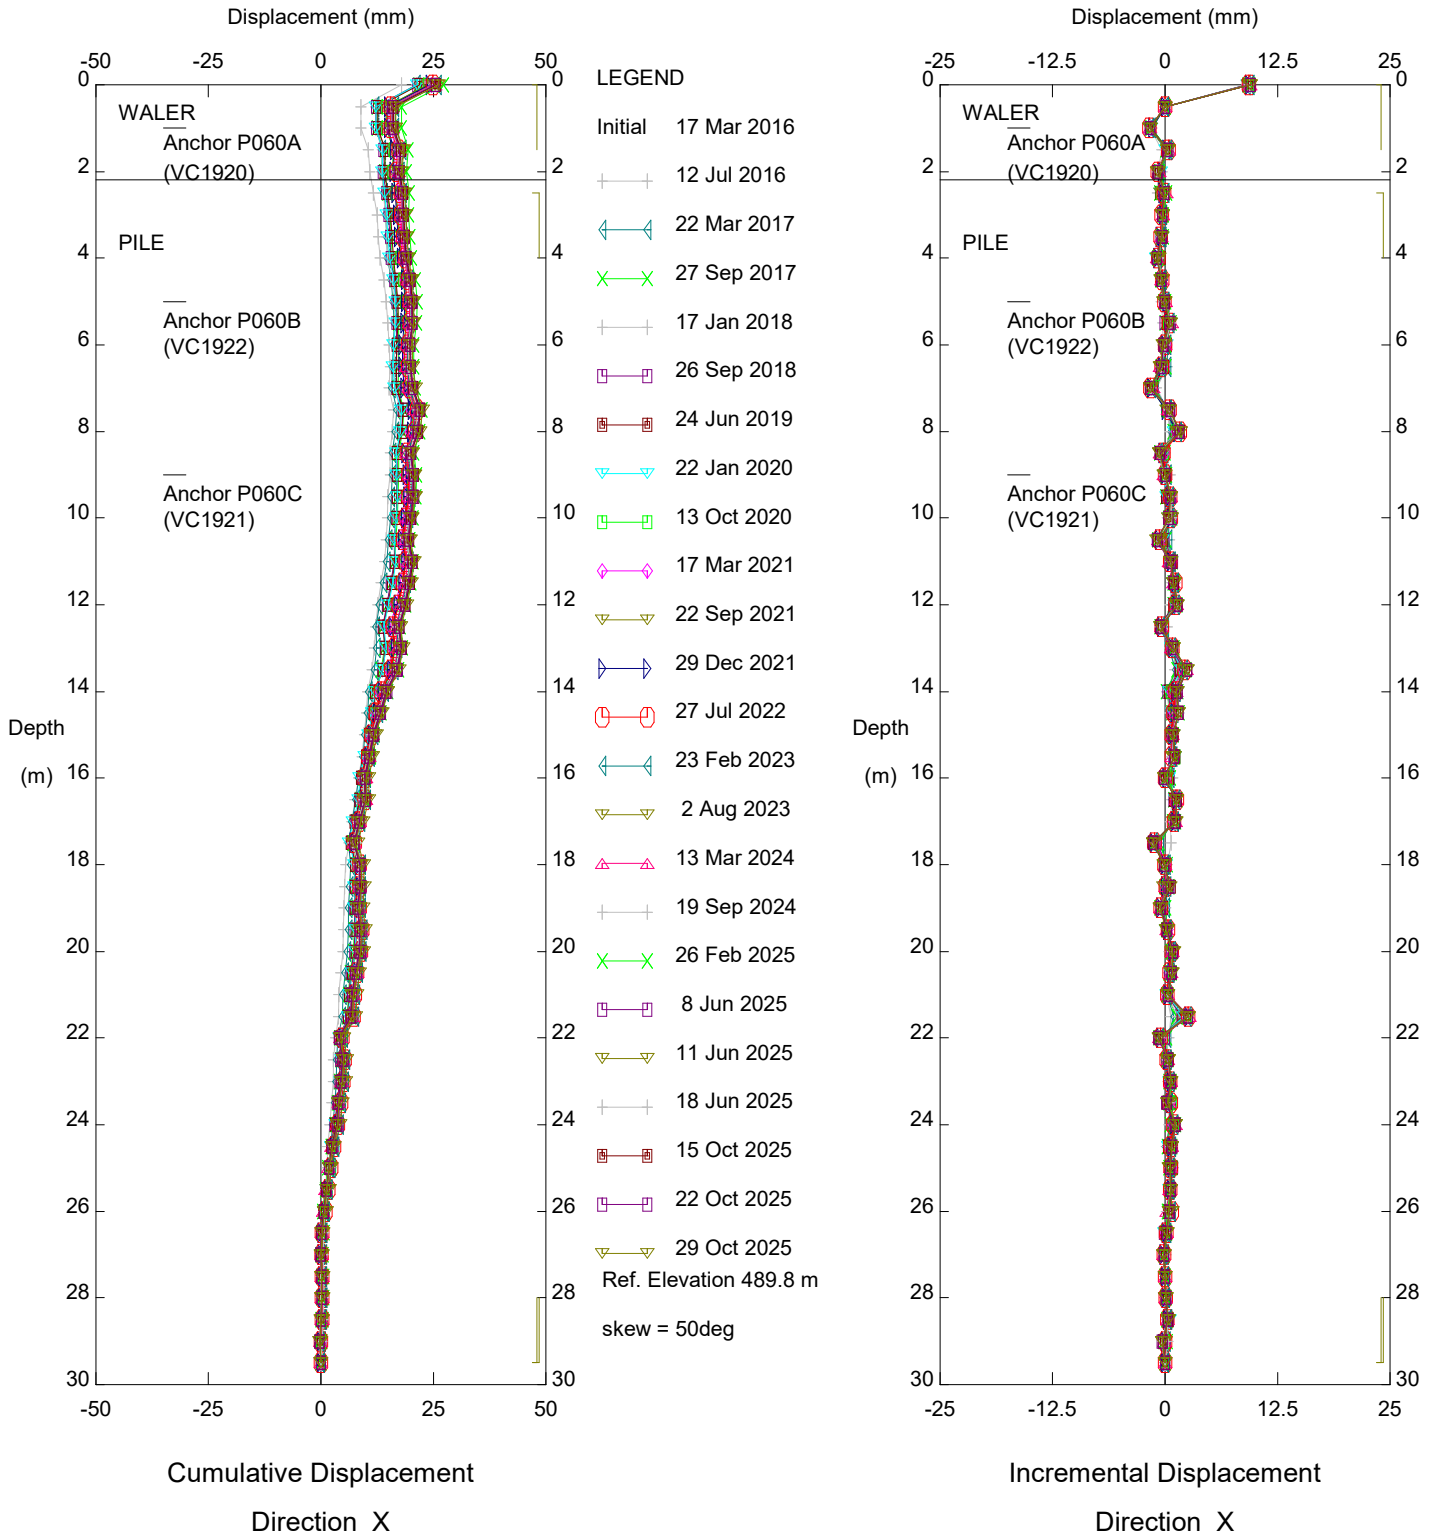
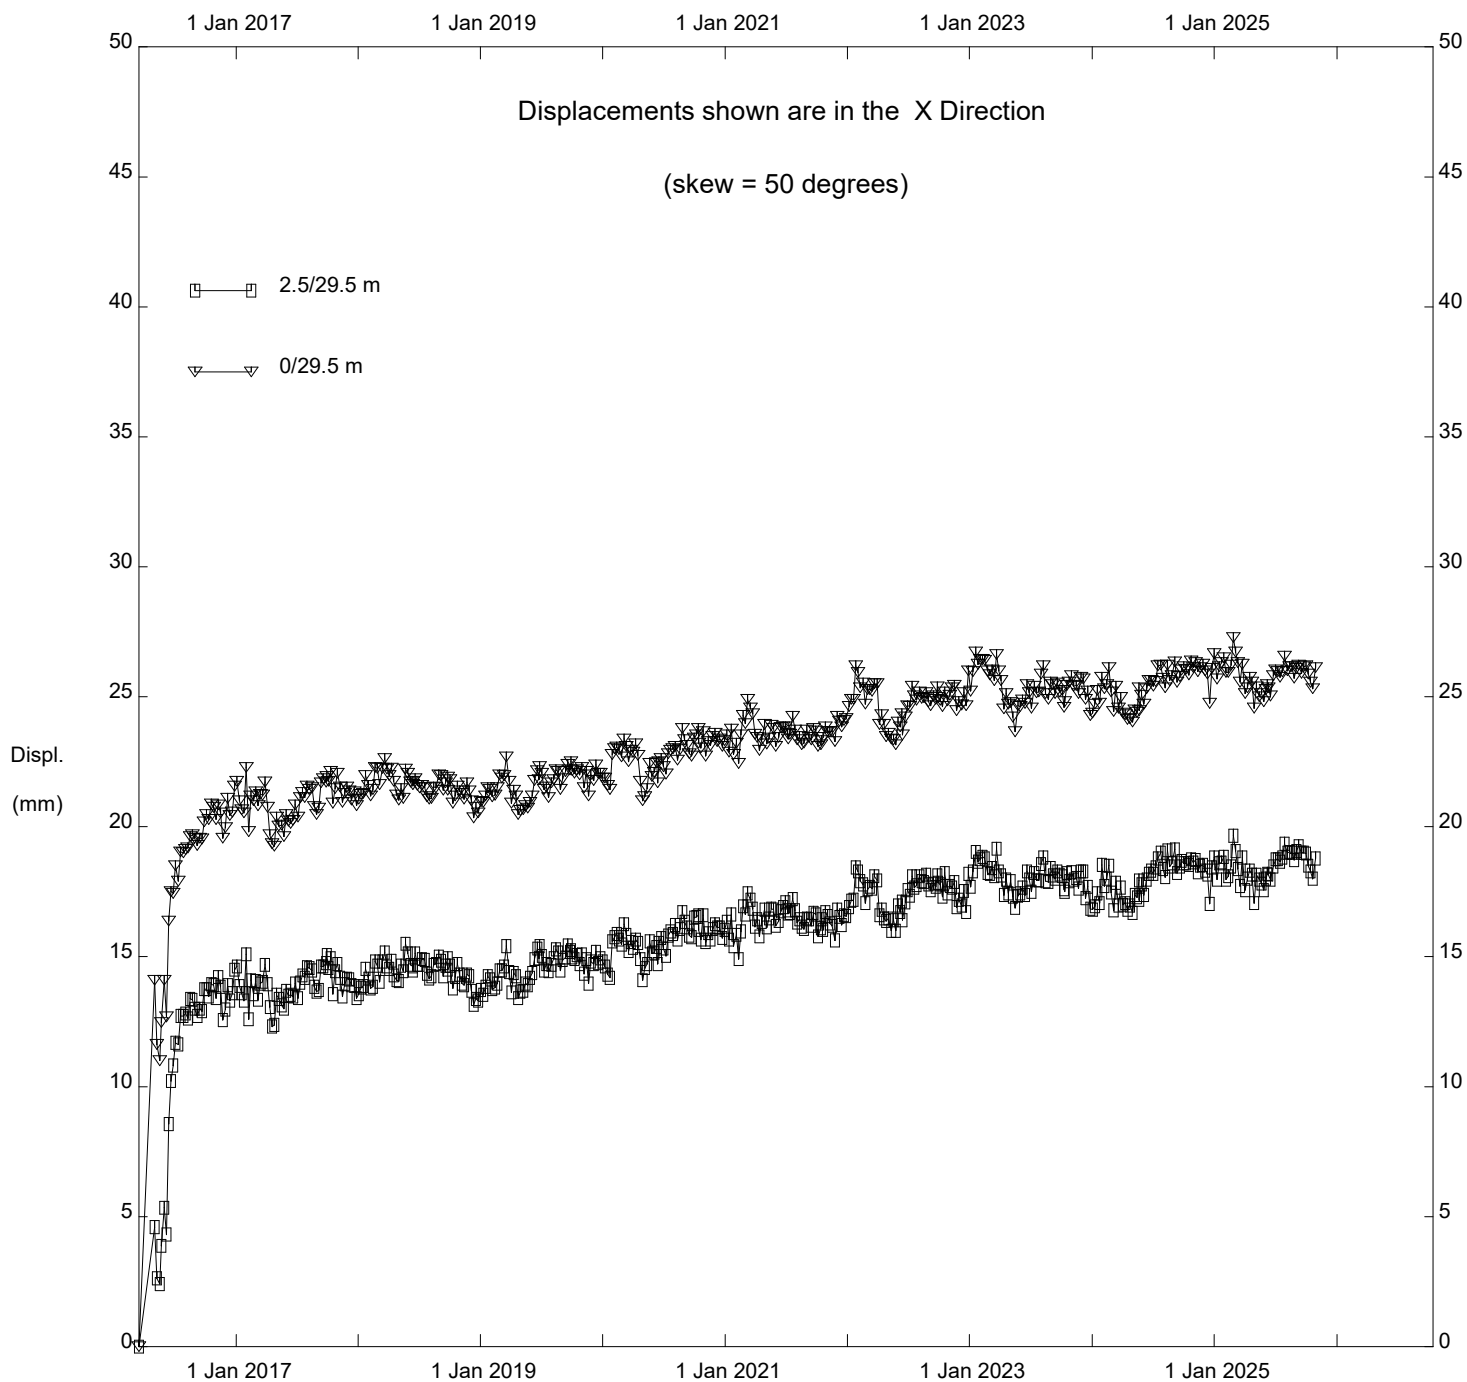
Hwy 986:01 Daishowa West, Inclinator SAA-P060

<p>completion of construction. Transitory seasonal peaks in the movement of about 3 mm are representative of late winter conditions. The general deformed shape can be described as tilted between 10 m and 27 m depth. The upper part of the pile is constrained by the three levels of anchors and at the top of the pile by the waler.</p> <p>SAA-P097 has no discernable movement since the spring of 2025 readings. SAA-P097 has shown a total pile head deflection of 18.6 mm in the downslope direction to date. SAA-P097 had shown an overall trend of steady downslope movement since the end of construction, with peaks in the pattern of movement of about 3 mm which are representative of late winter conditions. The general deformed shape is similar to that measured by SAA-P060.</p> <p>Piezometers</p> <p>Vibrating wire piezometers VW16-1A, VW16-1B, VW16-1C, VW16-2B, and VW16-2C are located immediately upslope of the wall and showed groundwater level increases of 0.48 m, 0.13 m, 0.05 m, 0.44 m, 0.36 m, and 0.06 m, respectively, since the spring of 2025. The groundwater level of 482.35 m, measured in VW16-2C on August 22, 2025, was the highest measured in the instrument since it was initialized. The overall trend since the end of construction is a gradual increase in the groundwater table upslope of the wall to what now appears to be a relatively steady level with cyclical seasonal fluctuations up to one metre.</p> <p>VW16-2A continued to be dry (this piezometer has only shown a groundwater level above the tip during a period between August 9, 2022, and September 21, 2022).</p> <p>Of the piezometers located downslope of the wall, VW16-3A showed a decrease in groundwater level of 0.16 m, and VW16-3B showed an increase in groundwater level of 0.06 m since the spring of 2025 readings. Over the long term both VW16-3A and VW16-3B show stable groundwater levels with minor seasonal fluctuations.</p> <p>VW16-4A continued to be dry and tends to remain dry, except for brief periods that correspond to either higher than normal rainfall or spring thaw. VW16-5A continued to be dry until July 2025 but was damaged and could not be read further.</p> <p>Strain Gauges</p> <p>The strain gauge readings in Pile P066 are summarized in Table PH071-3 and shown in Figure PH071-3 and PH071-4. Overall, the strain gauges showed relatively small changes in microstrain value compared to the previous readings in the spring of 2025. The greatest change in microstrain was in strain gauge #12 at 2.6 m depth in the upslope face of the pile, which showed a decrease in positive (compressive) microstrain of 11.2 microstrain compared to the spring of 2025 readings.</p> <p>Load Cells</p> <p>The three load cells at each of pile P022, P060 and P097 show similar loading patterns. The middle anchor at each pile carries the greatest load, followed by the upper anchor. The lowest anchor carries the least load. Seasonal peaks in load are recorded during winter months, with loads decreasing to a seasonal trough during summer months. The seasonal peaks are greatest in the upper row of anchors and the least in the lowest anchor row.</p> <p>The load cells generally showed small increases in measured load compared to the spring of 2025 readings. Overall, the loads in the upper and middle anchor sets for pile P060 and P097 have been relative stable since 2022. The loads in the lower anchors at all three piles, and to a lesser extent in the middle and upper load cells at P022, continue to increase. All loads, except the lower anchor load at P097, exceed the design load.</p>
