Site Number	Location	Name	Hwy	km
PH071	Hwy 986:01 C1 28.474	Daishowa West Hill	986:01	Km 28.5
Legal Description:		UTM Co-ordinates		
8-9-85-21 W5		11U E 485023	N	6245526

Current Monitoring:	24-Sep-2025 to 29-Oct-2025	Previous Monitoring	8-Jun-2025
Instruments Read By:	Mr. Niraj Regmi, G.I.T and Mr. Angelo Castillo, of Thurber

**ALBERTA TRANSPORTATION AND ECONOMIC CORRIDORS GRMP (CON0022164)
PEACE REGION (PEACE RIVER DISTRICT)
INSTRUMENTATION MONITORING RESULTS**

SITE PH071: HWY 986:01, DAISHOWA WEST HILL

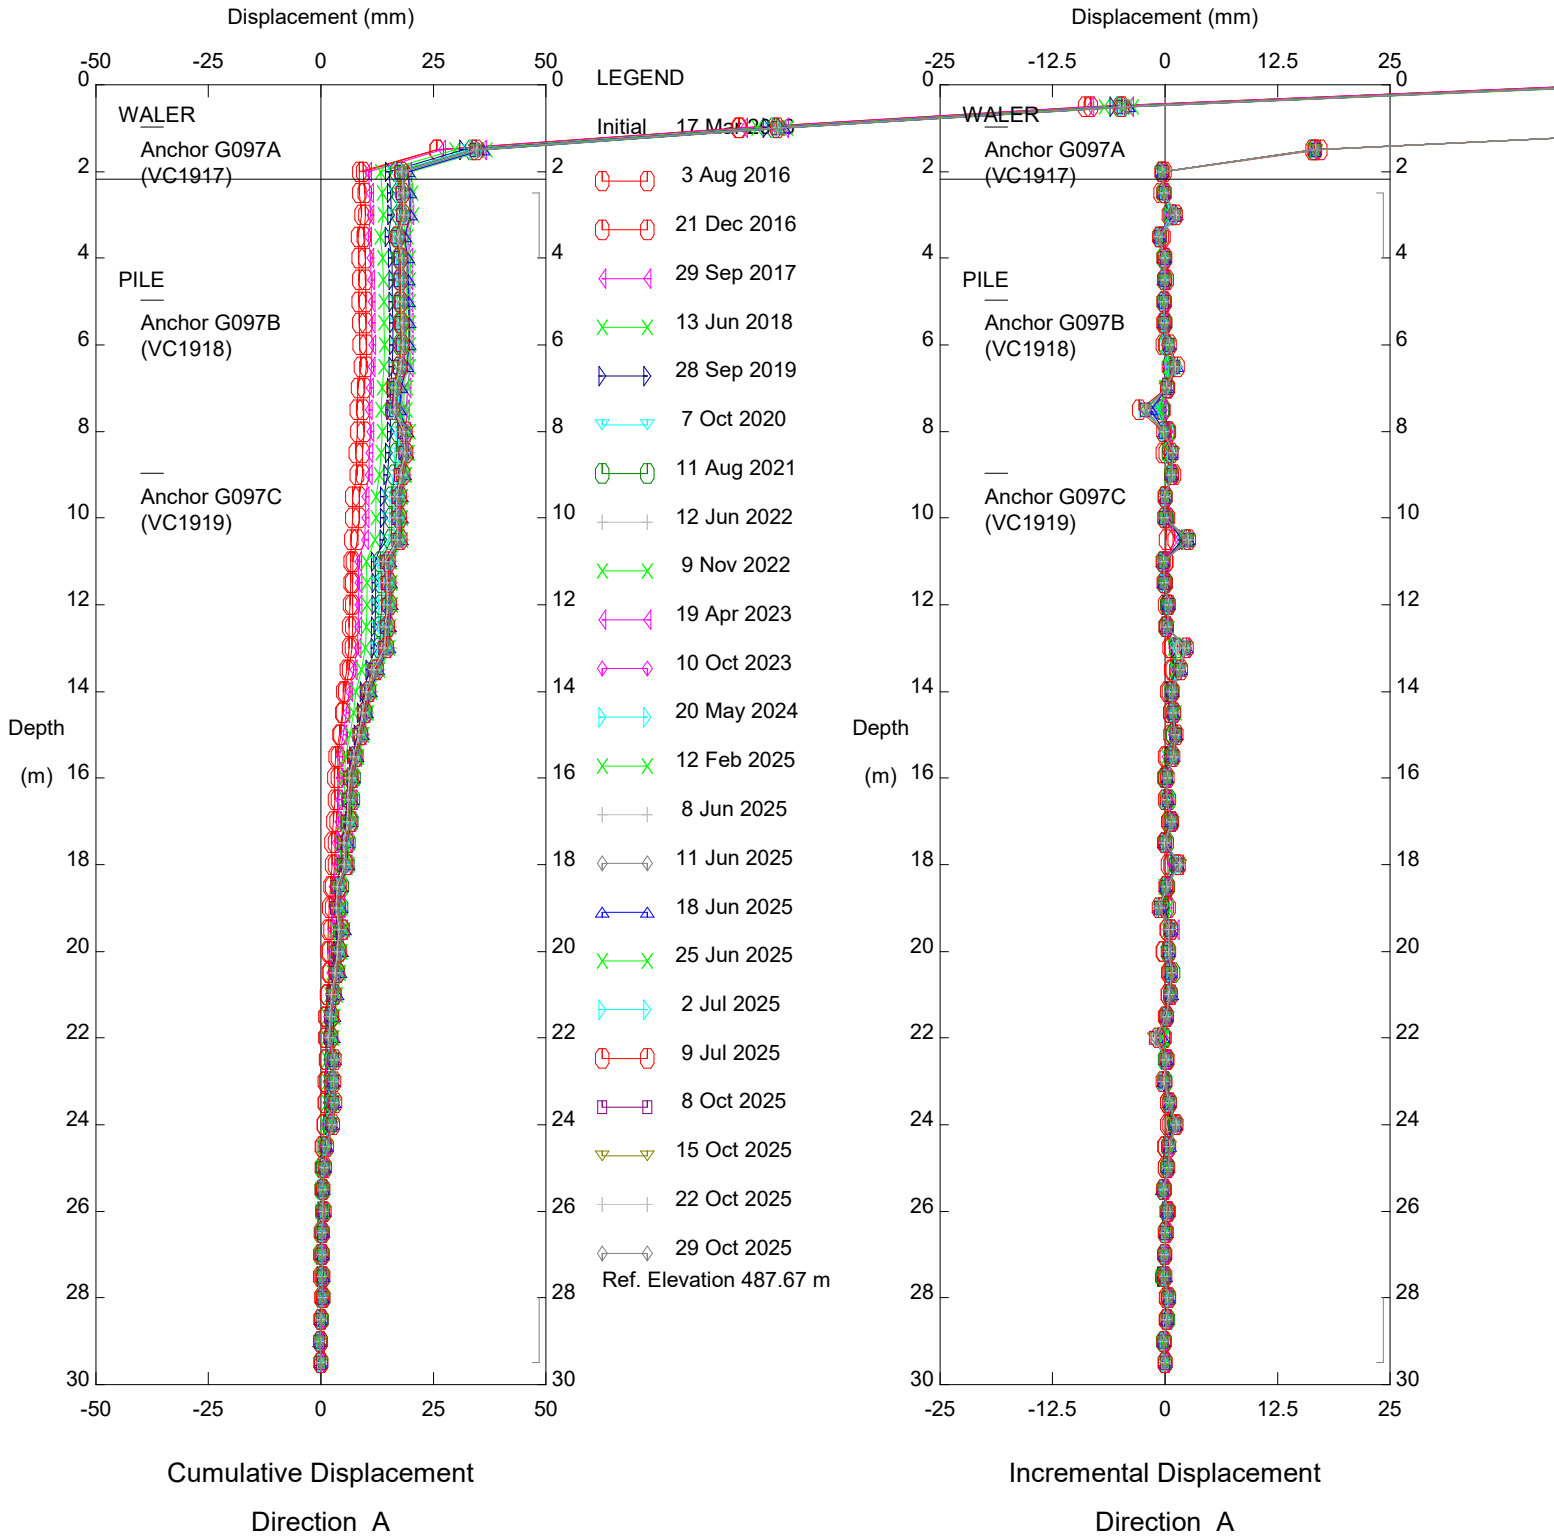
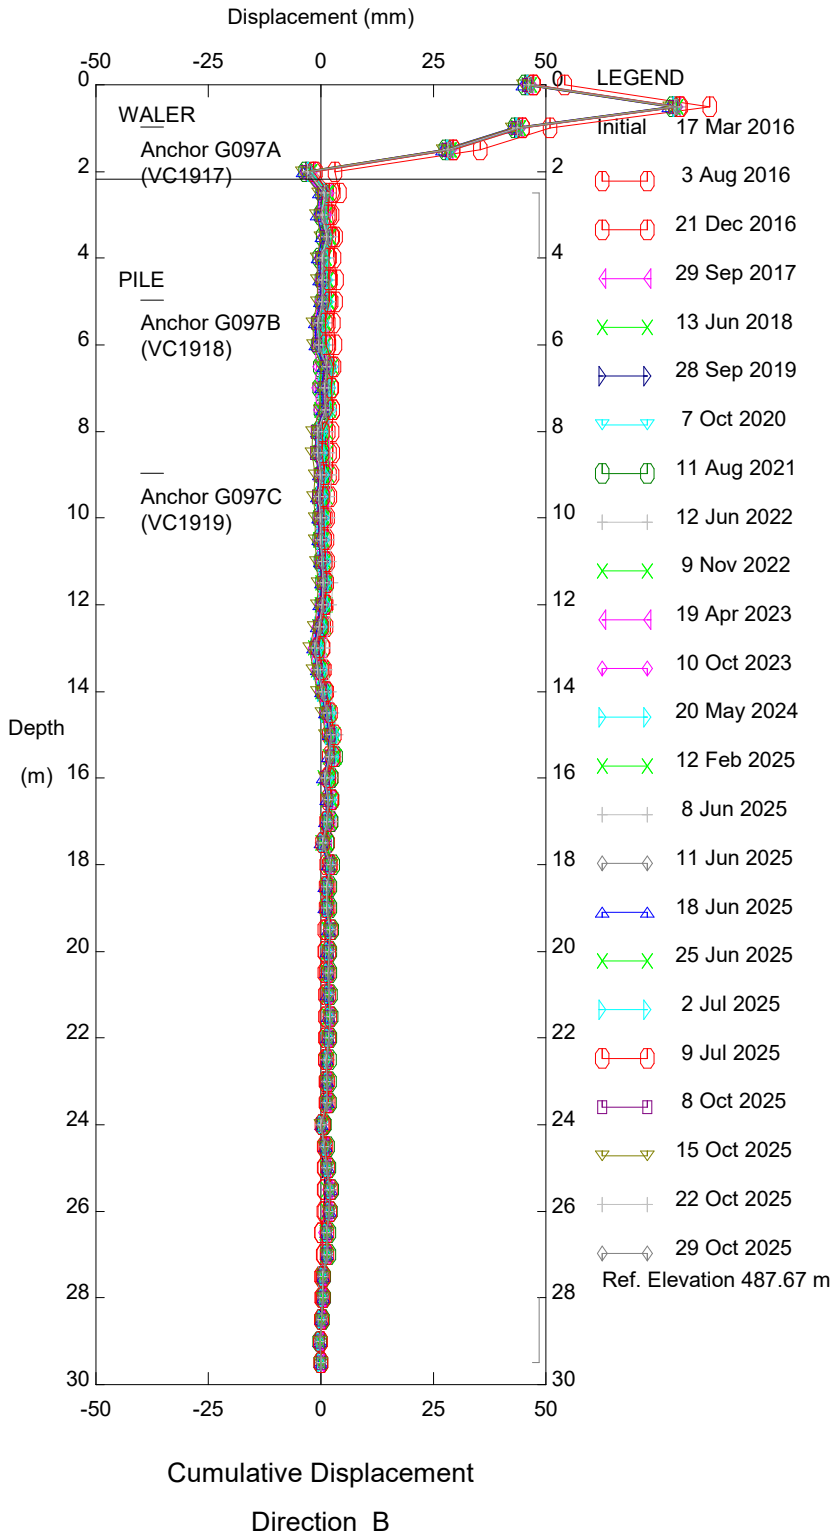
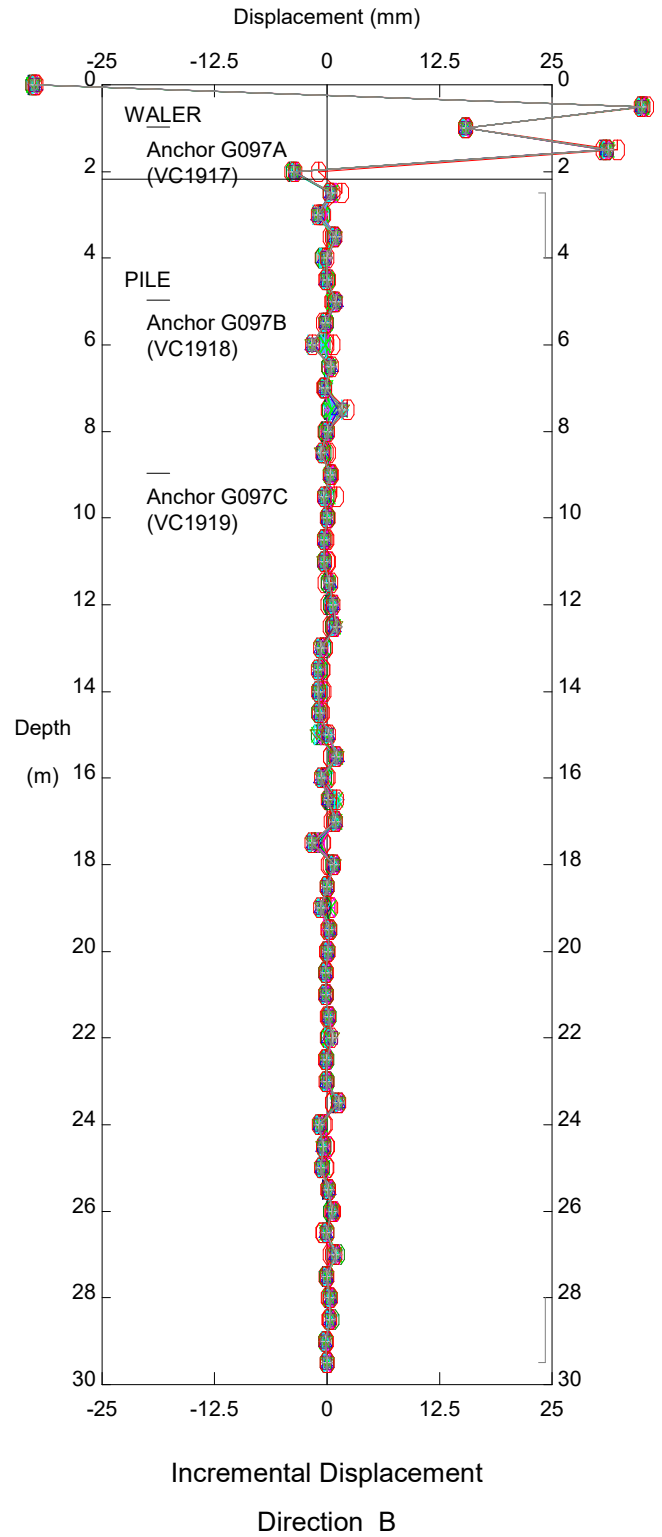
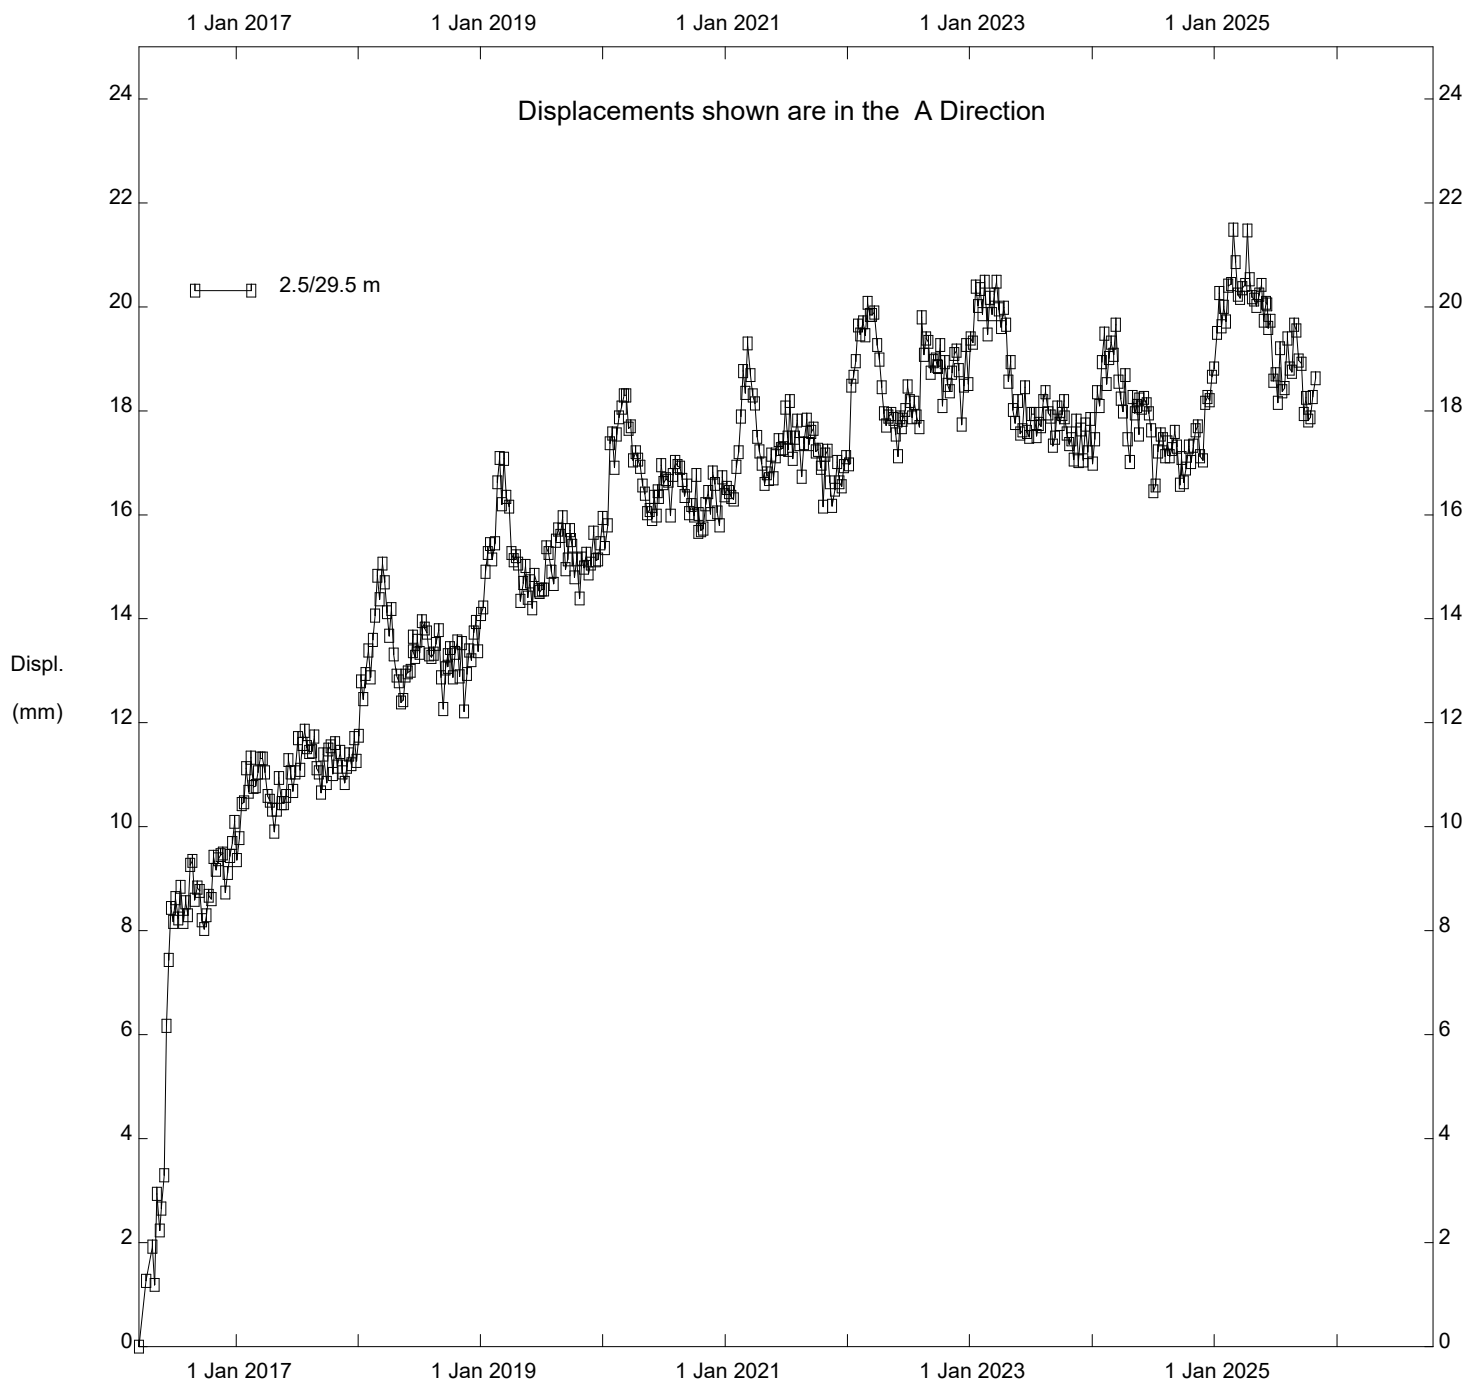
Hwy 986:01 Daishowa West, Inclinometer SAA-P097

<p>completion of construction. Transitory seasonal peaks in the movement of about 3 mm are representative of late winter conditions. The general deformed shape can be described as tilted between 10 m and 27 m depth. The upper part of the pile is constrained by the three levels of anchors and at the top of the pile by the waler.</p> <p>SAA-P097 has no discernable movement since the spring of 2025 readings. SAA-P097 has shown a total pile head deflection of 18.6 mm in the downslope direction to date. SAA-P097 had shown an overall trend of steady downslope movement since the end of construction, with peaks in the pattern of movement of about 3 mm which are representative of late winter conditions. The general deformed shape is similar to that measured by SAA-P060.</p> <p>Piezometers</p> <p>Vibrating wire piezometers VW16-1A, VW16-1B, VW16-1C, VW16-2B, and VW16-2C are located immediately upslope of the wall and showed groundwater level increases of 0.48 m, 0.13 m, 0.05 m, 0.44 m, 0.36 m, and 0.06 m, respectively, since the spring of 2025. The groundwater level of 482.35 m, measured in VW16-2C on August 22, 2025, was the highest measured in the instrument since it was initialized. The overall trend since the end of construction is a gradual increase in the groundwater table upslope of the wall to what now appears to be a relatively steady level with cyclical seasonal fluctuations up to one metre.</p> <p>VW16-2A continued to be dry (this piezometer has only shown a groundwater level above the tip during a period between August 9, 2022, and September 21, 2022).</p> <p>Of the piezometers located downslope of the wall, VW16-3A showed a decrease in groundwater level of 0.16 m, and VW16-3B showed an increase in groundwater level of 0.06 m since the spring of 2025 readings. Over the long term both VW16-3A and VW16-3B show stable groundwater levels with minor seasonal fluctuations.</p> <p>VW16-4A continued to be dry and tends to remain dry, except for brief periods that correspond to either higher than normal rainfall or spring thaw. VW16-5A continued to be dry until July 2025 but was damaged and could not be read further.</p> <p>Strain Gauges</p> <p>The strain gauge readings in Pile P066 are summarized in Table PH071-3 and shown in Figure PH071-3 and PH071-4. Overall, the strain gauges showed relatively small changes in microstrain value compared to the previous readings in the spring of 2025. The greatest change in microstrain was in strain gauge #12 at 2.6 m depth in the upslope face of the pile, which showed a decrease in positive (compressive) microstrain of 11.2 microstrain compared to the spring of 2025 readings.</p> <p>Load Cells</p> <p>The three load cells at each of pile P022, P060 and P097 show similar loading patterns. The middle anchor at each pile carries the greatest load, followed by the upper anchor. The lowest anchor carries the least load. Seasonal peaks in load are recorded during winter months, with loads decreasing to a seasonal trough during summer months. The seasonal peaks are greatest in the upper row of anchors and the least in the lowest anchor row.</p> <p>The load cells generally showed small increases in measured load compared to the spring of 2025 readings. Overall, the loads in the upper and middle anchor sets for pile P060 and P097 have been relative stable since 2022. The loads in the lower anchors at all three piles, and to a lesser extent in the middle and upper load cells at P022, continue to increase. All loads, except the lower anchor load at P097, exceed the design load.</p>

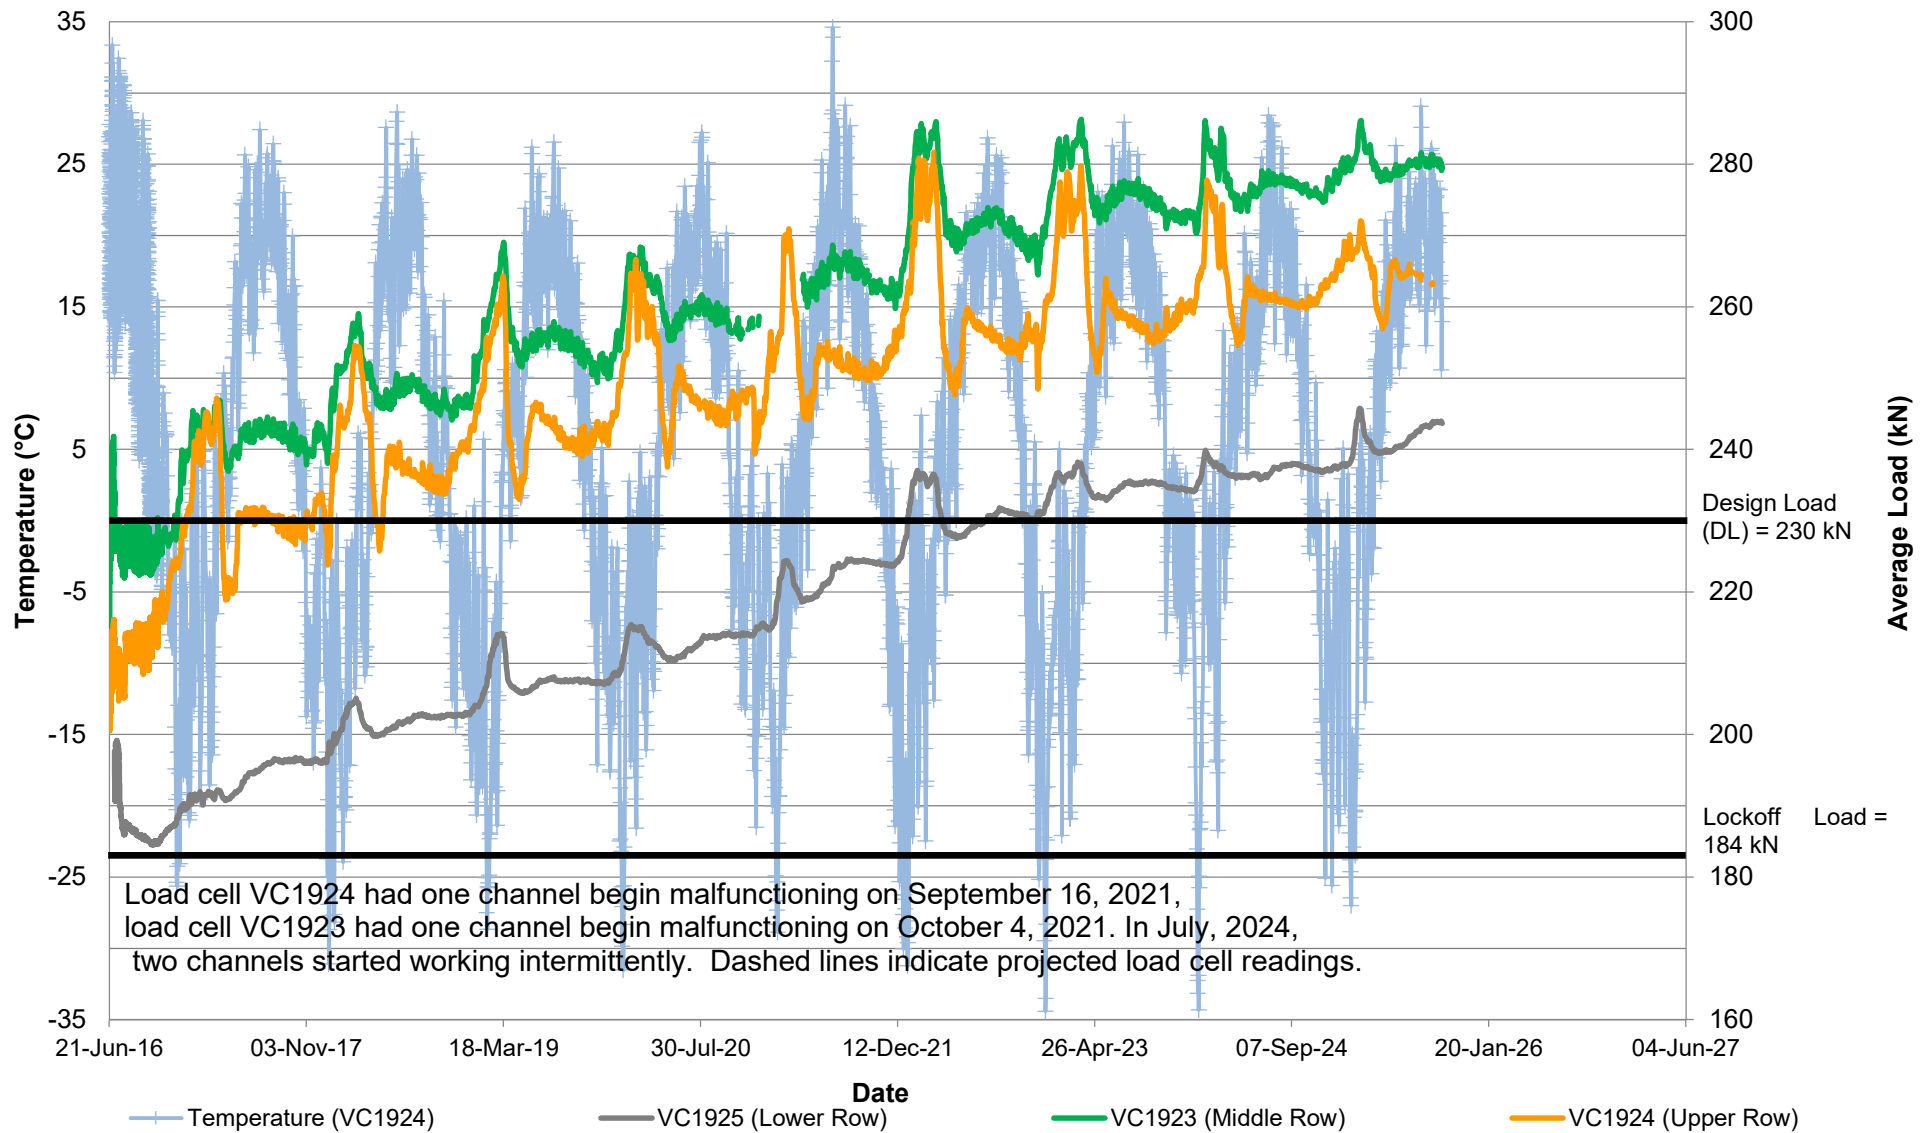
FIGURE PH071-5
LOAD CELL DATA FOR HWY 986:01, DAISHOWA WEST (PILE P022)

Instrumentation Repairs:	VW16-5B was damaged and may be removed.
Additional Comments:	Load cells at pile P022 have not shown a clear trend of leveling off and projected loads are up to 50 kN above the design load level. With respect to these observations, a review of the current anchor load distribution could be undertaken to better assess the overall pile wall performance.

<p>Since the spring of 2025 readings, the load cells showed readings ranging from a decrease of 10.7 kN in VC1920 (anchor P060A) to an increase of 3.3 kN in VC1925 (anchor P022C). The highest load recorded is 303 kN in P097A, which is 126% of design load, well within the range of performance testing undertaken during construction.</p> <p>It should be noted that load cells VC1924 (anchor P022A), VC1923 (anchor P022B), VC1920 (anchor P060A), VC1918 (anchor P097B), and VC1919 (anchor P097C) have each lost the function of one vibrating wire channel. The loads that are now reported for these three load cells are based on the average of the two functioning channels and a projected third channel reading to account for the malfunctioning channel. The damaged channels cannot be repaired.</p>
Future Work:	The instruments should be read again in the spring of 2026. It is recommended to continue monitoring the deflections in the pile wall and the load cell readings to see if there are further increases in deflection or loads compared to the warning threshold values. If the deflections and or load cell readings continue to increase, it may become necessary to add additional anchors to the pile wall.
