Site Number	Location	Name	Hwy	km
PH071	Hwy 986:01 C1 28.474	Daishowa West Hill	986:01	Km 28.5
Legal Description:		UTM Co-ordinates		
8-9-85-21 W5		11U E 485023	N	6245526

Current Monitoring:	8-Jun-2025	Previous Monitoring	19-Sep-2024
Instruments Read By:	Mr. Niraj Regmi, G.I.T and Mr. Godfred Etiendem, of Thurber

**ALBERTA TRANSPORTATION AND ECONOMIC CORRIDORS GRMP (CON0022164)
PEACE REGION (PEACE RIVER DISTRICT)
INSTRUMENTATION MONITORING RESULTS**

SITE PH071: HWY 986:01, DAISHOWA WEST HILL

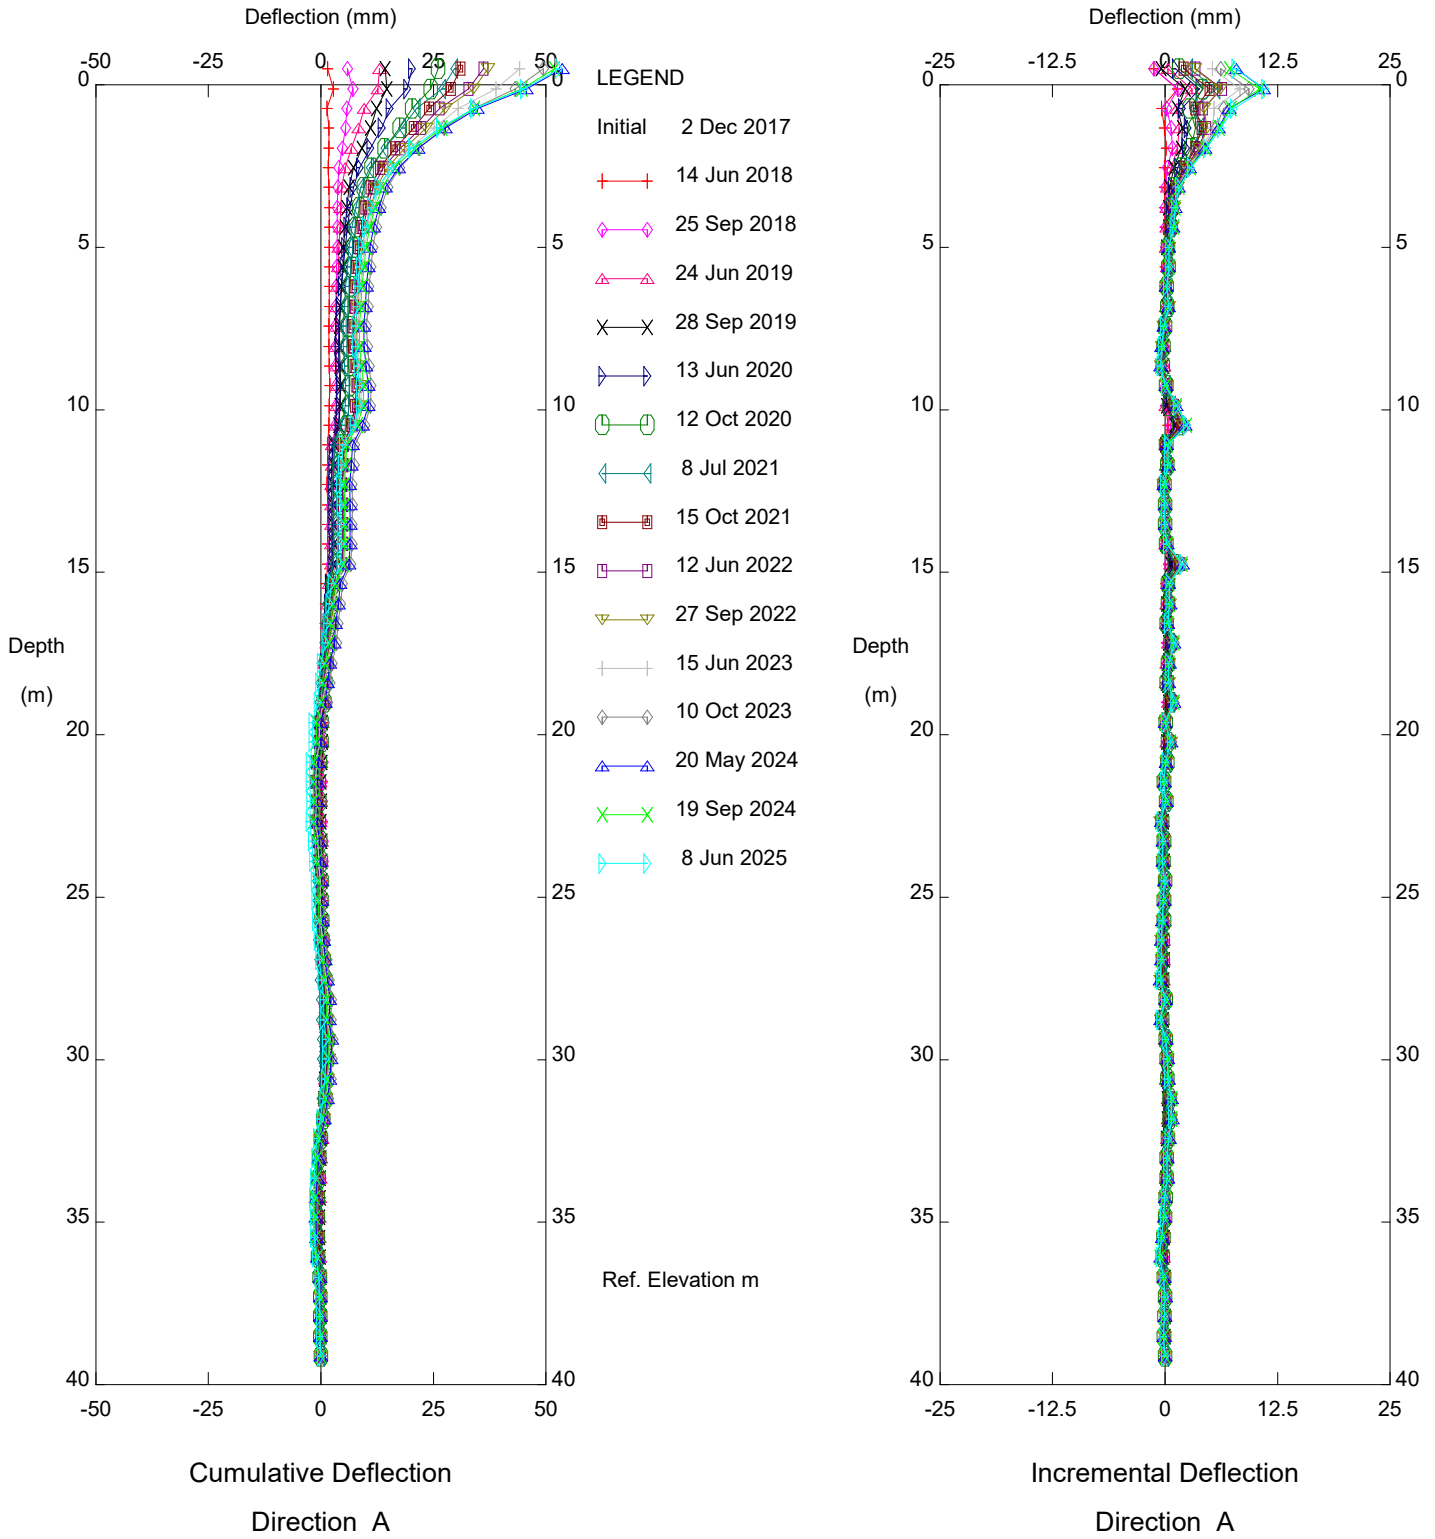
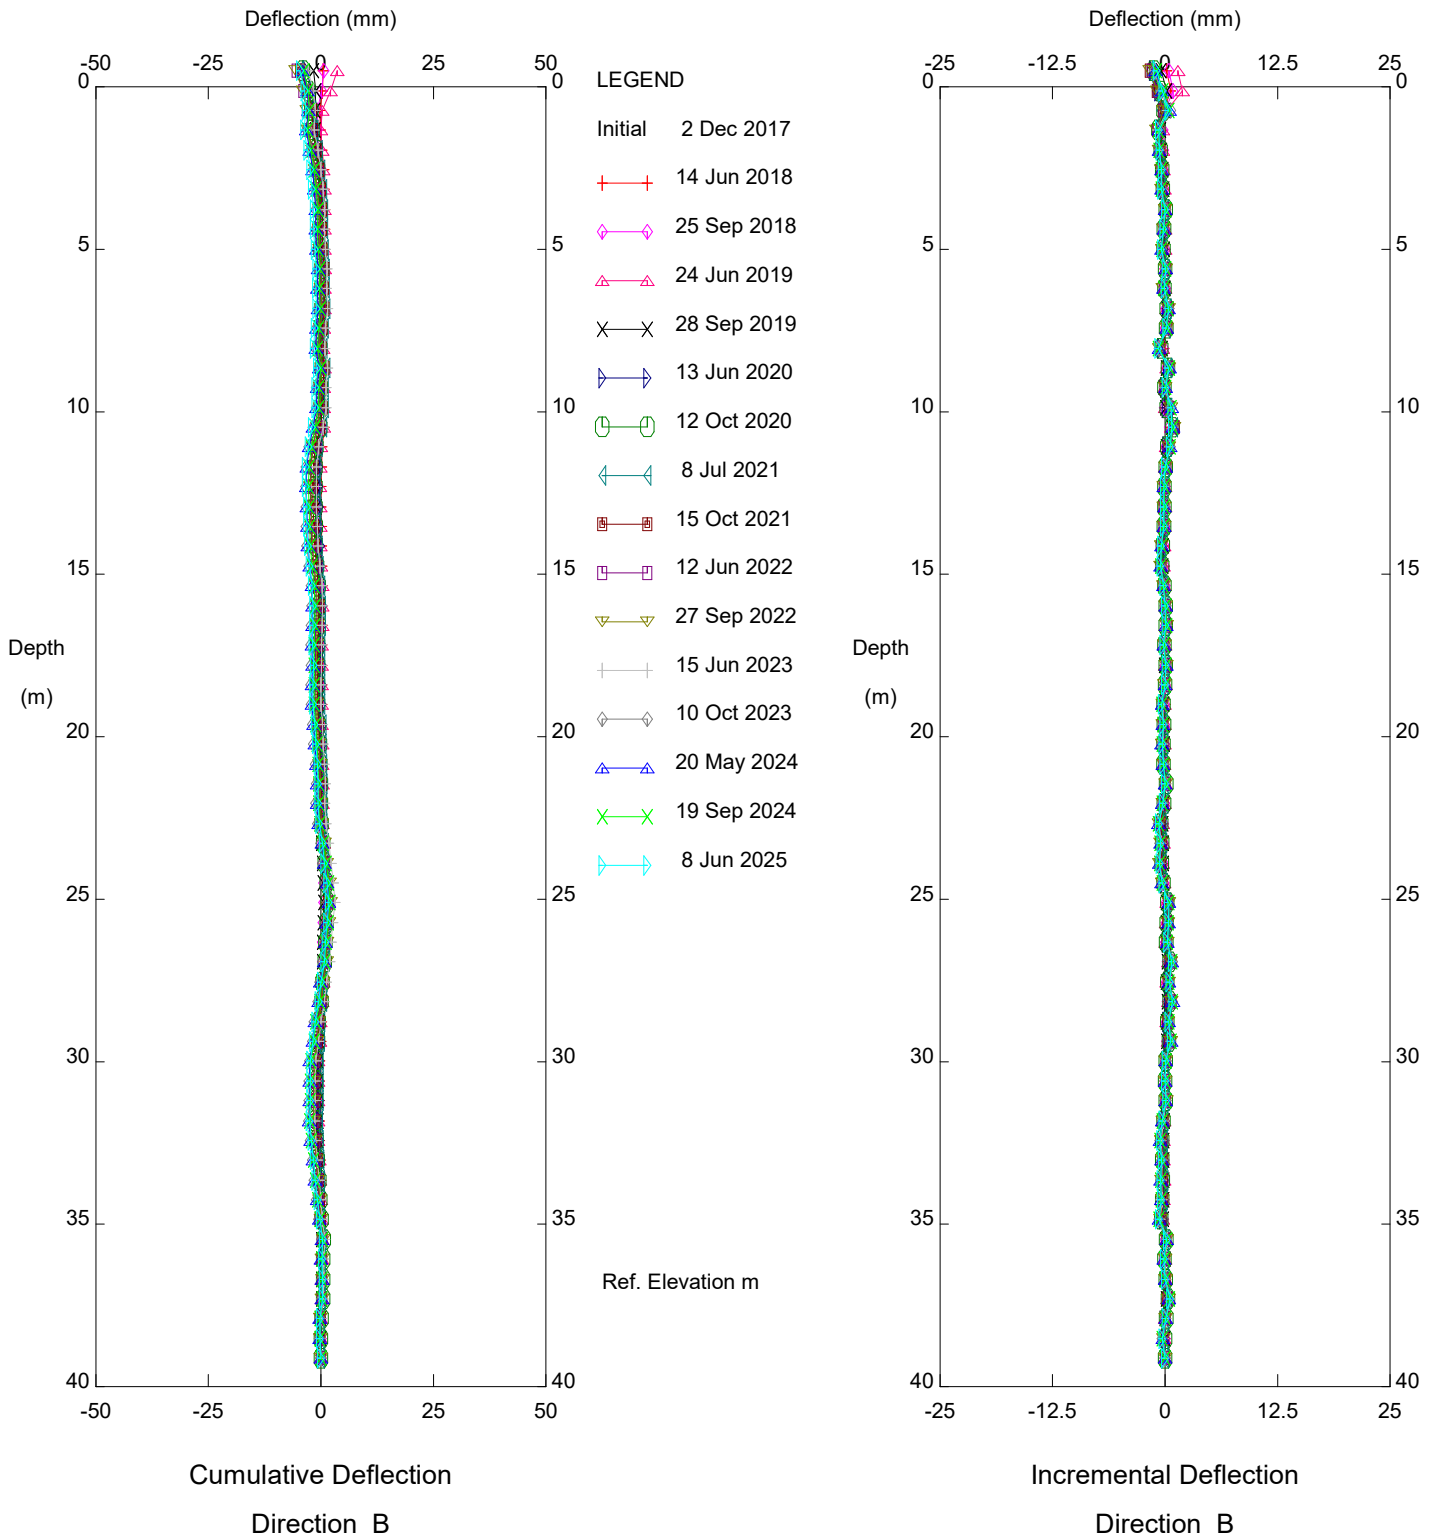
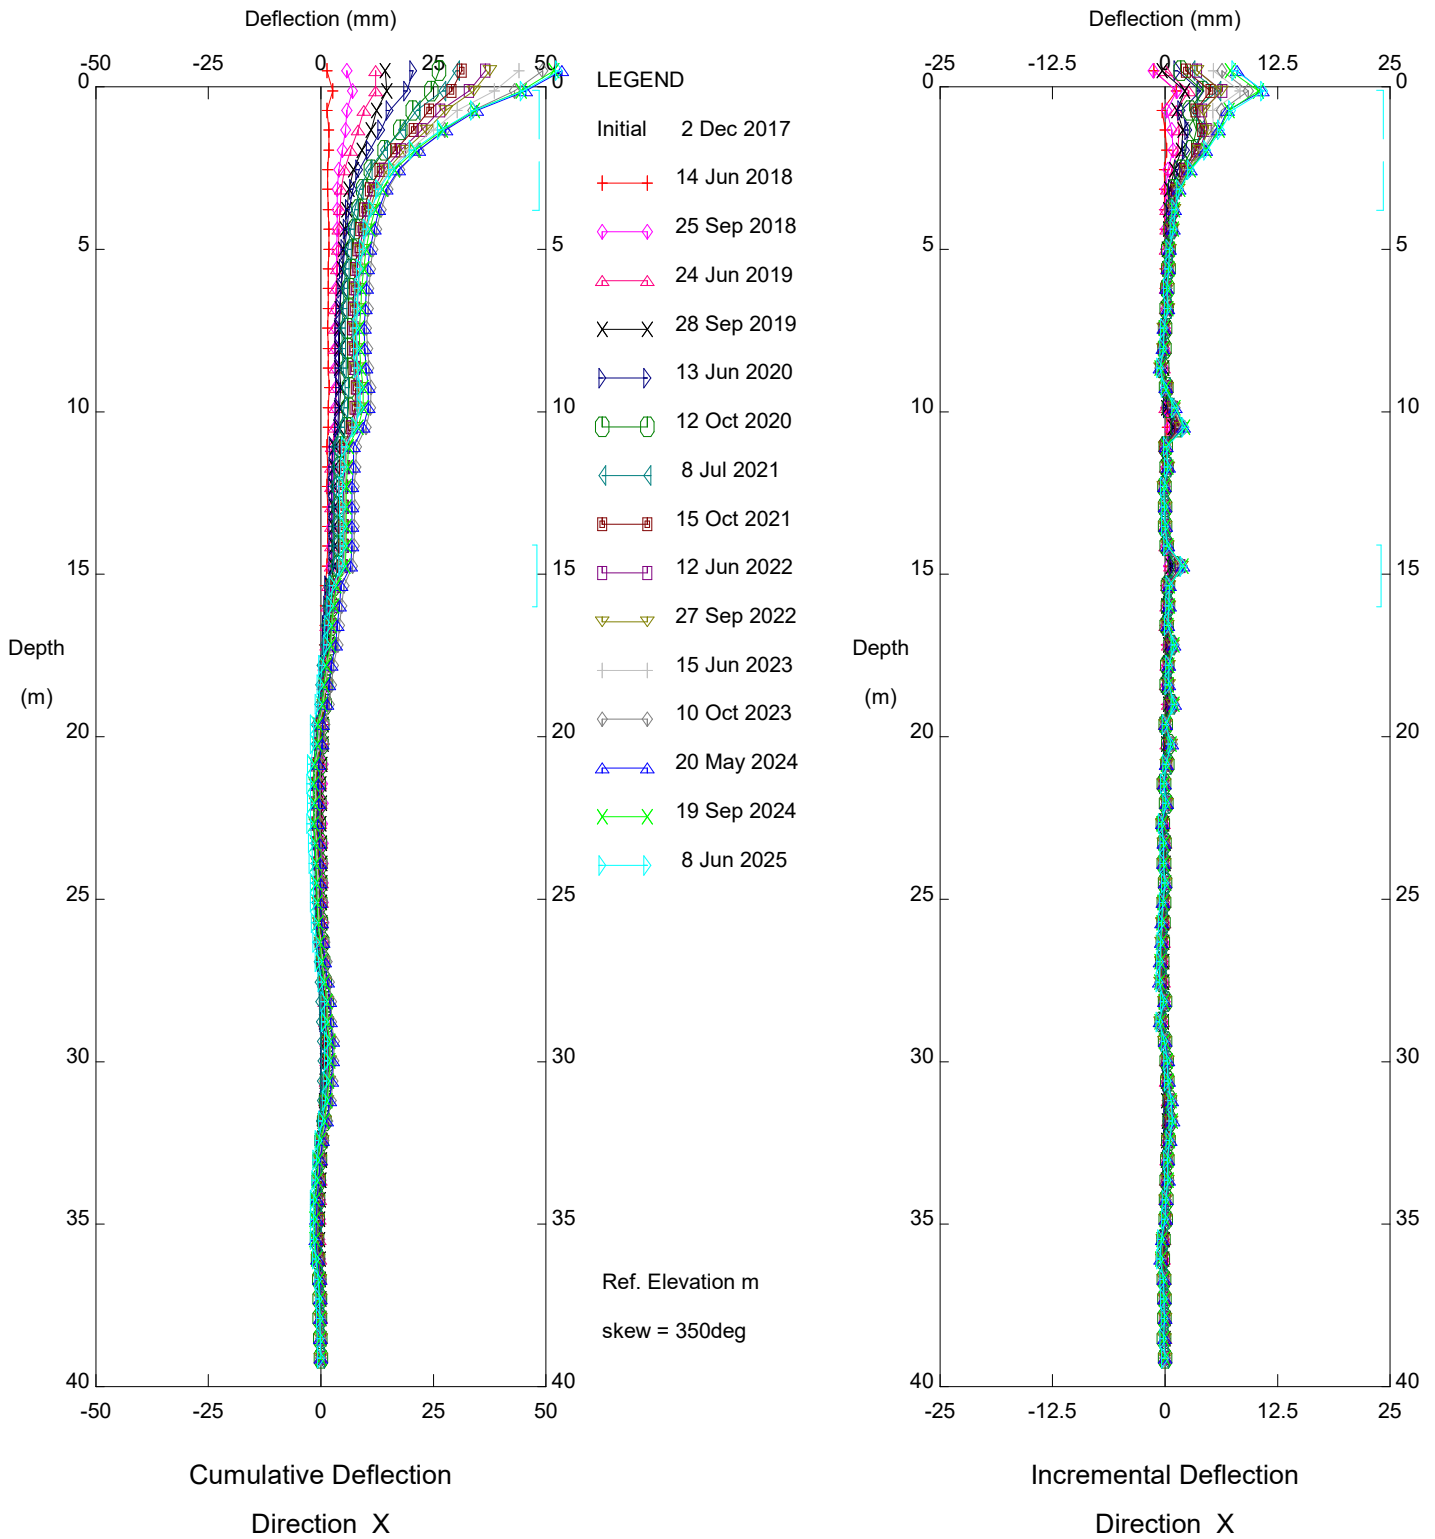
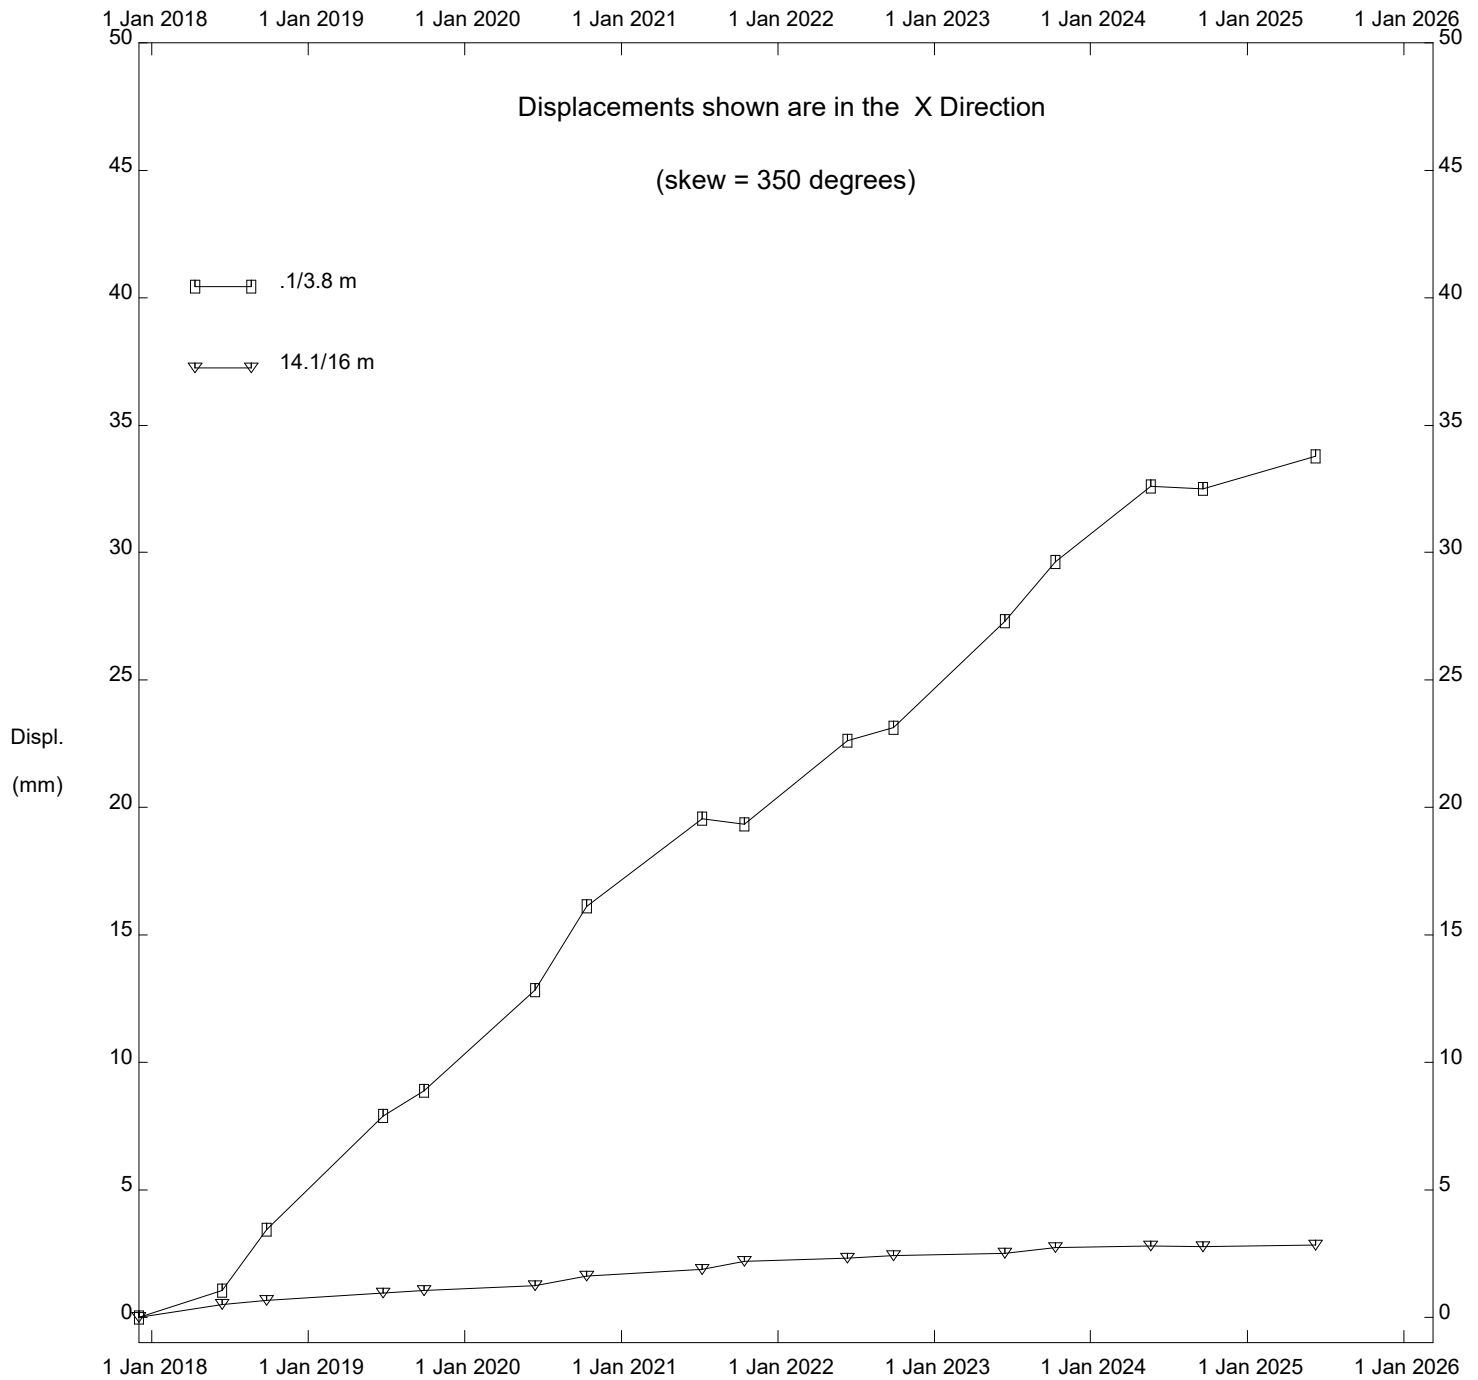
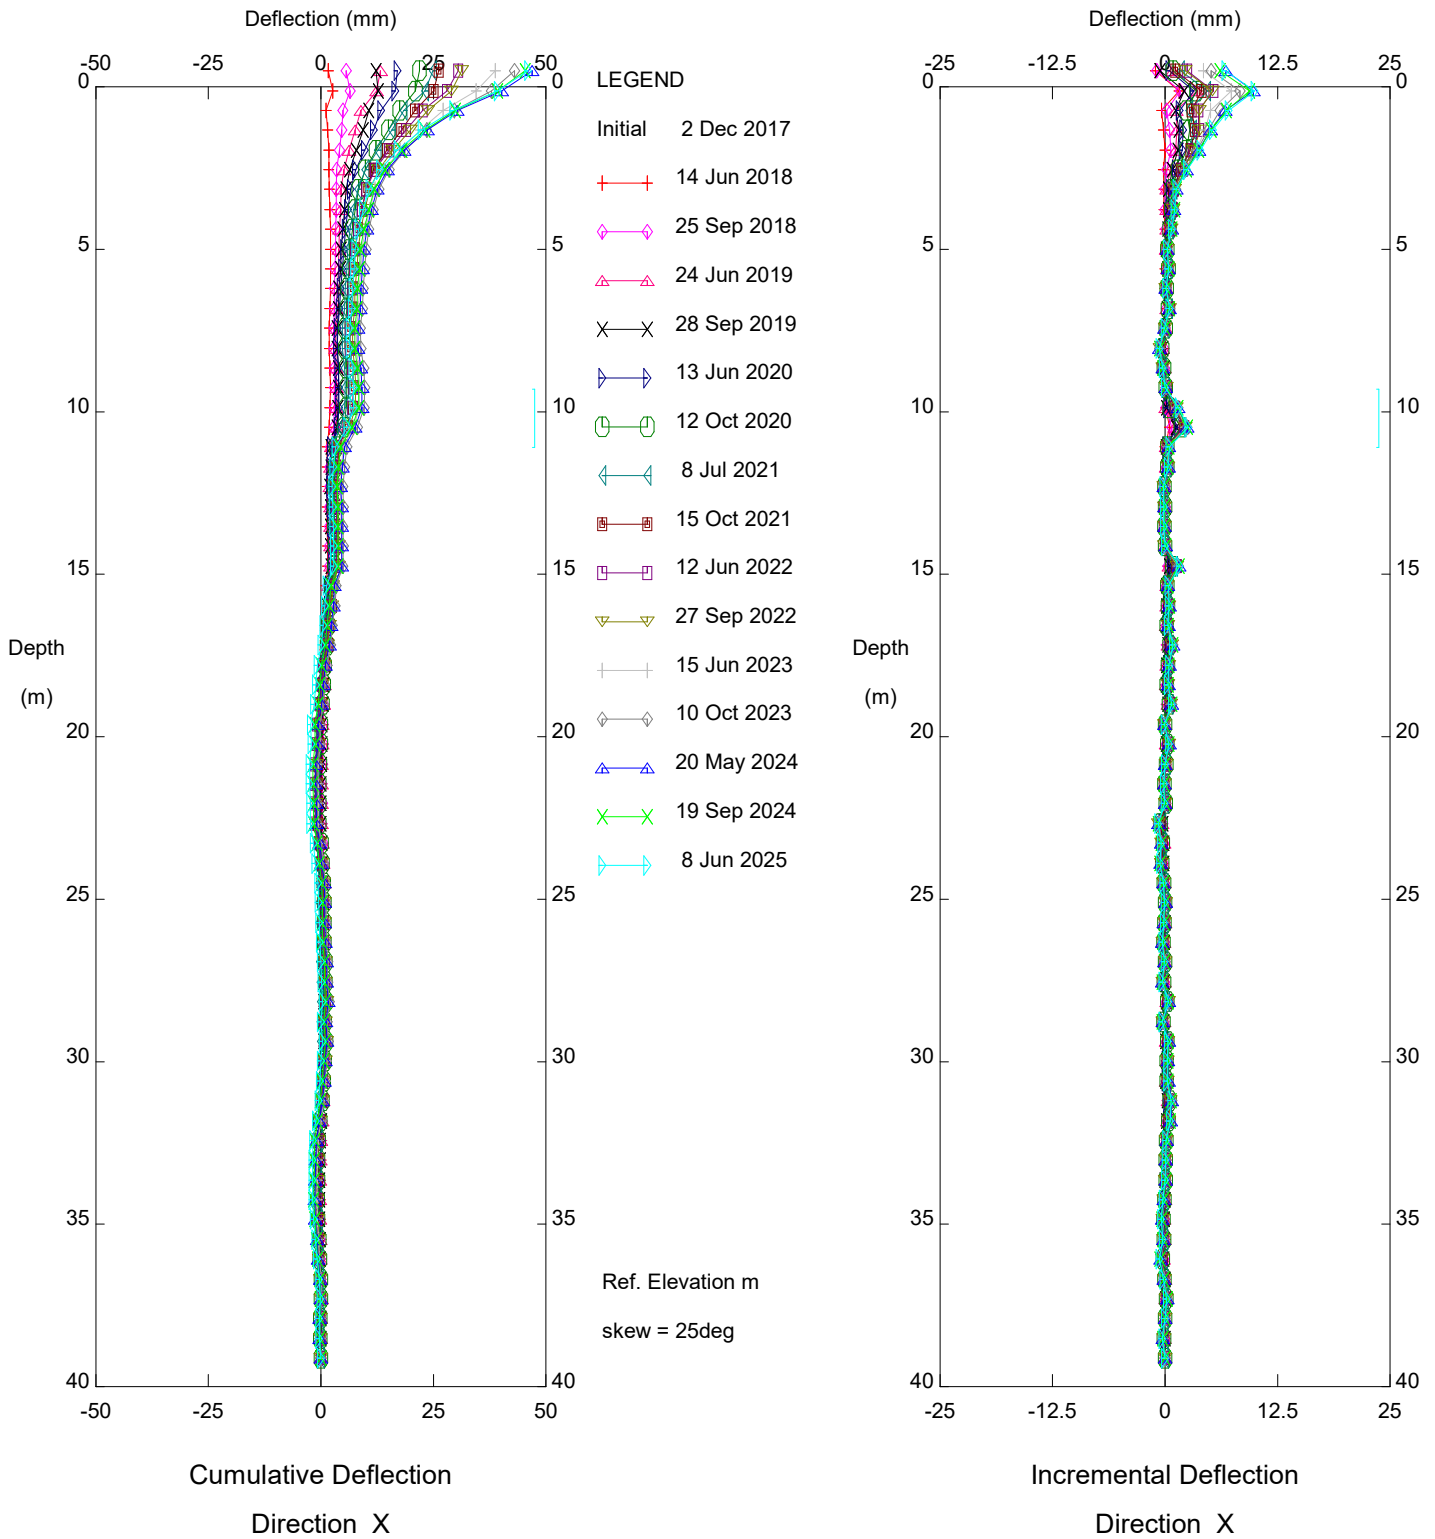
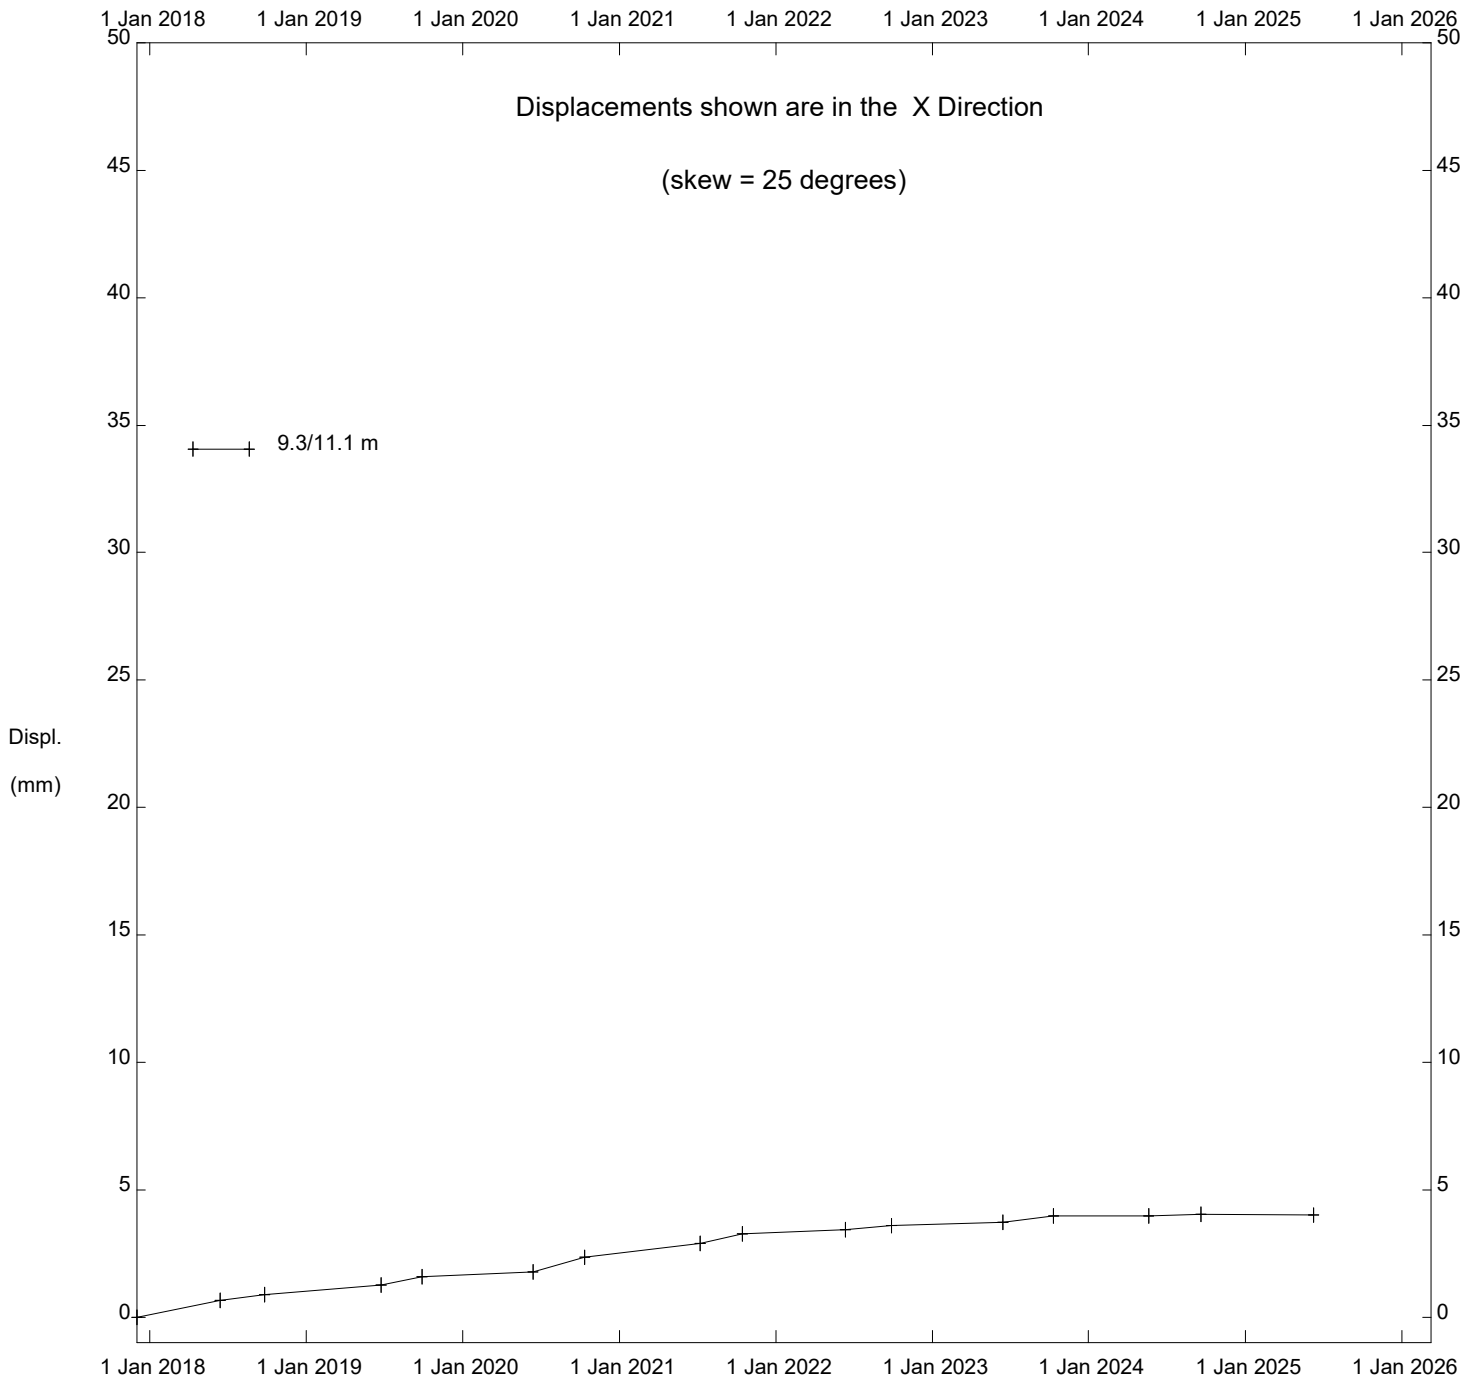
PH071 Daishowa West, Inclinometer SI16-3

Discussion	
Zones of New Movement:	None
Interpretation of Monitoring Results:	<p>Slope Indicators and SAAs</p> <p>SI16-3 is located 7 m downslope of the pile wall and has three movement zones. Rates of movement of 1.8 mm/yr over 0.1 m to 3.8 m depth, less than 0.1 mm/yr over 9.3 m to 11.1 m depth, and no discernible movement over 14.1 m to 16.0 m depth, were measured since the fall of 2024 readings. These movement rates are reduced from, or consistent with those observed over the past 3 years.</p> <p>SAA-P060 showed no discernible movement over 2.5 m to 29.5 m depth, nor over the full length of the pile and waler since the fall of 2024 readings. SAA-P060 has shown a cumulative pile head deflection of 18.2 mm to date in the downslope direction and a long-term rate of movement of 0.75 mm/yr. SAA-P060 has shown an overall relatively steady rate of movement since the end of construction with a total incremental movement of about 6.2 mm in the downslope direction since completion of construction. Transitory seasonal</p>

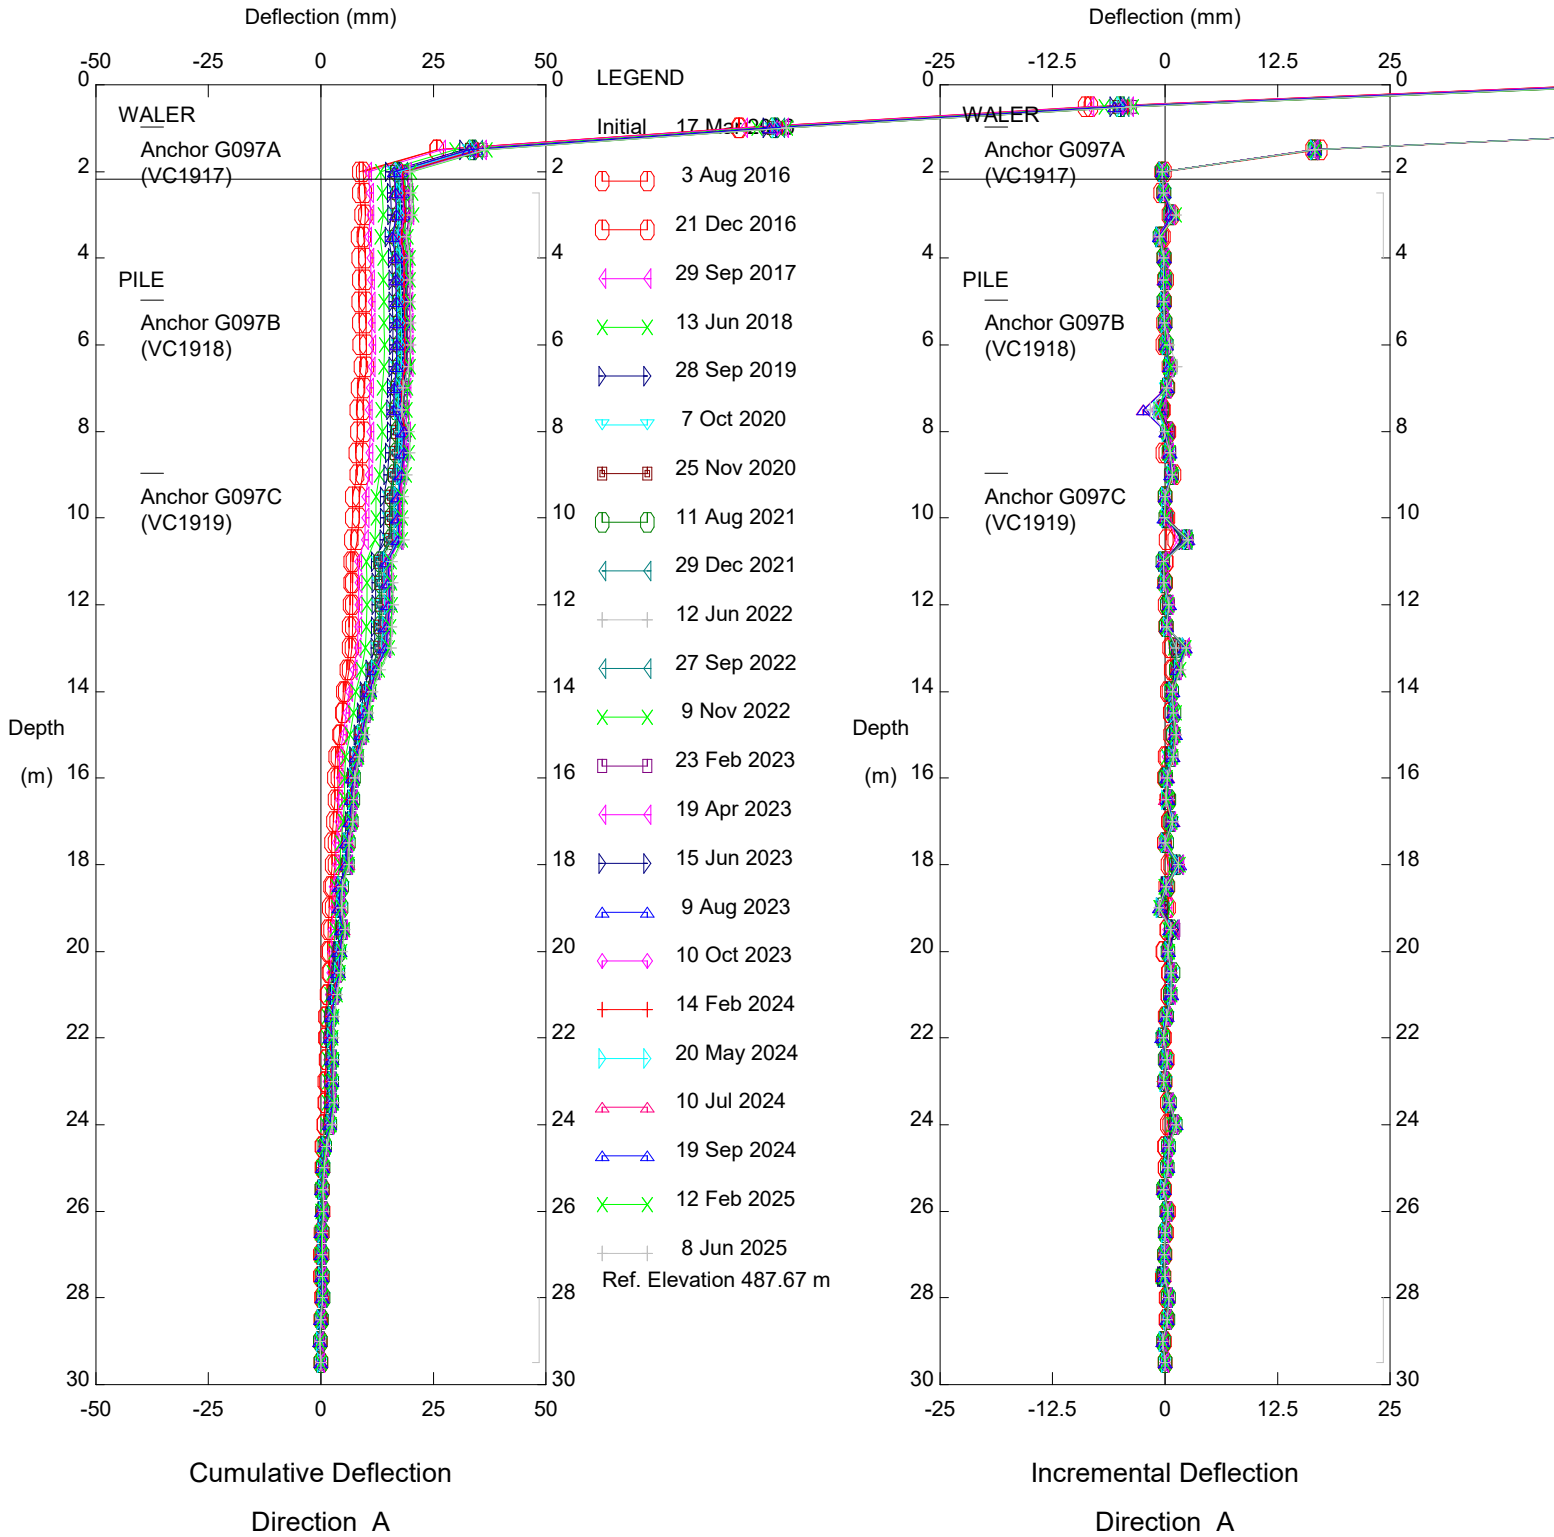
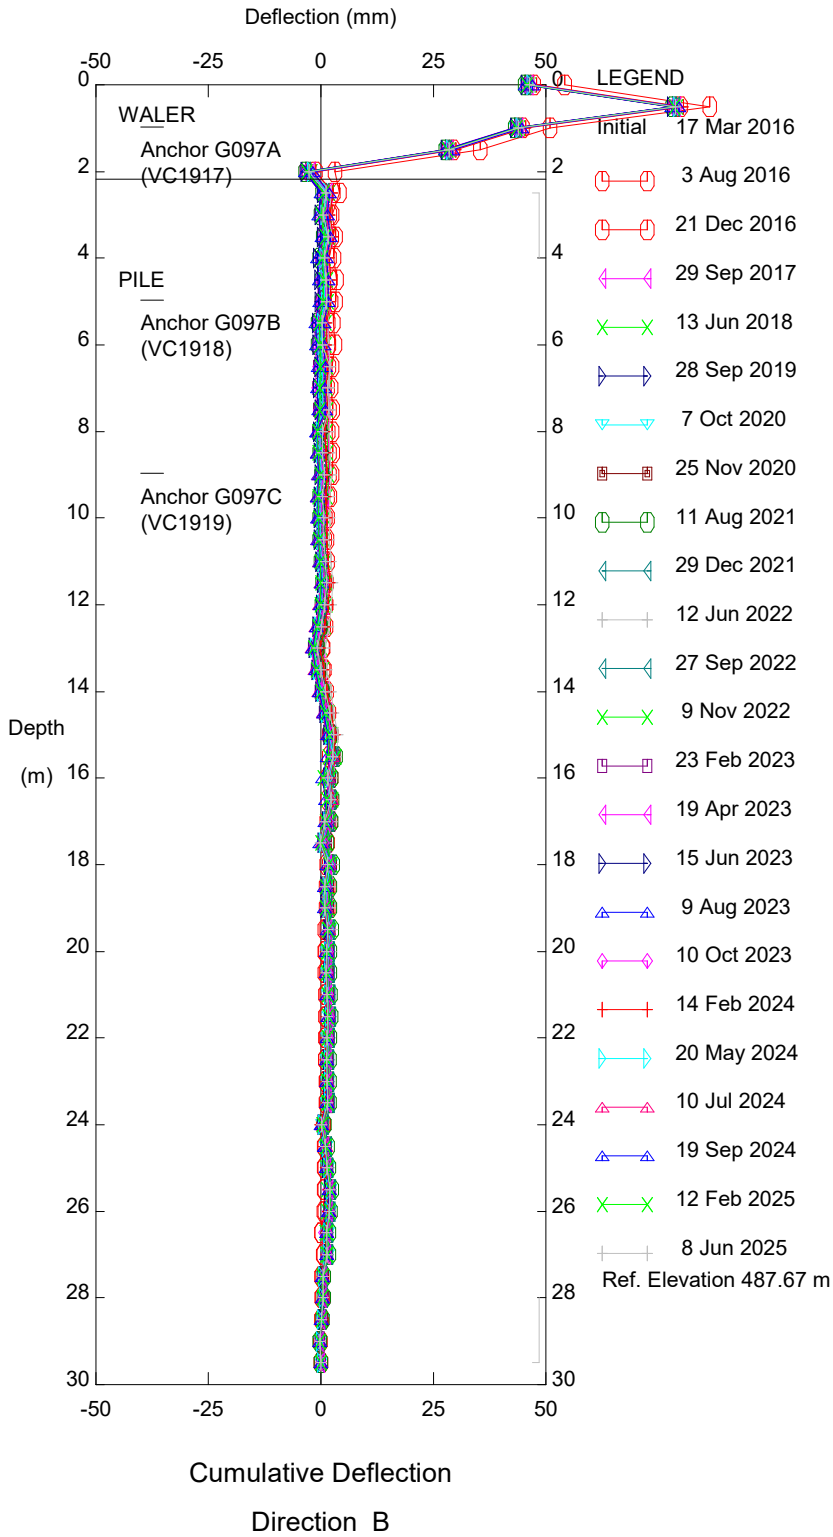
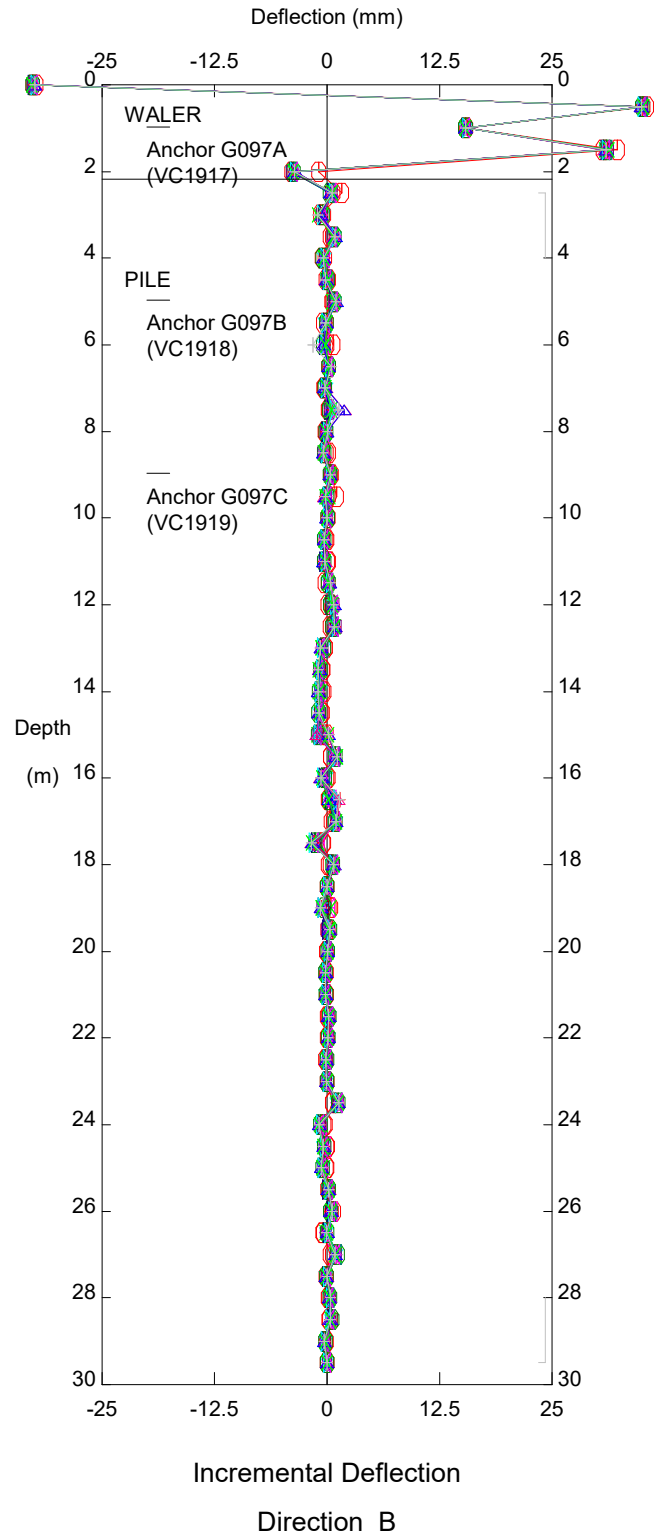
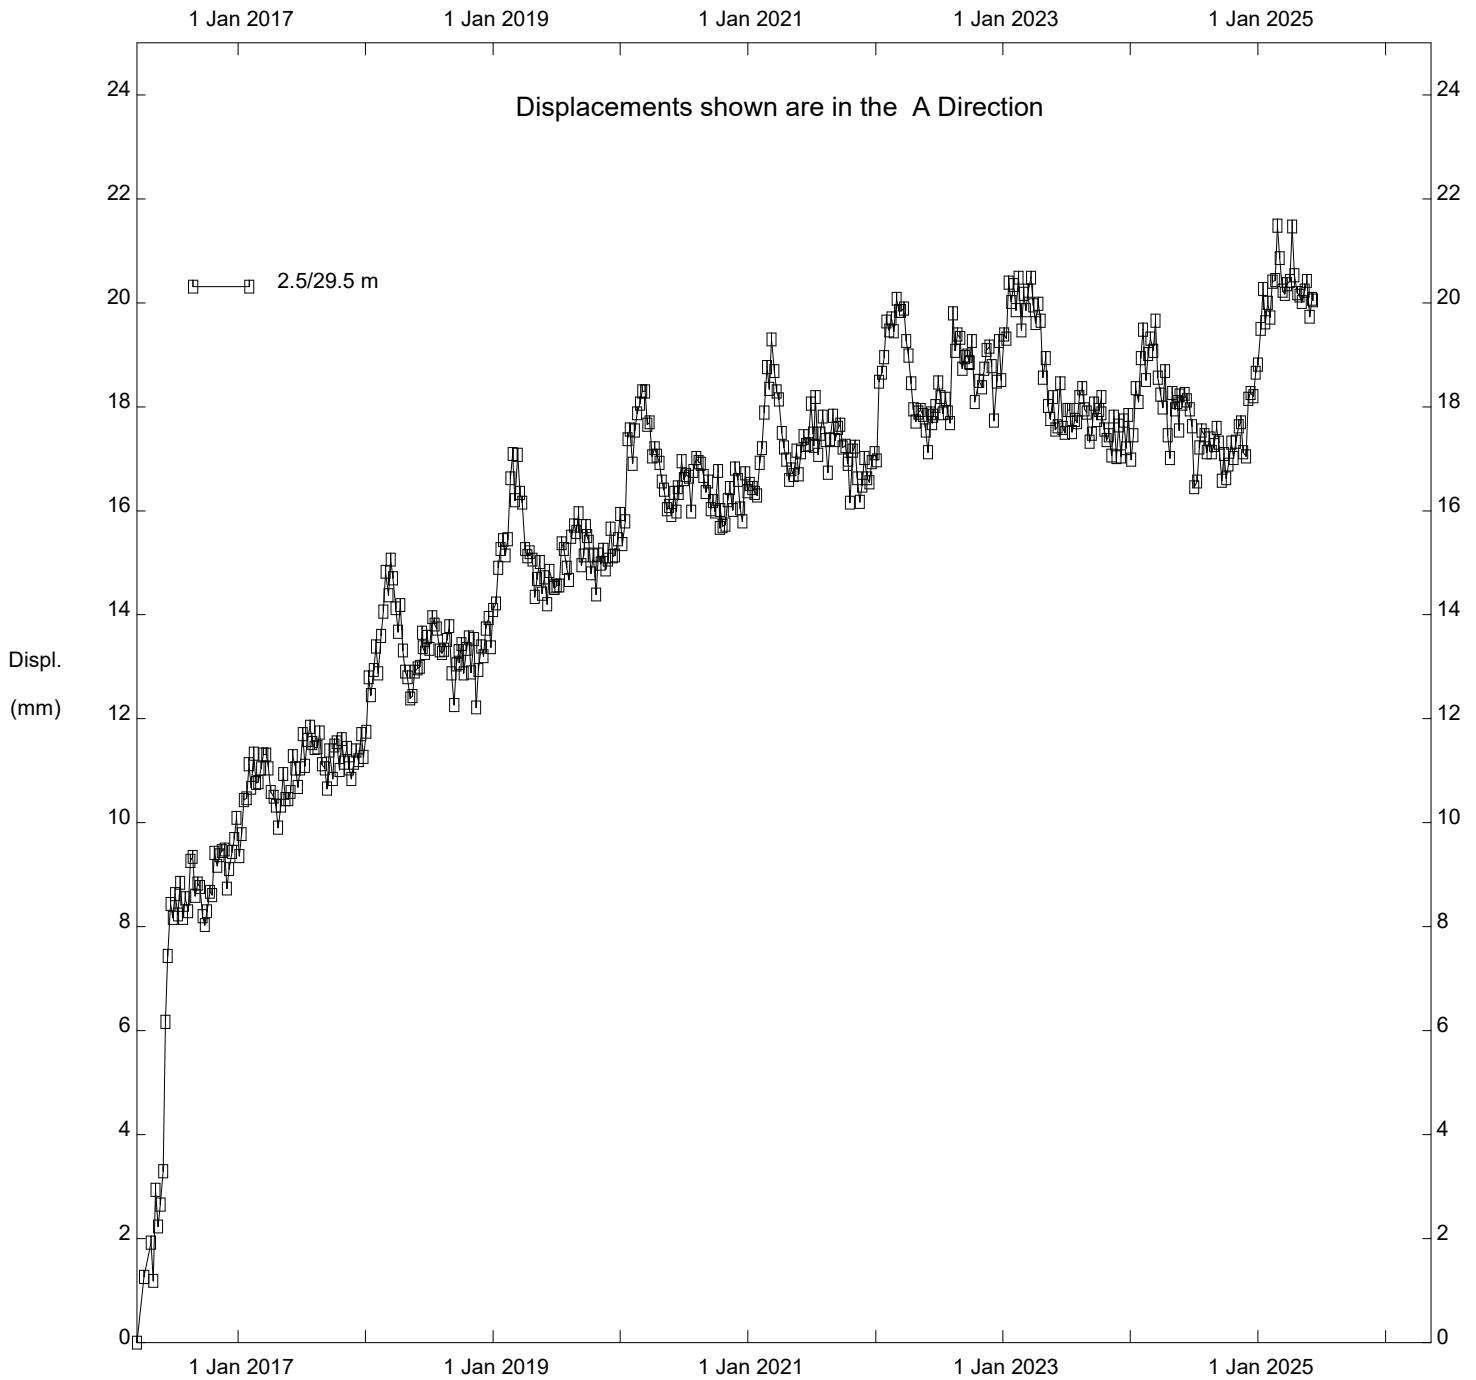
Hwy 986:01 Daishowa West, Inclinator SAA-P097

<p>peaks in the movement of about 3 mm are representative of late winter conditions.</p> <p>SAA-P097 has a rate of movement of 4.8 mm/yr since the fall of 2024 readings. SAA-P097 has shown a total pile head deflection of 20.0 mm in the downslope direction to date. SAA-P097 had shown an overall trend of steady downslope movement since the end of construction, with peaks in the pattern of movement of about 3 mm which are representative of late winter conditions.</p> <p>Strain Gauges</p> <p>The strain gauge readings in Pile P066 are summarized in Table PH071-3 and shown in Figure PH071-3 and PH071-4. Overall, the strain gauges showed relatively small changes in microstrain value compared to the previous readings in the fall of 2024. The greatest change in microstrain was in strain gauge #17 at 2.6 m depth in the downslope face of the pile, which showed a decrease in positive (compressive) microstrain of 11.7 microstrain compared to the fall of 2024 readings.</p> <p>Load Cells</p> <p>The three load cells at each of pile P022, P060 and P097 show similar loading patterns. The middle anchor at each pile carries the greatest load, followed by the upper anchor. The lowest anchor carries the least load. Seasonal peaks in load are recorded during winter months, with loads decreasing to a seasonal trough during summer months. The seasonal peaks are greatest in the upper row of anchors and the least in the lowest anchor row.</p> <p>The load cells generally showed small increases in measured load compared to the fall of 2024 readings, ranging from an increase of 1.0 kN in VC1918 (anchor P097B) to an increase of 5.9 kN in VC1917(anchor P097A). Load Cells VC1919 (anchor P097C), VC1921 (anchor P060C), and VC1925 (anchor P022C) showed the highest loads measured in the respective instruments between February 26 and February 27, 2025.</p> <p>It should be noted that load cells VC1924 (anchor P022A), VC1923 (anchor P022B), VC1922 (anchor P060B), VC1918 (anchor P097B), and VC1919 (anchor P097C) have each lost the function of one vibrating wire channel. The loads that are now reported for these three load cells are based on the average of the two functioning channels and projected reading for the now malfunctioning channel based on the last reading taken for that channel and the changes observed in the other two channels since that time. The damaged channels cannot be repaired.</p> <p>Since the end of construction, the load cells have generally shown an overall trend of increasing load, with the highest seasonal loads measured towards the end of each winter. The current loads measured in the upper two anchor rows at all three piles, as well as the lower row at P022 and P060, are above the design loads. The highest load recorded is 303 kN in P097A, which is 126% of design load, well within the range of performance testing undertaken during construction.</p> <p>Piezometers</p> <p>Vibrating wire piezometers VW16-1A, VW16-1C, VW16-2B, and VW16-2C located upslope of the wall, showed decreases in groundwater level of 0.61 m, 0.16 m, 0.43 m, and 0.16 m respectively since the fall of 2024 readings. VW16-1B, also located upslope of the wall, showed an increase in groundwater level of 0.02 m, respectively since the fall of 2024 readings. The groundwater level of 482.14 m, measured in VW16-2C on September 21, 2024, was the highest measured in the instrument since it was initialized. However, the overall trend since end of construction had been a gradual increase in the groundwater table upslope of the wall to what now appears to be a relatively steady level with cyclical seasonal fluctuations.</p>
