Site Number	Location	Name	Hwy	km
PH071	Hwy 986:01 C1 28.474	Daishowa West Hill	986:01	Km 28.5
Legal Description:		UTM Co-ordinates		
8-9-85-21 W5		11U E 485023	N	6245526

Current Monitoring:	8-Jun-2025	Previous Monitoring	19-Sep-2024
Instruments Read By:	Mr. Niraj Regmi, G.I.T and Mr. Godfred Etiendem, of Thurber

**ALBERTA TRANSPORTATION AND ECONOMIC CORRIDORS GRMP (CON0022164)
PEACE REGION (PEACE RIVER DISTRICT)
INSTRUMENTATION MONITORING RESULTS**

SITE PH071: HWY 986:01, DAISHOWA WEST HILL

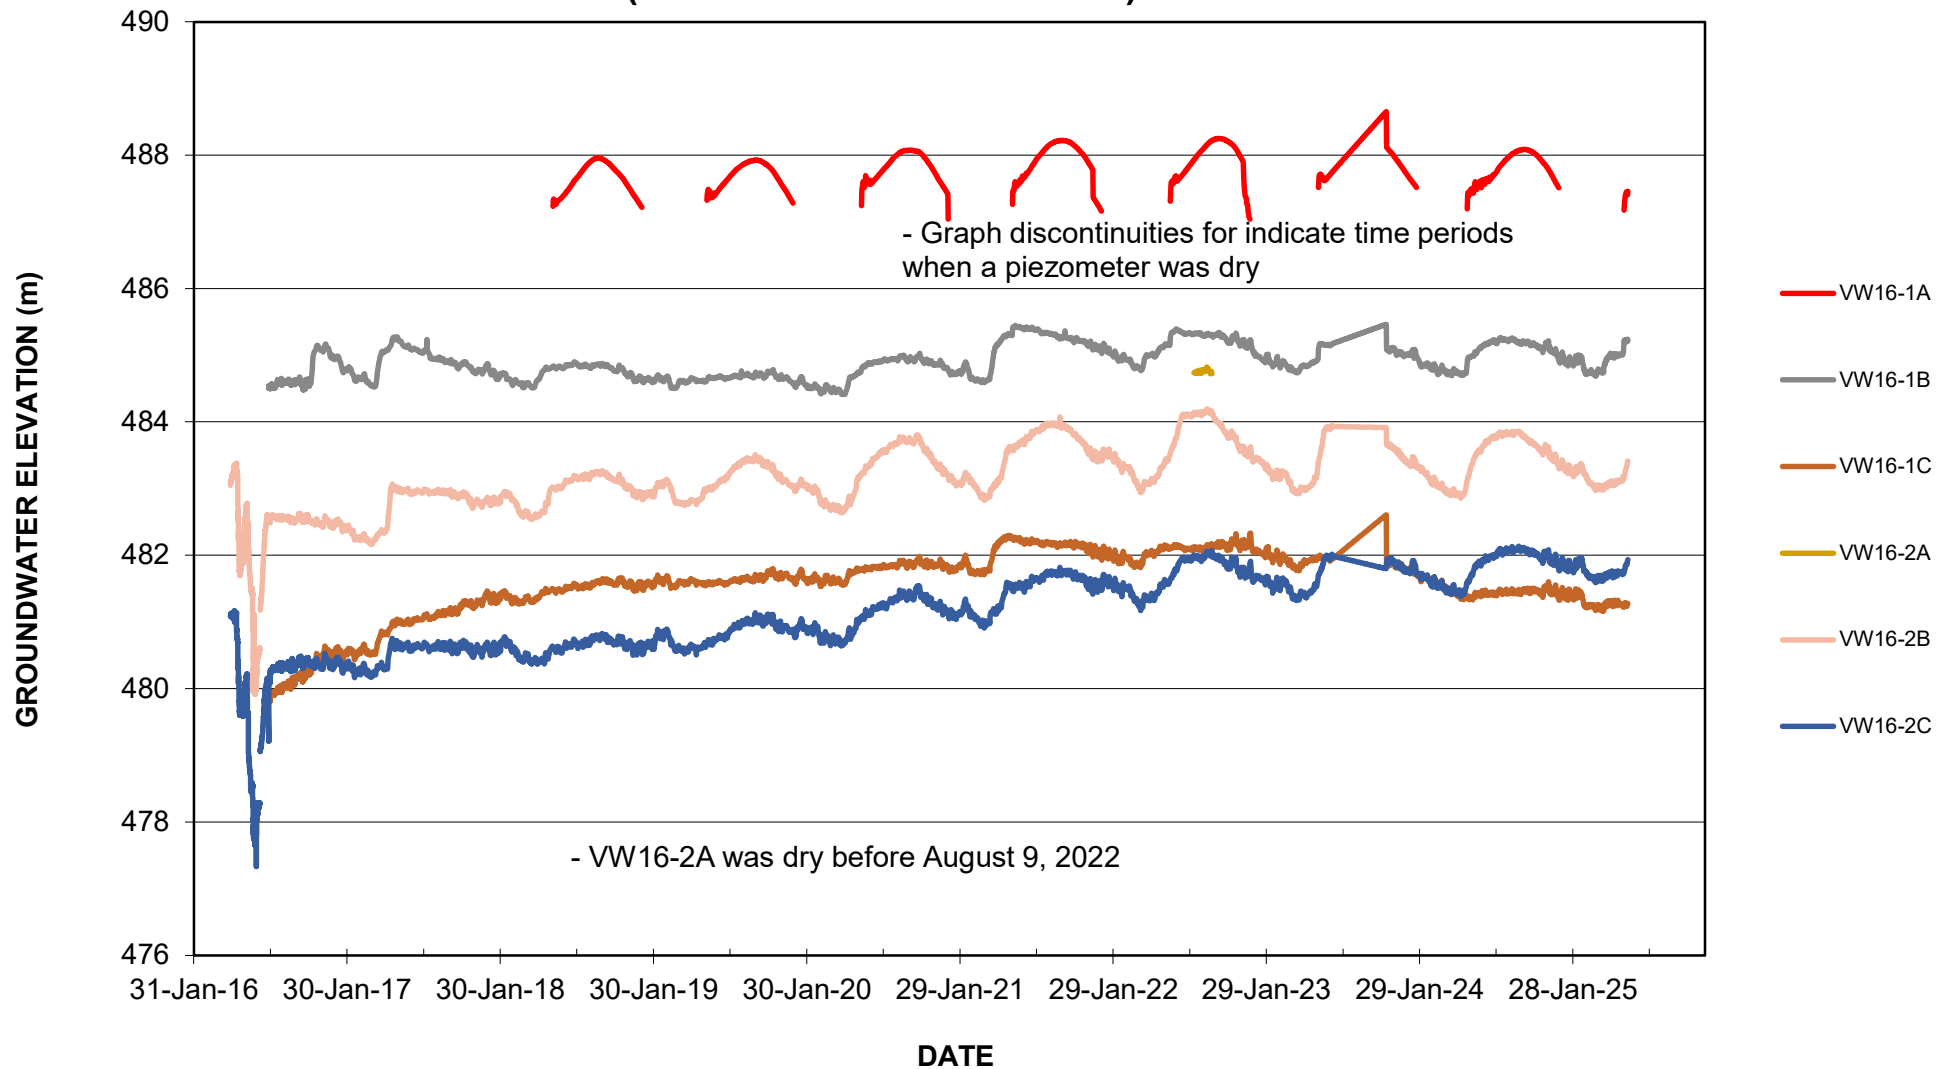
FIGURE PH071-1
PIEZOMETRIC ELEVATION FOR HWY 986:01, DAISHOWA WEST HILL
(UPSLOPE PIEZOMETERS)

<p>VW16-2A continued to be dry (this piezometer has only shown a groundwater level above the tip during a period between August 9, 2022, and September 21, 2022).</p> <p>Of the piezometers located downslope of the wall, VW16-3A showed a decrease in groundwater level of 0.21 m, and VW16-3B showed an increase in groundwater level of 0.32 m since the fall of 2024 readings.</p> <p>VW16-4A and VW16-5A continued to be dry, and tend to remain dry, except for brief periods that correspond to either higher than normal rainfall or spring thaw.</p>
Future Work:	The instruments should be read again in the fall of 2025. It is recommended to continue monitoring the deflections in the pile wall and the load cell readings to see if there are further increases in deflection or loads compared to the warning threshold values. If the deflections and or load cell readings continue to increase, it may become necessary to add additional anchors to the pile wall.

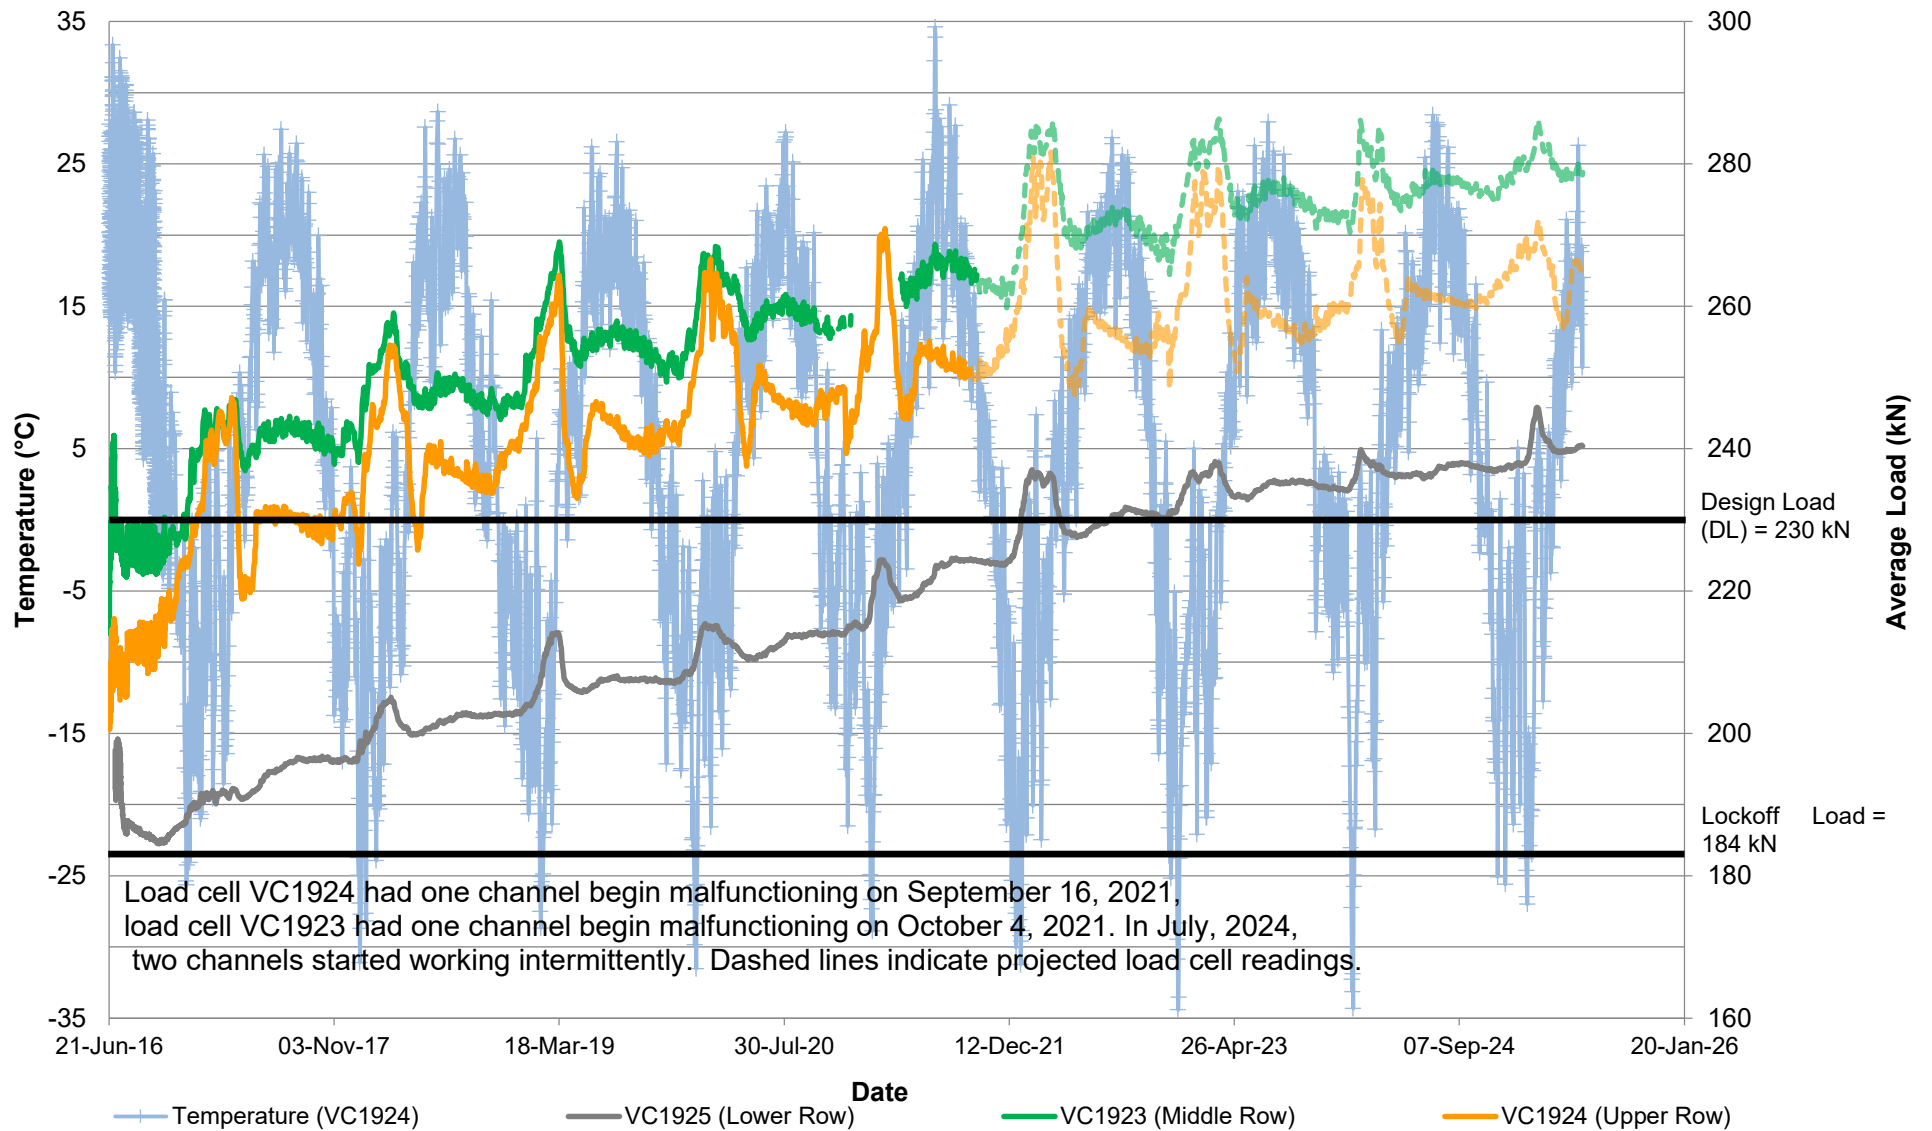
FIGURE PH071-5
LOAD CELL DATA FOR HWY 986:01, DAISHOWA WEST (PILE P022)

Instrumentation Repairs:	No instrument repairs are required at this time.
Additional Comments:	Load cells VC1924 (anchor P022A) and VC1923 (anchor P022B) have not shown a clear trend of leveling off and projected loads are up to 50 kN above the design load level. With respect to these observations, a review of the current anchor load distribution could be undertaken to better assess the pile wall performance.
