GEOHAZARD ASSESSMENT PROGRAM
PEACE REGION – PEACE RIVER/HIGH LEVEL
2013 INSPECTION

Site Number	Location	Name	Hwy	km
PH64	Southwest of Worsley	BF79554 Sideslope Instabilities	64:02	≈52.7
Legal Description		UTM Co-ordinates (NAD 83)		
SW17/NE8-85-8-W6		11 N 6248726	E 363151

**PEACE REGION (PEACE RIVER/HIGH LEVEL)
PH 64 - WATERCOURSE CULVERT ON HWY 64,
22 KM SW OF WORSELY**

2013 PH64 INSPECTION PLAN

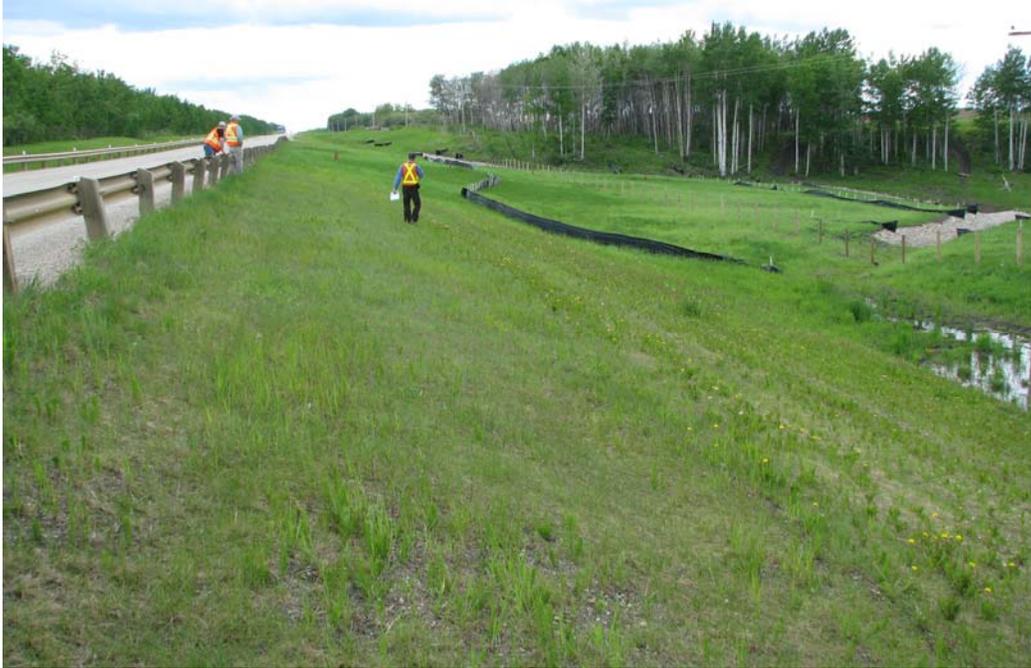
On the north (upstream) side: The inclinometers are still indicating some movements (in particular SI09-1 near the original toe at 6mm/year at elevation 623m, and SI09-3 near the highway with the last reading prior to destruction of 4mm/year at elevation 628m). But these rates of movement appear to be steadily decreasing, and are significantly less than those recorded since the spring of 2012, and this suggests they may be due to settlements as the soil reaches equilibrium from the recent construction.

Photo 1 – Looking northwest at the upstream (north) embankment sideslope and old slide area.

North Embankment (Upstream on north side): Continue monitoring the remaining inclinometers/piezometers, the crack/patch in the WB lane over the old slide, and the erosion at the transitions between the gabions/riprap near the culvert inlet. Patch the dip and seal the crack as required. Repair the 0.5m diameter hole in the gabion wire on the west flank just on the south side of the fence. The transitions of the gabions/riprap should be repaired by removing the riprap and damaged gabion baskets in the affected eroded areas, rebuilding the base with well compacted clay to form a ~1m vertical elevation drop at the new transition point of gabion to riprap and extending the compacted clay underneath the culvert collar to provide support, install a steel plate the entire width of the channel and extending at least 1m below the lower riprap base level, install new gabions with non-woven underlay on the compacted clay upper level, install new non-woven and additional riprap as required on the compacted clay lower level, and place the new gabions so that it extends a minimum lateral distance of 1m overtop the newly placed riprap at the compacted lower level.

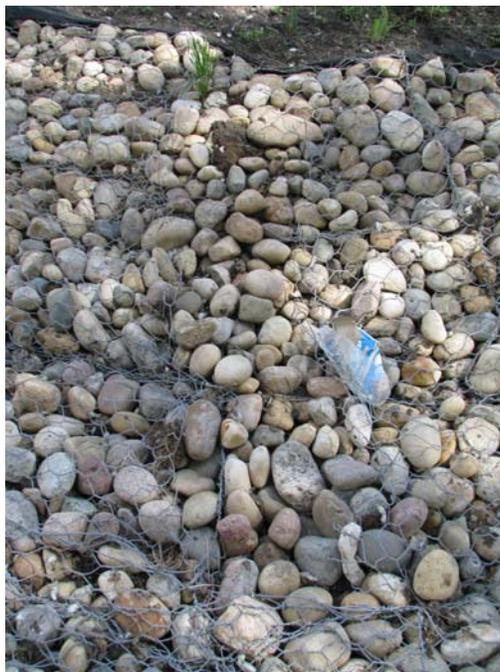
Photo 2 - Looking at the hole in the gabion mattress wire along the west flank just south of the fence. The unsecured area appears to have enlarged since last year.

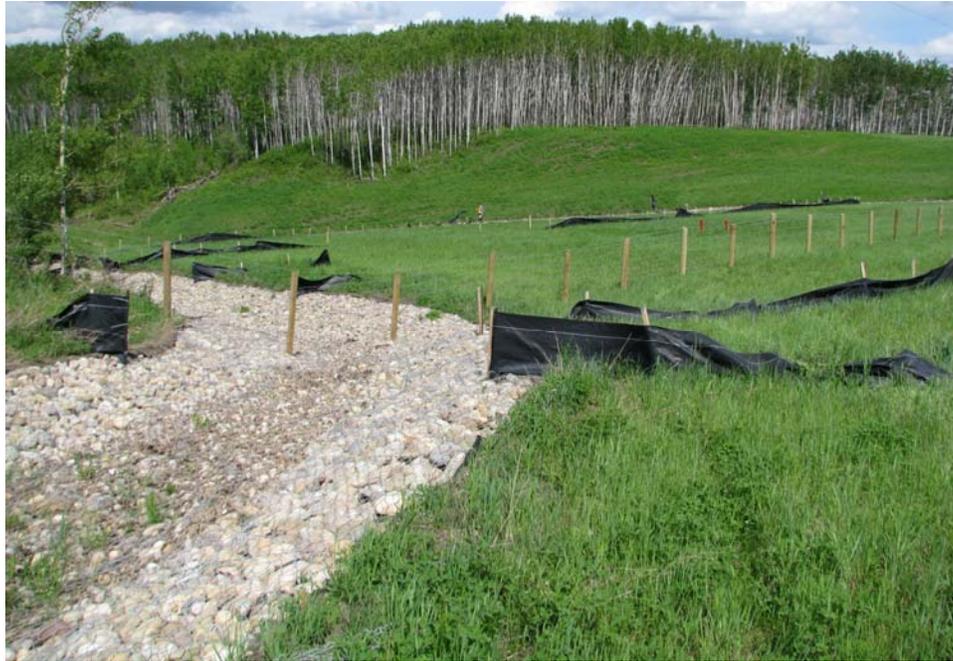
Photo 3 - Looking northeast at the toe of the upstream slope and south gabion leading to the culvert inlet of the north embankment.

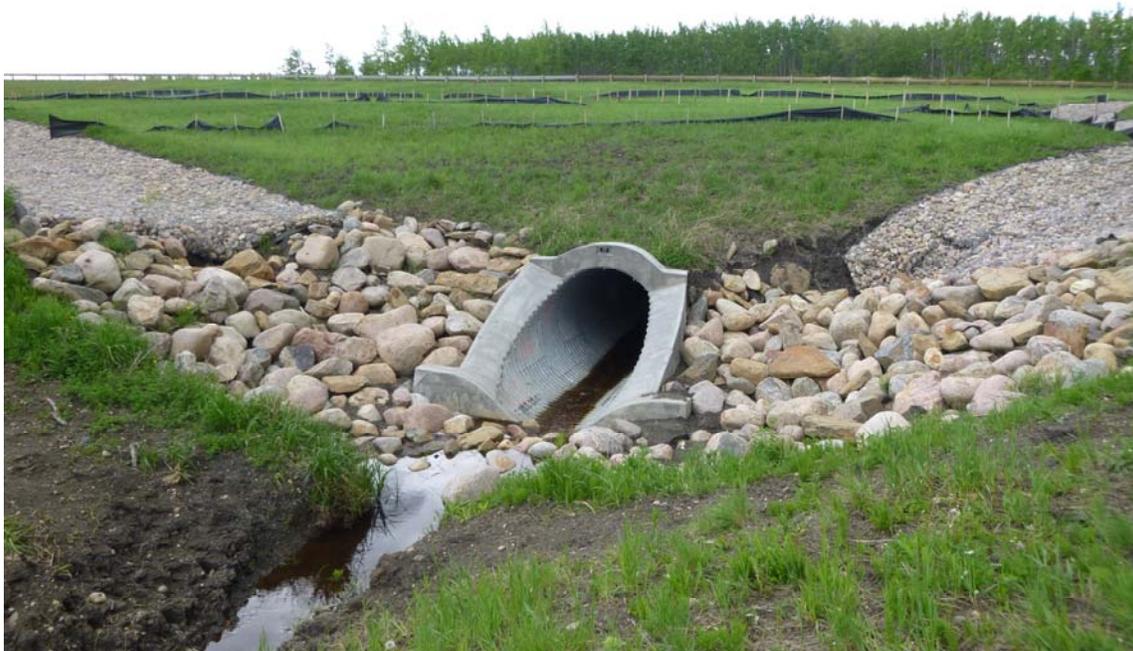
The erosion observed last year at the transitions between the gabions and the riprap near the culvert inlets has increased on the west side where it has migrated to create soil loss underneath the culvert inlet concrete collar.

Photo 4 - Looking south at the culvert inlet and gabion/riprap transition areas. Note the erosion at the transitions between the gabion and riprap areas on both sides of the culvert.

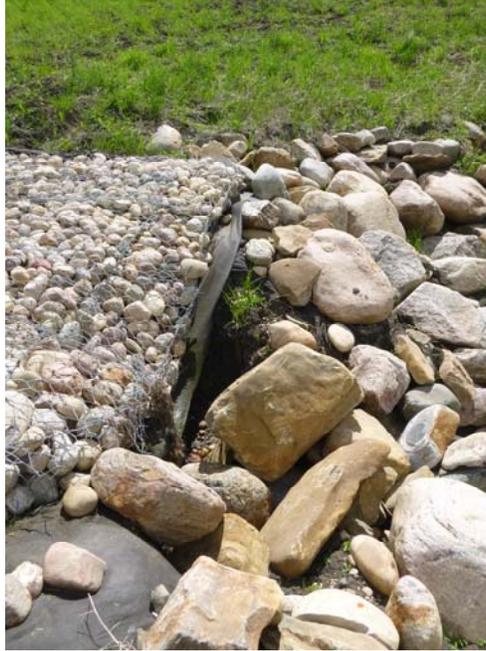
Photo 5 - Looking at the east gabion/riprap transition leading to the culvert inlet. Some more separation and undermining/erosion has occurred since last year, causing distress to the last 1m length of gabion baskets.

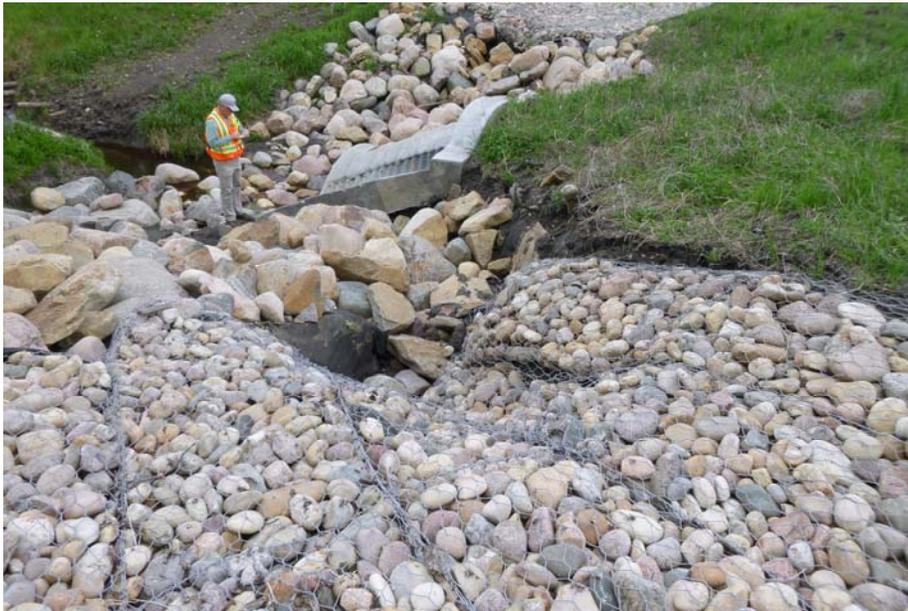
<input type="checkbox"/> Seepage		<input type="checkbox"/>
<input checked="" type="checkbox"/> Bridge/Culvert Distress	Some undermining of the west side of the concrete collar at the culvert inlet is beginning to form from the liner transition erosion noted above.	<input type="checkbox"/>
<input type="checkbox"/> Other		<input type="checkbox"/>

Photo 6 - Looking at the west gabion/riprap transition leading to the culvert inlet. More undermining/erosion has occurred since last year, causing subsidence to the last 2 m length of gabion baskets, and undermining the concrete collar of the culvert inlet.

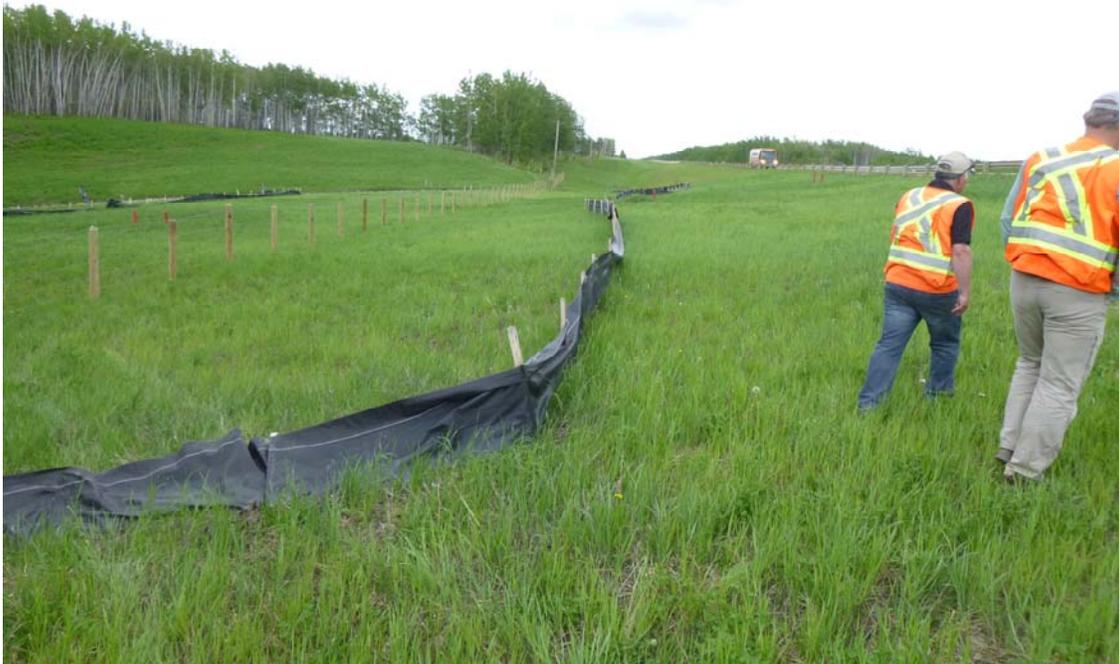
Photo 7 - Looking east along the south embankment slope from the west end.

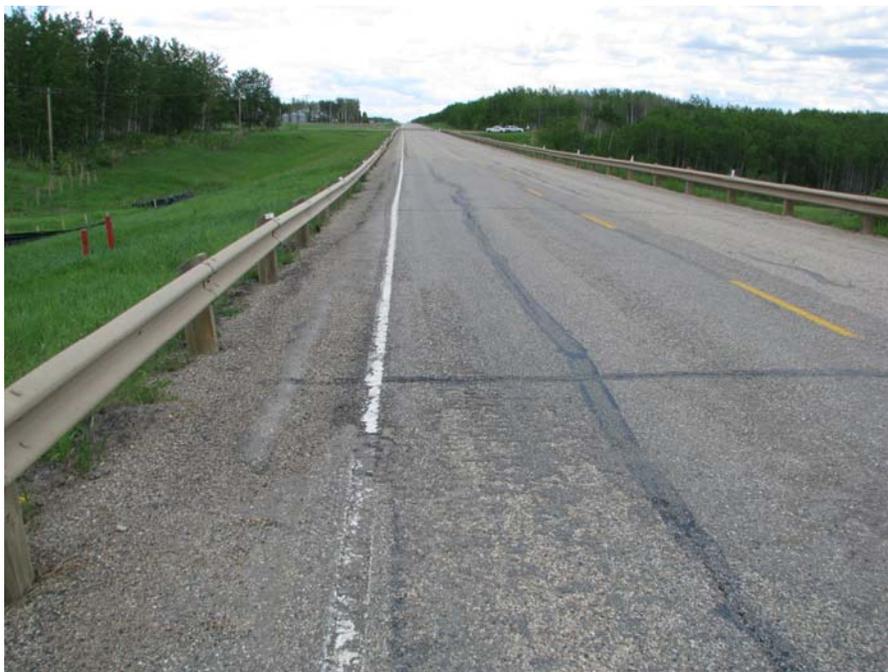
Photo 8 – Looking east along the highway where the north embankment slide has affected the road. The crack with 25 mm differential settlement still exists through the old patch.

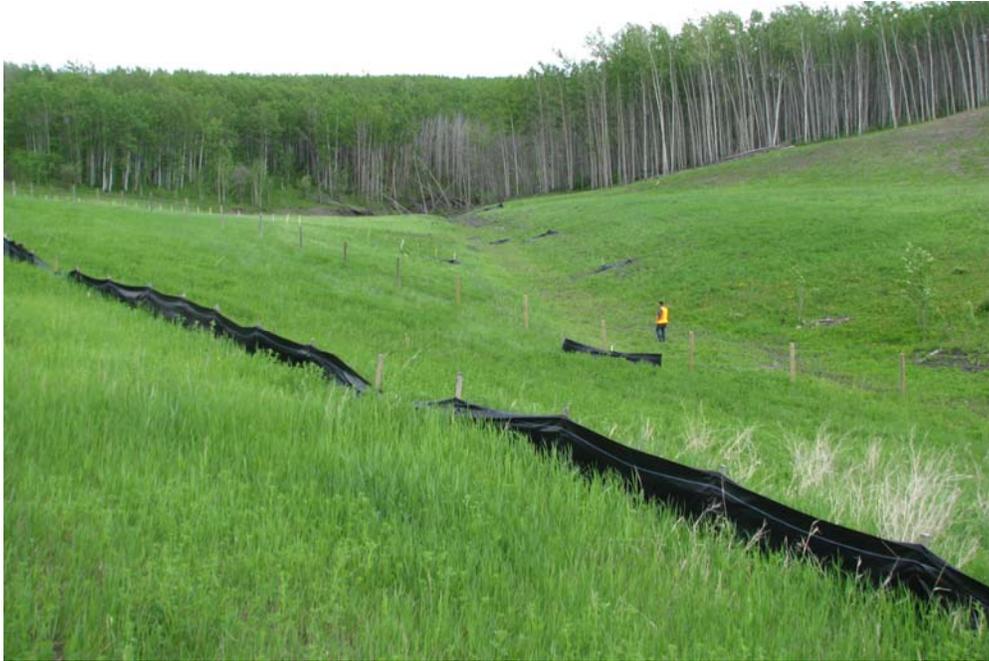
Photo 9 – Looking southeast along the south embankment slope from the west end.

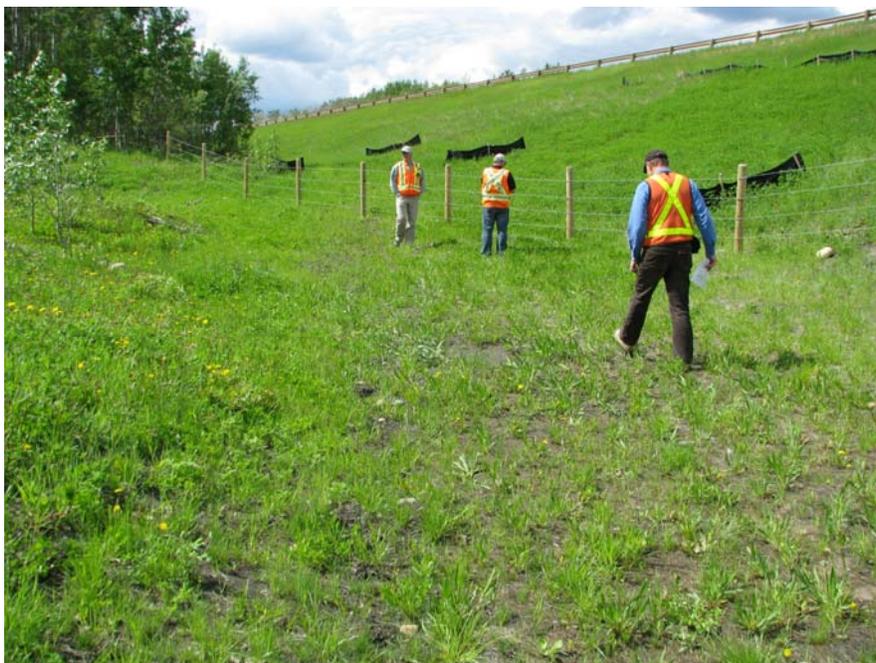
Photo 10 - Looking northwest at the west flank of the beginning of the erosion control soil covering (ECSC) liner. Note that the surface runoff erosion observed last year off of the outside edge of the ECSC liner has diminished and is now OK.

South Embankment (Downstream or south side): Monitor the extent of the slide downstream of the riprap bowl and in the channel to see if it enlarges. Monitor the erosion on the west ECSC to ensure it has abated.

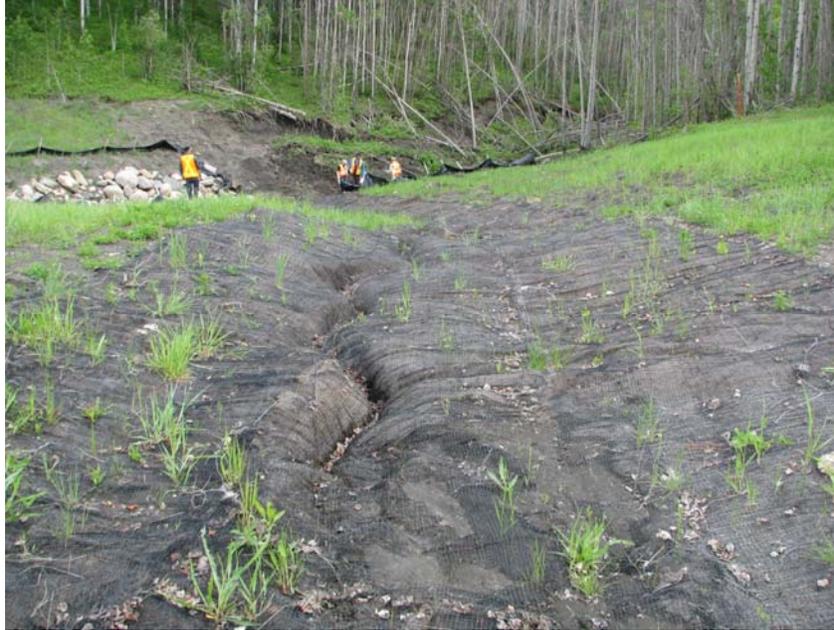
Photo 11 - Looking southeast along the ECSC liner towards the culvert outlet. Note that the erosion control liner has settled neatly overtop of the erosion gully that formed underneath the liner, and now appears to be functioning properly.

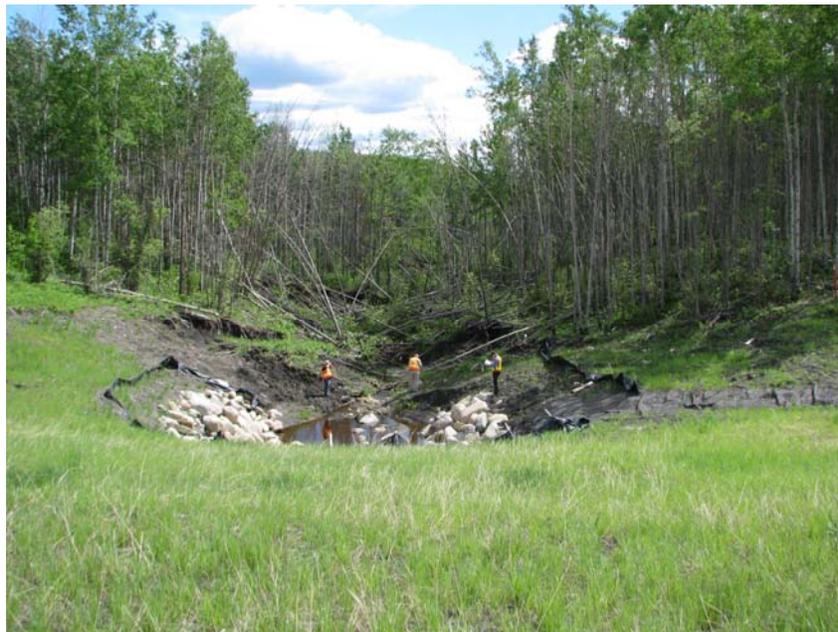
On the South (downstream) side: The slide repair did not extend beyond the end of the riprap bowl at the culvert outlet, and significant slumping was observed on the channel walls further downstream of the riprap. It is possible the slide could eventually enlarge and extend back into the riprap bowl area. The erosion observed last year along the edge of and extending underneath the west ditch liner has diminished, and appears to be OK.

Photo 12 – Looking south at the culvert outlet area. Note the slumping on both sides of the drainage channel further downstream of the ripped area.

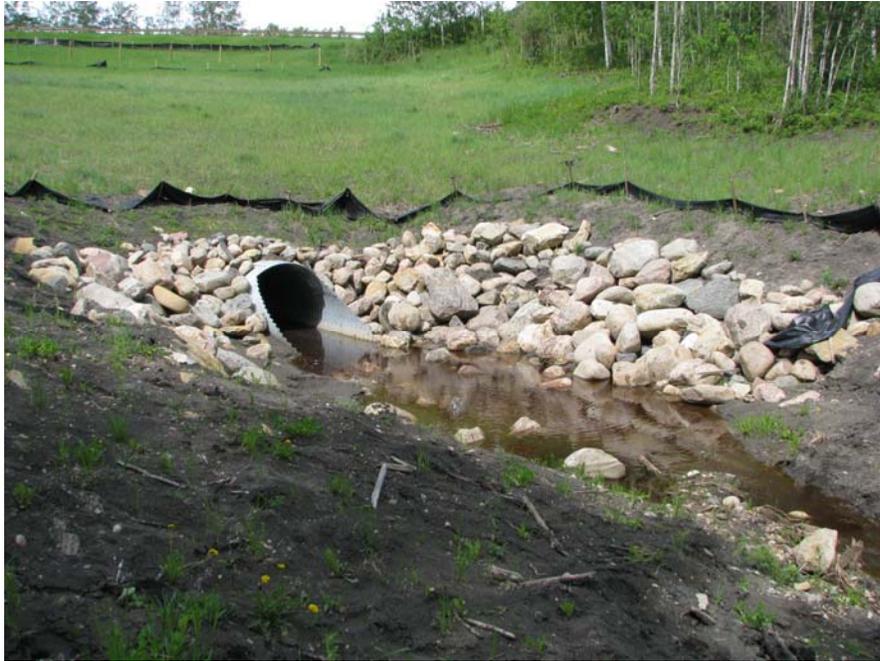
Photo 13 - Looking northeast at the culvert outlet area and downstream embankment slope.

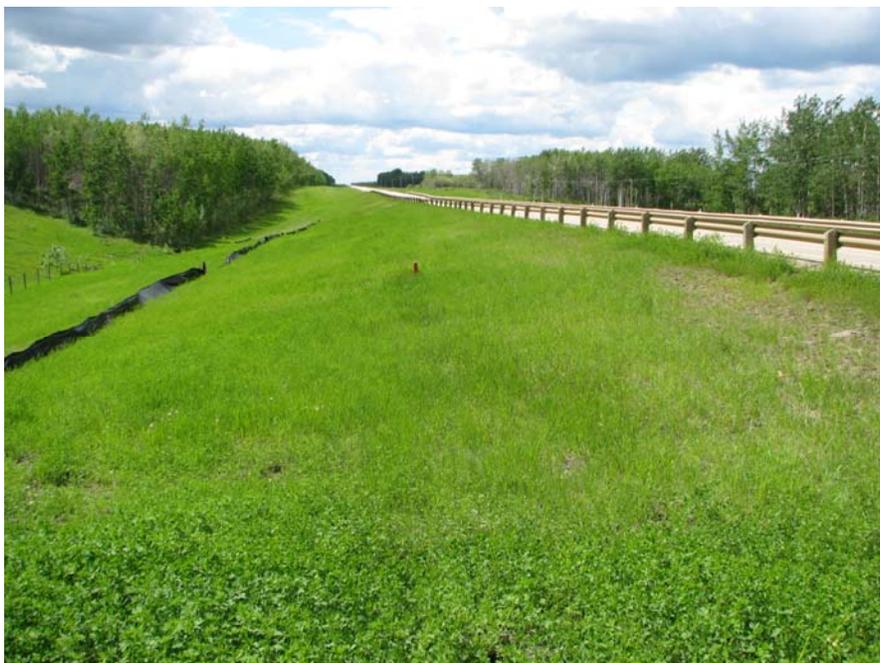
Photo 14 - Looking west parallel to the highway along the well vegetated downstream embankment.
