**GEOHAZARD ASSESSMENT PROGRAM**  
**PEACE REGION – PEACE RIVER/HIGH LEVEL**  
**2014 INSPECTION**

Site Number	Location	Name	Hwy	km
PH64	Southwest of Worsley	BF79554 Sideslope Instabilities	64:02	≈52.7
Legal Description		UTM Co-ordinates (NAD 83)		
SW17/NE8-85-8-W6		11 N 6248726	E 363151

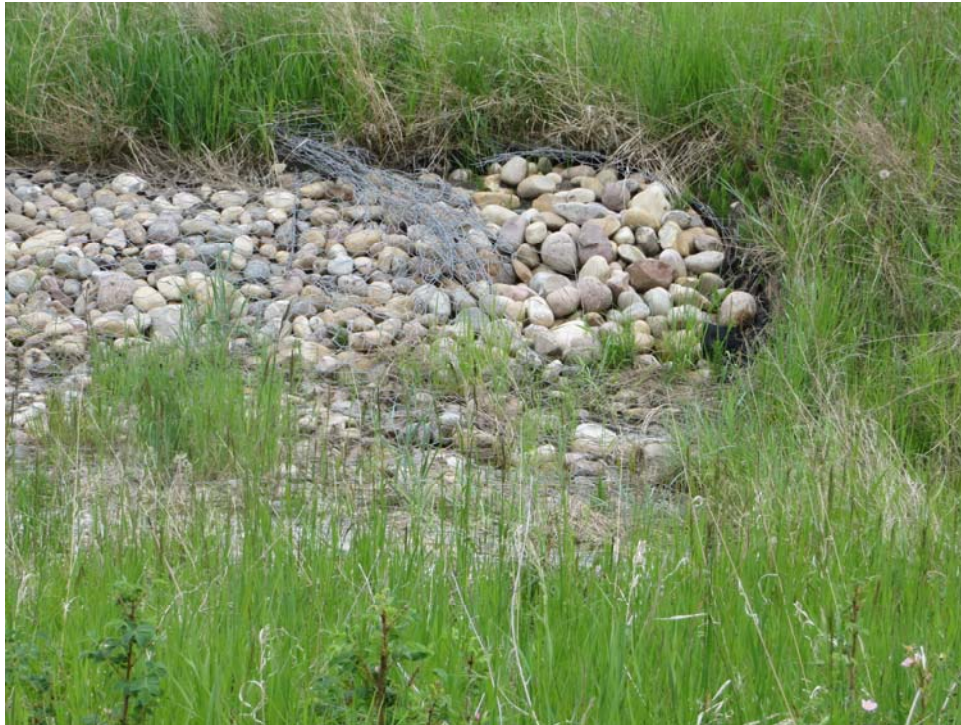
Photo 1 - Looking at a torn gabion mattress wire at the beginning of the west flank on the north side of the highway.

Repair the two gabion baskets that are torn.

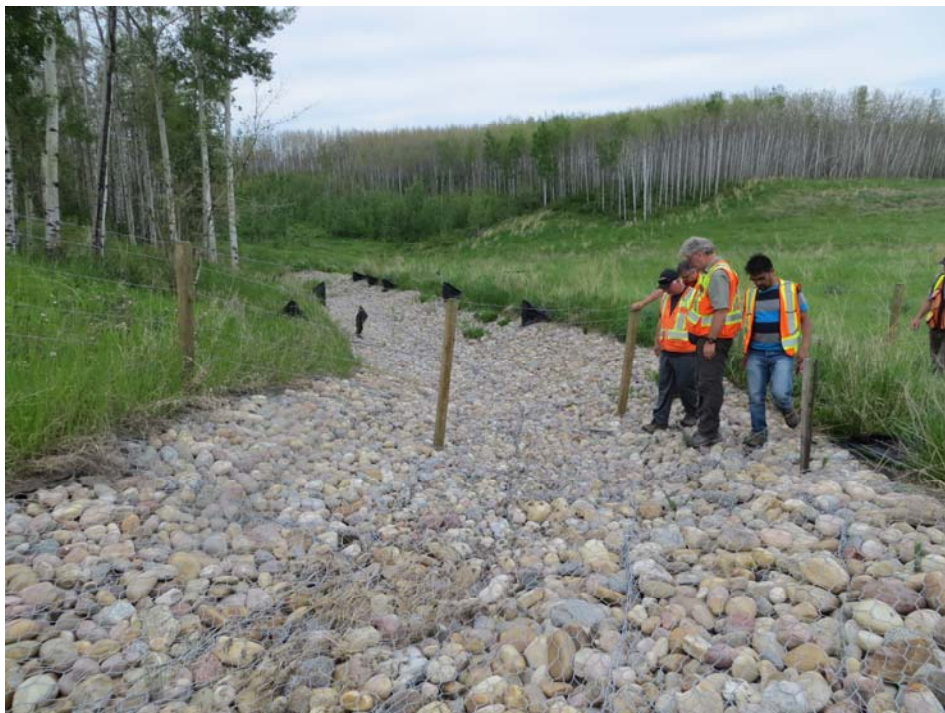
Photo 2 - Looking northeast at the toe of the upstream slope and south gabion leading to the culvert inlet of the north embankment.

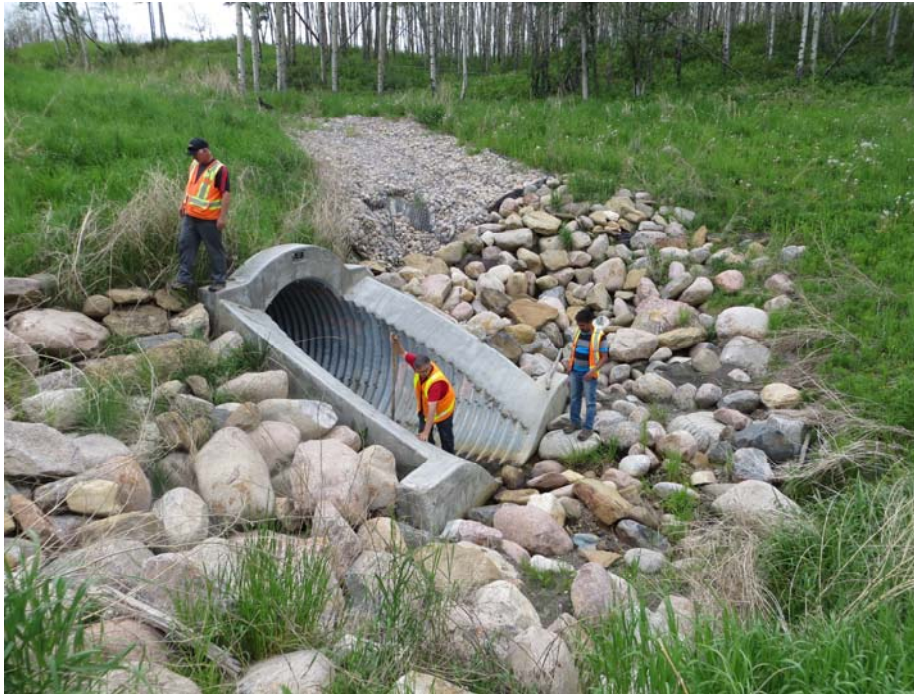
The erosion observed last year at the transitions between the gabions and the riprap near the culvert inlets has increased on both the west and east sides, and on the west side it has migrated to create soil loss underneath the culvert inlet concrete collar.

Photo 3 - Looking northwest at the culvert inlet and gabion/riprap transition areas. Note the erosion at the transitions between the gabion and riprap areas on both sides of the culvert.

North Embankment (Upstream on north side): Continue monitoring the remaining inclinometers/piezometers, the cracks/patch in the WB lane over the old slide, and the erosion at the transitions between the gabions/riprap near the culvert inlet. Patch the dip and seal the crack as required. Repair the two torn gabion mattress wire areas on the west flank south of the fence. The transitions of the gabions/riprap should be repaired (see Photo 6 attached) by removing the riprap and damaged gabion baskets in the affected eroded areas, rebuilding the base with well compacted clay to form a ~1m vertical elevation drop at the new transition point of gabion to riprap and extending the compacted clay underneath the culvert collar to provide support, install a vertical steel plate the entire width of the channel and extending at least 1m below the lower riprap base level, install new gabions with non-woven underlay on the compacted clay upper level, install new non-woven and additional riprap as required on the compacted clay lower level, and place the new gabion mat so that it extends a minimum lateral distance of 1m overtop the newly placed riprap at the compacted lower level.

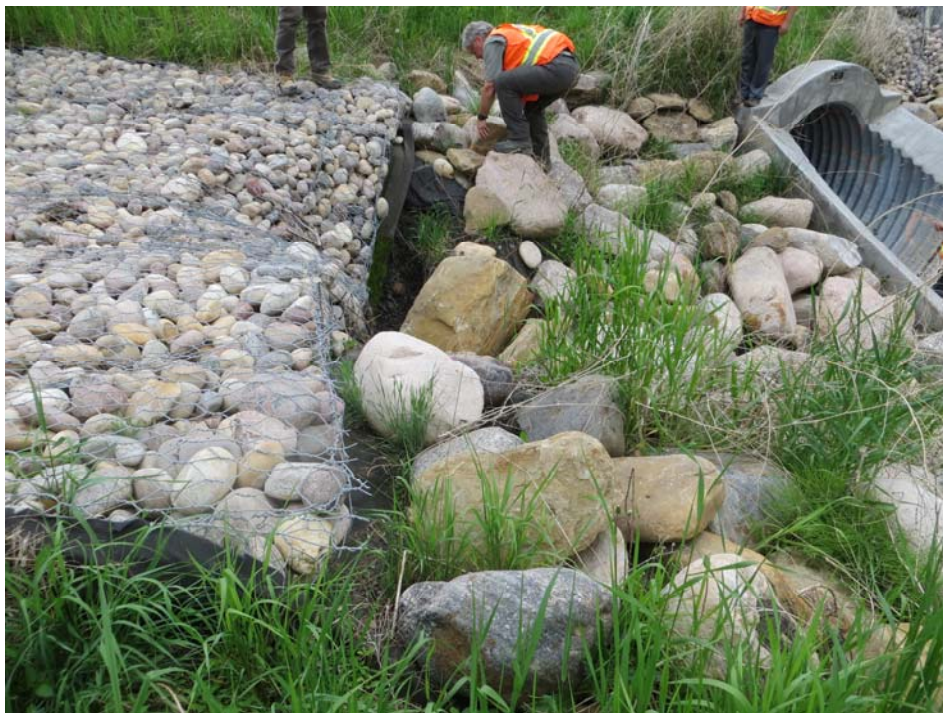
Photo 4 - Looking at the east gabion/riprap transition leading to the culvert inlet. Some more separation and undermining/erosion has occurred since last year, causing distress to the last 1m length of gabion baskets.

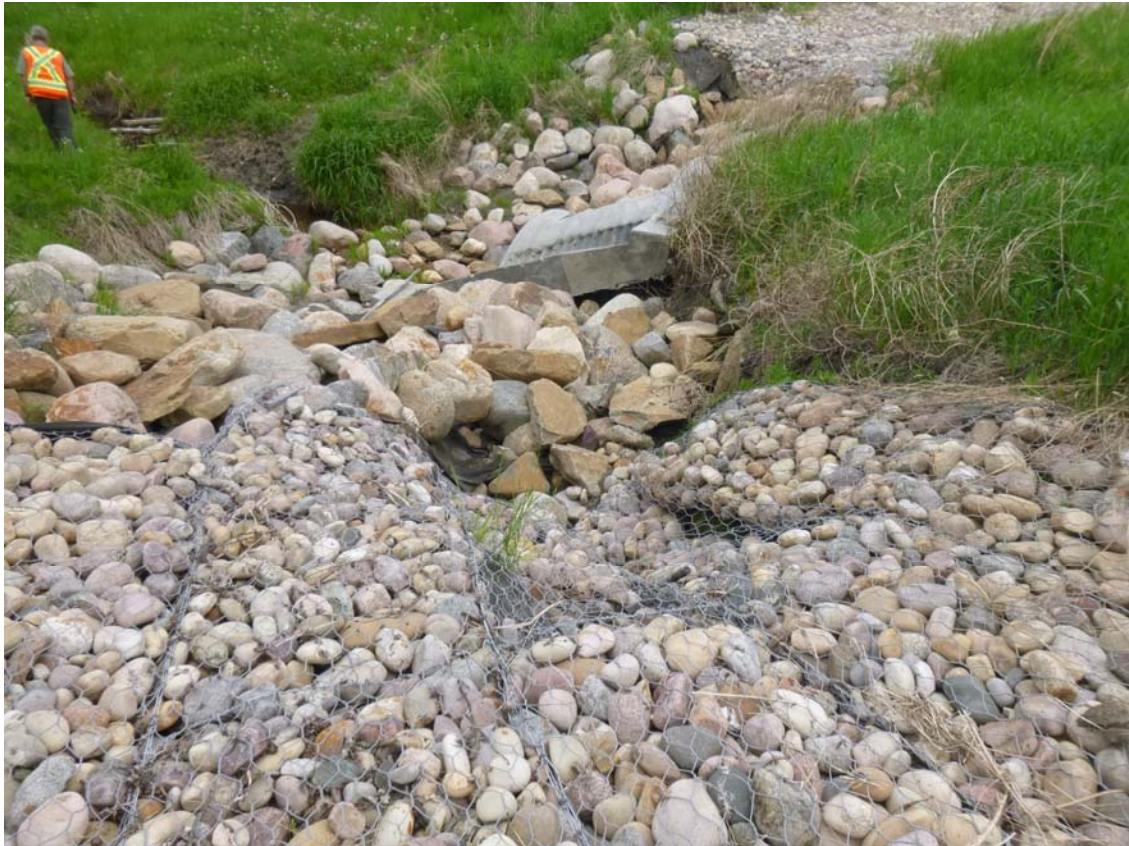
<input type="checkbox"/> Seepage		<input type="checkbox"/>
<input checked="" type="checkbox"/> Bridge/Culvert Distress	Some undermining of the west side of the concrete collar at the culvert inlet is beginning to form from the liner transition erosion noted above.	<input type="checkbox"/>
<input type="checkbox"/> Other		<input type="checkbox"/>

Photo 5 - Looking at the west gabion/riprap transition leading to the culvert inlet. More undermining/erosion has occurred since last year, causing subsidence to the last 2 m length of gabion baskets, and undermining the concrete collar of the culvert inlet.

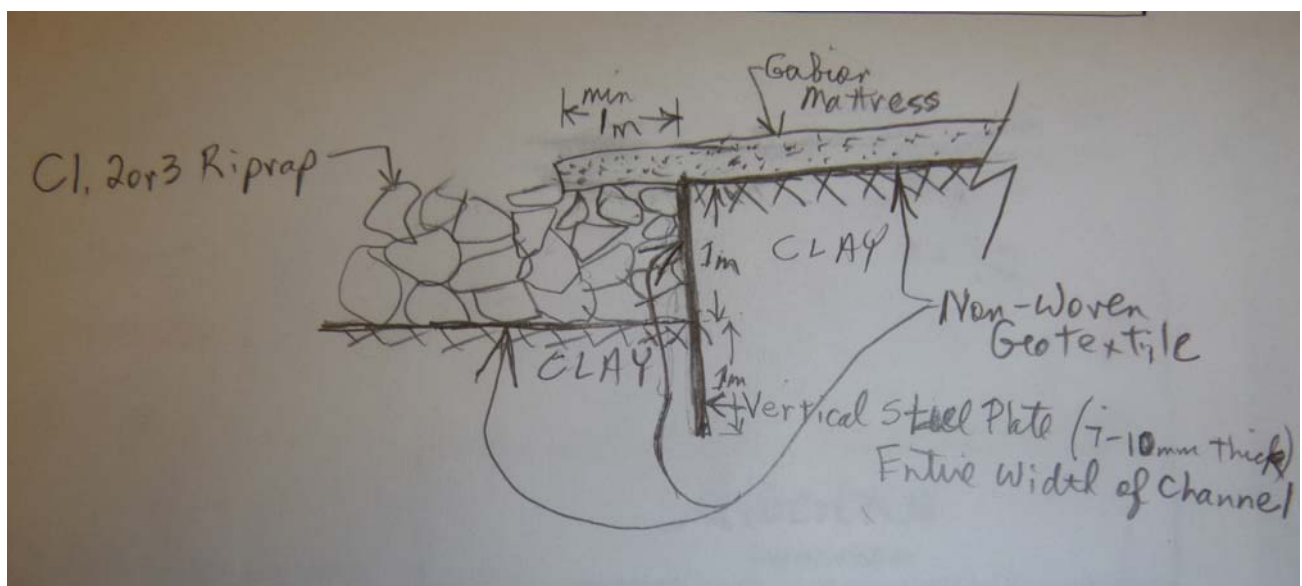
Photo 6 – A proposed repair sketch for the gabion to riprap transition areas.

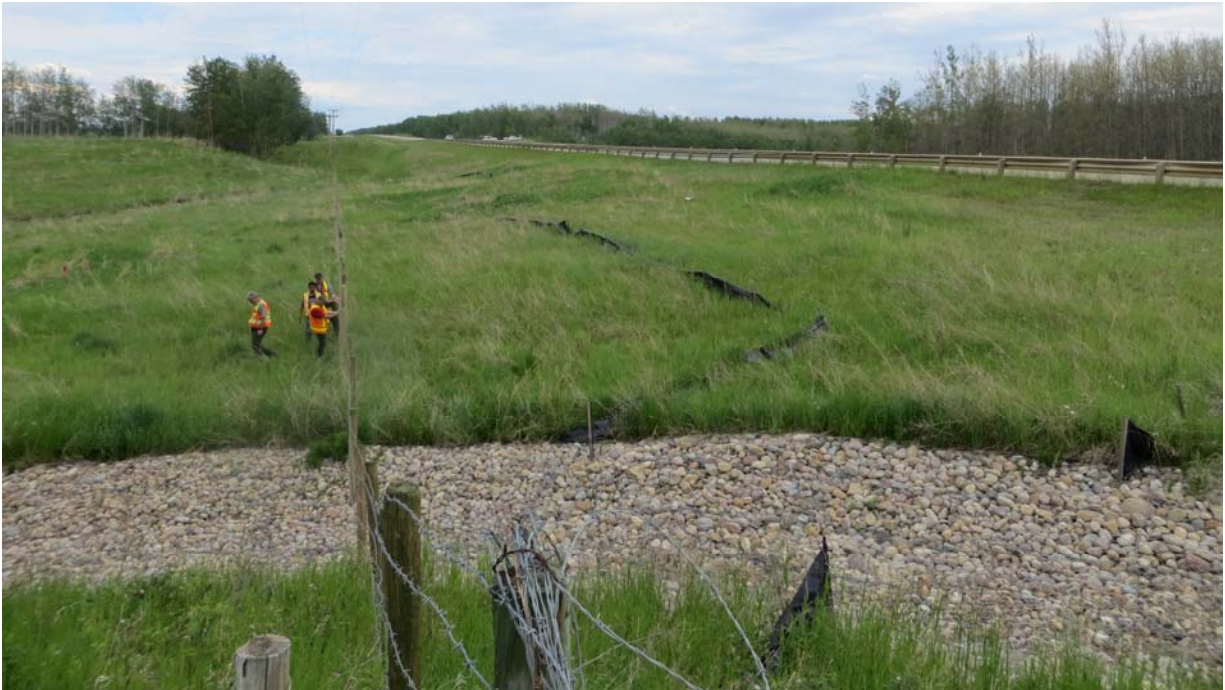
Photo 7 - Looking east along the south embankment slope from the west end.

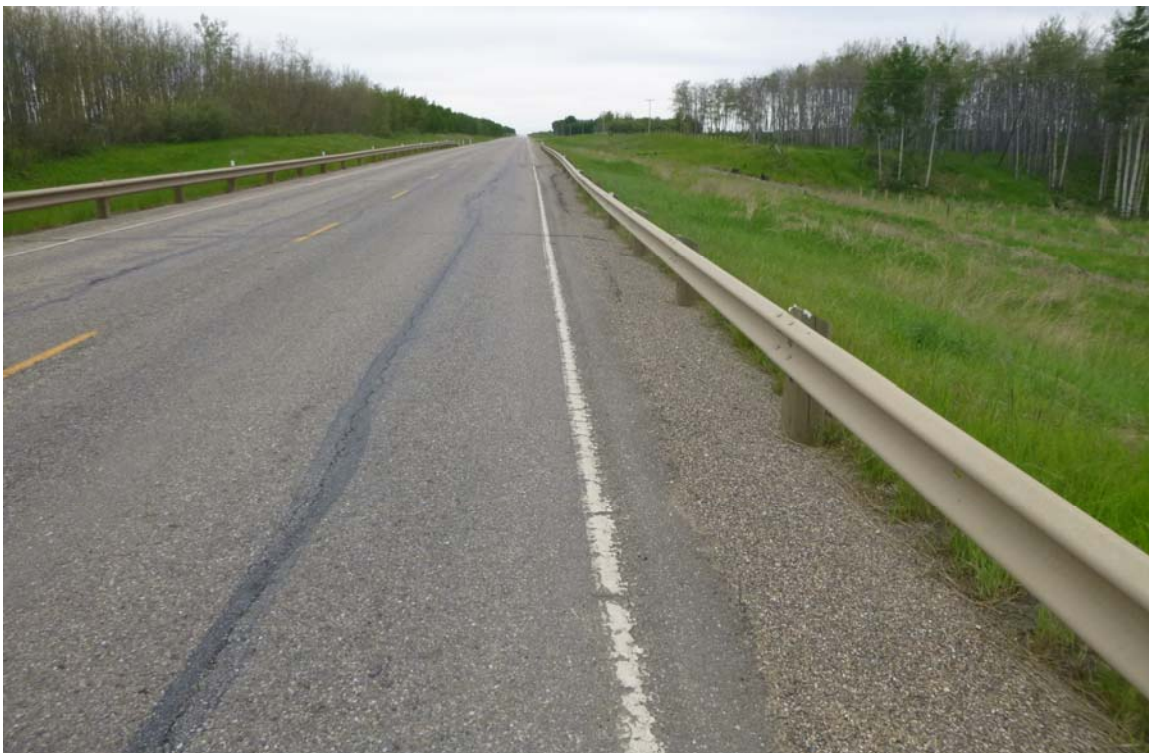
Photo 8 – Looking west along the highway where the north embankment slide has affected the road. The crack along the OWP through the old patch has increased to 30 mm differential this year, and a new crack about 100 mm wide exists along the north edge.

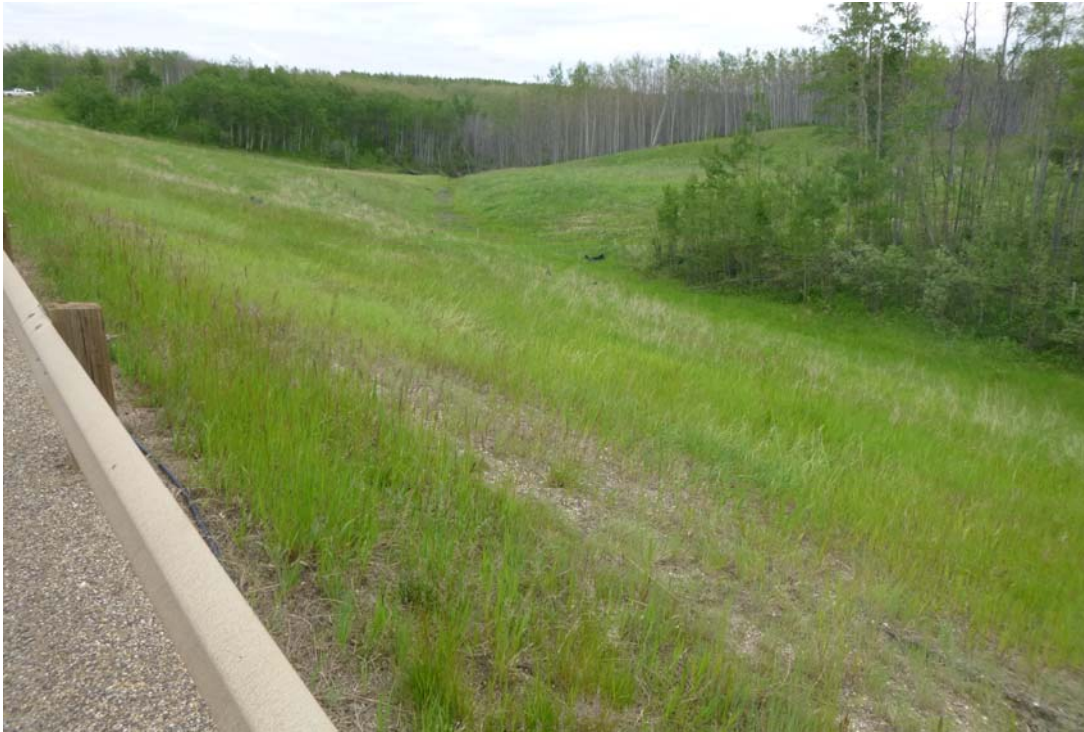
Photo 9 – Looking southeast along the south embankment slope from the west end.

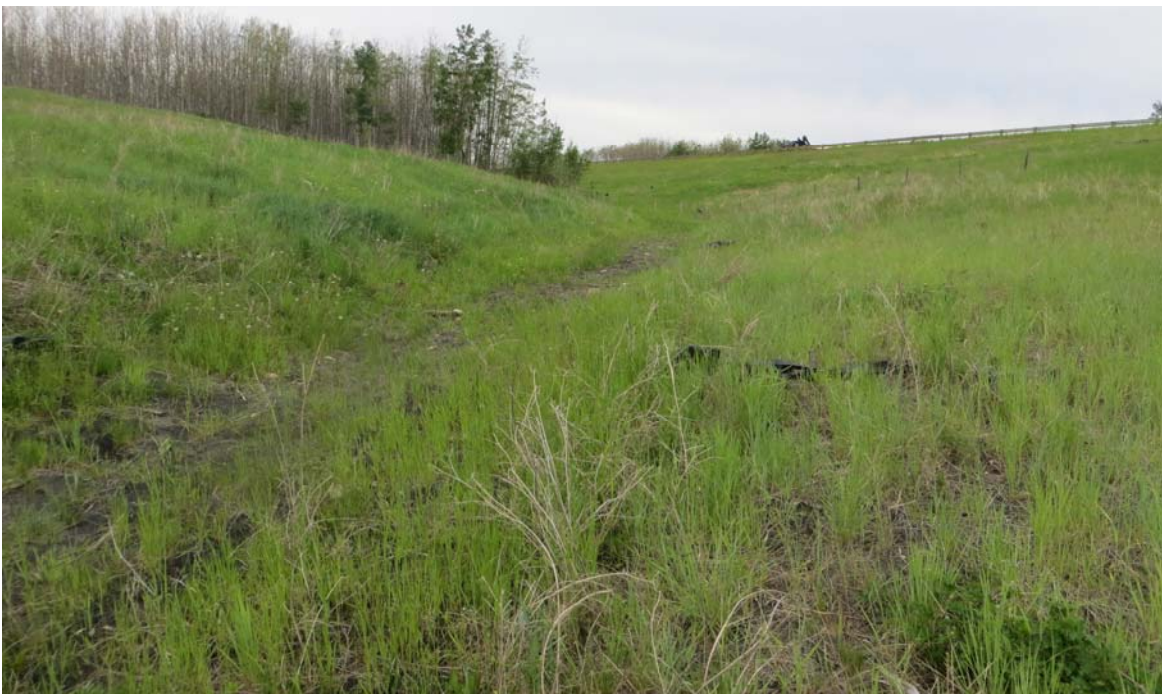
The erosion observed two years ago along the edge of and extending underneath the west ditch liner has diminished, and appears to be OK.

Photo 10 - Looking northwest at the west flank of the beginning of the erosion control soil covering (ECSC) liner south of the highway. Note that the surface runoff erosion observed last year off of the outside edge of the ECSC liner has diminished and is now OK.

South Embankment (Downstream or south side): Monitor the extent of the slide downstream of the riprap bowl and in the channel to see if it enlarges. Monitor the erosion on the west ECSC to ensure it has abated.

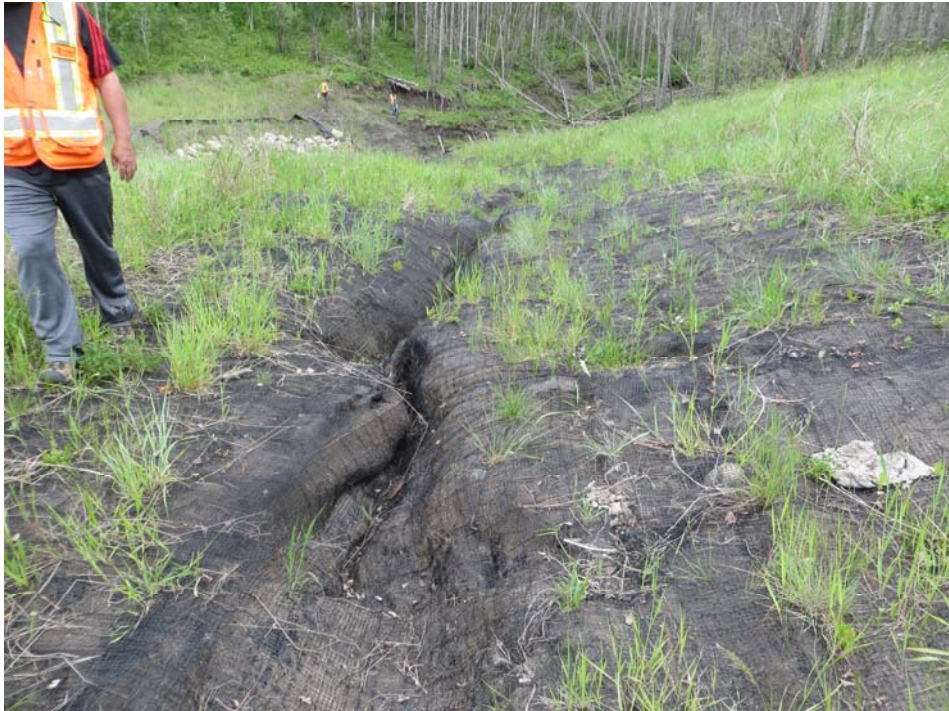
Photo 11 - Looking southeast along the ECSC liner towards the culvert outlet. Note that the erosion control liner has settled neatly overtop of the erosion gully that formed underneath the liner, and now appears to be functioning properly (unchanged from last year).

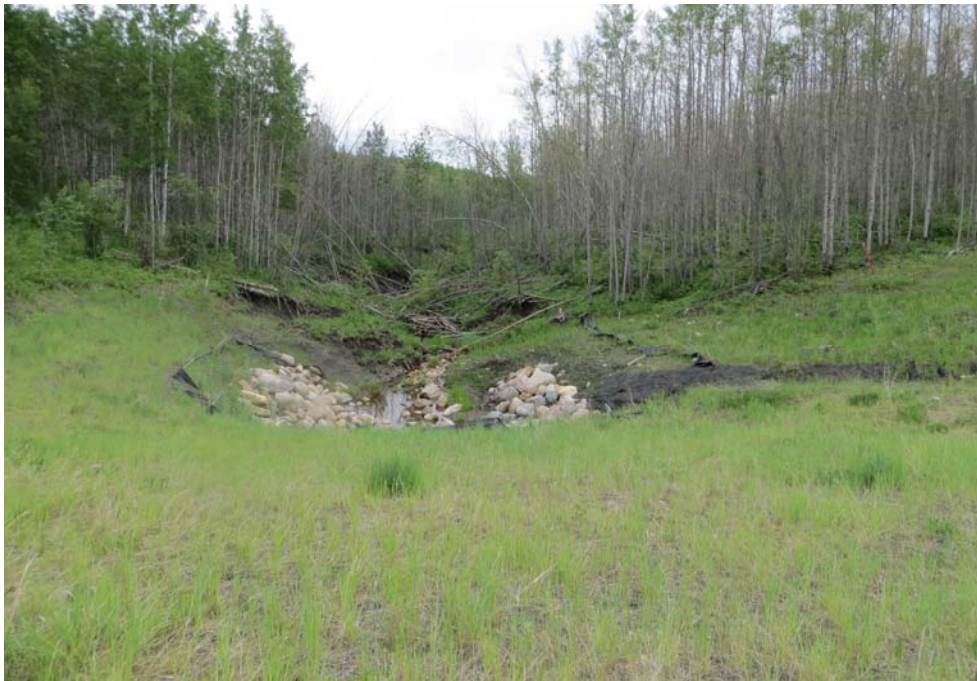
On the South (downstream) side: The slide repair did not extend beyond the end of the riprap bowl at the culvert outlet, and significant slumping was observed on the channel walls further downstream of the riprap. It is possible the slide could eventually enlarge and extend back into the riprap bowl area.

Photo 12 – Looking south at the culvert outlet area. Note the additional slumping on both sides of the drainage channel further downstream of the riprapped area.

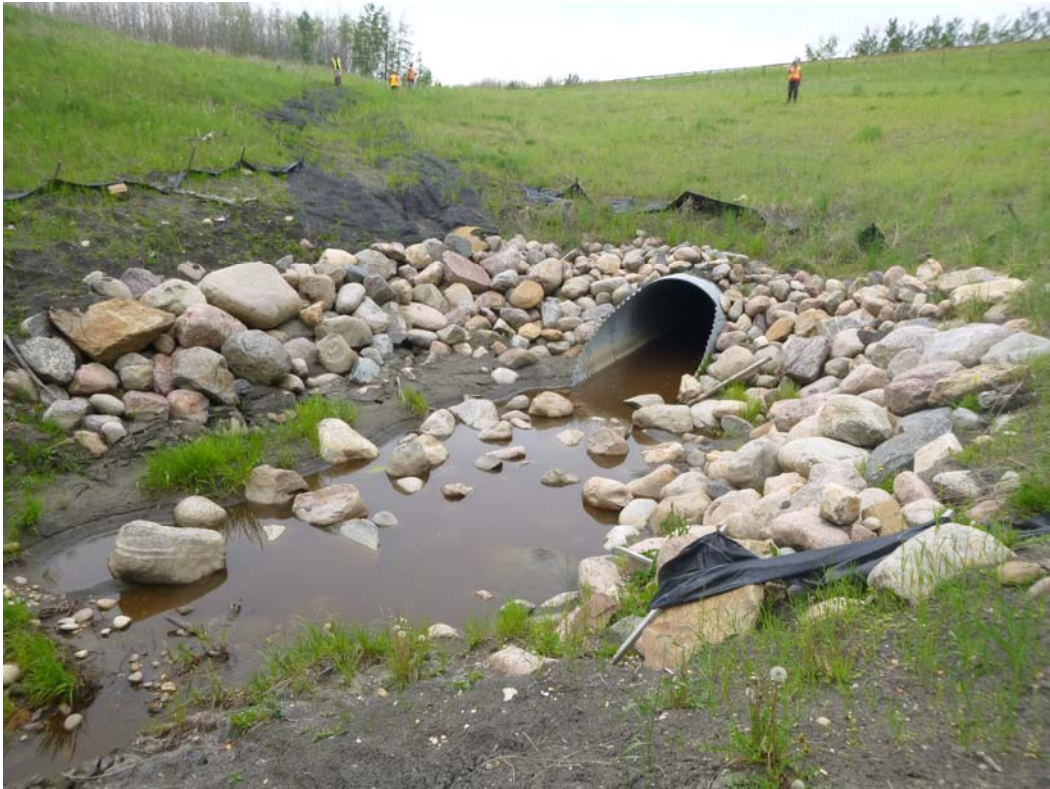
Photo 13 - Looking northwest at the culvert outlet area and downstream embankment slope. Note some of the smaller riprap has washed further downslope.

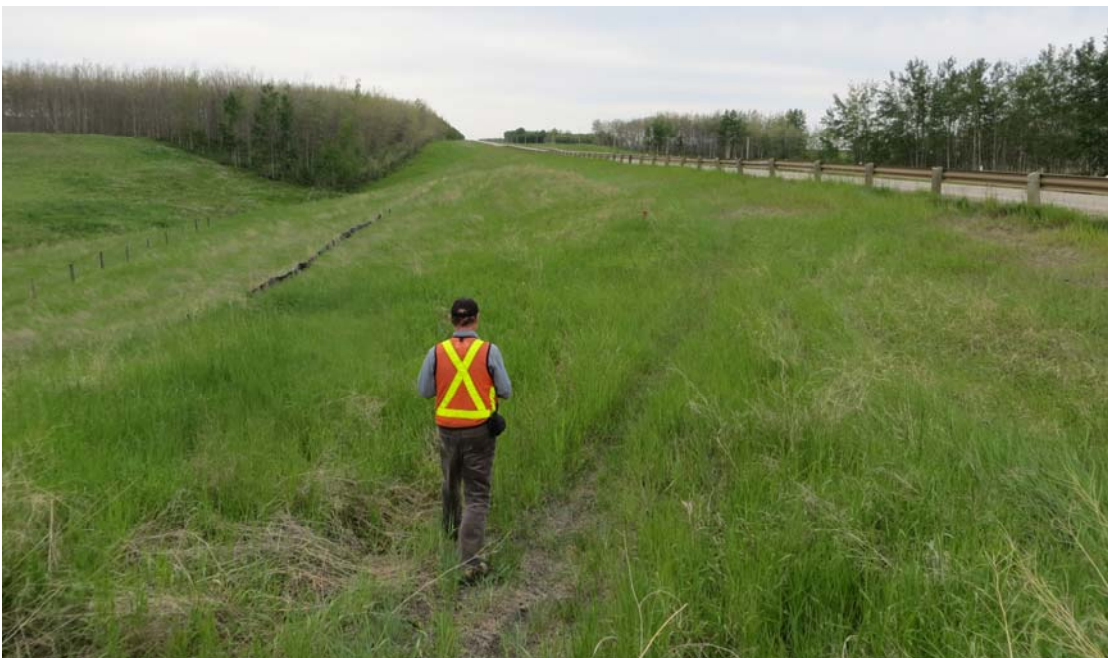
Photo 14 - Looking west parallel to the highway along the well vegetated downstream embankment.
