**ALBERTA TRANSPORTATION
PEACE REGION (PEACE RIVER / HIGH LEVEL)
INSTRUMENTATION MONITORING RESULTS**

FALL 2020

SECTION C

SITE PH064-1: HWY 64:02 CULVERT REHABILITATION SW OF WORSLEY

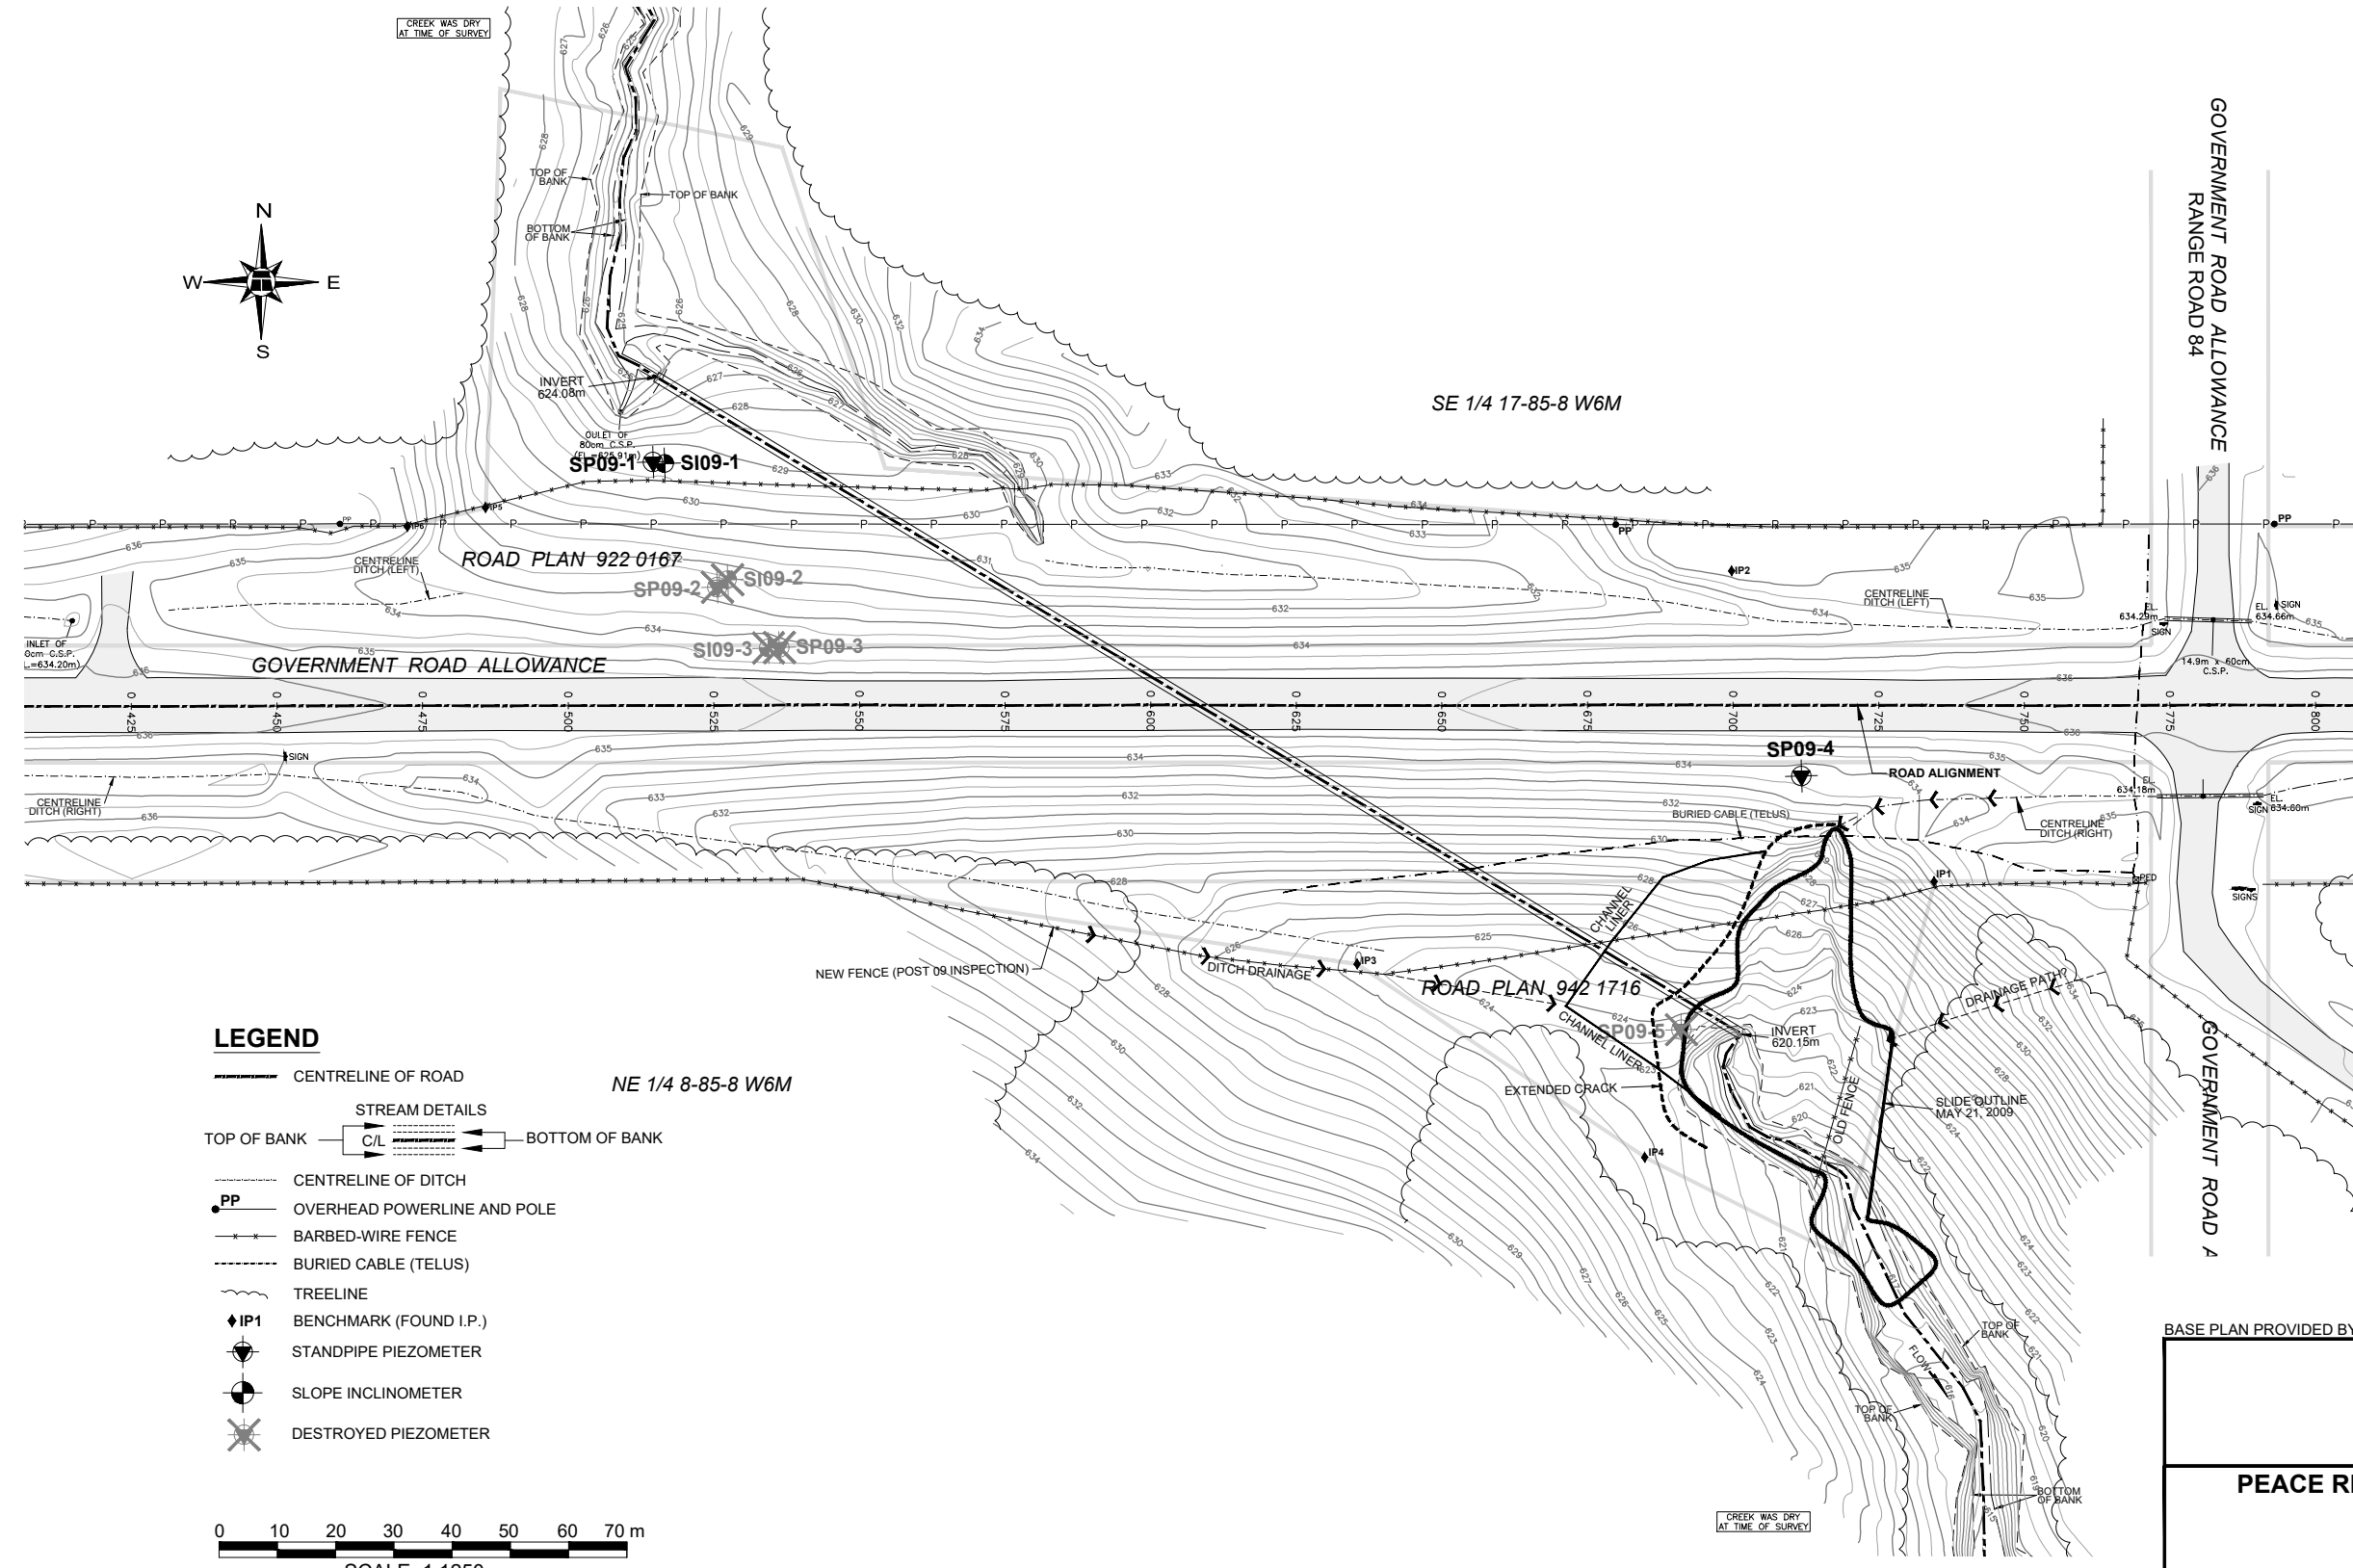
DWG No. 13351-PH064-1-1

Drawing 13351-PH064-1-1 in Section D provides a sketch of the approximate location of the monitoring instrumentation for this site.

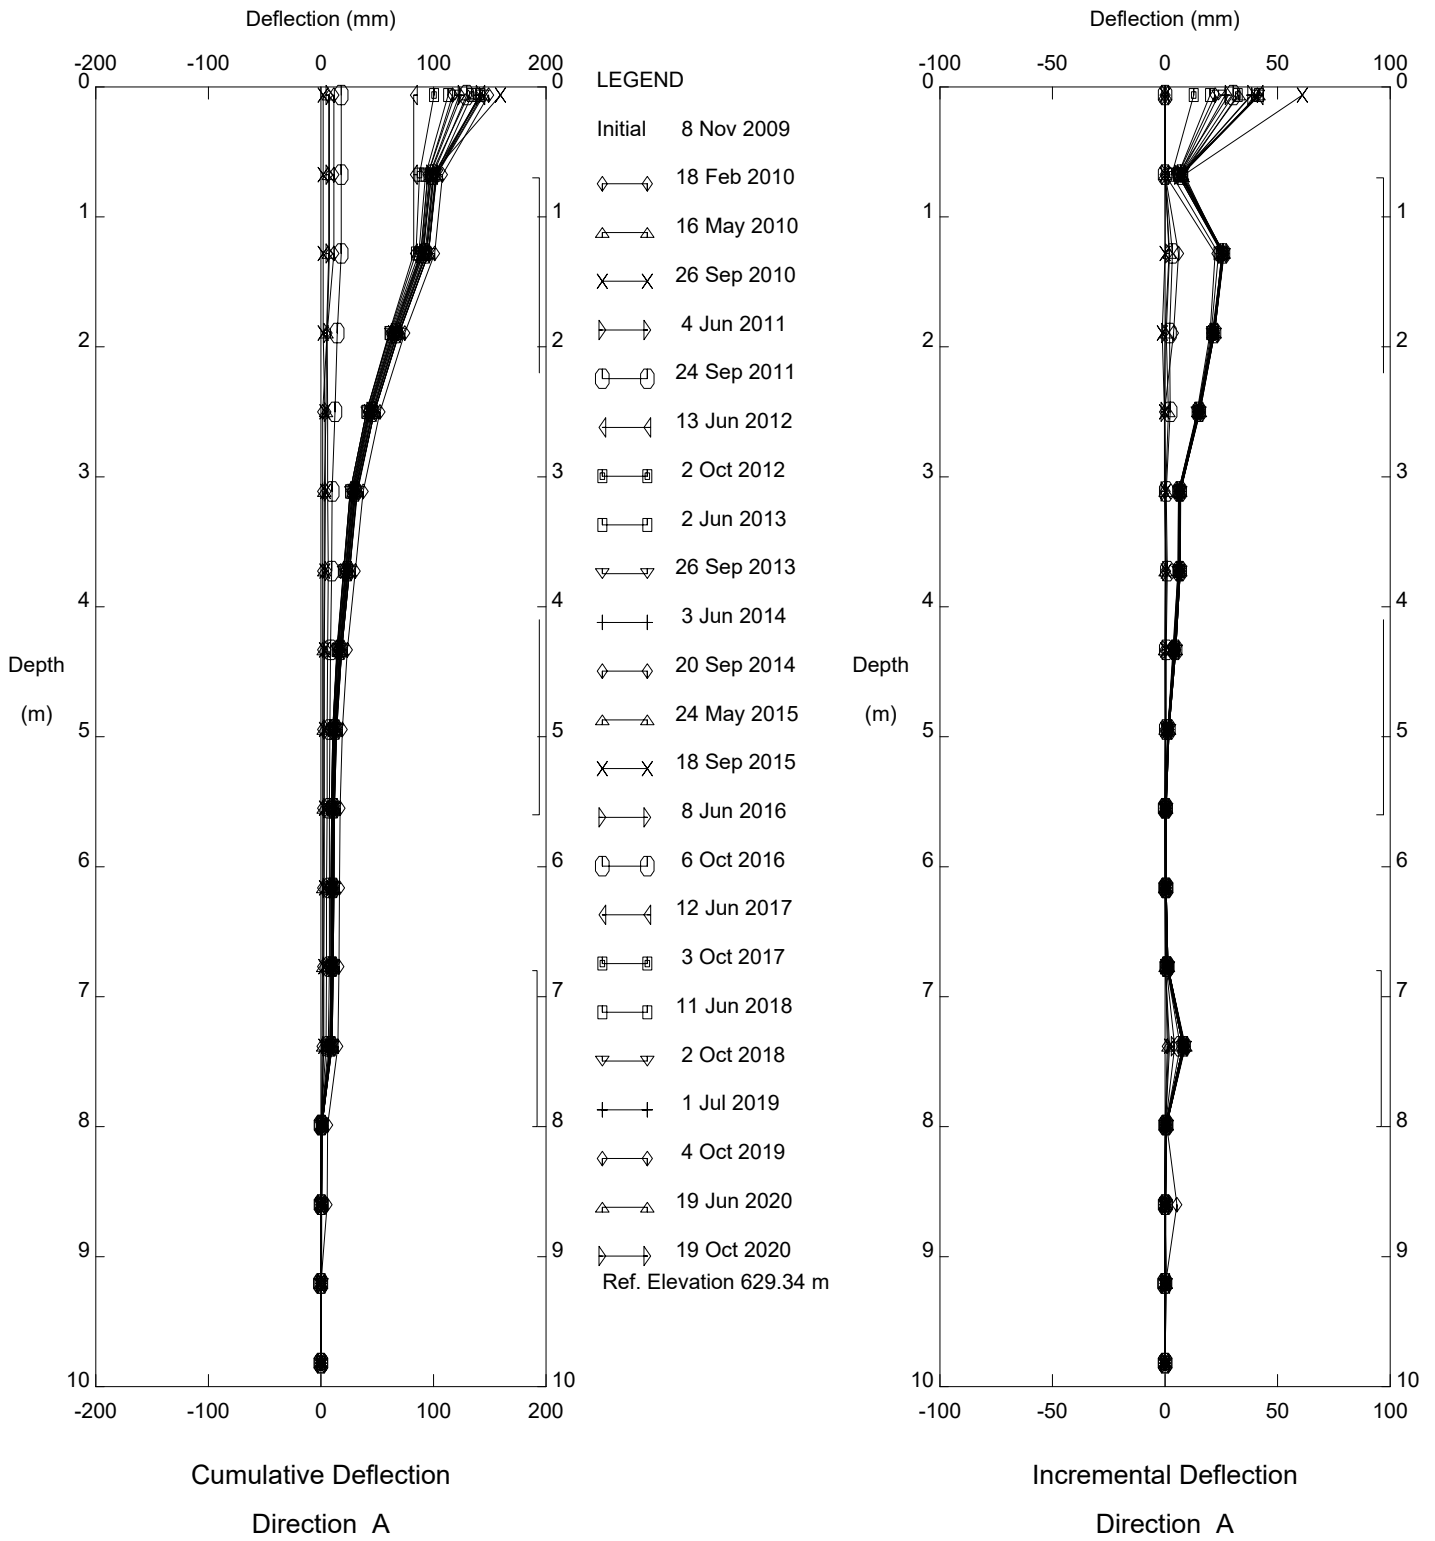
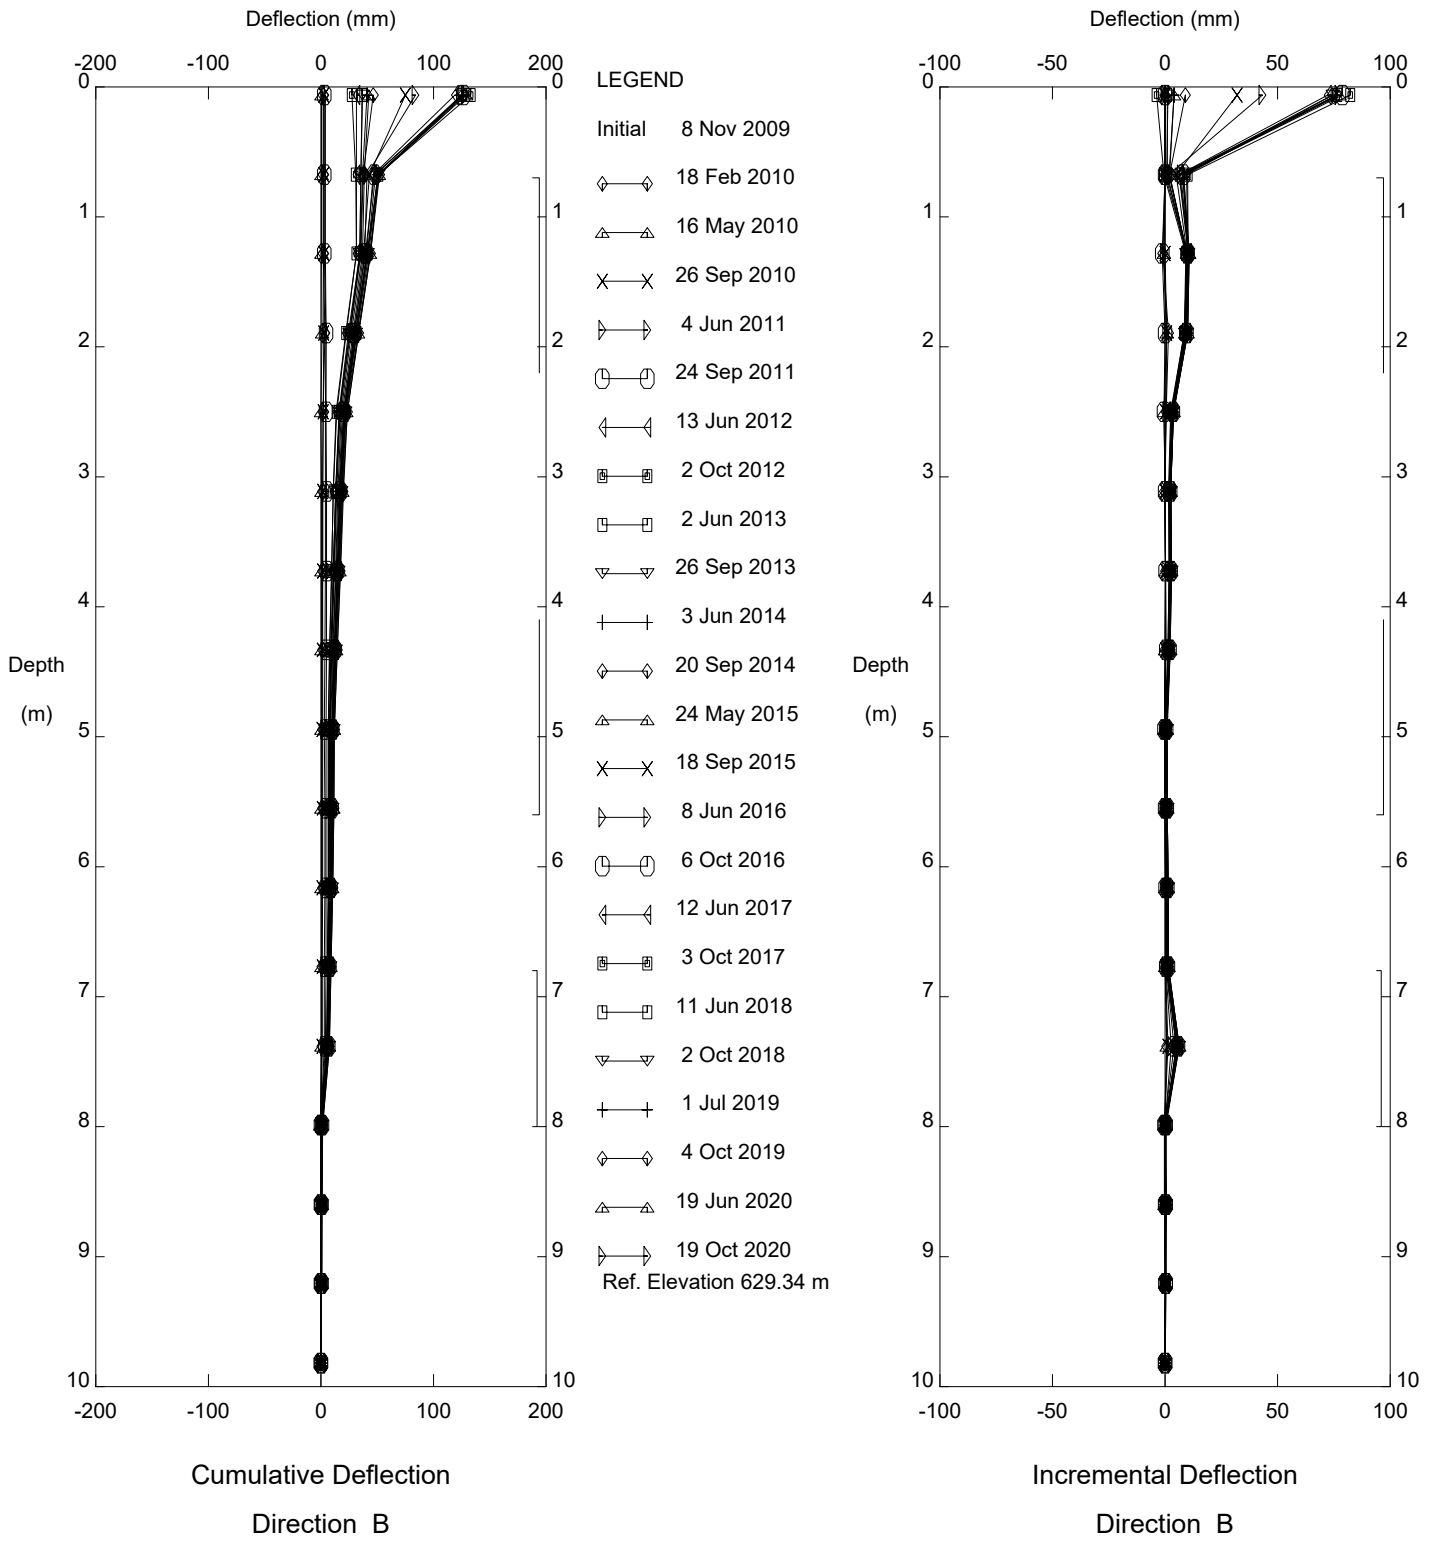
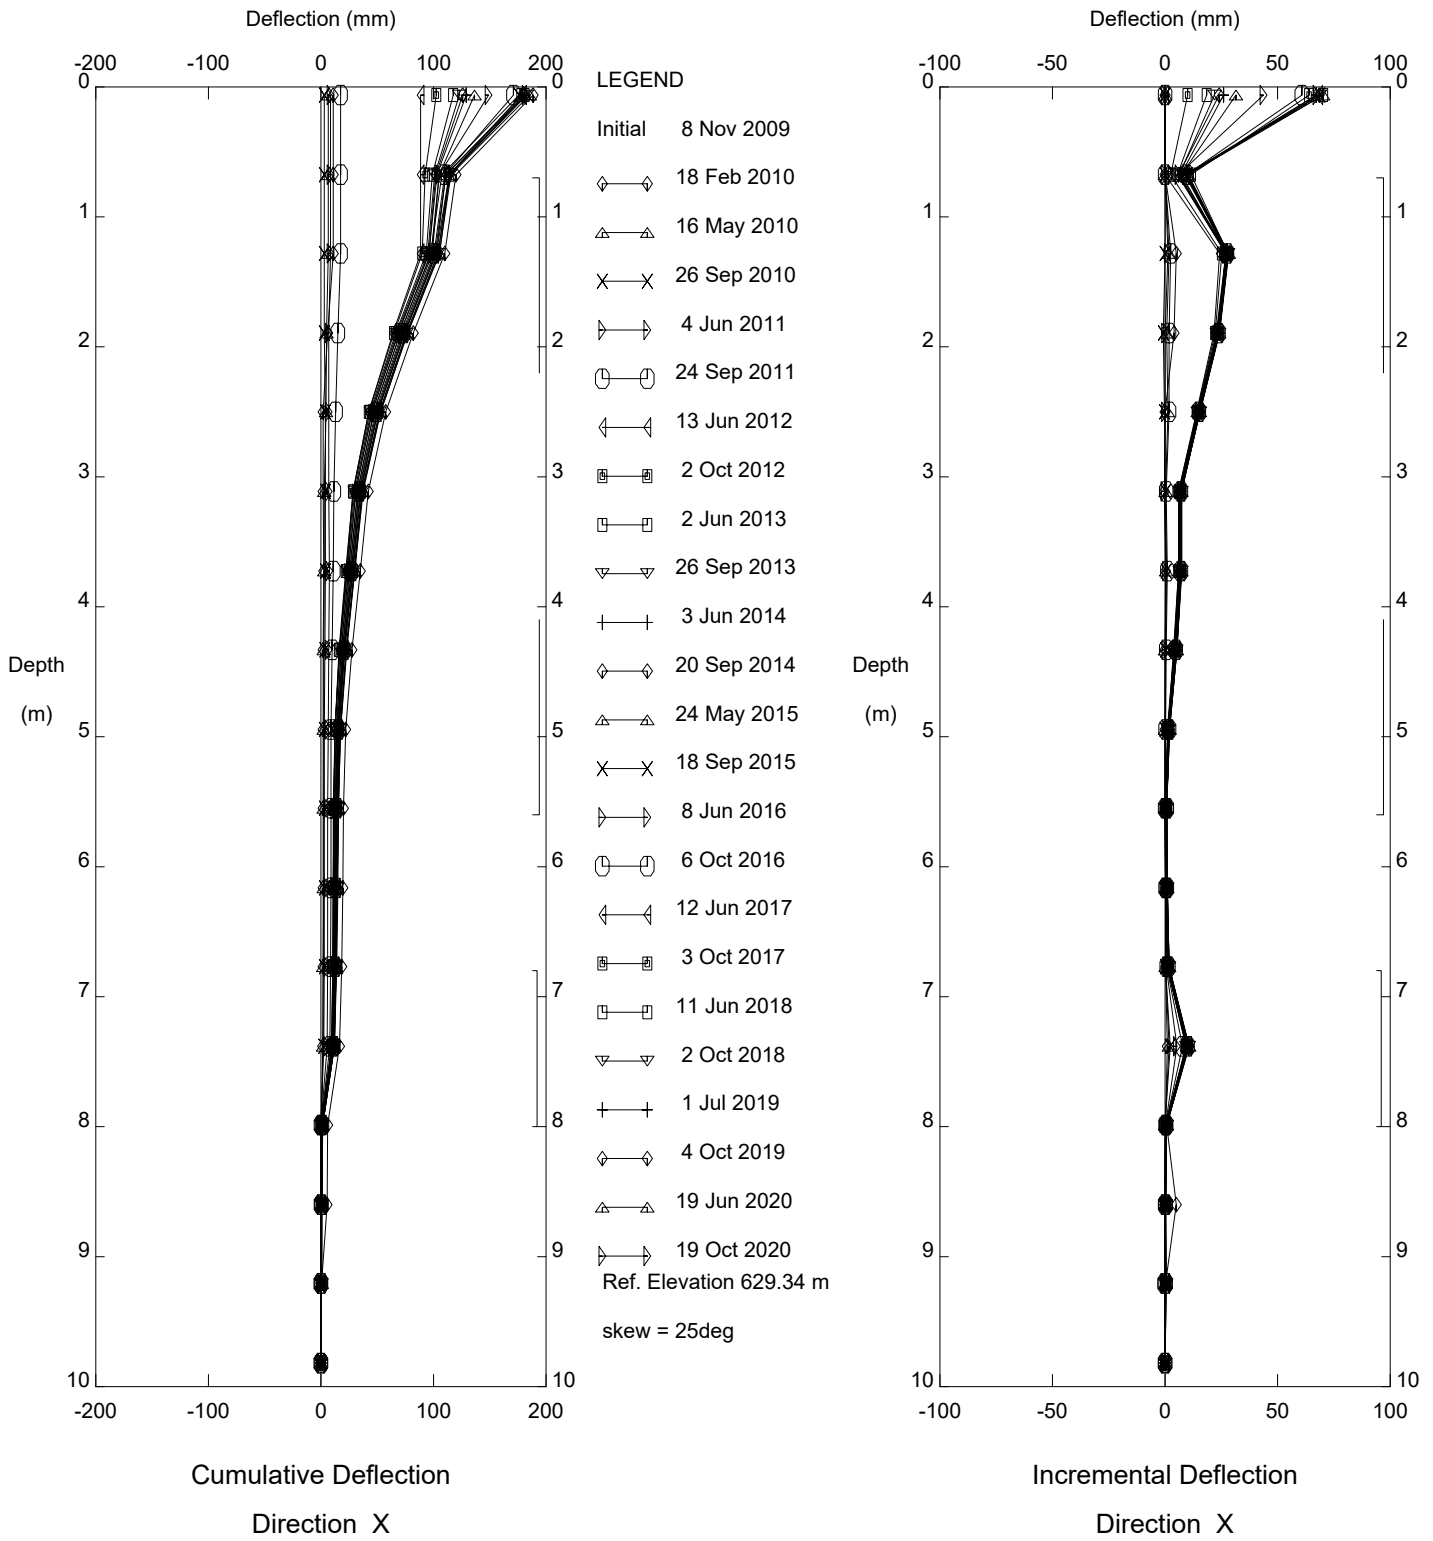
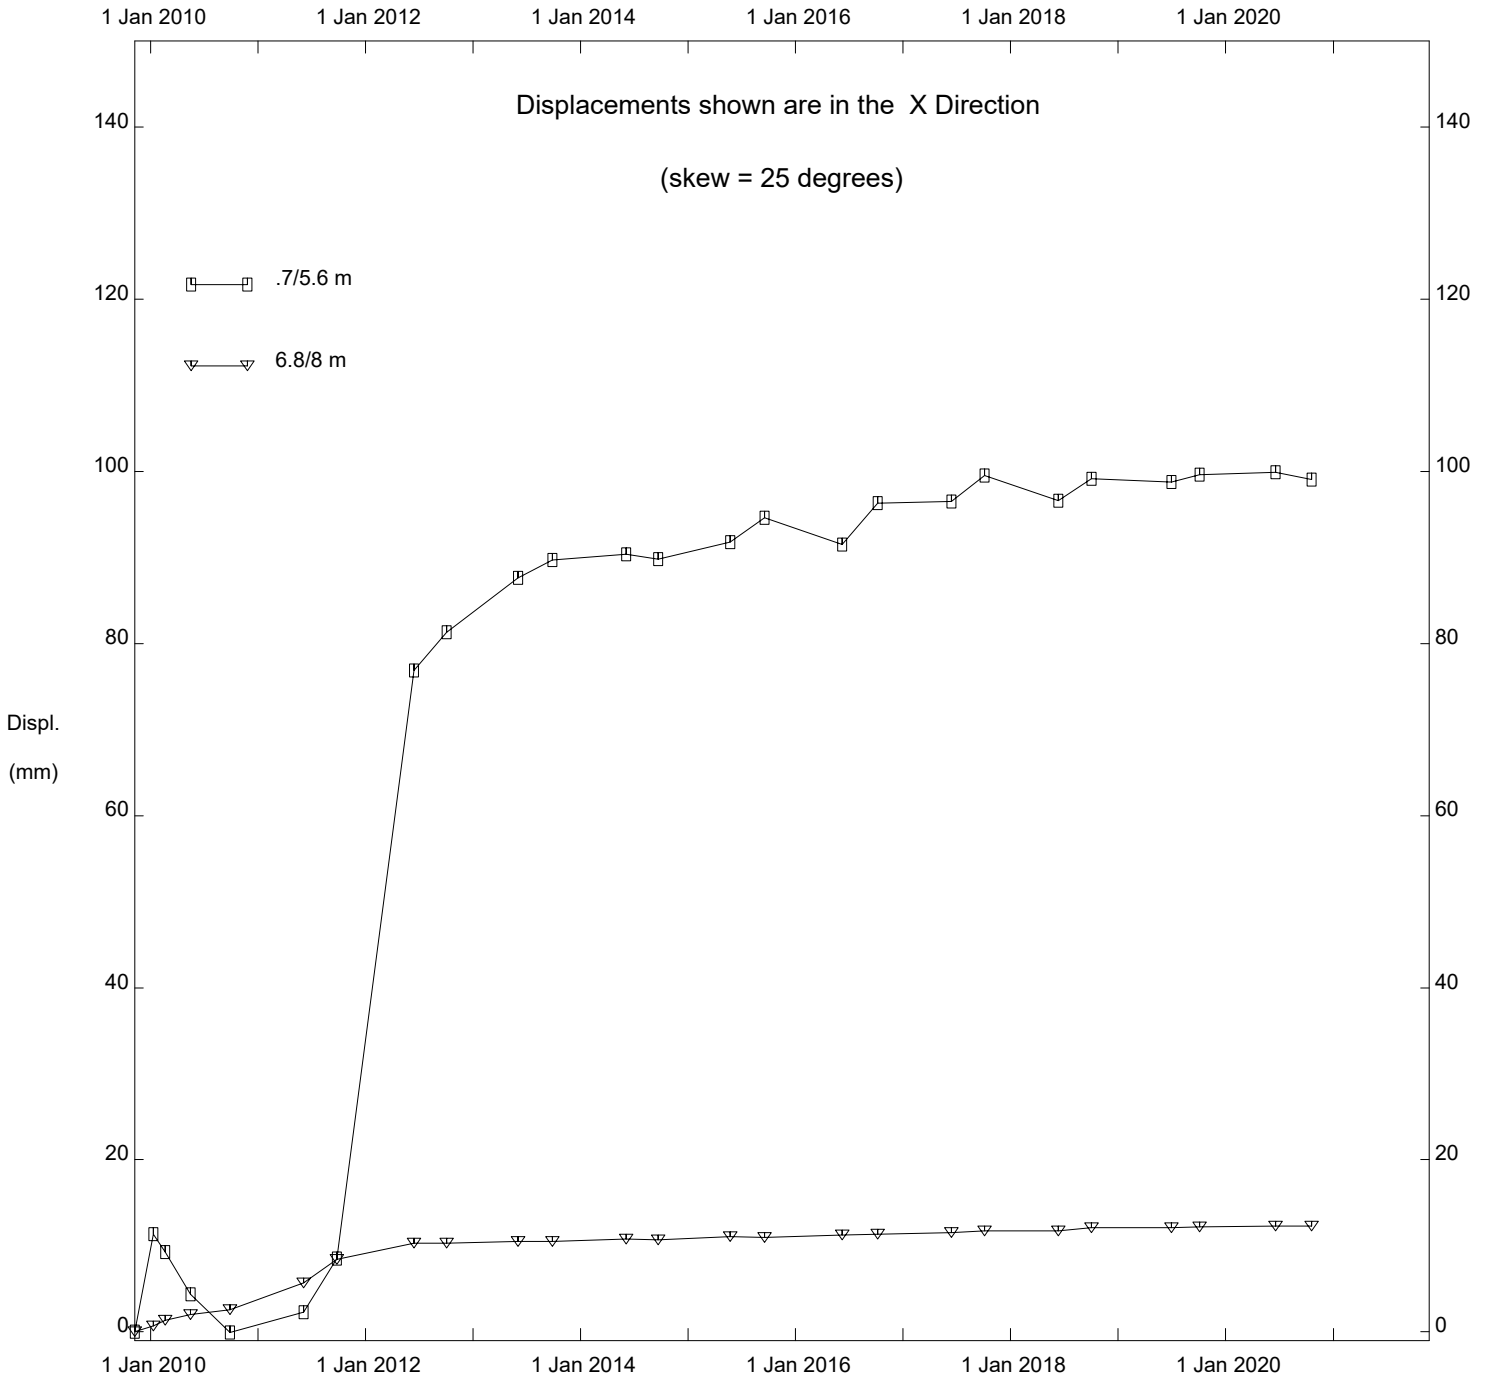
PH064-1 HWY 64:02, Inclinometer SI09-1

No zones of new movement were not observed in slope inclinometer SI09-1 since the previous reading in the spring of 2020.

Slope inclinometer SI09-1 showed no discernible movement since the spring of 2020 readings.

SI casing Slanted. Hard to push @4-6 ft

The instruments should be read again in the spring of 2021.

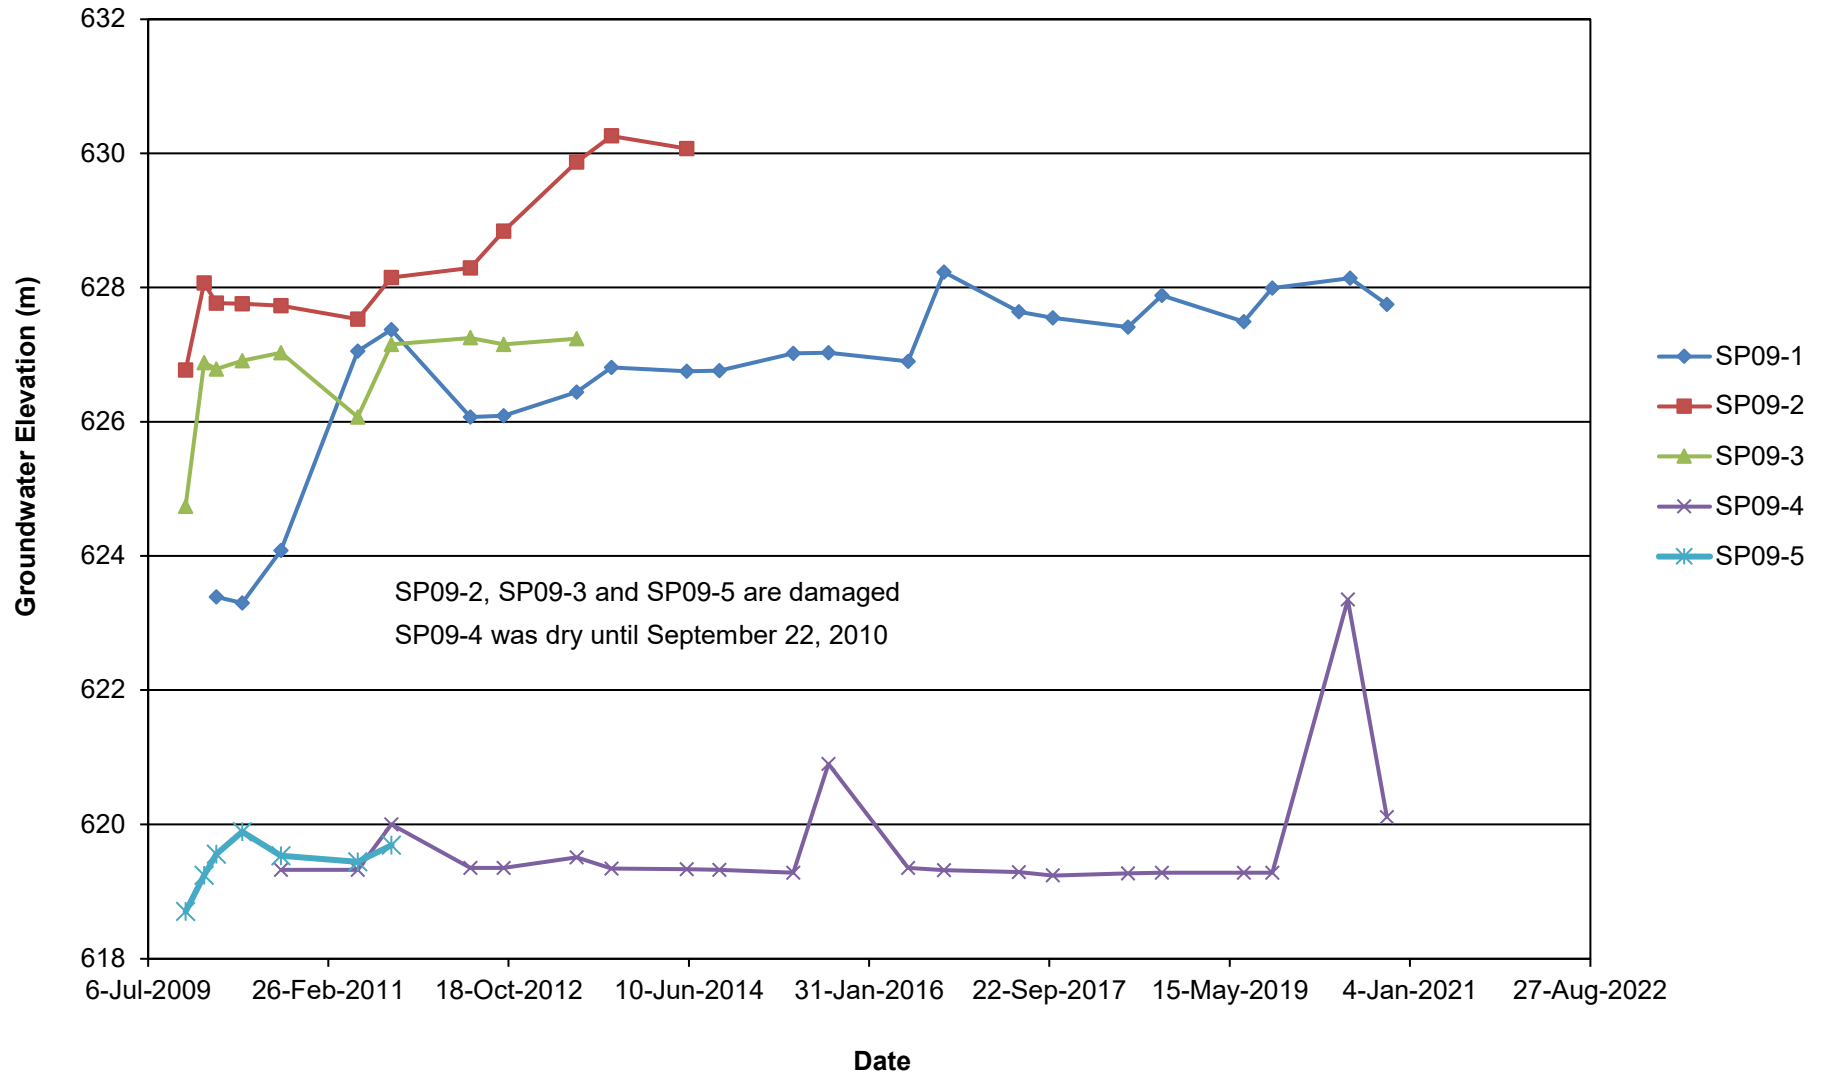
**FIGURE PH064-1-1
PIEZOMETRIC ELEVATIONS FOR HWY 64:02 CULVERT REHABILITATION**

Standpipe piezometers SP09-1 and SP09-4 showed decreases in groundwater level of 0.39 m and 3.24 m, respectively, since the spring of 2020 readings. The standpipe piezometer readings are summarized in Table PH064-1-2 below and are plotted by elevation and by depth in Figures PH064-1-1 and PH064-1-2, respectively, in Section D.
