**ALBERTA TRANSPORTATION
GEOHAZARD ASSESSMENT PROGRAM
PEACE REGION – HIGH LEVEL
2017 INSPECTION**

| Site Number | Location | Name | Hwy | km |
|---|---|---|---|---|
| PH047-1 | West of Deadwood, AB | Deadwood Slide | 690:02 | 2.4 |

**PH047: HWY 690:02 DEADWOOD SLIDE
GEOHAZARD ASSESSMENTS**

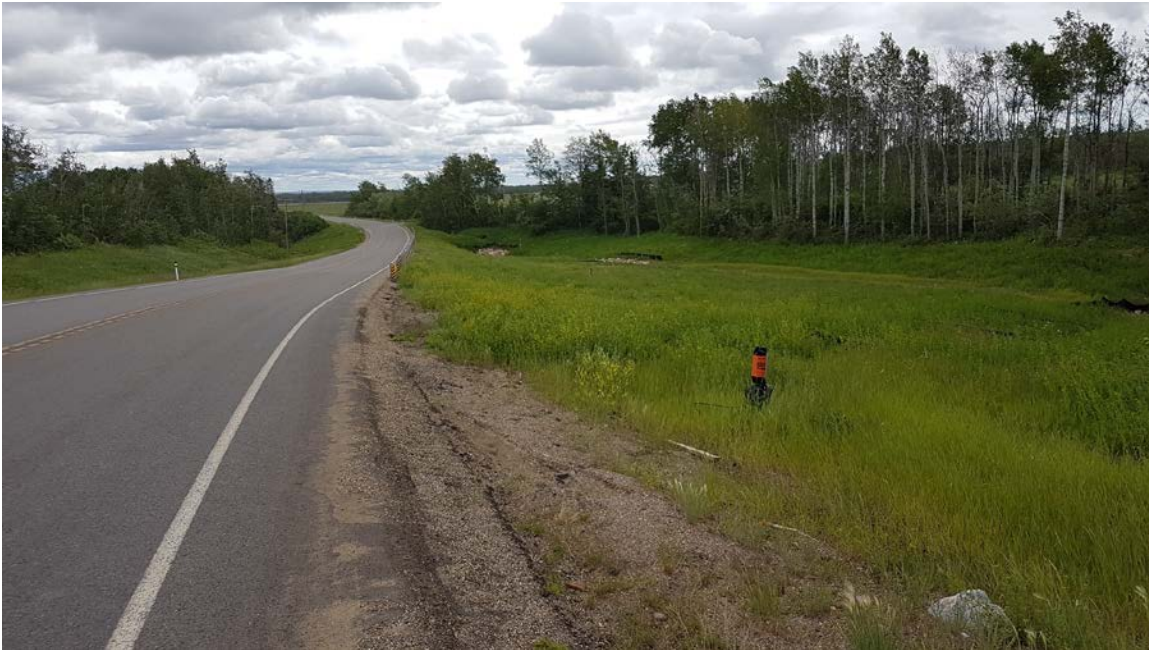
| <input checked="" type="checkbox"/> Slope Movement | Slow creep movement significantly reduced with placement of toe berm | <input type="checkbox"/> |

Photo 1 – Looking east over repaired highway and toe berm.

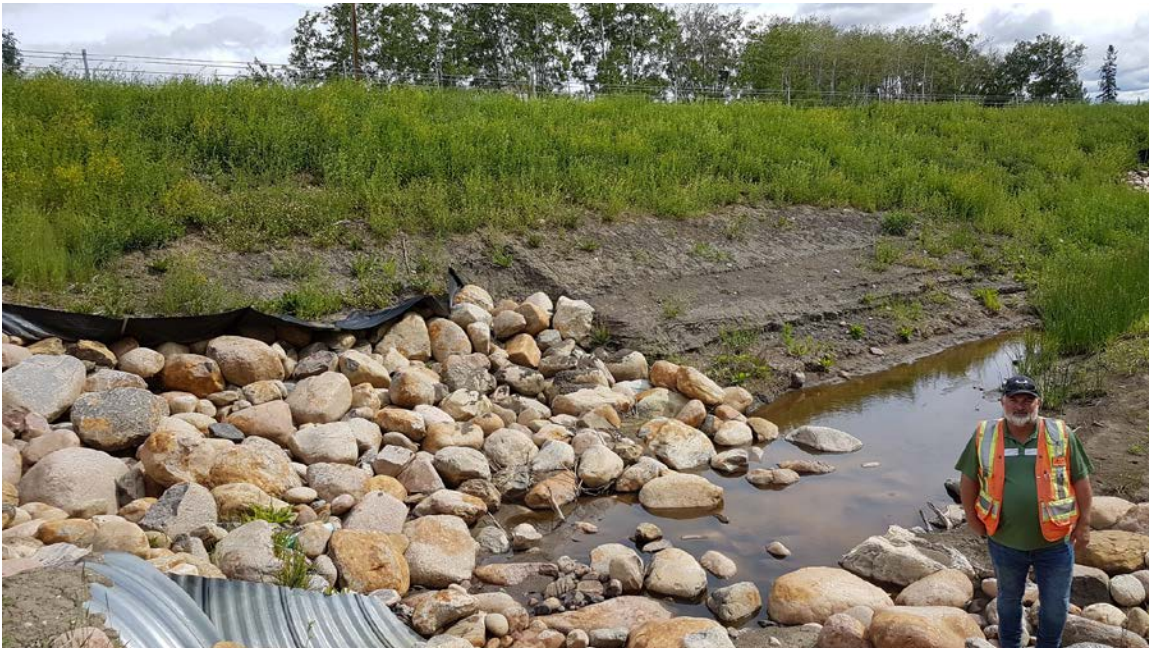
Photo 4 – Looking west at bare area at culvert outlet where possible tension cracks may be forming. Subdrain outlet is just on the far side of the culvert outlet.

- Remove or clean the grate at the subdrain outlet to improve flow.
- Consider placing temporary erosion control blanket over erosion at culvert inlet.
- Reseed and protect the bare spot between the end of the swale and the outlet riprap apron.
- Backfill voids around HTSCB posts.
