**ALBERTA TRANSPORTATION  
GEOHAZARD ASSESSMENT PROGRAM  
PEACE REGION – HIGH LEVEL  
2018 INSPECTION**

Site Number	Location	Name	Hwy	km
PH047-1	West of Deadwood, AB	Deadwood Slide	690:02	2.4
Legal Description		UTM Co-ordinates		
SW28-89-23-W5M		11U E 462,972	N	6,288,759

**PH047: HWY 690:02 DEADWOOD SLIDE  
2018 GEOHAZARD ASSESSMENT**

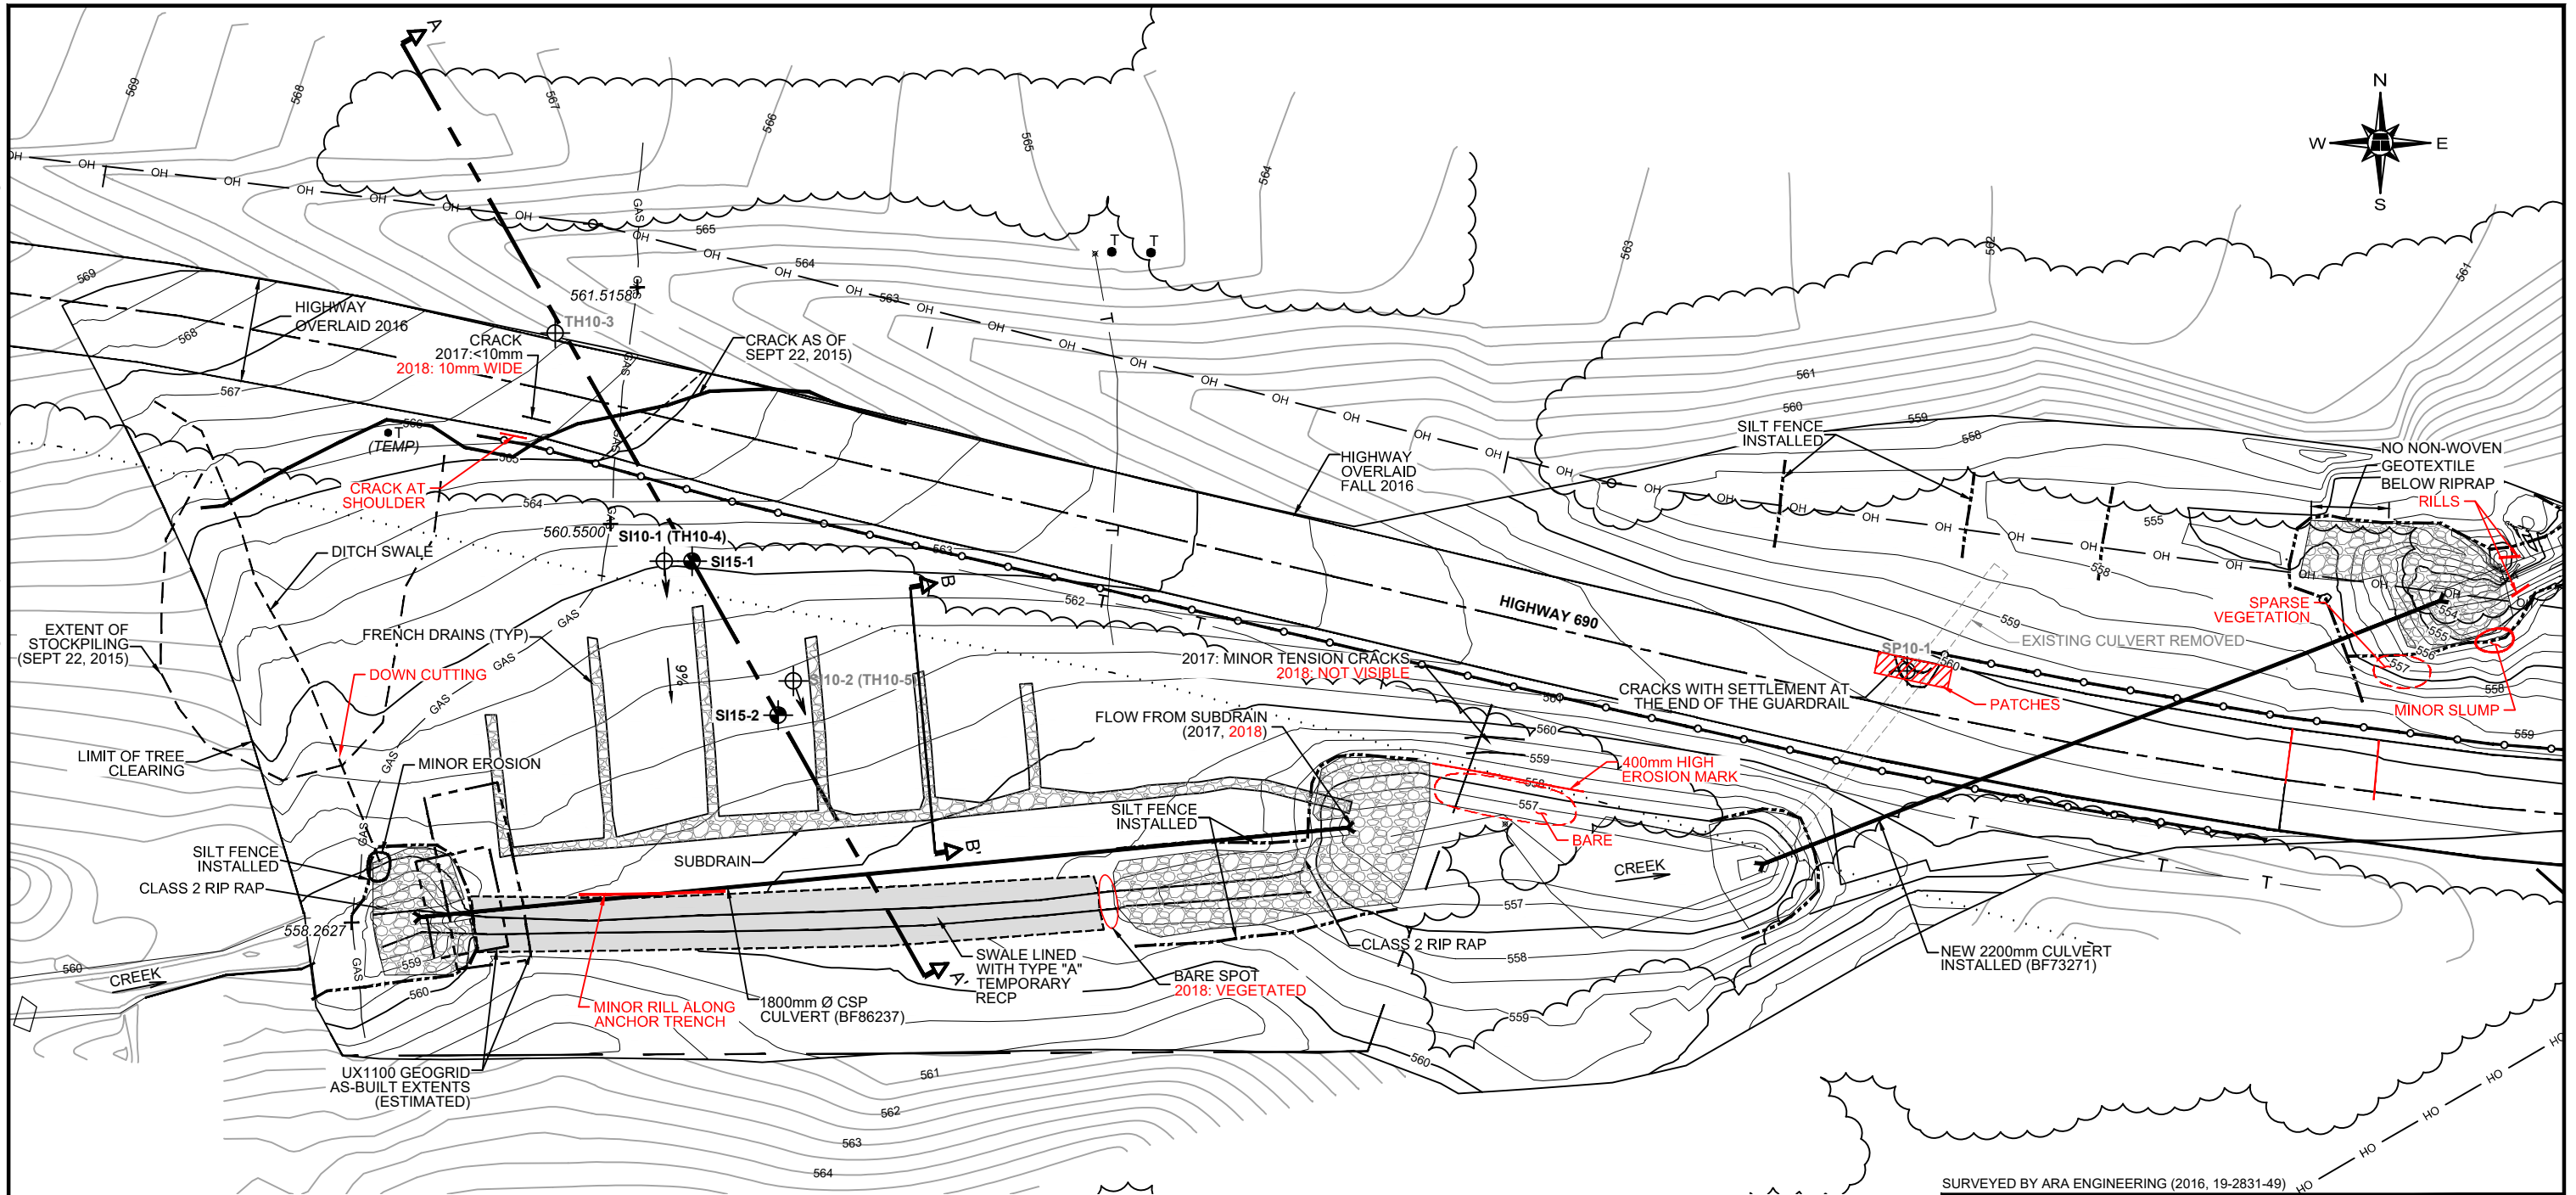
**DWG No. 13351-PH047-1-1**

1. JUNE 2018 OBSERVATIONS SHOWN IN RED

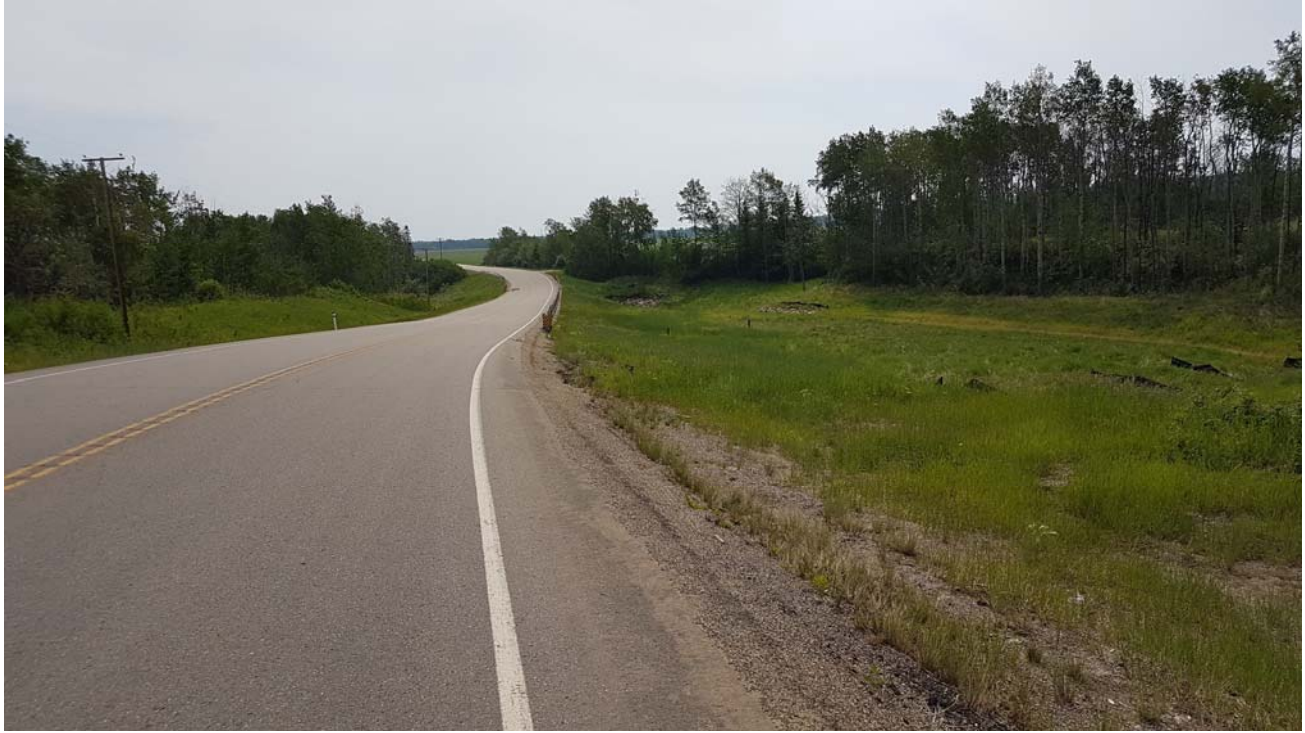
In 2016, the highway was overlaid and high-tension steel cable barriers (HTSCB) installed through portions of the site. The toe berm appears to be performing well although the one crack that was noted in the old slide area in 2017 increased slightly in length in 2018 and a second crack was observed at the shoulder. Seepage was observed from the subdrain outlet. Minor erosion was noted in the ditch above and at the culvert inlet riprap (west side of site). Some erosion was observed on the banks beyond each culvert outlet likely as a result of the high flows experienced in Spring 2018. Two patches have been placed at the west end of the north HTSCB which may be associated with poorly-compacted fill in the post holes.

Photo 1 – Looking east over repaired highway and toe berm.

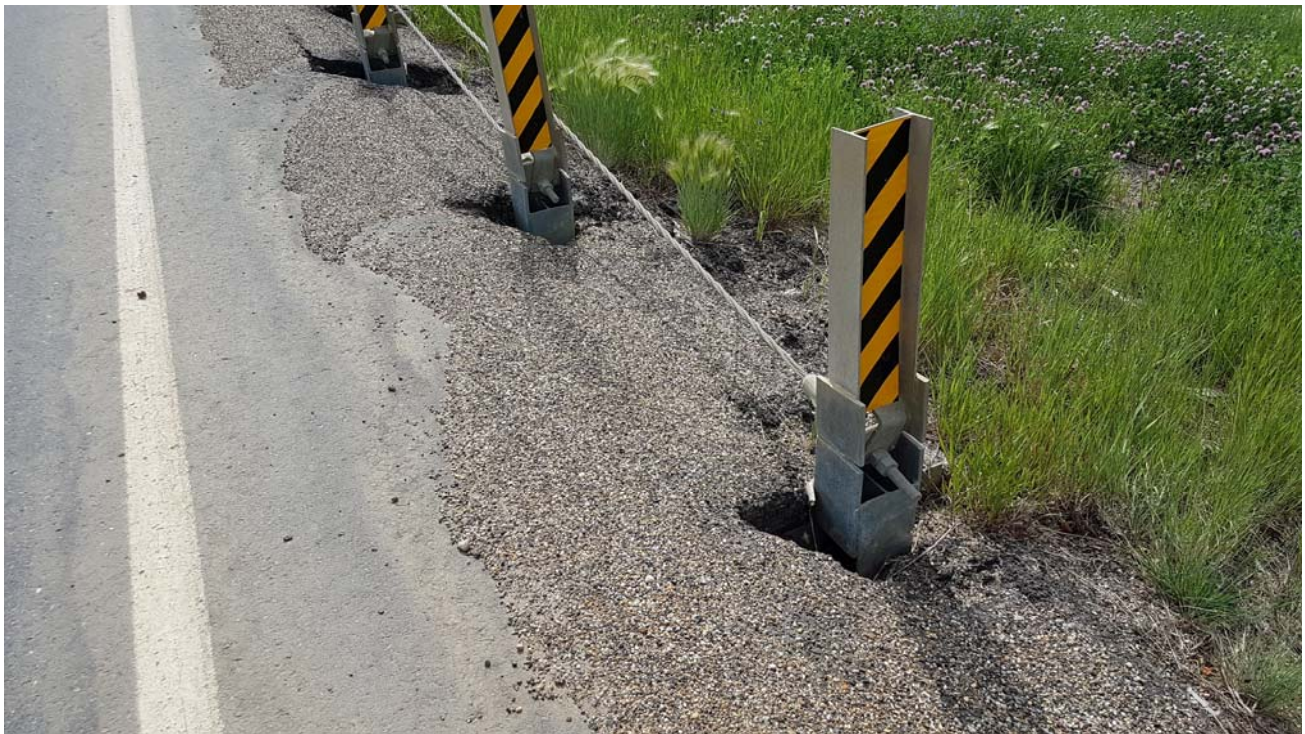
Photo 2 – Looking at voids around HTSCB on south side of highway at the west end.

- Remove or clean the grate at the subdrain outlet to improve flow.
- Consider placing additional seed and temporary erosion control blanket over erosion on south sideslope just east of the toe berm culvert outlet.
- Backfill voids around HTSCB posts.

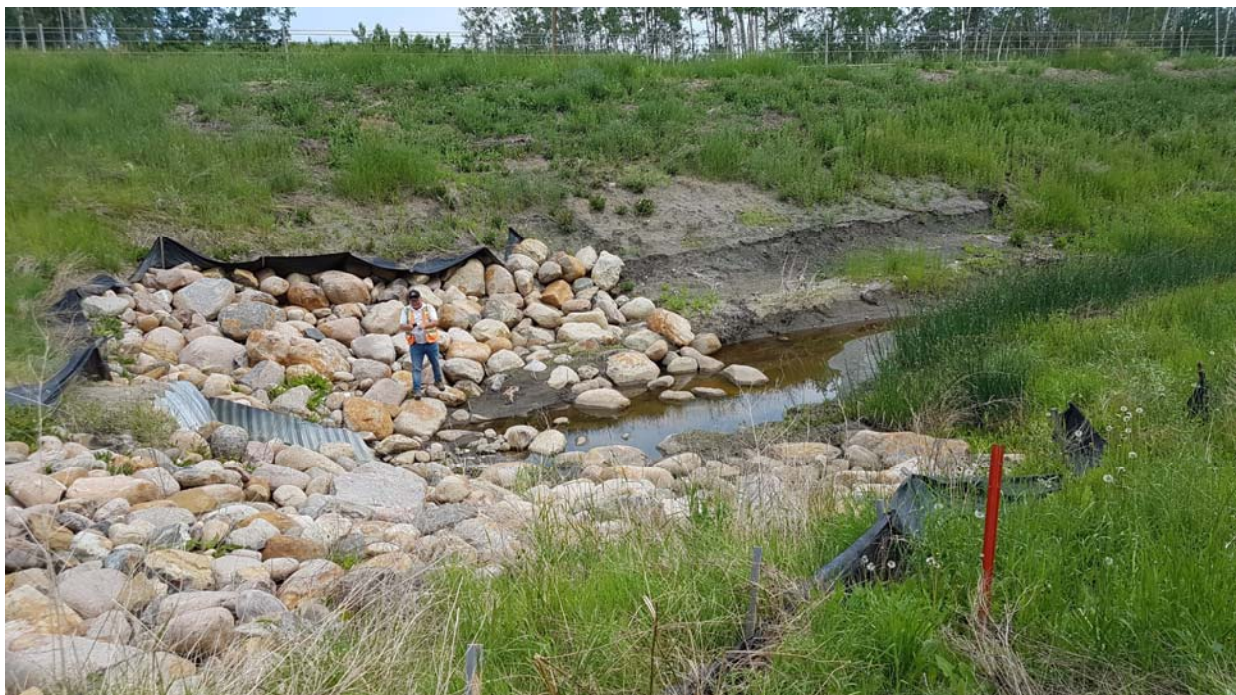
Photo 4 – Looking west at bare area at culvert outlet where possible tension cracks may be forming. Subdrain outlet is just on the far side of the culvert outlet. Note the eroded bare spot just beyond the riprap.

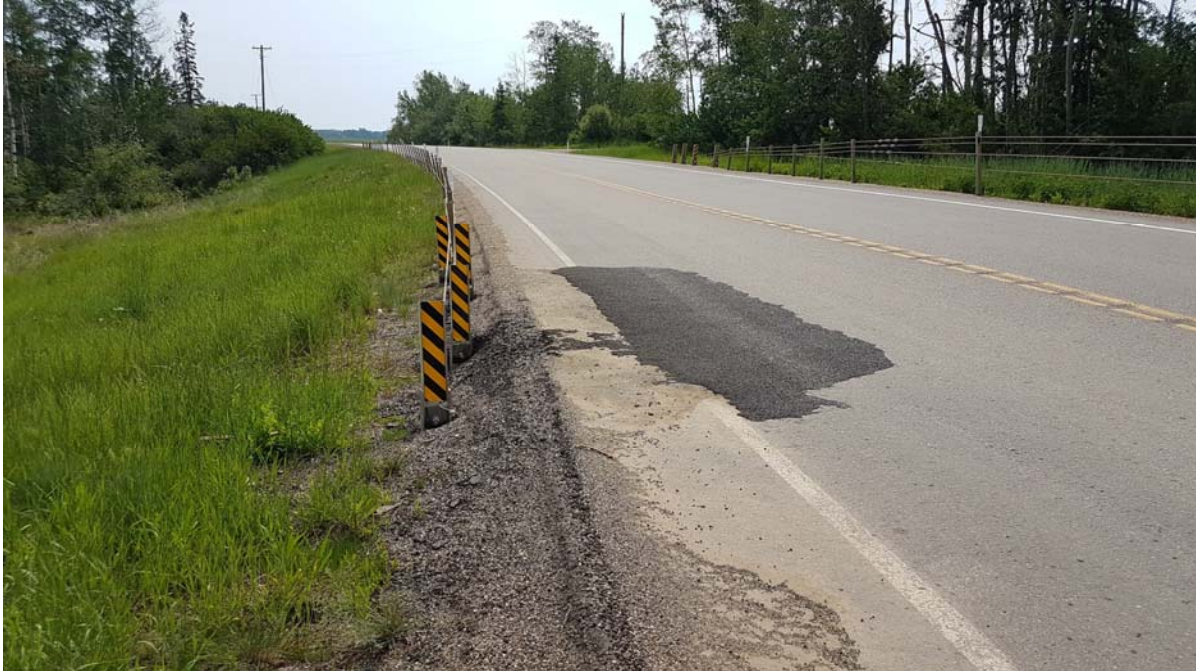
Photo 7 – Looking east at voids around HTSCB posts and settlement cracking of the pavement at west end of the north barrier located by the outlet of BF72371 culvert. Note that two patches have been required in this area.

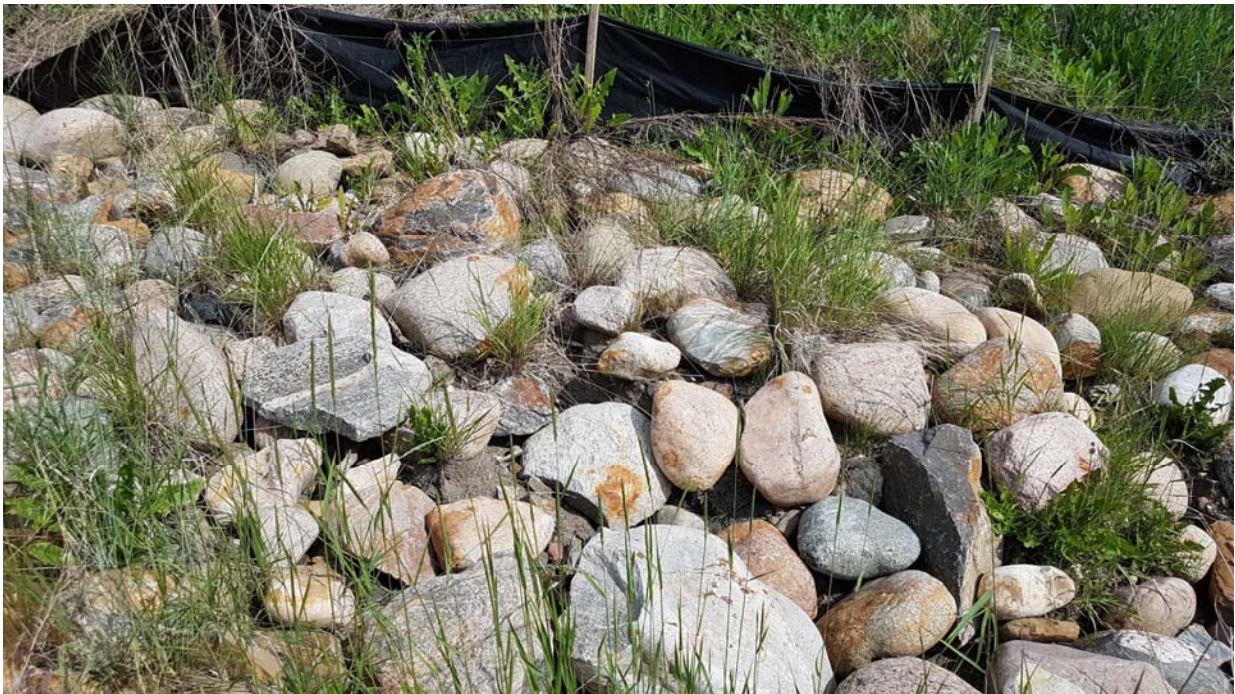
Photo 8 – Looking at riprap placed over bare ground (no non-woven fabric below) at east end of north ditch at the outlet of BF72371.
