August 23, 2011

File: 15-16-262

**PEACE REGION (PEACE RIVER/HIGH LEVEL) GEOHAZARD ASSESSMENT
HWY 986:01 (PH 41), DAISHOWA SITE 5 – STATION 12+000
2011 ANNUAL INSPECTION REPORT**

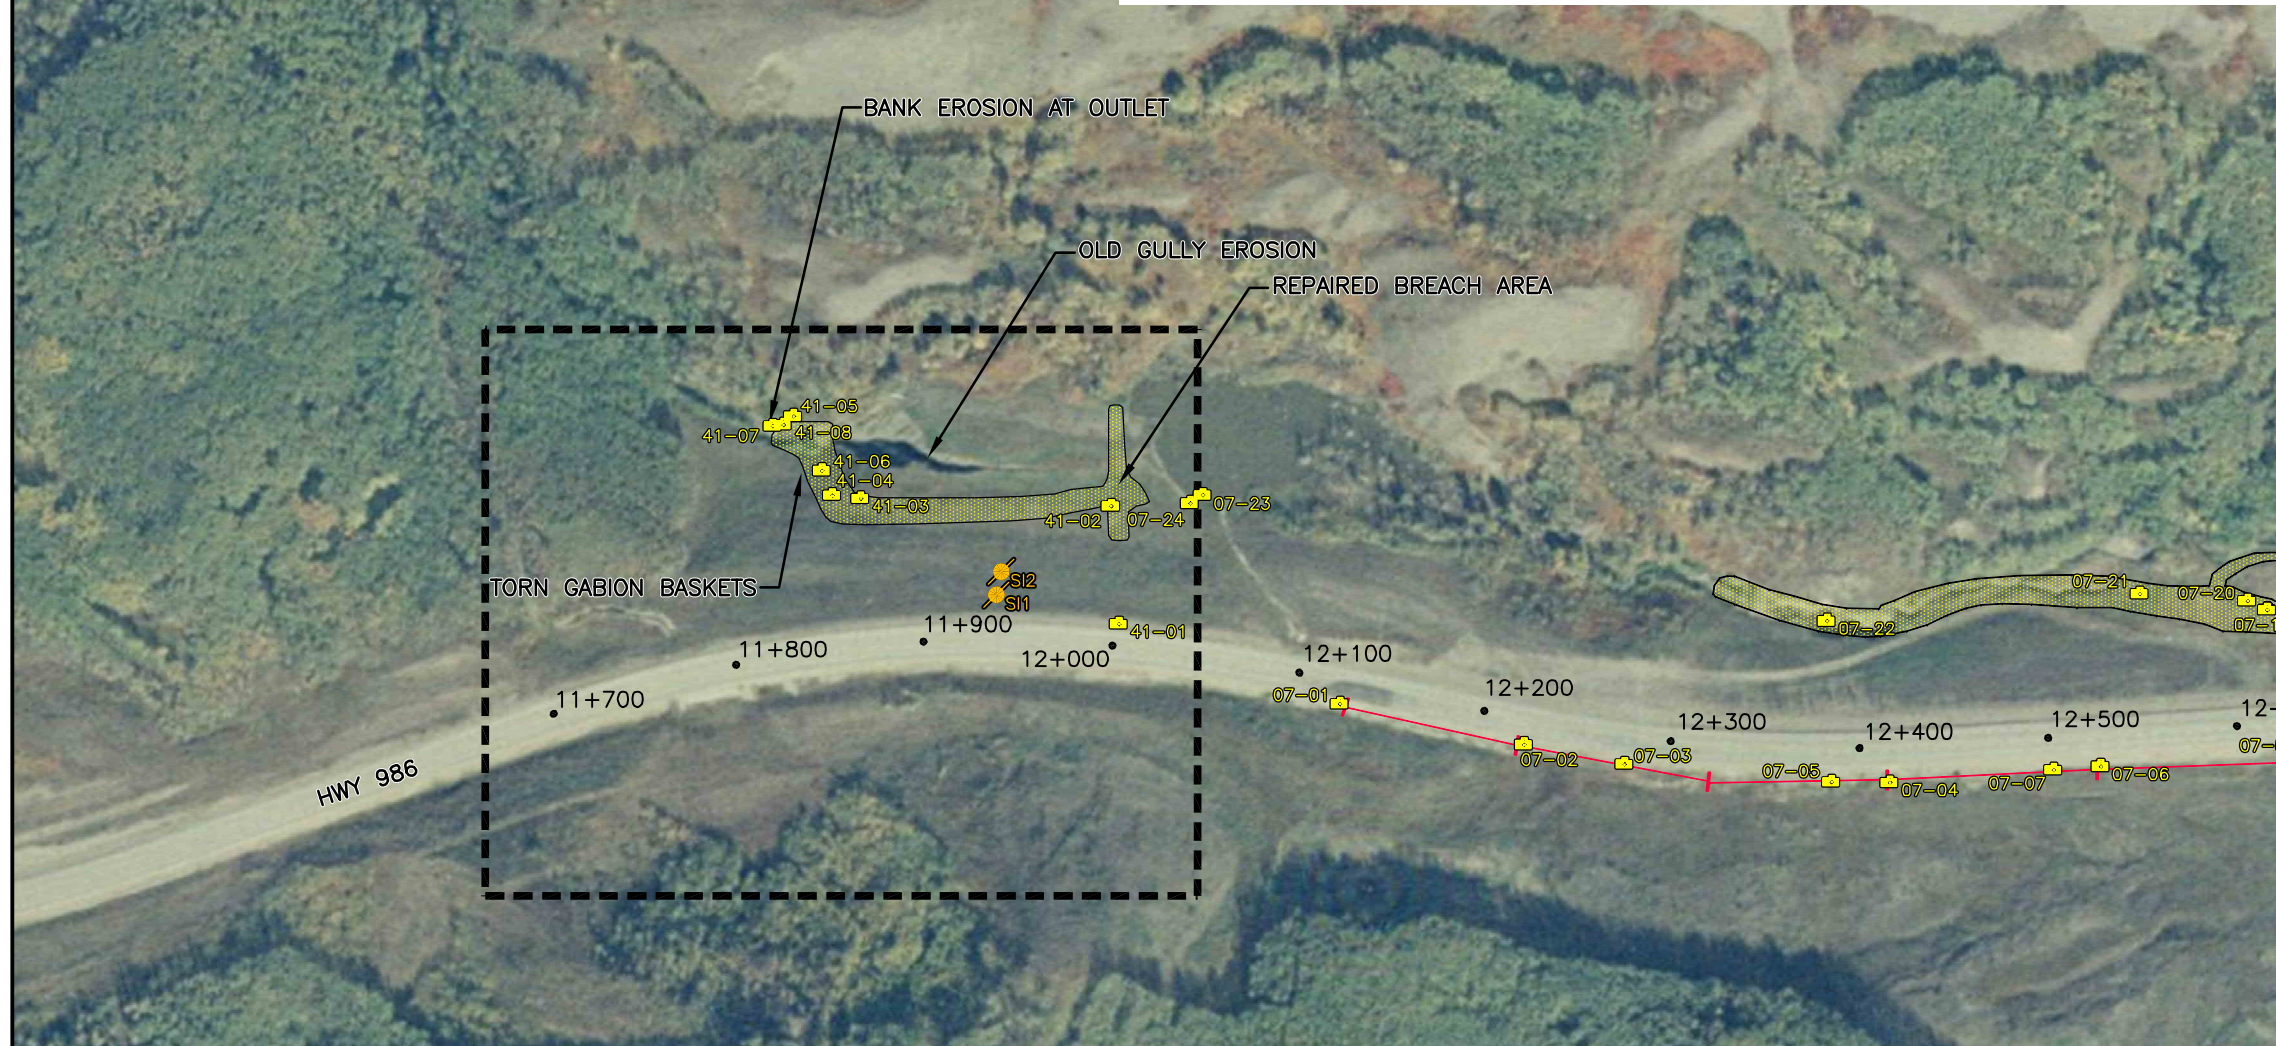
FIGURE PH41-1

The site location and observations noted during the 2011 inspection are shown in Figure PH41-1.

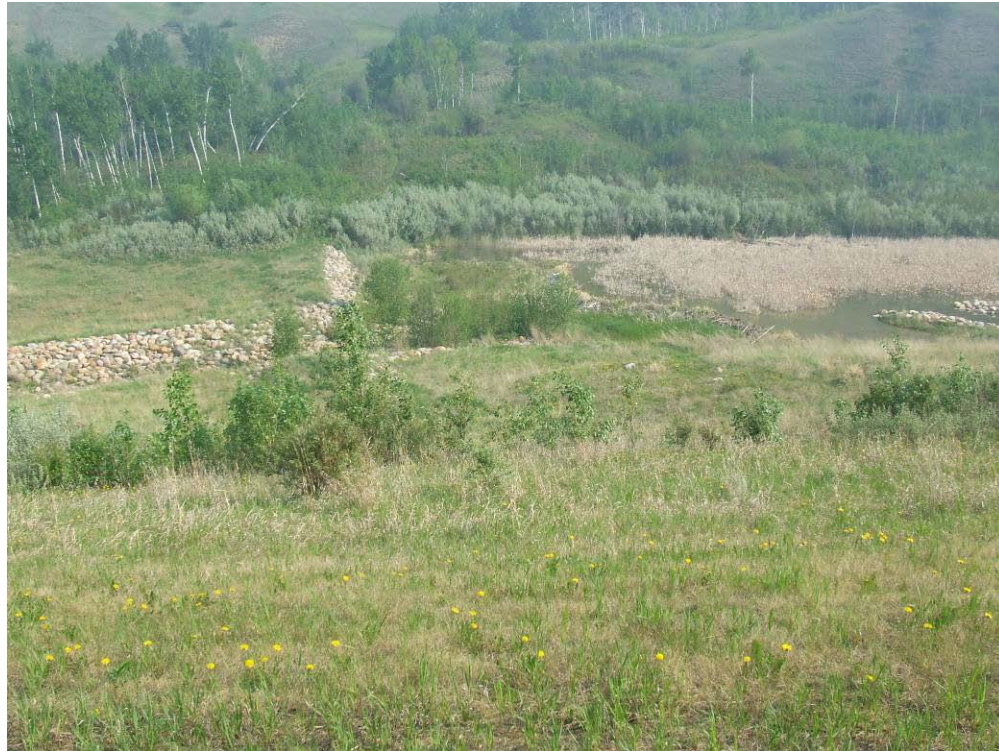
Photo 41-01

- No discernible changes were observed within the fill slope below the roadway since the 2010 site inspection (Photo 41-01).
- The armoured channel between the inlet and outlet structures is becoming vegetated with willows (Photo 41-02).
- The energy dissipation/outlet structure is in good overall condition (Photos 41-03 to 41-06). The steel plate weir at the inlet to this structure noted to be deformed downstream in 2008 was unchanged since 2009 (Photo 41-03). However, numerous gabion baskets have torn panels and need to be repaired (Photo 41-06).
- The erosion along the north bank of the natural channel at the outlet of the large gabion energy dissipation structure is relatively unchanged from 2010. This erosion is partially the result of shifting of large riprap in the discharge area (Photo 41-07) directing flow towards the natural bank (Photo 41-08).

Looking downslope at slope below roadway. Inlet to armoured channel in the distance.

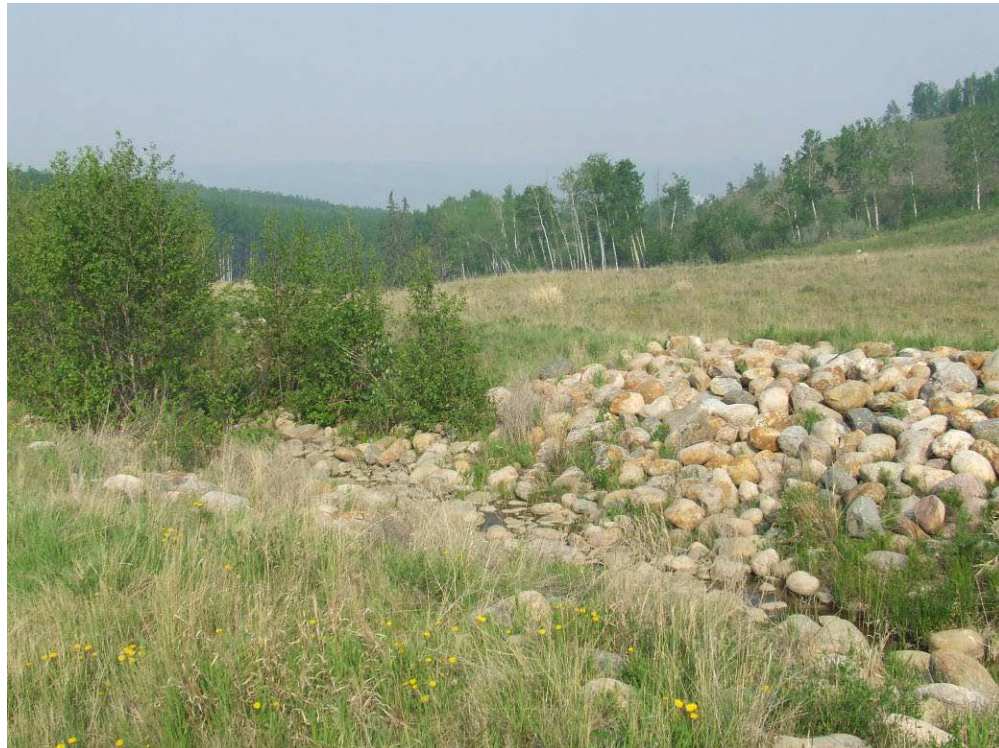
Photo 41-02

Looking west down armoured channel just below inlet. Note the willows and brush growing along edges of channel.

In addition, the effect of the willows growing in the upper portion of the armoured channel should be assessed by a hydraulic engineer. If it is determined that the hydraulic capacity of the channel is being adversely affected by their presence, they should be cut flush to the channel bottom with the roots left in place.

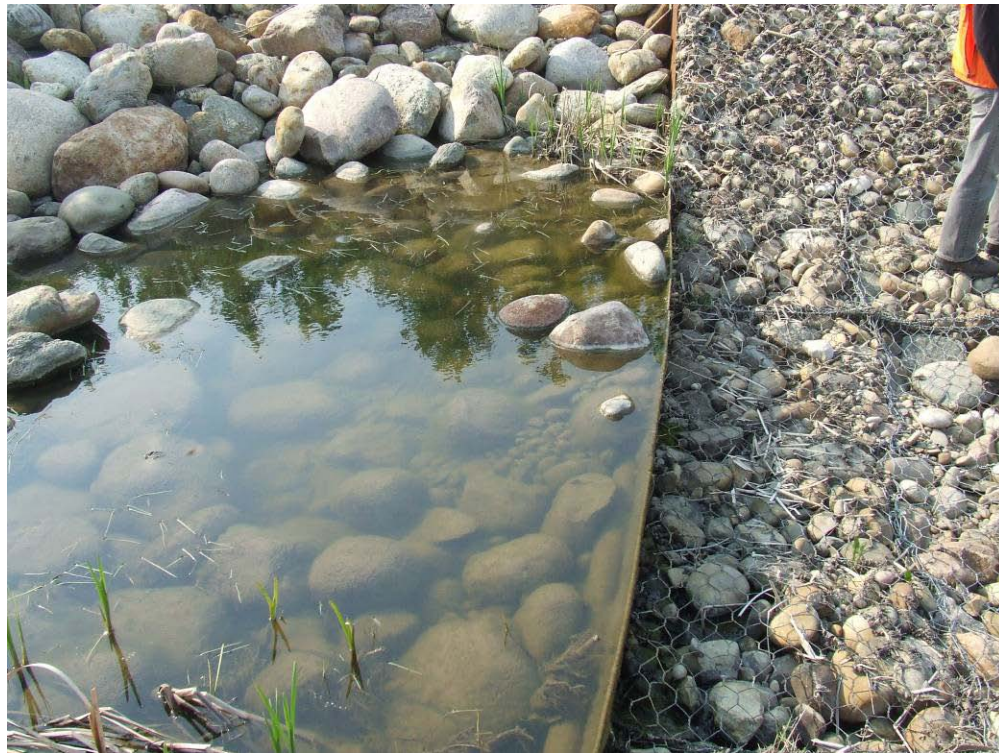
Photo 41-03

Looking at steel weir at top of gabion energy dissipation structure. Steel plate noticeably deformed (bowed) downstream but similar to previous years.

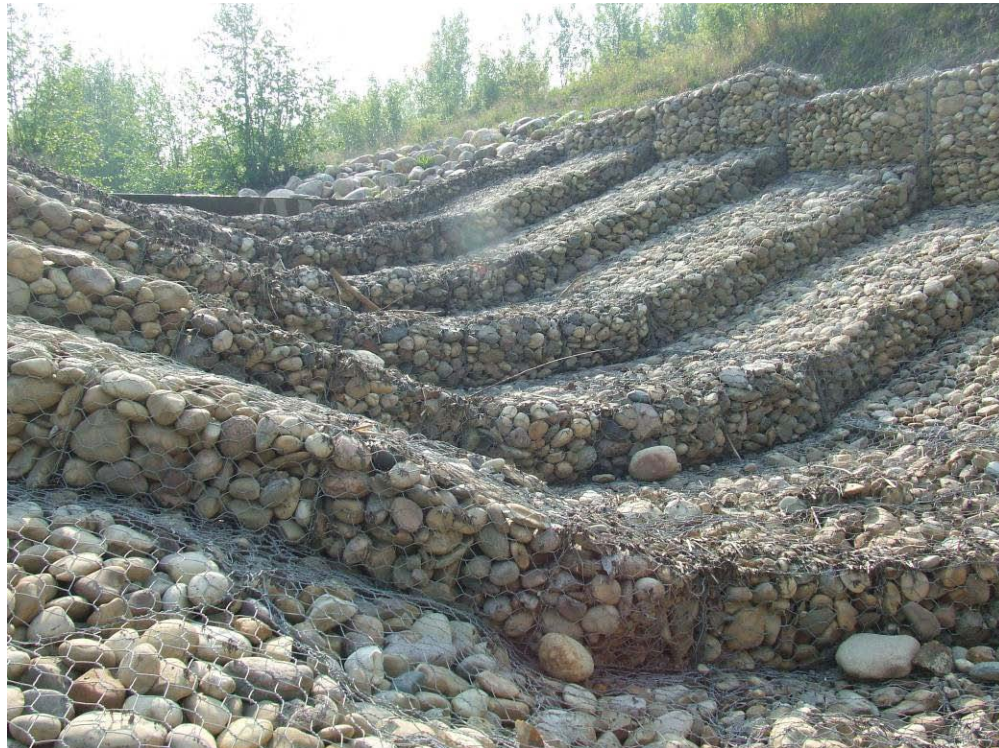
Photo 41-04

Looking upstream at upper portion of gabion energy dissipation structure.

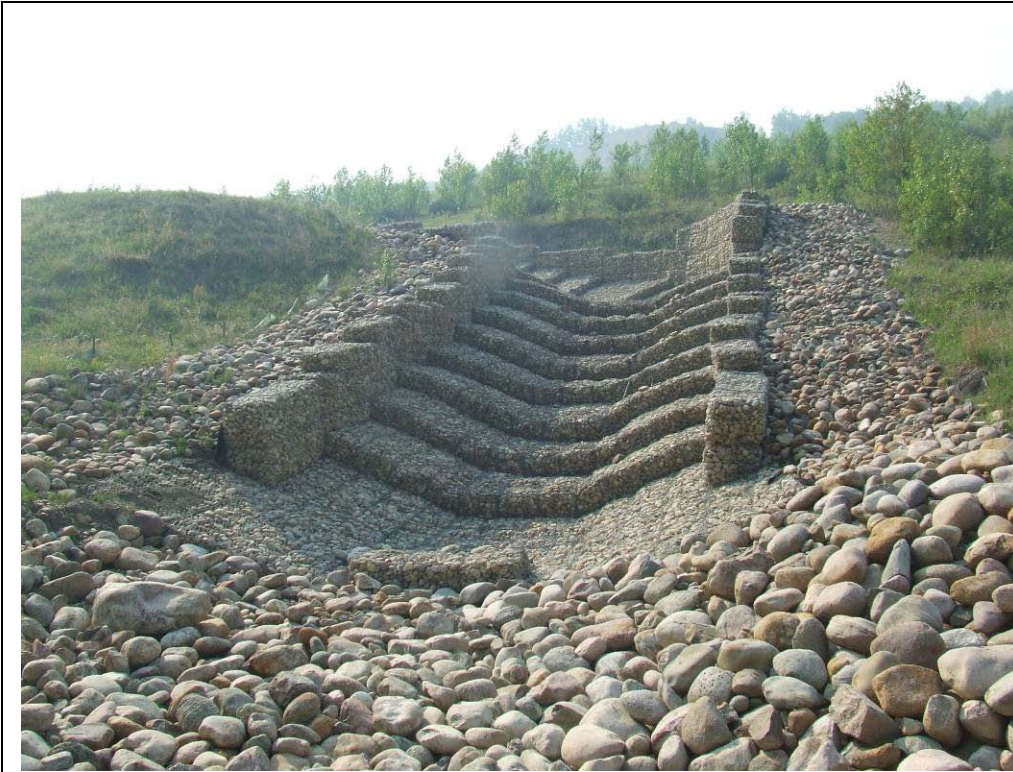
Photo 41-05

Looking upstream at lower portion of gabion energy dissipation structure.

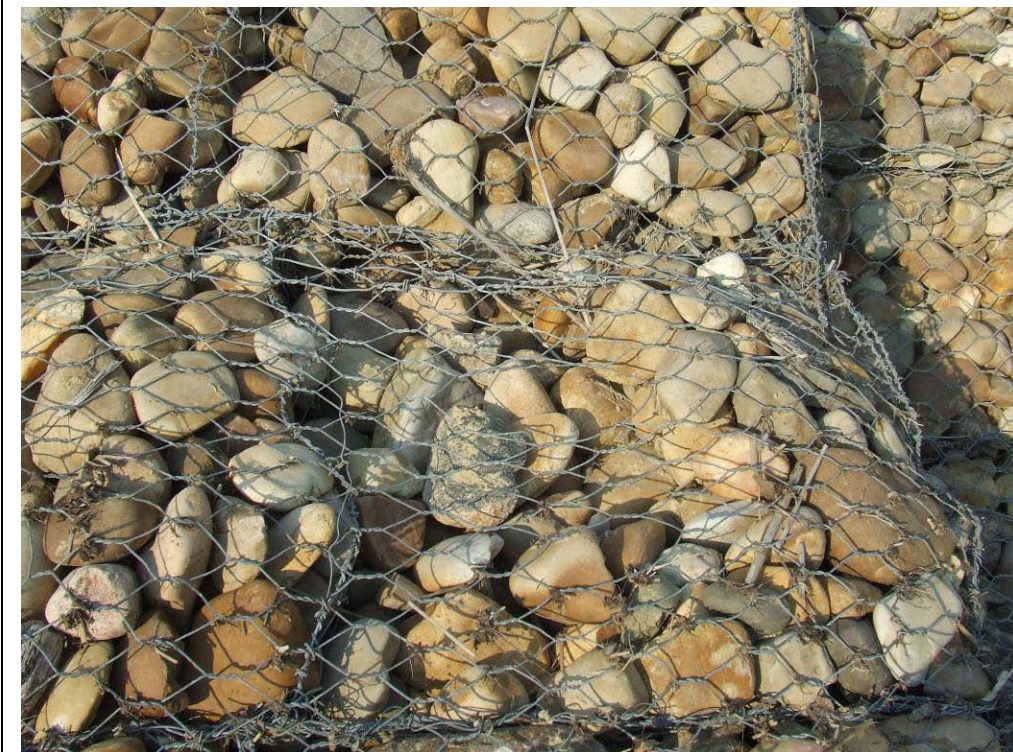
Photo 41-06

Close-up of one of several damaged gabion baskets.

The gabion baskets within the energy dissipation structure and channel should be inspected every spring following break-up and repairs made as required to ensure the baskets do not open further and lose their integrity. Damaged baskets and torn panels noted since 2010 did not appear to have been repaired last year and should be undertaken as soon as possible.

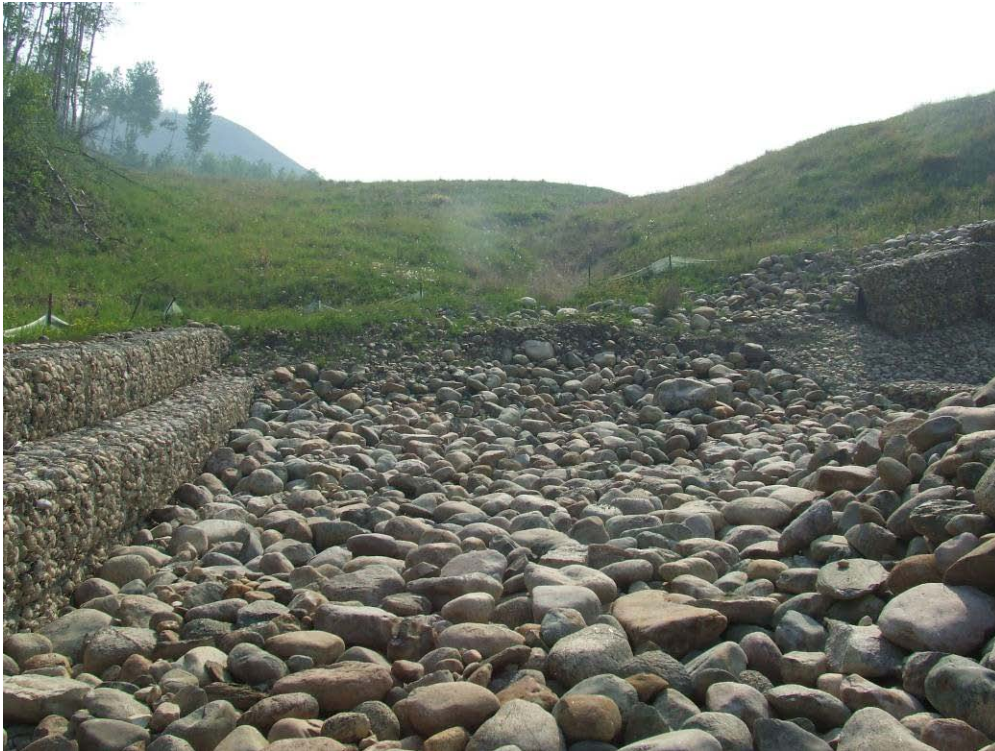
Photo 41-07

Looking upstream at old gully erosion (distance) that no longer receives flow since construction of new channel and energy dissipation structure.

In the short term, the riprap at the outlet of the energy dissipation structure should be readjusted so as not to direct flow towards the eroding natural bank just downstream of the discharge area. Alternately, consideration could be given to adding additional riprap to armour this area.

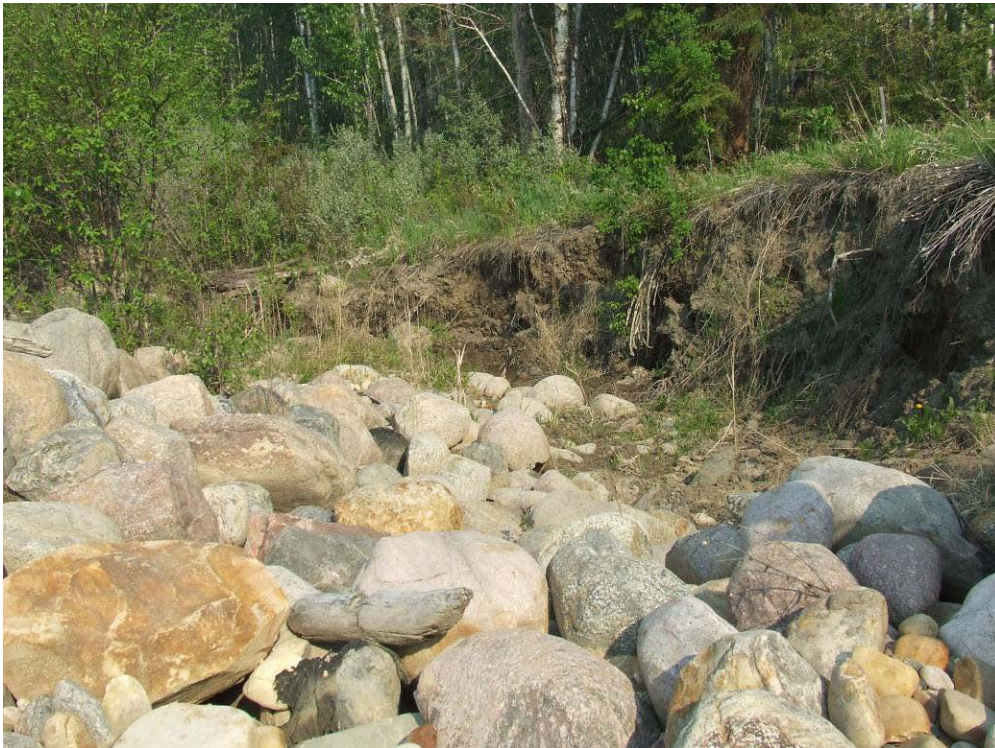
Photo 41-08

Looking downstream at bank erosion of native channel immediately downstream of armoured section.
