THURBER ENGINEERING LTD.

**ALBERTA TRANSPORTATION GRMP (CON0022164)
PEACE REGION (PEACE RIVER DISTRICT)
INSTRUMENTATION MONITORING RESULTS – SPRING 2022**

**SITE PH041: HWY 986:01, DAISHOWA EAST HILL
(STATION 12+000 SITE 5 GULLY AND DITCH)**

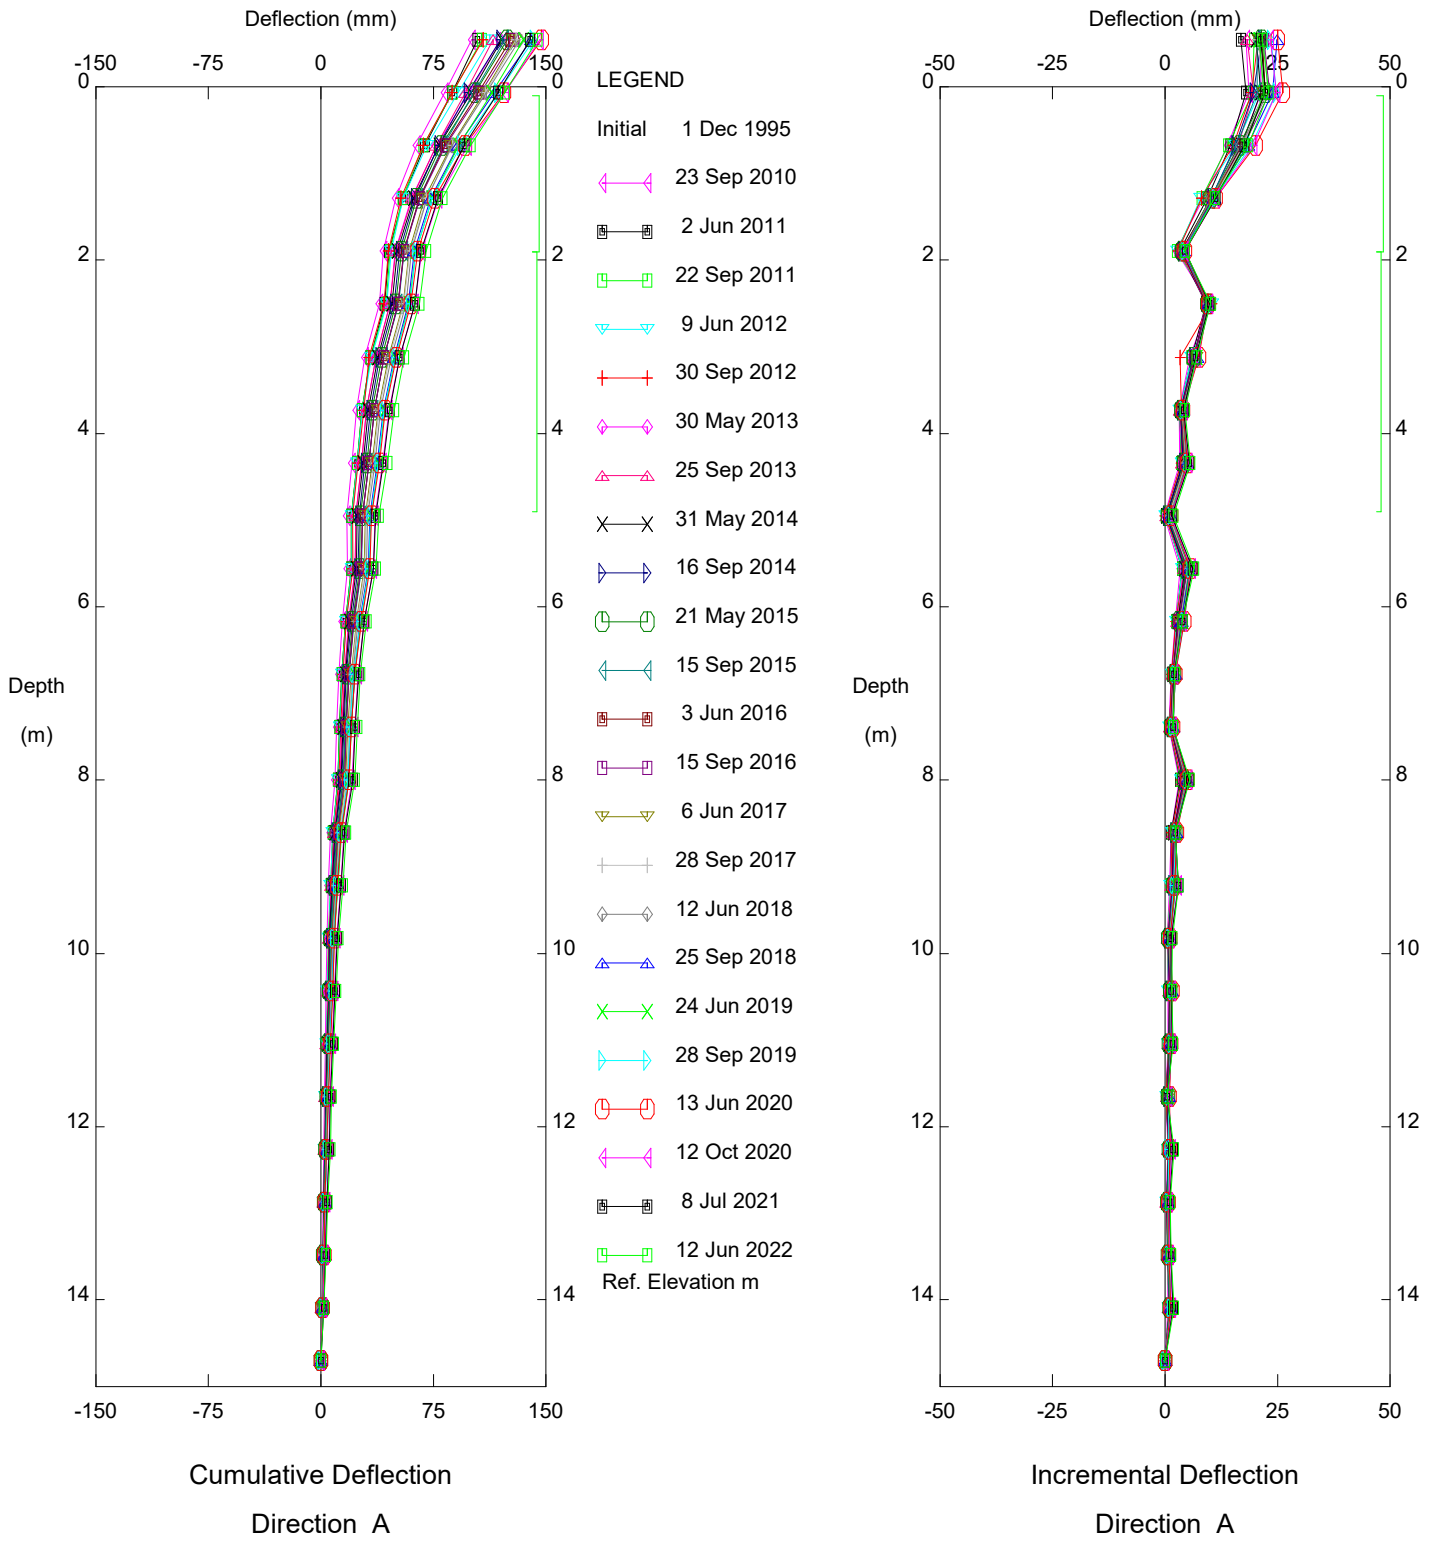
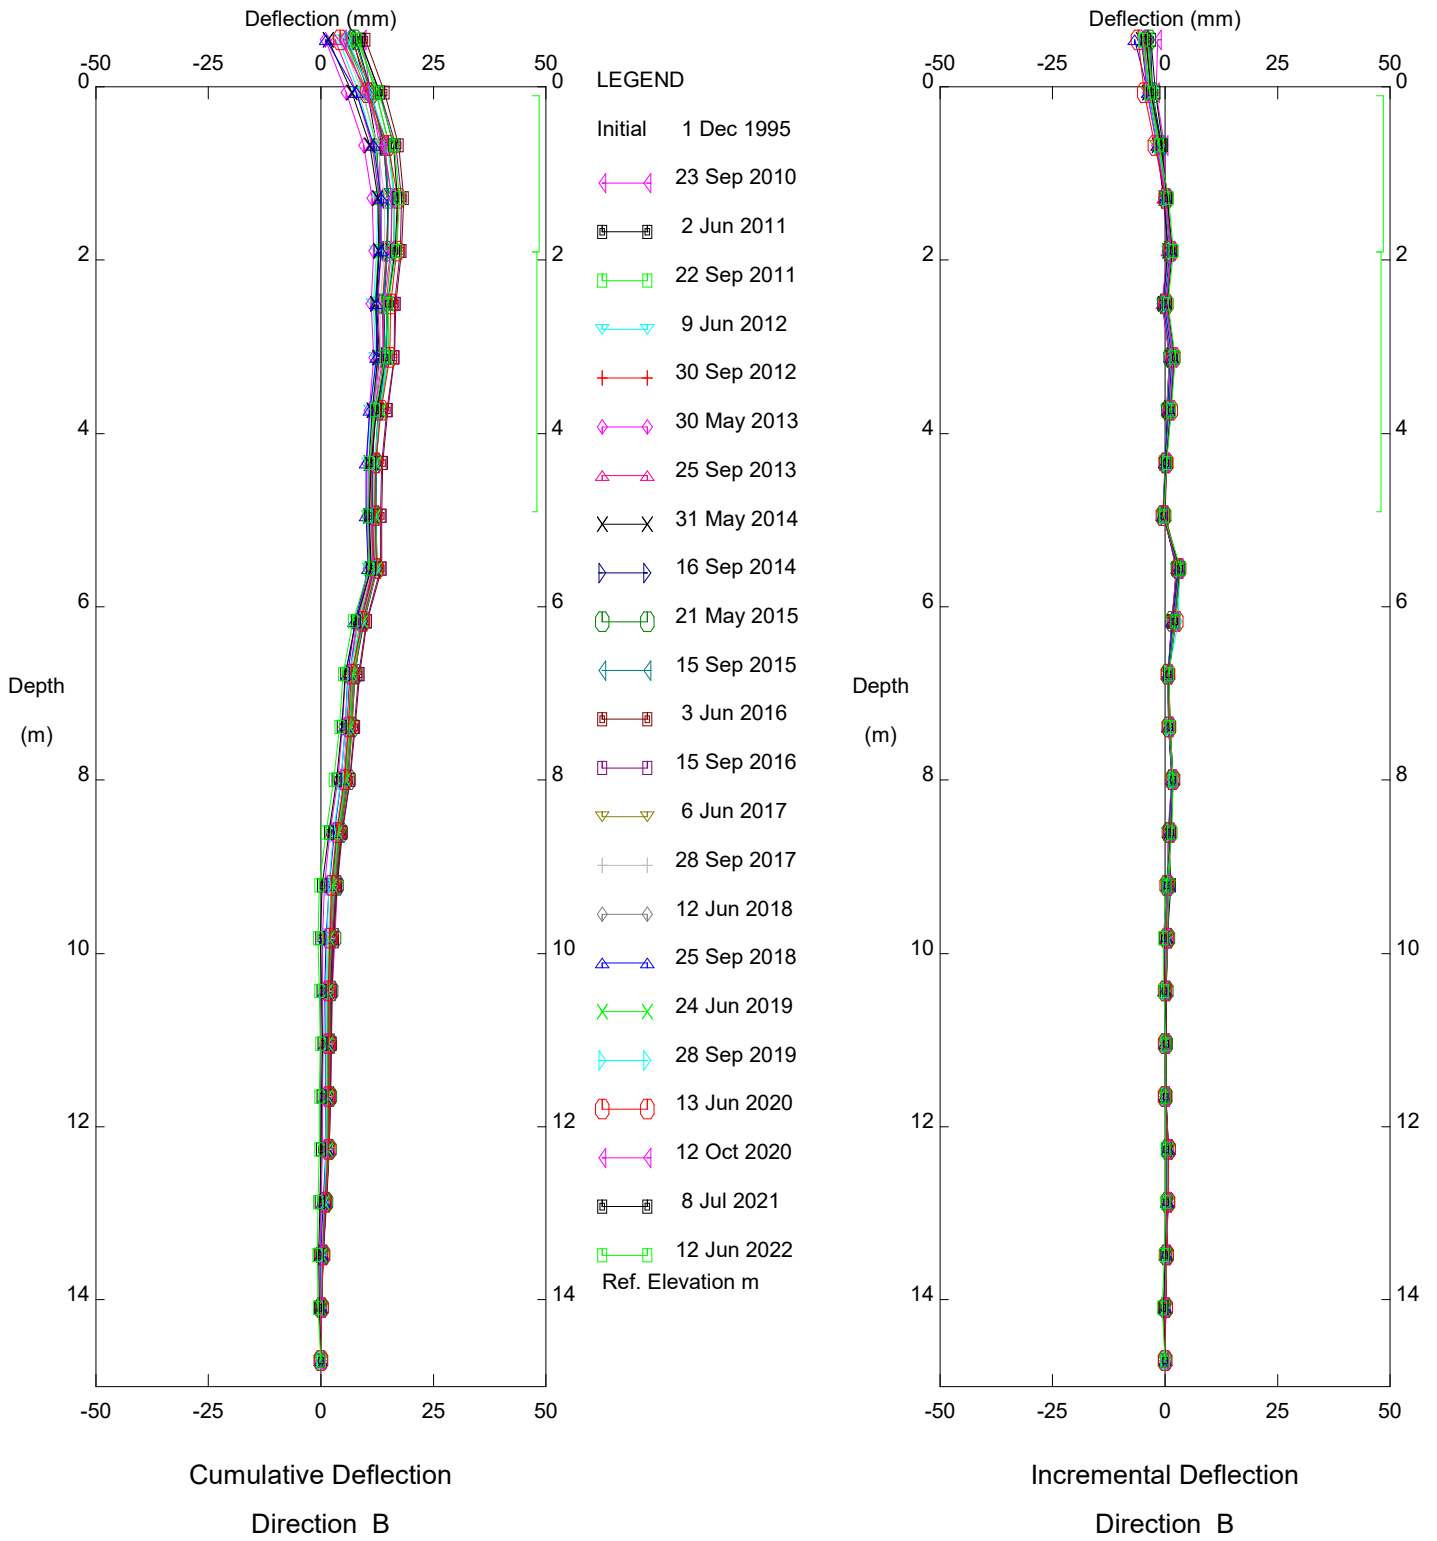
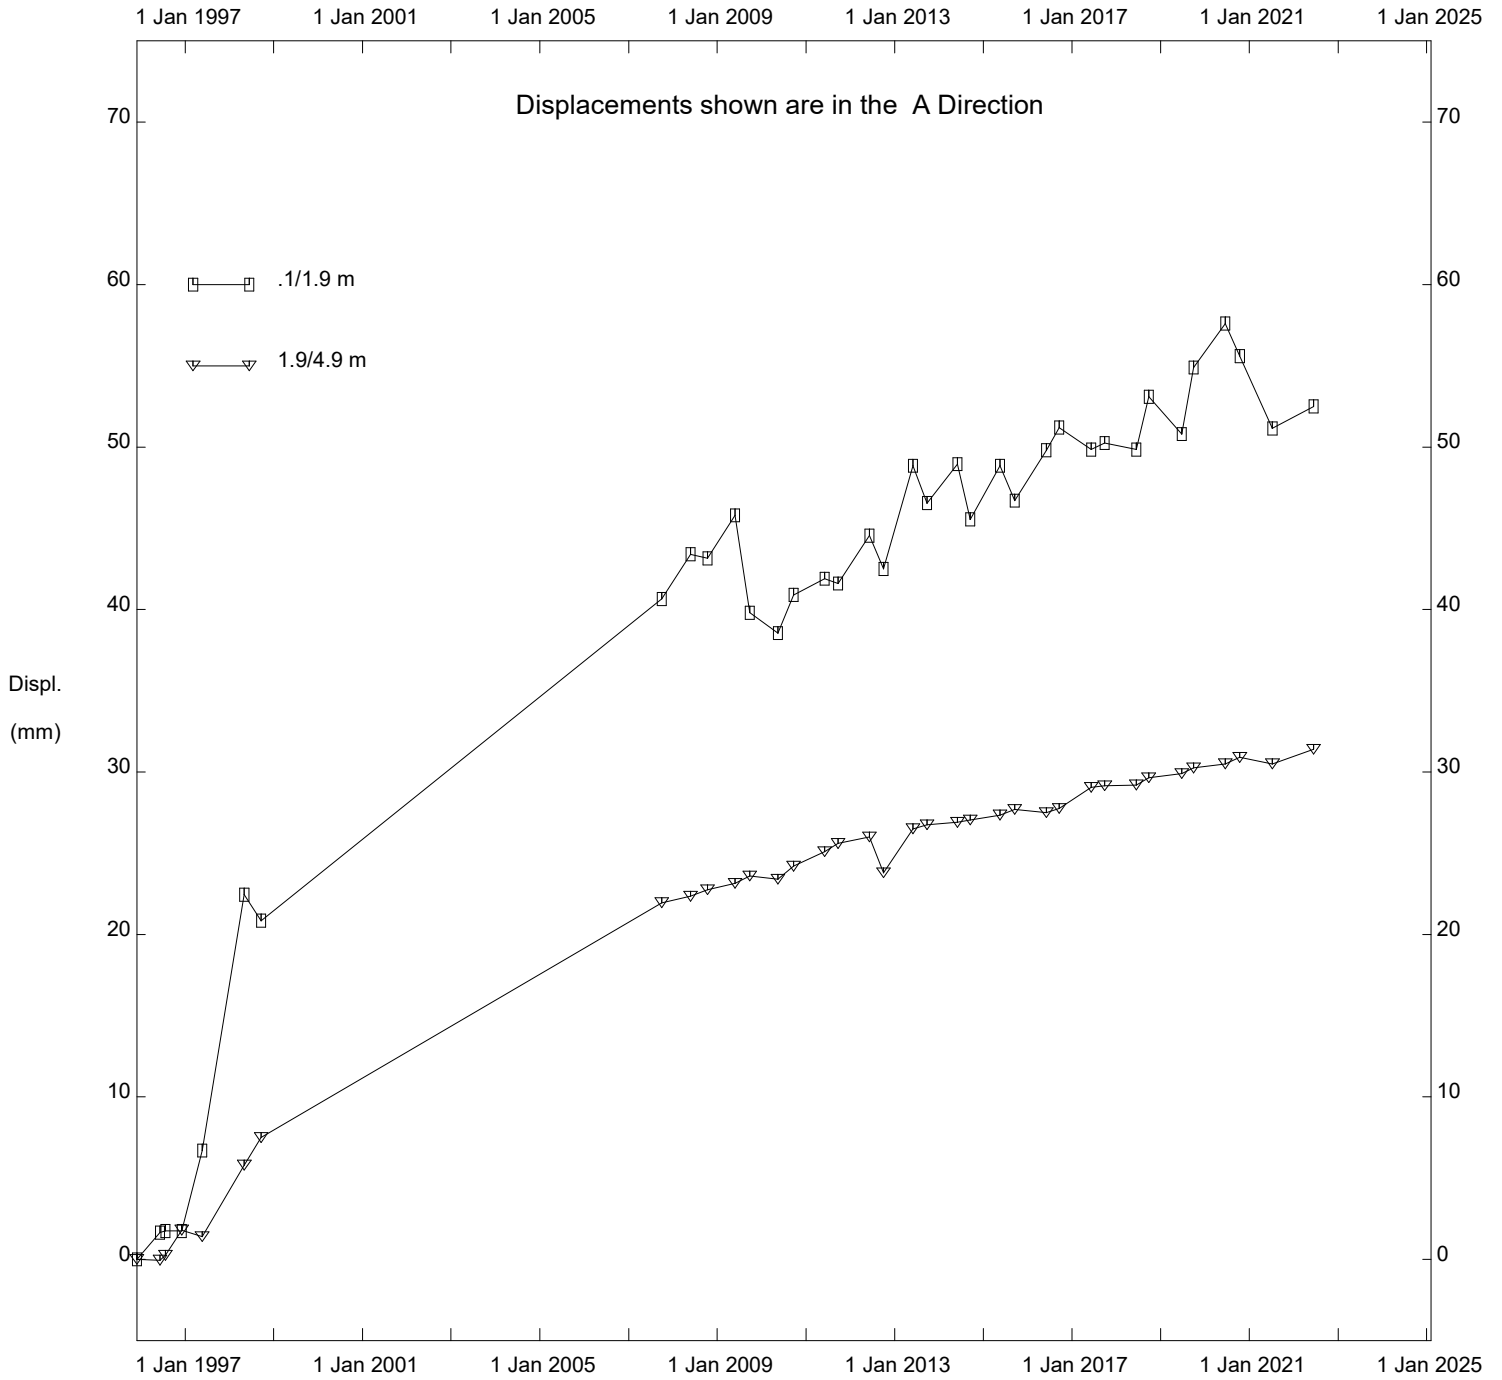
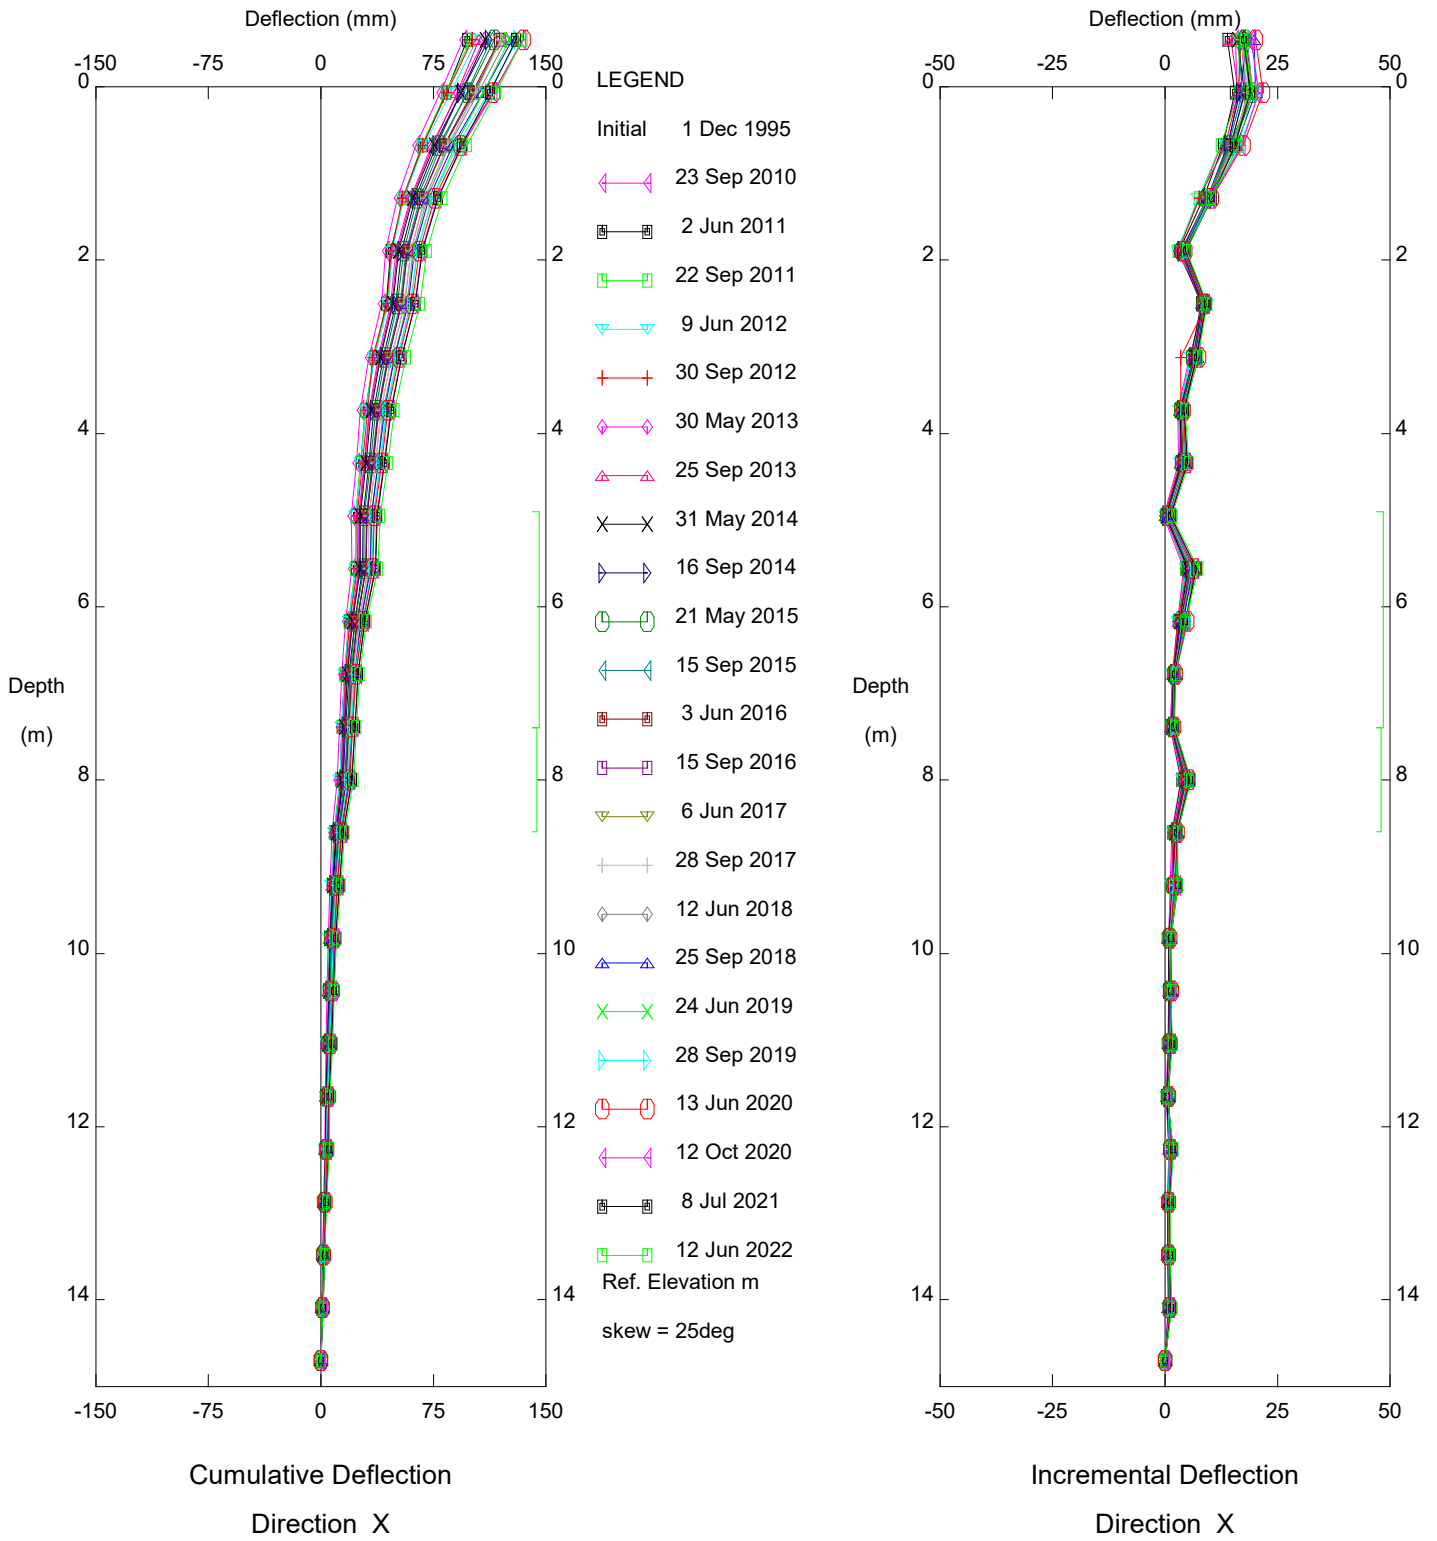
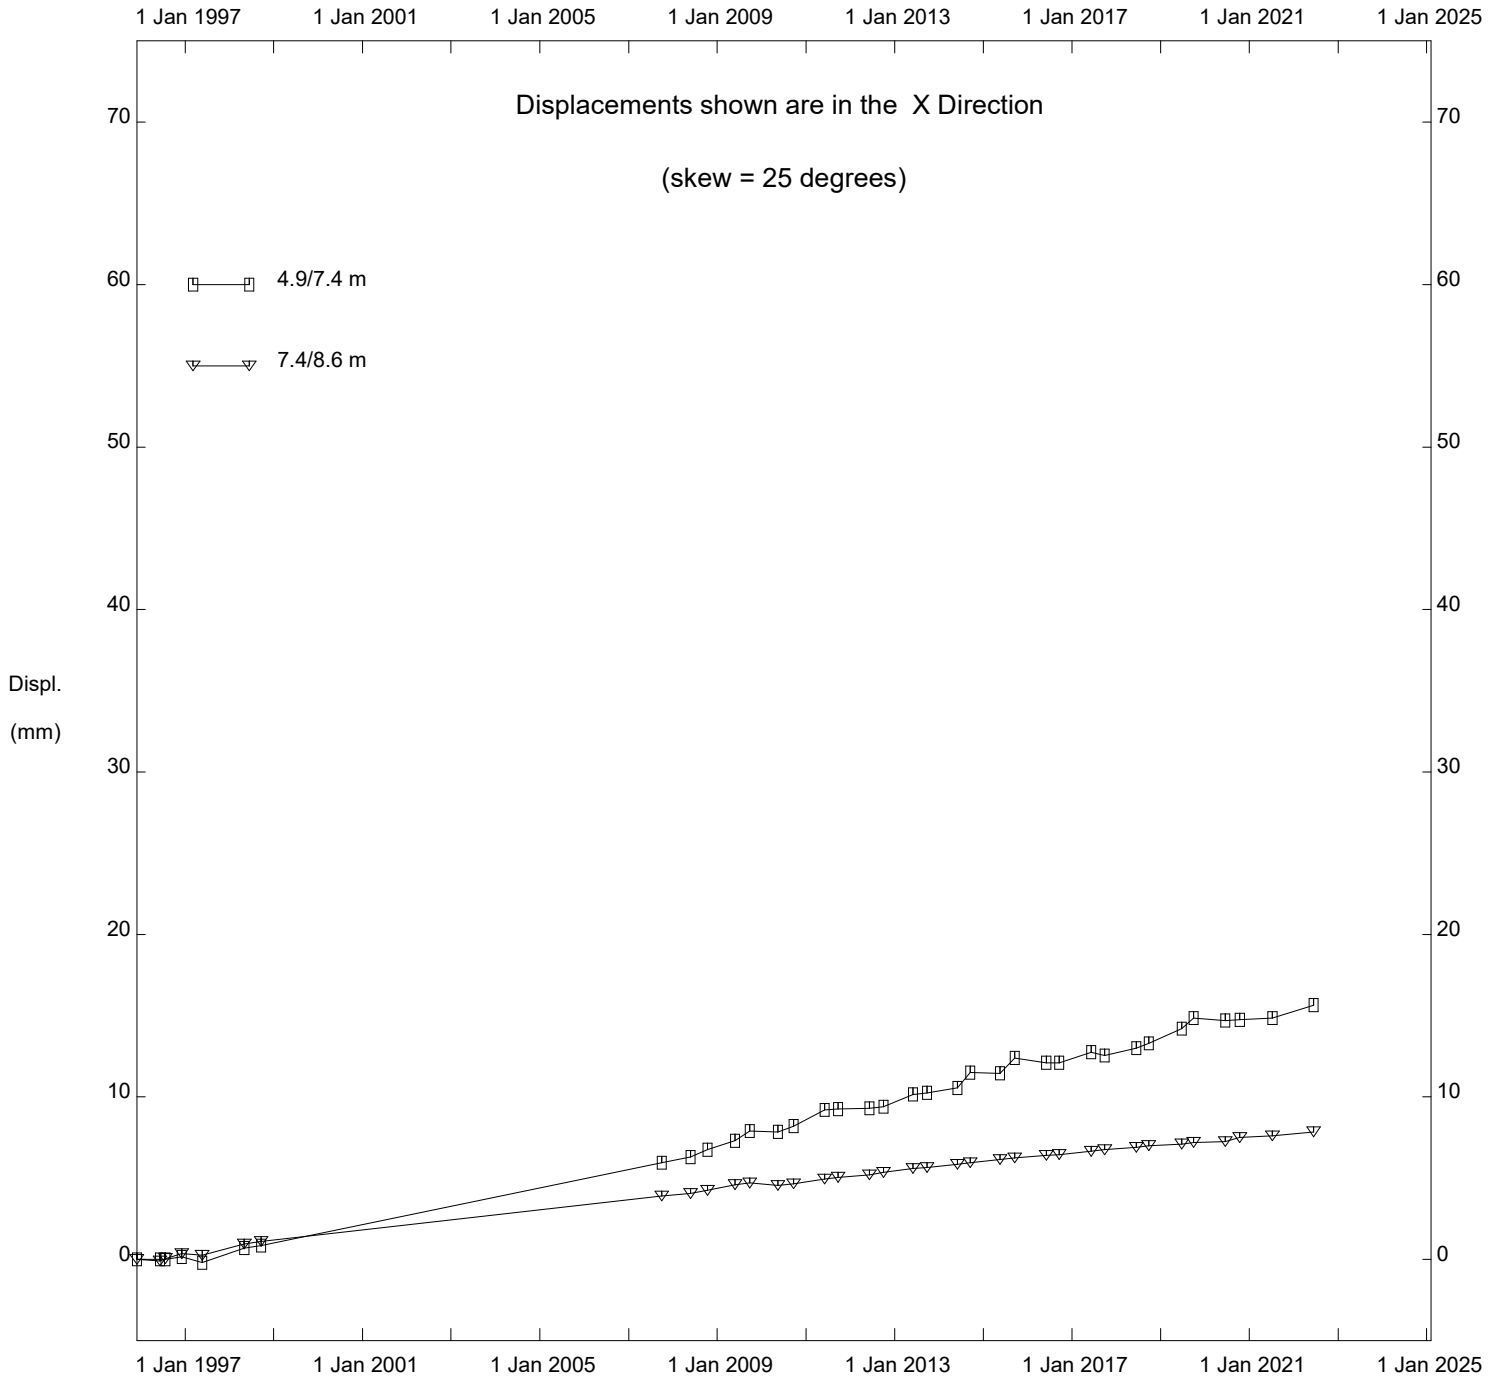
HWY 986:01 - STA. 11+960, Inclinometer SI1

Slope inclinometer SI-1 showed a rate of movement of 1.5 mm/yr over 0.1 m to 1.9 m depth, a rate of movement of 1.0 mm/yr over 1.9 m to 4.9 m depth, a rate of movement of 0.9 mm/yr over 4.9 m to 7.4 m depth and a rate of movement of 0.3 mm/yr over 7.4 m to 8.6 m depth since the spring of 2021 readings. The measured rates of movement in SI-1 have been oscillating but show a general trend of approximately 1 mm/yr since 2009 (0.1 m to 1.9 m depth). Slope inclinometer SI-2 showed rates of movement of 0.9 mm/yr and 0.7 mm/yr over 5.6 m to 8.6 m depth and 13.5 m to 14.7 m depth, respectively, since the spring of 2021 readings. The measured rates of movement in SI-2 have shown a steady trend of approximately 0.5 to 1 mm/yr since 2007 in both zones.

The instruments should be read again in the spring of 2023.
