THURBER ENGINEERING LTD.

**ALBERTA TRANSPORTATION GRMP (CON0022164)
PEACE REGION (PEACE RIVER DISTRICT)
INSTRUMENTATION MONITORING RESULTS – SPRING 2022**

**SITE PH041: HWY 986:01, DAISHOWA EAST HILL
(STATION 12+000 SITE 5 GULLY AND DITCH)**

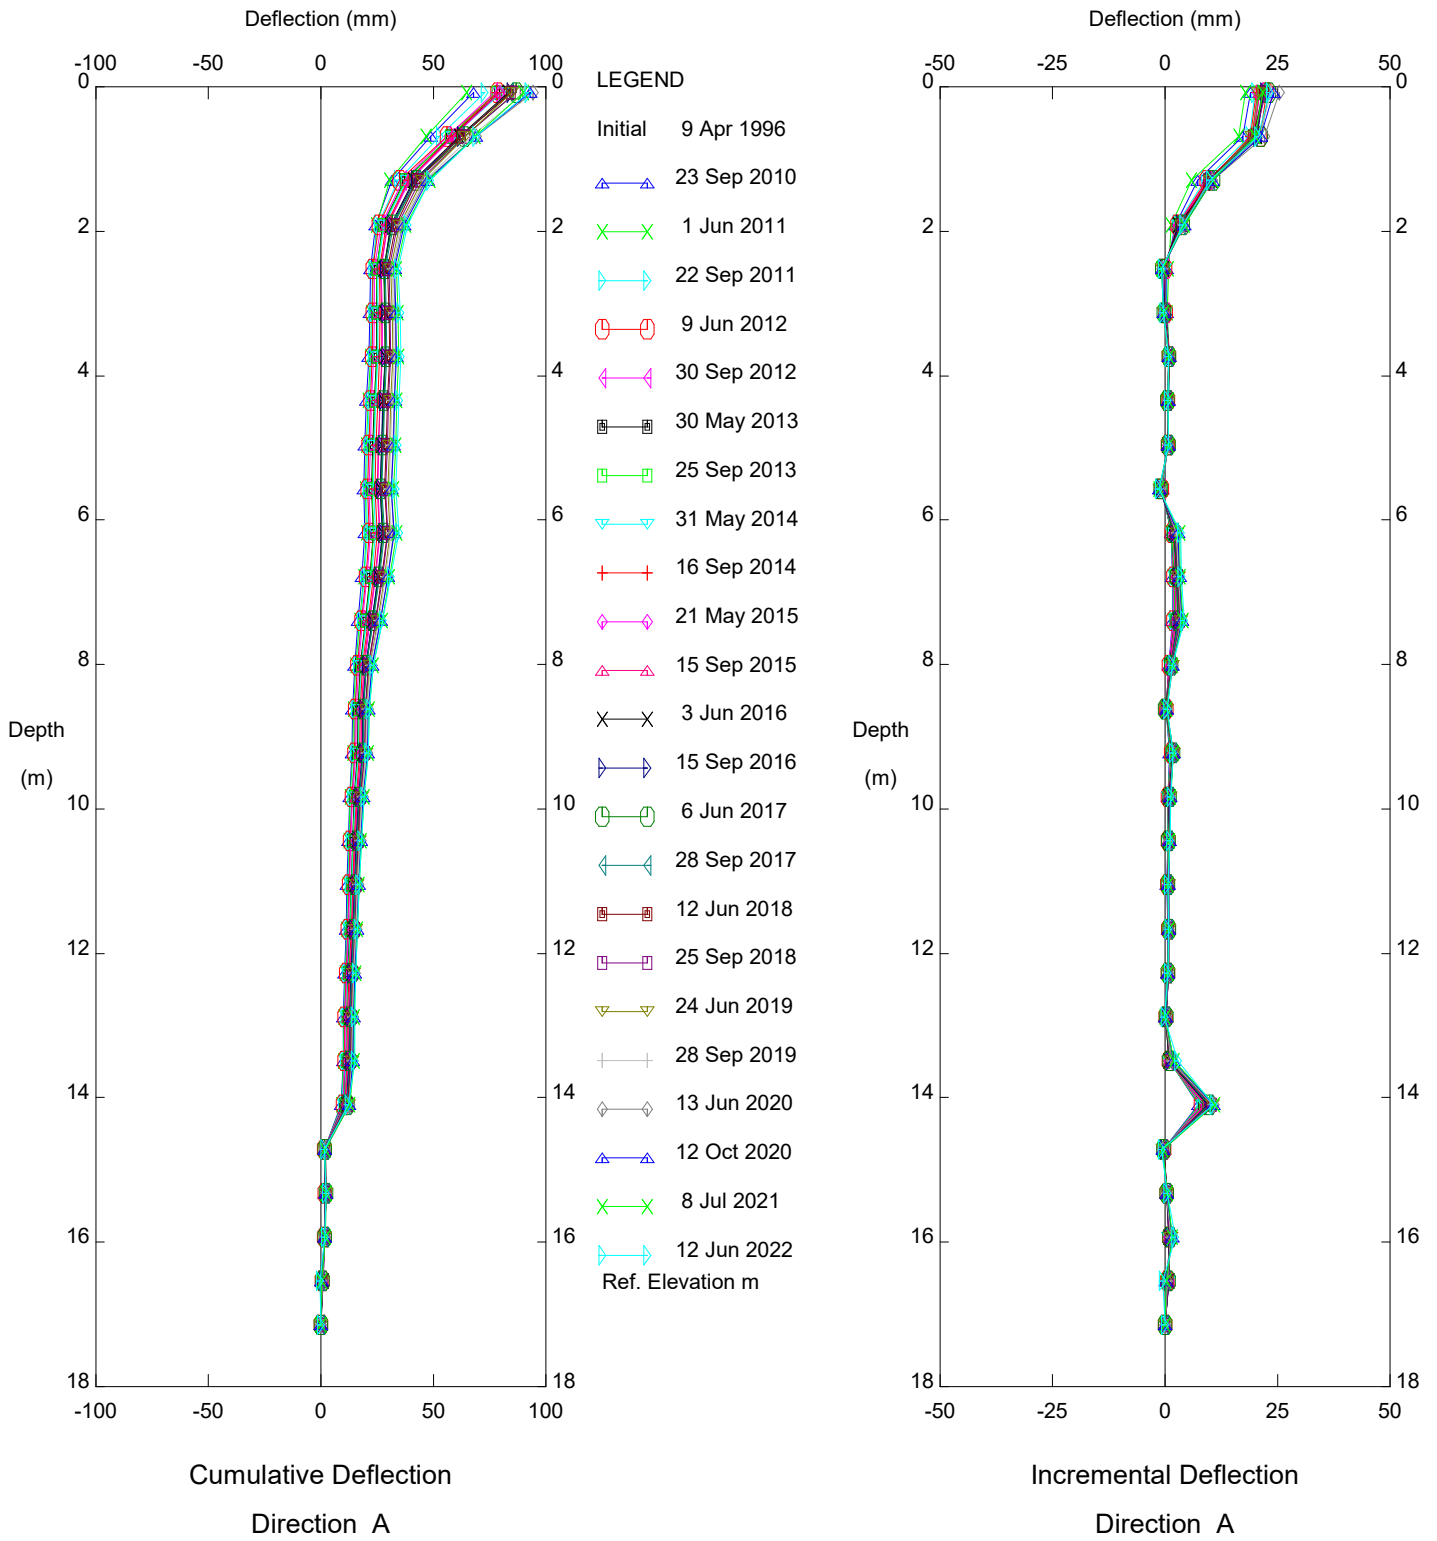
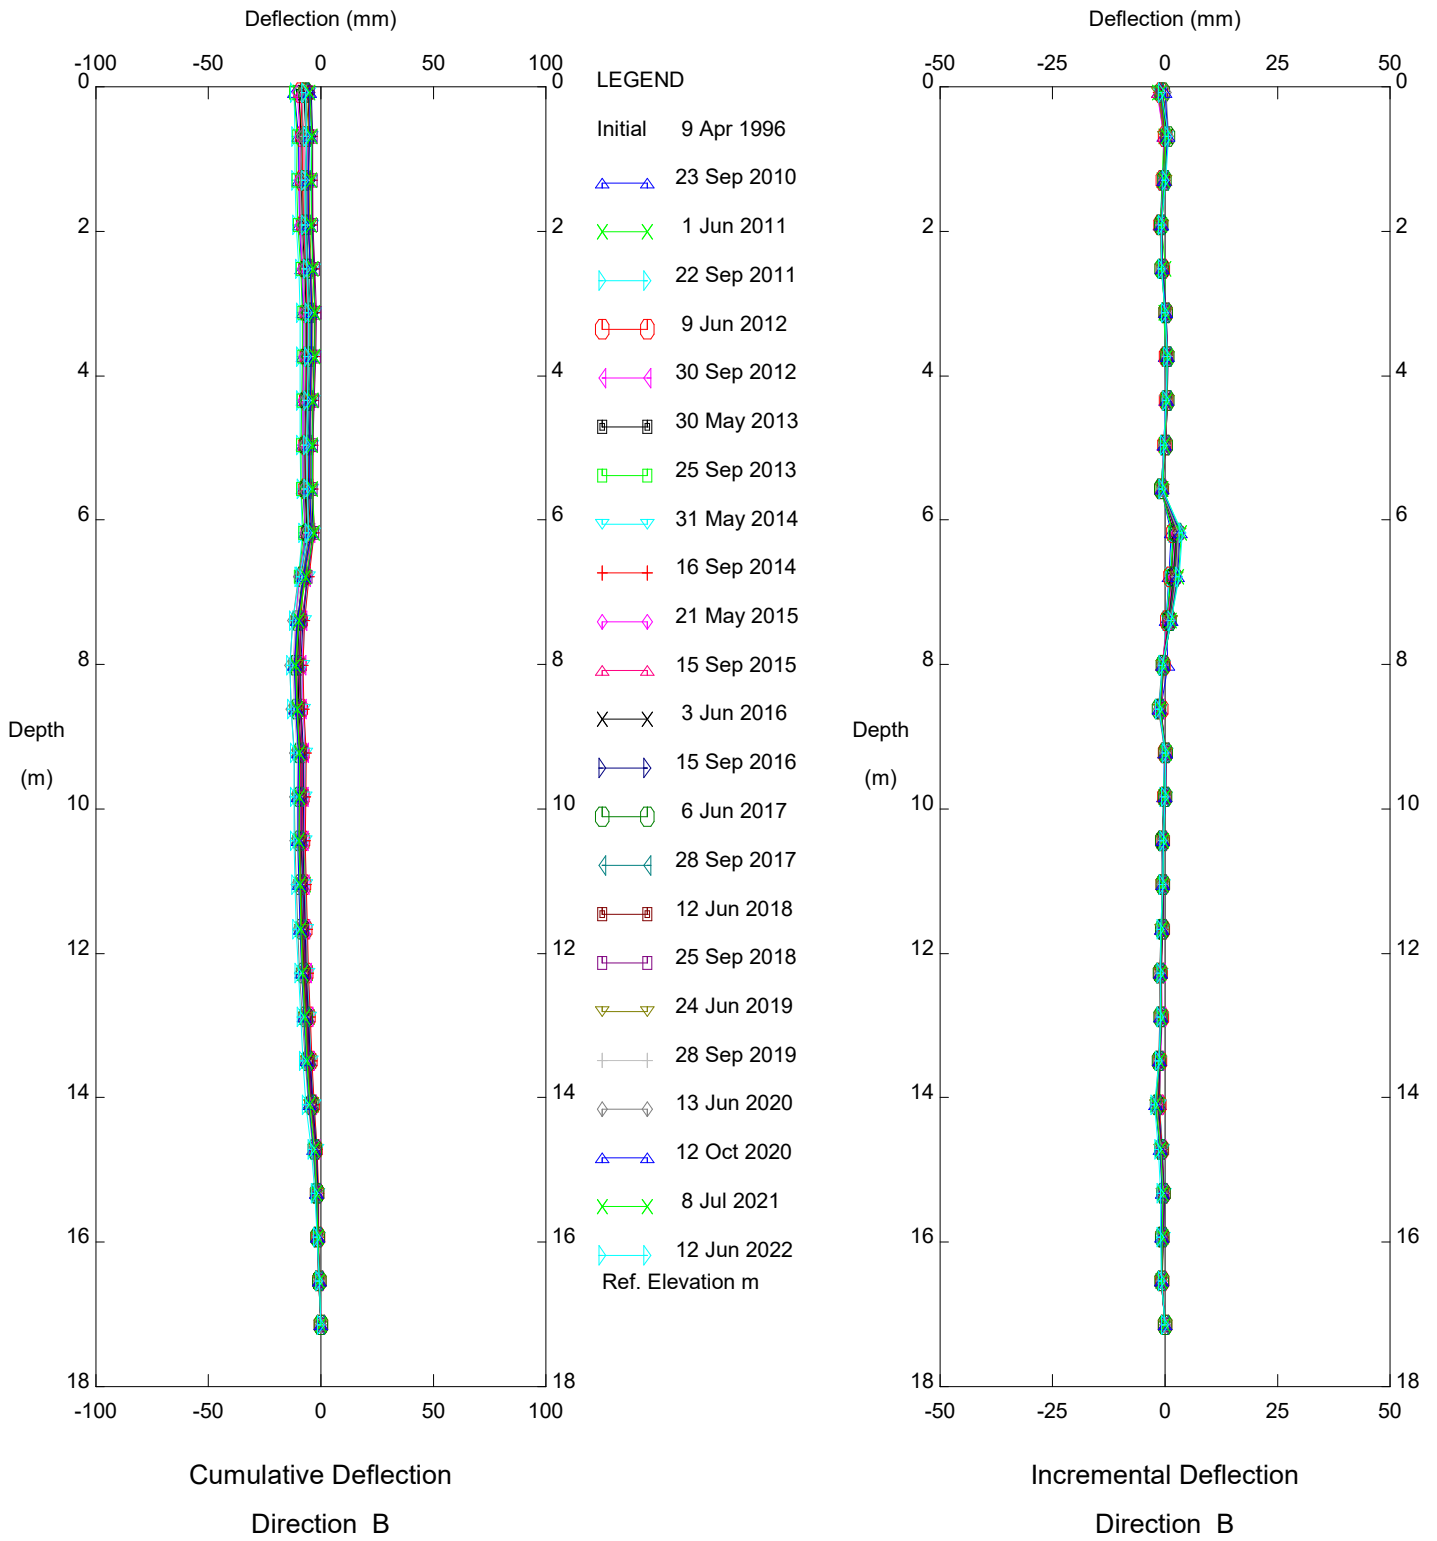
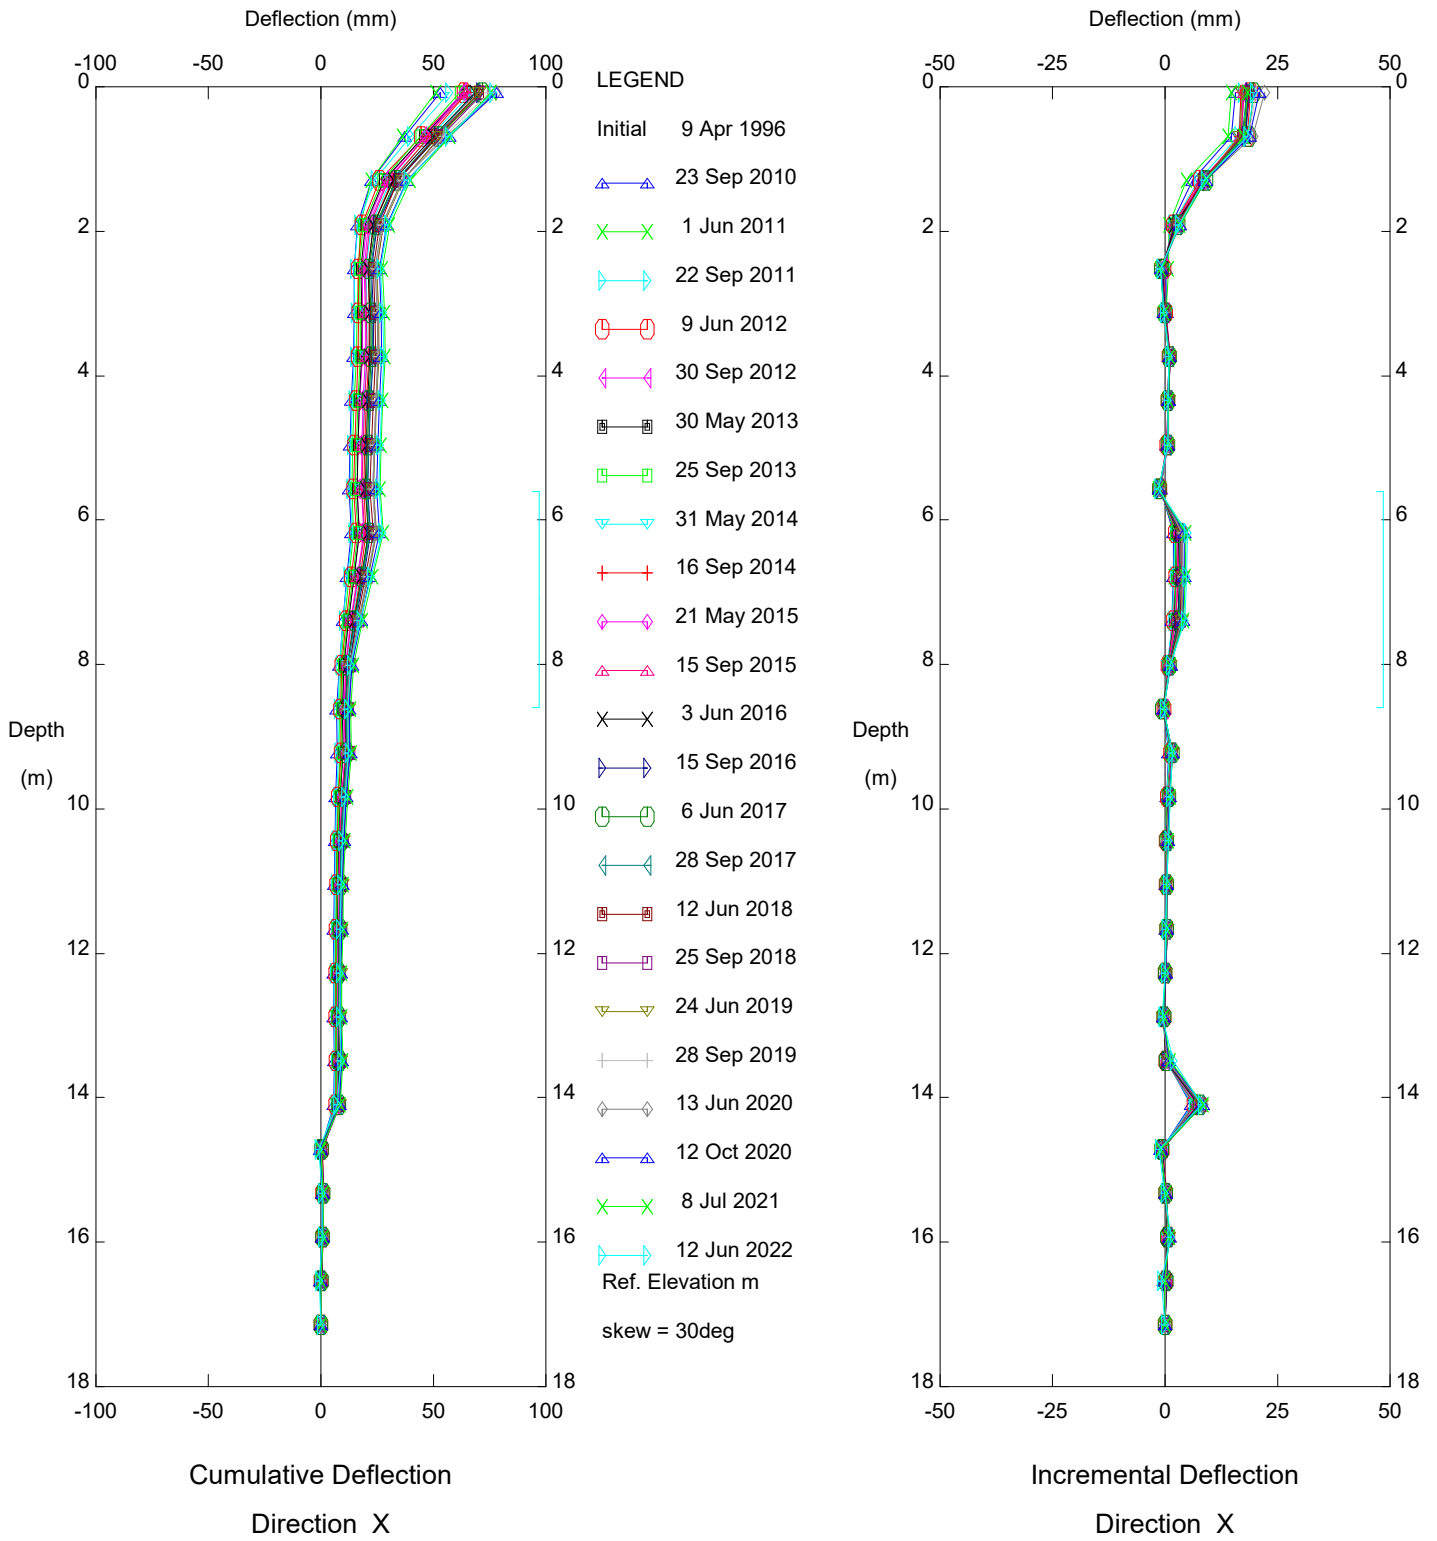
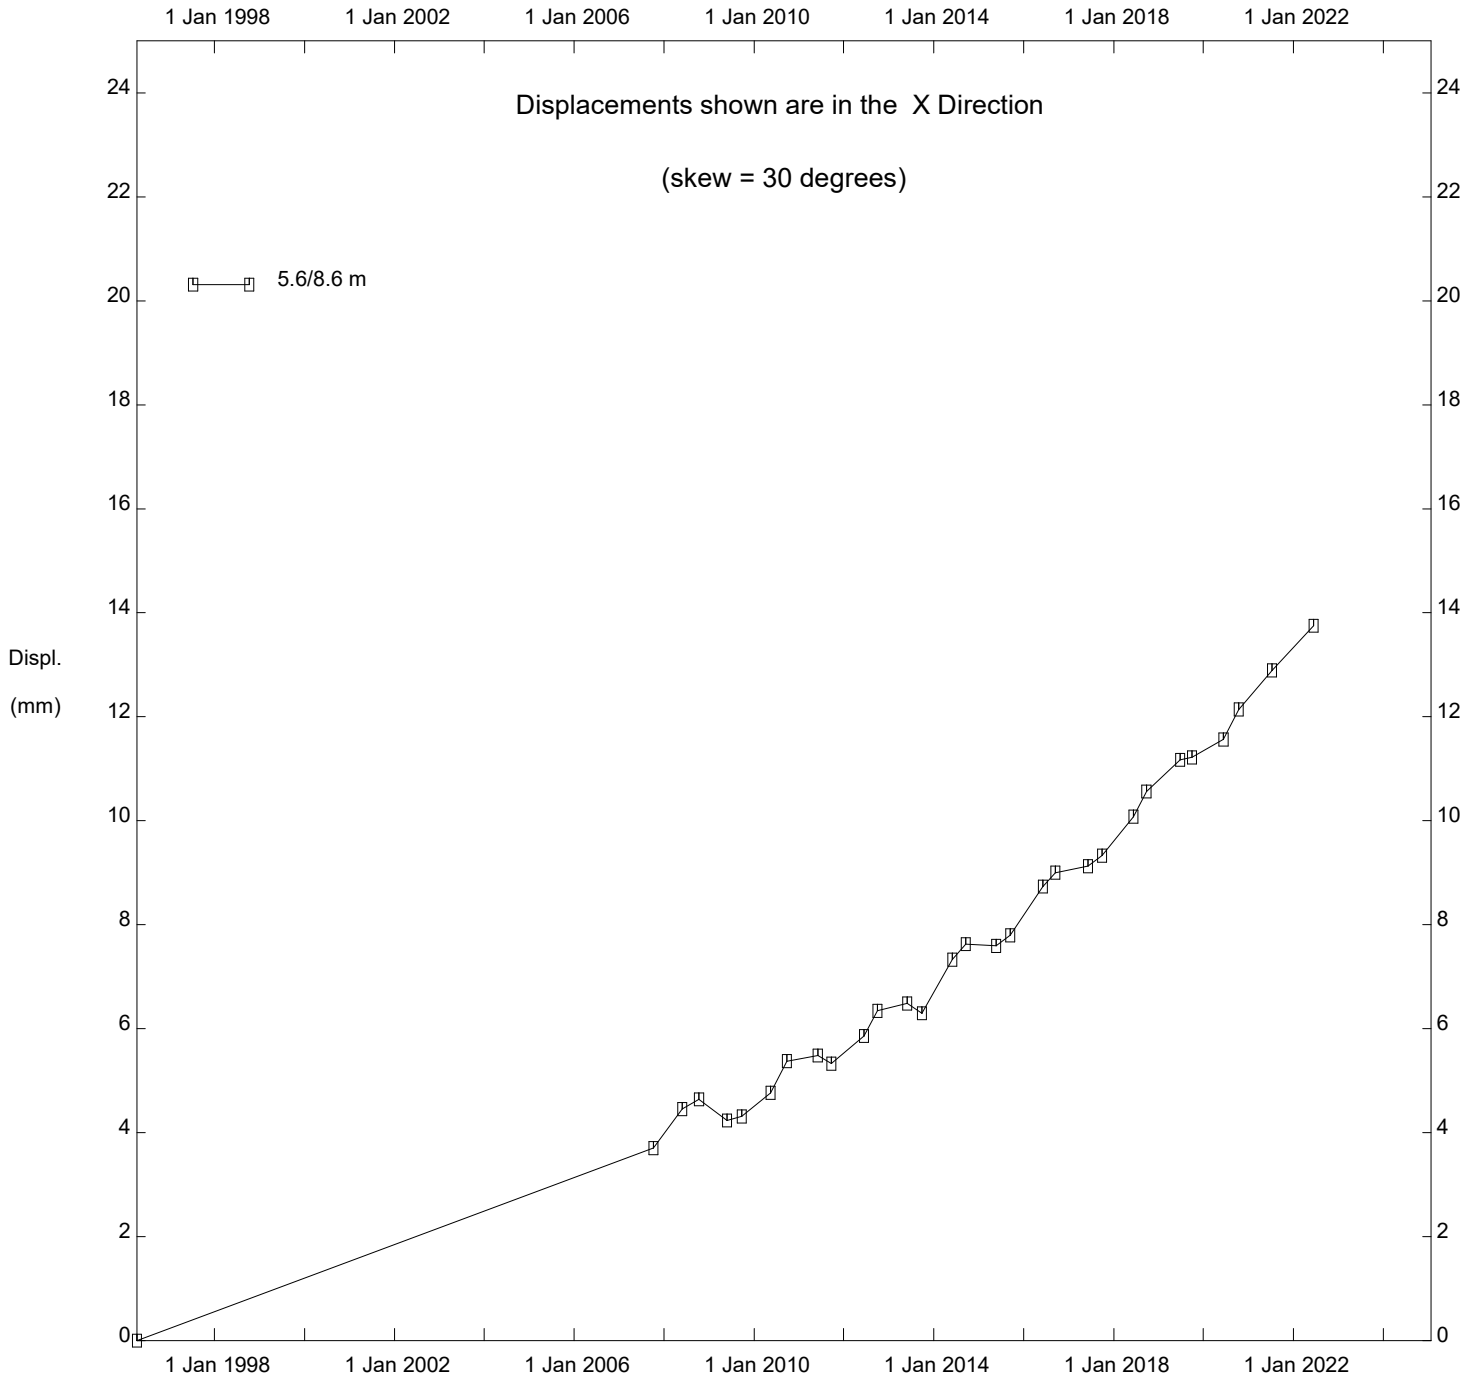
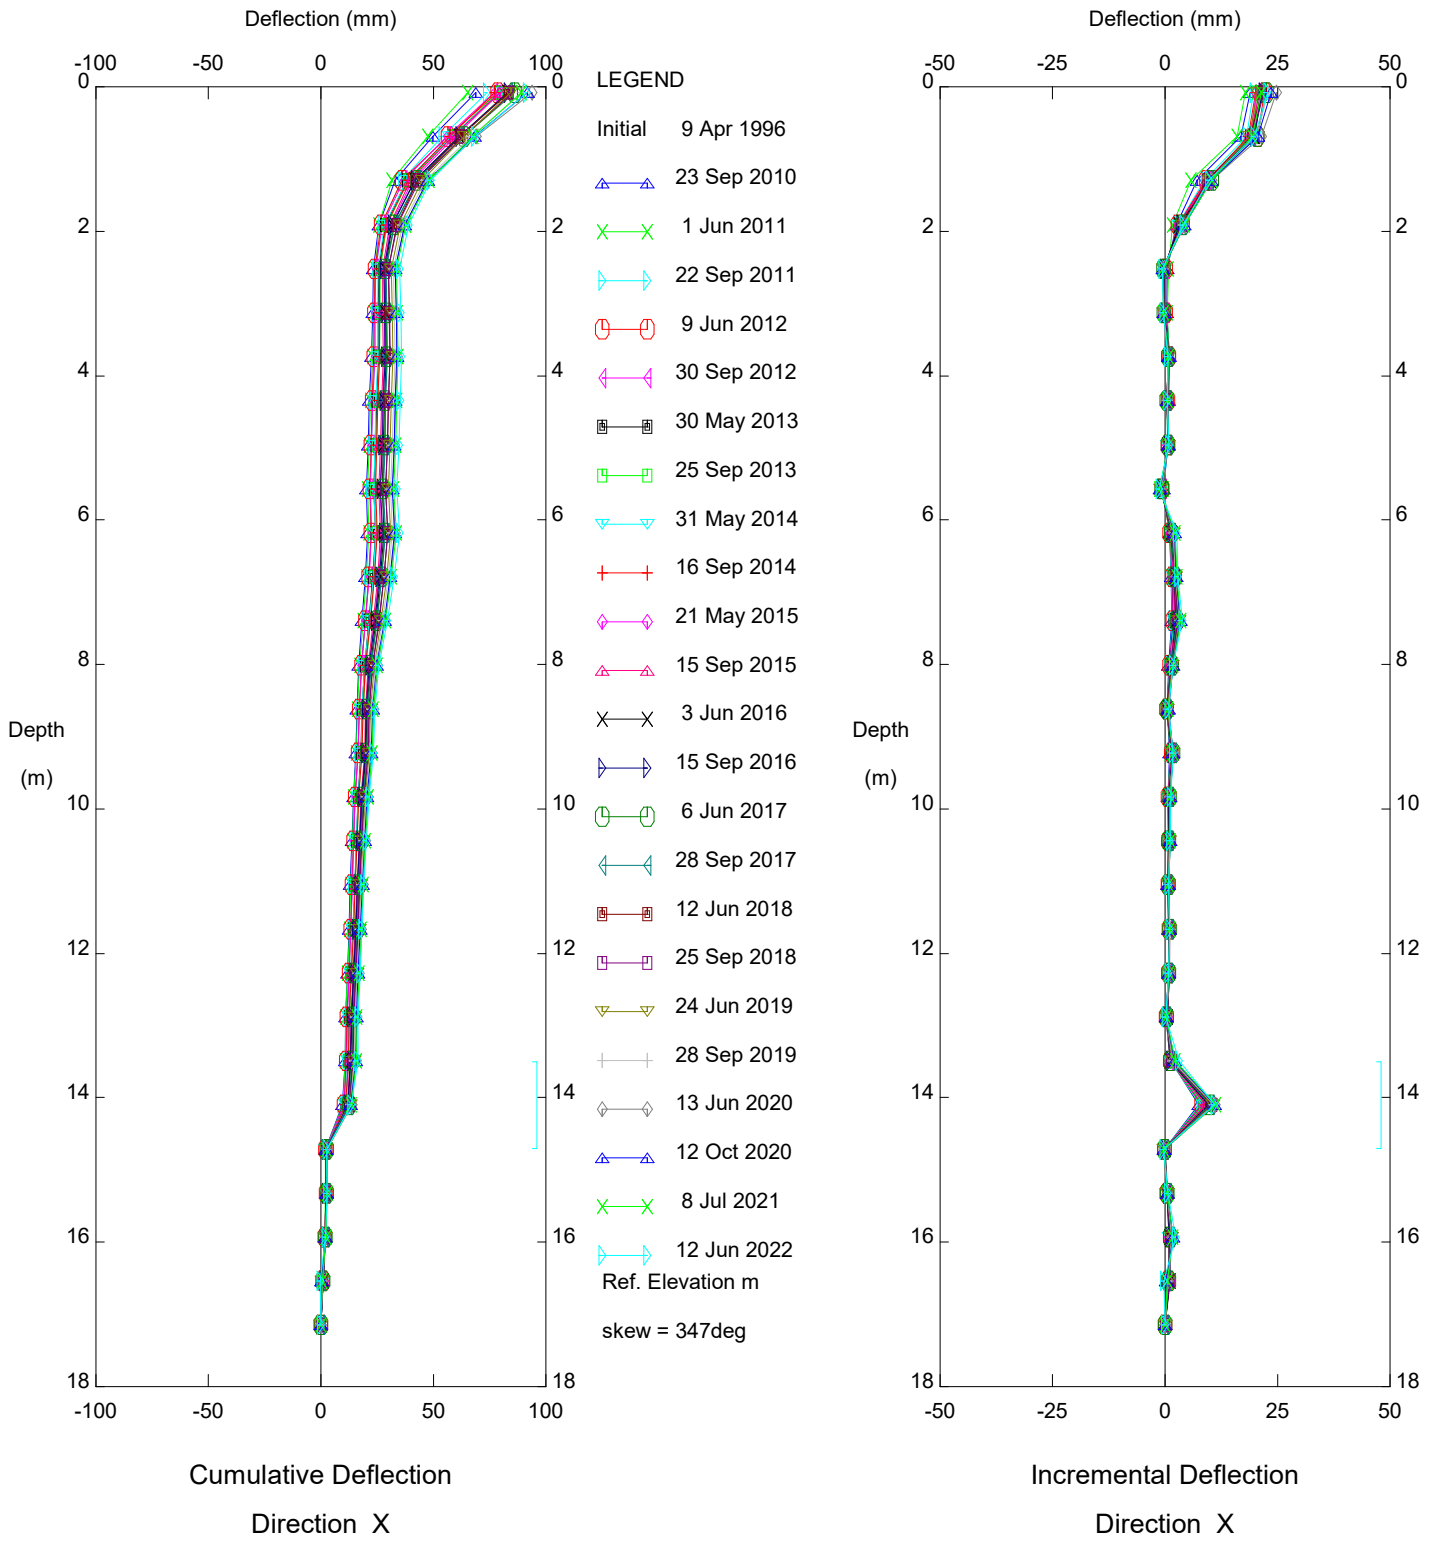
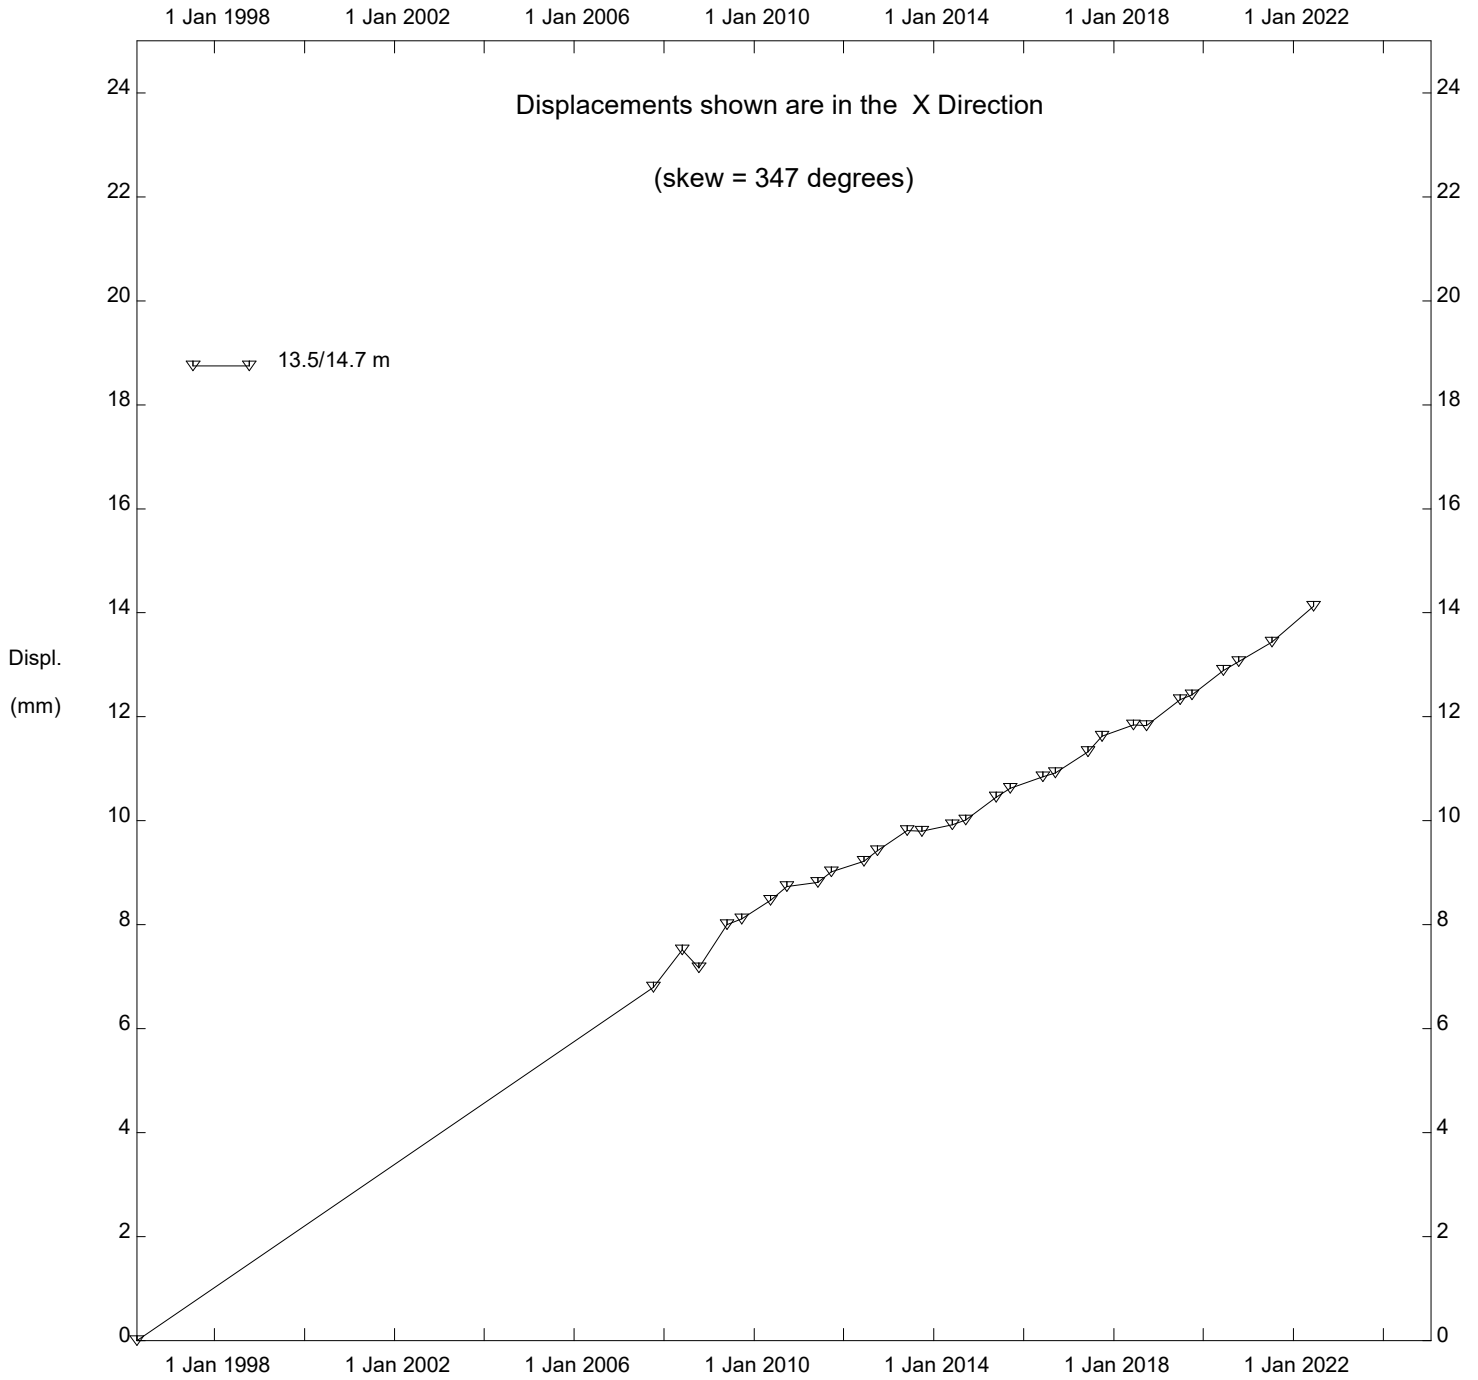
HWY 986:01 - STA. 11+960, Inclinometer SI-2

Slope inclinometer SI-1 showed a rate of movement of 1.5 mm/yr over 0.1 m to 1.9 m depth, a rate of movement of 1.0 mm/yr over 1.9 m to 4.9 m depth, a rate of movement of 0.9 mm/yr over 4.9 m to 7.4 m depth and a rate of movement of 0.3 mm/yr over 7.4 m to 8.6 m depth since the spring of 2021 readings. The measured rates of movement in SI-1 have been oscillating but show a general trend of approximately 1 mm/yr since 2009 (0.1 m to 1.9 m depth). Slope inclinometer SI-2 showed rates of movement of 0.9 mm/yr and 0.7 mm/yr over 5.6 m to 8.6 m depth and 13.5 m to 14.7 m depth, respectively, since the spring of 2021 readings. The measured rates of movement in SI-2 have shown a steady trend of approximately 0.5 to 1 mm/yr since 2007 in both zones.

The instruments should be read again in the spring of 2023.
