ALBERTA TRANSPORTATION AND ECONOMIC CORRIDORS GRMP PEACE REGION – (PEACE RIVER DISTRICT) INSTRUMENTATION MONITORING - SPRING 2025

Site Number	Location	Name	Hwy	km
PH041	Hwy 986:01 C1 31.92	Daishowa East Hill	986:01	31.9
Legal Description):	UTM Co-ordinates		
16-12-85-21 W5		11U E 489840	N 624	46240

SITE PH041: HWY 986:01, DAISHOWA EAST HILL (STATION 12+000 SITE 5 GULLY AND DITCH)

PH041: HWY 986:01 - DAISHOWA EAST HILL (STA. 12+000 SITE 5 GULLY & DITCH EROSION) INSTRUMENT LOCATIONS

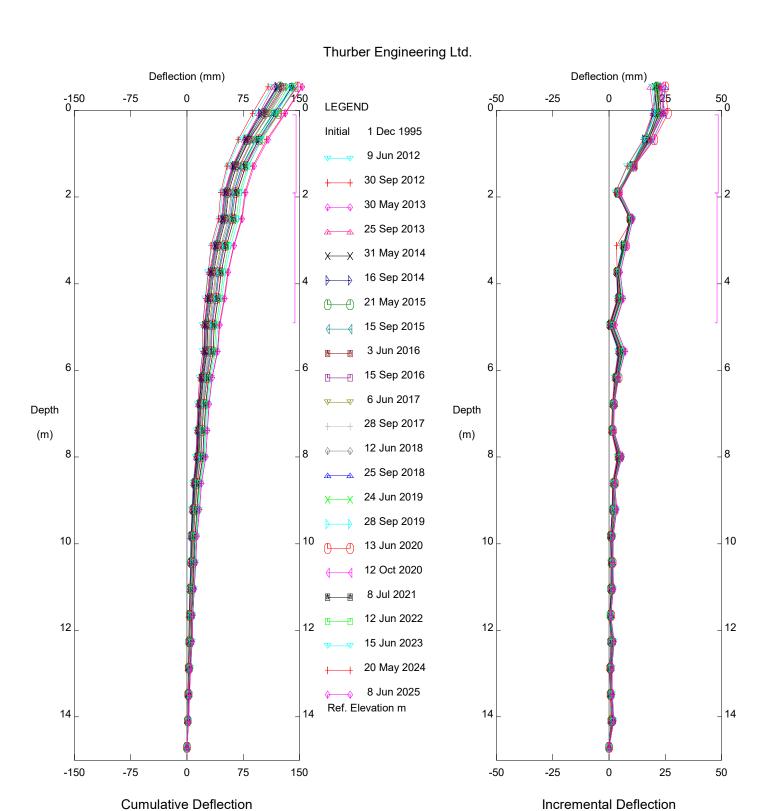
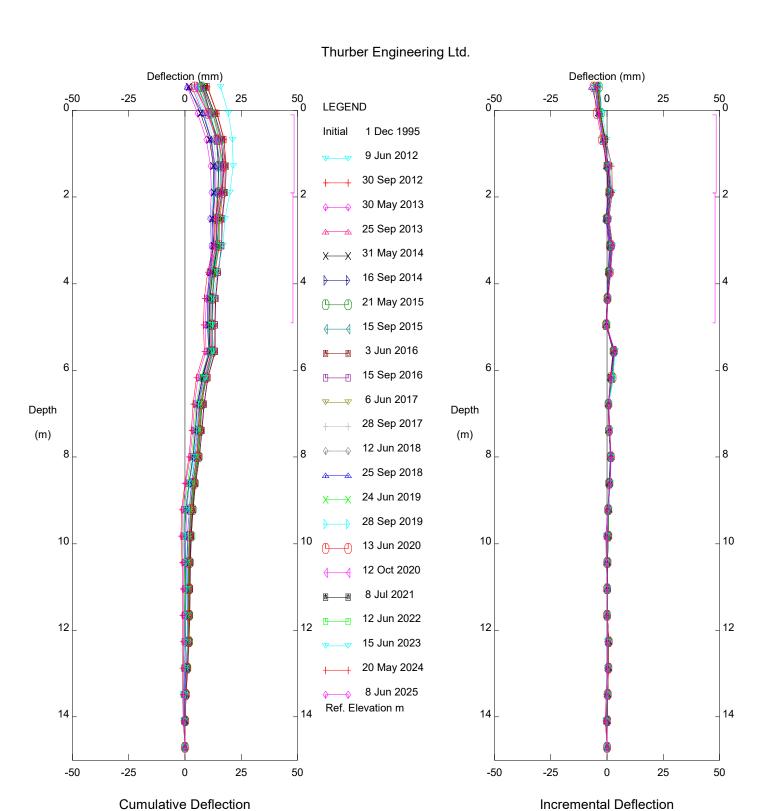
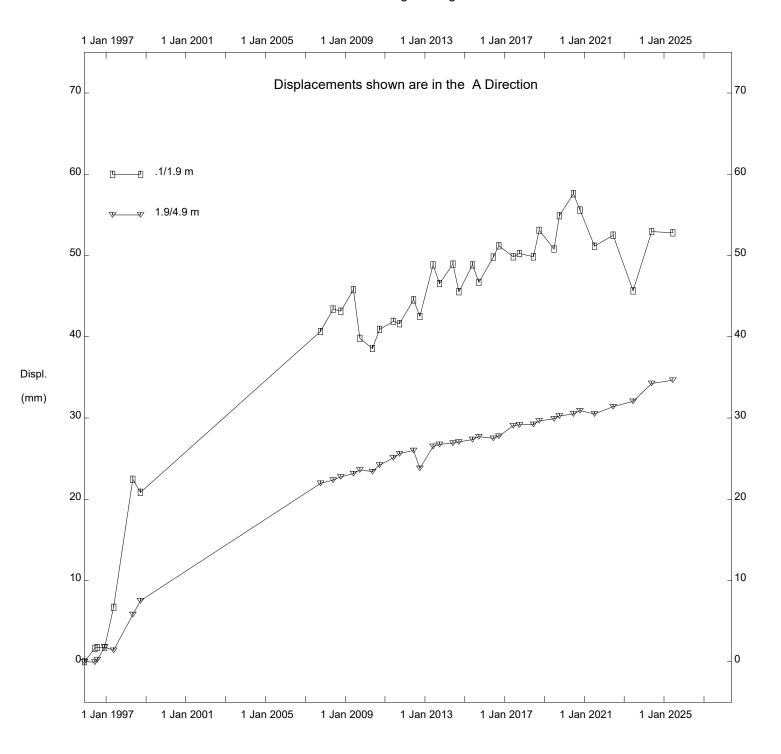
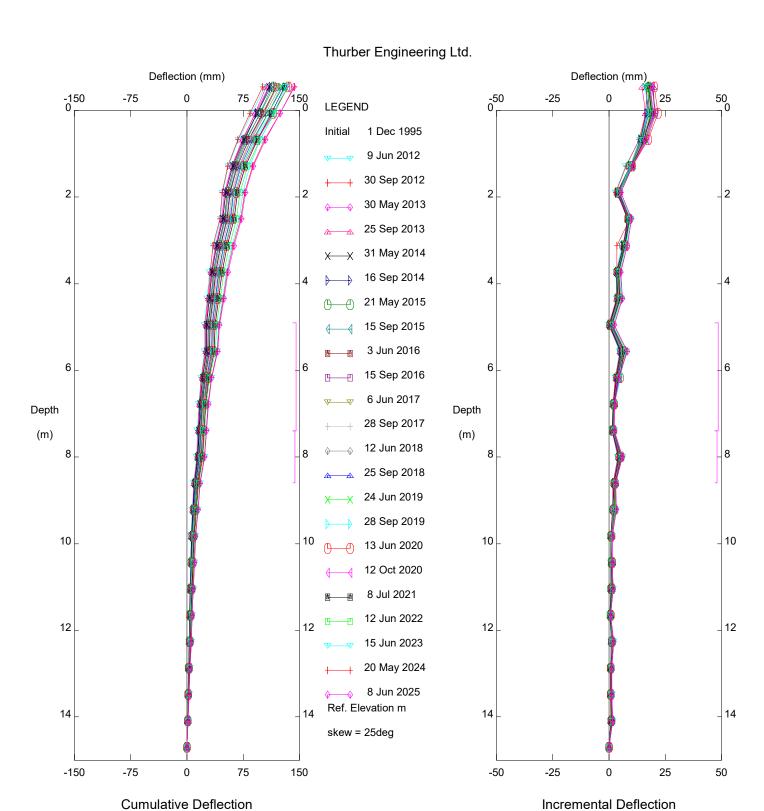
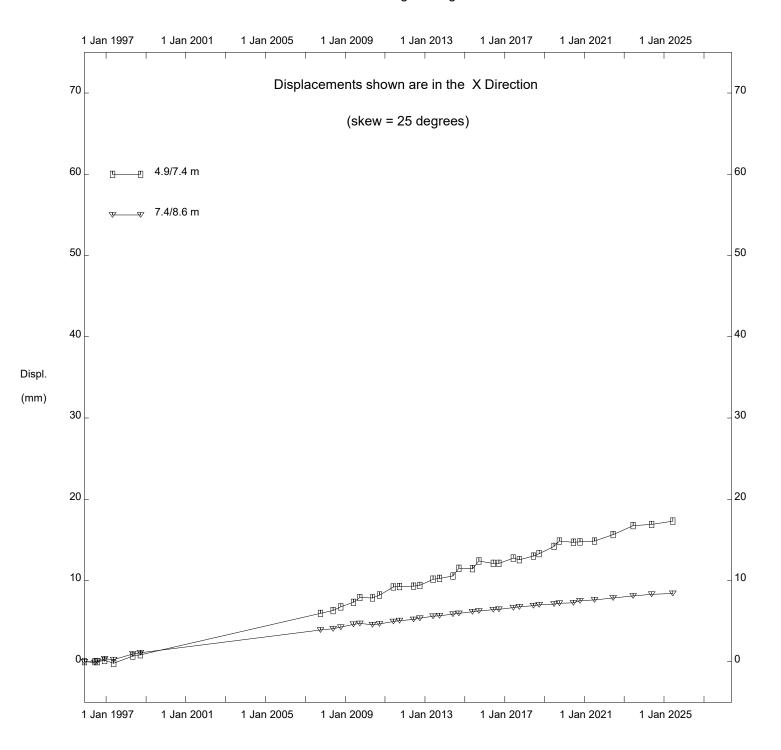
HWY 986:01 - STA. 11+960, Inclinometer SI1

Discussion						
Zones of New Movement:	None						
Interpretation of Monitoring Results:	Slope inclinometer SI-1 has several subtle zones of movement. No discernible movement was recorded over 0.1 m to 1.9 m depth nor over 1.9 m depth to 4.9 m depth, corresponding to decreases in rate of movement of 8.0 mm/yr and 2.0 mm/yr, respectively, since the spring of 2024 readings. SI-1 showed a rate of movement of 0.4 mm/yr over 4.9 m to 7.4 m depth, and a rate of movement of less than 0.1 mm/yr over 7.4 m depth to 8.6 m depth. Since 2007 the long-term movement rate at these the upper three zones is about 0.6 mm/year; the long term rate in the lowest movement zone is about 0.3 mm/year.						
	Slope inclinometer SI-2 showed rates of movement of 0.5 mm/yr and 0.5 mm/yr over 5.6 m to 8.6 m depth and 13.5 m to 14.7 m depth, respectively, since the spring of 2024 readings. The long-term movement rates are 0.9 mm/year and 0.5 mm/year respectively. Both slope indicators show more rapid movements in the upper movement zones relative to the lower movement zones.

34.6 mm over 1.9 m to 4.9 m depth in 11° direction	4.6 mm/yr between May 1997 and May 1998		June 15, 2023	No Discernible Movement	N/A	-2.0
SI-1		17.3 mm over 4.9 m to 7.4 m depth in 47° direction	3.3 mm/yr between May and September 2014	Operational		0.4	0.4	0.2

8.4 mm over 7.4 m to 8.6 m depth in 47° direction	5.1 mm/yr Between October and December 1997			0.1	<0.1	-0.1
61.0	Ans 0 4000	16.5 mm over 5.6 m to 8.6 m depth in 52° direction	2.9 mm/yr in December 1996	Operational	June 12,	0.6	0.5	-0.8
SI-2	Apr. 9, 1996	15.1 mm over 13.5 m to 14.7 m depth in 9° direction	1.8 mm/yr in October 2005	Operational	2022	0.5	0.5	0.3

Future Work:	The instruments should be read again during the spring of 2026 reading program.						
Instrumentation Repairs:	No instrument repairs are required at this time.						
Additional Comments:
